**FORTH REPLACEMENT CROSSING**

**AIR QUALITY MONITORING REPORT**  
**FEBRUARY 2013**

**REP-000-0096-00**

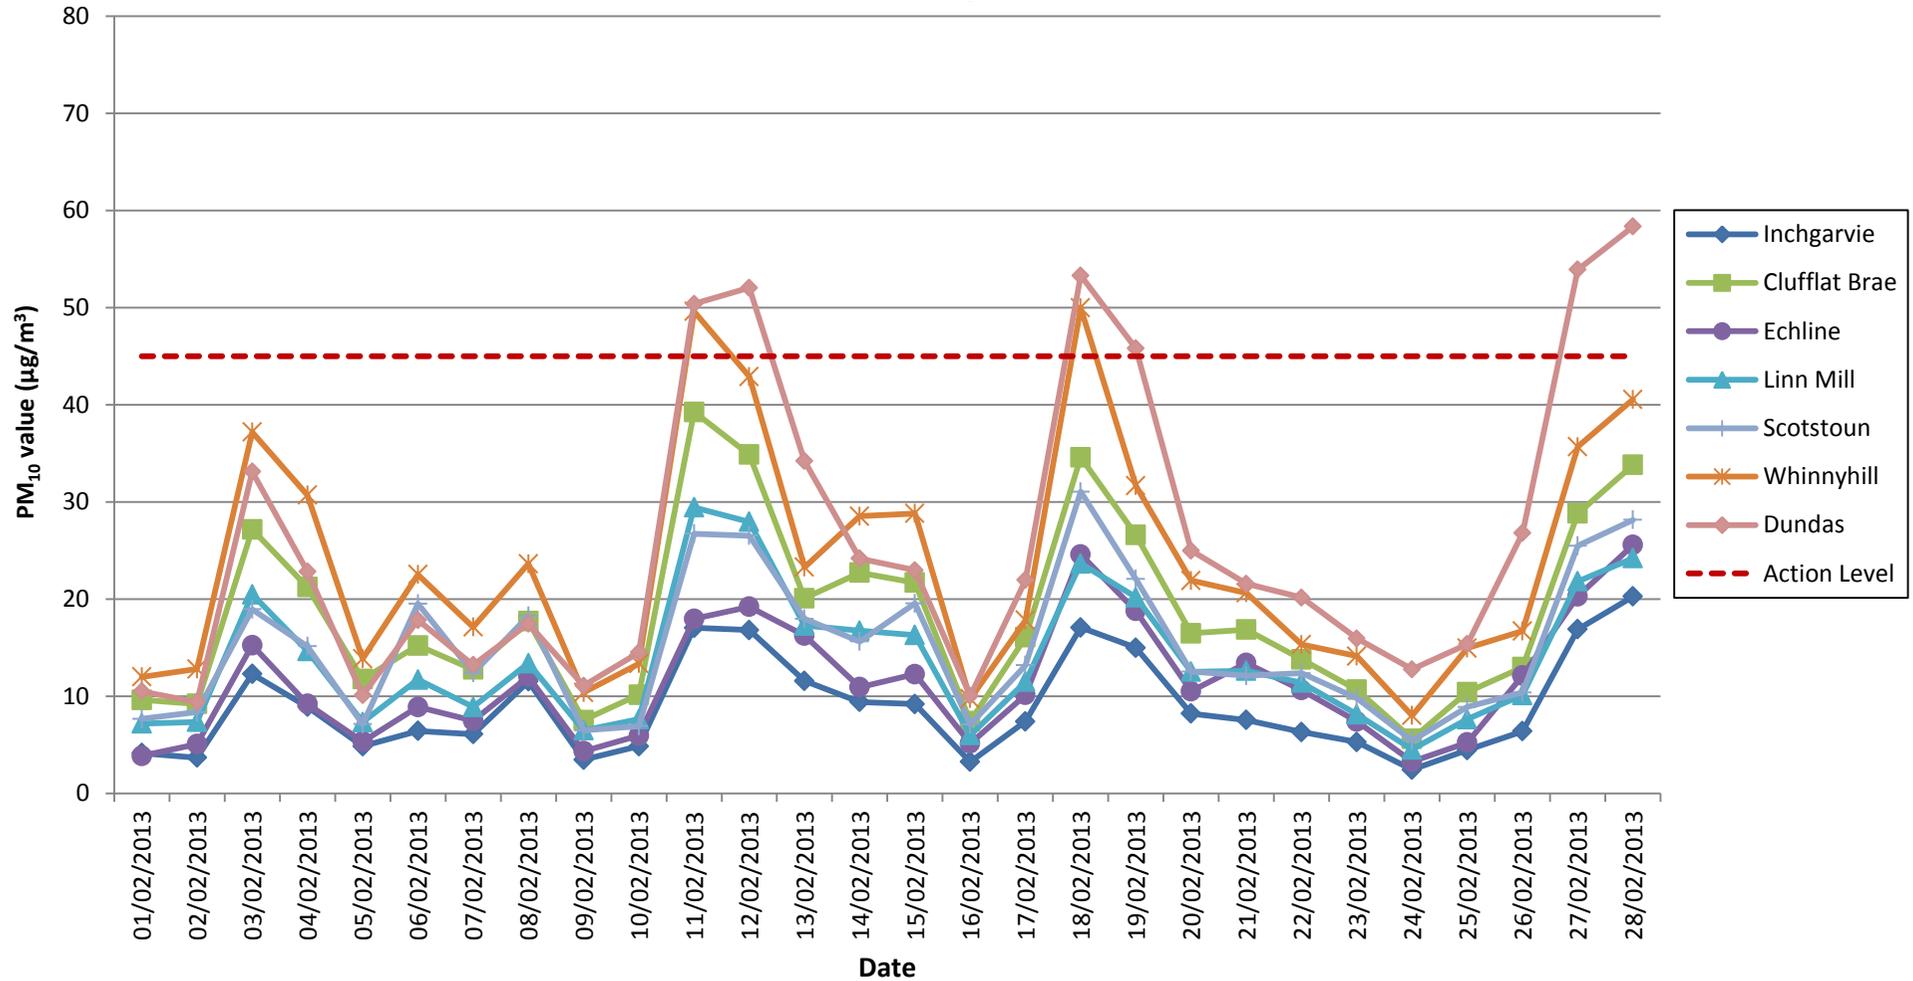
## Air Quality Monitoring Particulate Matter (PM10) Results for all Monitoring Locations February 2013

3.1.1. Light scatter results for February 2013 have been presented in a monthly chart; this can be found in Appendix A. Results show that the PM<sub>10</sub> levels were largely below threshold levels and followed the same pattern across the site. During February there were eight exceedances of the threshold; these occurred at Whinny Hill on 11 and 18 February and at Dundas on 11, 12, 18, 19, 27 and 28 February. However, construction works are not considered to have been the cause of these exceedances. Rather, the exceedances coincide with days on which the weather conditions were such that the light scatter meter readings were affected, as set out in paragraph 2.2; snow, haze and foggy conditions were noted on the dates on which exceedances occurred. Furthermore,

when automatic alerts were received on these dates within site working hours, inspections were undertaken which confirmed no visible signs of dust arising from the site and wet or frozen ground conditions ensured prevention of dust generation from any construction activities.

**Note:** The exceedances of the threshold are not considered to be related to construction works. Please refer to section 3.1 of the Air Quality Monitoring Report: February 2013

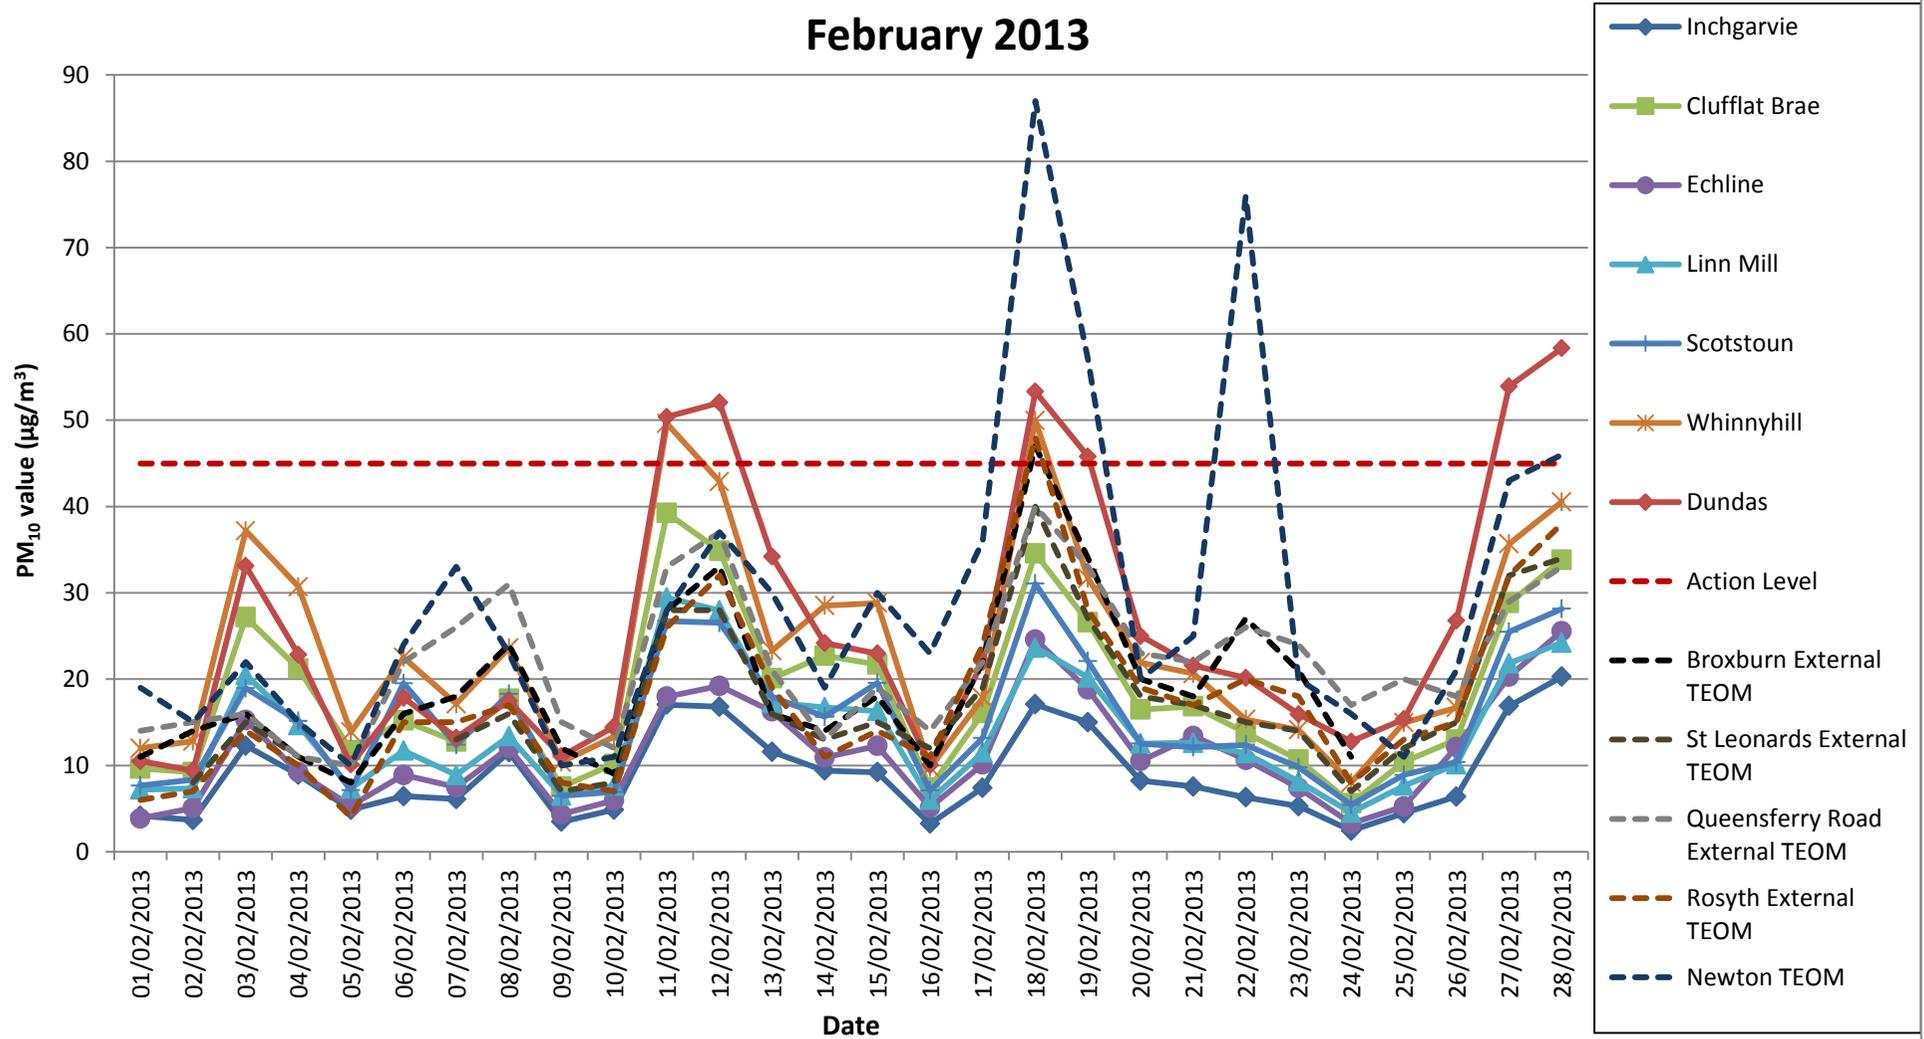
## Particulate Matter (PM<sub>10</sub>) Results for all Monitoring Locations (with TEOM)

- 3.1.2.** The PM<sub>10</sub> results have also been compared to the daily mean results obtained from the TEOM air quality monitoring stations located in Newton, Rosyth, Broxburn, Queensferry Road, Edinburgh and St Leonards, Edinburgh (an urban background site). The TEOM at Newton was installed by West Lothian Council, facilitated by FCBC, during May 2012. The comparison between the light scatter and TEOM results demonstrates that both sets of results generally follow the same pattern at similar levels, indicating that the pattern observed throughout February was largely due to regional changes in air quality. On the dates on which exceedances occurred at the light scatter meters at Dundas and Whinny Hill, increased levels were also noted at all the TEOM monitors, demonstrating further that the light scatter exceedances were caused by regional conditions.

**Note:** The exceedances of the threshold are not considered to be related to construction works. Please refer to section 3.1 of the Air Quality Monitoring Report: February 2013

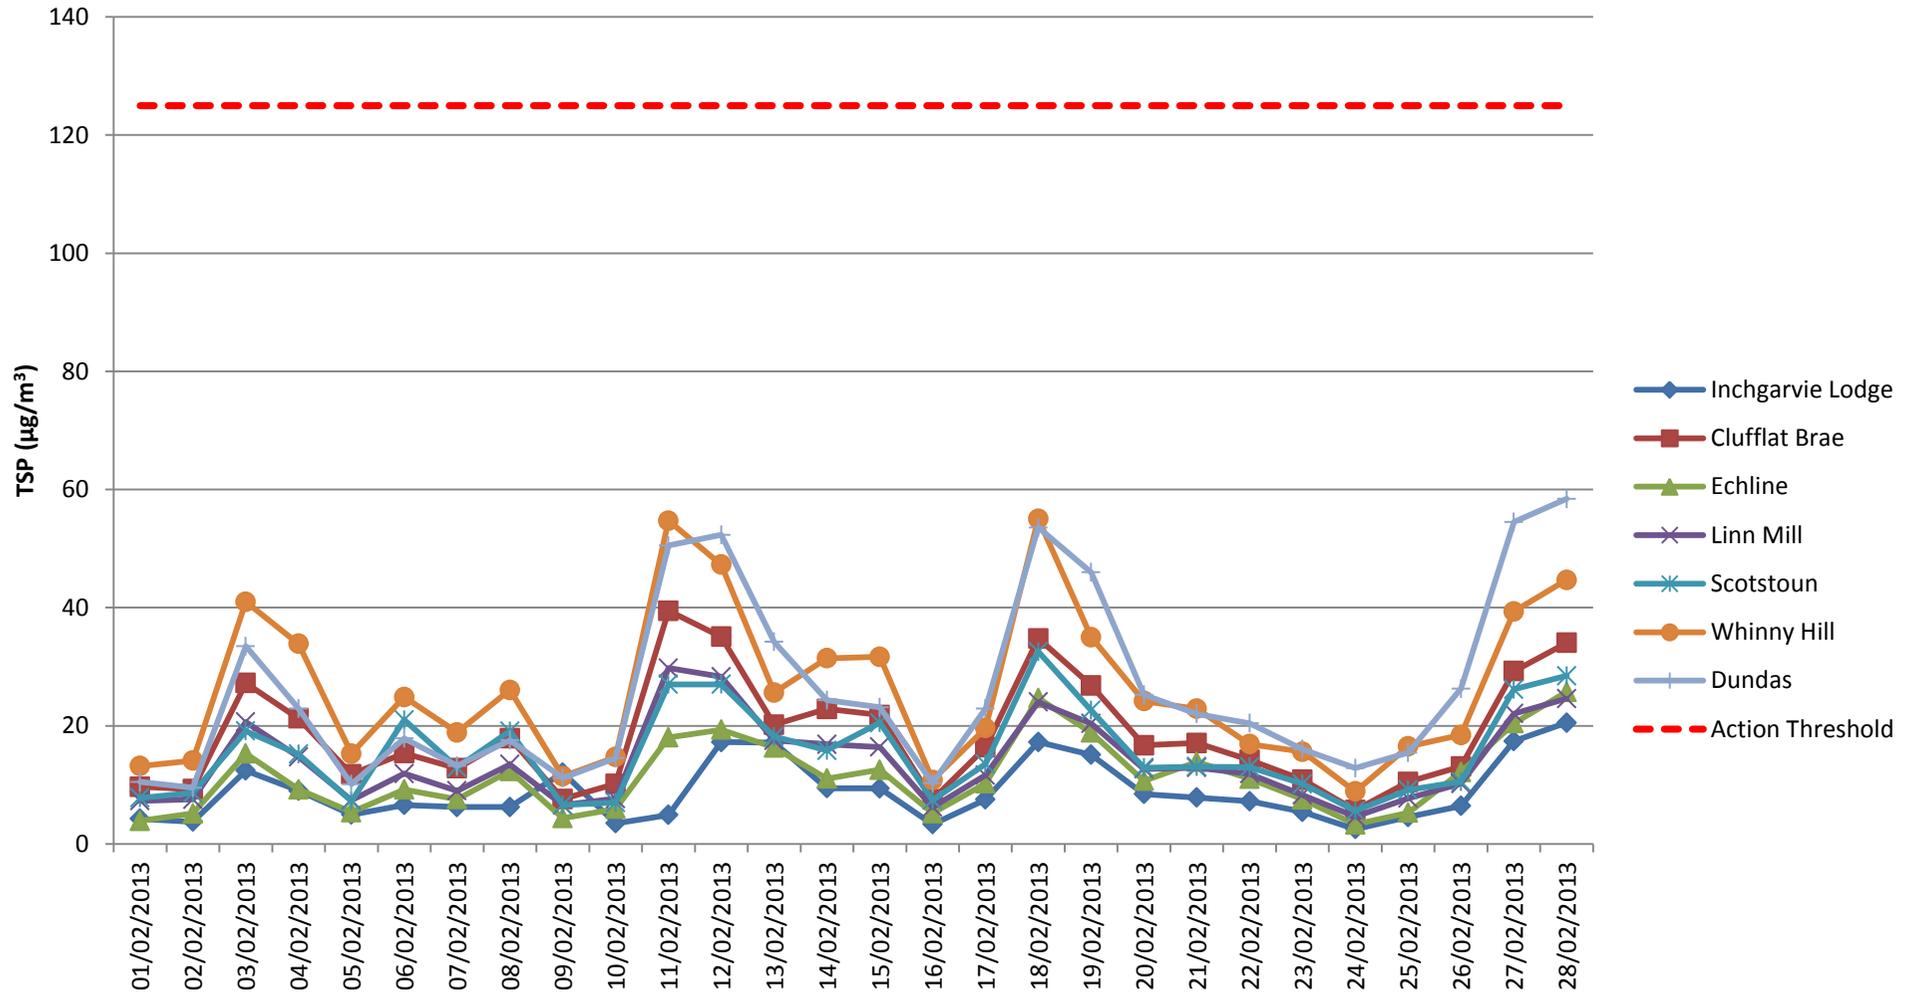
# Total Suspended Particles (TSP) Results February 2013

- 3.2.1.** The TSP results for February 2013 have been presented in a monthly chart; this can be found in Appendix B. The TSP levels at all monitoring locations throughout February were low and within the threshold level. All locations were found to follow a similar pattern across the site, demonstrating that in general the levels are influenced by regional changes in TSP levels, rather than construction works.

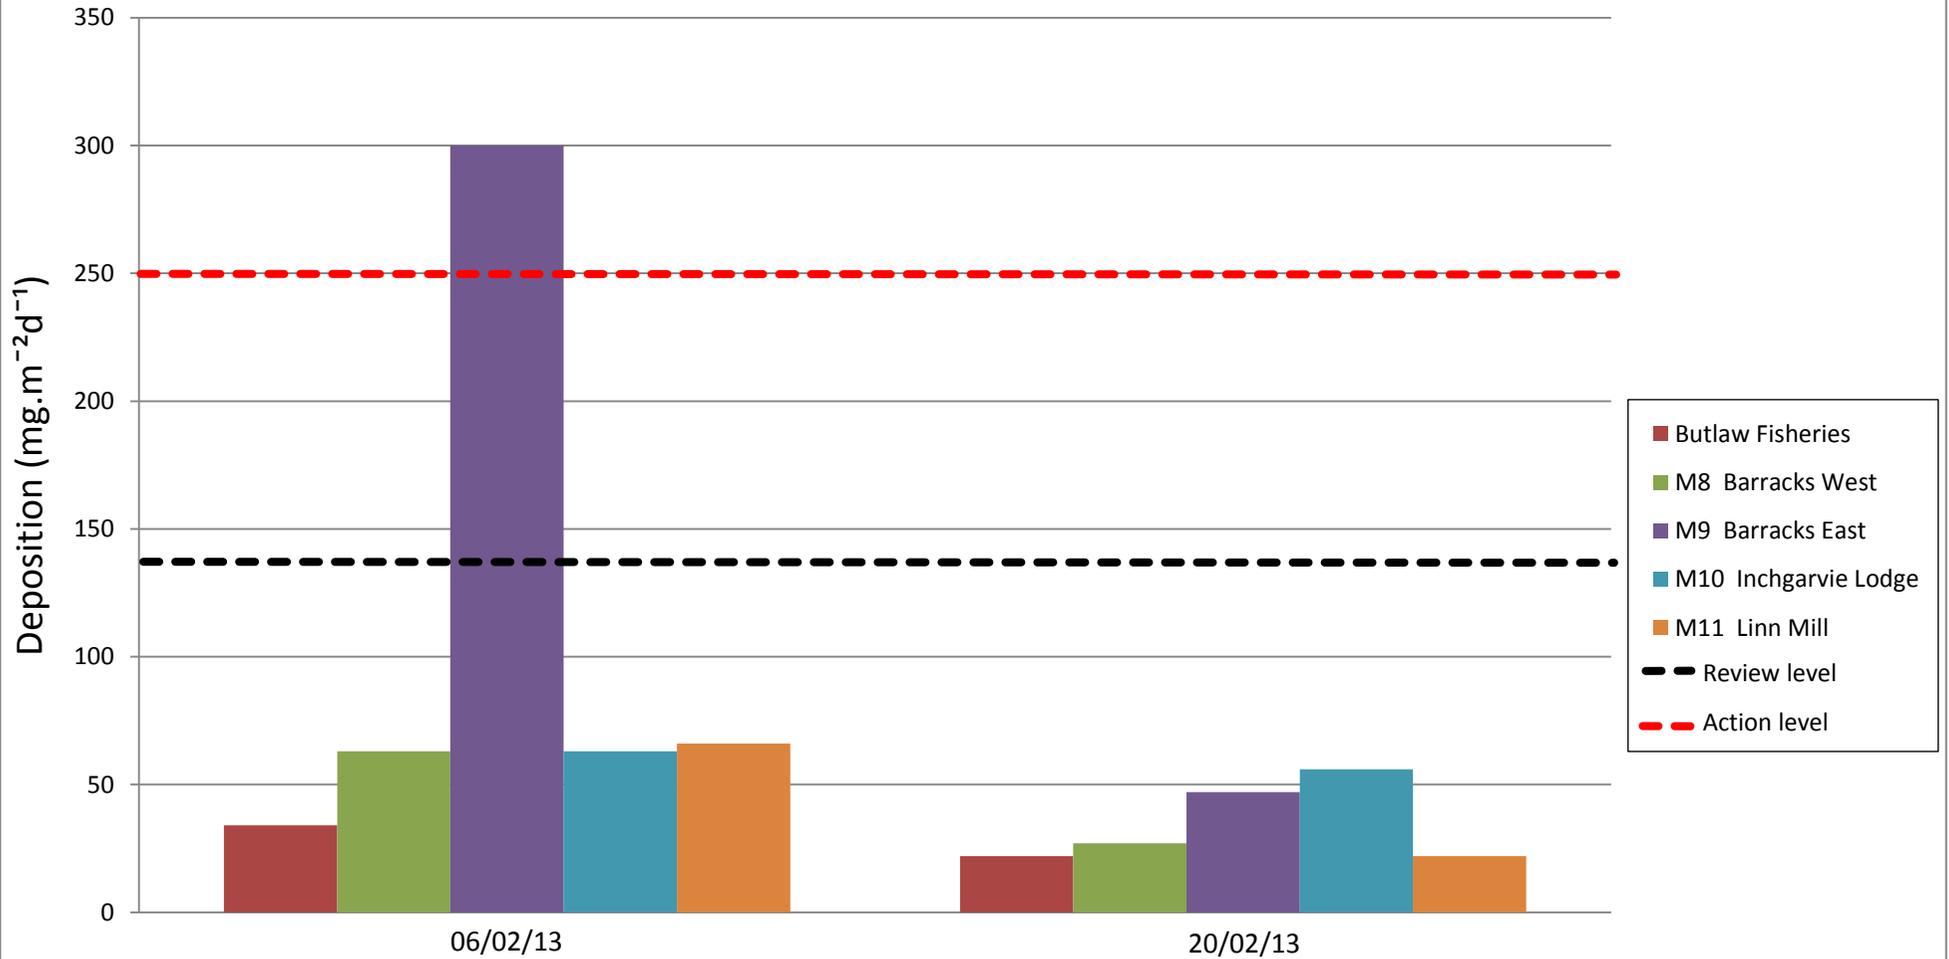
**Frisbee Dust Deposition Results: Group 1**  
**Locations: M7 Butlaw Fisheries, M8 Barracks West, M9 Barracks East, M10 Inchgarvie Lodge and M11 Linn Mill**

**3.3.4.** During February there was a single exceedance of the site action threshold at Barracks (east). This exceedance was investigated by the FCBC Environmental Team and it was attributed to a stockpile of material that was stored immediately adjacent to the Frisbee gauge. In consideration of the results for the other nearby monitoring locations, this exceedance was found to be a very localised incident; notably, the results for Barracks (west), which is located within 100 meters of Barracks (east), were very found to be significantly below both the review and action thresholds. Additionally, investigations found that it is likely that the exceedance occurred at the point at which the stockpile was created; no exceedance occurred for the second fortnight during

February, during which, movement of materials also occurred as the stockpile was moved during this time. The stockpiling of this material was, therefore, following the procedures set out within the FCBC Dust and Air Quality Management Plan, as the stockpile existed for only a short time and was stored away from sensitive receptors; no residential properties are in close proximity to the Barracks (east) monitoring location.

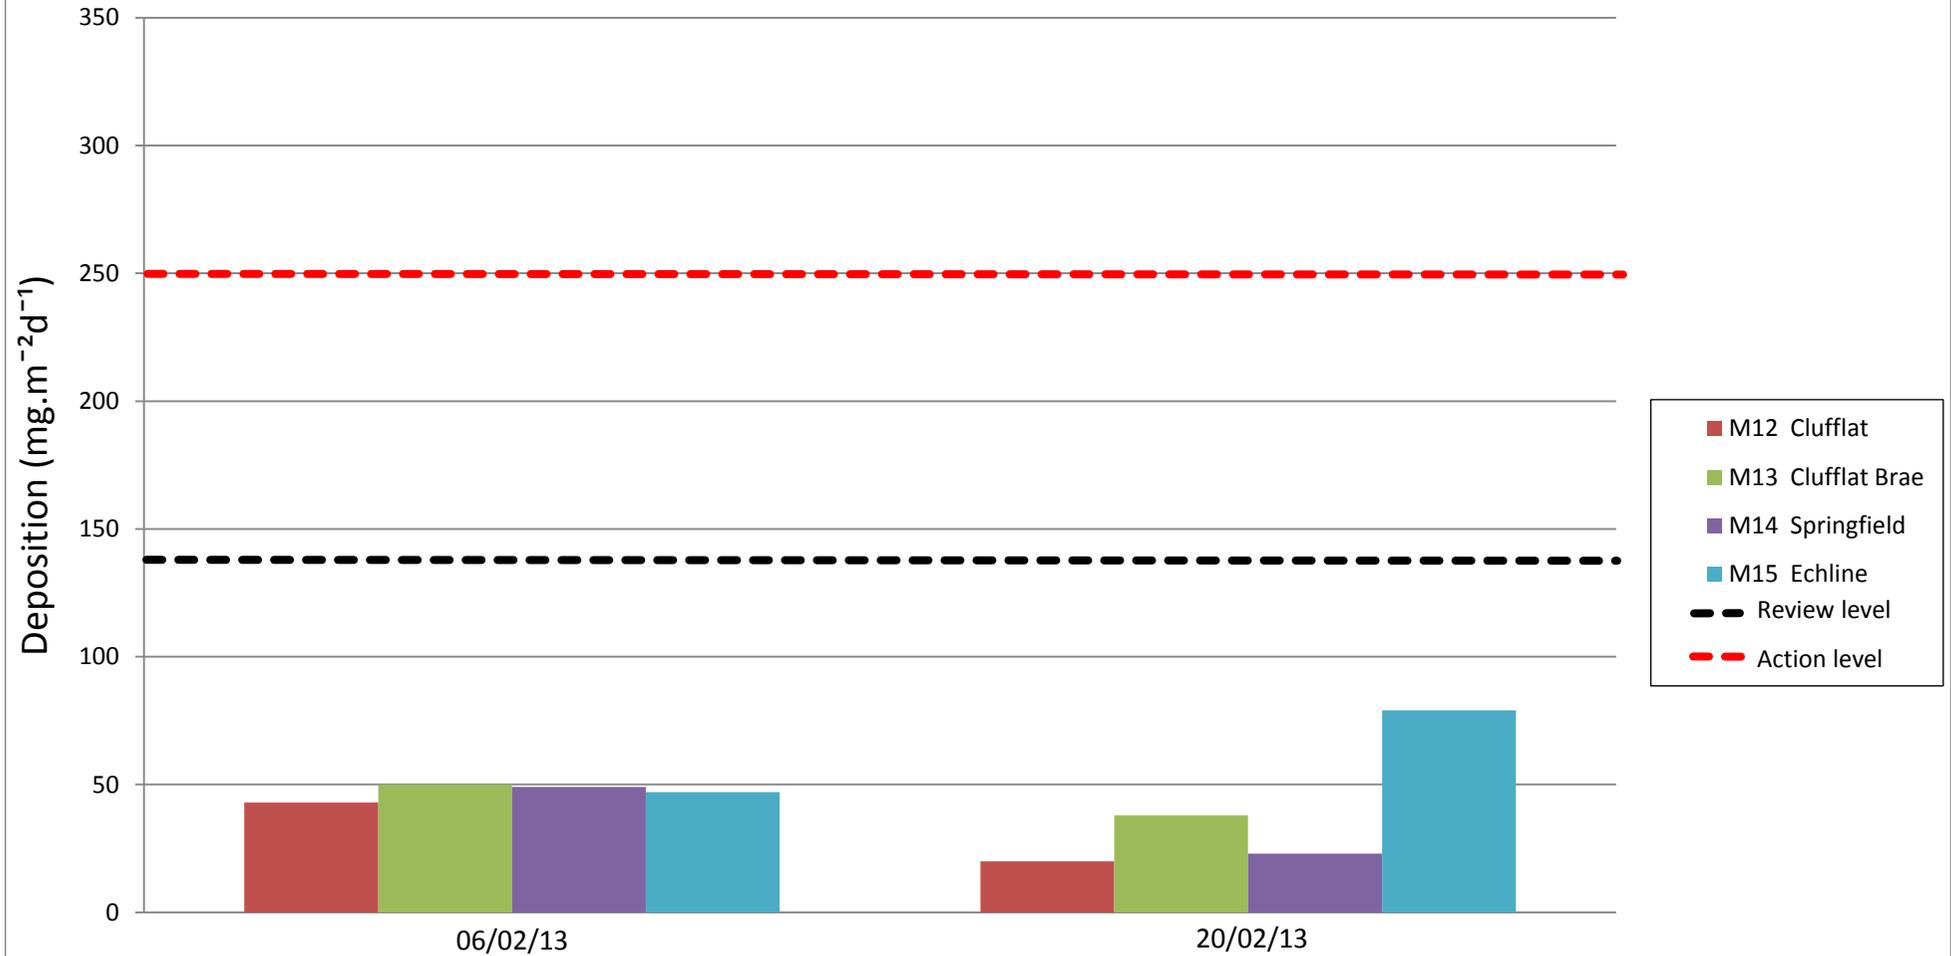
# Frisbee Dust Deposition Results: Group 2

- 3.3.5.** Frisbee results from all monitoring locations across site were found to be low.

## Locations: M12 Clufflat, M13 Clufflat Brae, M14 Springfield and M15 Echline

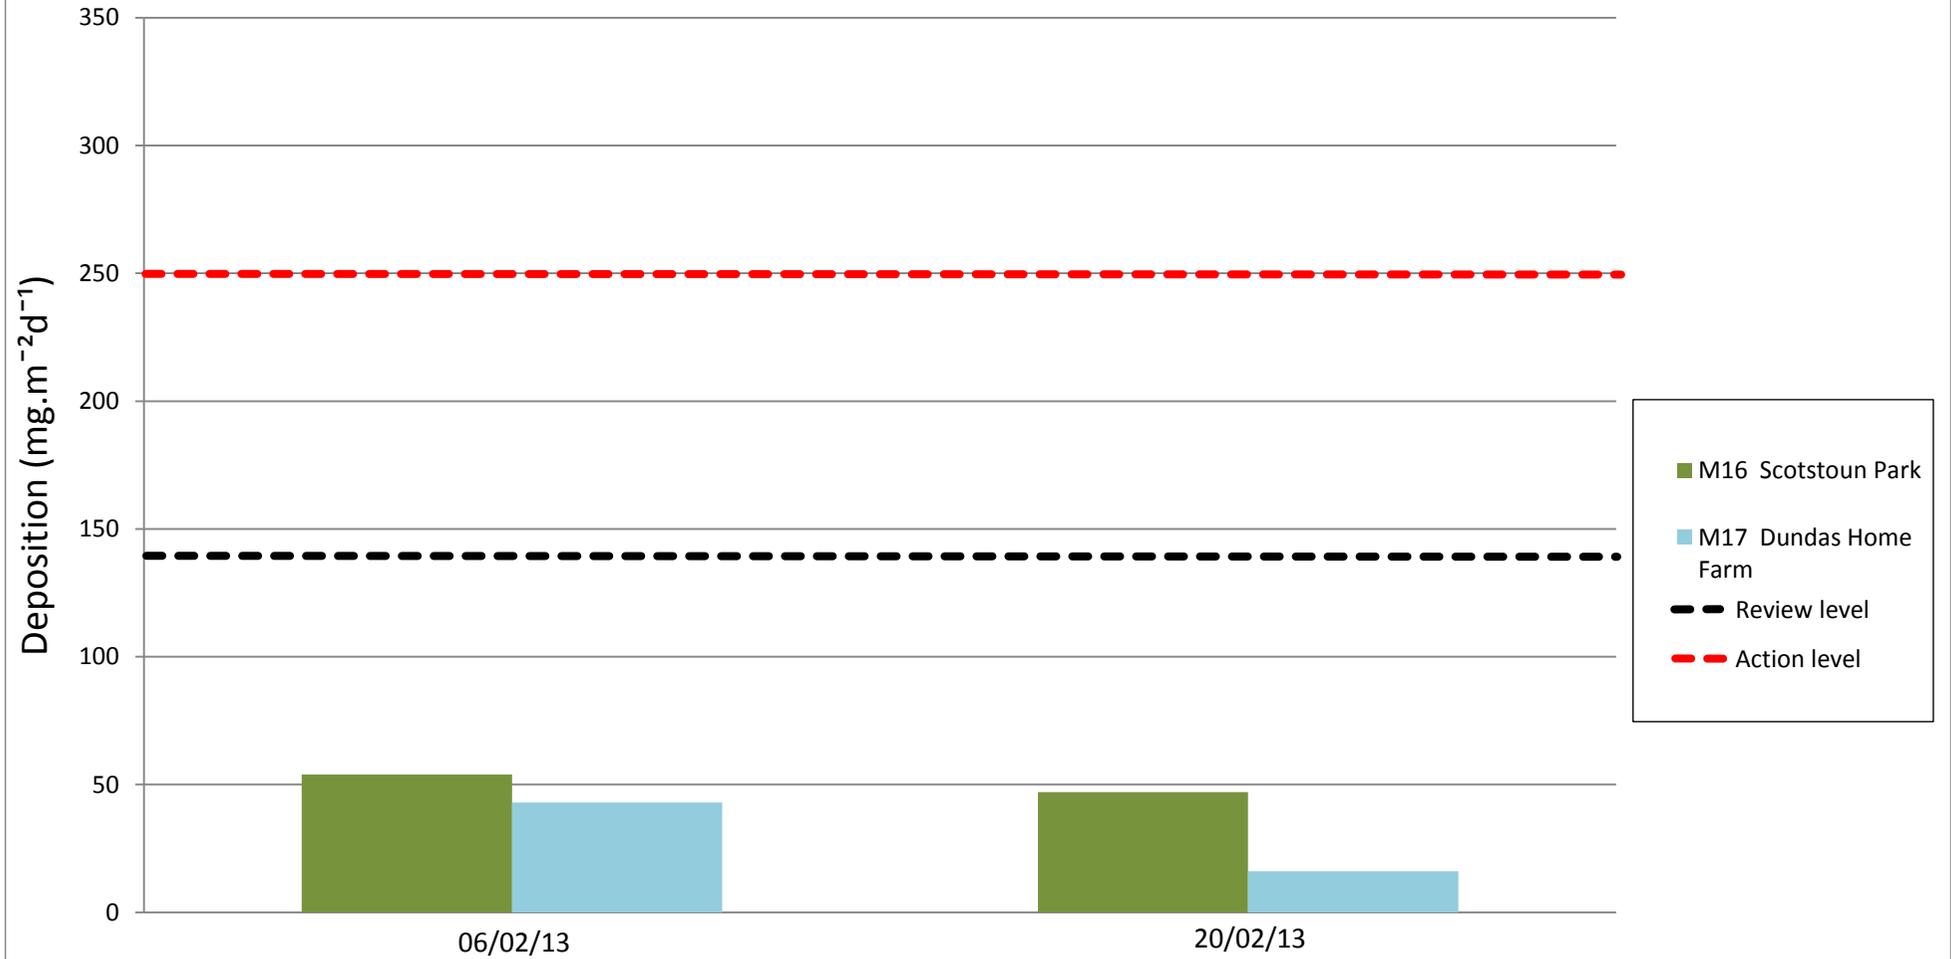
### Frisbee Dust Deposition Results: Group 3

#### Locations: M16 Scotstoun Park and M17 Dundas Home Farm

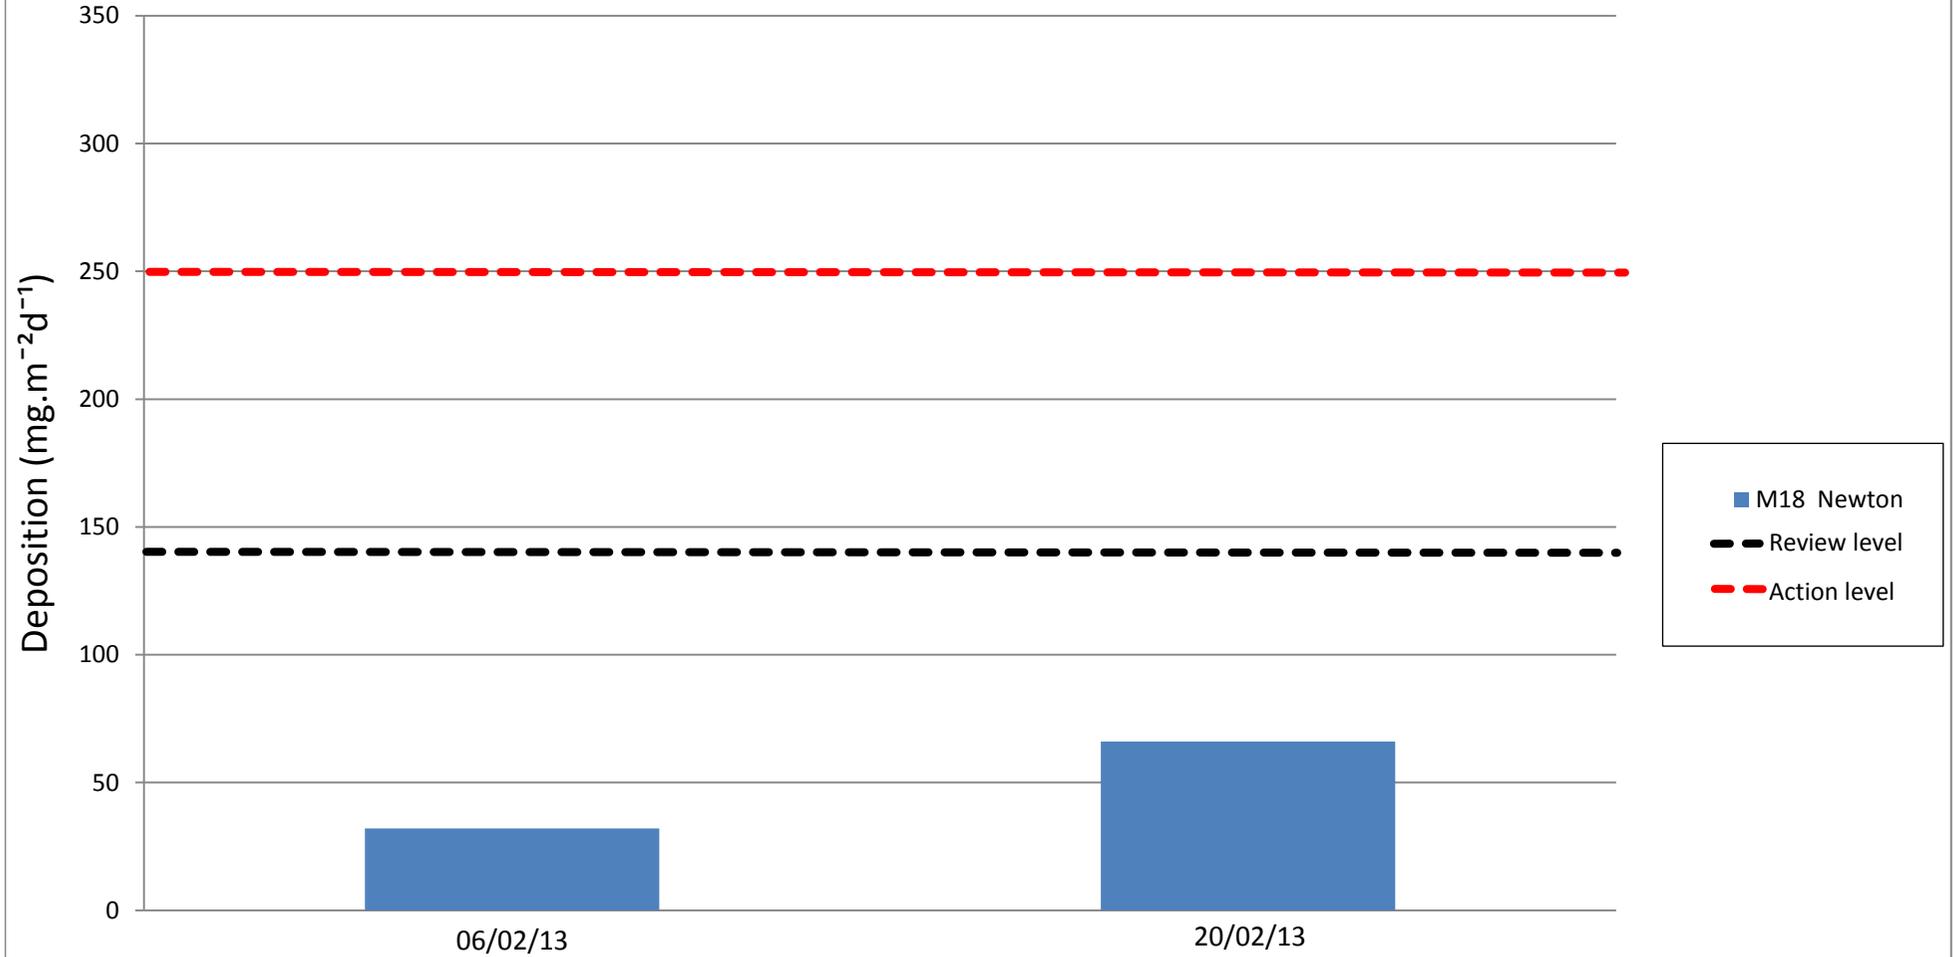
# Frisbee Dust Deposition Results: Group 4

## Locations: M18 Newton

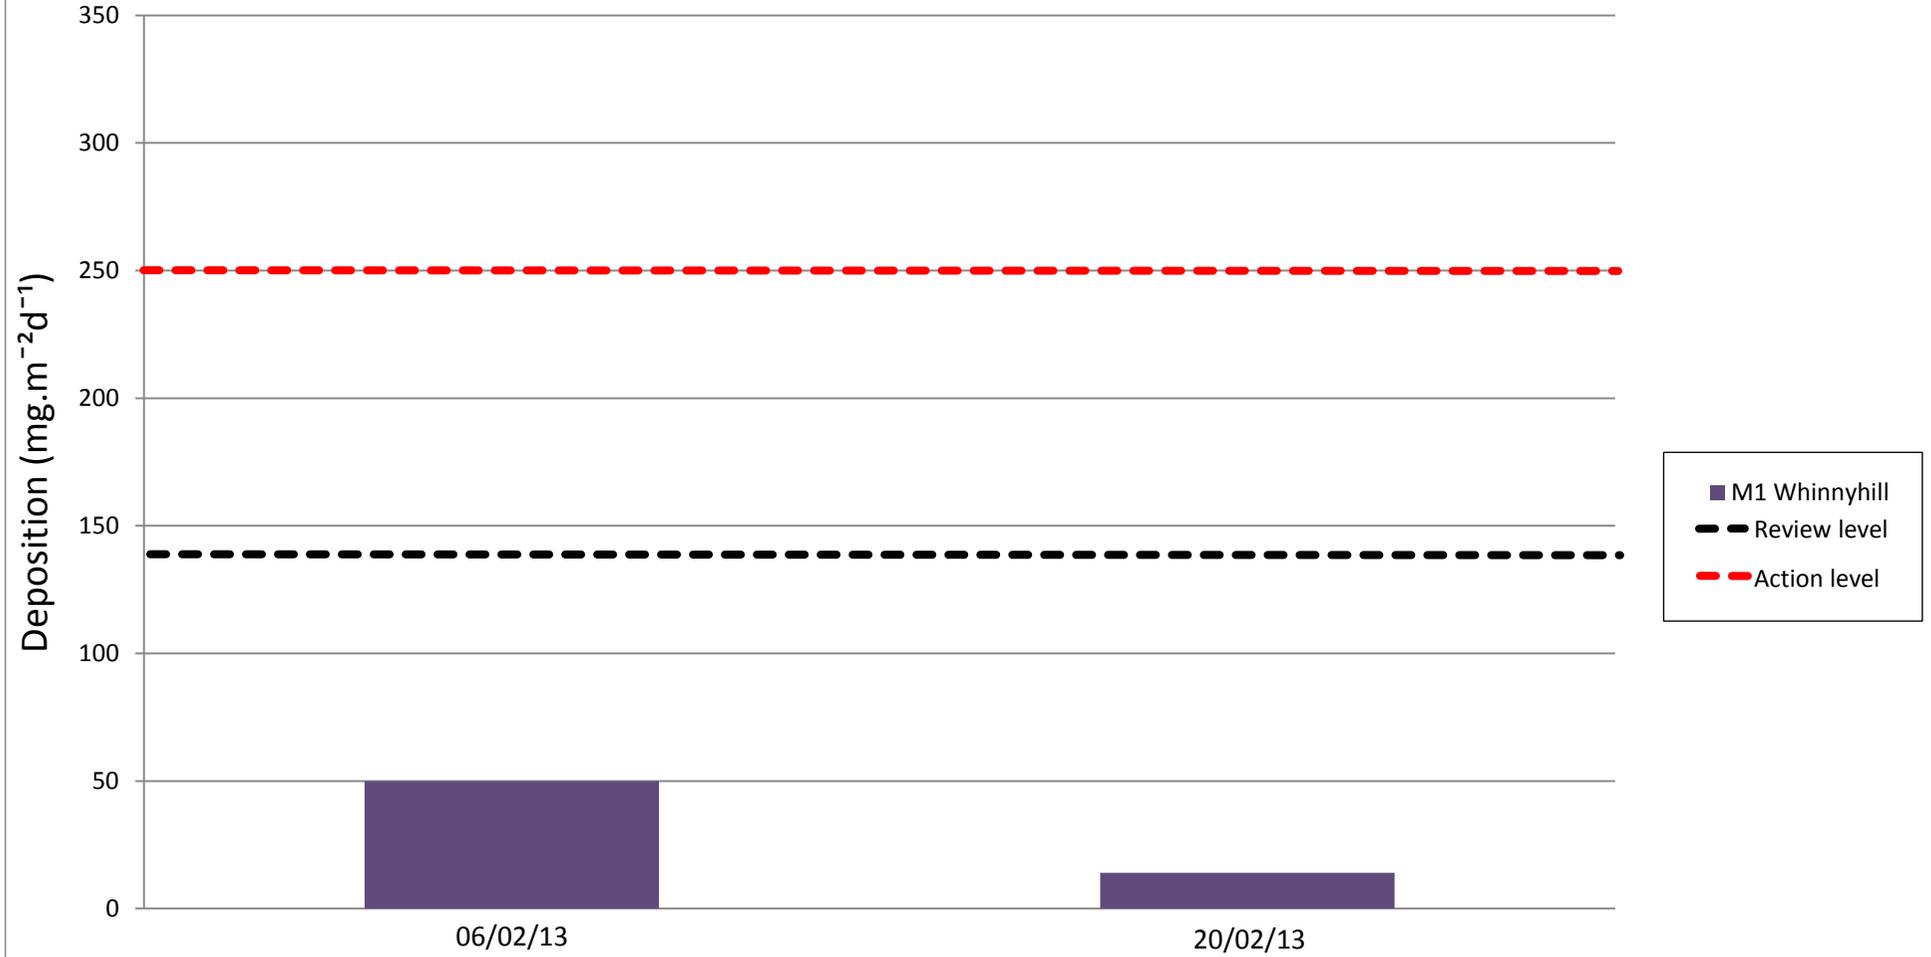
# Frisbee Dust Deposition Results: Group 5

## Locations: M1 Whinny Hill
