Scottish Trunk Road Infrastructure Project Evaluation - Appendix B
Evaluation Data

C ENVIRONMENT

The environmental mitigation measures originally proposed for M80 Stepps to Haggs were obtained from the project’s ES. A review of these was carried out in February 2014. Following this review, a site visit was undertaken to establish whether or not the proposed mitigation measures as set out in the Schedule of Commitments within the ES had been implemented.

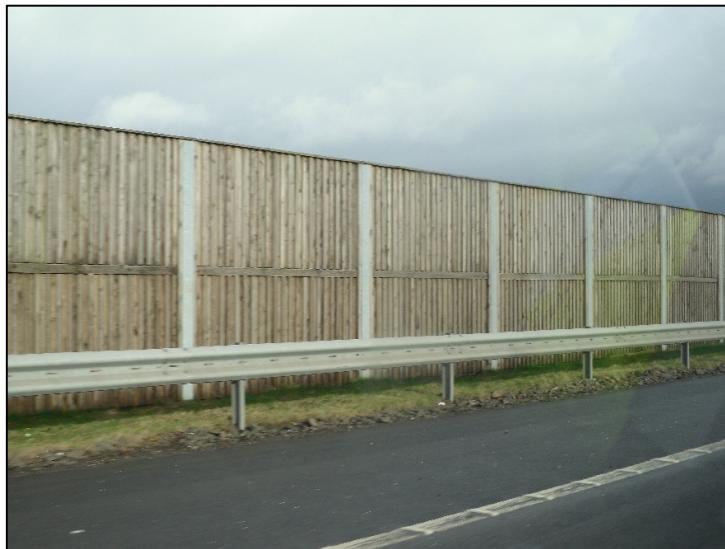
Figure 1 – Noise barrier along carriageway

Mitigation identified for the scheme included acoustic screening and use of low noise surfacing. Noise bunds and noise barriers were in place throughout the length of the scheme at various locations. Planting at these locations was also included which should provide additional visual screening over time.

Low noise surfacing was to be utilised during construction. No noise measurements were undertaken as part of the 1YA evaluation, but there was a notable difference observed in noise levels when travelling the route between the new surface of this scheme and the existing M80 surface.

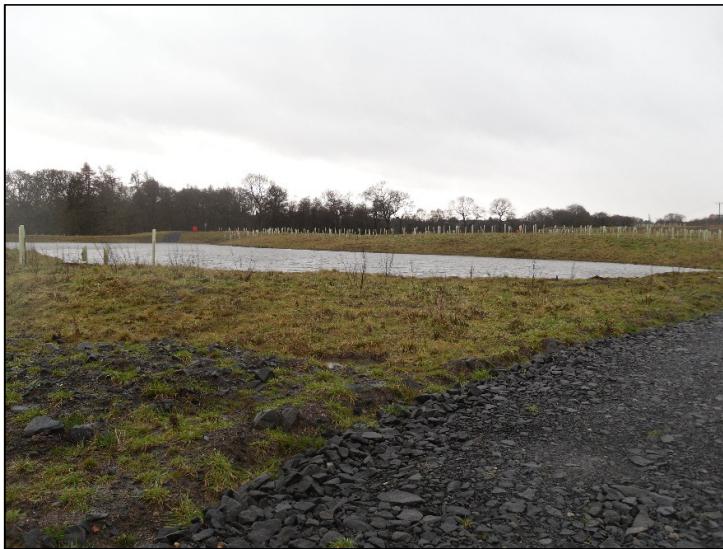
Figure 2 – Retention pond

The drainage system for the scheme was designed to treat all road drainage before reaching watercourses to ensure any discharge, including any pollution resulting from a serious accidental spillage, is at an acceptable level. This system includes primary treatment via filter drains along the length of the road verge and secondary treatment via retention ponds.

Both of these measures were found to be in place across the length of the scheme. The ES originally stated there would be 11 retention ponds, though this review concluded the SUDS constructed actually included more than 11 individual ponds. For example, at Castlecary, where the ES indicated only one, there was a small pond closest to the carriageway and five other larger ponds, which were connected via gabion channels, sited further back.

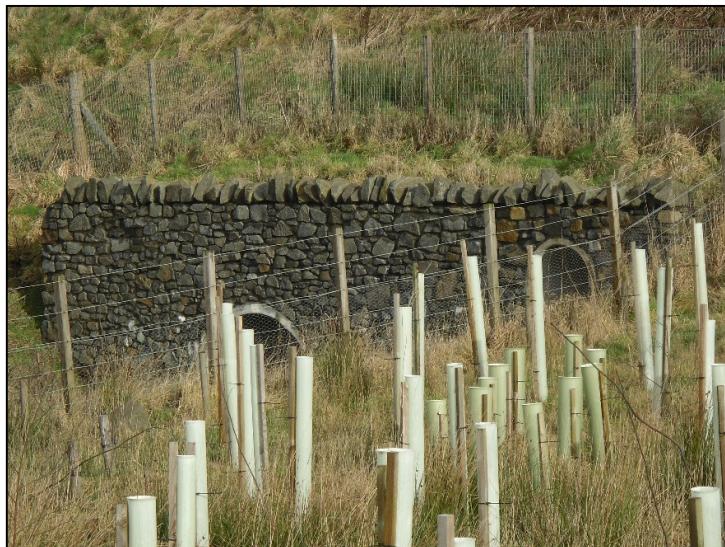
Figure 4 – Mammal tunnel at culvert

Provision of otter flood level ledges and otter fencing was also identified in the ES. During the site visit, a mammal tunnel was located on the north side of the carriageway at Bothlin Burn's culvert, set at a higher level than the culvert (Figure 4). An otter ledge was attached to both abutments of the wide culvert near Dalshannon at Luggie water where most otter activity had been observed (Figure 5).

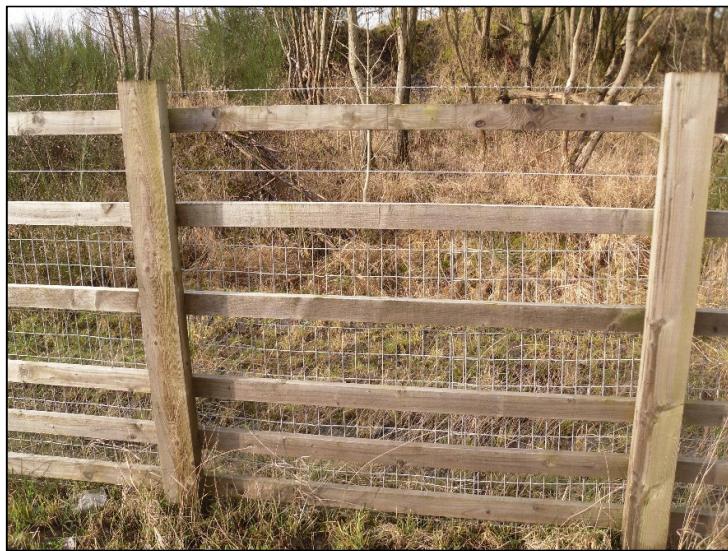
Figure 6 – Otter fencing

Otter fencing has been erected at various locations along the eastbound and westbound carriageways. The fencing was in good condition and had been dug in below ground level. However, the fencing intended to guide otters towards the otter ledge at Dalshannon appeared to stretch not as far as expected to the west of the culvert, in comparison with the eastern side and other parts of the scheme. This is where the otter fence met another metal fence surrounding two utility buildings and it was apparent that otters would be able to cross through at this point and under the more open metal fence and have access to the roadside verge in an area of known otter activity. Action is recommended to investigate the suitability of the fencing at the utility buildings near Dalshannon to ensure the

effectiveness of the implemented mitigation in directing otters to the otter ledge. It is recommended that the suitability of fence designs in this area are reviewed and the road kill / wildlife-related RTA data are assessed during the 3YA evaluation.

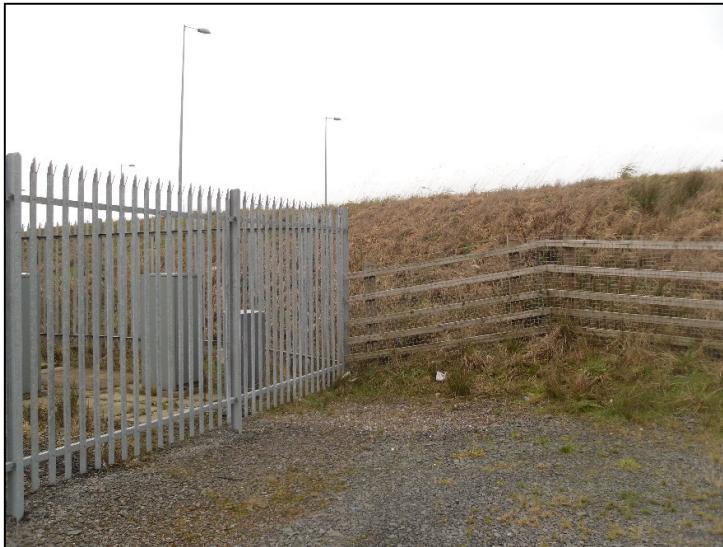
Figure 7 – Location of the end of the otter fencing and more open fence around the utility buildings near Dalshannon.

- **Biodiversity & Habitats:** review of the provision for otters at the utility buildings near Dalshannon, through investigating the fencing design used and road kill /wildlife-related RTA data during the 3YA evaluation.
- **Landscape & Visual Amenity:** continue to monitor the establishment of planting.

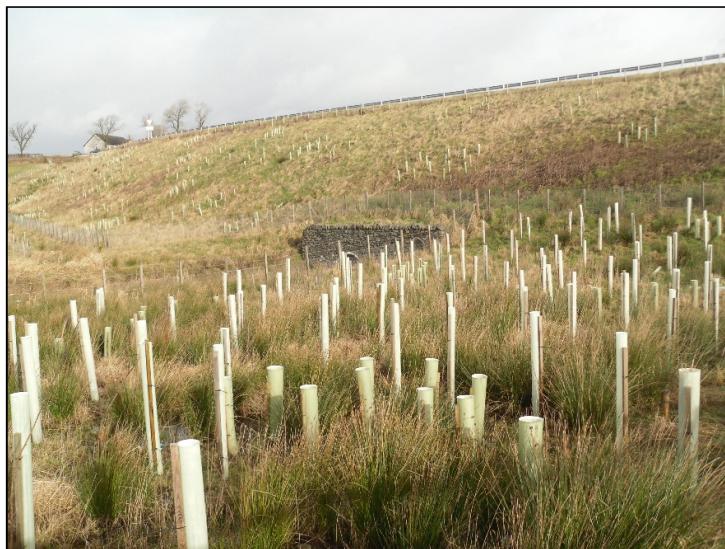
Figure 8 – Tree planting

Hedgerow planting was also not as evident as had been indicated in the ES at one location (Mollinsburn Junction), where a field boundary hedge (commitment LV2) was unable to be replaced due to the structural foundations of the piled embankment. A significant level of tree planting was carried out across the length of the scheme, mainly as small clumps of trees. Information from the contractor has advised that a shortfall in tree planting was addressed under Excluded Seasonal works in the 2012/2013 planting season. This will be evaluated again at the 3YA evaluation.

As detailed in previous sections, retention ponds, noise barriers and noise bunds have also been incorporated into the scheme. Where appropriate, land has been returned to agriculture. The landscaping Establishment Period is five years following completion of the construction stage and Transport Scotland's Managing Agents continually review and monitoring landscaping works. As such, it is expected that over time the features will weather, vegetation will grow and the scheme will assimilate better into the surrounding landscape and issues relating to the success of the establishment of the planting will be addressed (e.g. replace failed trees) to ensure the visual screening and habitat connectivity is implemented as proposed.

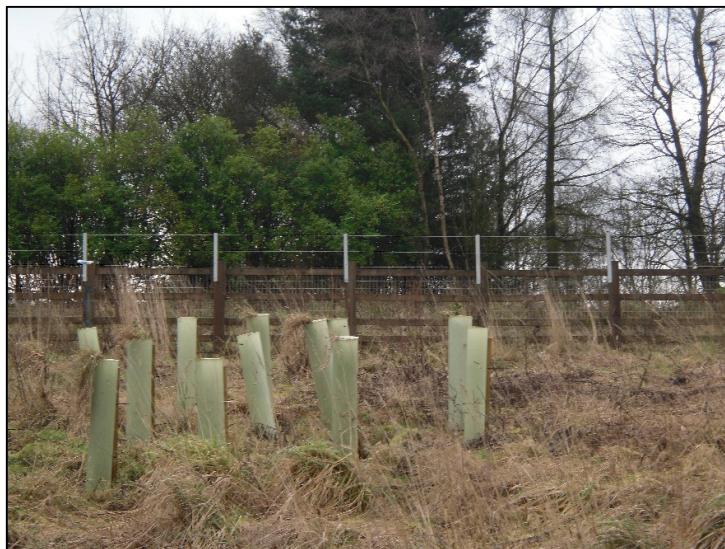
Figure 9 – Trees planted in small ‘clumps’

A number of trees (whips) were also observed to have been blown over and may require replanting, and were not well established in a marshy area near Bothlin Burn. Jacobs have commented that it was recognised that establishment of hedgerows has not been successful in many of the locations across the site due to the failure of plants and issues with predation of the plants by deer that have been accessing the road corridor. The poor establishment has been noted and raised with the Contractor to be addressed during the Establishment Period.
