## **A14.1: Cultural Heritage Desk-Based Survey**

- 1.1 This report presents the results of a cultural heritage desk-based survey undertaken to inform the Chapter 14 (Cultural Heritage) of the A96 Dualling Inverness to Nairn (including Nairn Bypass) Design Manual for Roads and Bridges (DMRB) Stage 3 Environmental Impact Assessment (EIA).

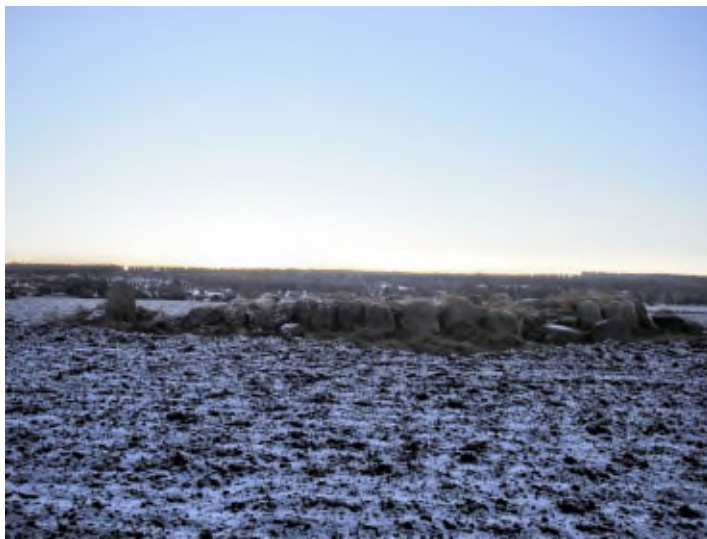
**Photo 1: Isle View Ring Cairn (Asset 85) from the North**

<b>Site Number</b>	85	<b>Site Name</b>	Isle View Ring Cairn
<b>Legal Status</b>	Scheduled Monument	<b>NGR</b>	NH7250047690
<b>Value</b>	High	<b>Condition</b>	Fair
<b>Site Type</b>	Ring Cairn	<b>Period</b>	Neolithic
<b>NMR ref</b>	SM5021	<b>HER ref</b>	14229MHG2948
<b>Description</b>			
<p>An oval cairn measuring 13.4m NE-SW by 11.2m transversely, which is bounded by a kerb of boulders on the north and west. On the north east, two stones, one standing, one fallen are probably all that survive of a stone circle. Between these two stones and the cairn is a stony platform edged with boulders on its north side. The area to be scheduled includes the structures described above and measures 40m in diameter as marked in red on the attached map. The site is of national importance because it is a well preserved example of a type of burial cairn found only in this area; it is of particular interest because of its unusual plan. It has the potential to enhance considerably our understanding of prehistoric burial and ceremonial practices. Additionally, the surface on which the cairn is built will preserve features and other information which will increase our knowledge of prehistoric land use and environment [1]. The cairn, oval in shape, measured 13.4m NE - SW by 11.2m NW-SE. Visited by OS (EGC) 25 April 1962. An air photograph, taken by Jill Harden in 1989, is in Inverness Museum (8901.33 INVMG) [2]. This structure has been greatly disturbed and robbed. However, part of a typical peristalith remains, fairly complete on the north and NW sides. It is built of boulders of considerable size set close together and ranging from 2ft 3ins to 2ft 9ins in height. Only one stone seems to be in place on the south side and two on the SE. Various other stones have fallen forwards from their original positions. The cairn seems to have been oval in plan, about 34ft N-S by 40ft E - W. There are a great number of boulders lying about the site, some split by blasting, and it is not easy to distinguish the stones that are in situ and those which have been moved, perhaps for the foundation of a building which once stood here. A certain amount of turf-covered cairn material remains inside the kerb and round the base of the monolith. A single stone 4ft 6ins high stands about 13ft outside the position of the kerb on the NE side, and another slab lies to the east of the cairn. These stones are probably survivors of</p>

the circle of monoliths. The standing stone has been joined to the kerb by a line of boulders, the foundation of a secondary wall. Close to the site on the NE, Anderson (1831) records another cairn, thought not to have been opened. It was bounded by a kerb "15 paces" in diameter, and said to have been surrounded by a ditch, but apparently without a monolithic circle. No signs of this monument remain [3]. During the walkover survey this asset was found to be as described. This asset is located on slightly raised ground in a gently rolling landscape approximately 30m south of the existing A96. There are good all round views although the existing A96 dominates views to the north and the modern developments of Culloden and Balloch are conspicuous in views to the south. Views to the south are further constrained by rising topography. This asset is intervisible with Assets 74, 75, 86, 87 and 96-98 with which it may have had a relationship [4].

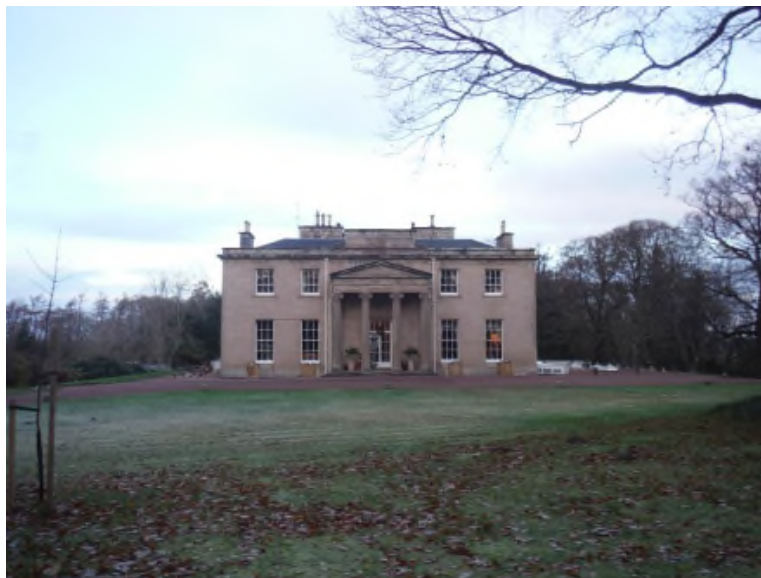
**Photo 2: Boath House Category A Listed Building South-east Facing Principal Elevation**

- 15.3 Boath House (Asset 328; Category A Listed Building) was constructed in the 1830s by Naval Officer, Captain Sir James A. Dunbar. The Regency period property was built over the site of a 16th century manor house, and former family seat. The house adheres to classical architectural principles and comprises a five-bay two-storey ashlar façade with central portico entrance supported by fluted Ionic columns. The property is set within established gardens, with aviary, bowling green and walled garden, and an extensive woodland beyond. Boath House is one of a number of gentry houses constructed in the first half of the 19th century in response to wider societal changes and evolving expectations of the gentry elite (Girouard 1979, 13). The classical design of many of these properties, argues Girouard (1979, 15), reflects the Regency Man's desire to use architectural taste as a reflection of Christian and moral convictions. The construction of these properties was also timed to symbolically enforce the notion that gentry ownership was part of contemporary social structure (Dalglish and Tarlow 2012, 14). In consideration of the legibility of the architectural design of the property, its historical significance as an example of a remodelled 19th century gentry estate, and reflecting its designation as a Category A Listed Building; Asset 328 has been assessed to be of high value.

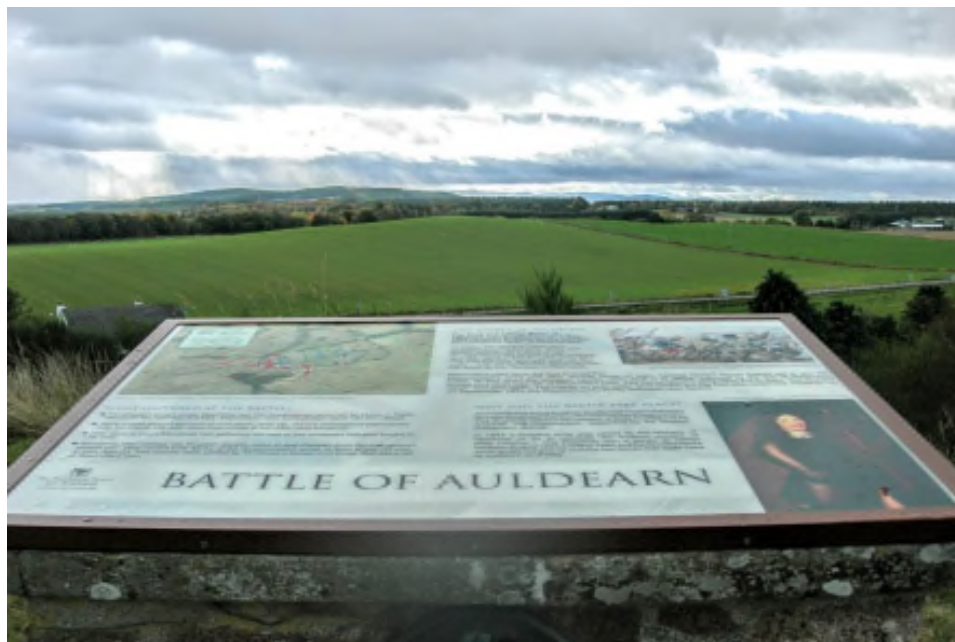
**Photo 3: View from Dooket Hill at the National Trust for Scotland Viewpoint Towards Garlic Hill**

- The terrain surrounding Dooket Hill (Photo 3) and views to the monument from the Royalist positions in the village. This landscape feature is key to understanding how Montrose effectively exploited the terrain to outmanoeuvre the Covenanter army.
