A96 Dualling Inverness to Nairn (including Nairn Bypass) Highlands Archaeological Geophysical Survey (Phase 2)

A96 Dualling Inverness to Nairn (including Nairn Bypass), Highlands Archaeological Geophysical Survey, (Phase 2)

A96 Dualling: Inverness to Nairn (including Nairn Bypass) Archaeological Metal Detecting Survey Report

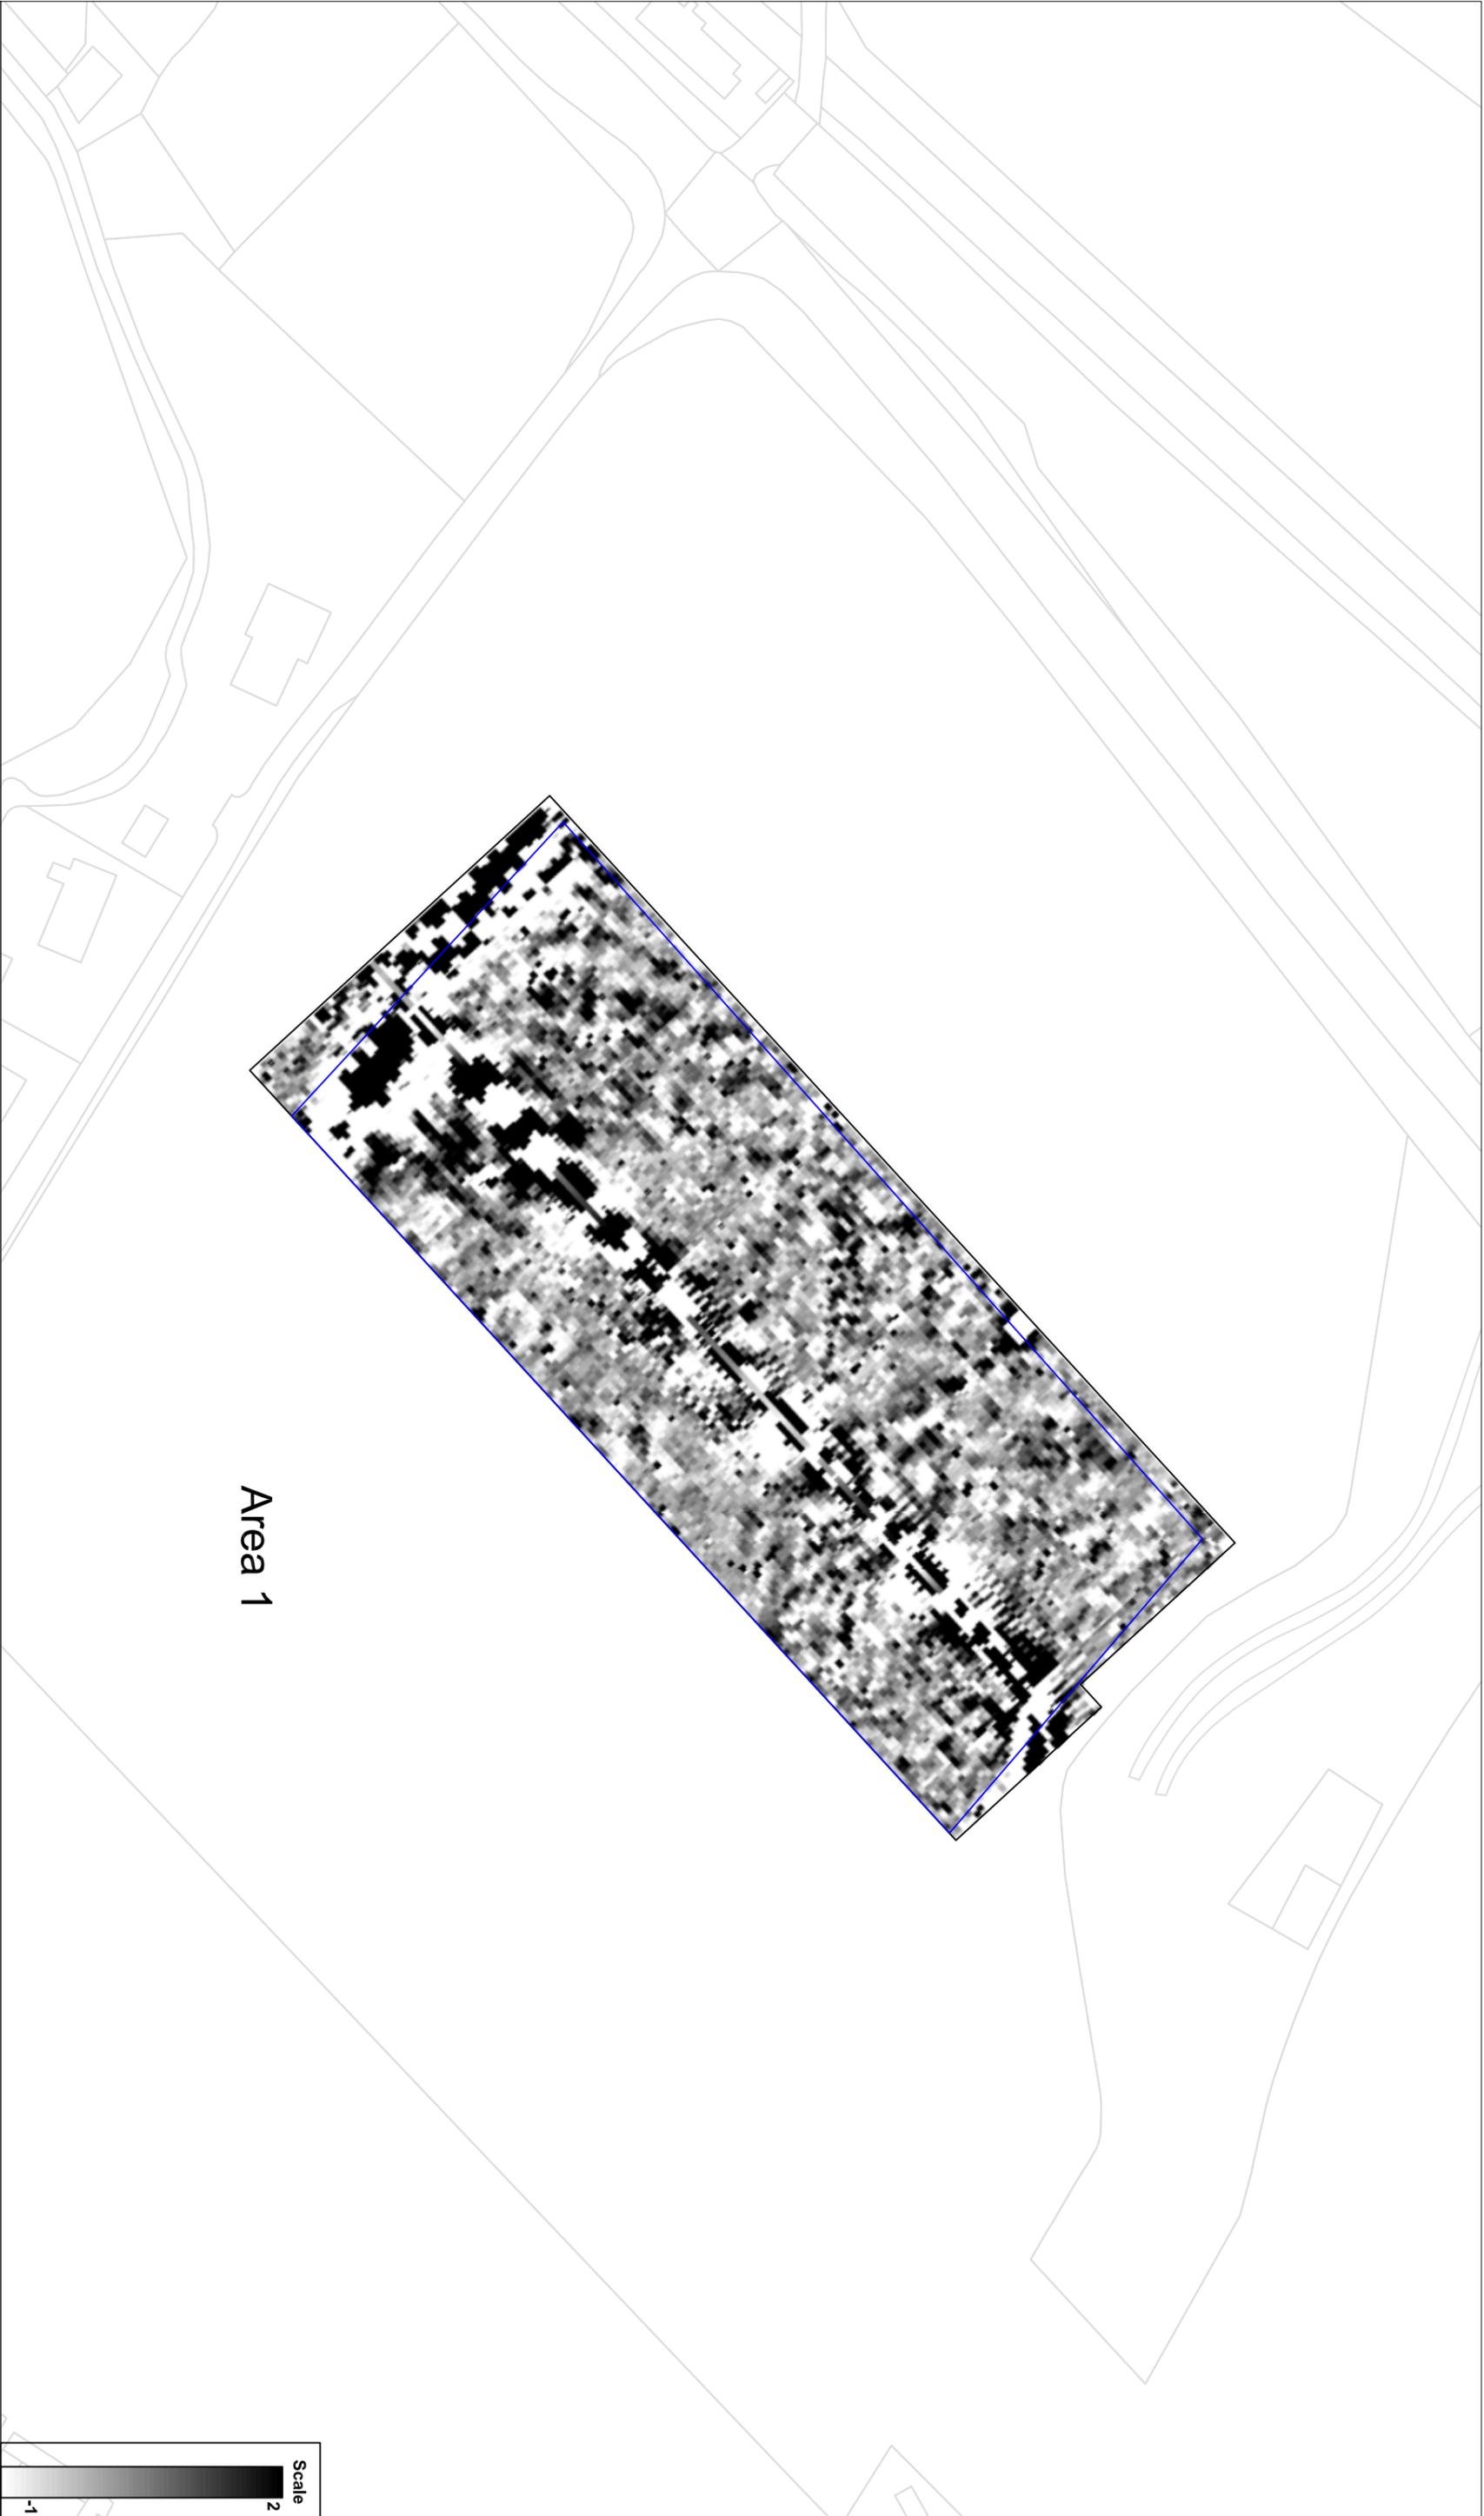
Figure
3

Unprocessed gradiometer survey results - greyscale plot: Area 1

- 6.1 The gradiometer survey results have been visualised as greyscale plots with raw data plotted at -5 to 10nT and processed data plotted at -1 to 2nT; these are followed by an interpretation of each area (**Figures 3 to 26**). An individual characterisation of identified anomalies can be found in Appendix 6.

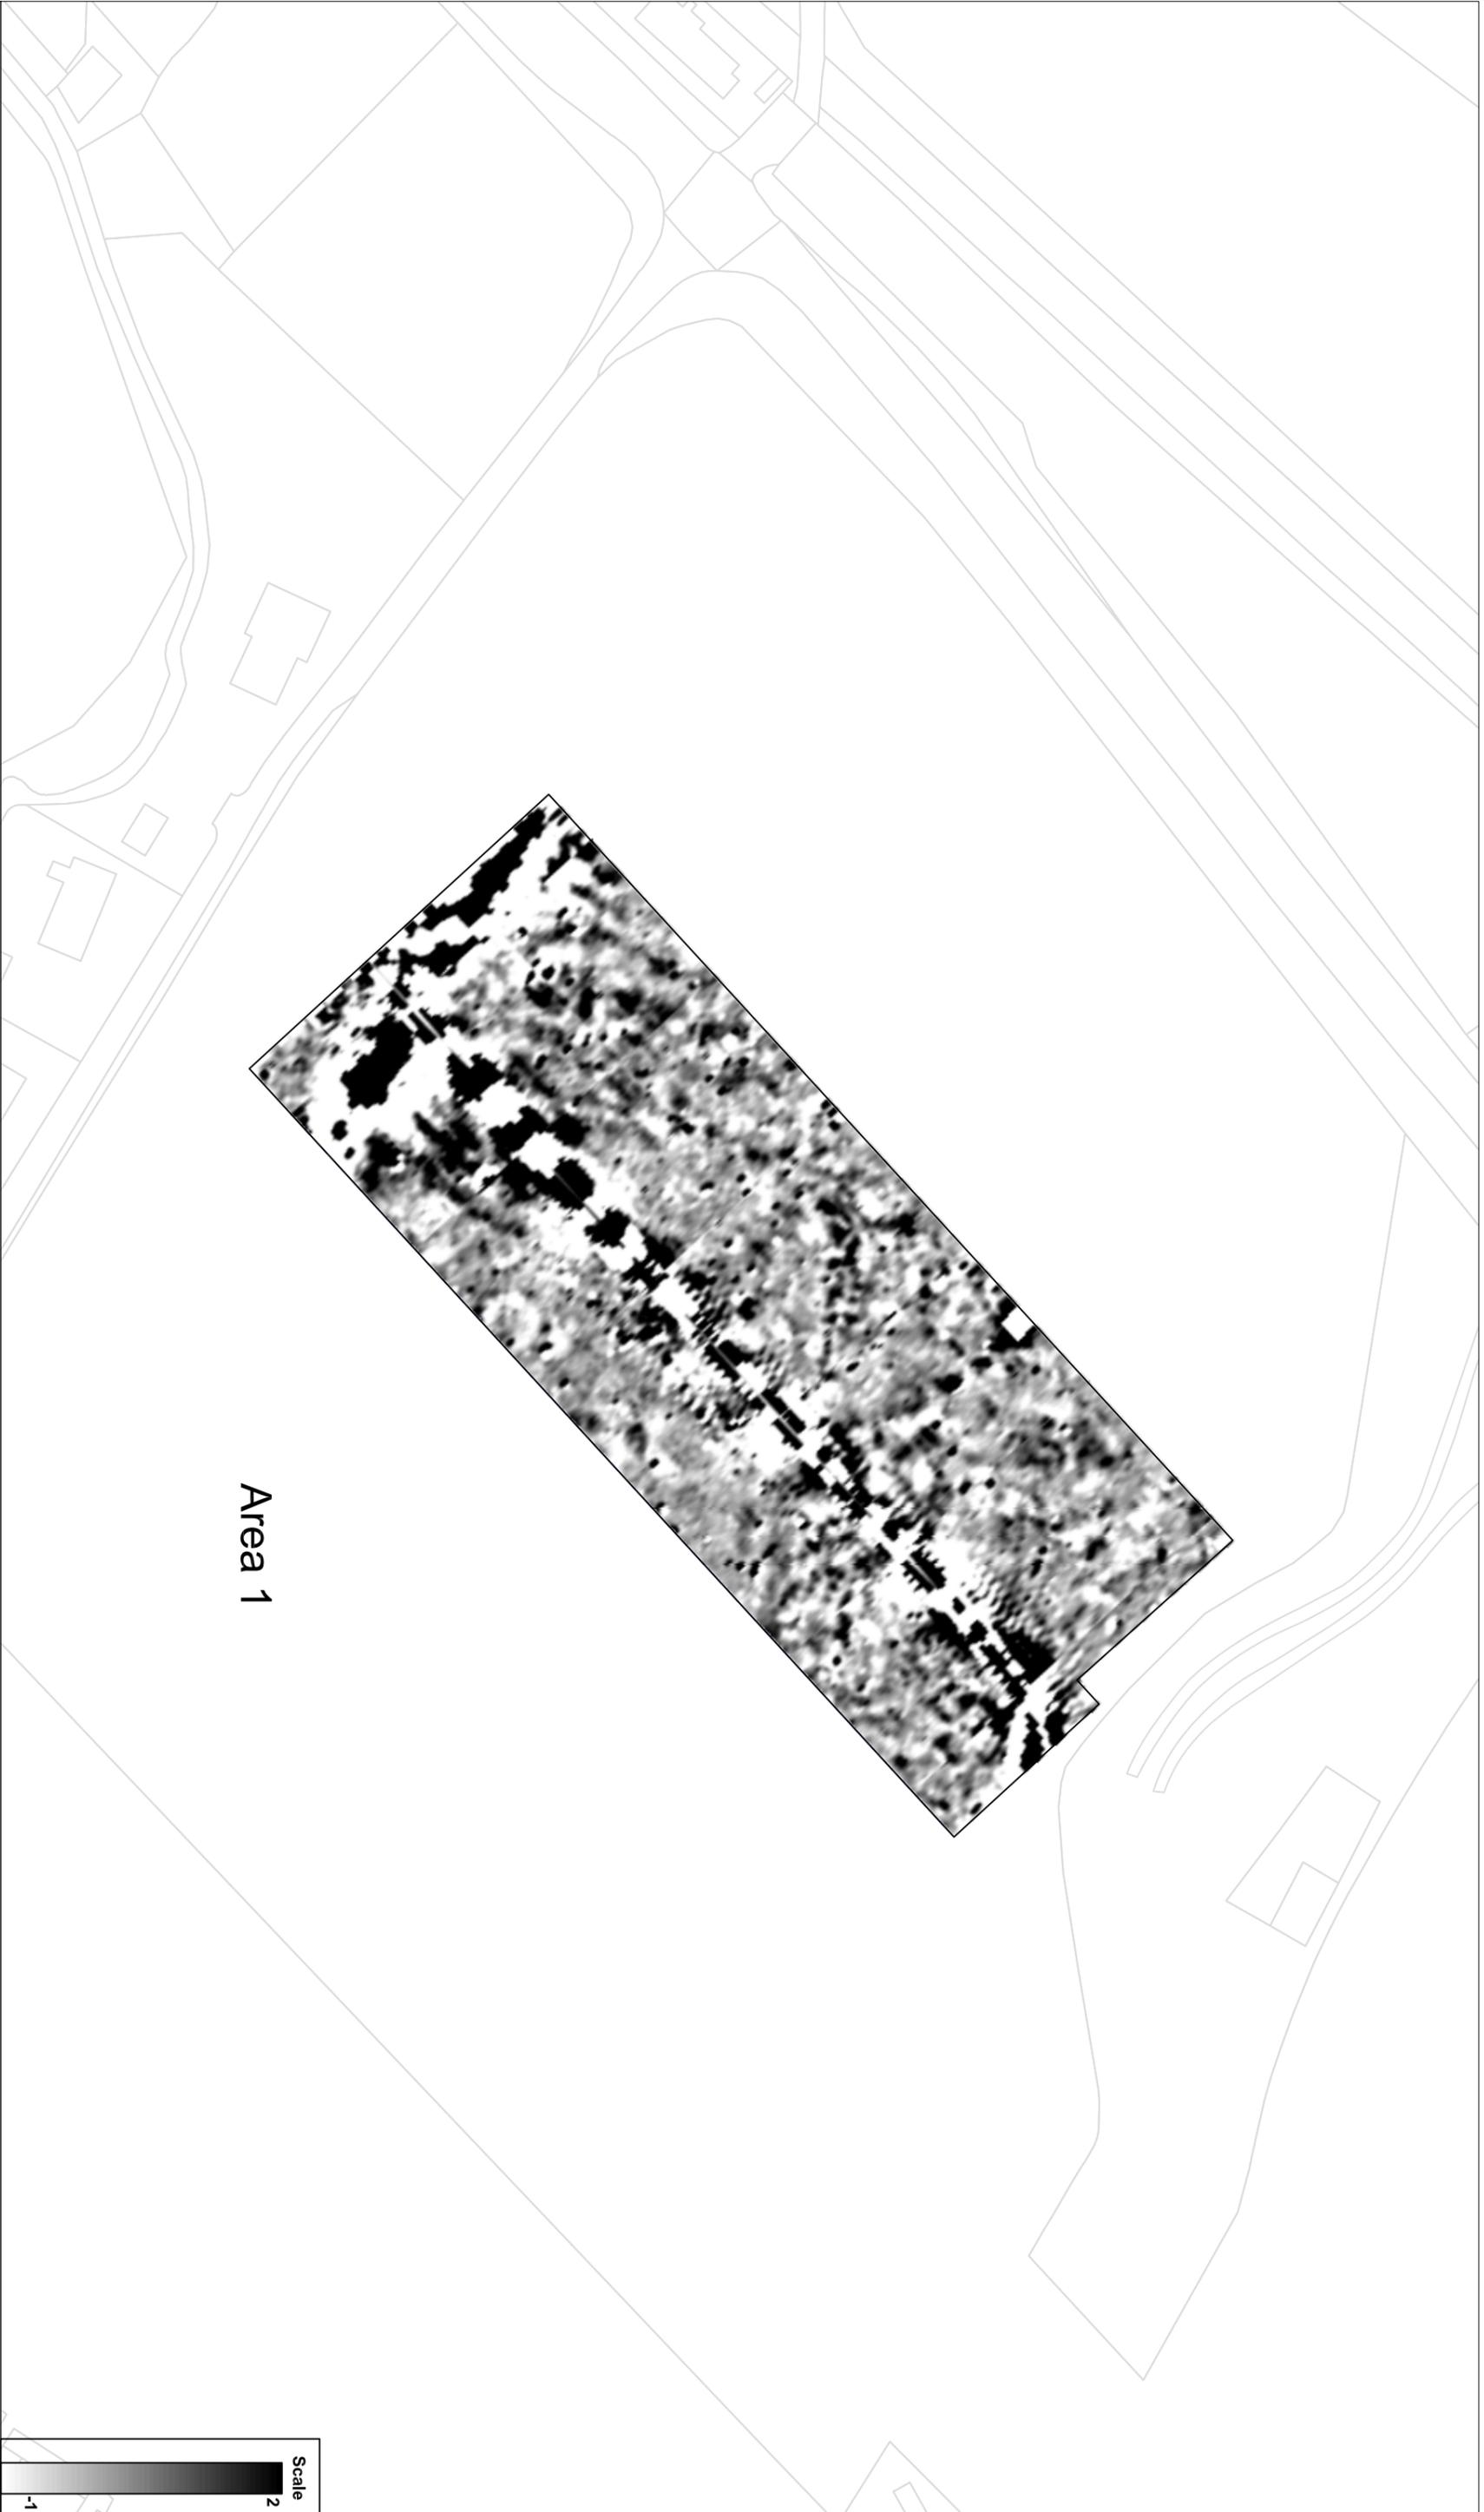
Figure
4

Processed gradiometer survey results - greyscale plot: Area 1

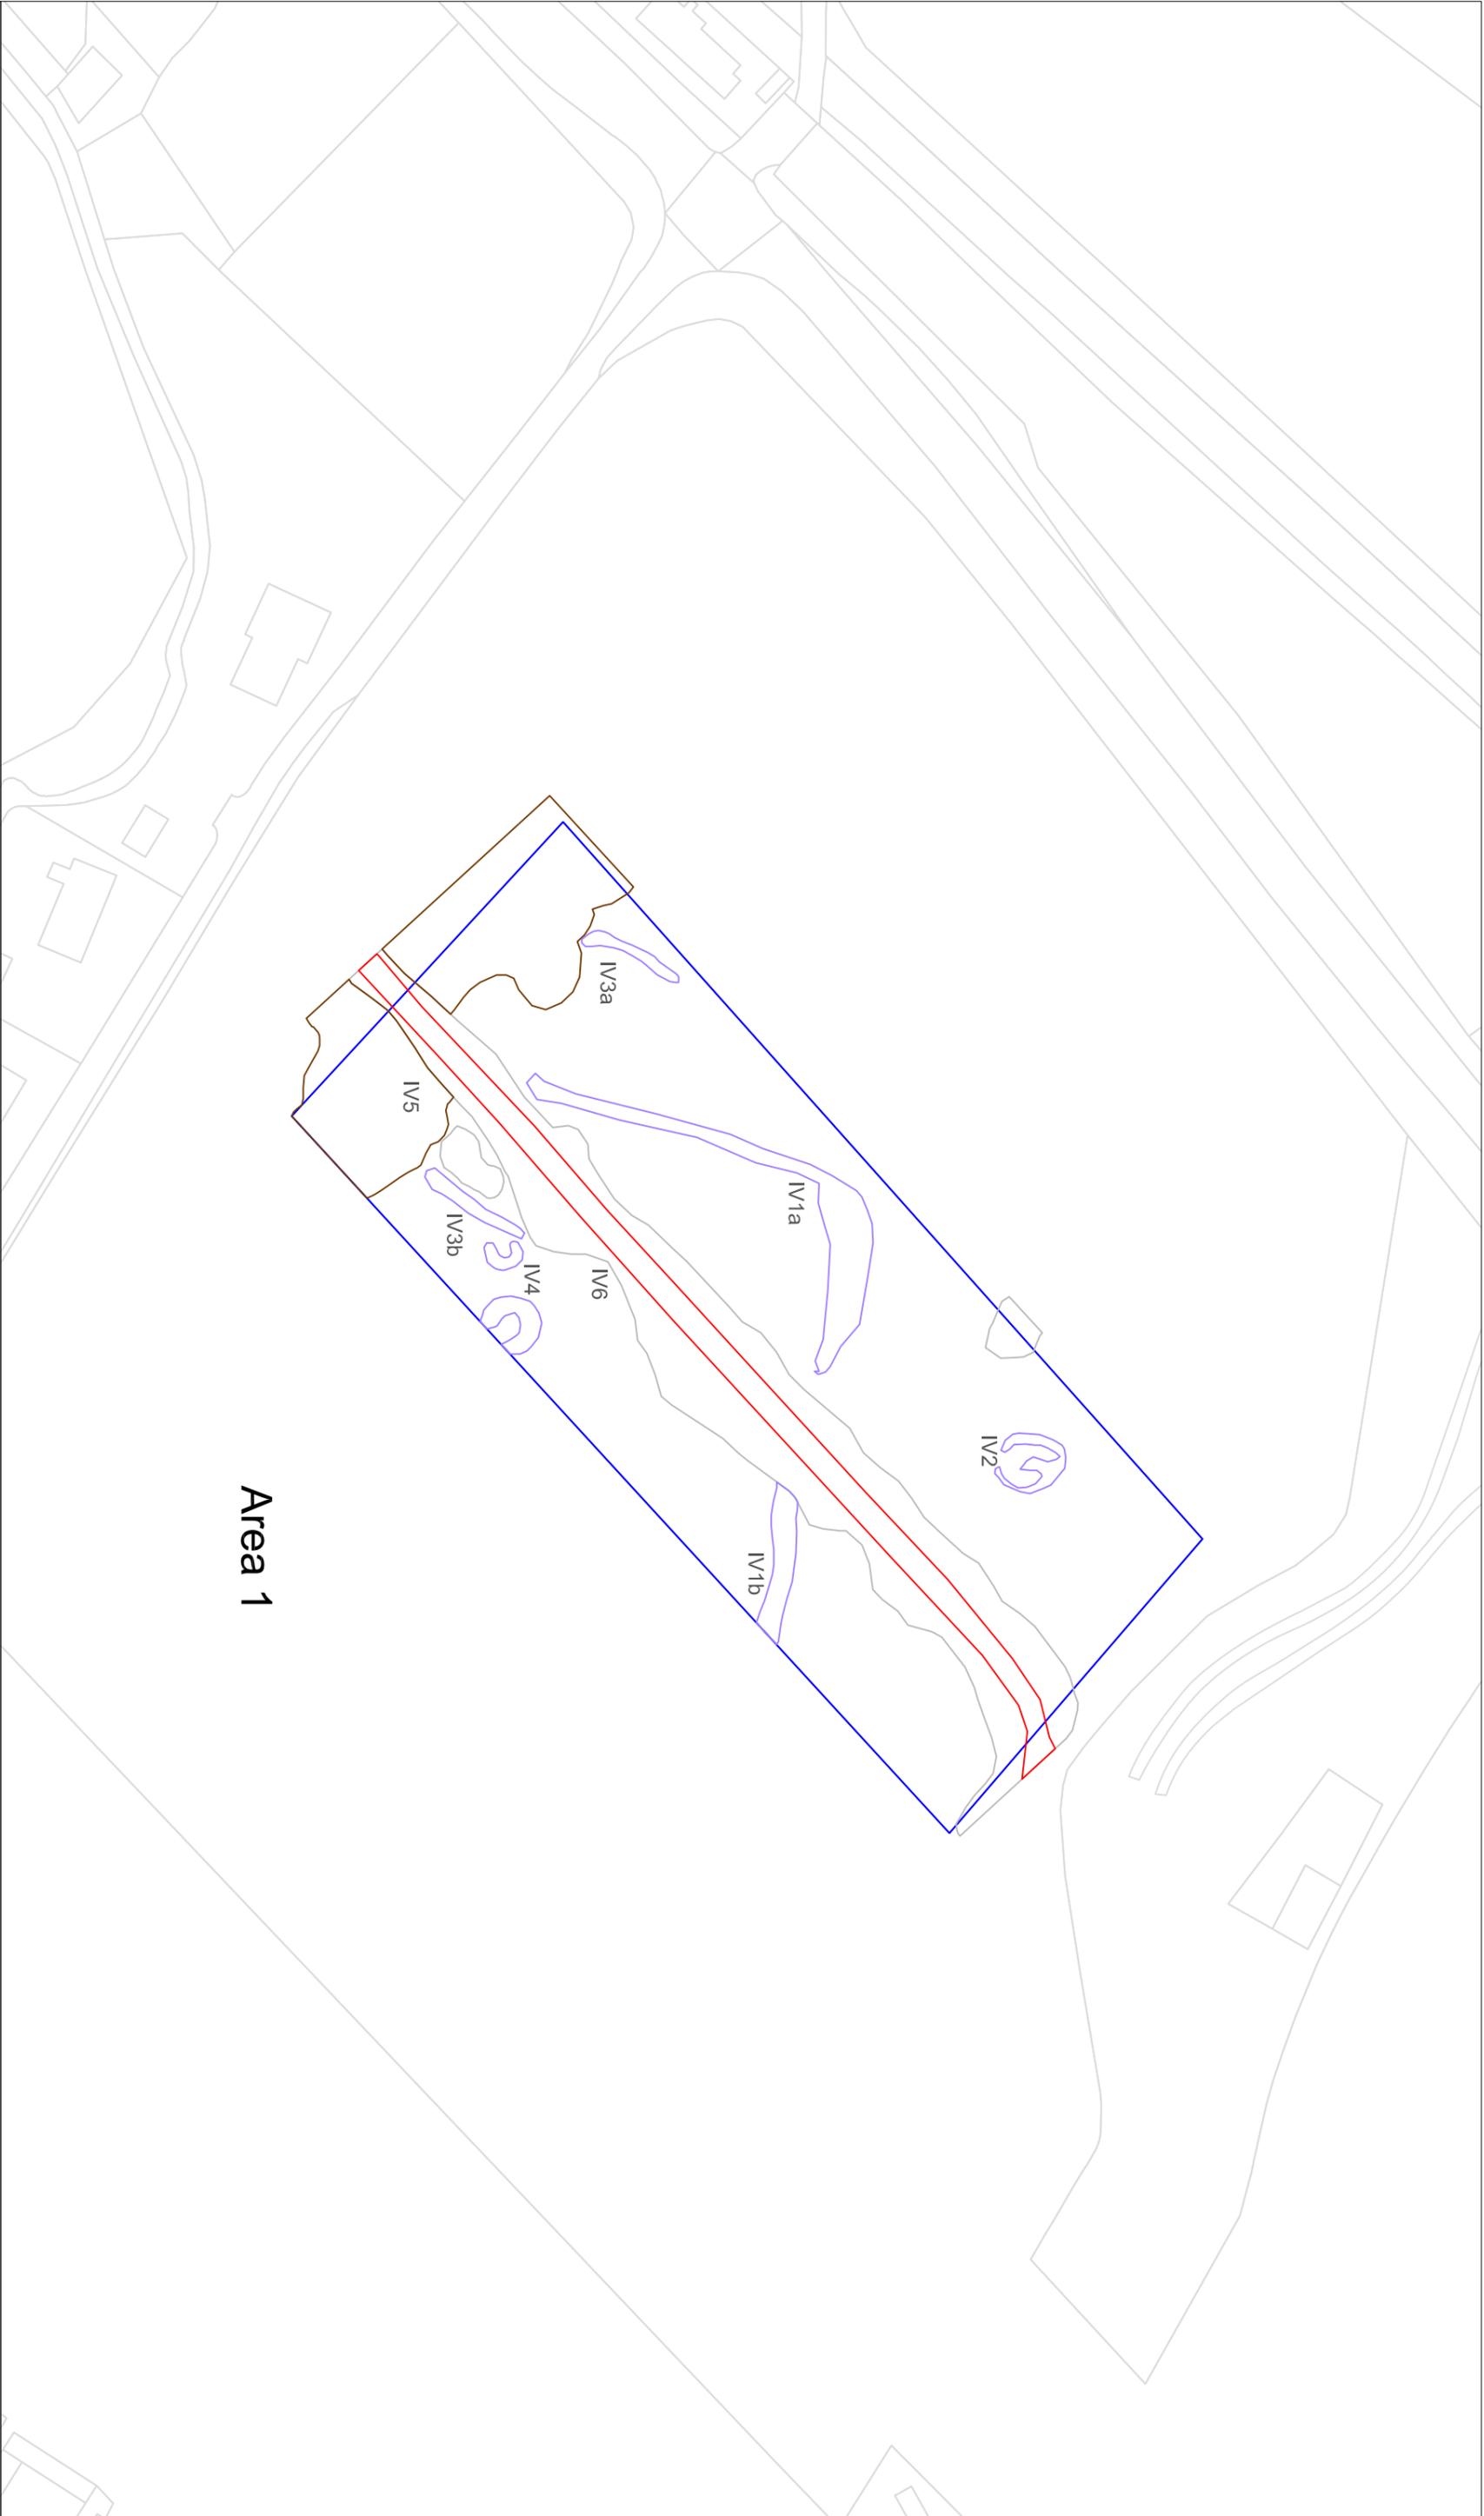
<p>Figure 5</p>		<p>Possible archaeology Linear trend (plough)</p> <p>Linear trend (archaeology?) Possible archaeology Linear trend (modern) Disturbed area (modern)</p>	<p>Survey area Modern services Ferrous Geology</p>	<p>1:1000 at A3</p>	
-----------------	--	---	--	---------------------	--

Interpretation of gradiometer survey results: Area 1

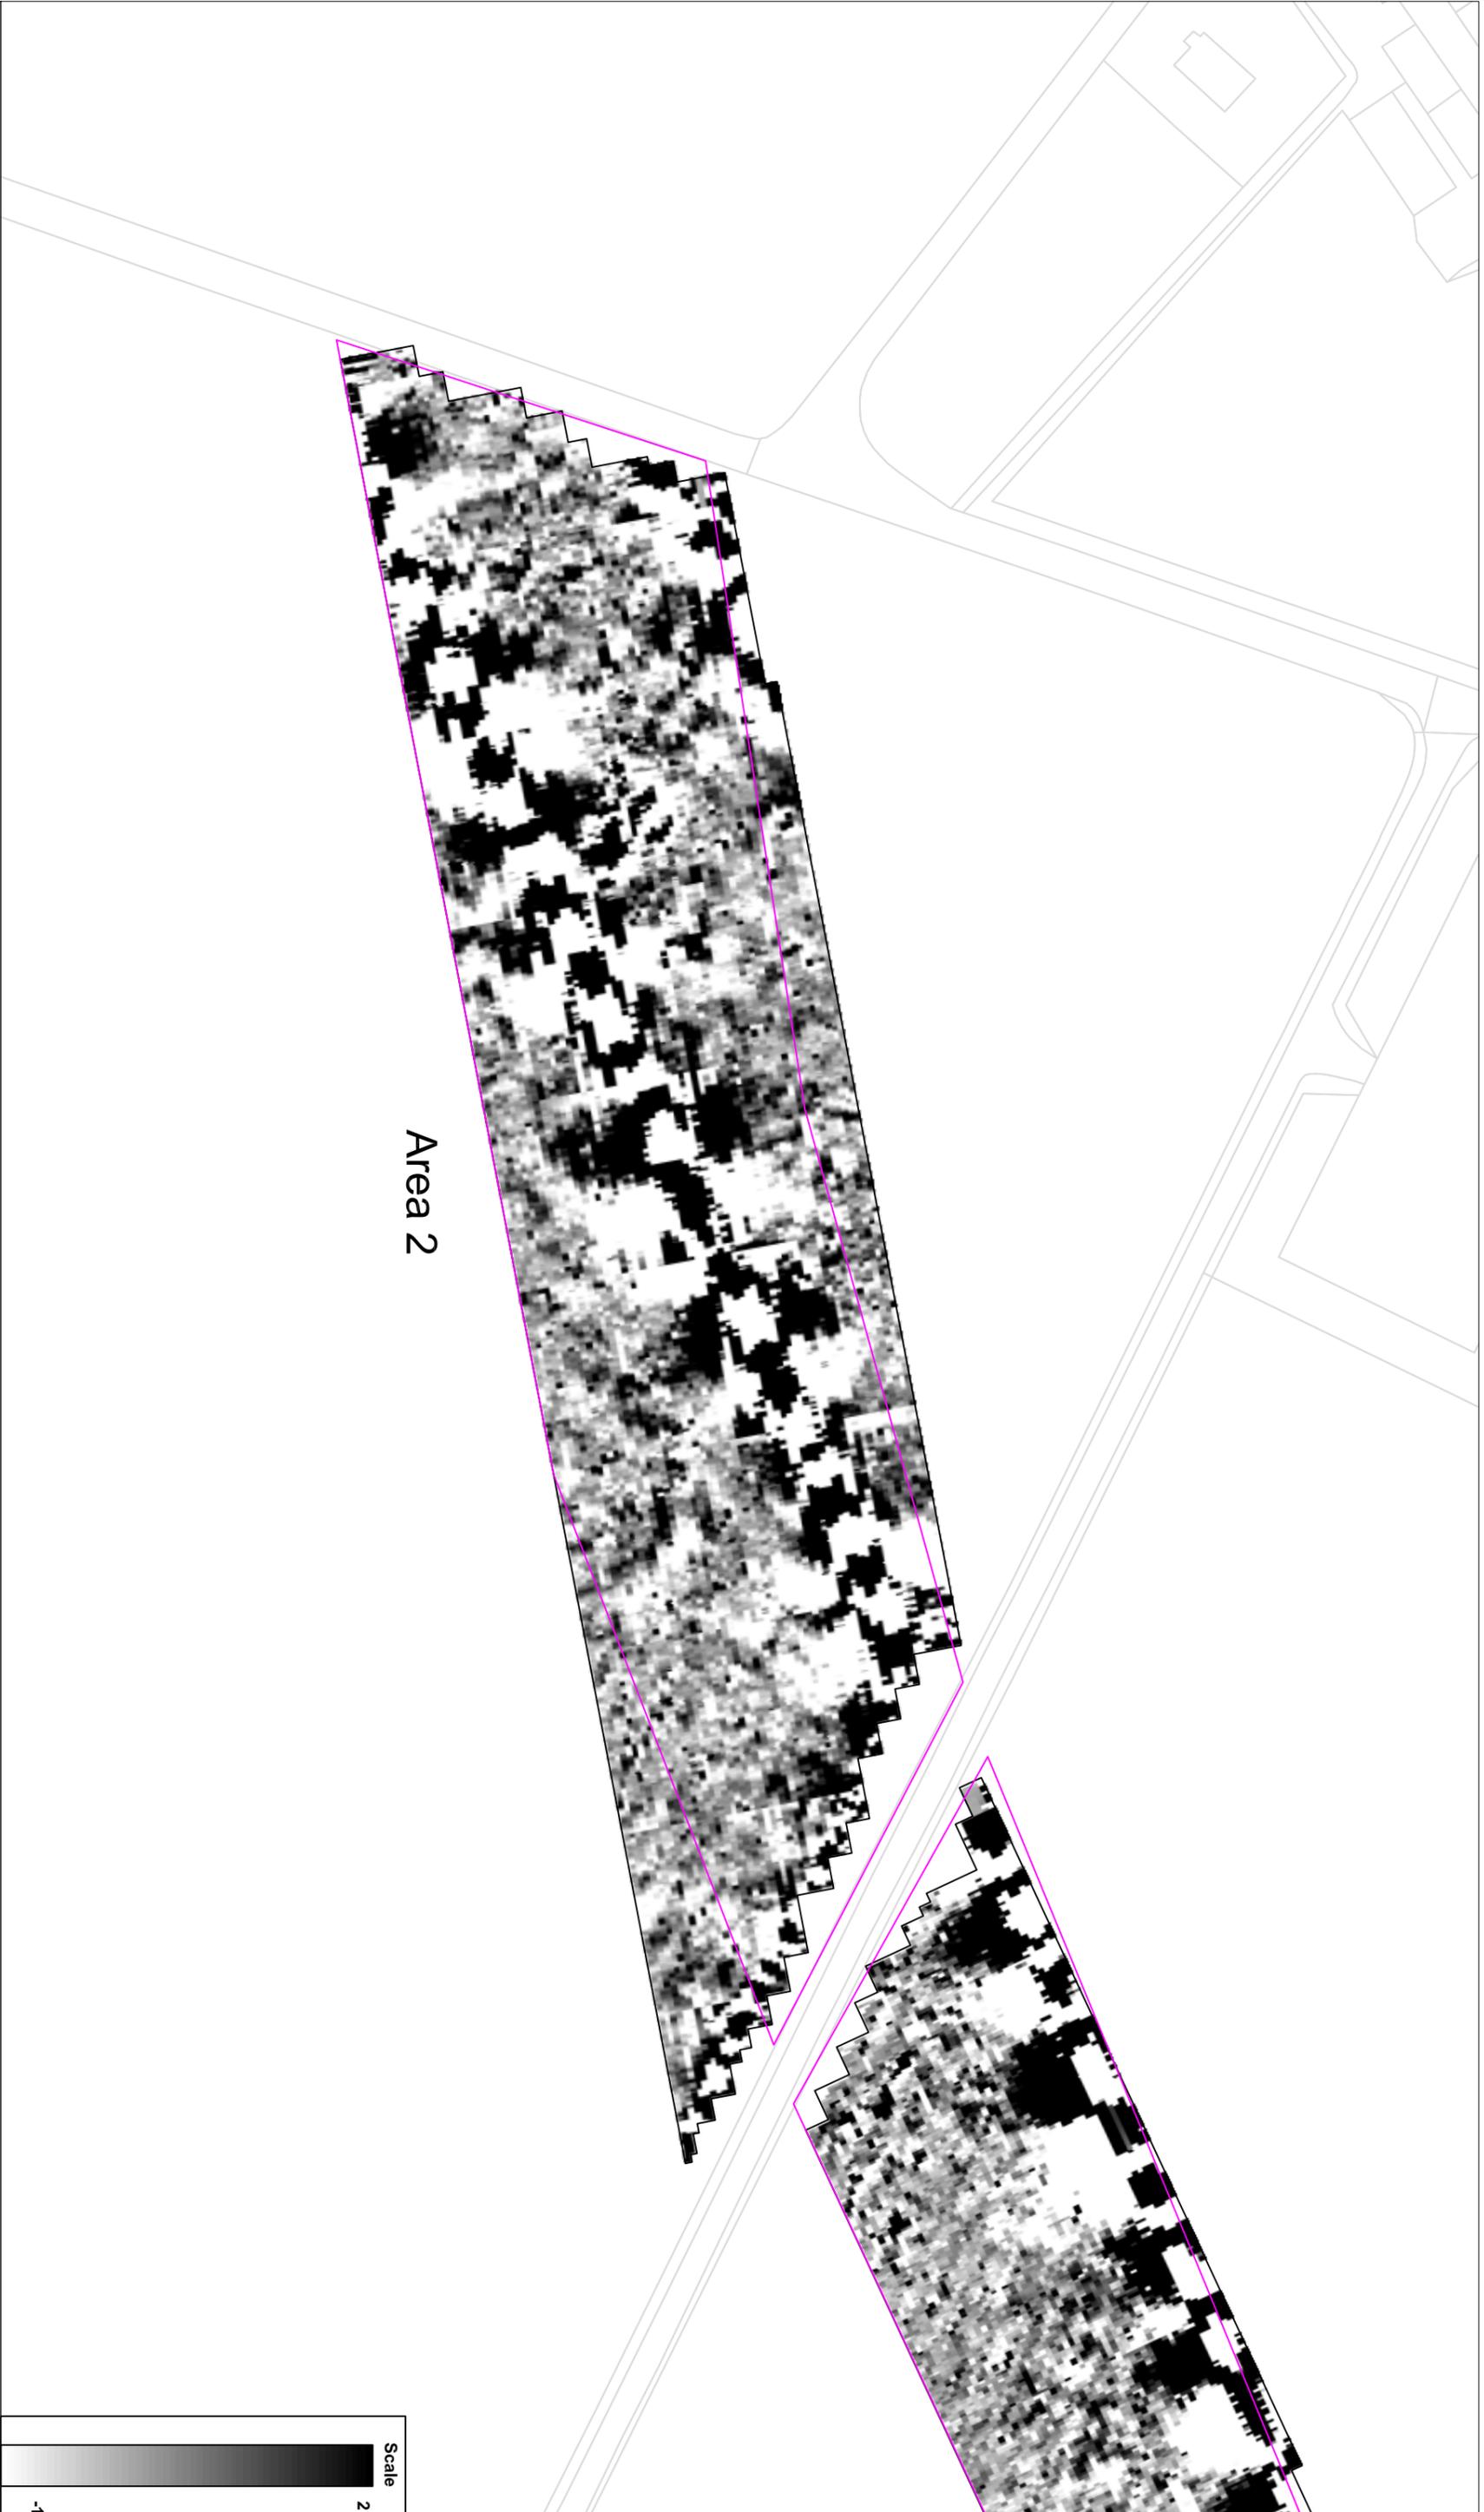
Figure
6

Unprocessed gradiometer survey results - greyscale plot: Area 2

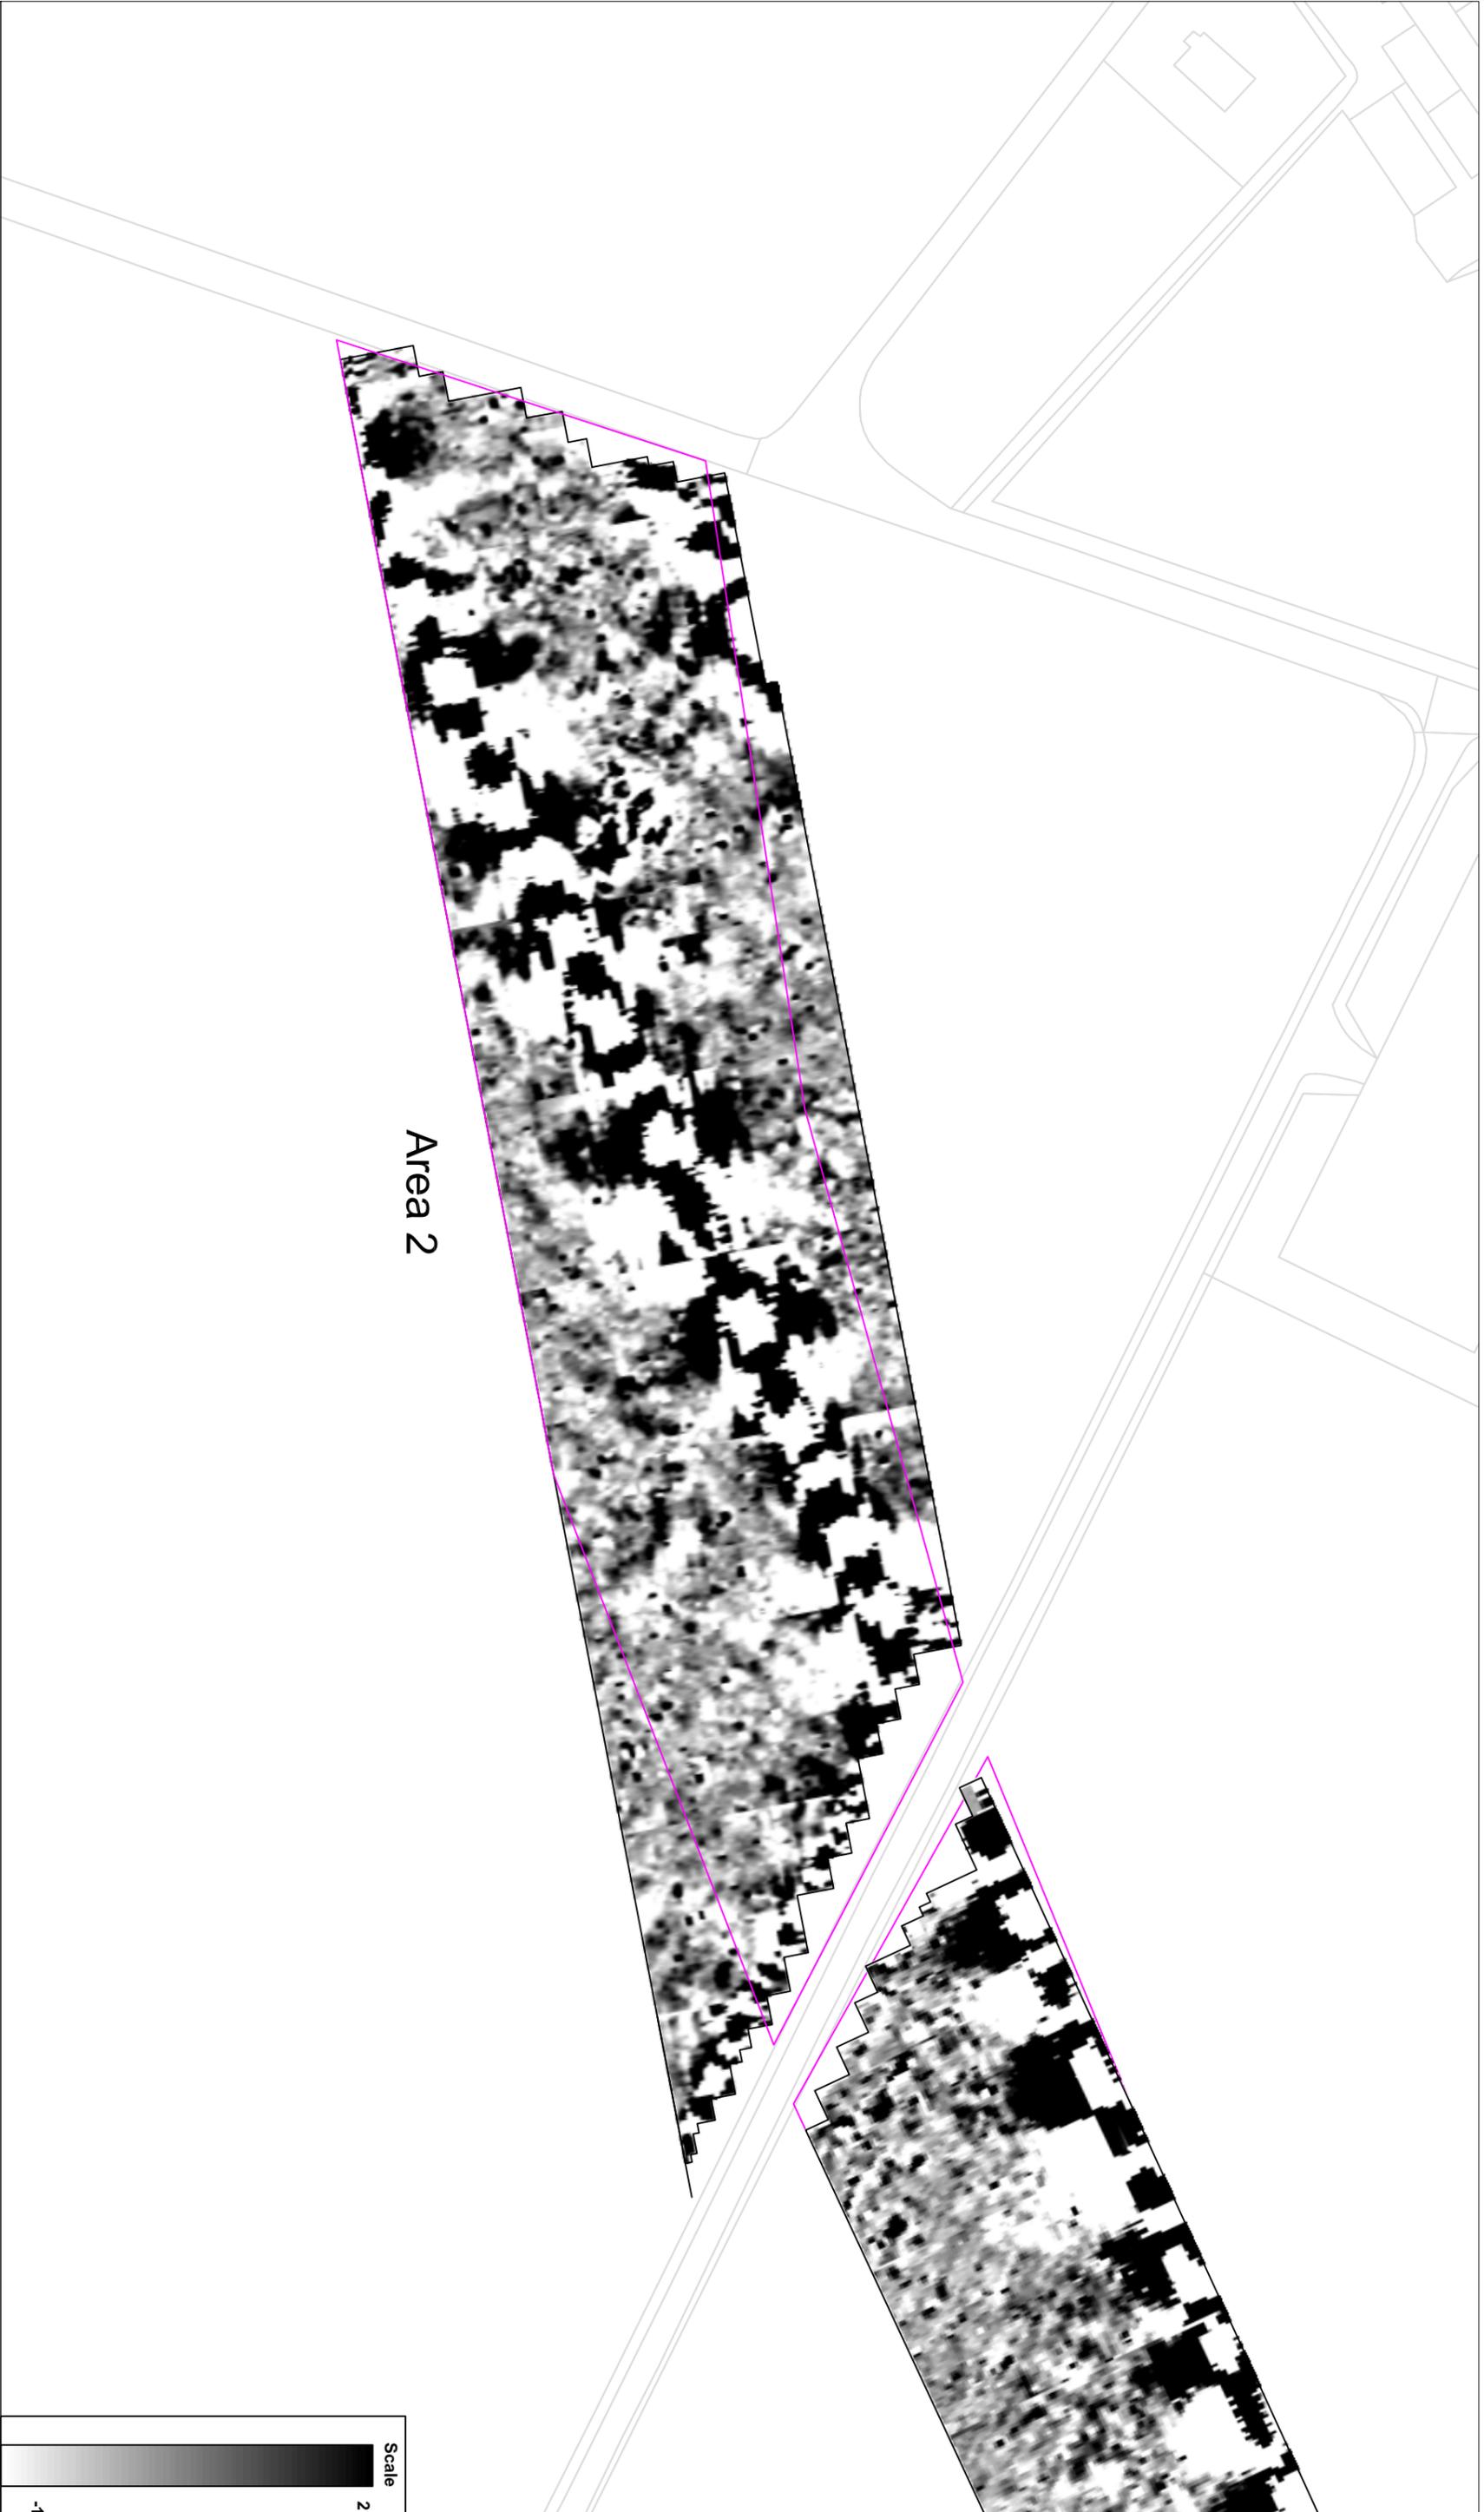
Figure
7

Processed gradiometer survey results - greyscale plot: Area 2

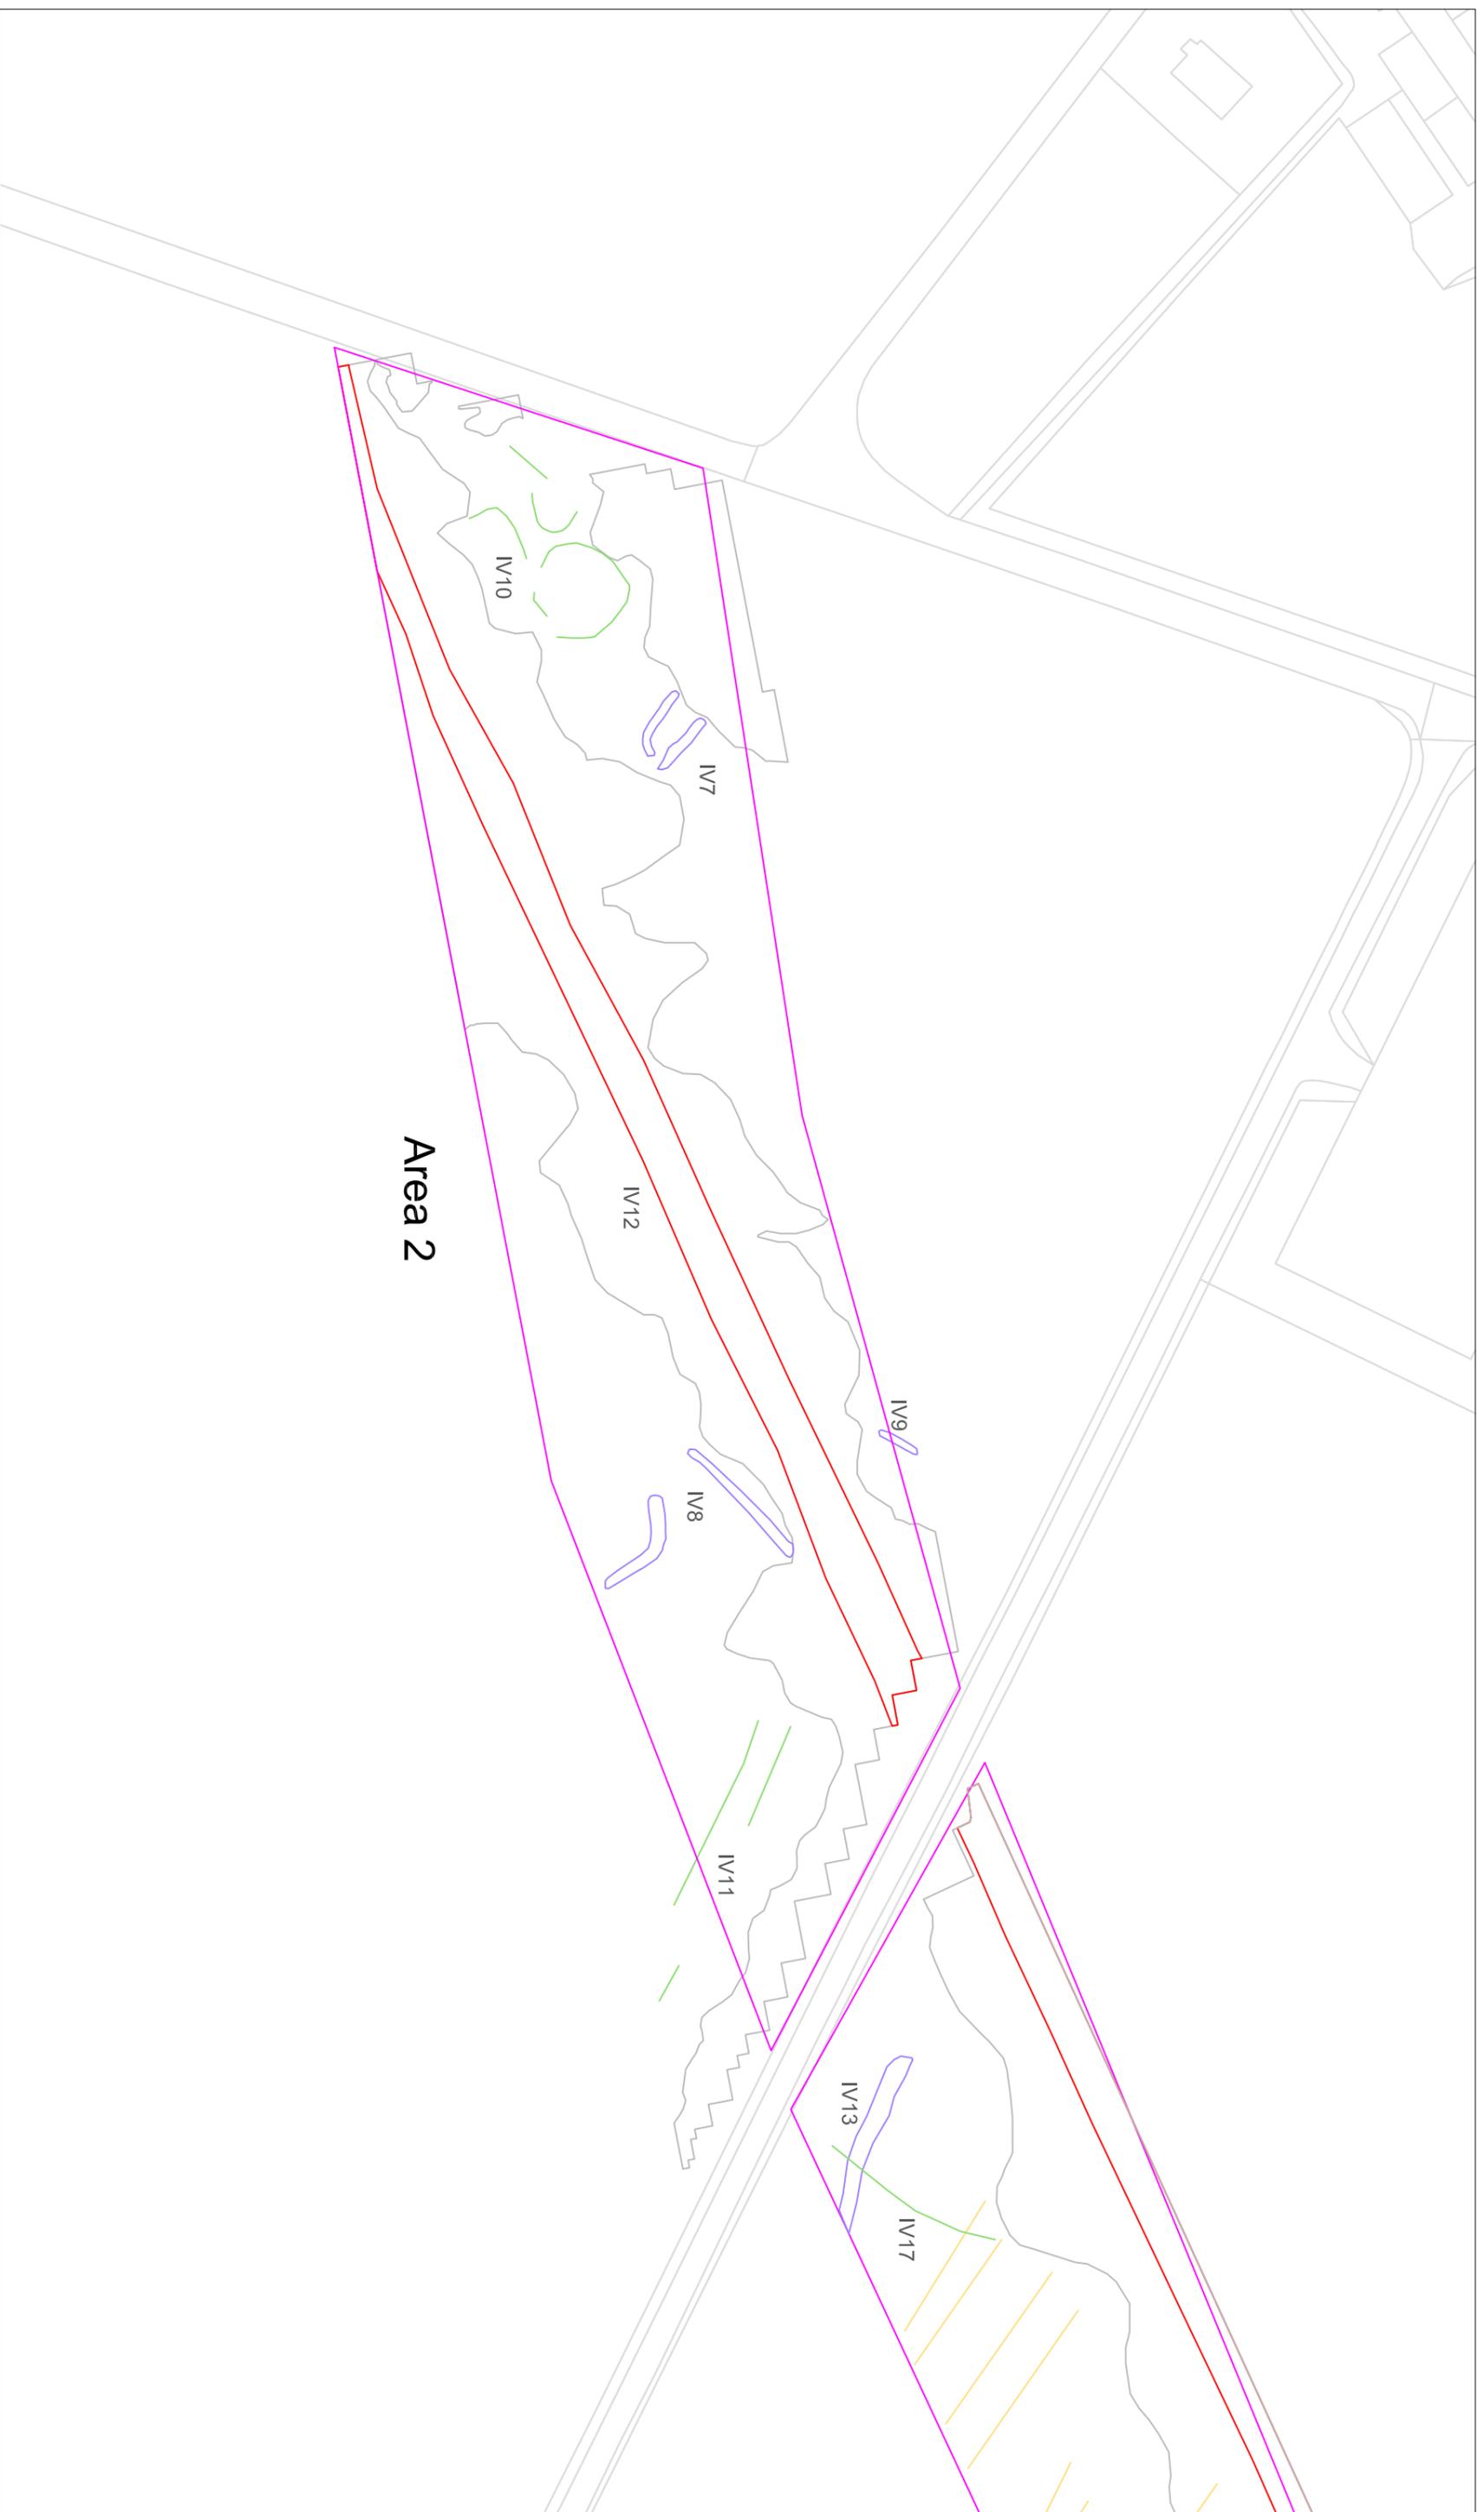
Figure 8

Interpretation of gradiometer survey results: Area 2
