A96 Dualling Inverness to Nairn (including Nairn Bypass) Highlands Archaeological Geophysical Survey (Phase 2)

A96 Dualling Inverness to Nairn (including Nairn Bypass), Highlands Archaeological Geophysical Survey, (Phase 2)

A96 Dualling: Inverness to Nairn (including Nairn Bypass) Archaeological Metal Detecting Survey Report

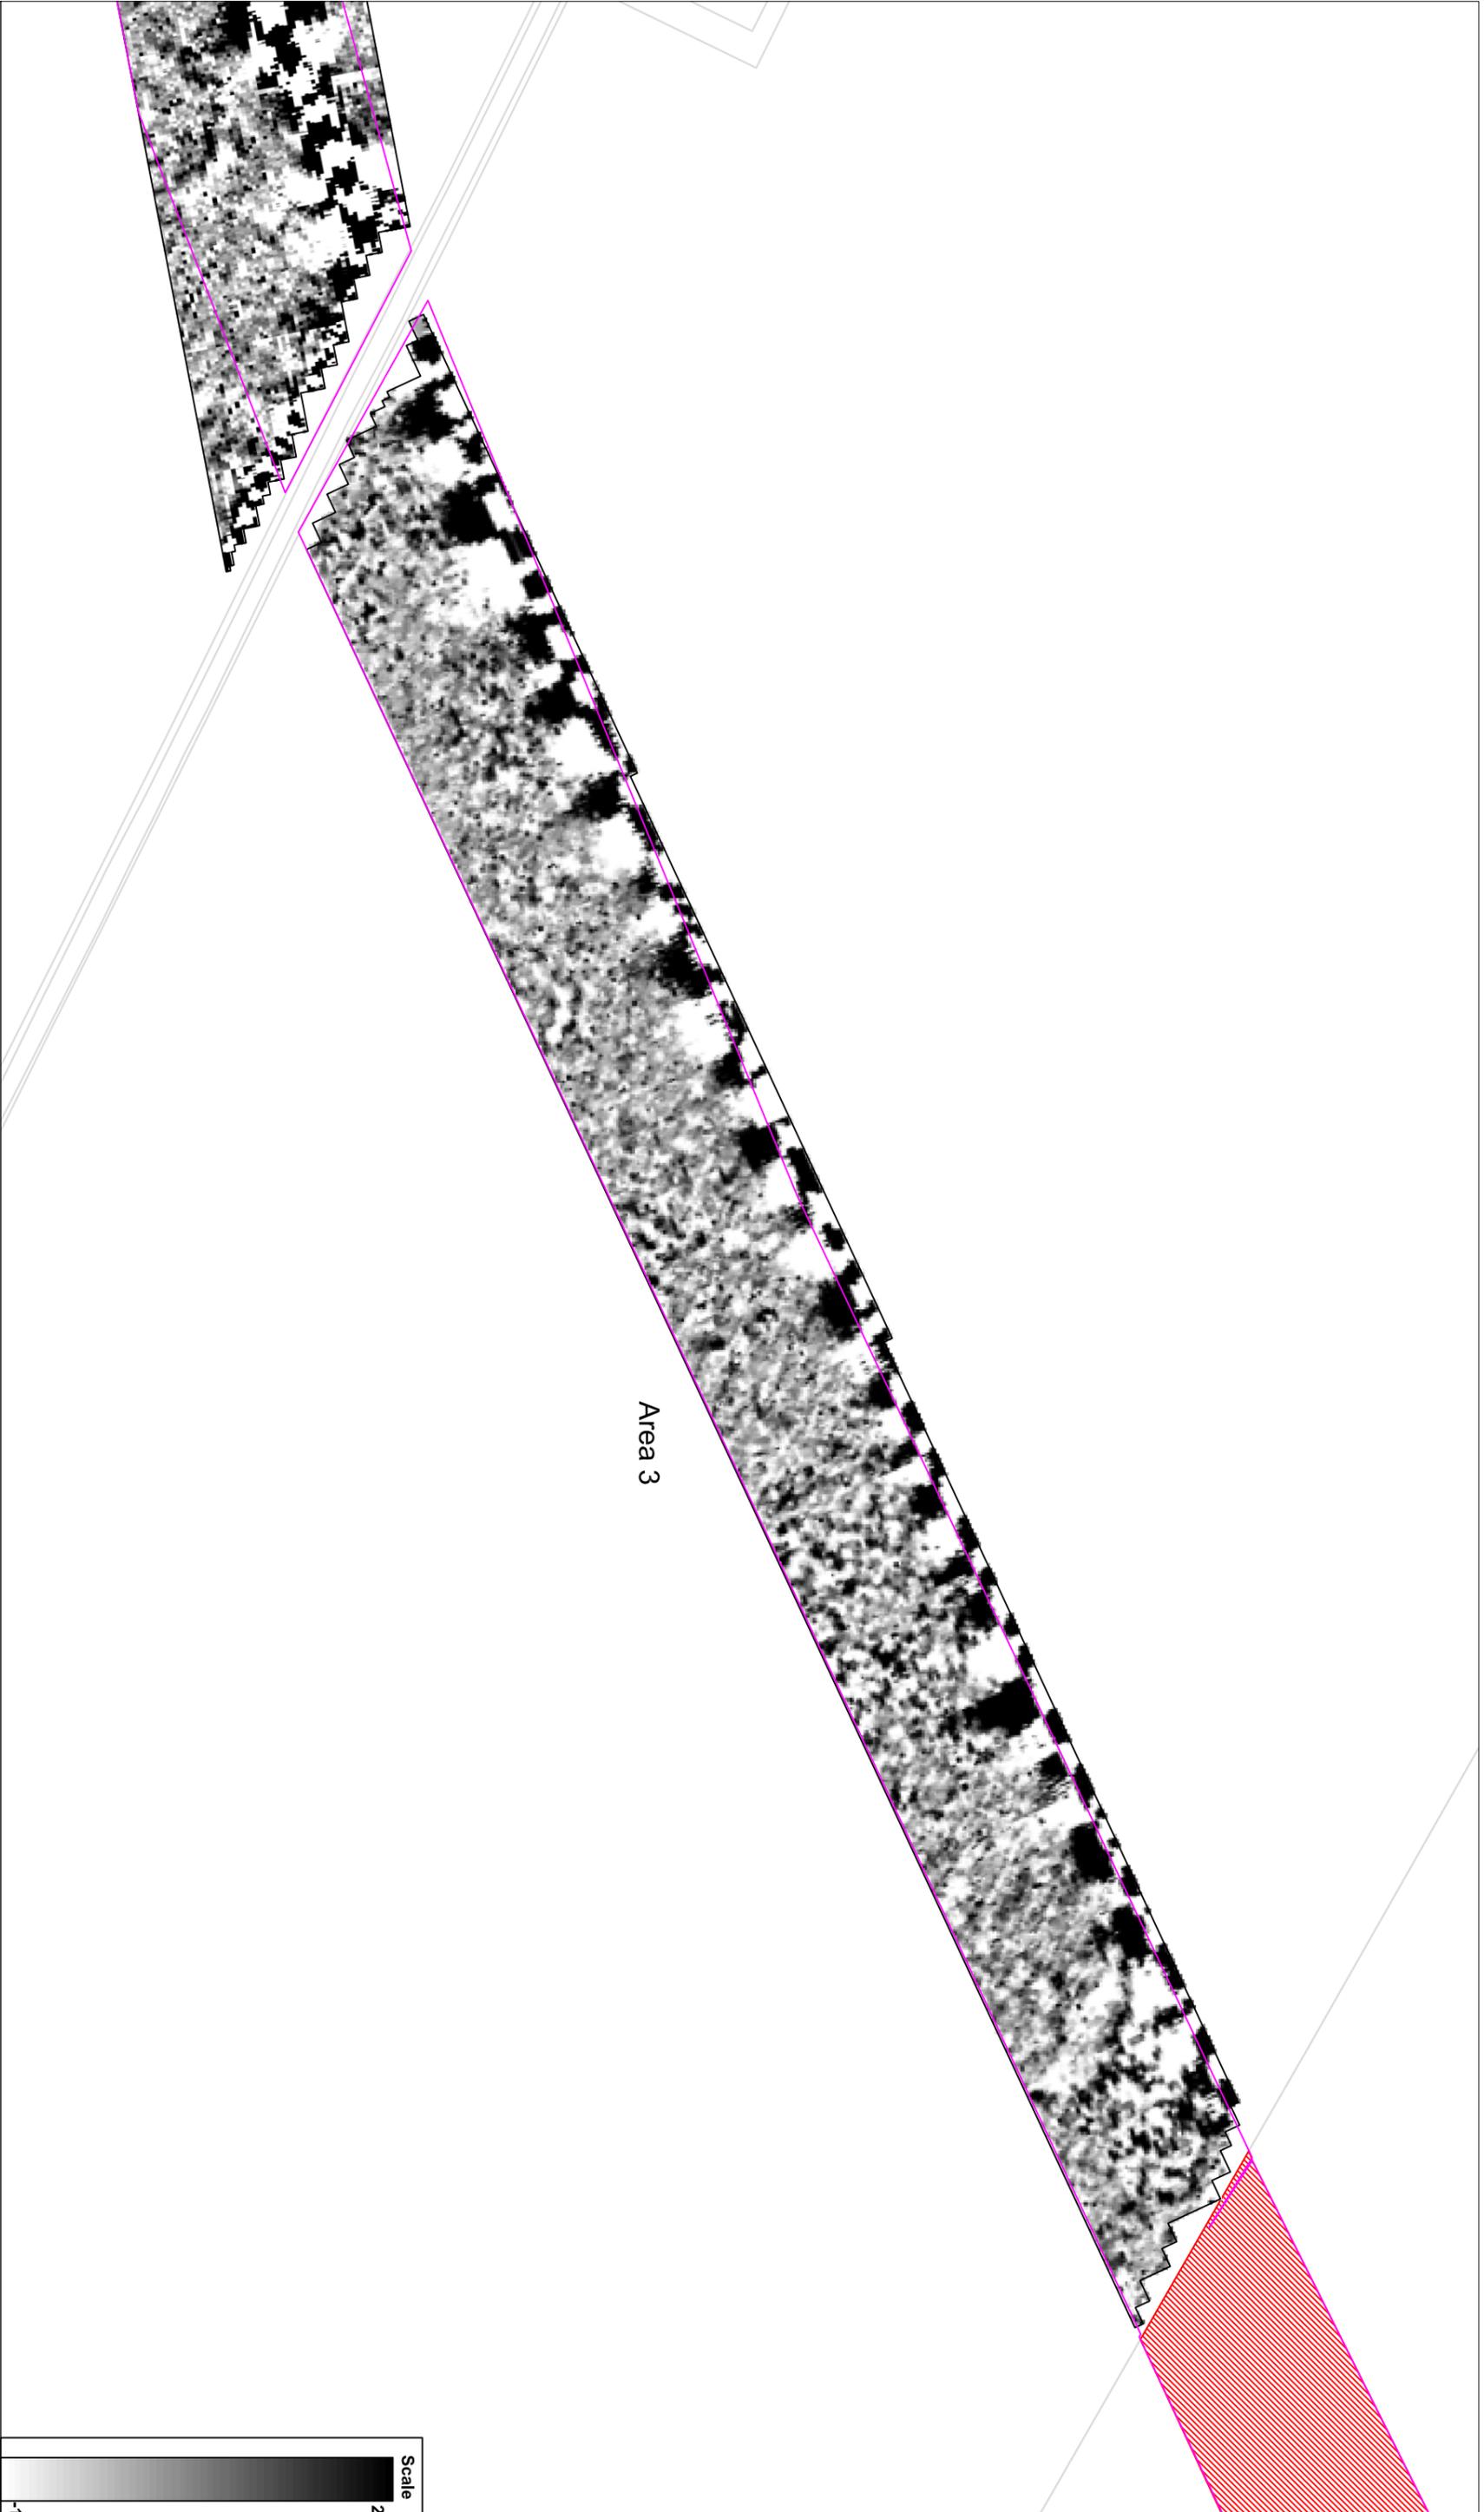
Figure
9

Unprocessed gradiometer survey results - greyscale plot: Area 3

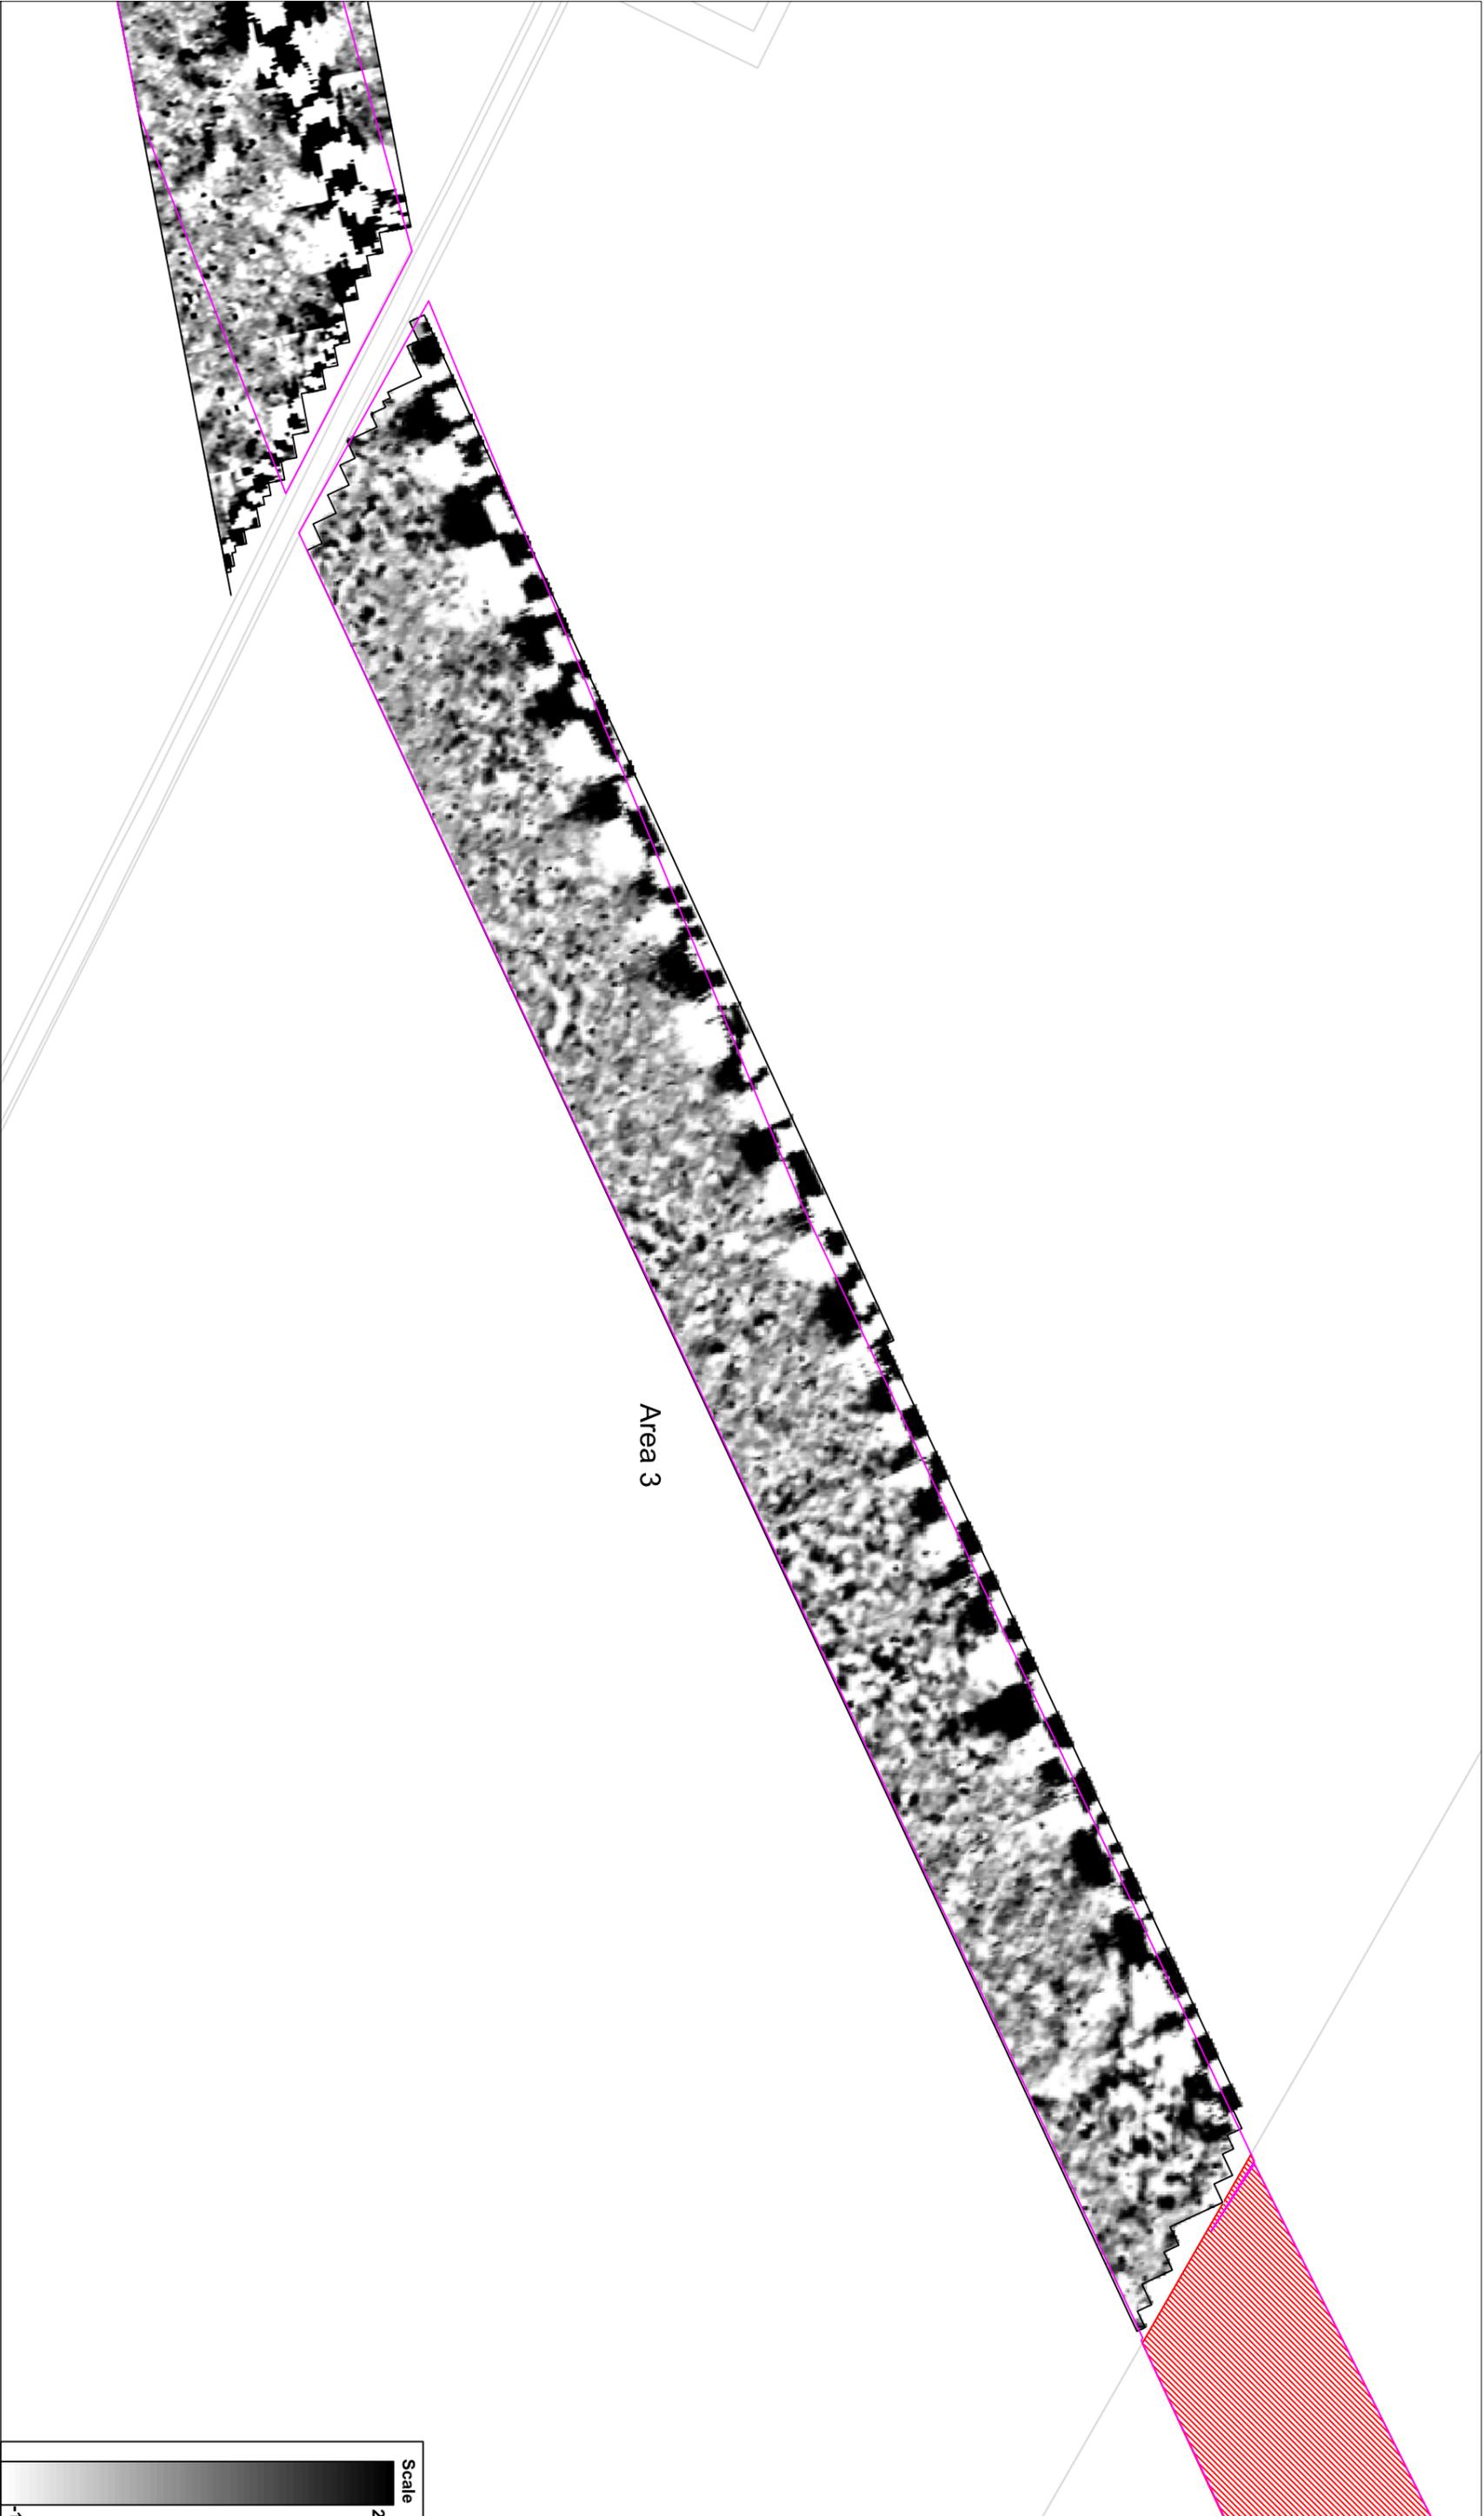
Figure
10

Processed gradiometer survey results - greyscale plot: Area 3

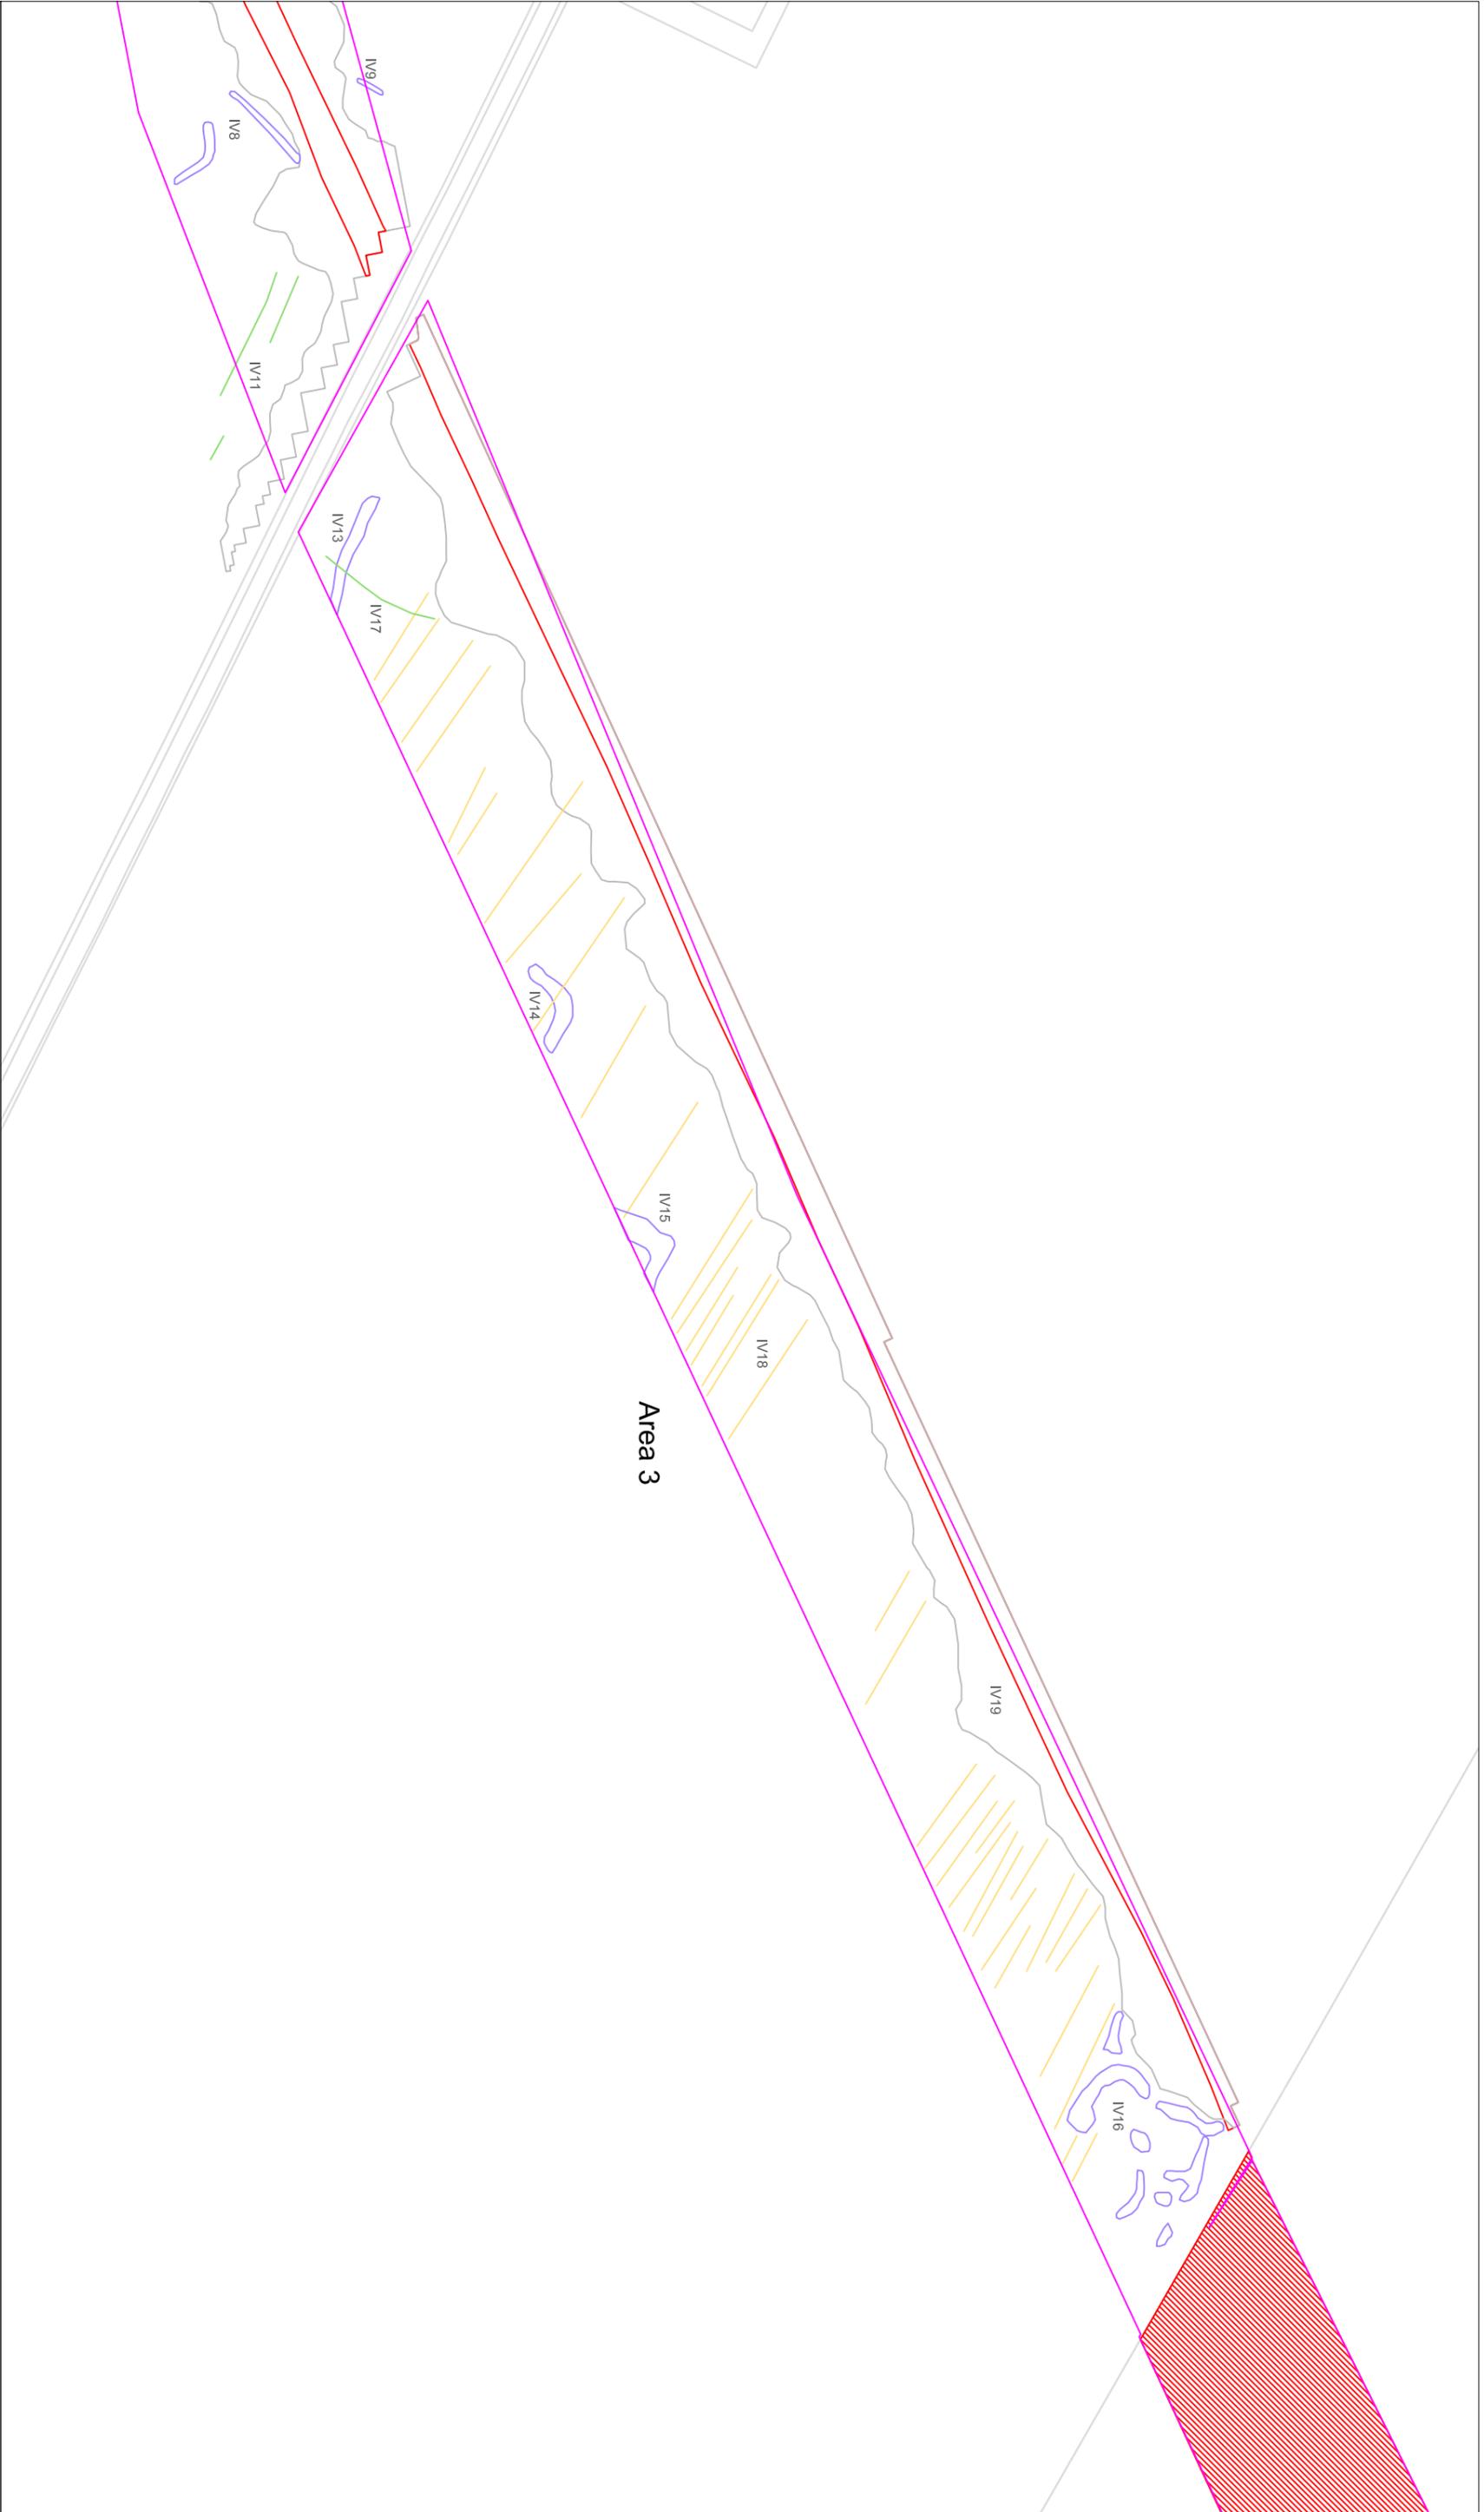
Figure 11

Interpretation of gradiometer survey results: Area 3

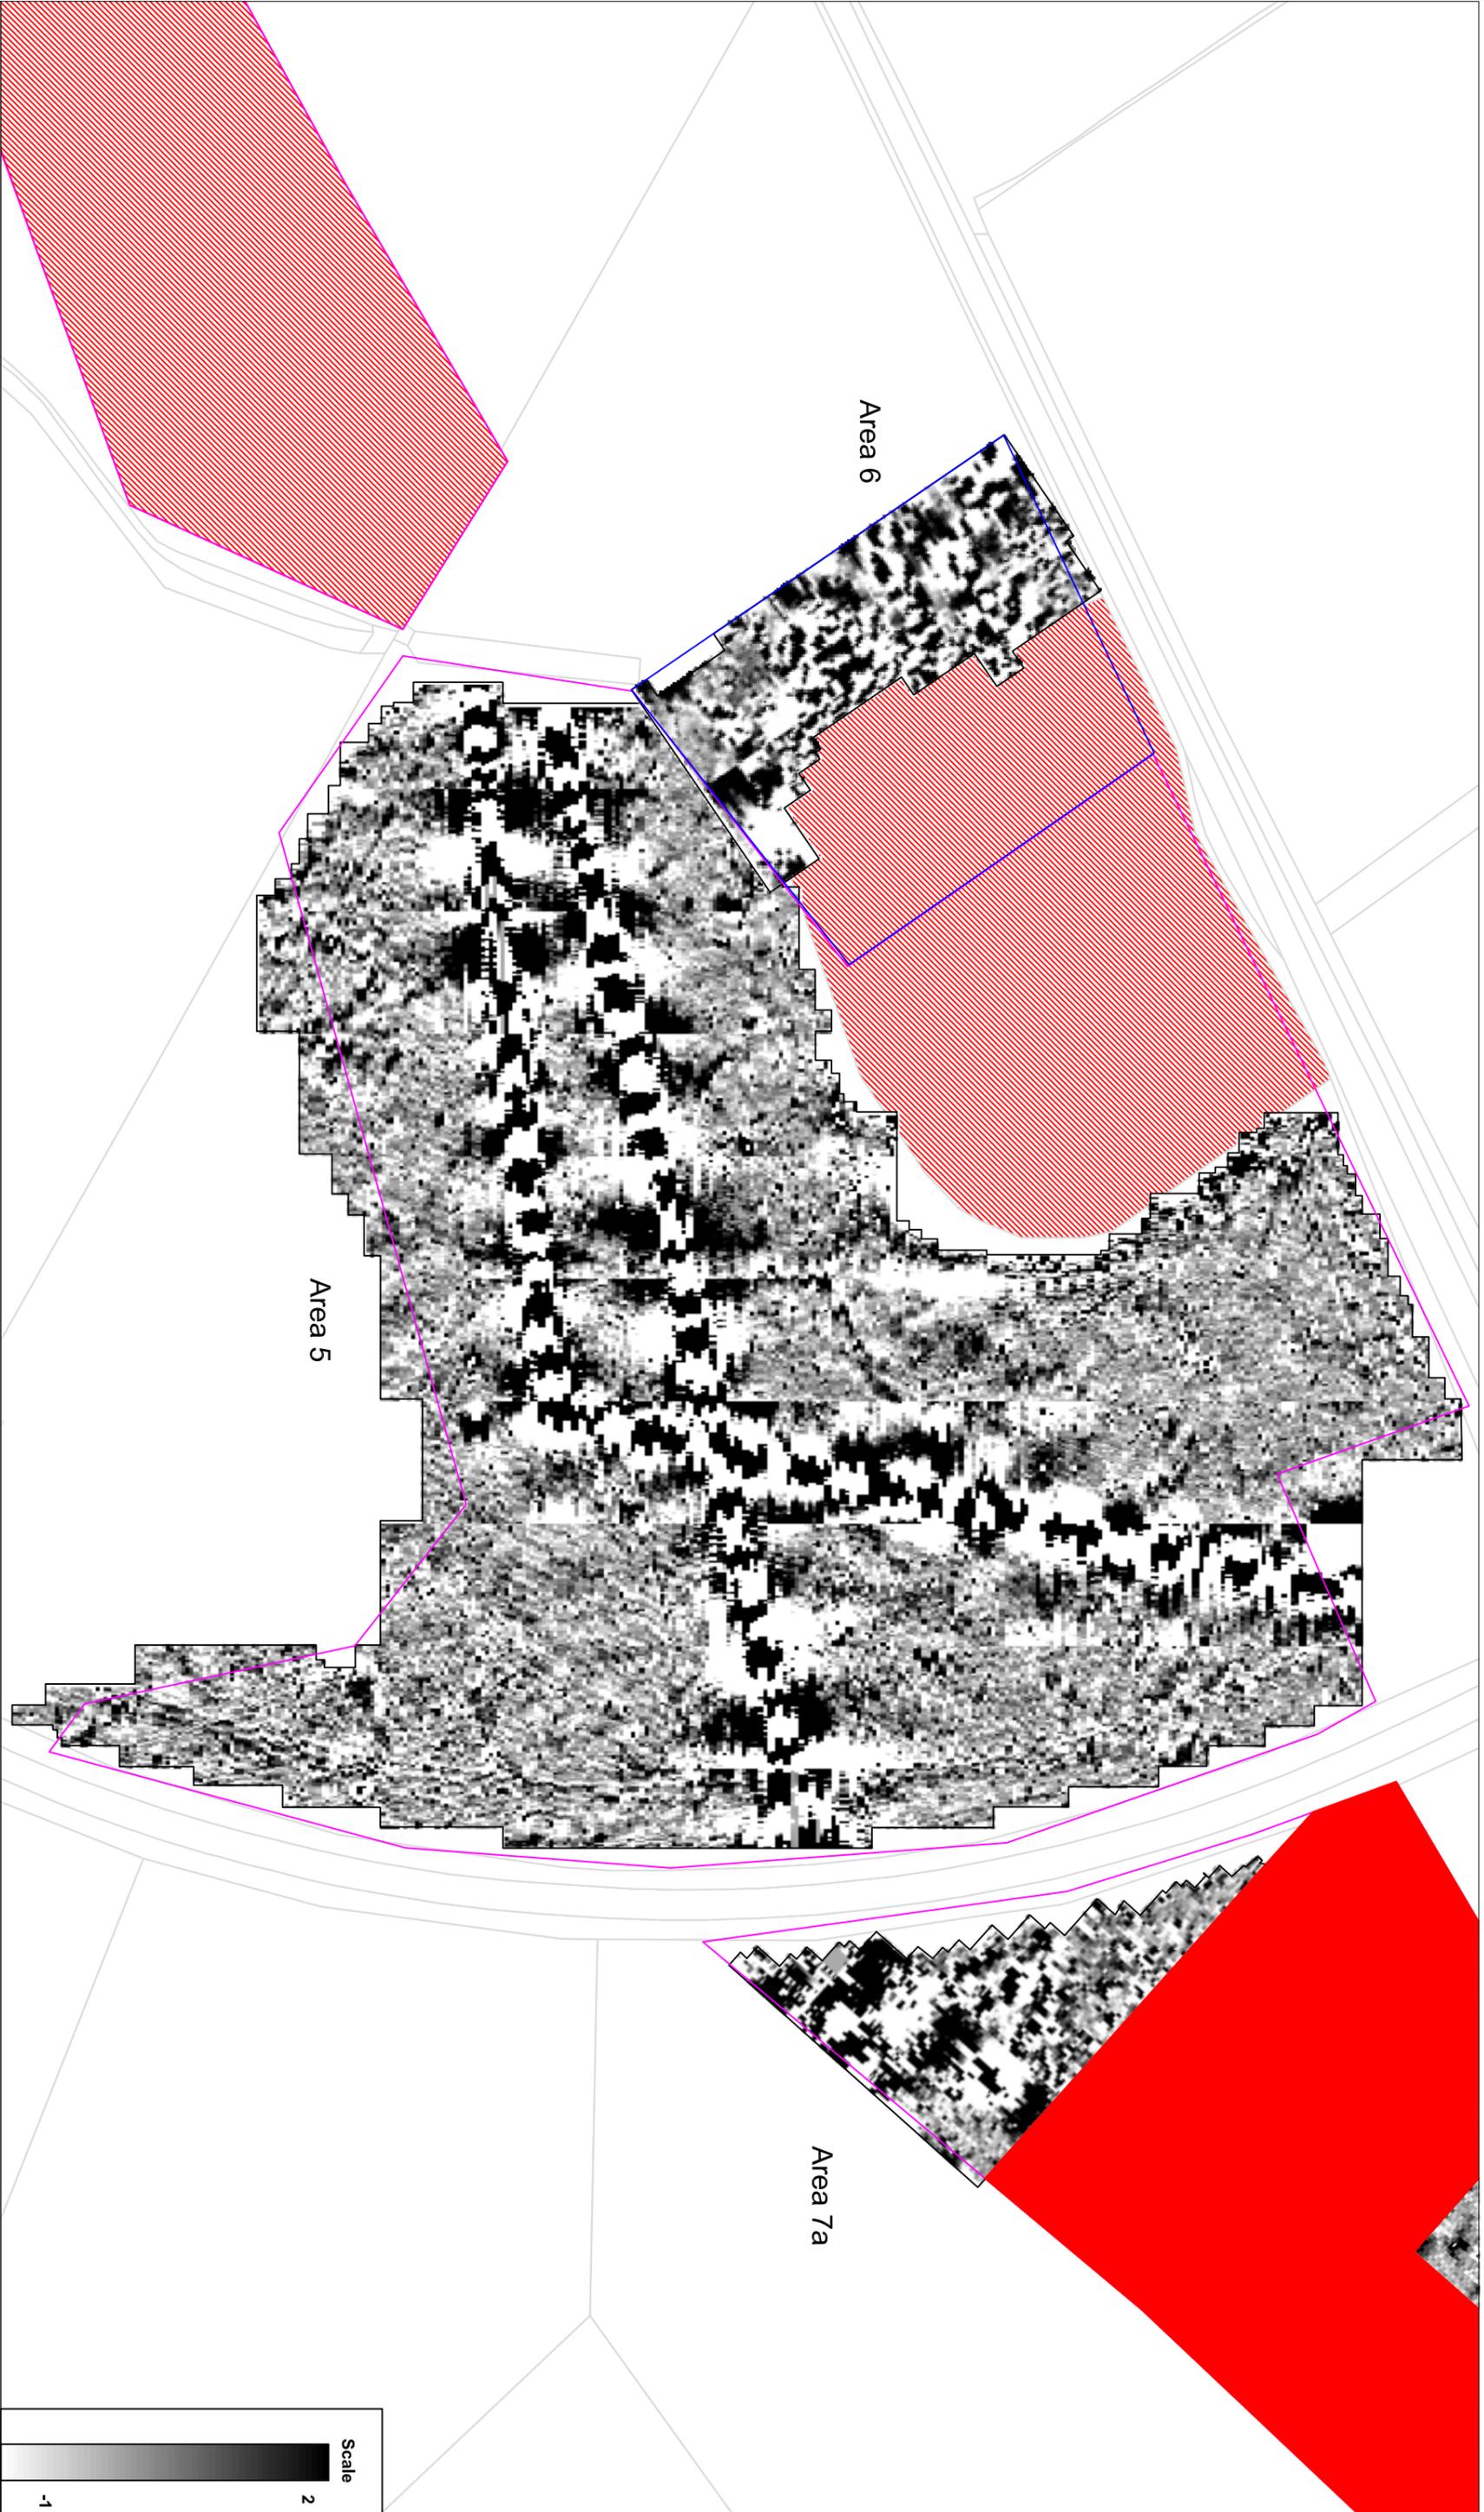
Figure 12

Unprocessed gradiometer survey results - greyscale plots: Areas 5 and 6

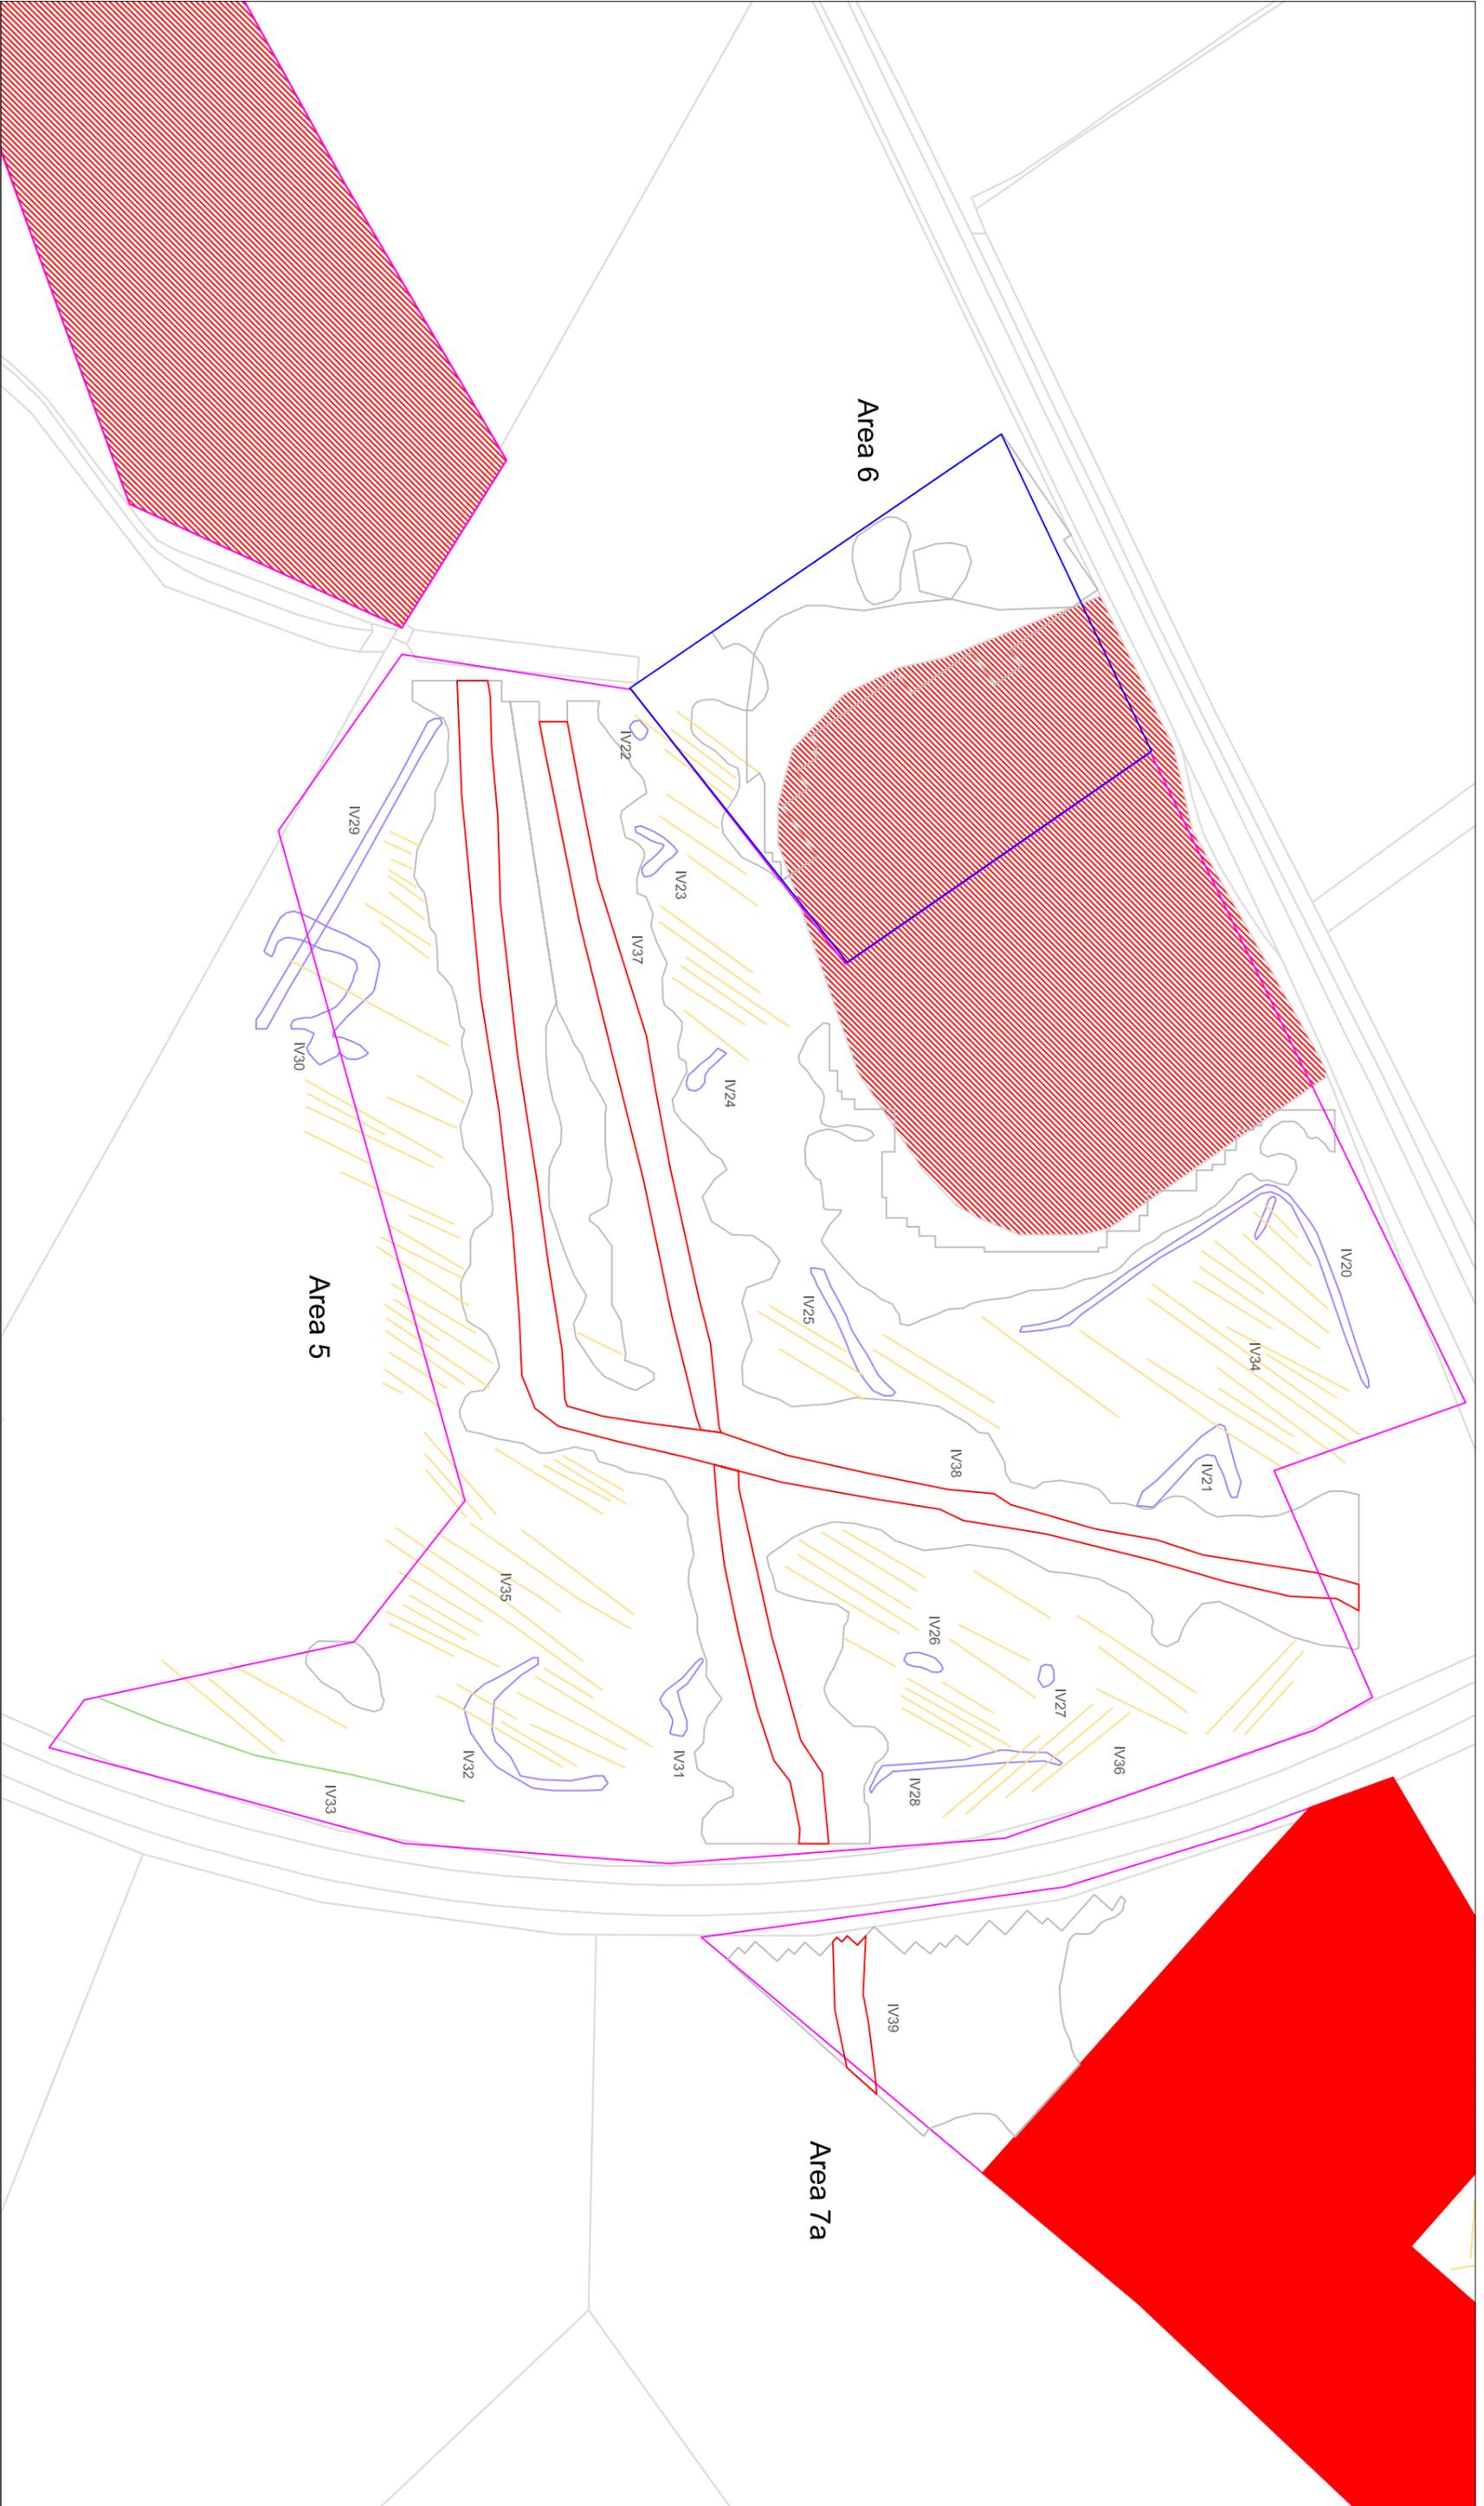
Figure 14

Interpretation of gradiometer survey results: Areas 5 and 6

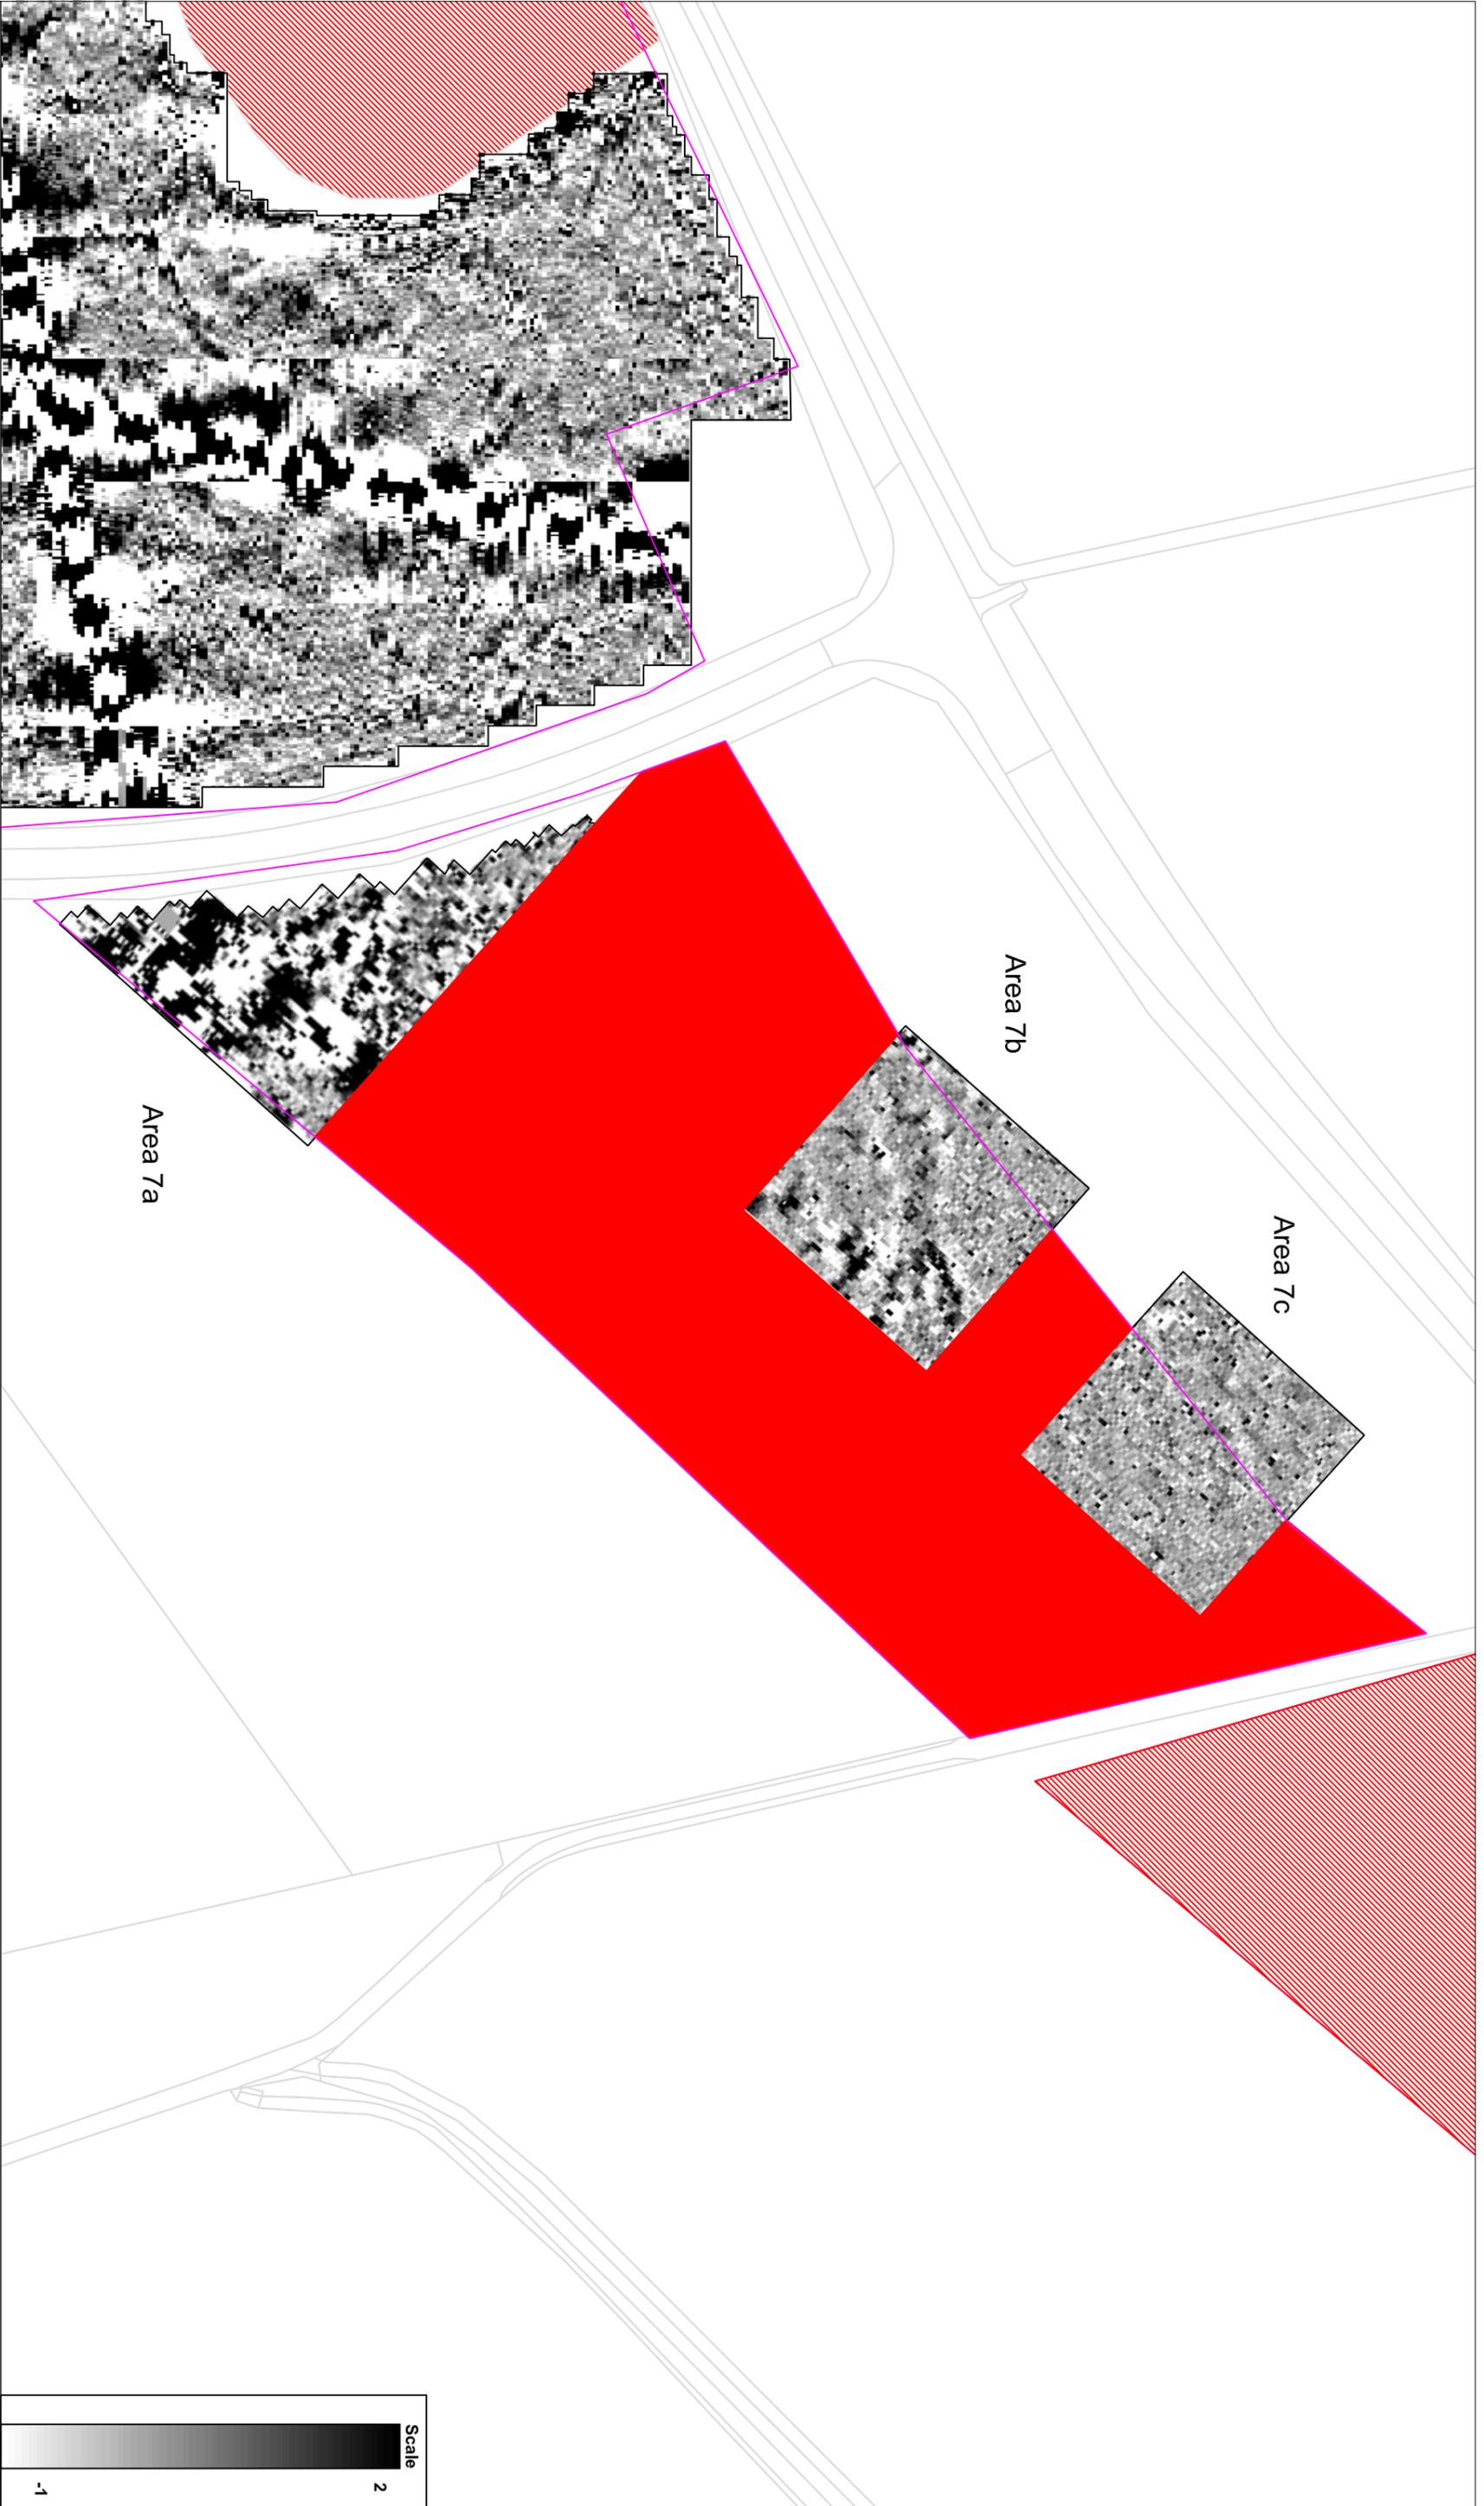
Figure 15

Unprocessed gradiometer survey results - greyscale plot: Area 7
