A96 Dualling Inverness to Nairn (including Nairn Bypass) Highlands Archaeological Geophysical Survey (Phase 2)

A96 Dualling Inverness to Nairn (including Nairn Bypass), Highlands Archaeological Geophysical Survey, (Phase 2)

A96 Dualling: Inverness to Nairn (including Nairn Bypass) Archaeological Metal Detecting Survey Report

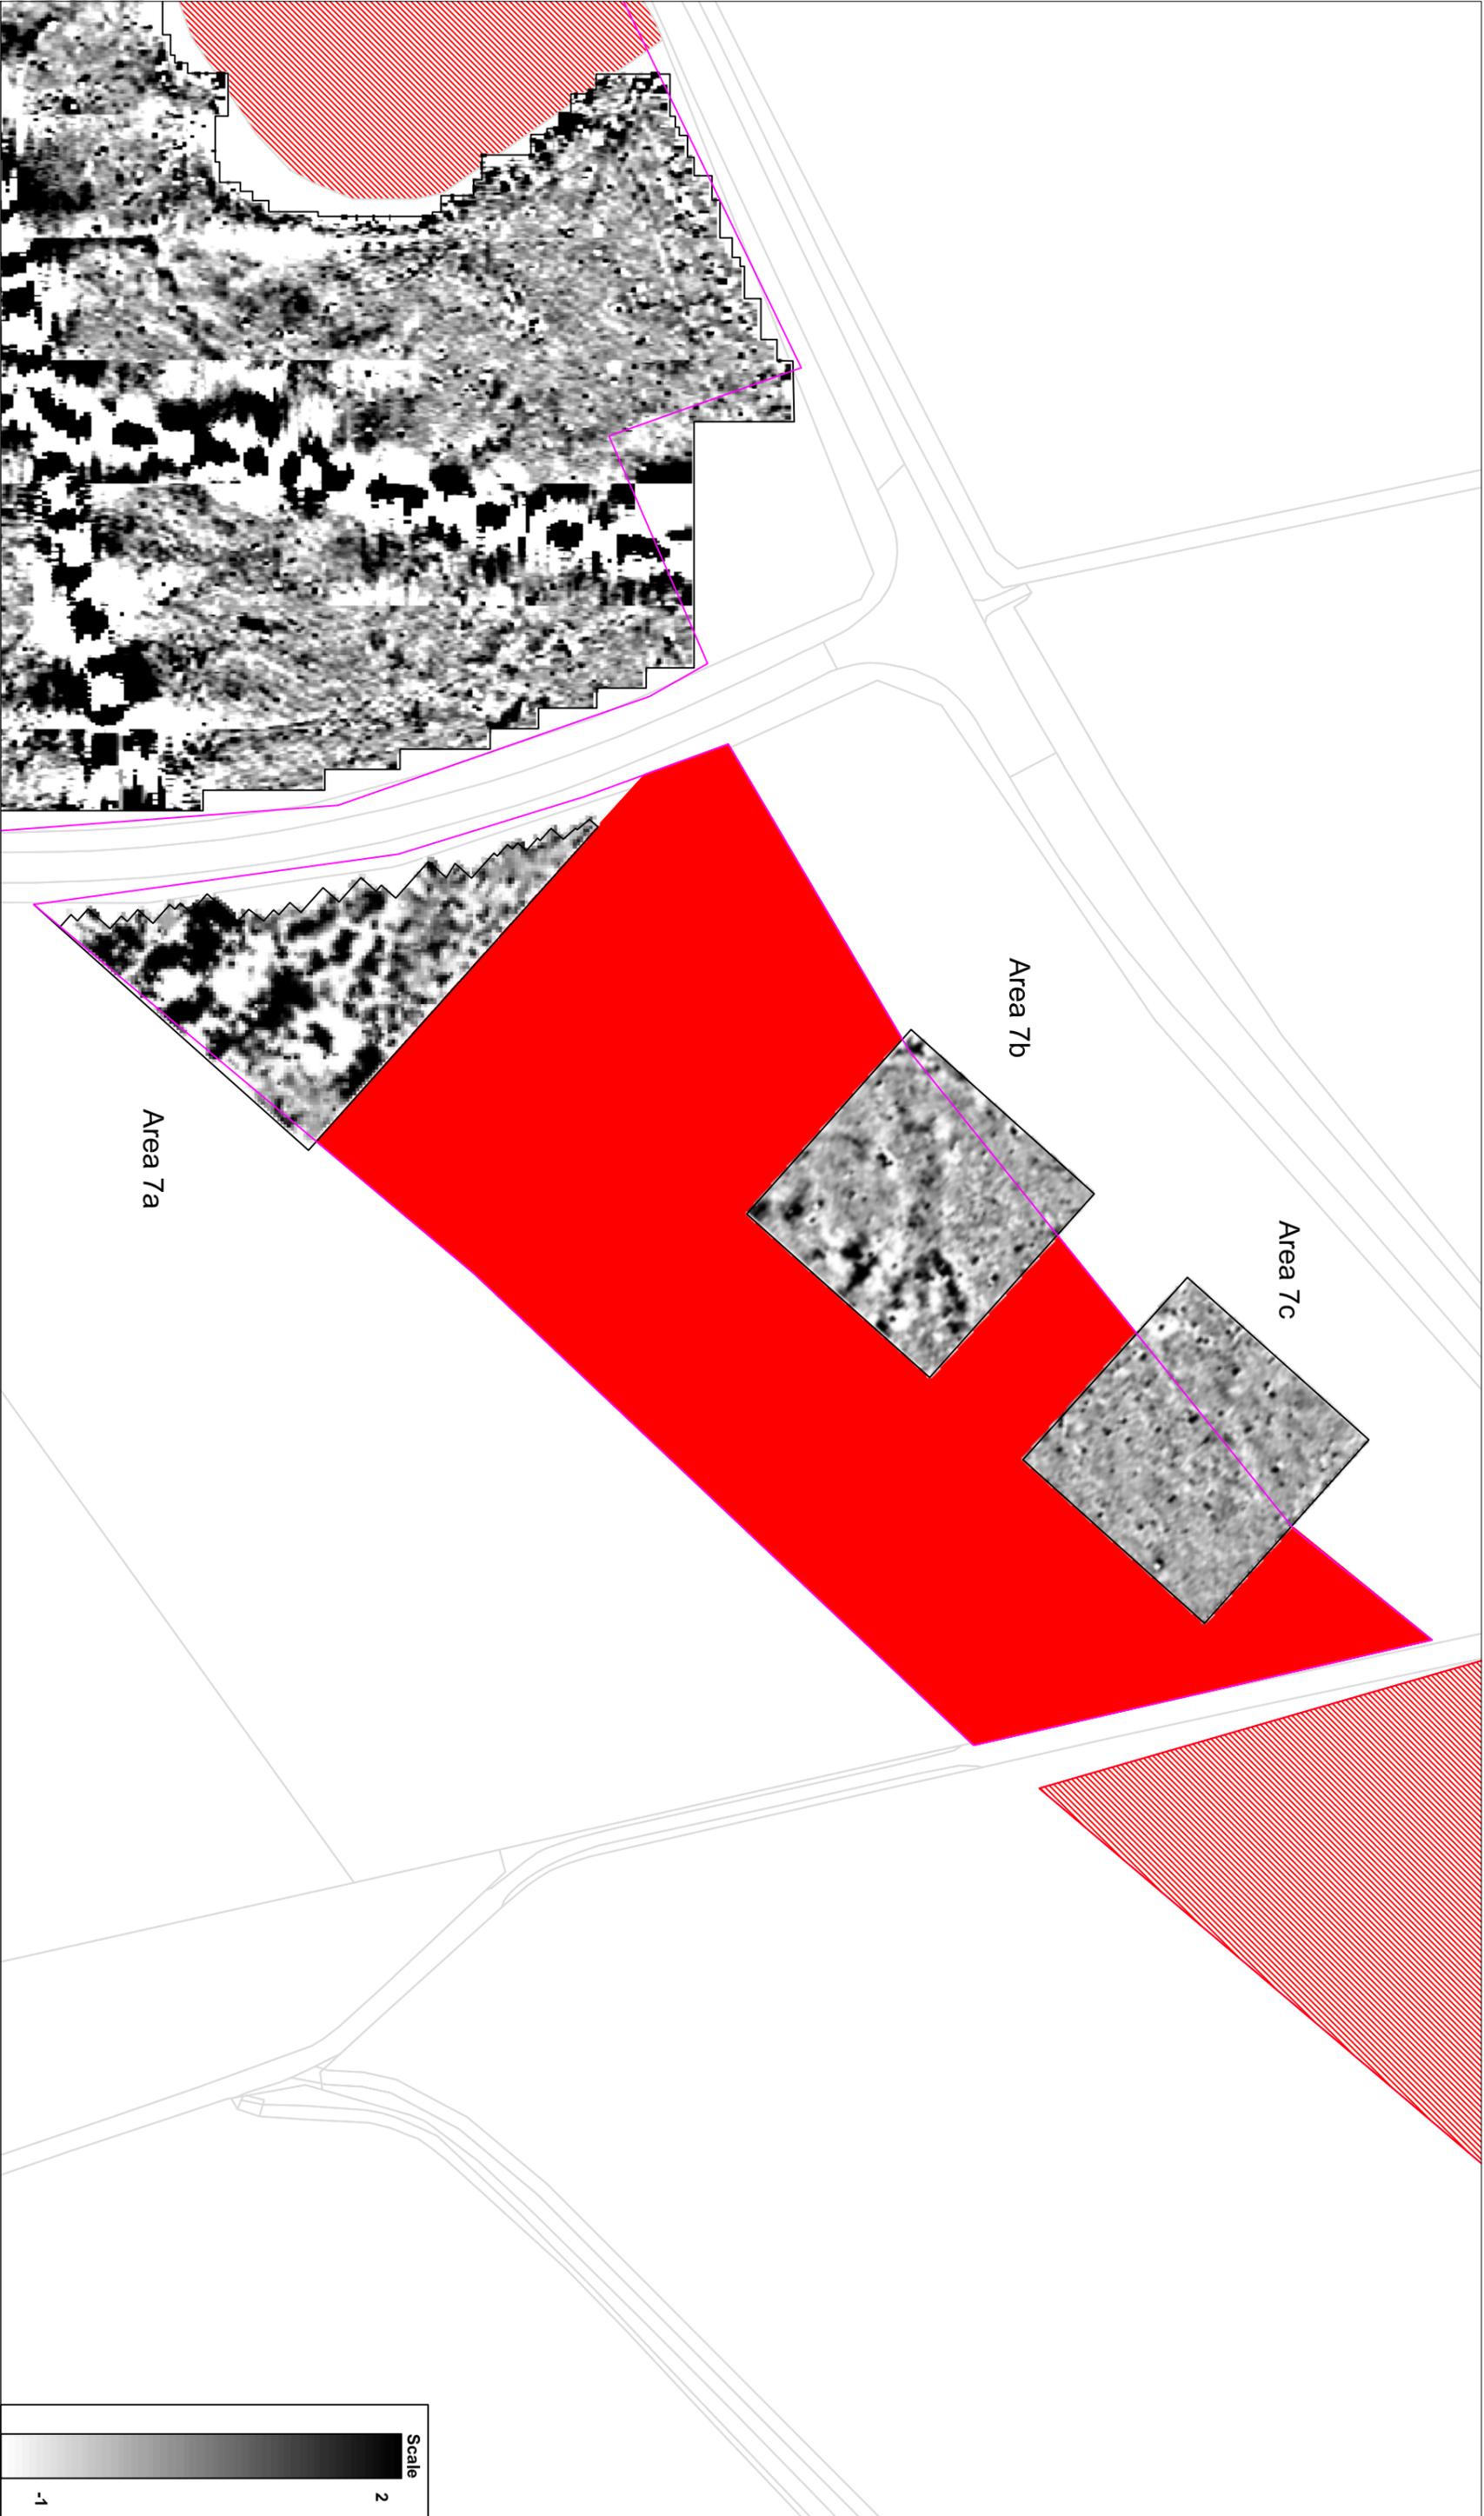
Figure 16

Processed gradiometer survey results - greyscale plot: Area 7

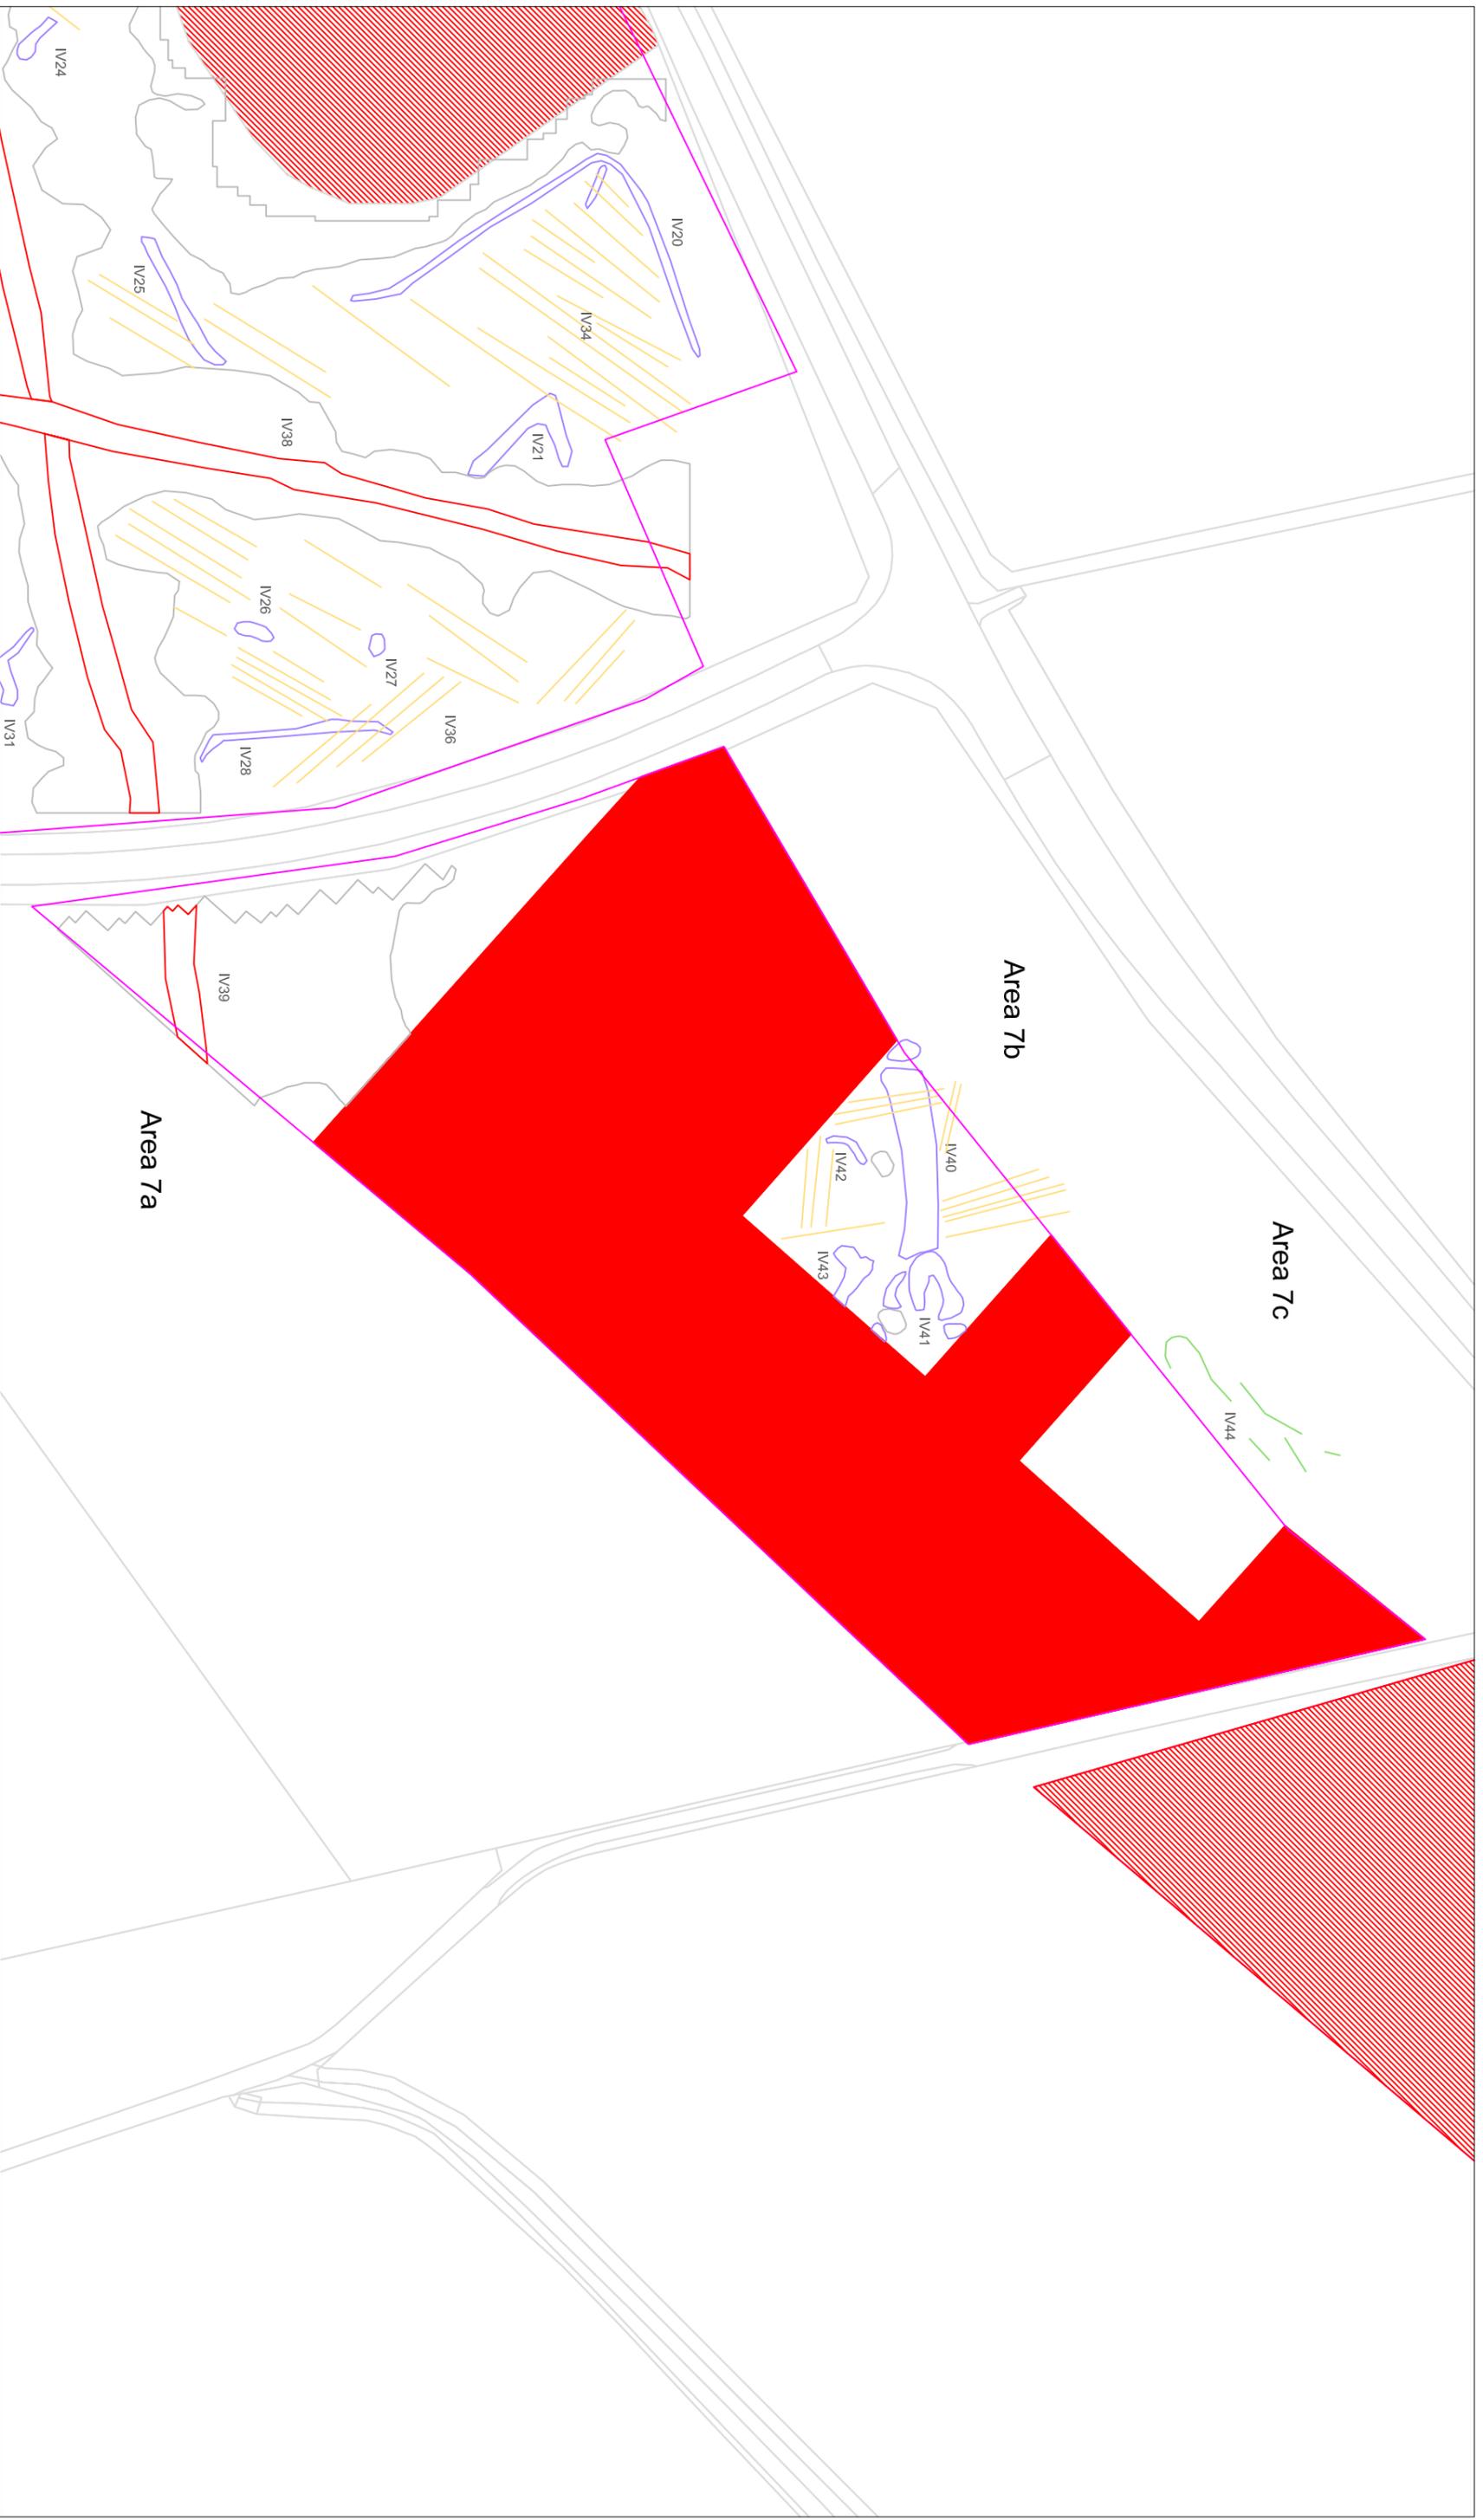
Figure 17

Interpretation of gradiometer survey results: Area 7

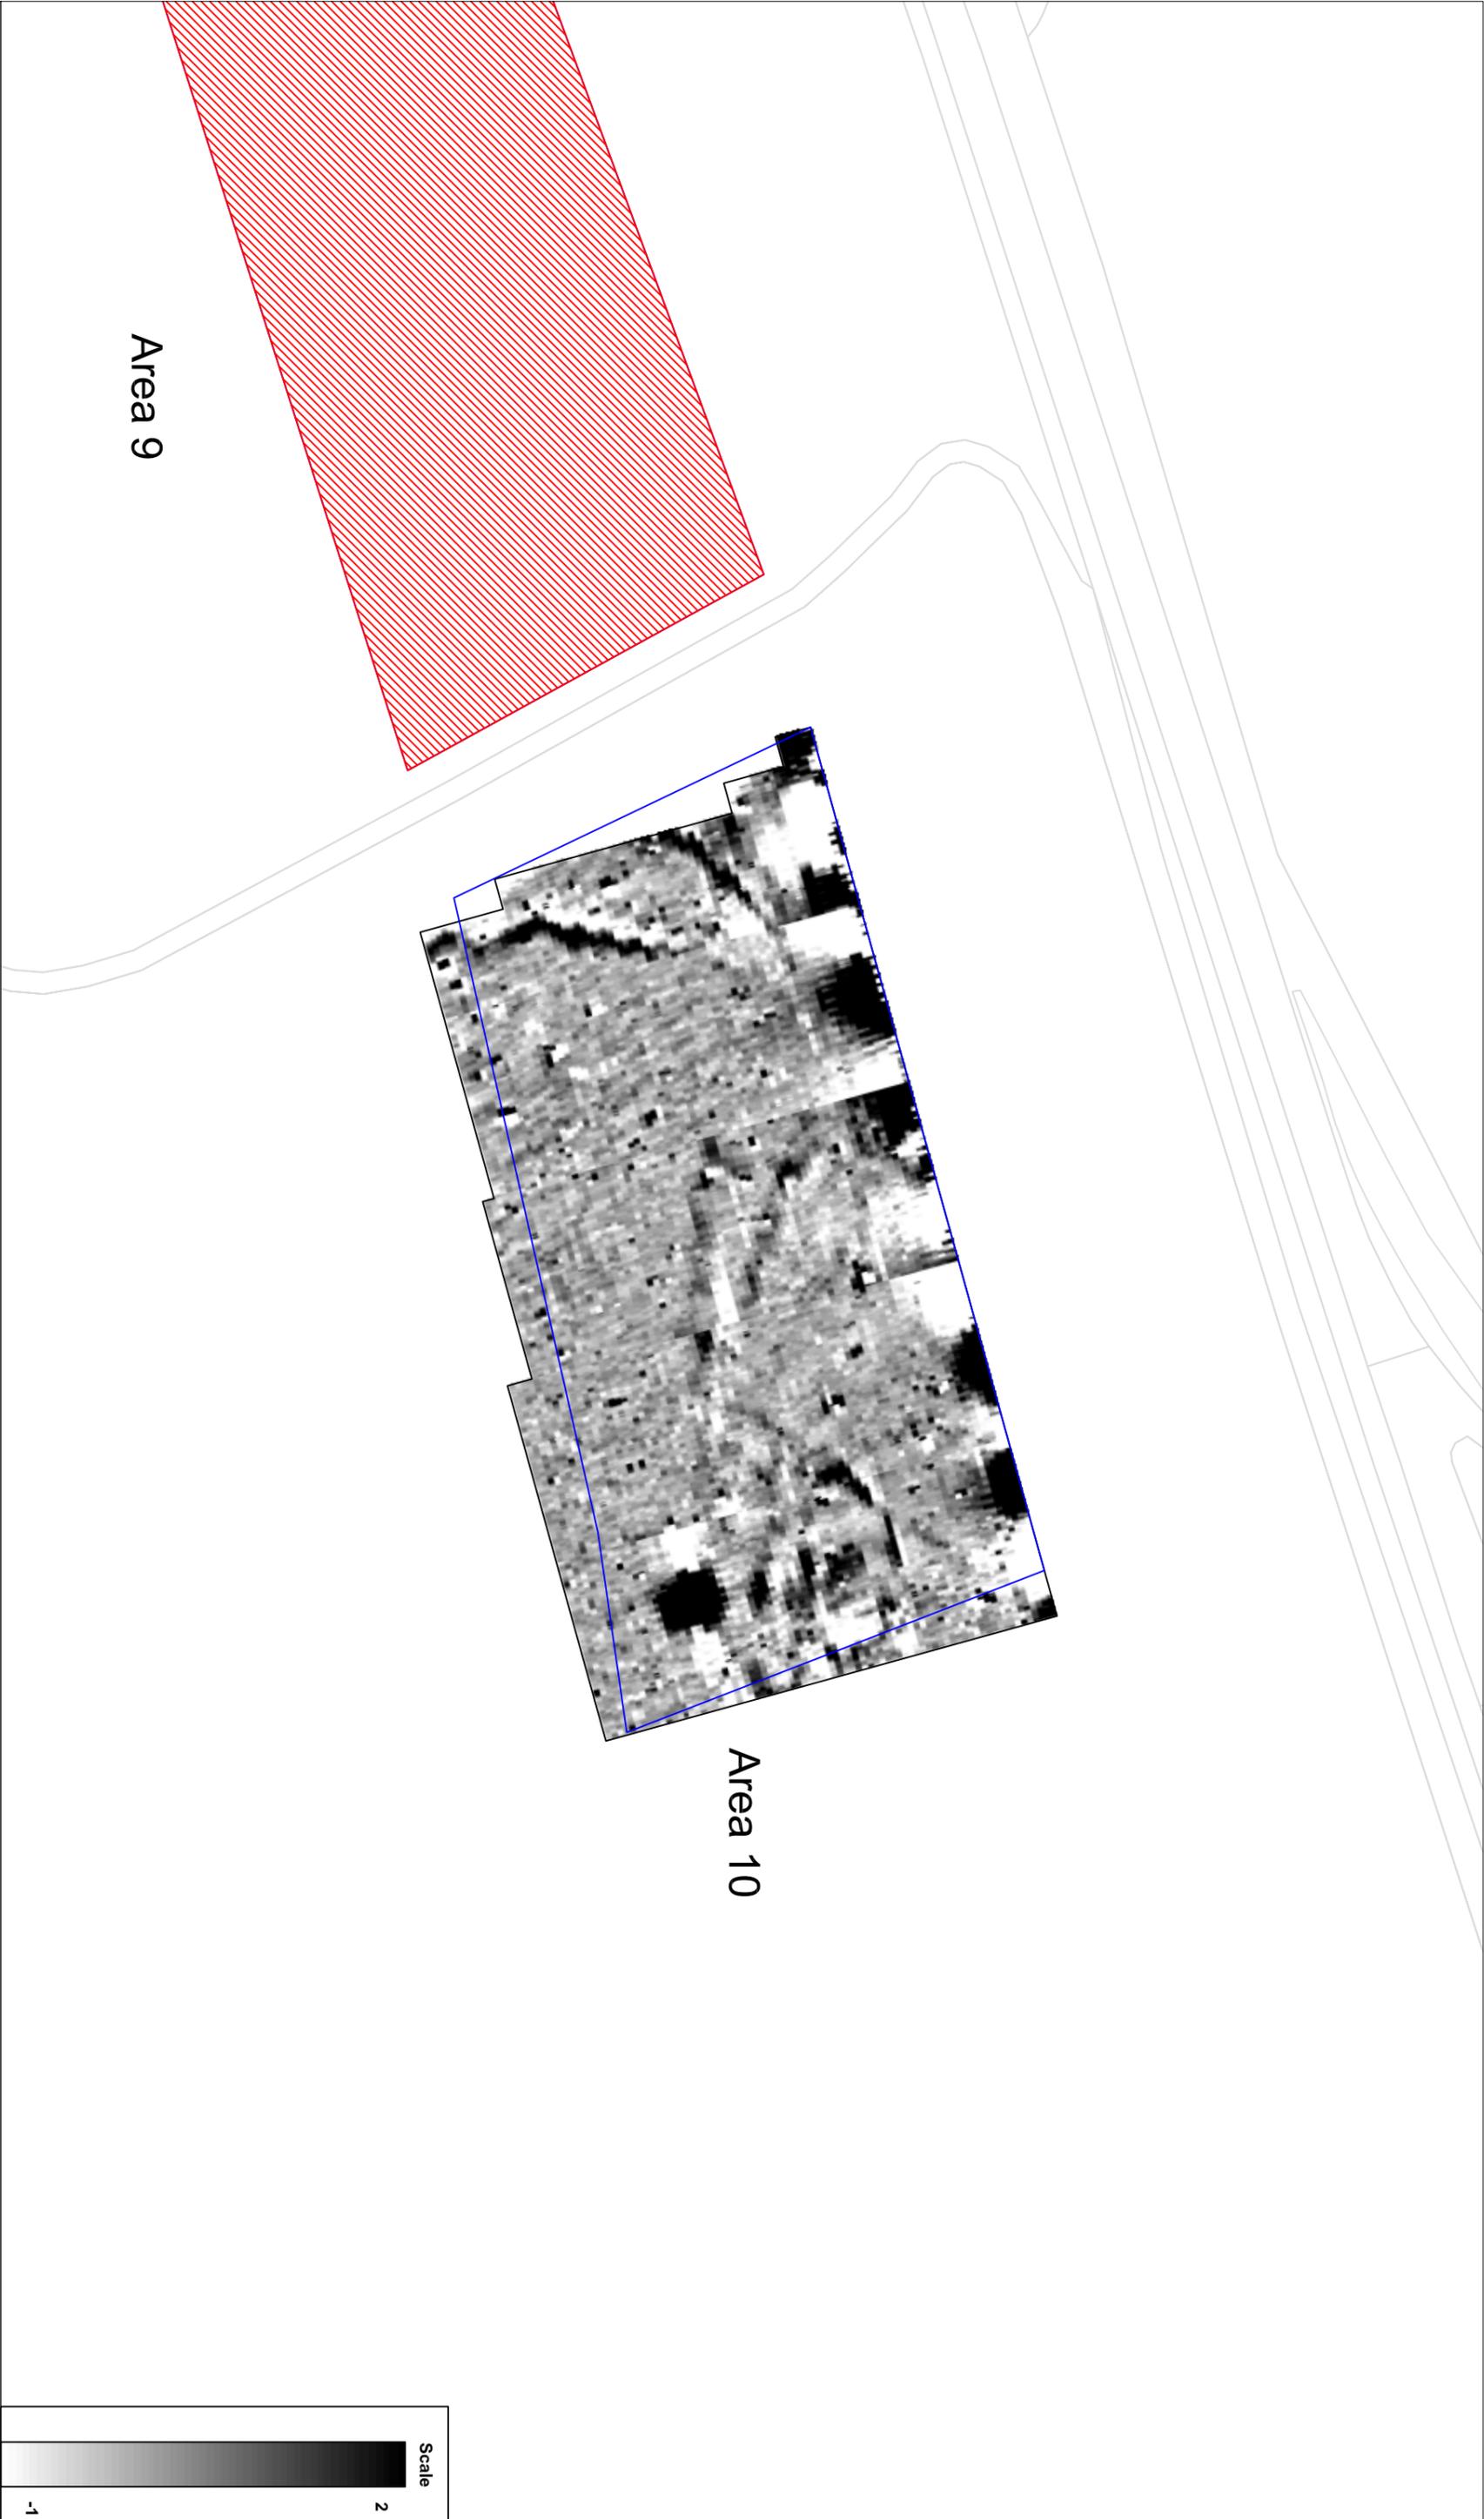
Figure
18

Unprocessed gradiometer survey results - greyscale plot: Area 10

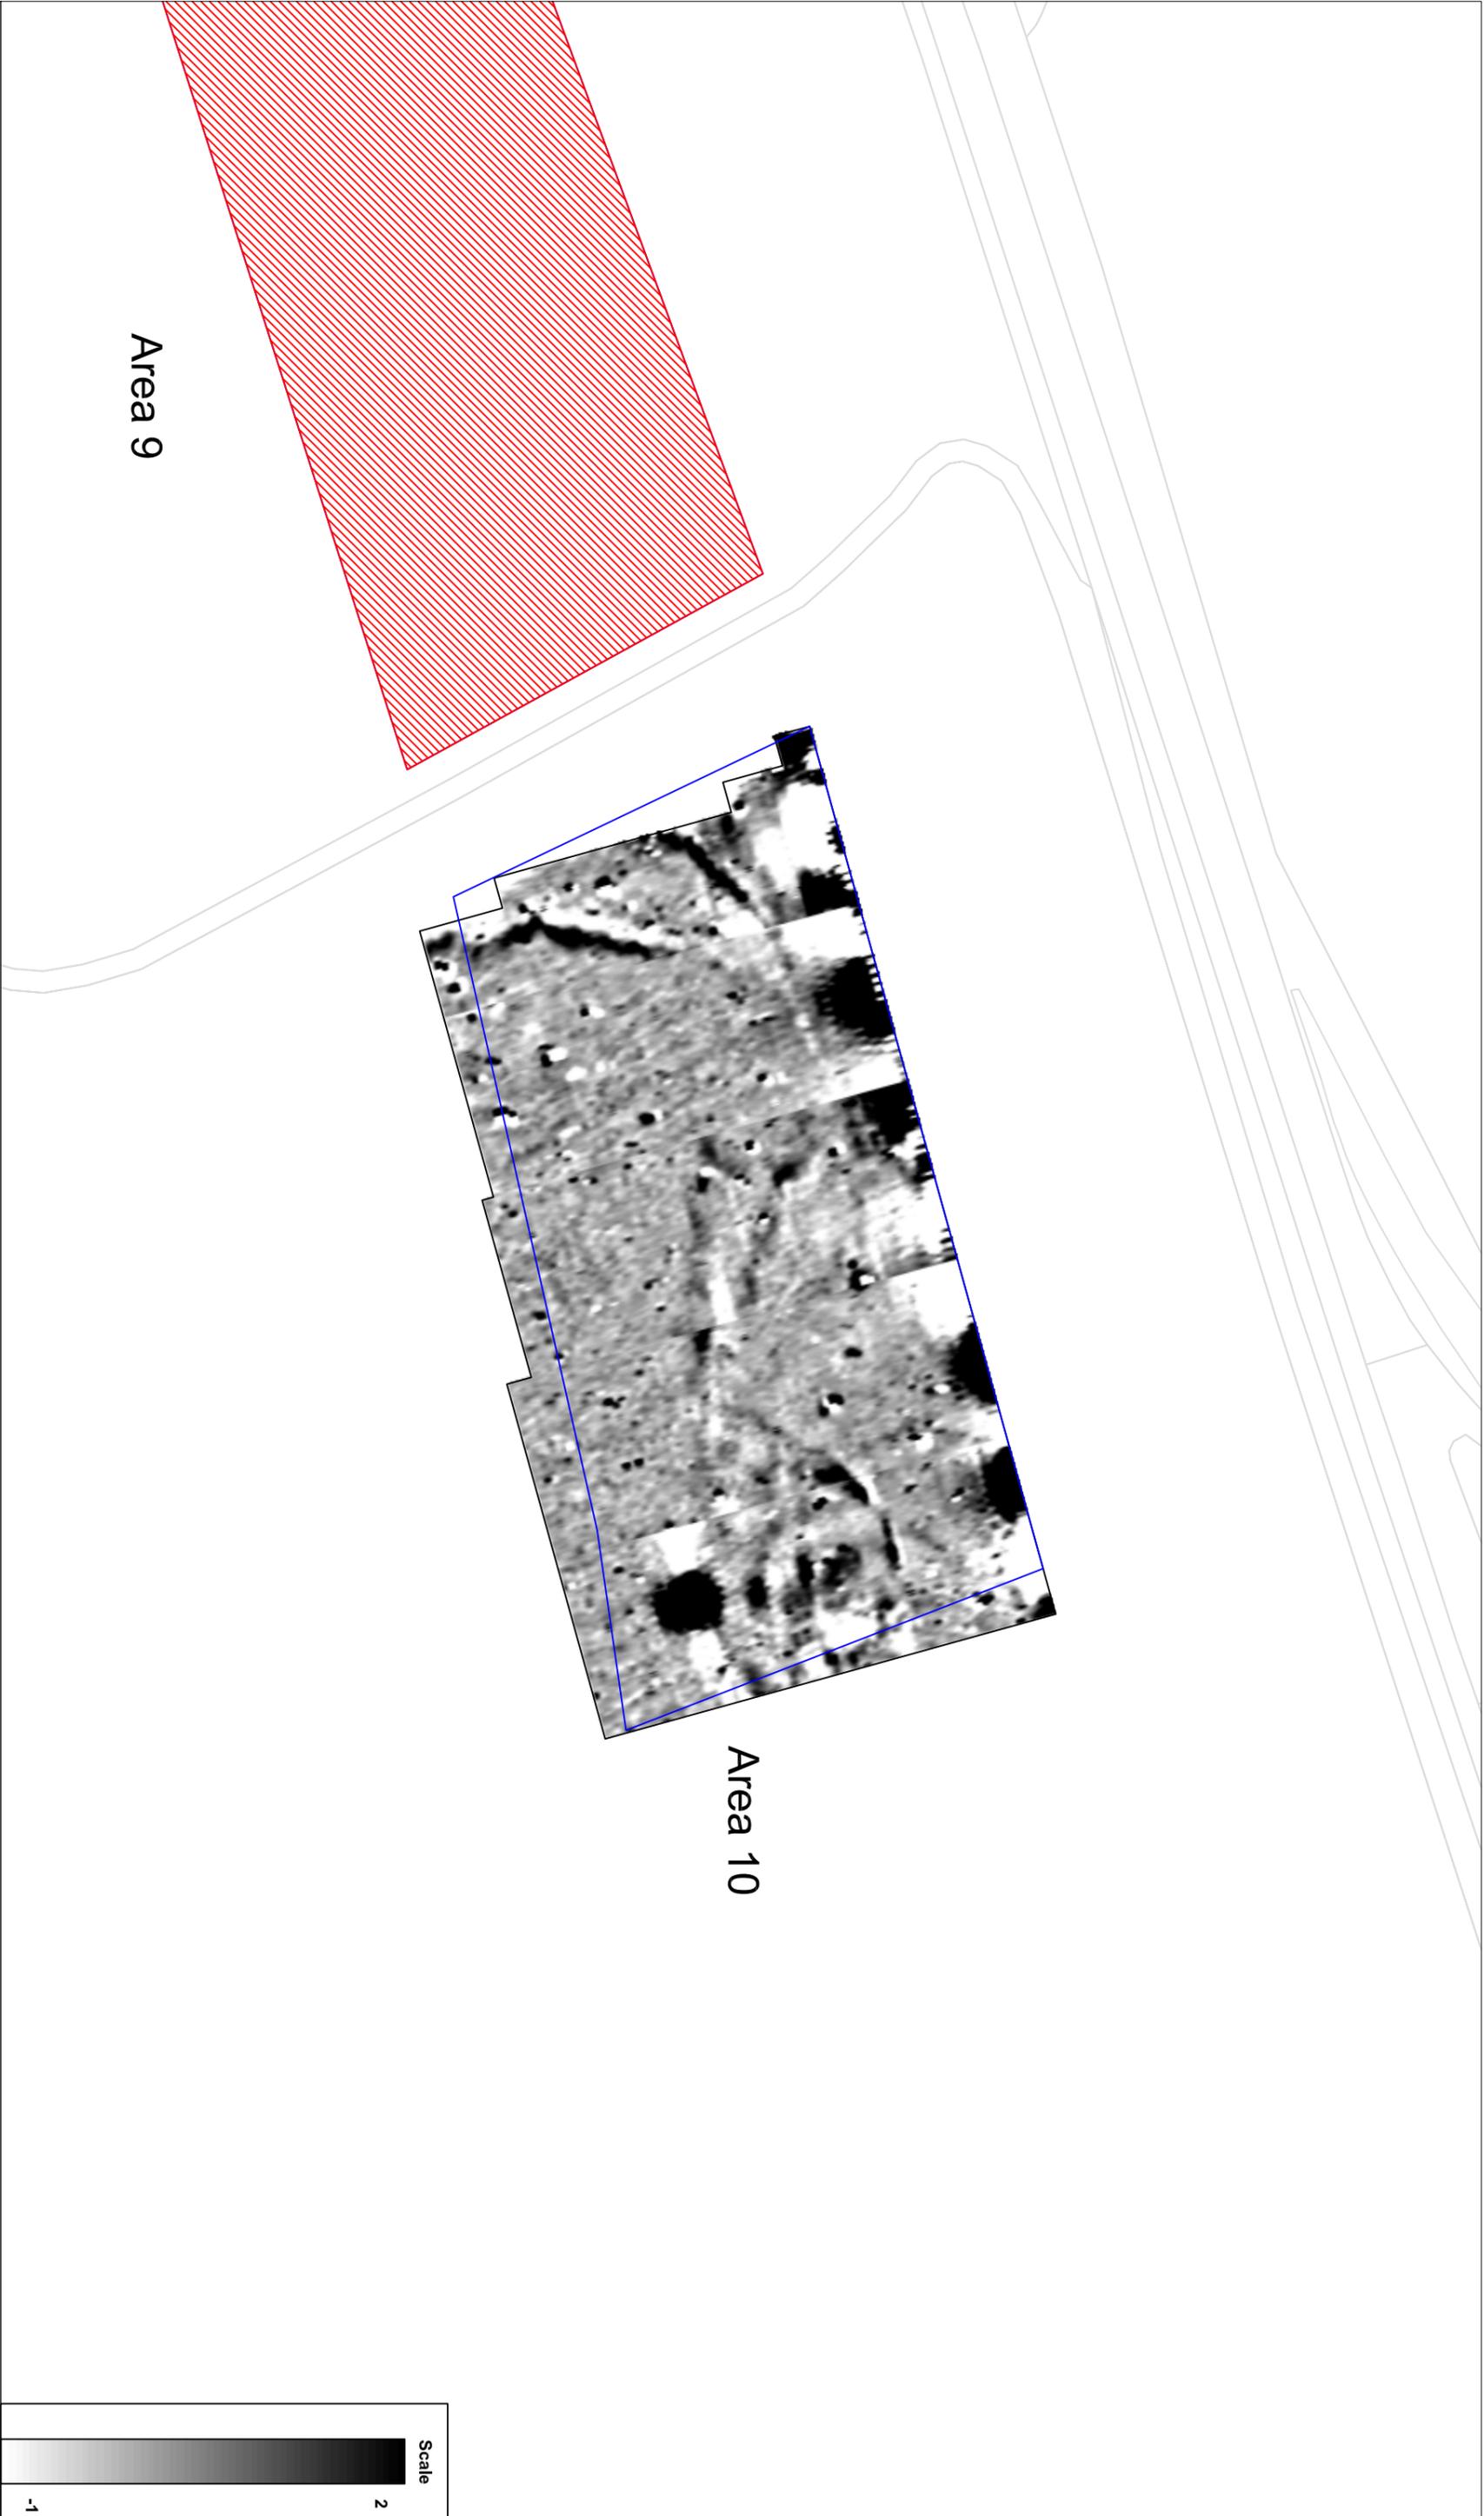
Figure 19

Processed gradiometer survey results - greyscale plot: Area 10

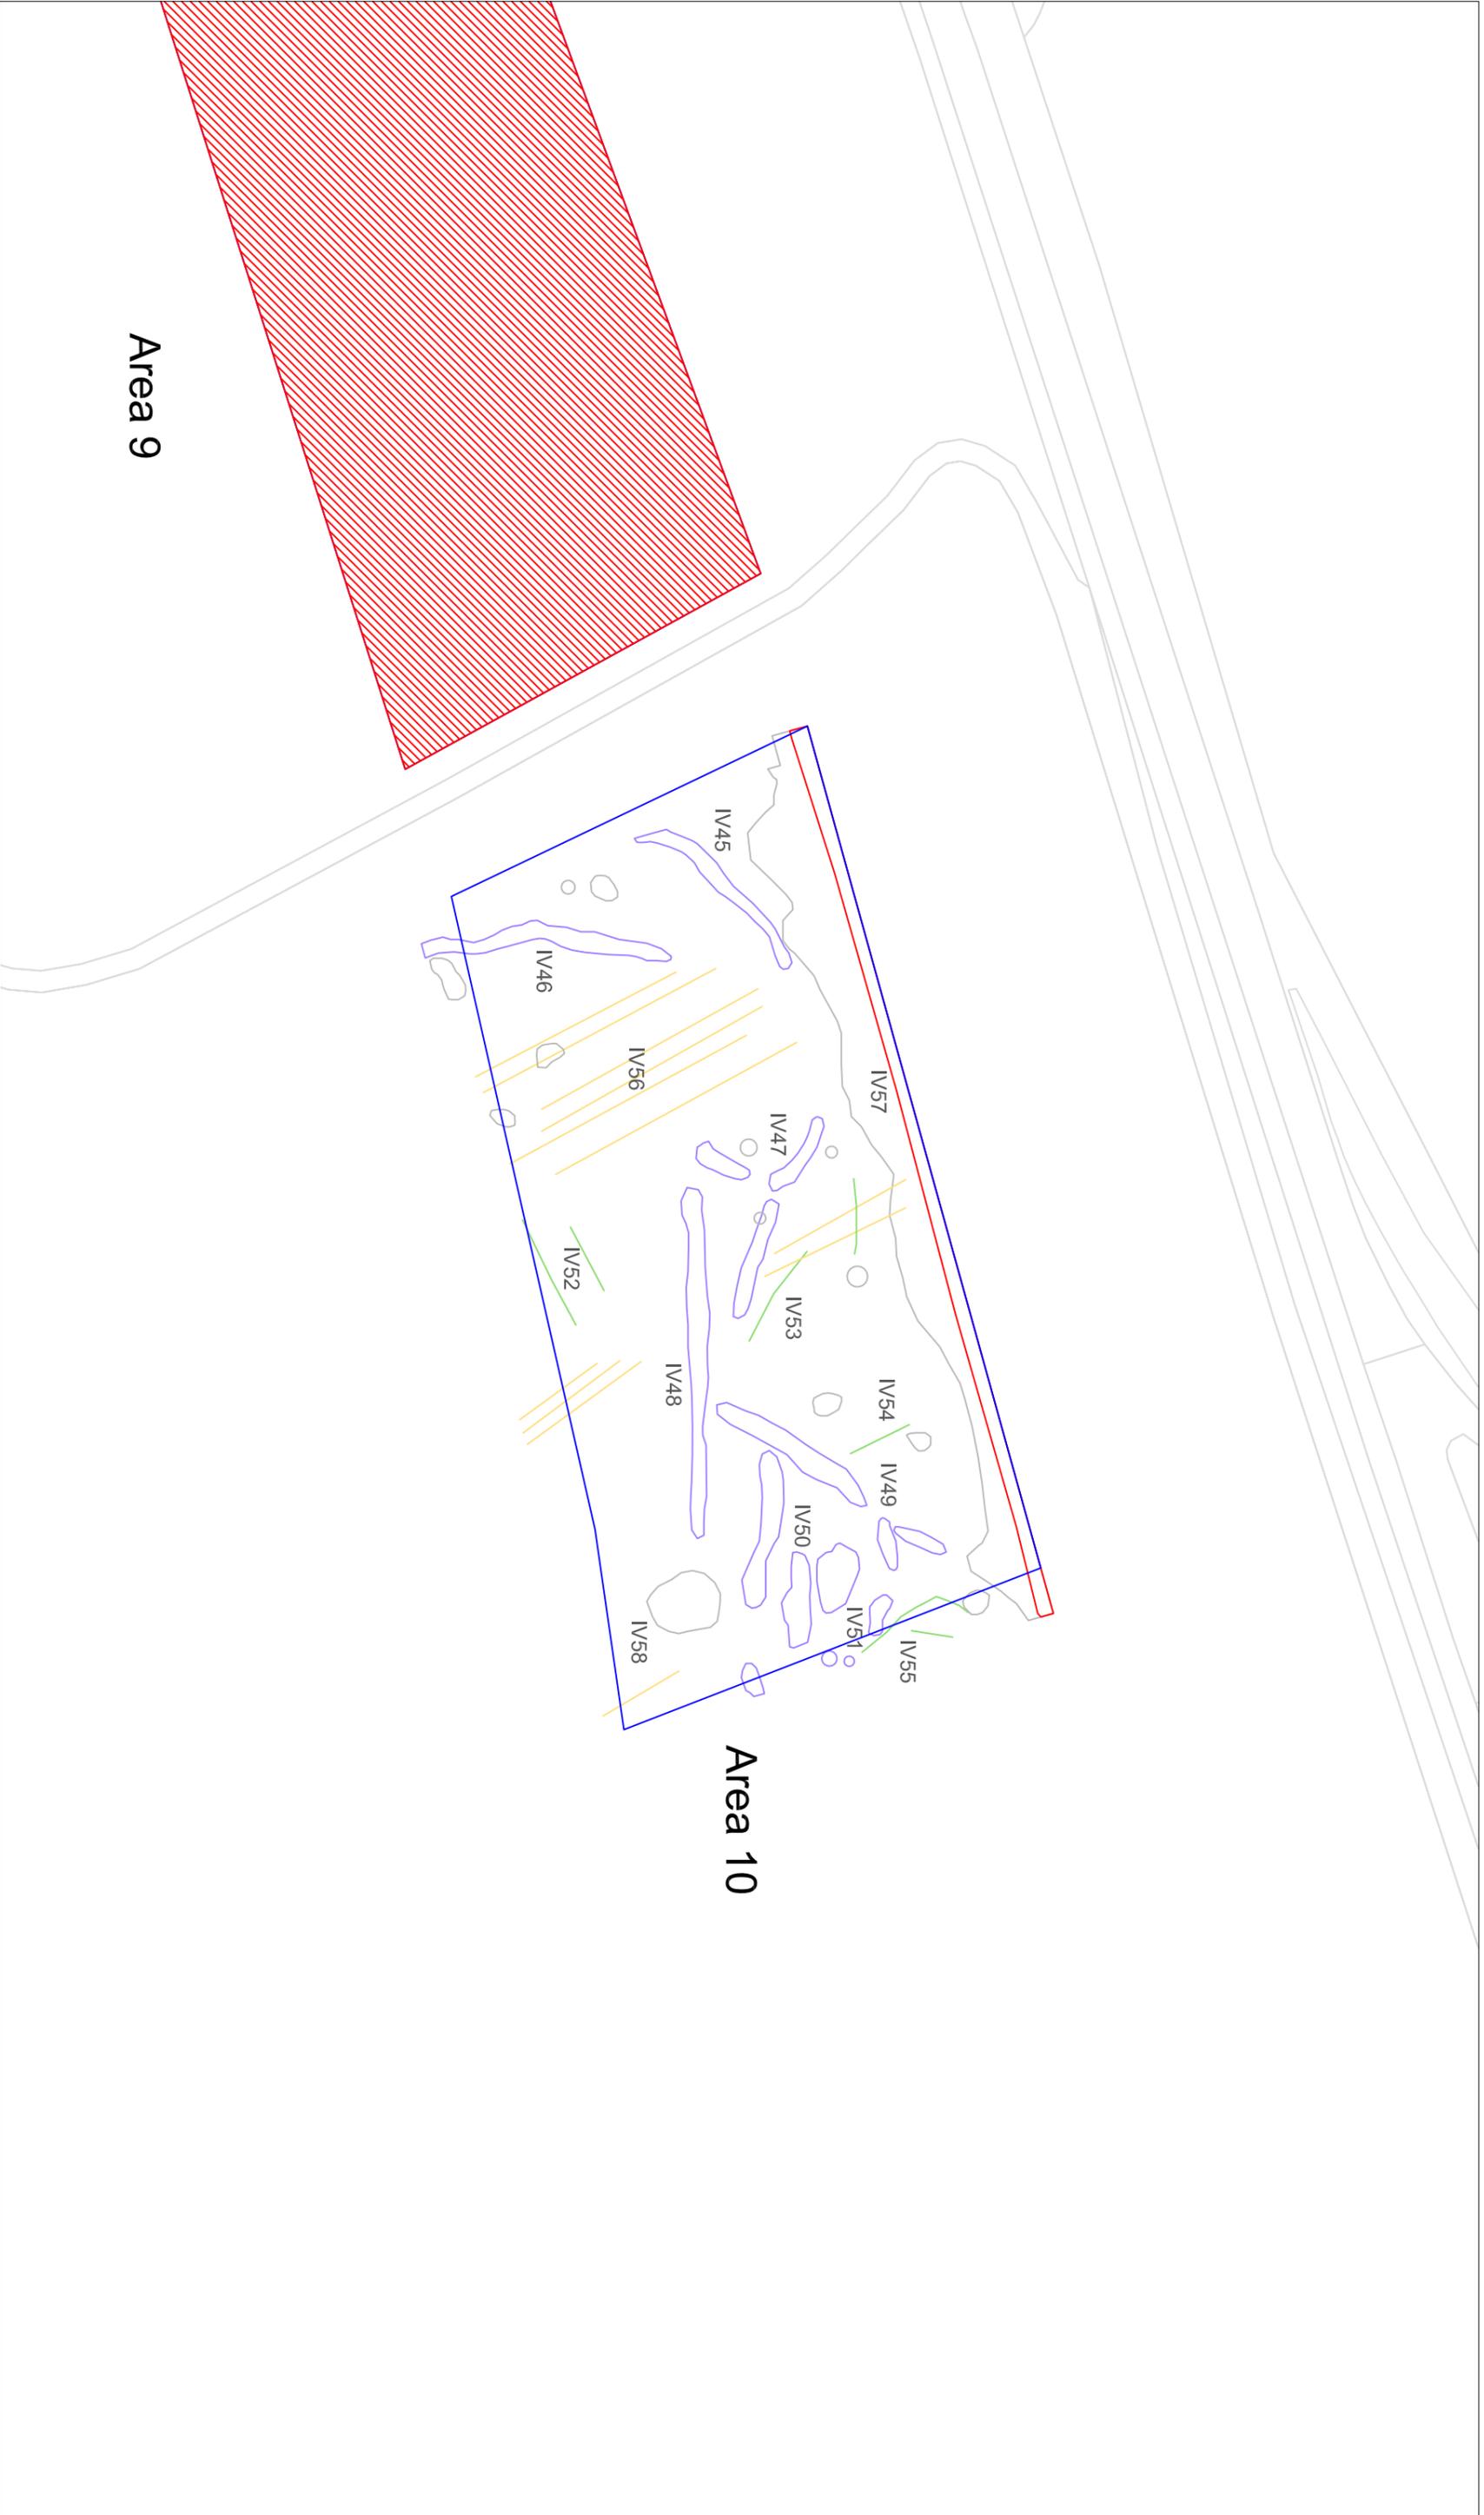
Figure 20

Interpretation of gradiometer survey results: Area 10

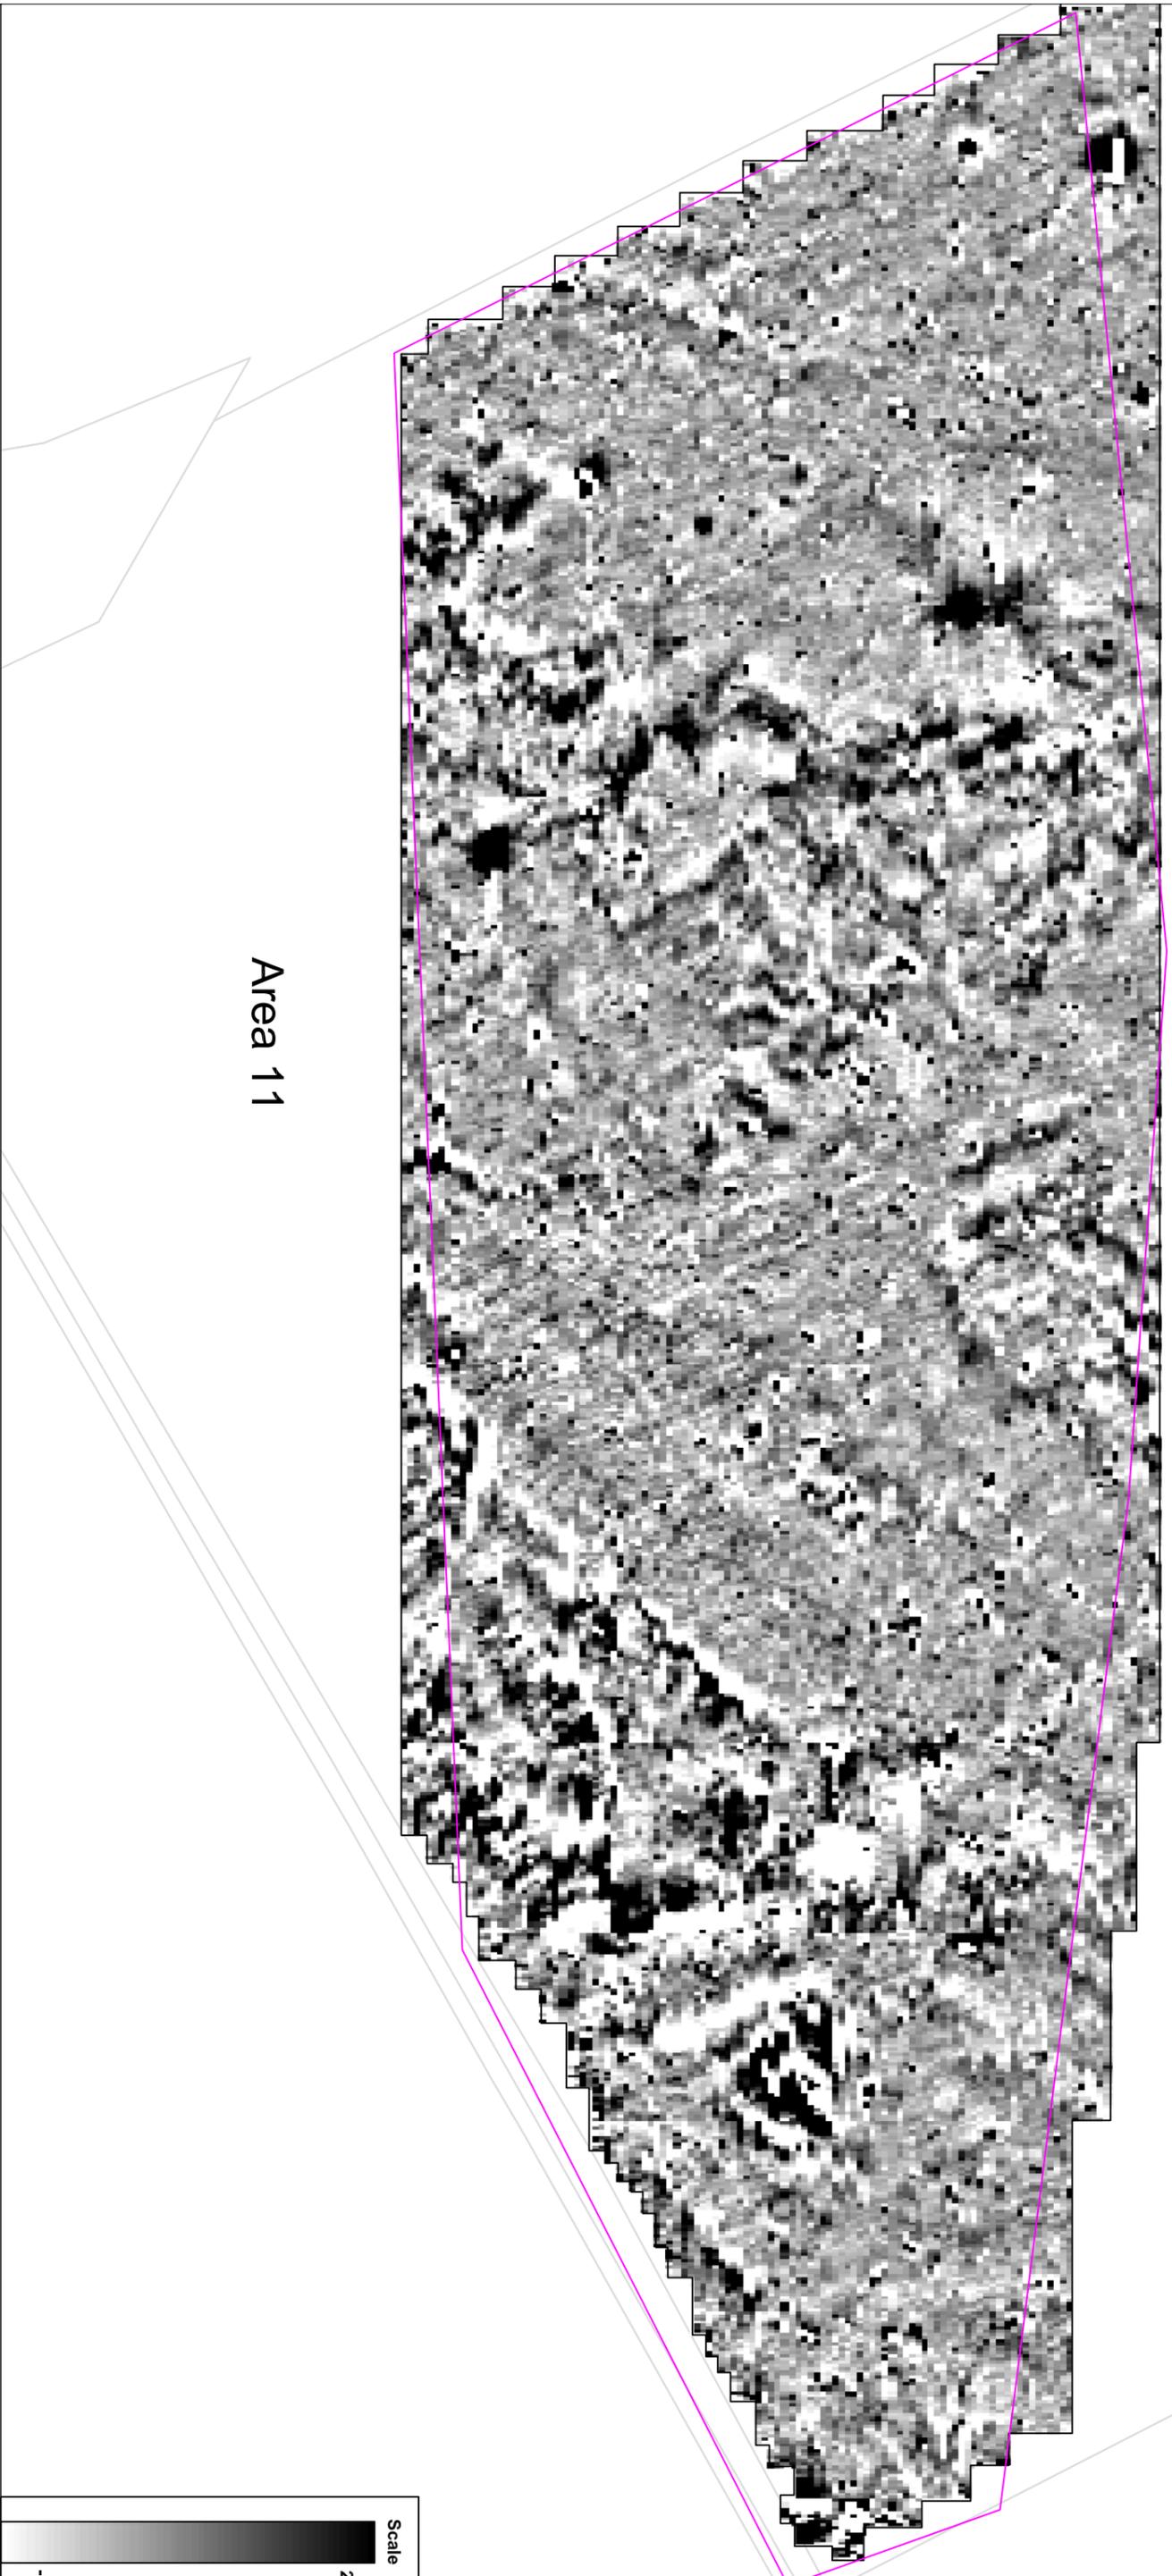
Figure
21

Unprocessed gradiometer survey results - greyscale plots: Area 11
