A96 Dualling Inverness to Nairn (including Nairn Bypass) Highlands Archaeological Geophysical Survey (Phase 2)

A96 Dualling Inverness to Nairn (including Nairn Bypass), Highlands Archaeological Geophysical Survey, (Phase 2)

A96 Dualling: Inverness to Nairn (including Nairn Bypass) Archaeological Metal Detecting Survey Report

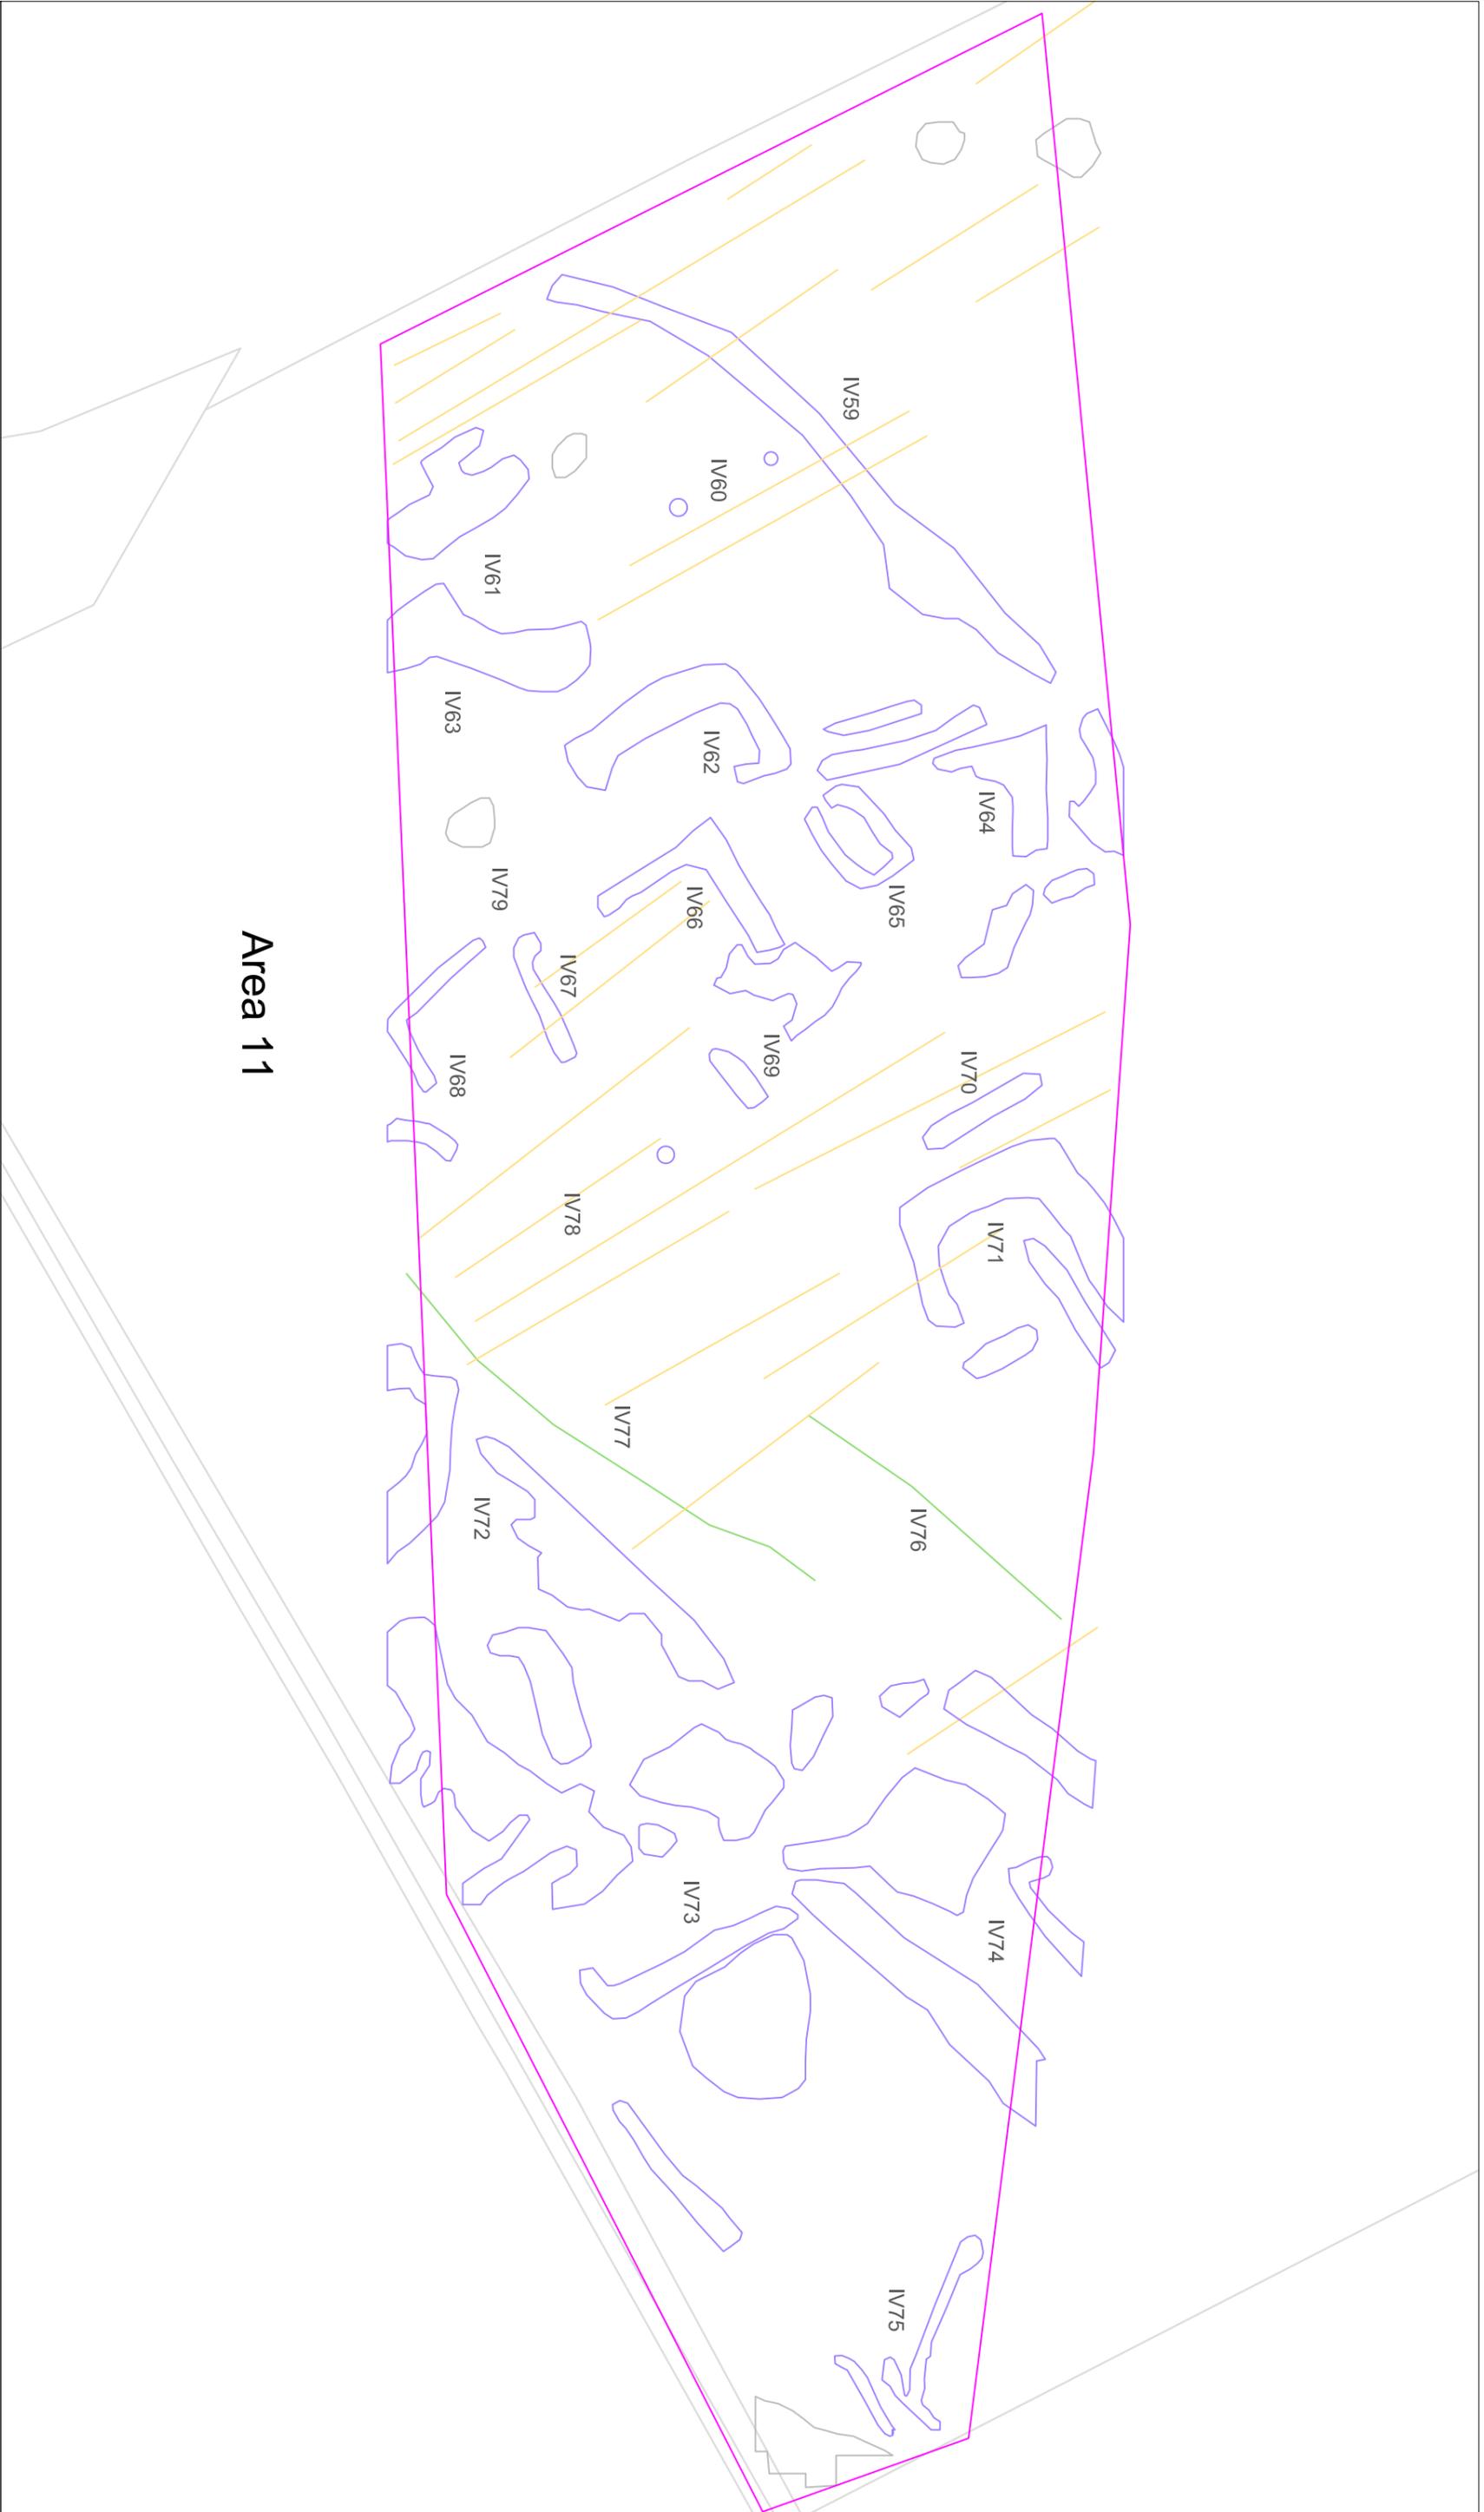
Interpretation of gradiometer survey results: Area 11

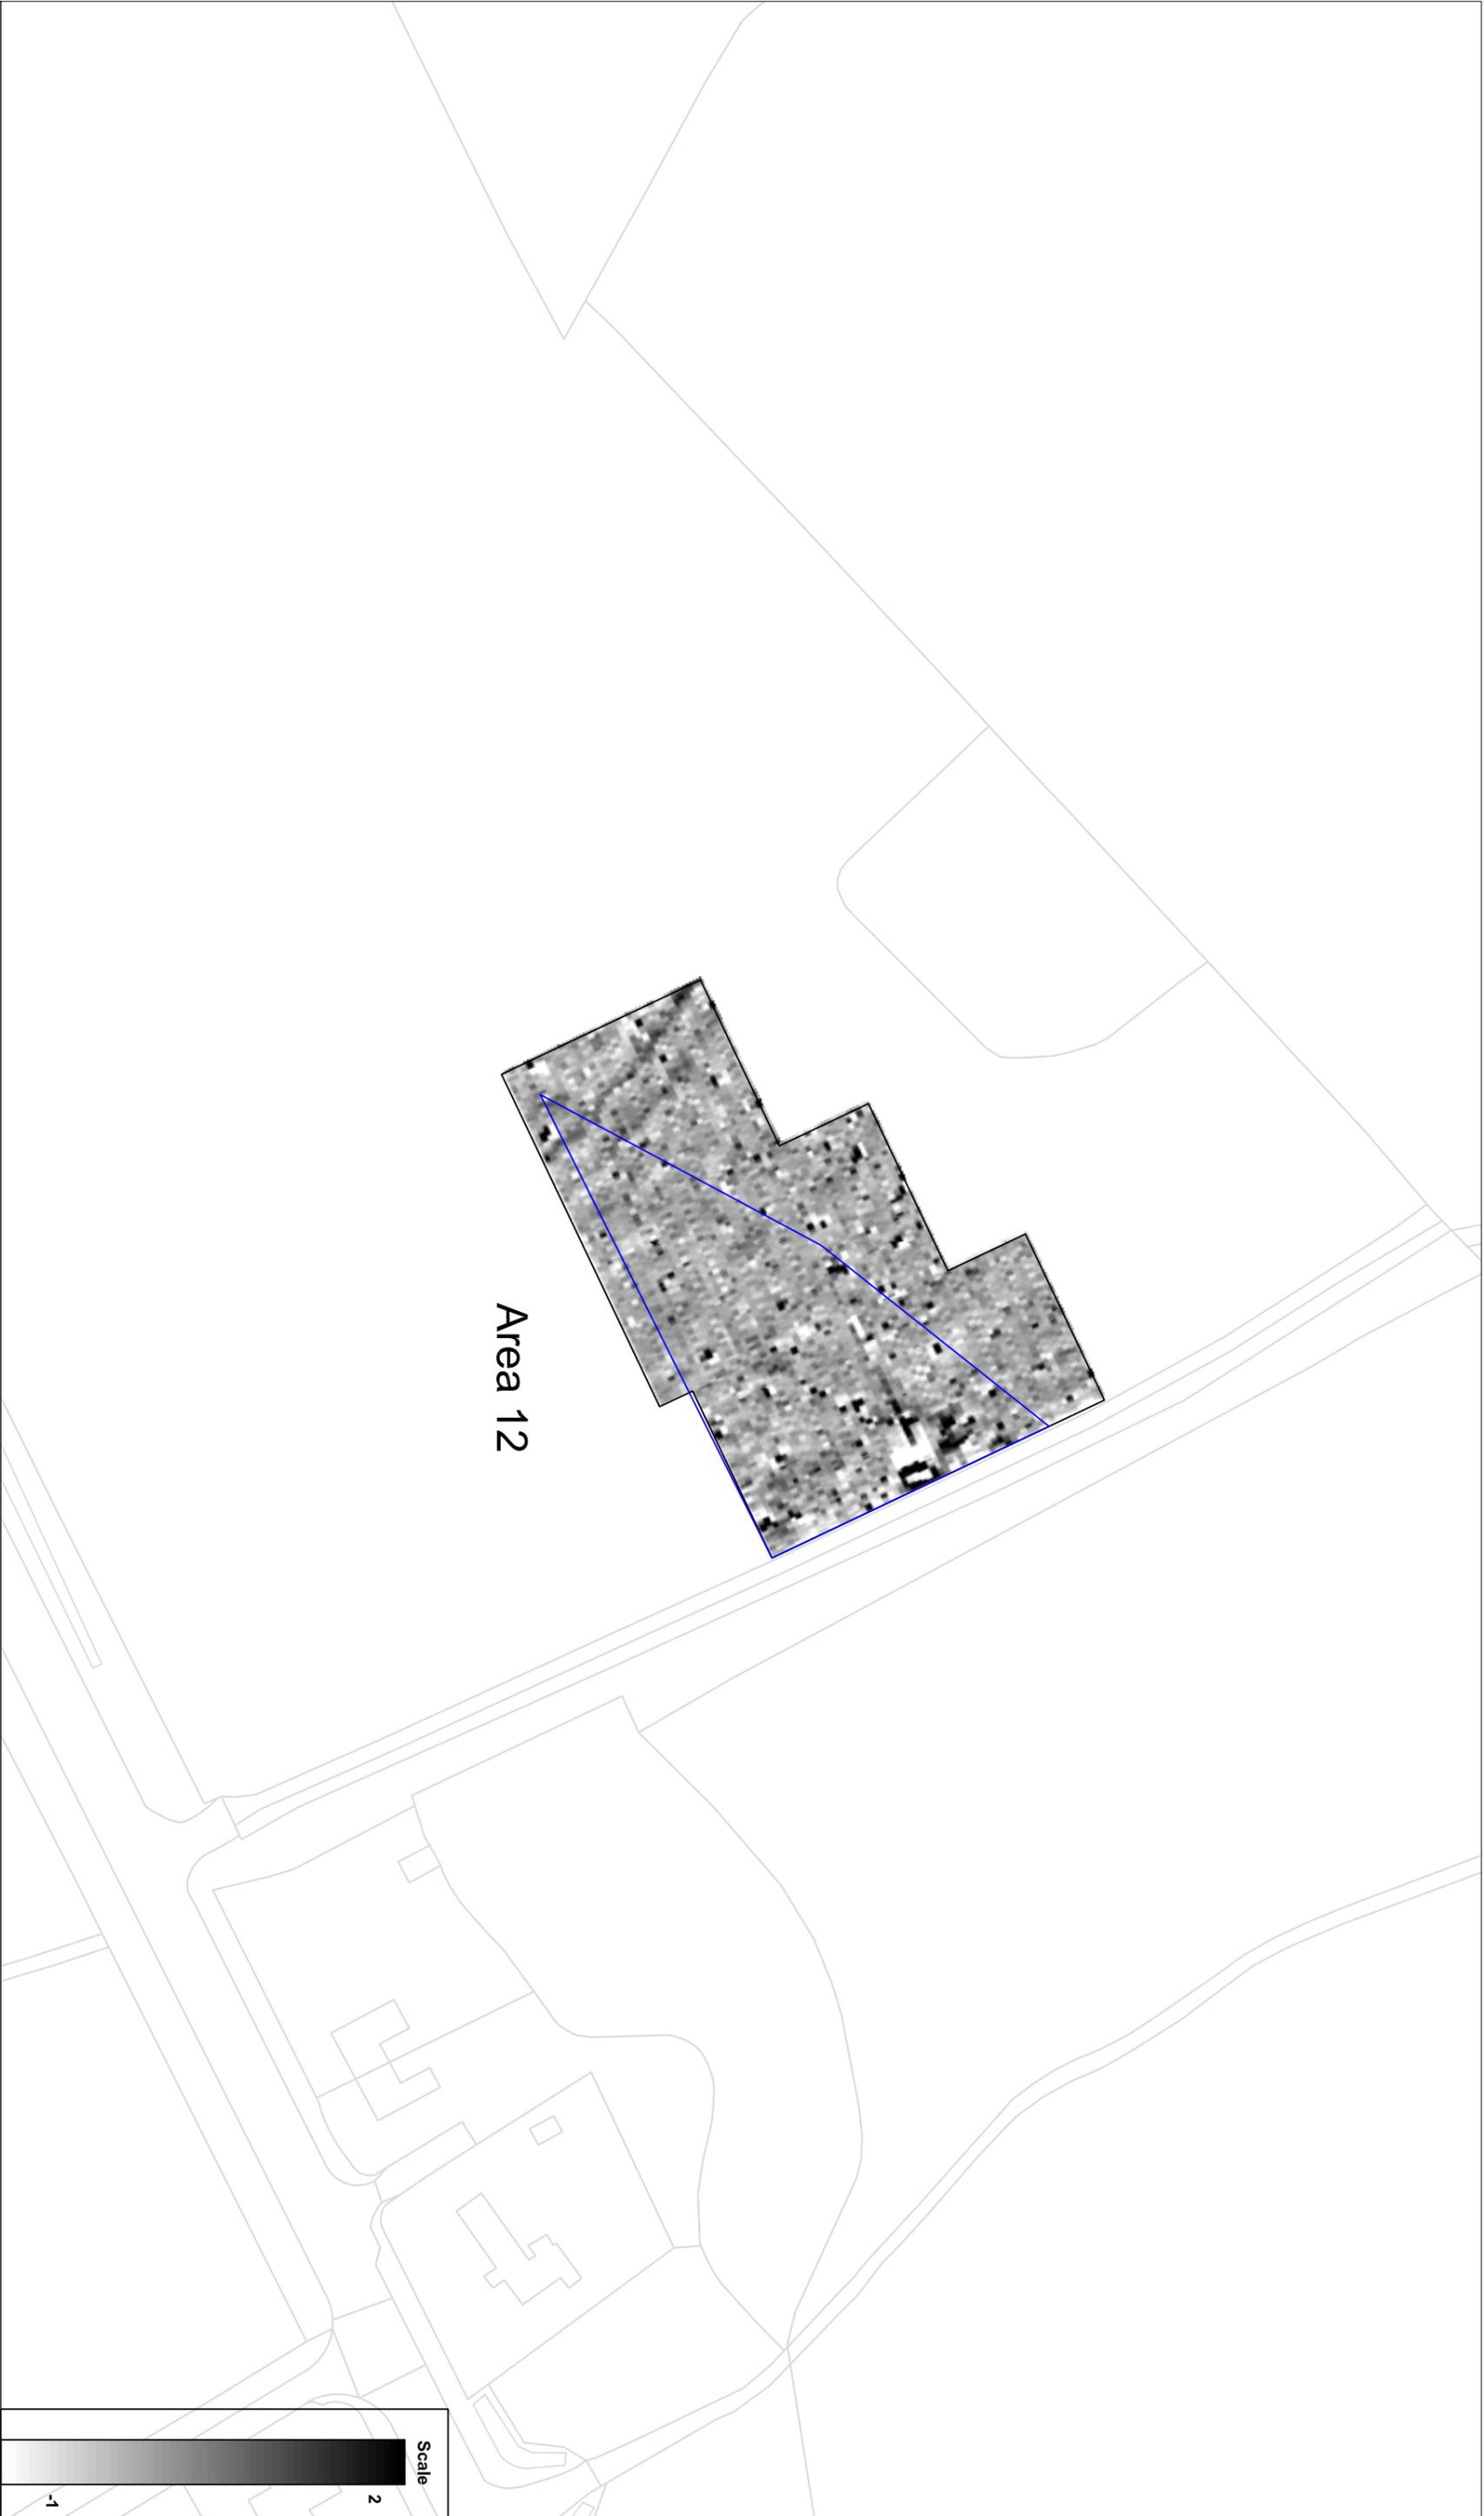
Figure
24

Unprocessed gradiometer survey results - greyscale plot: Area 12

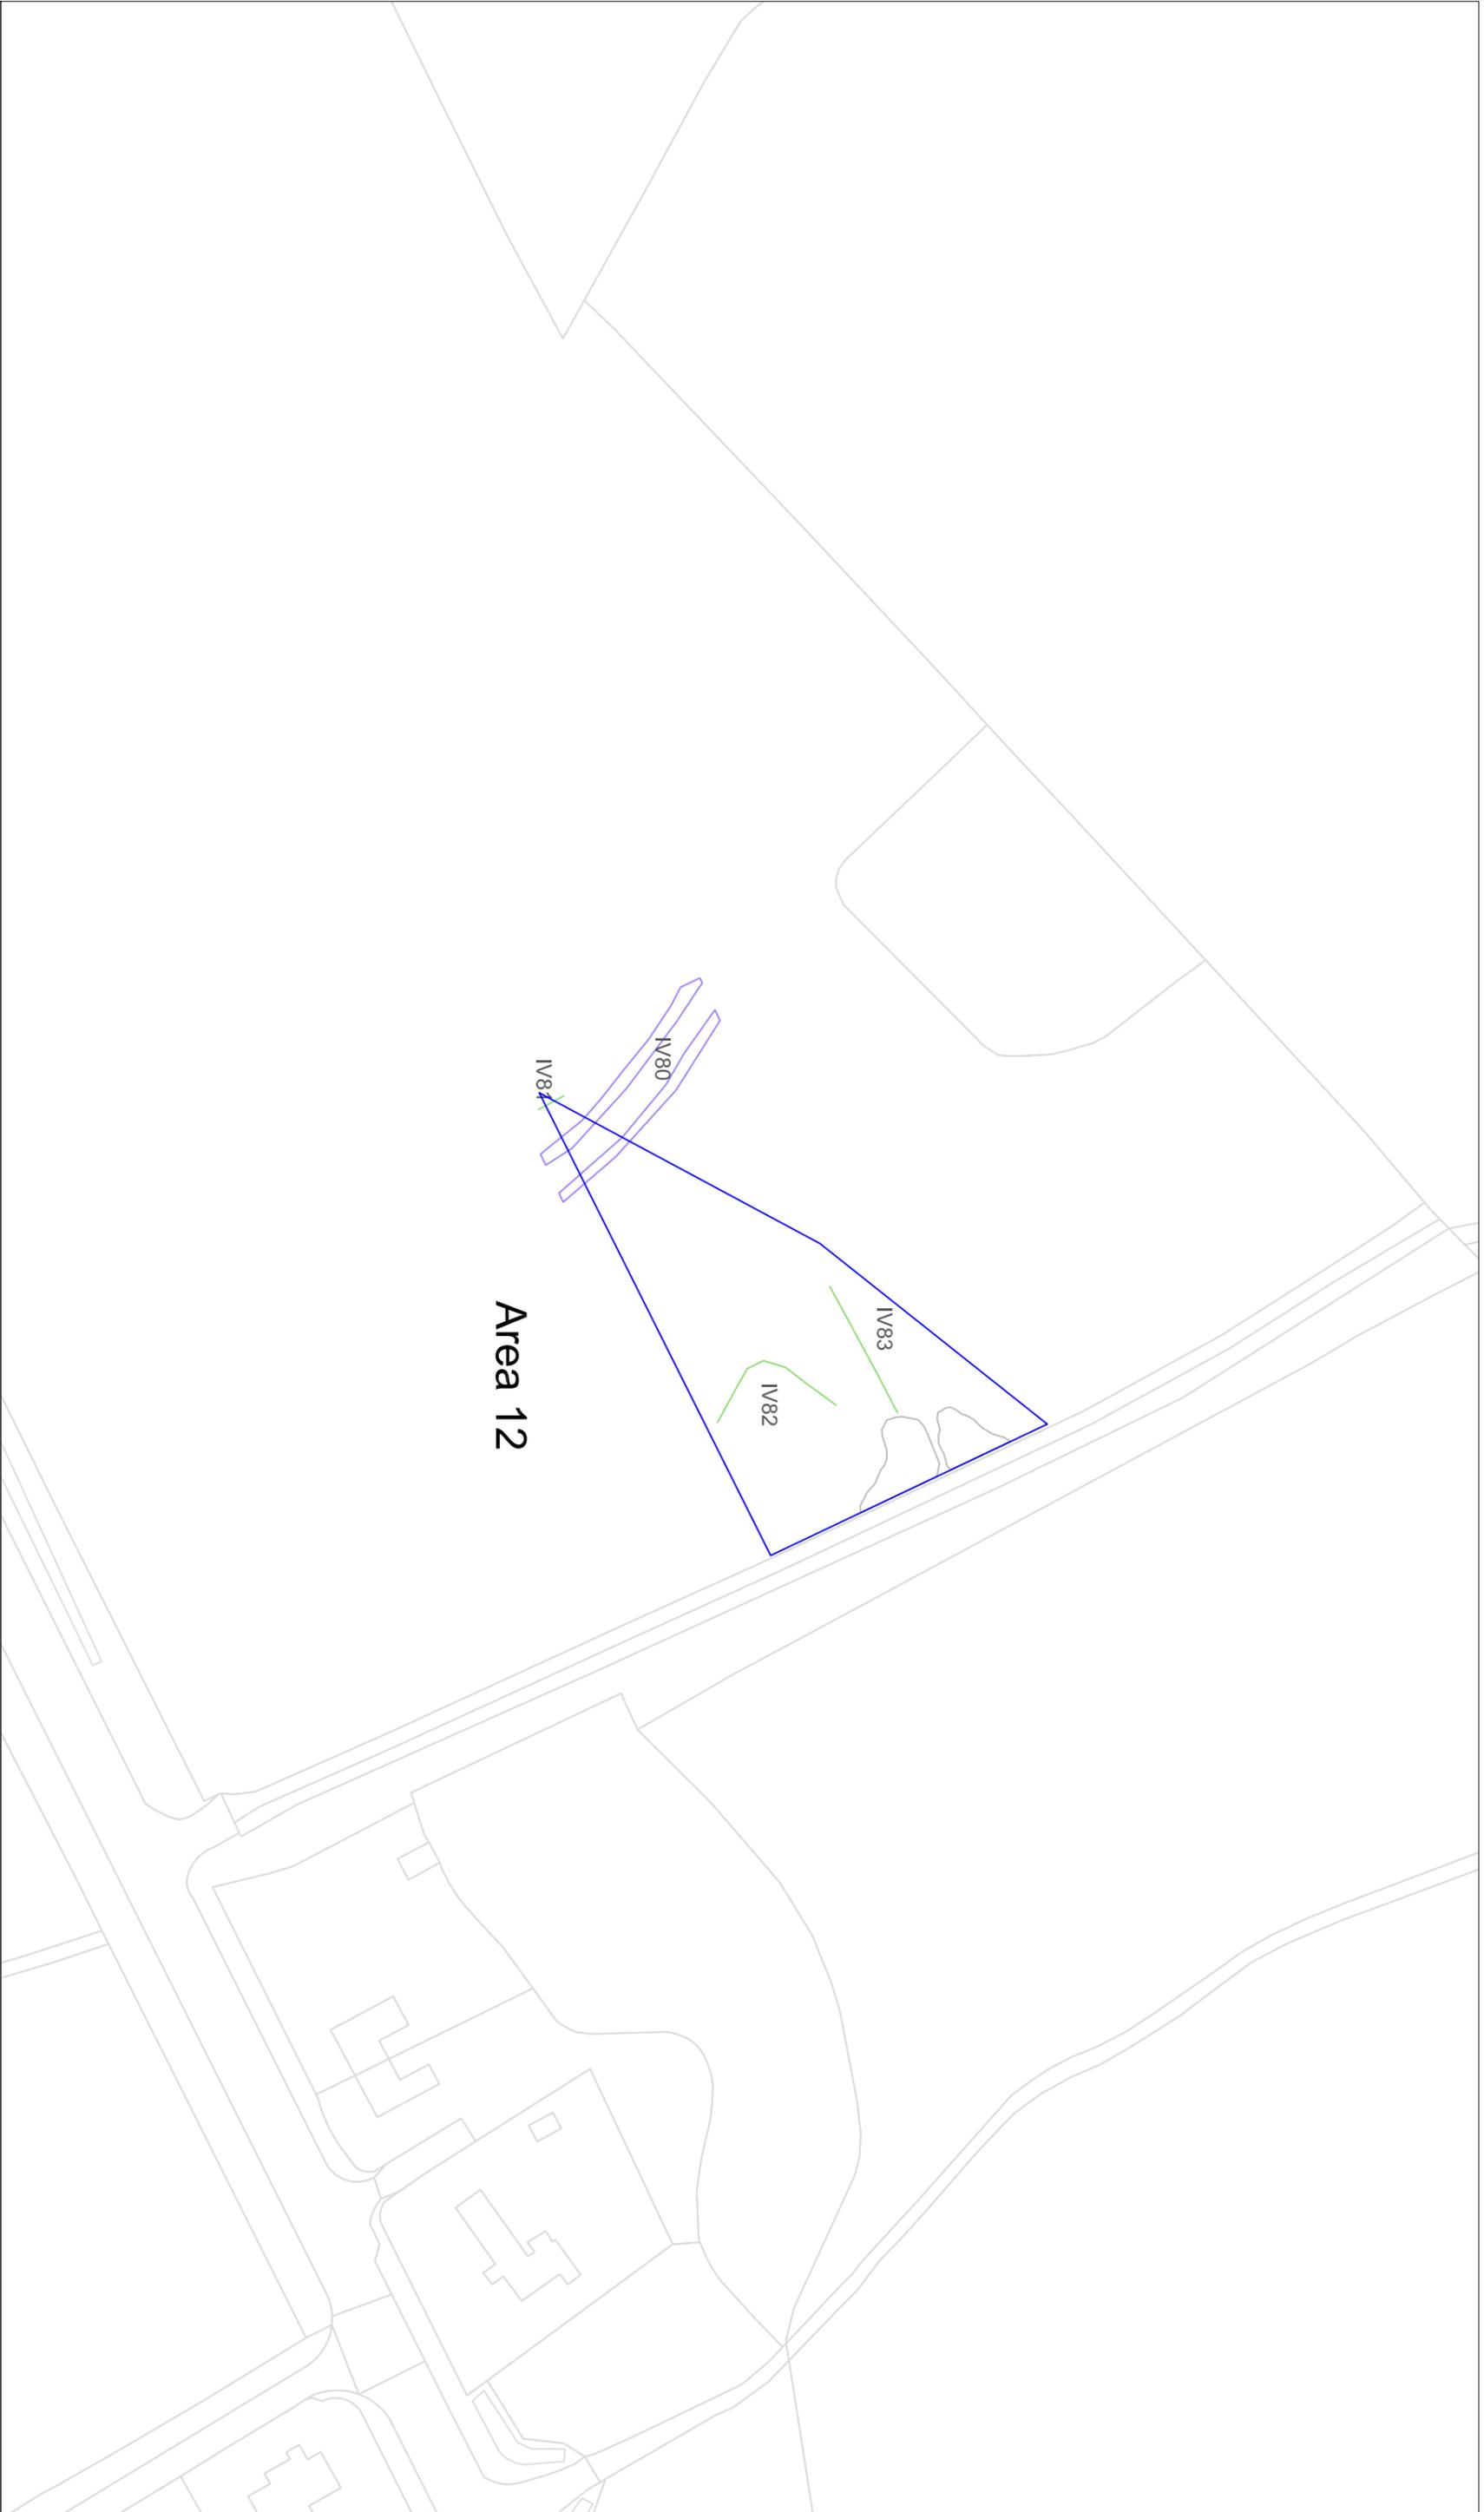
Figure 26

Interpretation of gradiometer survey results: Area 12

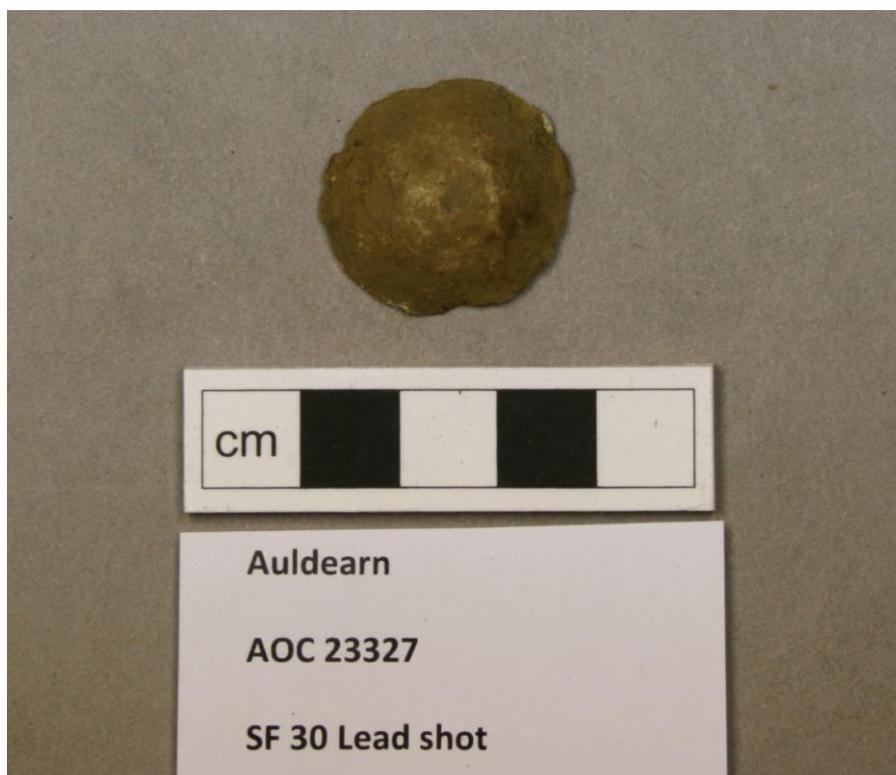
Plate 16: SF30, lead shot.

29. Two impacted lead musket balls (SF 30 & 100) were recovered from the southeastern part of the area Plate 1 and 2). Both had been partially flattened due to impact, with SF 30 almost completely flattened. A segmented strip of lead (SF 24) was also recovered from this area.

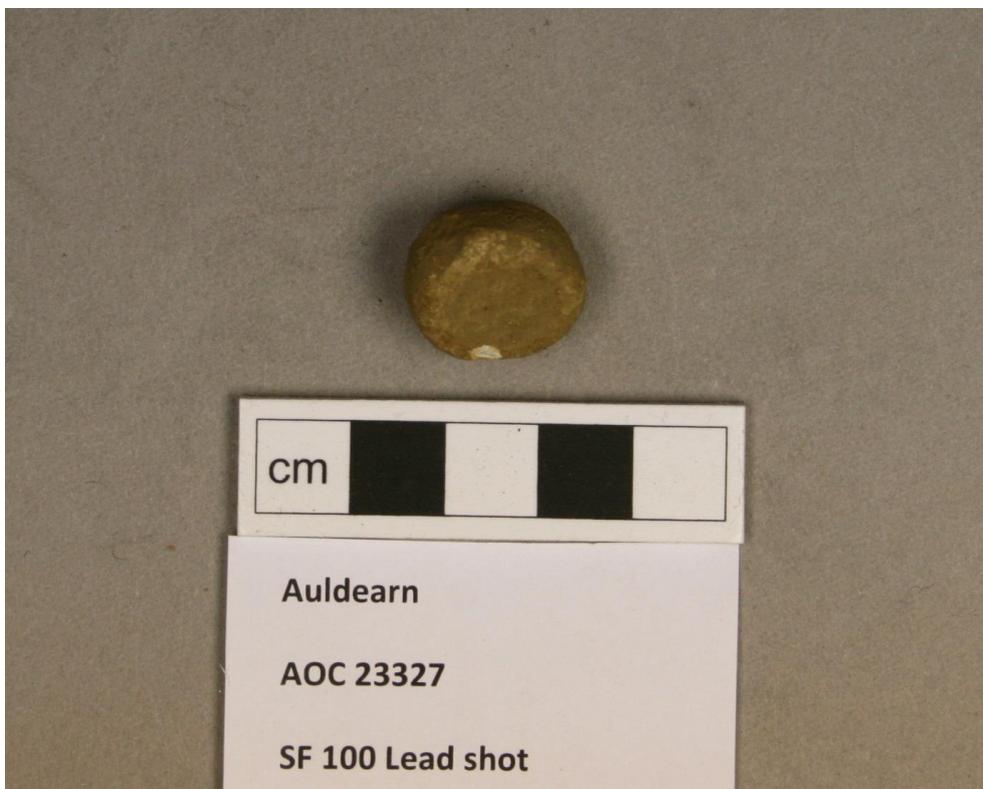
Plate 34: SF100, lead shot.
