Project FORTH REPLACEMENT CROSSING

CONSTRUCTION NOISE MONITORING REPORT: APRIL 2014

REP-00180 02

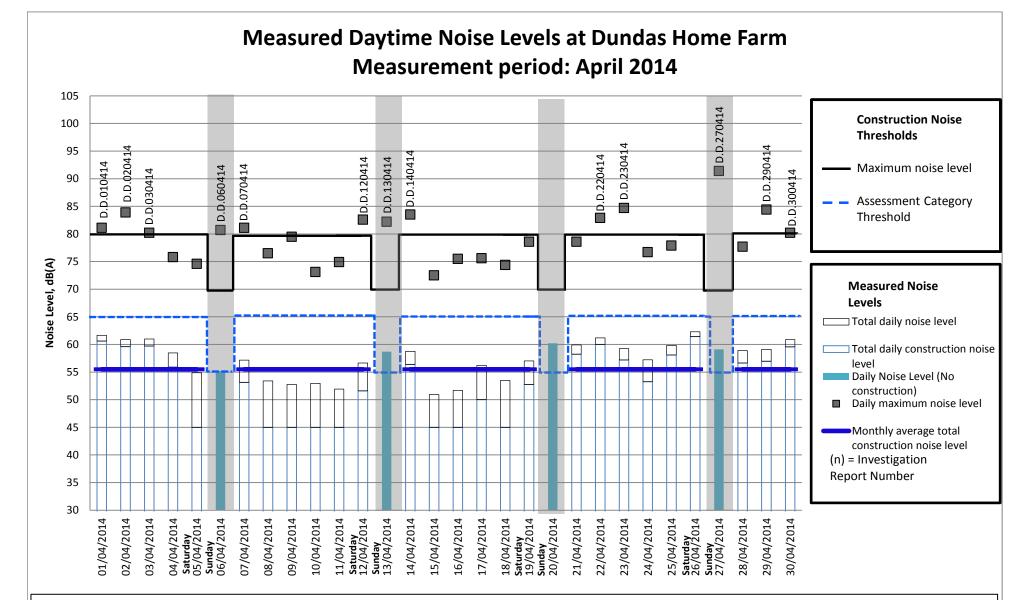
Note: The grey areas of the chart represent days on which no construction works have been conducted. The Sunday average has not been included as no Sunday works have been conducted at this location.

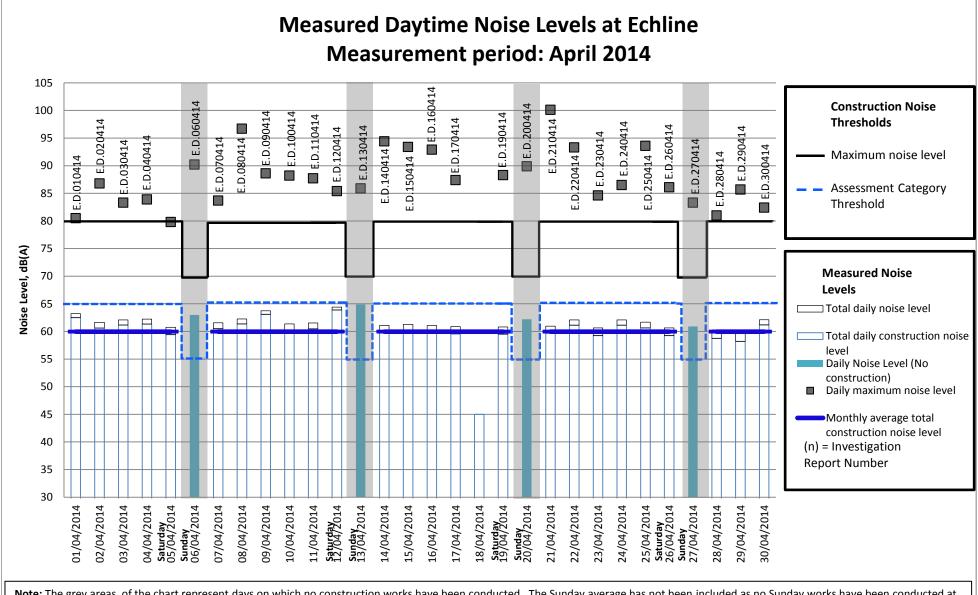
Note: The grey areas of the chart represent days on which no construction works have been conducted. The Sunday average has not been included as no Sunday works have been conducted at this location.

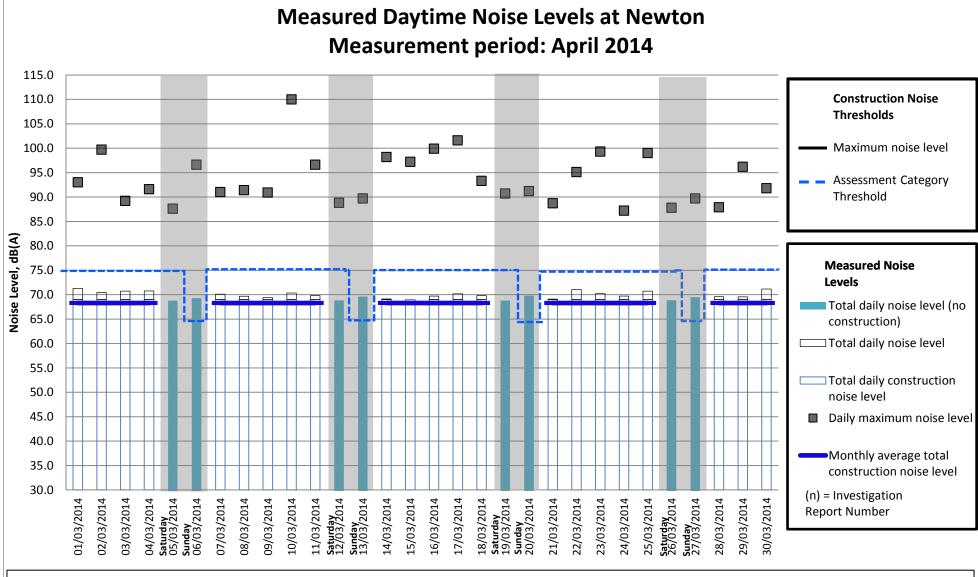
Note: The grey areas of the chart represent days on which no construction works have been conducted. It should be noted that the measured noise levels Mon - Fri can not be attributed to construction works due to the considerable distance (1.75 kilometers) between this monitoring location and the closest construction works.

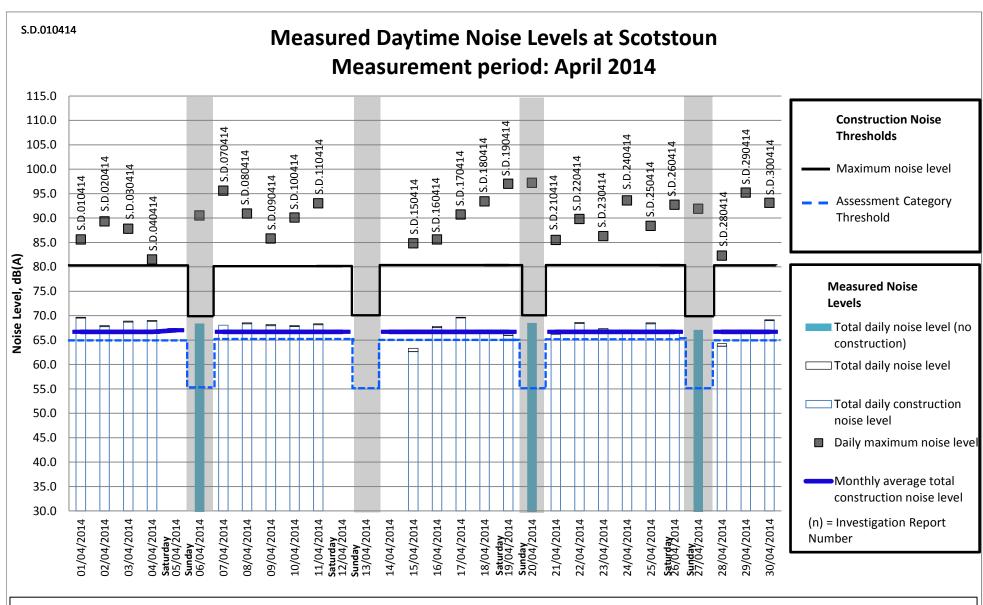
Note: The grey areas of the chart represent days on which no construction works have been conducted. The monthly average construction noise for Sunday has not been included as no Sunday works have been conducted at this location. The following data is missing from the following dates due to equipment issues: 06/04/14, 12/04/14 - 14/04/14.
