FORTH REPLACEMENT CROSSING

**CONSTRUCTION NOISE MONITORING
 REPORT: FEBRUARY 2014**

REP-00171

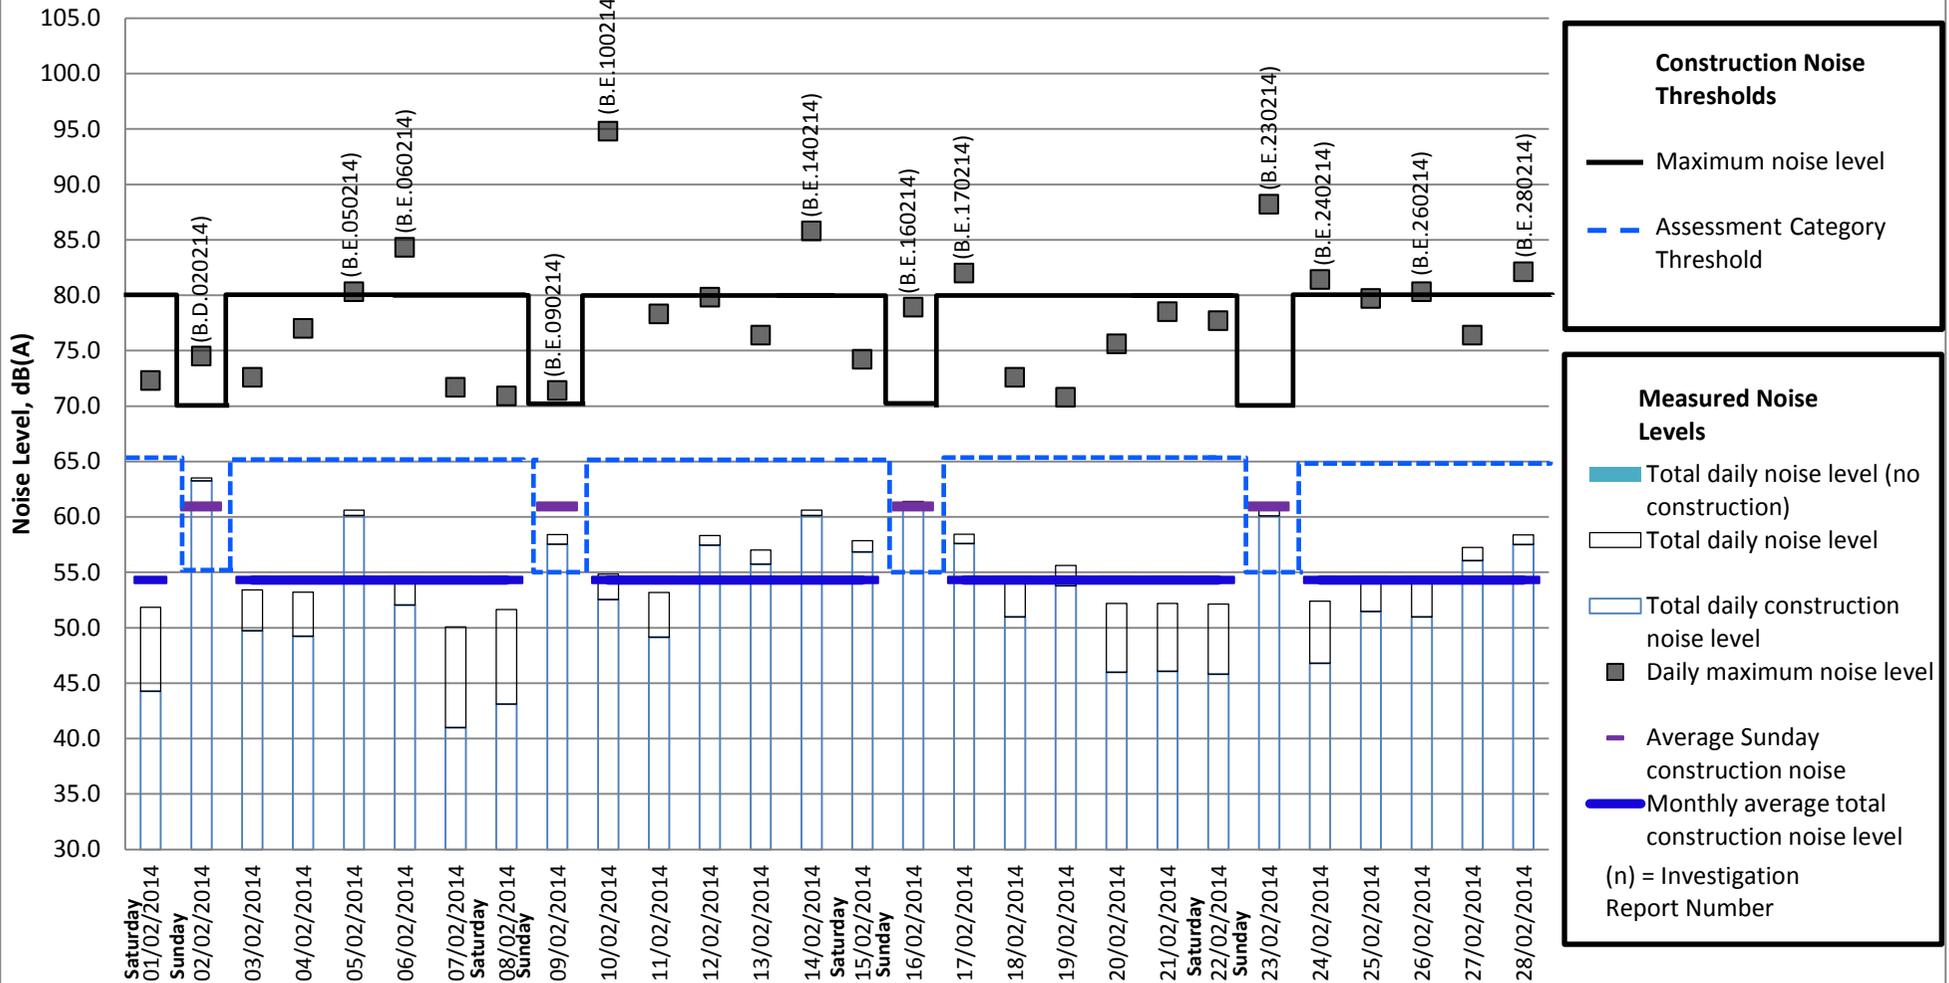
Measured Daytime Noise Levels at Butlaw Fisheries

Measurement period: February 2014

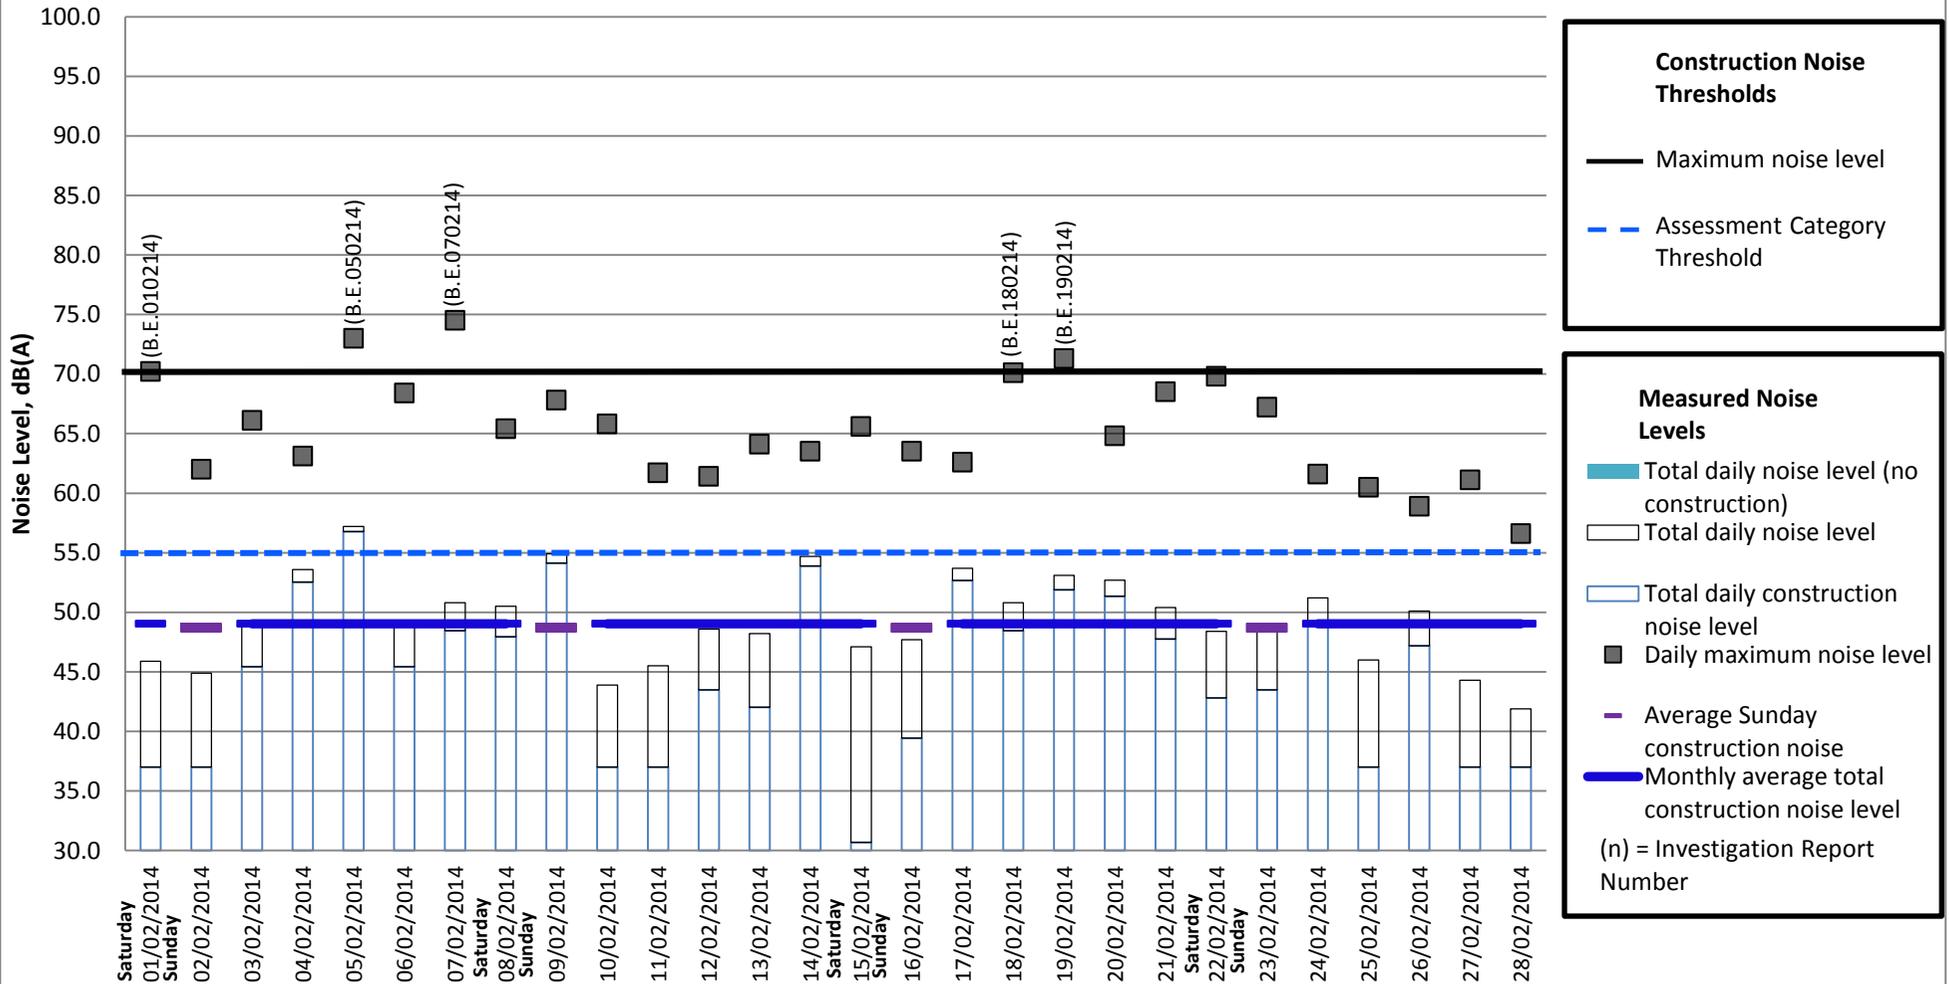
Measured Evening Noise Levels at Butlaw Fisheries

Measurement period: February 2014

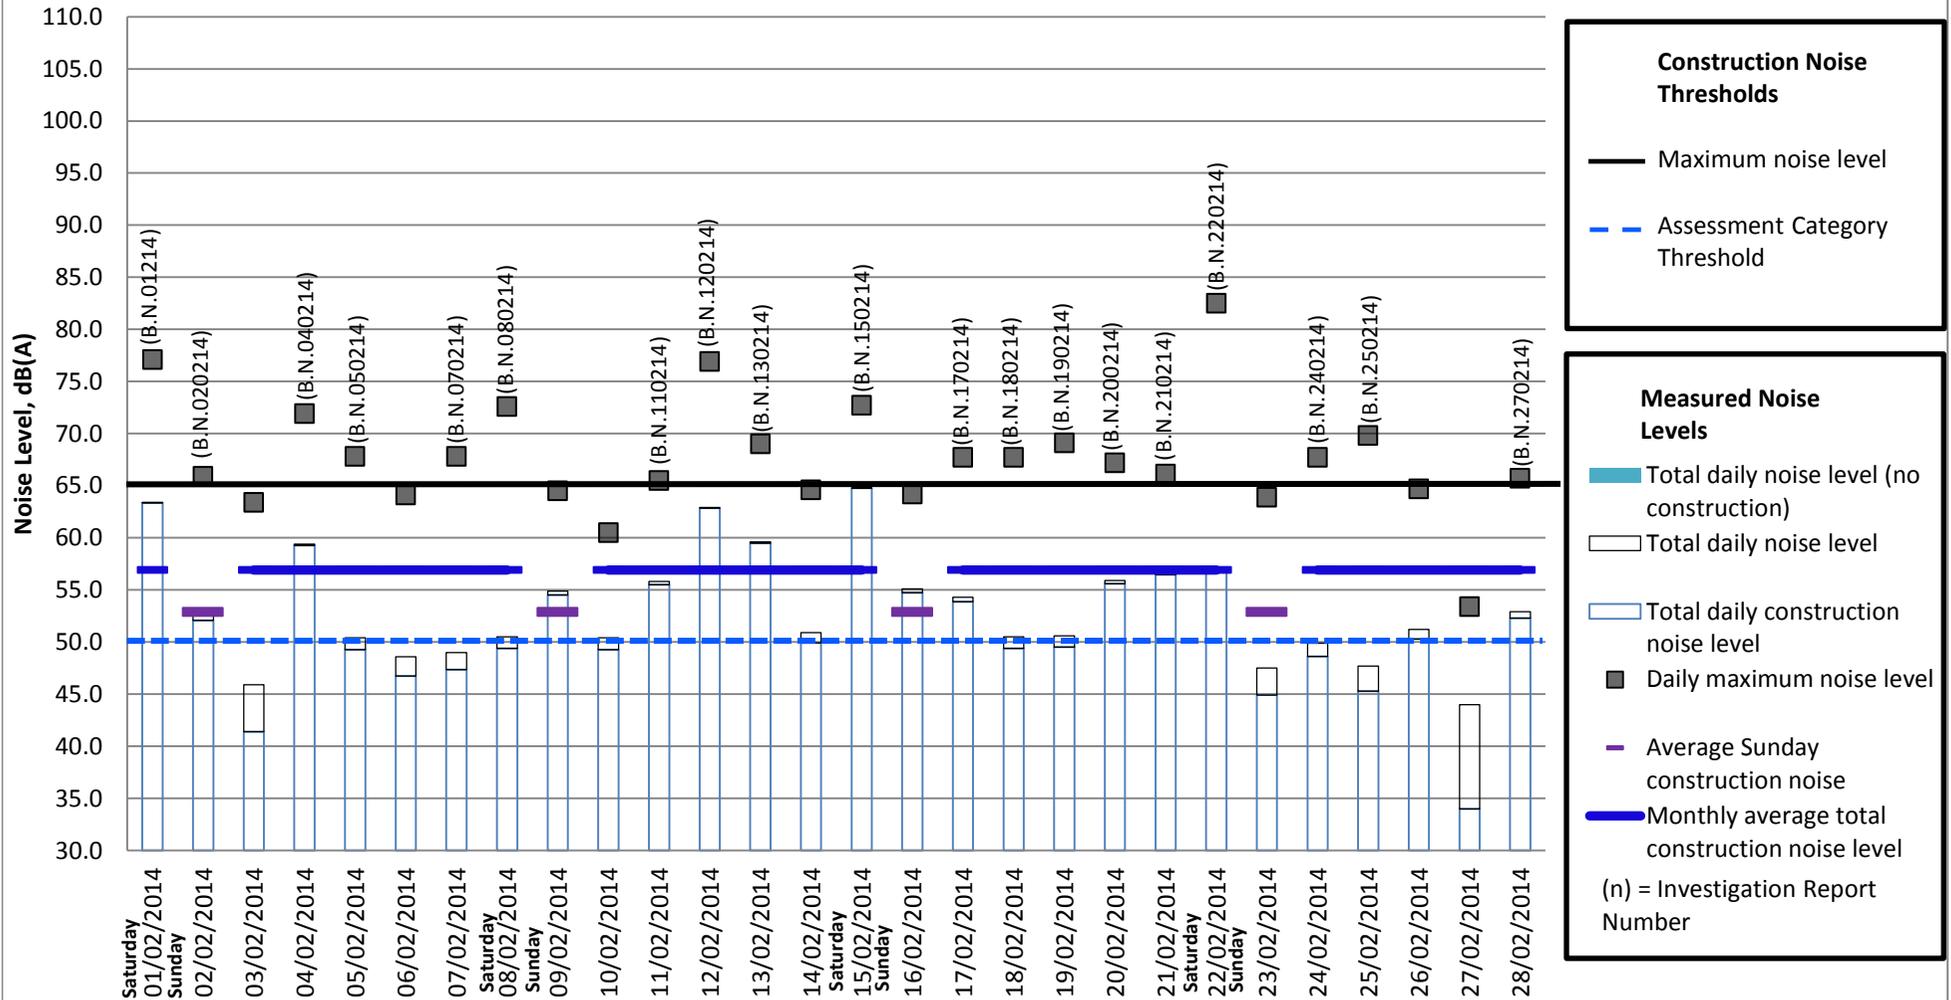
Measured Night time Noise Levels at Butlaw Fisheries

Measurement period: February 2014

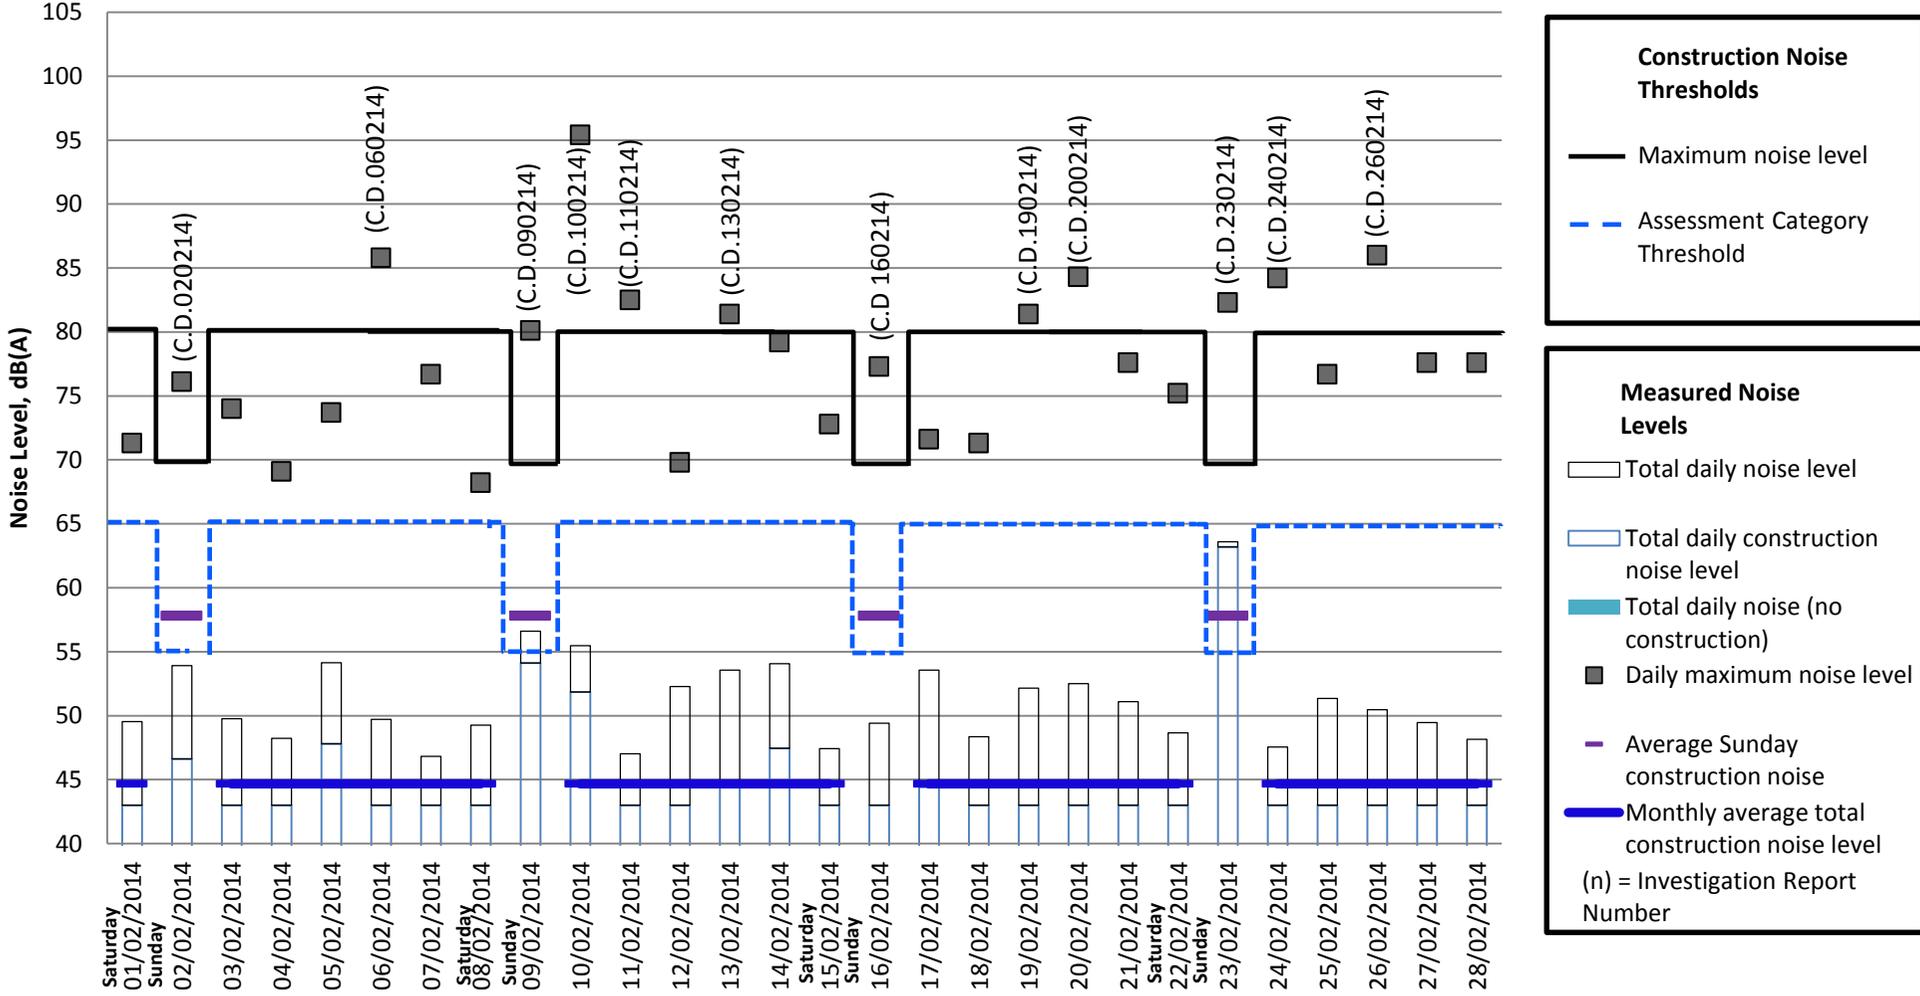
Measured Daytime Noise Levels at Clufflat Brae

Measurement period: February 2014

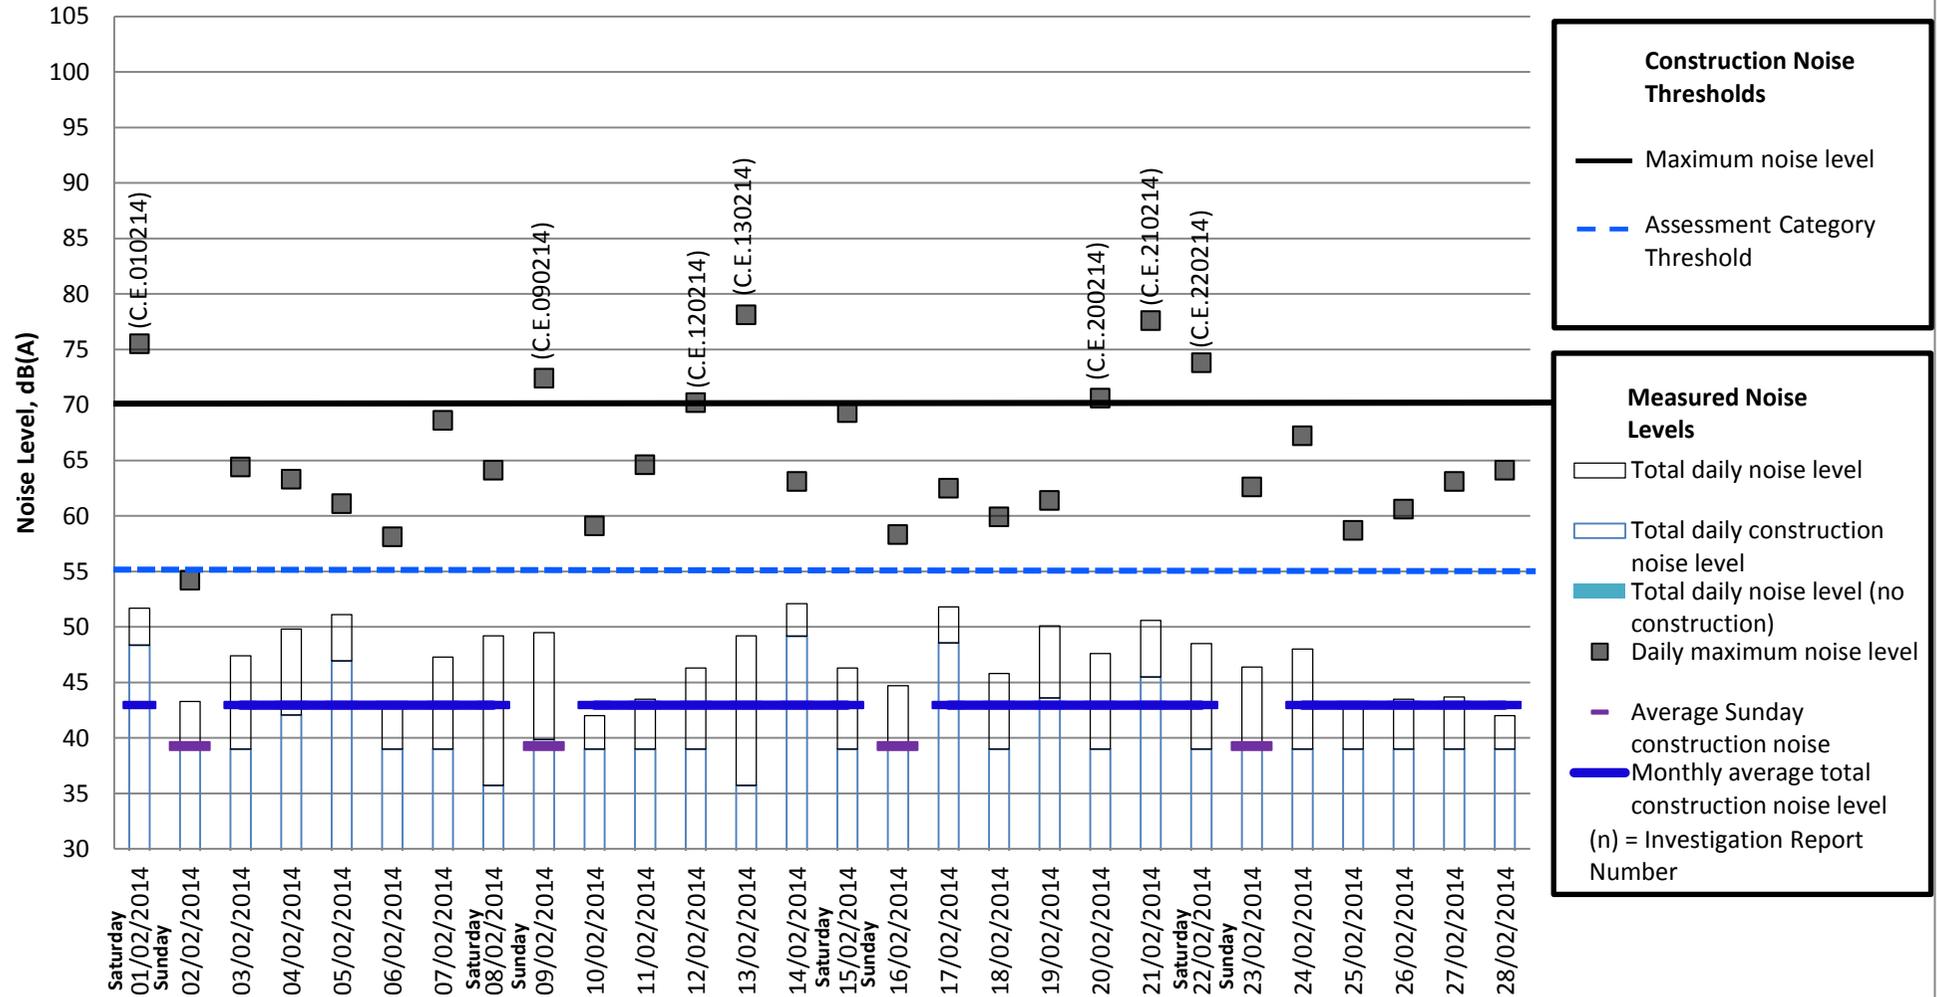
Measured Evening Noise Levels at Clufflat Brae

Measurement period: February 2014

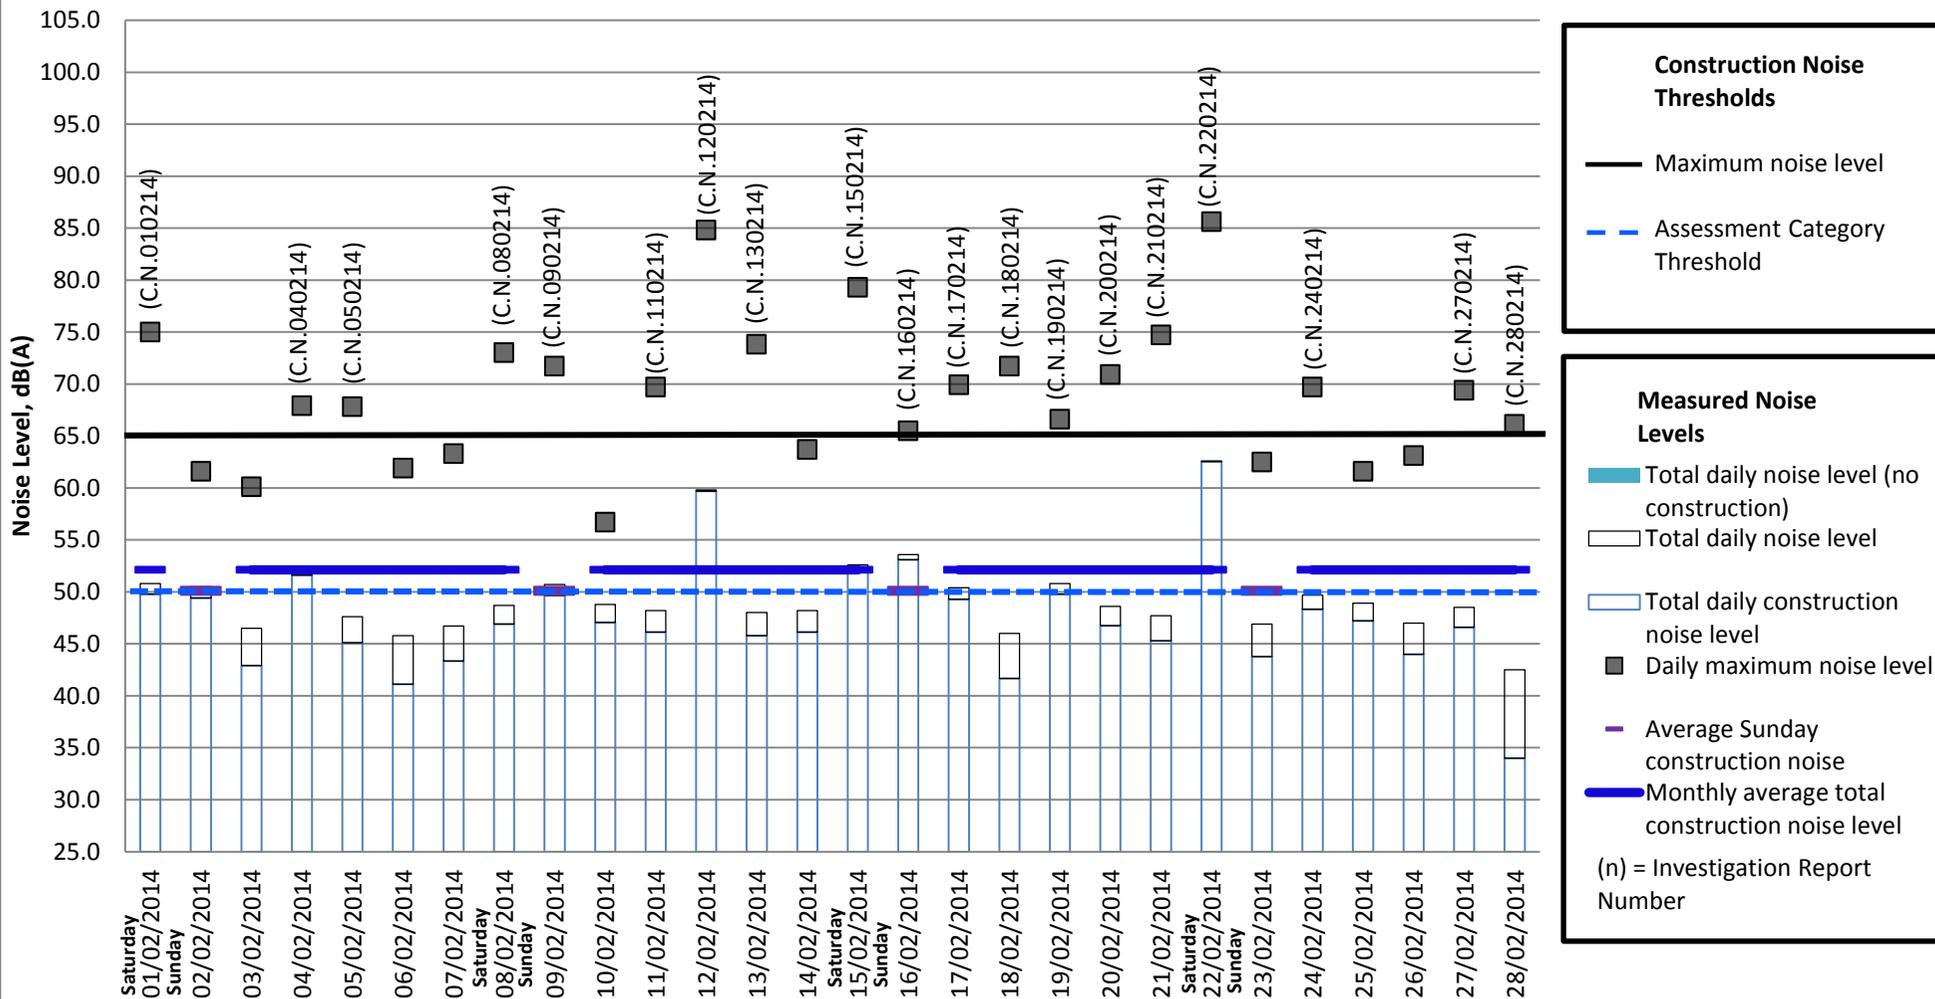
Measured Night-time Noise Levels at Clufflat Brae

Measurement period: February 2014

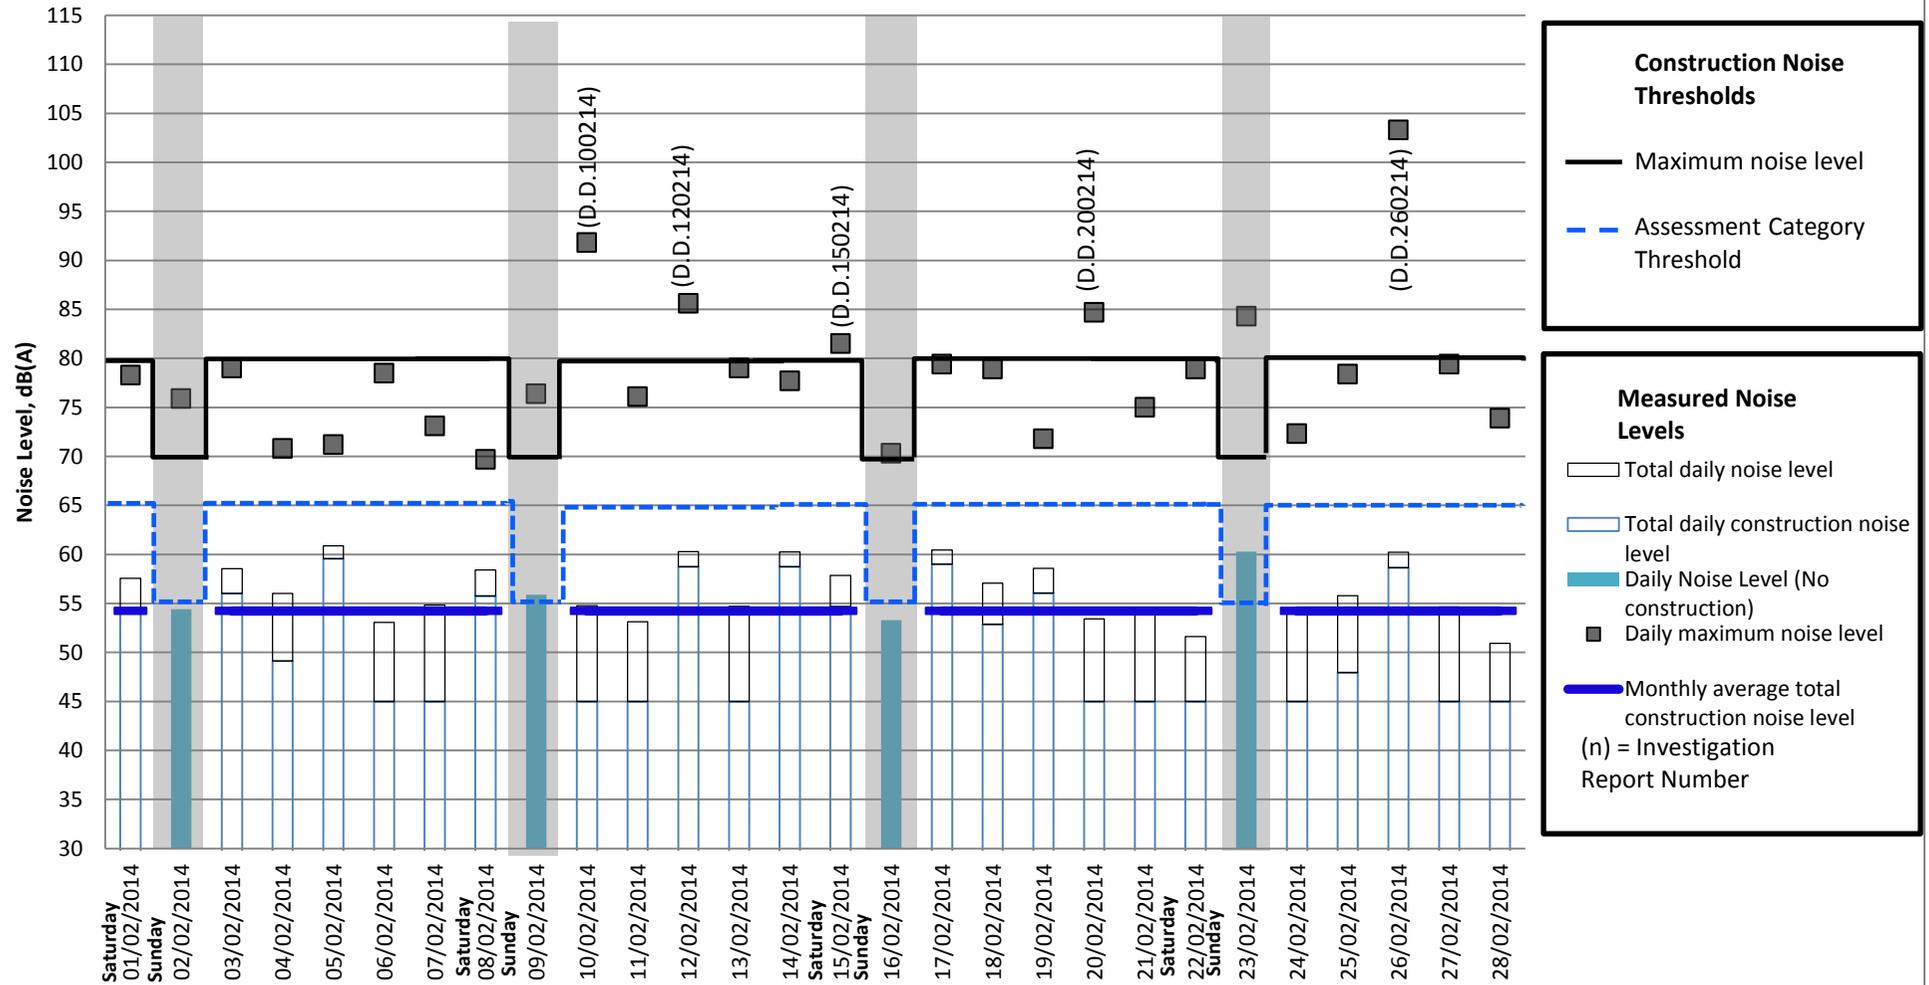
Measured Daytime Noise Levels at Dundas Home Farm Measurement period: February 2014

Note: The grey areas of the chart represent days on which no construction works have been undertaken at this location. A Sunday average has not been included for this location as no Sunday works have been undertaken.

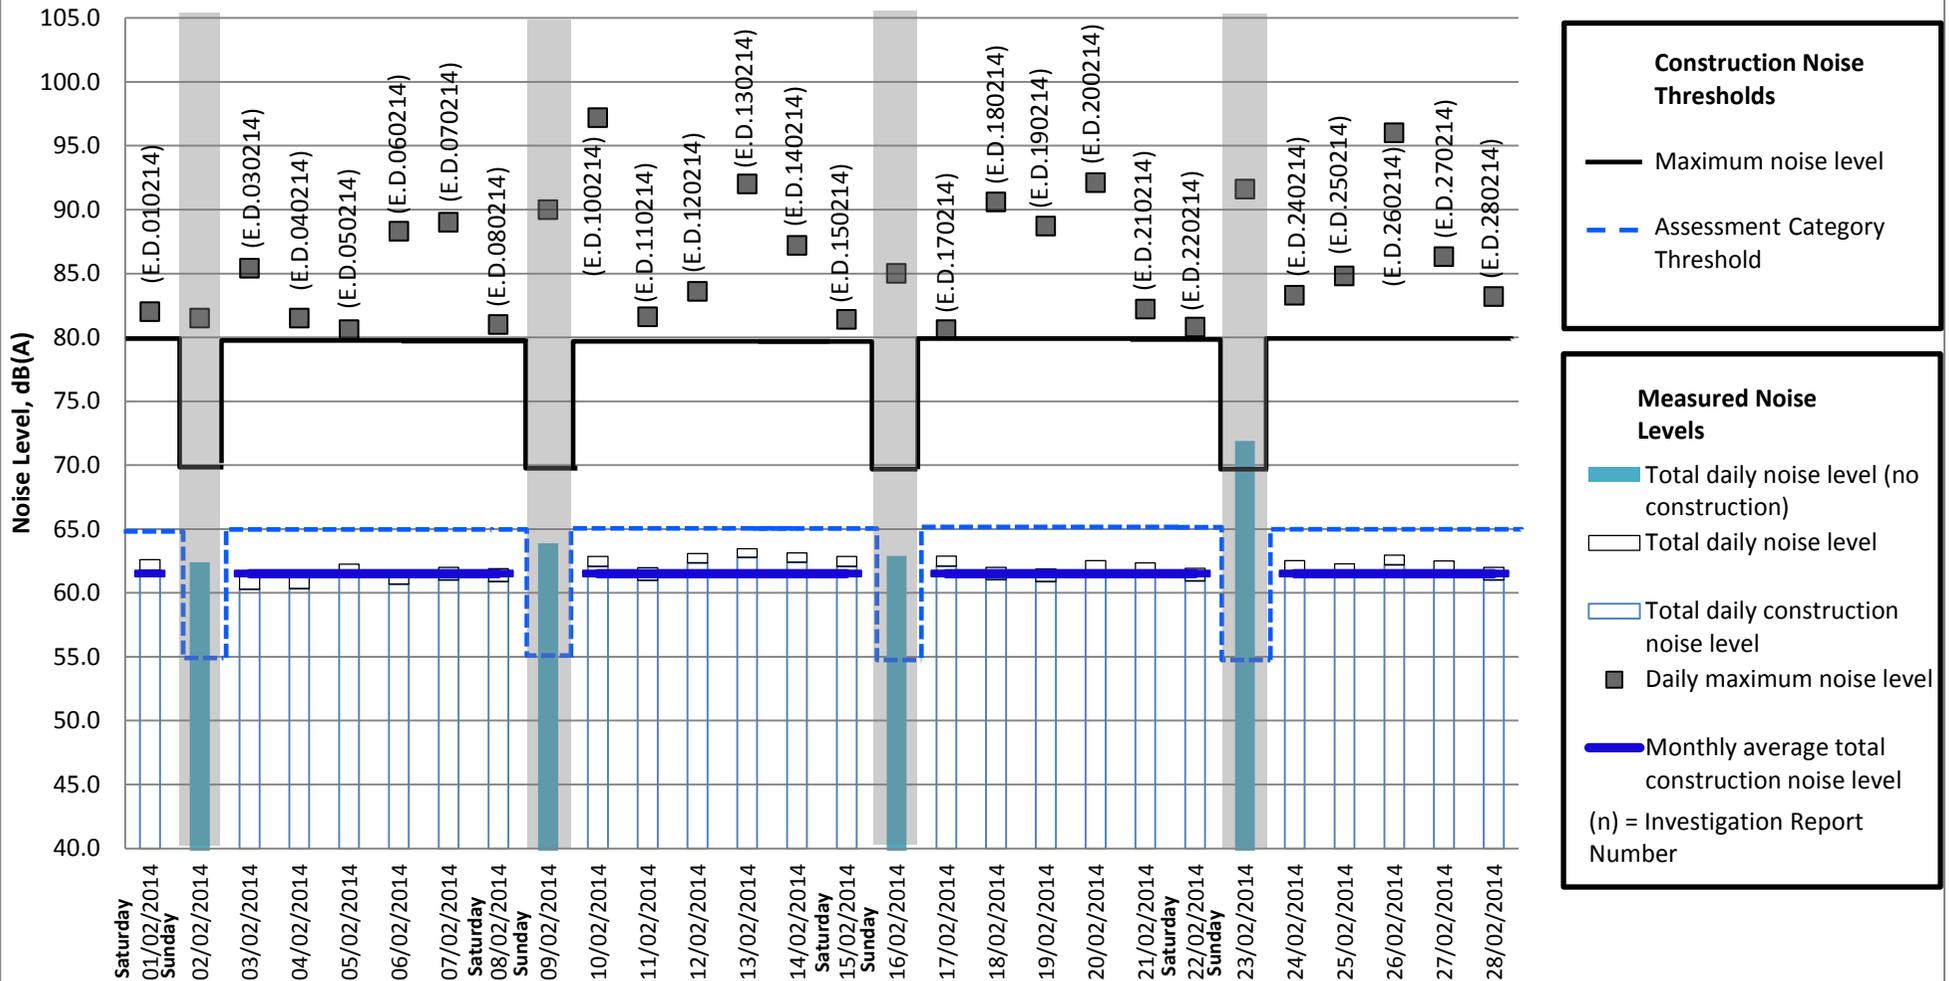
Measured Daytime Noise Levels at Echline Field Measurement period: February 2014

Note: The grey areas of the chart represent days on which no construction works have been conducted. A Sunday average has not been included on the graph as no Sunday works have been undertaken at this location. There were one off works on the nights commencing on the 24/02/14 and 25/02/14 on the A904 East (In the vicinity of the noise monitor at Echline corner). Throughout these works there were no construction exceedences.

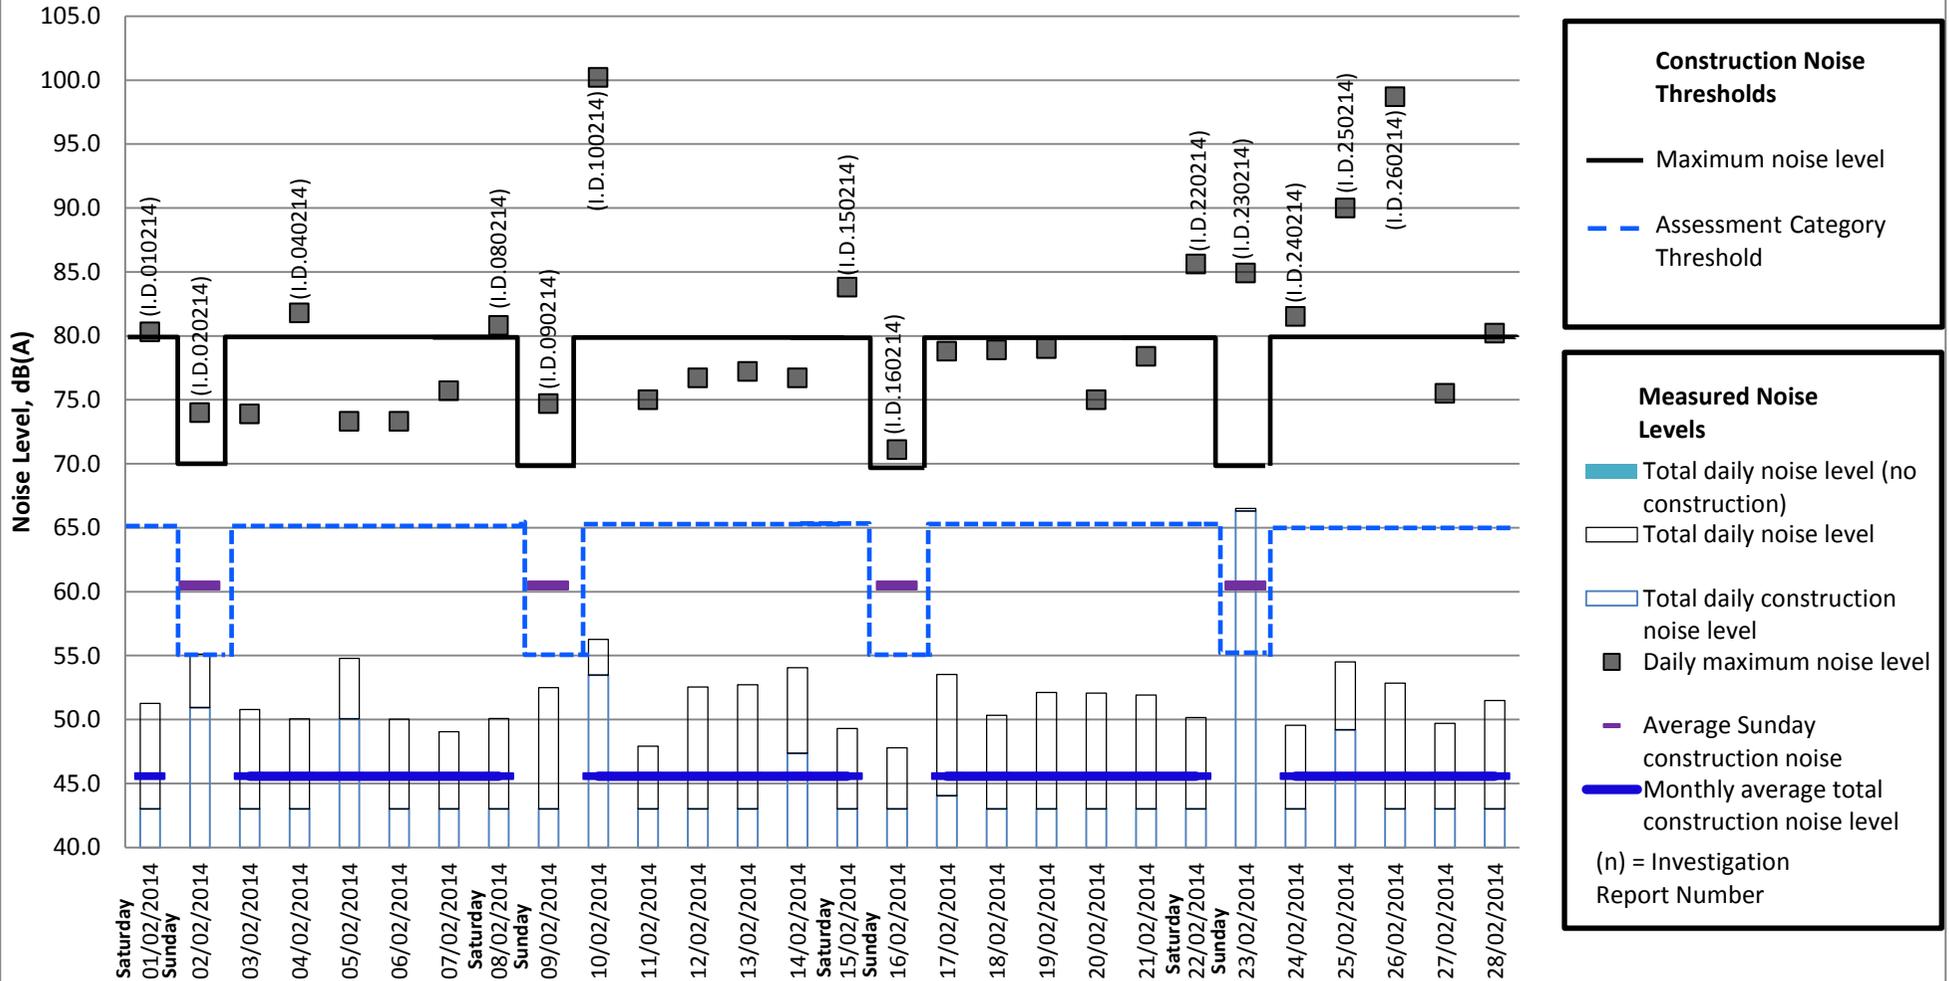
Measured Daytime Noise Levels at Inchgarvie

Measurement period: February 2014

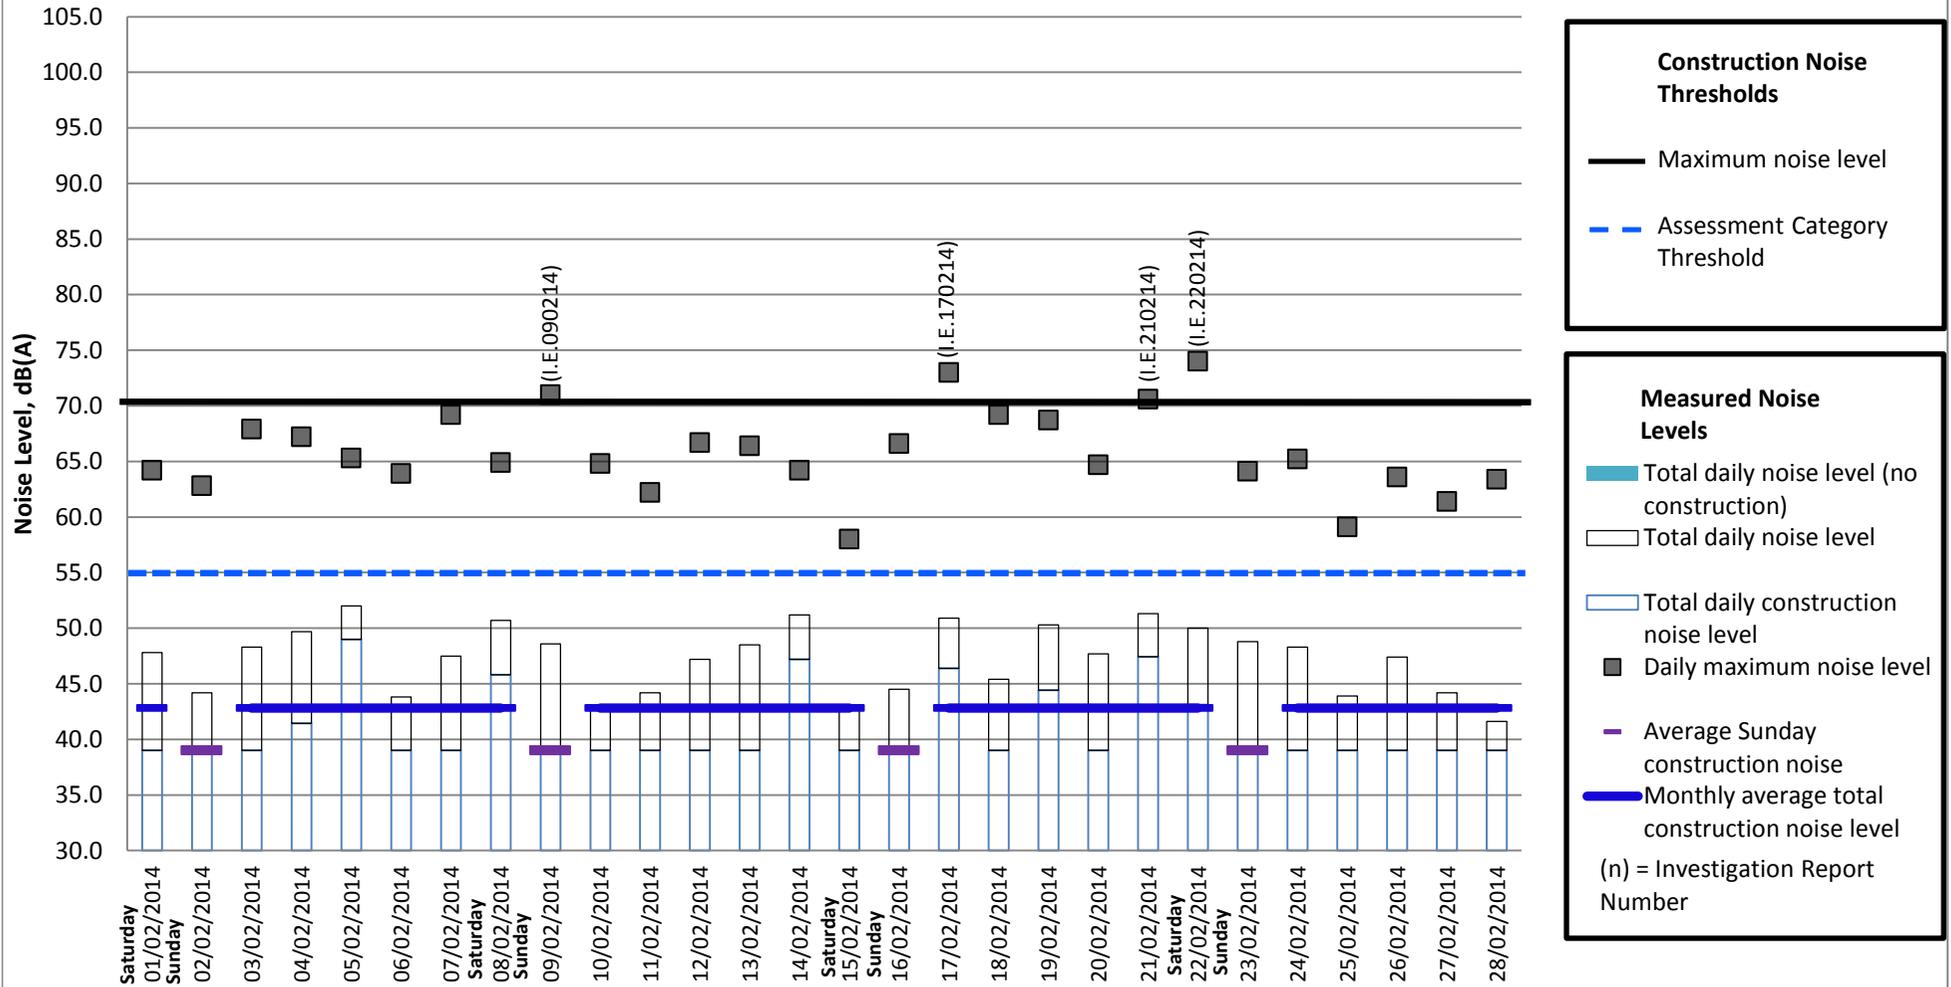
Measured Evening Noise Levels at Inchgarvie

Measurement period: February 2014

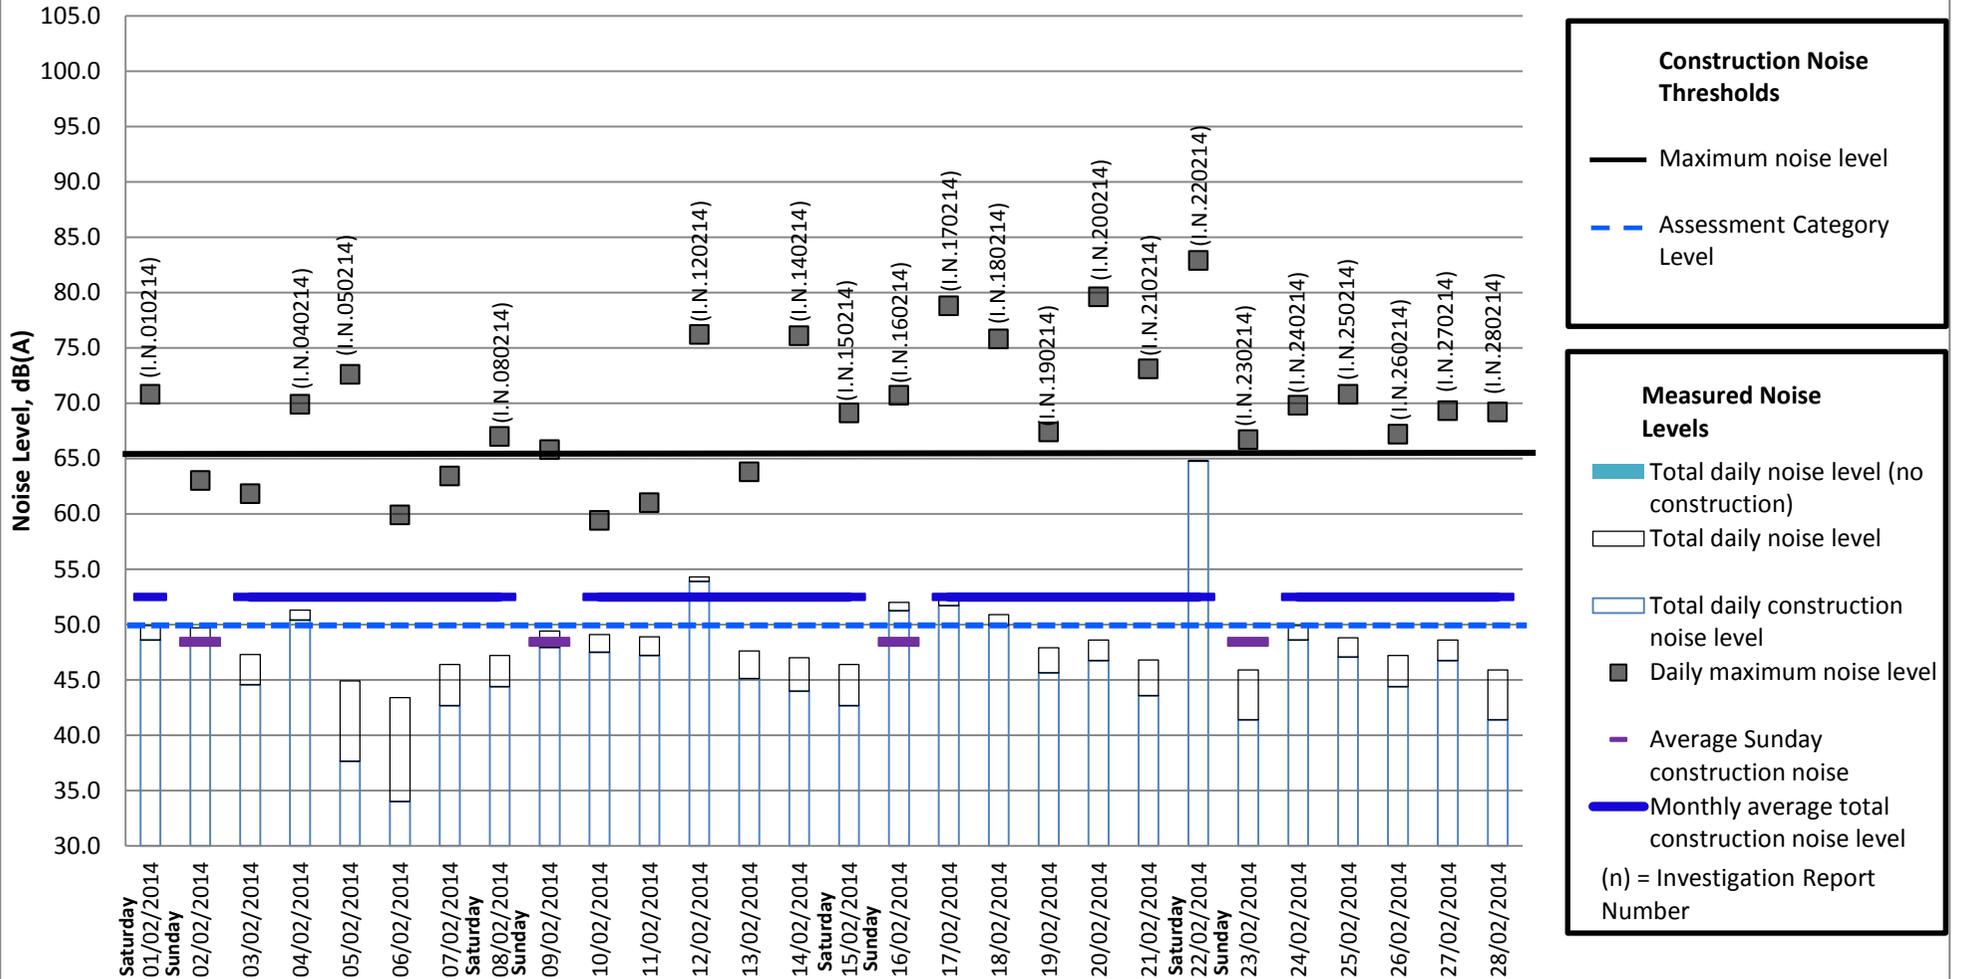
Measured Night-time Noise Levels at Inchgarvie Measurement period: February 2014
