FORTH REPLACEMENT CROSSING

**CONSTRUCTION NOISE MONITORING
 REPORT: FEBRUARY 2014**

REP-00171

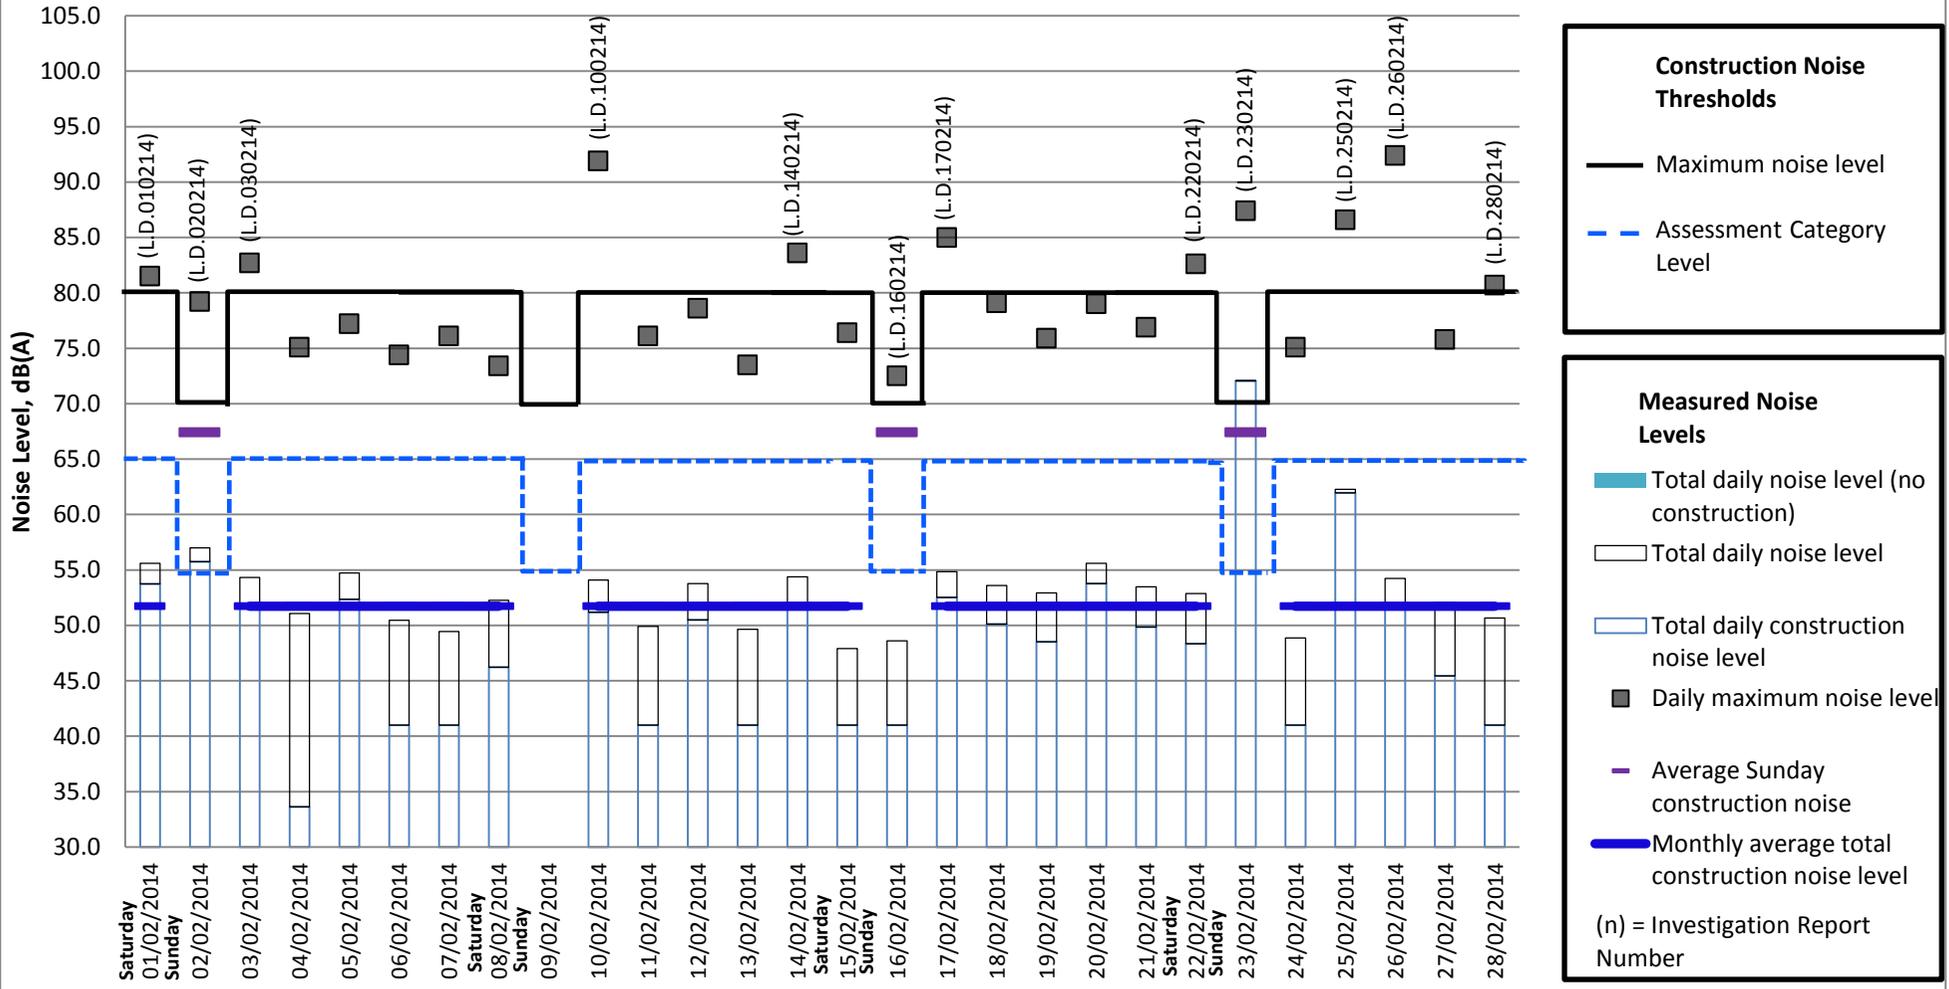
Measured Daytime Noise levels at Linn Mill Measurement period: February 2014

Note: Due to adverse weather conditions, data is missing for 09/02/14.

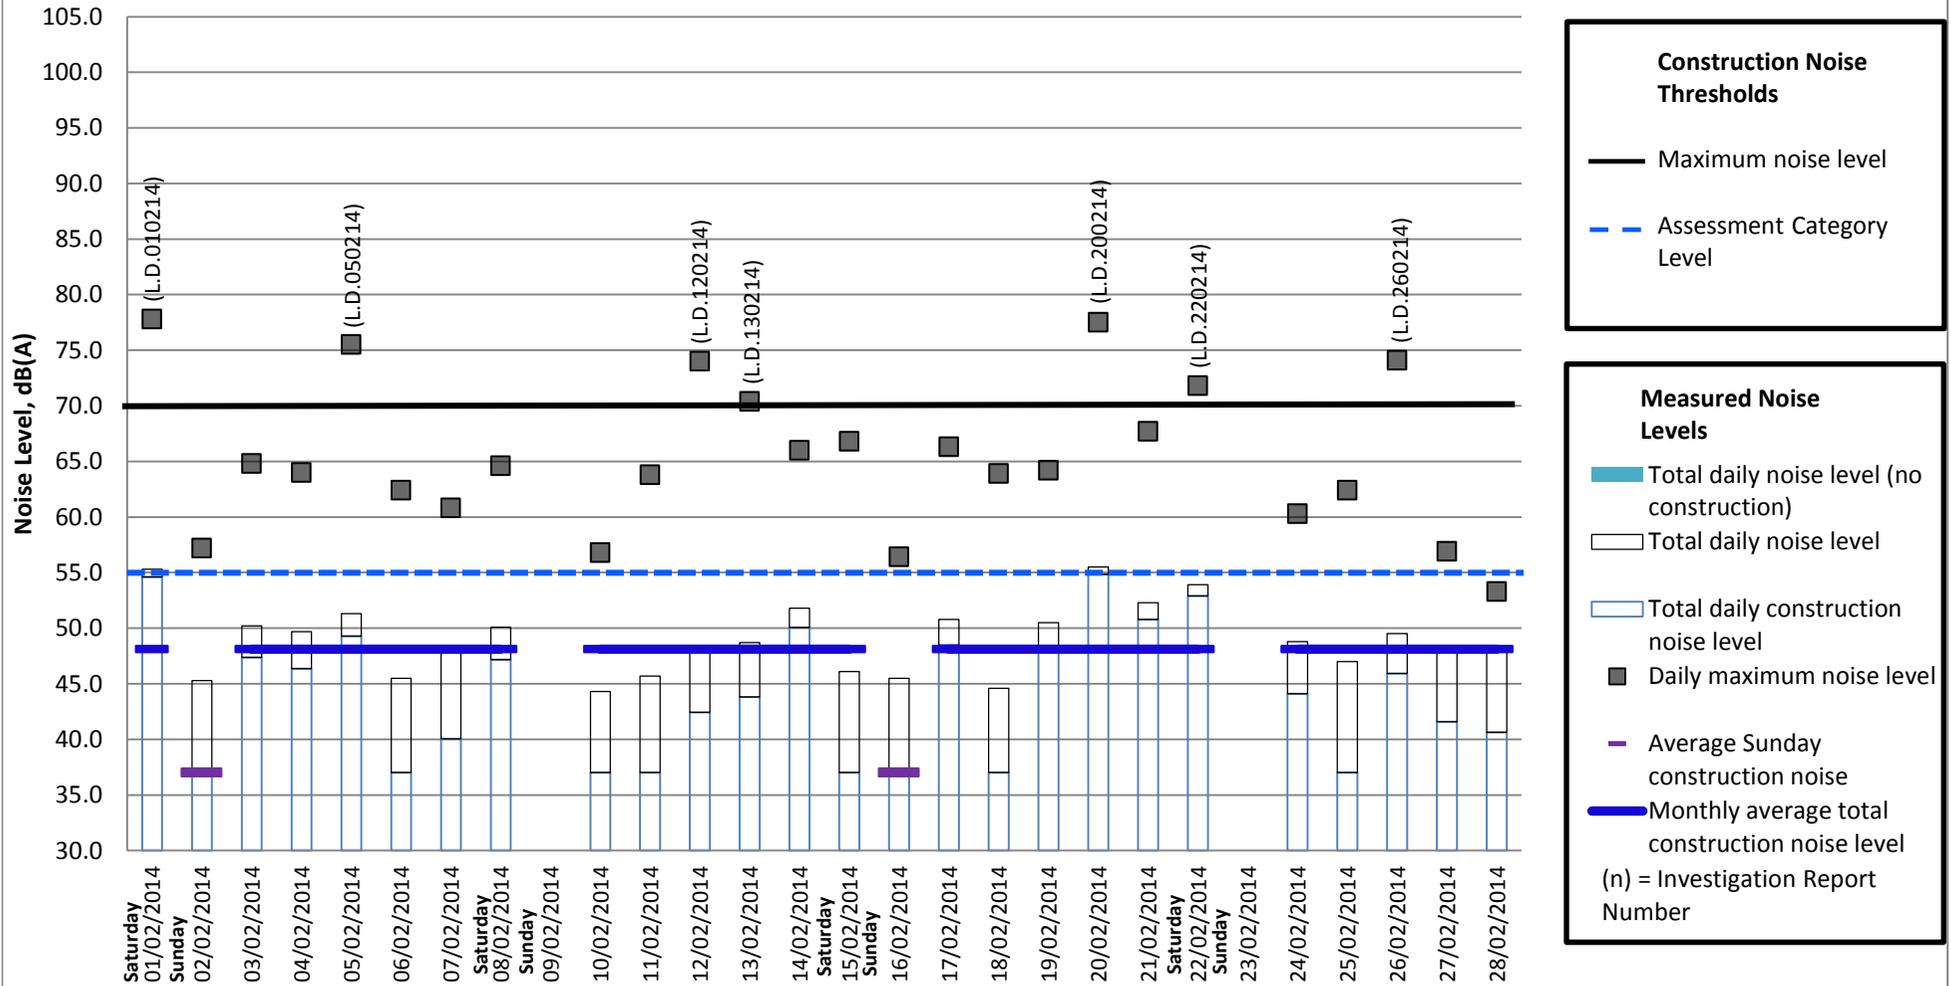
Measured Evening Noise Levels at Linn Mill Measurement period: February 2014

Note: Due to adverse weather conditions, data is missing for 09/02/14 and 23/02/14.

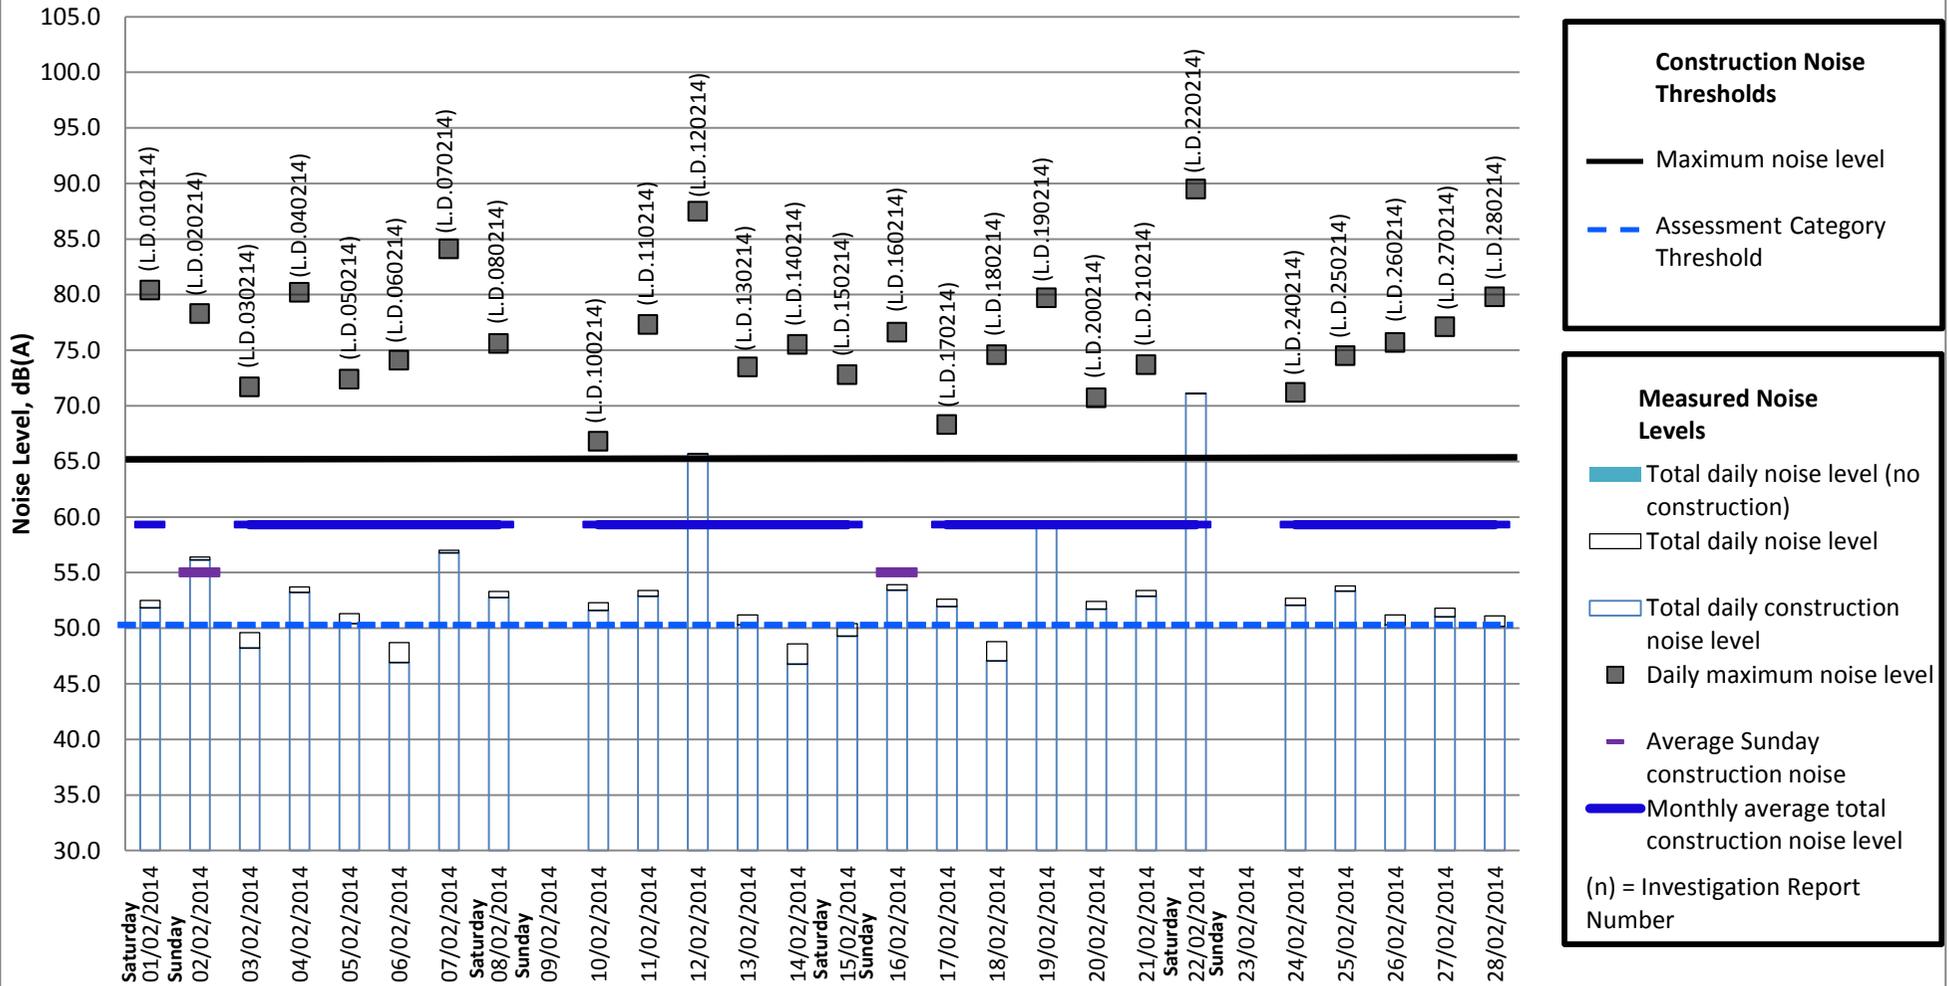
Measured Night-time Noise Levels at Linn Mill Measurement period: February 2014

Note: Due to adverse weather conditions, data is missing for 09/02/14 and 23/02/14.

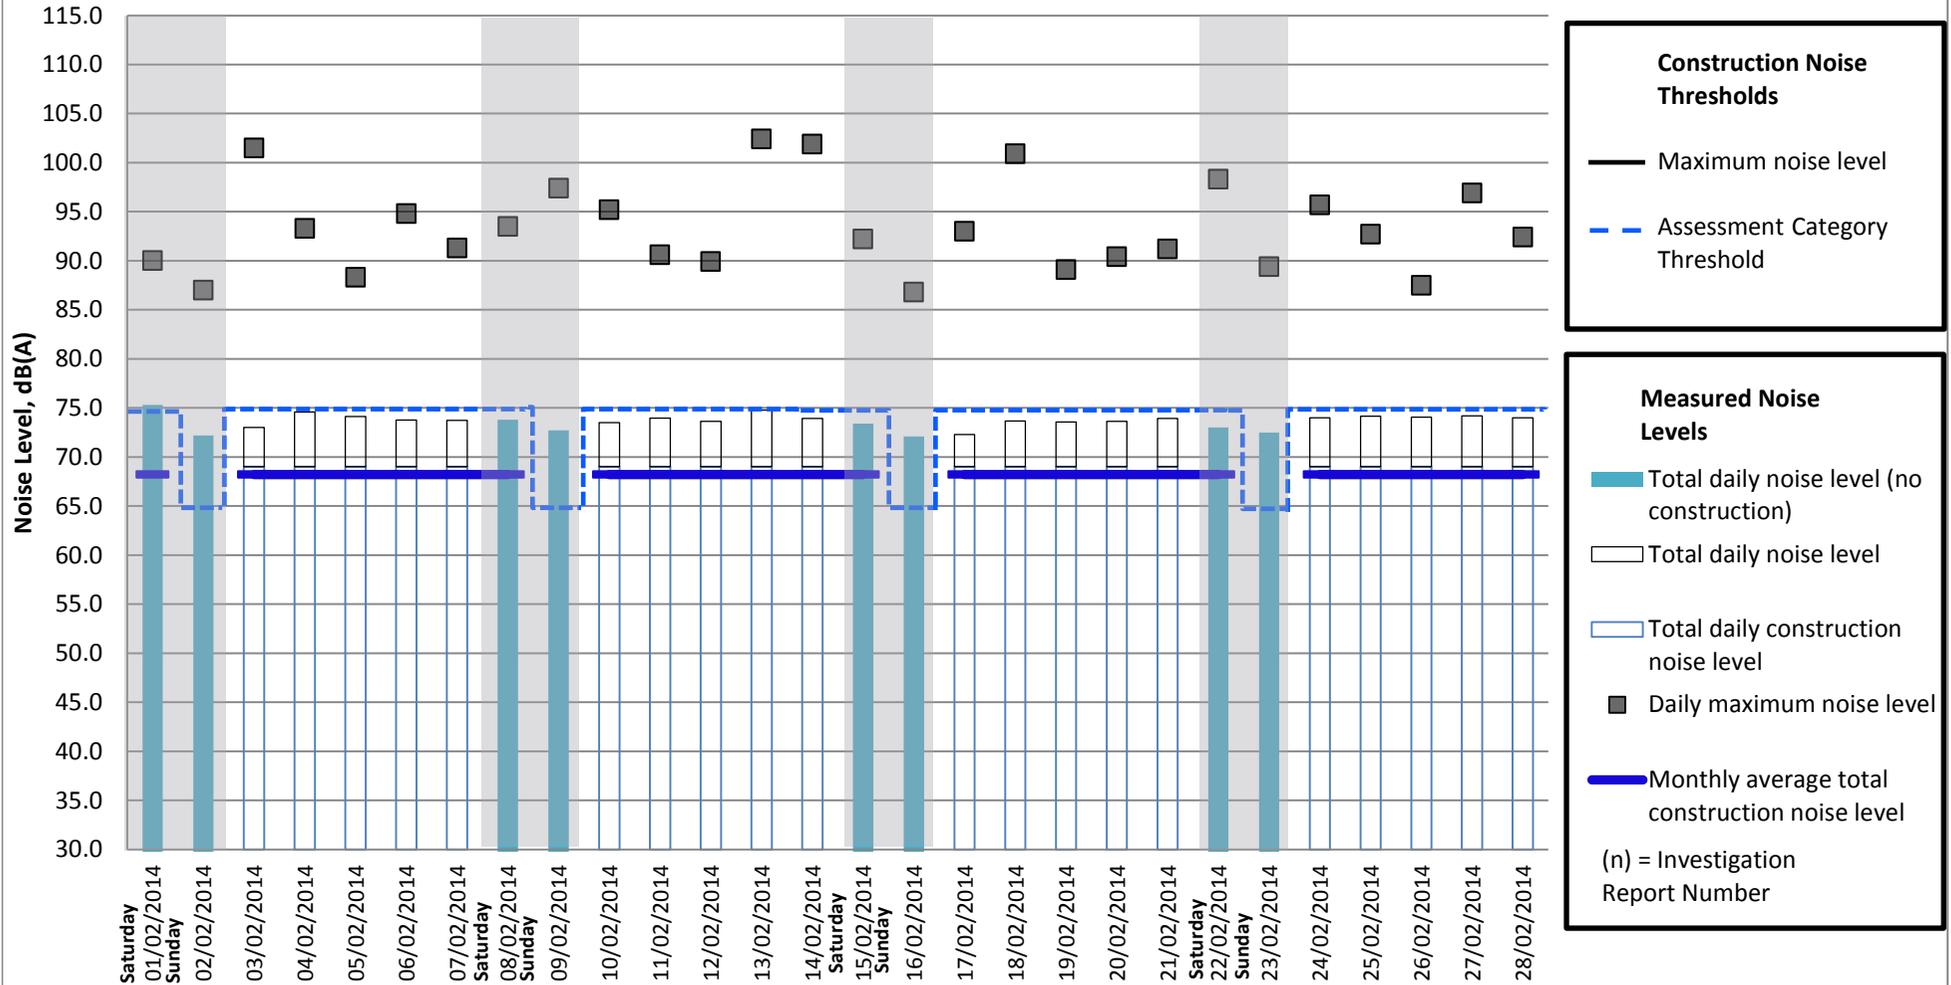
Measured Daytime Noise Levels at Newton Measurement period: February 2014

Note: The grey areas of the chart represent days on which no construction works have been conducted; no works have been conducted near this location on Saturday or Sunday. It should be noted that the measured noise levels Mon - Fri can not be attributed to construction works due to the considerable distance (1.75 kilometers) between this monitoring location and the closest construction works.

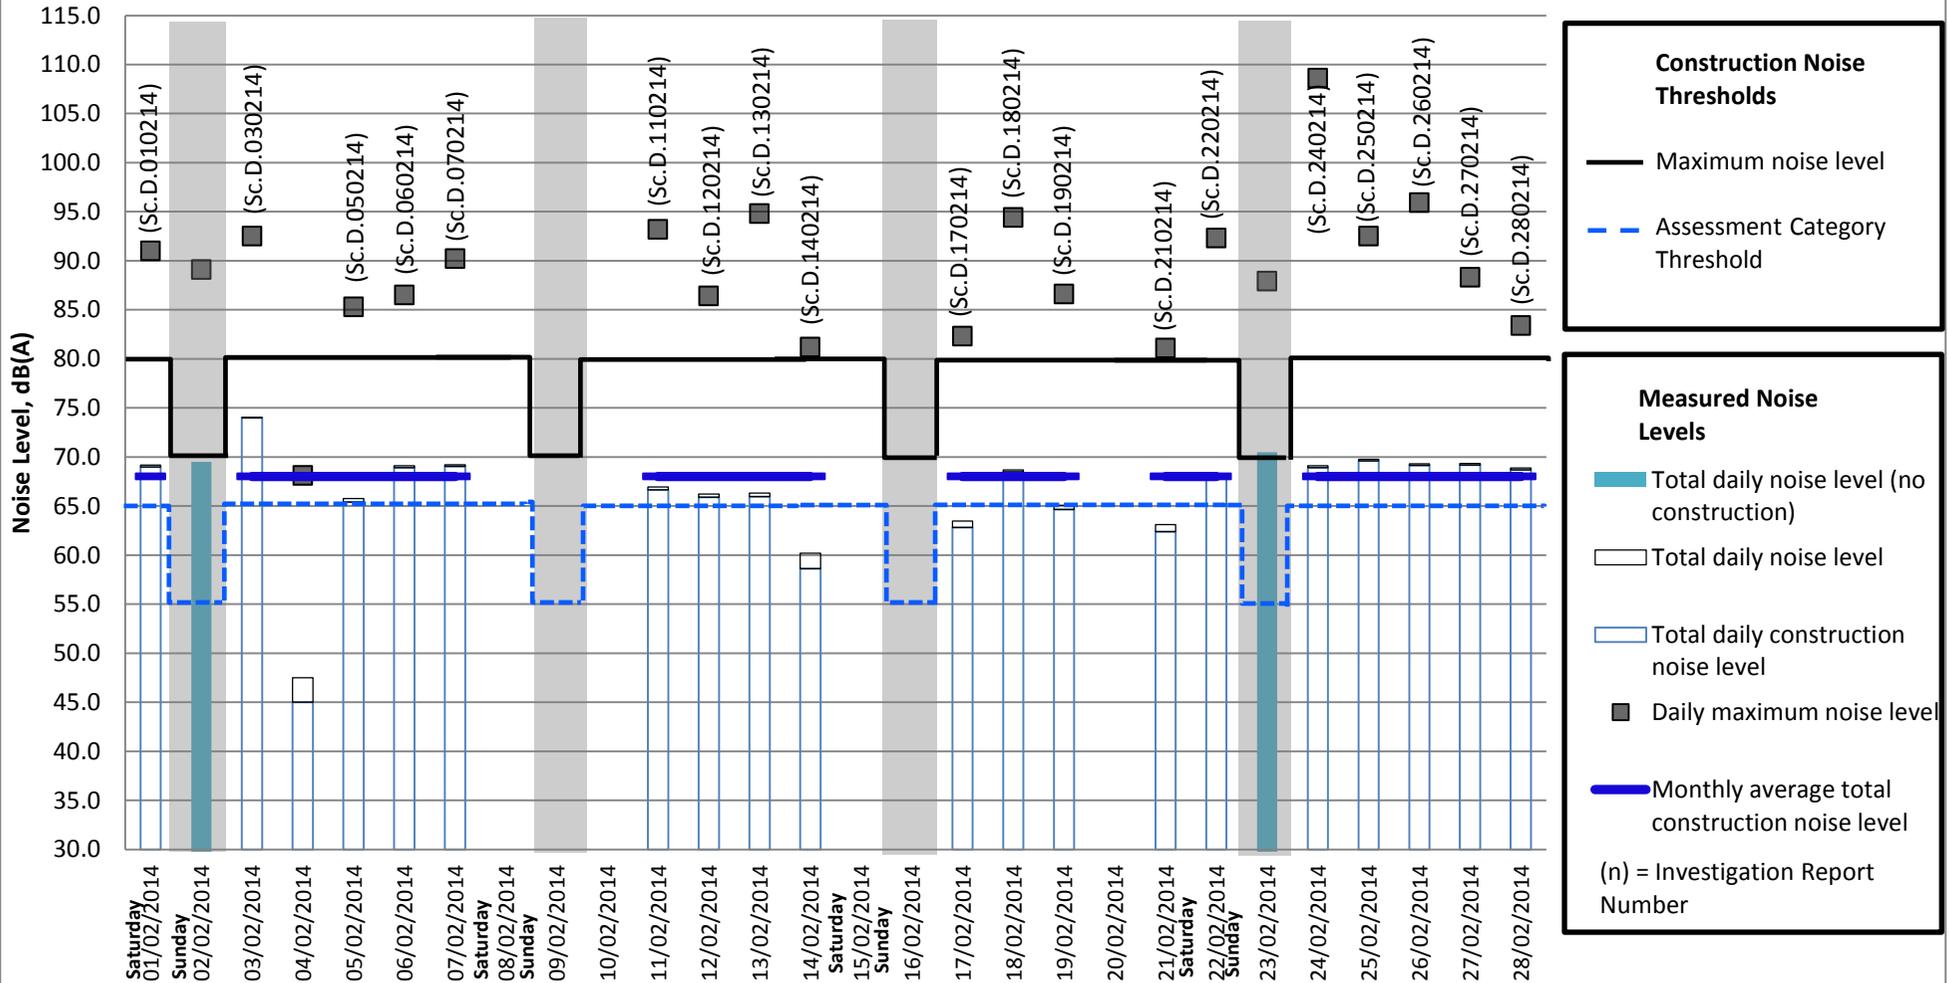
Measured Daytime Noise Levels at Scotstoun

Measurement period: February 2014

Note: The grey areas of the chart represent days on which no construction works have been conducted. The monthly average construction noise for Sunday has not been included as no Sunday works have been conducted at this location. The following dates have missing data due to a power issue (broken power cable): 08/02/14-10/02/14, 15/02/14, 16/02/14 & 20/2/14.

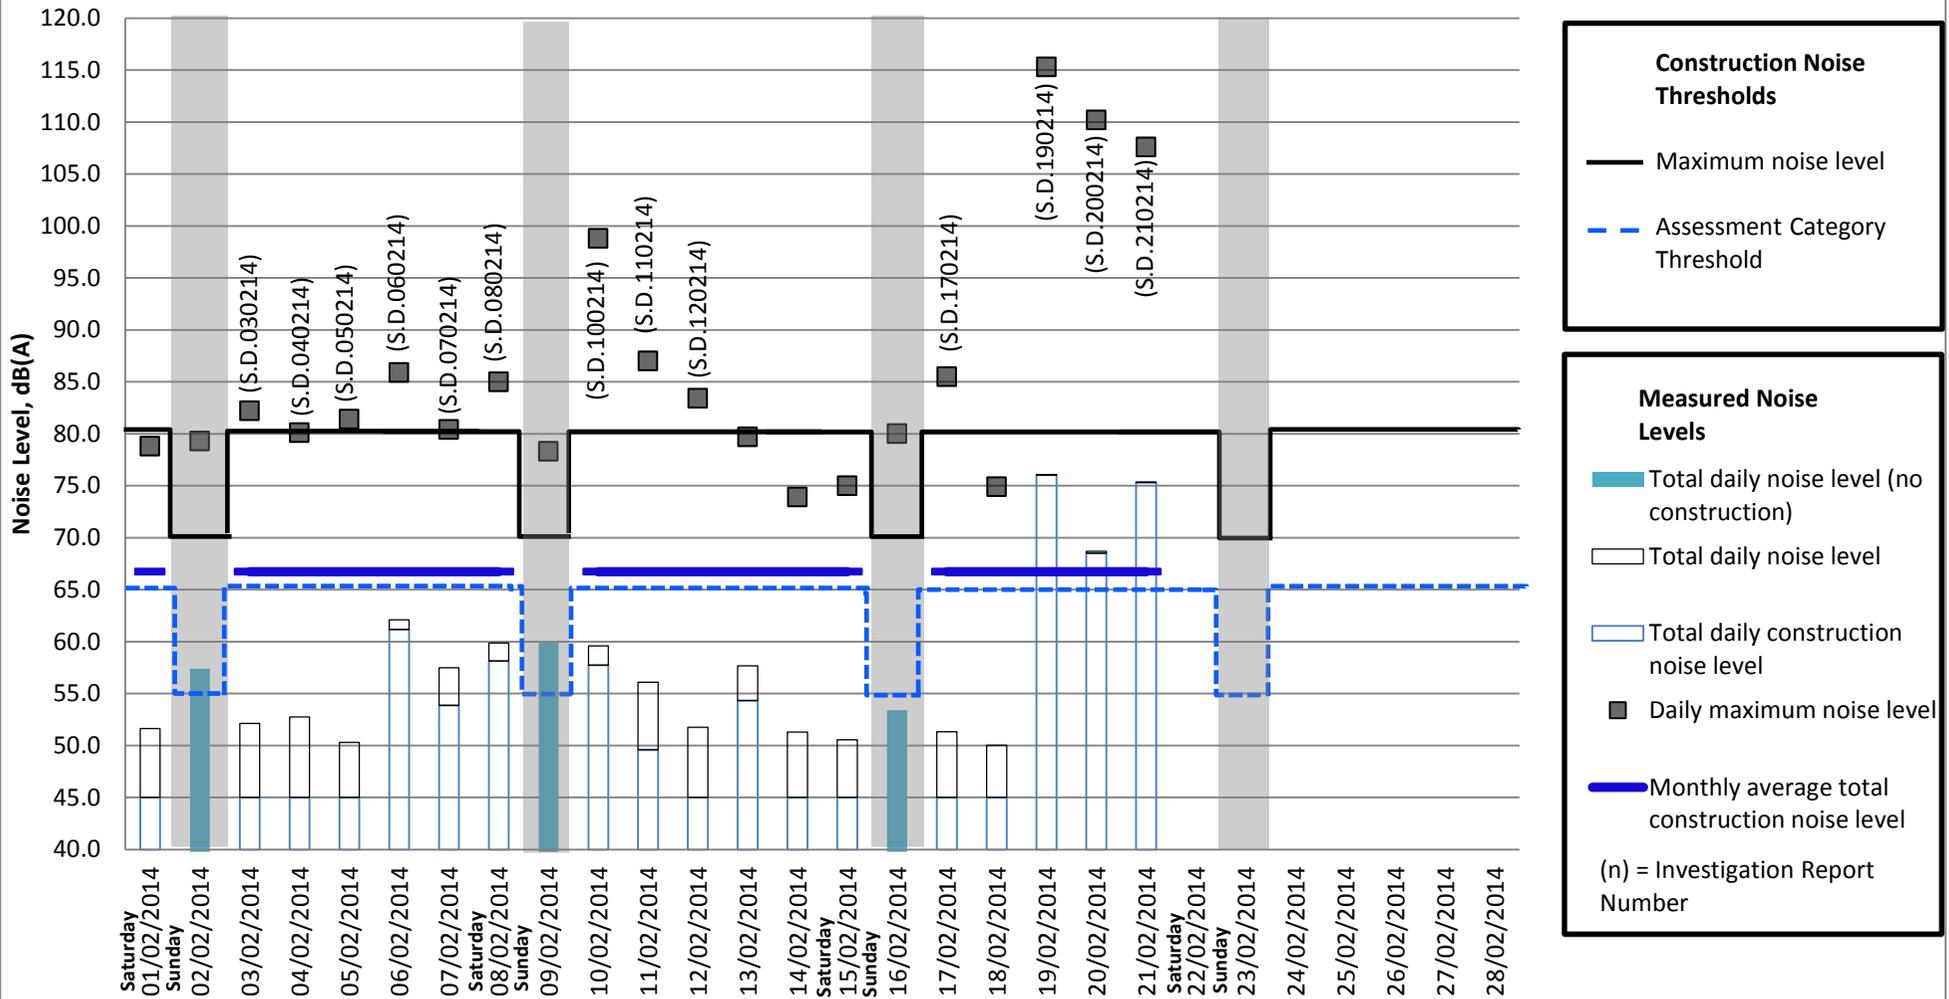
Measured Daytime Noise Levels at Springfield Measurement period: February 2014

Note: The grey areas of the chart represent days on which no construction works have been conducted. There is no data at the following dates due to exterior house renovations at monitor location: 22/02/14 - 28/02/14 .

3.5 With regard to the exceedance of the threshold at Springfield, it was found that house renovations which began on the 18 February significantly influenced the noise levels at this location on 19, 20 and 21 of February, prior to the meter then being temporarily removed to enable the works to be undertaken. The exceedance of the daytime average at Scotstoun is due to increased background noise levels due to the location of the meter directly adjacent to the road. The average for February is consistent with levels for previous months.

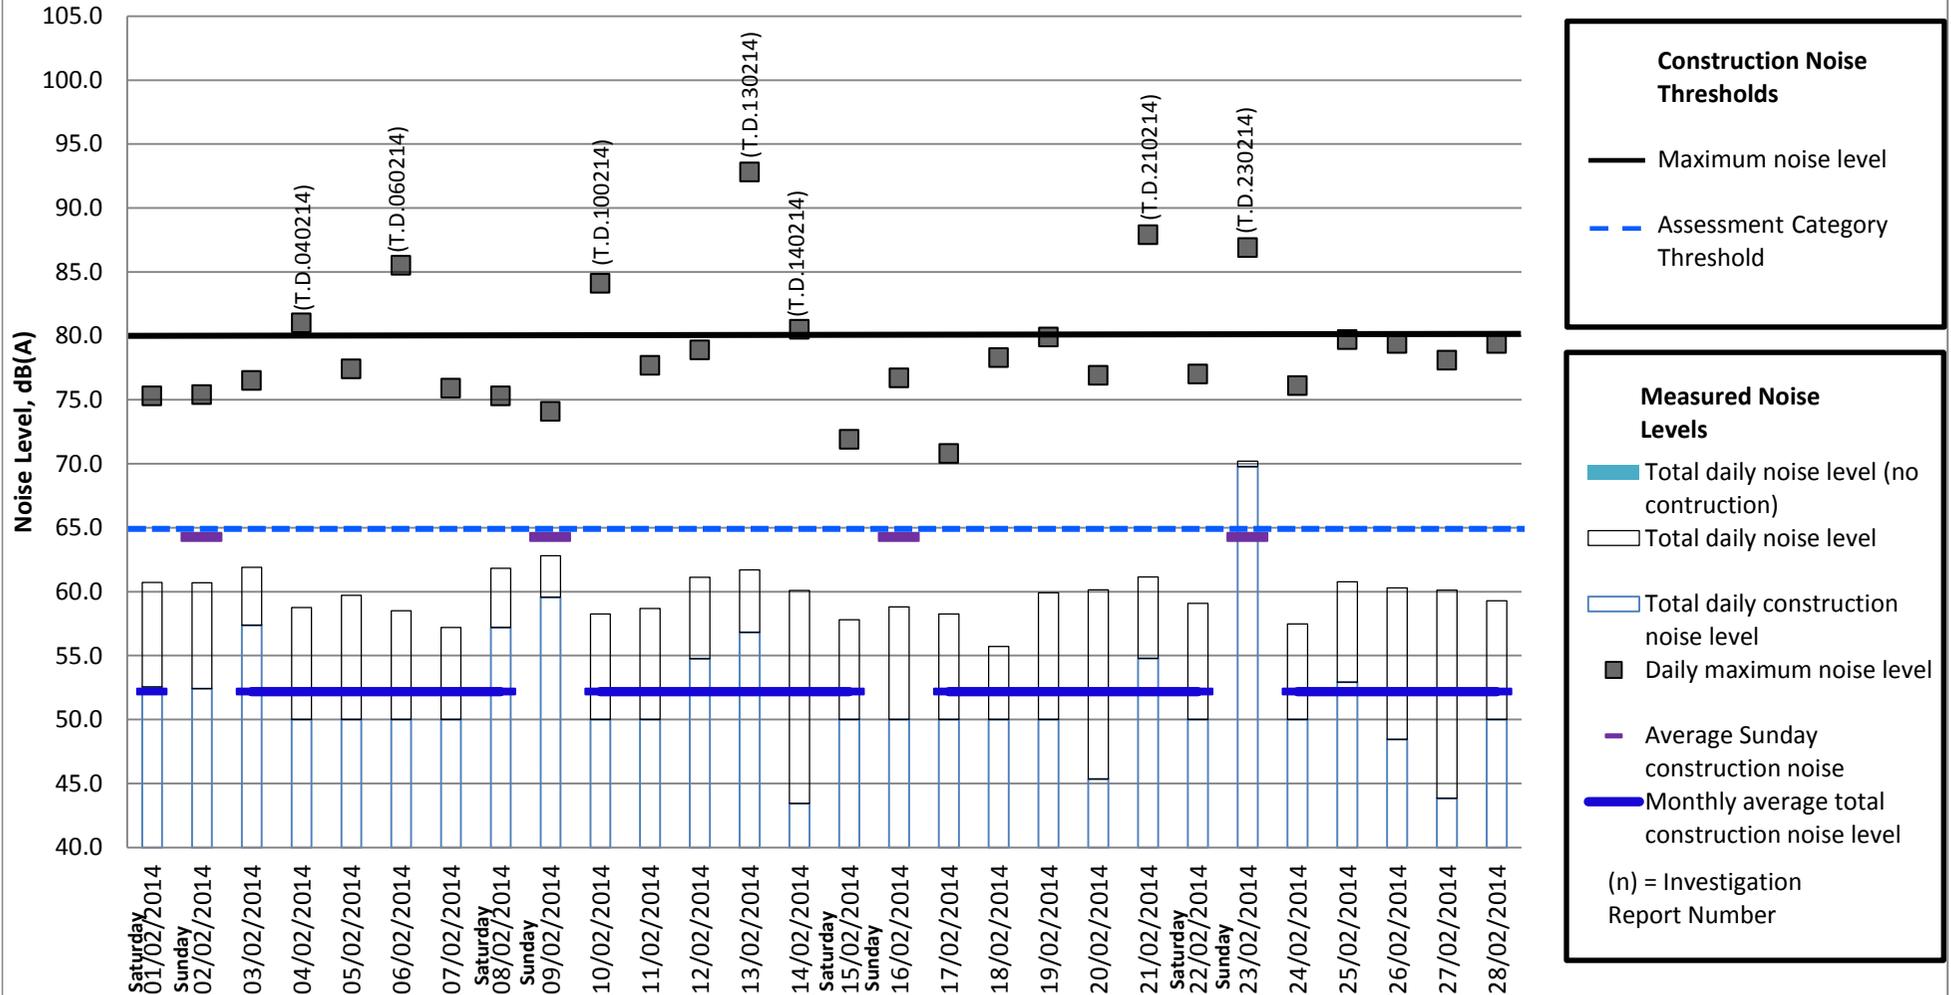
Measured Daytime Noise Levels at Tigh-Na-Grian Measurement period: February 2014

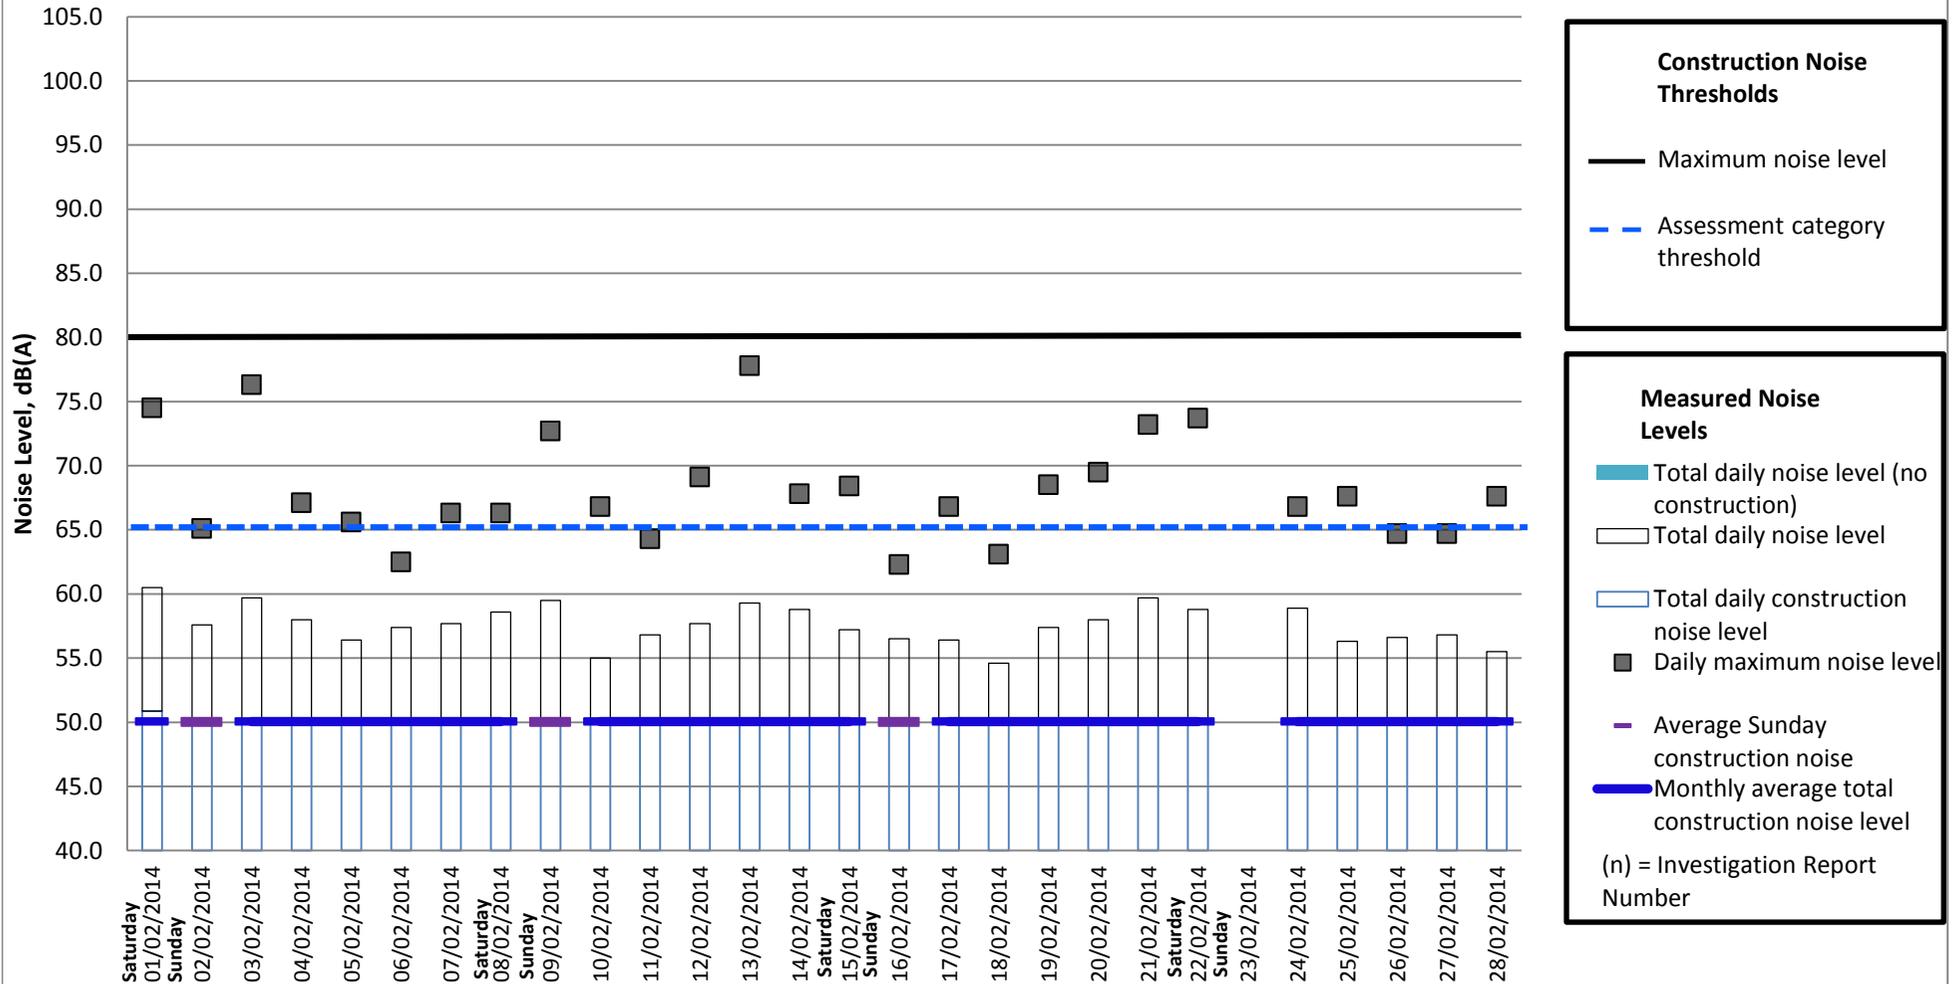
Measured Evening Noise Levels at Tigh-Na-Grian Measurement period: February 2014

Note: Due to adverse weather conditions, data is missing for 23/02/14.

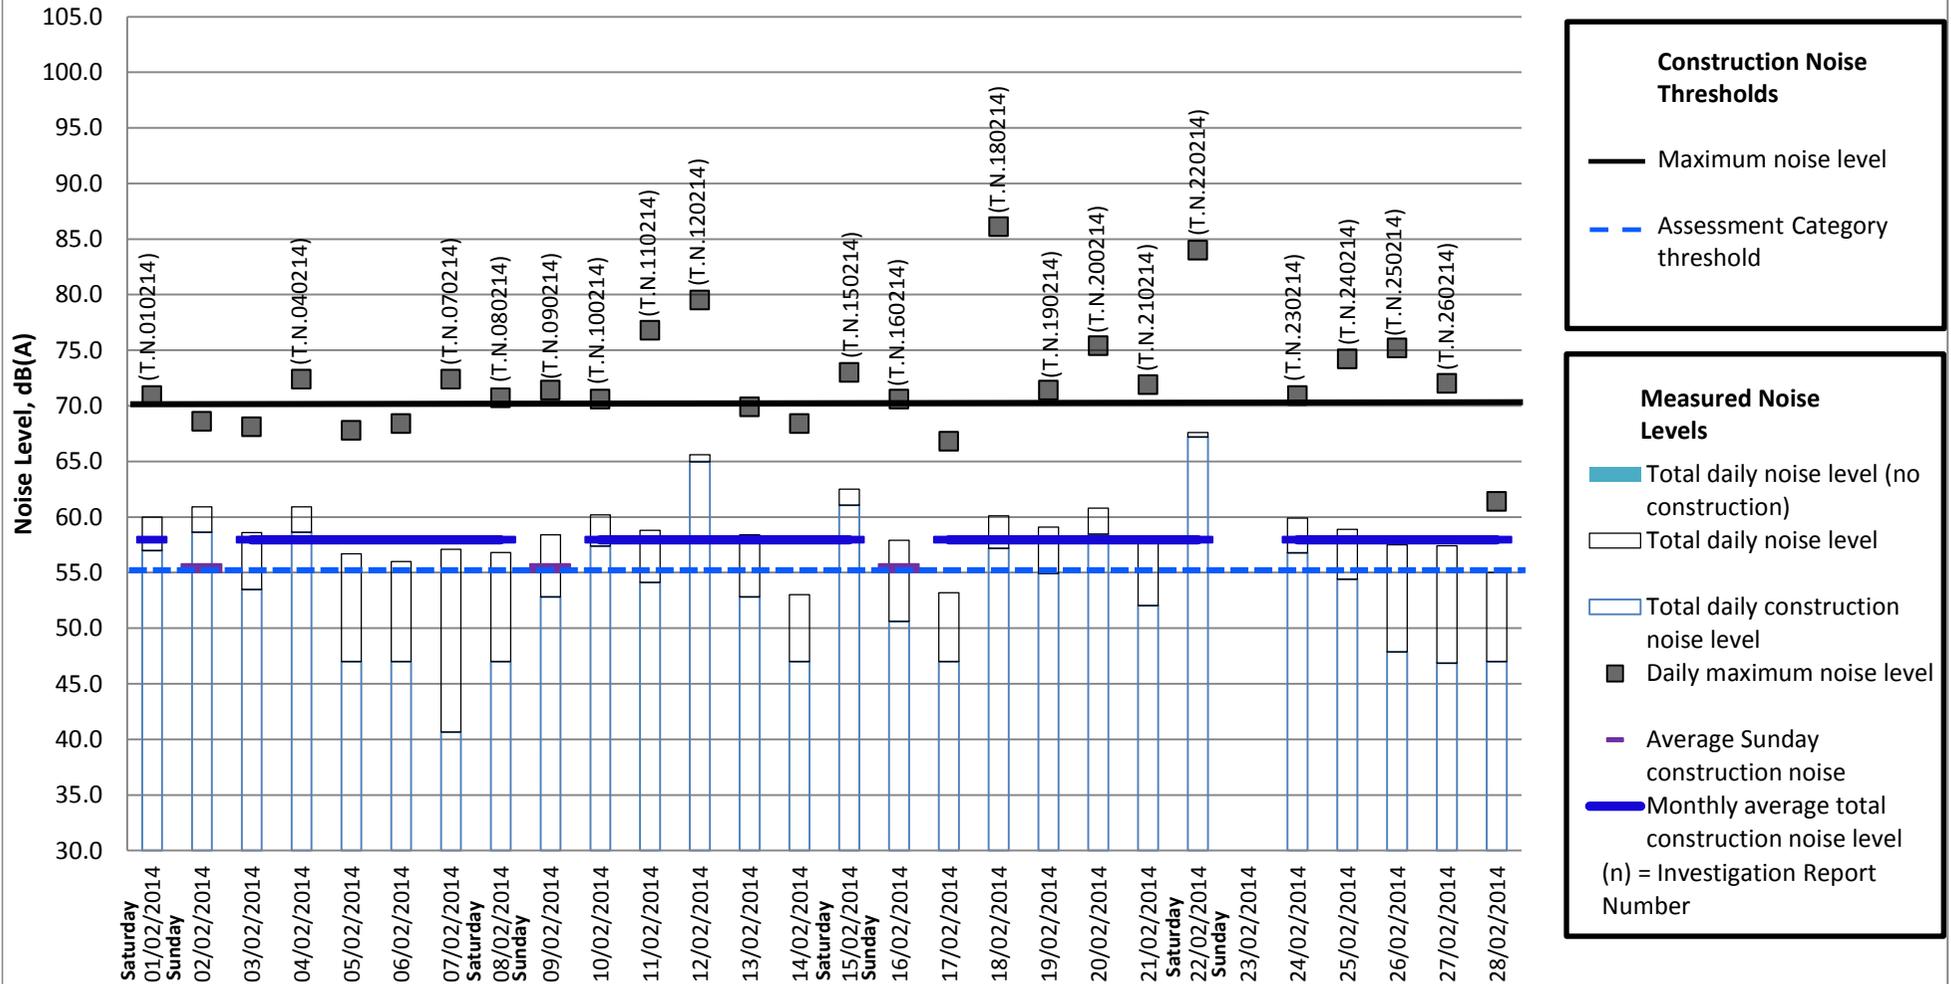
Measured Night-time Noise Levels at Tigh-Na-Grian Measurement period: February 2014

Note: Due to adverse weather conditions, data is missing for 23/02/14.

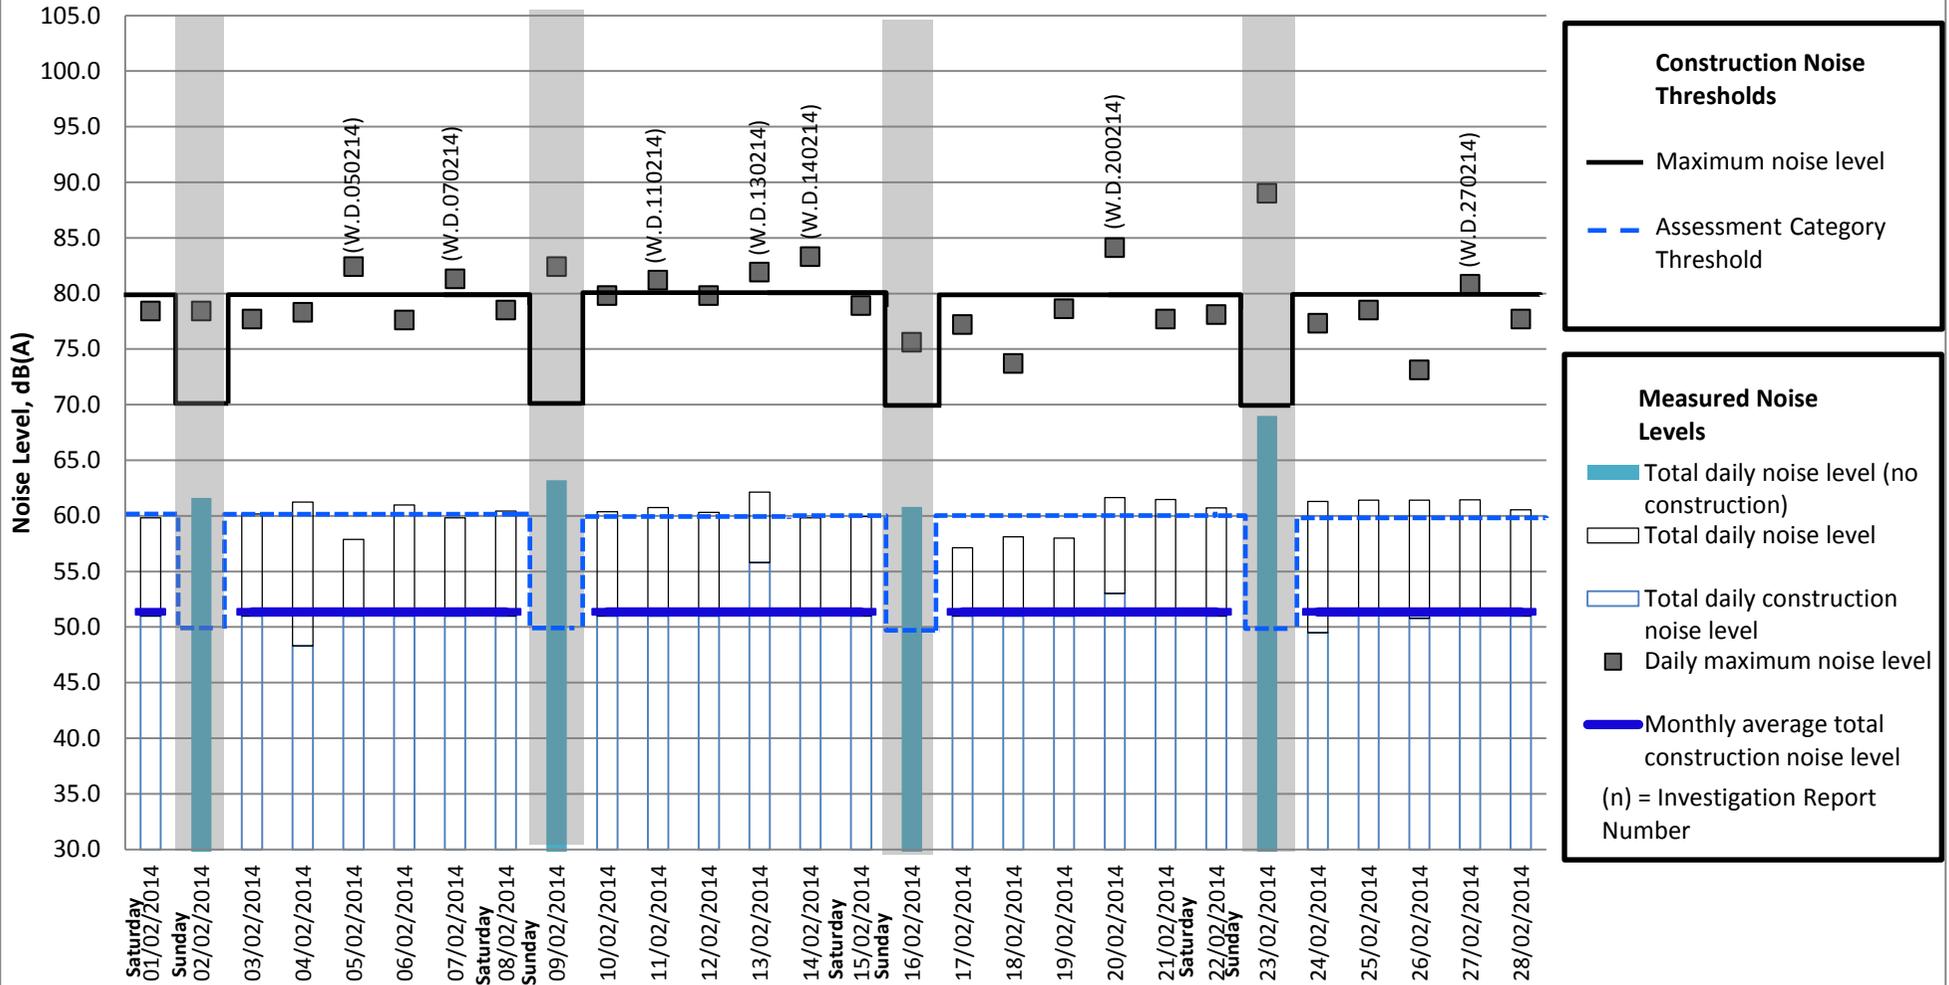
Measured Daytime Noise Levels at Whinny Hill

Measurement period: February 2014

Note: The grey areas of the chart represent days on which no construction works have been conducted. The monthly average construction noise for Sunday has not been included as no Sunday works have been conducted at this location during this period.
