Project **FORTH REPLACEMENT CROSSING**

CONSTRUCTION NOISE MONITORING REPORT: OCTOBER 2015

Document number	Rev
REP-00256	00

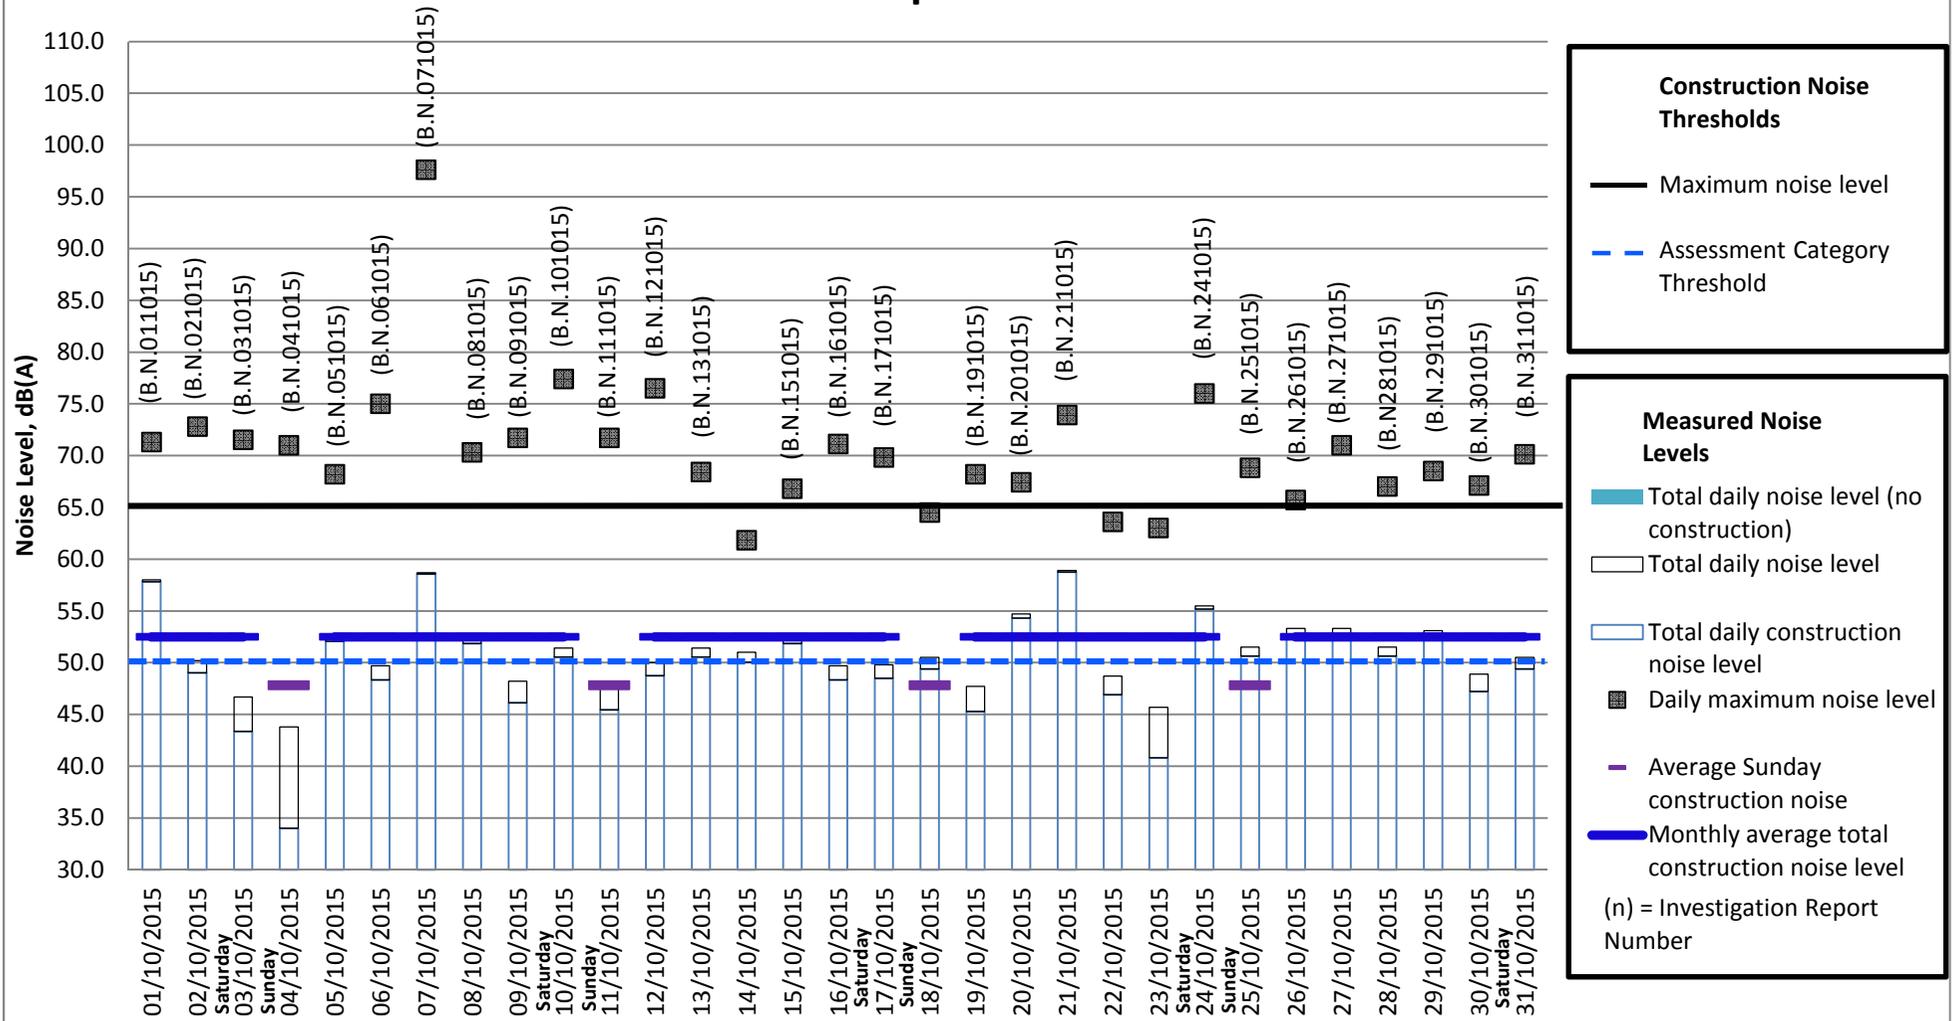
Measured Night time Noise Levels at Butlaw Fisheries Measurement period: October 2015

Note: After investigation, it was concluded that the exceedances of the LAeq 'Total Daily Construction' through the month were caused by birds and waves.

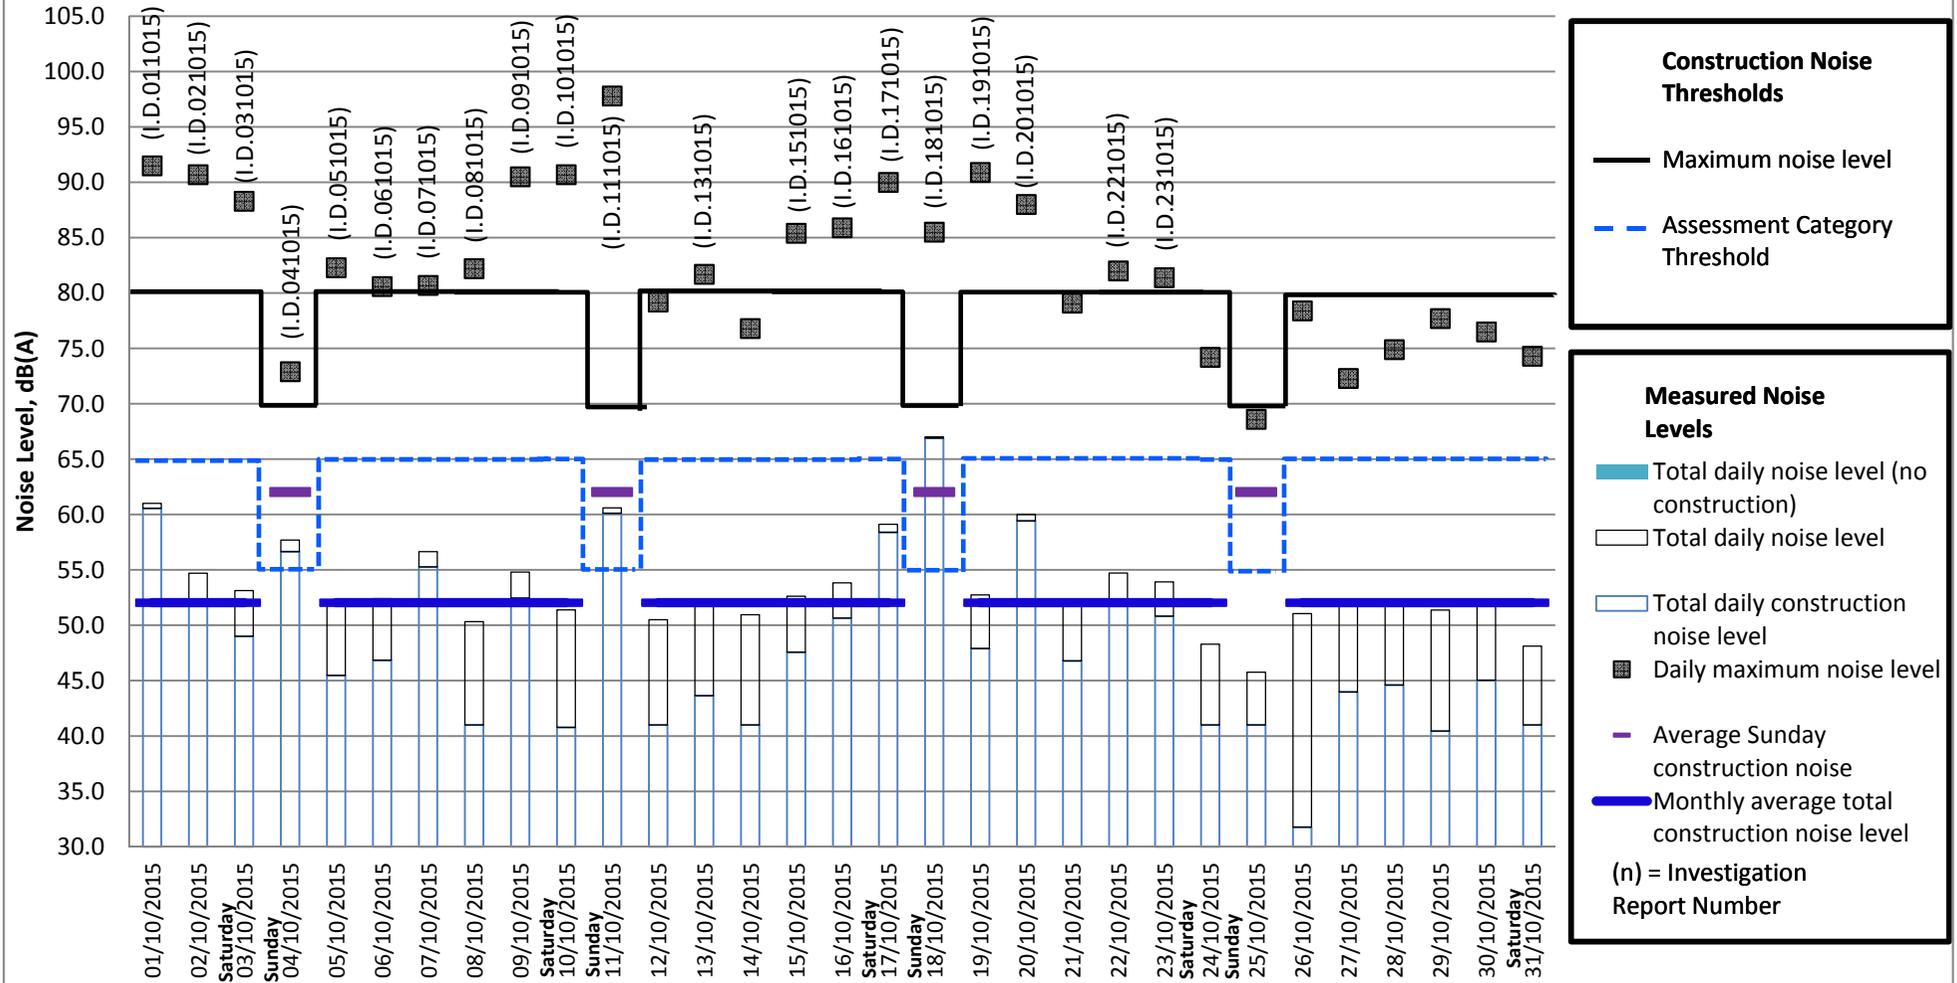
Measured Daytime Noise Levels at Inchgarvie Measurement period: October 2015

Note; After investigation it was concluded that the exceedances of the 'Average Sunday construction noise' through the month were caused by residential building works

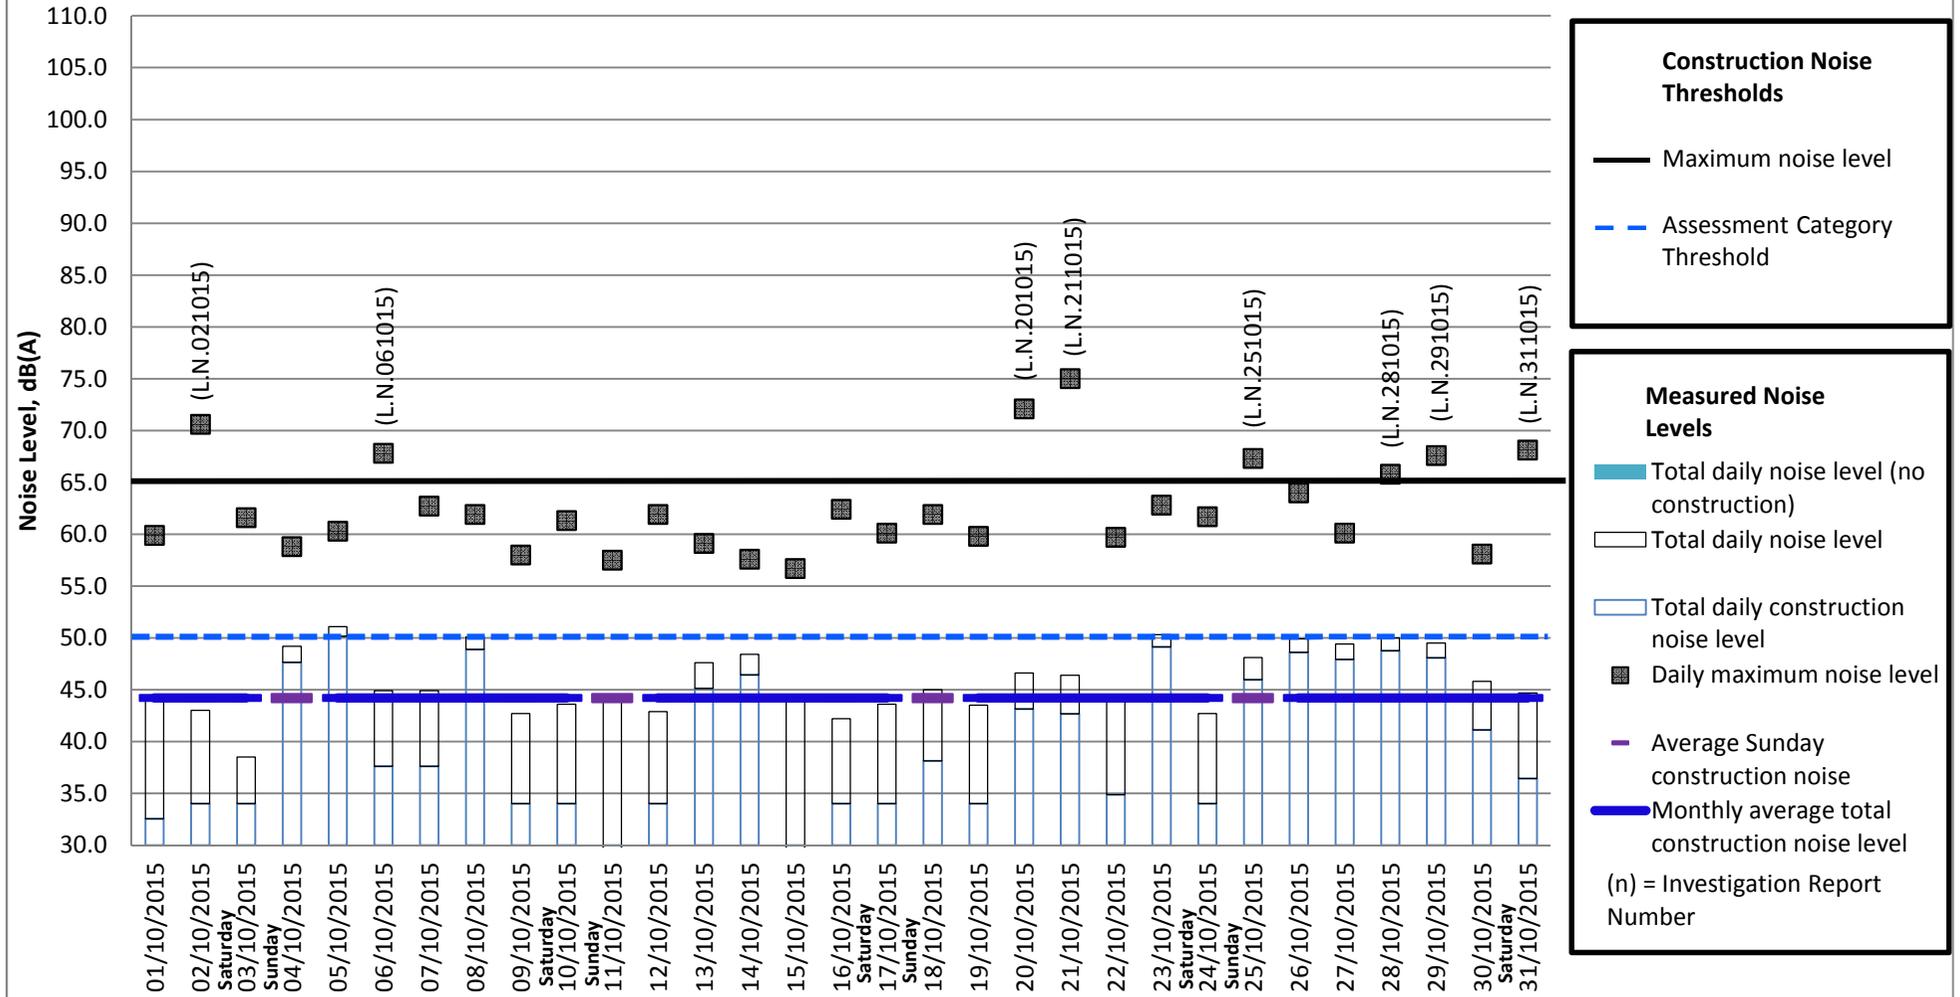
Measured Night time Noise Levels at Linn Mill

- 3.7** During the month of October it was noted that there was construction related noise at Linn Mill. The exceedance at Linn Mill on the 2nd at night was due to a vehicle accessing the site before working hours. The environmental team made the site agent aware of this. The exceedances on the 5th, 6th and 29th October during the day seemed to be coming from the Scaffold/Timber storage area which is near the noise monitor. The Environmental team have contacted the relevant site agent and asked that staff be reminded to keep noise to a minimum, the environmental team will continue to monitor the situation closely. There were three exceedances at Dundas that occurred during the day time period, on the 23rd 26th and 27th October. This was caused by piling activity. There were two construction related exceedances at Tigh-Na-Grain. An exceedance occurred during the night of the 5th, apparently caused by somebody using either a loud hailer or perhaps a car stereo. This may or may not have been from vessels. A brief was given to site staff about keeping quiet at night. The exceedance on the 8th occurred at night and was due to hammering noises. The environmental team contacted site teams to remind them about hammering at night.

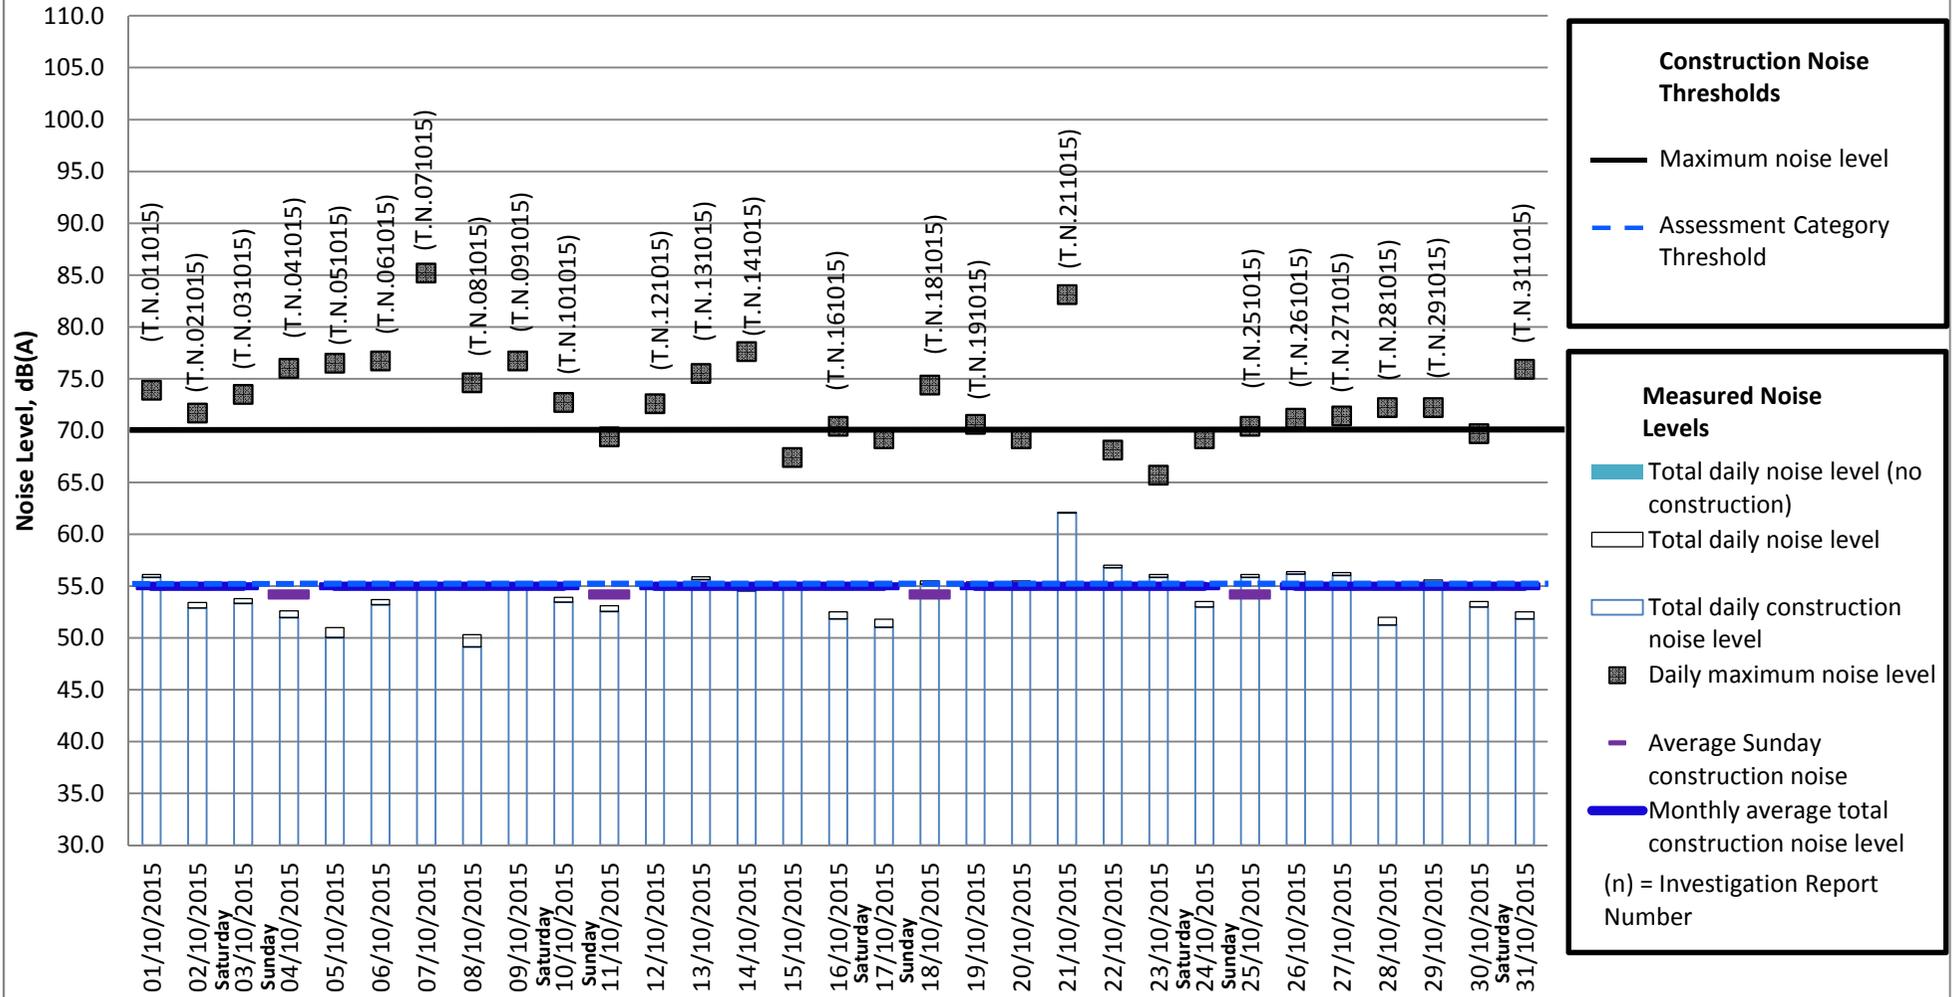
Measured Night time Noise Levels at Tigh-Na-Grian Measurement period: October 2015

Note: After investigation, it was concluded that the exceedances of the LAeq 'Total Daily Construction' on the 21st was caused by high winds

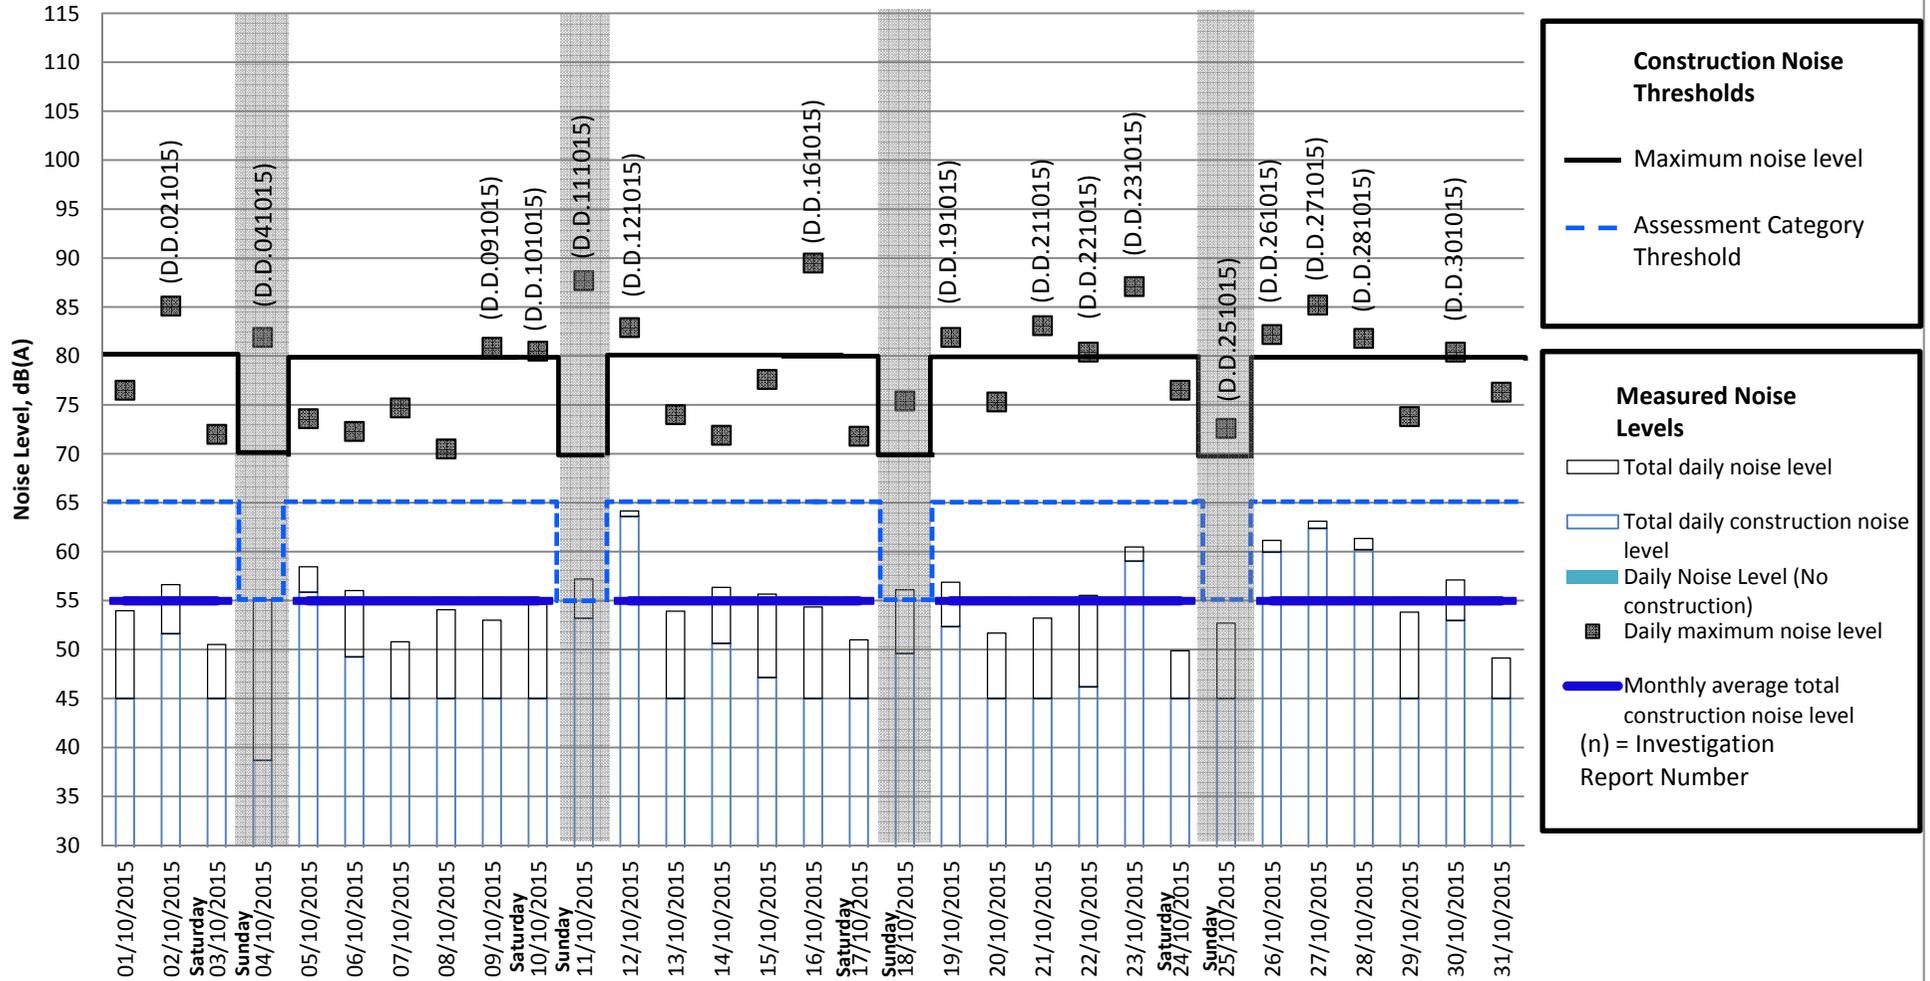
Measured Daytime Noise Levels at Dundas Home Farm Measurement period: October 2015

Note: The grey areas of the chart represent days on which no construction works have been conducted.

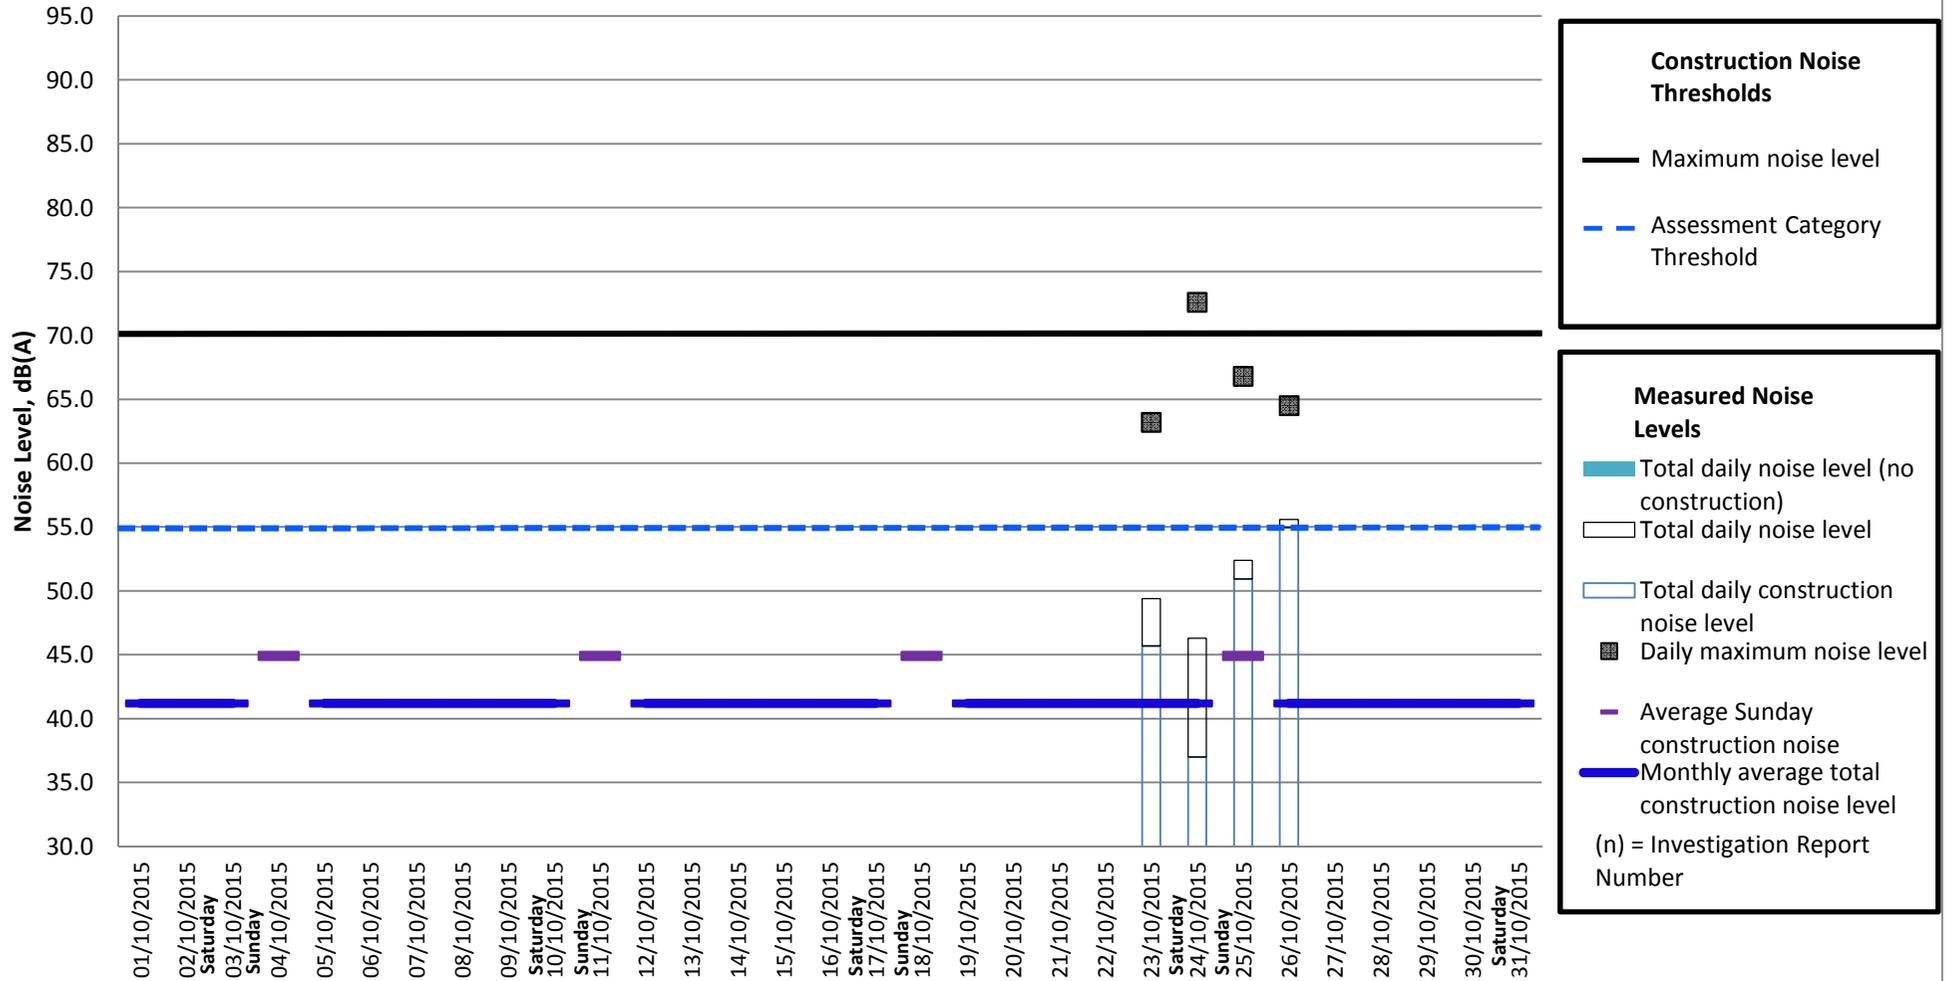
Measured Evening Noise Levels at Dundas Home Farm Measurement period: October 2015

Note; The B800 bridge demolition took place over from 24/10/2015 at 22:00 until 26/10/2015 at 07:00. Noise levels have been included if for this month

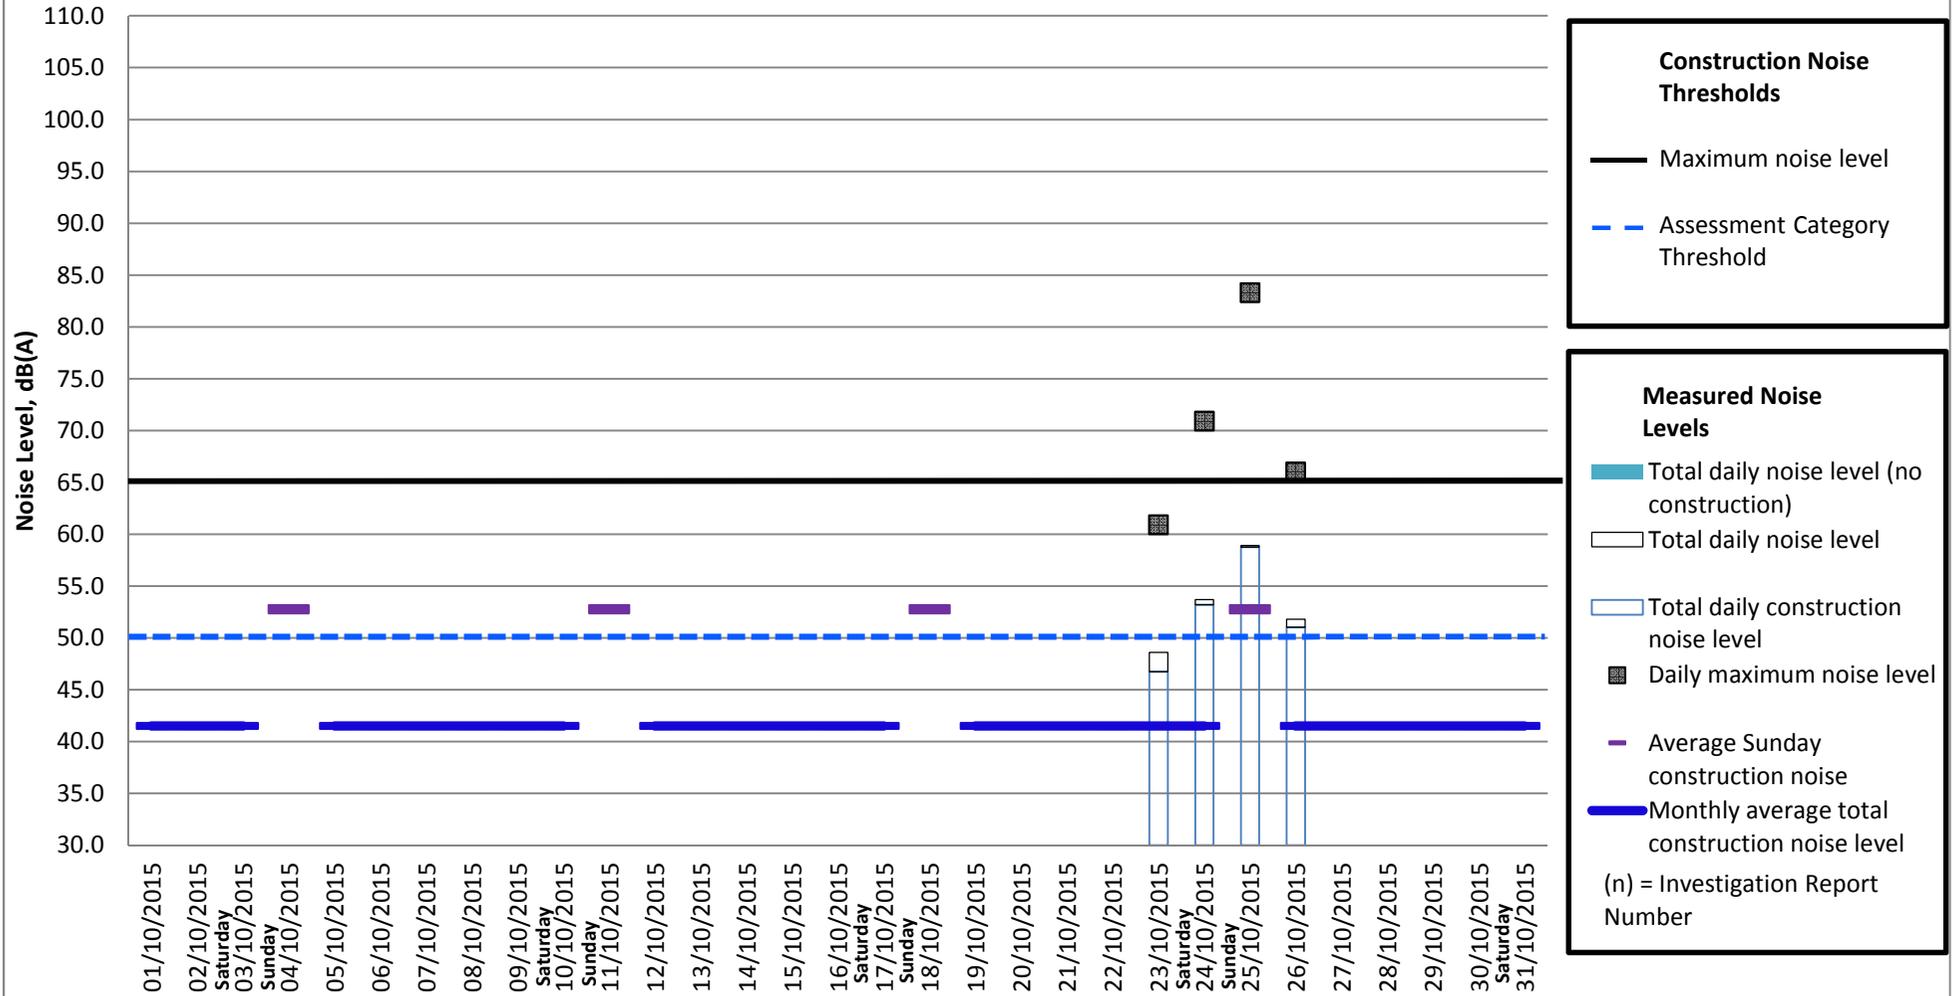
Measured Night time Noise Levels at Dundas Home Farm Measurement period: October 2015

Note; The B800 bridge demolition took place over from 24/10/2015 at 22:00 until 26/10/2015 at 07:00. Noise levels have been included ifor this month

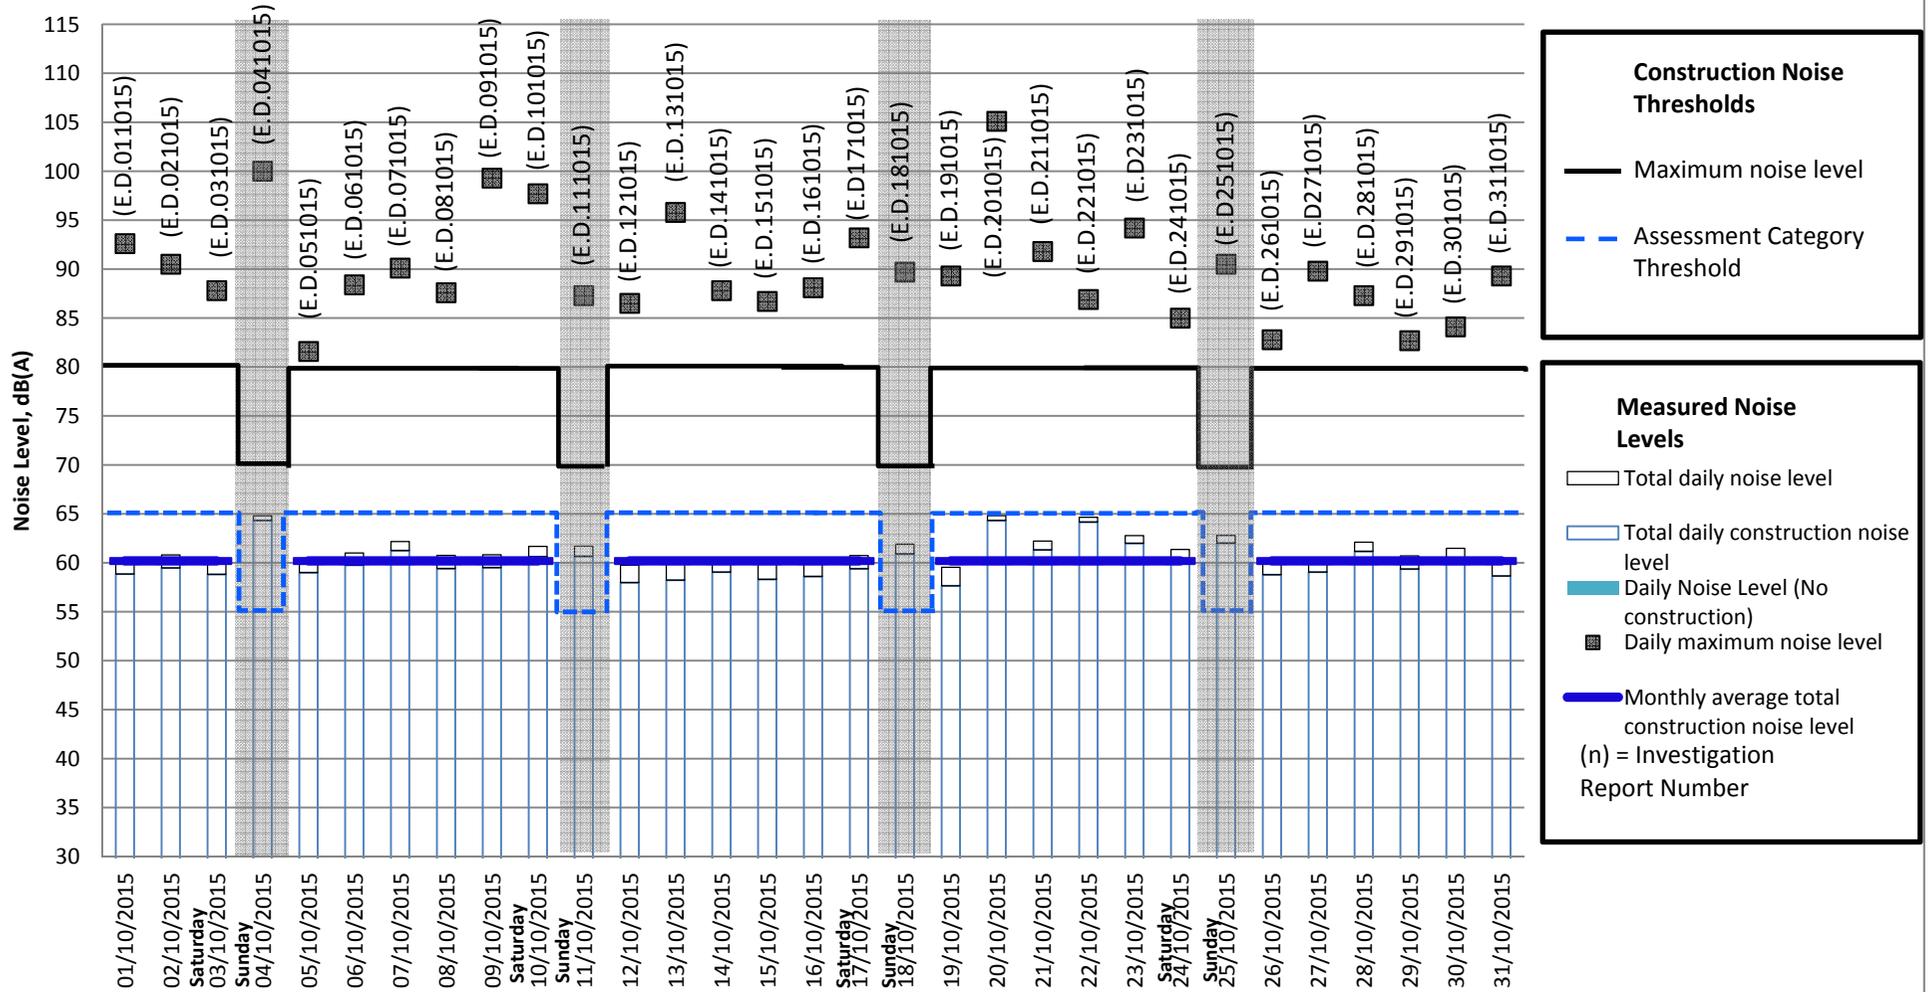
Measured Daytime Noise Levels at Echline Measurement period: October 2015

Note: The grey areas of the chart represent days on which no construction works have been conducted.

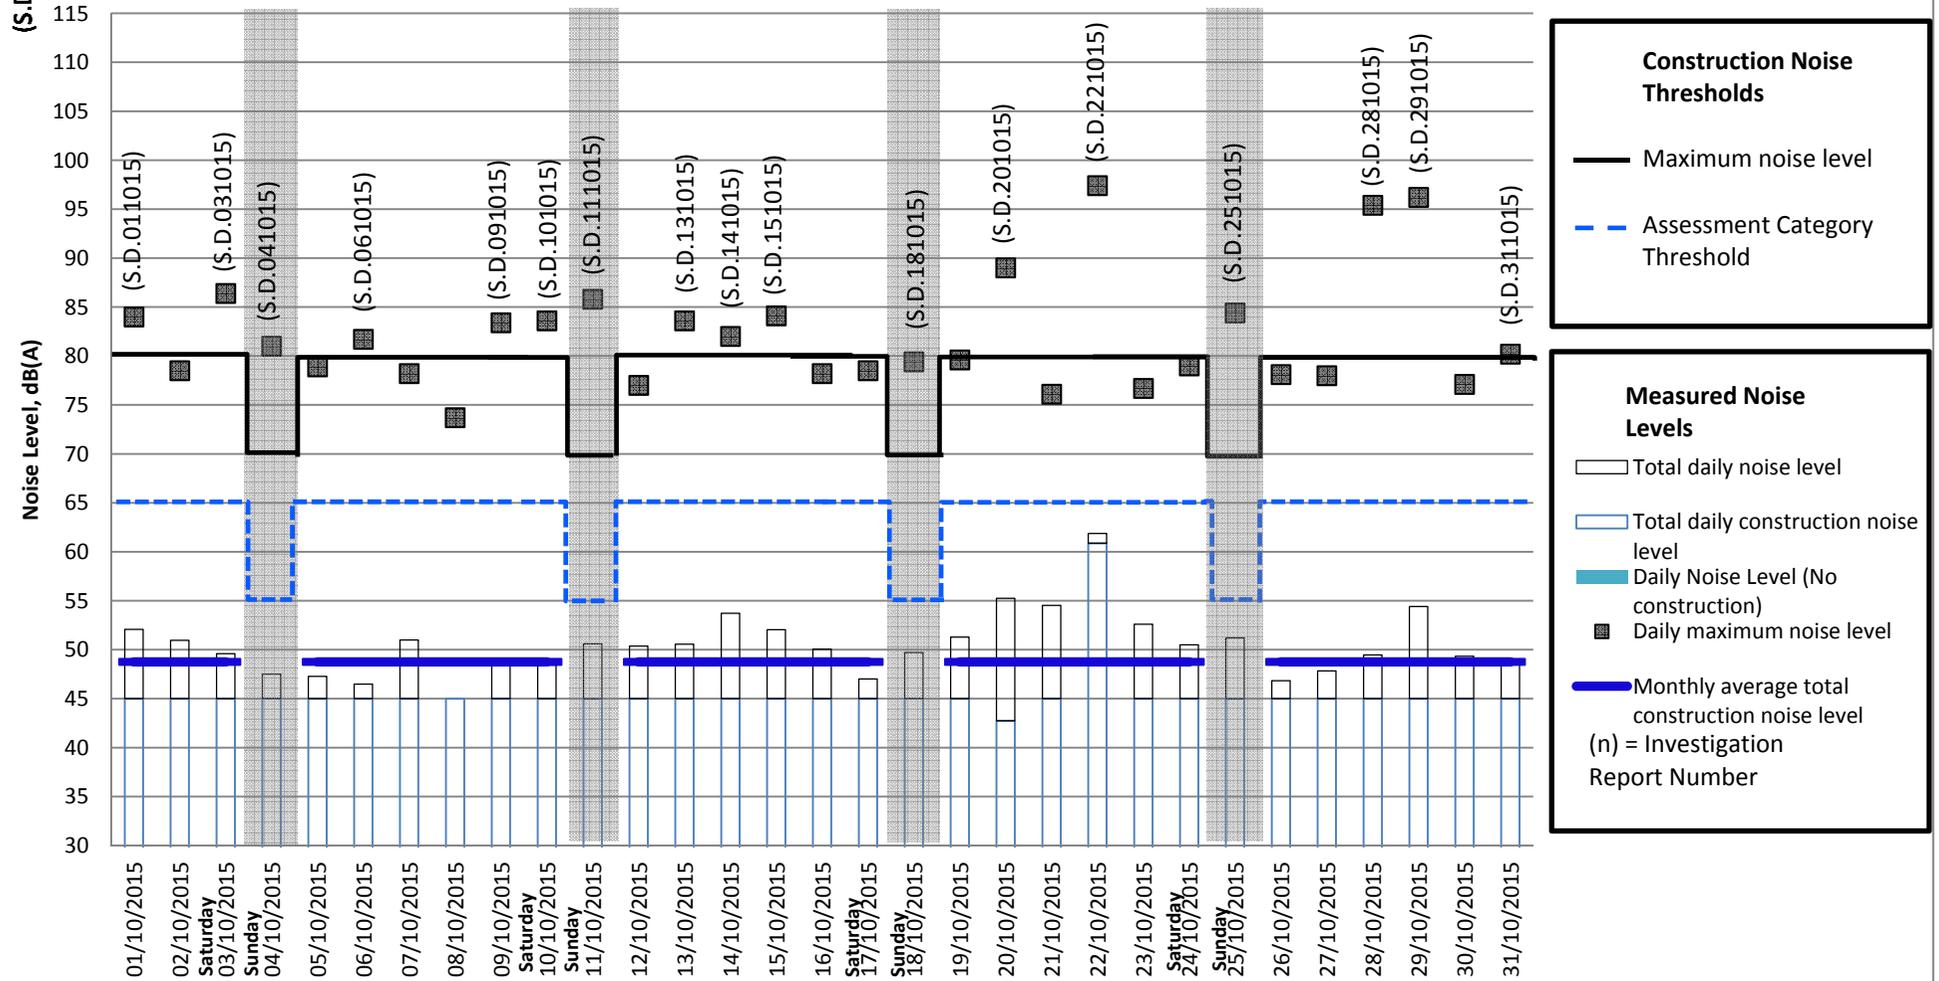
Measured Daytime Noise Levels at Springfield Measurement period: October 2015

Note: The grey areas of the chart represent days on which no construction works have been conducted.

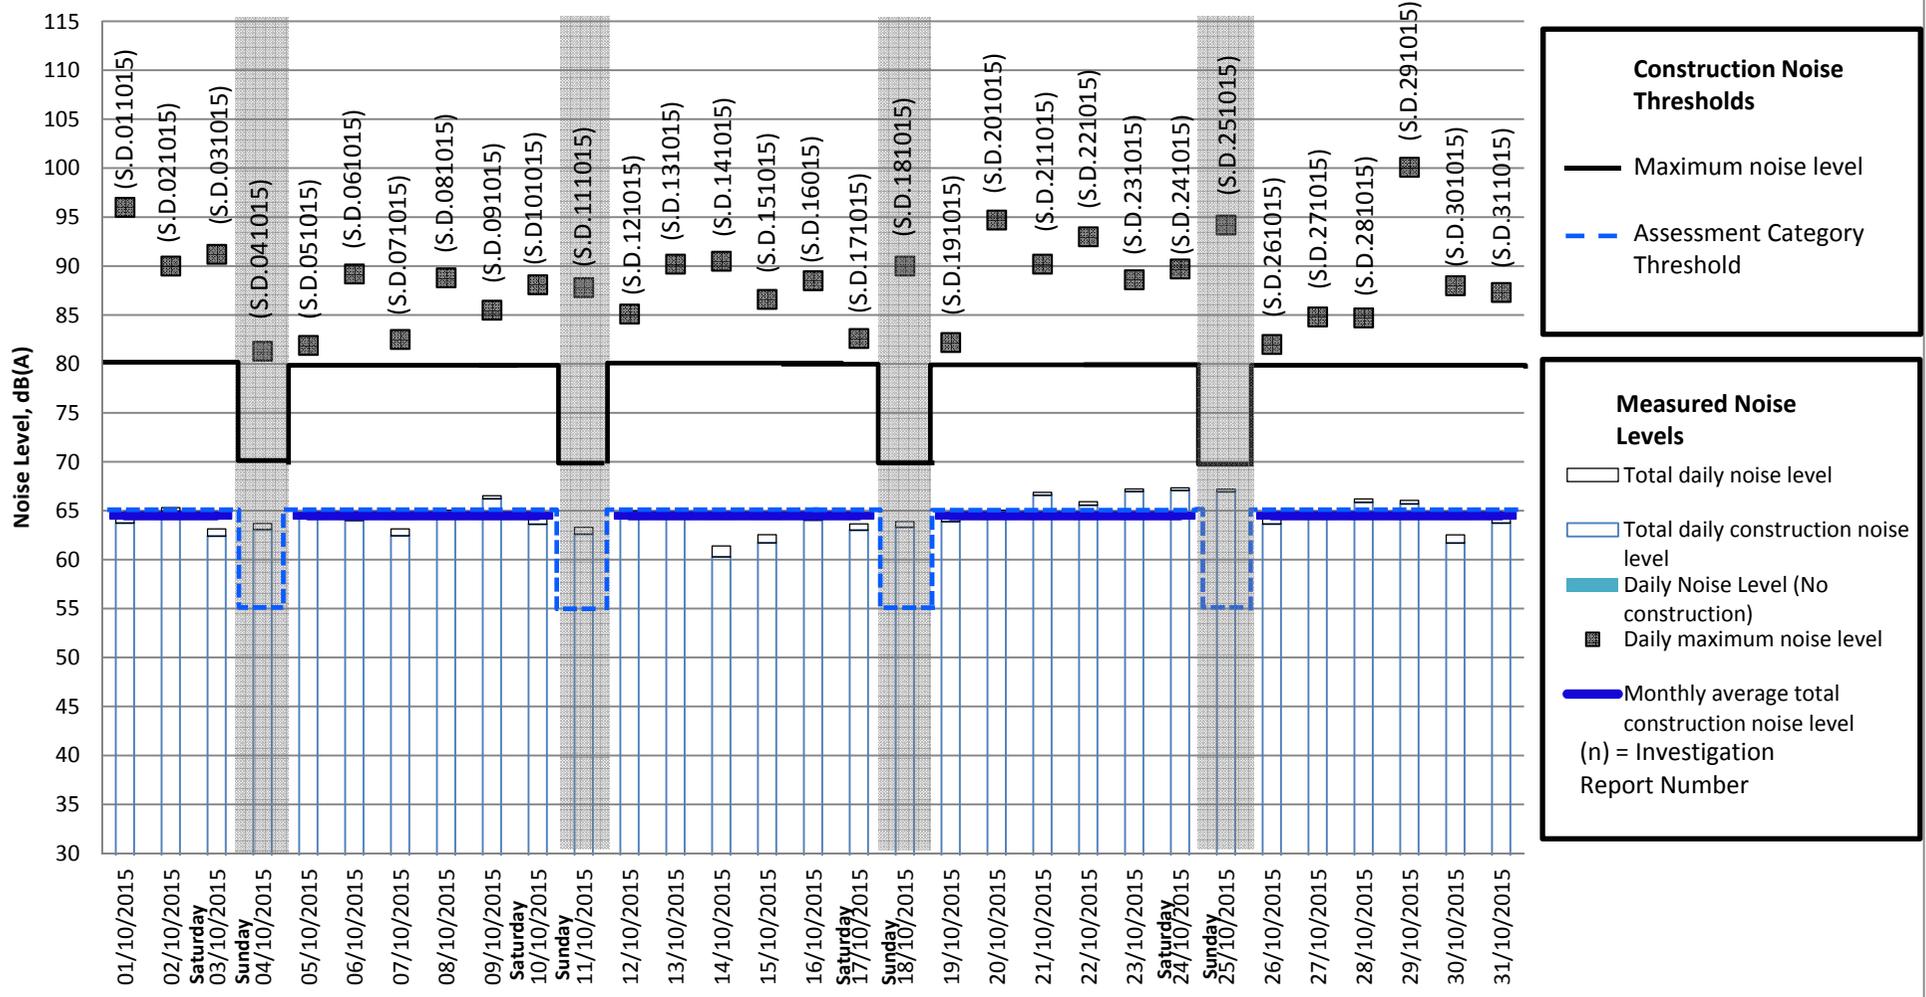
Measured Daytime Noise Levels at Scotstoun

- 3.4** The rises in daytime exceedances at Scotstoun are likely to be due to the very close proximity of construction to the monitoring location. The works are very similar to previous works in the vicinity and construction noise levels at residential receptors were unlikely to be higher than before. No complaints were received from any of the residents in the location of the works during this period. There was a construction related exceedance at Scotstoun on the 1st, 6th, 8th, 9th, 10th, 13th, 23rd and 27th October

Note: The grey areas of the chart represent days on which no construction works have been conducted.

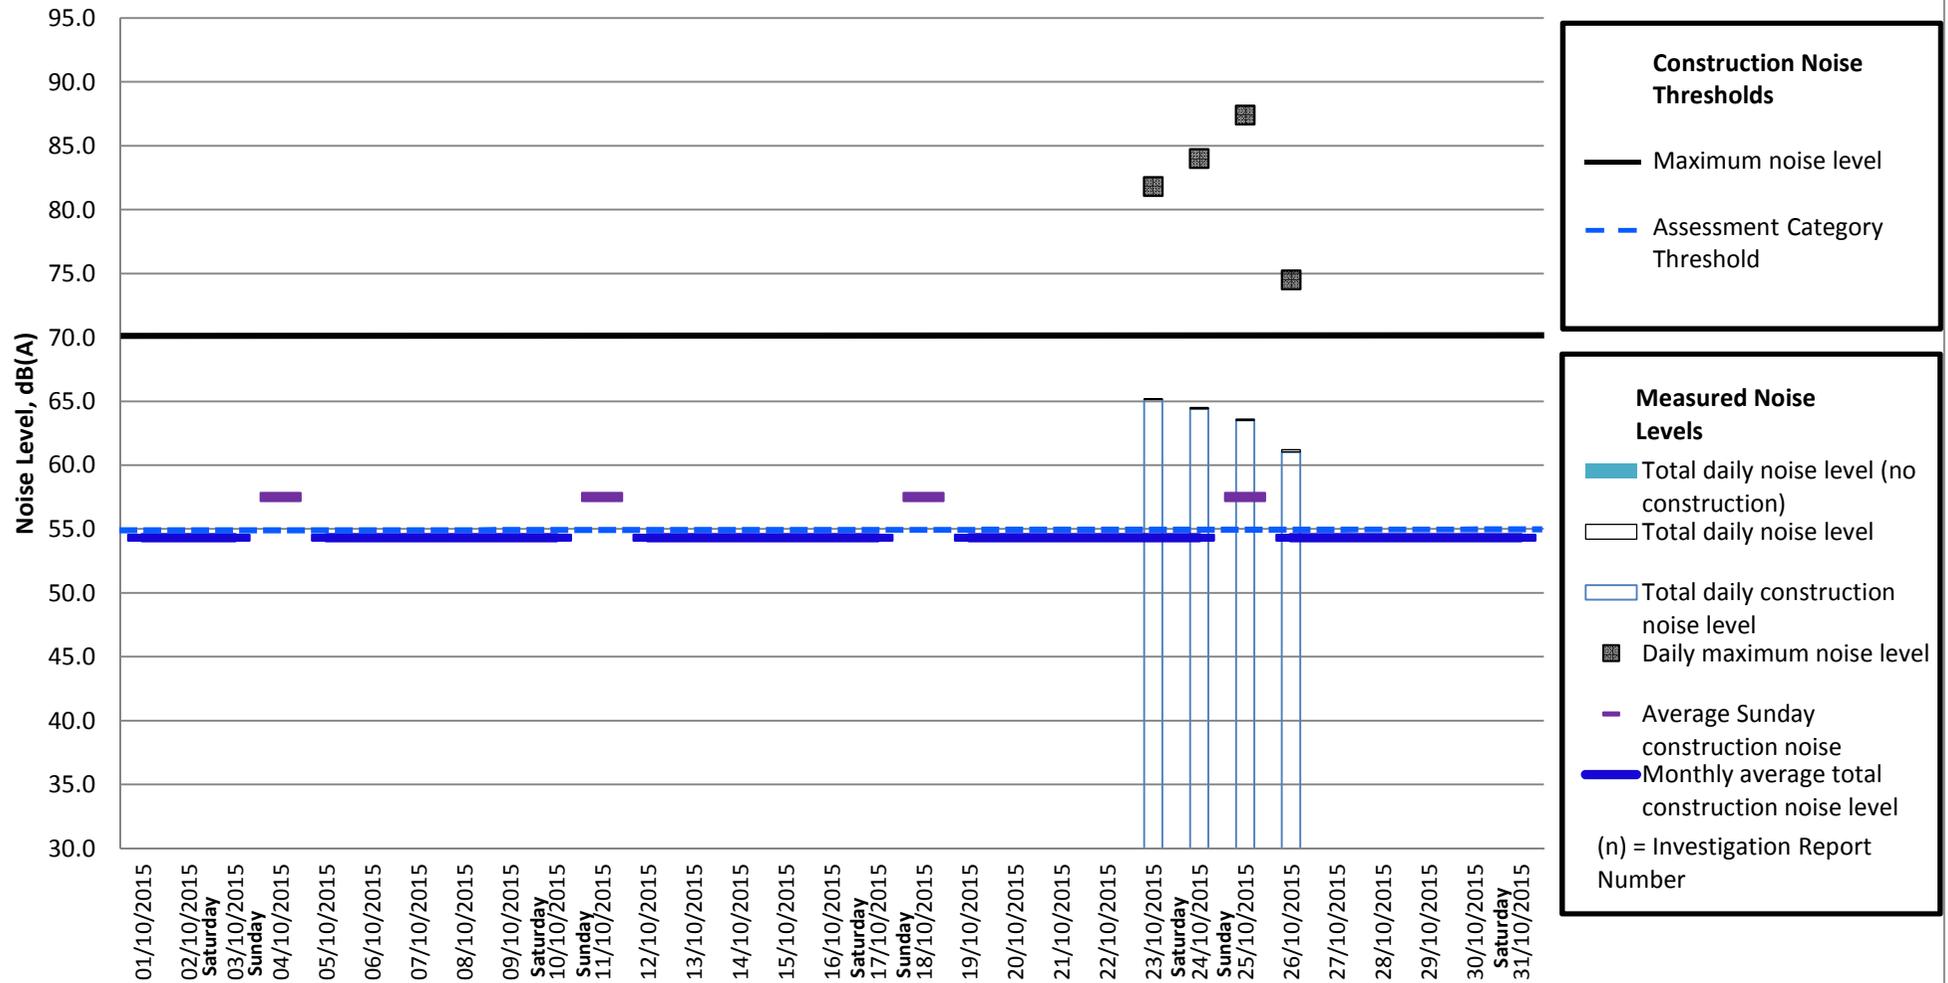
Measured Evening Noise Scotstoun Measurement period: October 2015

Note; The B800 bridge demolition took place over from 24/10/2015 at 22:00 until 26/10/2015 at 07:00. Noise levels have been included ifor this month
