Project **FORTH REPLACEMENT CROSSING**

CONSTRUCTION NOISE MONITORING REPORT: OCTOBER 2015

Document number	Rev
REP-00256	00

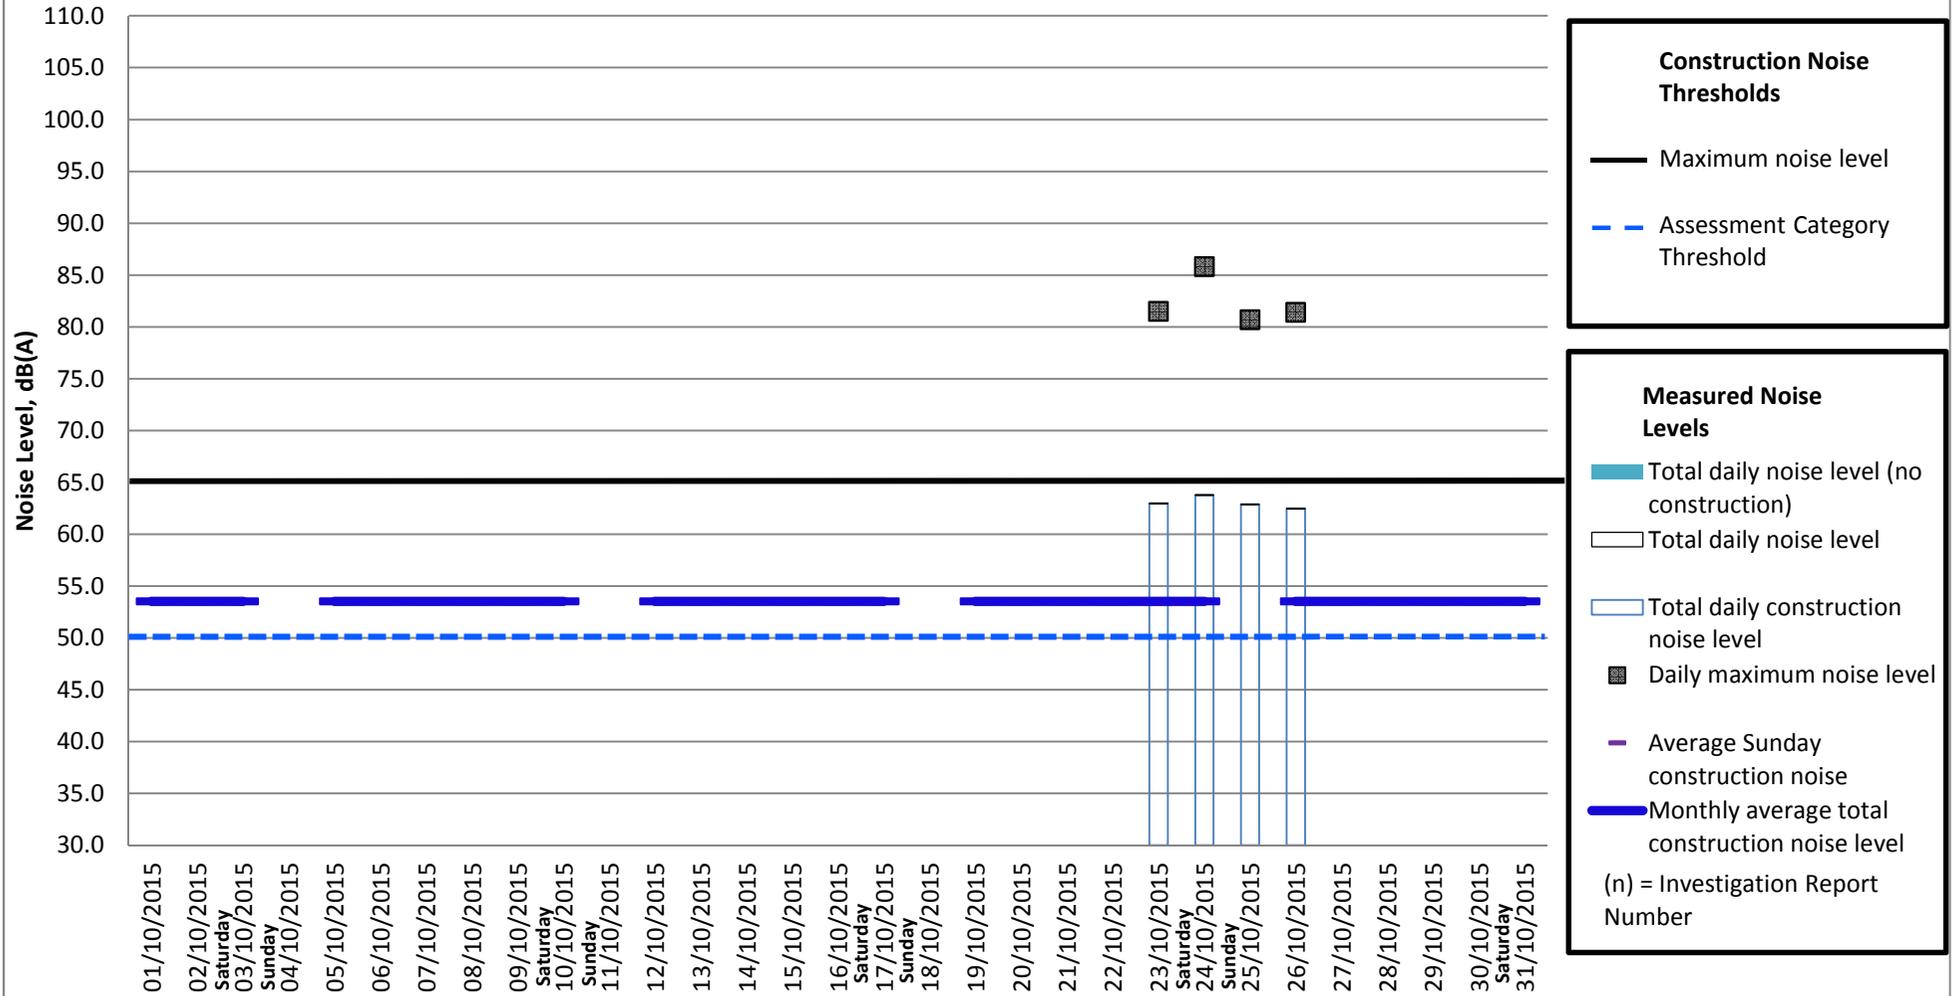
Measured Night time Noise Levels at Scotstoun Measurement period: October 2015

Note; The B800 bridge demolition took place over from 24/10/2015 at 22:00 until 26/10/2015 at 07:00. Noise levels have been included ifor this month

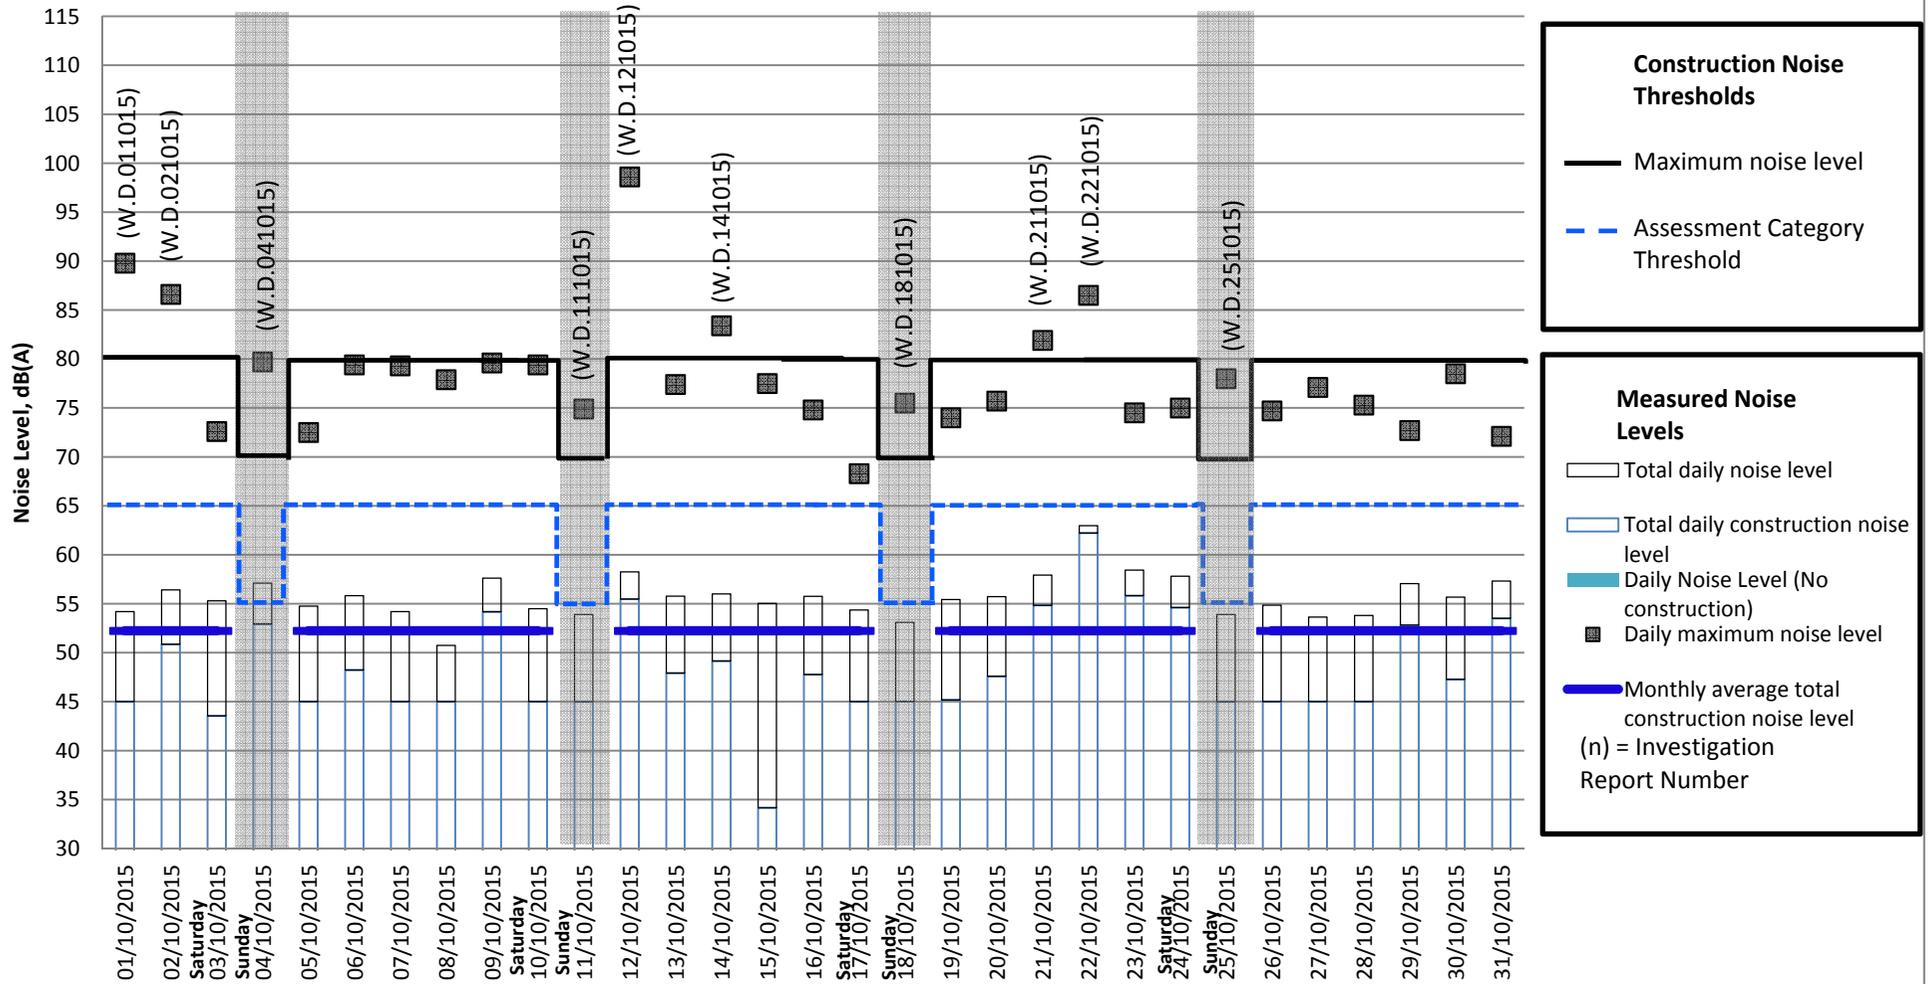
Measured Daytime Noise Levels at Whinnyhill Measurement period: October 2015

Note: The grey areas of the chart represent days on which no construction works have been conducted.

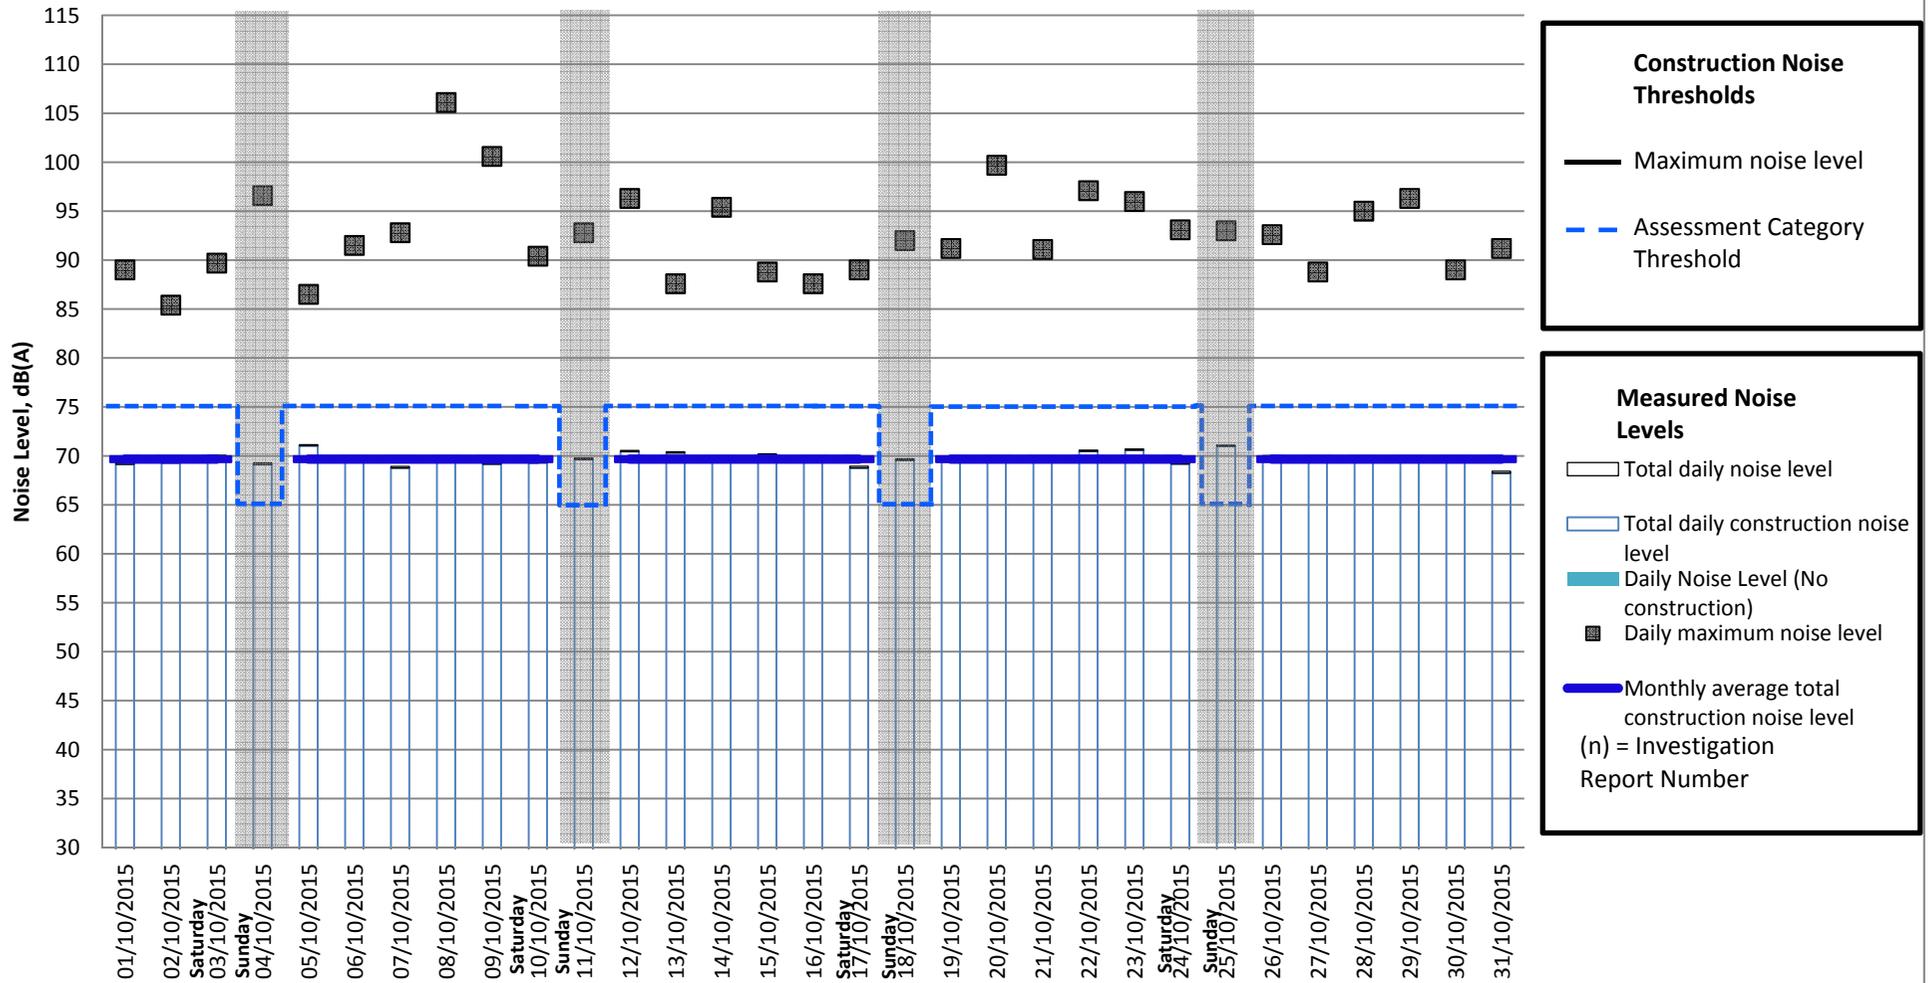
Measured Daytime Noise Levels at Newton Measurement period: October 2015

Note: The grey areas of the chart represent days on which no construction works have been conducted. It should be noted that the measured noise levels Mon - Fri can not be attributed to construction works due to the considerable distance (1.75 kilometers) between this monitoring location and the closest construction works.

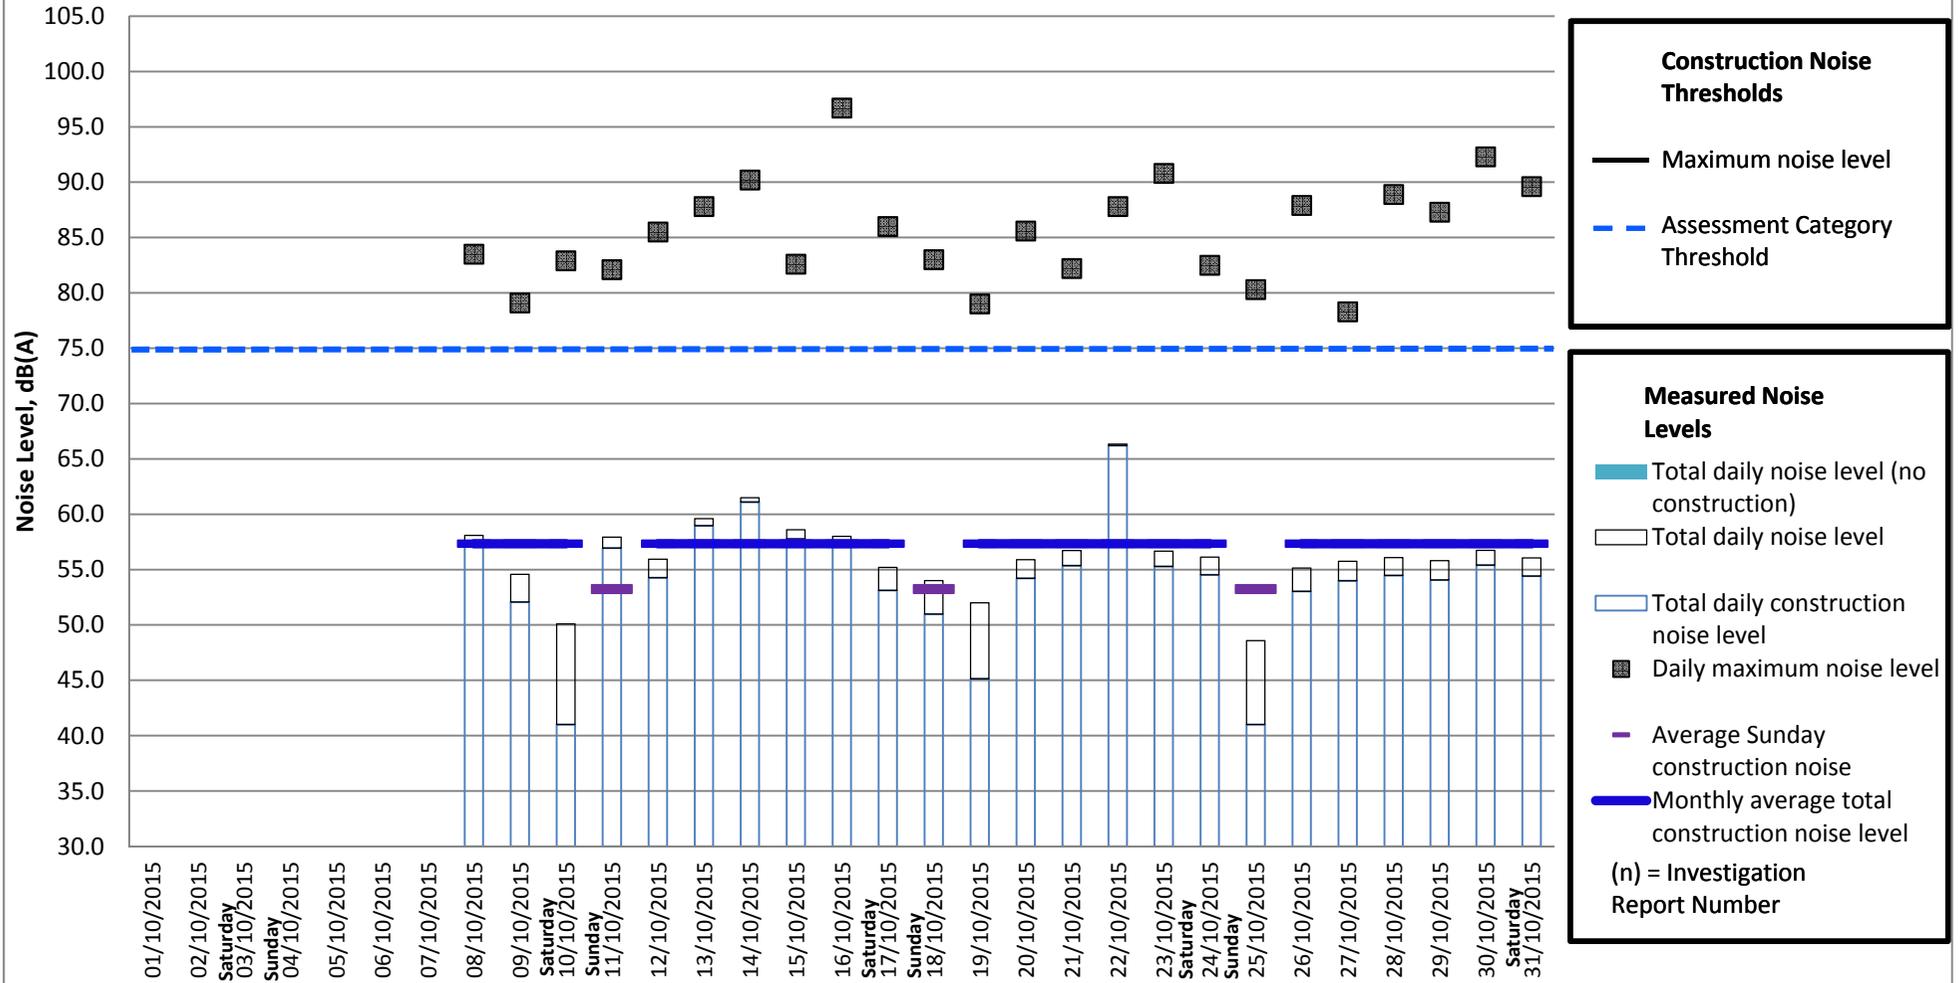
Measured Daytime Noise Levels at Port Edgar Measurement period: October 2015

Note: There is no data before 08/10/2015 due to a problem with the monitor

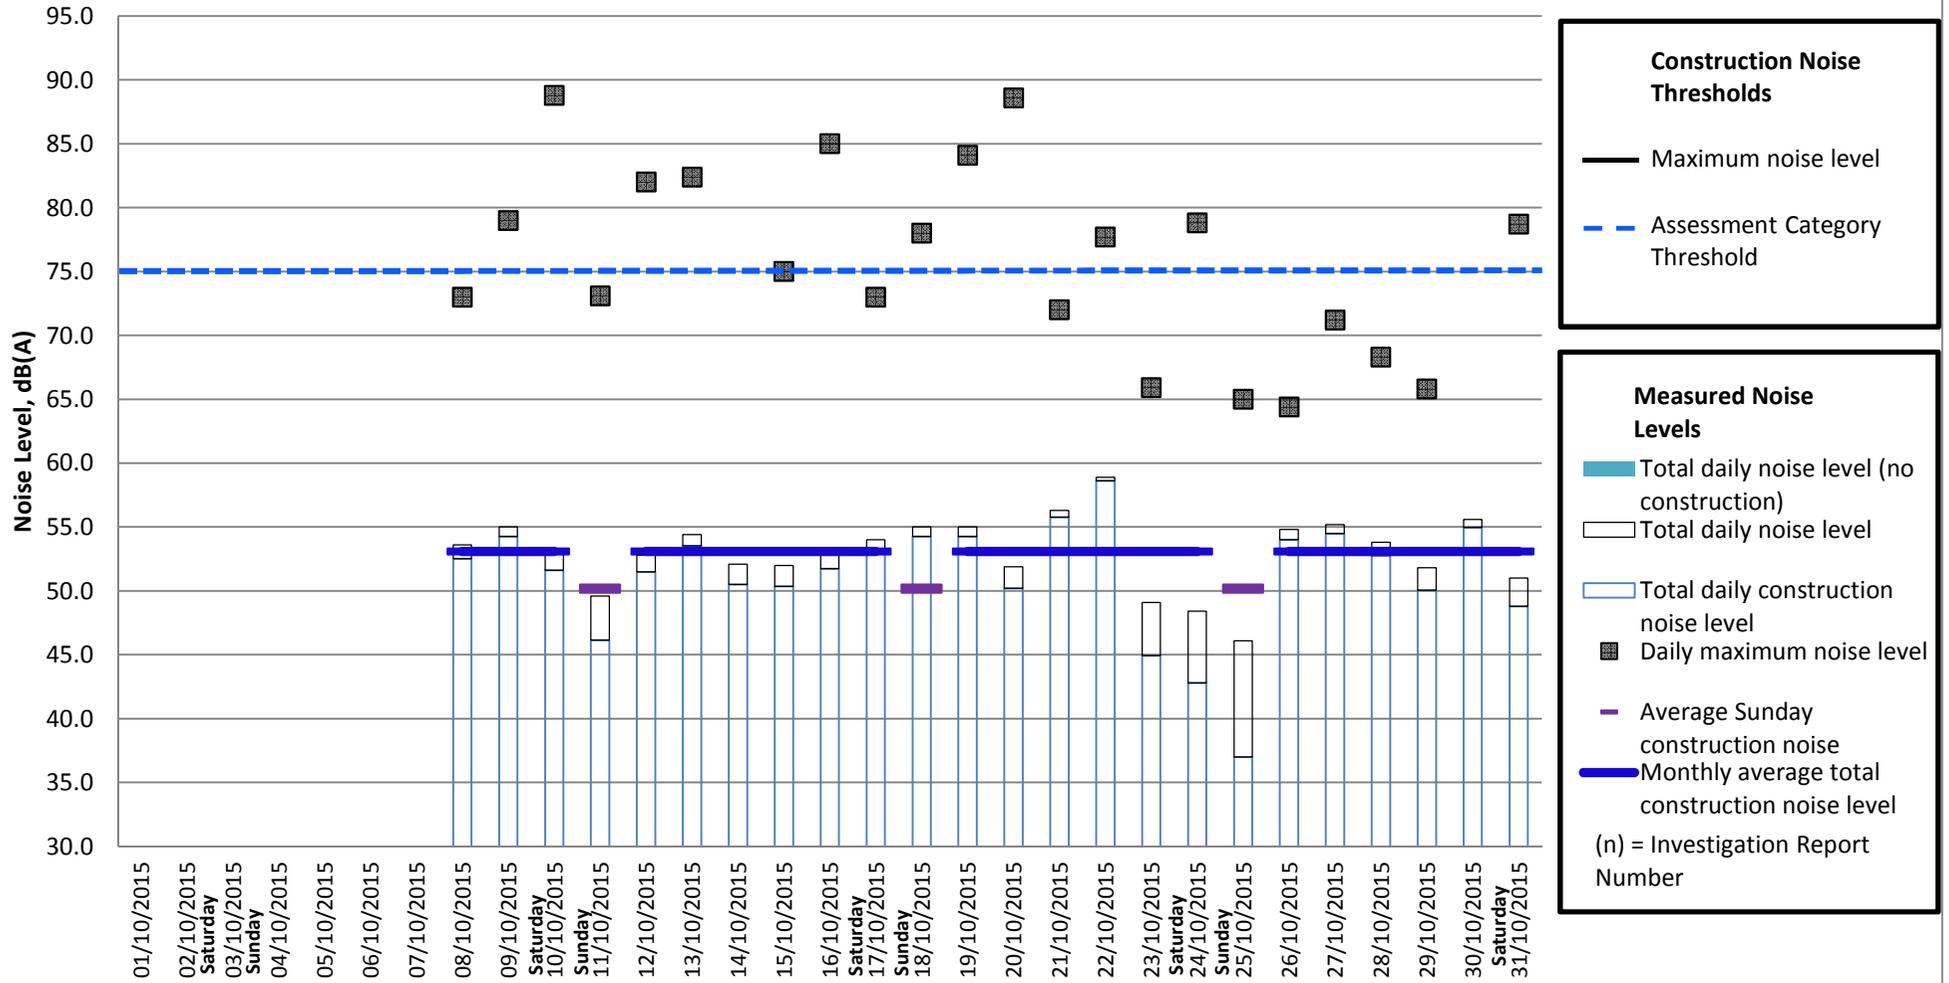
Measured Evening Noise Levels at Port Edgar Measurement period: October 2015

Note: There is no data before 08/10/2015 due to a problem with the monitor

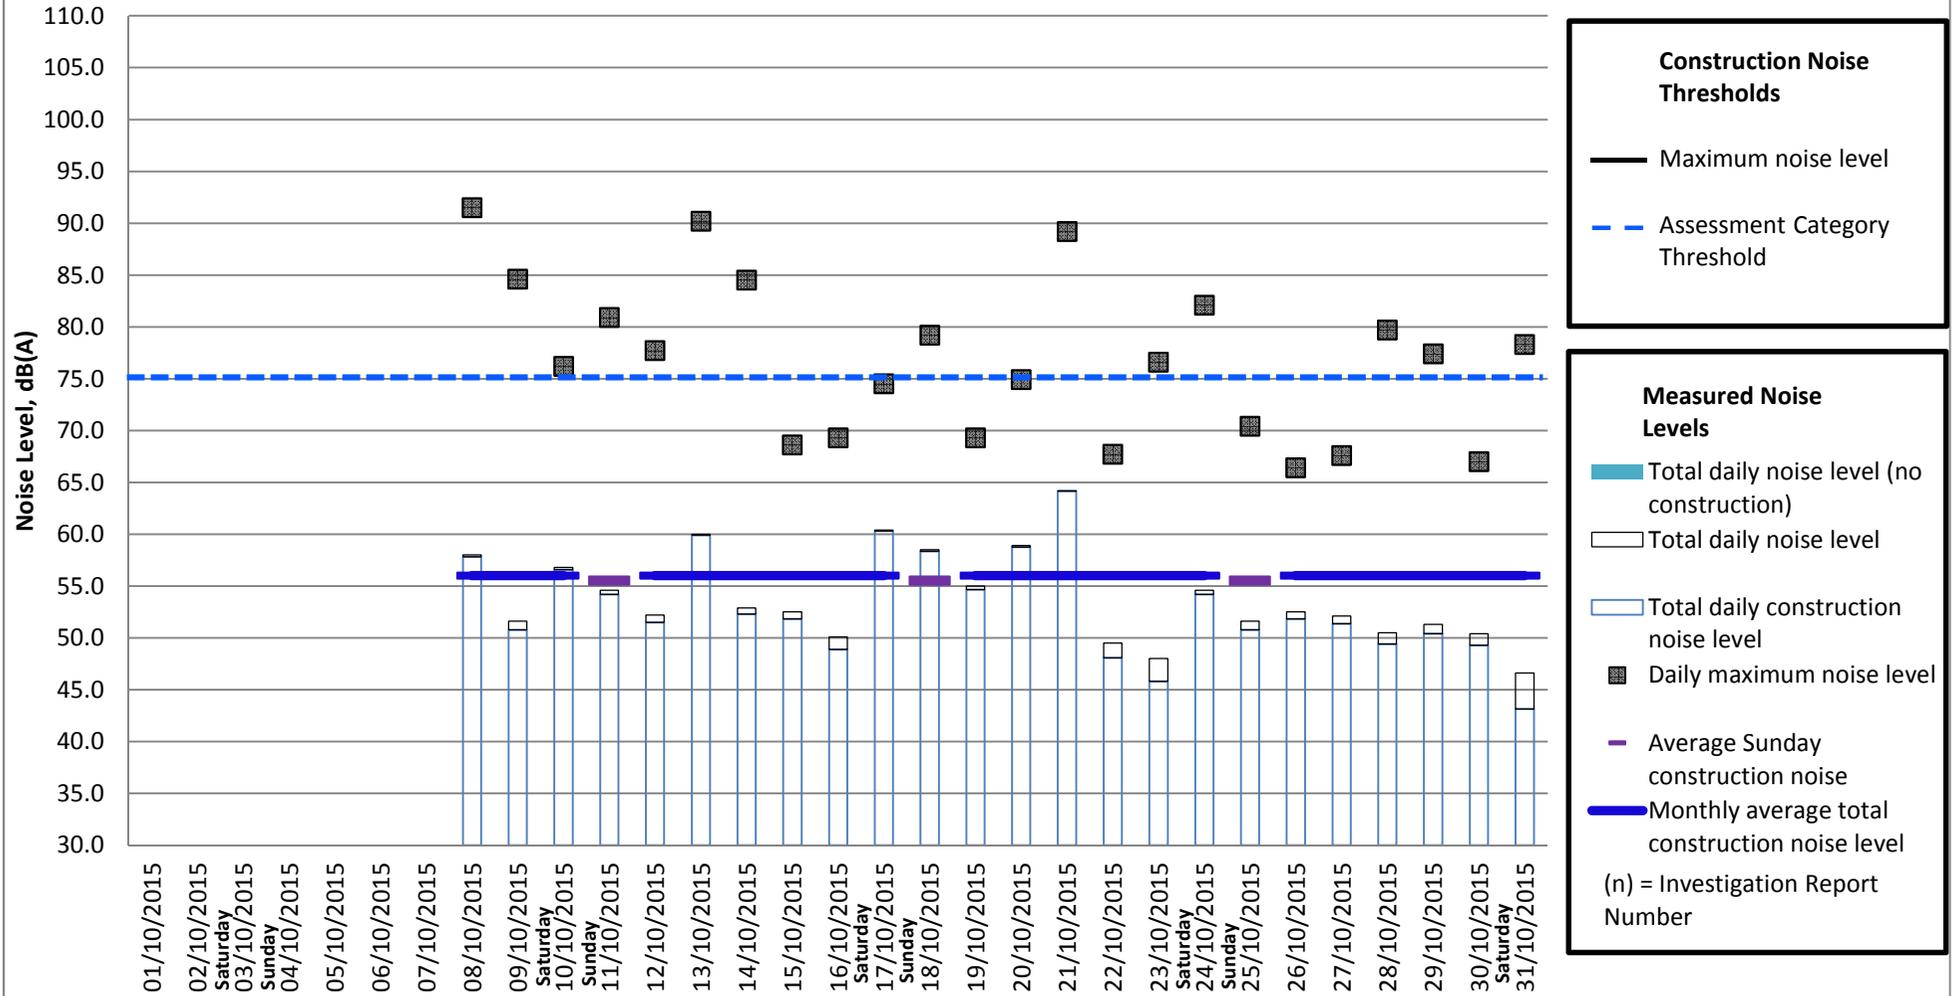
Measured Night time Noise Levels at Port Edgar Measurement period: October 2015

Note: There is no data before 08/10/2015 due to a problem with the monitor
