Project **FORTH REPLACEMENT CROSSING**

**VIBRATION MONITORING REPORT
MAY 2015**

Document number	Rev
REP-00234	00

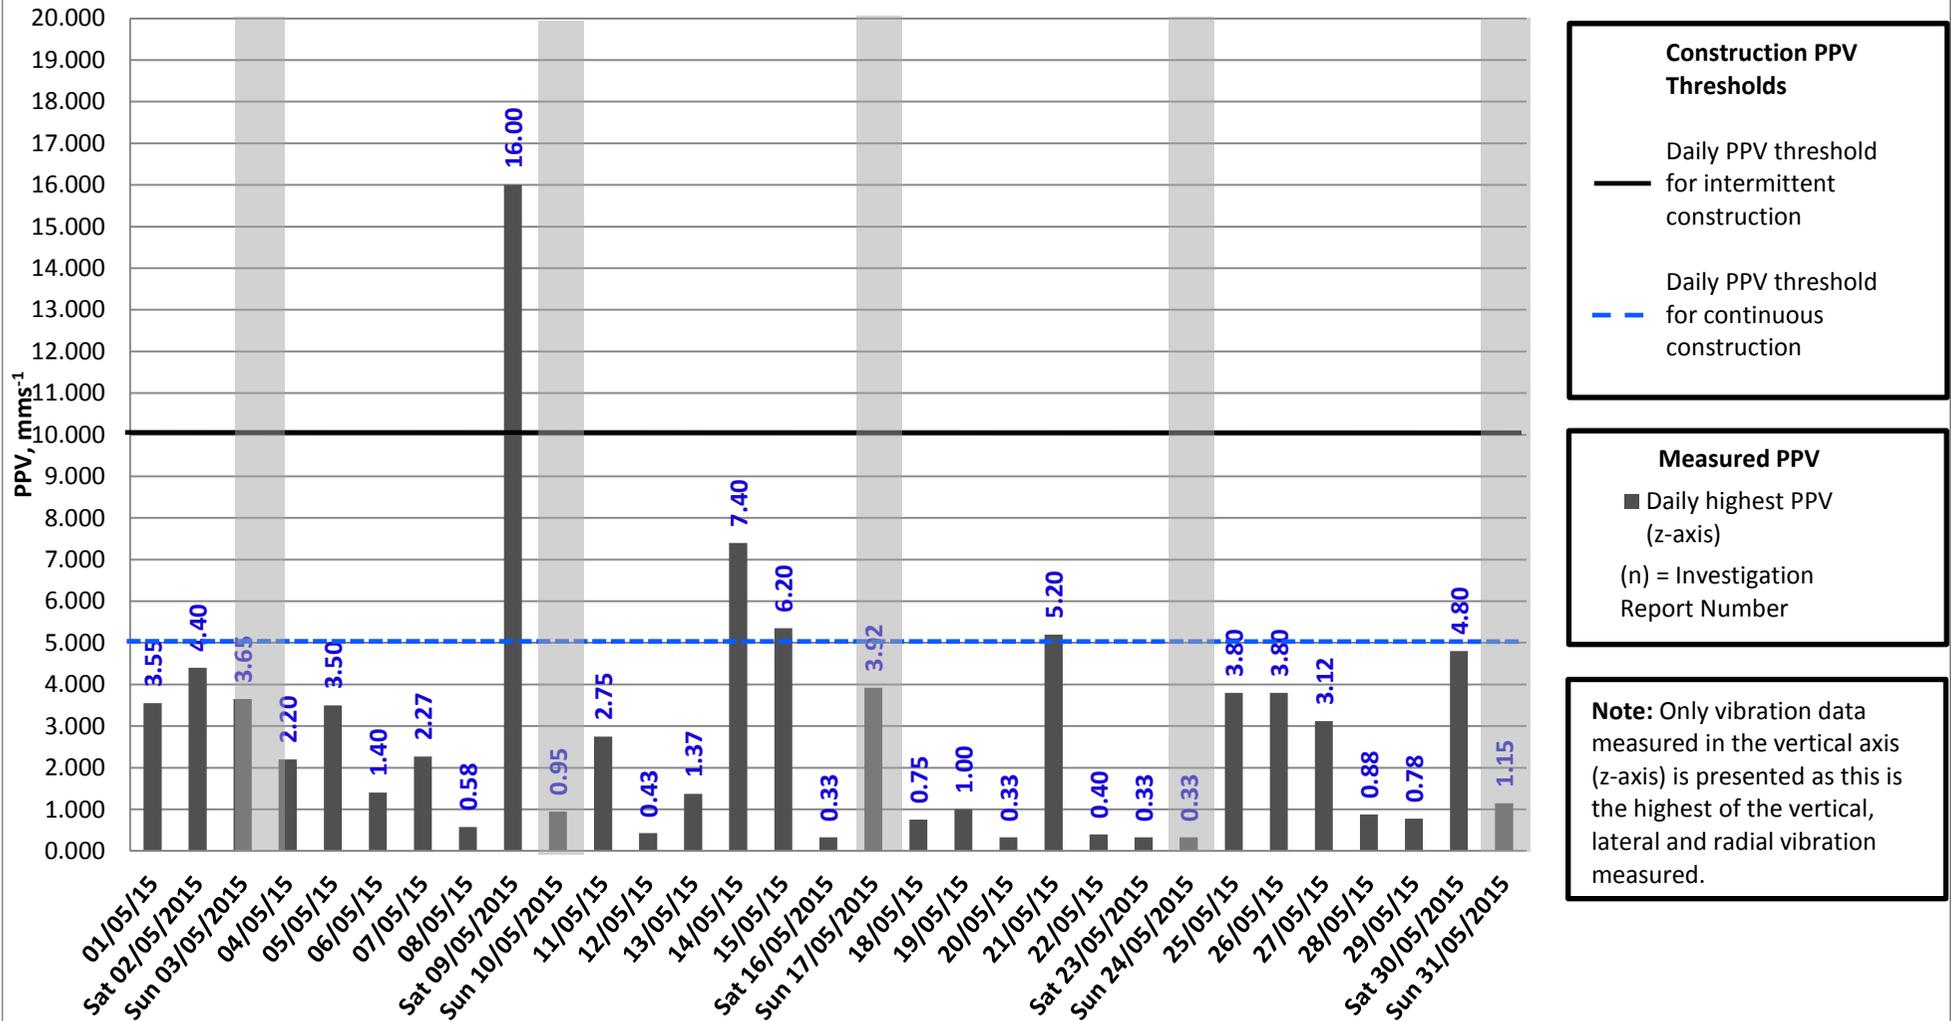
Measured highest Daily Peak Particle Velocity (PPV), Clufflat Brae, Measurement period: May 2015

Note: The PPV values on 09/05/15, 14/05/15, 15/05/15 and 21/05/15 have all been investigated and have been seen to be individual, isolated events within the period. These figures are due to monitor maintenance and most likely due to external activity near/ directly above the transducers.

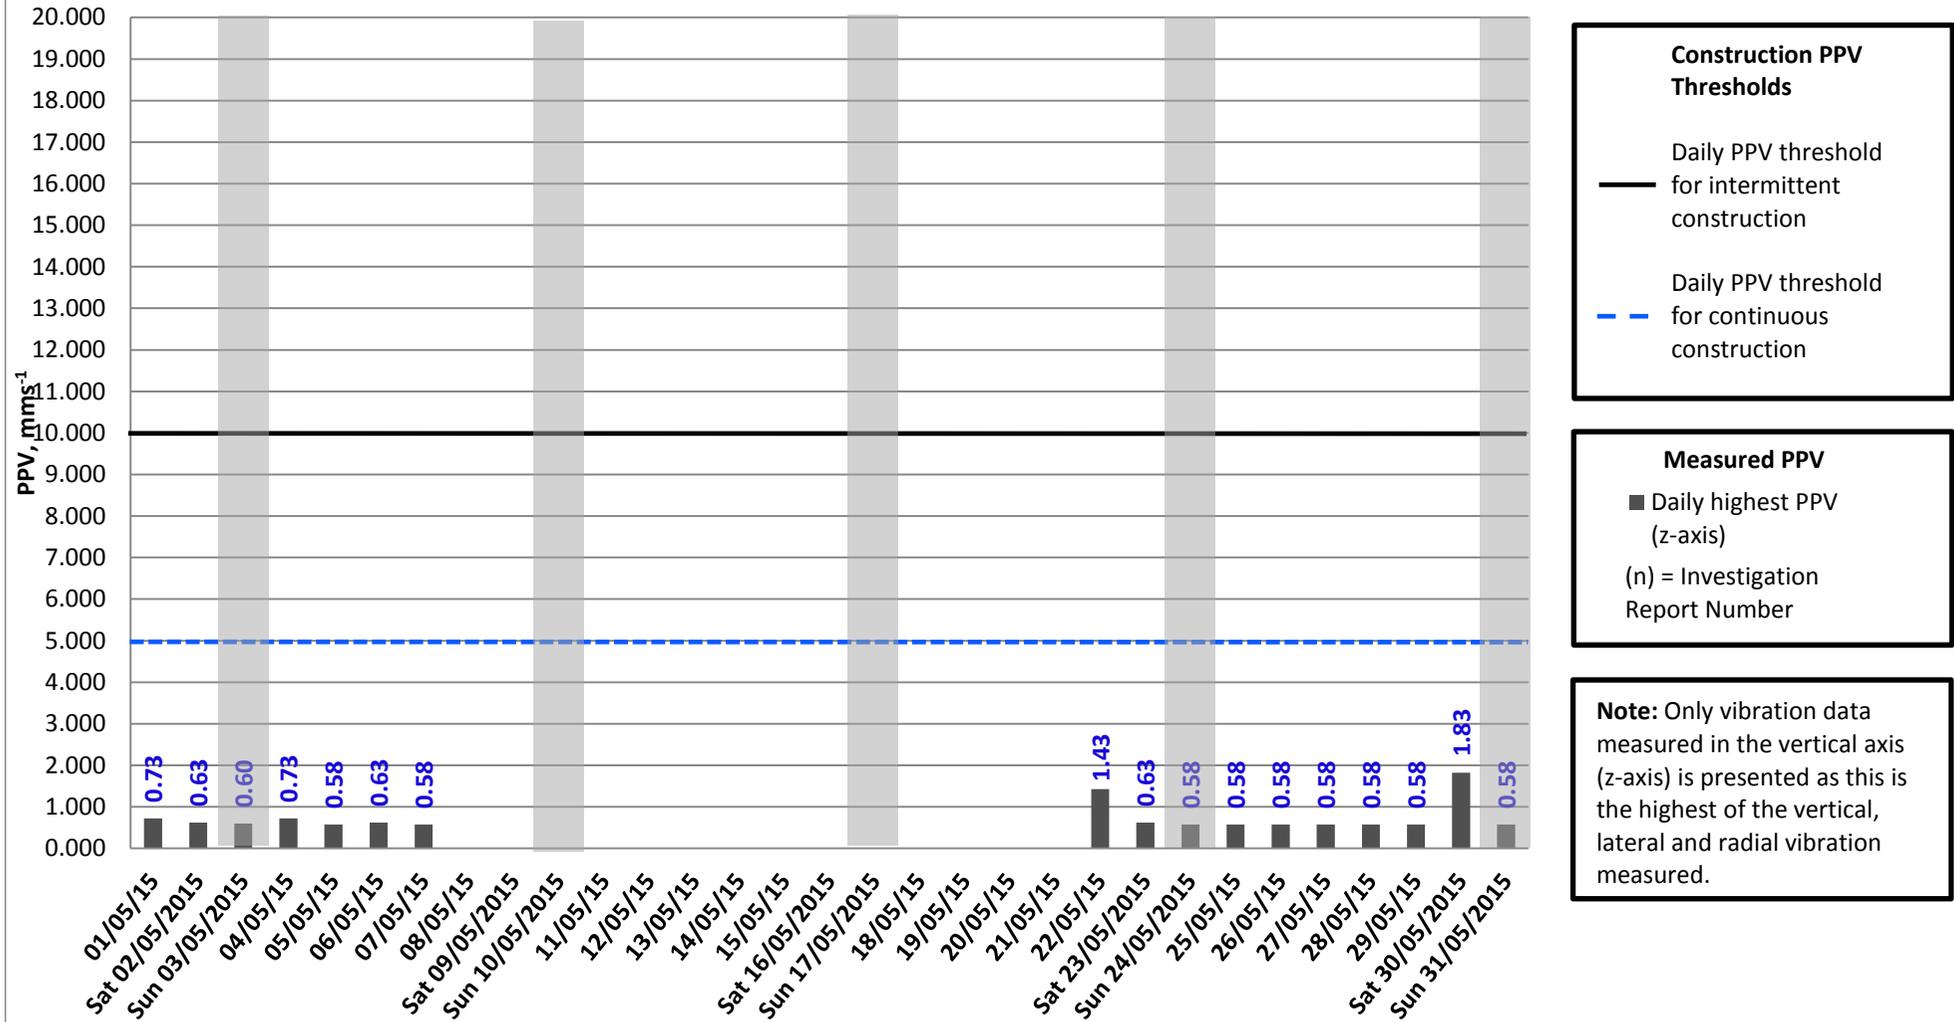
Measured highest Daily Peak Particle Velocity (PPV), Dundas Home Farm, Measurement period: May 2015

Note: Data is missing due to a power supply issue at the device 08/05/2015-19/05/2015

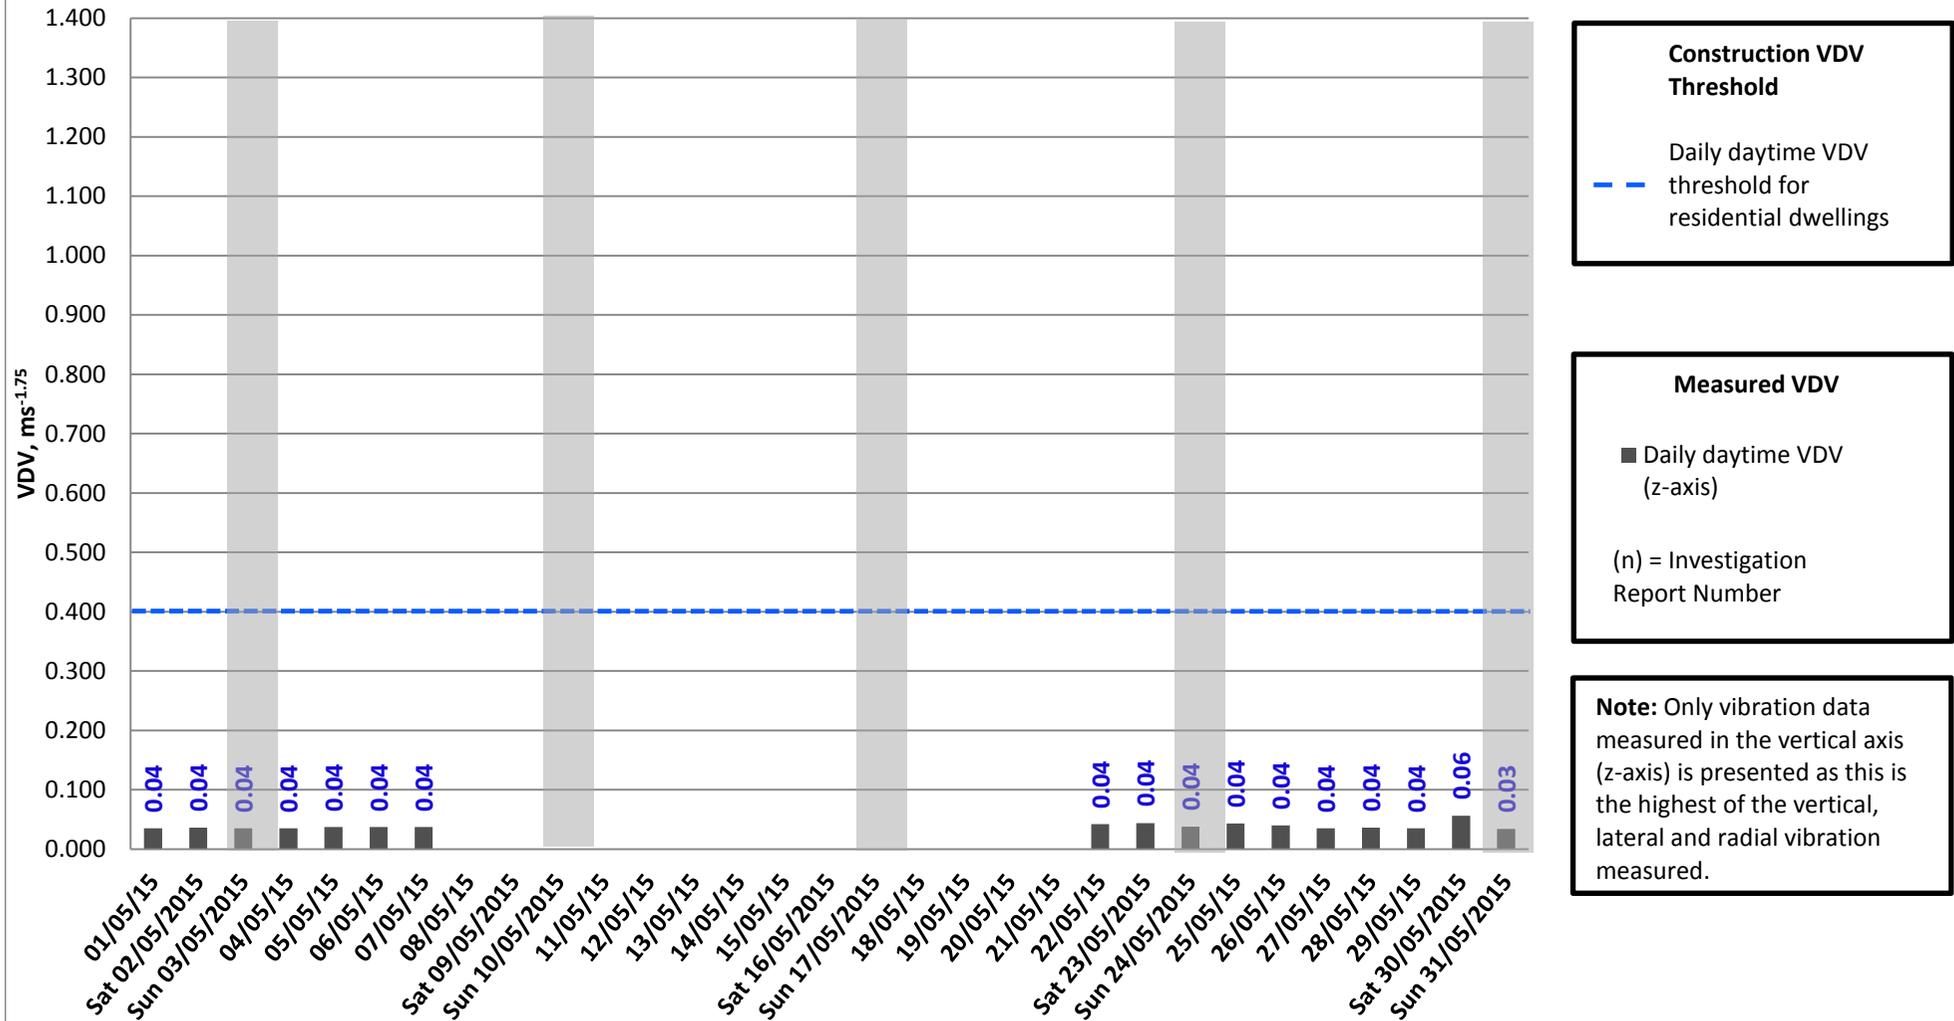
Measured Daytime (07:00-23:00) Vibration Dose Values (VDV), Dundas Home Farm, Measurement period: May 2015

Note: Data is missing due to a power supply issue at the device 08/05/2015-19/05/2015

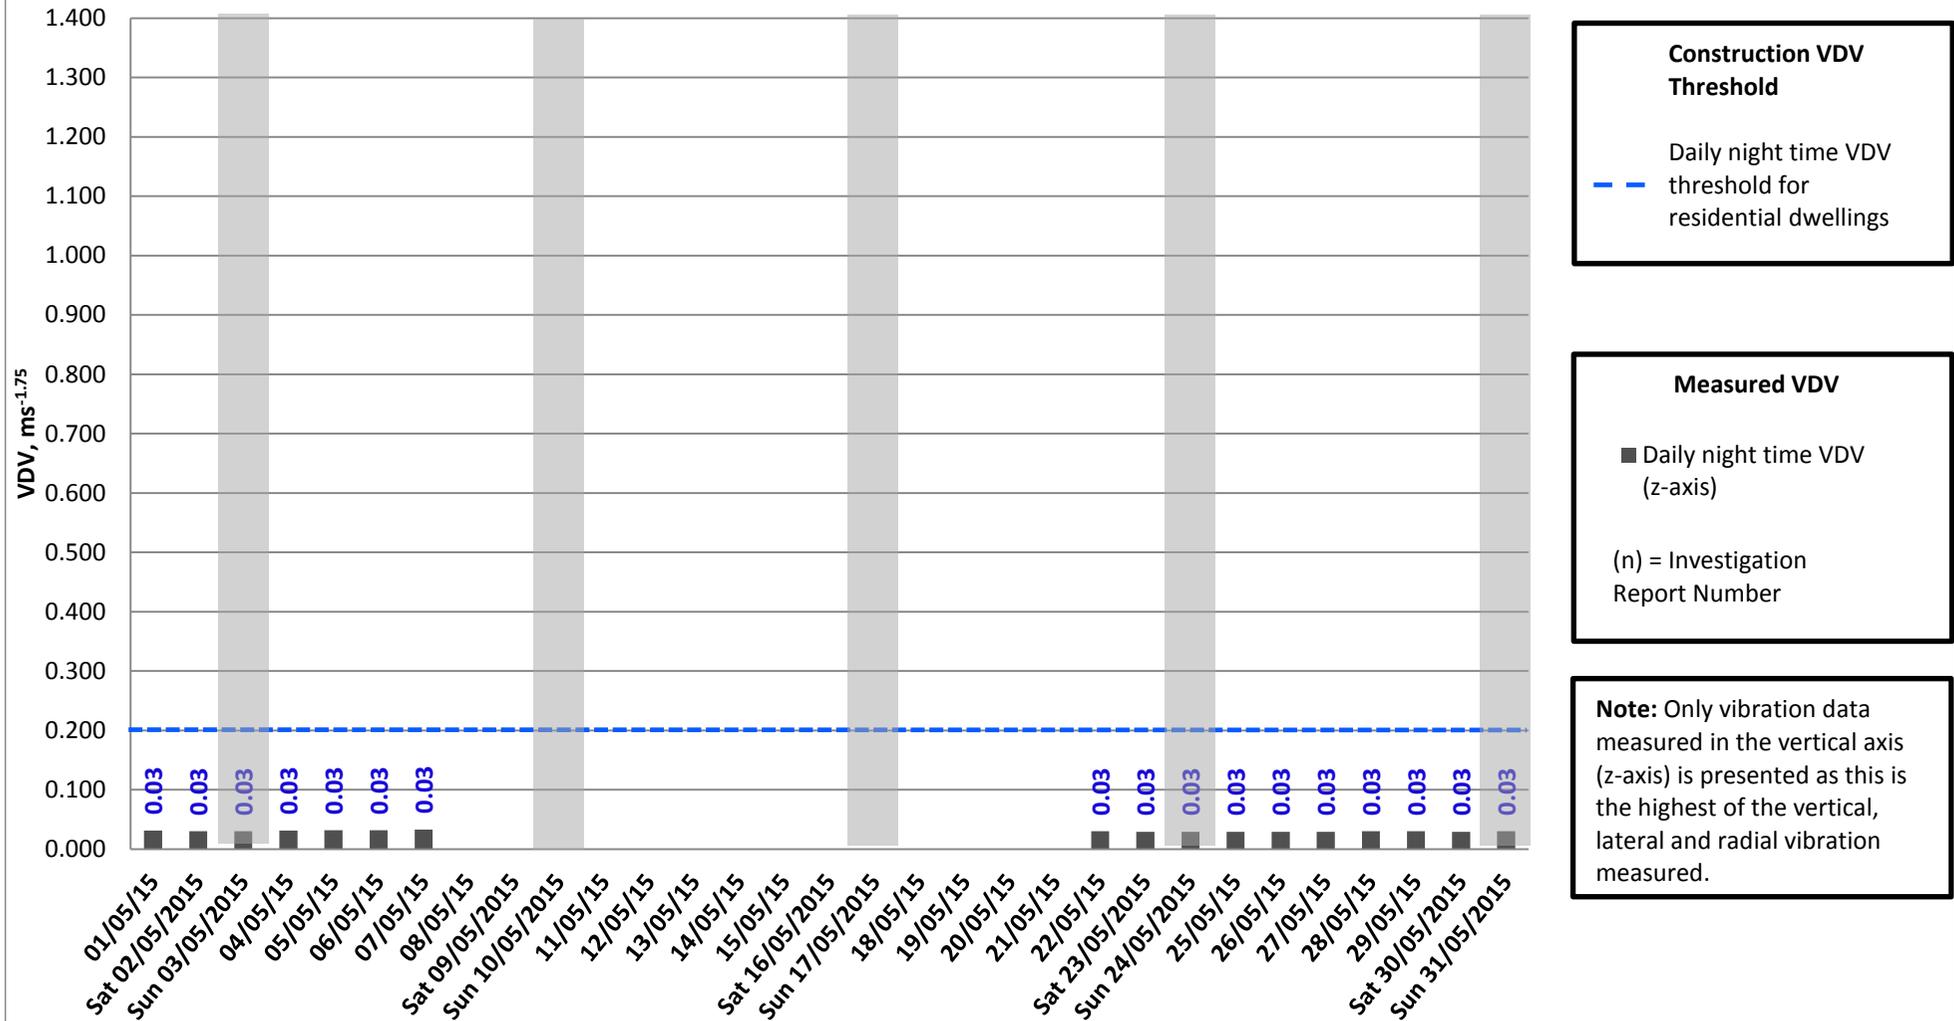
Measured Night Time (23:00-07:00) Vibration Dose Values (VDV), Dundas Home Farm, Measurement period: May 2015

Note: Data is missing due to a power supply issue at the device 08/05/2015-19/05/2015

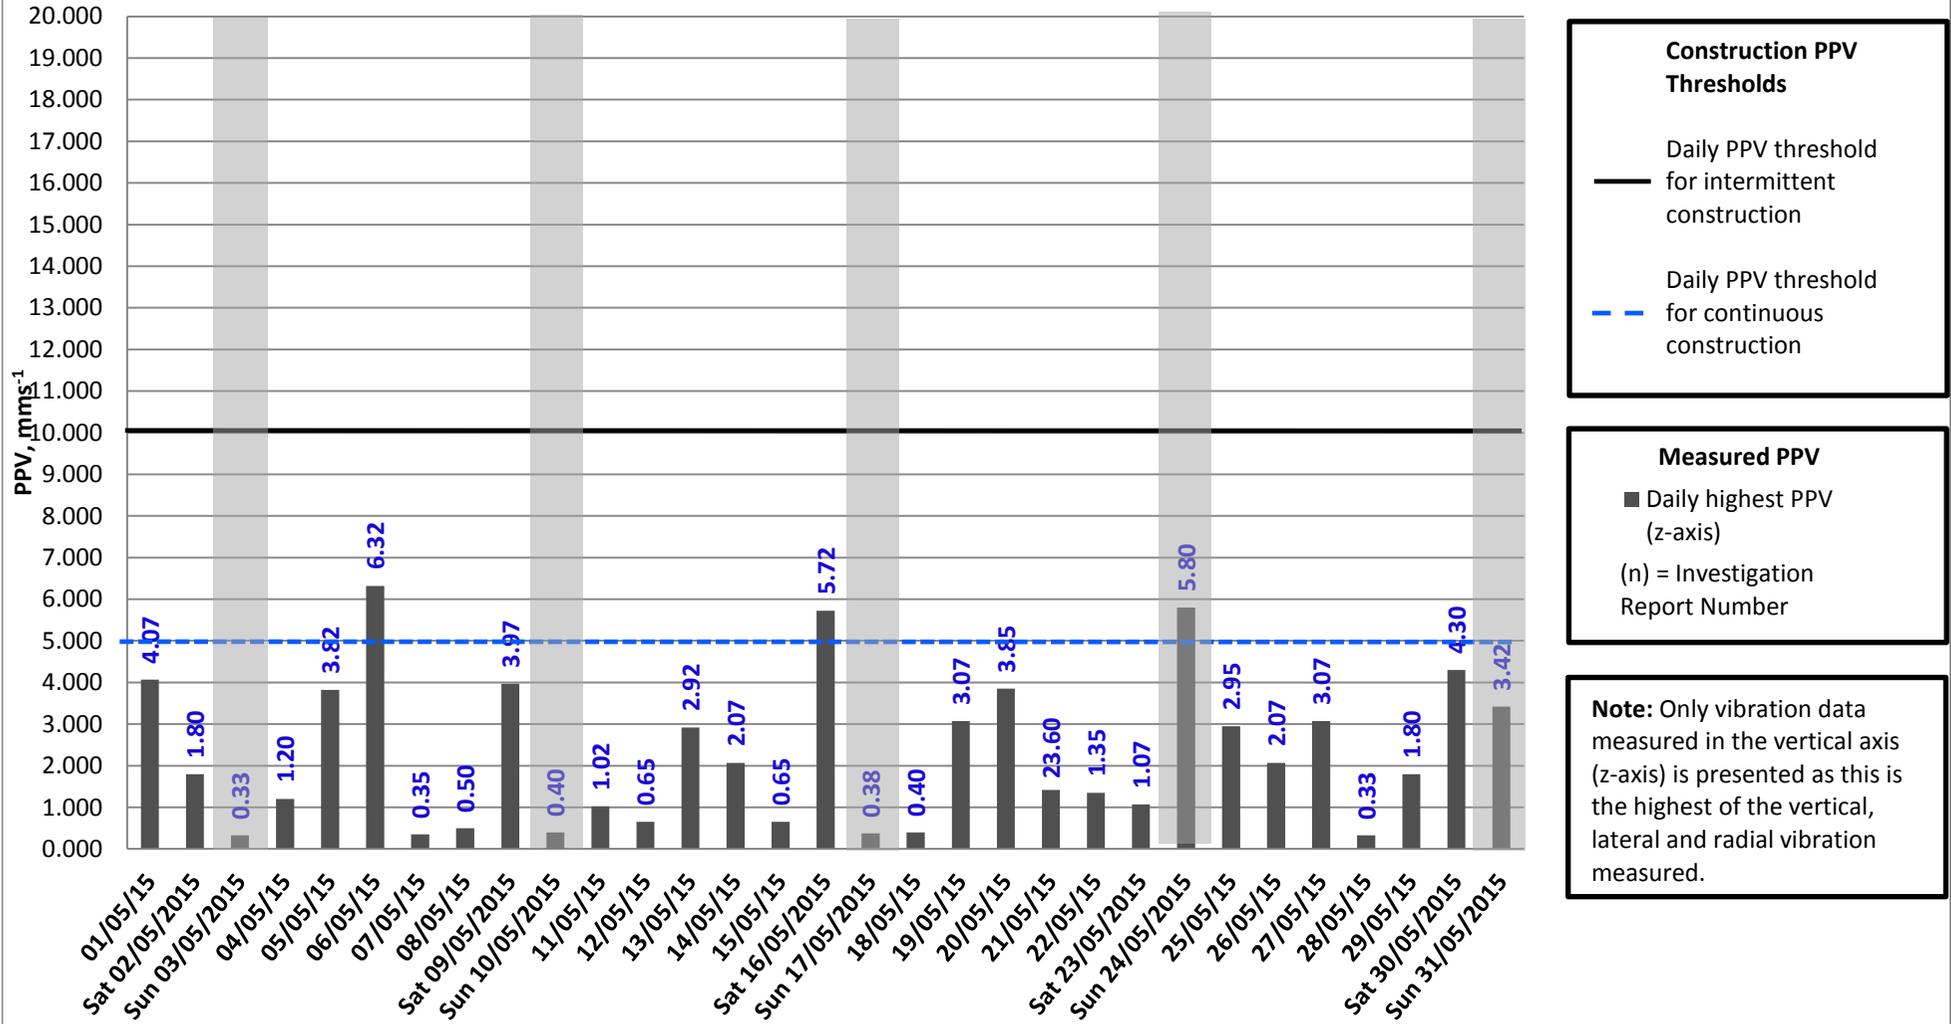
Measured highest Daily Peak Particle Velocity (PPV), Echline, Measurement period: May 2015

Note: The PPV values on 06/05/15 and 16/05/15 have all been investigated and have been seen to be individual, isolated events within the period. These figures are due to monitor maintenance and most likely due to external activity near/ directly above the transducers.

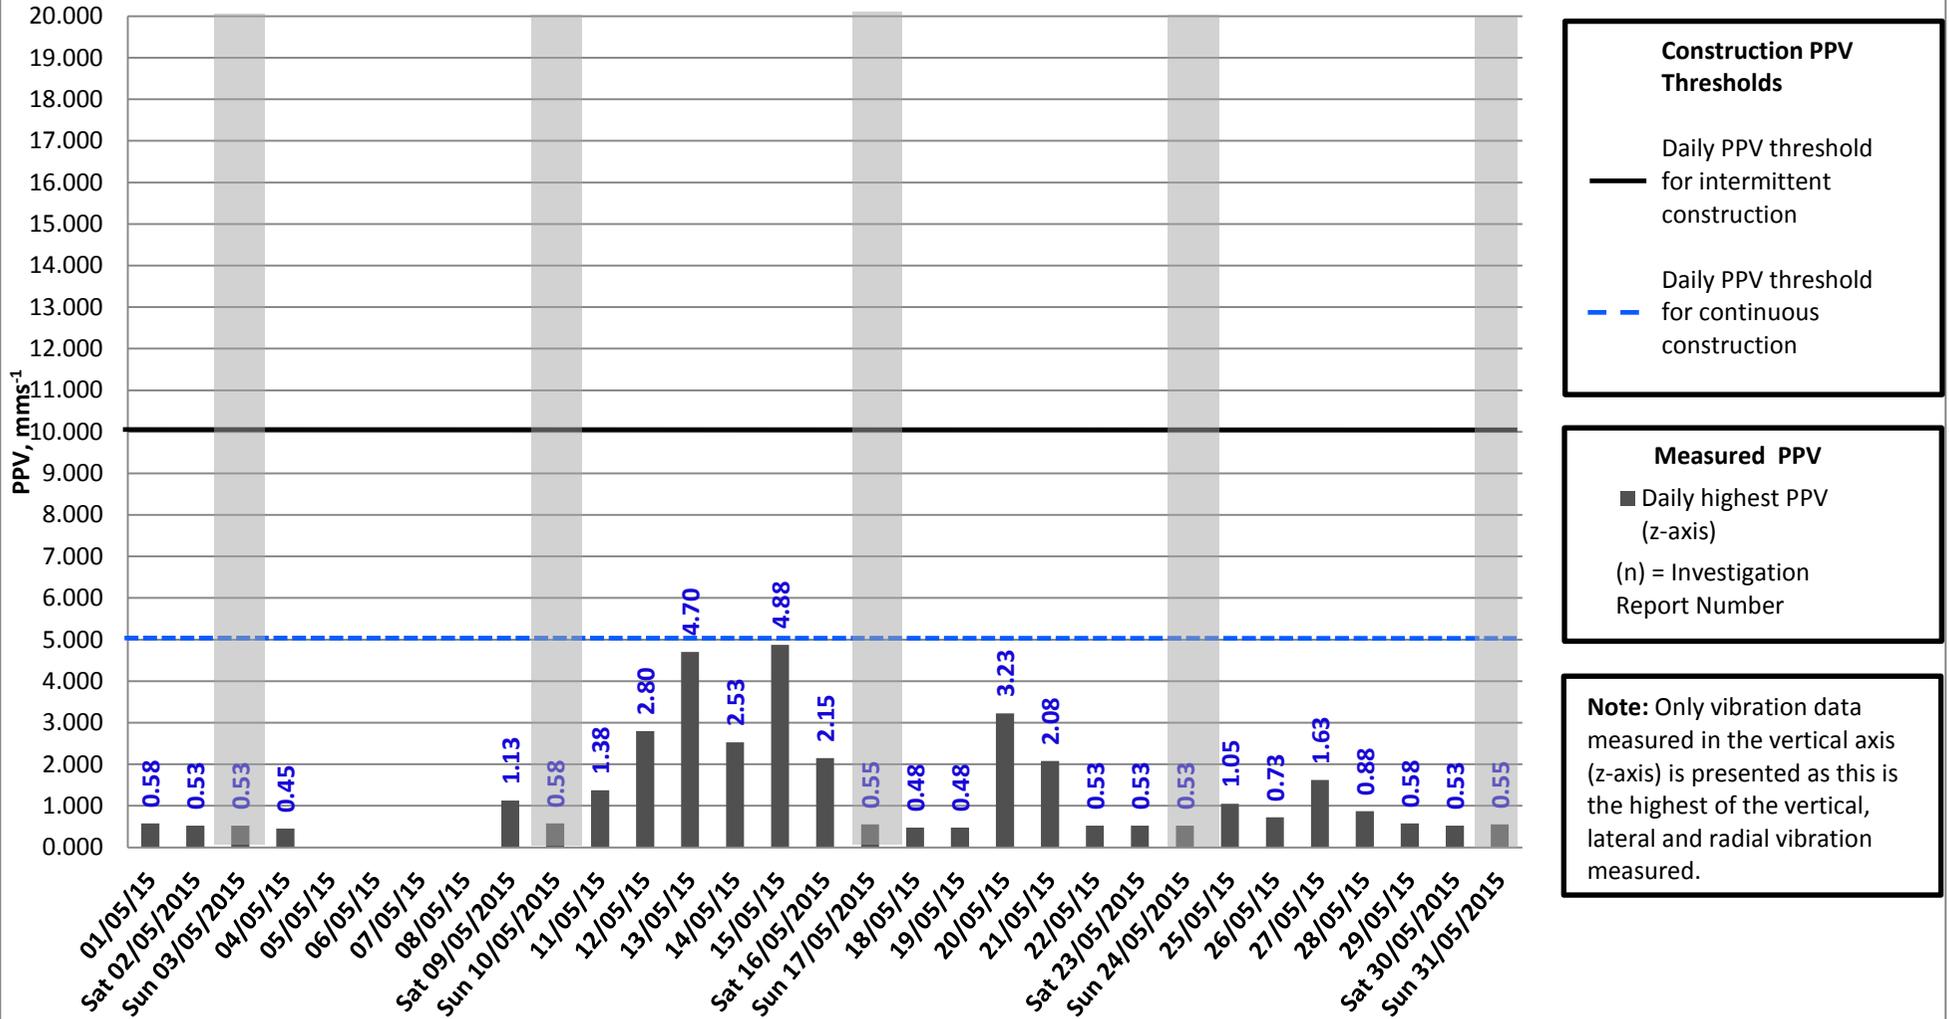
Measured highest Daily Peak Particle Velocity (PPV), Scotstoun, Measurement period: May 2015

Note: Data missing due to a power issue at the device 05/05/2015 - 09/05/2015

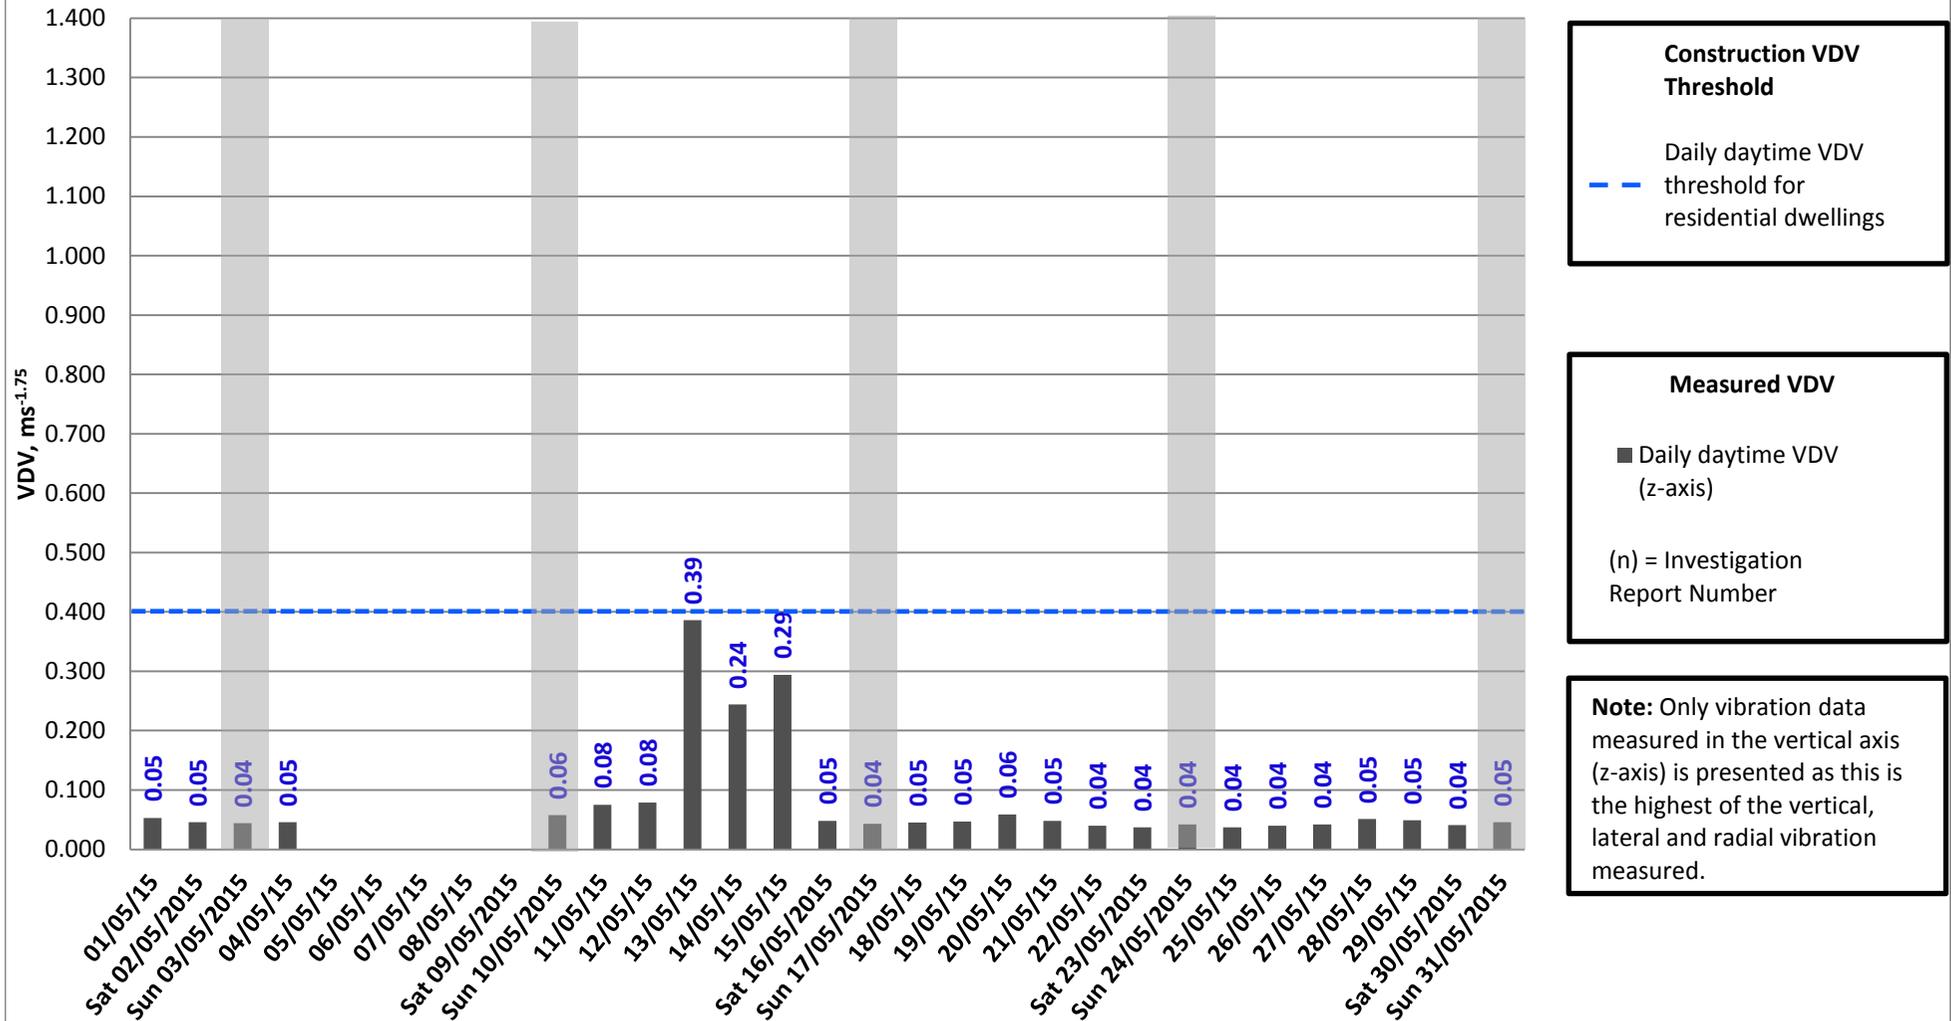
Measured Daytime (07:00-23:00) Vibration Dose Values (VDV), Scotstoun, Measurement period: May 2015

Note: Data missing due to a power issue at the device 05/05/2015 - 09/05/2015

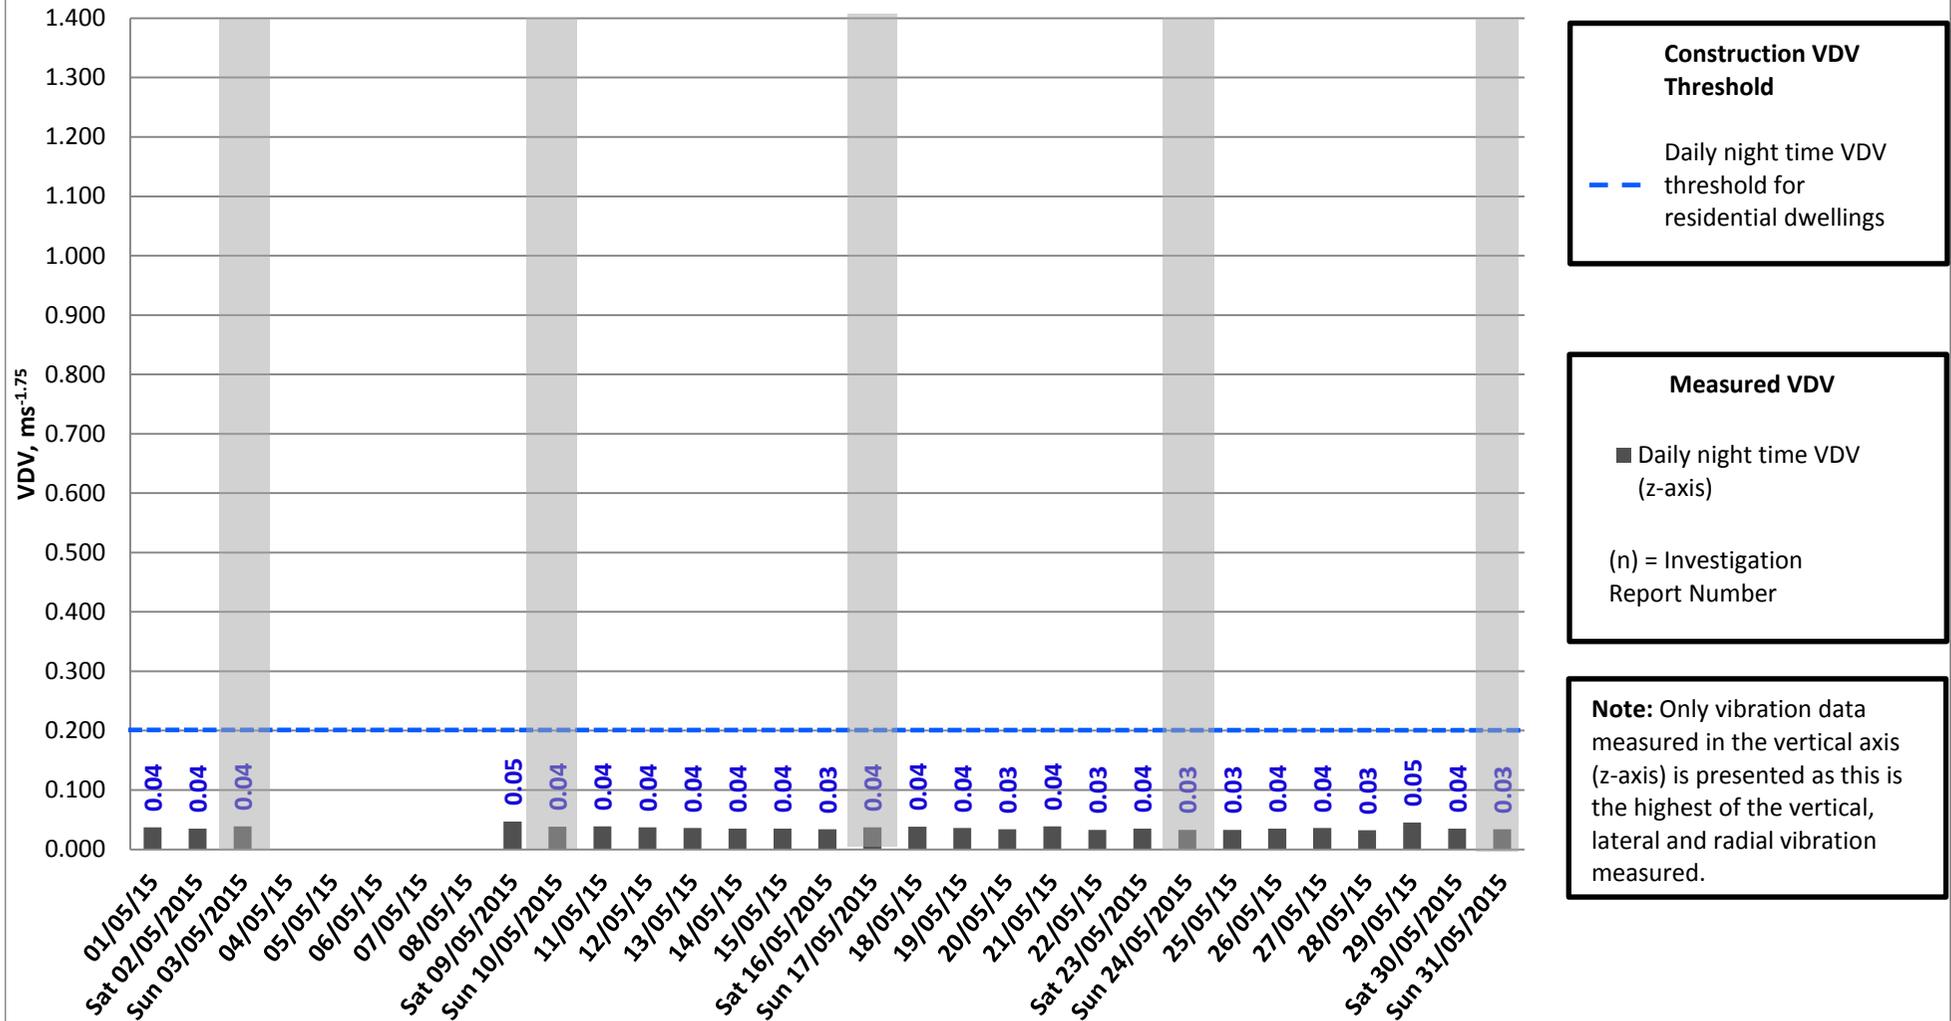
Measured Night Time (23:00-07:00) Vibration Dose Values (VDV), Scotstoun, Measurement period: May 2015

Note: Data missing due to a power issue at the device 05/05/2015 - 09/05/2015

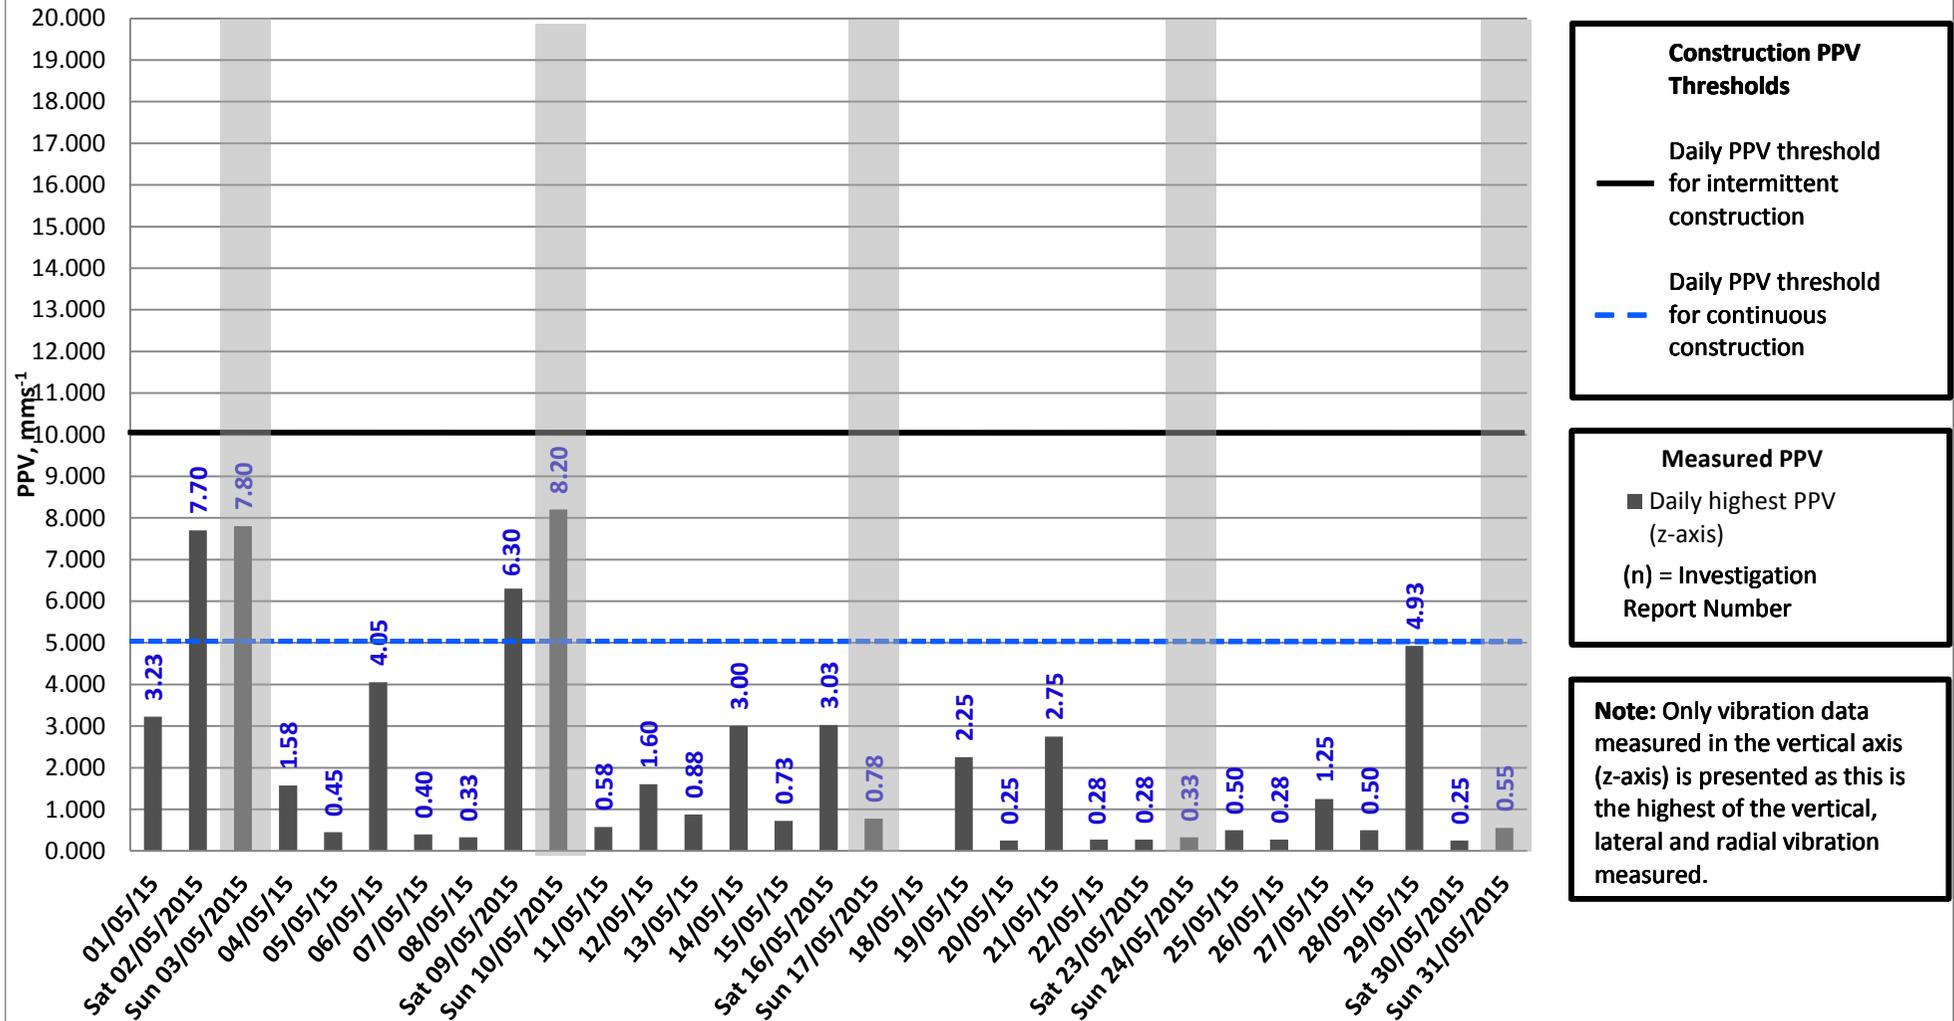
Measured highest Daily Peak Particle Velocity (PPV), Tigh-Na Grian, Measurement period: May 2015

Note: The PPV values on 02/05/15 and 09/05/15 have all been investigated and have been seen to be individual, isolated events within the period. These figures are due to monitor maintenance and most likely due to external activity near/ directly above the transducers.

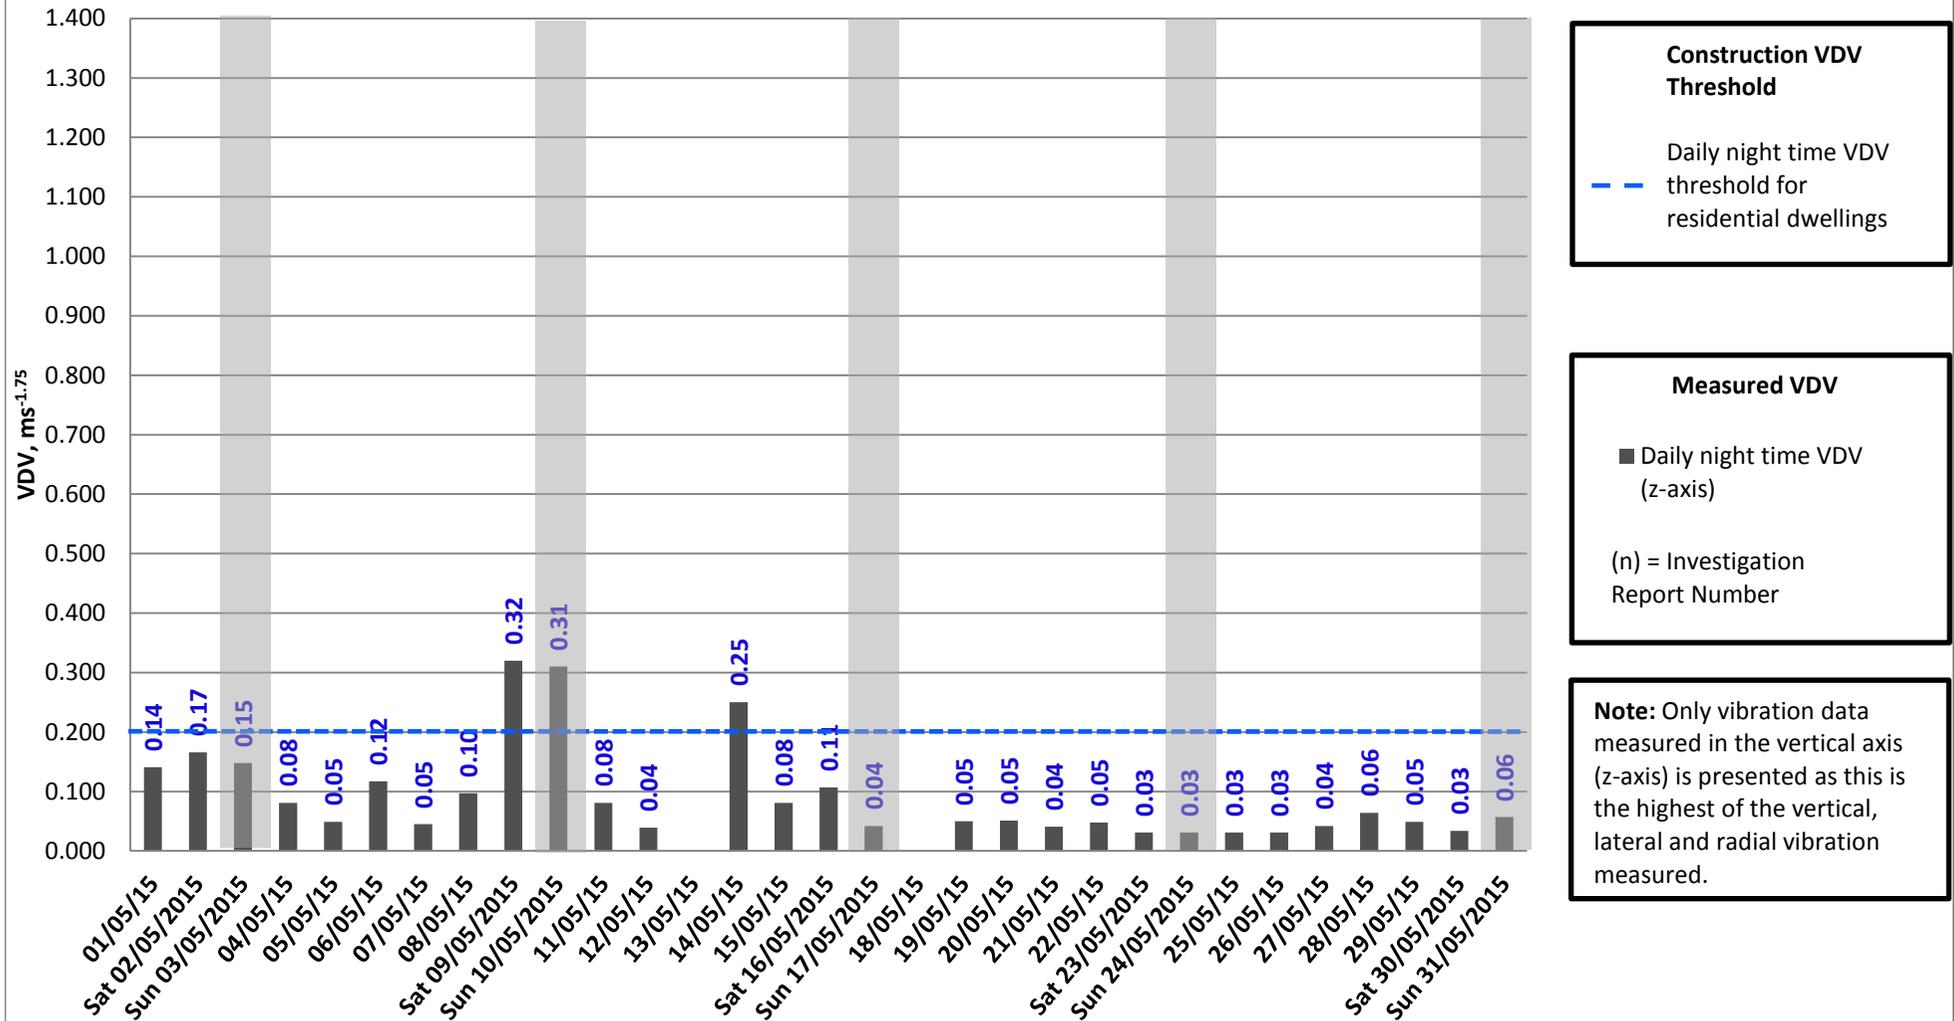
Measured Night Time (23:00-07:00) Vibration Dose Values (VDV), Tigh-Na Grian, Measurement period: May 2015

Note: The Night time VDV values on 09/05/15 and 14/05/15 have all been investigated. No night time works were conducted in the vicinity of Tigh-Na Grian during the days in question. These figures are most likely due to external activities near/ directly above the transducers.
