Project **FORTH REPLACEMENT CROSSING**

**VIBRATION MONITORING REPORT
DECEMBER 2015**

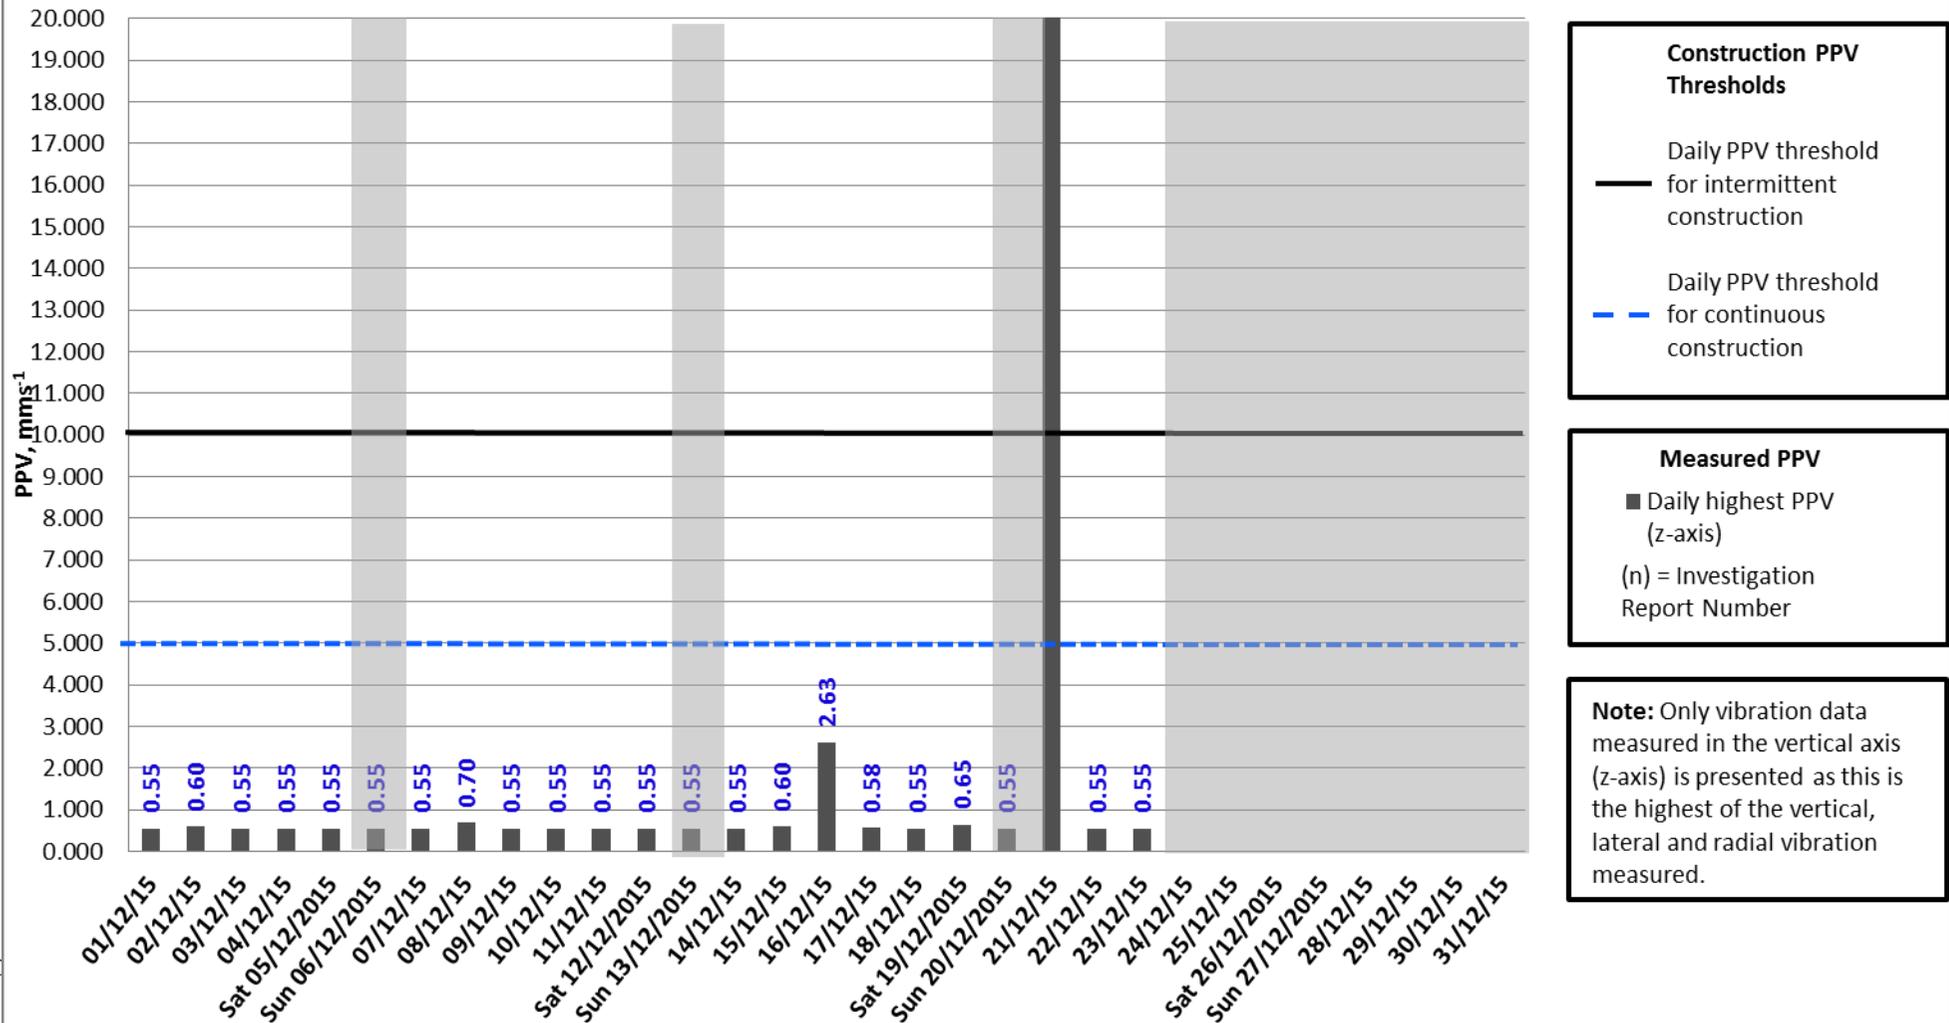
Measured highest Daily Peak Particle Velocity (PPV), Butlaw, Measurement period: December 2015

Note: Only vibration data measured in the vertical axis (z-axis) is presented as this is the highest of the vertical, lateral and radial vibration measured.

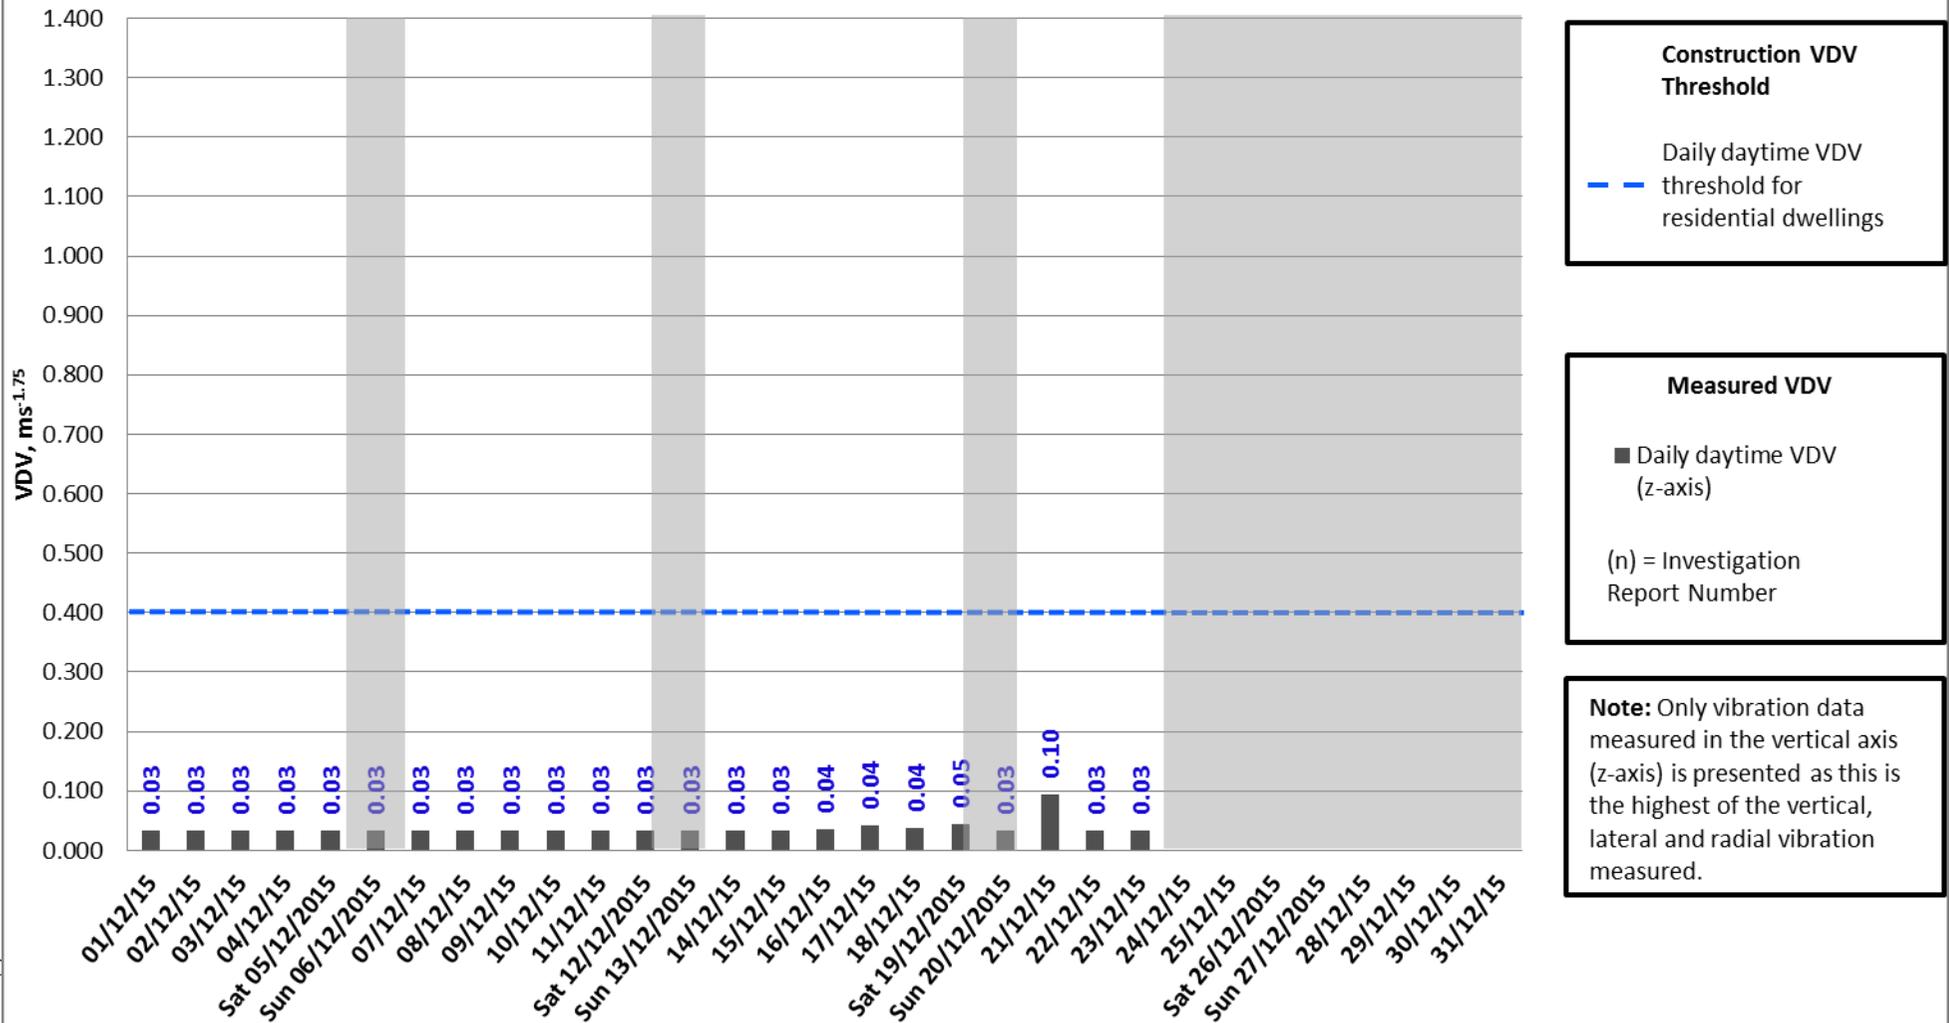
Measured Daytime (07:00-23:00) Vibration Dose Values (VDV), Butlaw, Measurement period: December 2015

Note: Only vibration data measured in the vertical axis (z-axis) is presented as this is the highest of the vertical, lateral and radial vibration measured.

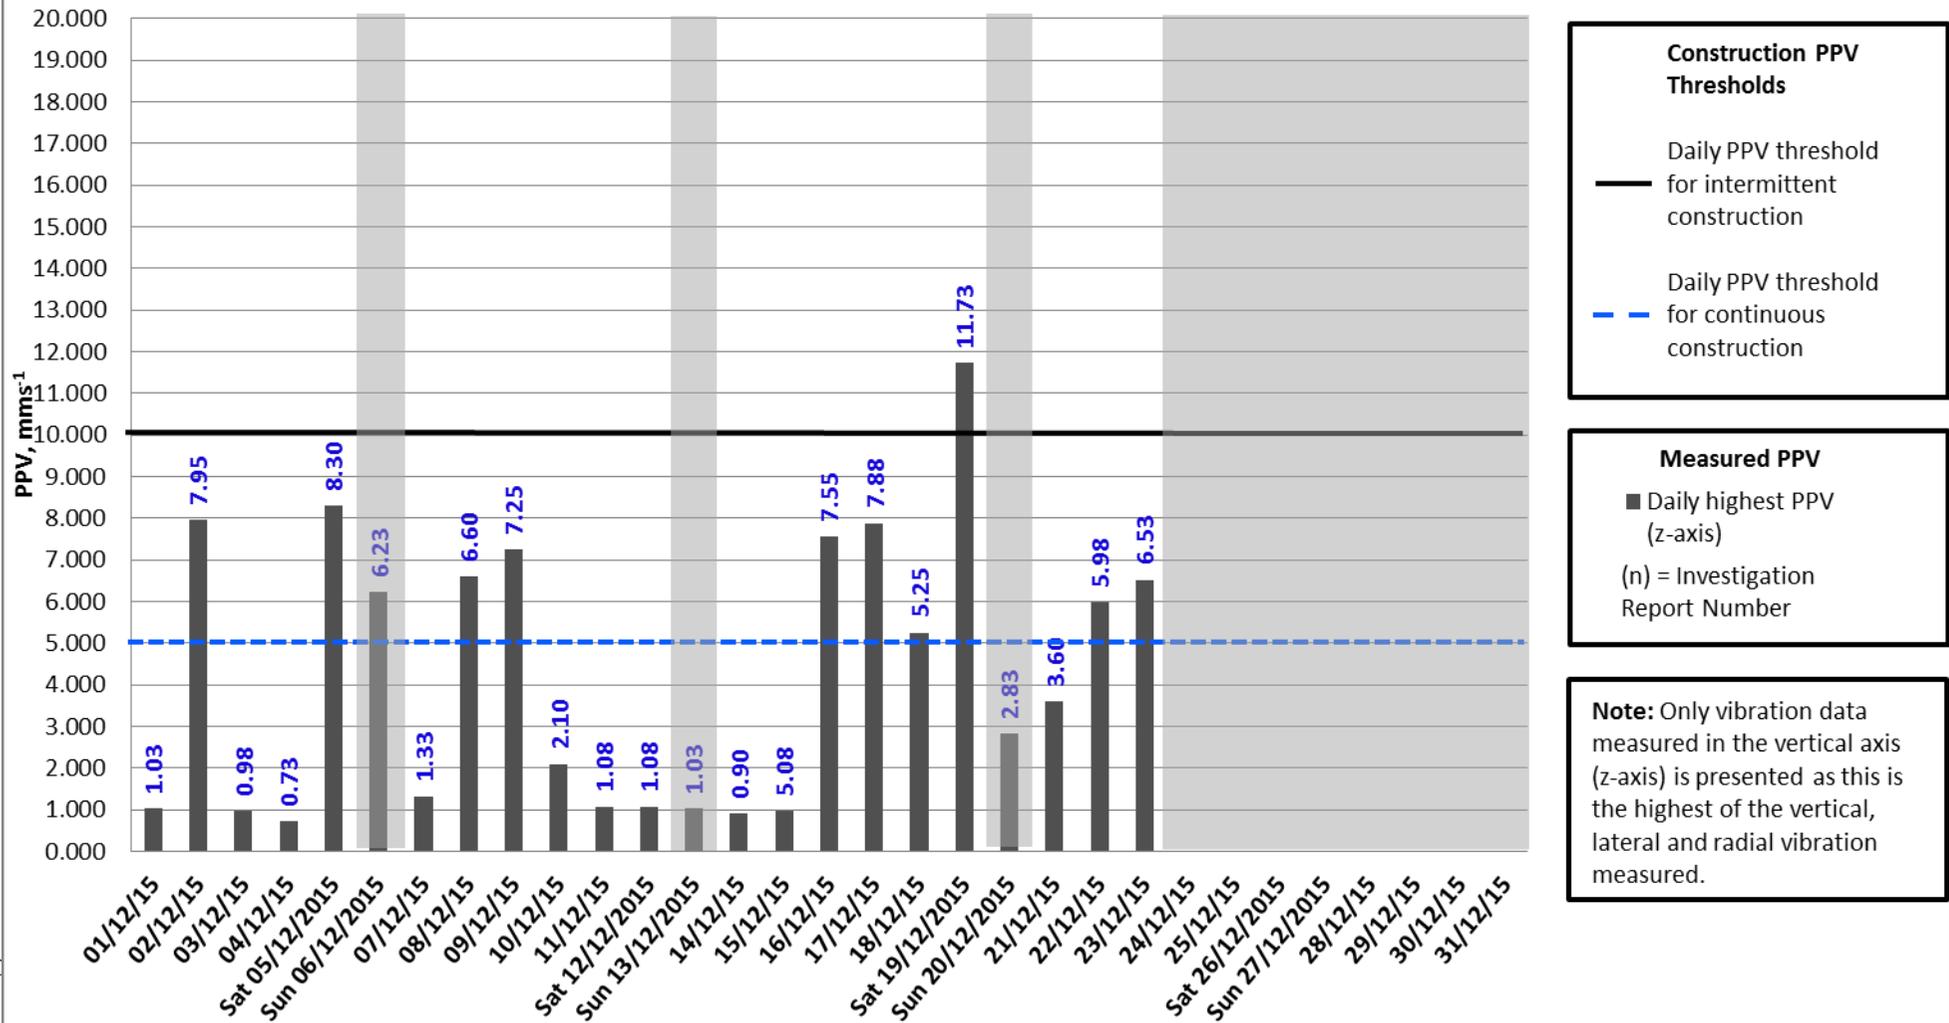
Measured highest Daily Peak Particle Velocity (PPV), Clufflat Brae, Measurement period: December 2015

All exceedance in the month of December at Clufflat have been investigated and found to be one off isolated events that are highly unlikely to have been caused by construction related activities (graph above from the 06/12/2015).

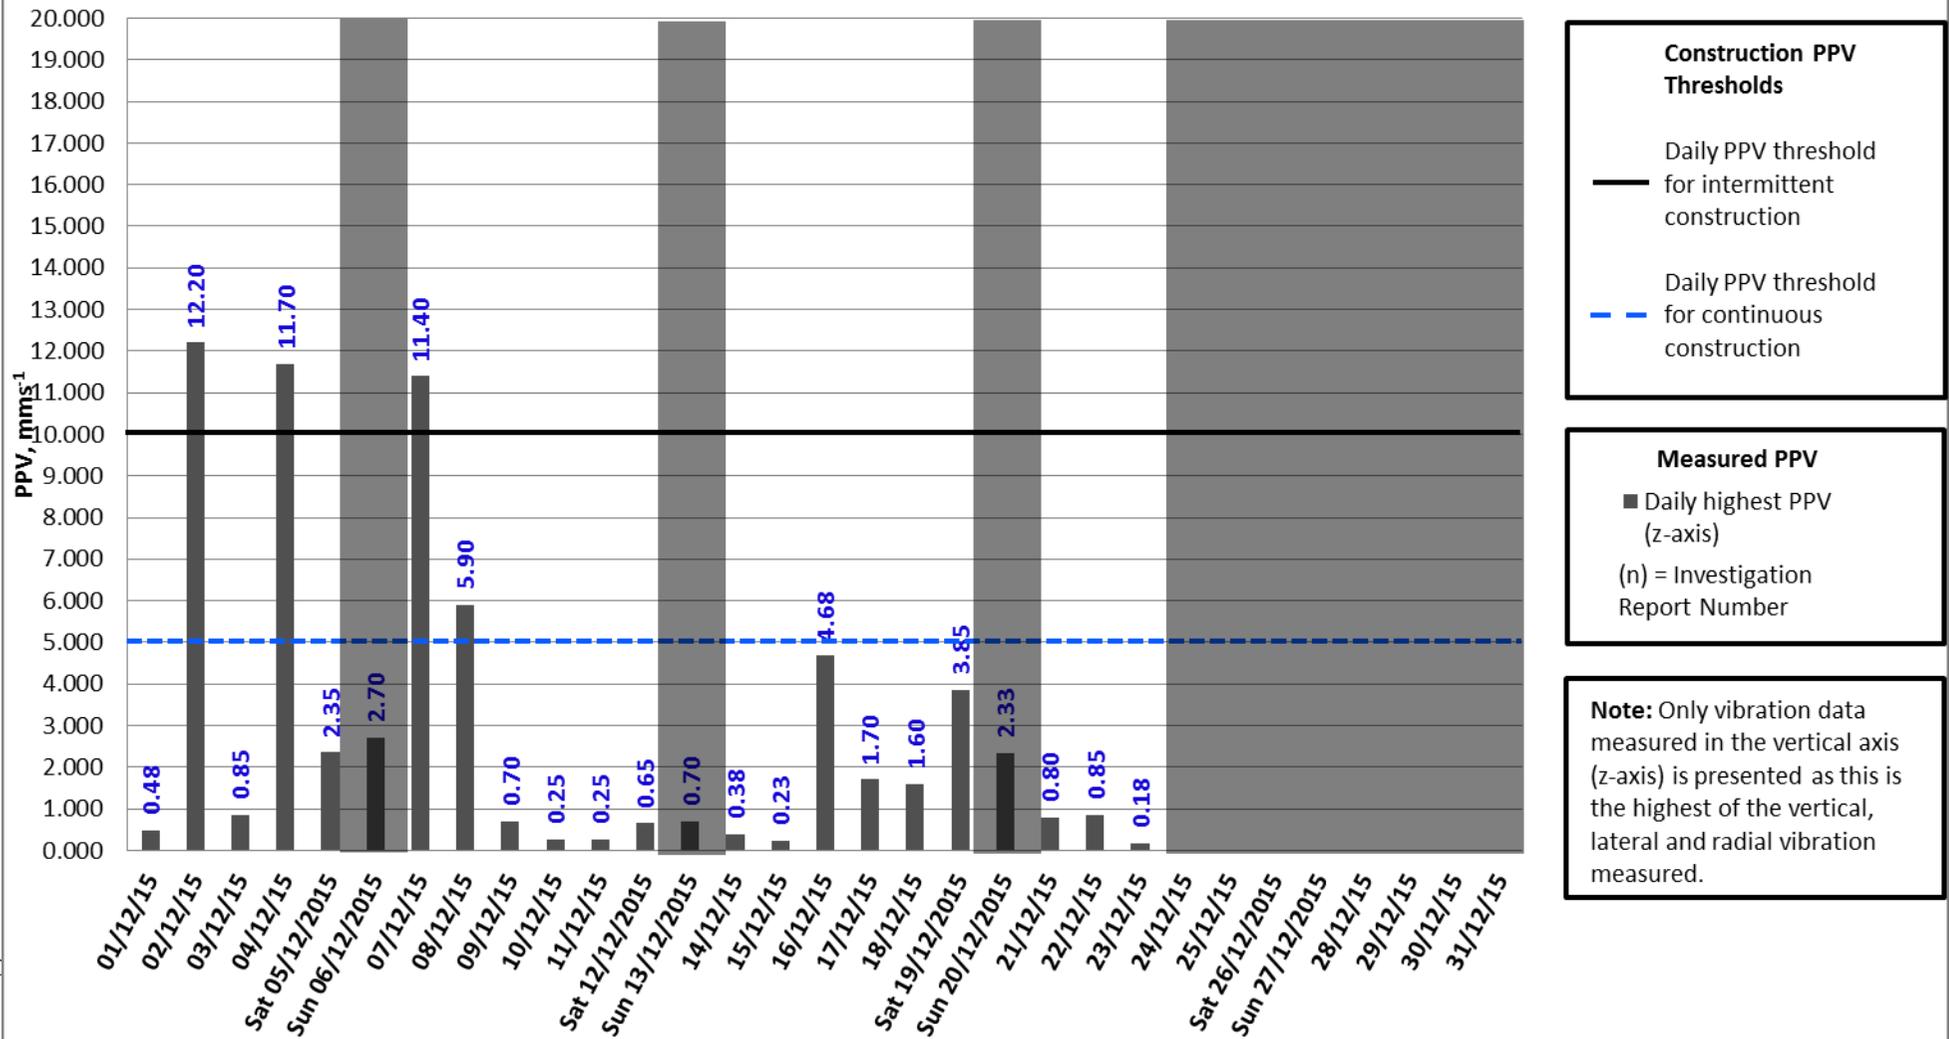
Measured highest Daily Peak Particle Velocity (PPV), Inchgarvie Lodge, Measurement period: December 2015

Exceedances on the 2nd, 4th, 7th and 8th of December have been investigated and found to be either intermittent or one off isolated events in which the source of the vibration could not be determined. It is highly unlikely to have been caused by construction related activities (graph above from the 08/12/2015). There is however, works ongoing at the property where the vibration monitor is sited, which could be causing the intermittent vibration levels.

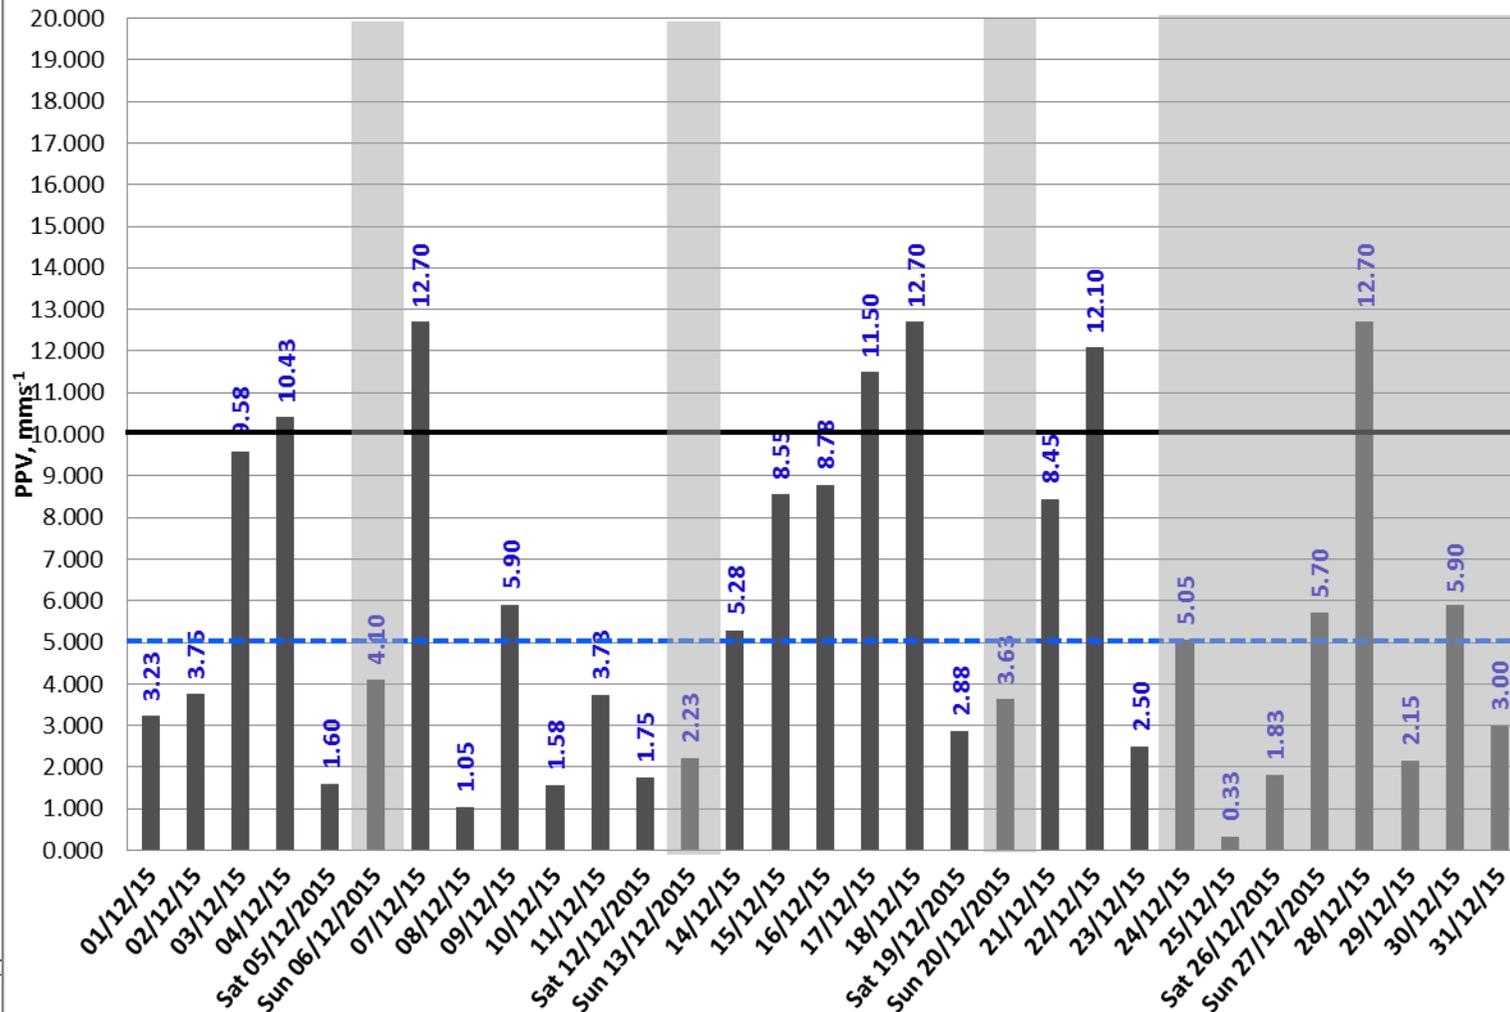
Measured highest Daily Peak Particle Velocity (PPV), 5 Linn Mill, Measurement period: December 2015

Exceedances throughout the month of December at Linn Mill have been investigated and found to be due to intermittent or one off isolated events in which the source of the vibration could not be determined. However, it is highly unlikely that these events were caused by construction related activities (graph above from the 03/12/2015). The monitor is situated in close proximity to the residents outdoor log store situated in the back garden. It is envisaged that these high readings were in fact due to the residents fetching logs from this store area. (note that the levels after the 23rd of December have been displayed to show a continued trend of high readings after construction works terminated).

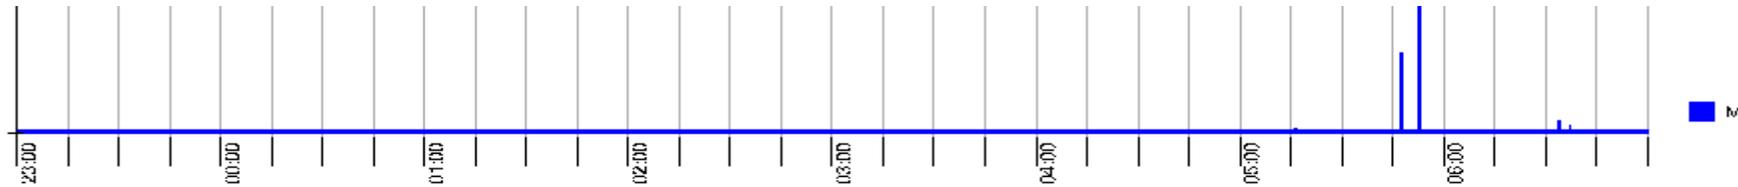
Exceedances on the 18th and 22nd of December have been investigated and found to be out with normal working hours. Because of this, it is highly unlikely that these events were caused by construction related activities (graph above from the 22/12/2015). Works that were ongoing during the night were at a great enough distance to have minimal impact at this location (distance between the monitor and the closest works is 1050m). The monitor is situated in close proximity to the residents outdoor log store situated in the back garden. It is envisaged that these high readings were in fact due to the residents fetching logs from this store area (note that levels after the 23rd of December have been displayed to show a continued trend of high readings after construction works terminated).

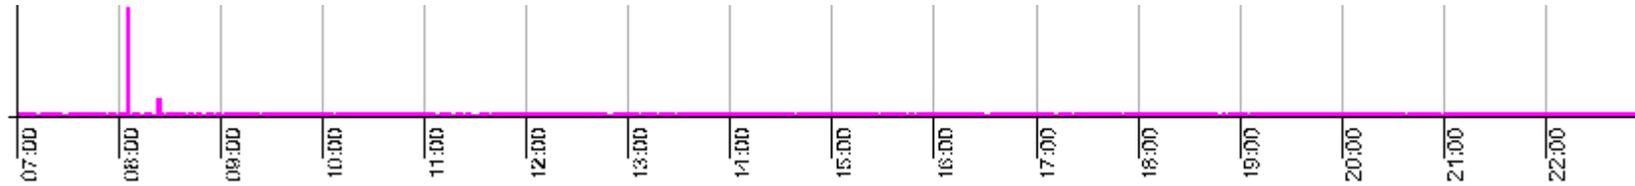
Exceedances on the 13th, 16th, 18th, 19th and 20th of December have been investigated and found to be one off isolated events that are unlikely to have been caused by work related activities. They are more likely to have been caused by more 'localised' activity near or close by the vibration monitor (graph above form the 18/12/2015).

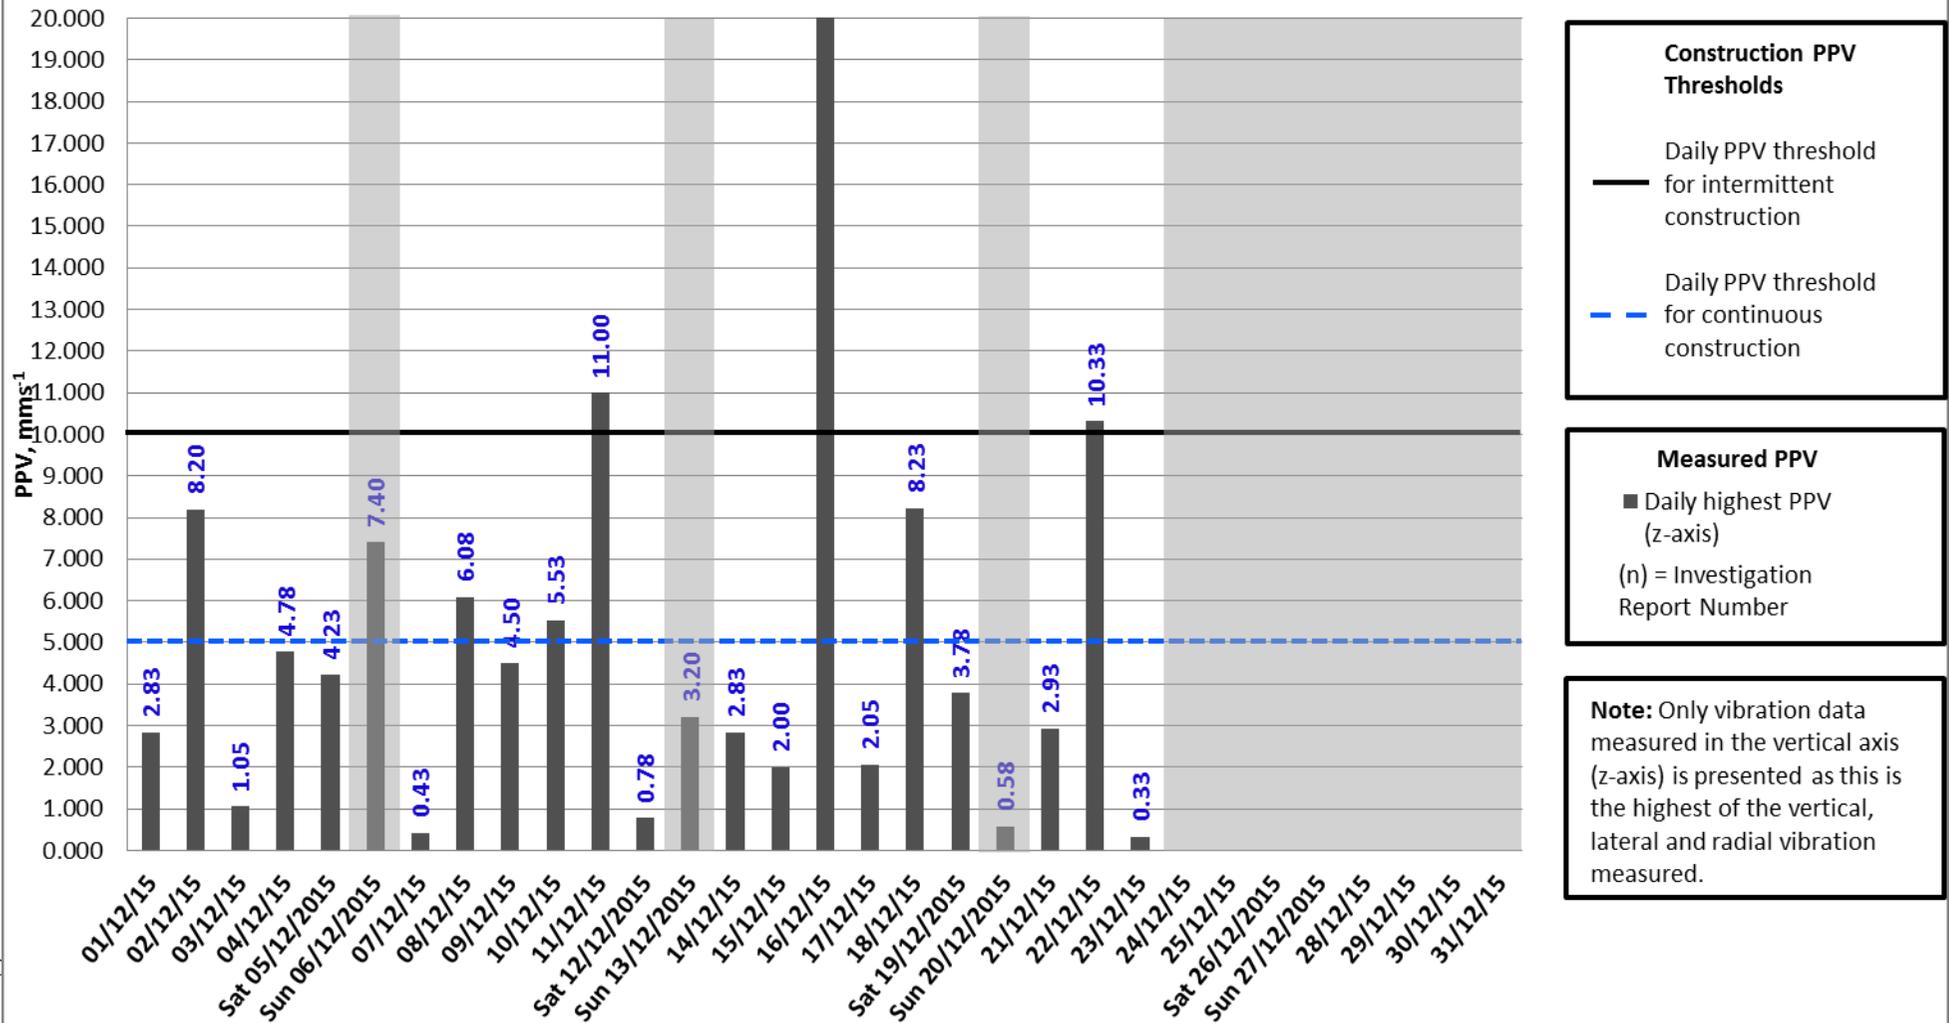
Measured highest Daily Peak Particle Velocity (PPV), Whinnyhill, Measurement period: December 2015

Exceedances on the 2nd, 8th, 11th, 18th and 22nd of December have been investigated and found to be one off isolated events that are highly unlikely to have been caused by construction related activities. They are more likely to have been caused by ‘localised’ activity close to the monitor (graph above from the 08/12/2015).

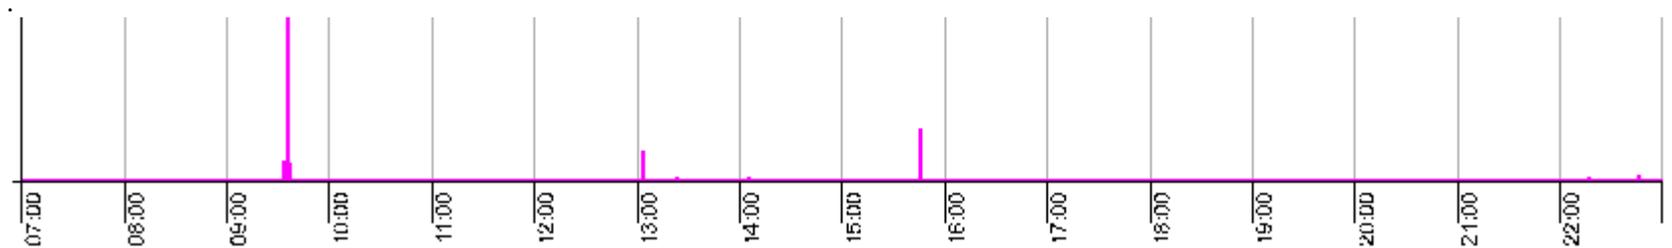
Exceedance on the 6th and 10th of December have been investigated and found to be out with normal working hours and is highly unlikely to have been caused by construction related activities (graph above from the 10/12/2015).
