Project **FORTH REPLACEMENT CROSSING**

VIBRATION MONITORING REPORT
MARCH 2015

Made by Stuart Swainson	Checked By: Liam Soden
Initials: SSN	Initials: LSN
Document number	Rev
REP-00228-01	01

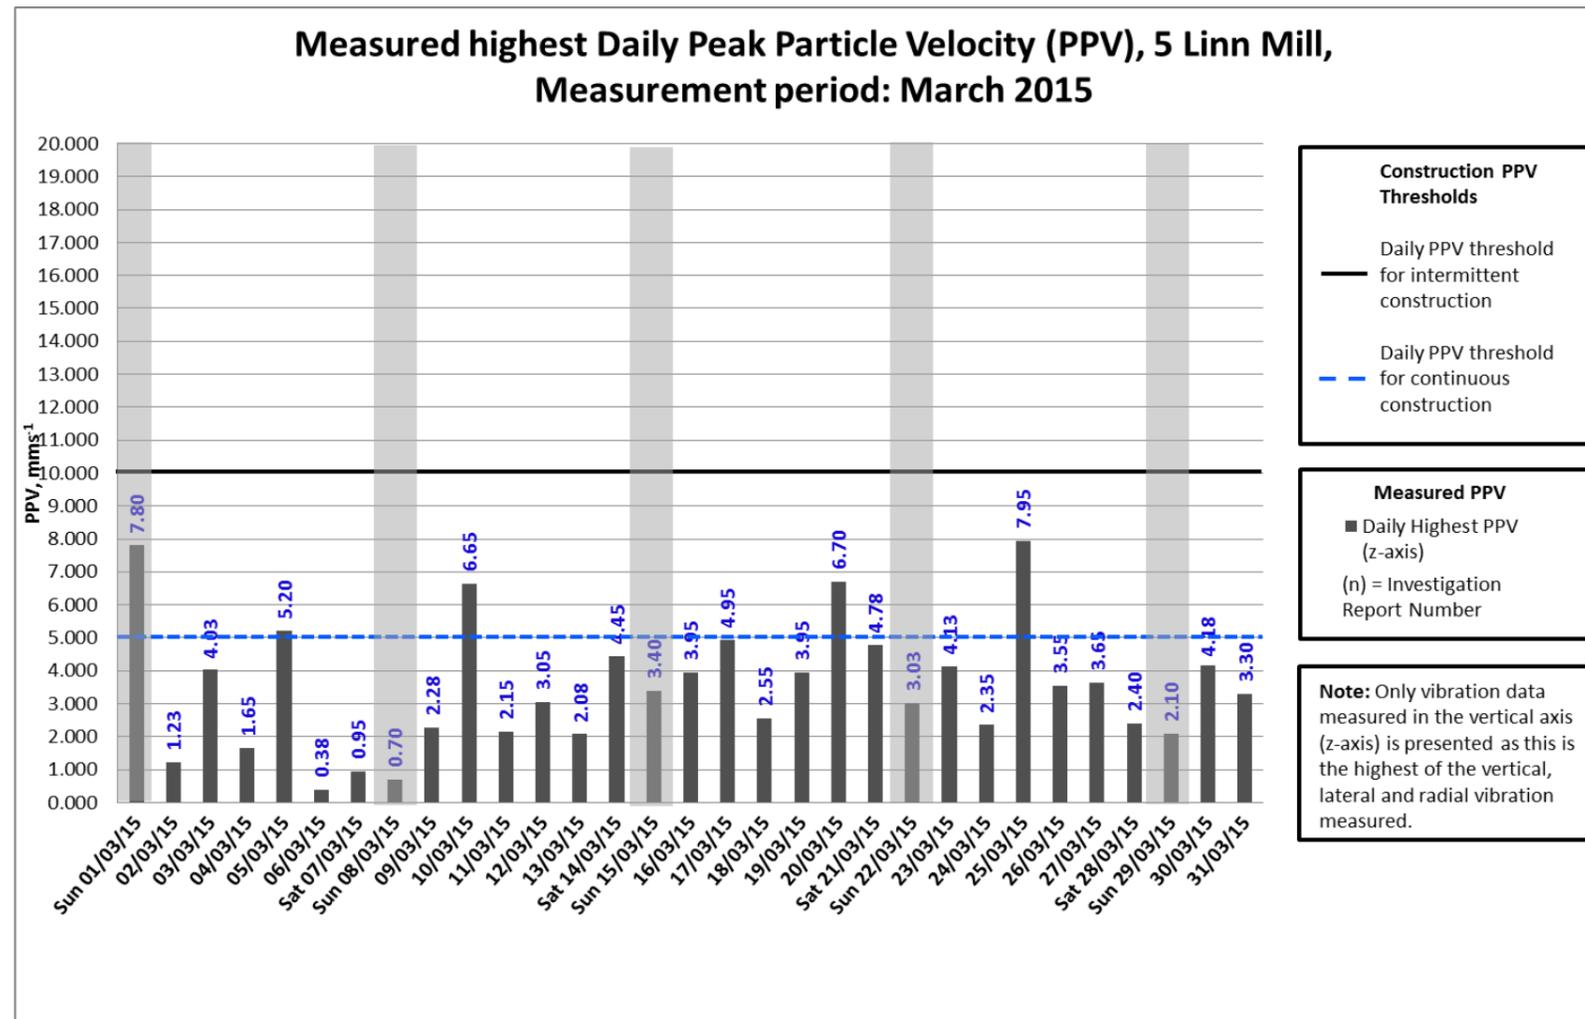
- The grey areas of the chart represent the days on which no construction works were undertaken; no works were conducted in the vicinity of the Linn Mill monitor on Sundays.

The PPV values on 01/03/15, 05/03/15, 10/03/15, 20/03/15 and 25/03/15 have all been investigated and have been seen to be individual, isolated events within the period (see Vibrock graph below from 25/05/15), all of which are within the intermittent threshold of 10mm/s. The nearest earthworks are over 500m away from this monitor with only reb-bar tying and bearing installation the only operations conducted in the location on Linn Mill both of which have no vibratory impact on properties. These exceedances could be due to monitor maintenance or other external activity near/ directly above the transducers.

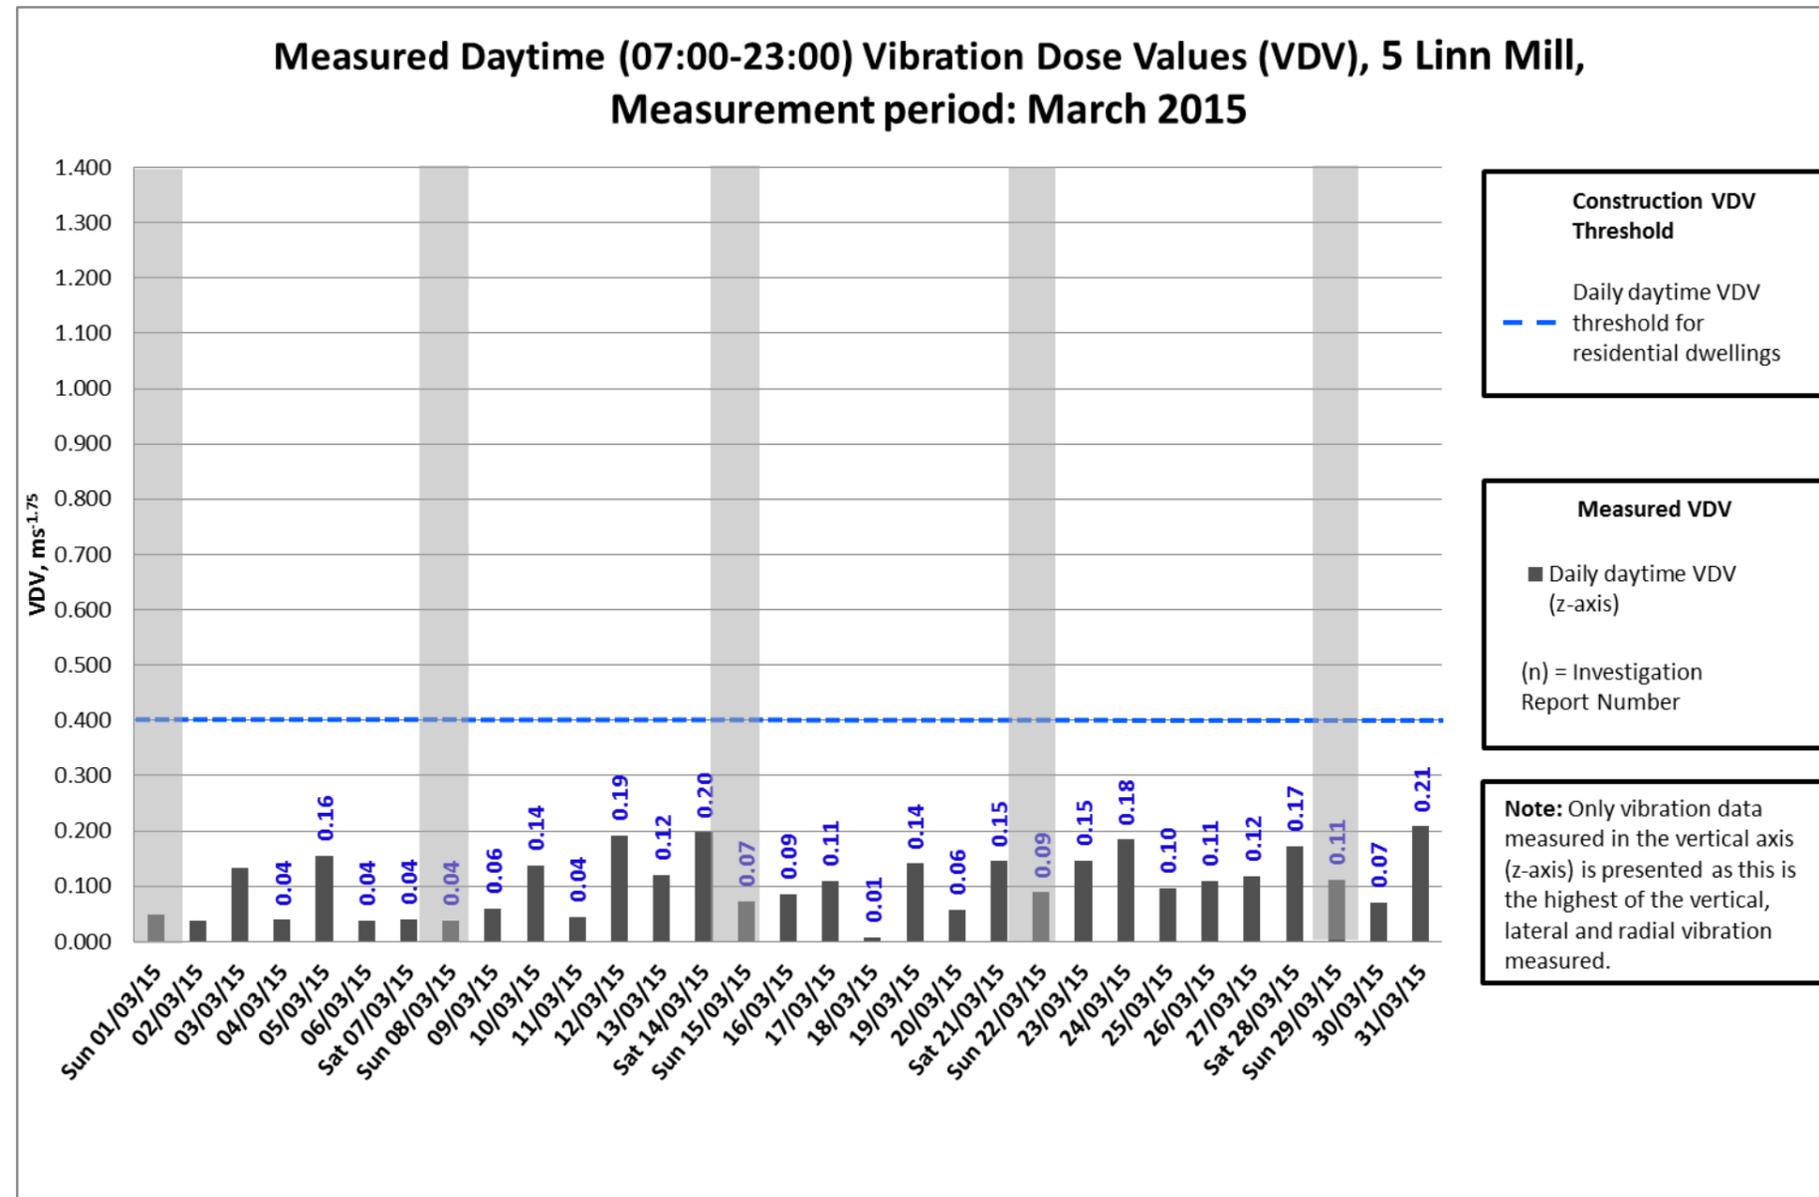
- The grey areas of the chart represent the days on which no construction works were undertaken; no works were conducted in the vicinity of the Linn Mill monitor on Sundays.

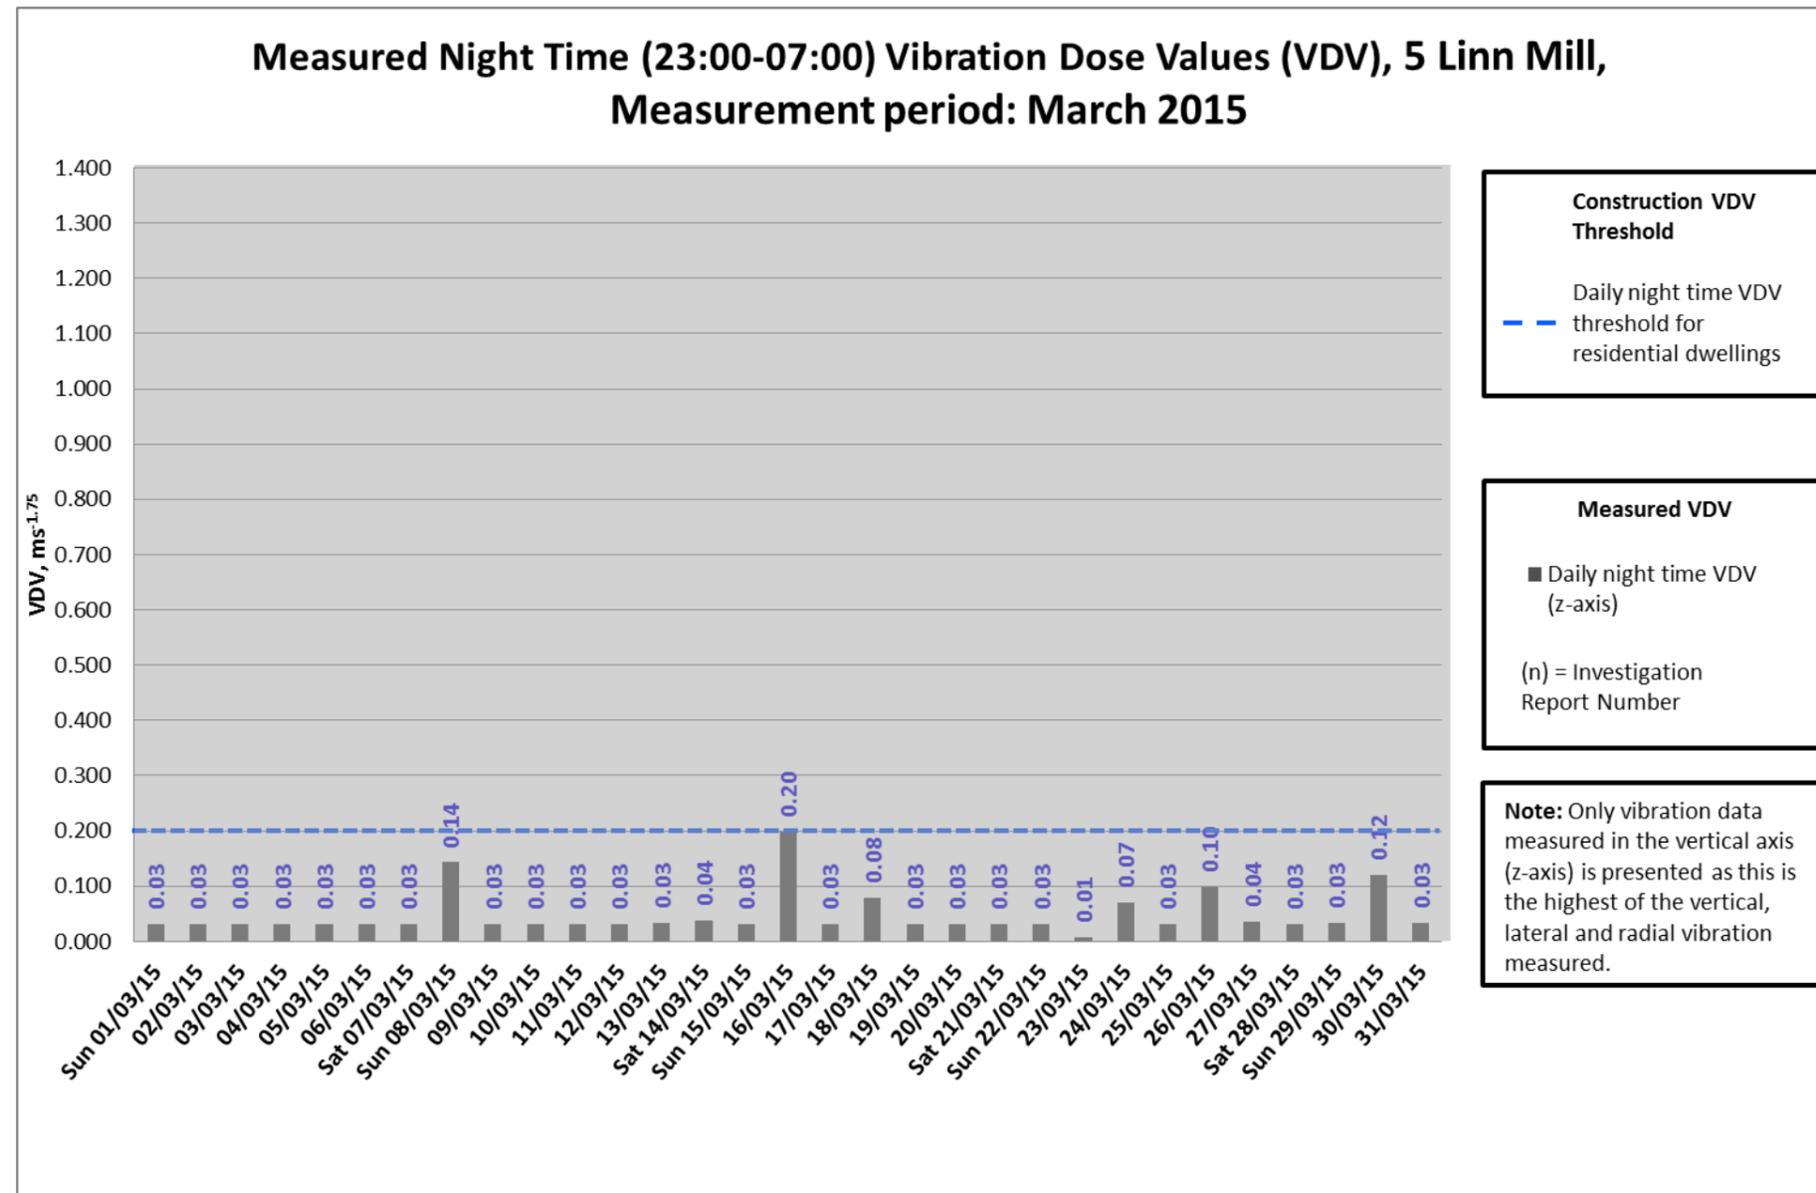
- The grey areas of the chart represent the days on which no construction works were undertaken; no night time works were conducted in the vicinity of the Linn Mill vibration monitor throughout the month of March 2015. This graph is included for illustrative purposes only.

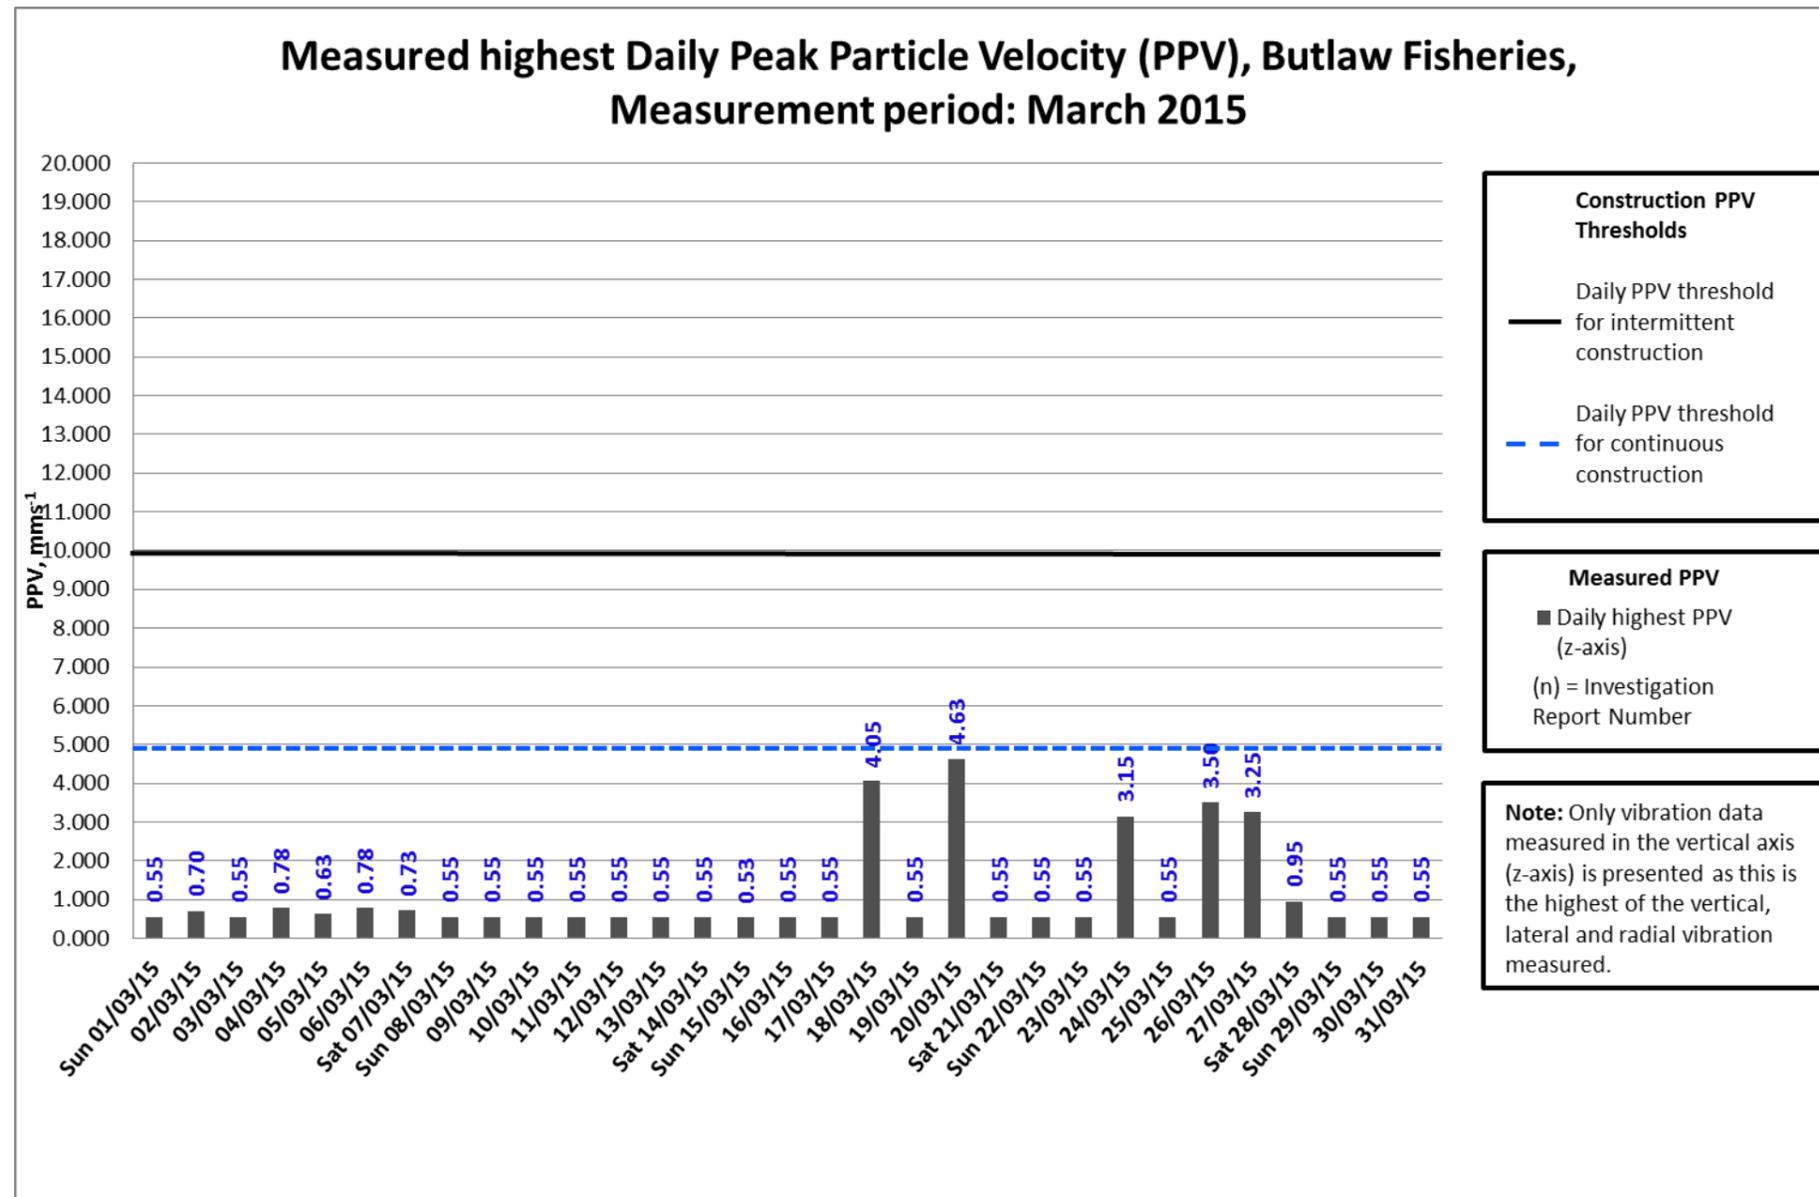
Measured highest Daily Peak Particle Velocity (PPV), Butlaw Fisheries, Measurement period: March 2015

Note: Only vibration data measured in the vertical axis (z-axis) is presented as this is the highest of the vertical, lateral and radial vibration measured.

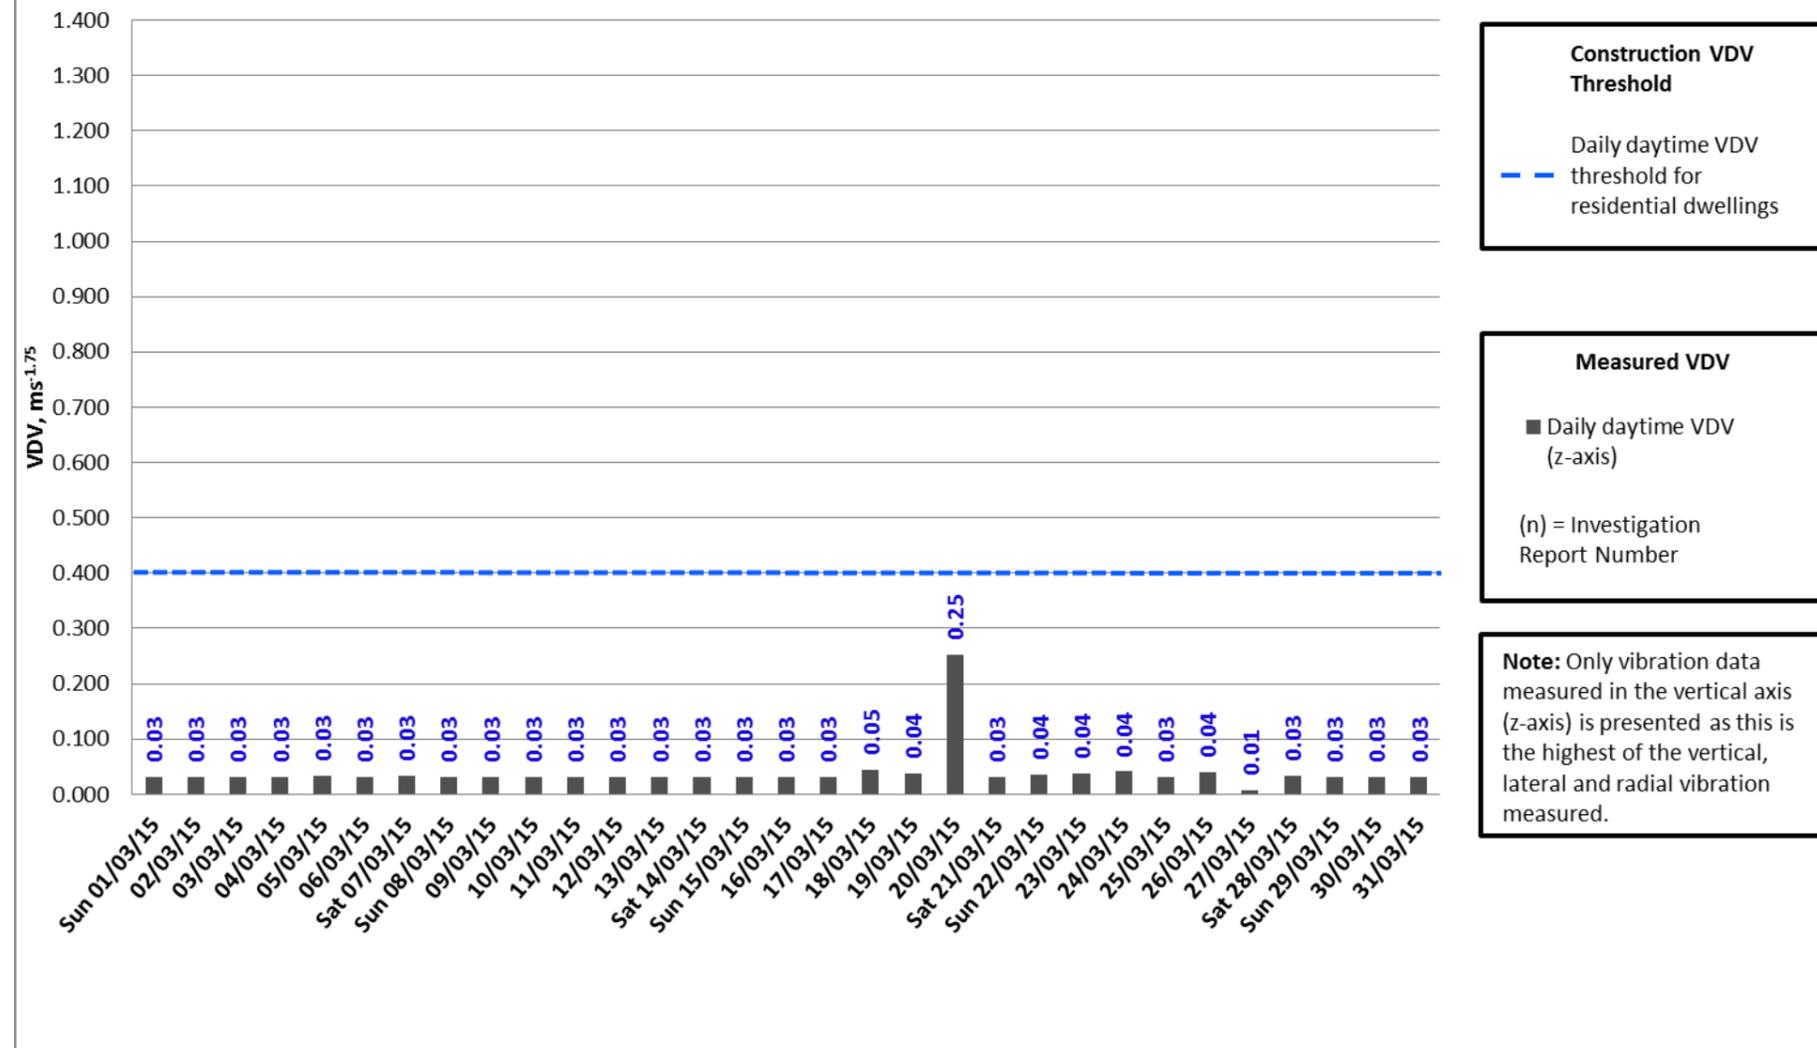
**Measured Daytime (07:00-23:00) Vibration Dose Values (VDV), Butlaw Fisheries,
 Measurement period: March 2015**

Note: Only vibration data measured in the vertical axis (z-axis) is presented as this is the highest of the vertical, lateral and radial vibration measured.

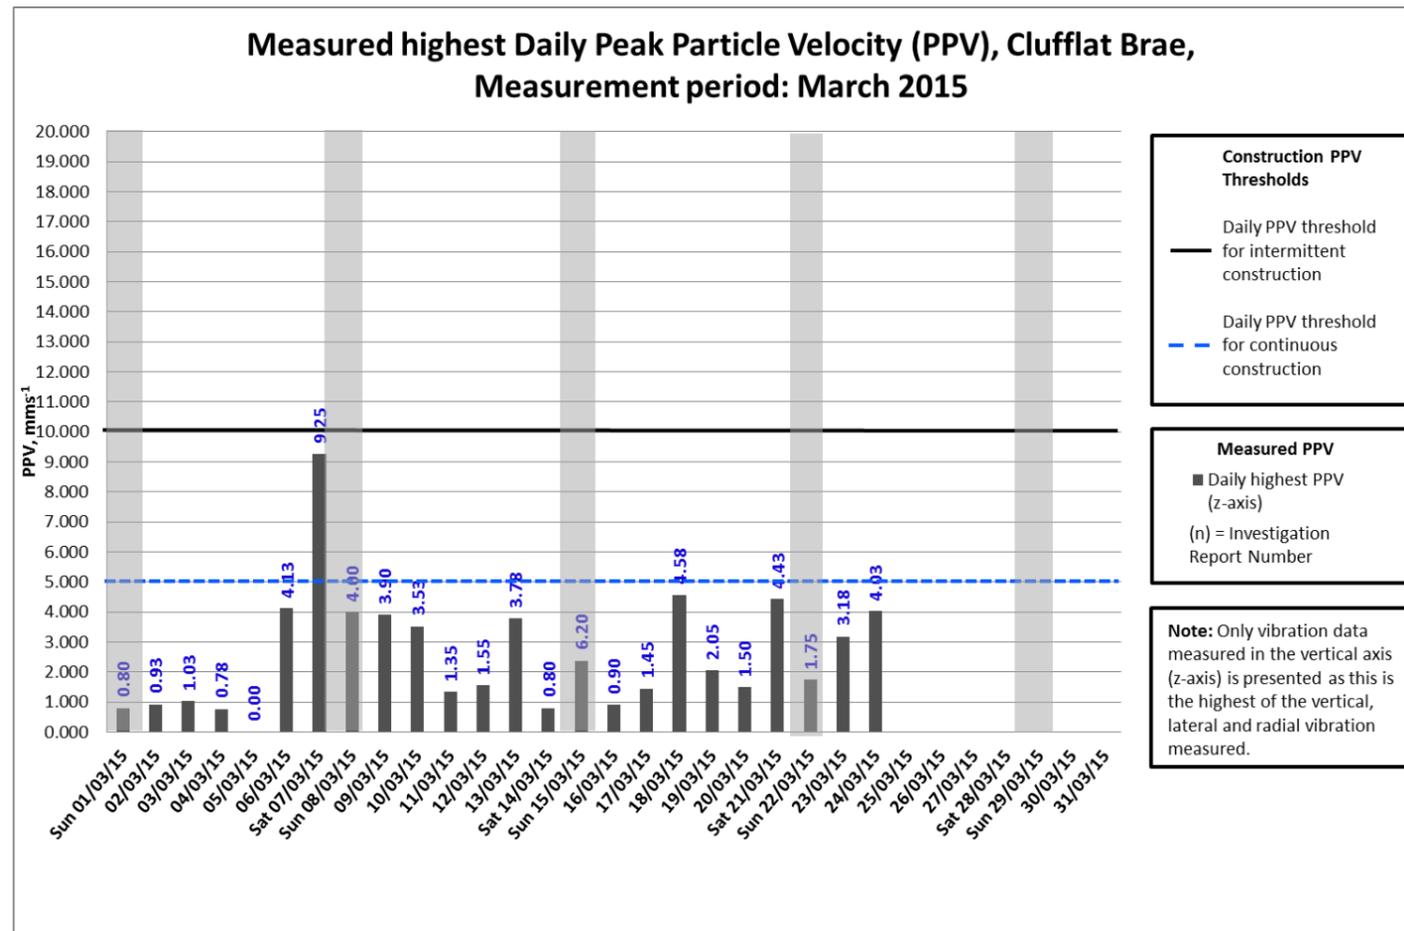
- The grey areas of the chart represent the days on which no construction works were undertaken; no works were conducted in the vicinity of the Clufflat Brae monitor on Sundays.
- The PPV value on 07/03/15 has been investigated and was due to an individual, isolated event, which was not due to FCBC works within the period (see Vibrock PPV graph below from 07/03/15). All values are within the intermittent threshold of 10mm/s.
- Data is missing from the period 25/03/15- 31/03/15 due to device error.

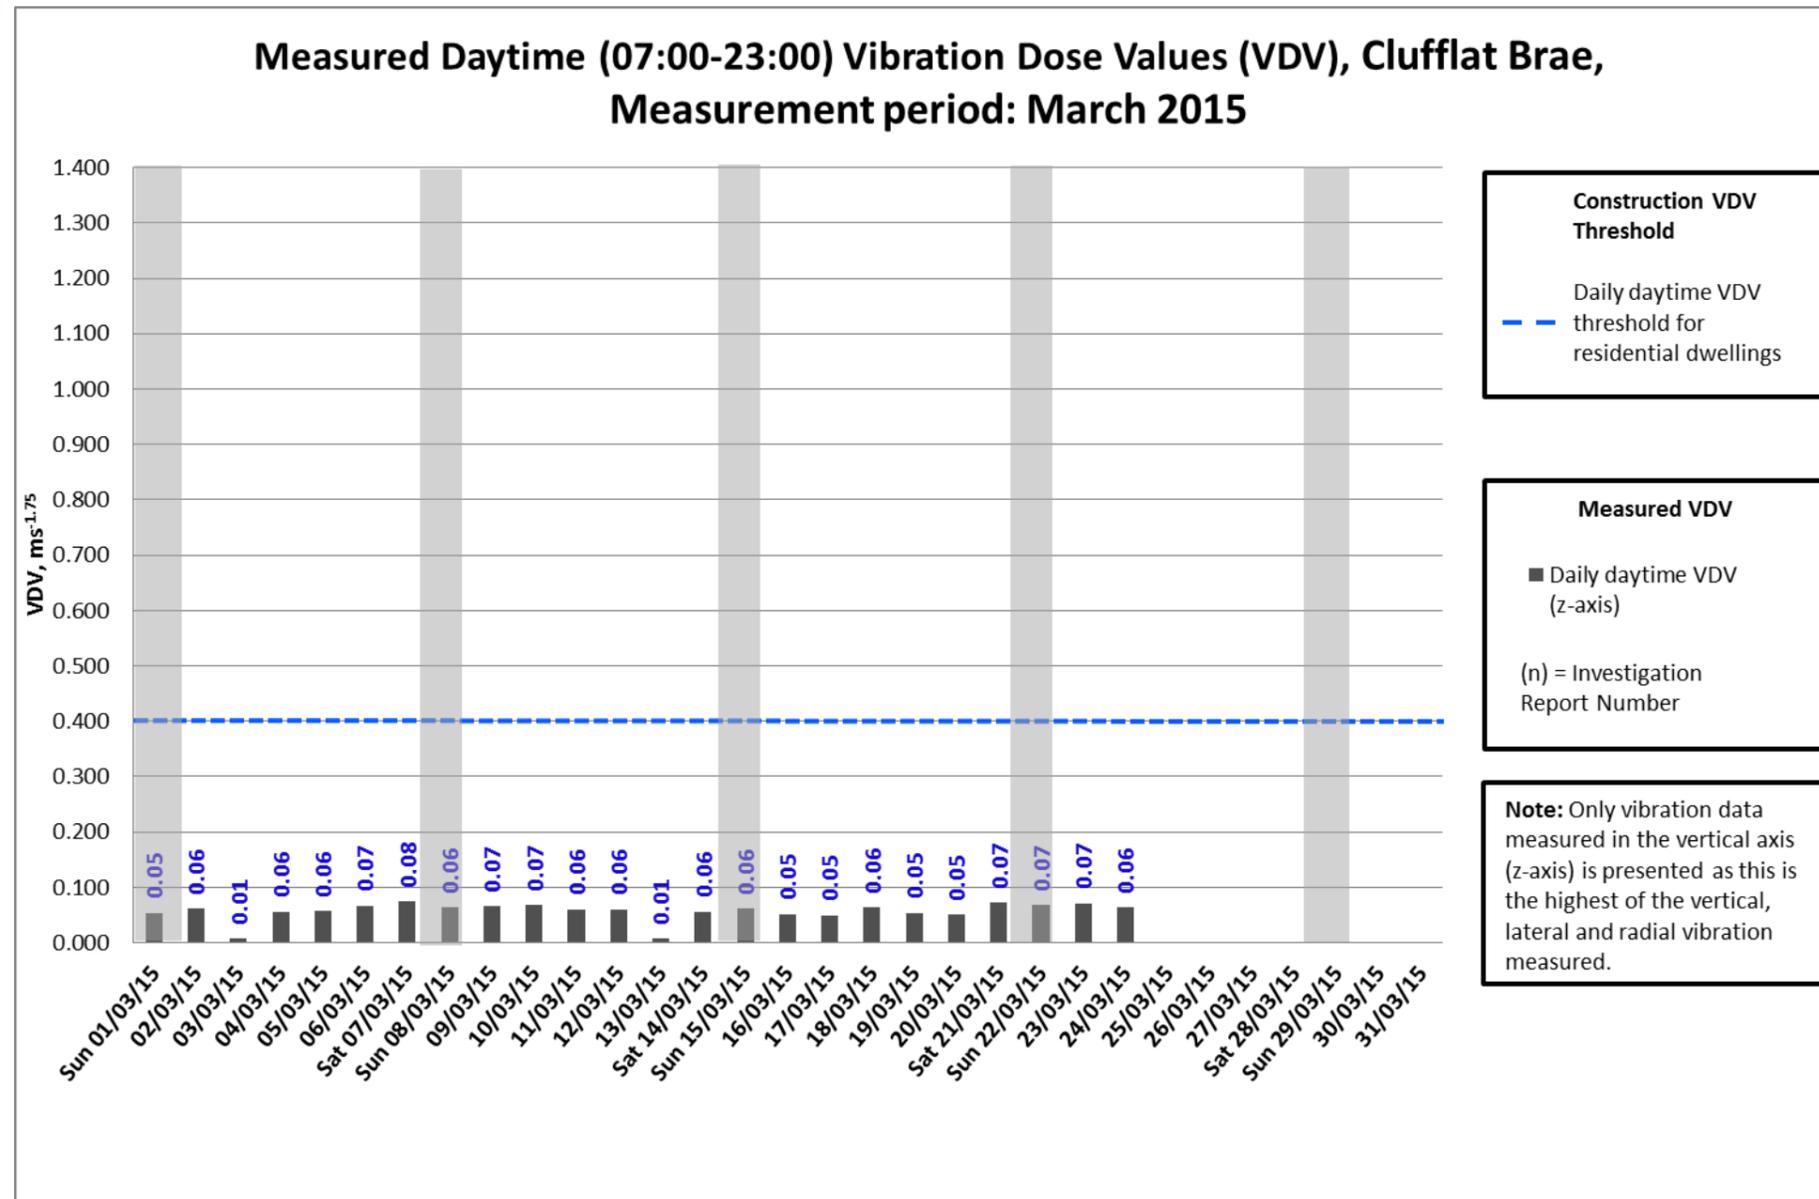
- The grey areas of the chart represent the days on which no construction works were undertaken; no works were conducted in the vicinity of the Clufflat Brae monitor on Sundays.
- Data is missing from the period 25/03/15- 31/03/15 due to device error.

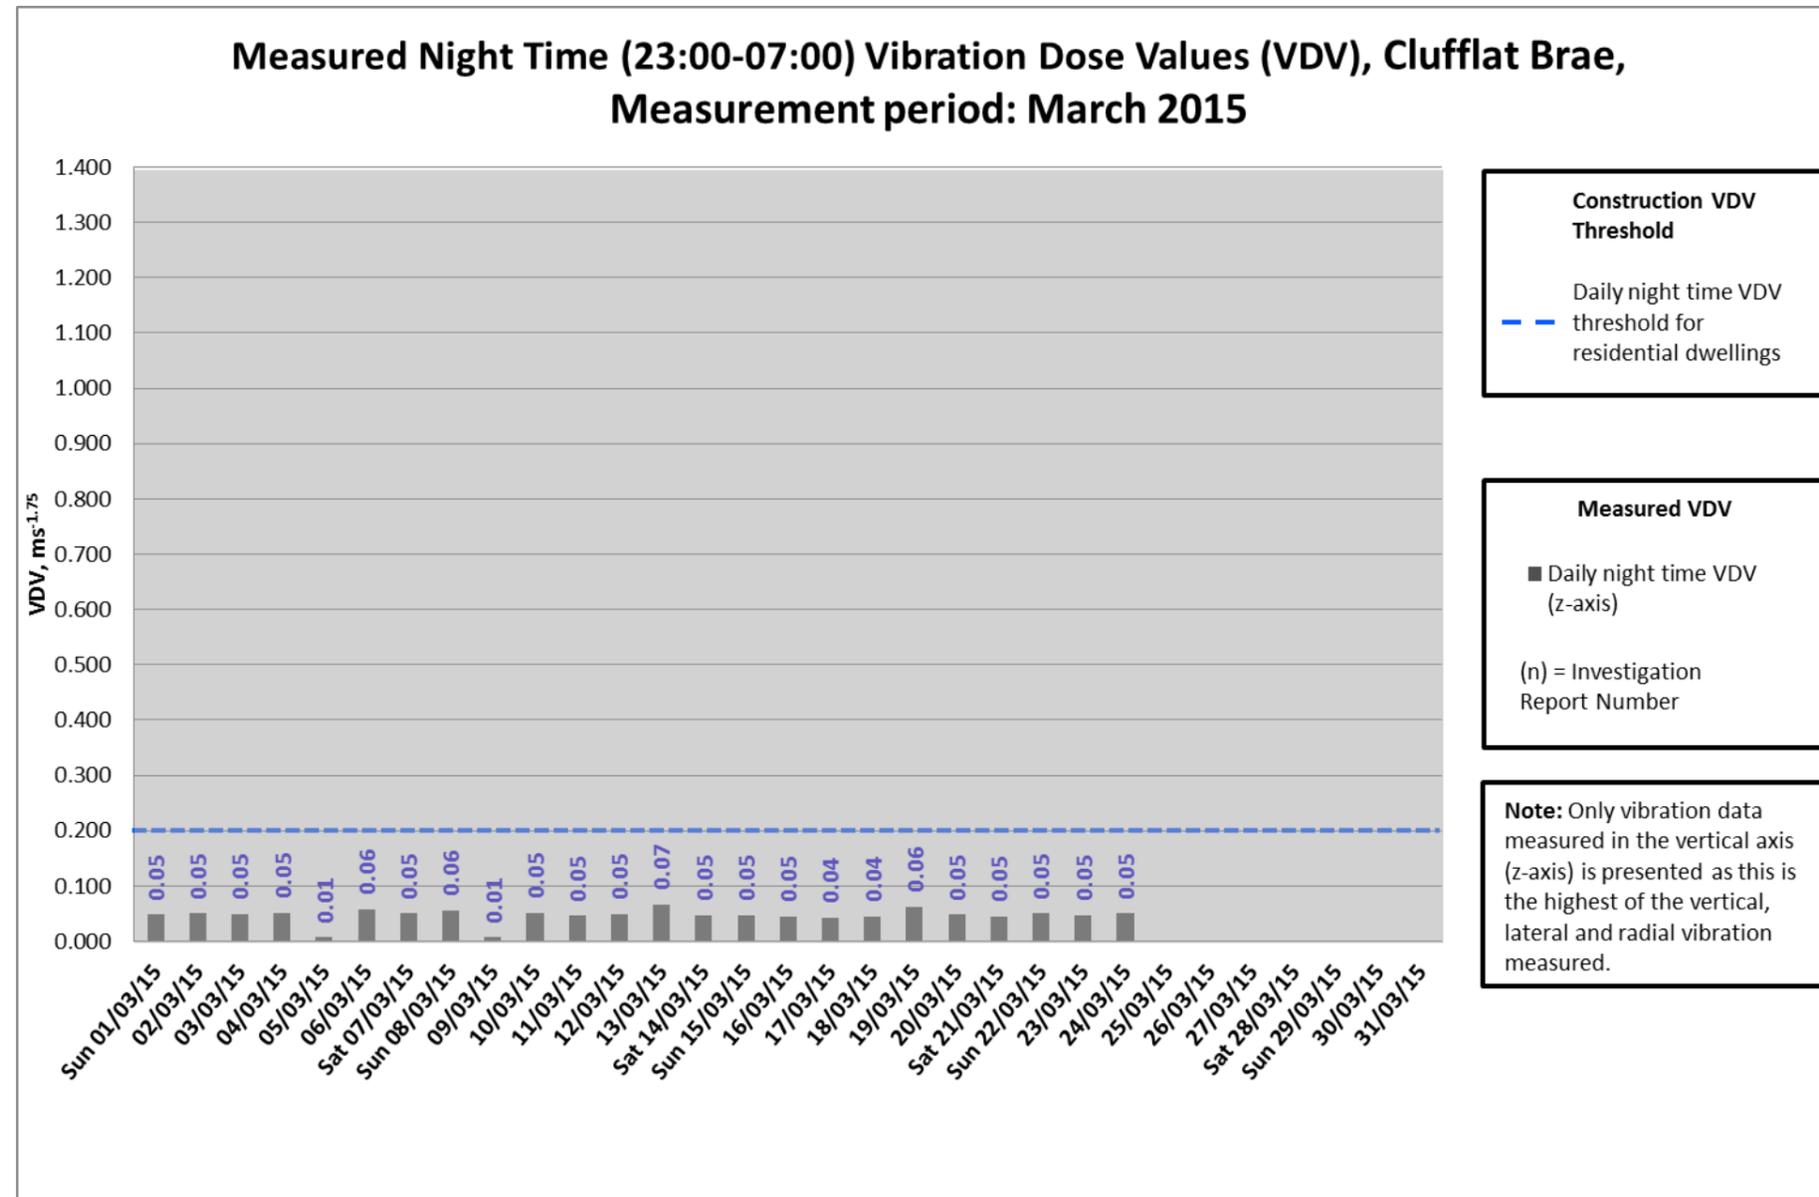
- Notes:**
- The grey areas of the chart represent the days on which no construction works were undertaken; no night time works were conducted in the vicinity of the Clufflat Brae vibration monitor throughout the month of March 2015. This graph is included for illustrative purposes only.
 - Data is missing from the period 25/03/15- 31/03/15 due to device error.

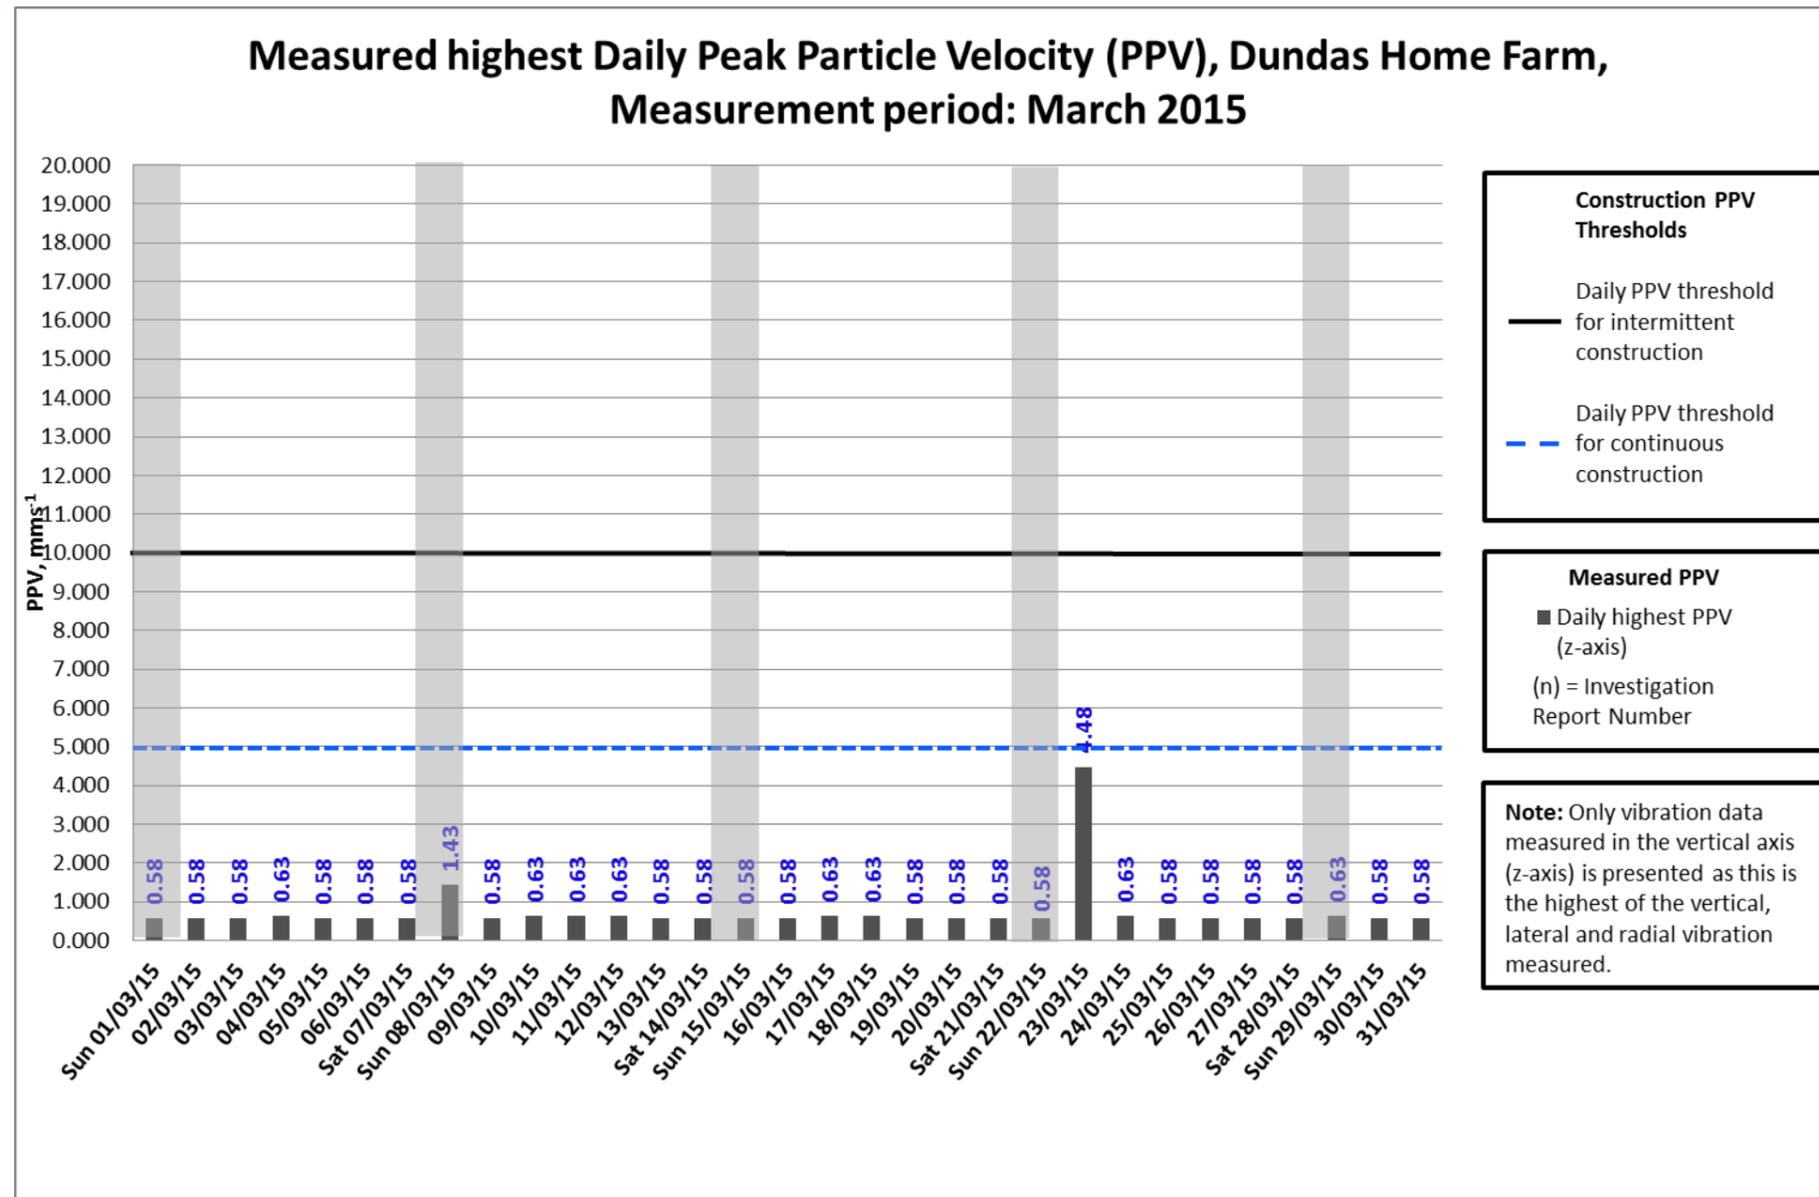
- The grey areas of the chart represent the days on which no construction works were undertaken; no works were conducted in the vicinity of the Dundas monitor on Sundays.

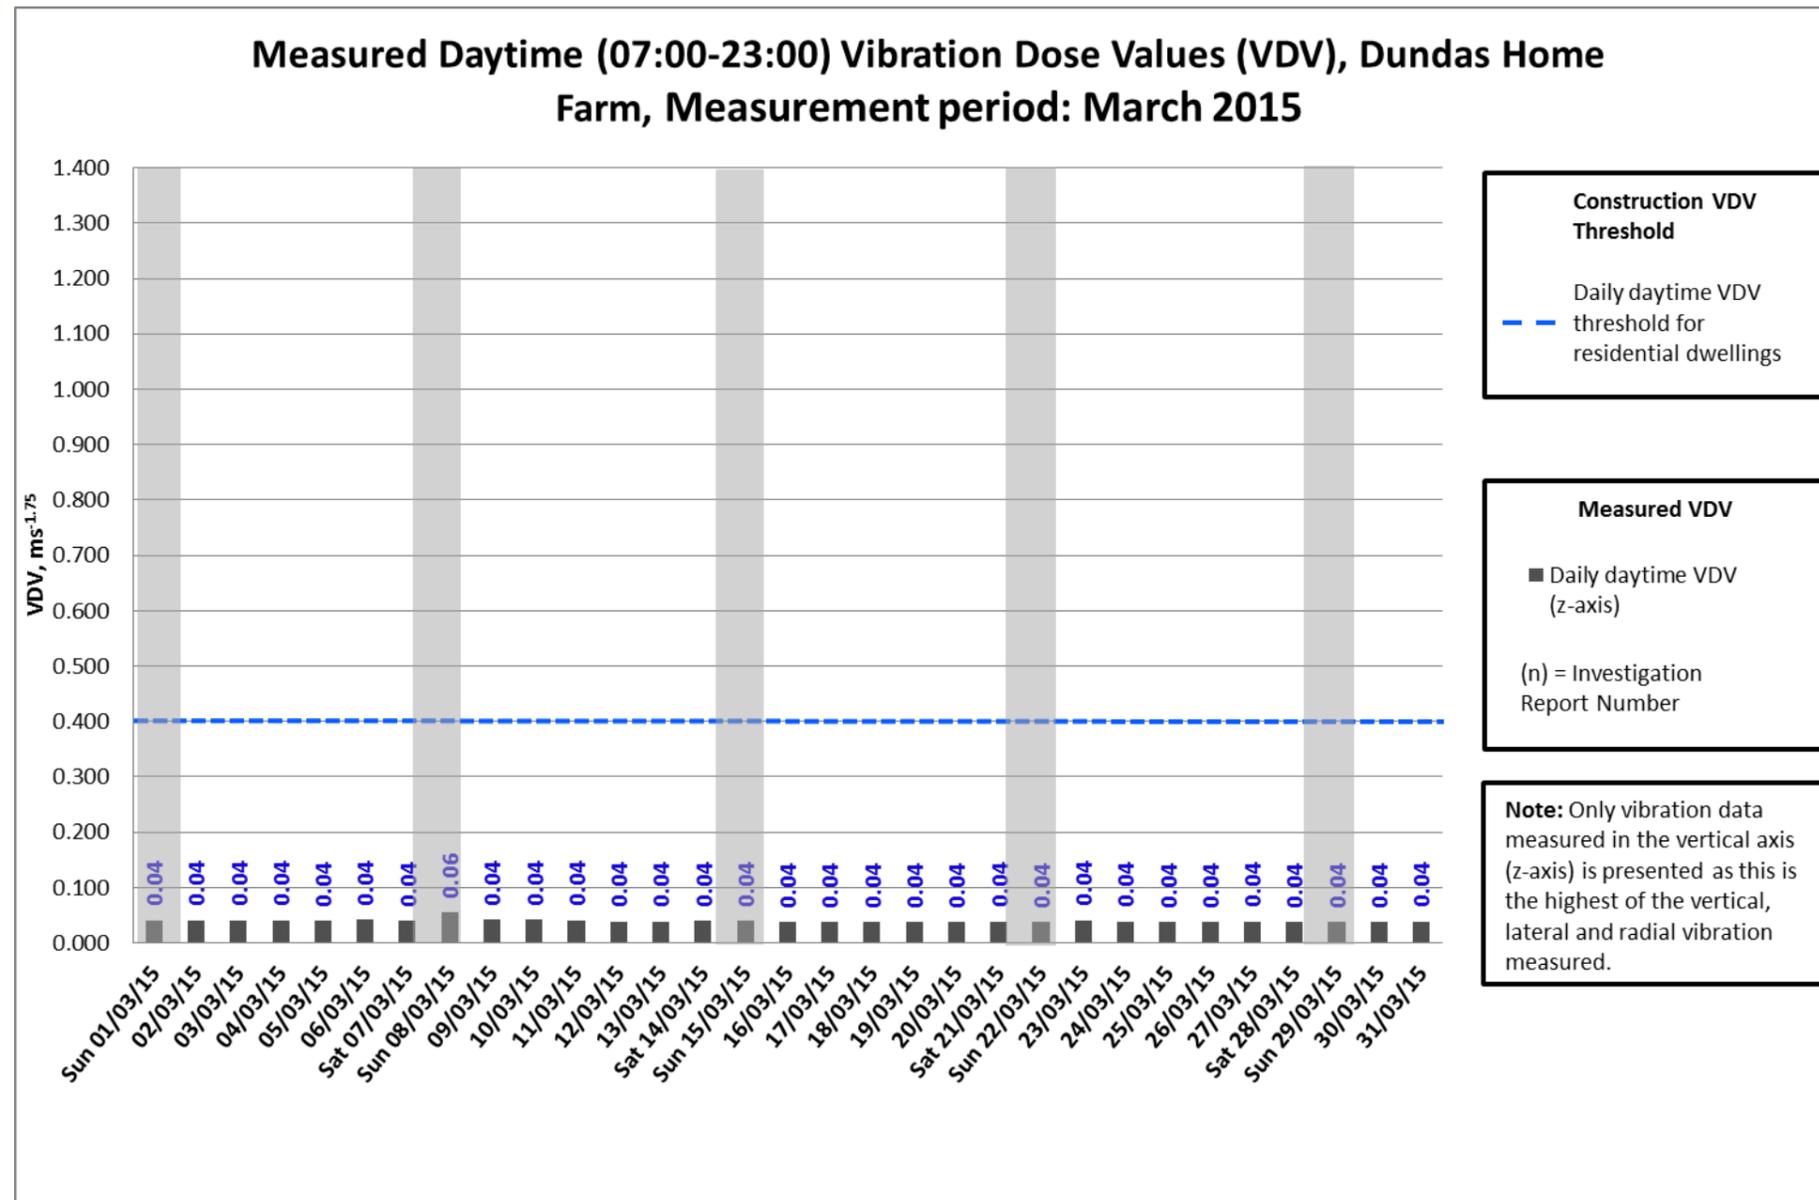
- The grey areas of the chart represent the days on which no construction works were undertaken; no works were conducted in the vicinity of the Dundas monitor on Sundays.

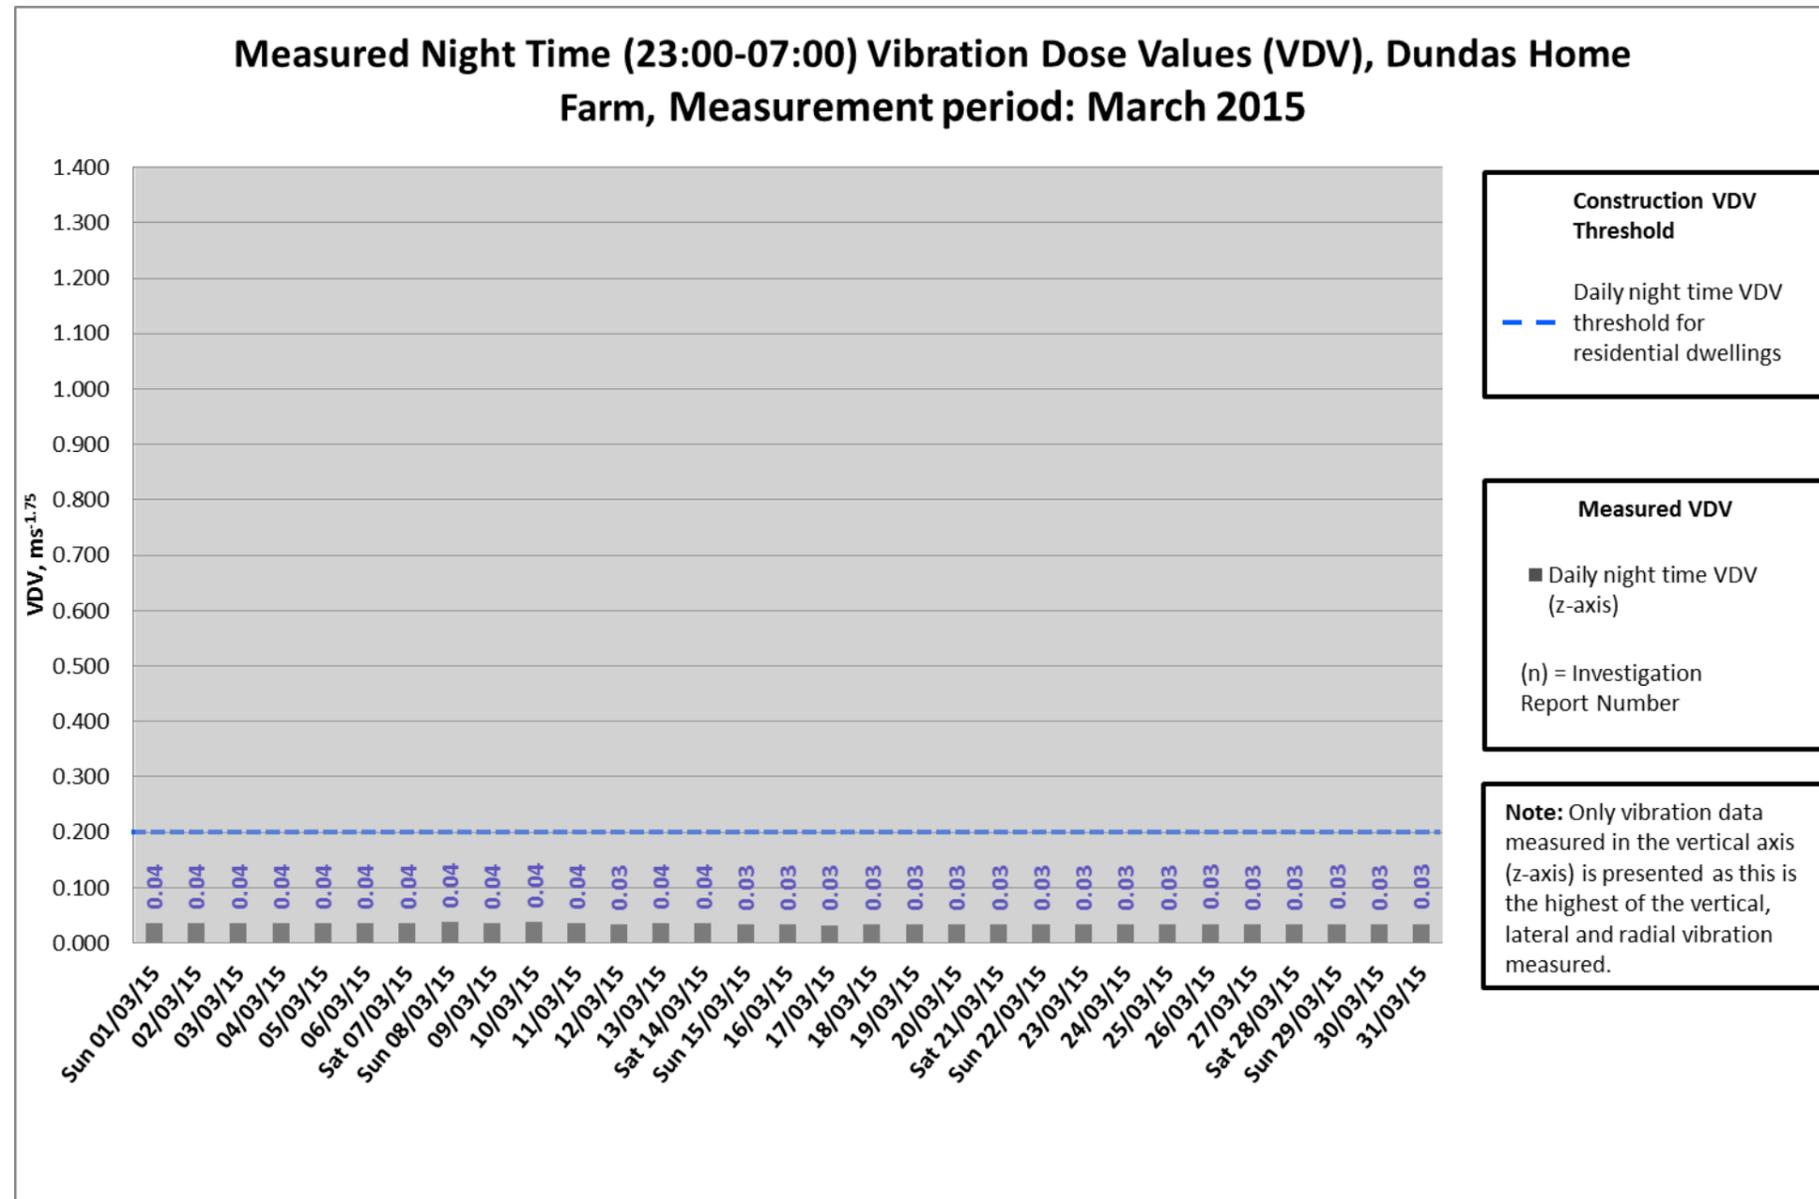
- The grey areas of the chart represent the days on which no construction works were undertaken; no night time works were conducted in the vicinity of the Dundas Home Farm vibration monitor throughout the month of March 2015. This graph is included for illustrative purposes only.
