Project **FORTH REPLACEMENT CROSSING**

VIBRATION MONITORING REPORT
MARCH 2015

Made by Stuart Swainson	Checked By: Liam Soden
Initials: SSN	Initials: LSN
Document number	Rev
REP-00228-01	01

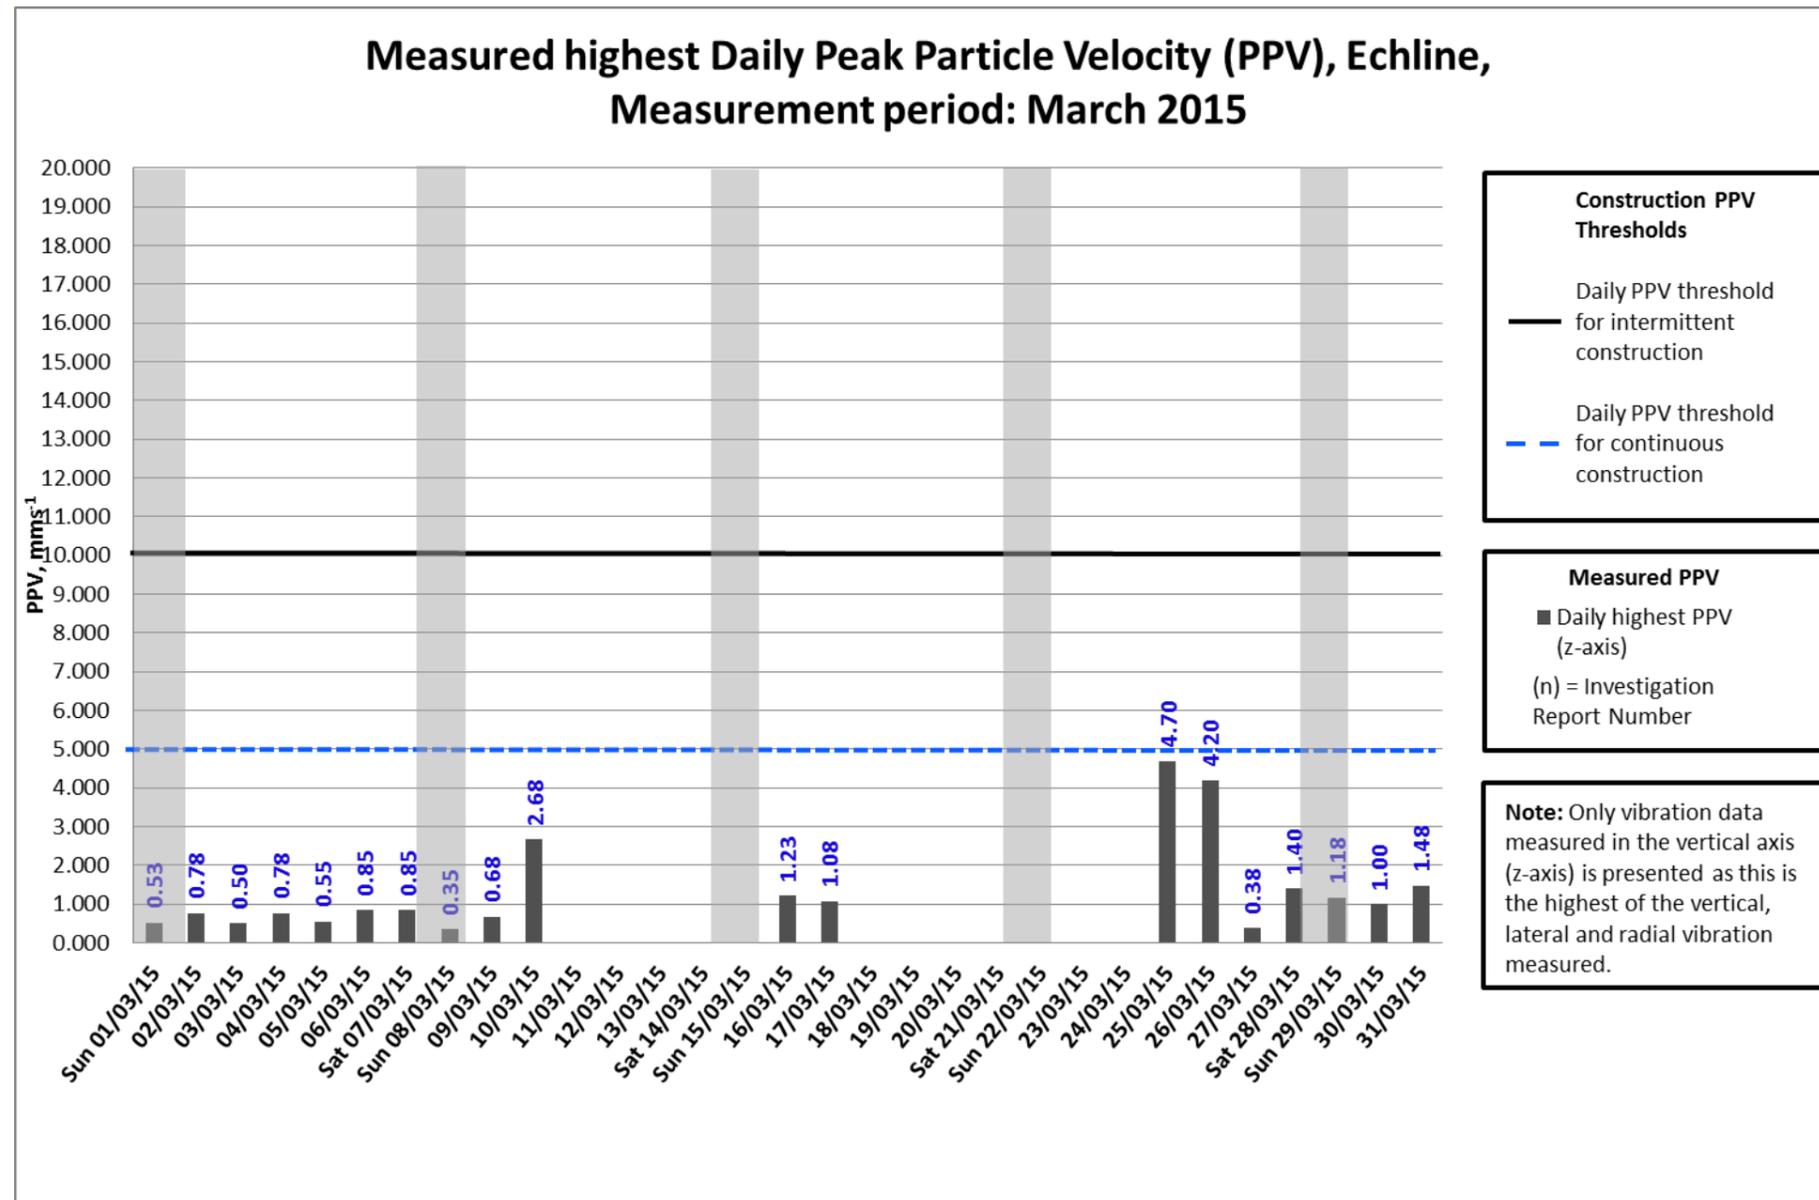
- The grey areas of the chart represent the days on which no construction works were undertaken; no works were conducted in the vicinity of the Echline monitor on Sundays.
- Data is missing from the period 11/03/15 – 15/03/15 and the period 18/03/15- 24/03/15 due to device error.

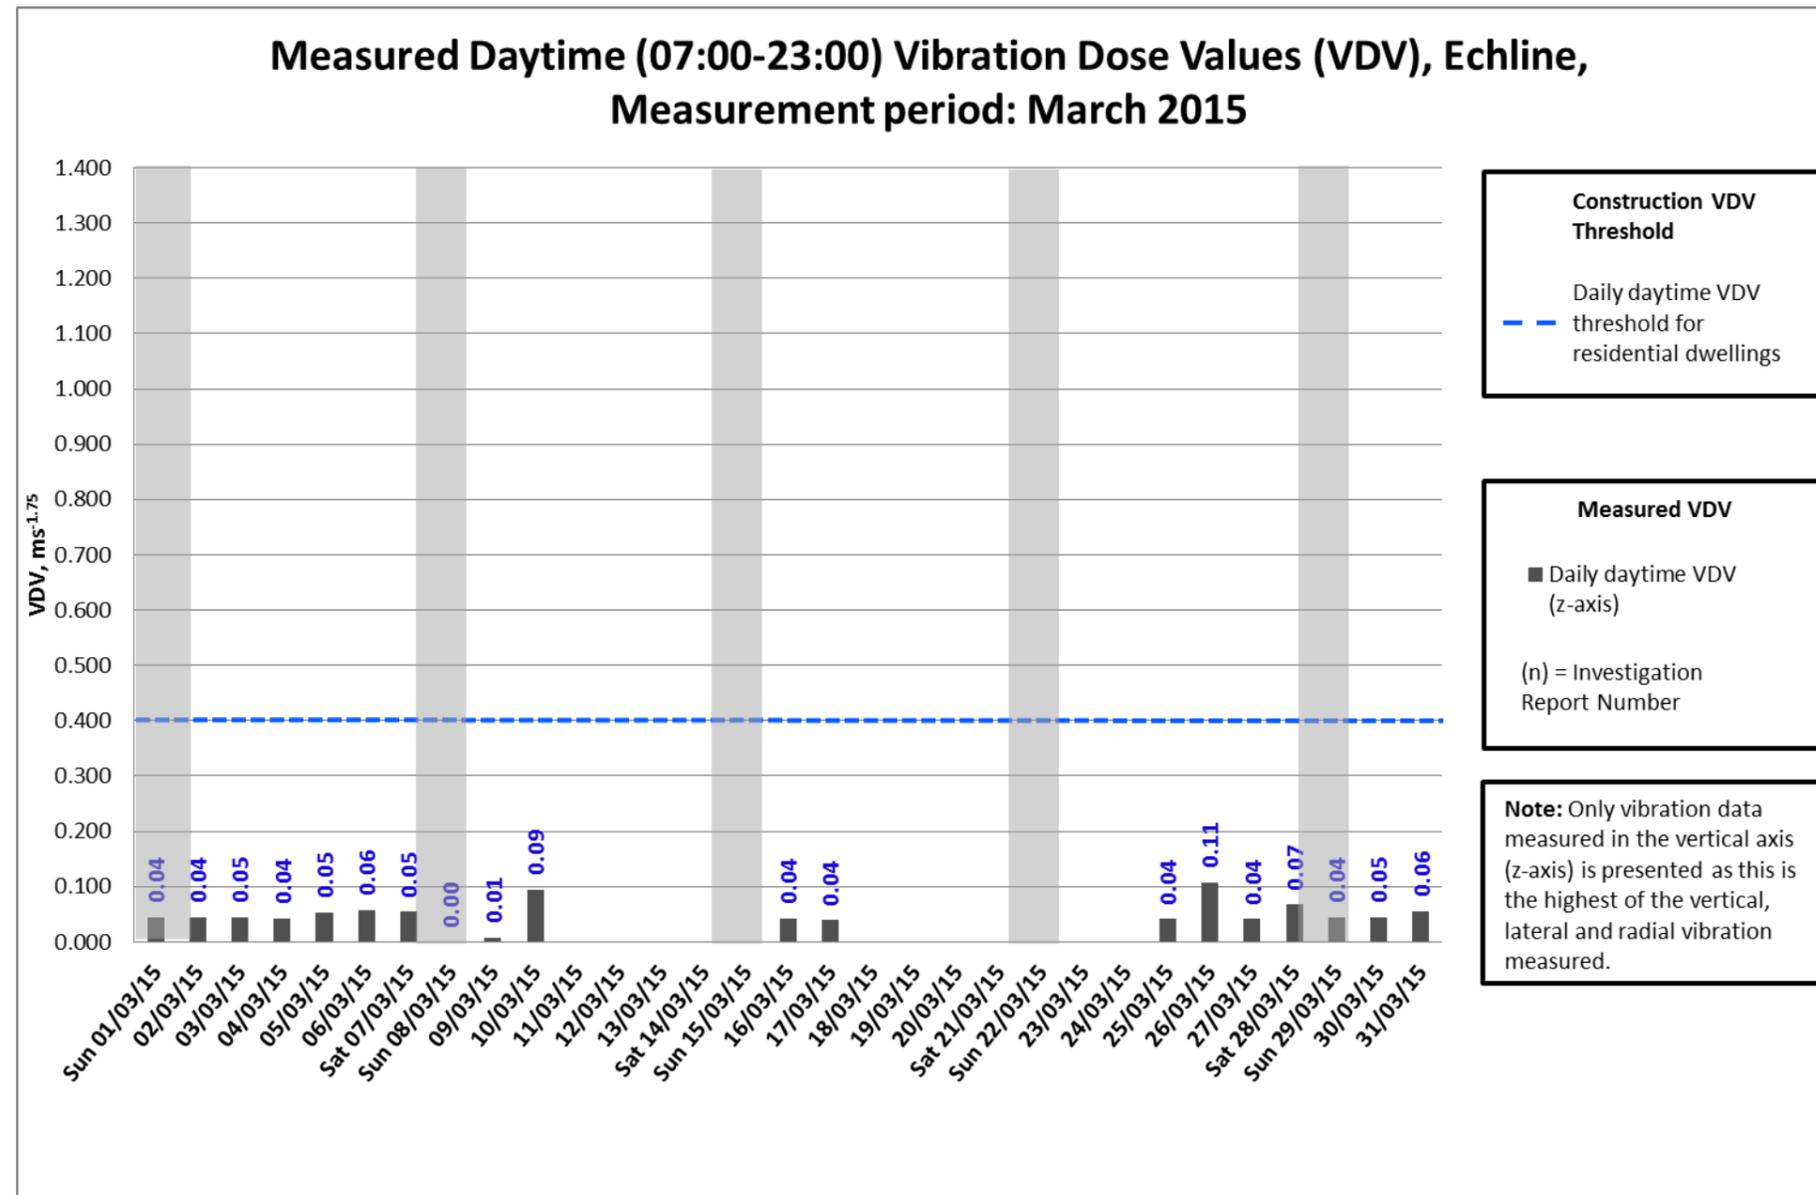
- The grey areas of the chart represent the days on which no construction works were undertaken; no works were conducted in the vicinity of the Echline monitor on Sundays.
- Data is missing from the period 11/03/15 – 15/03/15 and the period 18/03/15- 24/03/15 due to device error.

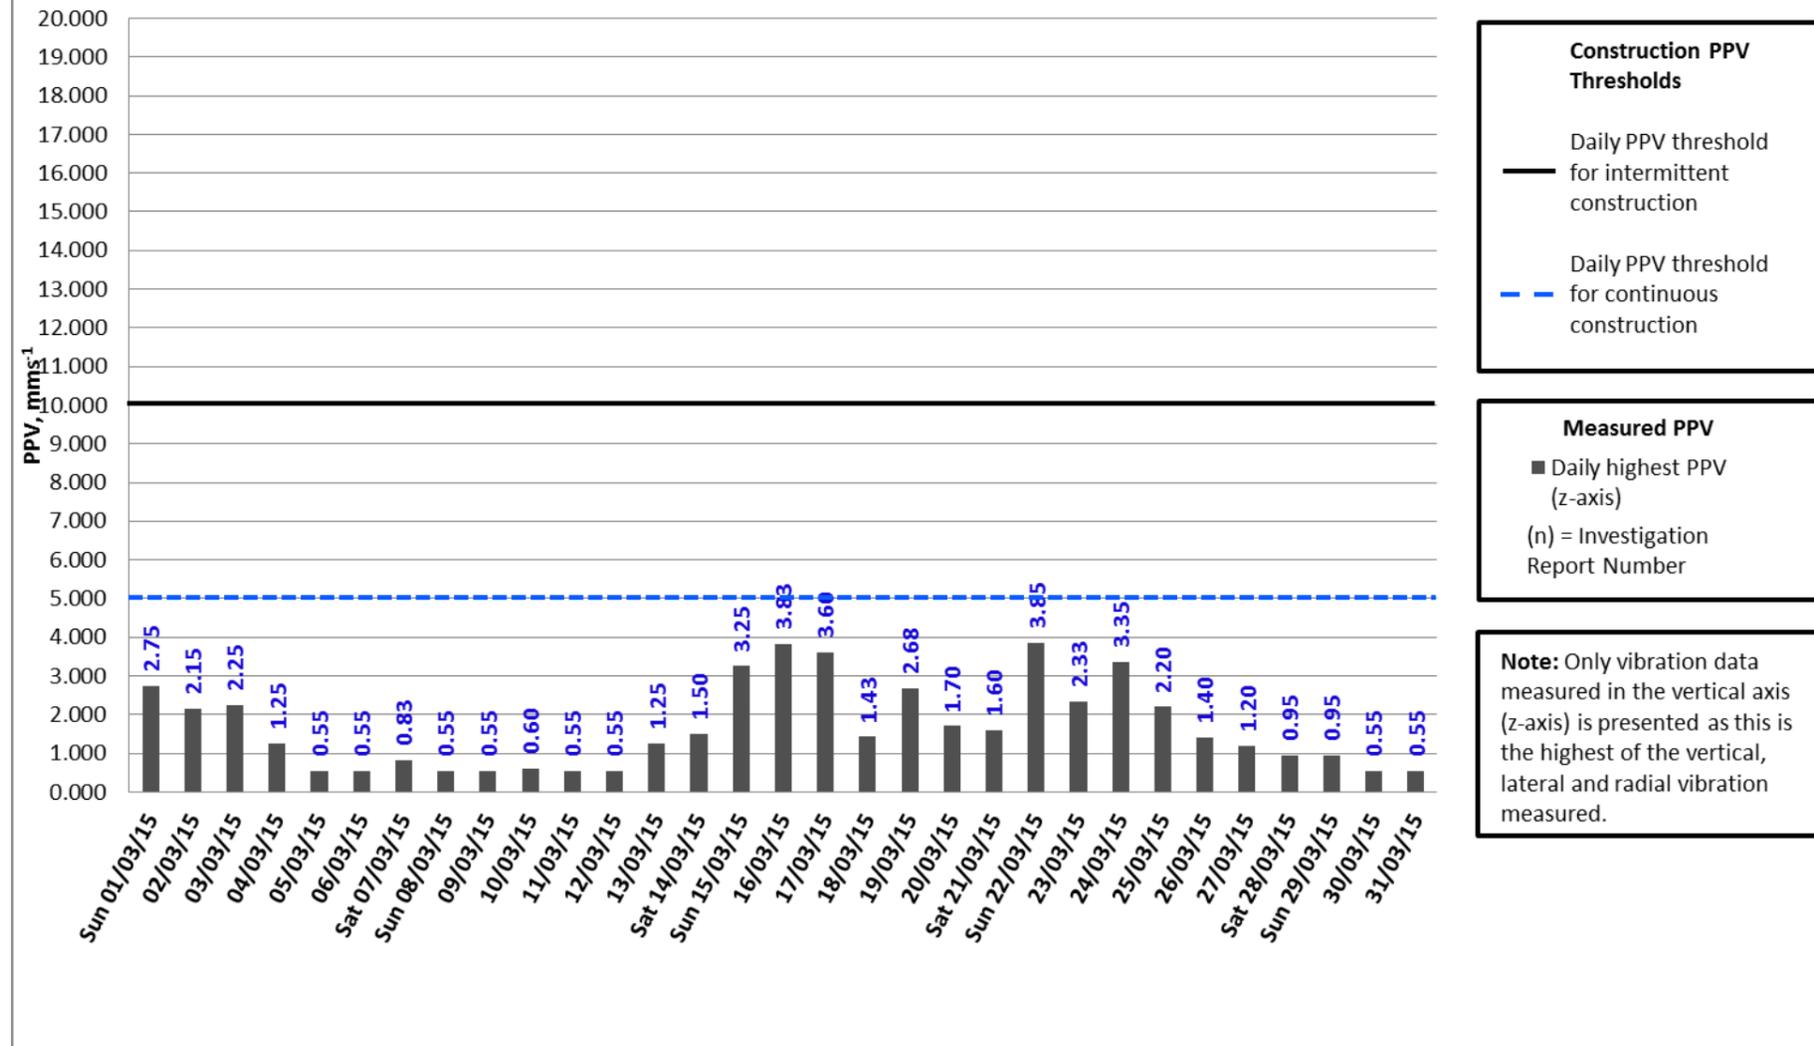
Measured highest Daily Peak Particle Velocity (PPV), Inchgarvie Lodge, Measurement period: March 2015

Note: Only vibration data measured in the vertical axis (z-axis) is presented as this is the highest of the vertical, lateral and radial vibration measured.

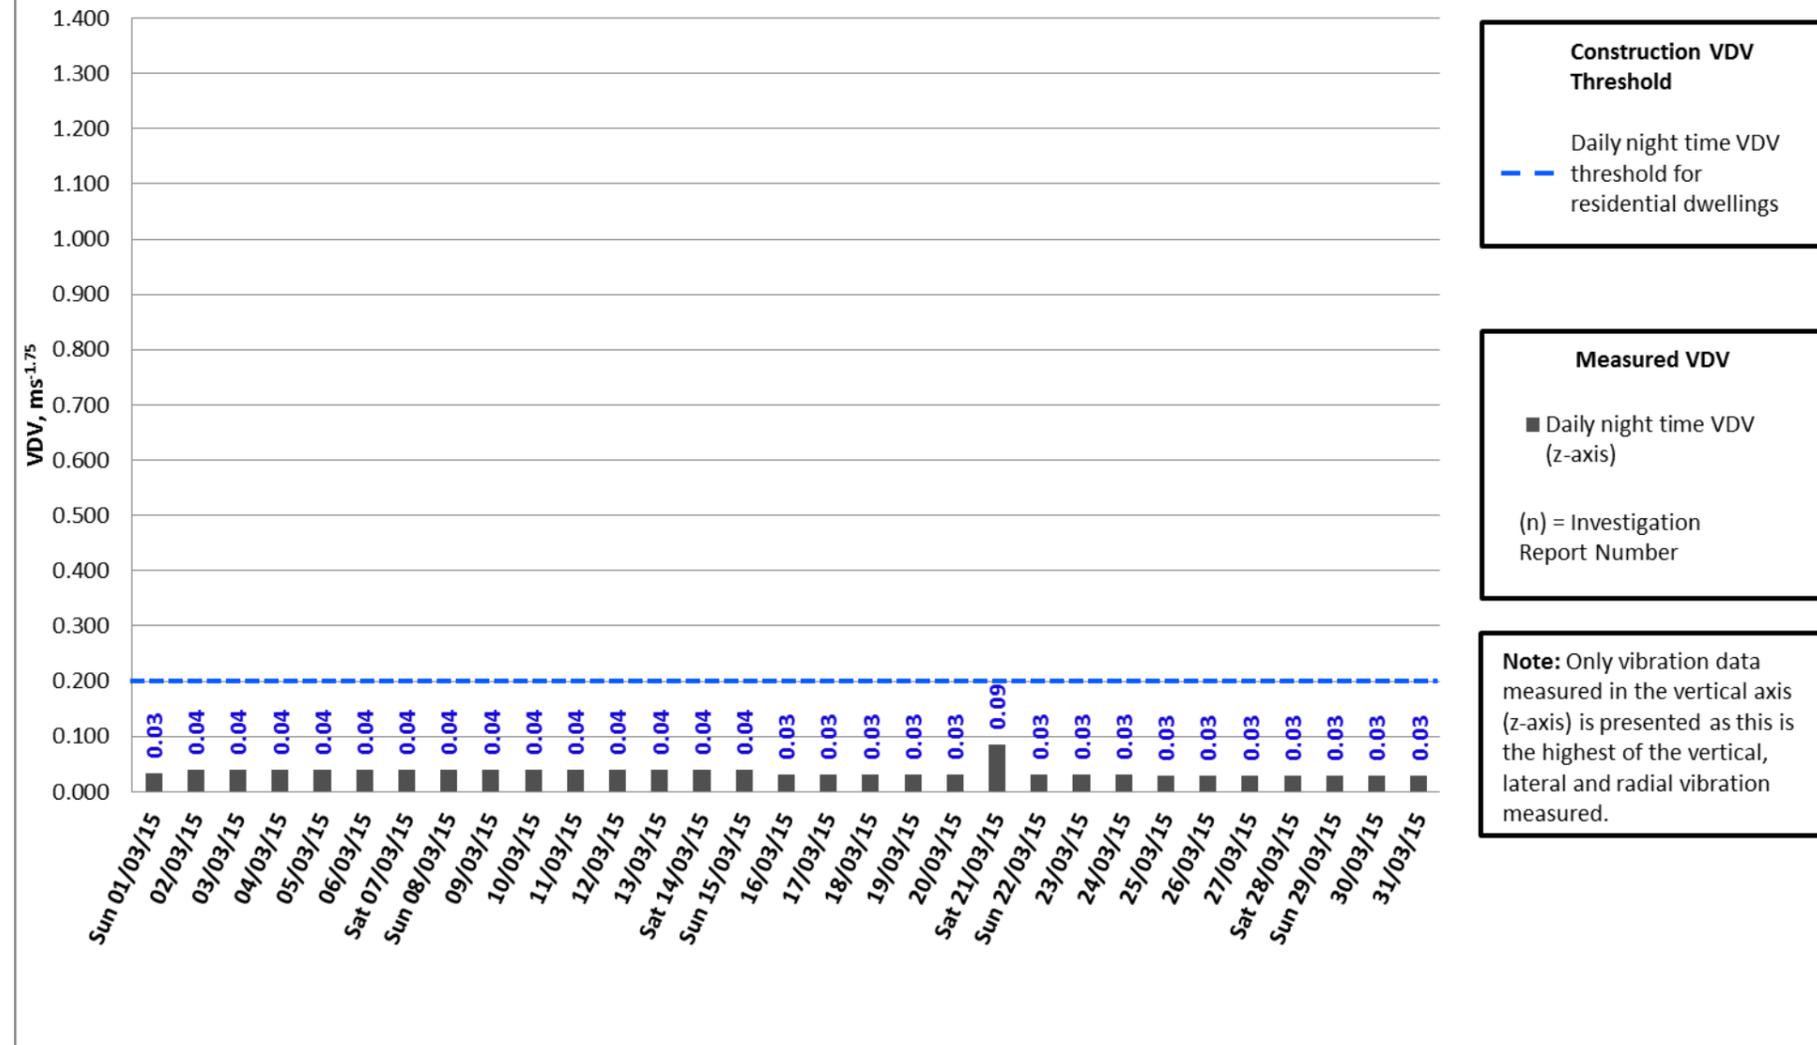
Measured Night Time (23:00-07:00) Vibration Dose Values (VDV), Inchgarvie Lodge, Measurement period: March 2015

Note: Only vibration data measured in the vertical axis (z-axis) is presented as this is the highest of the vertical, lateral and radial vibration measured.

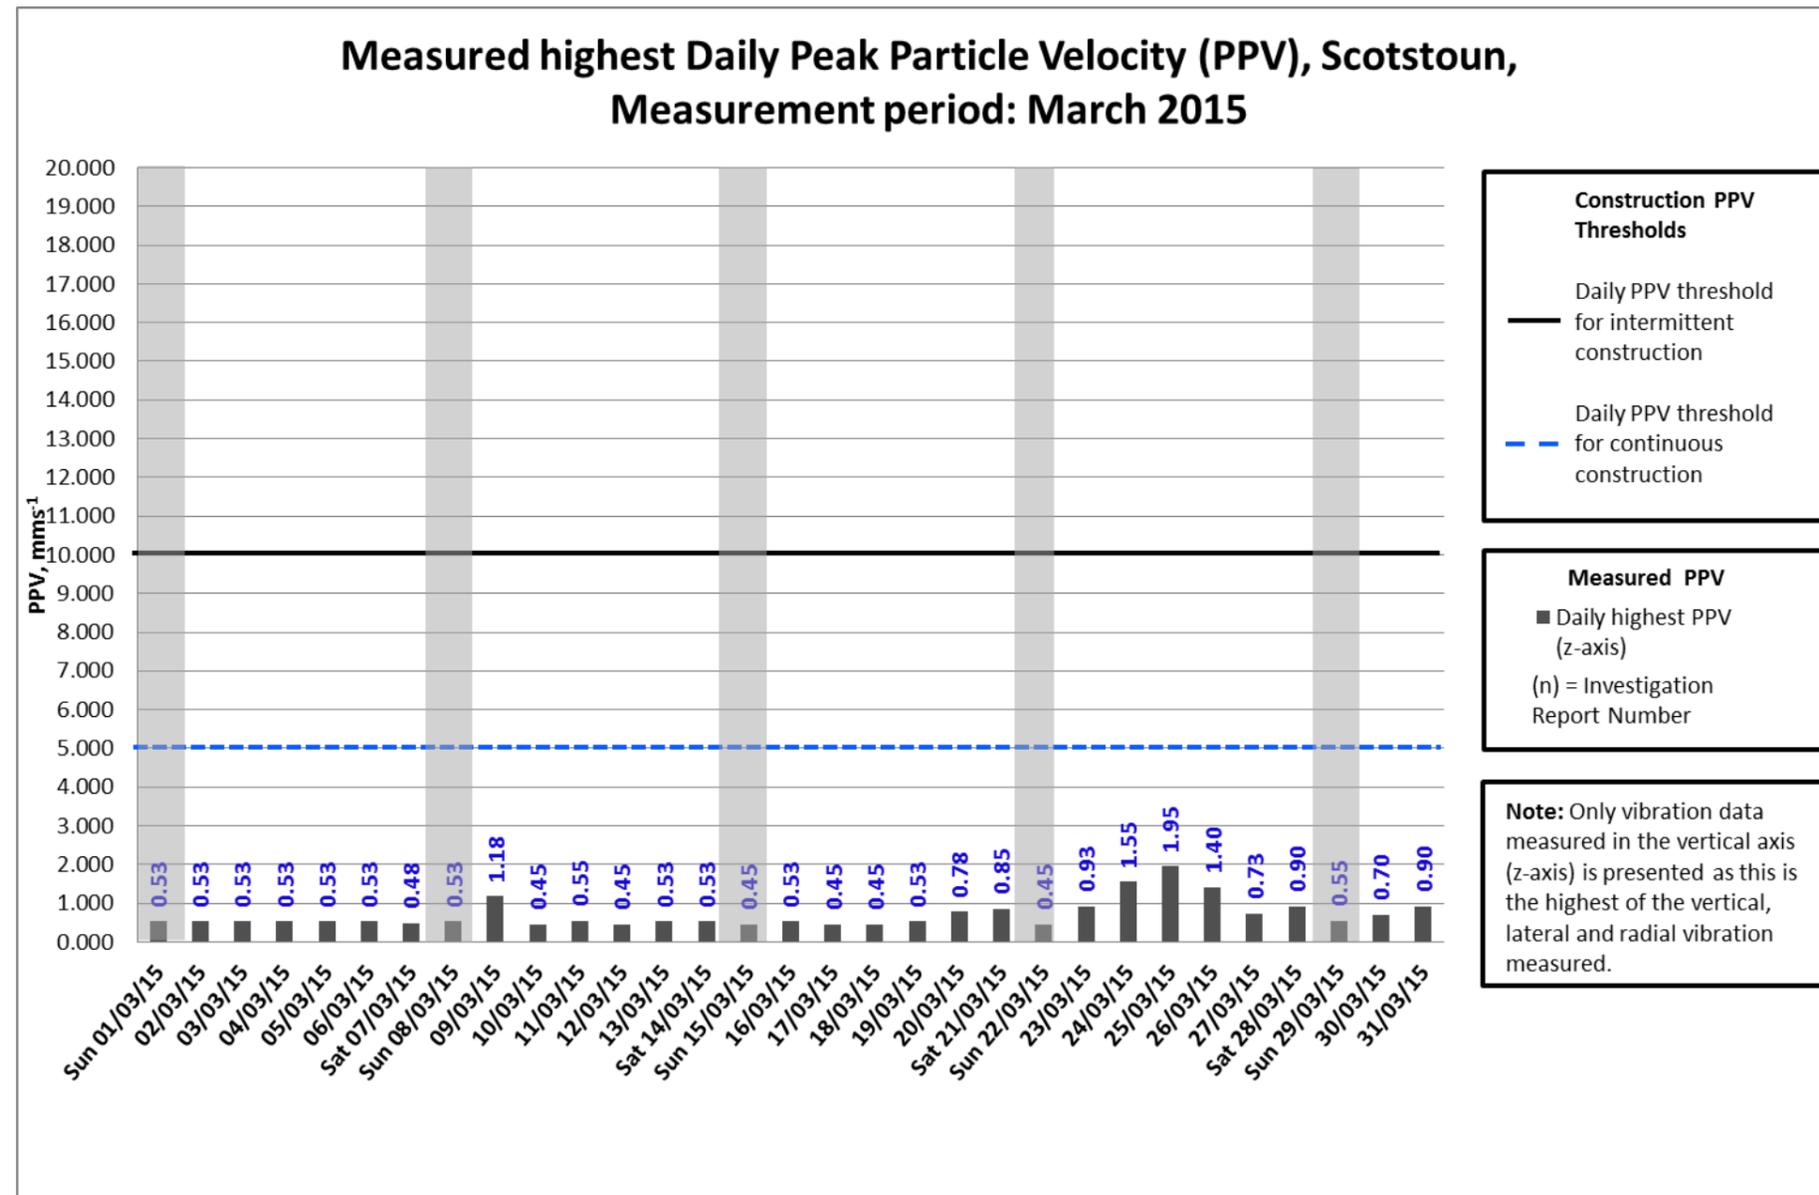
- The grey areas of the chart represent the days on which no construction works were undertaken; no works were conducted in the vicinity of the Scotstoun monitor on Sundays.

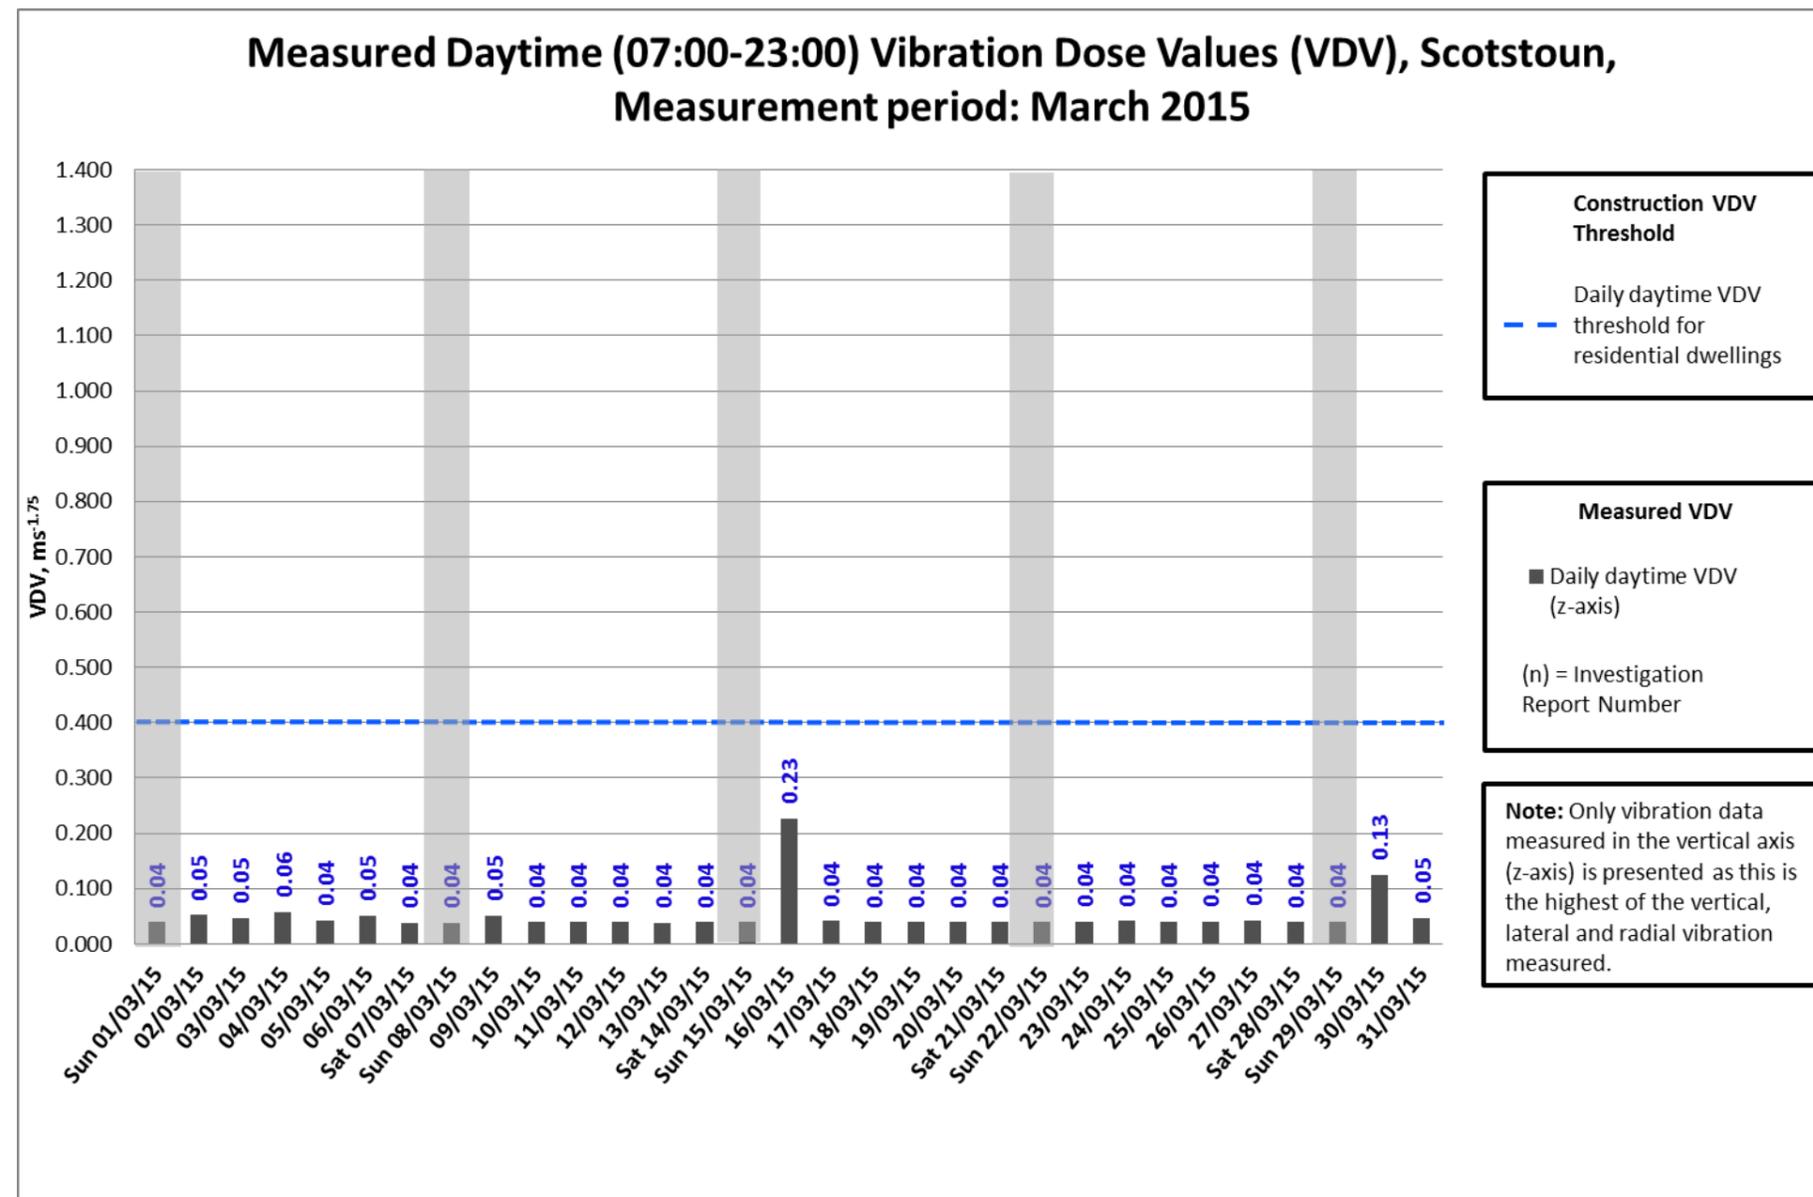
- The grey areas of the chart represent the days on which no construction works were undertaken; no works were conducted in the vicinity of the Scotstoun monitor on Sundays.

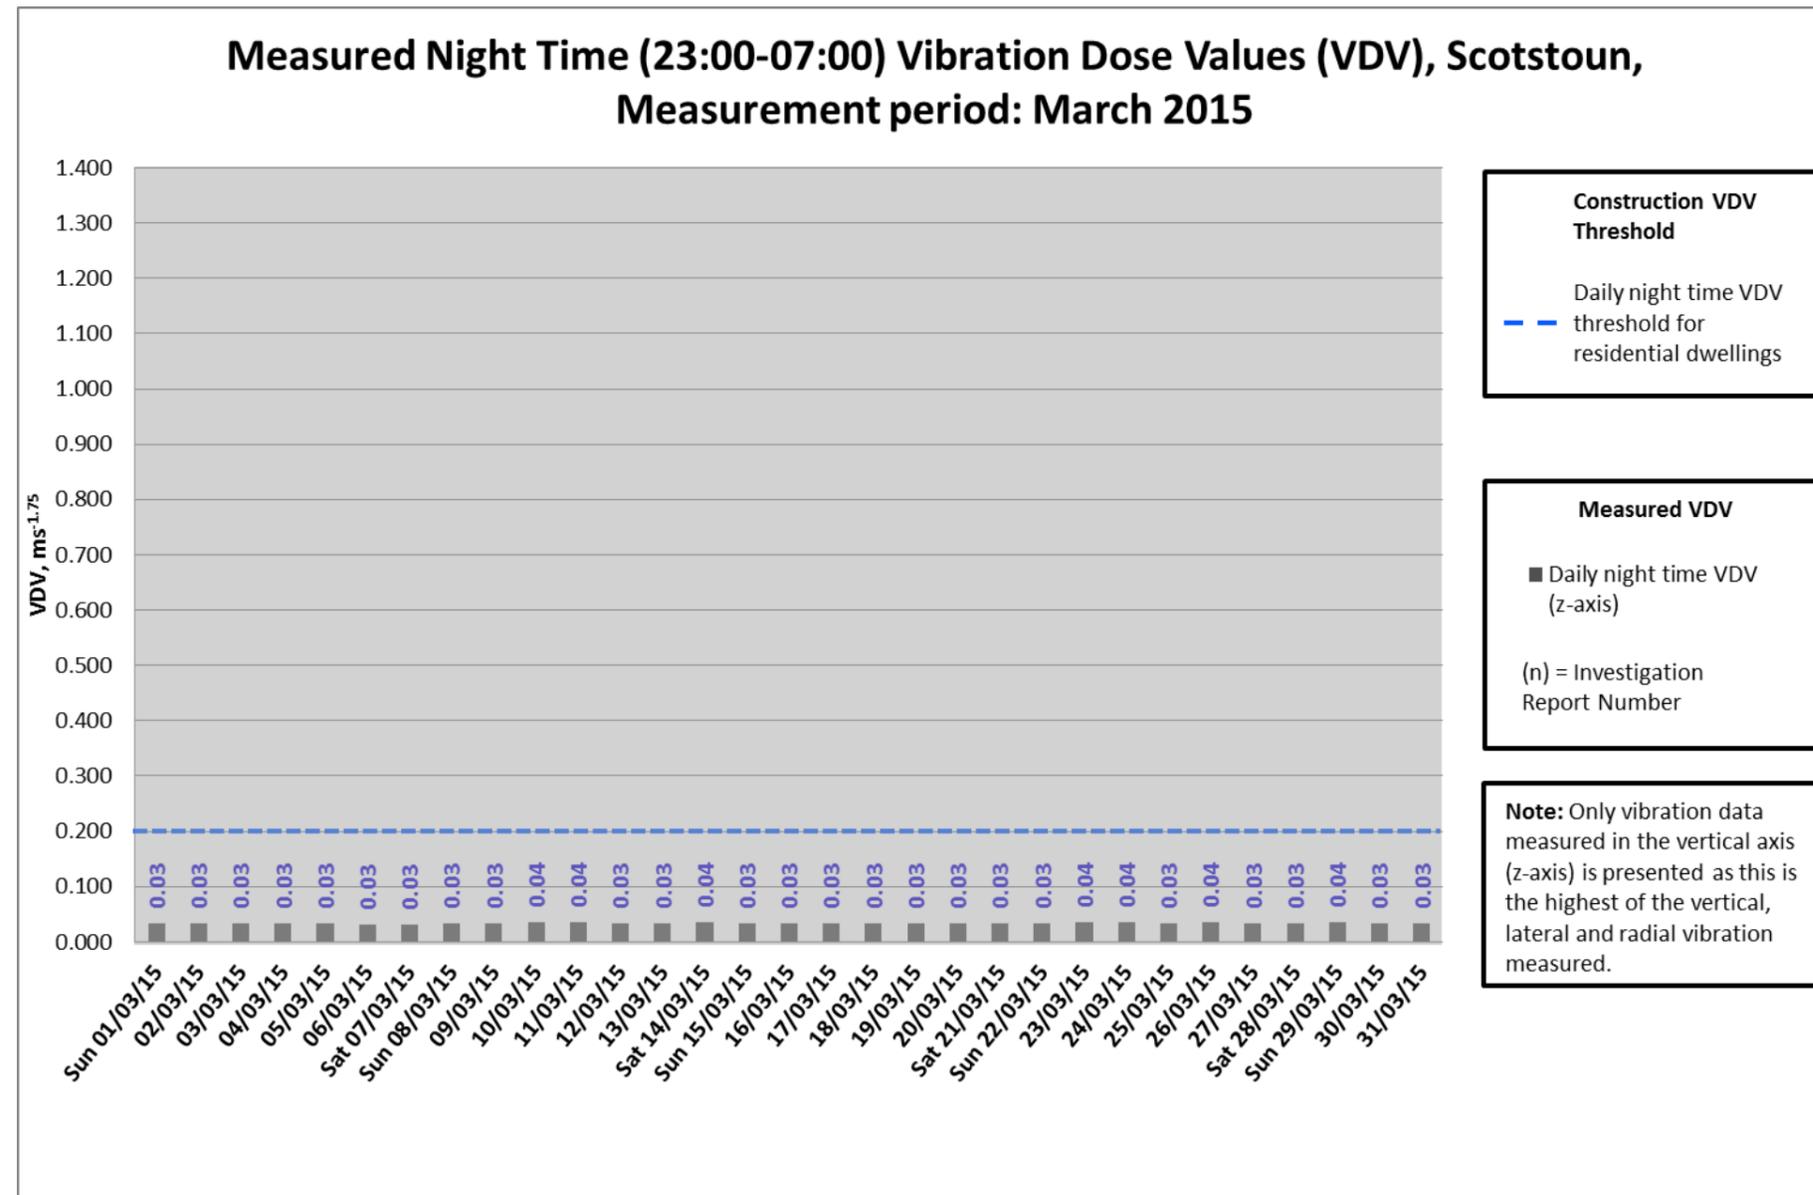
- The grey areas of the chart represent the days on which no construction works were undertaken; no night time works were conducted in the vicinity of the Scotstoun vibration monitor throughout the month of March 2015. This graph is included for illustrative purposes only.

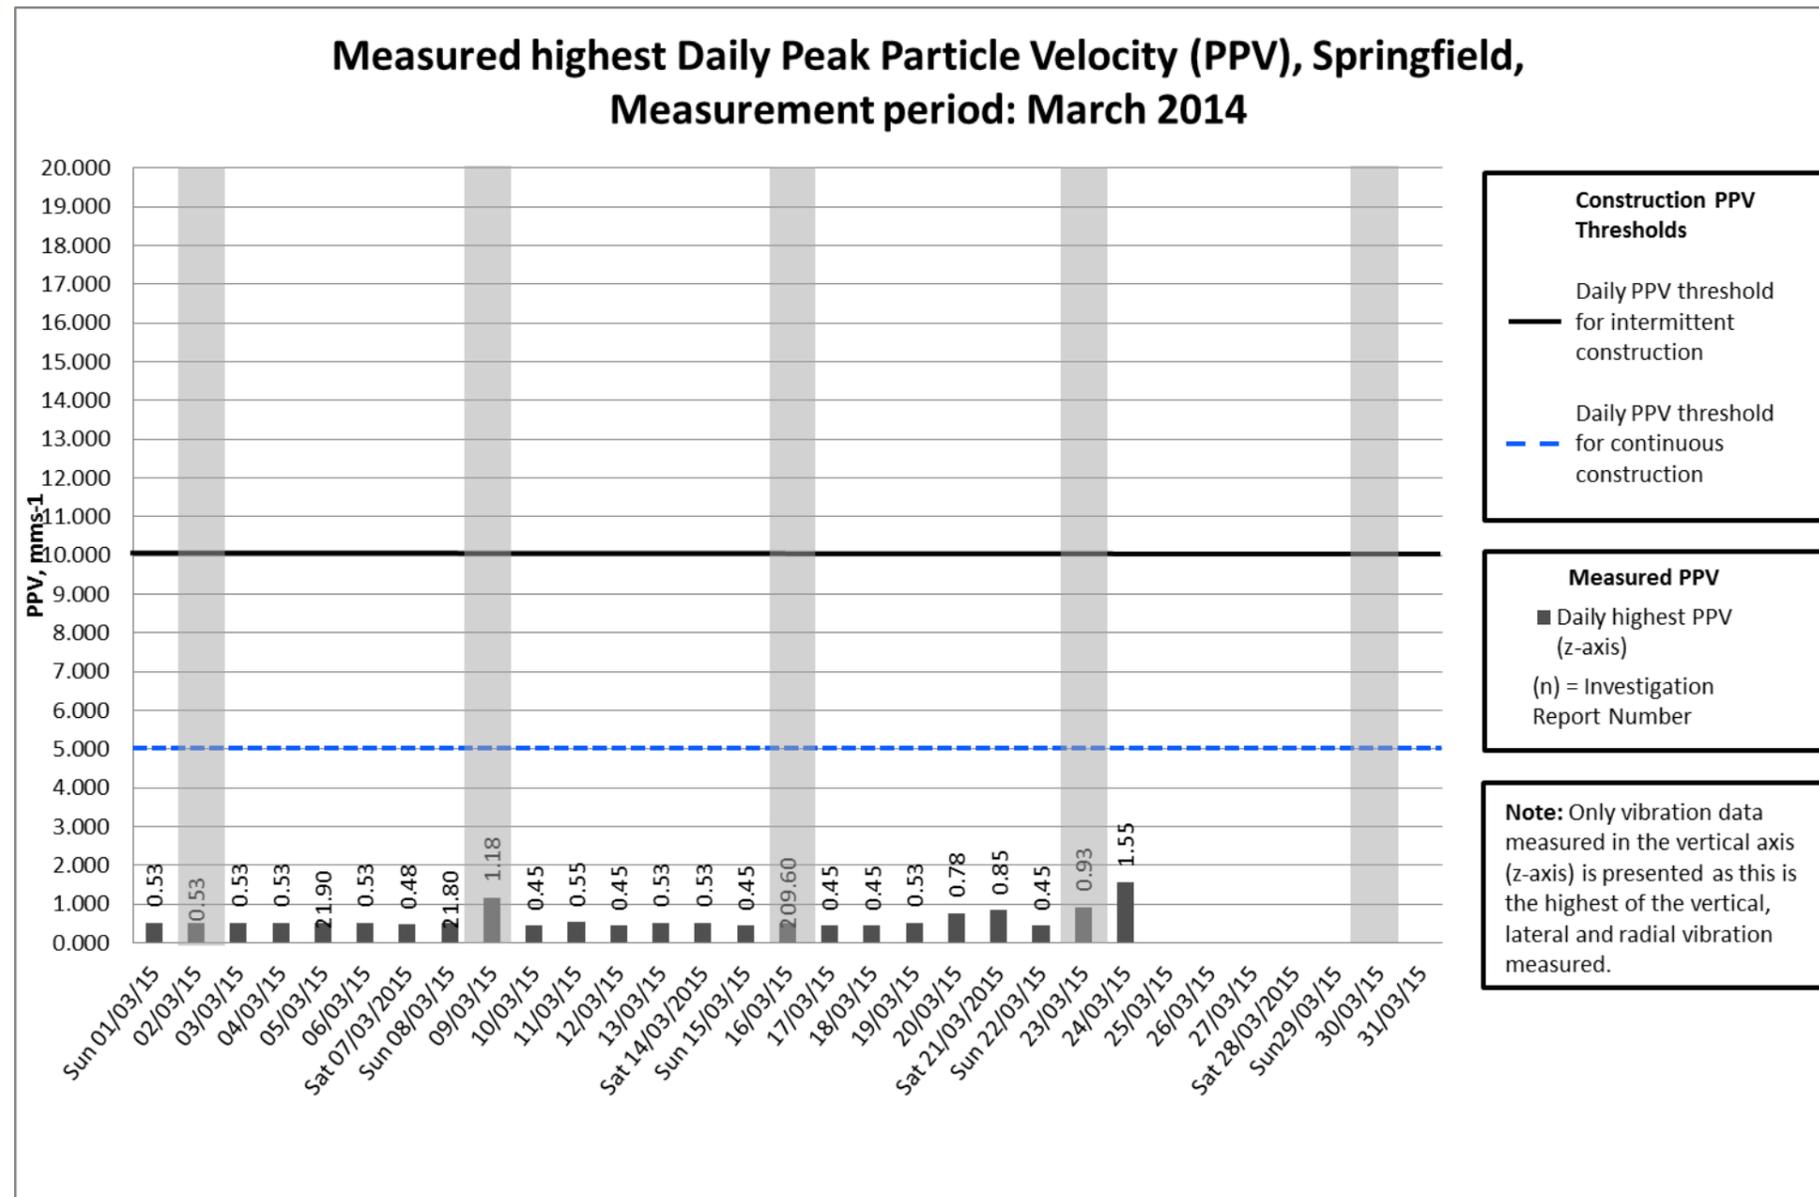
- The grey areas of the chart represent the days on which no construction works were undertaken; no works were conducted in the vicinity of the Springfield monitor on Sundays.
- The Data is missing from the period 25/03/15 – 31/03/15 was due to device error.

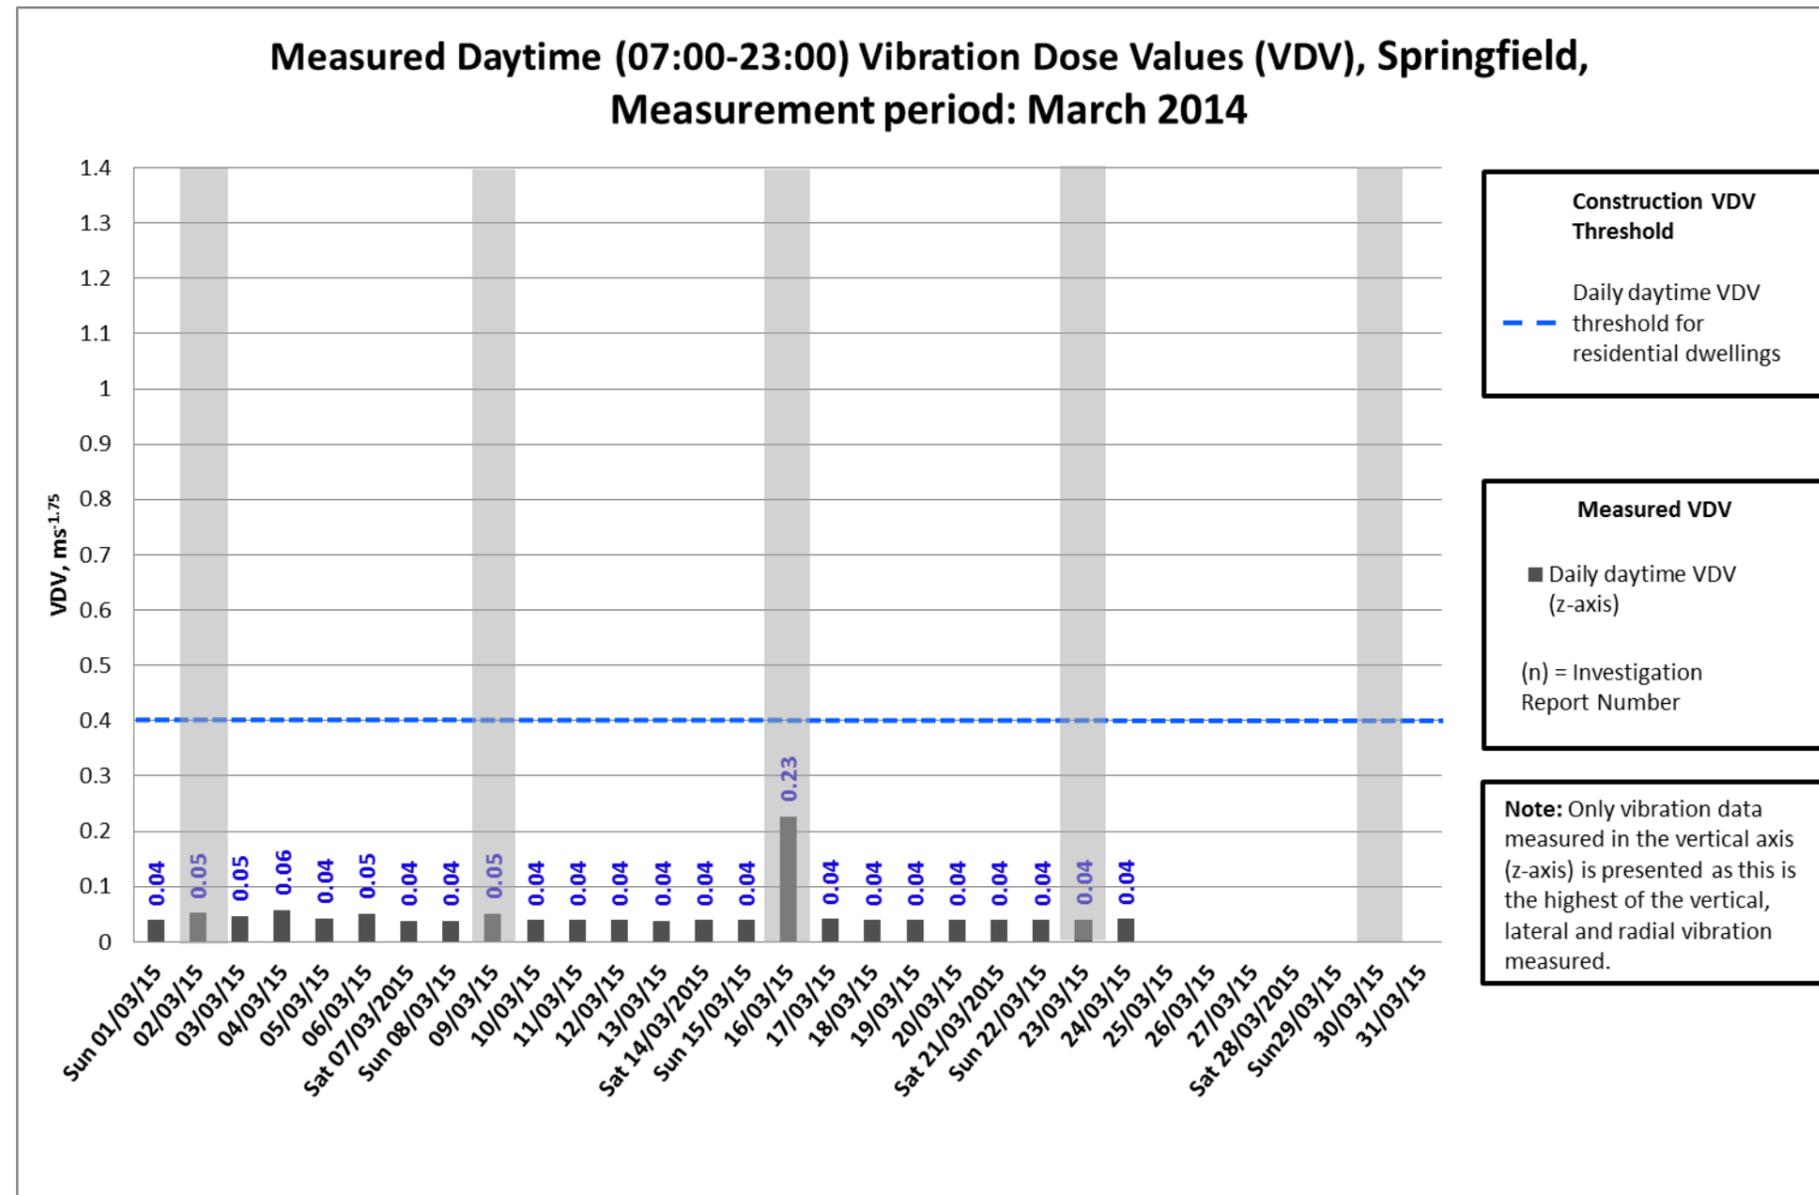
- The grey areas of the chart represent the days on which no construction works were undertaken; no works were conducted in the vicinity of the Springfield monitor on Sundays.
- The Data is missing from the period 25/03/15 – 31/03/15 was due to device error.

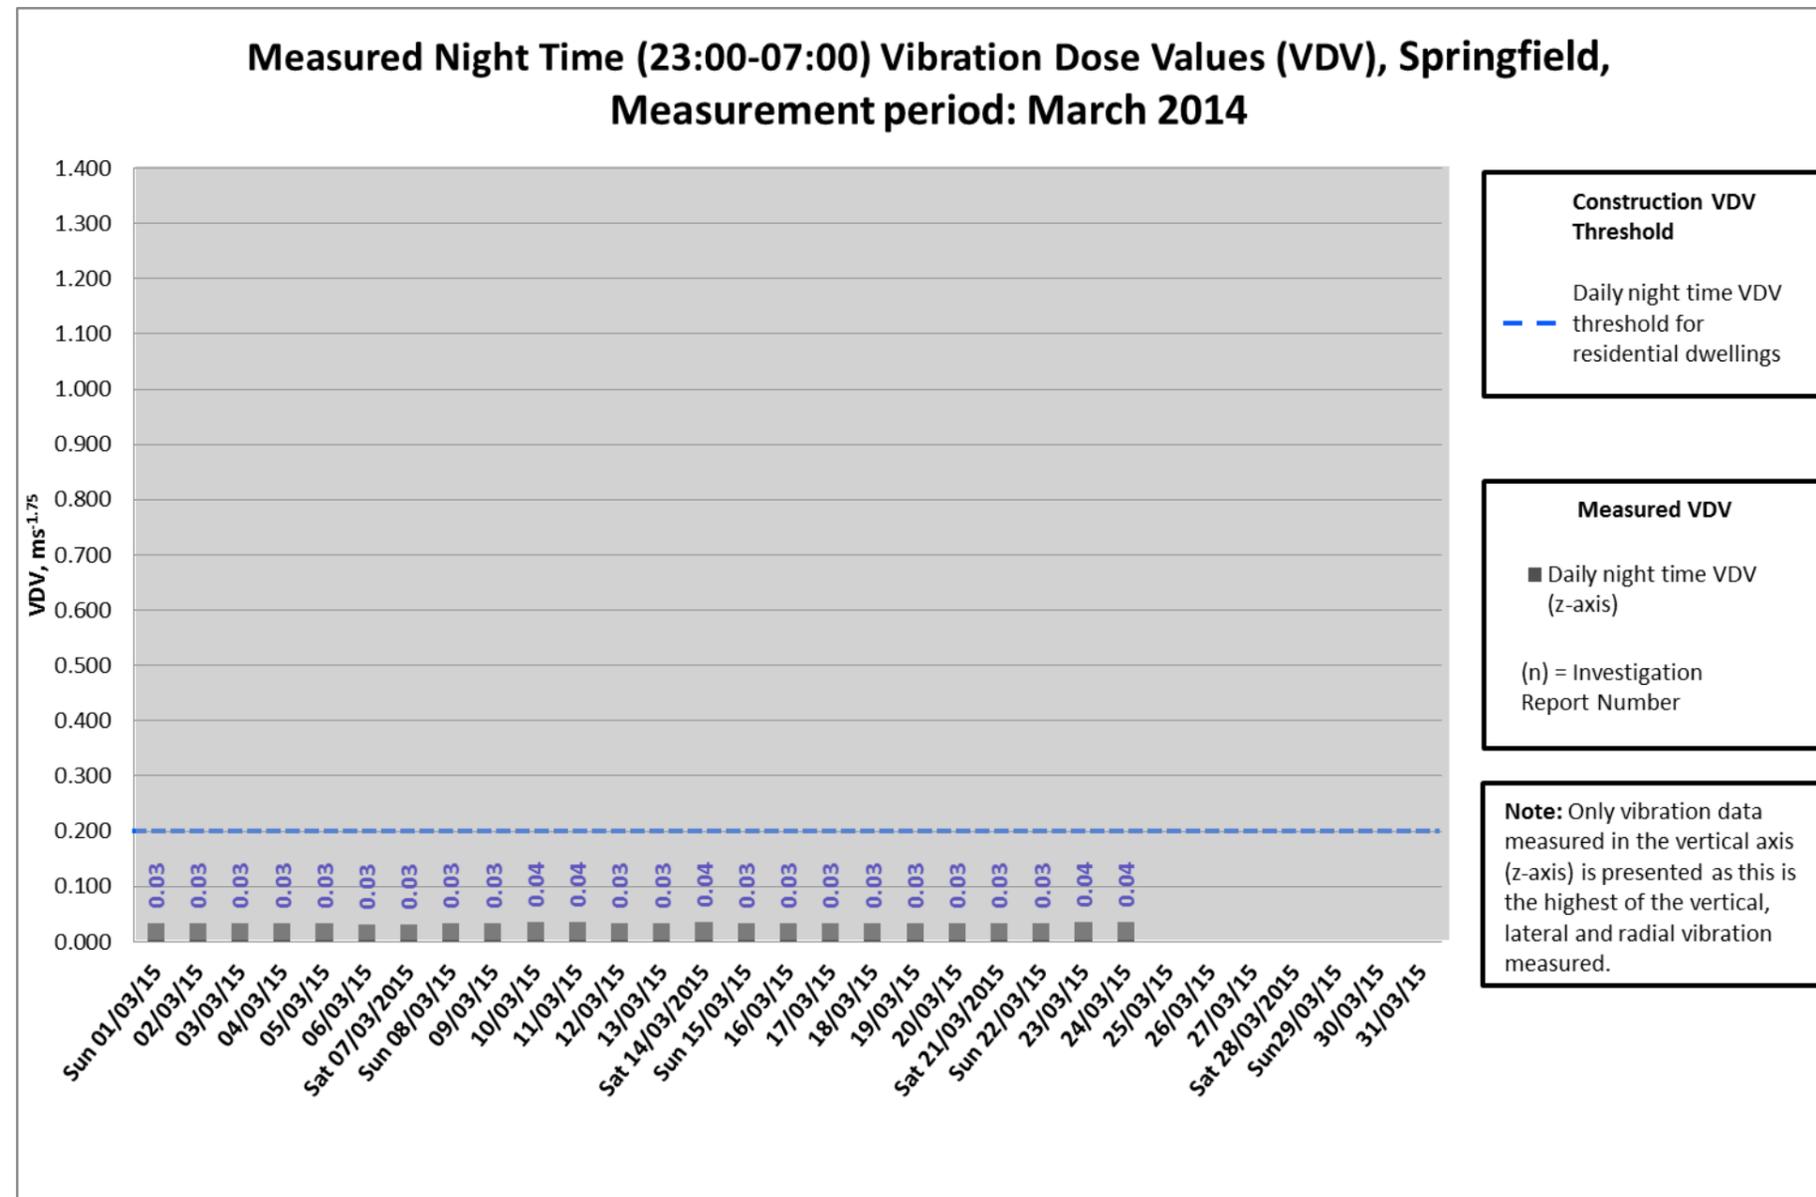
- Notes:**
- The grey areas of the chart represent the days on which no construction works were undertaken; no night time works were conducted in the vicinity of the Springfield vibration monitor throughout the month of March 2015. This graph is included for illustrative purposes only.
 - The Data is missing from the period 25/03/15 – 31/03/15 was due to device error.
