Project **FORTH REPLACEMENT CROSSING**

VIBRATION MONITORING REPORT
MARCH 2015

Made by Stuart Swainson	Checked By: Liam Soden
Initials: SSN	Initials: LSN
Document number	Rev
REP-00228-01	01

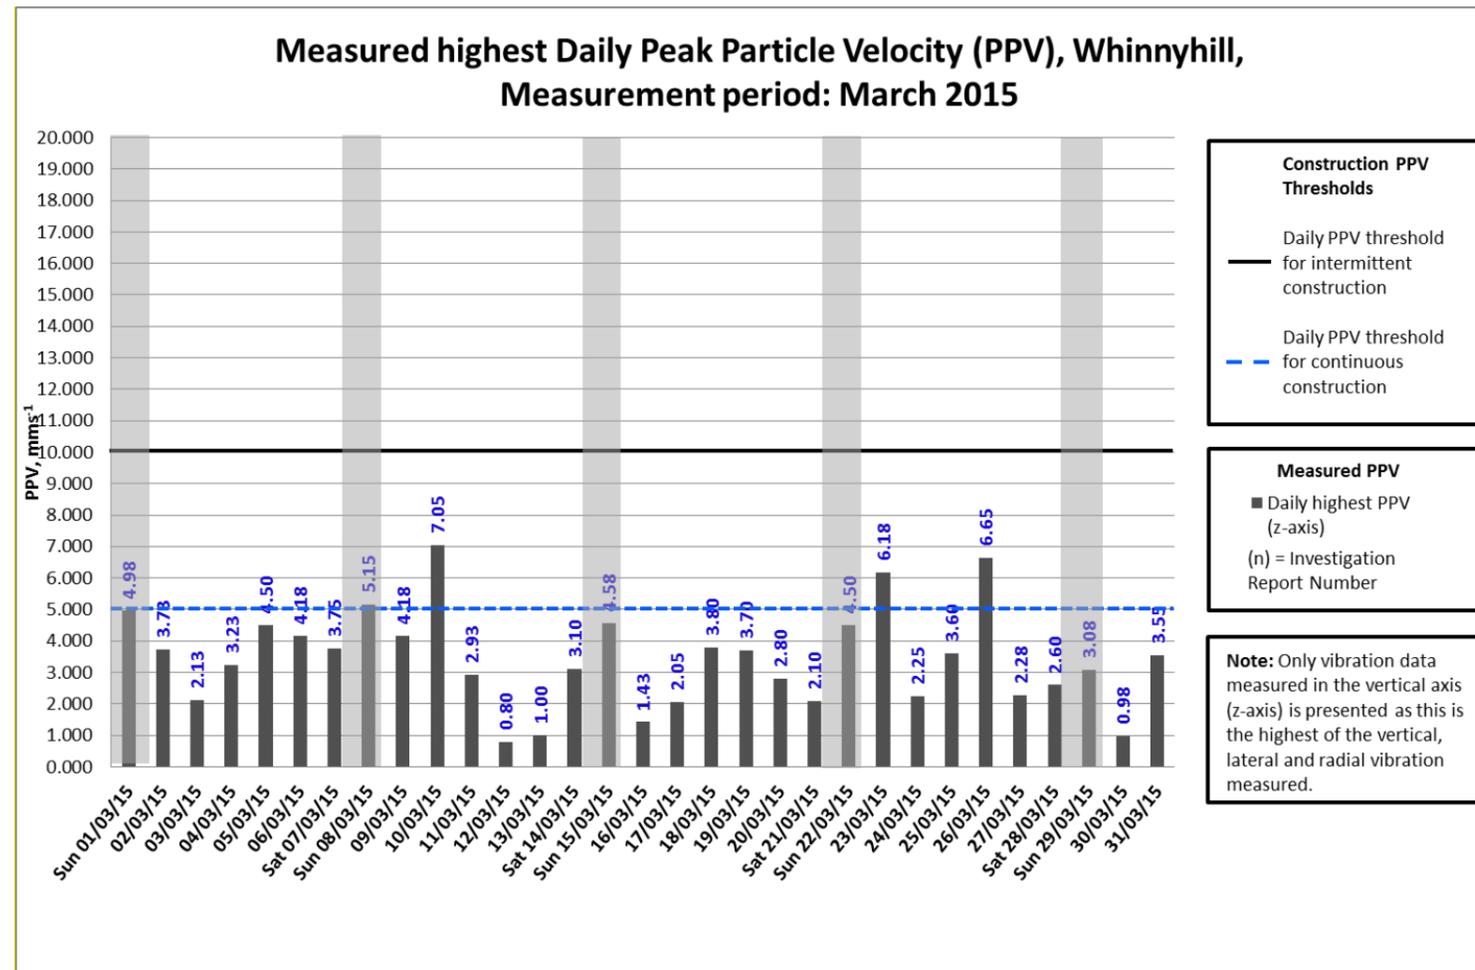
- The PPV values recorded on 05/02/15, 23/03/15 and 26/03/15 have been investigated and were seen to be an individual, isolated event within the period (see Vibrock PPV graph below from 10/02/15) and coincides with maintenance of noise monitoring equipment stationed in the same area. These values are within the intermittent threshold of 10mm/s.

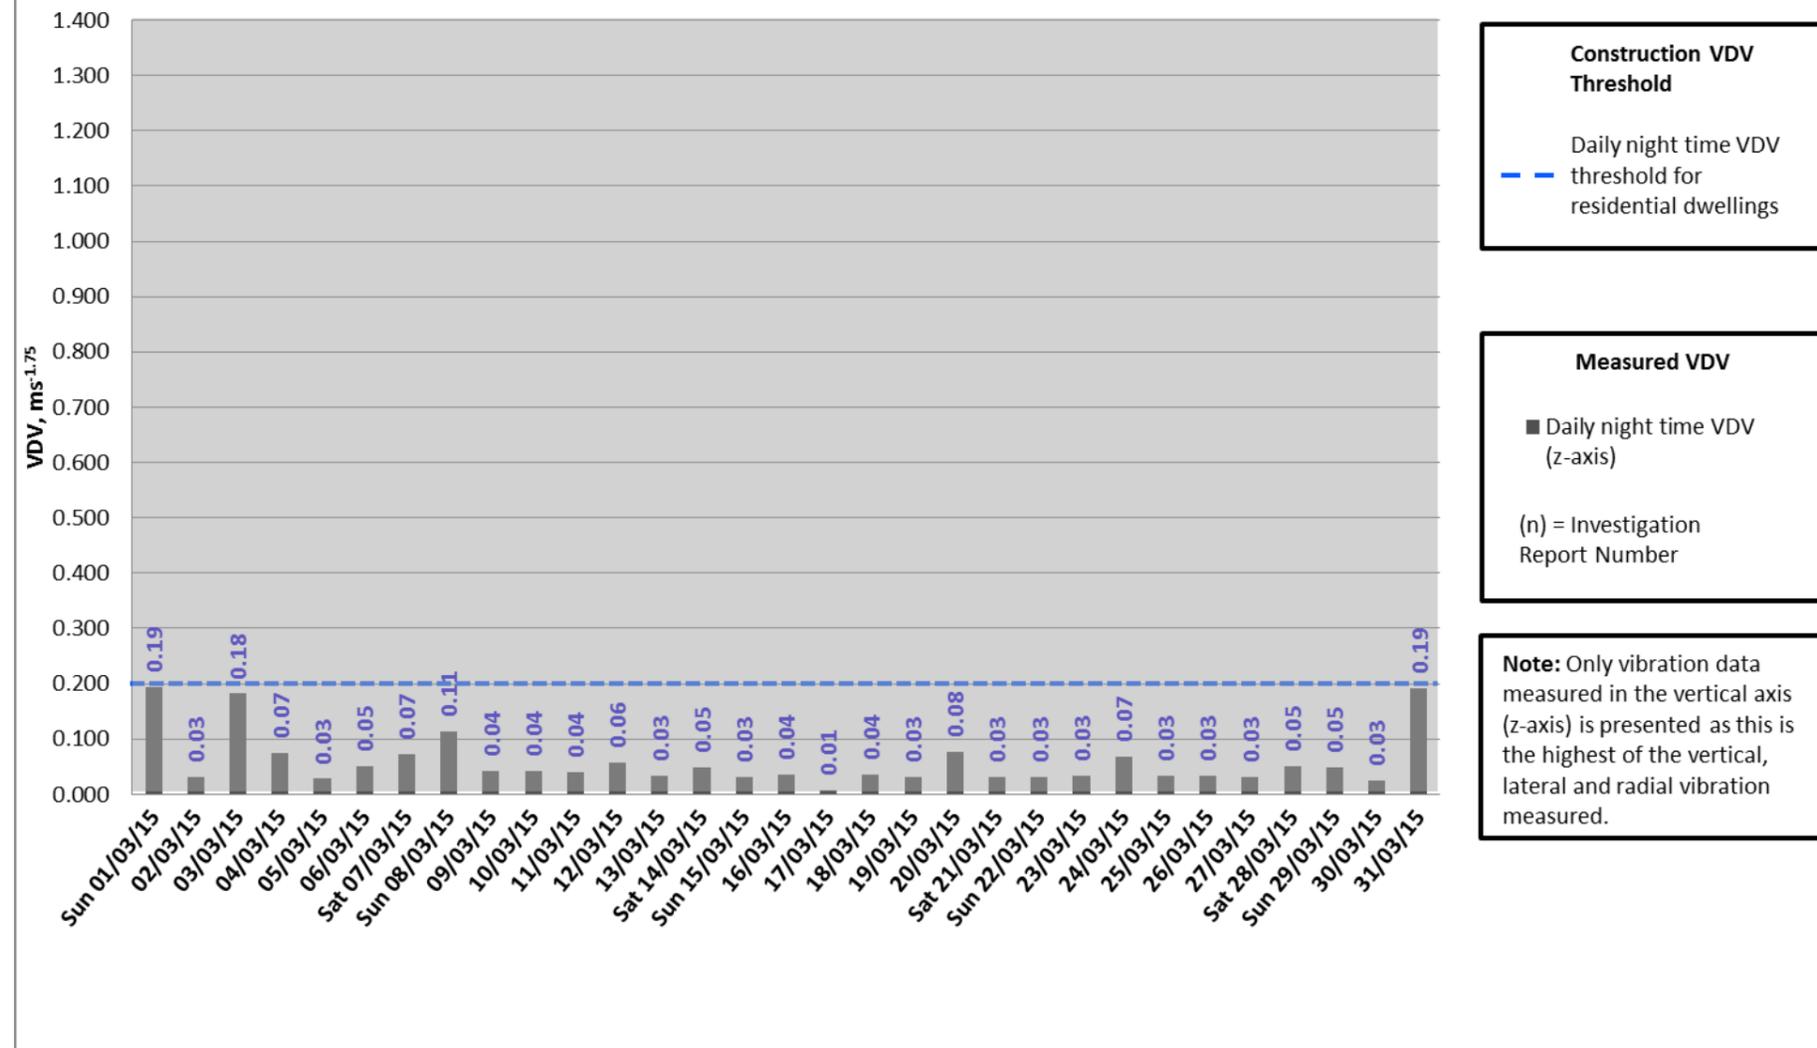
Measured Night Time (23:00-07:00) Vibration Dose Values (VDV), Whinnyhill, Measurement period: March 2015

Note: Only vibration data measured in the vertical axis (z-axis) is presented as this is the highest of the vertical, lateral and radial vibration measured.

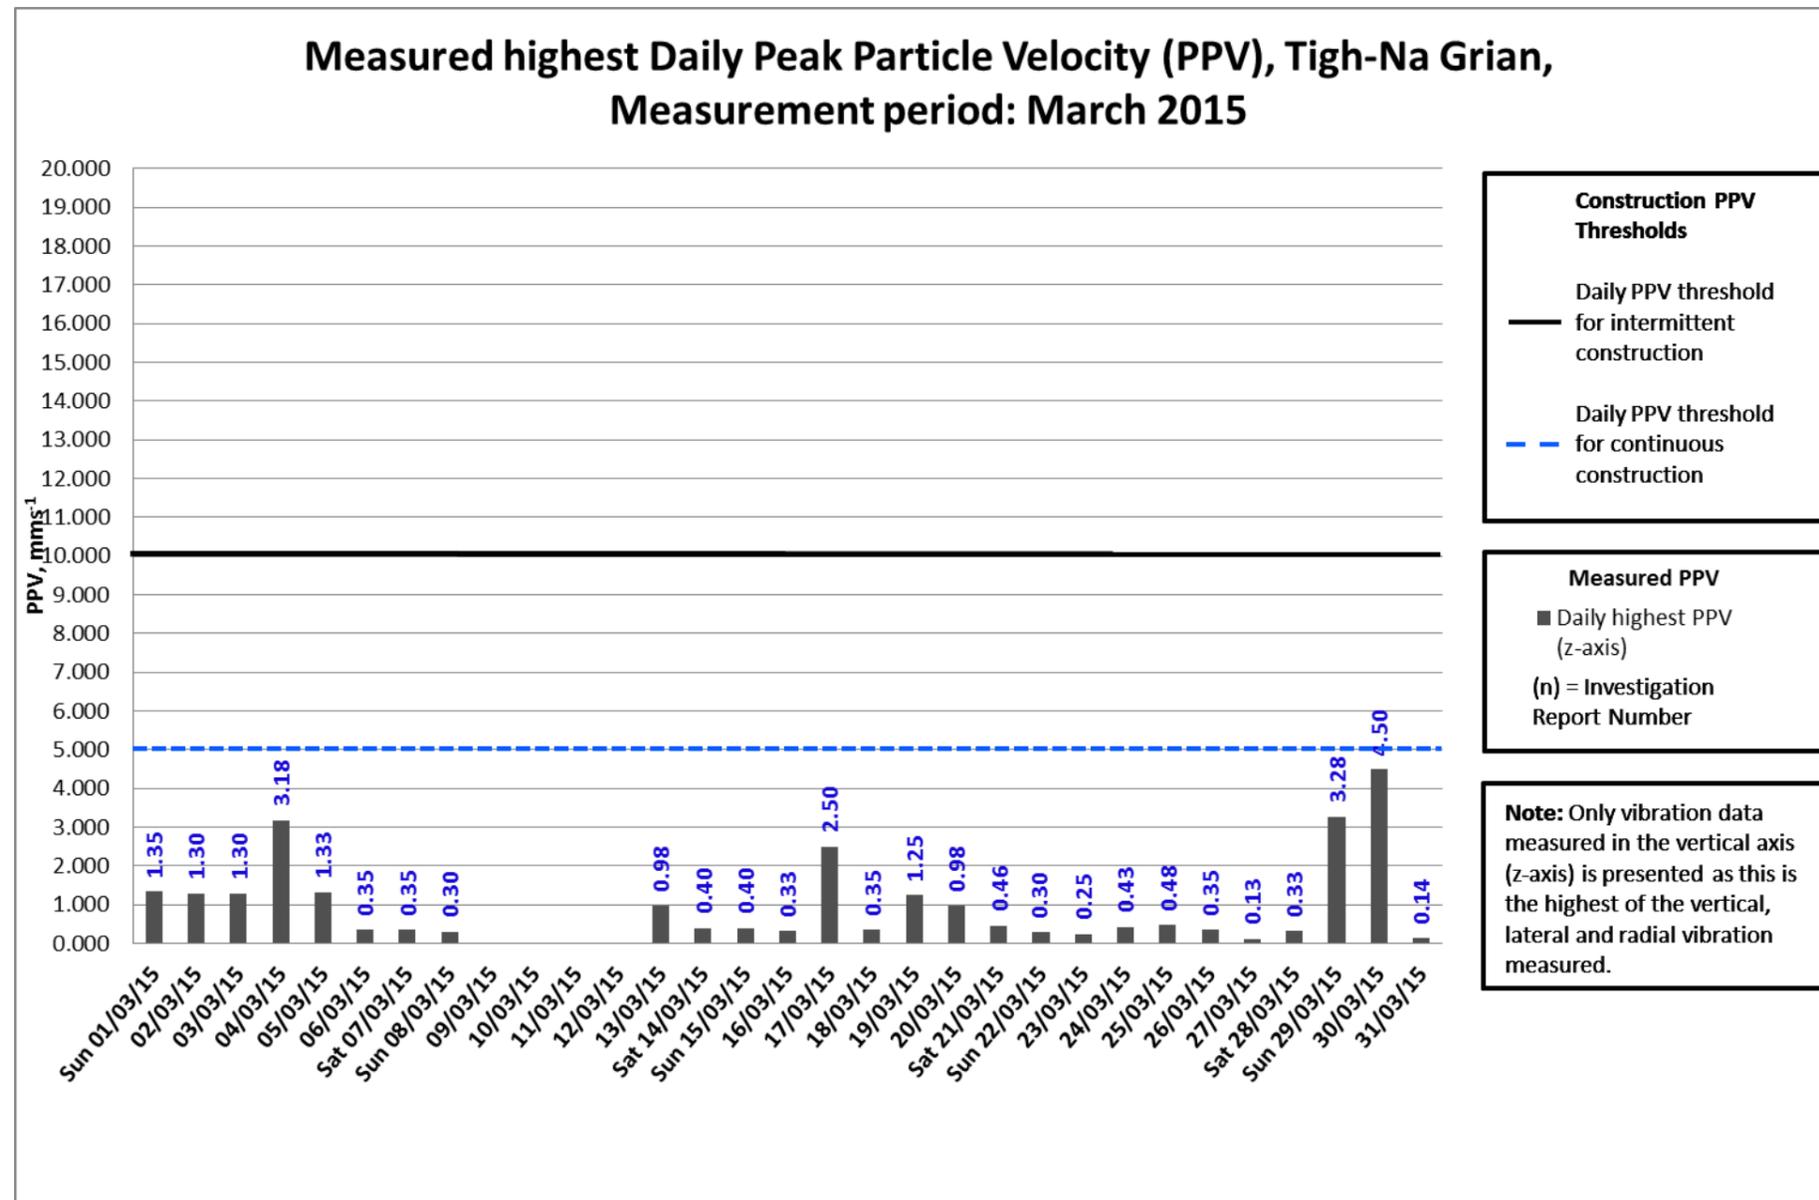
- Data is missing from 09/03/15 - 12/03/15 due to device error.

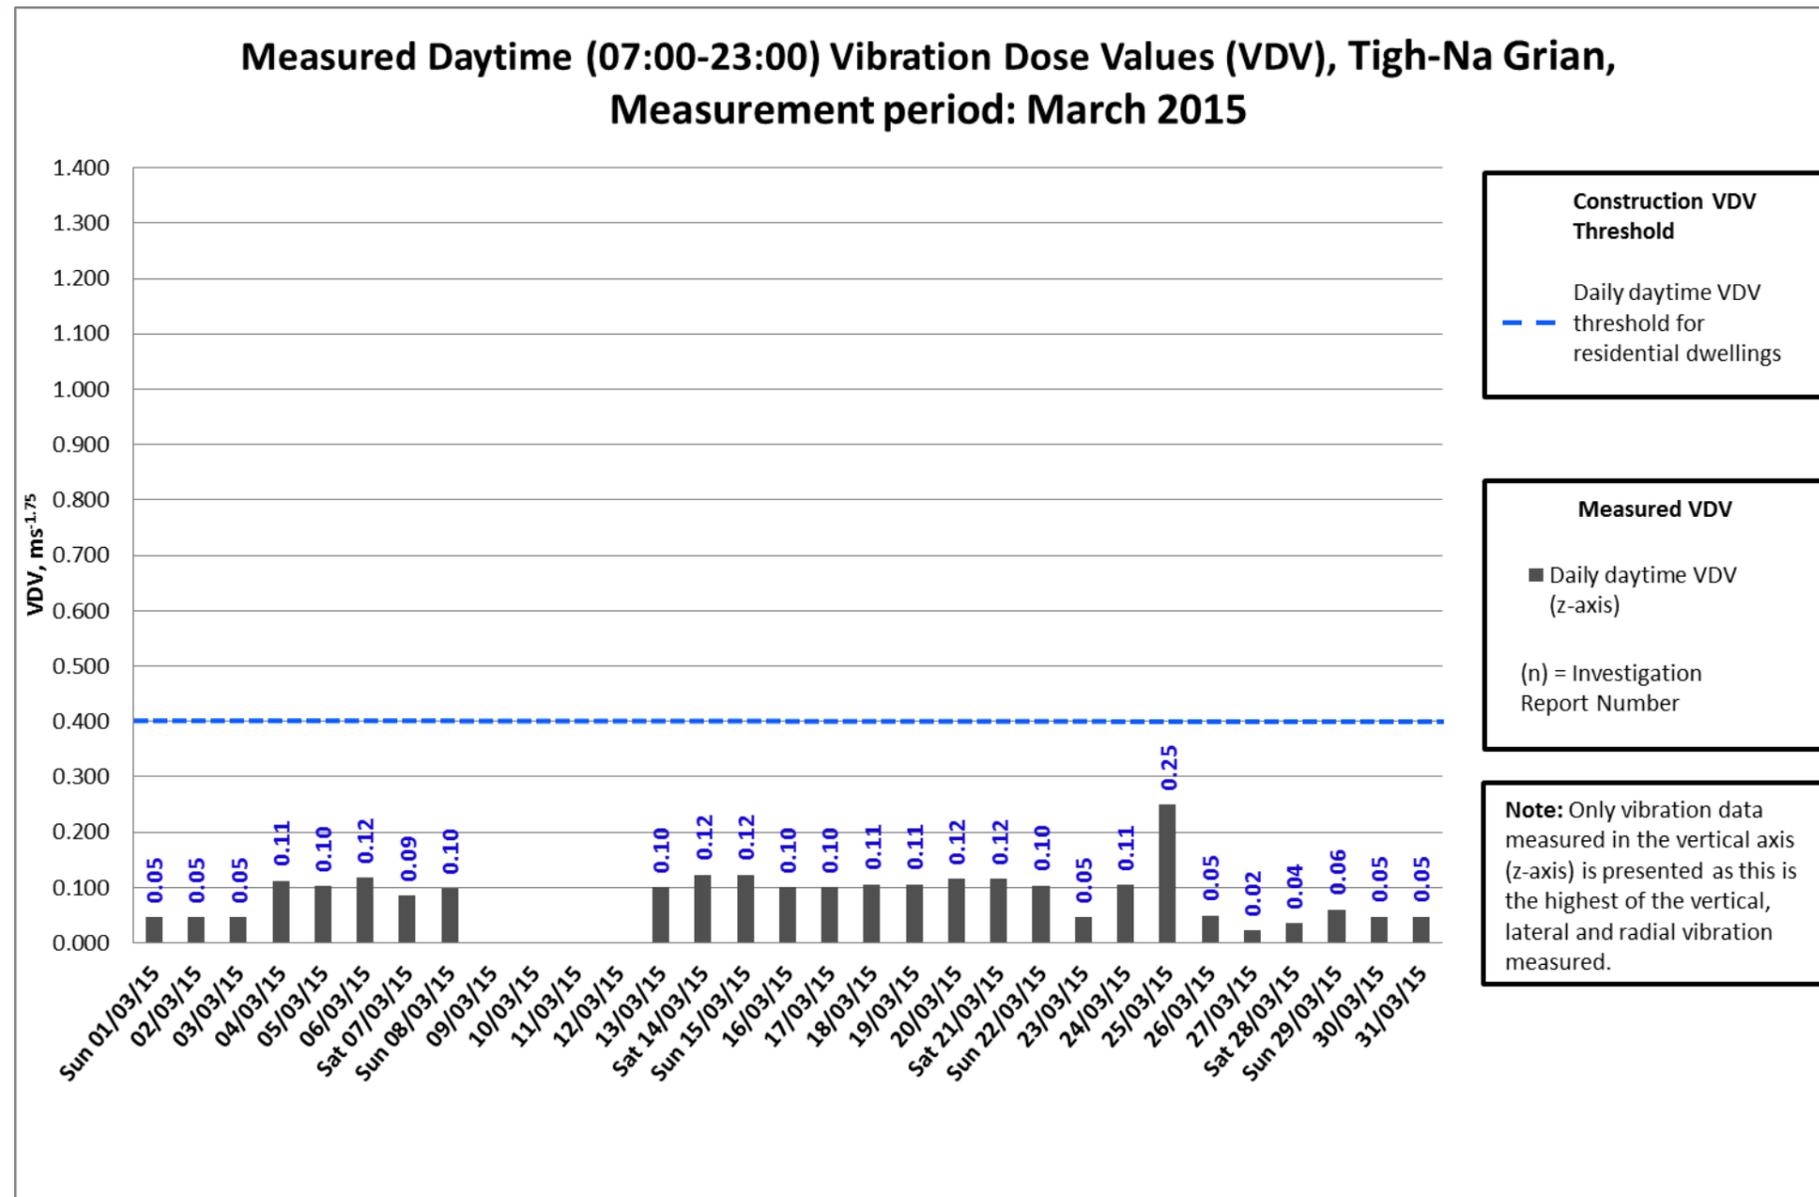
- Data is missing from 09/03/15 - 12/03/15 due to device error.

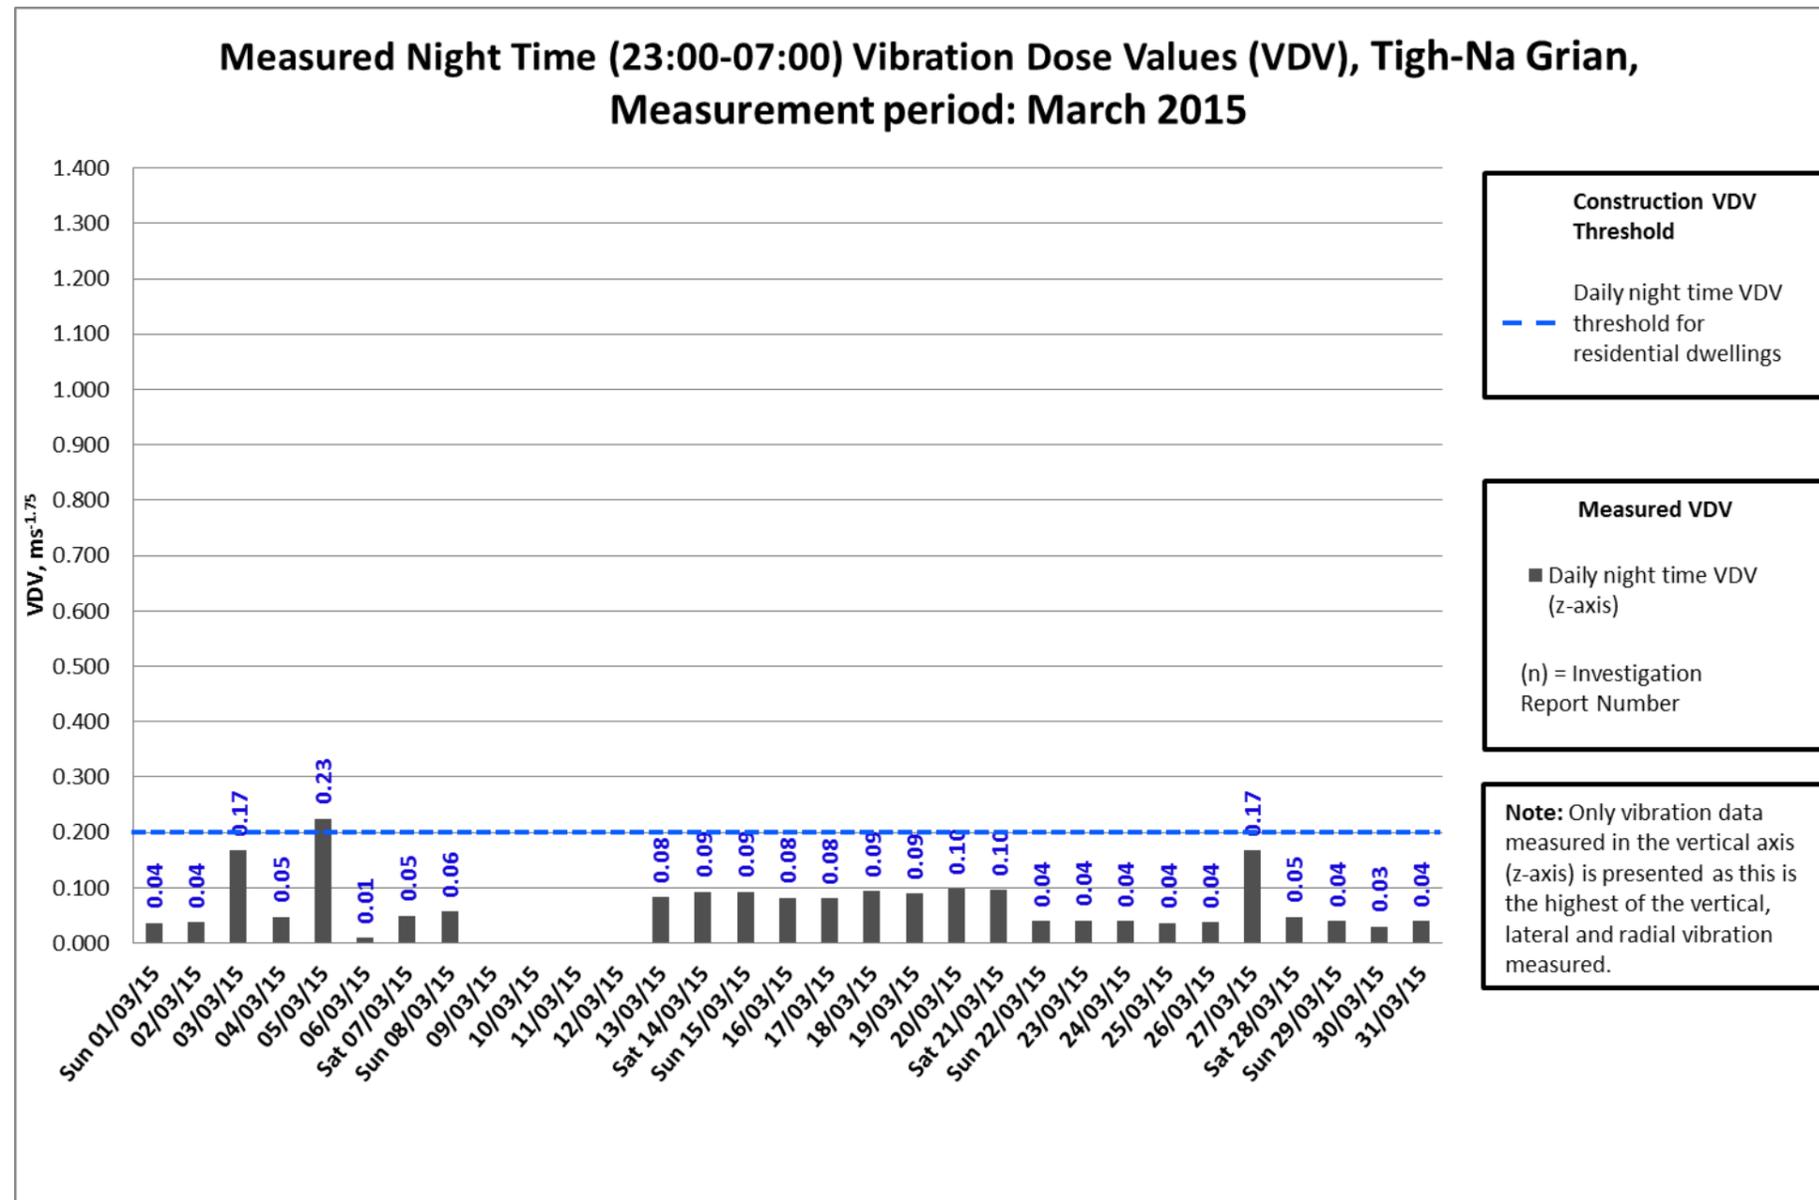
- Data is missing from 09/03/15 - 12/03/15 due to device error.
