FORTH REPLACEMENT CROSSING

**AIR QUALITY MONITORING REPORT
 JULY 2014**

REP-00189-00

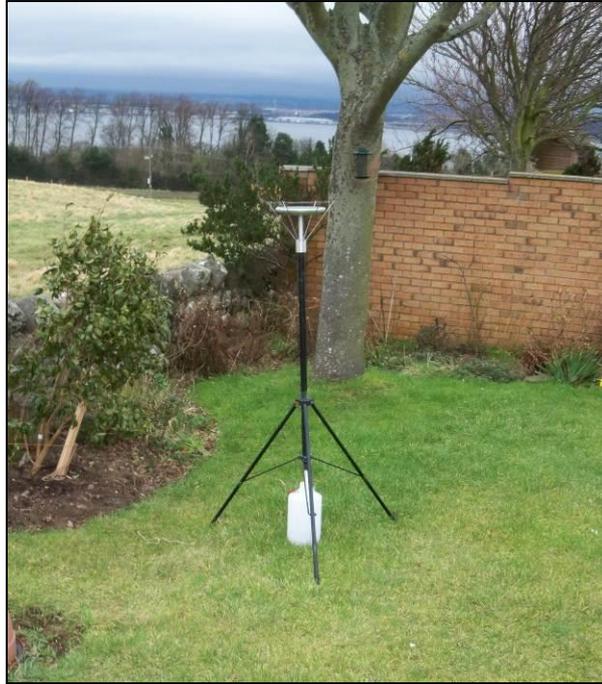
Figure 1: Example of an Installed Frisbee Gauge Meter

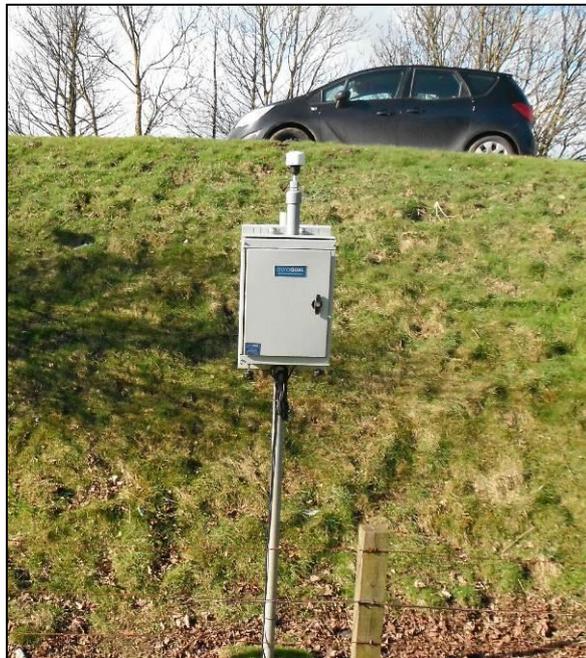
Figure 2: Example of an installed Automatic Light Scatter Dust Meter

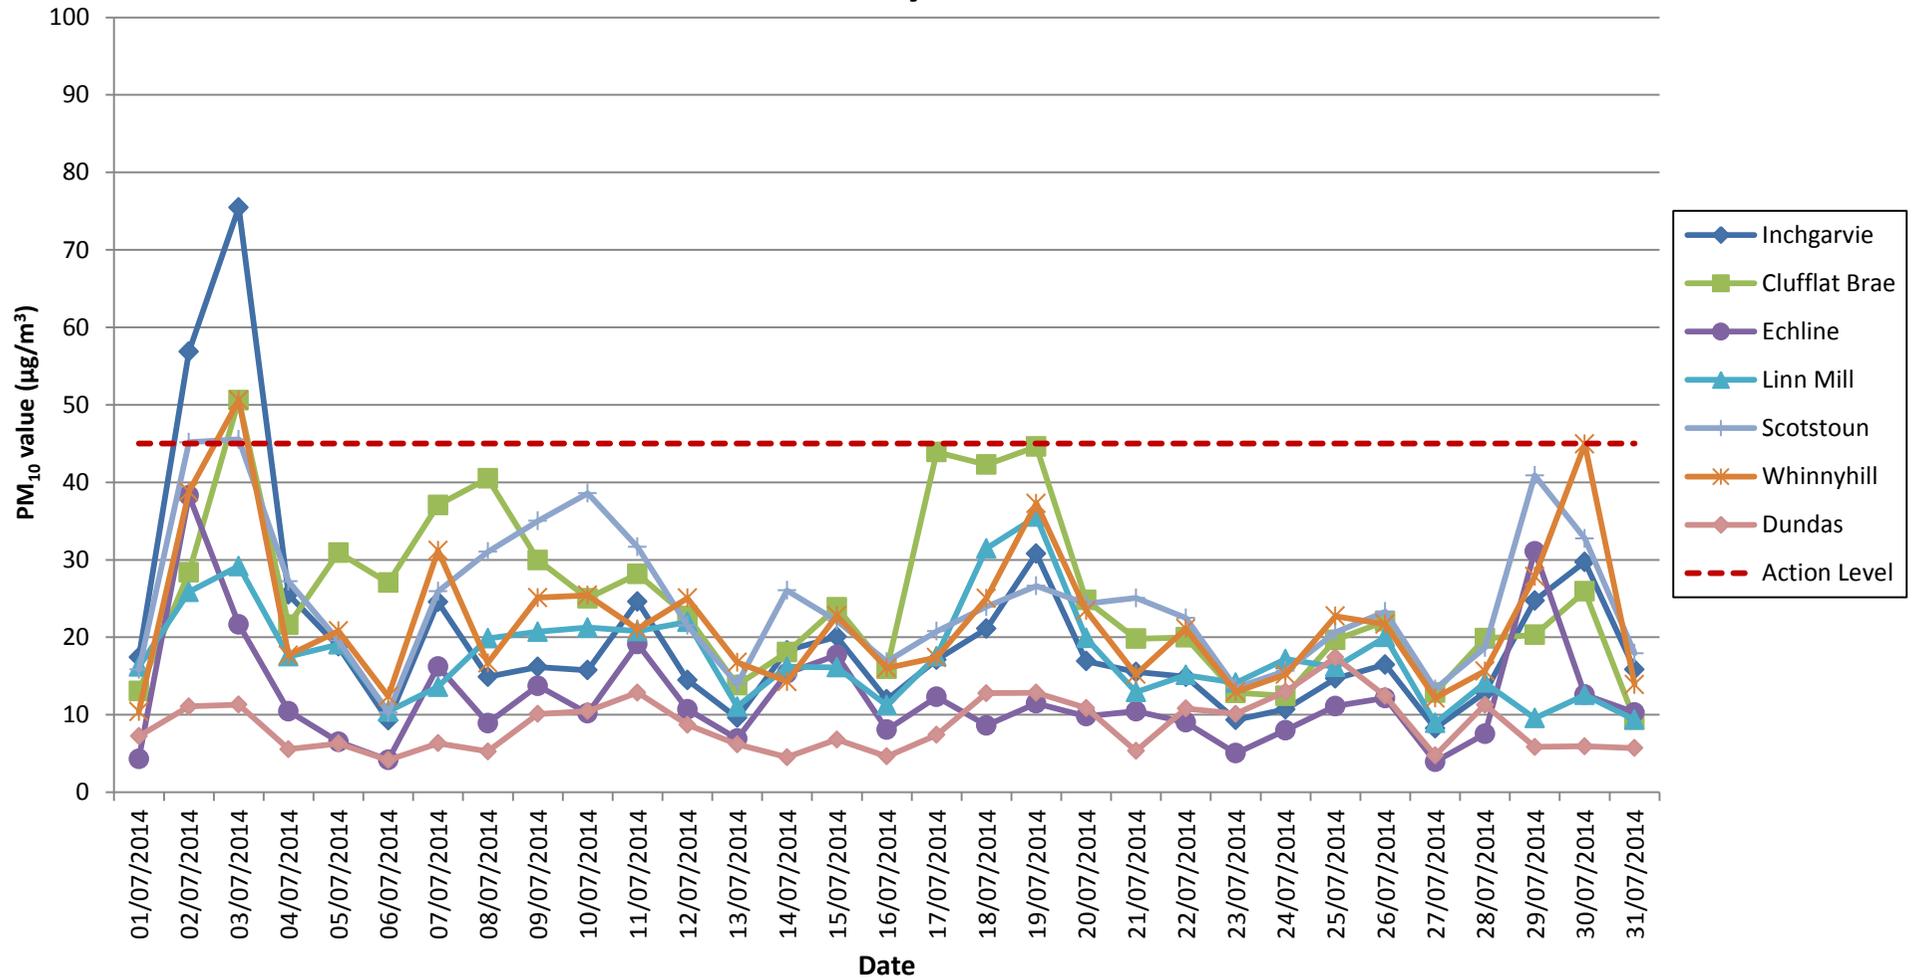
APPENDIX A: LIGHT SCATTER METER RESULTS

3.1.1. Light scatter results for July 2014 have been presented in a monthly chart; this can be found in Appendix A. Results show that the PM₁₀ levels were below threshold levels throughout the month with six exceptions spread over 2 days, the 2nd & 3rd July. The monitors at Inchgarvie, Clufflat, Scotstoun and Whinnyhill all had either one or two exceedances of the action level during these two days. All seven monitors follow the same general pattern throughout the month of July.

3.1.2. It was noted that foggy conditions occurred on the evening of the 2nd and 3rd and morning of the 4th July. Ground conditions during the 2nd and 3rd were dry and damp respectively. Although four monitors recorded exceedances, increases in recorded values over both of these days were observed at all seven monitors across site. For the exceedances of the action level, a review of the works in each of the areas, weather conditions, and the mitigation measures in place was undertaken. No construction activities were taking place in proximity to any of the monitors and damp ground conditions would

have suppressed dust being generated via vehicle movements. The fact that all seven monitors showed the same pattern would suggest that a regional event affected the levels across the whole area rather than the increases being related to works activities in one specific area affecting only a few monitors.

Particulate Matter (PM10) Results for all Monitoring Locations

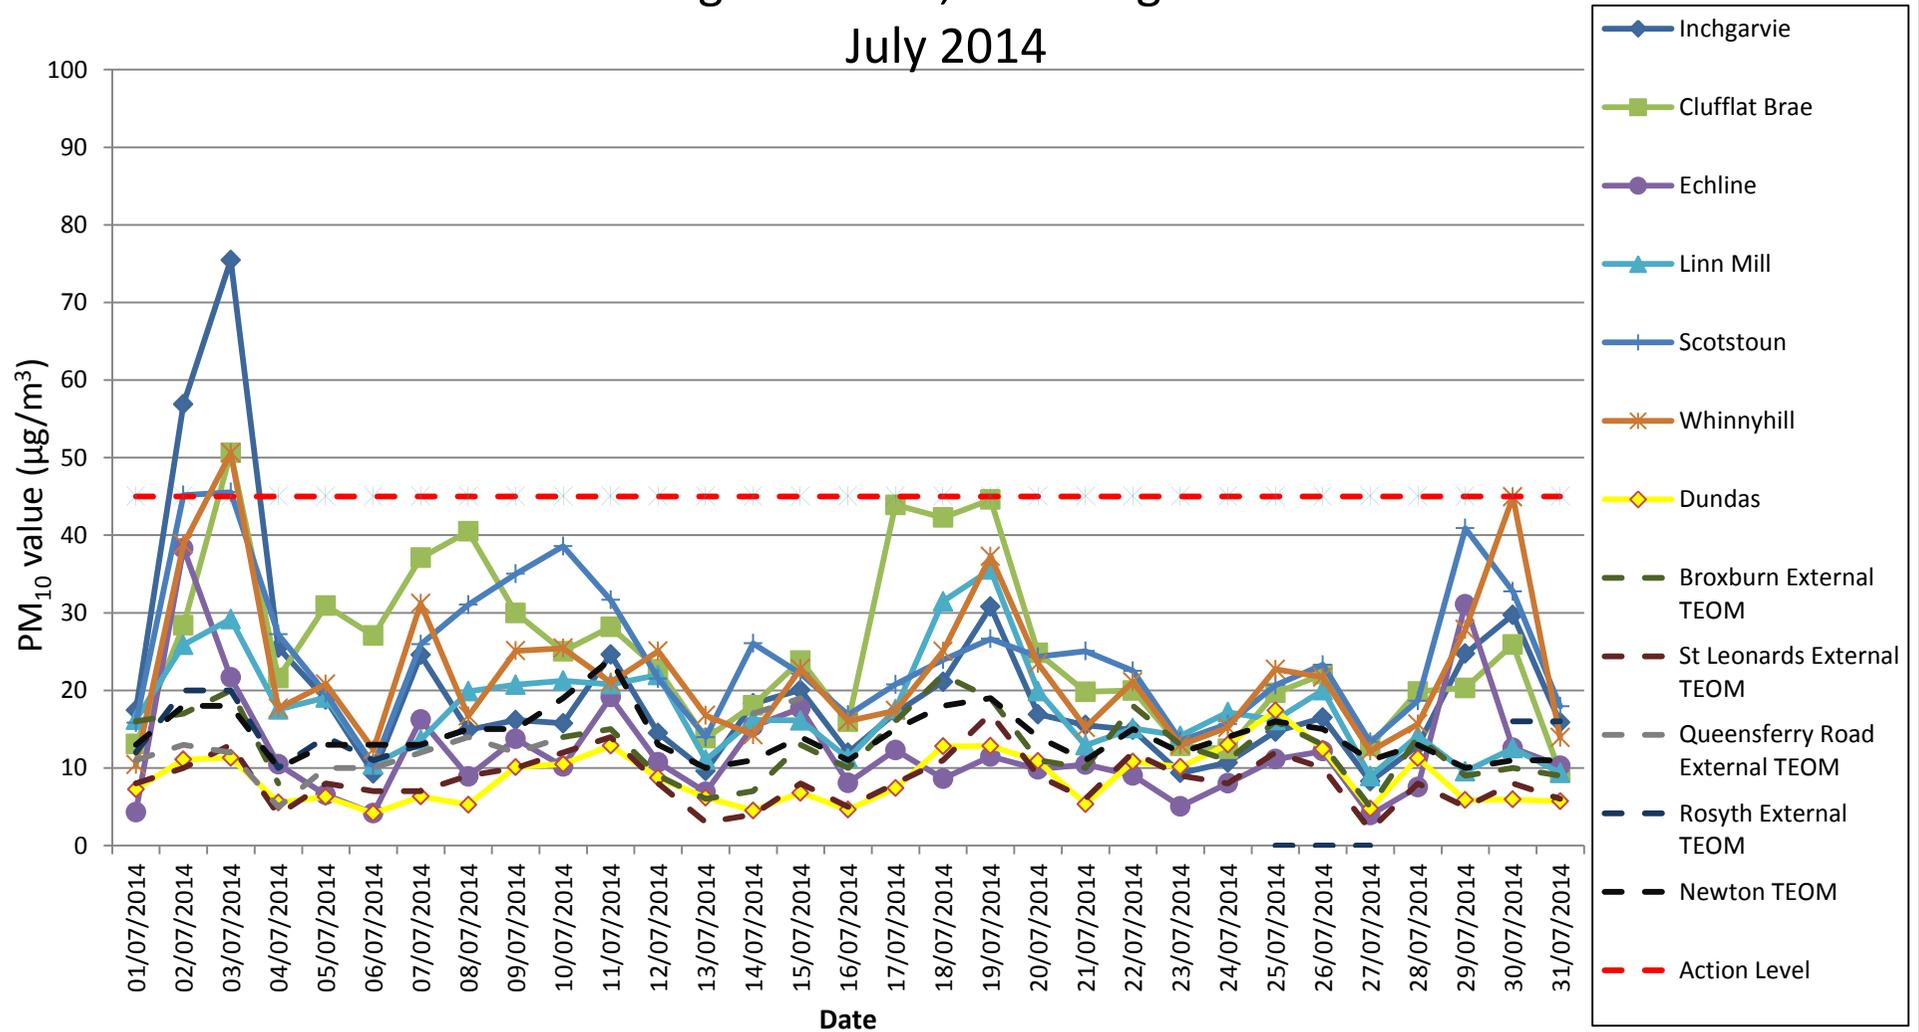
- 3.1.5.** The PM₁₀ results have also been compared to the daily mean results obtained from the TEOM air quality monitoring stations located in Newton, Rosyth, and Broxburn, and from the TEOM FDMS stations located at Queensferry Road, Edinburgh and St Leonards, Edinburgh (an urban background site). The TEOM at Newton was installed by West Lothian Council, facilitated by FCBC, during May 2012. The comparison between the light scatter and TEOM results demonstrates that both sets of results generally follow the same pattern but with the light scatter results registering at higher levels at some locations. This indicates that the results are largely driven by regional changes in air quality.

Air Quality Monitoring: Particulate Matter (PM10) Results for all Monitoring Locations, including TEOM data July 2014

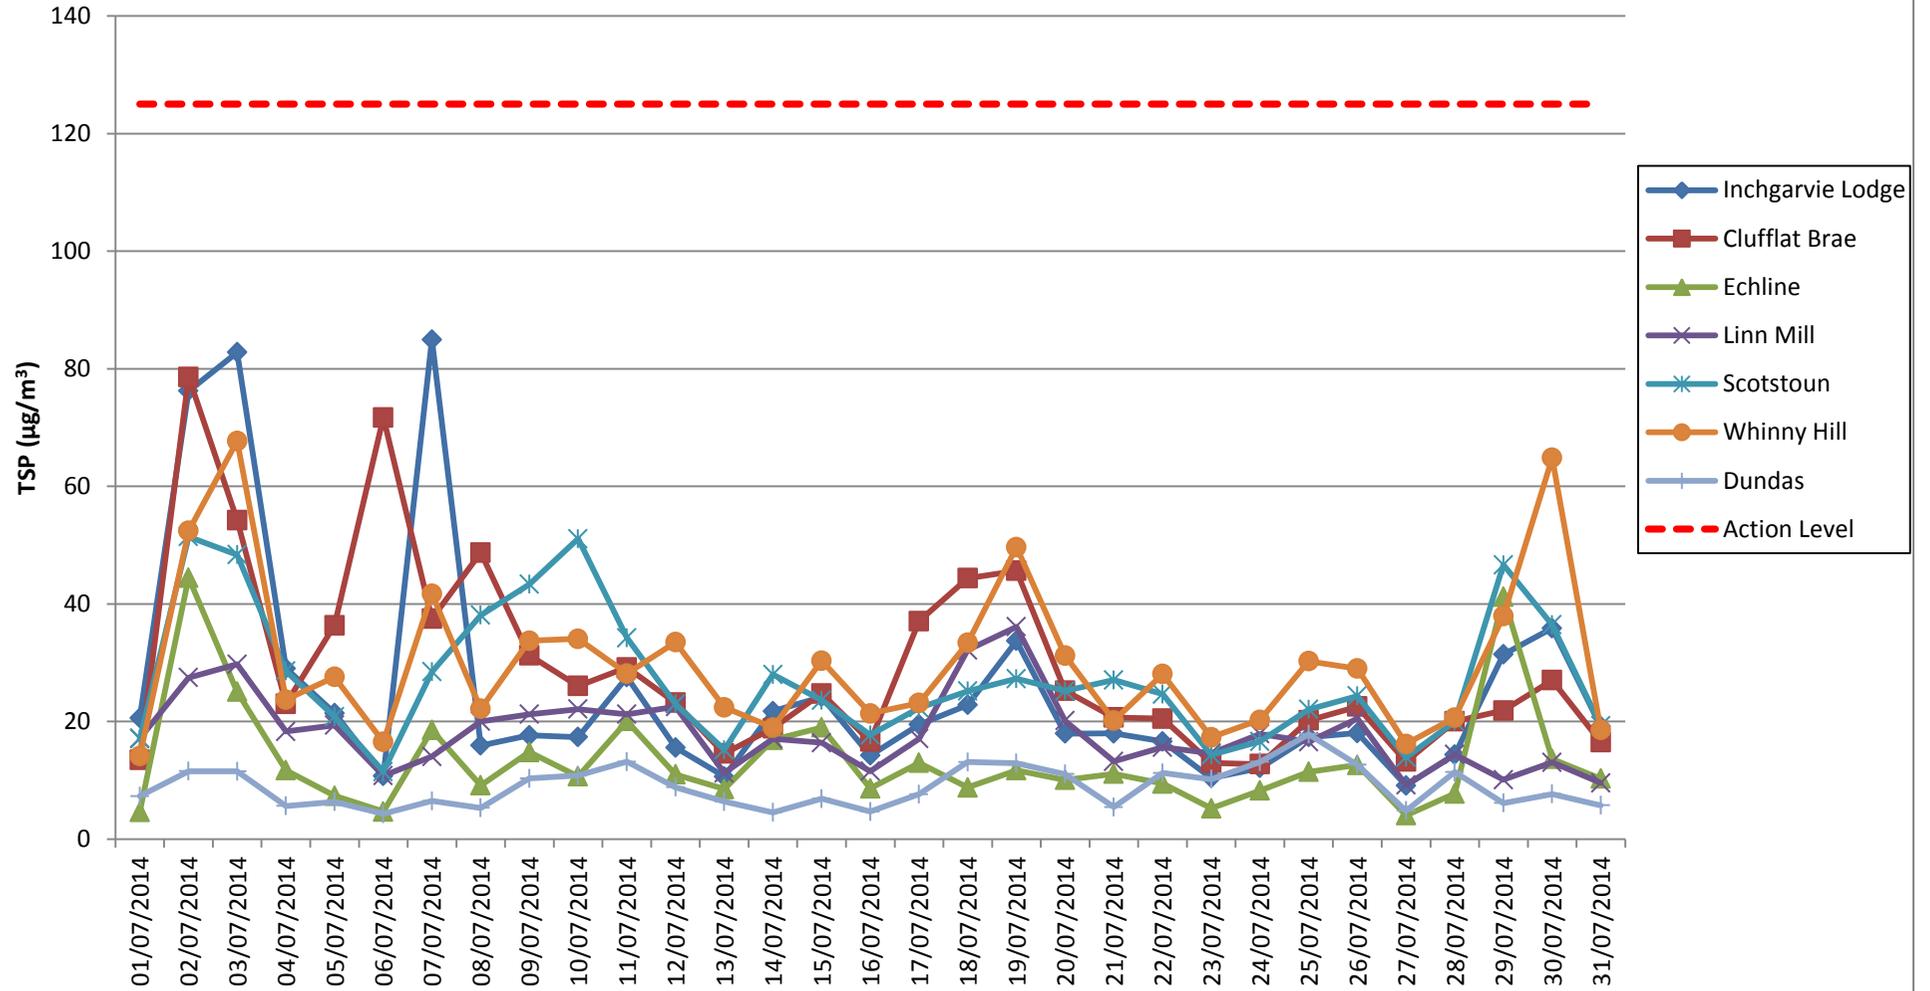
APPENDIX B: TOTAL SUSPENDED PARTICLES

- 3.2.1.** The TSP results for July 2014 have been presented in a monthly chart; this can be found in Appendix B. The TSP levels at monitoring locations during July

were found to be low and all within the threshold level. All locations were mostly found to follow a similar pattern across the site, demonstrating that, in general, the levels were influenced by regional changes in TSP levels, rather than construction works.

Total Suspended Particles (TSP) Results July 2014

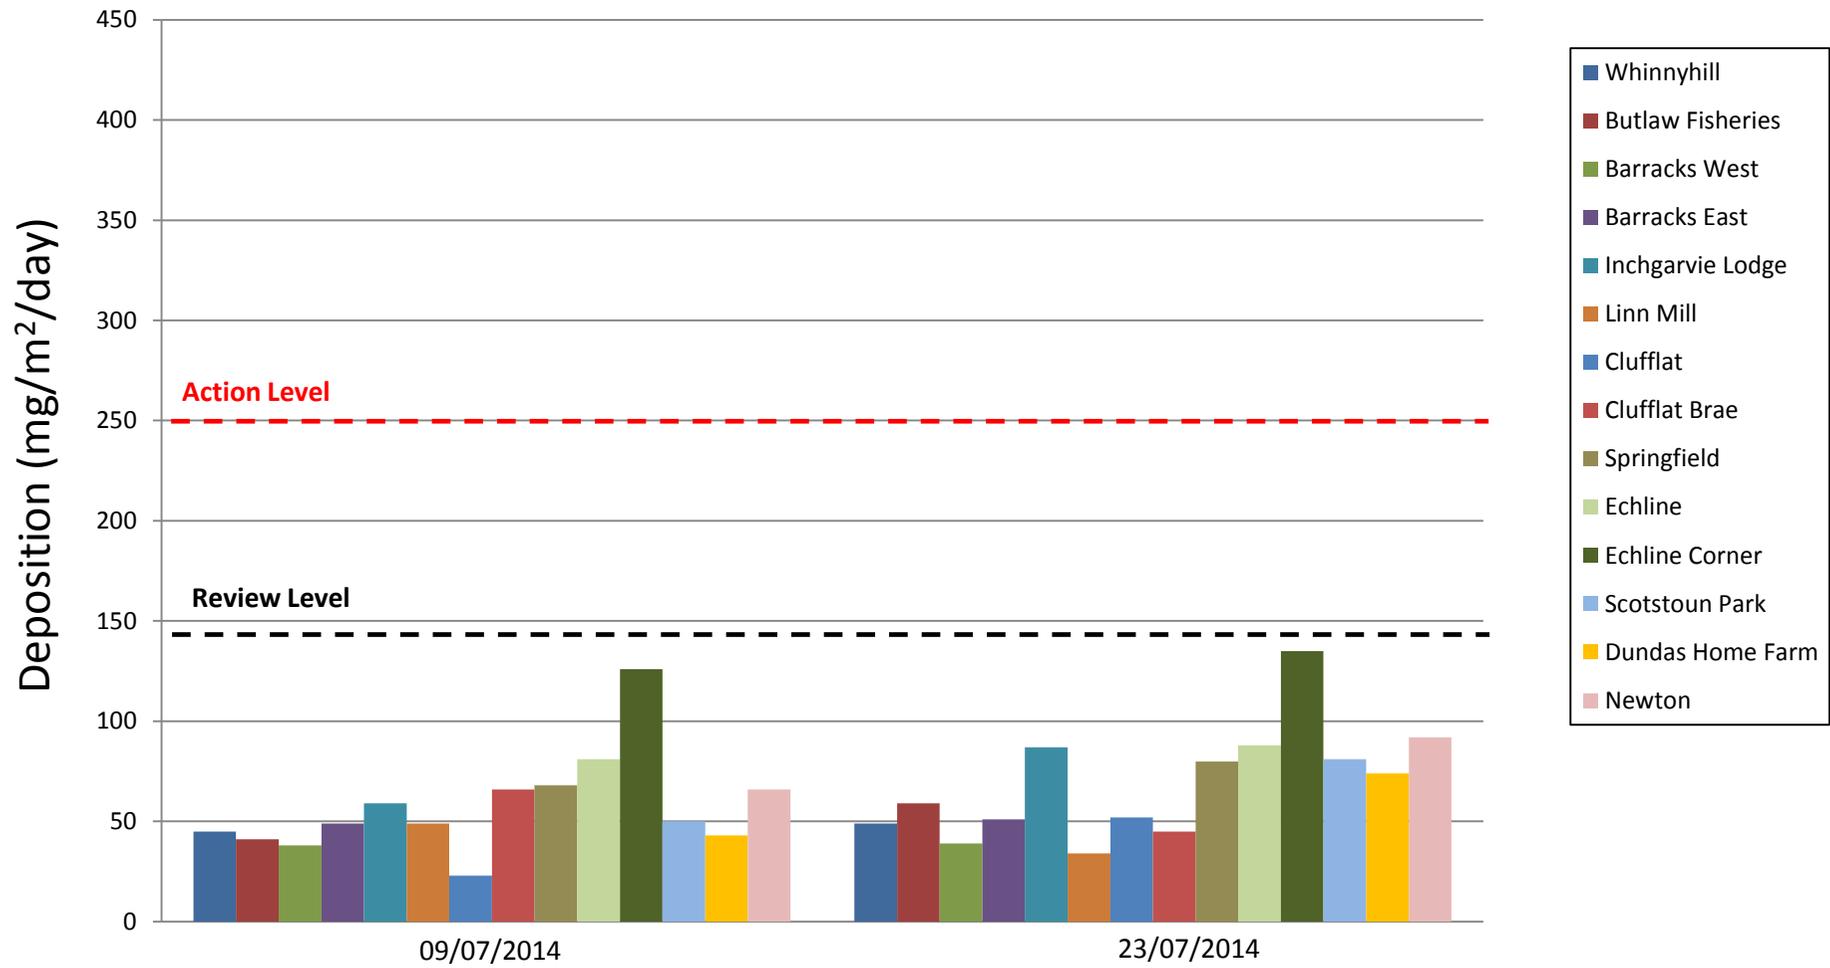
APPENDIX C: FRISBEE GAUGE RESULTS

3.3.1. The Frisbee dust deposition results for July 2014 have been presented in a chart and can be found in Appendix C. Frisbee dust deposition results were collected fortnightly, and the results averaged over this fortnight period to give a daily dust deposition rate. Two collections were made in July, on the 9th and 23th. The next collection will take place on the 6th August 2014.

3.3.2. The site action level for the dust deposition rate has been set at 250 mg/m²/day. Exceedances of this level are treated as a potential incident and a review of the works in the vicinity of the site is instigated. A lower, site review level has been set at 140 mg/m²/day. Where concentrations exceed the lower review threshold the site works are reviewed to ensure good practice is implemented; it is essentially a warning that additional controls may be required.

3.3.3. During July there were no exceedances of the site review level. Frisbee results from monitoring locations across site were generally low.

Frisbee Dust Deposition Results: July 2014
