FCBC
Queensferry
Crossing

Project **FORTH REPLACEMENT CROSSING**

**AIR QUALITY MONITORING REPORT
SEPTEMBER 2016**

Document number	Rev
REP-00296	00

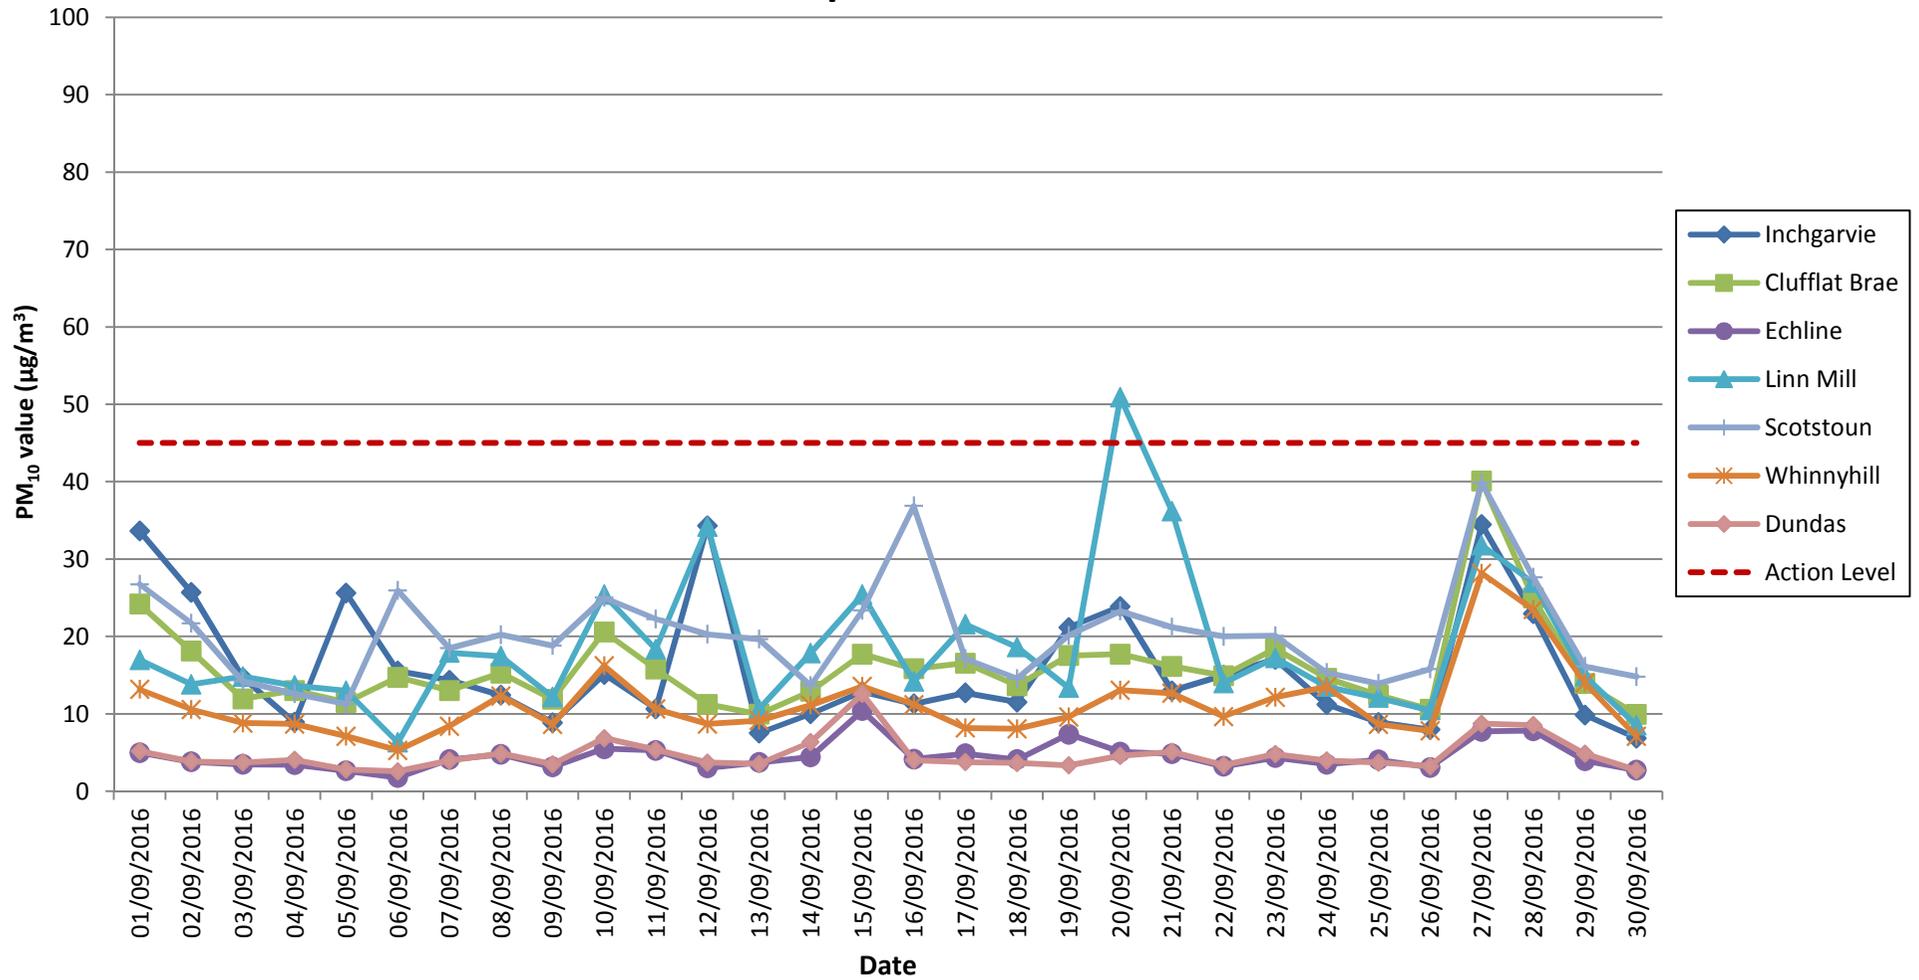
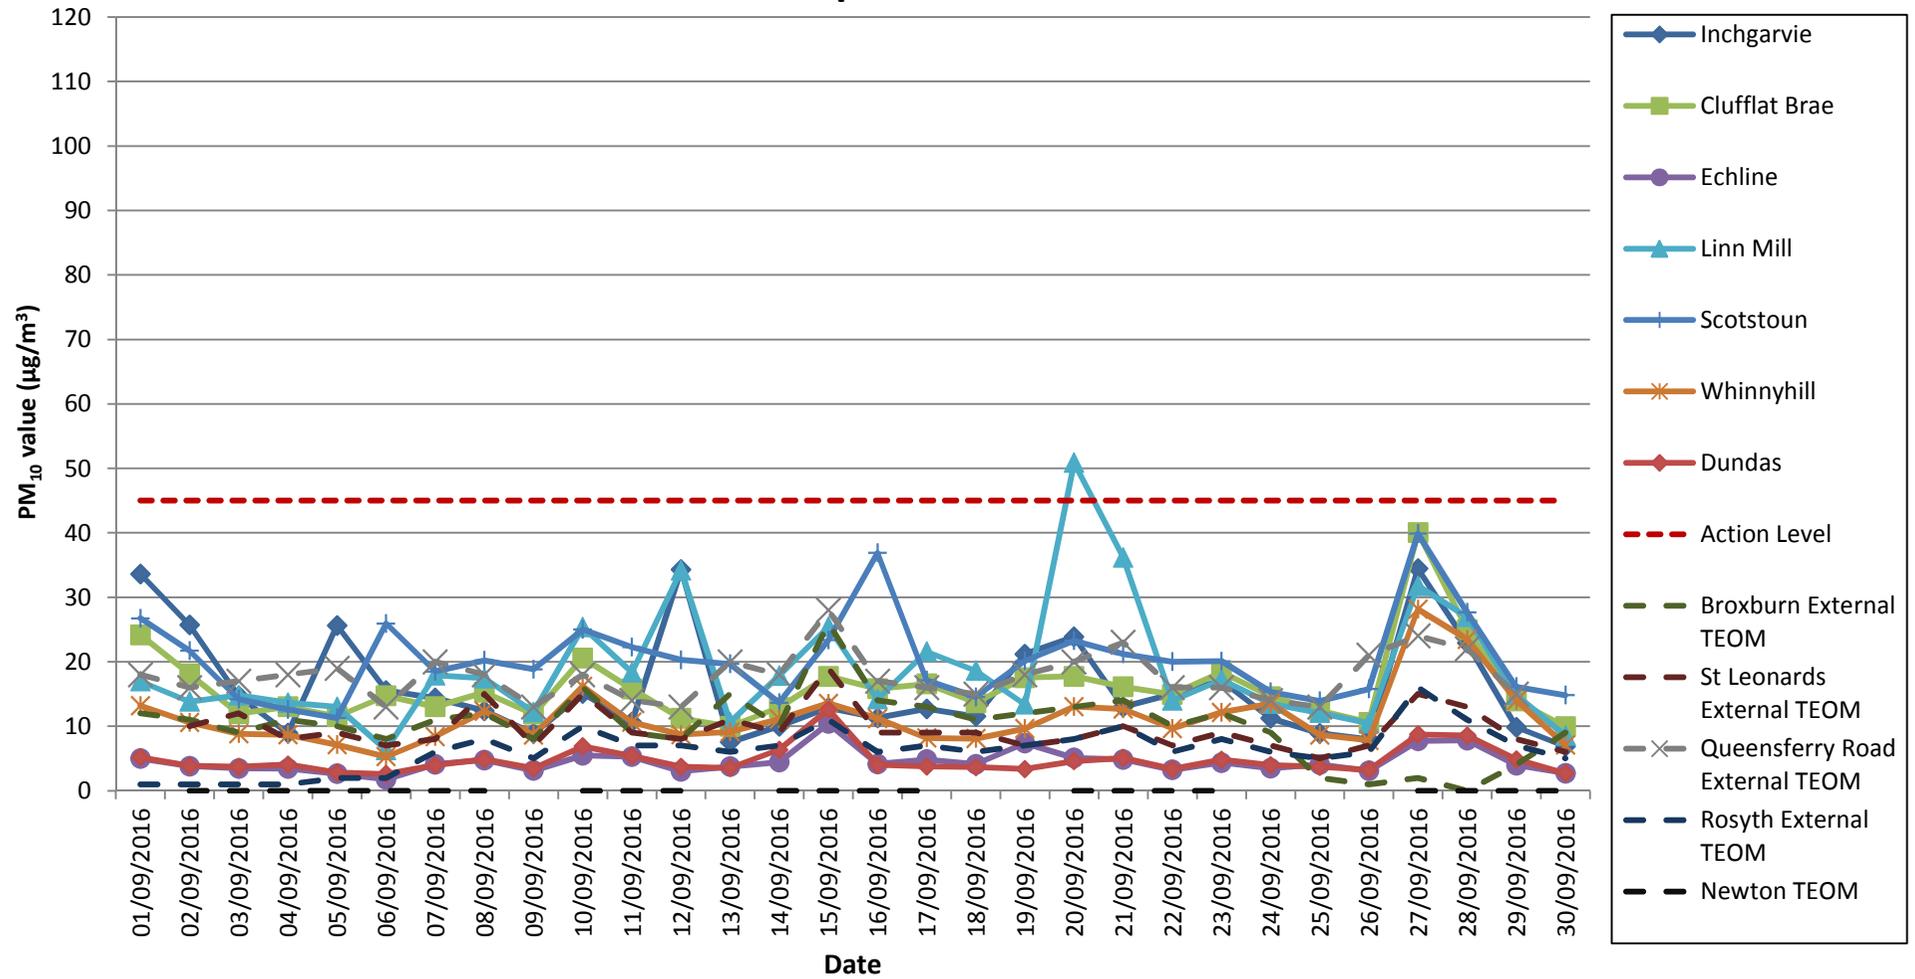
Air Quality Monitoring: Particulate Matter (PM10) Results for all Monitoring Locations, including TEOM data September 2016

3.1.1. Light scatter meter results for September 2016 have been presented in a monthly chart; this can be found in Appendix A. Results show that the PM₁₀ levels were below threshold levels throughout September with the exception of Linn Mill on the 20th September. All monitors generally follow the same pattern throughout the month, with the exception of the exceedance noted above, in addition to Inchgarvie on 5th and 12th September, Scotstoun on the 6th and 16th September and Linn Mill on the 12th and 21st September (although below the threshold level on these dates). With the exceedance on the 20th September at Linn Mill, the light scatter meter registered 15 minute exceedances for PM₁₀. The FCBC Environmental Coordinator investigated the area and confirmed that conditions were not dusty and that sufficient mitigation was in place. There were no works being undertaken at the SUDS pond adjacent to the monitor on this day. The highest PM₁₀ levels occurred during the day and may have been caused by traffic on the access road. However, the results also indicate high levels of PM₁₀ during the

evening, including between 10pm and 11pm, which would suggest elevated levels which are not due to any construction activities. FCBC will continue to regularly dampen the access road during dry conditions to minimise dust generation.

3.1.2. The PM₁₀ results have also been compared to the daily mean results obtained from the TEOM air quality monitoring stations located in Newton, Rosyth, and Broxburn, and from the TEOM FDMS station located at Queensferry Road and St Leonards, Edinburgh (an urban background site). The TEOM at Newton was installed by West Lothian Council, facilitated by FCBC, during January 2012. The comparison between the light scatter and TEOM results demonstrates that both sets of results generally follow the same pattern with the exception of Inchgarvie on 12th September, Scotstoun on the 6th and 16th September and Linn Mill on the 12th and 20th September.

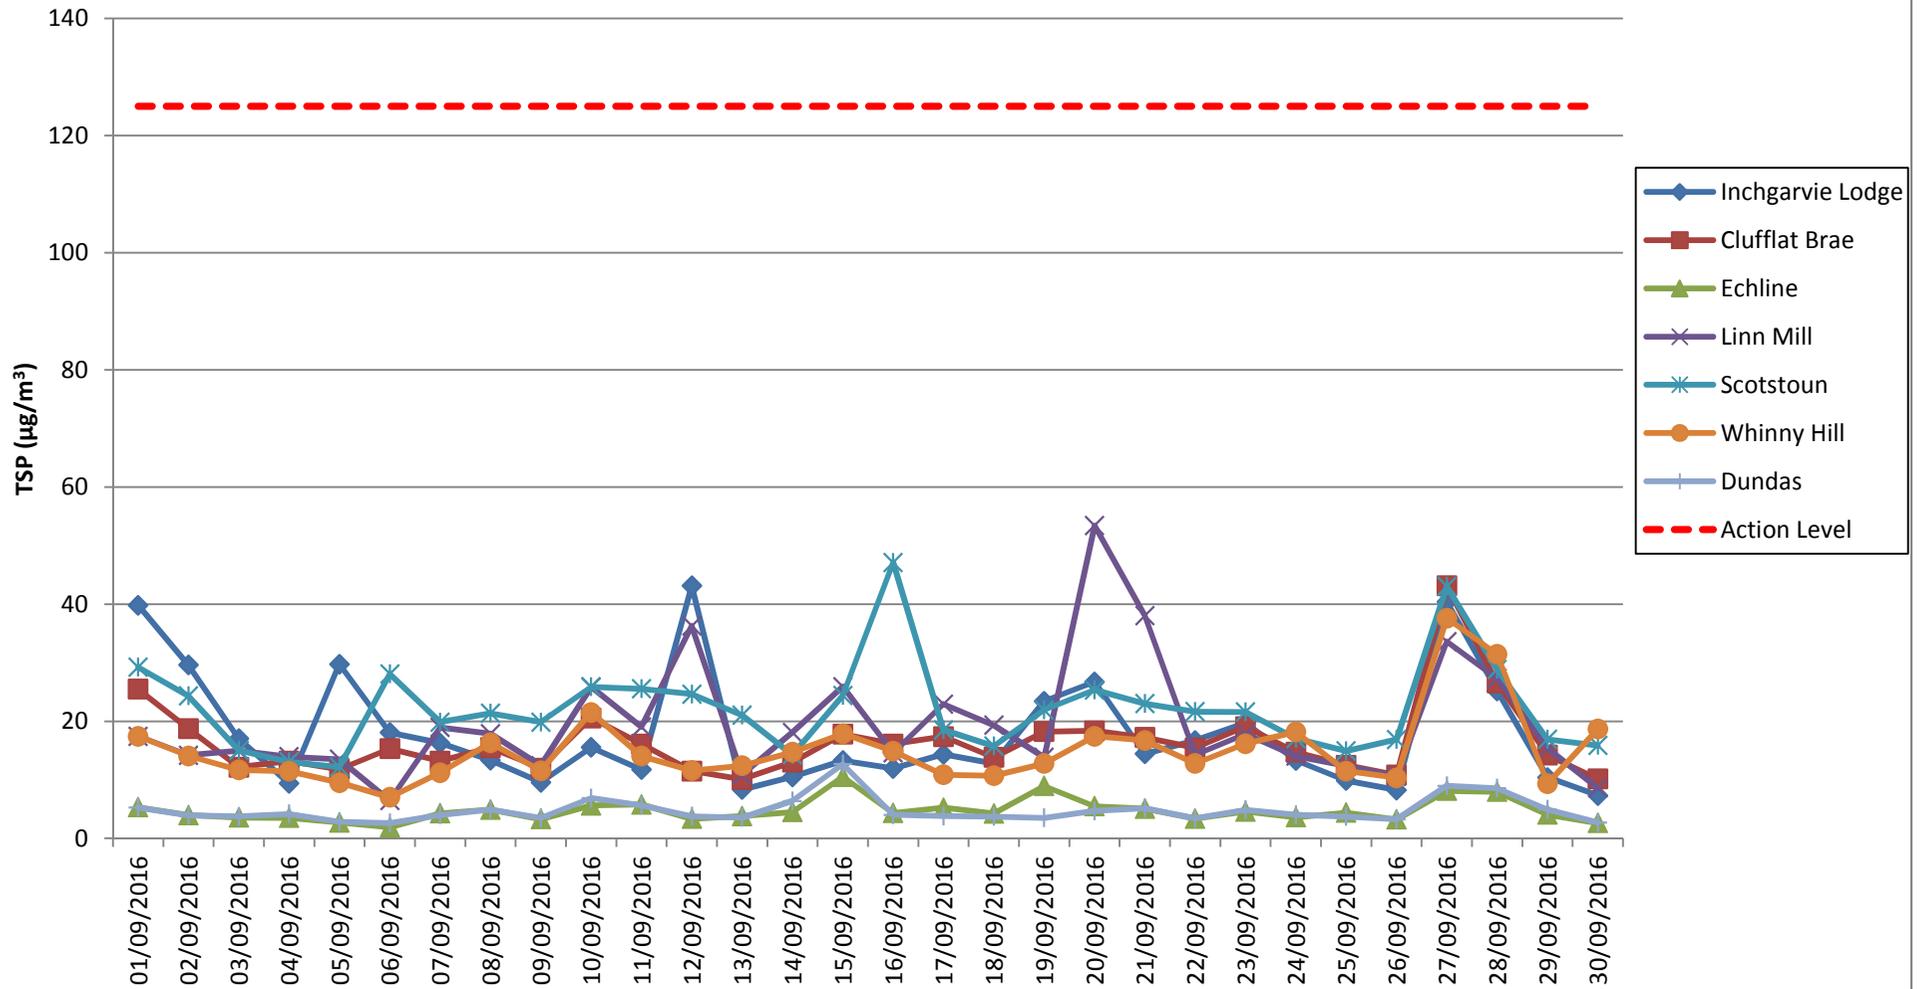
Total Suspended Particles (TSP) Results September 2016

3.2.1. The TSP results for September 2016 have been presented in a monthly chart; this can be found in Appendix B. The TSP levels at monitoring locations during September were all within the threshold. The TSP pattern at locations across the site was similar to that observed for PM₁₀ levels. As with PM₁₀ it is considered that the TSP levels across site were generally influenced by regional changes in TSP levels, with the exception of results corresponding with the higher peaks noted in 3.1.1 and 3.1.2 above.

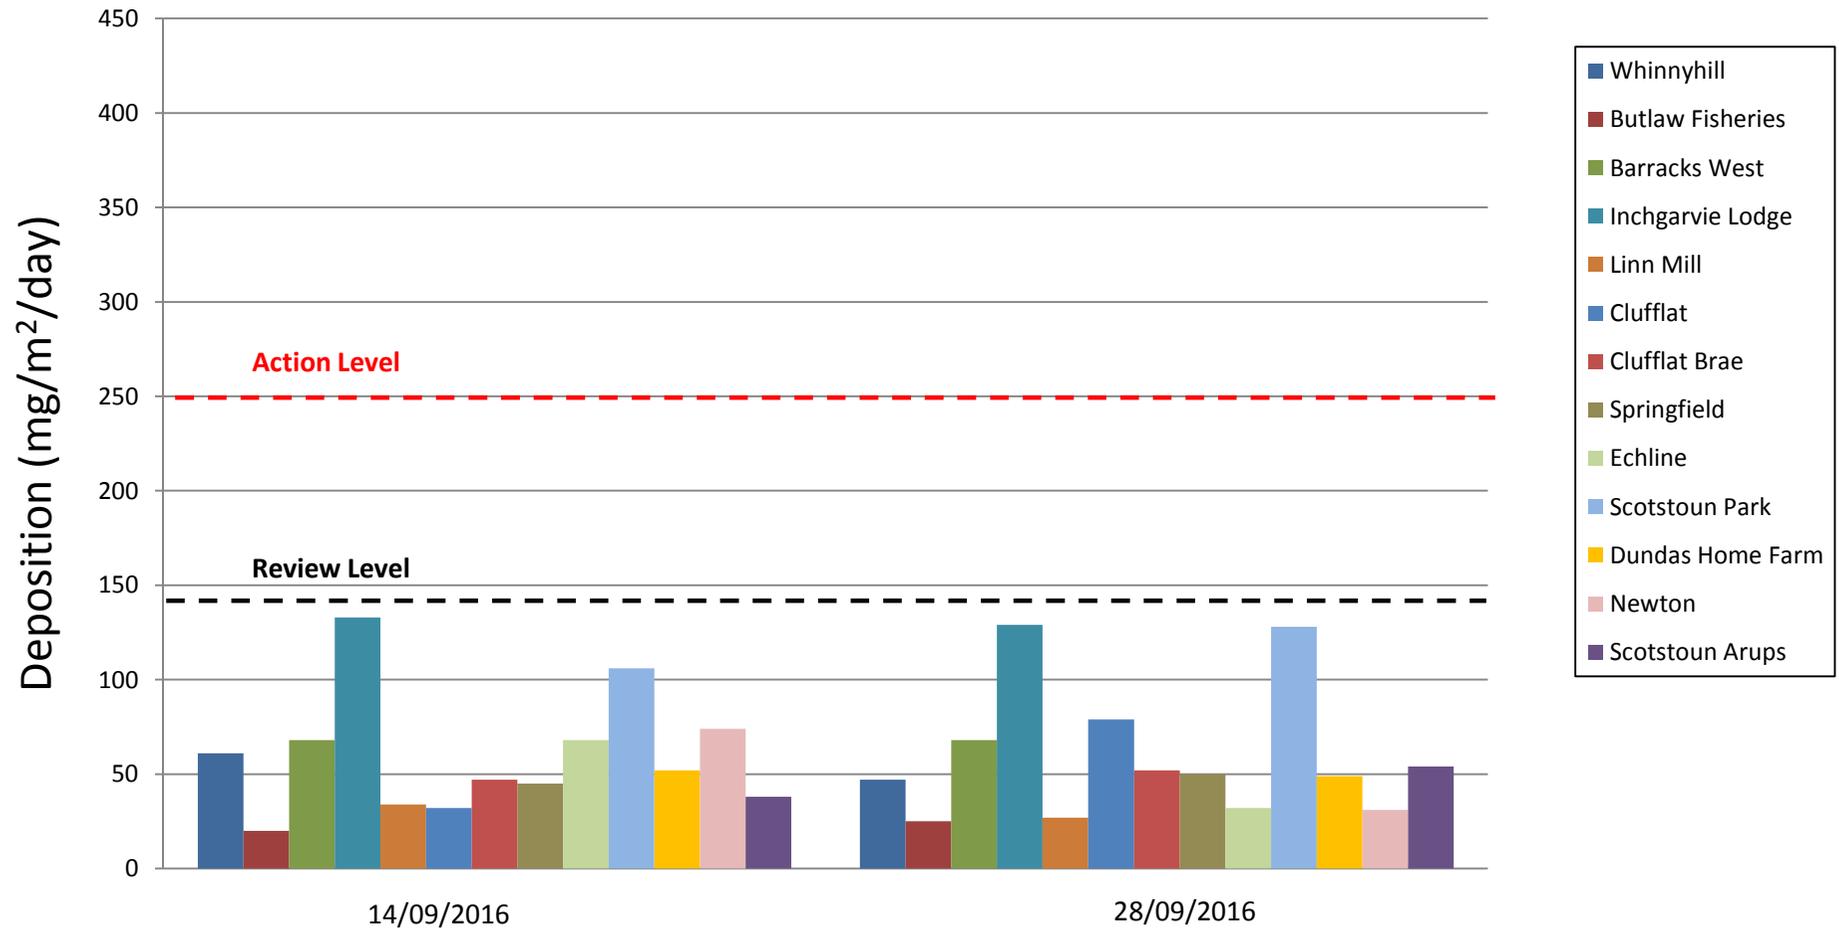
Frisbee Dust Deposition Results: September 2016

3.3.1. The Frisbee dust deposition results for September 2016 have been presented in a chart and can be found in Appendix C. Two collections were made in September; these occurred on the 14th and 28th September 2016.

3.3.2. The site action level for the dust deposition rate has been set at 250 mg/m²/day. Exceedances of this level are treated as a potential incident and a review of the works in the vicinity of the site is instigated. A lower site review level has been set at 140 mg/m²/day. Where concentrations exceed the lower review threshold the site works are reviewed to ensure good practice is implemented; it is essentially a warning that additional controls may be required.

3.3.3. During September there were no exceedances of either the site review or action levels.
