Project **FORTH REPLACEMENT CROSSING**

**AIR QUALITY MONITORING REPORT  
NOVEMBER 2016**

Document number	Rev
<b>REP-00302</b>	<b>00</b>

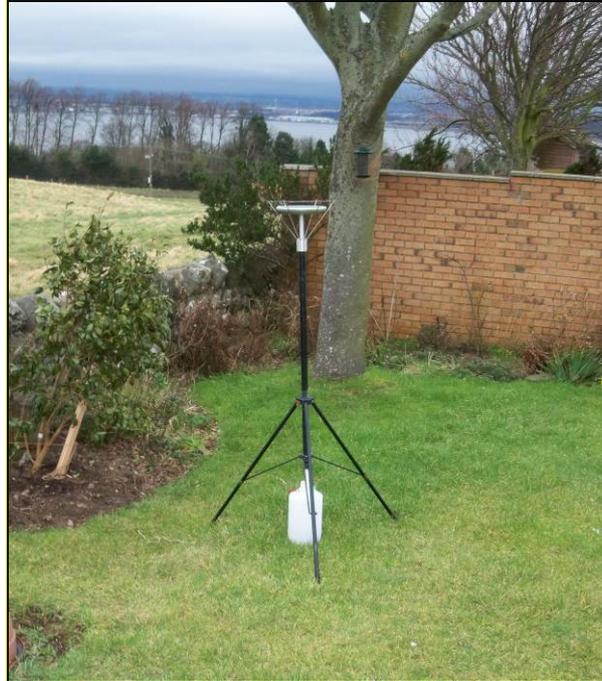
**Figure 1: Example of an Installed Frisbee Gauge Meter**

**2.1.** Air quality is being monitored on site using both automatic light scatter dust meters and Frisbee gauge dust deposition monitoring. Twelve Frisbee gauges are currently set up at sensitive locations across the site to measure dust deposition rates (Figure 1). Seven automatic light scatter meters have also been installed at various sensitive locations to measure real time particulate matter (PM<sub>10</sub>) concentrations and the Total Suspended Particle (TSP) concentrations (Figure 2). These meters are calibrated annually. Table 1 lists the air quality monitoring equipment present at each monitoring location, including the date it was installed.

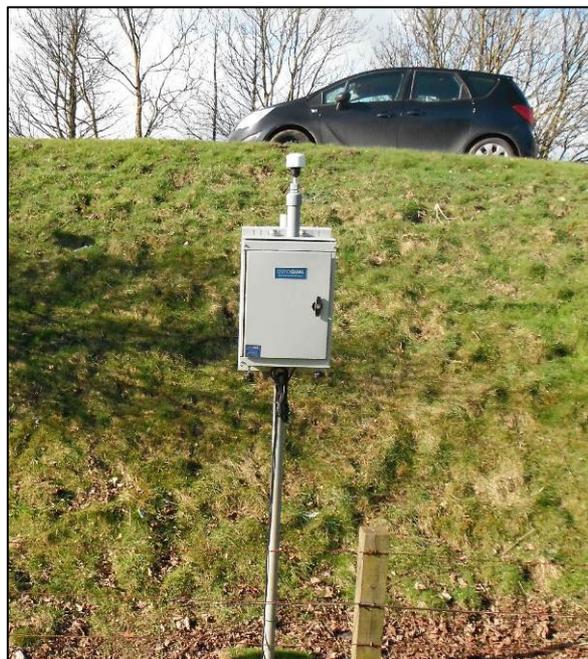
**Figure 2: Example of an installed Automatic Light Scatter Dust Meter**

**2.2.** Light scatter type monitoring equipment have been selected as a site monitoring tool to create a live network which assesses the levels of fugitive particulate matter, principally airborne dust. These monitors require less space, maintenance and power than other real time monitors such as a Tapered Element Oscillating Microbalance (TEOM) which is used and designed to measure particulate levels to exceedingly high standards, including measuring long-term compliance to statutory limits. Light scatter meters are more practicable to deploy. However, the meters do generally record levels higher than those measured by the TEOM. The meters can also be affected by atmospheric moisture content which further increases reported levels. Accordingly, any elevations of statutory limits should be treated as precautionary exceedances. The monitors are reliable for on-site monitoring and the establishment of action thresholds to ensure unforeseen activities generating significant dust are identified and suitably controlled. Light scatter meters are becoming the construction and waste industries norm for particulate dust monitoring.
