A83 Trunk Road Route Study Consultation Response Paper

Project: A83 Trunk Road Route Study
Client: Transport Scotland
Document Title: Consultation Response Paper
Ref. No:

Appendix A Debris Flow Barrier Product Literature

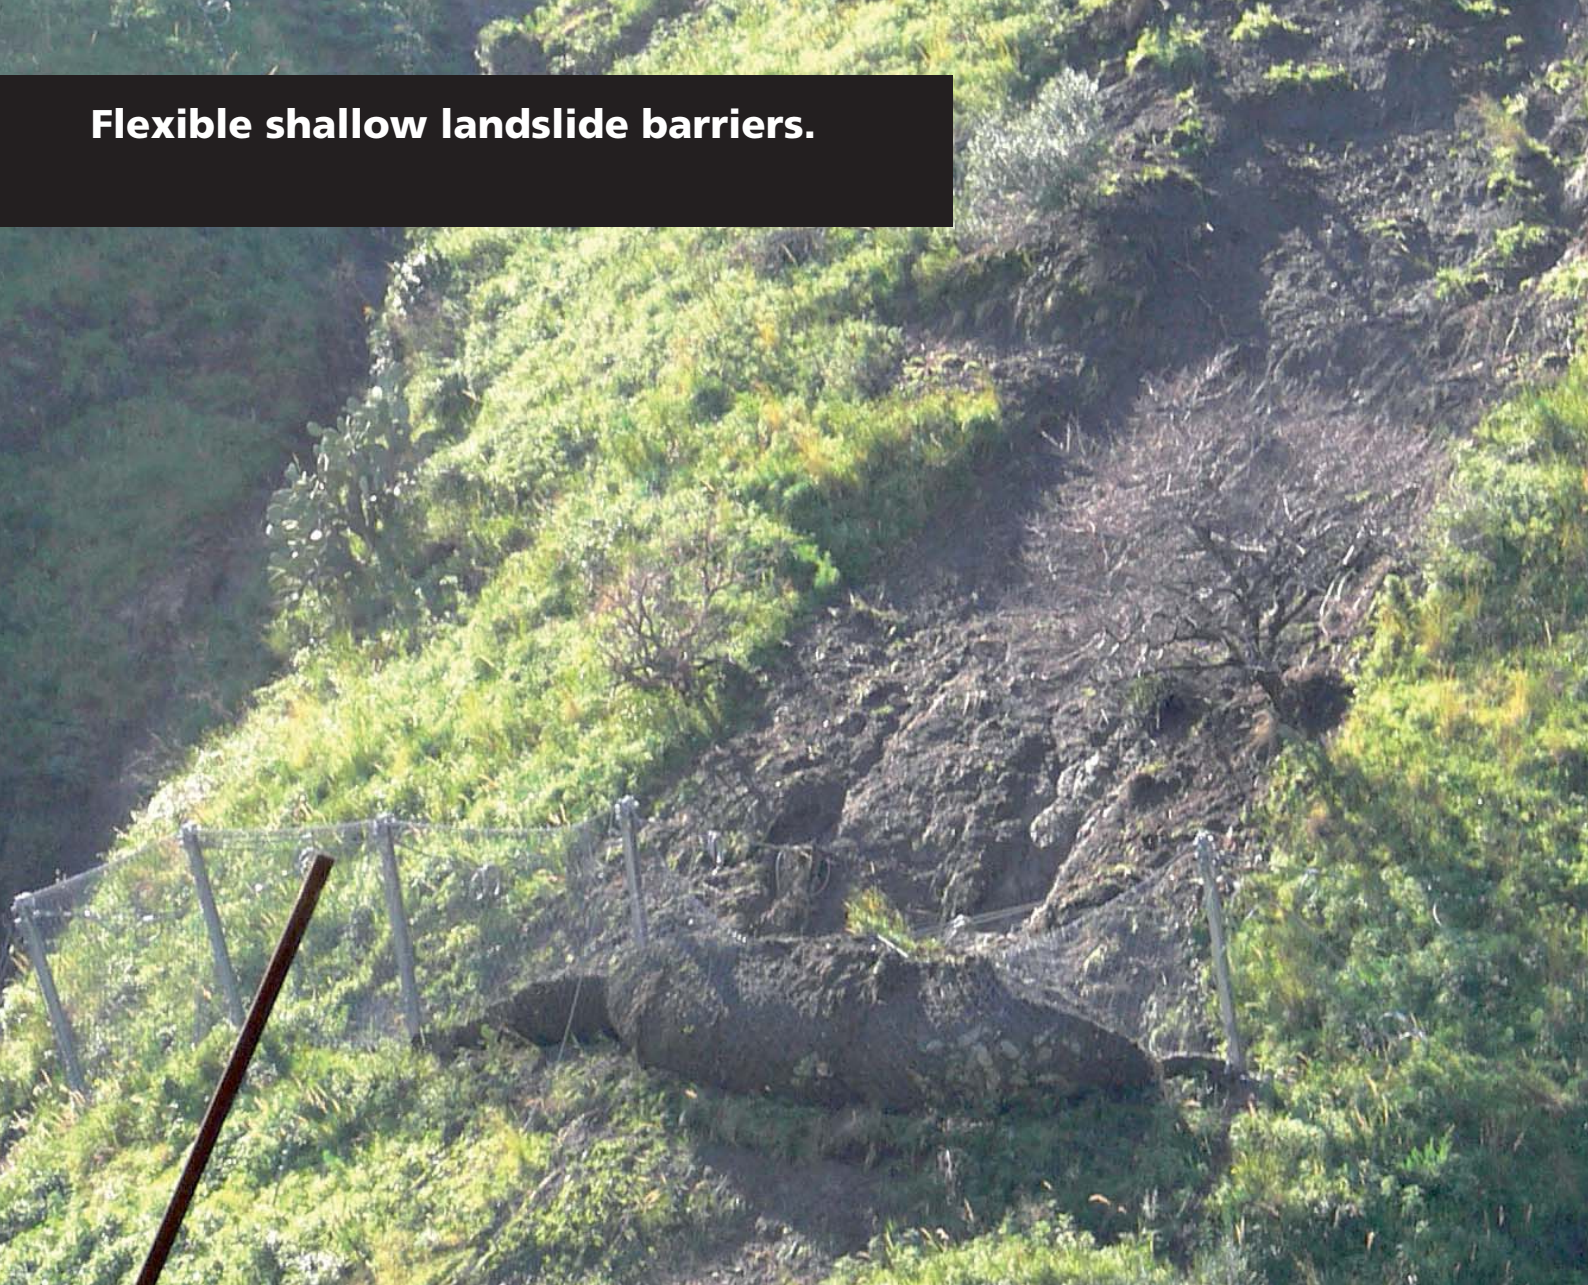
1. Shallow landslide barrier SL 130/150 for pressure up to 150 kN/m²

A SPIDER® spiral rope net together with a secondary mesh with a mesh width of 50 mm is installed in the danger zone, with posts installed up to eight meters apart. The retaining ropes and the upper and lower support ropes affixed to the ends of the protective structure are fitted with brake rings. This type of protective structure is suitable for use with a span width of up to 30 m without support rope separation and a construction height of up to 4 m. It can withstand pressure of up to 150 kN/m².

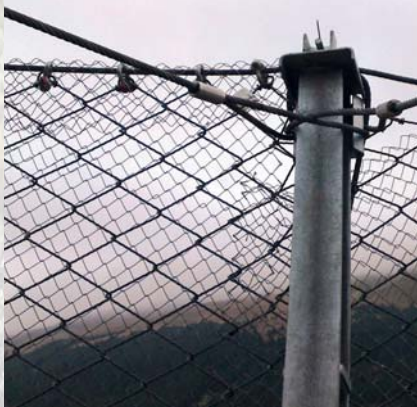
The SPIDER® spiral rope net — manufactured from a spiral rope made of high-strength 4 mm steel wires has a tensile strength of more than 1770 N/mm². The spiral rope net made with a rhomboid mesh shows a load capacity of 220 kN/m lengthwise.

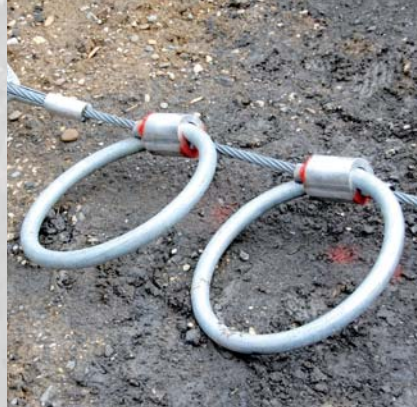
The brake ring

Brake rings are incorporated in the support and retaining ropes. With major events the brake rings are activated, dissipating energies from the SPIDER® spiral rope net without damaging the ropes. The rope breaking load is not reduced by the activation of the brakes, enabling the force-path characteristic to be fully utilized.

The main replacement parts are the brake rings: After events they must be inspected and changed where necessary. We also recommend that nets and ropes are inspected for serviceability.

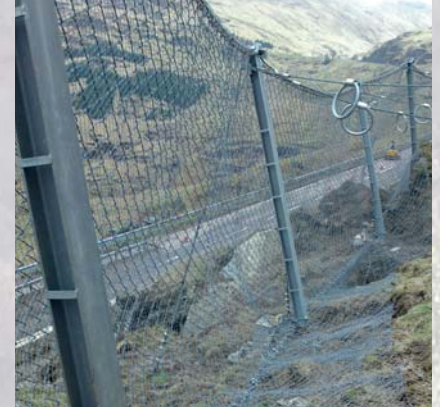
The posts

For shallow landslide barriers we use posts of type RXI, that are mounted on a baseplate via a link. Their function is to guide the ropes to which the SPIDER® spiral rope net is suspended. The associated guides are rounded to protect these support ropes.

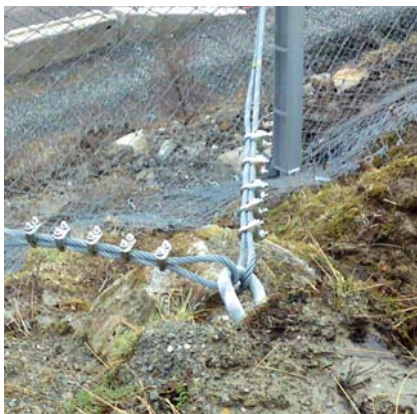
The spiral rope anchors

'If it can bend it won't break': The heads of our anchors are flexible and thus unsusceptible to impact. The spiral rope is made from steel wires with a strength of 1770 N/mm². Our spiral rope anchors are superior to traditional anchors — because they are also suitable for diverting forces in the direction of tension that can deviate by up to 30 degrees from the drill axis without loss of supporting capacity.

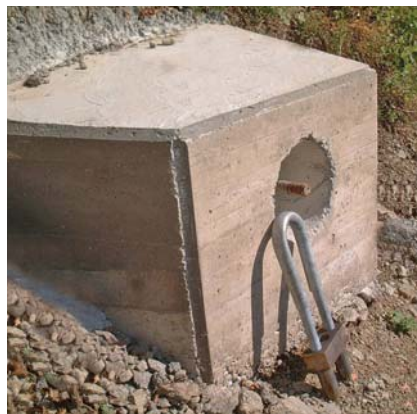
Self-drilling anchor with Geobrugg FLEX head

The FLEX head absorbs tension and bending forces according to the same principle as the head of the Geobrugg spiral rope anchor. It is unsusceptible to impact and can be mounted to self-drilling anchors available on the market. A concrete foundation is required for the transition from the anchor bar to the FLEX head.

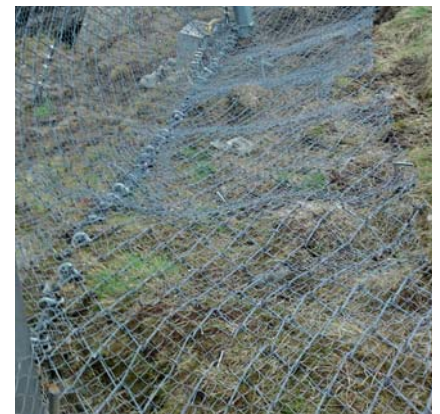
Protective mesh apron

A protective apron is installed across the entire width of the barrier to form an erosion seal between it and the ground below and to prevent erosion and material seepage.

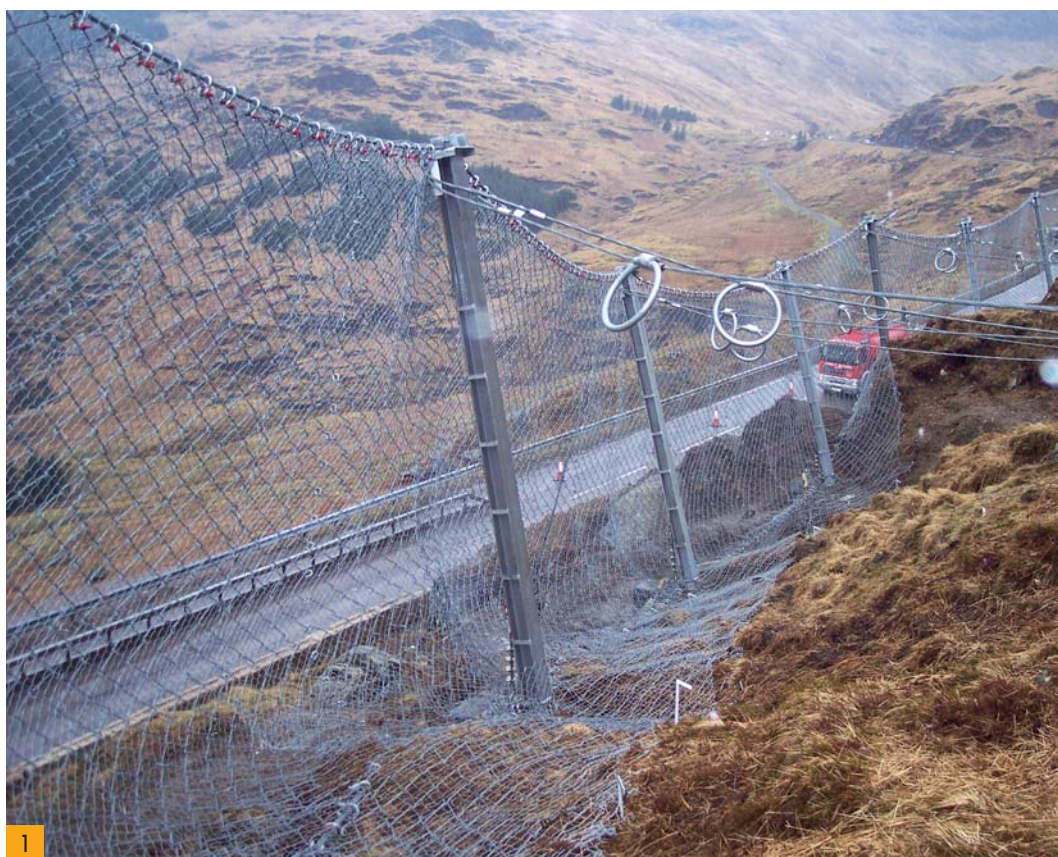
Rest and be Thankful, Scotland

A shallow landslide barrier 80 m long and 4 m high was installed, complete with a SPIDER® spiral rope net and a secondary mesh with a mesh width of 50 mm. As a combined measure, an additional VX debris flow barrier, 15 m long and 4 m high and fitted with ROCCO ring nets, was installed in an adjacent gully to prevent material seepage from flooding beneath the road.

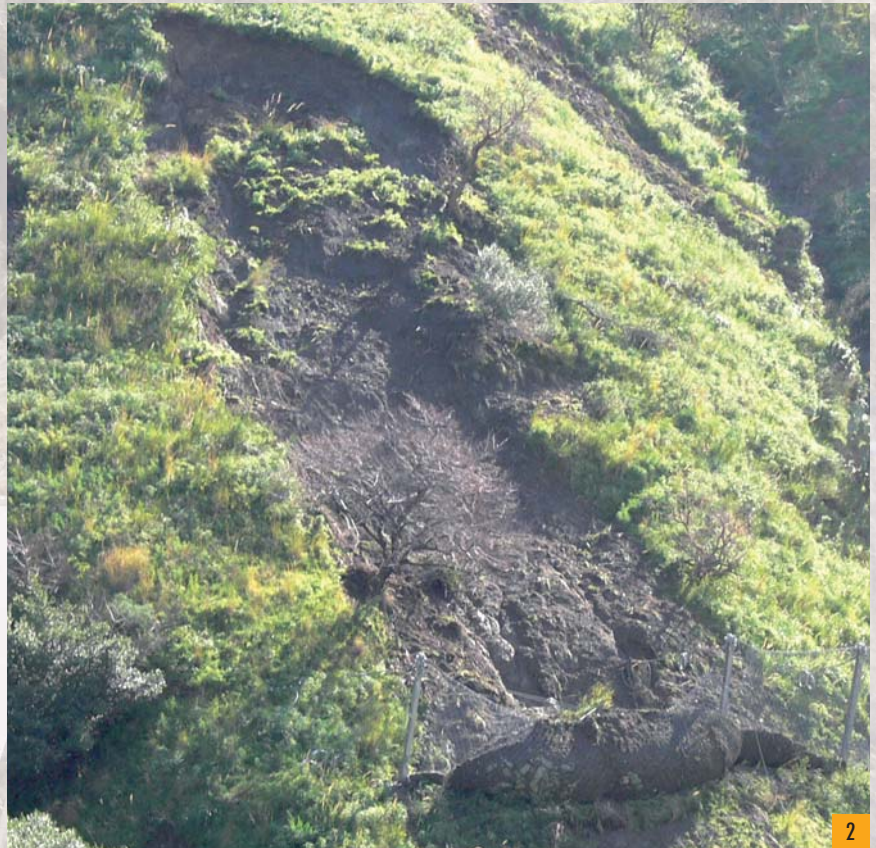
Giampilieri, Sicily, Italy

To protect the highway, debris flow barriers were installed on the steepest part of the slope. Where the slope was less steep – approx. 60 degrees – two 3.5 meter high flexible shallow landslide barriers were installed, one 25 and one 60 meters long and both fitted with a SPIDER S4/130 spiral rope net and secondary mesh, covering a total length of 85 meters. Heavy rain in January 2010 triggered a further shallow landslide. Around 90 m³ of material was successfully retained by the shorter of the two shallow landslide barriers, preventing the highway from having to be closed once again.

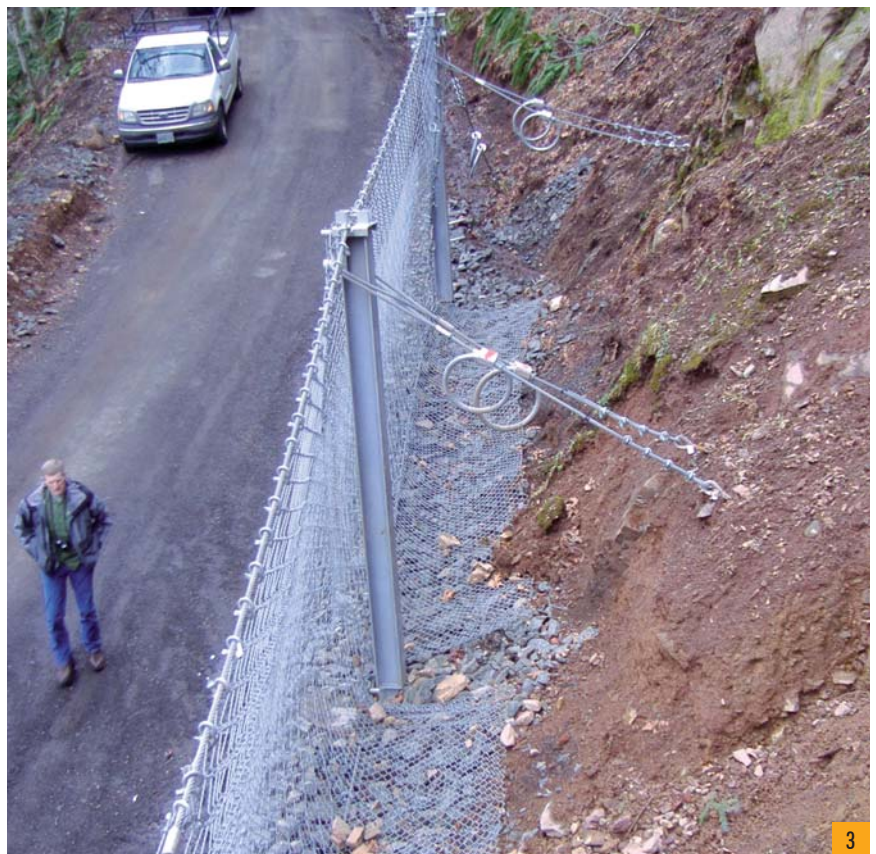
Lake Merwin, Washington, USA

In 2008, a wet snow storm in Amboy, Lake Merwin, Washington State, USA, triggered a shallow landslide, burying the road and damaging houses further down from the road. Loose masses of earth and unconsolidated soil on the steep slope posed a continued threat to the road and houses.

To guard against a further shallow landslide, a 3-meter-high and 15-meter-long flexible shallow landslide barrier was installed, complete with SPIDER® S4/130 spiral rope net and secondary mesh. The barrier was dimensioned using FARO simulation software, which is calibrated using data from large-scale field tests.

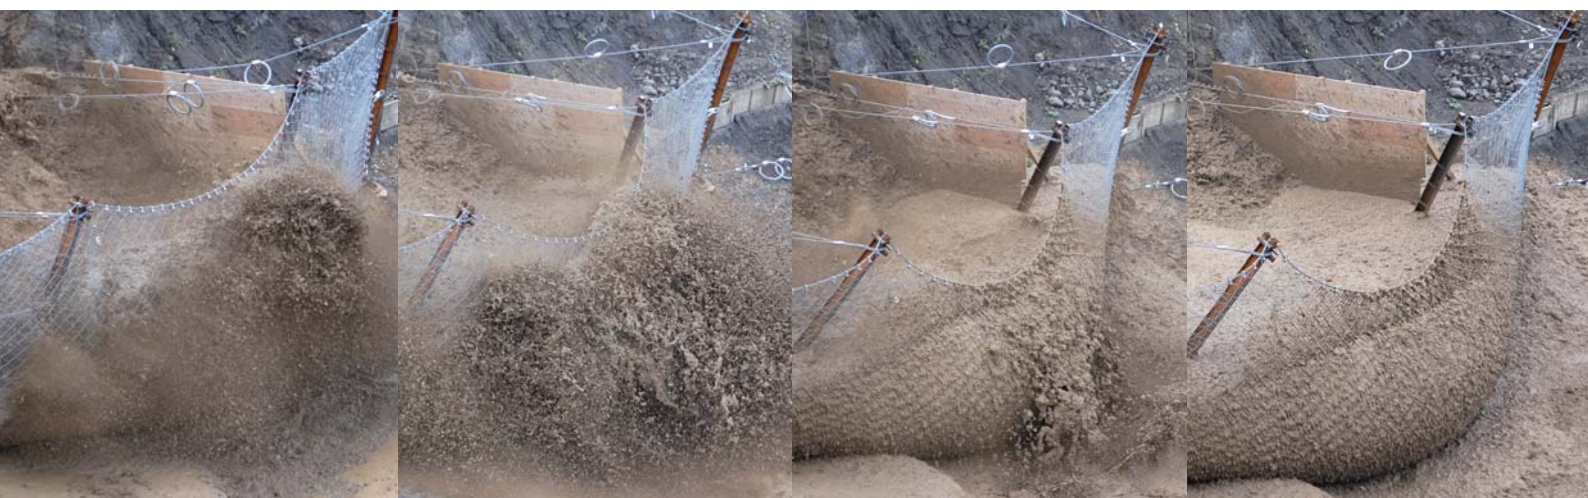
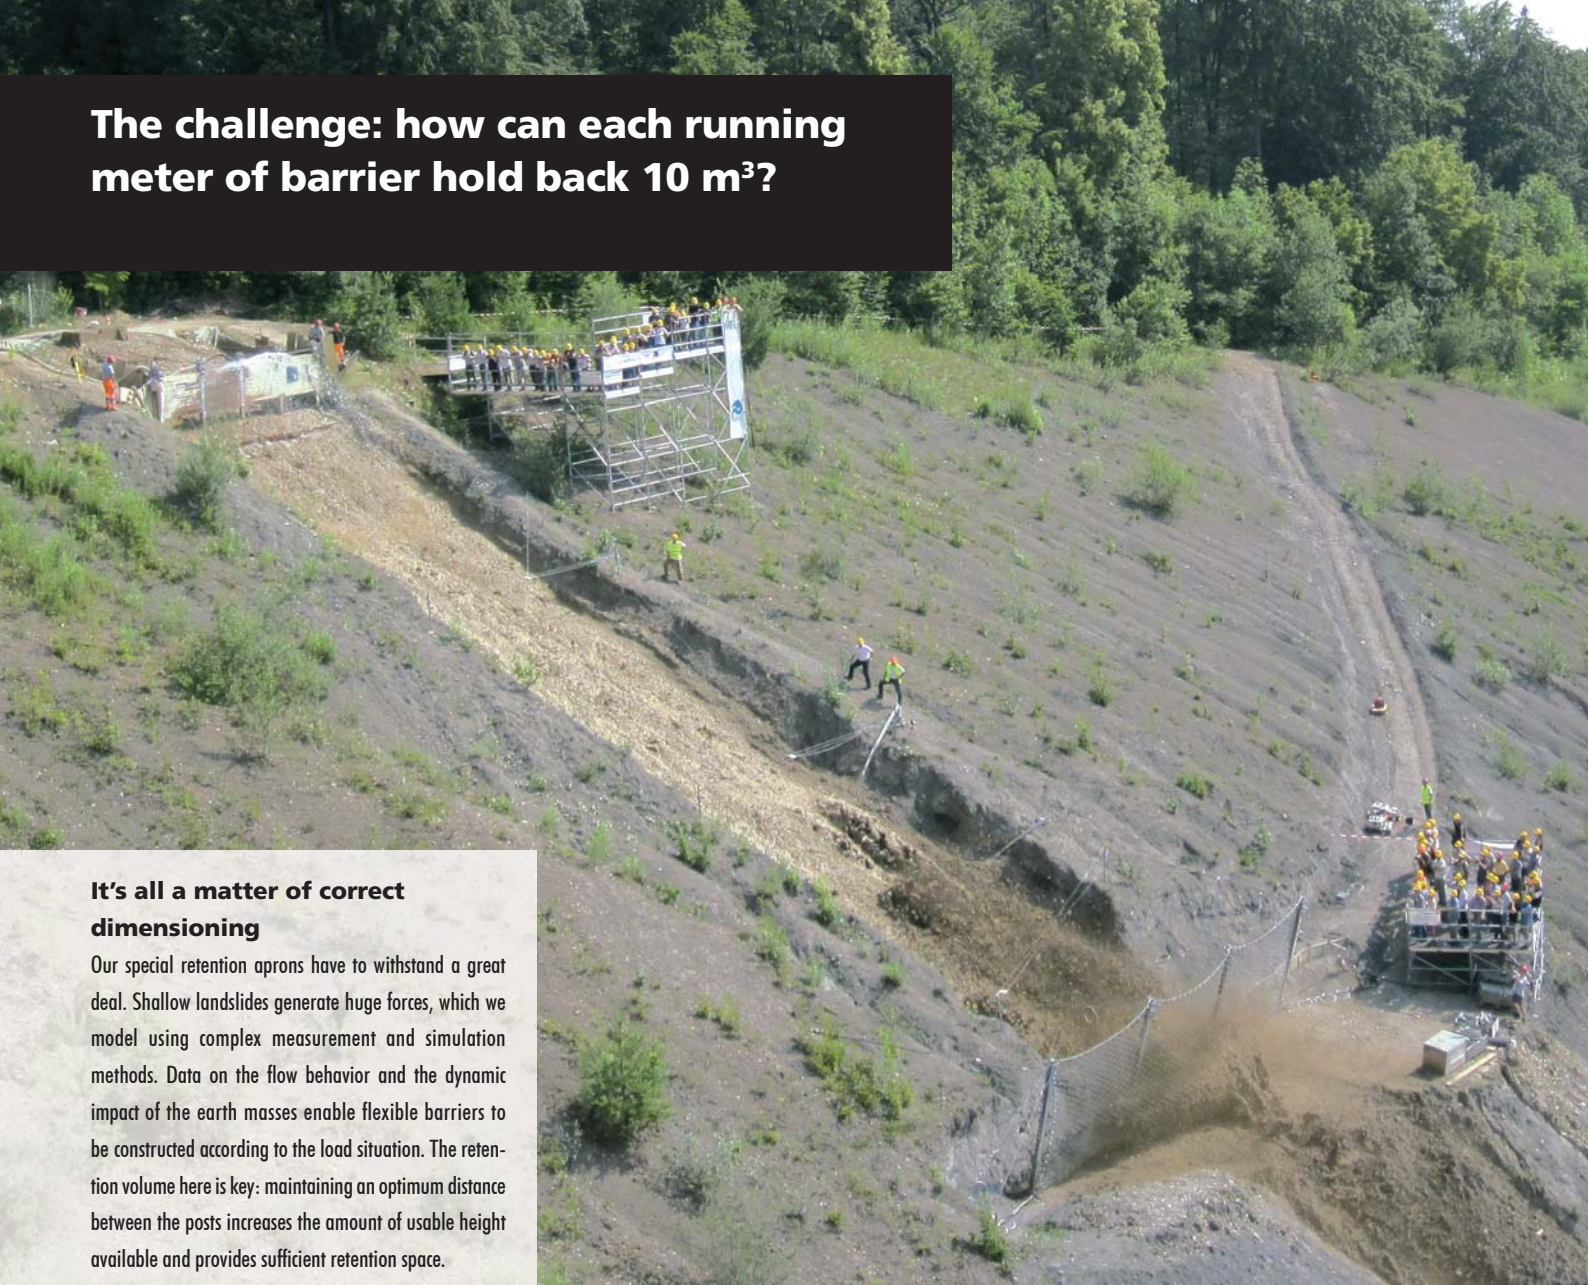
Under static and multiple load

After the first landslide, the net is filled evenly with mud, earth and rubble. Behind the barrier, a hydrostatic pressure distribution (P_{hyd}) initially builds up across the fill depth (h_{fill}). As the water drains away, this pressure is reduced to an active earth pressure (P_{stat}). If another landslide strikes, its dynamic pressure will overlap with the pressure exerted by the material still partially filling the barrier (picture-session below).

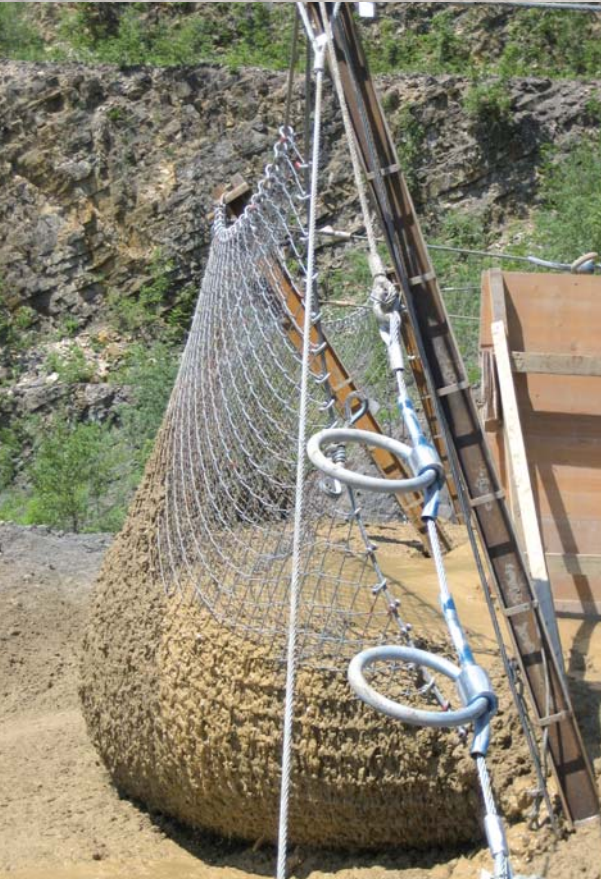
Geometric proportions of a filled shallow landslide net

- l_b = impact width
- ϕ_{ab} = inclination of retained material
- h_b' = reduced net height following impact
- h_{fill} = fill depth of the shallow landslide net
- l_{fill} = fill length of the shallow landslide net

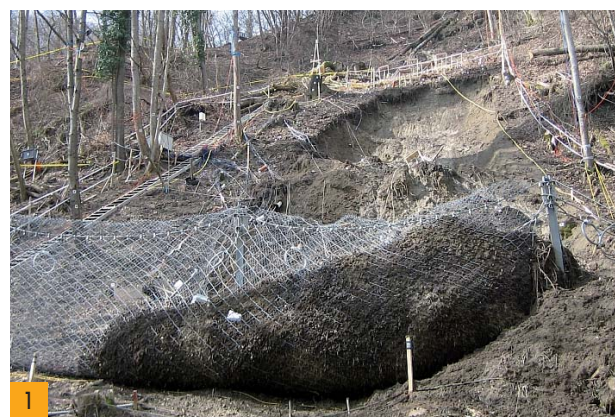
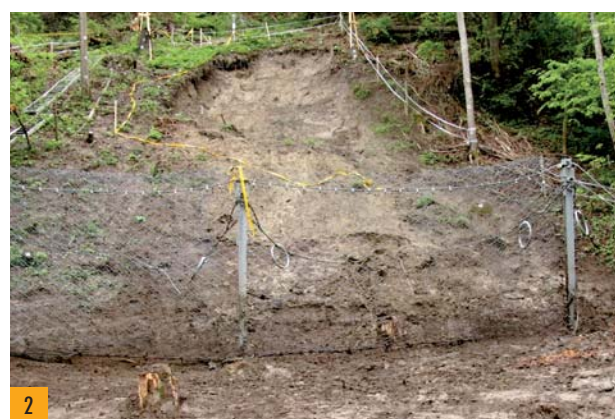
The easiest way is emptying the barrier from behind if accessible. More frequently the emptying happens from the front, as the deposit cone, compressed during the impact, is very stable. Nevertheless, the material can be excavated also from the front without dismantling the barrier (image above).

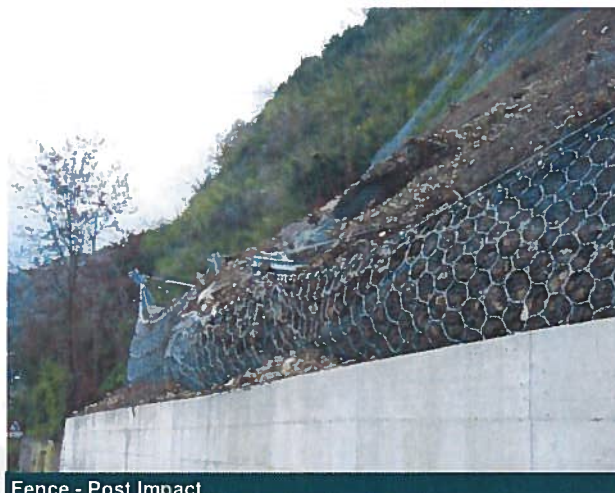
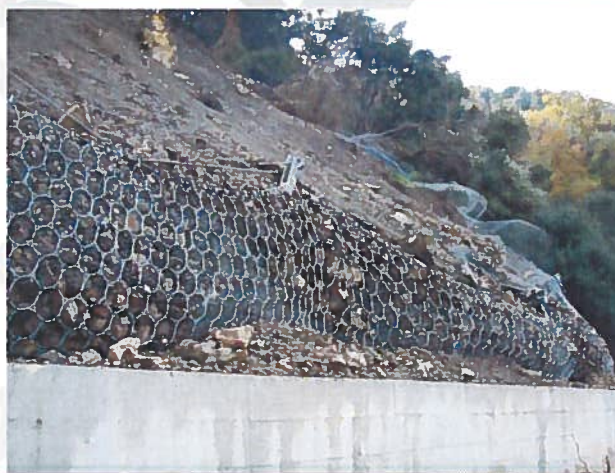
Fence - Post Impact

Maccaferri worked closely with the designer to provide the required Type 3 DF Series fences. During heavy rains in Autumn 2010 the site suffered a catastrophic slope failure manifested as a debris flow.

Despite being far in excess of the design volume and parameters of the predicted flow the DF Series fence held the material with no component failures and prevented any injuries from being sustained below the failure.

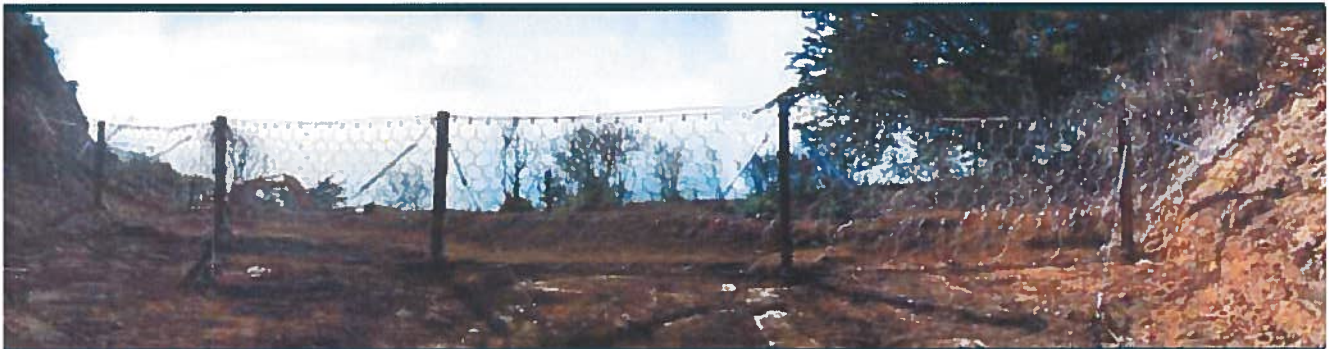
Completed Debris Flow Barrier

The four barriers ranged in dimension from 120 feet in length and 16 feet in height. The Maccaferri debris flow barrier is similar to the rockfall barrier, but has several differences, such as additional breaking elements and variable geometries. In addition, a combination of one foot and three foot diameter ring nets were used. The larger diameter ring nets were placed along the bottom of the structure in order to allow the small material and water to flow through. The barriers were designed to be in place until vegetation is re-established. They can then be removed leaving the foundation intact. They can be reinstalled if risks from debris flows increase in the future.

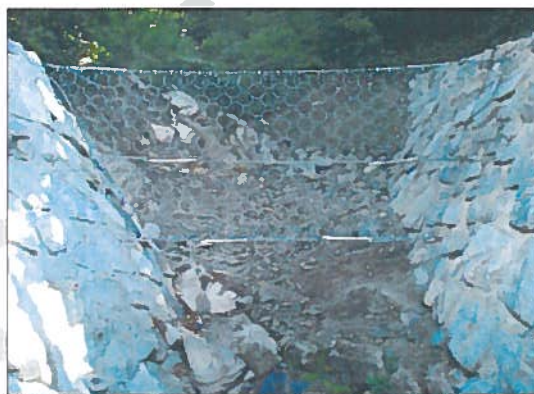
Fig. 3. OM CTR DF Barrier

The components are made to reduce the damages after impact, minimizing the maintenance operations. The post are free released by the mesh and their main function is holding the upper longitudinal cable. The posts can be left out if the barrier will be install in small size channel. The upslope bracing cables are equipped with brakes to minimizing the effect of the impacts. When a post is damaged, the next one can still afford the barrier functionality. The main mesh is made by steel rings. Special panels can be installed on the barrier sides to close eventually openings whether the structure has been installed into channel. In case of request, the barrier could be send together with another DT net, used to stop the most fine materials.

Series DF Barriers can be installed on each type of land, both on open slopes and depressions with difficult morphology. Their geometry configuration reduces both the impacting forces and consequently the entity of the foundations. The post foundations are made by steel bars or micropile. Even if shown in the installation manual, the double twist mesh is generally useless and/or dangerous for debris flow barriers. Therefore it will be supplied upon request only. DT mesh function is contain smaller parts of the debris mass, with a global higher loading of the entire structure as consequence, caused by the regular hydraulic flows impediment. DT mesh can be request to stop smaller elements for infrastructures protection when the barrier (with posts) is installed on open slopes. Otherwise, when this type of structures (without posts) are installed into channel, far from sensitive infrastructures, the ring mesh only is suggested (in order to help the passage of water). The barrier could also be used as protection against rockfall (they are not tested in accordance to ETAG 027). The system is easy to install, with difficult conditions as well. The assemblage can be done shortly. Maintenance is necessary after impact.
