## Appendix 13.1

Baseline Noise Measurements, 2008

## Appendix 13.2

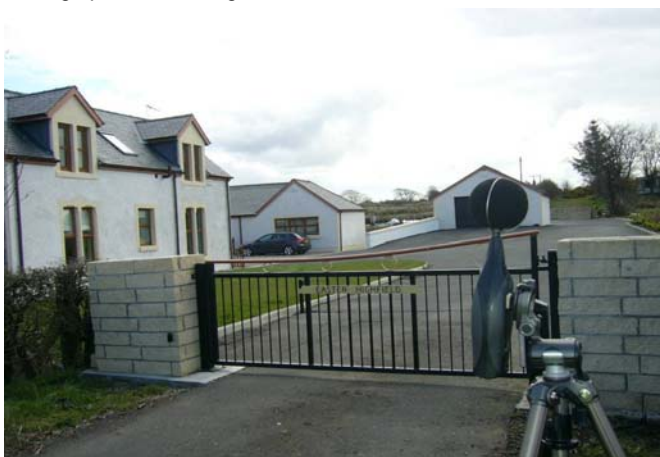
*Photograph 1 Easter Highfield measurement location*

The measurement location was 3.5m from the western facing property gates, which in turn was approximately 75m east of the A737. The sound level meter was located 1.2m above the ground in free field conditions. The monitoring equipment was calibrated both before and after the measurement period using an acoustic calibrator, which has itself been calibrated against a reference set traceable to National and International Standards. There was no significant shift in the observed calibration level.

At the time of measurement, the dominant noise at this location was road traffic noise arising from the A737. Also present was noise associated with intermittent dog barking and occasional birdsong, throughout the measurement procedure.

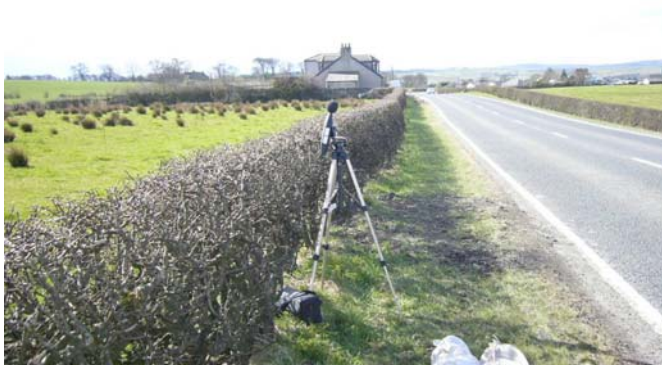
Photograph 2 Pasturehill Cottage measurement location

The measurement location was approximately 75m north east of the property boundary approximately 2m back from the near carriageway of the A737. This measurement position was at the request of the tenants of Pasturehill Cottage so as not to disturb the dogs within the dog kennels situated within the property grounds. The sound level meter was located 1.2m above the ground in free field conditions. The monitoring equipment was calibrated both before and after the measurement period using an acoustic calibrator, which has itself been calibrated against a reference set traceable to National and International Standards. There was no significant shift in the observed calibration level.

At the time of measurement, the dominant noise at this location was road traffic noise arising from the A737. Also present was occasional birdsong and intermittent dogs barking.

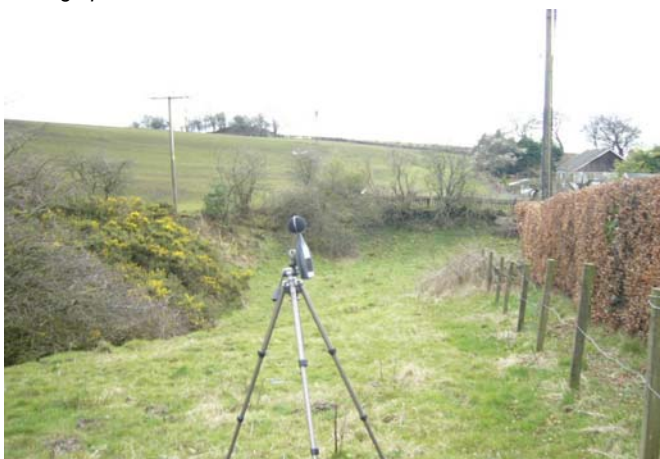
*Photograph 3 Greenacre measurement location*

The measurement location was 3.5m from the eastern facing garden boundary fence, which in turn was approximately 7m from the eastern façade of the property. The sound level meter was located 1.2m above the ground in free field conditions. The monitoring equipment was calibrated both before and after the measurement period using an acoustic calibrator, which has itself been calibrated against a reference set traceable to National and International Standards. There was no significant shift in the observed calibration level.

At the time of measurement, the dominant noise at this location was road traffic noise arising from the A737 situated, at its nearest point, approximately 55m to the west of the measurement location. Also present was occasional birdsong.

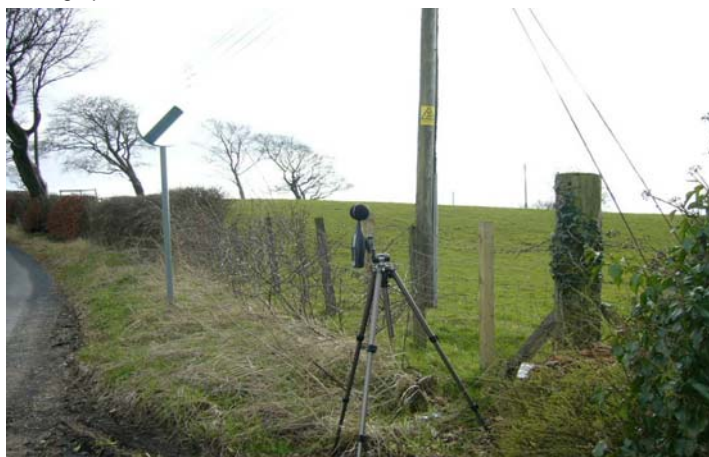
Photograph 4 Suilven measurement location

The measurement location was 1m from the access road to the A737, which in turn was approximately 7m from the south eastern corner of the property. The sound level meter was located 1.2m above the ground in free field conditions. The monitoring equipment was calibrated both before and after the measurement period using an acoustic calibrator, which has itself been calibrated against a reference set traceable to National and International Standards. There was no significant shift in the observed calibration level.

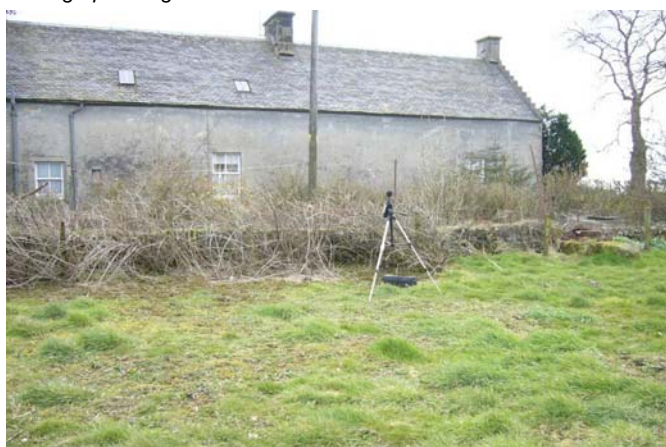
*Photograph 5 Highfield Farm measurement location*

The measurement location was 2m from the northwest facing garden boundary wall, which in turn was approximately 7.5m from the north western façade of the property. The sound level meter was located 1.2m above the ground in free field conditions. The monitoring equipment was calibrated both before and after the measurement period using an acoustic calibrator, which has itself been calibrated against a reference set traceable to National and International Standards. There was no significant shift in the observed calibration level.

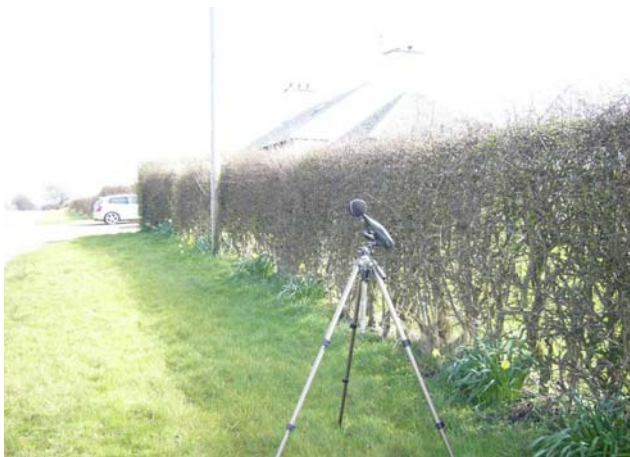
Photograph 6 Highfield Cottage measurement location

The measurement location was 3.5m from the north western facing garden boundary hedge, which in turn was approximately 9m from the north western façade of the property. The sound level meter was located 1.2m above the ground in free field conditions. The monitoring equipment was calibrated both before and after the measurement period using an acoustic calibrator, which has itself been calibrated against a reference set traceable to National and International Standards. There was no significant shift in the observed calibration level.

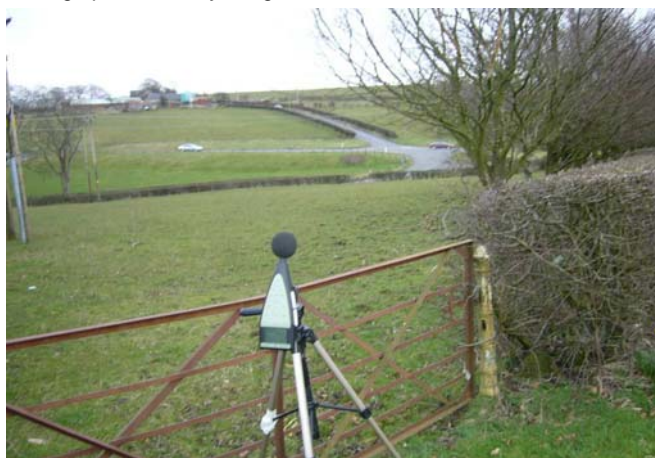
Photograph 7 Jimmary Lodge measurement location

The measurement location was approximately 40m south-east from the nearest facade of Jimmary Lodge. However this measurement location was considered to be representative of the noise climate at the Jimmary Lodge property. The sound level meter was located 1.2m above the ground in free field conditions. The monitoring equipment was calibrated both before and after the measurement period using an acoustic calibrator, which has itself been calibrated against a reference set traceable to National and International Standards. There was no significant shift in the observed calibration level.

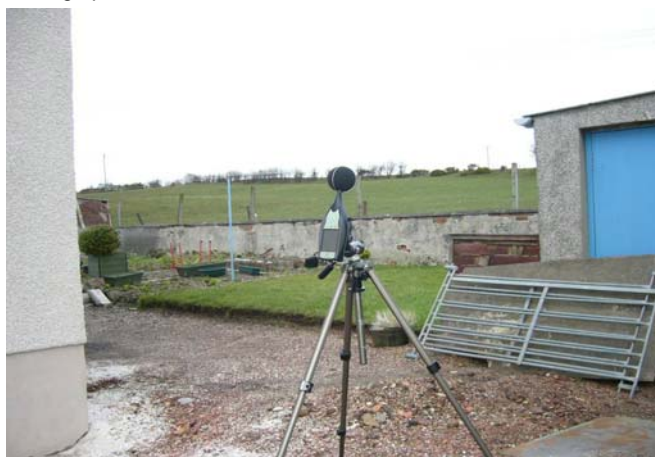
*Photograph 8 Glenfield measurement location*

The measurement location was 3.5m from the southern façade of the property, which in turn was approximately 25m from the A737, to the west. The sound level meter was located 1.2m above the ground in free field conditions. The monitoring equipment was calibrated both before and after the measurement period using an acoustic calibrator, which has itself been calibrated against a reference set traceable to National and International Standards. There was no significant shift in the observed calibration level.

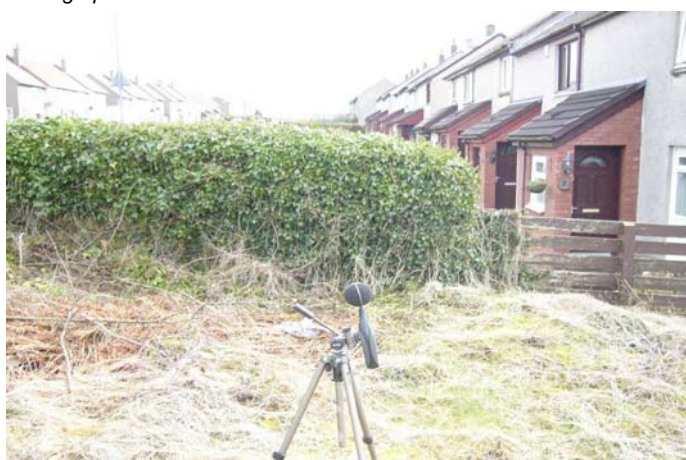
Photograph 9 8 Blair Road measurement location

The measurement location was 3.5m from the eastern facing garden boundary fence, which in turn was approximately 7m from the eastern façade of the property. The sound level meter was located 1.2m above the ground in free field conditions. The monitoring equipment was calibrated both before and after the measurement period using an acoustic calibrator, which has itself been calibrated against a reference set traceable to National and International Standards. There was no significant shift in the observed calibration level.

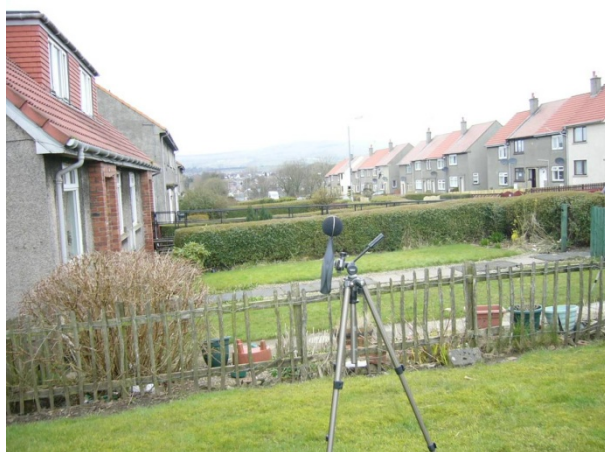
*Photograph 10 42 Blair Road measurement location*

The measurement location was 3.5m from the eastern facing garden boundary fence, which in turn was approximately 7m from the eastern façade of the property. The sound level meter was located 1.2m above the ground in free field conditions. The monitoring equipment was calibrated both before and after the measurement period using an acoustic calibrator, which has itself been calibrated against a reference set traceable to National and International Standards. There was no significant shift in the observed calibration level.

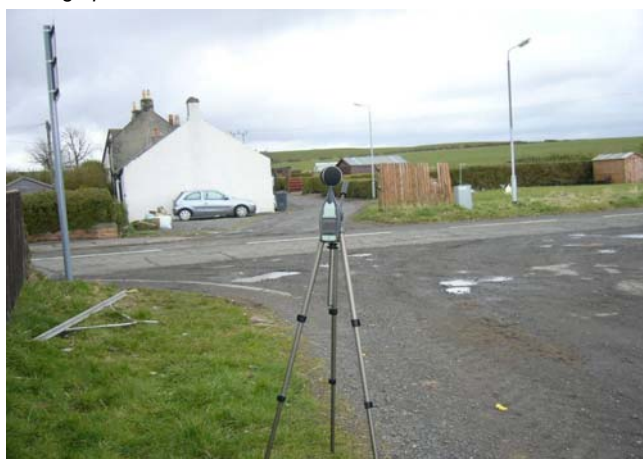
Photograph 11 78 Blair Road measurement location

The measurement location was 3.5m from the eastern facing garden boundary fence, which in turn was approximately 9m from the eastern façade of the property. The sound level meter was located 1.2m above the ground in free field conditions. The monitoring equipment was calibrated both before and after the measurement period using an acoustic calibrator, which has itself been calibrated against a reference set traceable to National and International Standards. There was no significant shift in the observed calibration level.

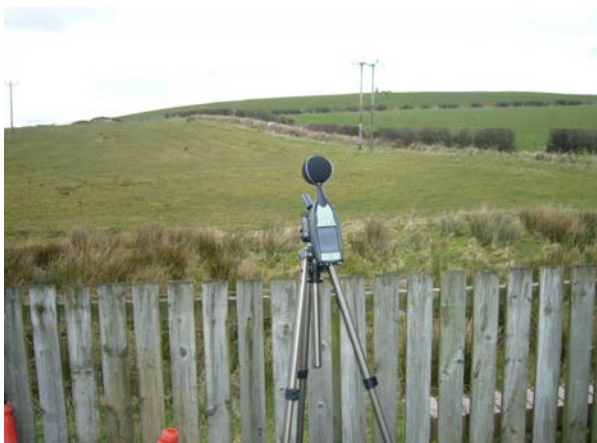
*Photograph 12 40 Kerse Avenue measurement location*

The measurement location was 3.5m from the north facing garden boundary fence, which in turn was approximately 3.5m from the northern façade of the property. The sound level meter was located 1.2m above the ground in free field conditions. The monitoring equipment was calibrated both before and after the measurement period using an acoustic calibrator, which has itself been calibrated against a reference set traceable to National and International Standards. There was no significant shift in the observed calibration level.

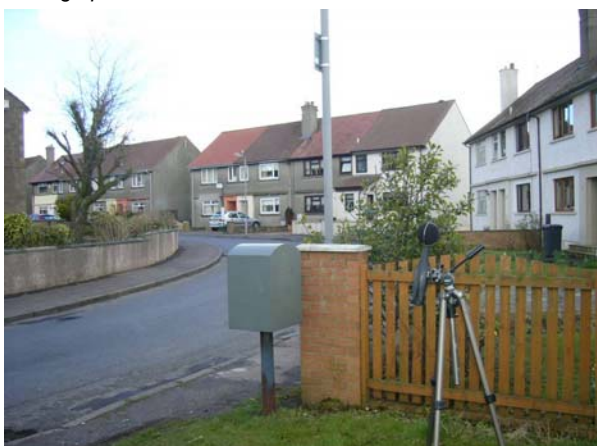
Photograph 13 71 Baidland Road measurement location

The measurement location was 3.5m from the western facing garden boundary fence, which in turn was approximately 8m from the western façade of the property. The sound level meter was located 1.2m above the ground in free field conditions. The monitoring equipment was calibrated both before and after the measurement period using an acoustic calibrator, which has itself been calibrated against a reference set traceable to National and International Standards. There was no significant shift in the observed calibration level.

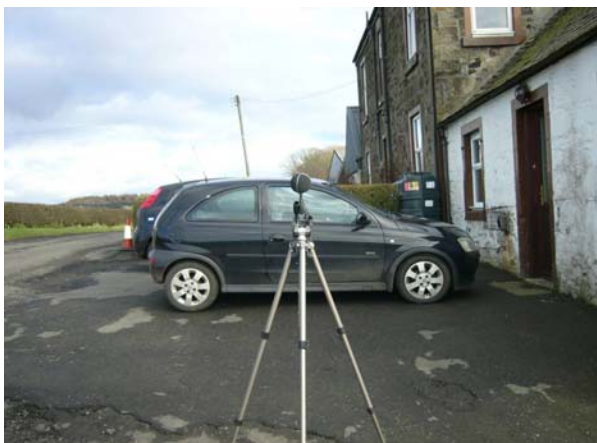
Photograph 14 Stoopshill Farm measurement location

The measurement location was 3.5m from the northern façade of the farm shop which is approximately 500m from the A737, at its nearest point. The sound level meter was located 1.2m above the ground in free field conditions. The monitoring equipment was calibrated both before and after the measurement period using an acoustic calibrator, which has itself been calibrated against a reference set traceable to National and International Standards. There was no significant shift in the observed calibration level.

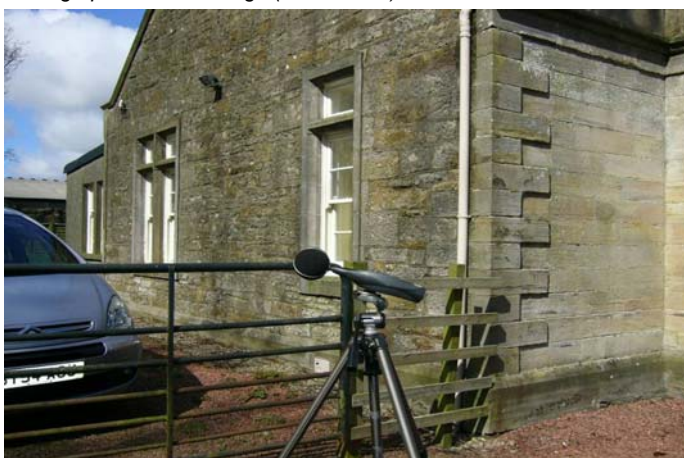
*Photograph 15 North Lodge (Blair Estate) measurement location*

The measurement location was 3.5m from the south western façade of the property. The sound level meter was located 1.2m above the ground in free field conditions. The monitoring equipment was calibrated both before and after the measurement period using an acoustic calibrator, which has itself been calibrated against a reference set traceable to National and International Standards. There was no significant shift in the observed calibration level.

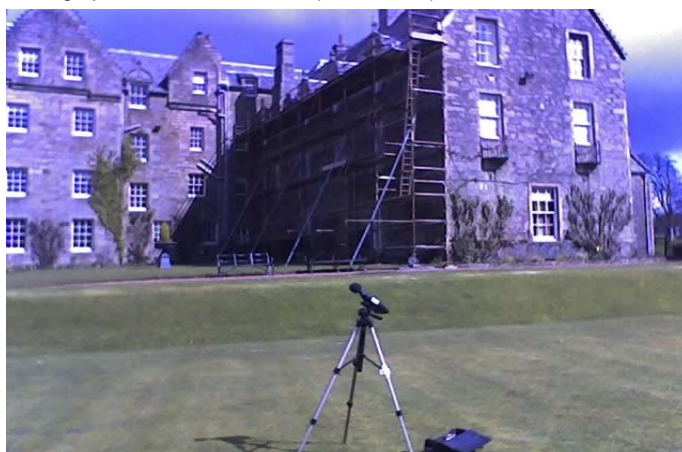
Photograph 16 The Main House (Blair Estate) measurement location

The measurement location was approximately 25m from the south western façade of the property, on the lawn. The sound level meter was located 1.2m above the ground in free field conditions. The monitoring equipment was calibrated both before and after the measurement period using an acoustic calibrator, which has itself been calibrated against a reference set traceable to National and International Standards. There was no significant shift in the observed calibration level.

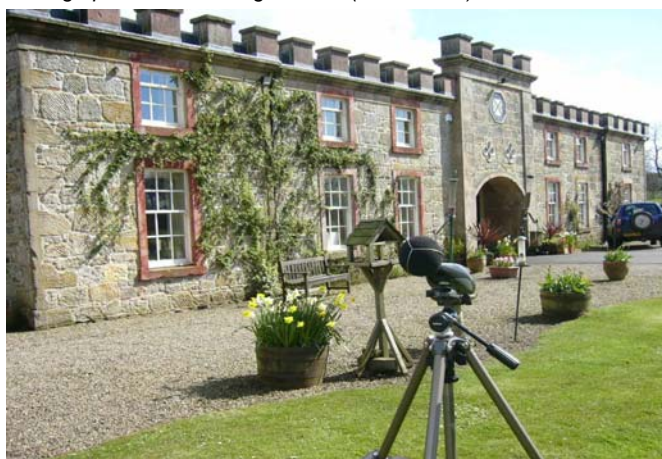
*Photograph 17 The Carriage House (Blair Estate) measurement location*

The measurement location was 7m from the south western façade of the property, on the lawn. The sound level meter was located 1.2m above the ground in free field conditions. The monitoring equipment was calibrated both before and after the measurement period using an acoustic calibrator, which has itself been calibrated against a reference set traceable to National and International Standards. There was no significant shift in the observed calibration level.

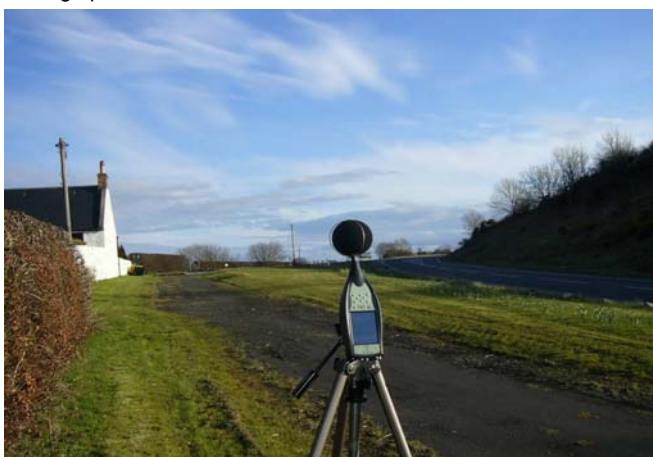
*Photograph 18 Hillend Farm measurement location*

The measurement location was 3.5m from the western facing garden boundary, which in turn was approximately 8m from the near carriageway of the A737. The sound level meter was located 1.2m above the ground in free field conditions. The monitoring equipment was calibrated both before and after the measurement period using an acoustic calibrator, which has itself been calibrated against a reference set traceable to National and International Standards. There was no significant shift in the observed calibration level.

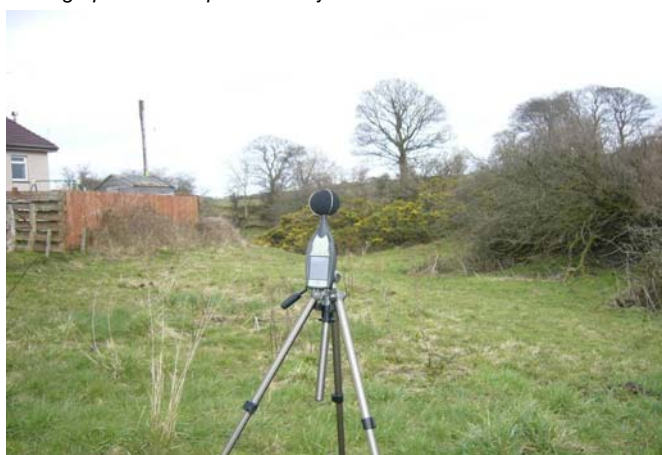
*Photograph 19 The open land adjacent to the Greenacre location*

The measurement location was 3.5m from the western boundary fence, which in turn was approximately 4m from the access road to the A737. The sound level meter was located 1.2m above the ground in free field conditions. The monitoring equipment was calibrated both before and after the measurement period using an acoustic calibrator, which has itself been calibrated against a reference set traceable to National and International Standards. There was no significant shift in the observed calibration level.

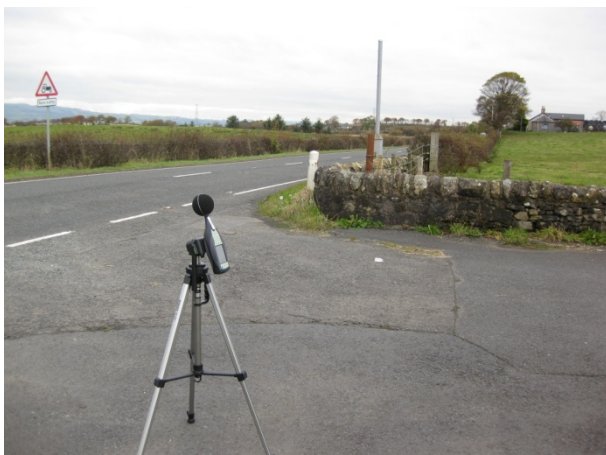
*Photograph 1 Easter Highfield daytime measurement location*

The daytime measurement location was 4m from the A737 at the entrance driveway to Easter Highfield Lodge. The sound level meter was located 1.2m above the ground in free field conditions.

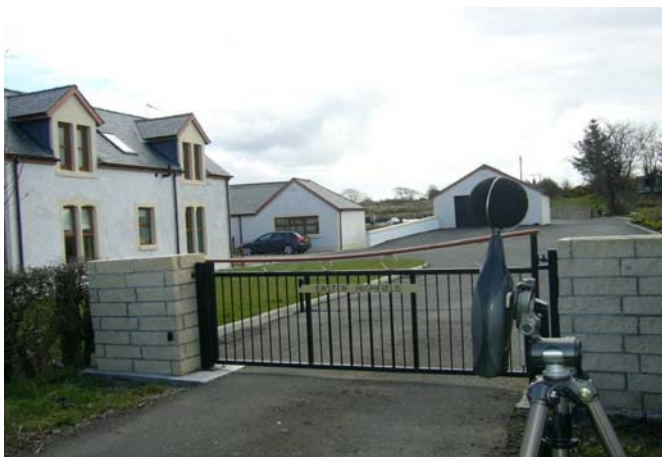
*Photograph 2 Indicative of the Easter Highfield night time measurement location*

The night time measurement location was 3.5m from the western facing property gates, which in turn was approximately 75m east of the A737. The sound level meter was located 1.2m above the ground in free field conditions.

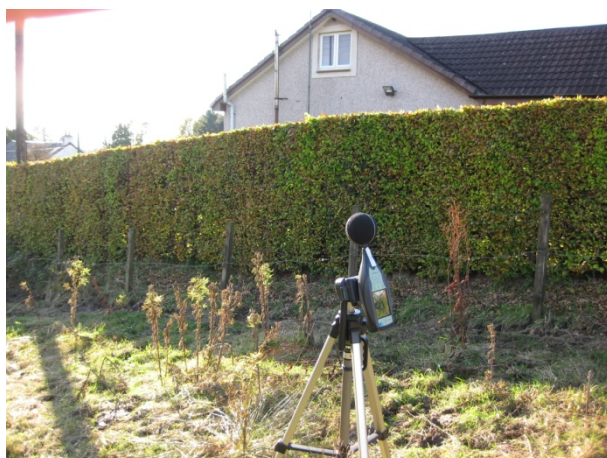
*Photograph 3 Greenacre daytime measurement location*

The measurement location was 3.5m from the eastern facing garden boundary fence, which in turn was approximately 7m from the eastern façade of the property. The sound level meter was located 1.2m above the ground in free field conditions.

During the daytime noise measurements, the dominant noise at this location was arising from road traffic movements along the A737, birdsong and the rustling of leaves in the nearby trees.

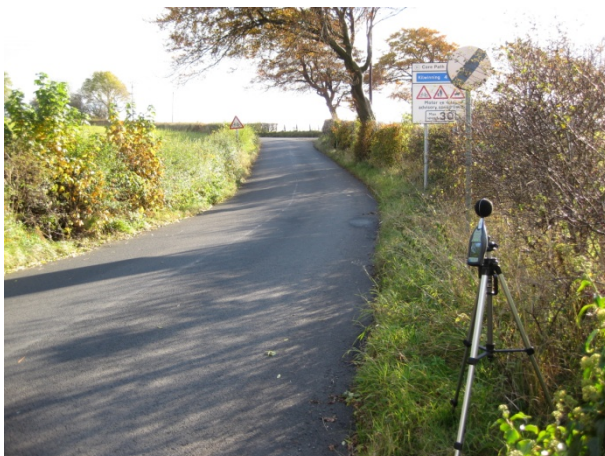
*Photograph 4 Suilven daytime measurement location*

The measurement location was 1m from the access road to the A737, which in turn was approximately 7m from the south eastern corner of the property. The sound level meter was located 1.2m above the ground in free field conditions.

During the daytime noise measurements, the dominant noise at this location was arising from road traffic movements along the A737 situated at its nearest point, approximately 65 meters to the west of Suilven. Birdsong and the rustling of leaves in the nearby trees were also noticeable during the measurement period.

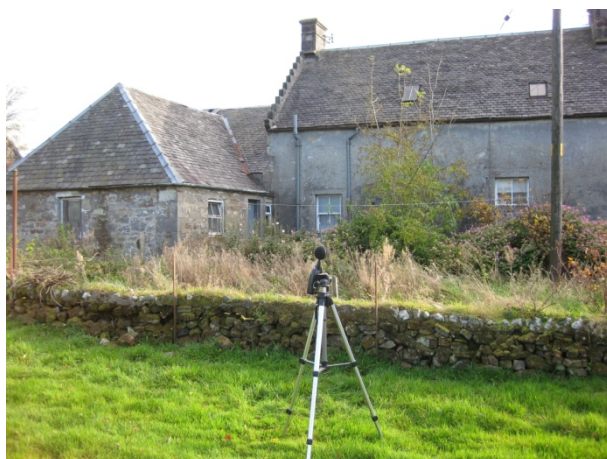
Photograph 5 Highfield Farm daytime measurement location

The day time measurement location was 2m from the northwest facing garden boundary wall, which in turn was approximately 7.5m from the north western façade of the property. The sound level meter was located 1.2m above the ground in free field conditions.

During the daytime and night time noise measurements, the dominant noise at this location was arising from road traffic movements along the A737. During periods of very low traffic movements on the A737 (particularly at night time), distant industrial noise was noticeable from a location north-west of the measurement location. During the daytime measurement periods, birdsong, the rustling of leaves on nearby trees and the occasional aircraft flying overhead were also noticeable.

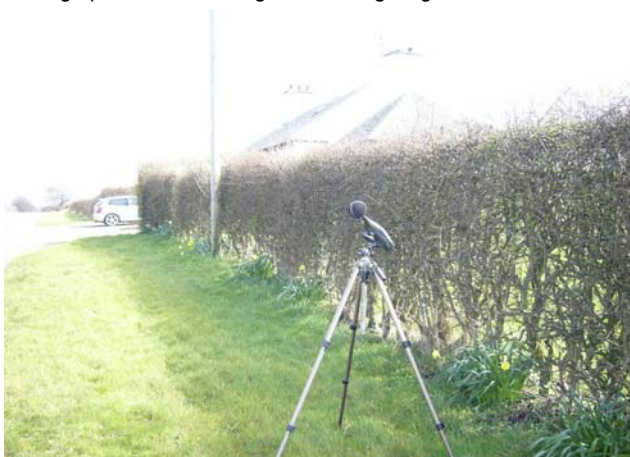
*Photograph 6 Indicative Highfield Cottage night time measurement location*

The night time measurement location was located on the grass verge to the west of the property. The sound level meter was located 1.2m above the ground in free field conditions.

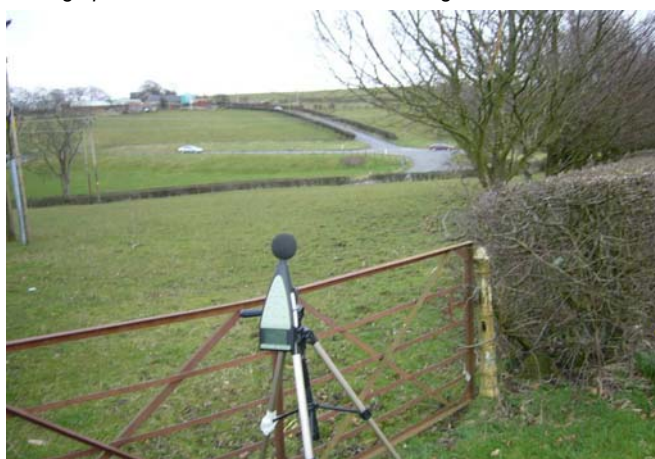
Photograph 7 Indicative of the 1 Carsehead night time measurement location

The measurement location was 3.5m from the property boundary facing south east towards the A737. The sound level meter was located 1.2m above the ground in free field conditions.

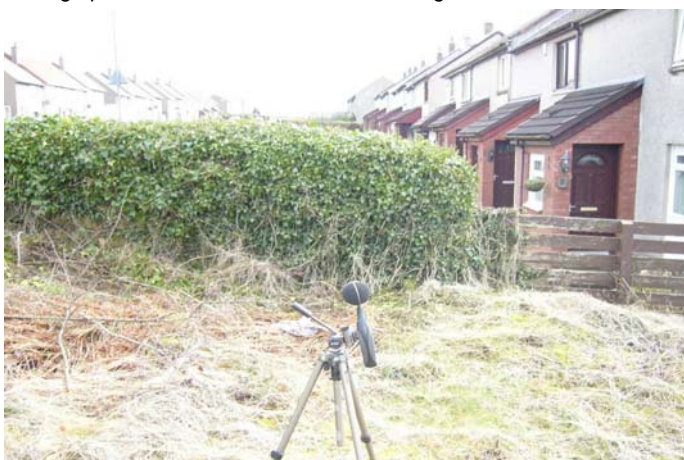
*Photograph 8 Indicative of the 8 Blair Road night time measurement location*

The measurement location was 3.5m from the eastern facing garden boundary fence, which in turn was approximately 7m from the eastern façade of the property. The sound level meter was located 1.2m above the ground in free field conditions.

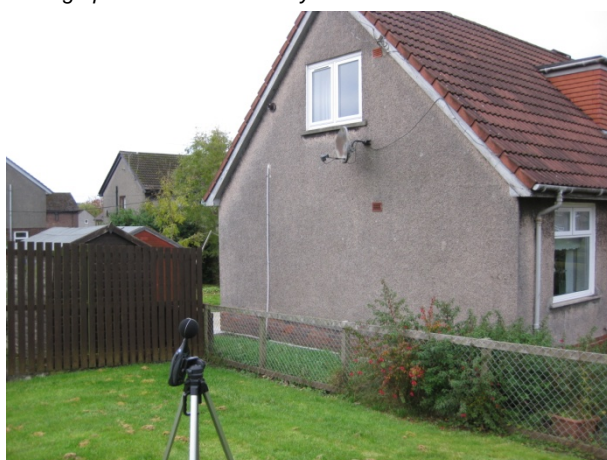
Photograph 9 42 Blair Road daytime measurement location

The daytime measurement location was 3.5m from the eastern facing garden boundary fence, which in turn was approximately 7m from the eastern façade of the property. The sound level meter was located 1.2m above the ground in free field conditions.

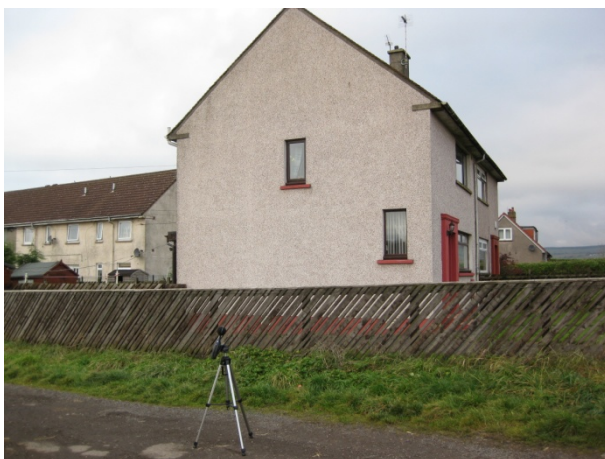
Photograph 10 78 Blair Road daytime measurement location

The daytime measurement location was 3.5m from the eastern facing garden boundary fence, which in turn was approximately 9m from the eastern façade of the property. The sound level meter was located 1.2m above the ground in free field conditions.

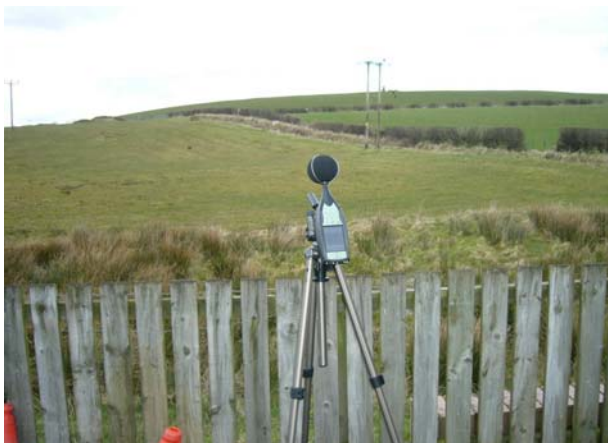
Photograph 11 Indicative of the 40 Kerse Avenue night time measurement location

The night time measurement location was 3.5m from the north facing garden boundary fence, which in turn was approximately 3.5m from the northern façade of the property. The sound level meter was located 1.2m above the ground in free field conditions.

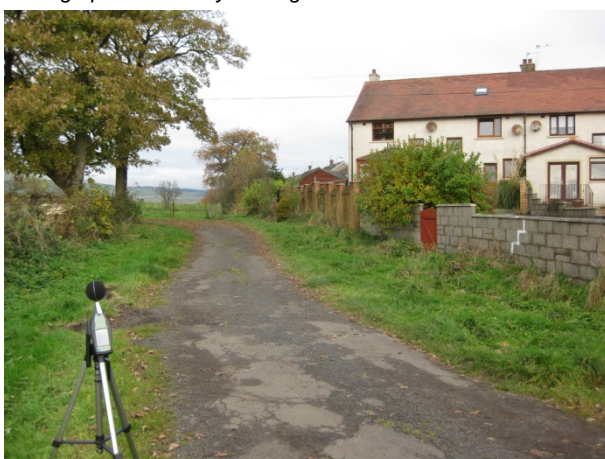
Photograph 12 13a daytime/night time measurement location

The daytime and night time measurement location was at the junction where the Blairlands farm driveway meets the track which is located along the south-eastern boundary of the properties which are on south-east side of Baidland Avenue. The sound level meter was located 1.2m above the ground in free field conditions.

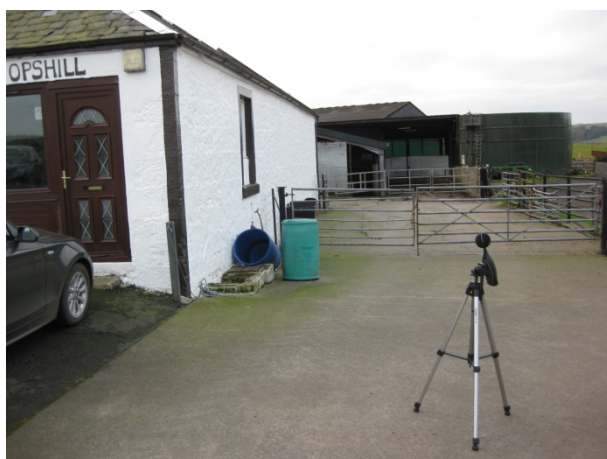
Photograph 13 Stoopshill Farm daytime measurement location

The daytime measurement location was 3.5m from the north-west corner of the façade of the farm shop which is approximately 500m from the A737, at its nearest point. The sound level meter was located 1.2m above the ground in free field conditions.

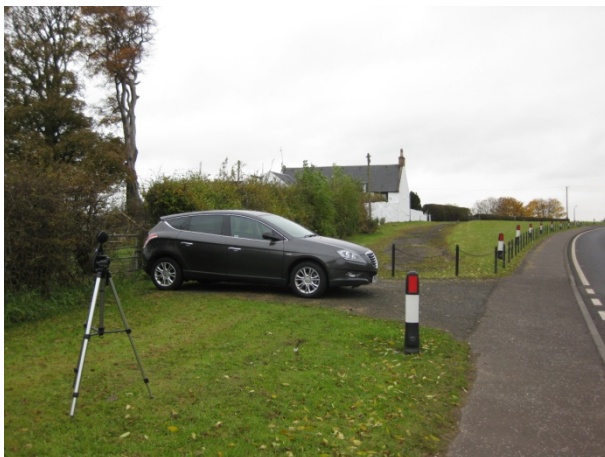
*Photograph 14 Hillend Farm daytime measurement location*

The daytime measurement location was approximately 65m north-west of the Hillend Farm building and 4m from the nearest carriageway of the A737. The sound level meter was located 1.2m above the ground in free field conditions.

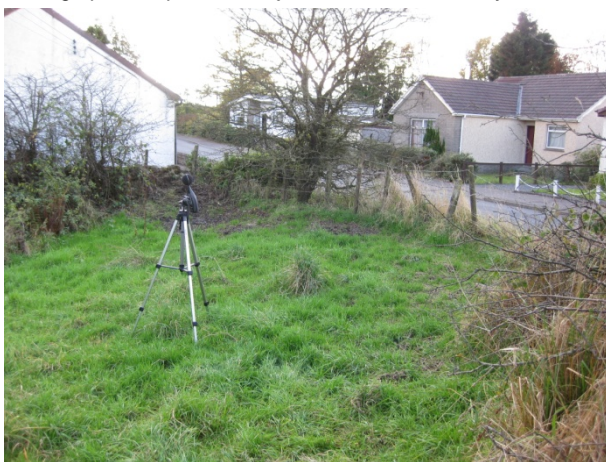
*Photograph 15 Open land adjacent to Greenacre daytime measurement location*

The measurement location was 3.5m from the western boundary fence, which in turn was approximately 7m from the access road to the A737. The sound level meter was located 1.2m above the ground in free field conditions.

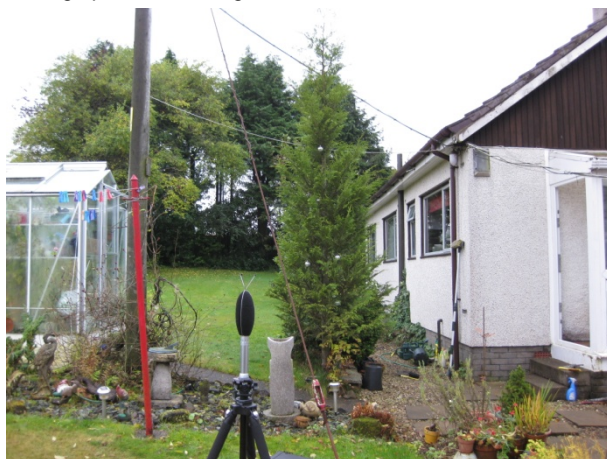
*Photograph 16 The Bungalow measurement location*

The measurement location was approximately 6m from the north east corner of the property facade. The sound level meter was located 1.2m above the ground in free field conditions.

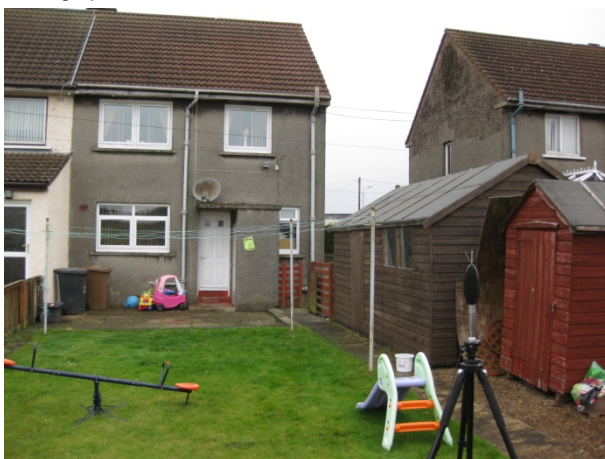
Photograph 17 25 Baidland Avenue measurement location

The measurement location was approximately 14m from the south eastern facing facade. The sound level meter was located 1.2m above the ground in free field conditions.
