# A83 Rest and Be Thankful

LTS EIAR VOLUME 4, APPENDIX 11.11 - BAT REPORT

A83AAB-AWJ-EAC-LTS\_GEN-RP-LE-000267

# A11-11. Bat Report

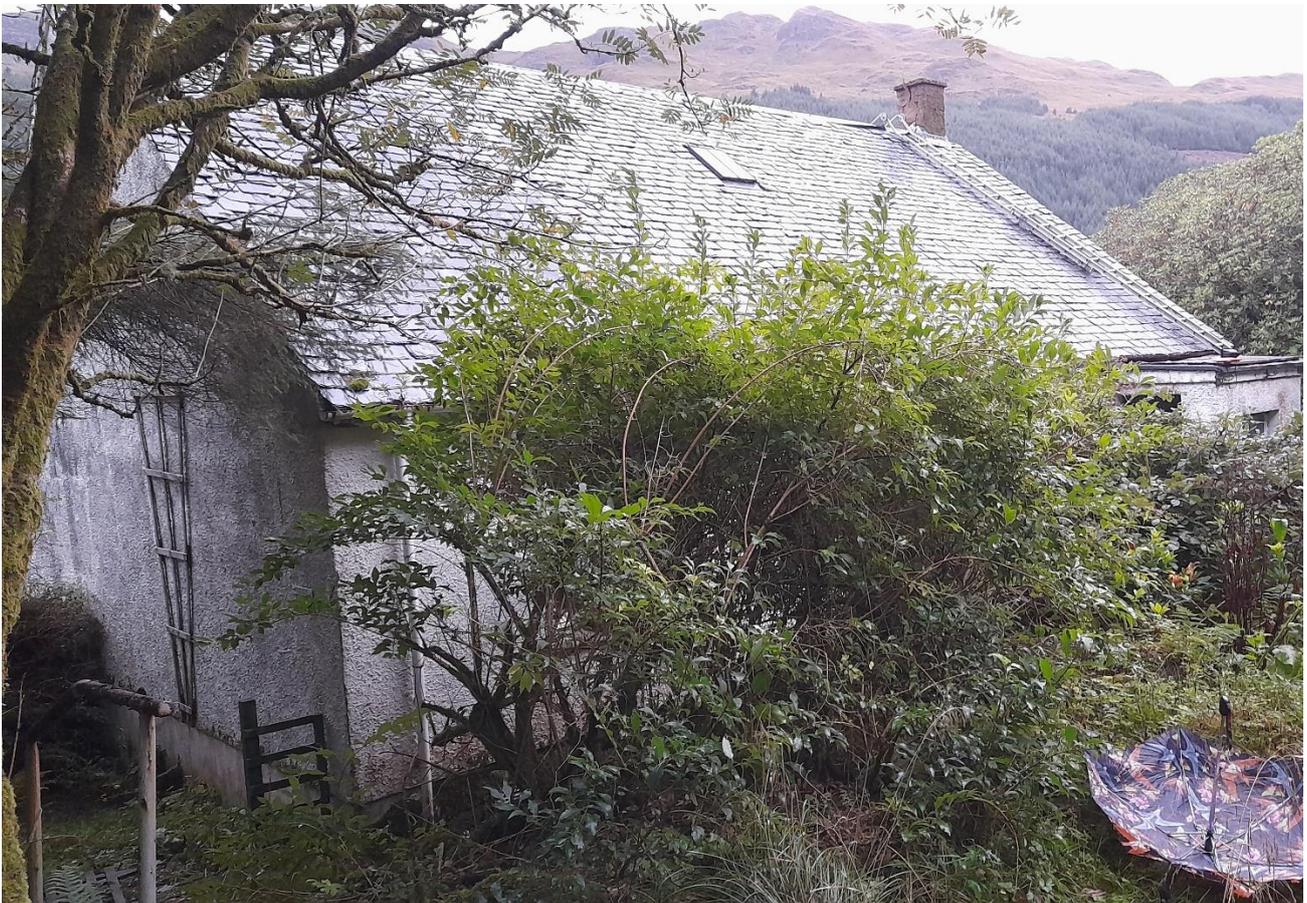
**Photograph 1: This photograph shows BB1, an abandoned residential building with a slate roof. Slipped tiles on the northeast and southwest pitches and lifted lead flashing around the chimney and roof ridge are present providing overall high roosting and hibernation suitability.**

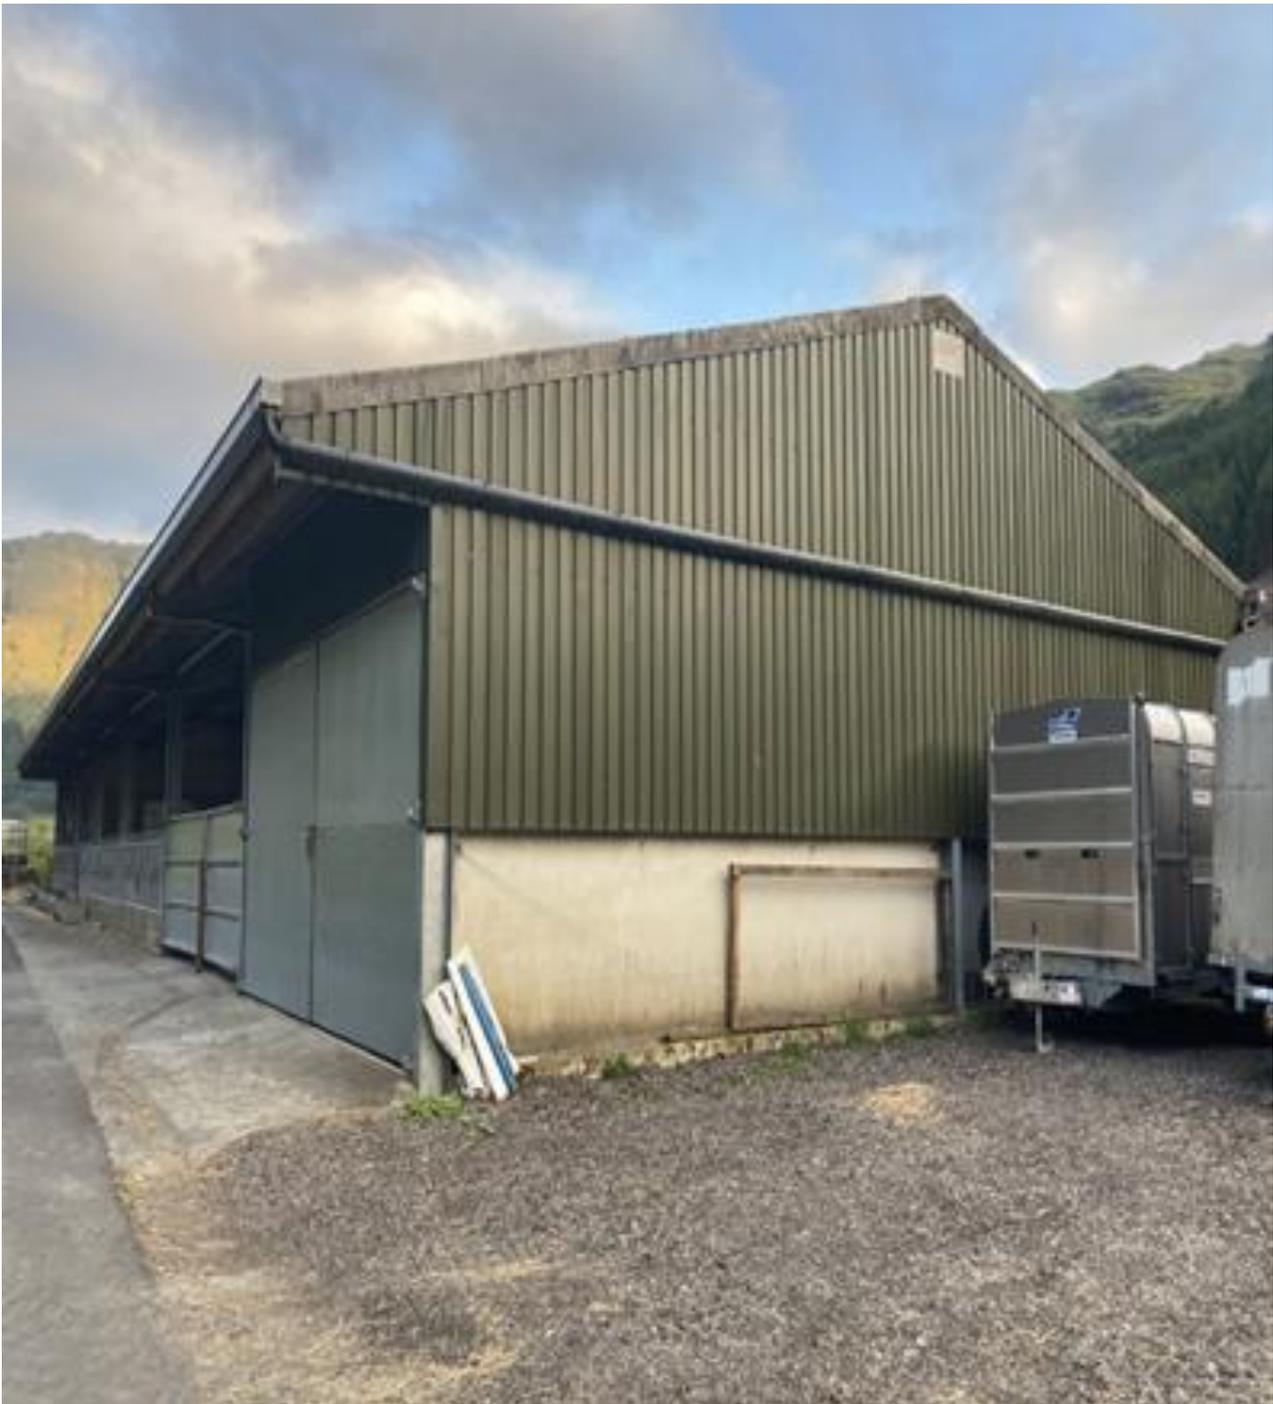
Photograph 3: This photograph shows BB3, a wooded cladded shed with a corrugated metal roof, where a confirmed roost is present and low hibernation suitability has been recorded.

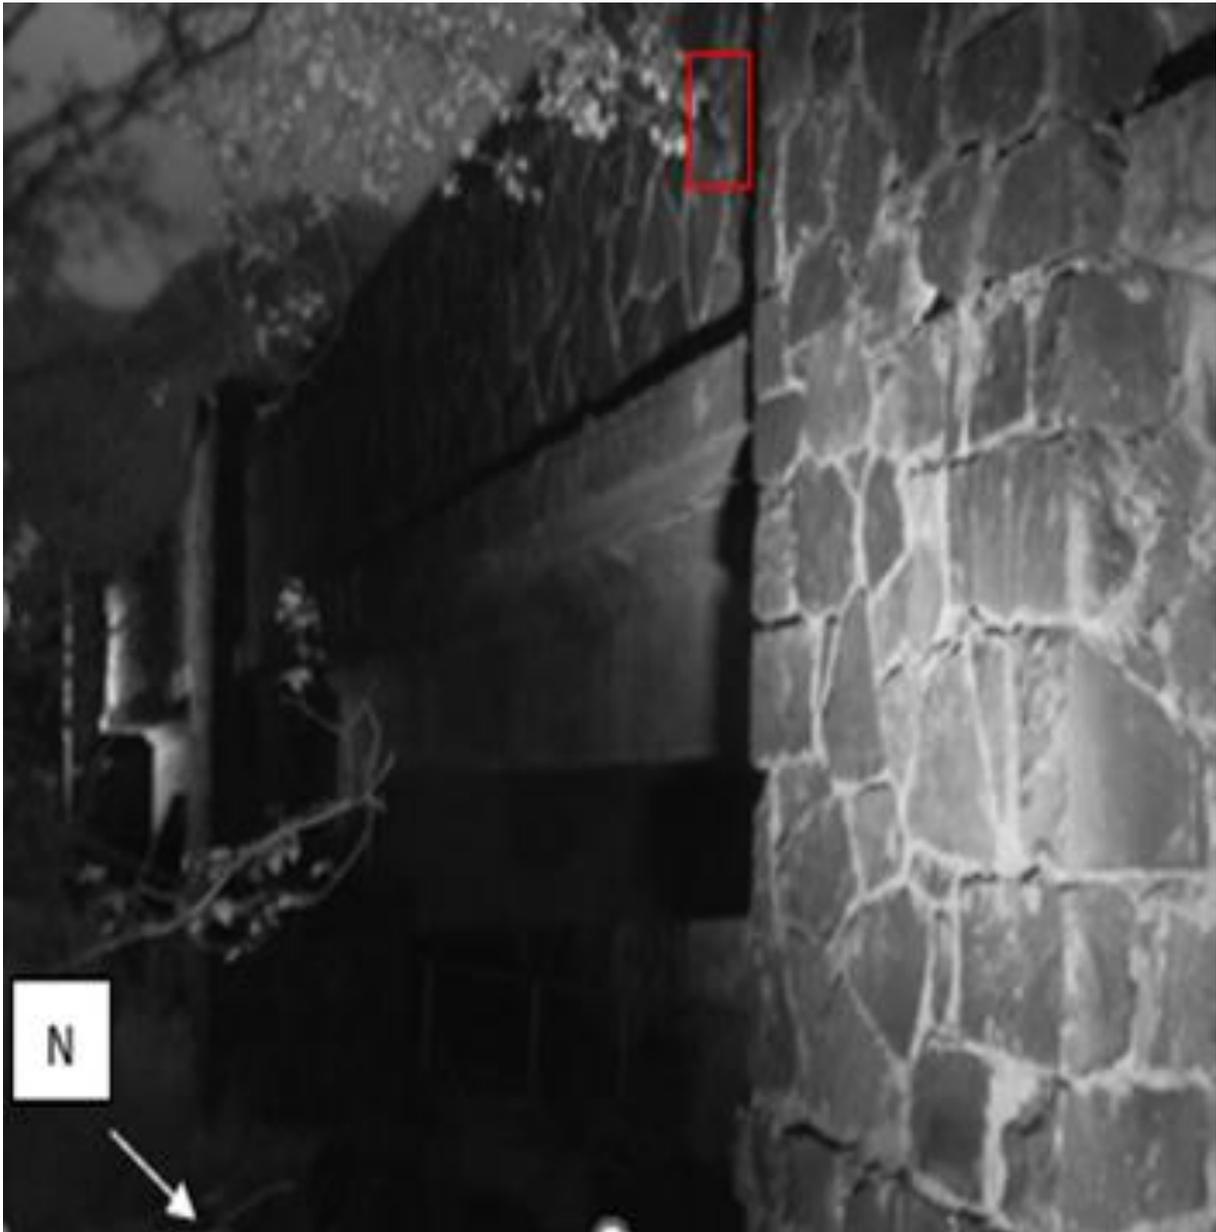
Photograph 13: The photograph shows BS2, the stone and concrete Cobbler bridge from the West. A red marker box has been added to show the location of the bat roost at the top of the bridge wing wall.

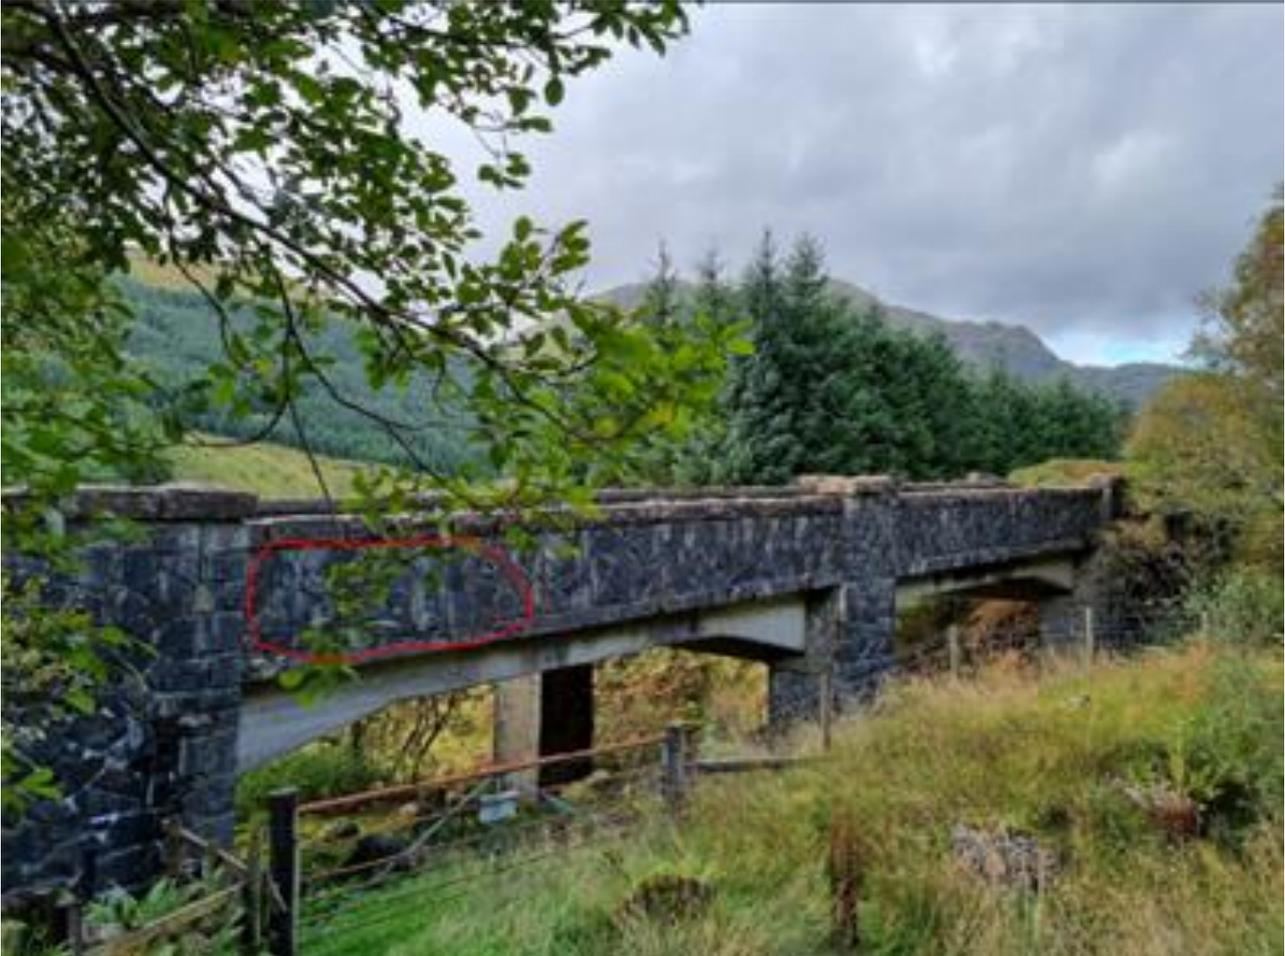
**Photograph 14: The photograph shows BS2, the stone and concrete Cobbler bridge. The red circle shows the location of another confirmed bat roost in this structure.**

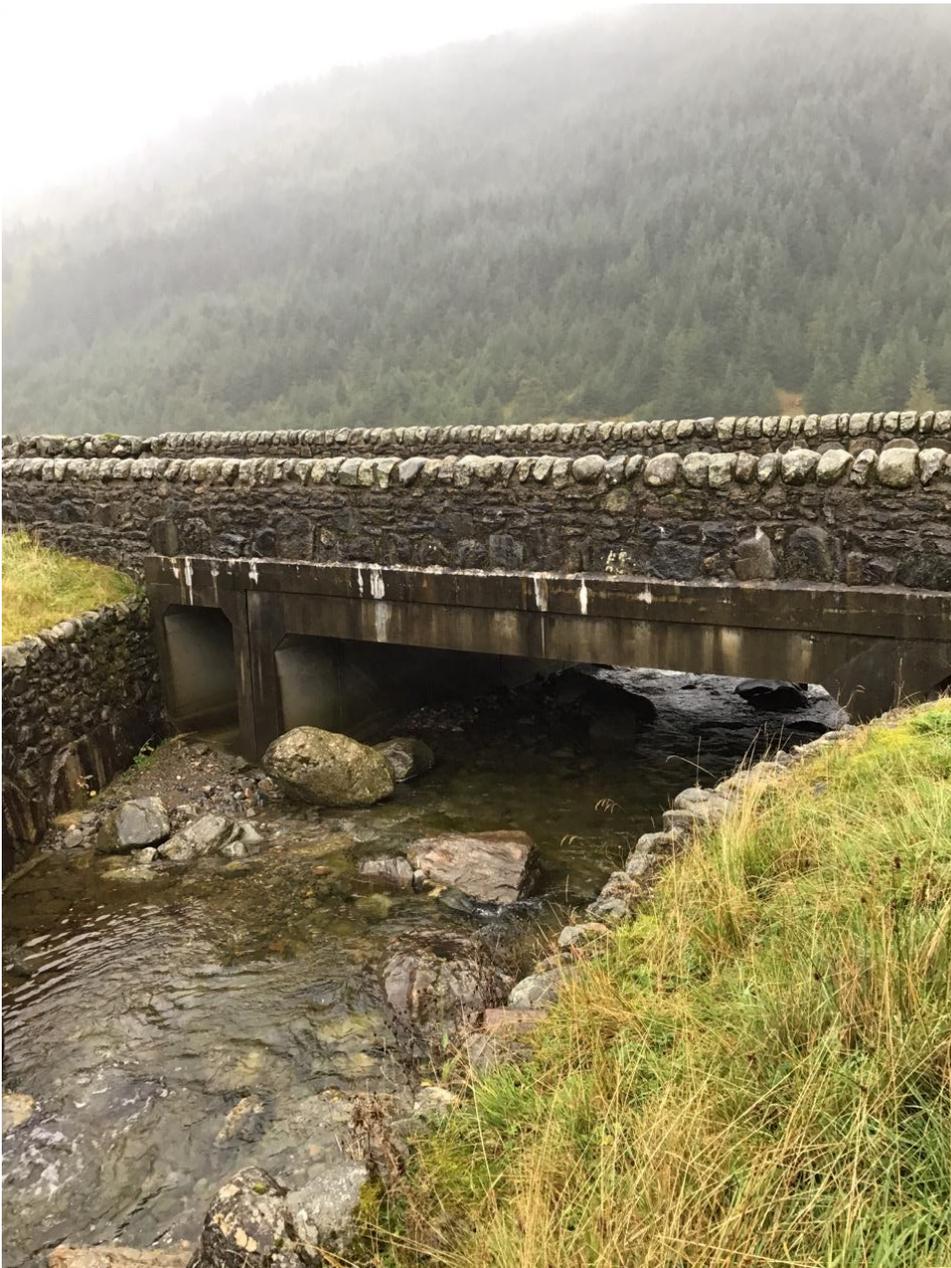
**Photograph 15: This photograph shows BS3, the side face of a stone bridge crossing over Croe Water. The bridge outer sides appear to be composed of stone and mortar, while the underside is composed of solid concrete sections. The structure was classified as having negligible roost suitability.**

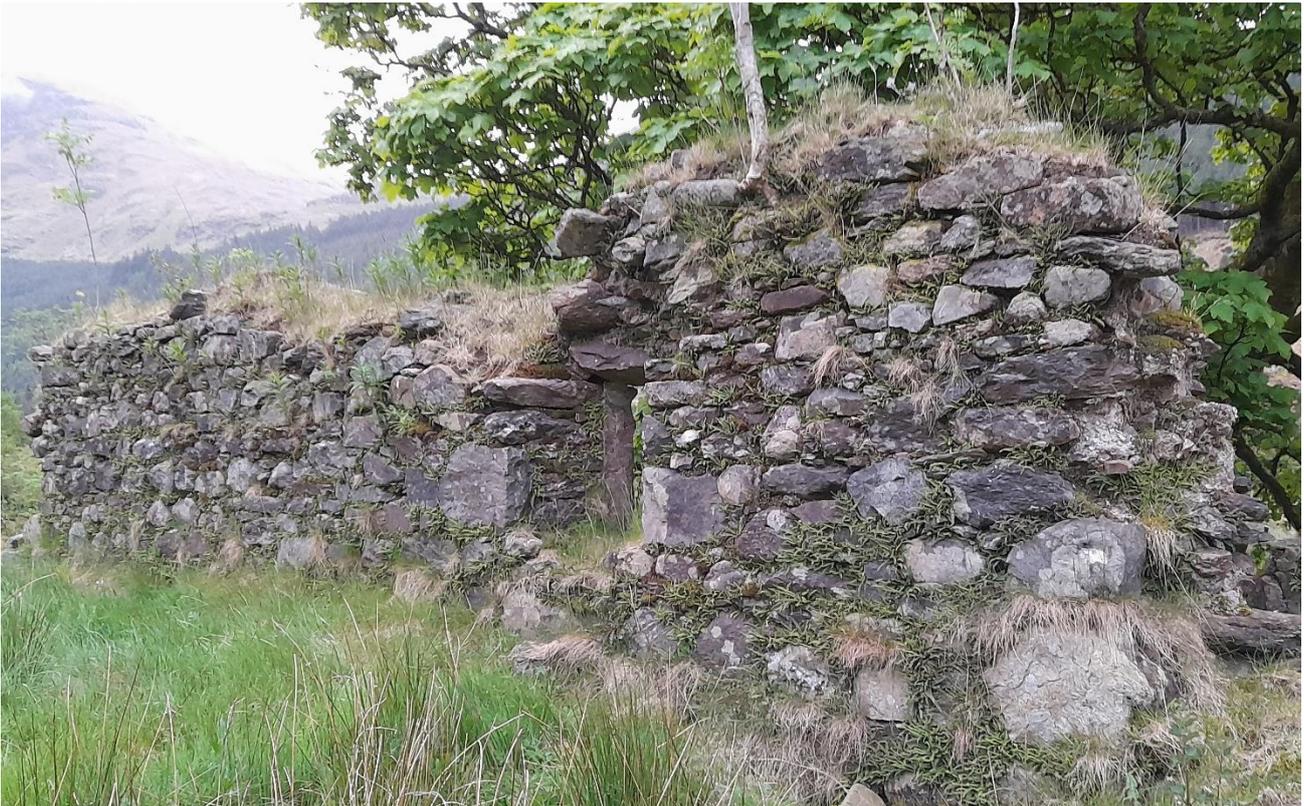
**Photograph 17: This photograph shows BS6, the stone remains of an old building present on the hillside. Most of the structure appears collapsed with vegetation overgrowth throughout. The structure was classified as having low roost and hibernation suitability.**

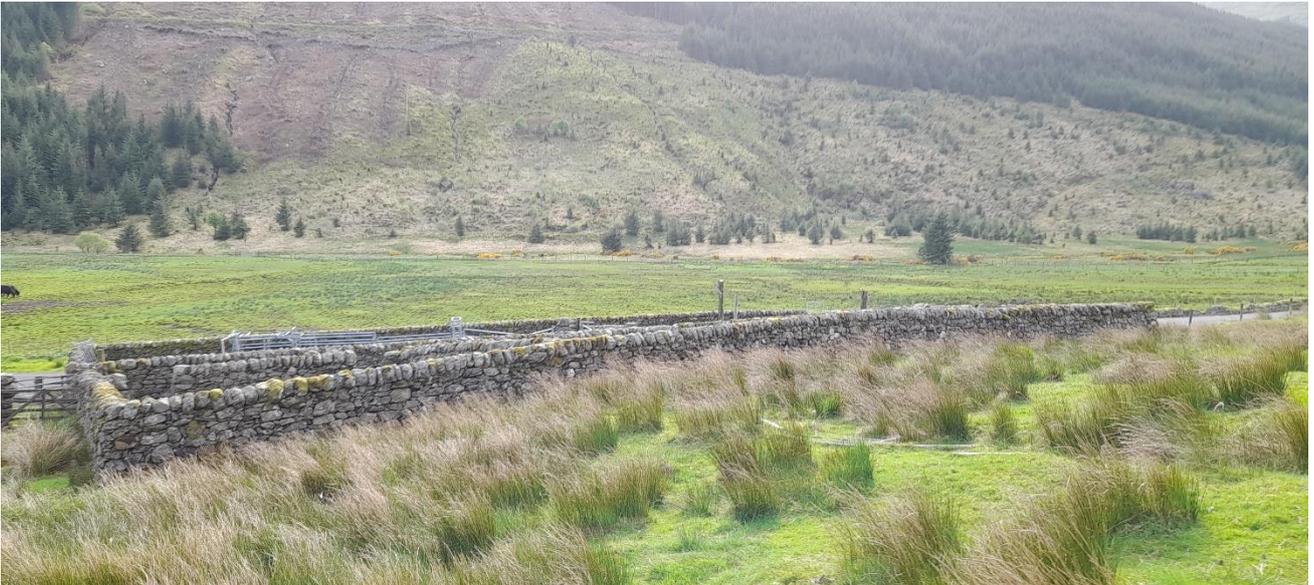
**Photograph 18: The photograph shows BS7, a sheep fank consisting of stone walls, in the middle of a grassy green field. The structure was classified as having moderate roost suitability and low hibernation suitability.**

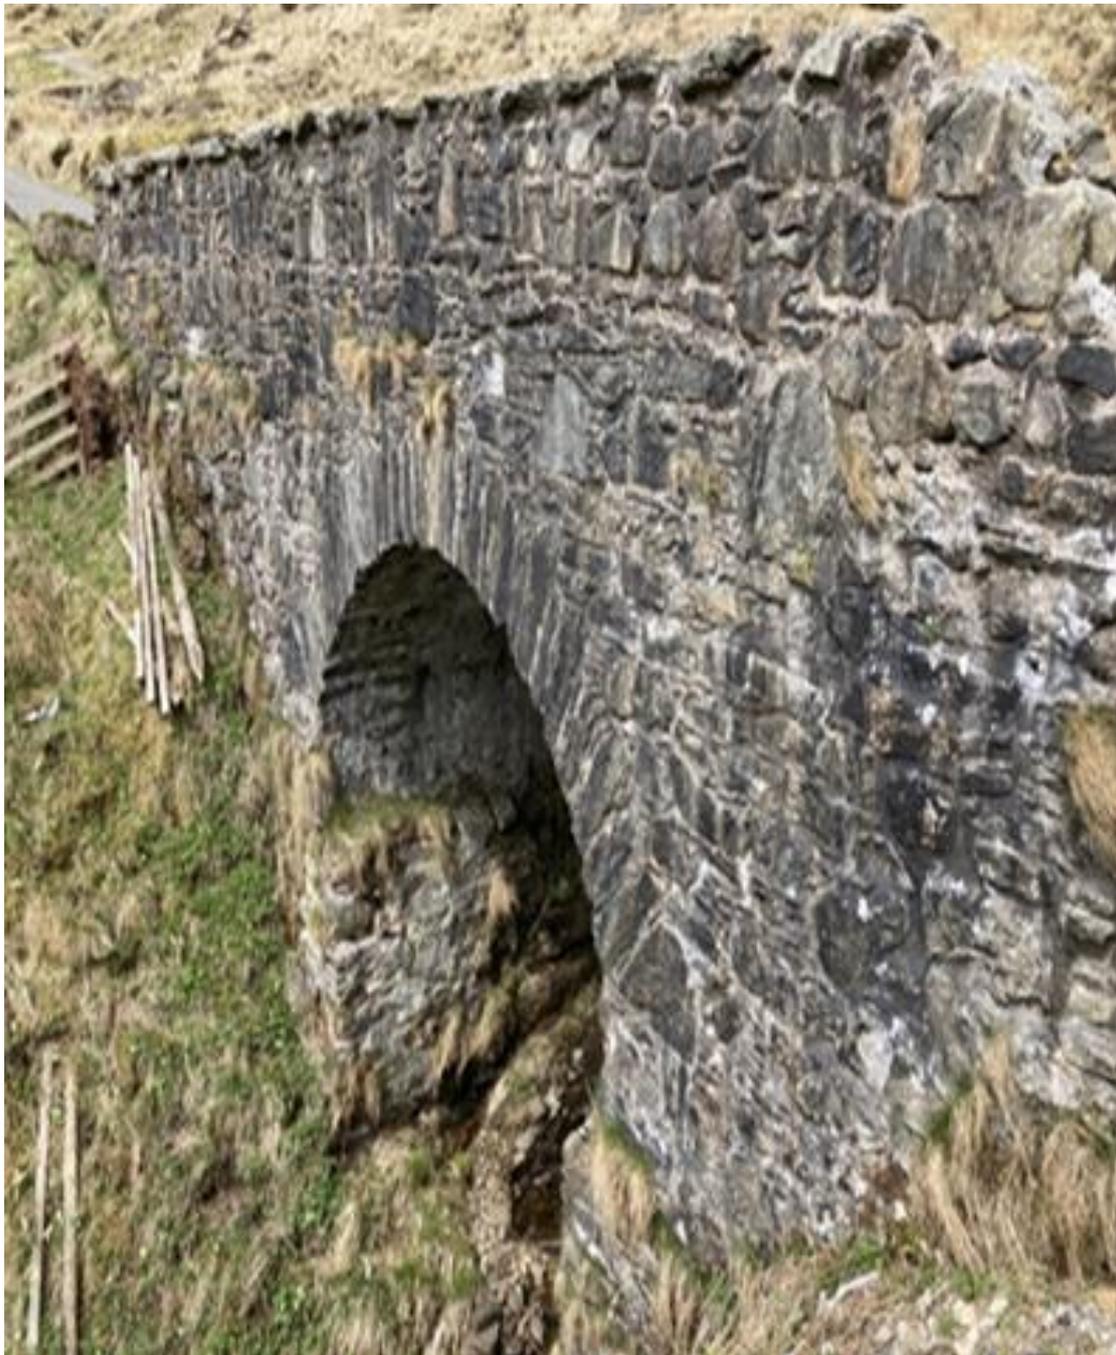
Photograph 21: The photograph shows BS11, a stone bridge arch on a hillside under the Old Military Road. The structure has a confirmed bat roost and was classified as having moderate hibernation suitability.

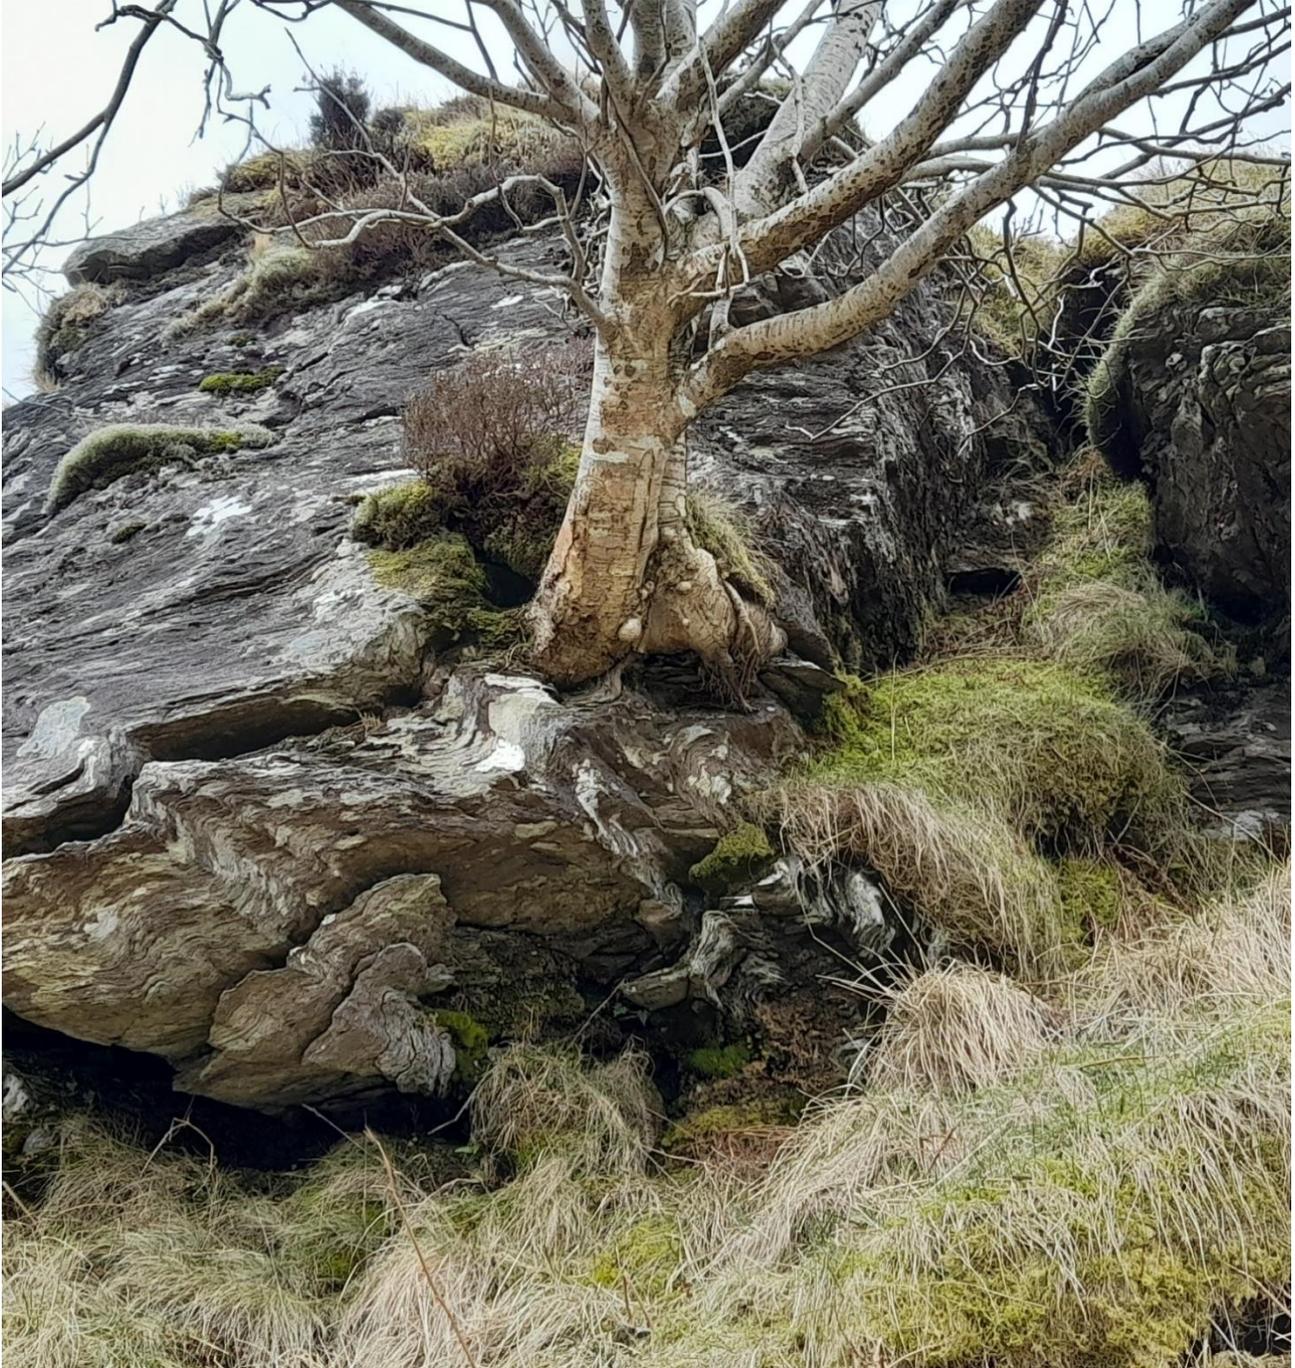
Photograph 28: The photograph shows BS18 (the 'Shrine') at the top of Rest and be thankful viewpoint. A large rock with an almost vertical deep joint is visible with grasses growing on the surrounding rock surfaces. The structure was classified as having low roost suitability and negligible hibernation suitability.

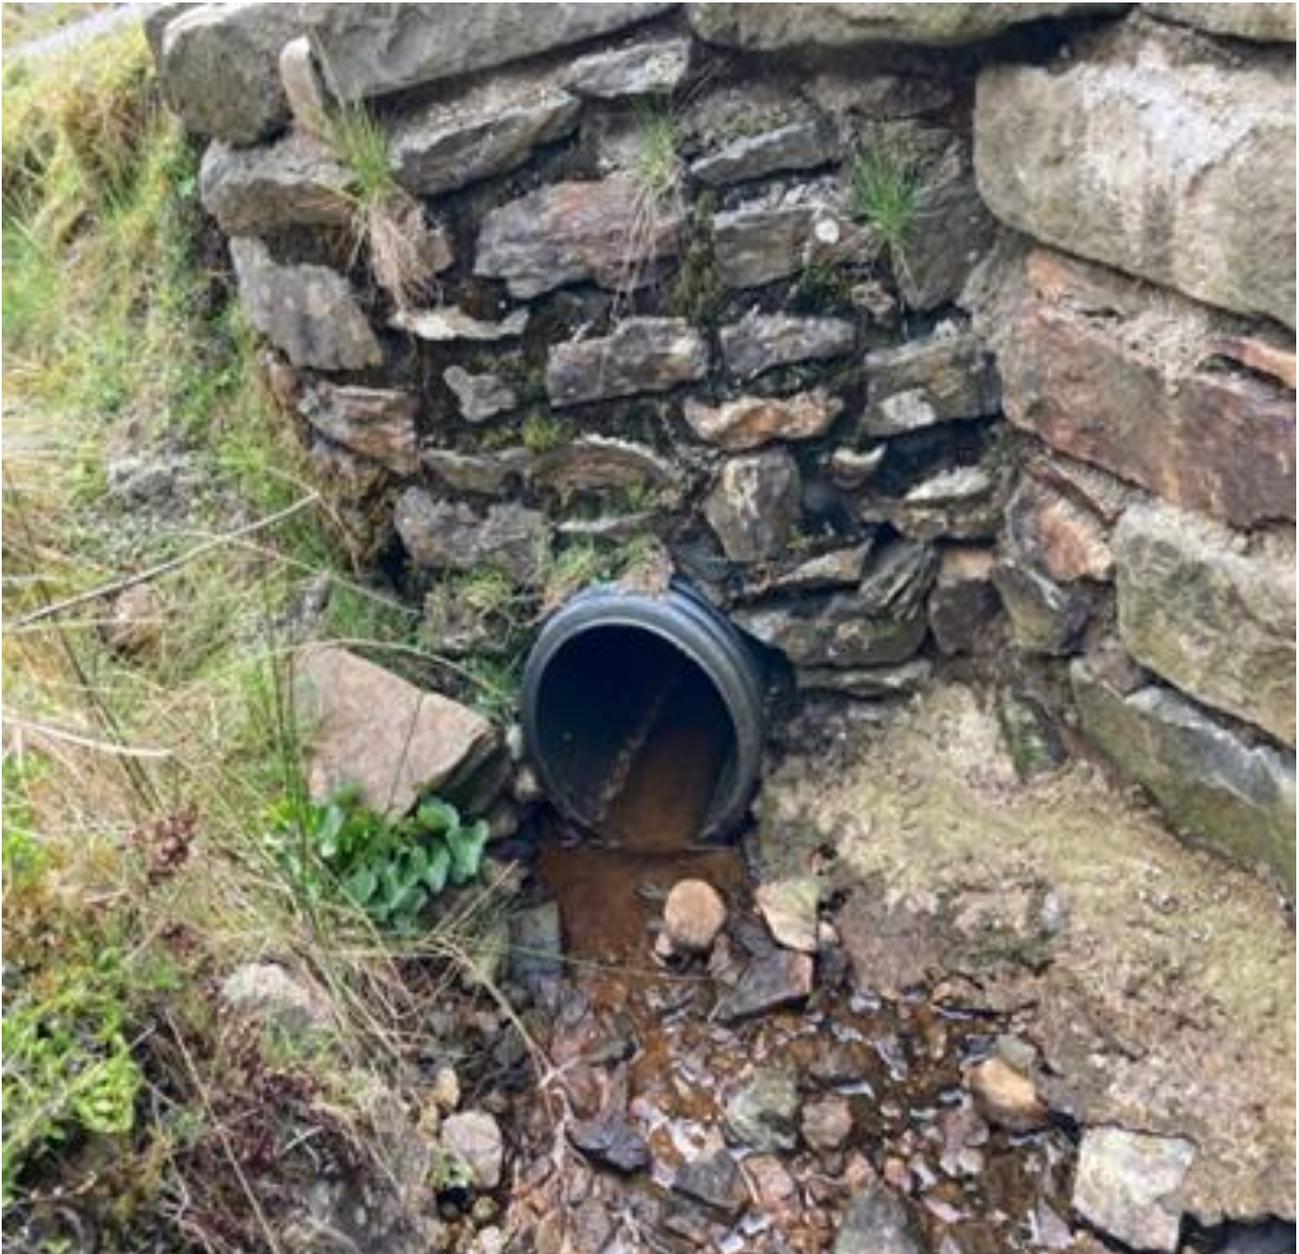
**Photograph 30: This photograph shows BS20, a piped culvert consisting of a stone wall, located just under the Old Military Road. The structure is located on a vegetated hillside with a water stream running downhill. The structure was classified as having low roost suitability.**

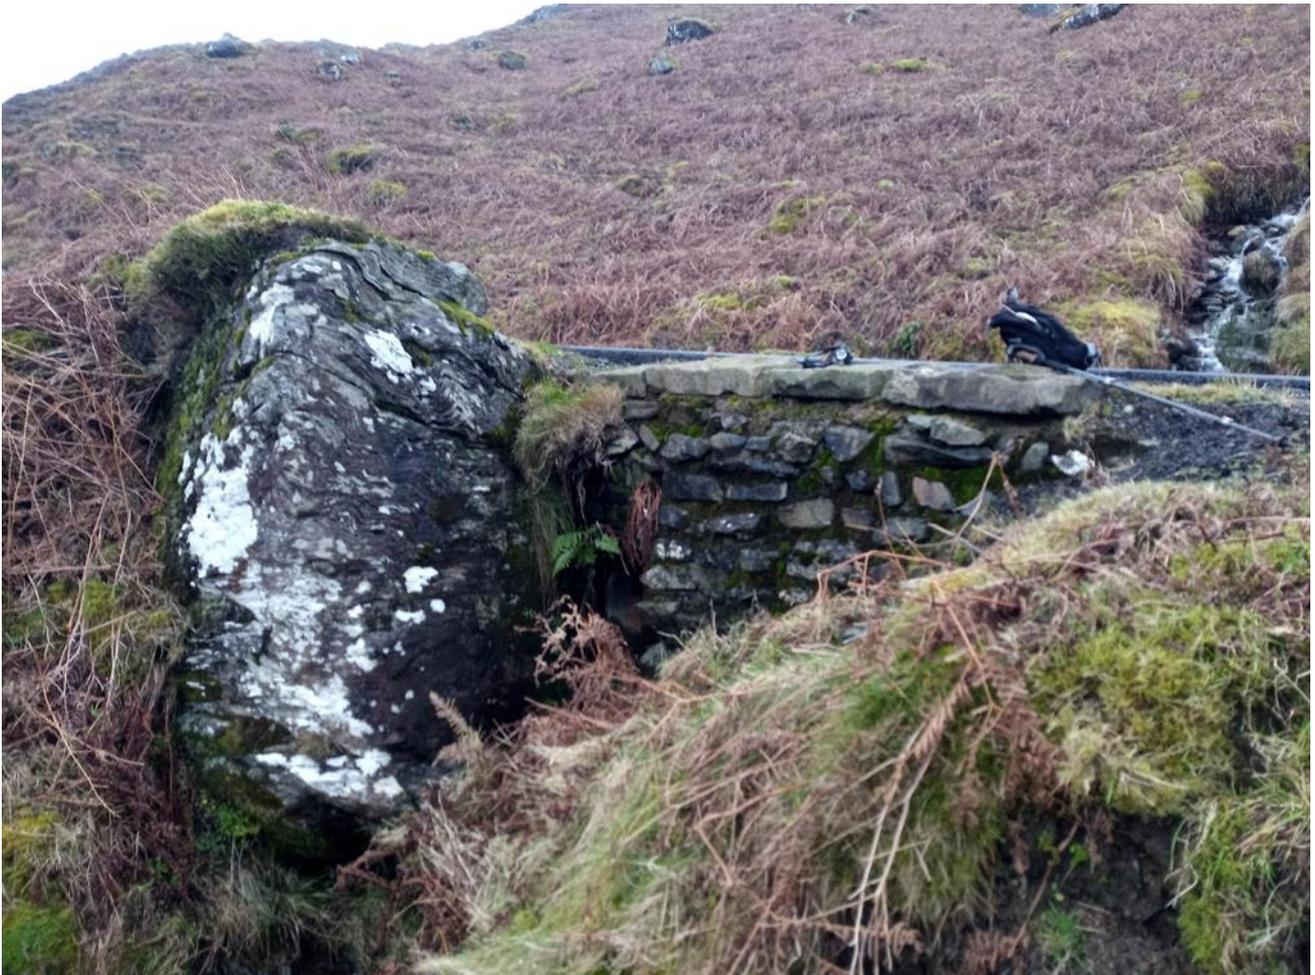
**Photograph 31: This photograph shows BS21, a piped culvert located under the Old Military Road. The structure consists of a stone wall with several moss growth. Water is collected the base of the pipe among rocky formations. The surrounding terrain appears uneven and natural with scattered rocks and vegetation. The structure was classified as having moderate roost suitability and low hibernation suitability.**

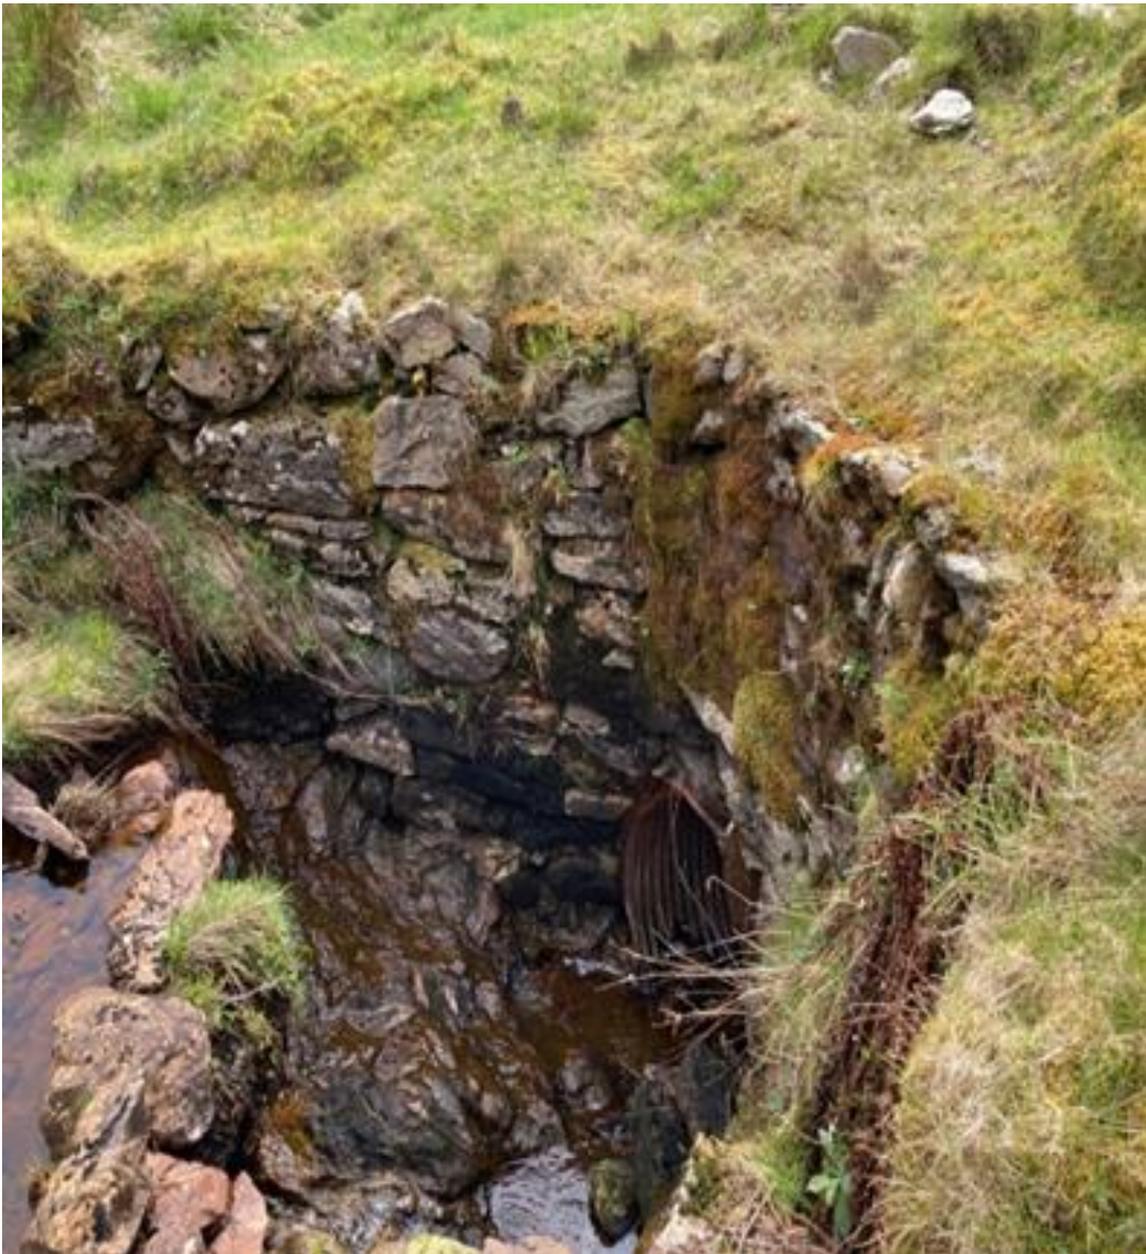
Photograph 32: This photograph shows BS22, a stone and concrete culvert located under the A83, carrying a headwater downhill towards the Croe Water. This structure is c.1.5m in height. Multiple crevices are located between the stones and concrete face of the culvert. Dense grassy vegetation surrounds the outside part of the structure. The structure was classified as having moderate roost and hibernation suitability.

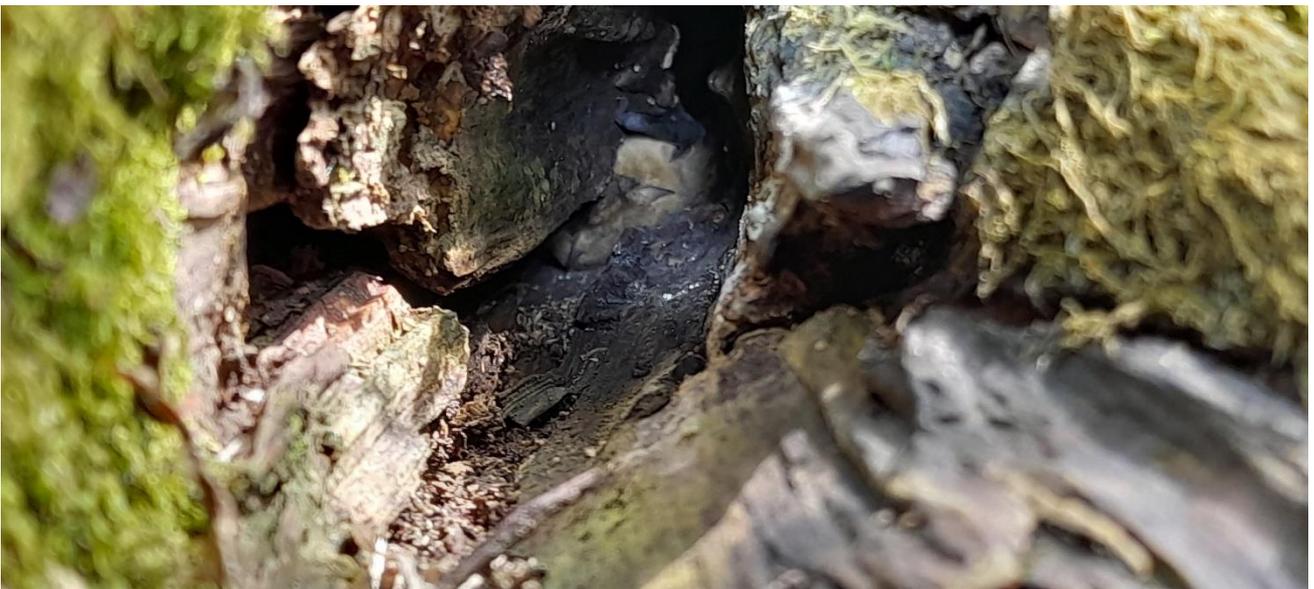
**Photograph 39:** This photograph shows BT6, the lichen and moss-covered branch of a tree which then splits into two further branches. The branches hang over a grassy bank and a watercourse. The tree was classified as having low roost suitability.

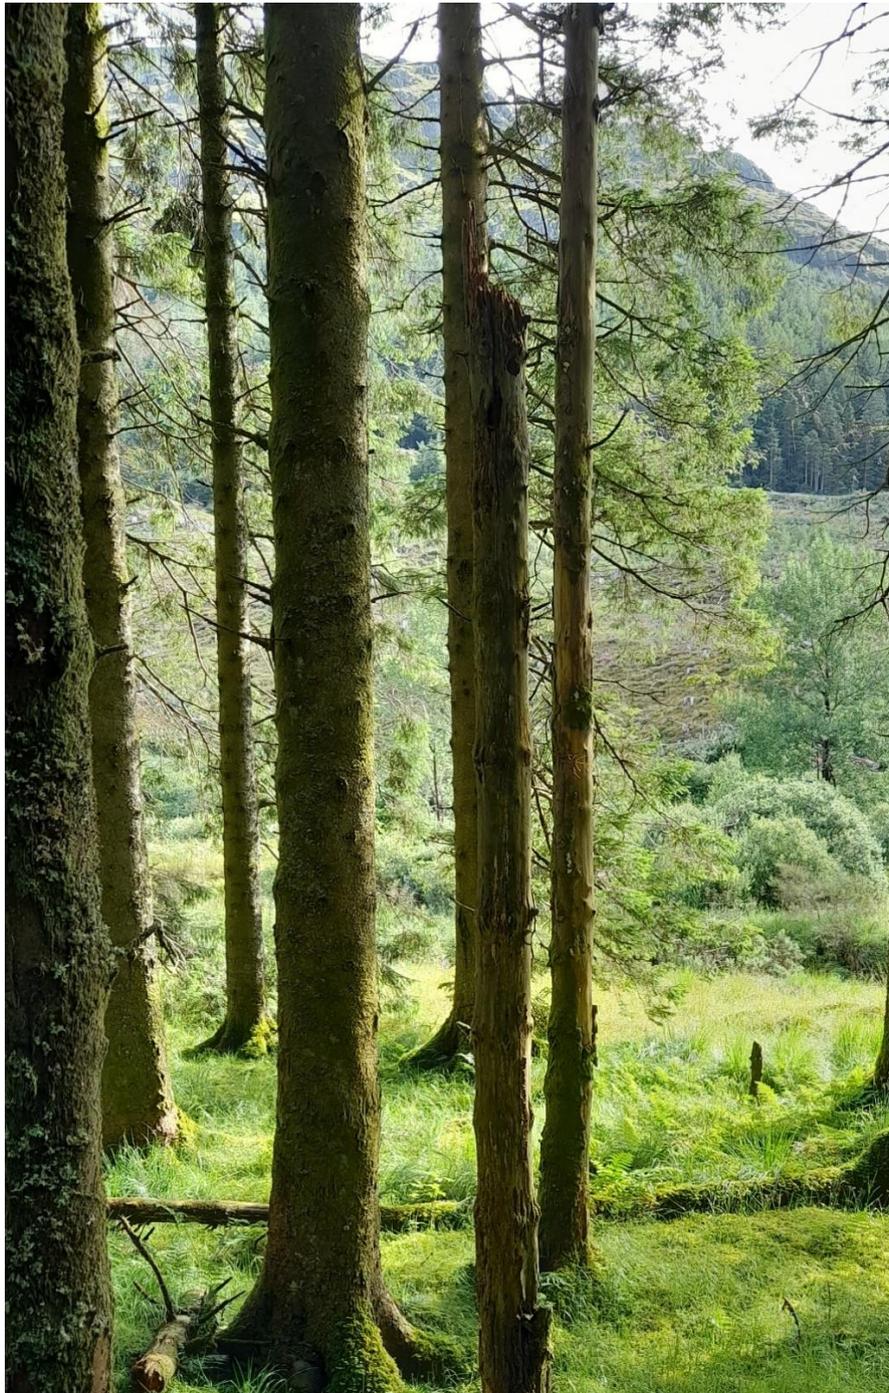
Photograph 41: This photograph shows BT8, a dead mature Sitka spruce (*Picea sitchensis*) tree with two woodpecker holes present at 3.5m. The tree was classified as having low roost suitability.

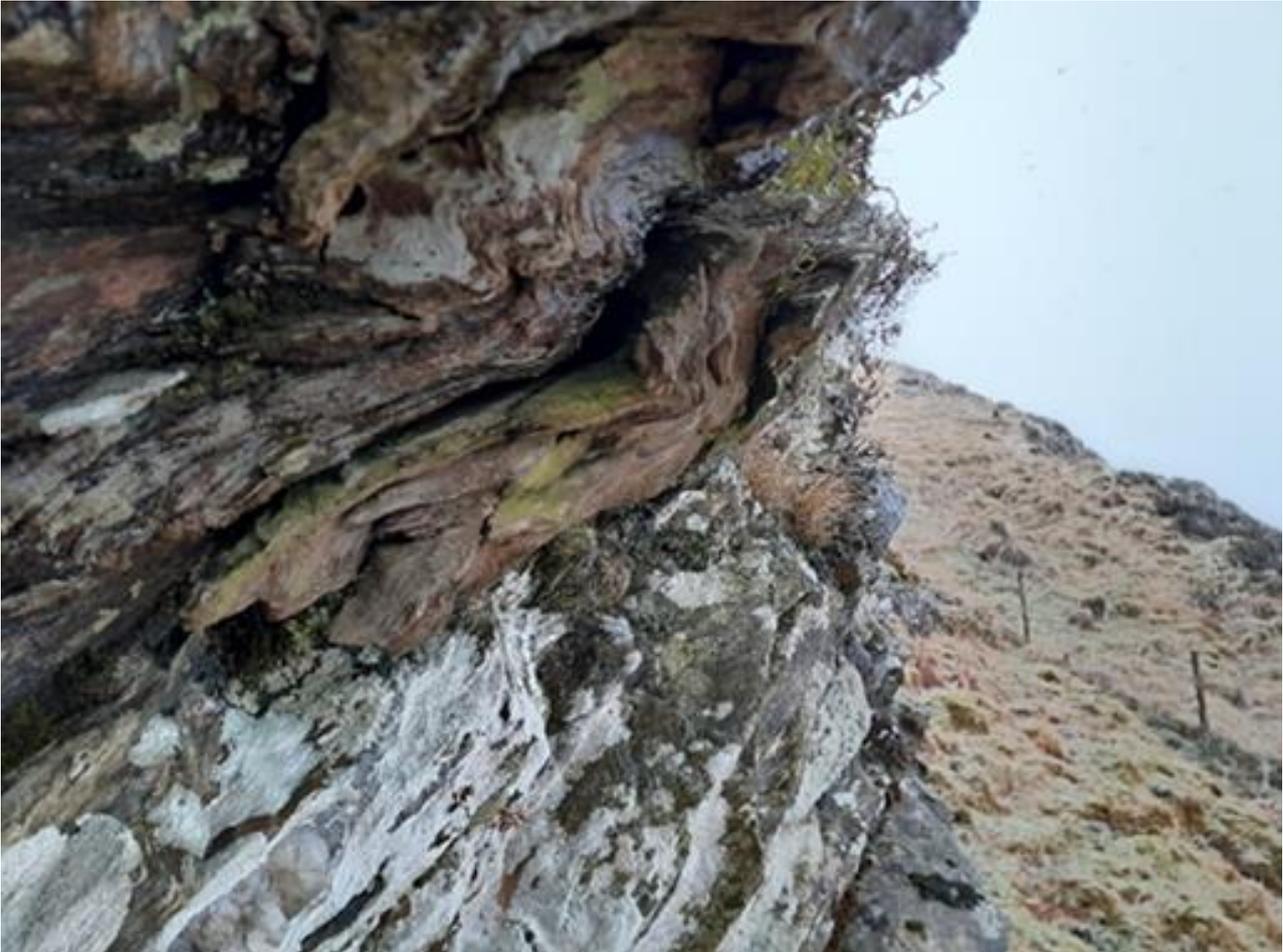
**Photograph 42:** This photograph shows the rock exposed on the hill, above the drilled/blasted rock face on A83 near the Rest and be Thankful car park. The photograph captures the joints and cavities present within the rock strata.

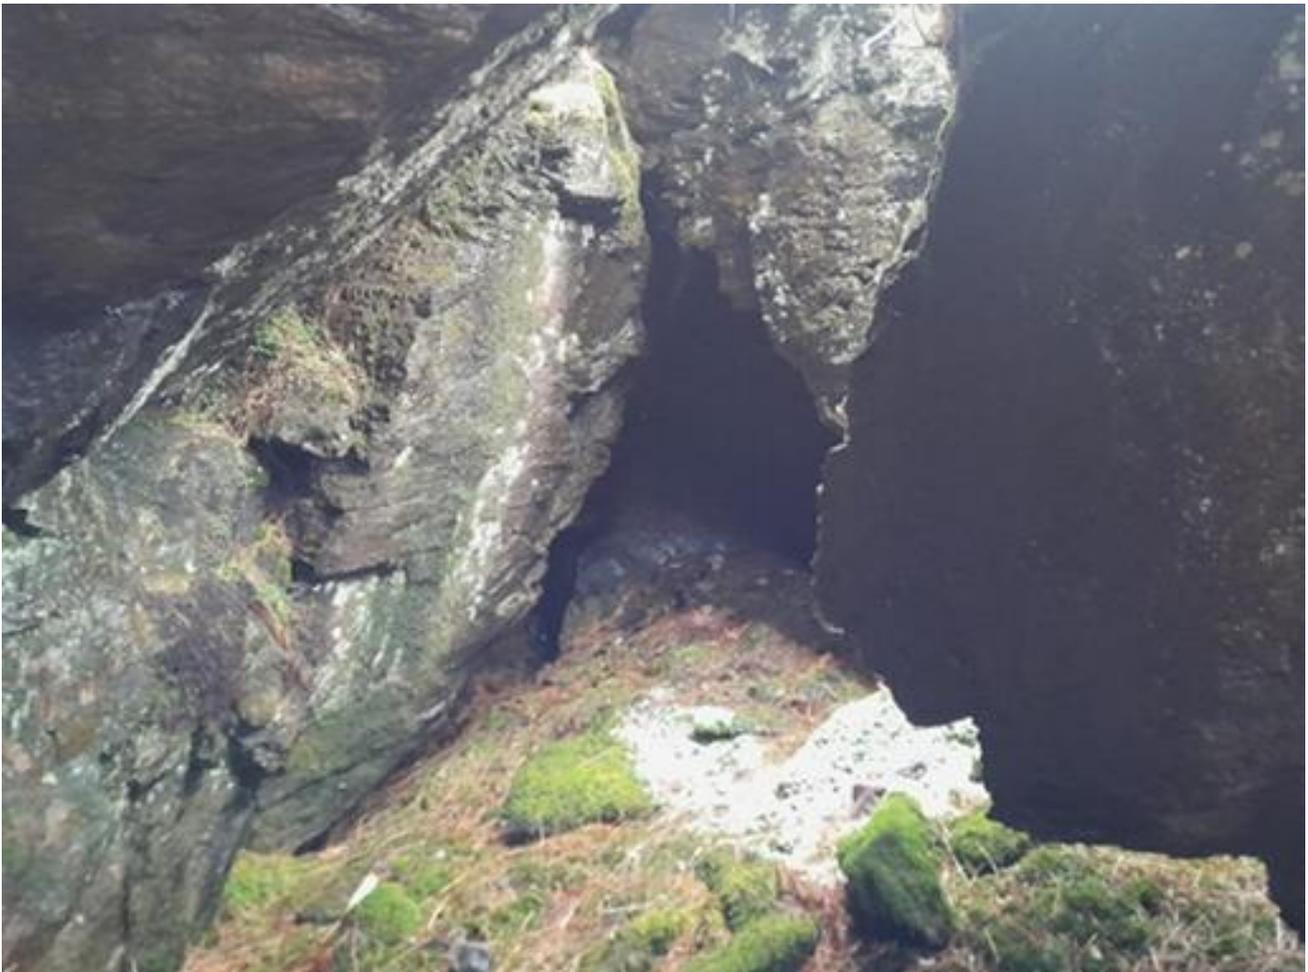
Photograph 45: This photograph shows the interior of a cave, where one hibernating brown long-eared bat was observed hanging from the cave roof.

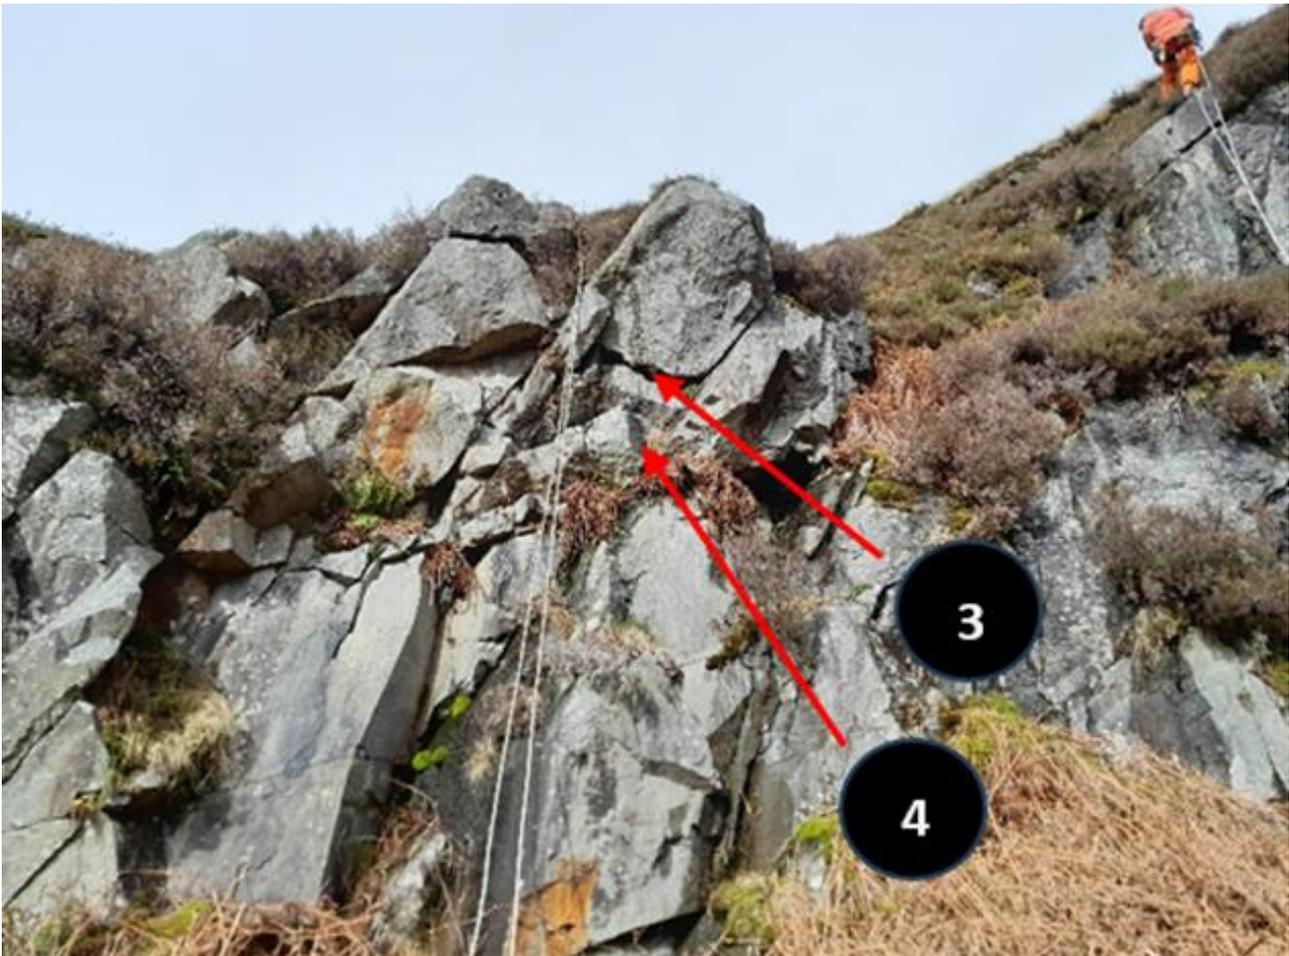
Photograph 5: The photograph shows the steep and rocky quarry wall with a surveyor hanging with a rope over the edge to investigate the PRF's.
