# A83 Rest and Be Thankful

LTS EIAR VOLUME 4, APPENDIX 11.11 - BAT REPORT

A83AAB-AWJ-EAC-LTS\_GEN-RP-LE-000267

# A11-11. Bat Report

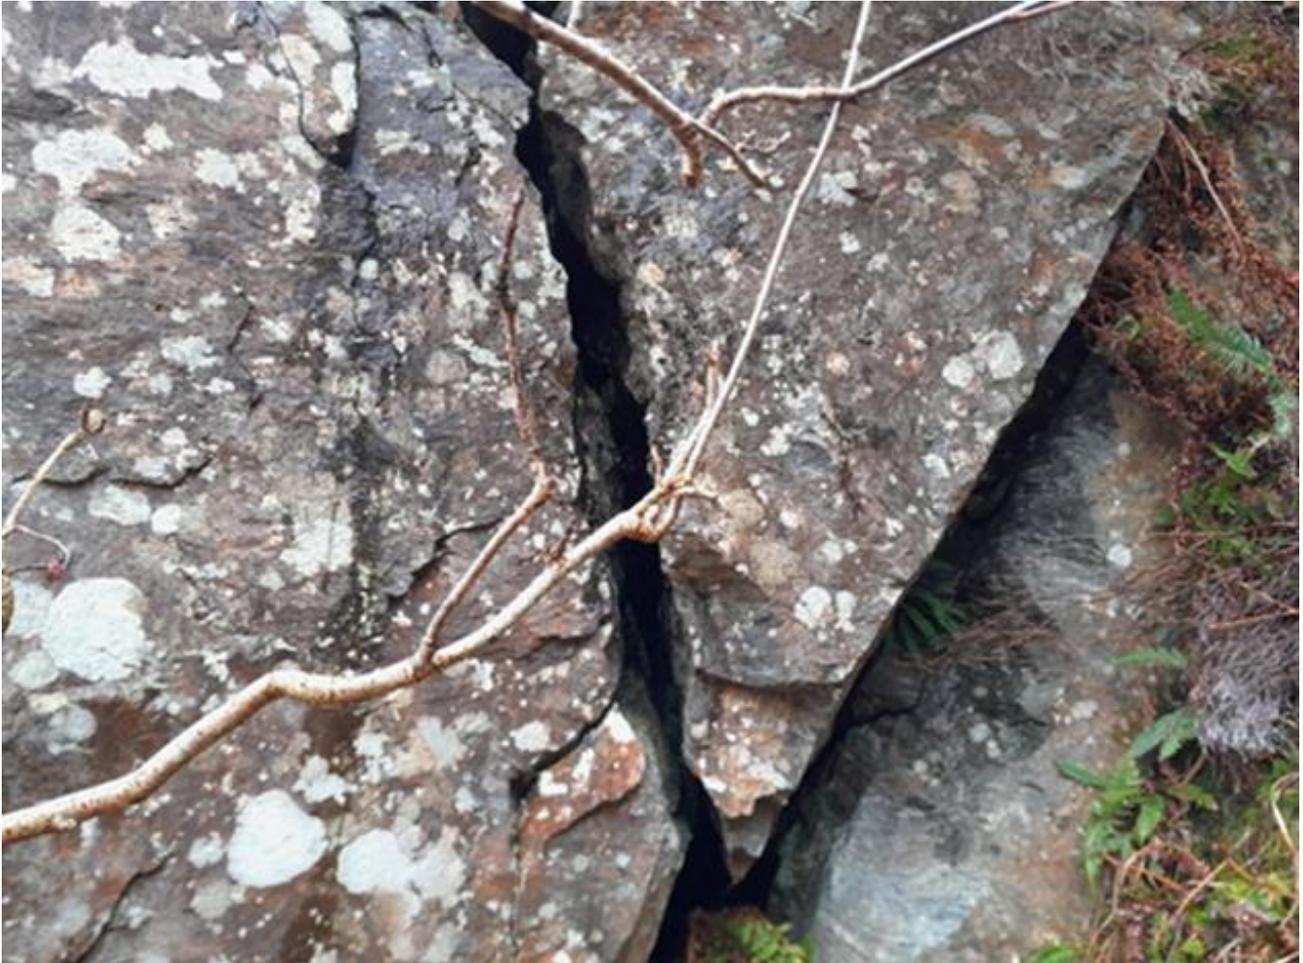
Photograph 10: The photograph shows a close-up view of the joints present in the lower rock face. Damp conditions with loose unstable rocks can be observed.

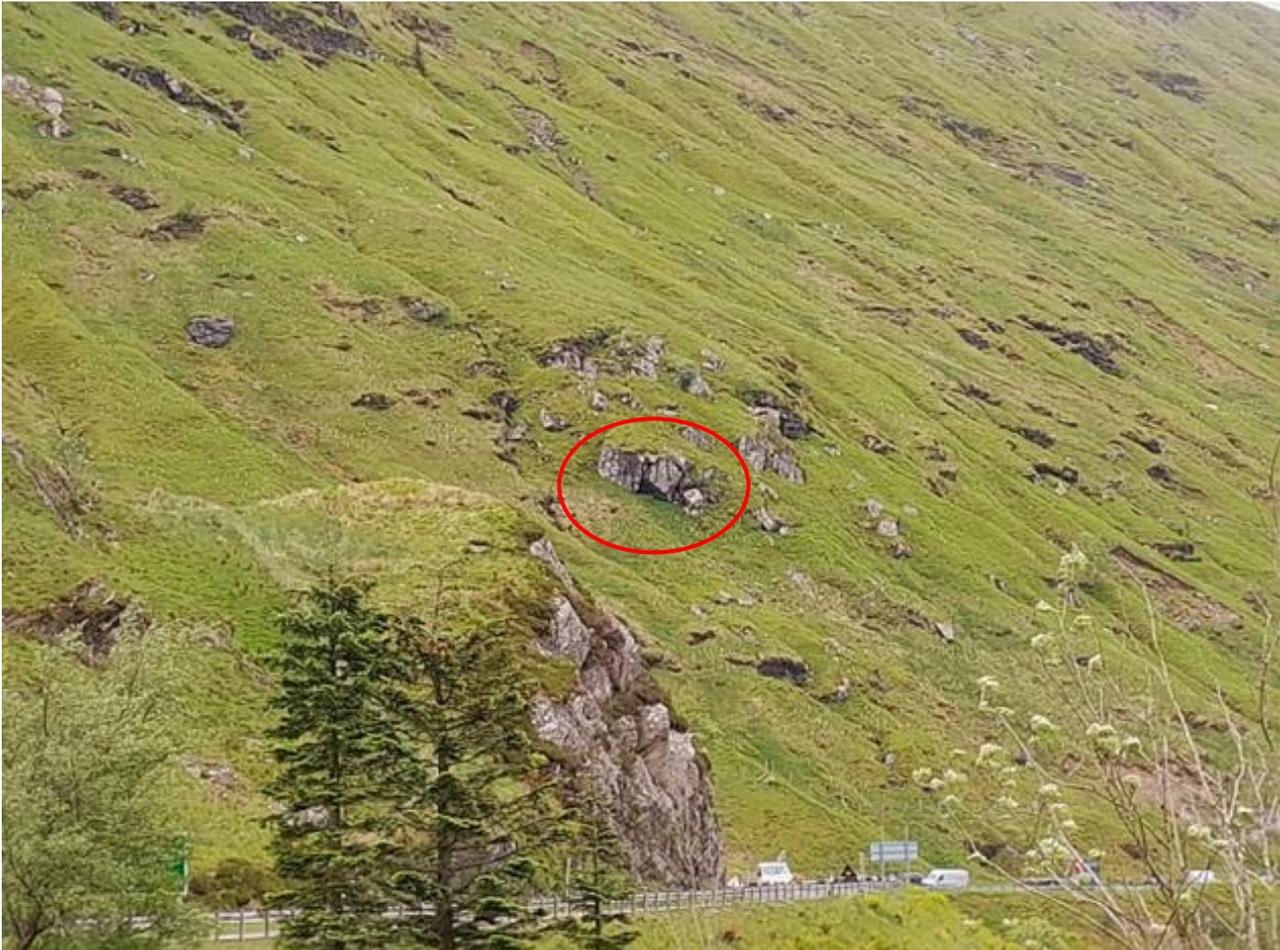
Photograph 13: The photograph shows the entrance point of a void surrounded by overhanging rocks, moss and fen vegetation.

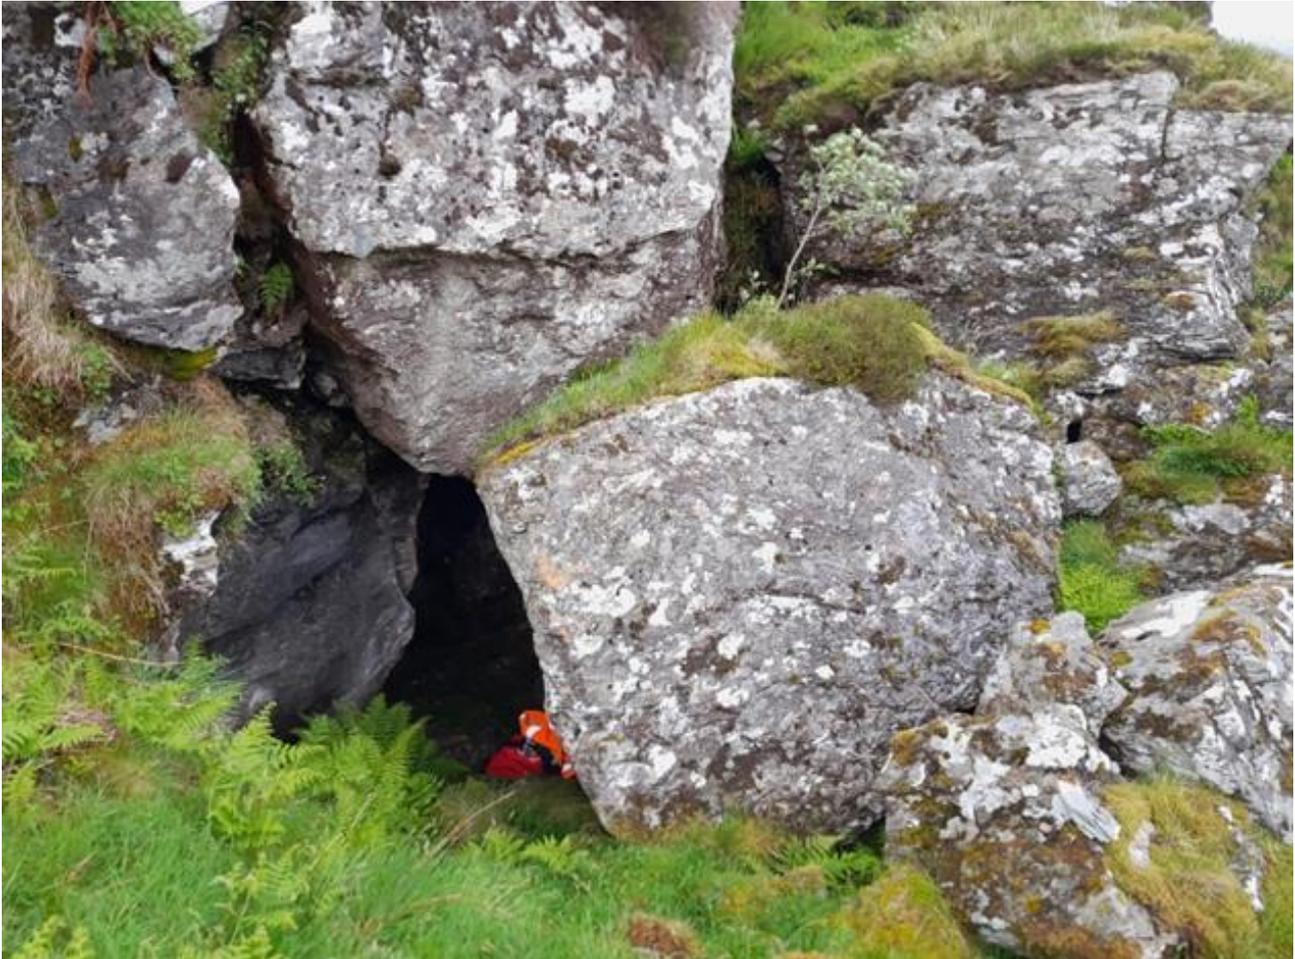
Photograph 14: The photograph shows a natural rock formation creating a cave or void with rugged rocks. Damp areas can be observed on some of the rock surface outside the void entrance.

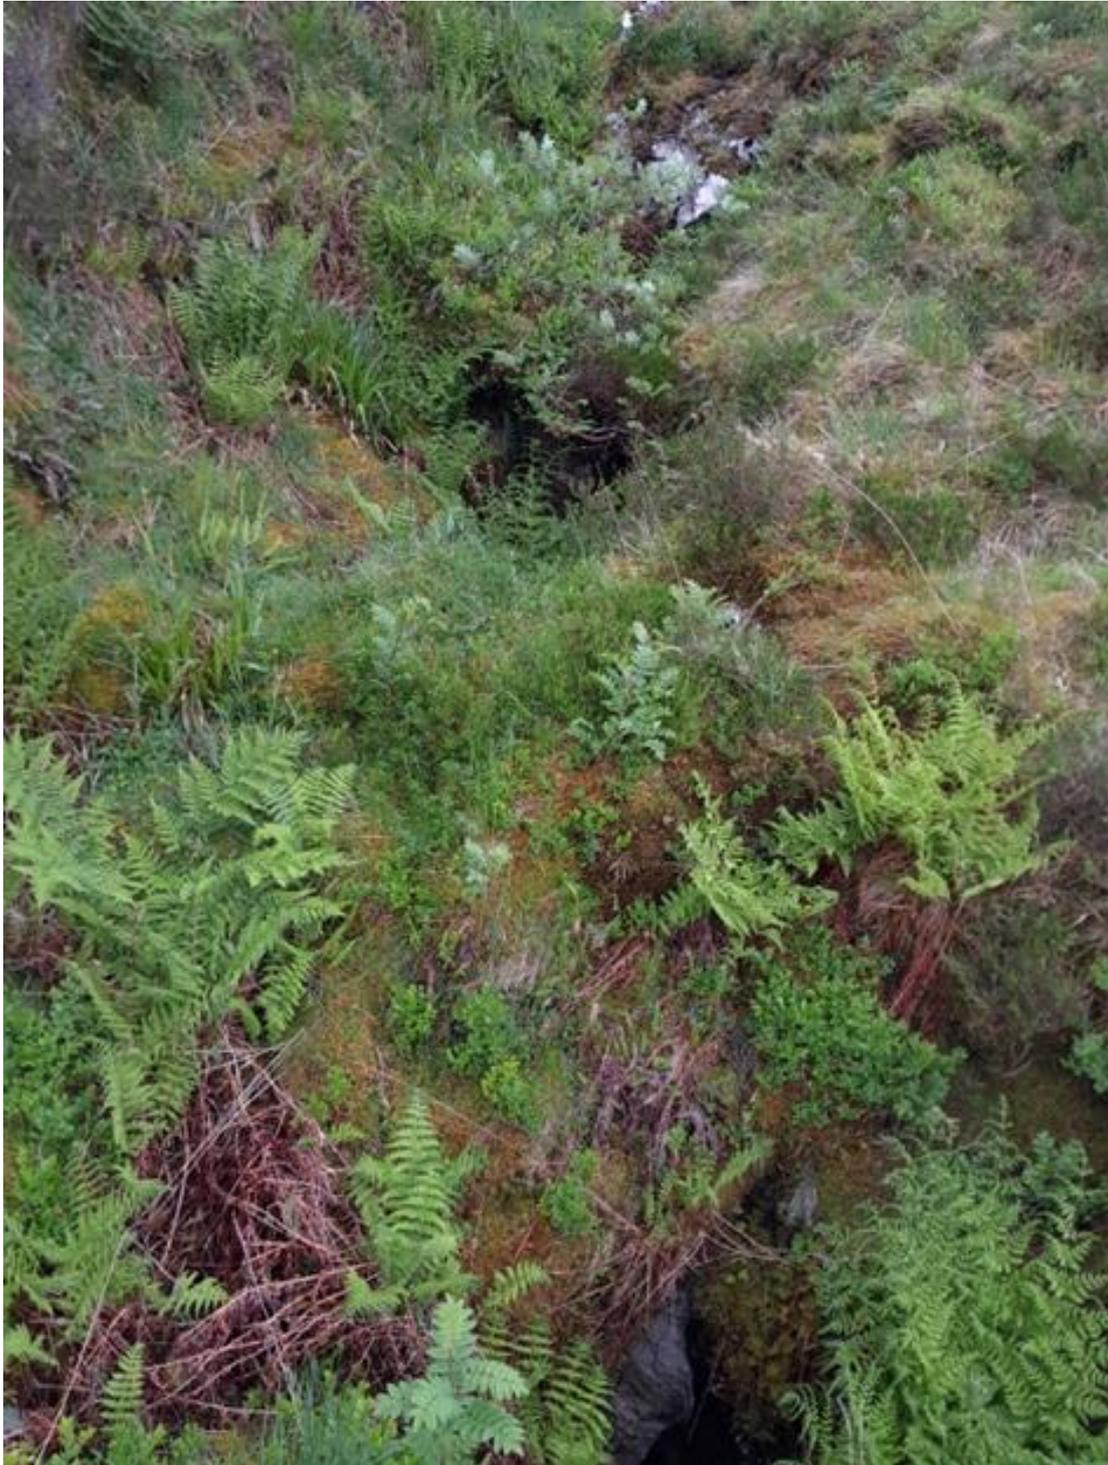
Photograph 20: The photograph shows a void present beneath a large boulder, extending into the hillside. The entrance of the void is covered by bracken vegetation.

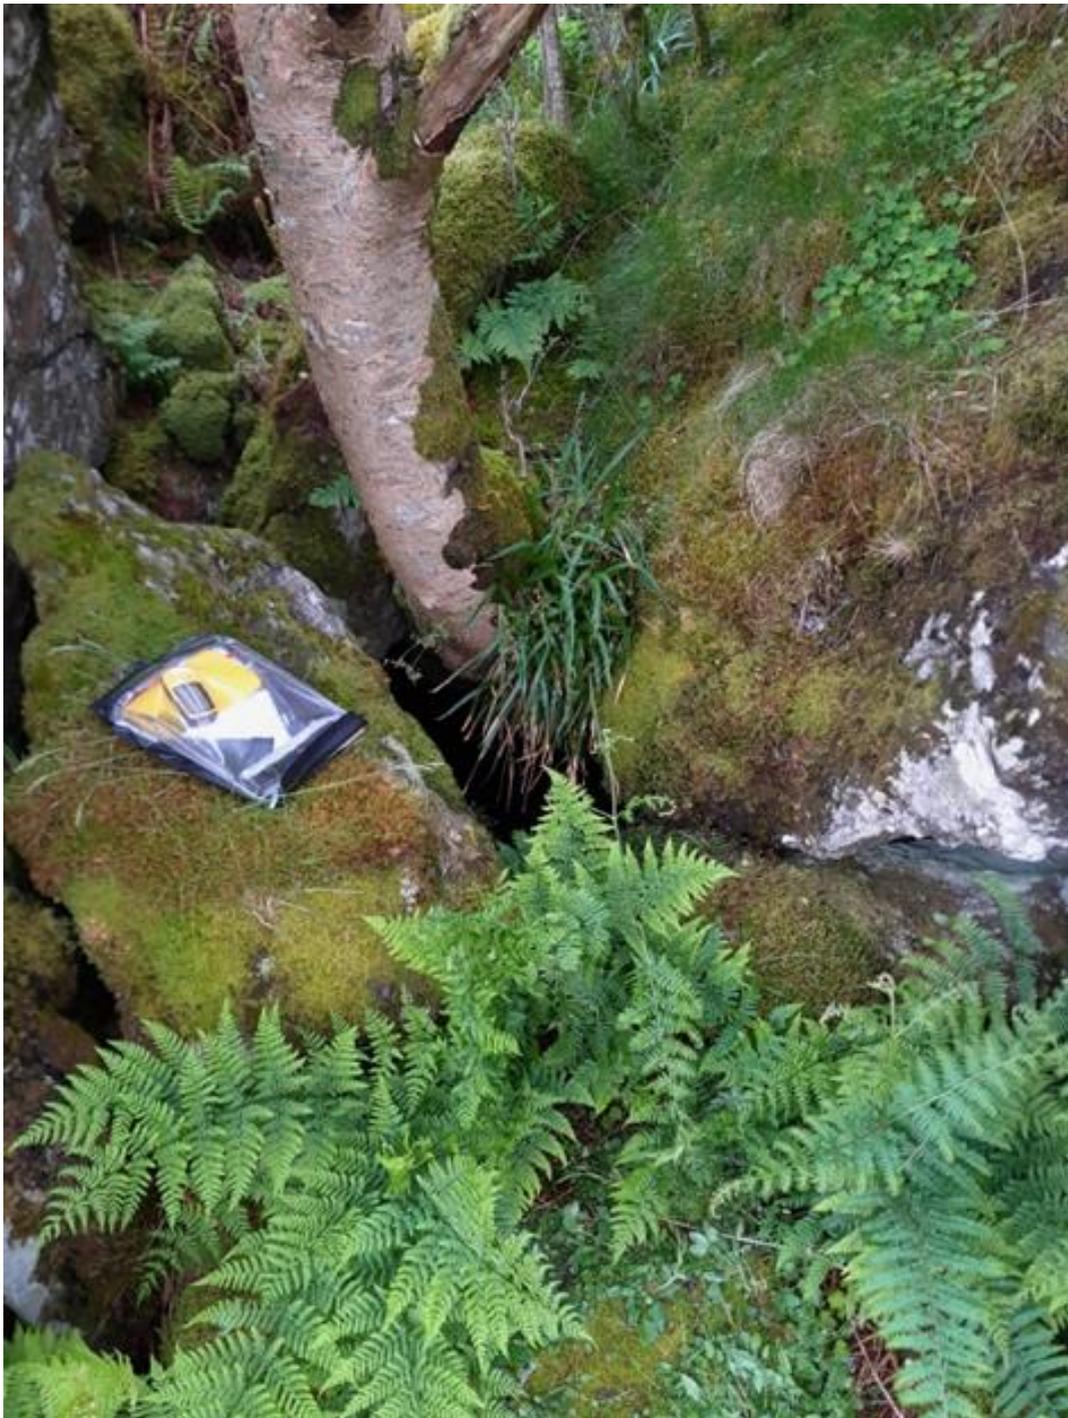
Photograph 21: The photograph shows a void present beneath a large boulder, extending into the hillside. The entrance of the void is covered by bracken vegetation.

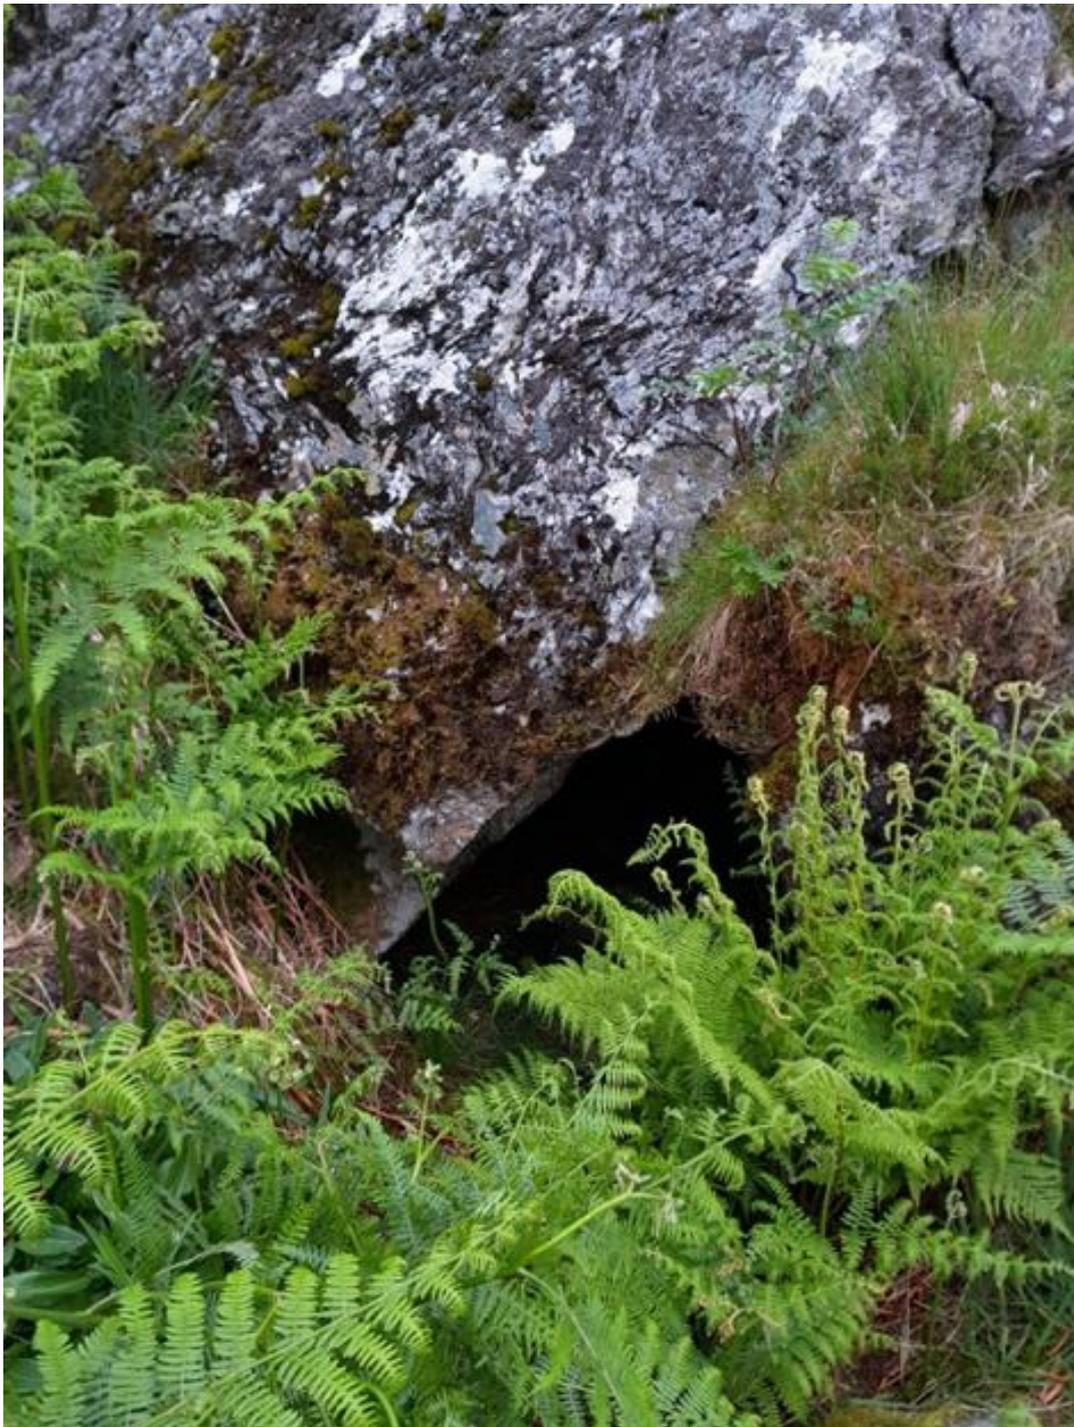
Photograph 22: The photograph shows a deep void extending into the hillside. The rocks surface appears to be dry with some crevices present.

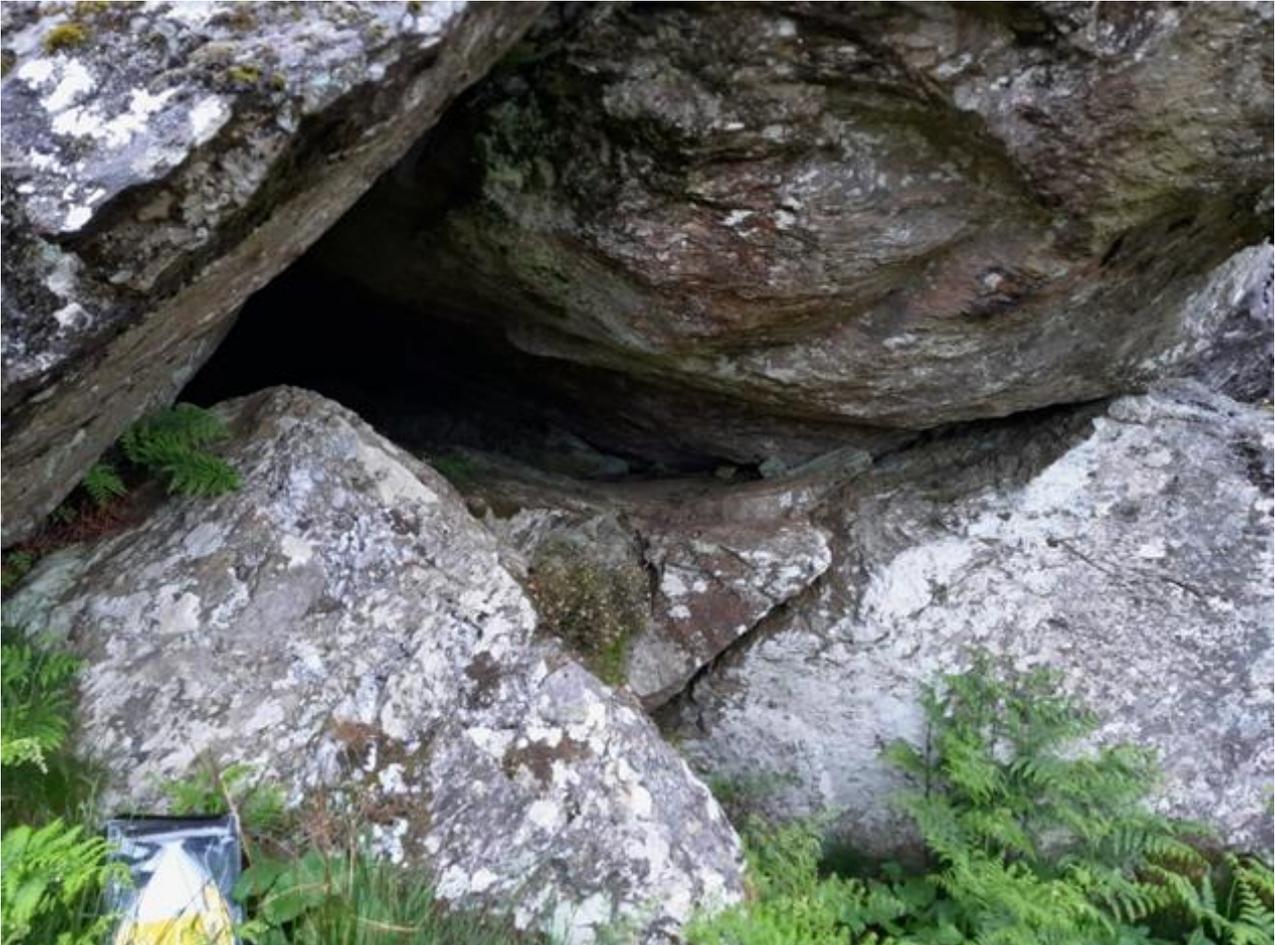
Photograph 23: The photograph shows a deep and wide void extending into the hillside. Damp conditions are observed on the rock surface.

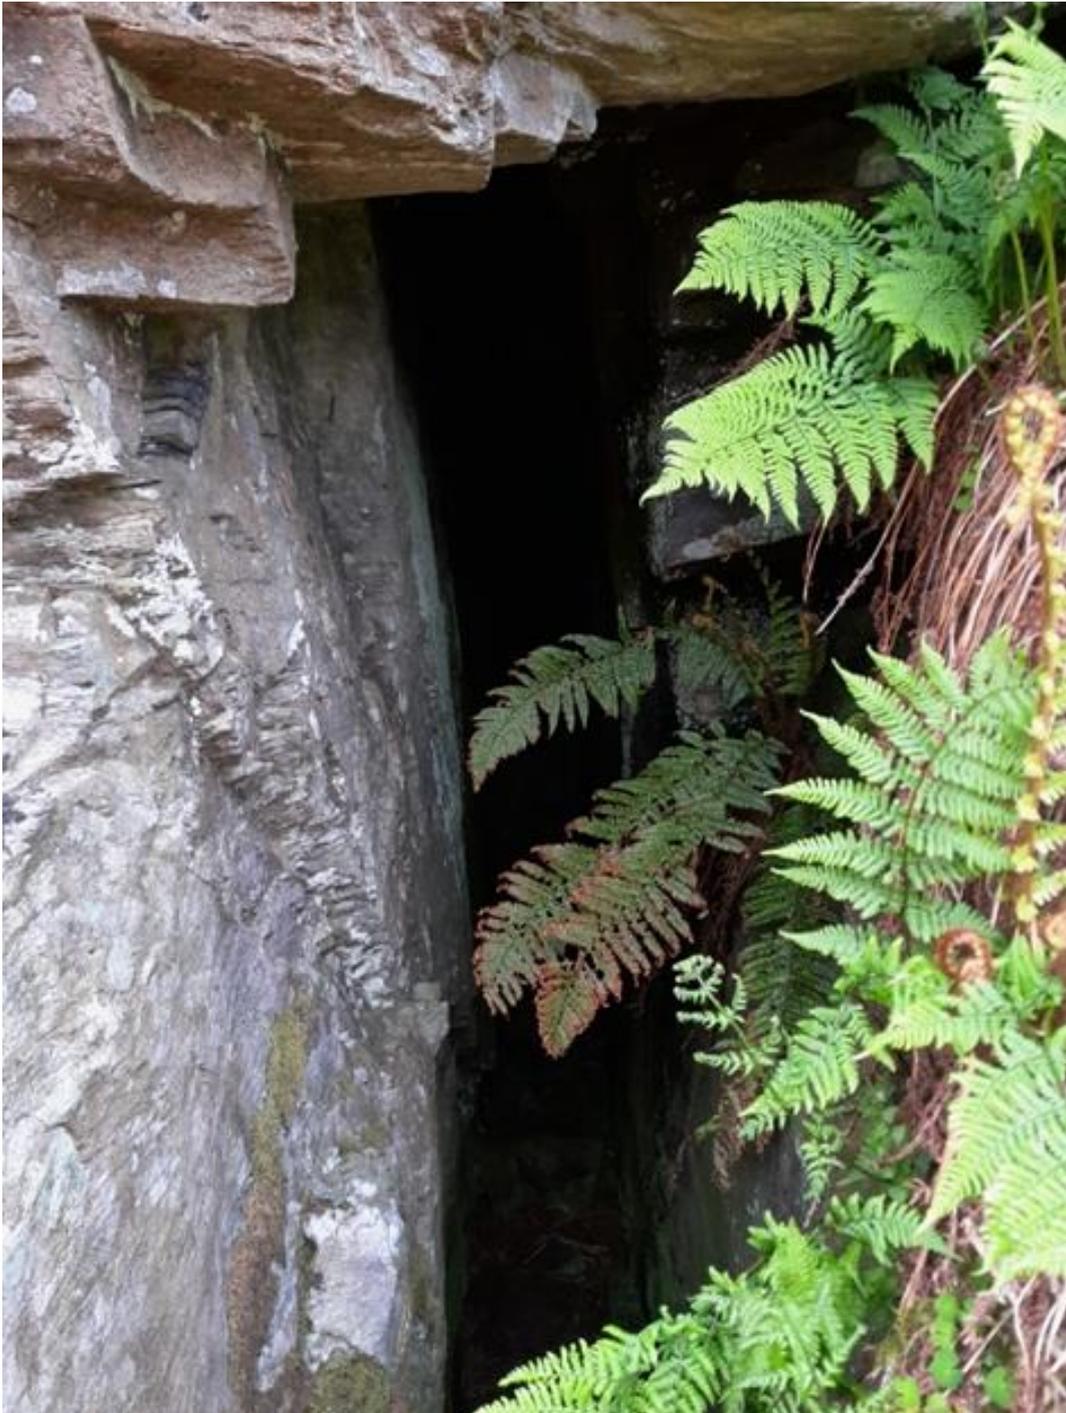
Photograph 24: The photograph shows a close-up view of a deep cleft that extends into the hillside. The rocks appear to be dry with some vegetation creeping through the right rock wall.

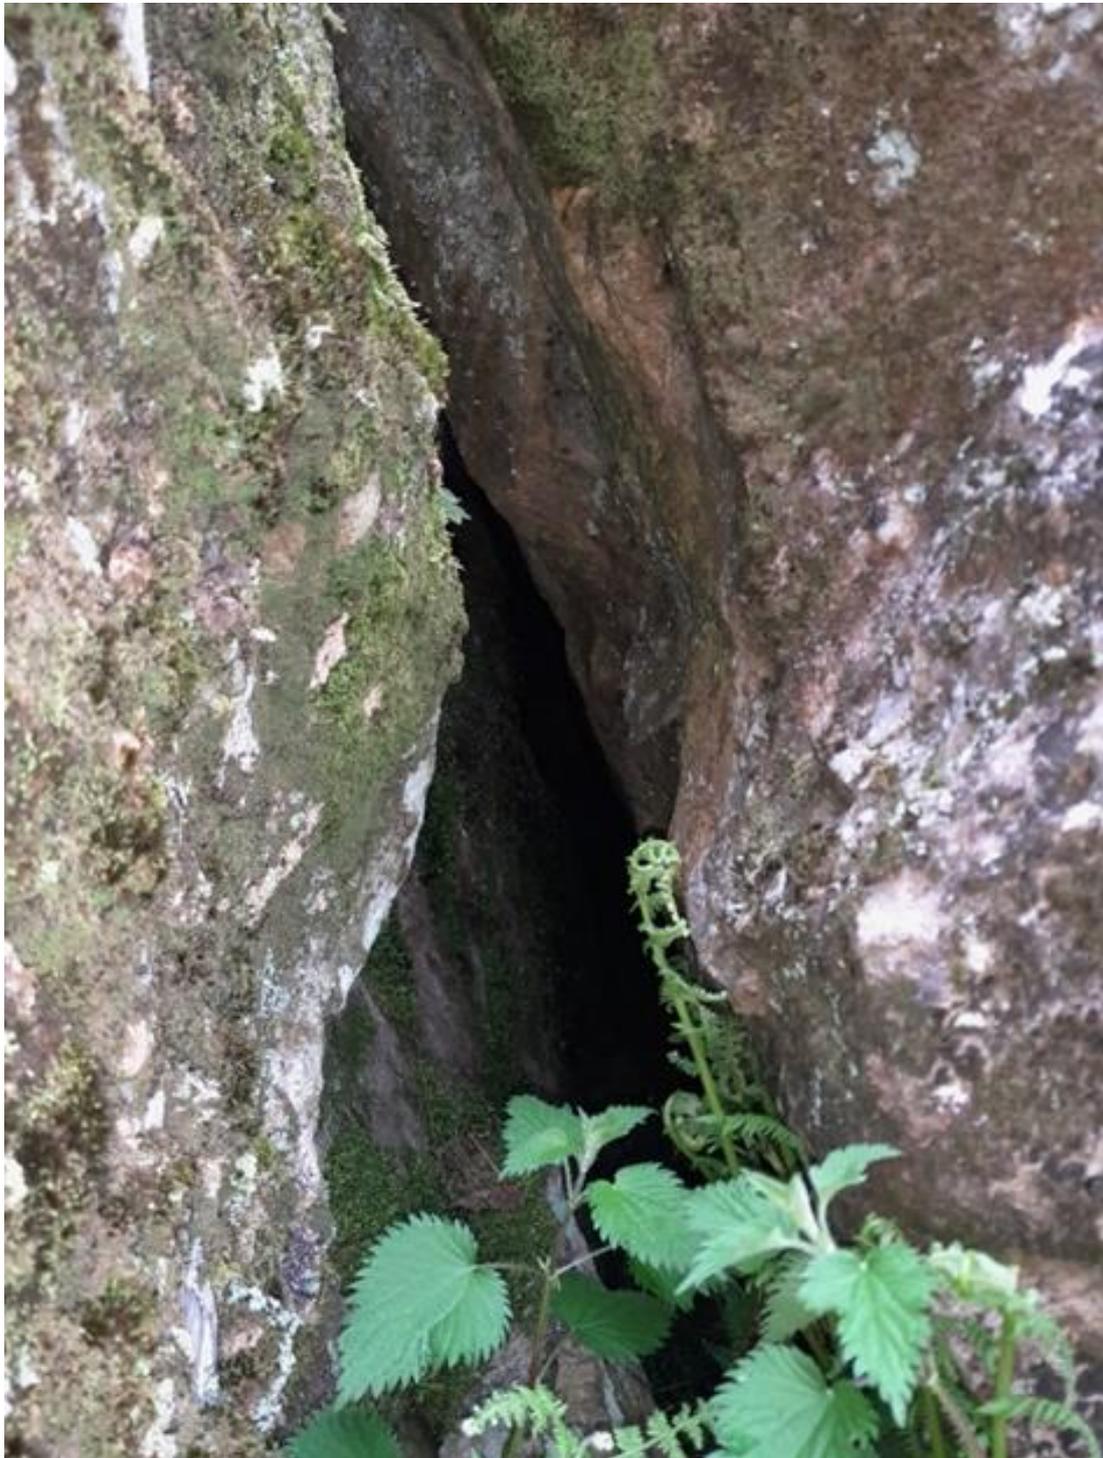
Photograph 25: The photograph shows a close-up view of a deep narrow cleft. The rocks appear to be dry with some vegetation creeping through the gap.

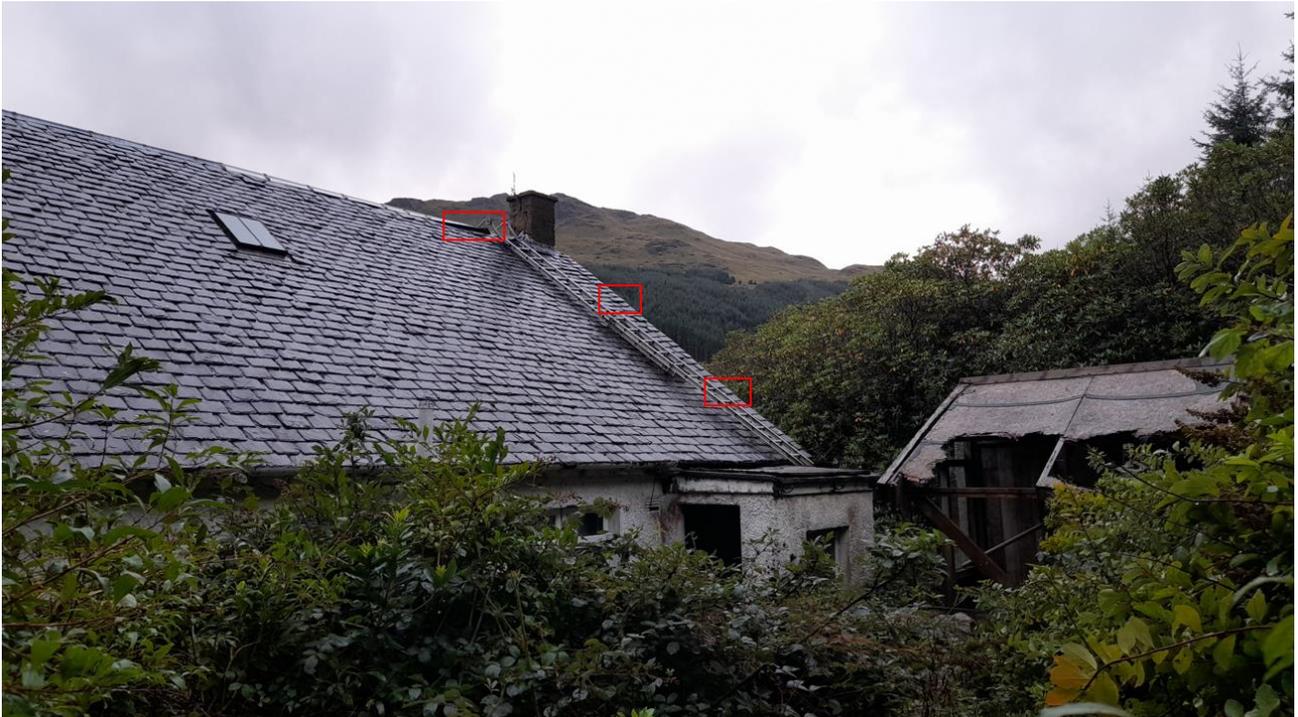
Photograph 1: This photograph shows BB1, roosts are located on the east aspect and are shown in the red boxes below.

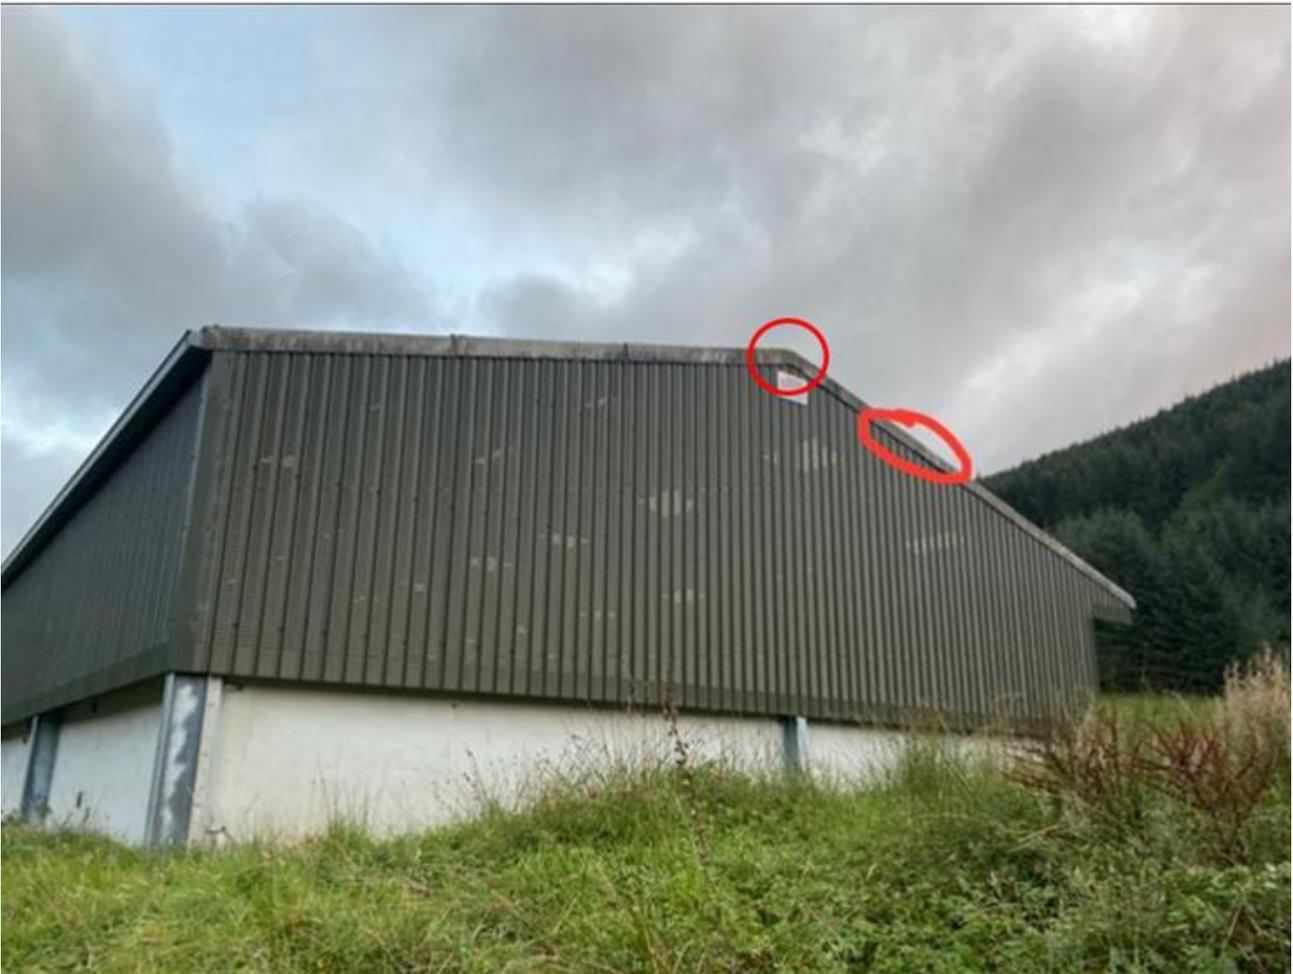
Photograph 2: This photograph shows BB2, roosts are located on the south aspect and are shown in the red boxes below.

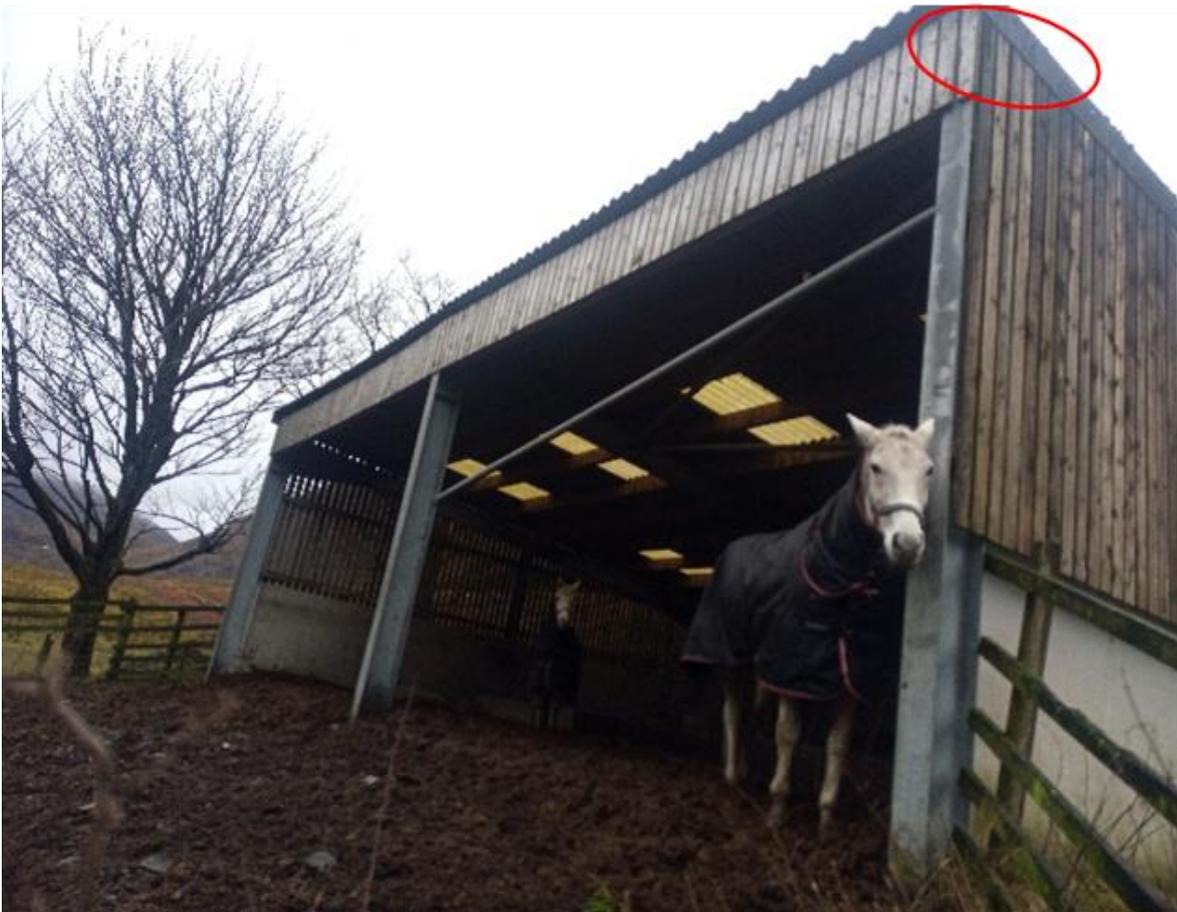
Photograph 3: This photograph shows BB3, a roost is located on the south aspect and is shown in the red box below.

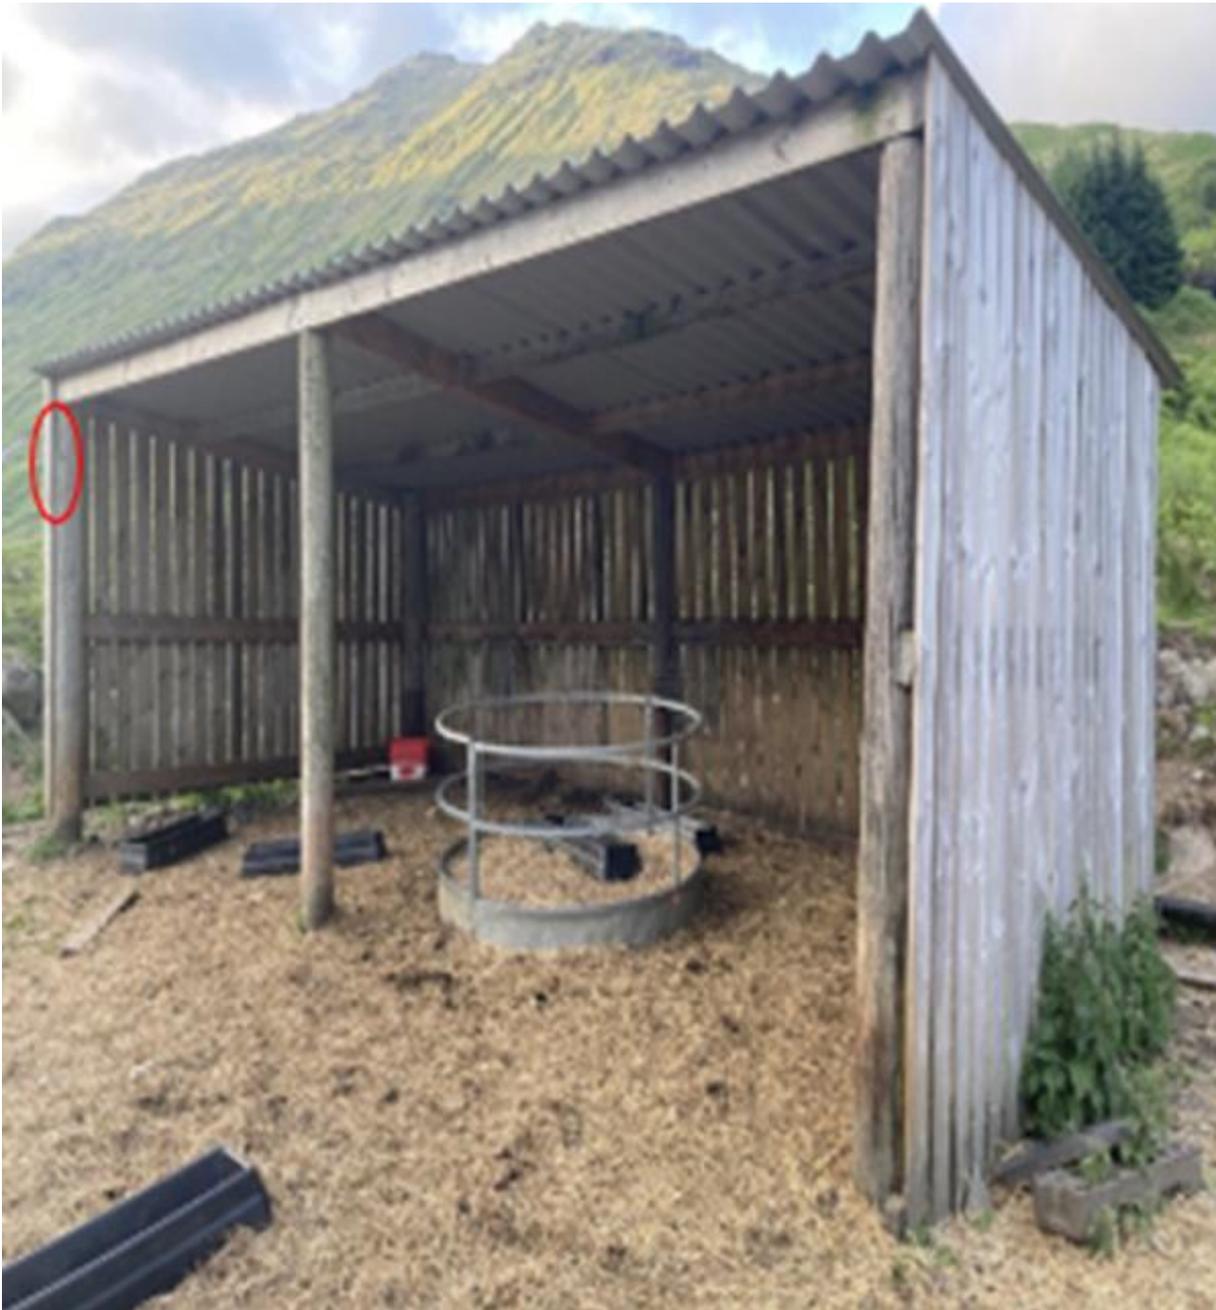
Photograph 3: This photograph shows BB4, a roost is located on the west face and is shown in the red box below.

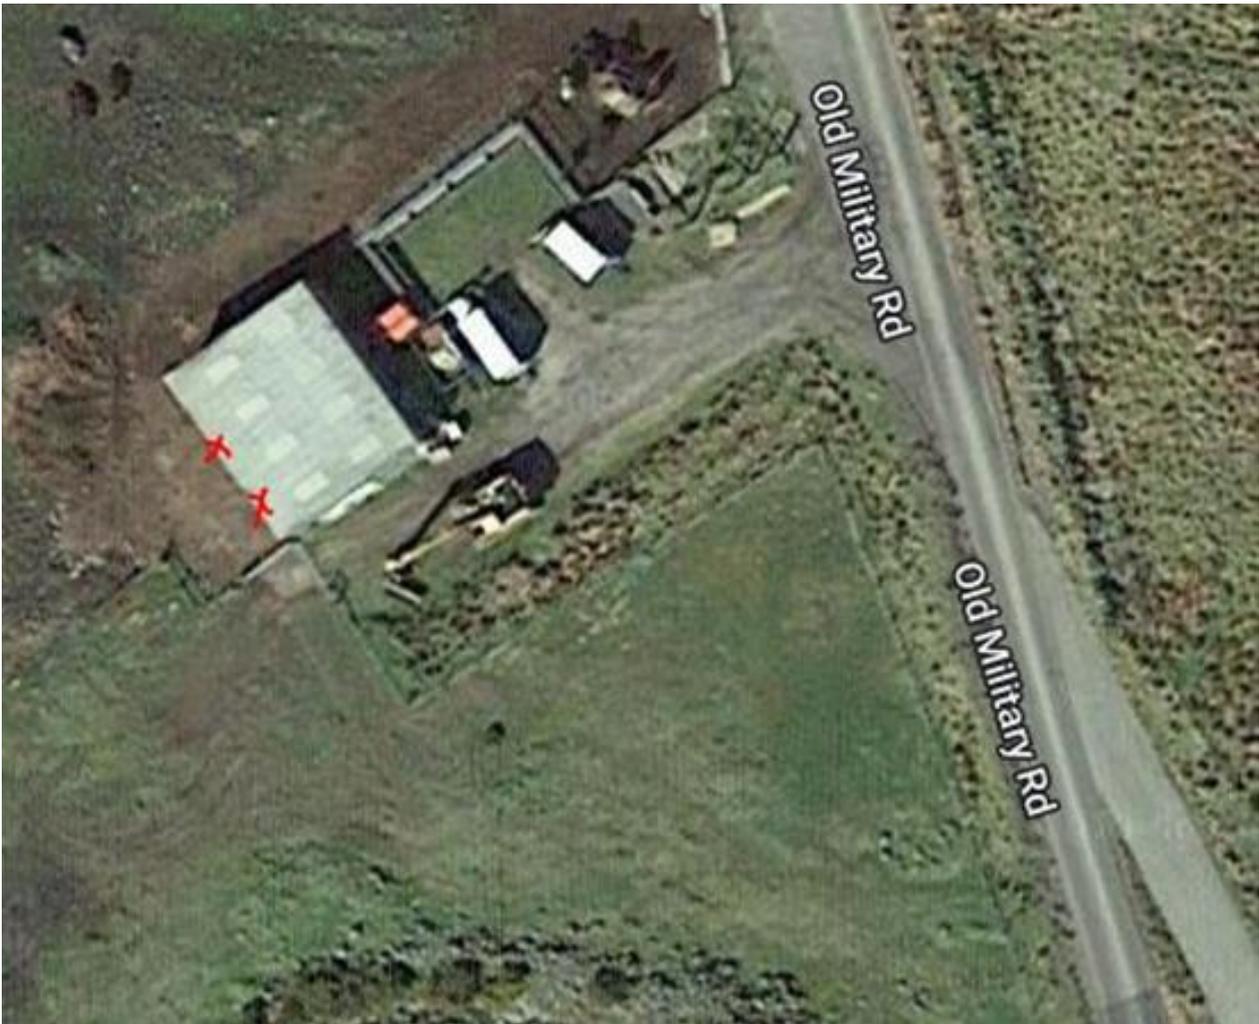
Photograph 5: This photograph shows BB5, roosts are located on the west aspect and are shown in the red crosses below.

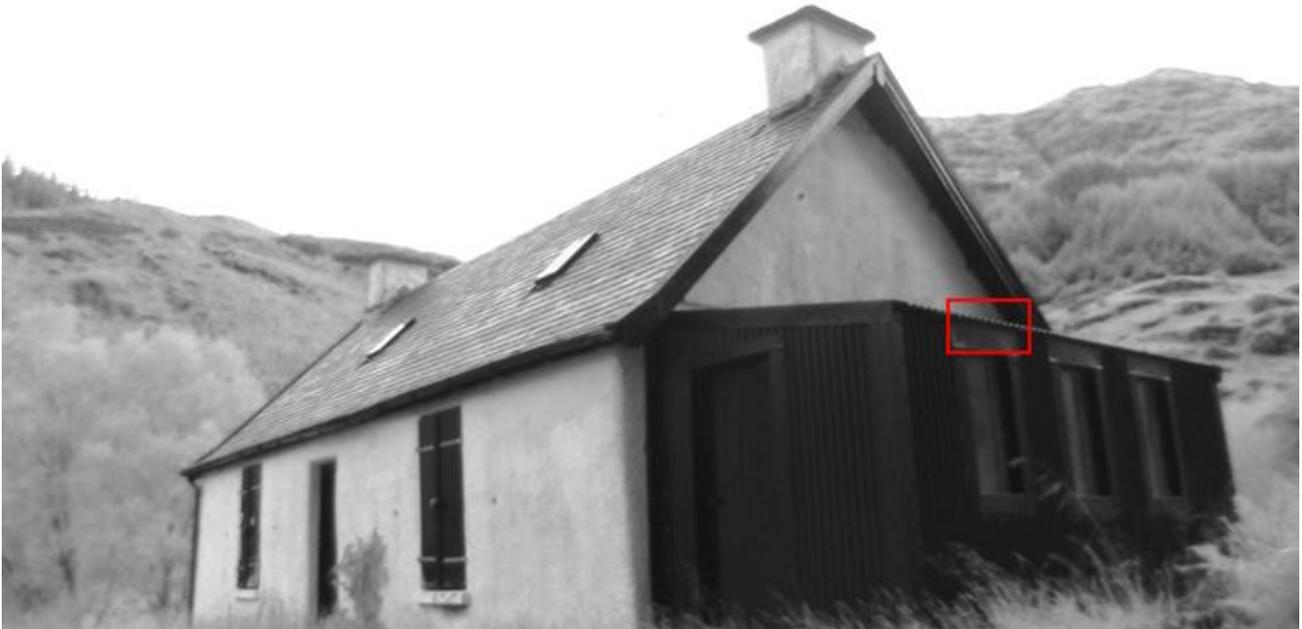
Photograph 2: This photograph shows BB8, roosts are located on the south aspect and are shown in the red boxes below.

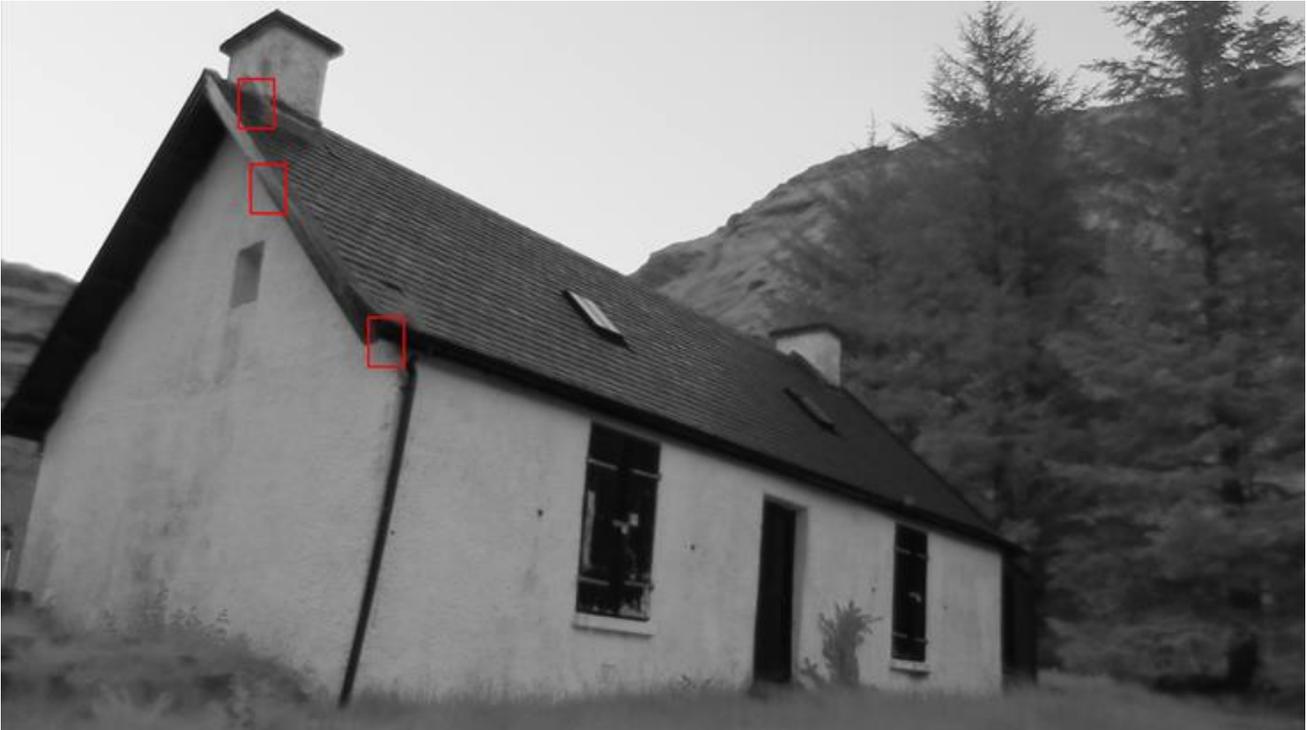
Photograph 3: This photograph shows BB8 from another angle, roosts are located on the northeast aspect and are shown in the red boxes below.

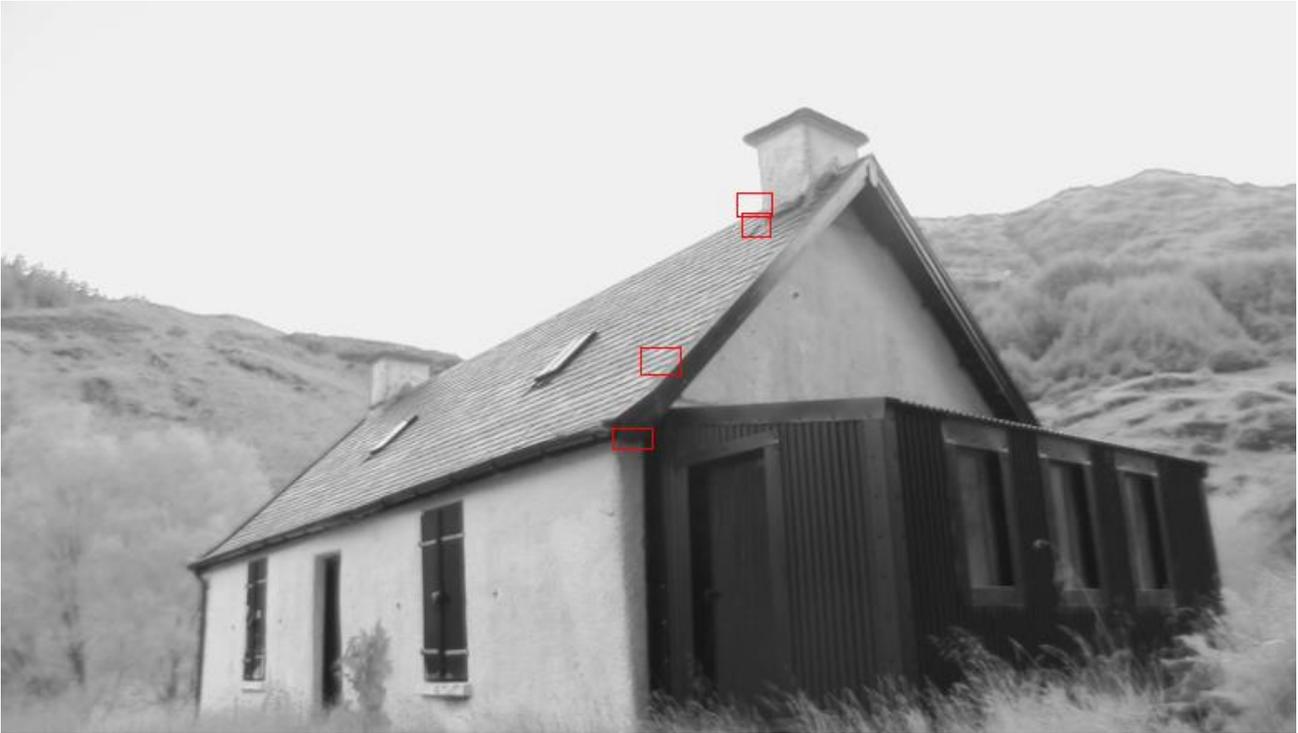
Photograph 4: Another photograph of BB8, roosts are located on the south/southwest aspect and are shown in the red boxes below.

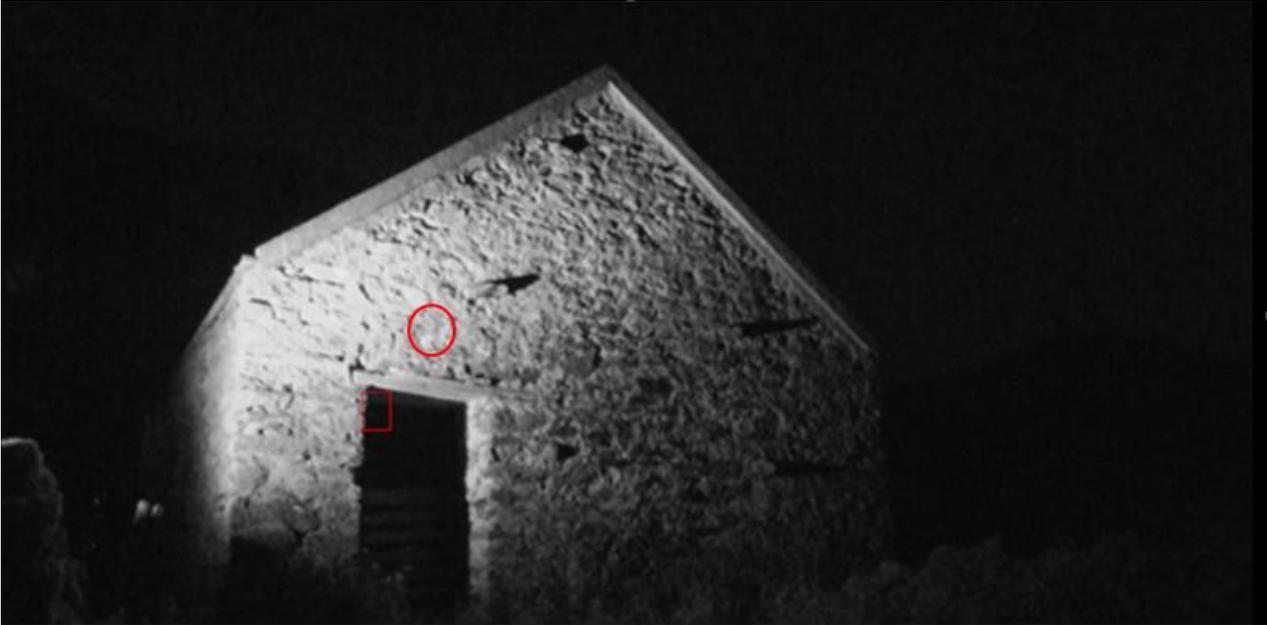
Photograph 5: This photograph shows BB10, roosts are located on the west aspect and are shown in the red boxes below.
