# A83 Rest and Be Thankful

LTS EIAR VOLUME 4, APPENDIX 11.11 - BAT REPORT

A83AAB-AWJ-EAC-LTS\_GEN-RP-LE-000267

# A11-11. Bat Report

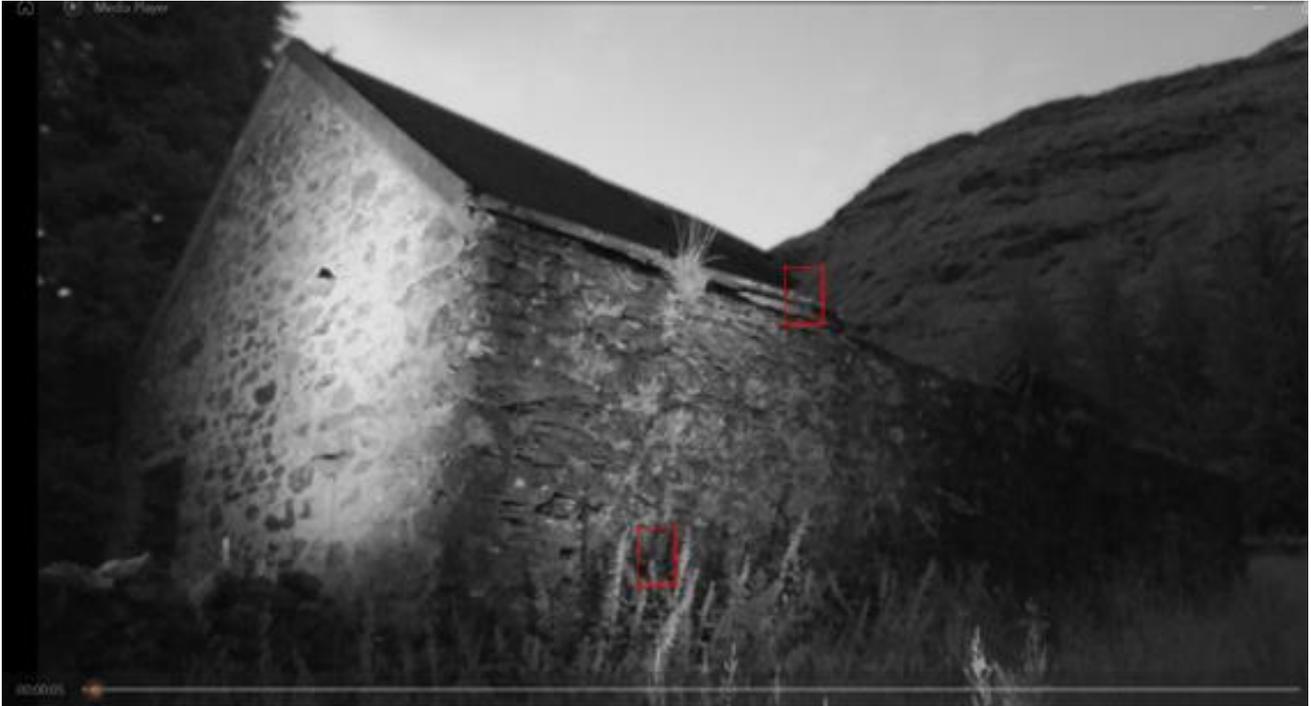
Photograph 6: Another photograph of BB10, roosts are located on the southwest aspect and are shown in the red boxes below.

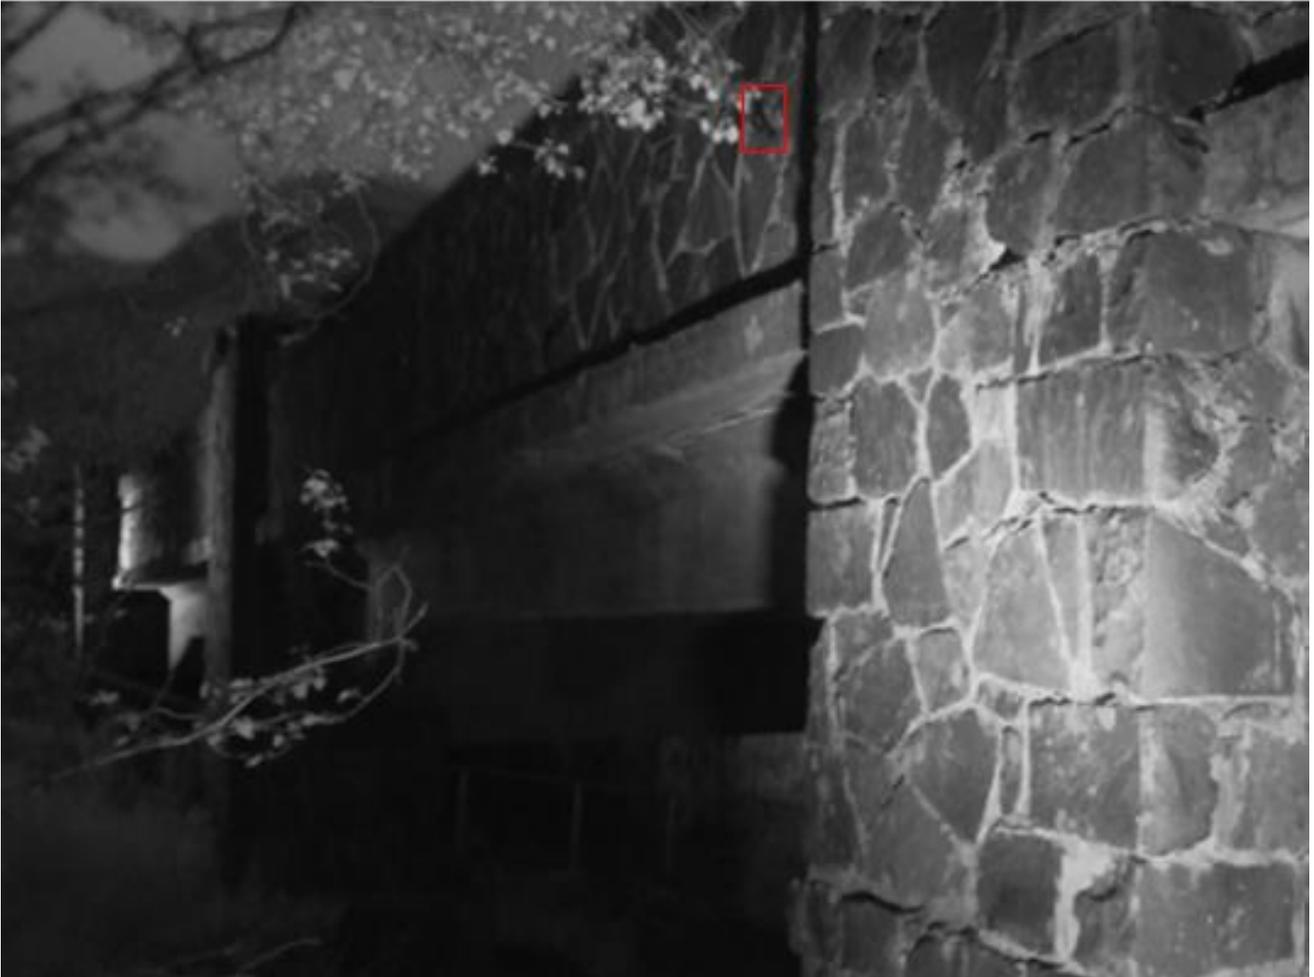
Photograph 7: This photograph shows BS2, a roost is located on the northeast aspect and is shown in the red box below.

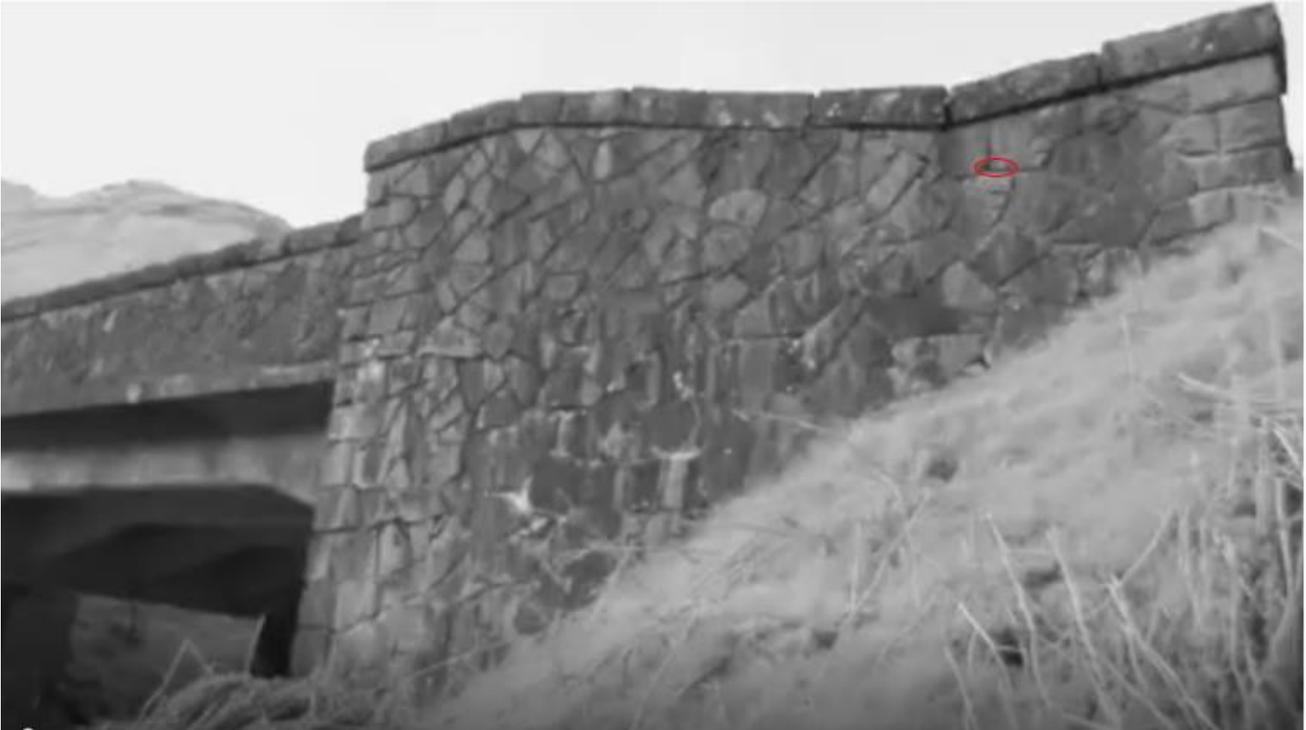
Photograph 8: Another photograph of BS2, a roost is located on the southwest aspect and is shown in the red box below

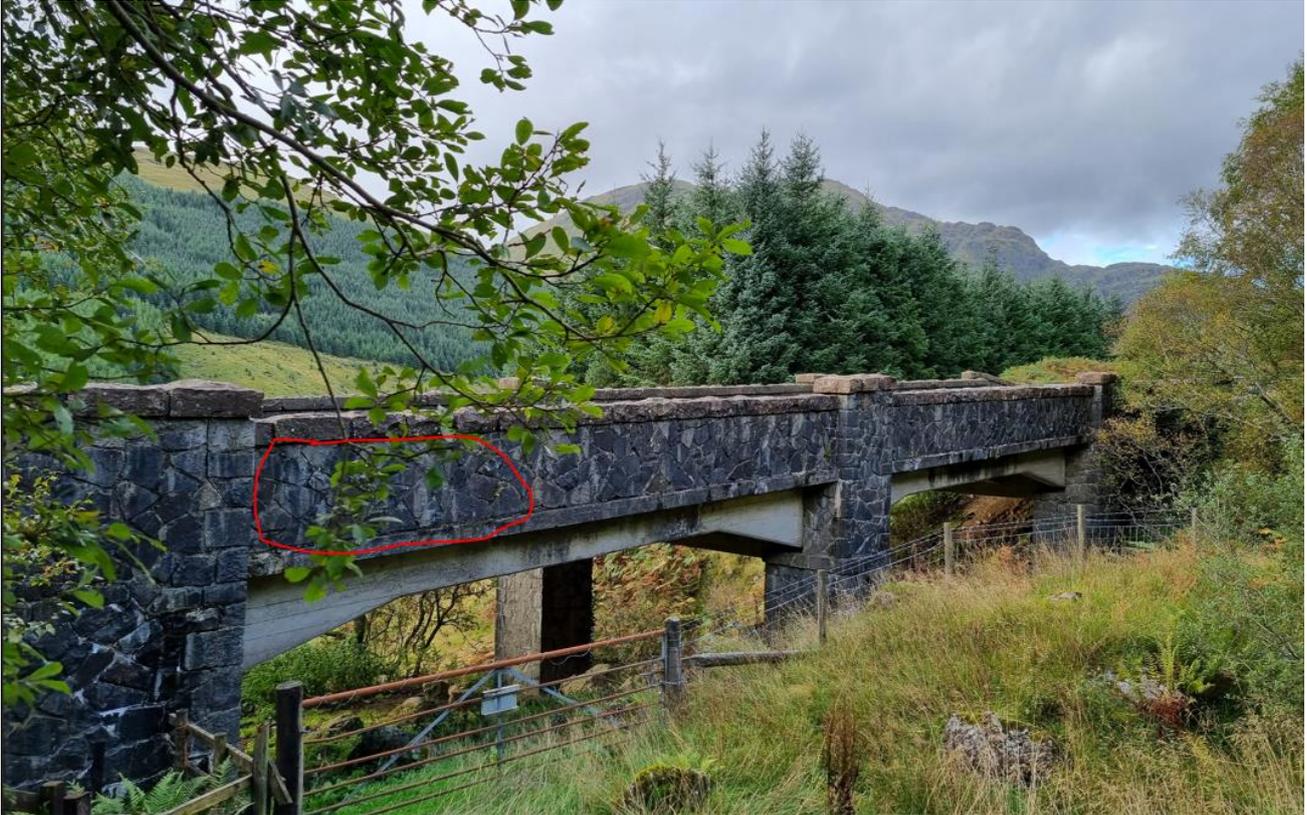
Photograph 9: Another photograph of BS2, a roost is located on the east aspect and is shown in the red box below

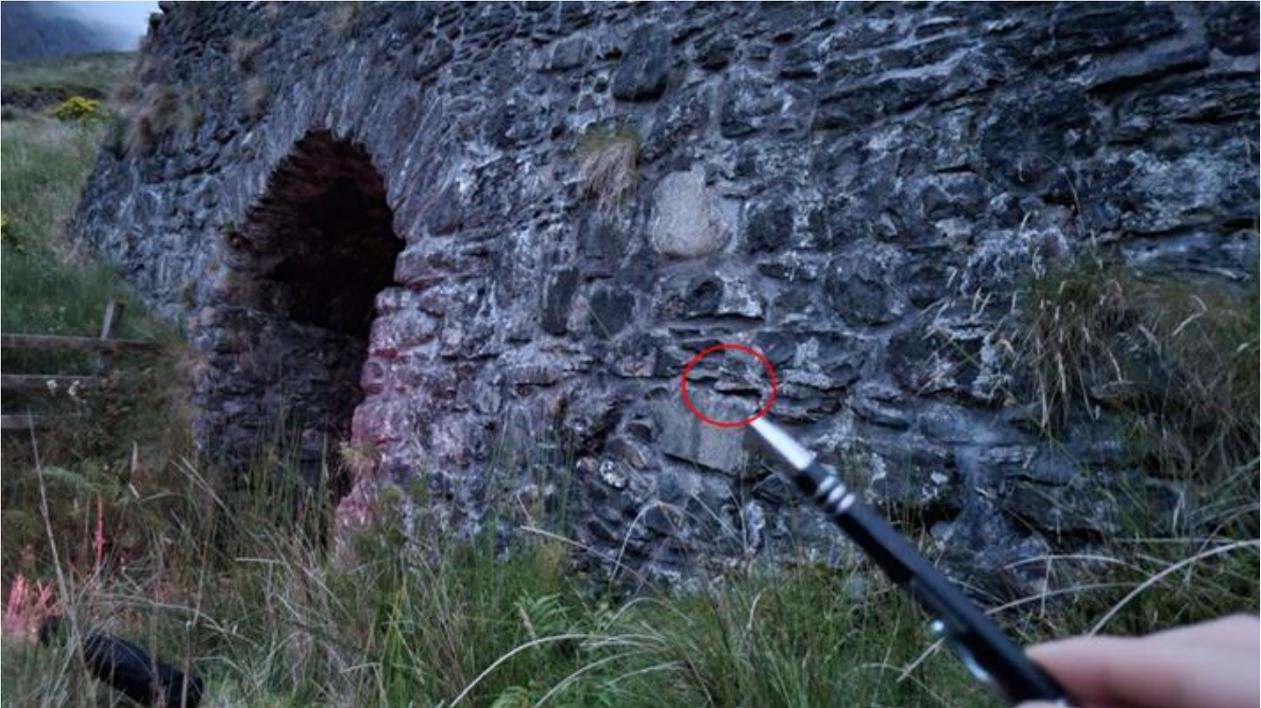
Photograph 10: This photograph shows BS11, a roost is located on the southwest aspect and is shown in the red circle below.

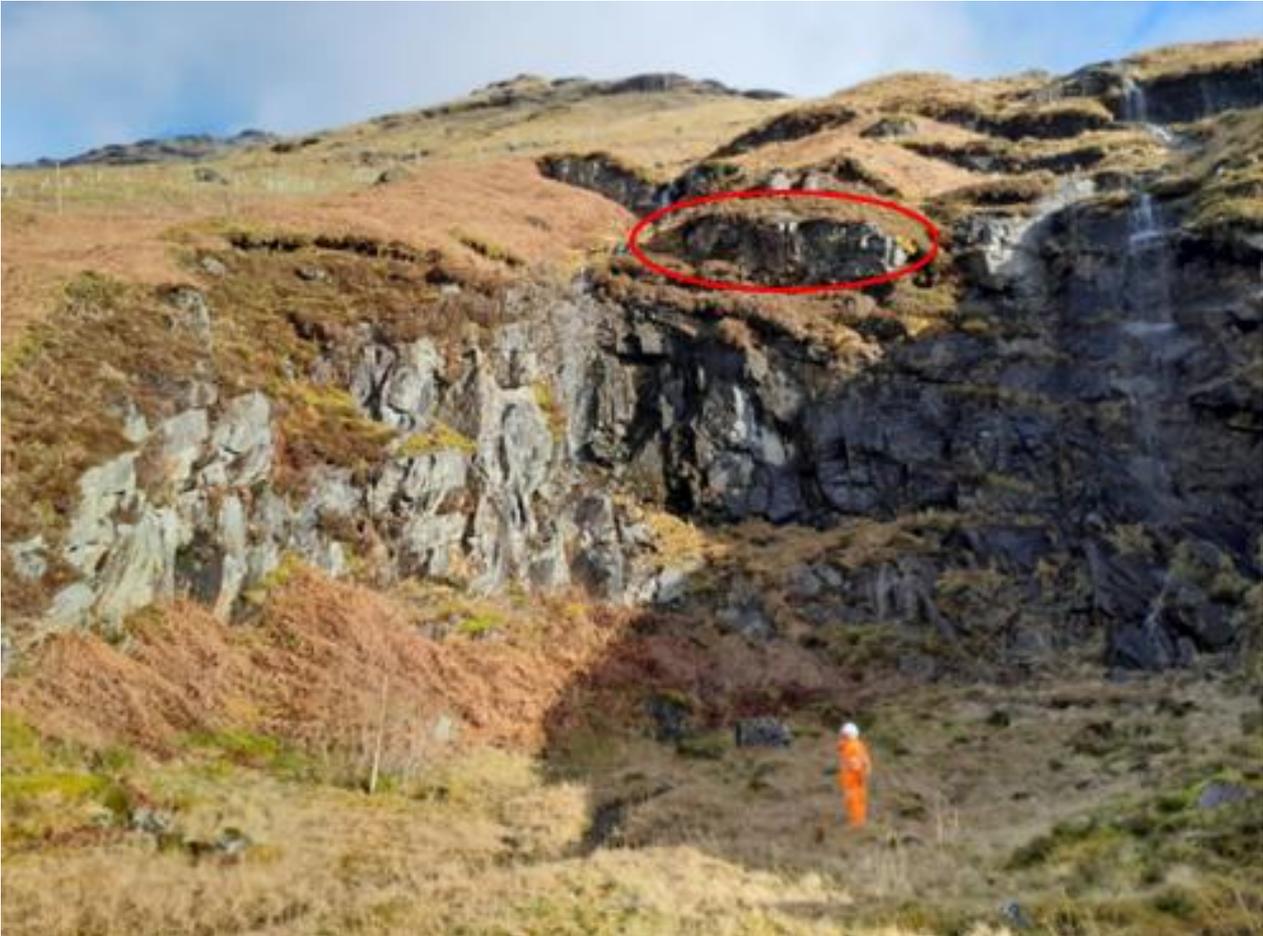
Photograph 11: This photograph shows BS24, a roost is located on the north aspect and is shown in the red circle below.

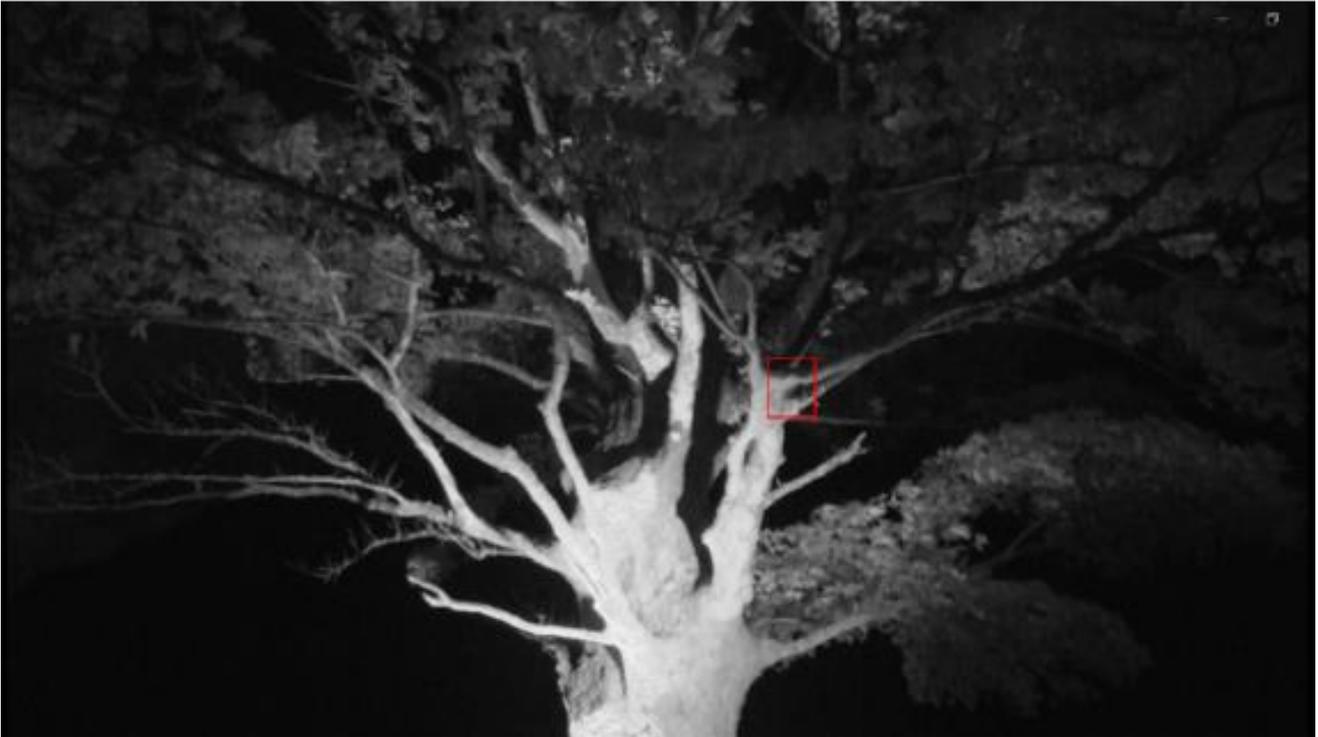
Photograph 12: This photograph shows BT3, a roost location on the east aspect is shown in the red box below.

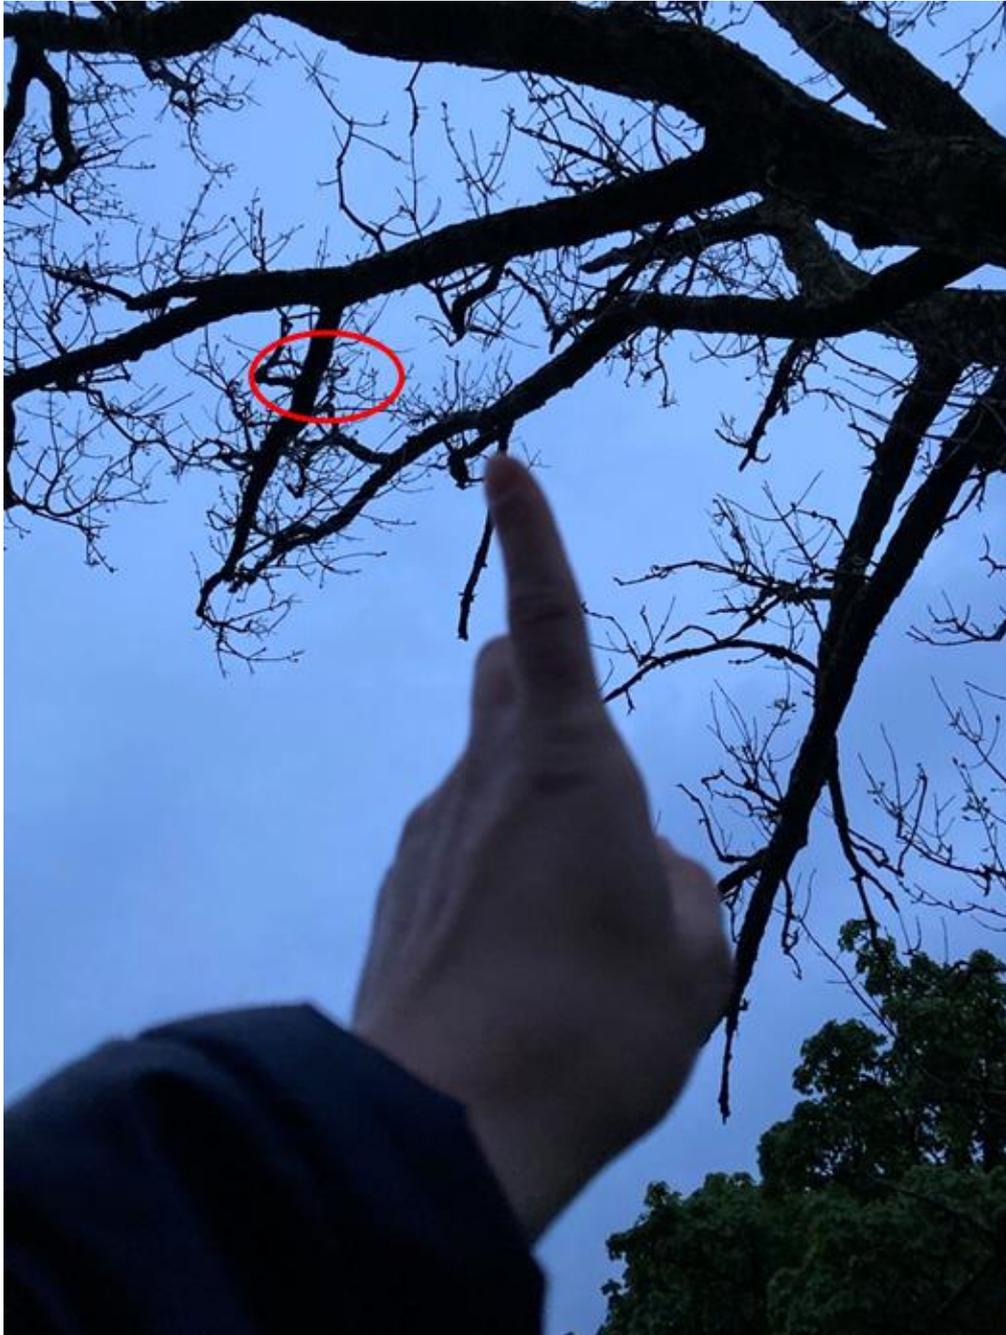
Photograph 13: This photograph shows BT4, a roost location on the south aspect is shown in the red circle below.

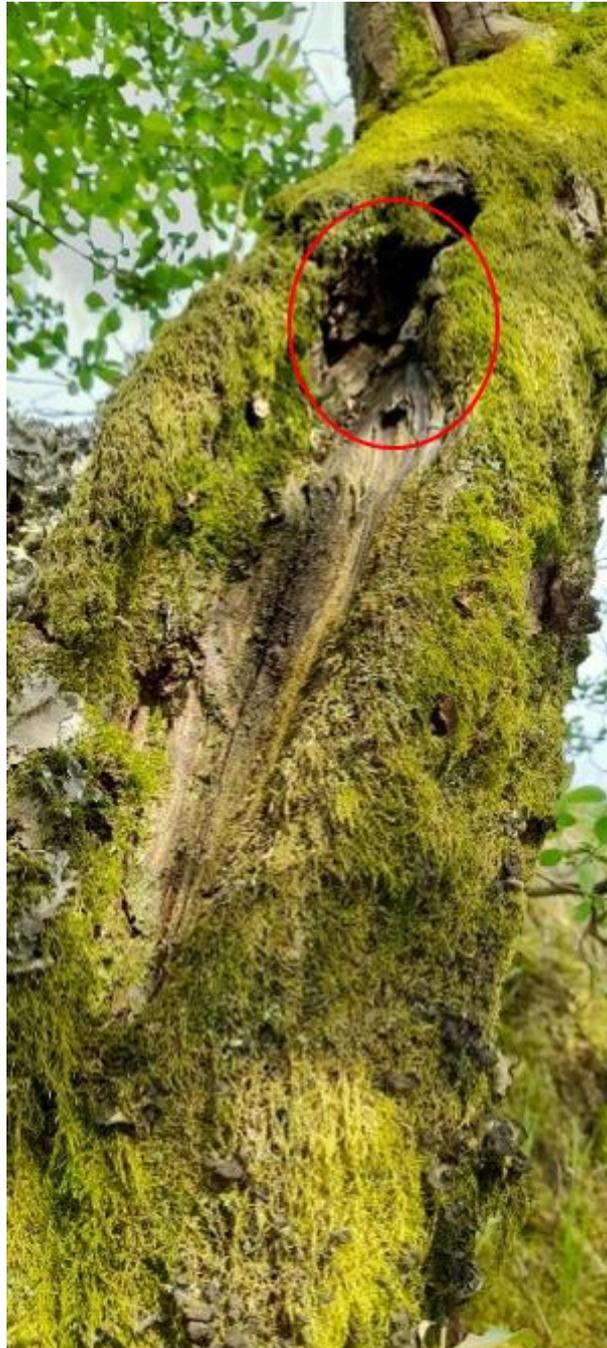
Photograph 14: This photograph shows BT5, a roost location on the south aspect is shown in the red circle below.

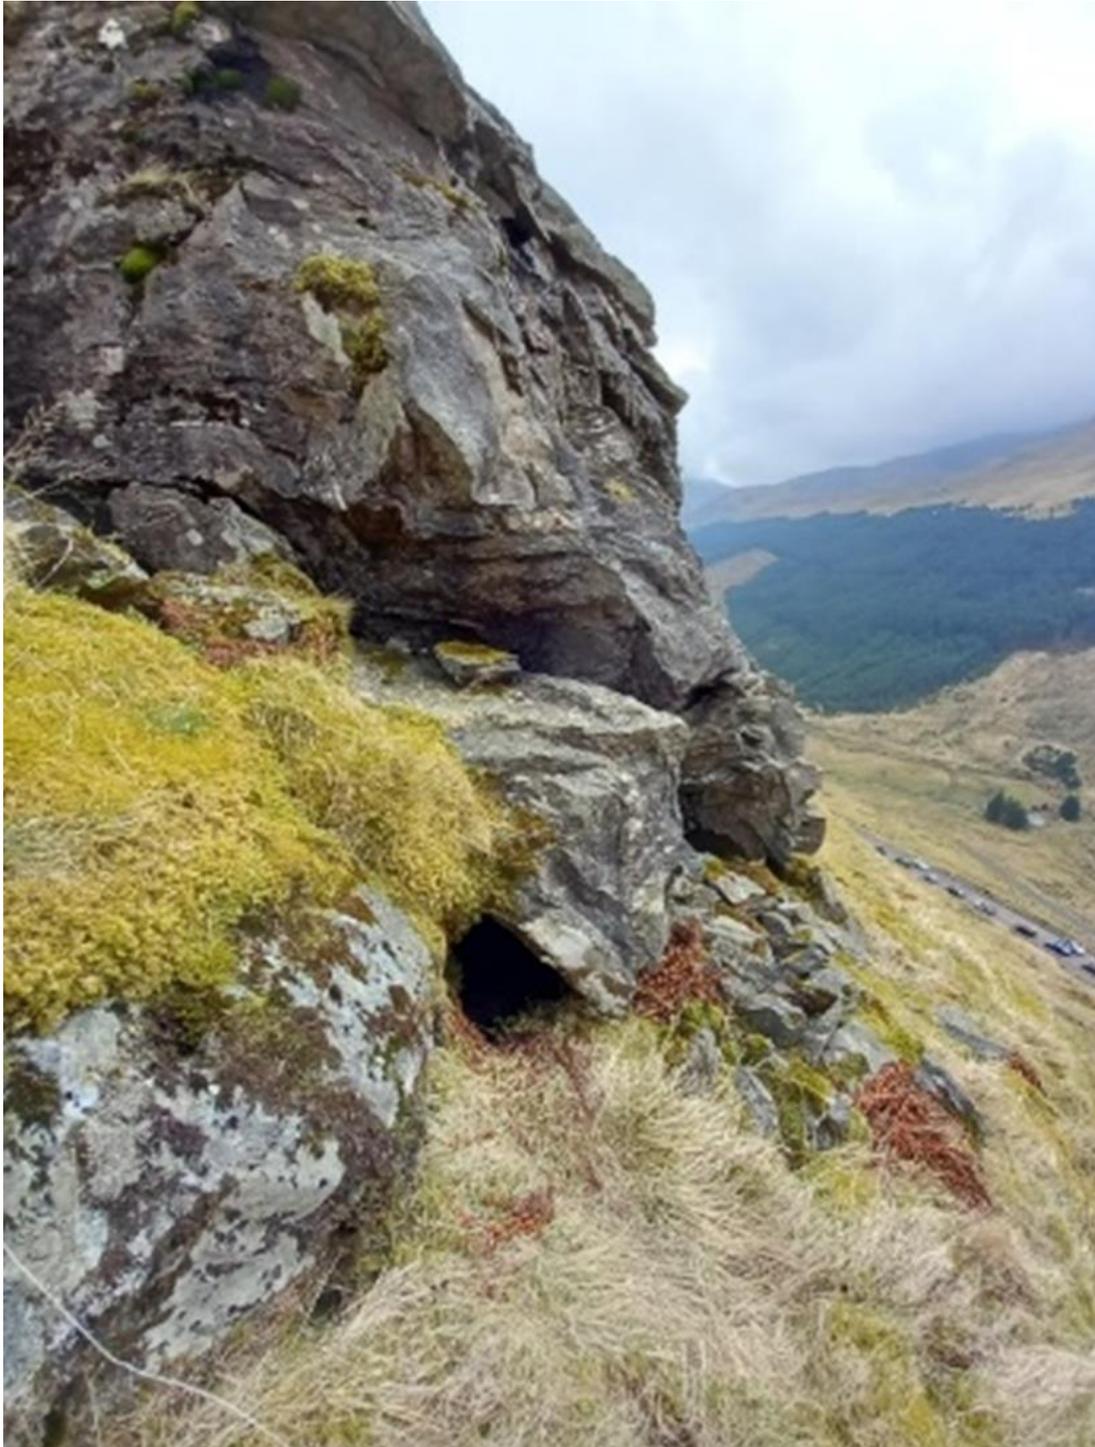
Photograph 15: This photograph shows PM5, a rock feature found to contain a bat roost during terrestrial mammal surveys.
