Project FORTH REPLACEMENT CROSSING

VIBRATION MONITORING REPORT APRIL 2016

Made by Michael Richardson	Checked By: Steven Westwater		
Initials: MRN	Initials: SWR		
Document number			
REP-00277	00

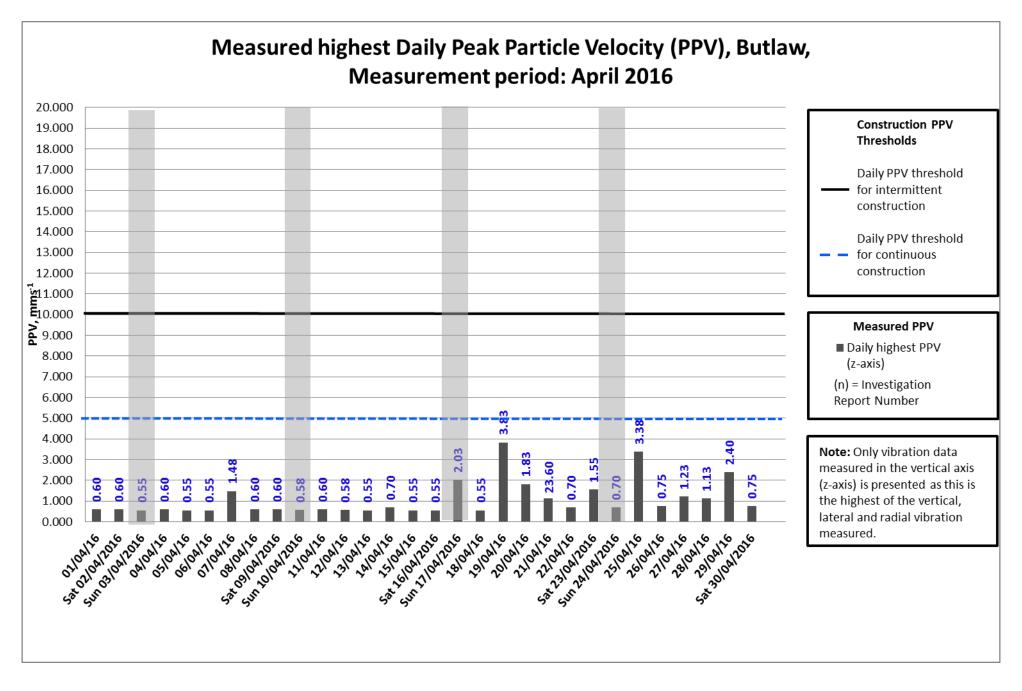
Exceedances on the 2nd, 3rd, 4th, 5th, 7th, 12th, 13th, 14th, 16th, 20th, 22nd, 25th, and 29th of April have been investigated and found to be caused by individual isolated events that are unlikely to have been construction related activities (graph above from the 07/04/2016).

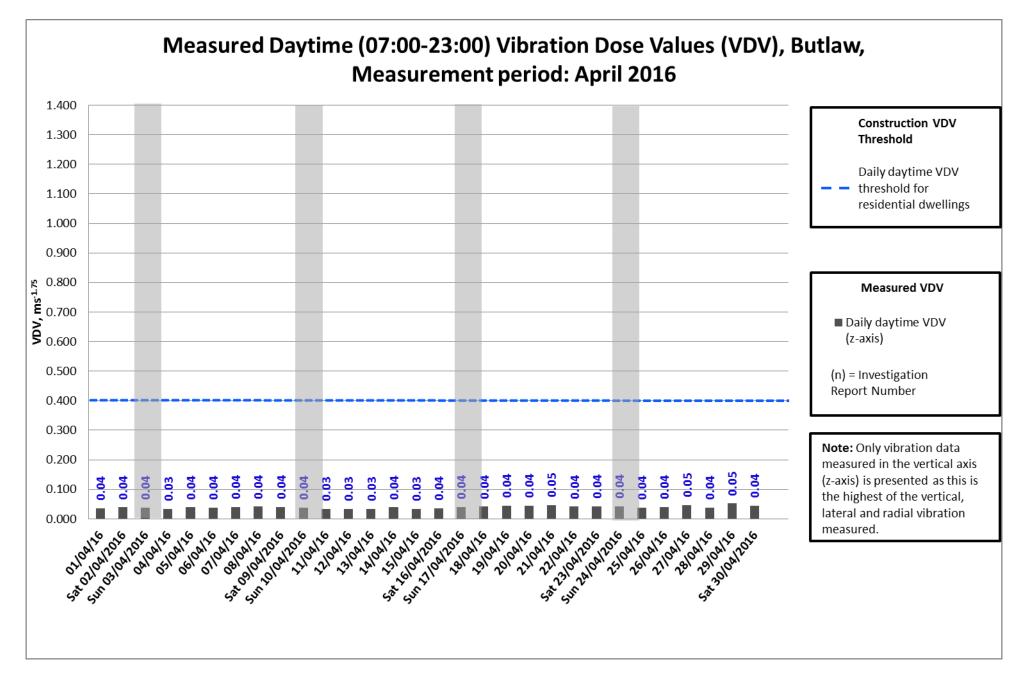
Exceedances on the 15th, 17th, 21st and 24th of April have been investigated and found to be caused out with construction working hours and therefore it is unlikely that construction related activity was the cause of these (graph above from the 15/04/2016).

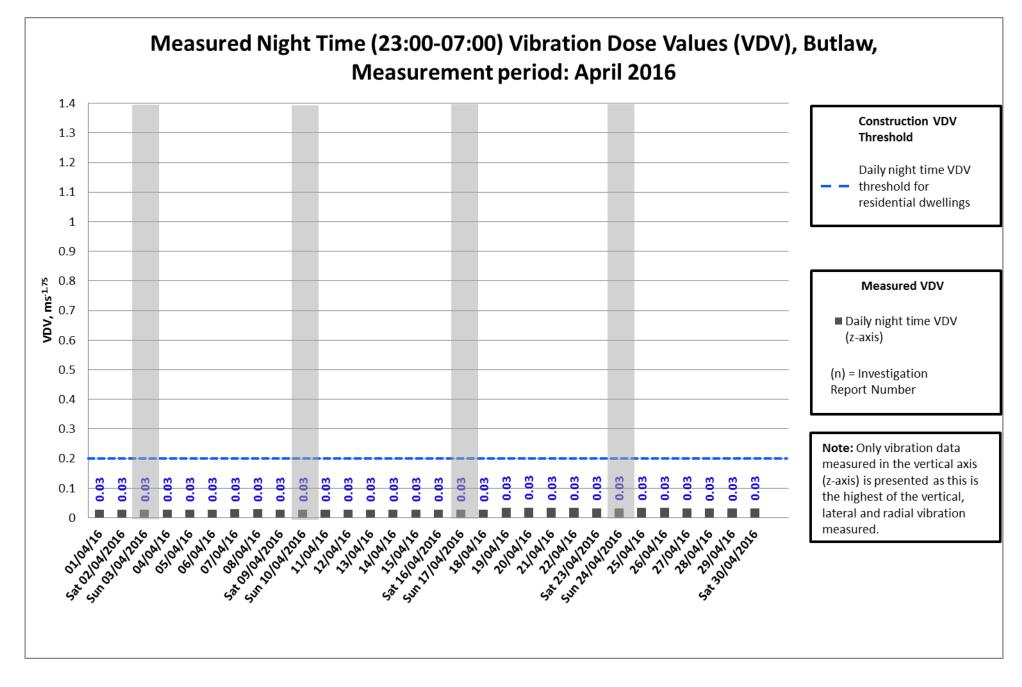
Exceedance on the 27th of April has been investigated and found to be caused by the Environmental department carrying out monitor maintenance within the location of the vibration monitor.

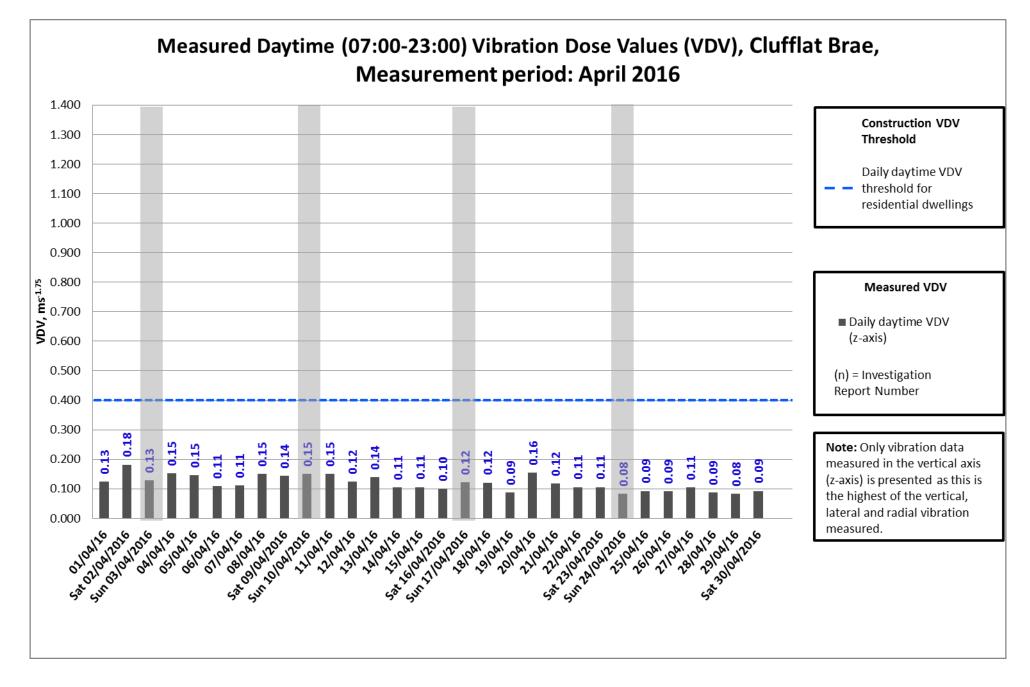
Data missing from the 6th to the 30th of April was caused by power issue at the monitor location. This has since been resolved on the 11th of May.

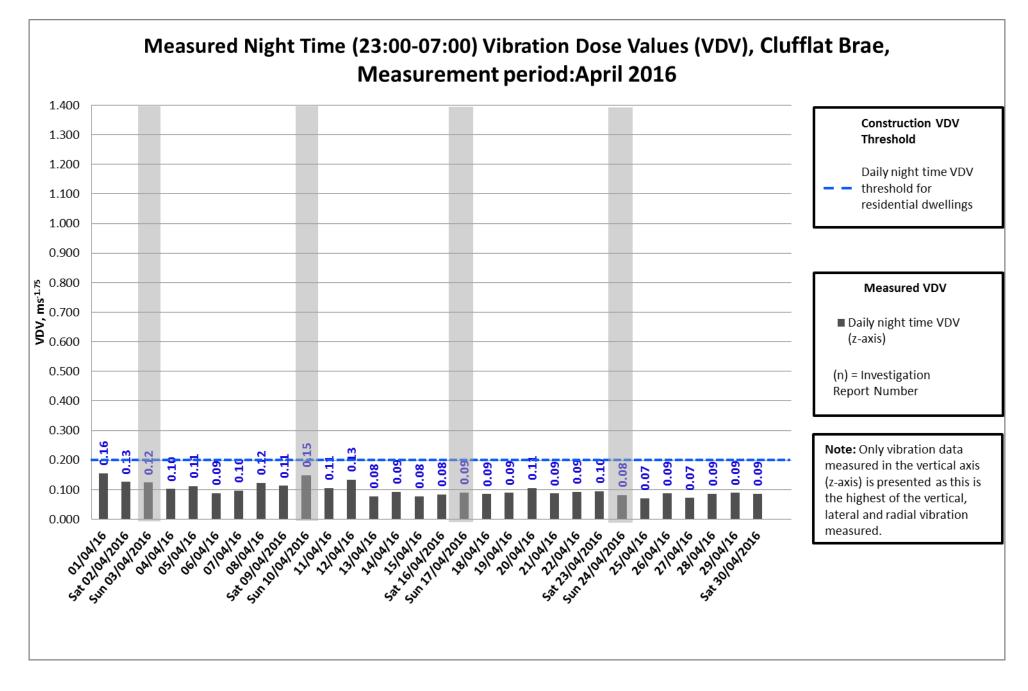
Data missing from the 6th to the 30th of April was caused by power issue at the monitor location. This has since been resolved on the 11th of May.

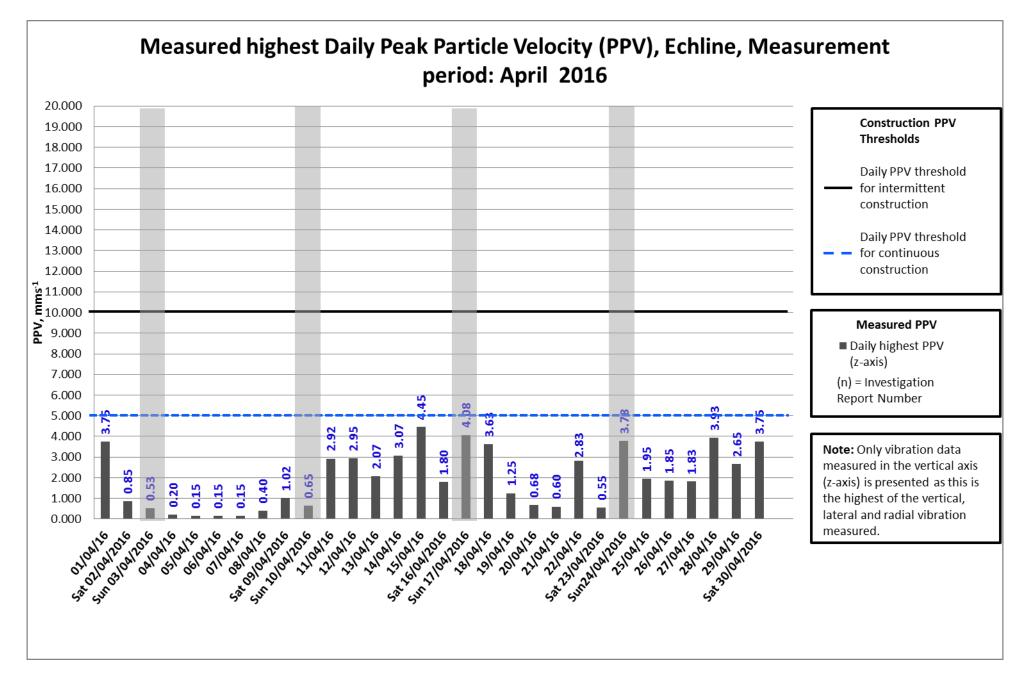
Exceedances on the 5th and 19th of April have been investigated and found to be caused by individual isolated events that are unlikely to have been construction related activities (graph above from the 05/04/2016).

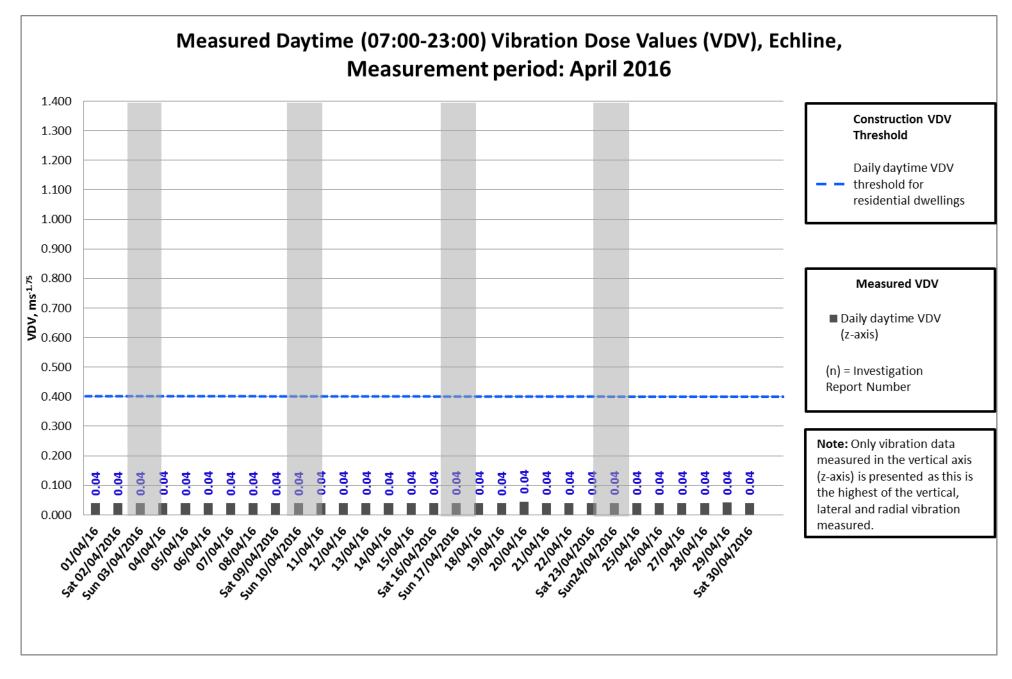
Exceedances on the 9th, 13th and 20th of April have been investigated and found to be caused out with construction working hours and therefore it is unlikely that construction related activity was the cause of these (graph above from the 09/04/2016).

During this period the resident at the property, where the monitor is situated, has ongoing private construction works. It is likely that exceedances within the graph above were caused by the works on the property rather than the construction of the new crossing and supporting infrastructure.

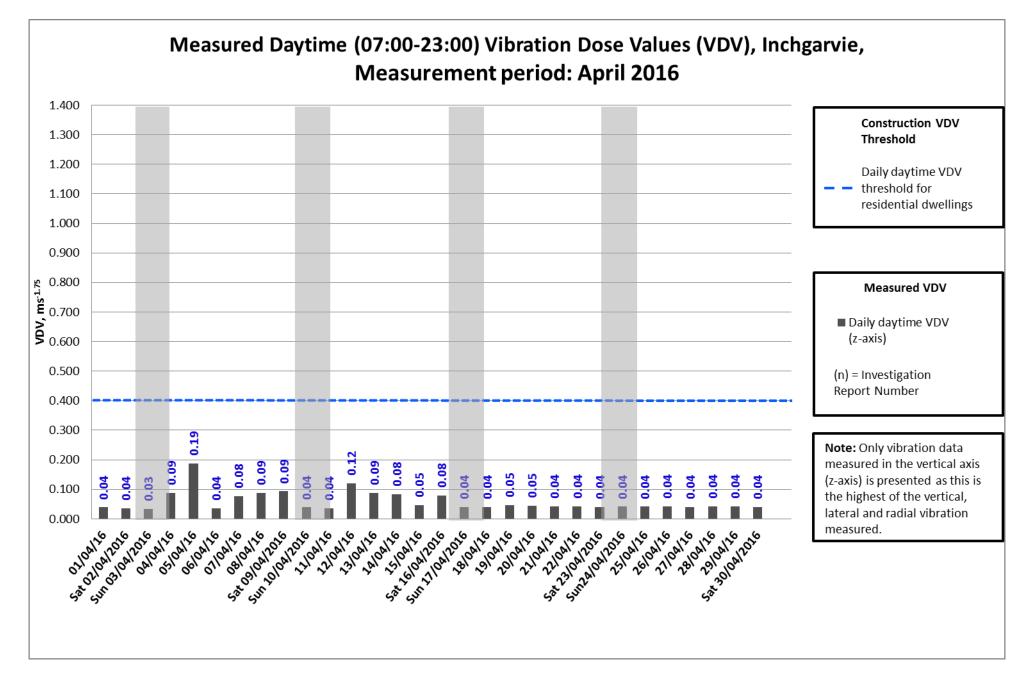
Exceedance on the 18th of April have been investigated and found to have occured outwith construction working hours and therefore it is unlikely that construction related activity was the cause of these (graph above from the 18/04/2016).

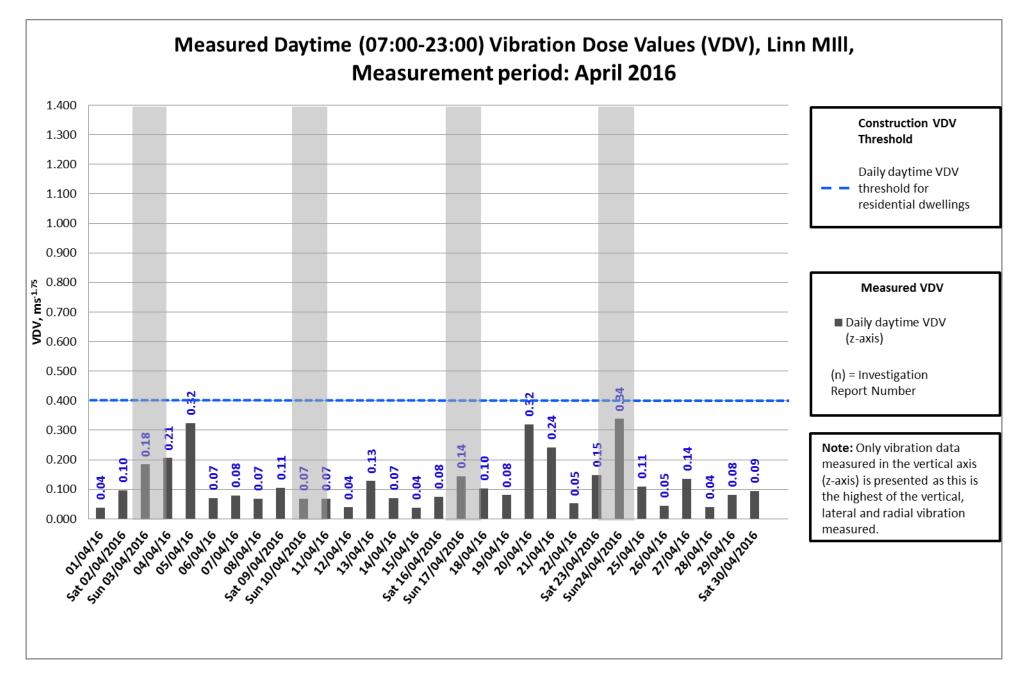
Exceedances on the 10th and 17th of April have been investigated and found to have occured outwith construction working hours and therefore it is unlikely that construction relate activity was the cause.

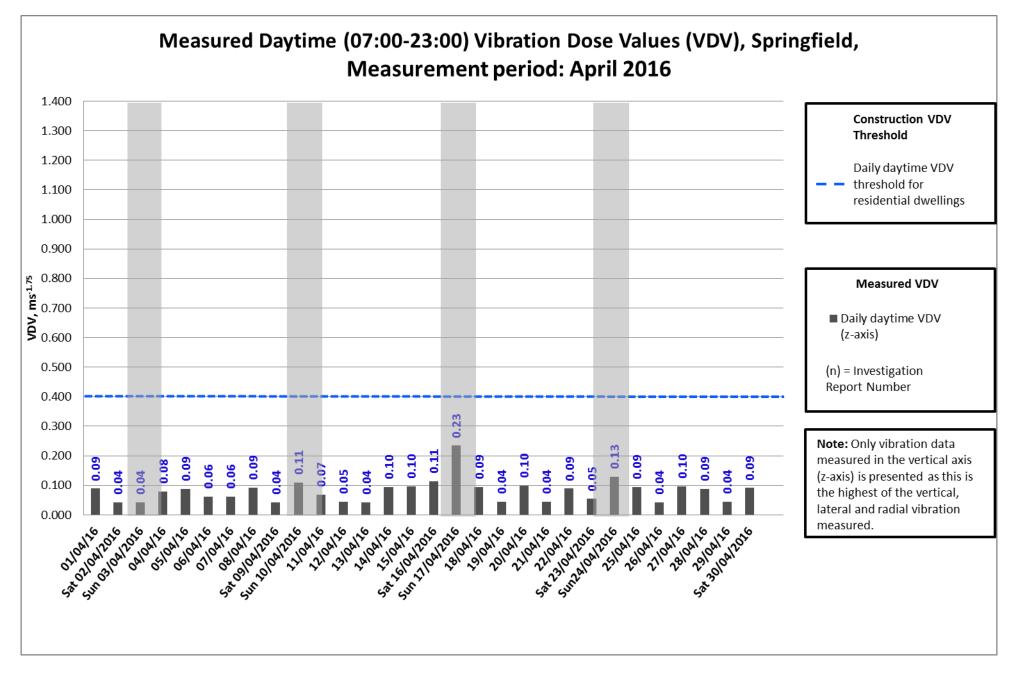
Exceedance on the 29th of April has been investigated and found to be caused by individual isolated events that are unlikely to have been caused by construction related activities (graph above from the 29/04/2016).
