FORTH REPLACEMENT CROSSING

VIBRATION MONITORING REPORT DECEMBER 2016

Made by David Clark Checked By: Steven Westwater	
Initials: DCK	Initials: SWR
Document number	
REP-00305	00

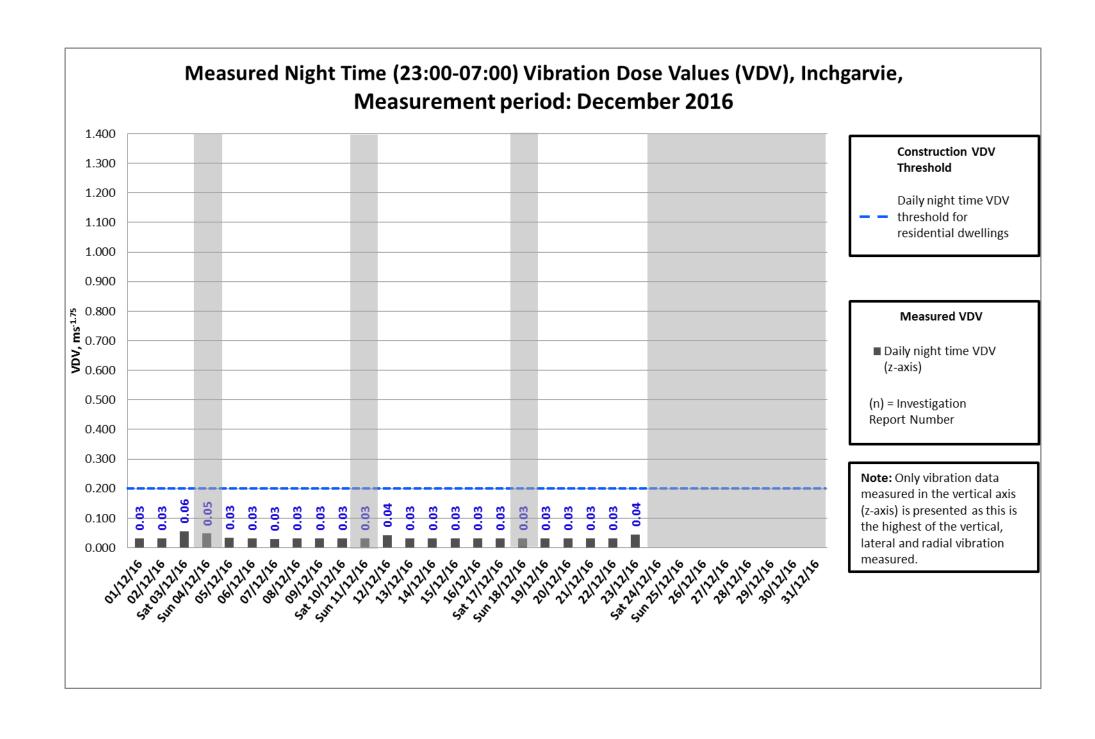
Exceedance on the 13th of December has been investigated and found to be caused out with construction working hours and therefore it is unlikely that a construction related activity (graph above from the 13/12/2016).

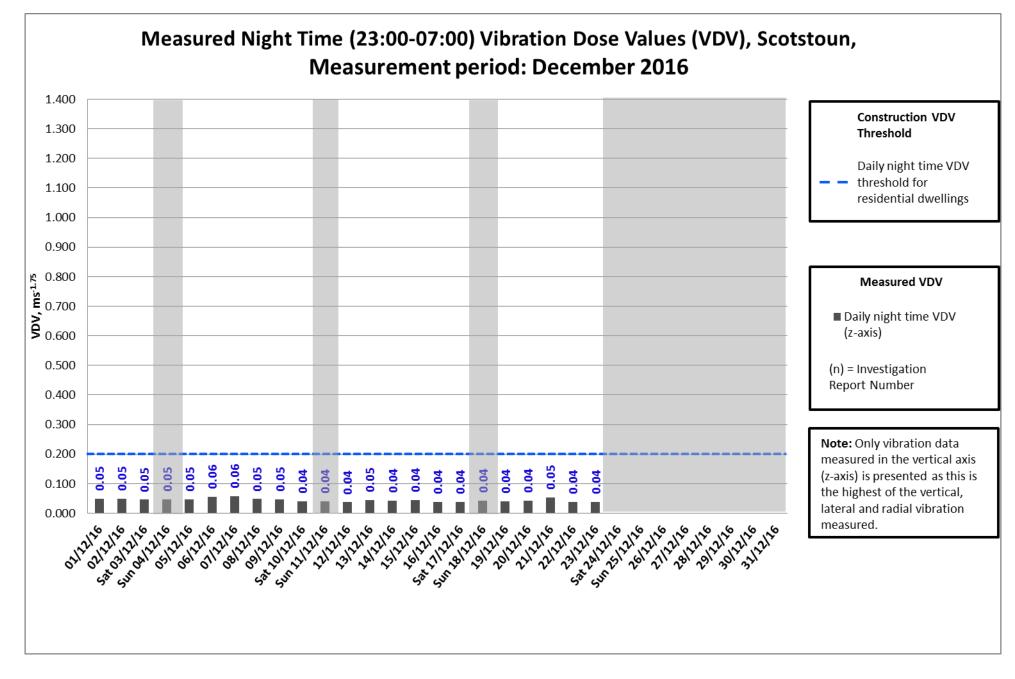
Exceedance on the 8th of December has been investigated and found to have been caused by an isolated event that is unlikely to have been due to a construction related activity (graph above from the 08/12/2016).

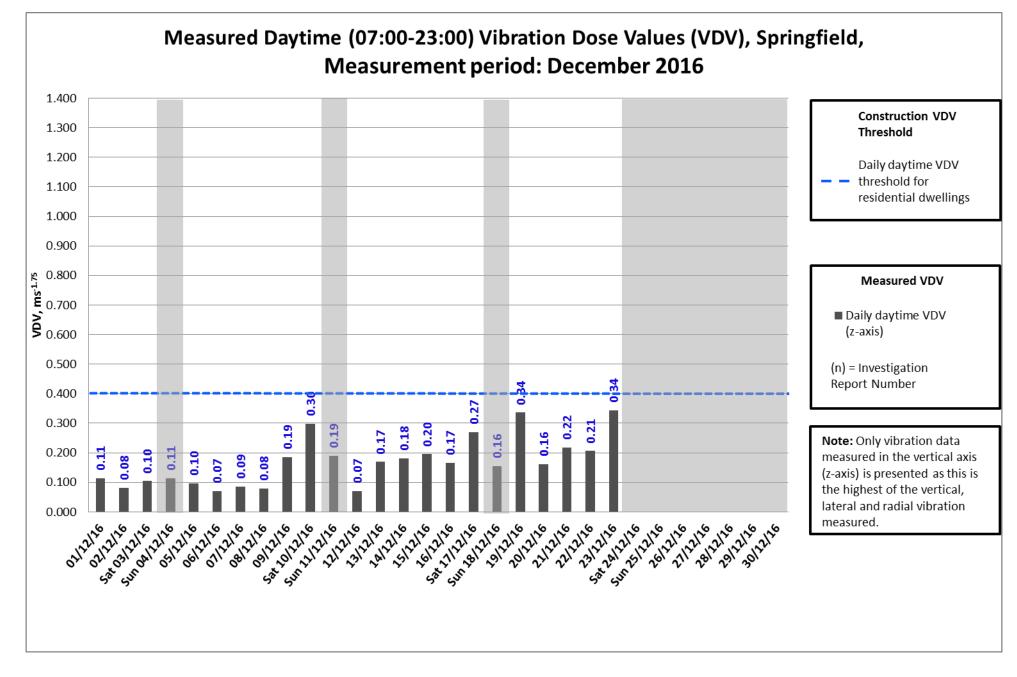
Exceedances throughout December have been investigated and found to be caused by individual isolated events that are unlikely to have been construction related activities (graph above from the 14/12/2016). The vibration monitor is located in the residents back garden, therefore resident's activity may have caused these exceedances.

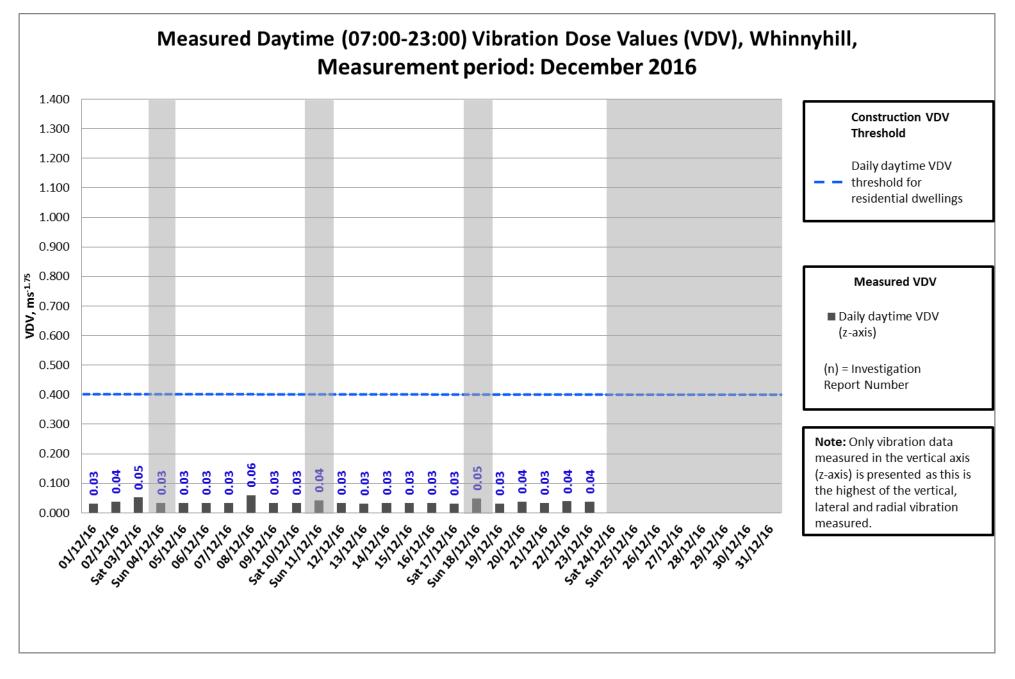
Exceedance on the 1st of December has been investigated and found to have been caused by an isolated event that is unlikely to have been due to a construction related activity (graph above from the 01/12/2016).
