Project FORTH REPLACEMENT CROSSING

VIBRATION MONITORING REPORT MARCH 2016

Made by Michael Richardson Checked By: Steven Westwater	
Initials: MRN	Initials: SWR
Document number	
REP-00273	00

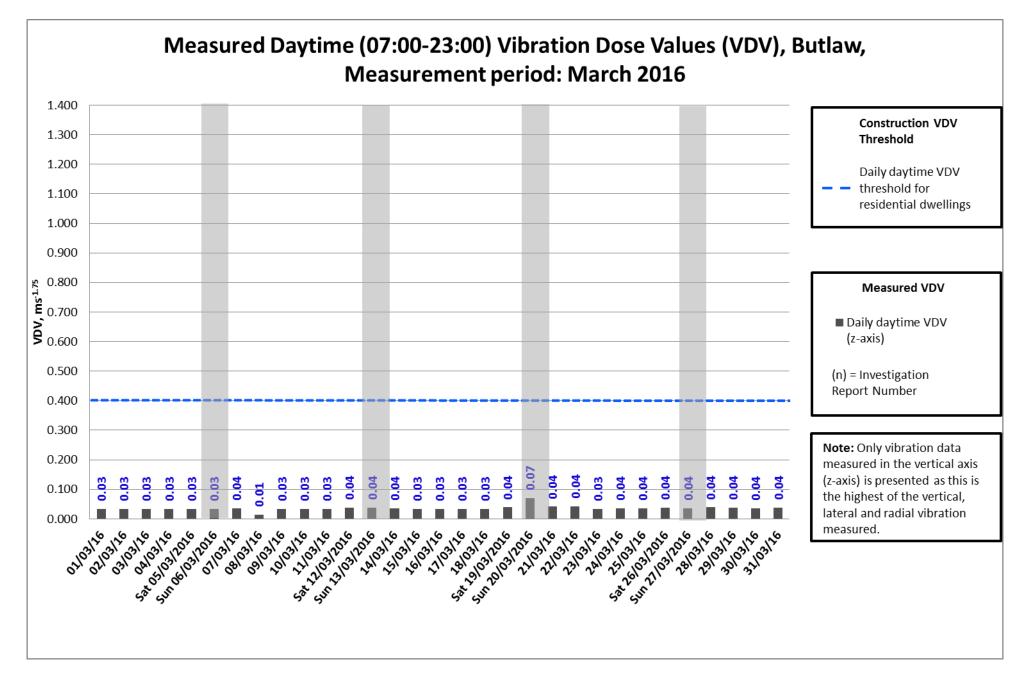
Exceedances on the 8th and 14th of March have been investigated and found to be caused by the environmental department carrying out maintenance to monitoring equipment in this location.

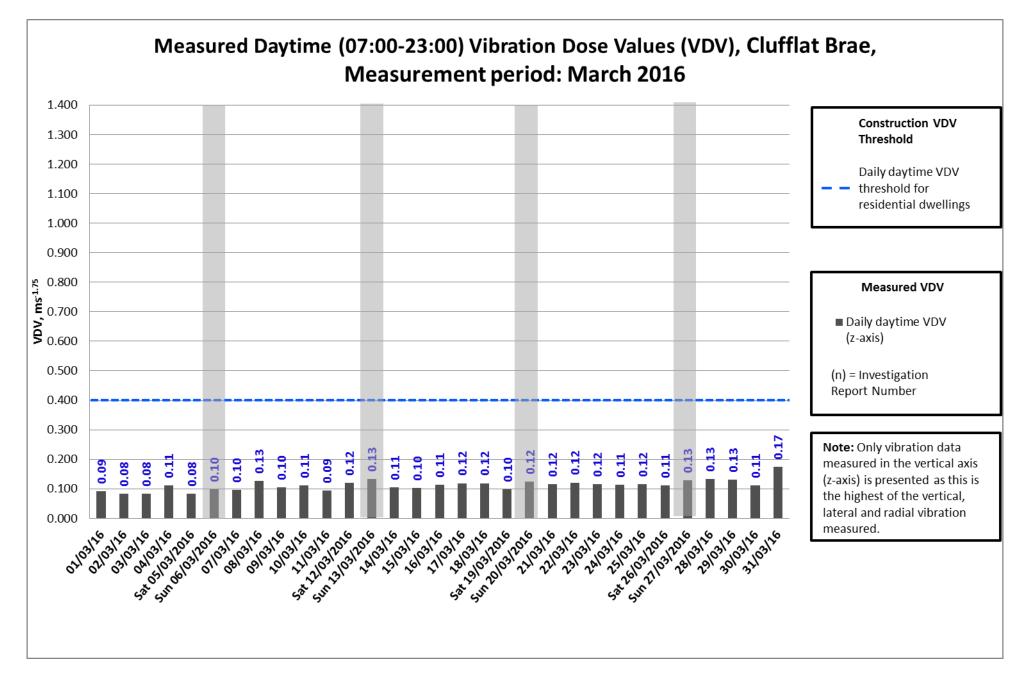
Exceedances on the 13th, 19th, 20th and 30th of March have been investigated and found to be caused out with construction working hours and therefore it is unlikely that construction relate activities was the cause of these (graph above from the 19/03/2016).

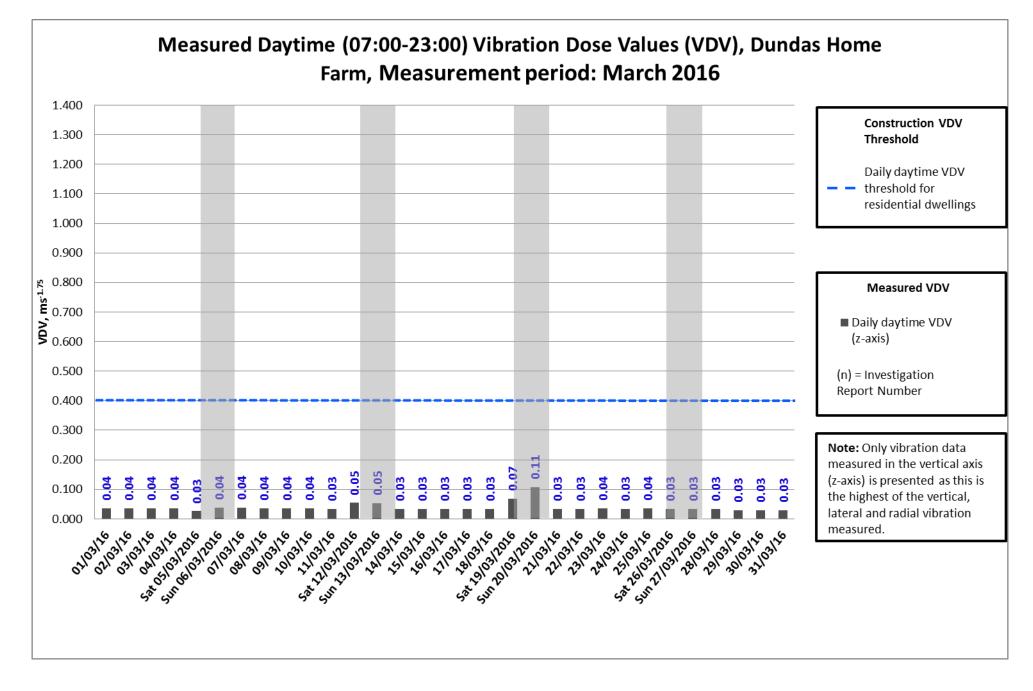
Exceedance on the 19th of March has been investigated and found to be an isolated event that is unlikely to have been caused by construction related activities (graph above from the 19/03/2016).

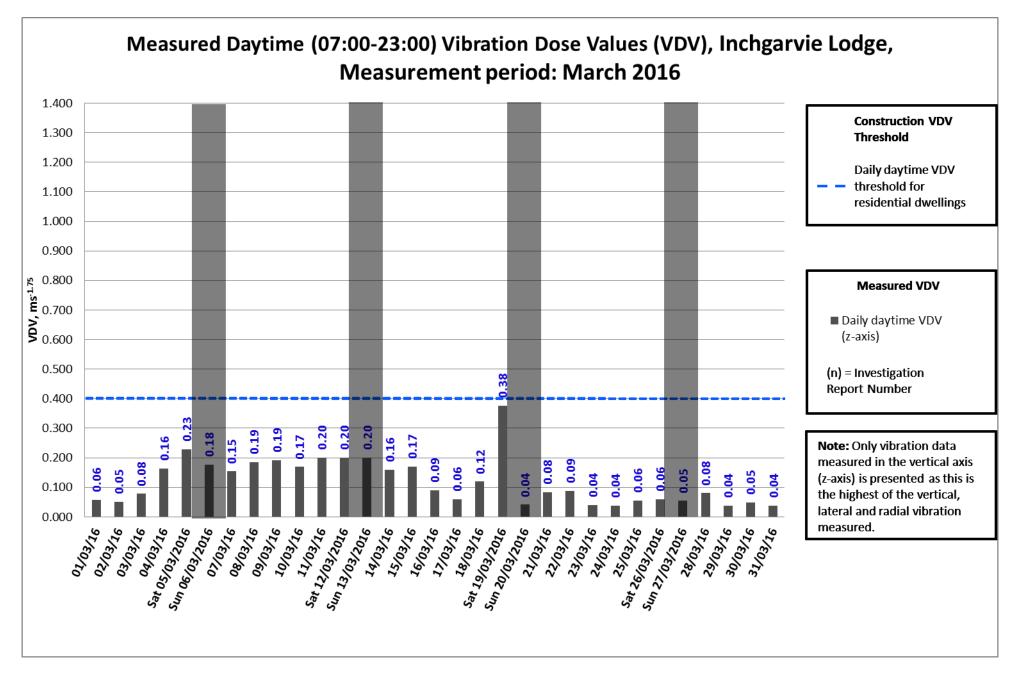
Exceedances on the 3rd,6th, 9th, 21st and 29th have been investigated and found to be one off isolated events. During this period the closest works to the vibration monitor was approximately 160m away with minimal vibration emitting equipment used (rebar and concrete works). The vibration monitor is situated at a resident's house in which there was ongoing private construction works on the property which are likely to have been the cause of the vibration levels. On this basis it is highly unlikely that the vibration levels seen above have been caused by construction related activities (graph above from the 12/03/2016).

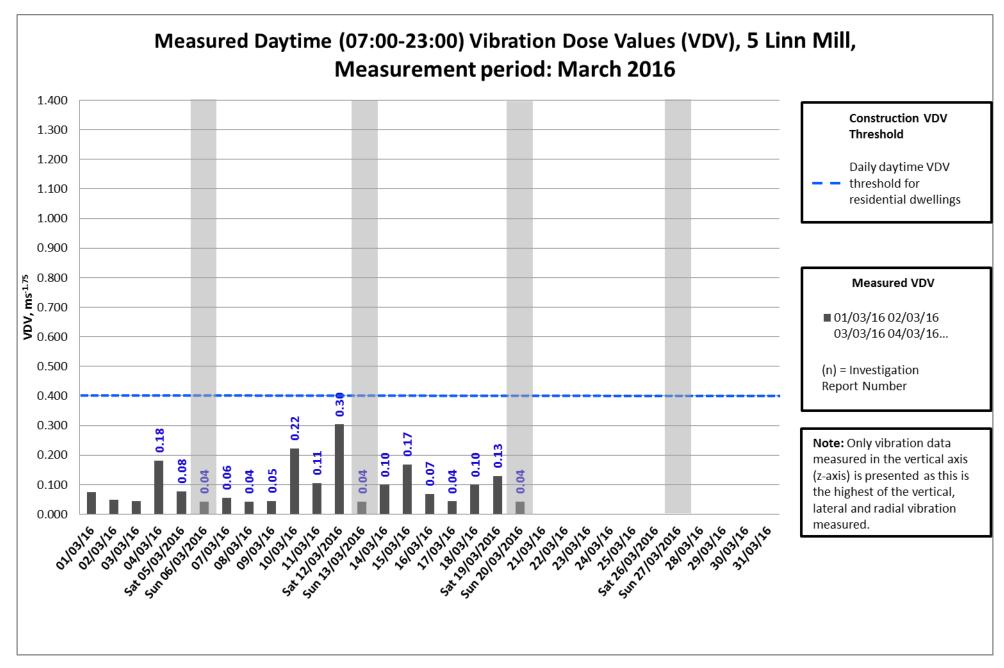
Data is missing during the period from 21st to the 31st of March due to a power fault to the monitor. This has since been resolved on the 1st of April.

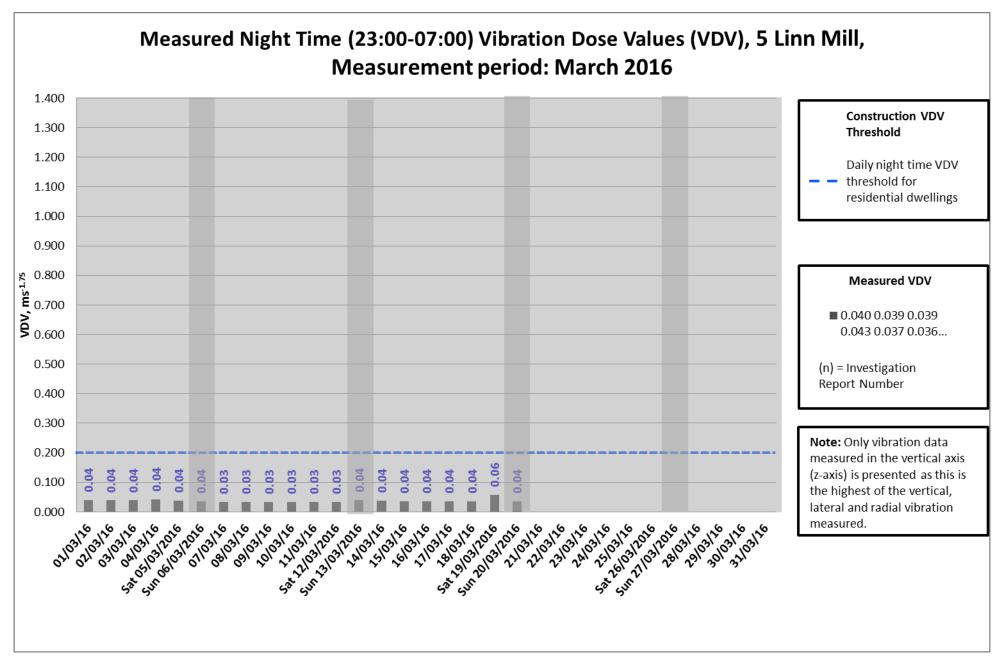
Data is missing during the period from 21st to the 31st of March due to a power fault to the monitor. This has since been resolved on the 1st of April.

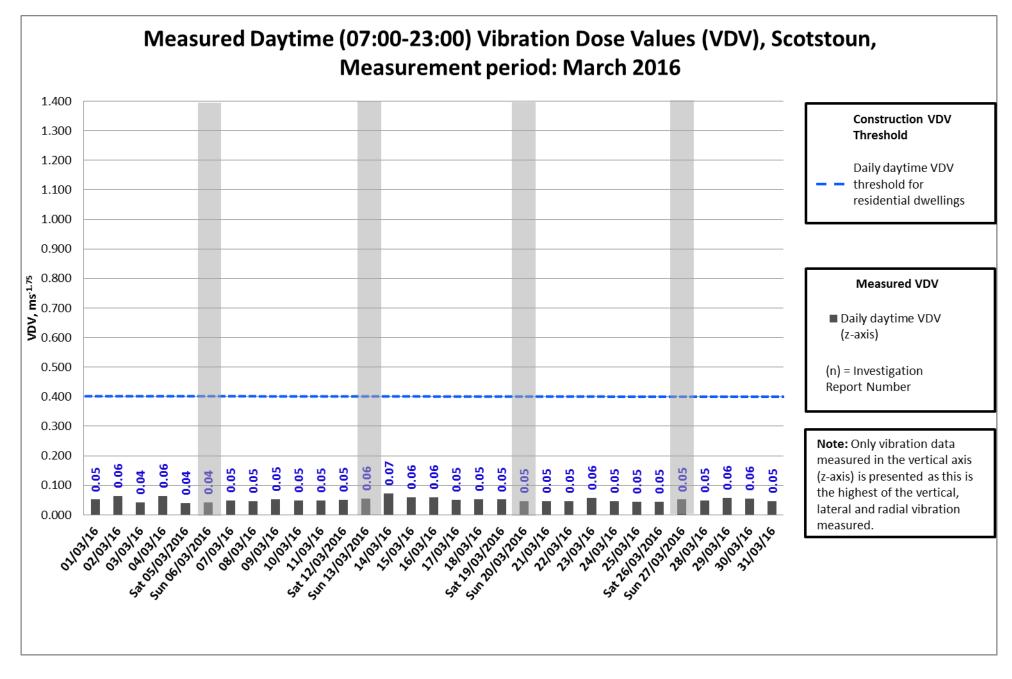
Exceedance on the 14th of March has been investigated and found to be out with normal working hours and is unlikely to have been caused by construction related activities (graph above from the 14/03/2016).

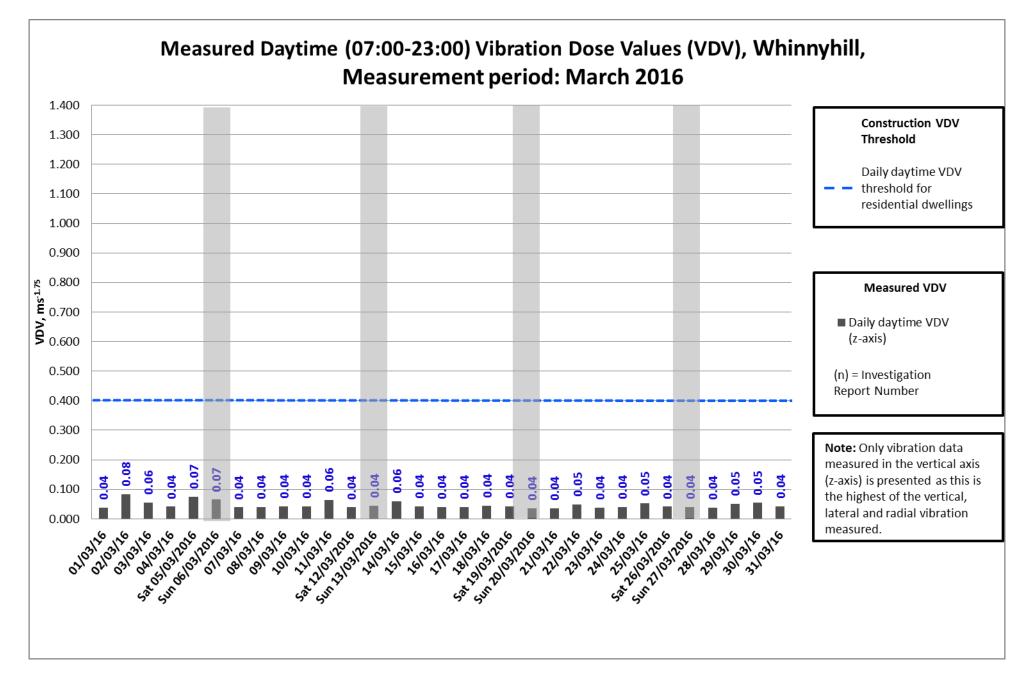
Exceedances on the 3rd, 14th and 21st of March have been investigated and found to be out with normal construction working hours of road networks with the closest works approximately 1700m away at north tower it is unlikely that the exceedances were caused by construction related activities.
