# FORTH REPLACEMENT CROSSING

# VIBRATION MONITORING REPORT SEPTEMBER 2016

Made by Steven Westwater Checked By: Lindsay McIntyre		
Initials: SWR	Initials: LME	
Document number	Rev	
REP-00294	00

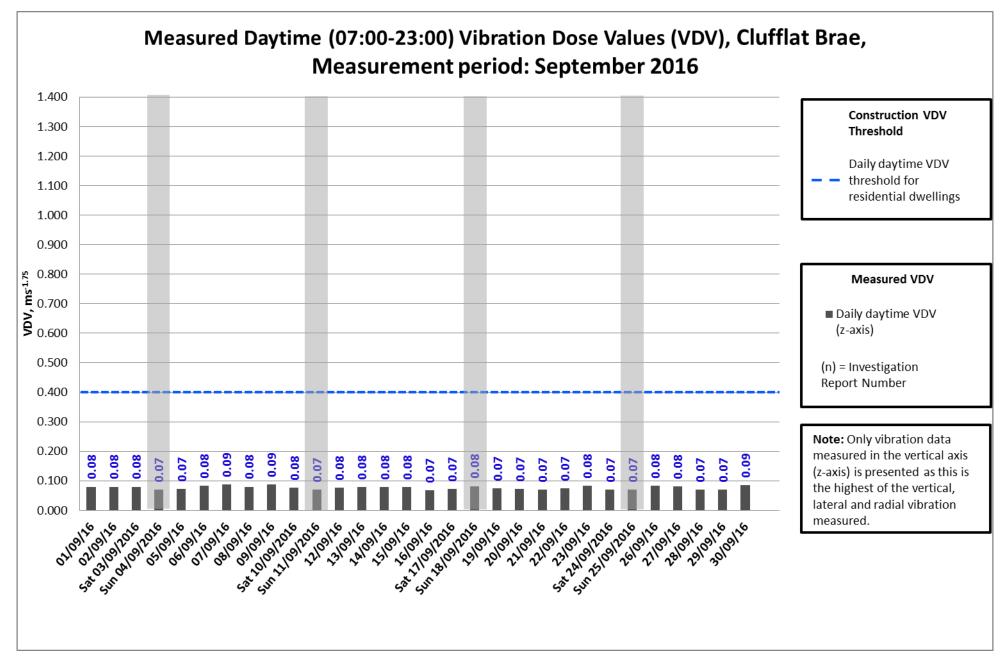
Exceedances on the 9<sup>th</sup>, 11<sup>th</sup>, 14<sup>th</sup>, 18<sup>th</sup>, 19<sup>th</sup>, 20<sup>th</sup>, 21<sup>st</sup>, 22<sup>nd</sup>, 26<sup>th</sup> and 27<sup>th</sup> of September have been investigated and found to be caused out with construction working hours and therefore it is unlikely that construction related activity was the cause of these events (graph above from the 11/09/2016).

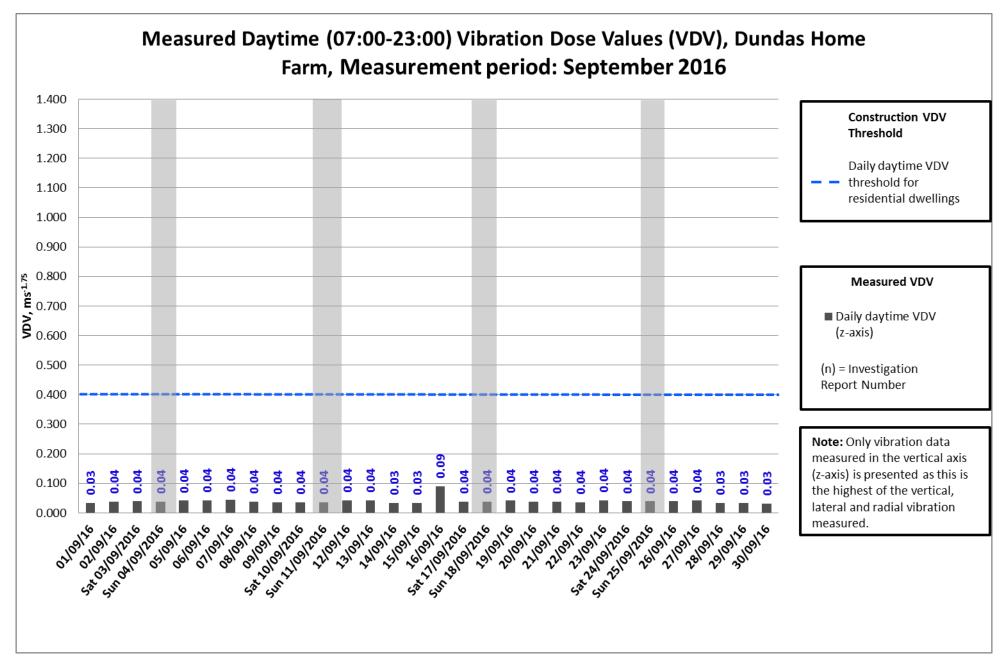
Exceedance on the 25<sup>th</sup> September has been investigated and found to be caused by an isolated event that is unlikely to have been a construction related activity.

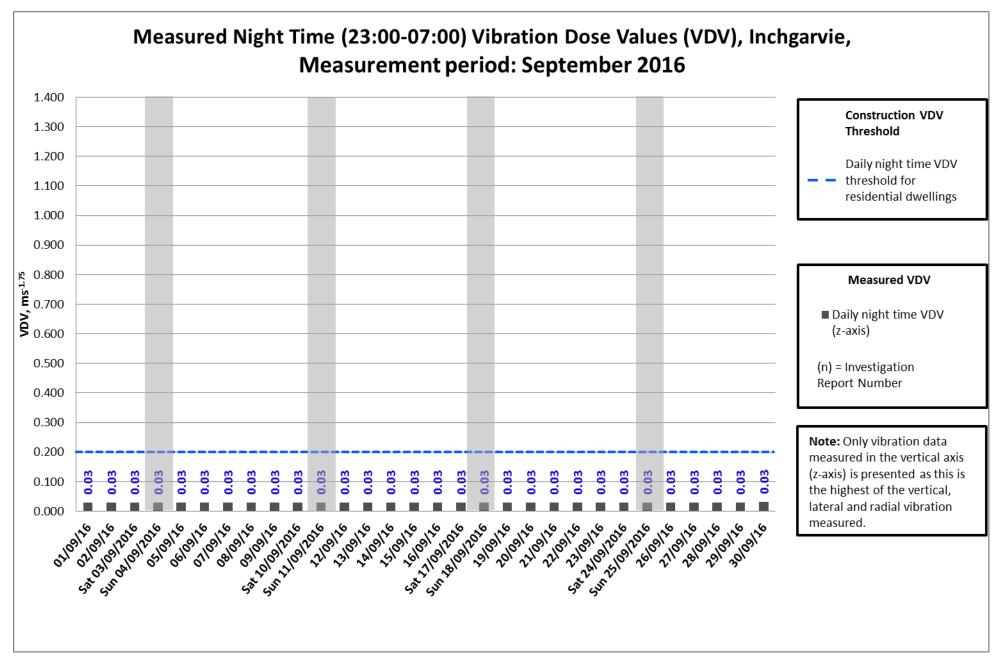
Exceedance on the 10<sup>th</sup> of September has been investigated and found to have been caused by the resident having private building work done on their property.

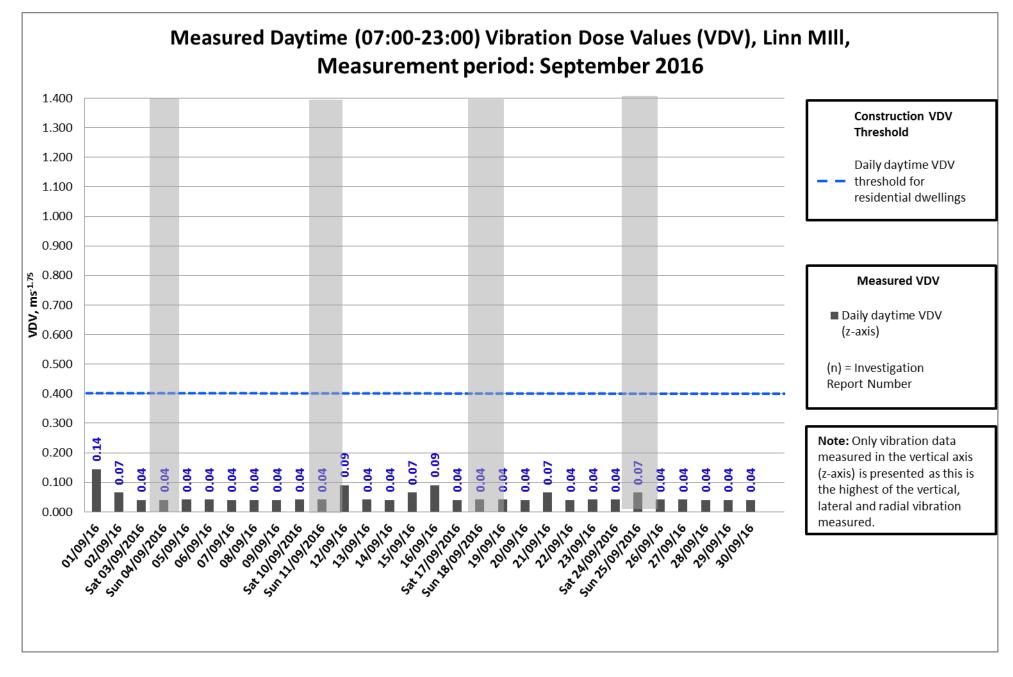
Exceedance on the 1<sup>st</sup> September has been investigated and found to have been caused by an individual isolated event that is unlikely to have been due to construction related activity.

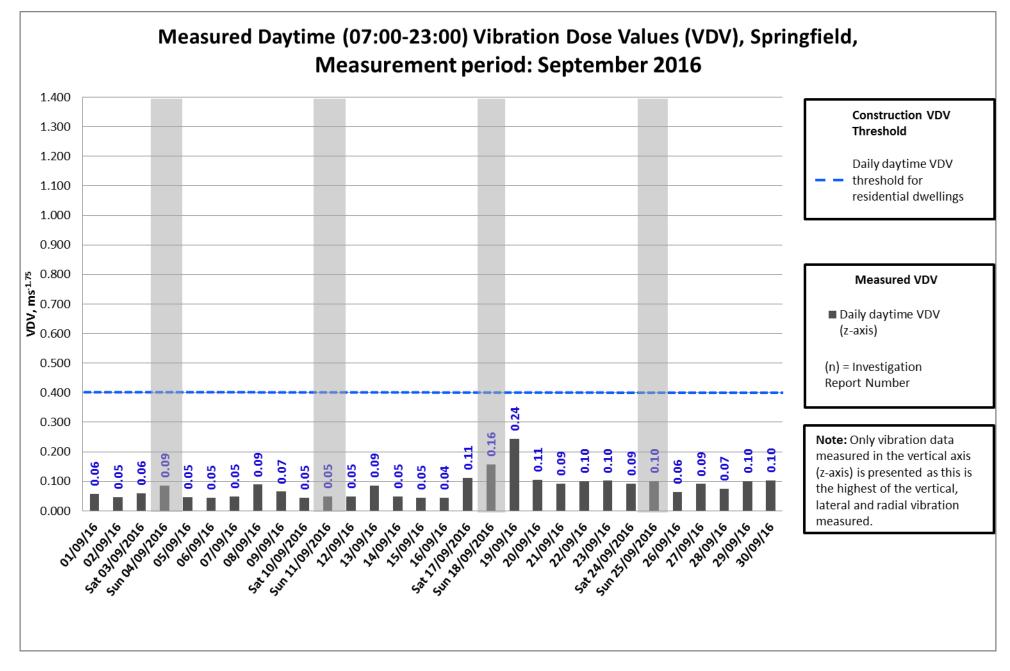
Exceedances on the 1<sup>st</sup>, 2<sup>nd</sup>, 3<sup>rd</sup>, 6<sup>th</sup>, 11<sup>th</sup>, 14<sup>th</sup>, 15<sup>th</sup>, 16<sup>th</sup>, 20<sup>th</sup>, 21<sup>st</sup> and 23<sup>rd</sup> of September have been investigated and found to be caused out with construction working hours and therefore it is unlikely that construction related activities were the cause for these exceedances (graph above from the 14/09/2016).

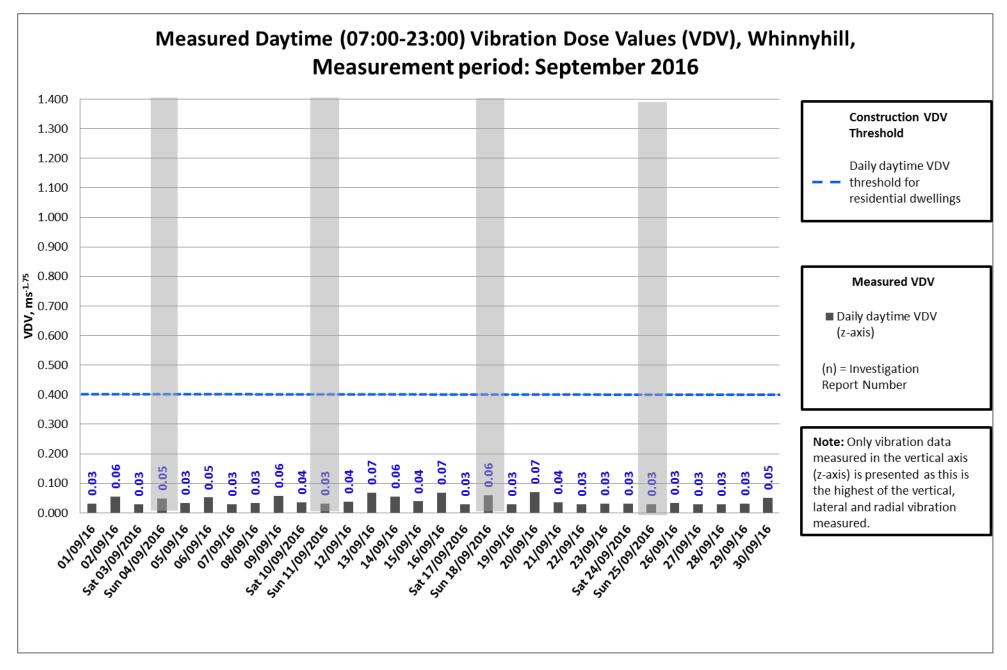
Exceedances on the 5<sup>th</sup> and 30<sup>th</sup> of September have been investigated and found to have been caused out with construction working hours and therefore it is unlikely that construction related activities were the cause for these exceedances (graph above from the 05/09/2016).
