A83 Tarbet – Lochgilphead – Kennacraig Trunk Road
Study into Potential Emergency Diversion Routes at the
Rest and Be Thankful

Transport Scotland

Report Title Study into Potential Emergency Diversion Routes at the Rest
and Be Thankful

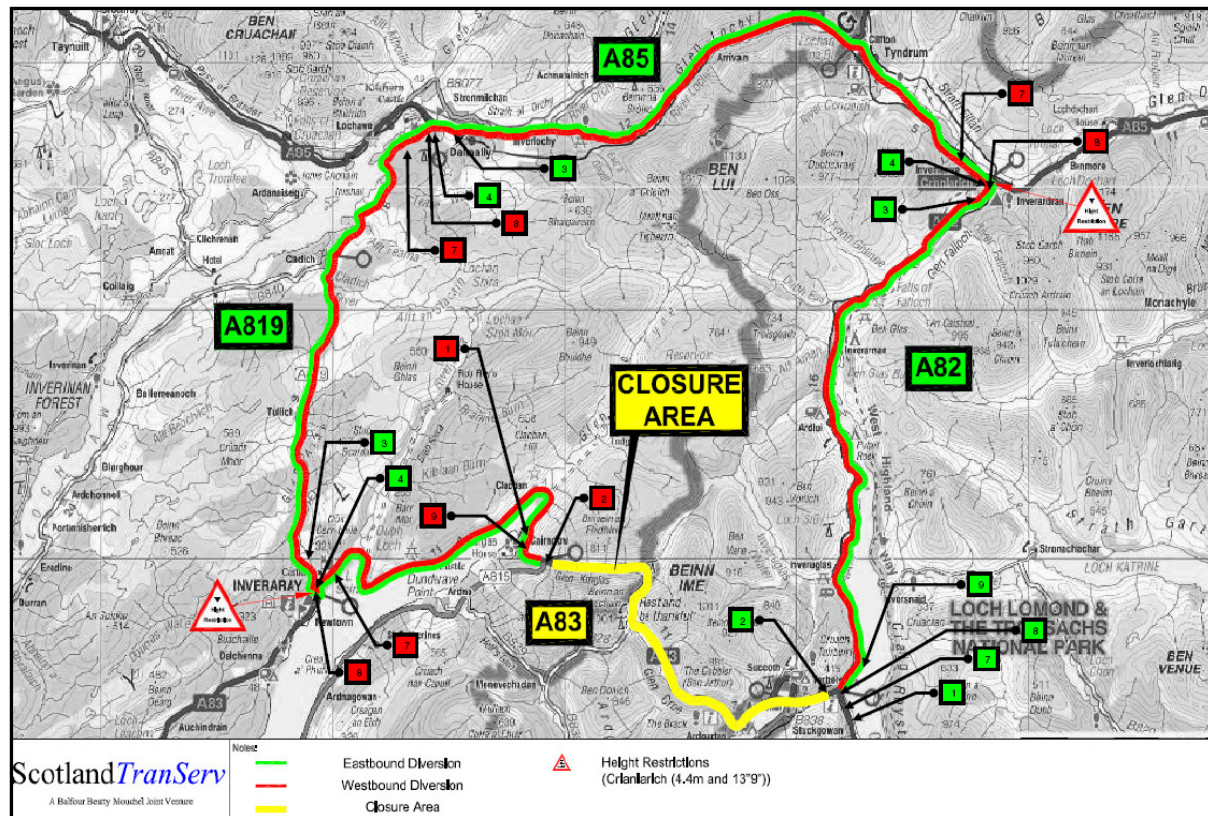
Figure 1: Pre-planned diversion route during closure of A83 at Rest and Be Thankful

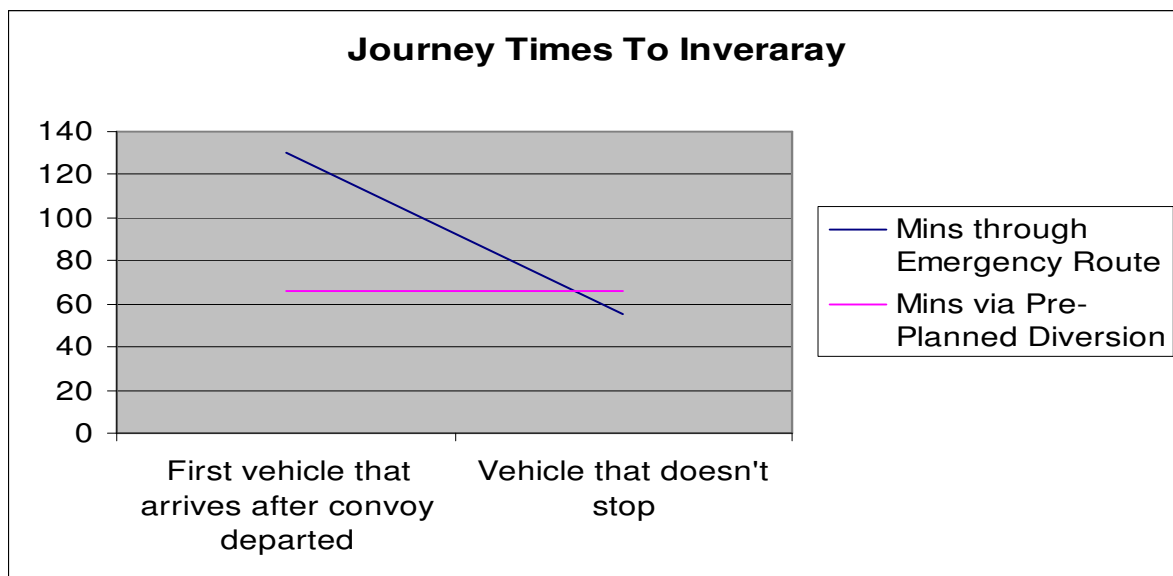
Figure 9: Potential journey times experienced by drivers

This shows that against the pre-planned diversion route, only a small number of drivers will benefit and have a reduced journey time. However, should there be a debris event when the A83 is being utilised to divert traffic from the improvement works at the A82 Pulpit Rock the maximum delay of 2 hours through the emergency route will be less than the 2 hours 31 minutes required to travel the A819, A85, A84, A811 to the A82 at Balloch.

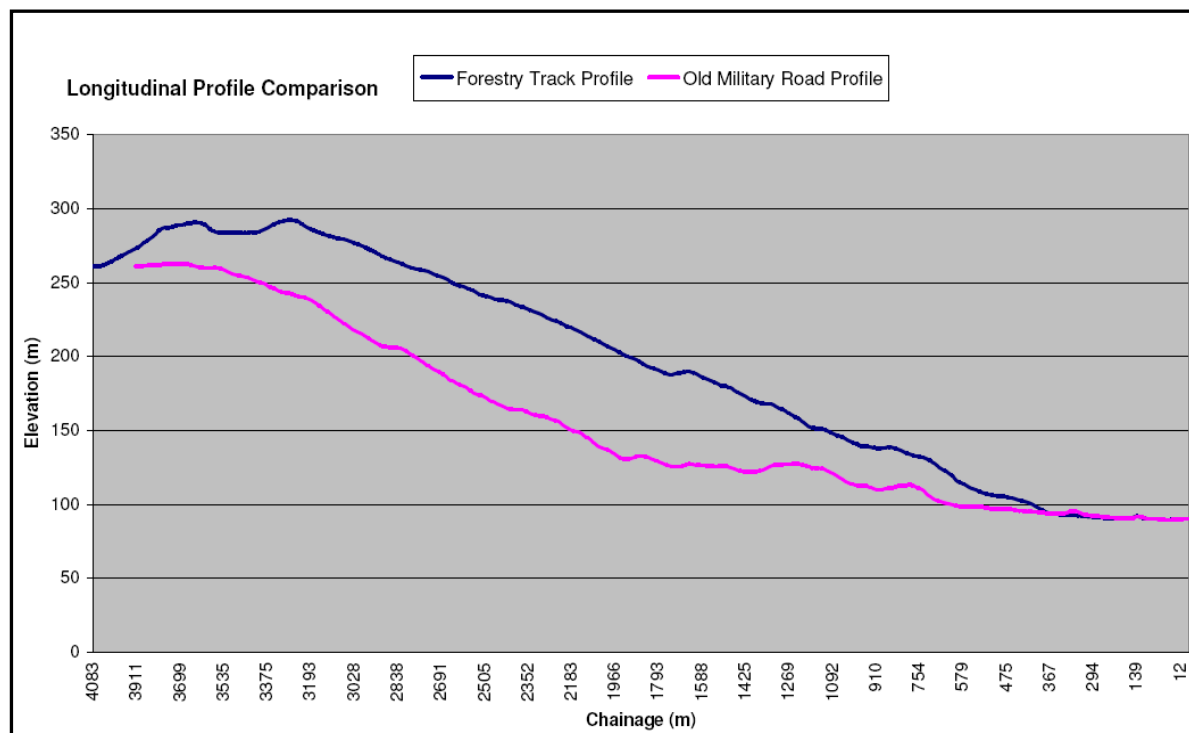
The gradient and alignment of the road is different to that of the forestry track. Travelling east to west the road sits for the majority of its length relatively level and straight beneath the A83. To illustrate this, a comparative long section of both the forestry track and military road has been provided in Figure 12 below.

Figure 12: Comparative long sections

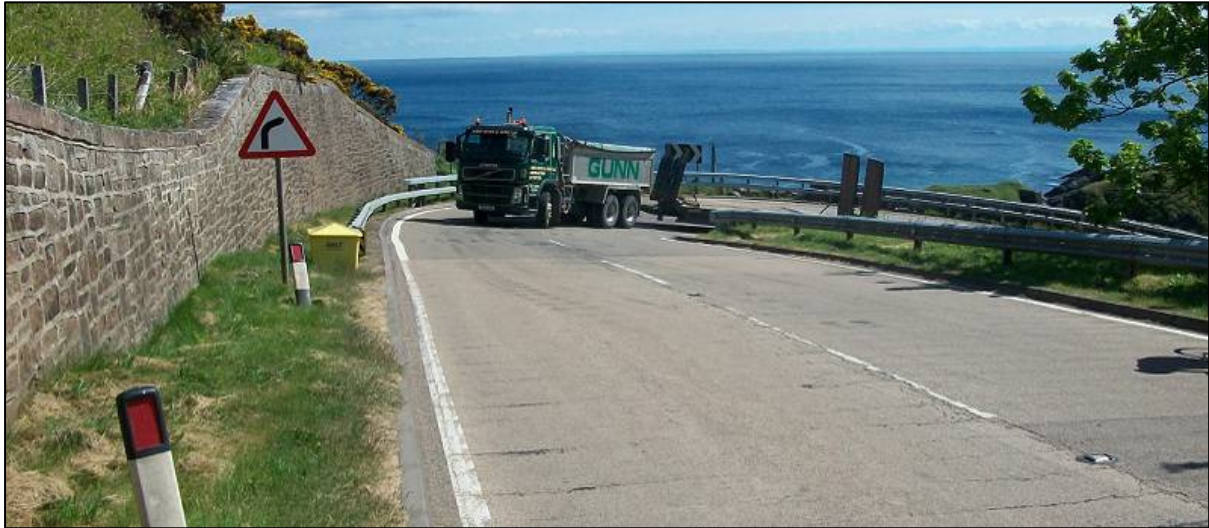
Towards the final third of the military road, the hill climb section, the road rises steeply at approximately 13% and twists and turns before finishing at the Rest and Be Thankful car park. This section is similar, in terms of alignment and gradient with the A9 at Berriedale Braes. See Figure 13 below.

Figure13: Image taken overlooking the hairpin at A9 Berriedale Bends

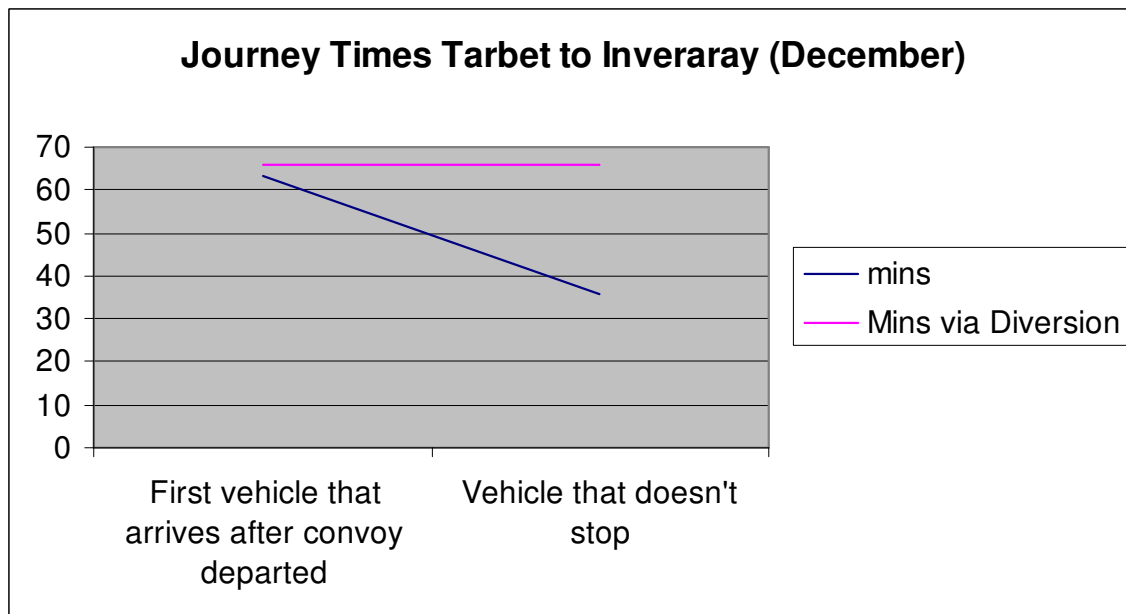
Again, due to the length of time to travel the route, the duration of an individual journey depends mostly on when the vehicle joins the queue. Using a convoy length of 100 vehicles (850m) the journey times experienced by drivers during December varies as follows:

Figure 15: Potential journey times experienced by drivers in December

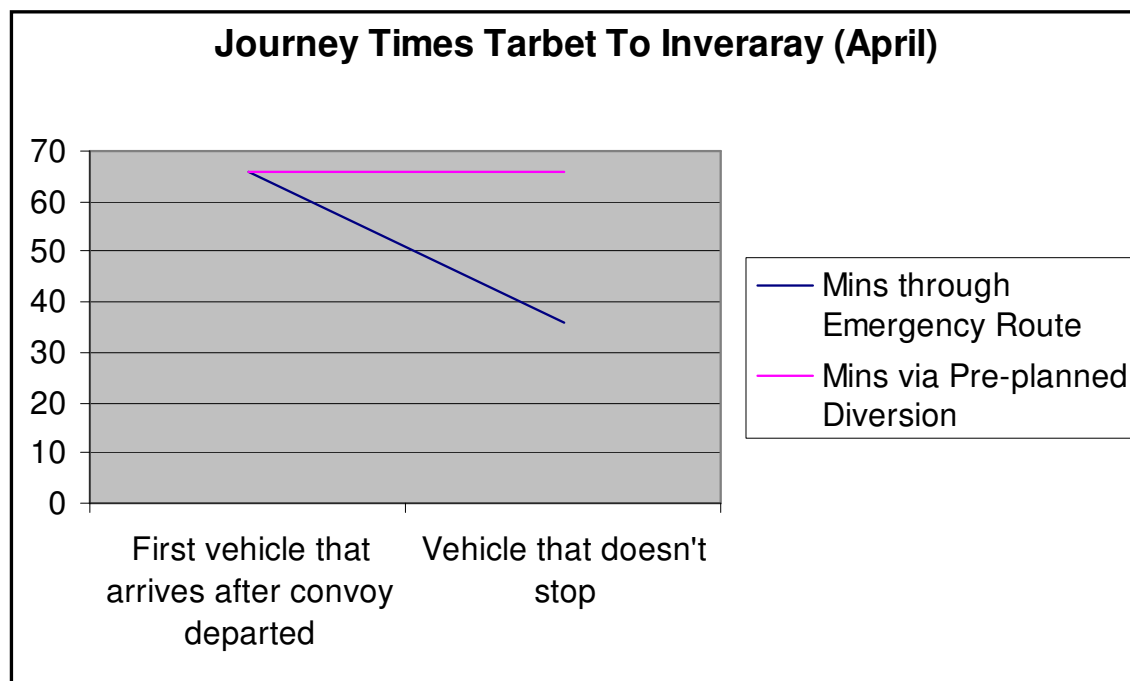
Even in April with its peak flows of three times that of December, the speed of the flow on the Military road means that journey times do not change greatly.

Figure 16: Potential journey times experienced by drivers in April
