Project FORTH REPLACEMENT CROSSING

AIR QUALITY MONITORING REPORT DECEMBER 2013

Document number REP-00152-00

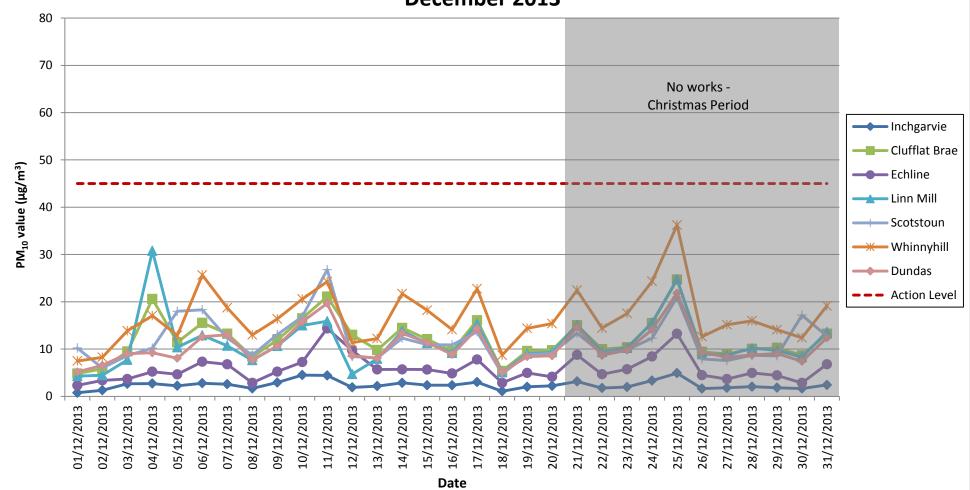
Note: Please refer to section 3 of the Air Quality Monitoring Report: December 2013. No works were conducted over the Christmas period (21/12/13 to 06/01/14). A correction factor has been applied to the data for Whinny Hill following consulation with the supplier; an error was identified with the settings on the meter and it was therefore required to make an adjustment to the data.

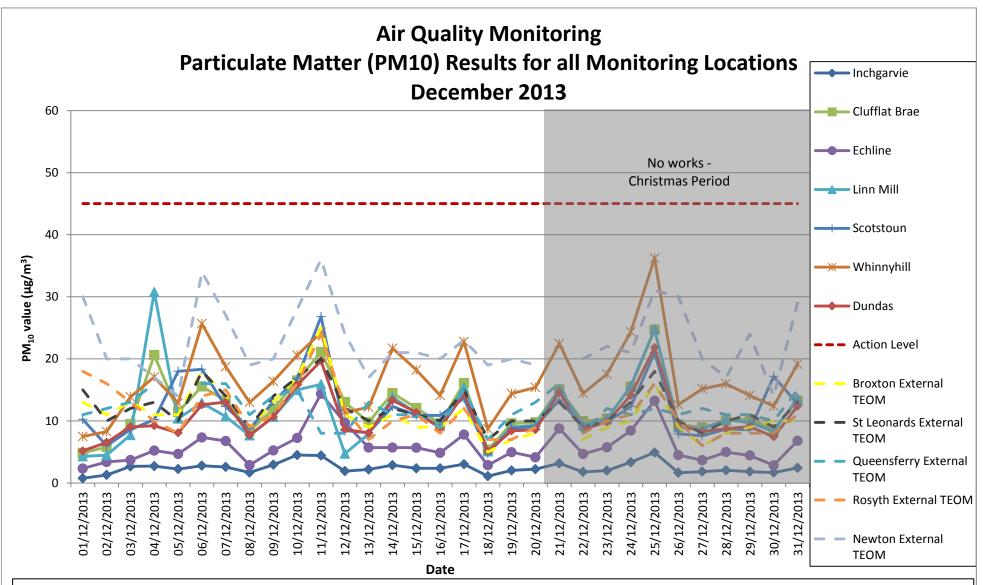
Note: Please refer to section 3 of the Air Quality Monitoring Report: December 2013. No works were conducted over the Christmas period (21/12/13 to 06/01/14). A correction factor has been applied to the data for Whinny Hill following consulation with the supplier; an error was identified with the settings on the meter and it was therefore required to make an adjustment to the data.

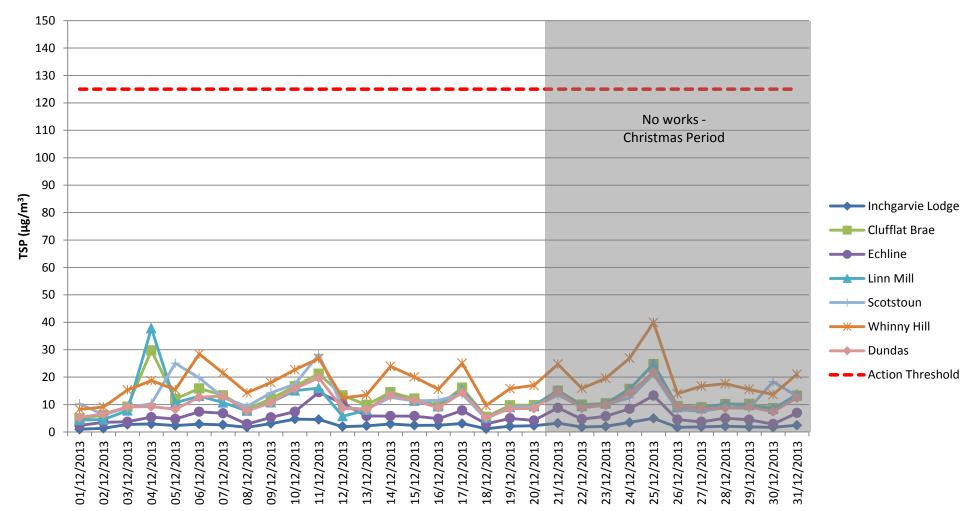
Note: Please refer to section 3 of the Air Quality Monitoring Report: December 2013. No works were conducted over the Christmas period (21/12/13 to 06/01/14). A correction factor has been applied to the data for Whinny Hill following consulation with the supplier; an error was identified with the settings on the meter and it was therefore required to make an adjustment to the data.
