Queensferry  
Crossing

Project FORTH REPLACEMENT CROSSING

VIBRATION MONITORING REPORT  
AUGUST 2017

Document number	Rev
<b>REP-00343</b>	<b>00</b>

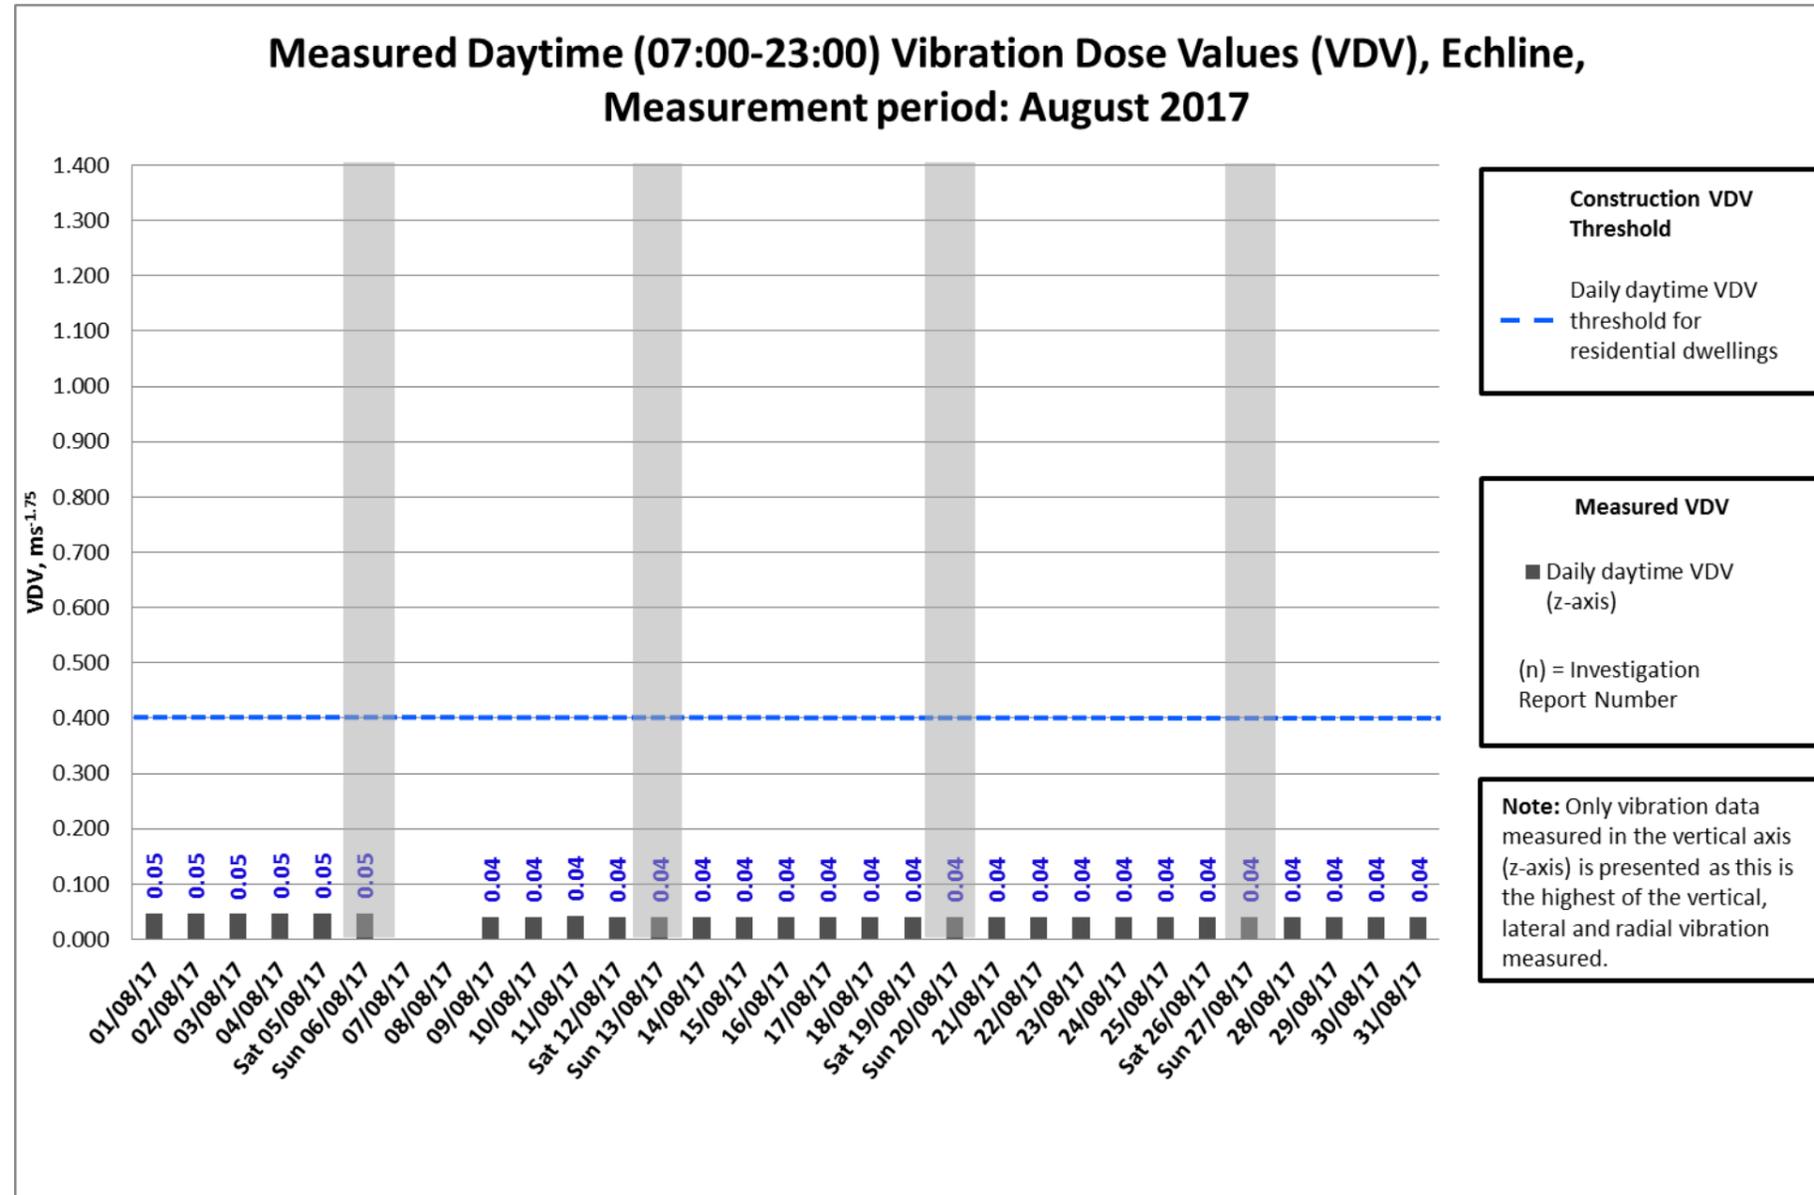
Data missing on the 7<sup>th</sup> - 8<sup>th</sup> August was caused by the annual calibration of the vibration monitor.

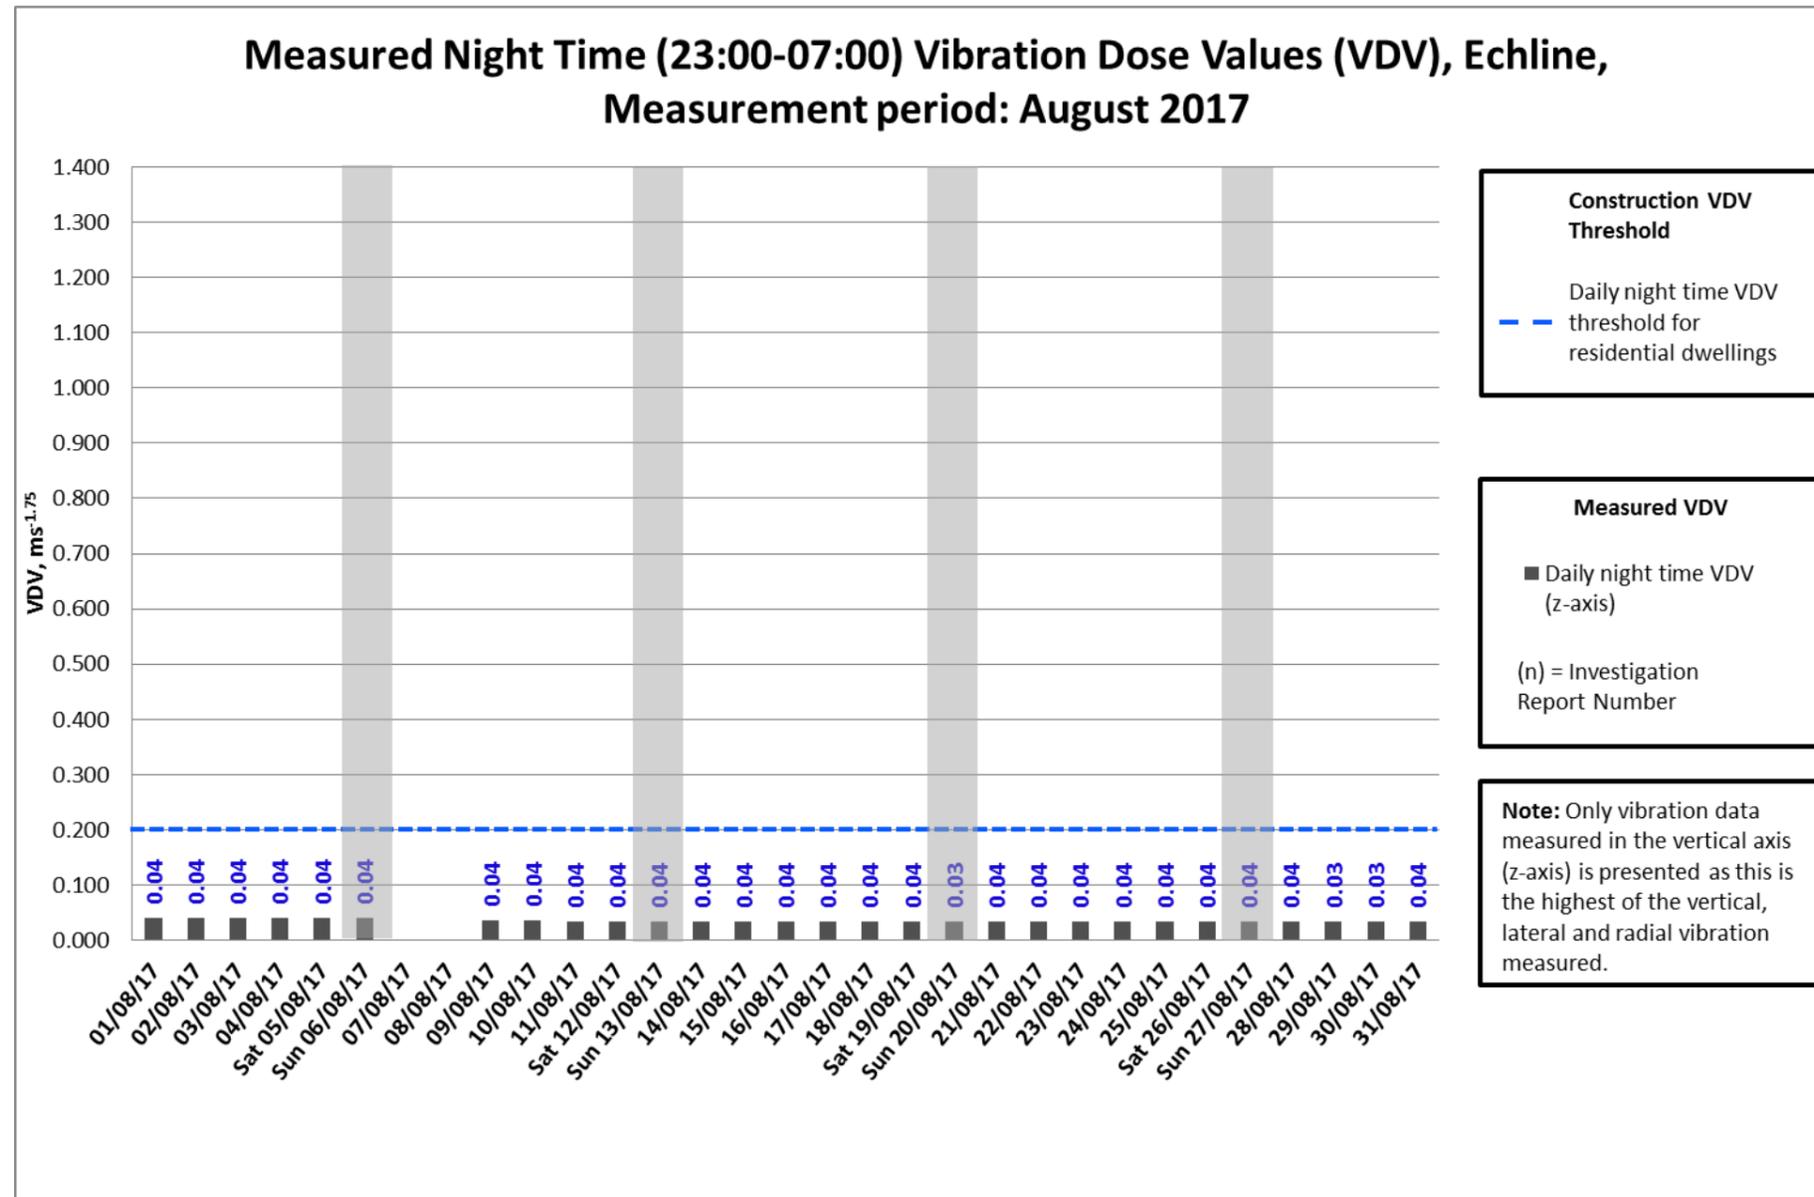
Data missing on the 7<sup>th</sup> - 8<sup>th</sup> August was caused by the annual calibration of the vibration monitor.

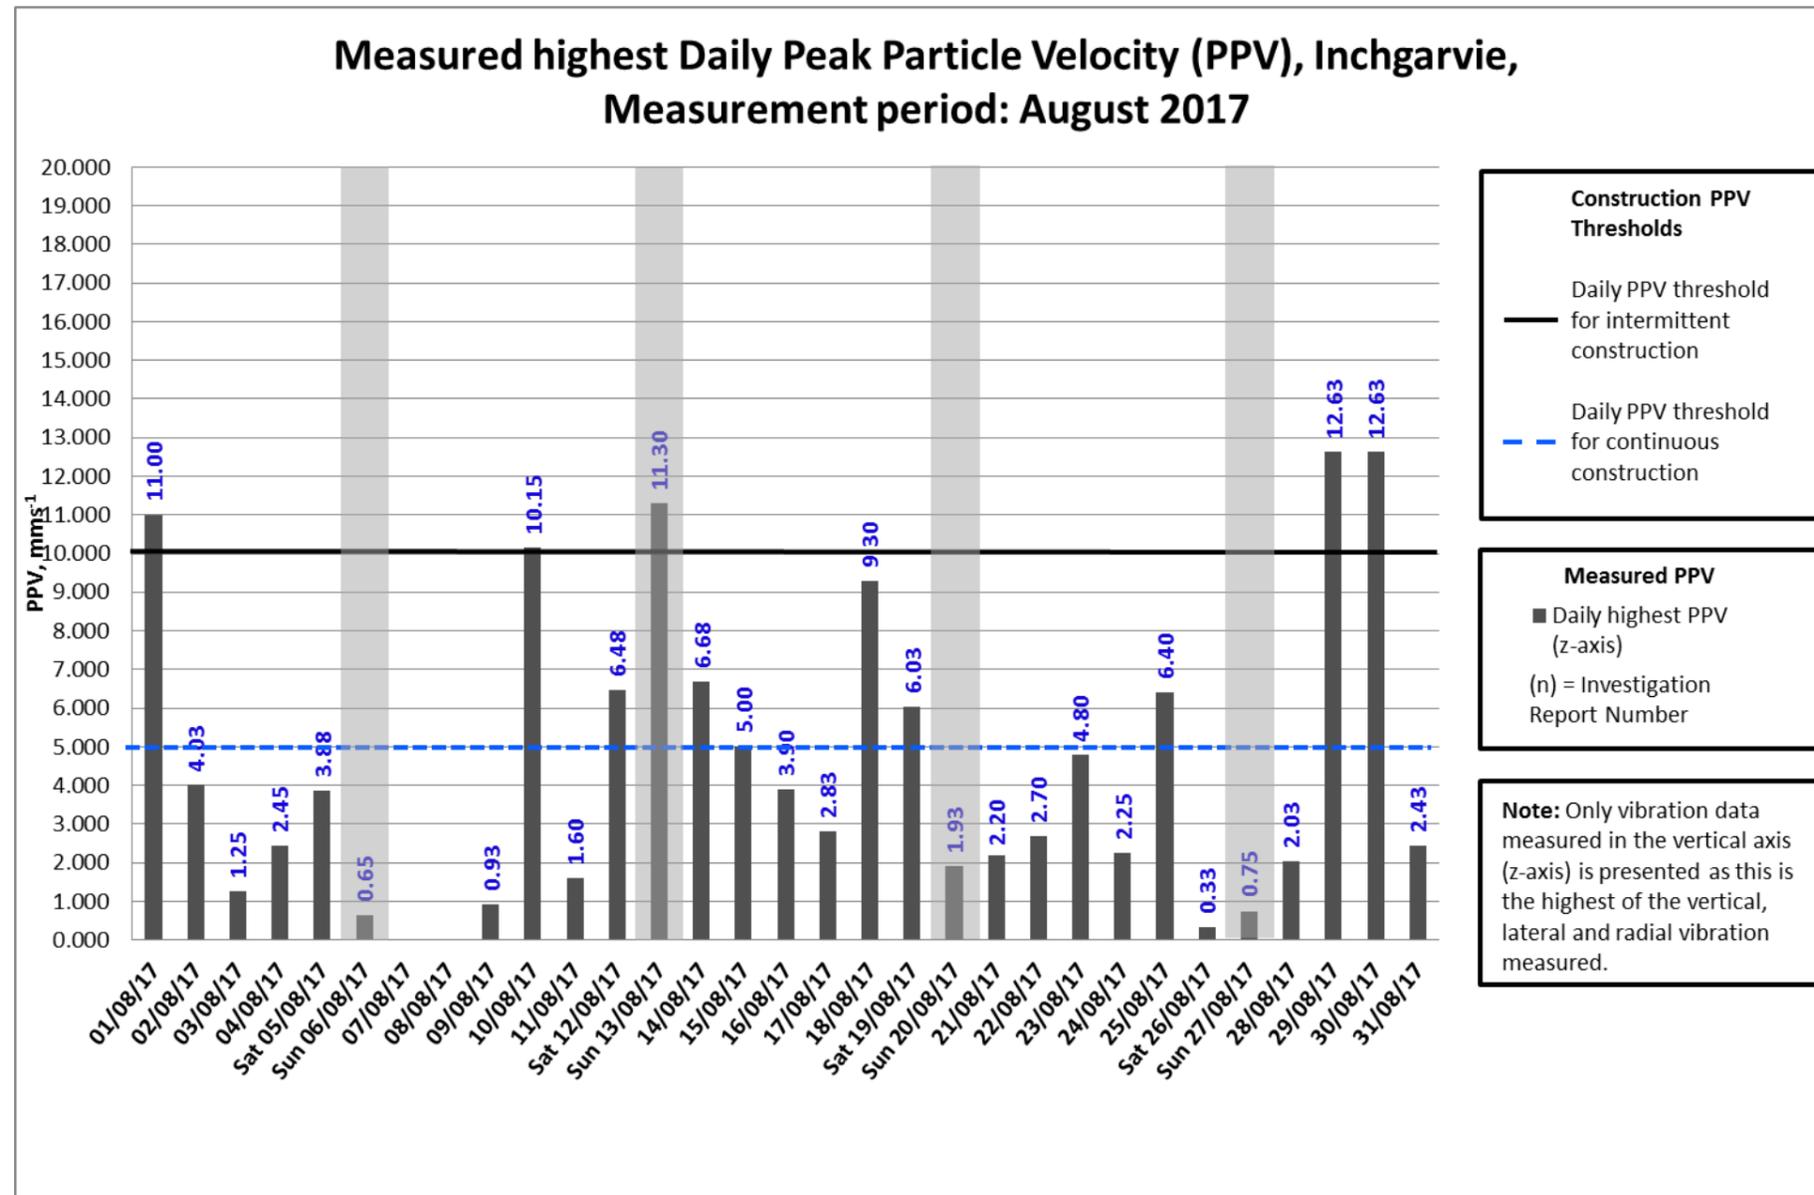
Data missing on the 7<sup>th</sup> - 8<sup>th</sup> August was caused by the annual calibration of the vibration monitor.

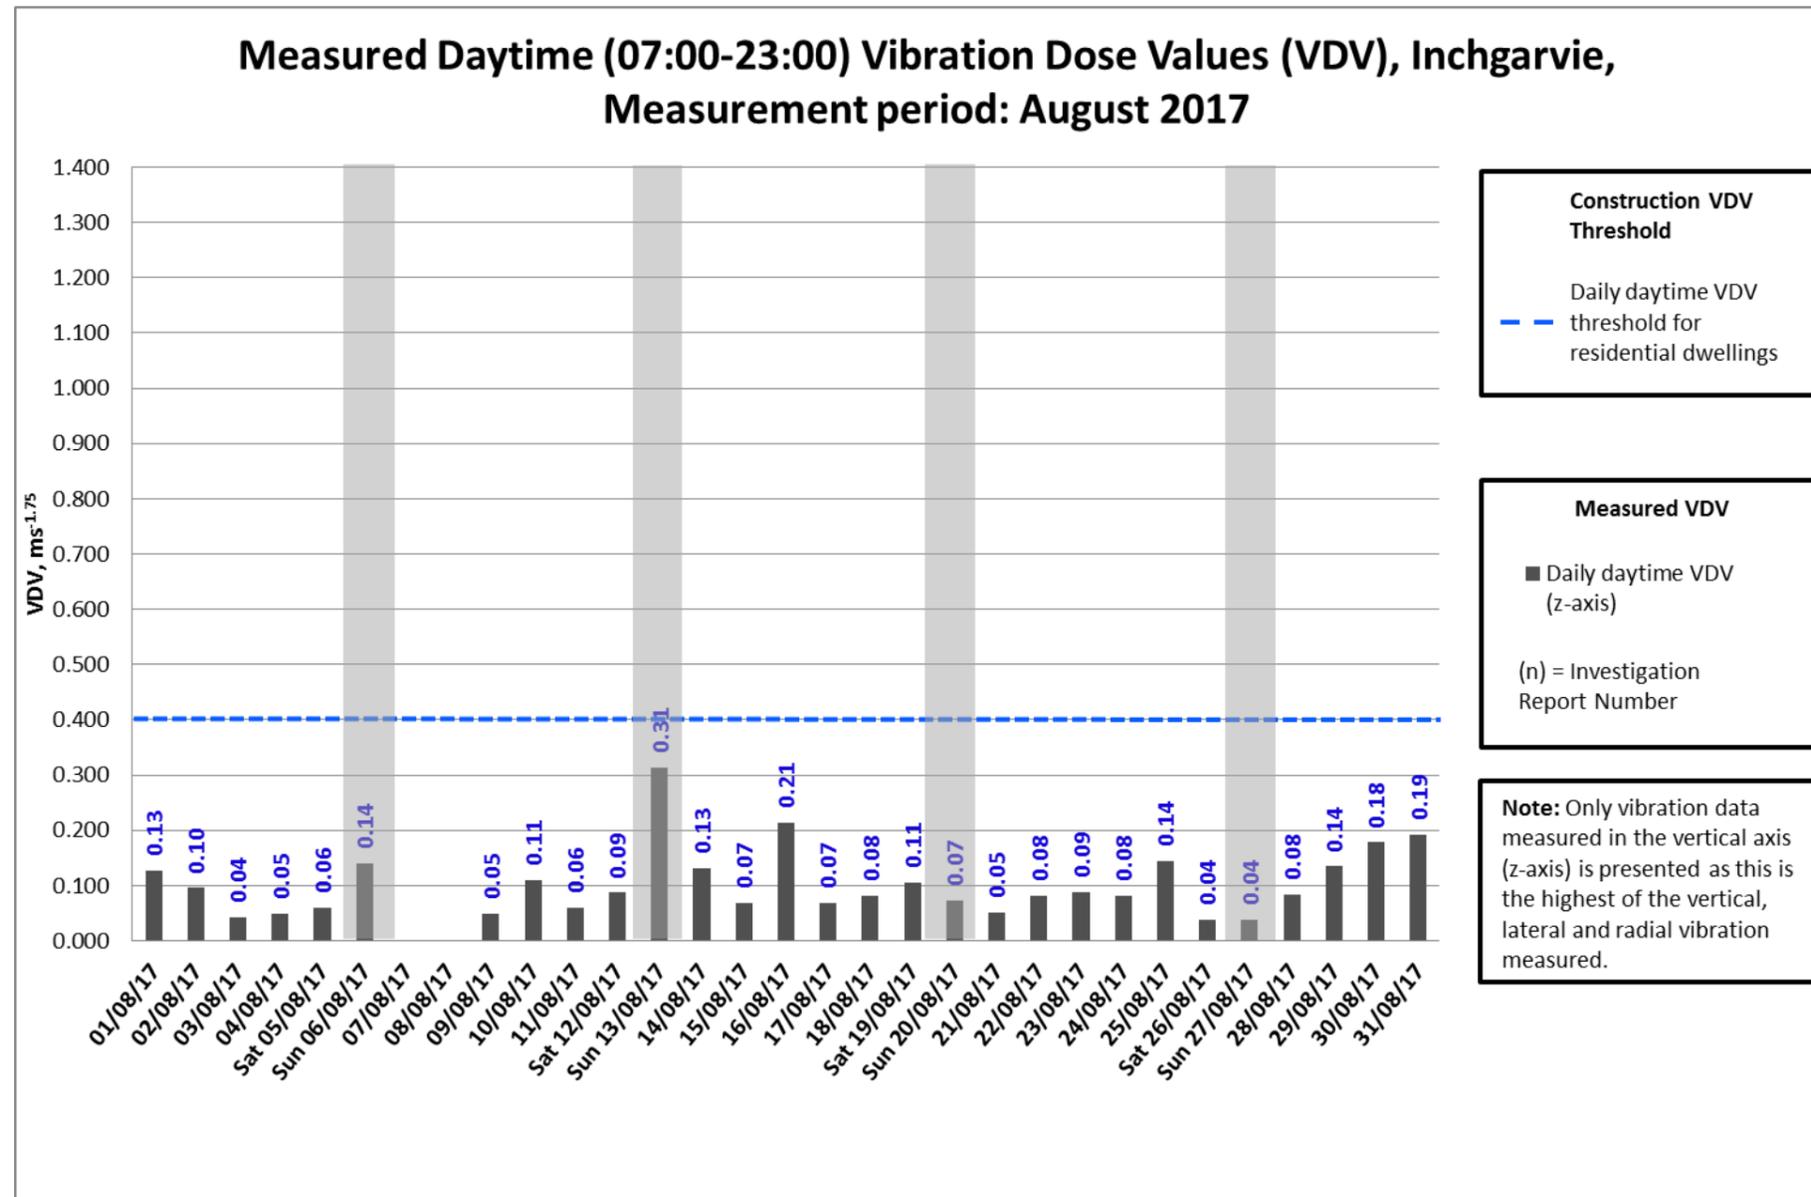
Data missing on the 7<sup>th</sup> - 8<sup>th</sup> August was caused by the annual calibration of the vibration monitor.

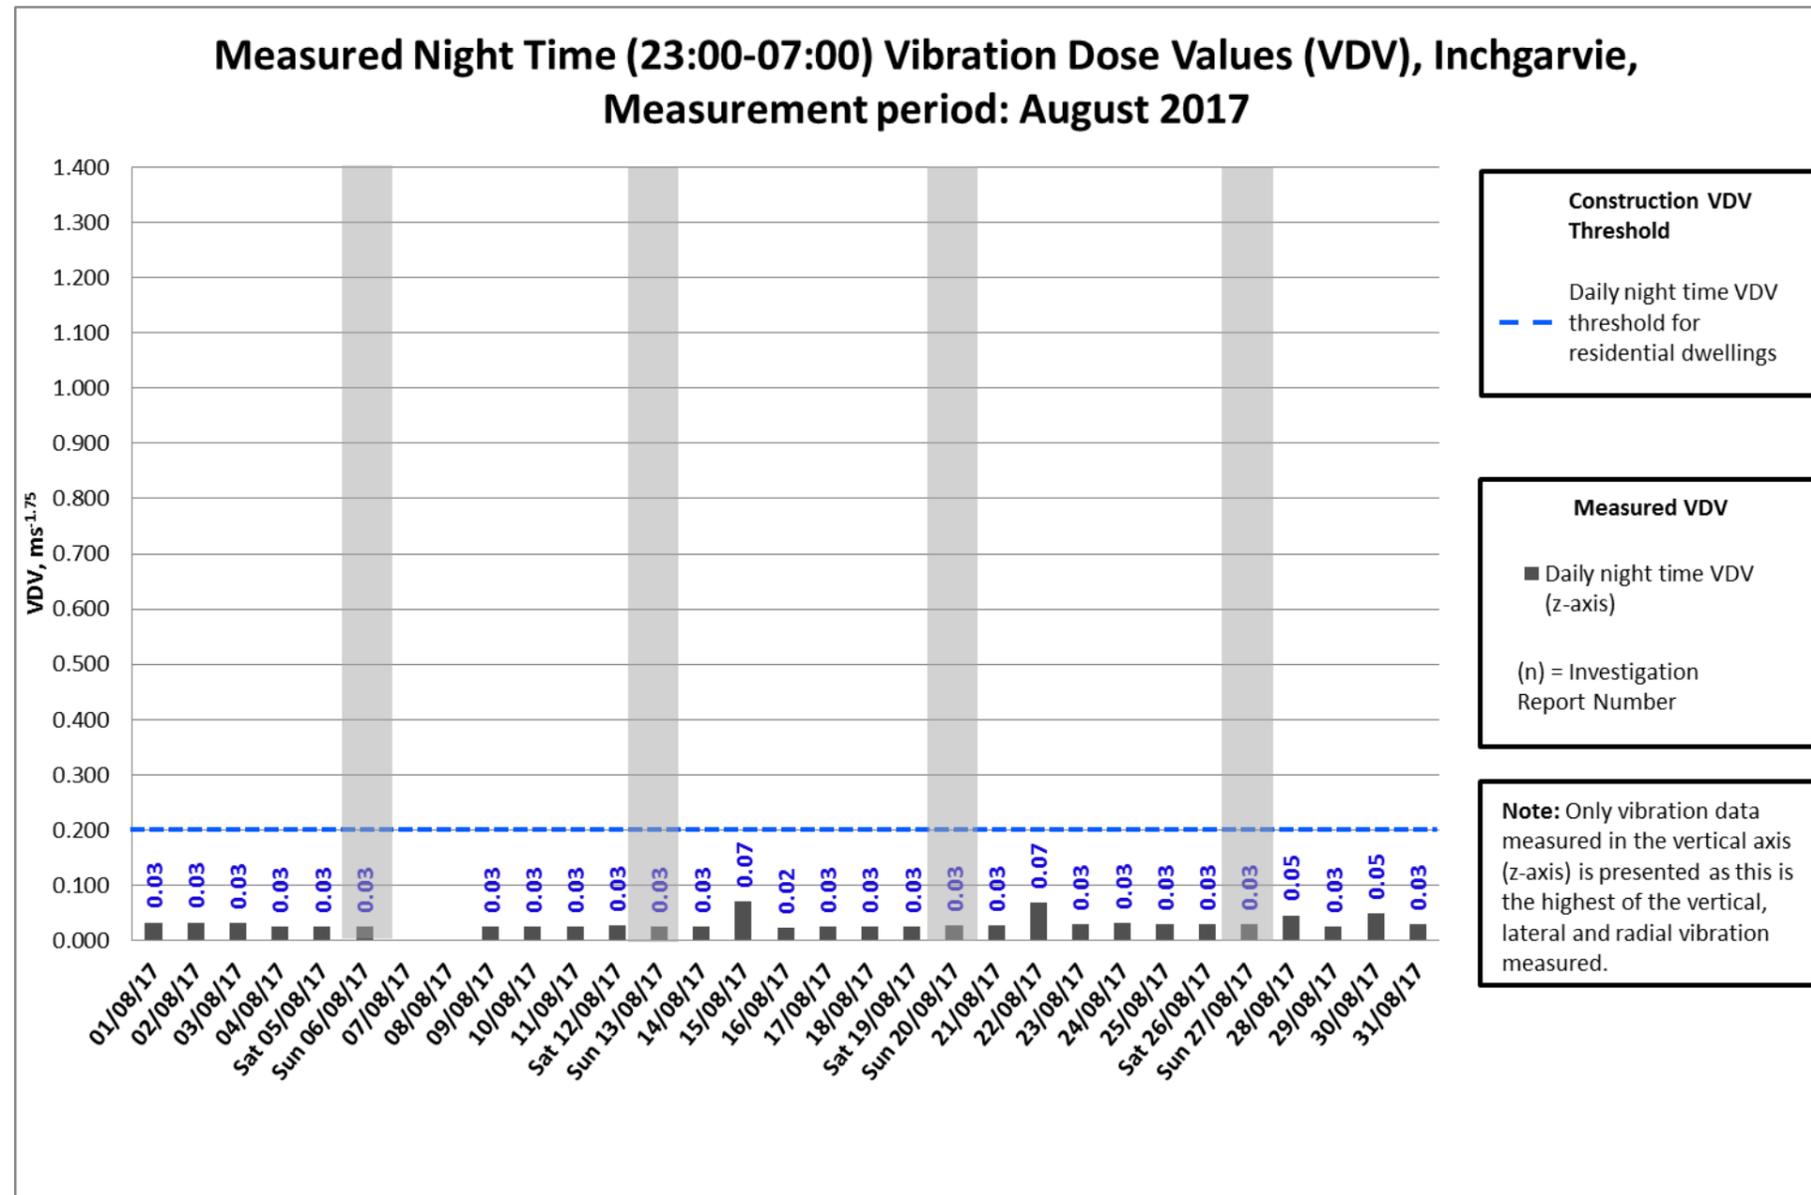
Data missing on the 7<sup>th</sup> - 8<sup>th</sup> August was caused by the annual calibration of the vibration monitor.

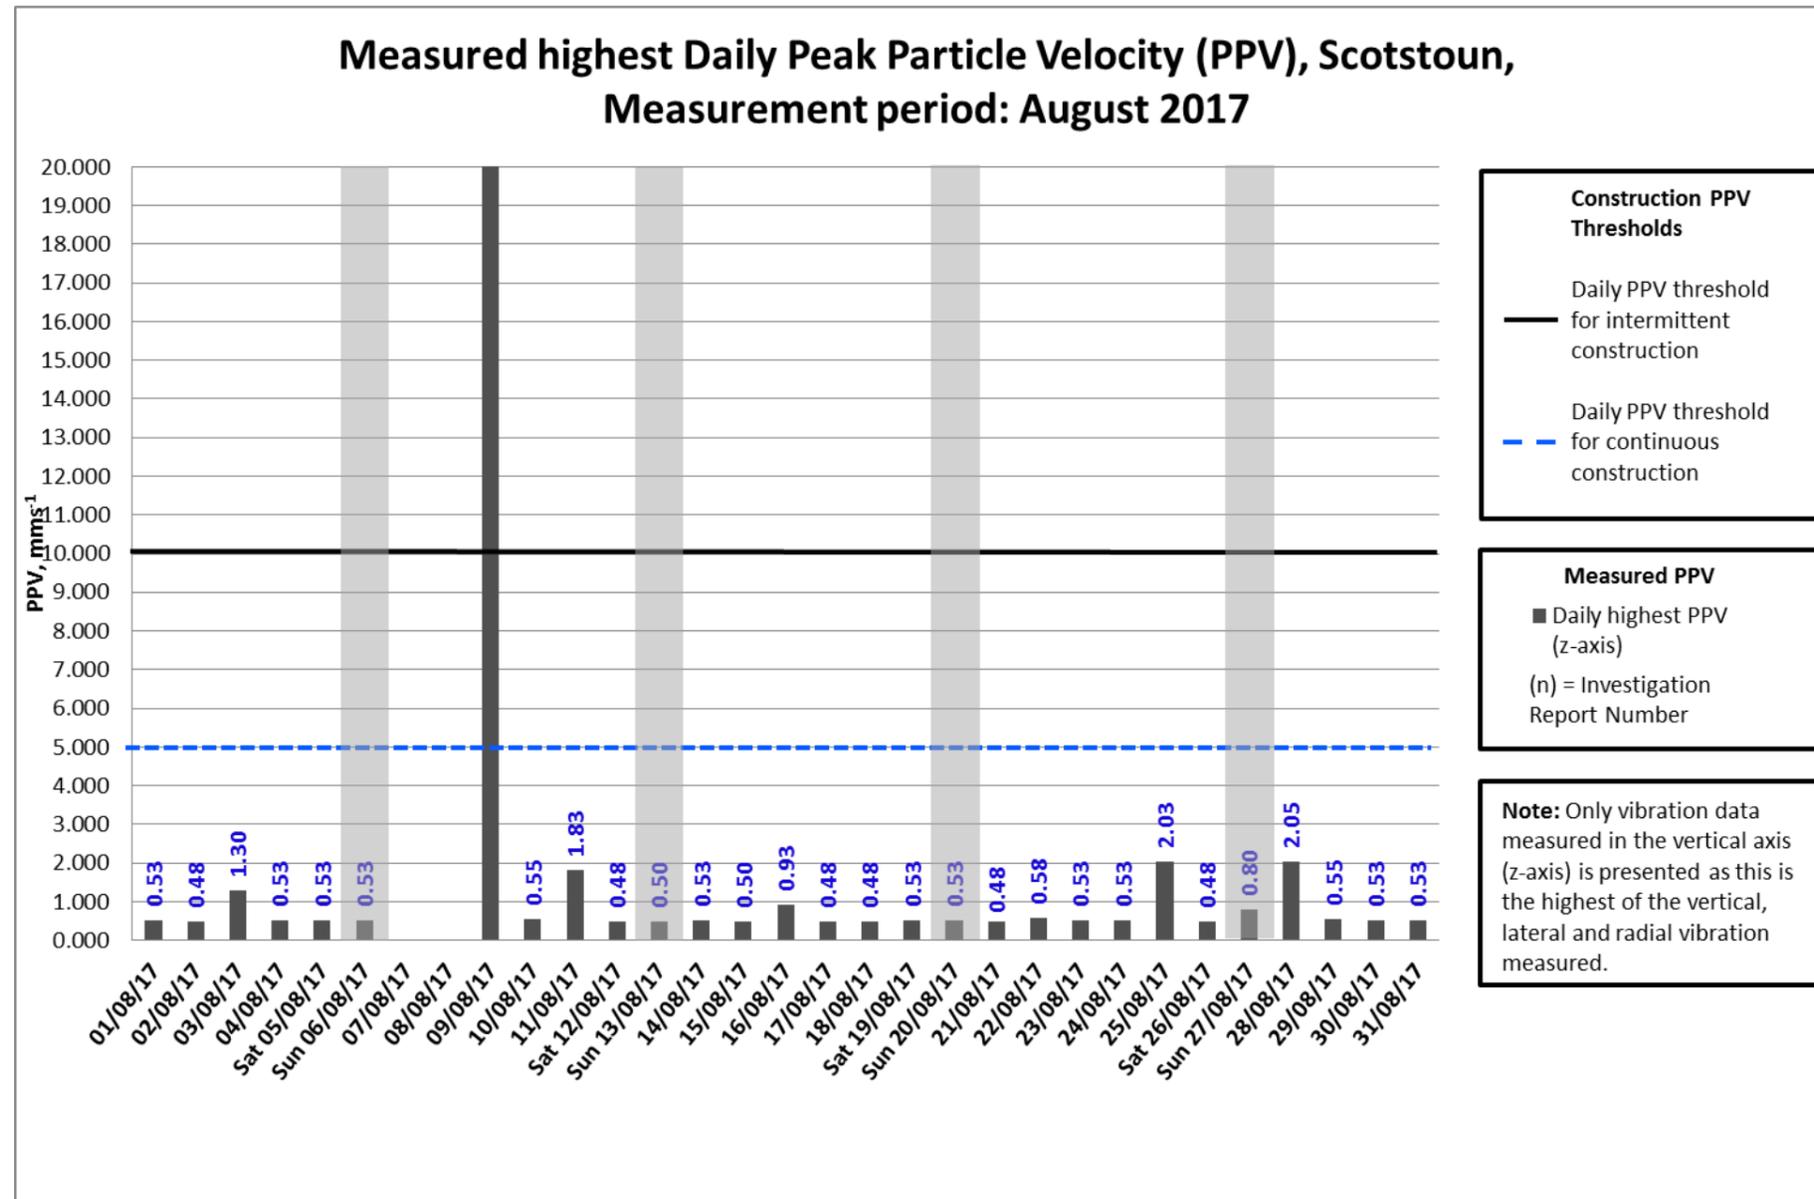
Data missing on the 7<sup>th</sup> - 8<sup>th</sup> August was caused by the annual calibration of the vibration monitor.

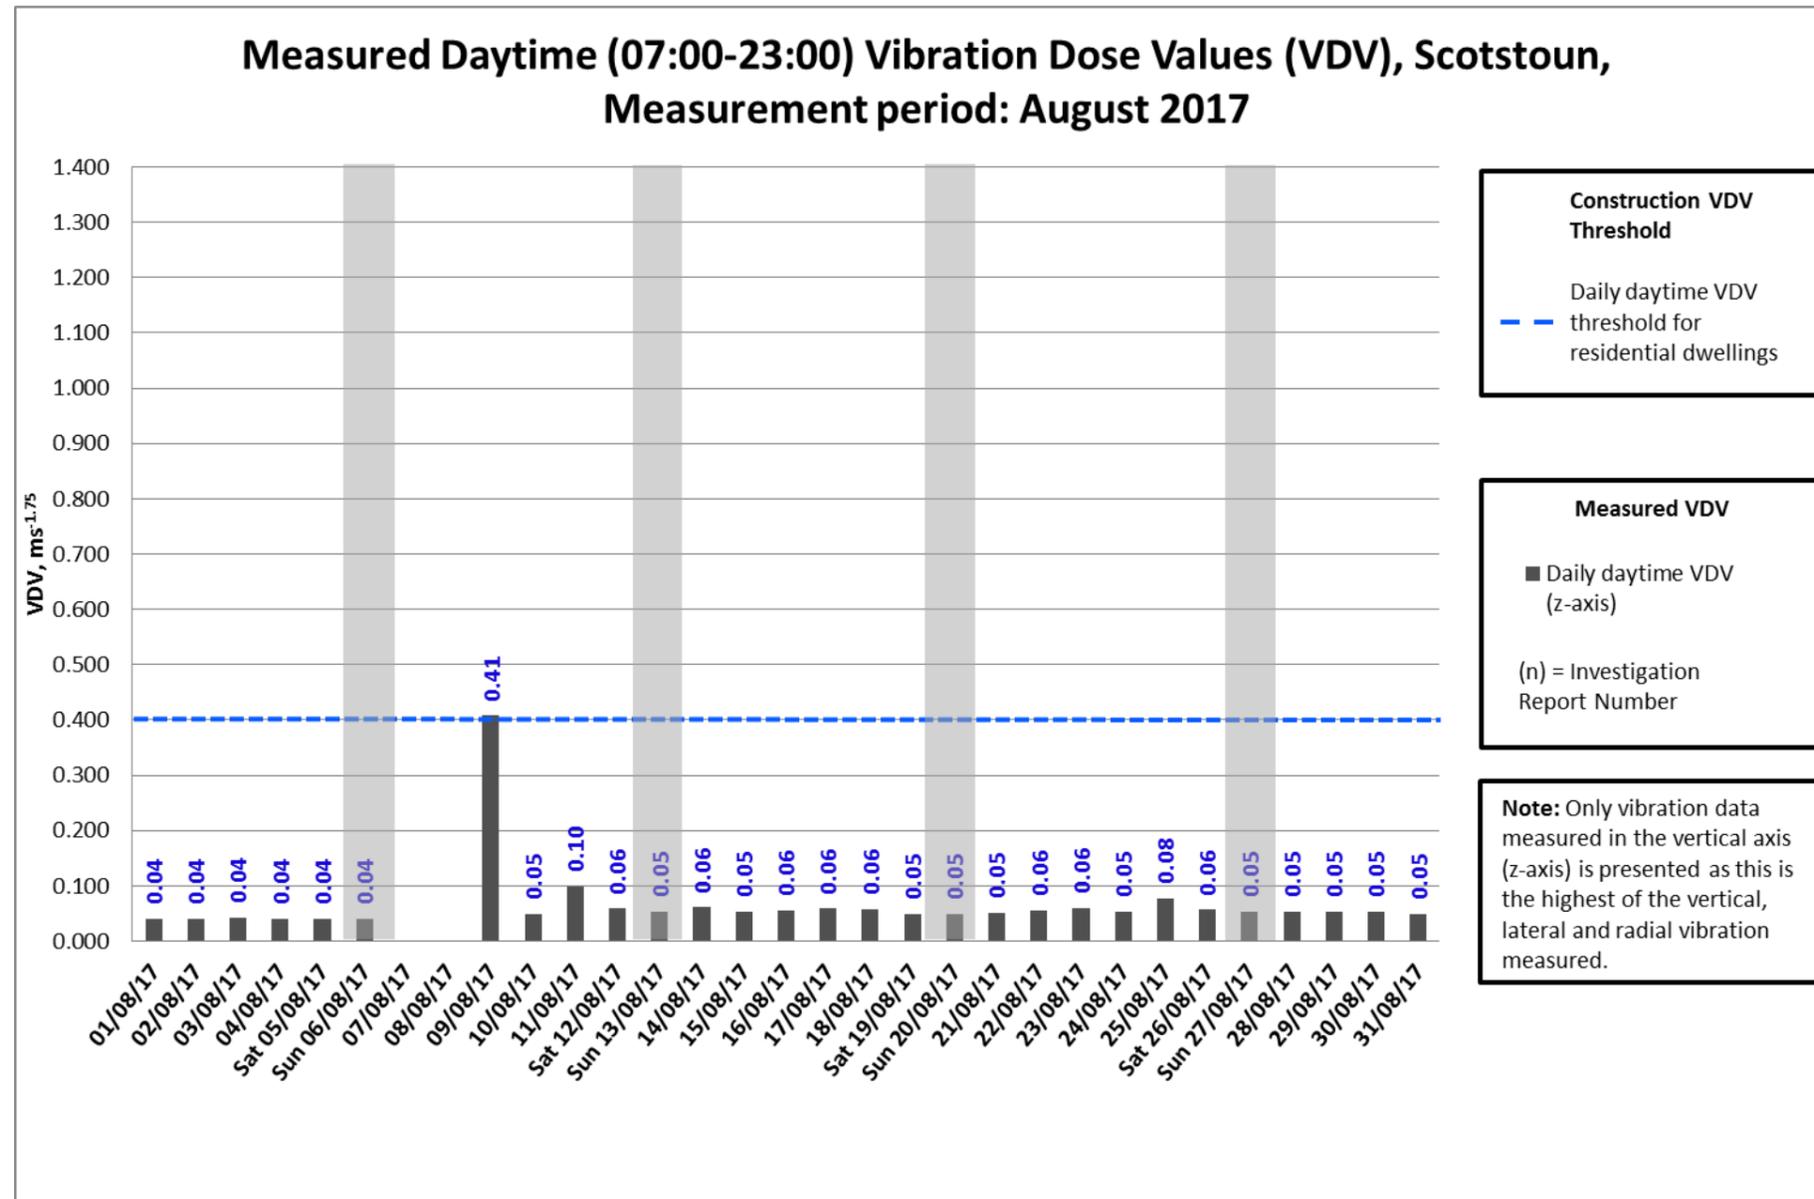
Data missing on the 7<sup>th</sup> - 8<sup>th</sup> August was caused by the annual calibration of the vibration monitor.

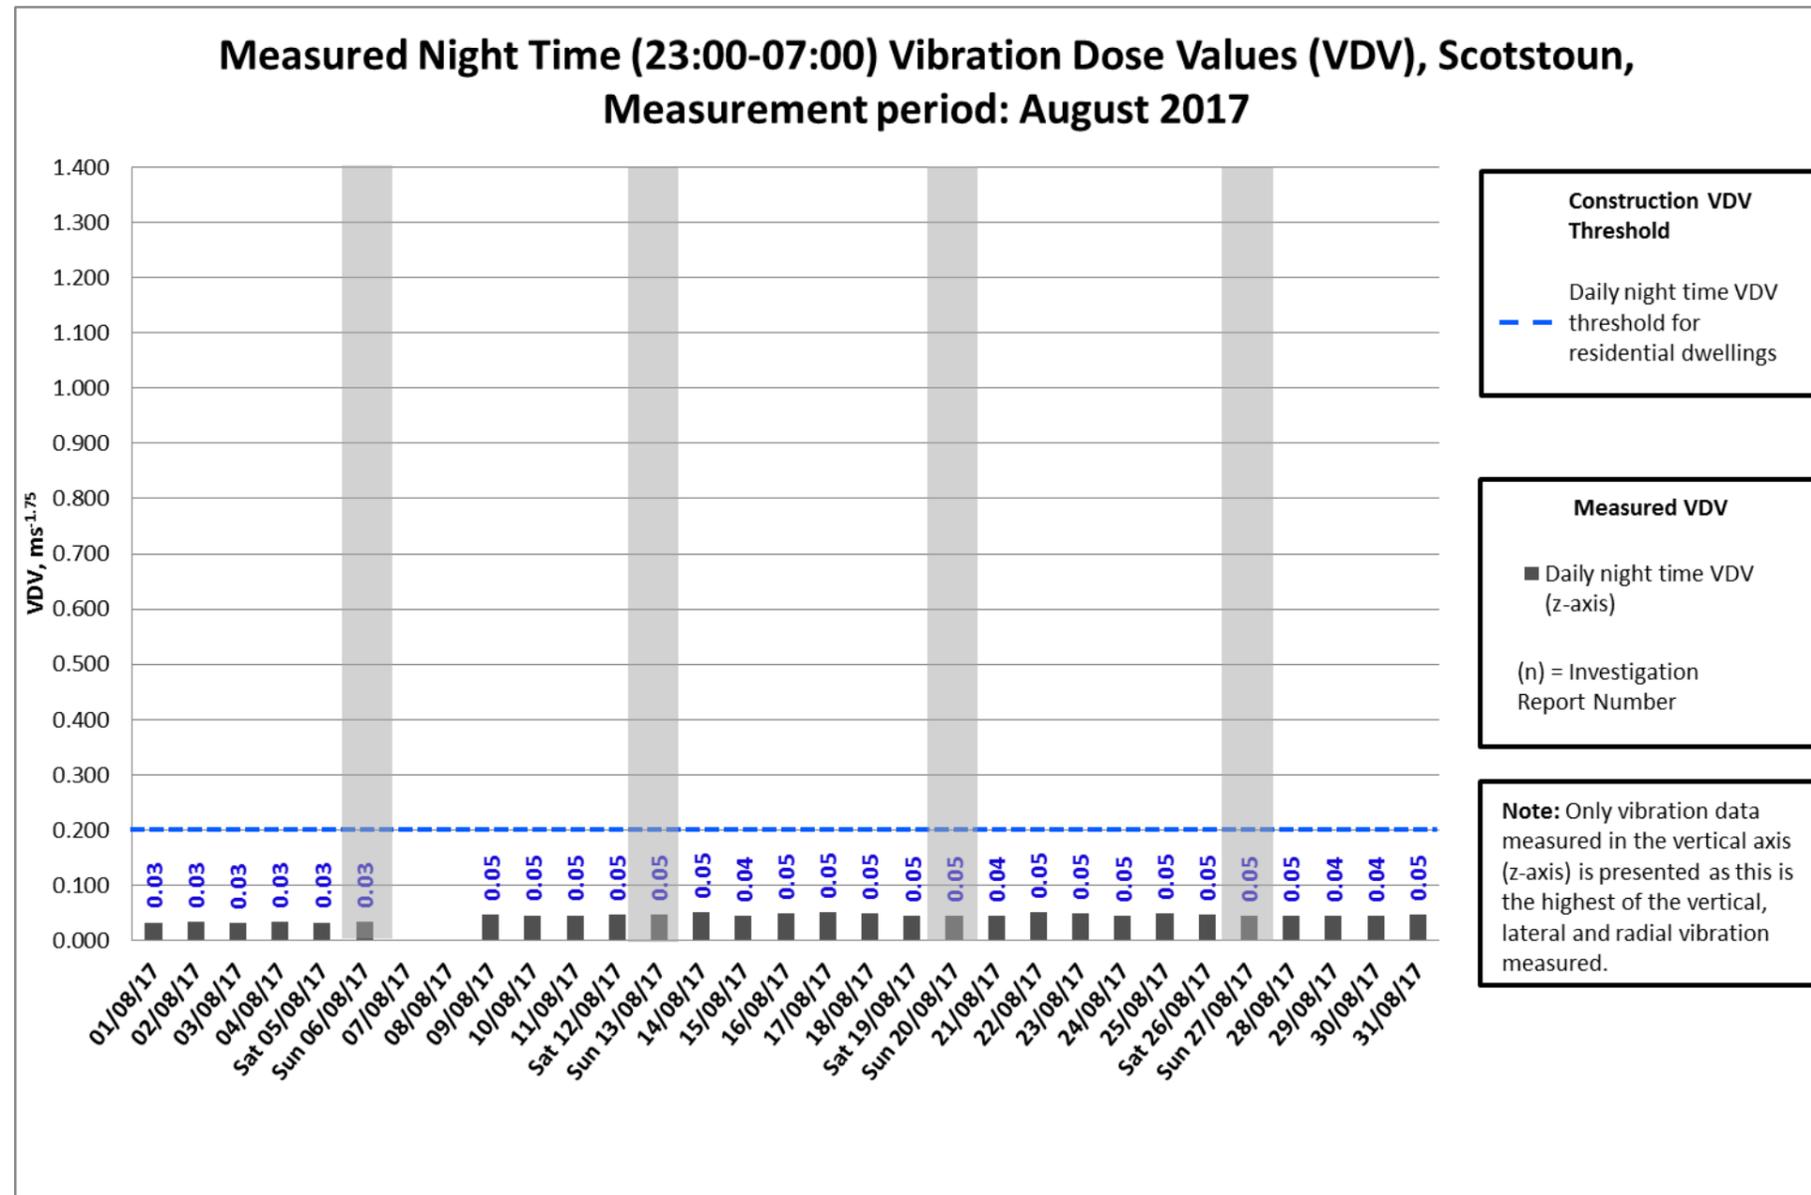
Data missing on the 7<sup>th</sup> - 8<sup>th</sup> August was caused by the annual calibration of the vibration monitor.

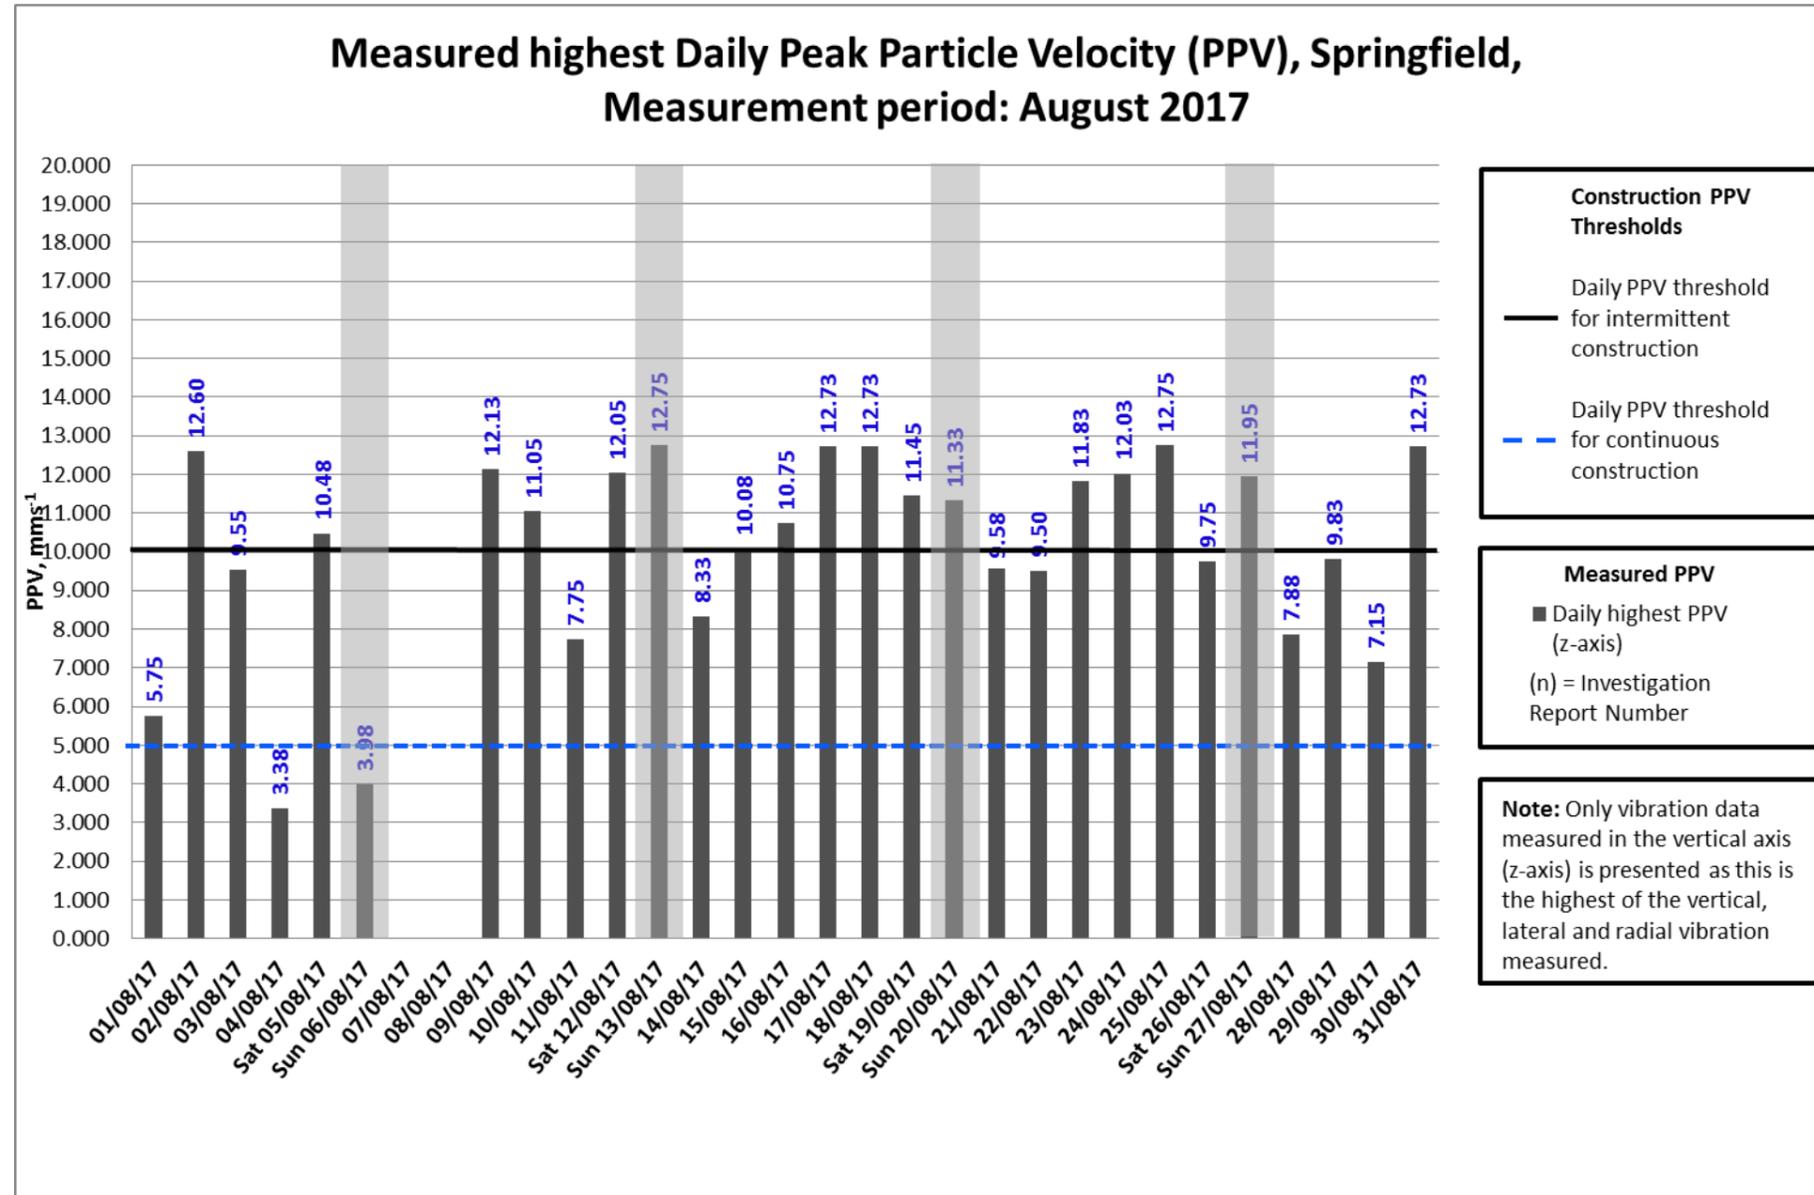
Data missing on the 7<sup>th</sup> - 8<sup>th</sup> August was caused by the annual calibration of the vibration monitor.

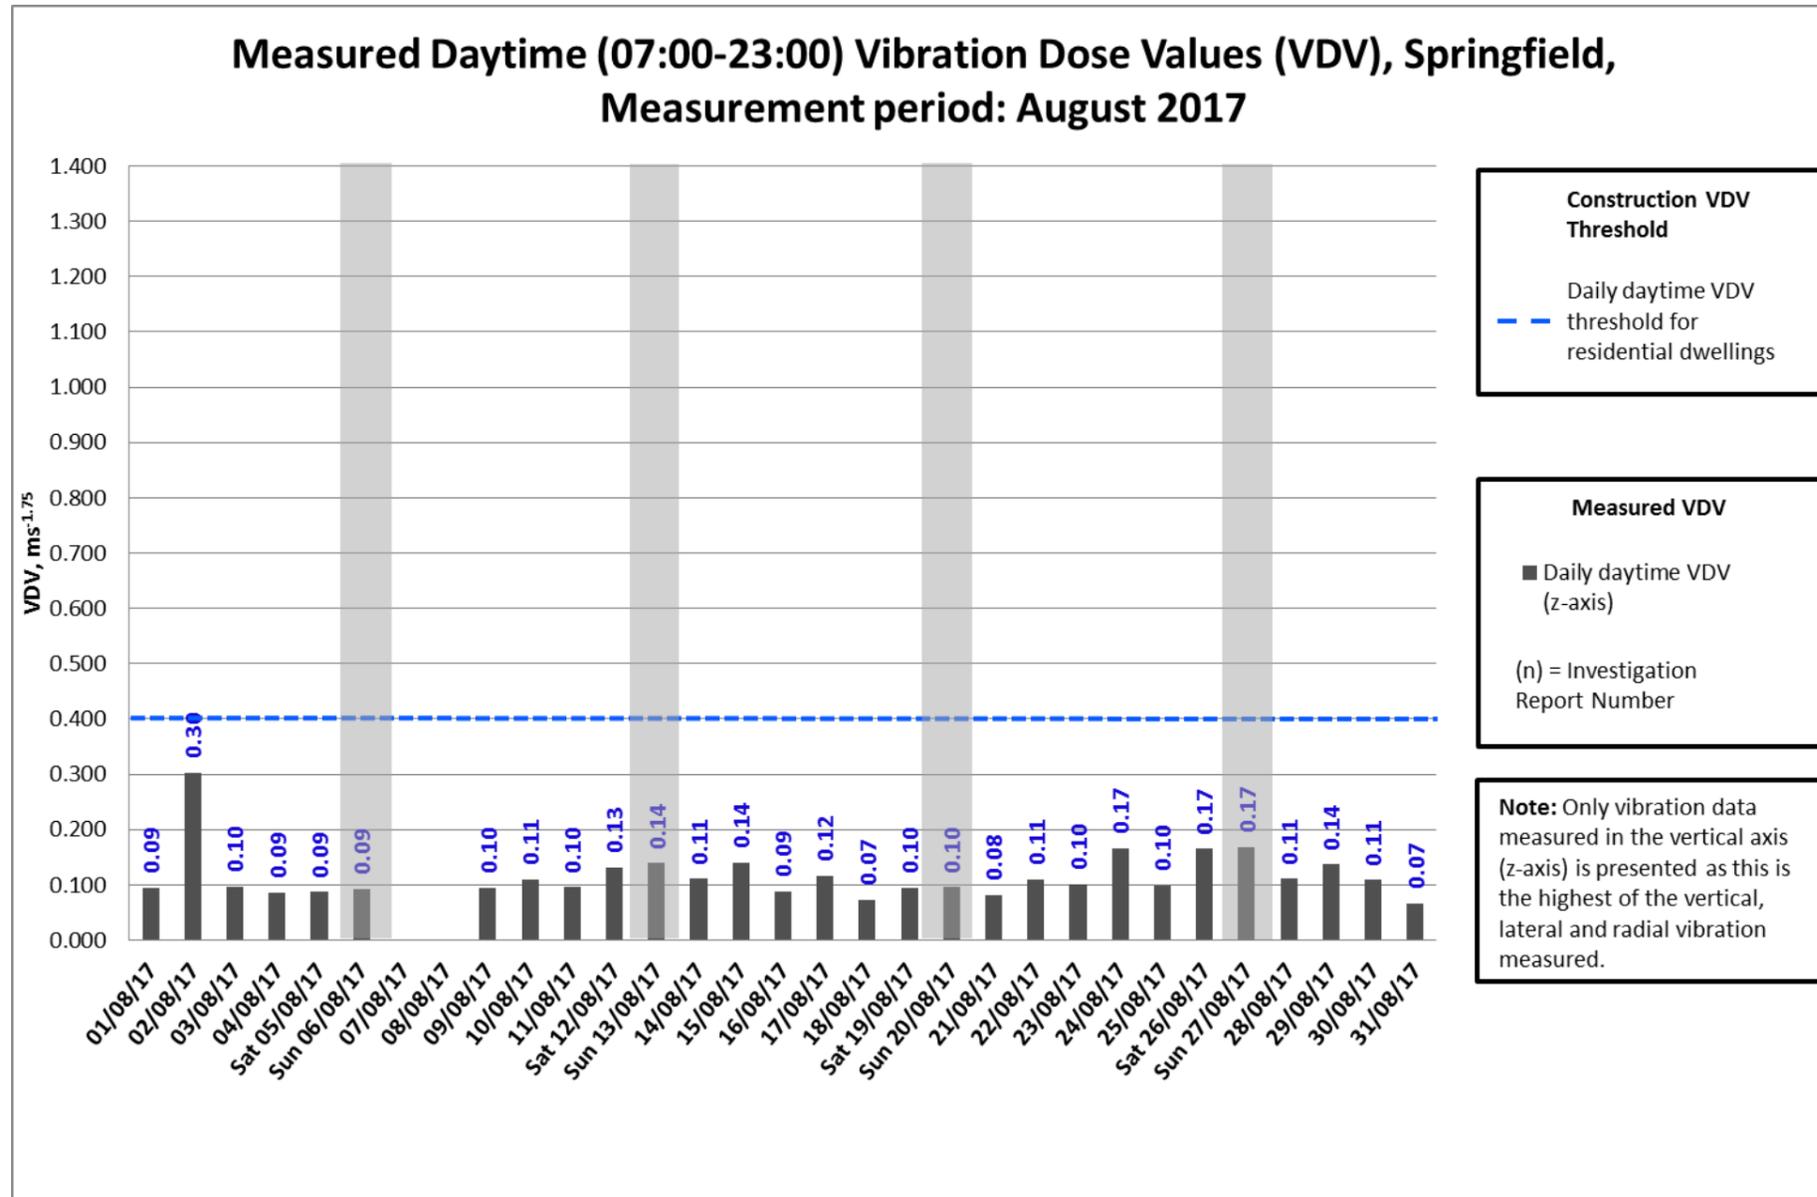
Data missing on the 7<sup>th</sup> - 8<sup>th</sup> August was caused by the annual calibration of the vibration monitor.
