Queensferry  
Crossing

Project FORTH REPLACEMENT CROSSING

VIBRATION MONITORING REPORT  
AUGUST 2017

Document number	Rev
<b>REP-00343</b>	<b>00</b>

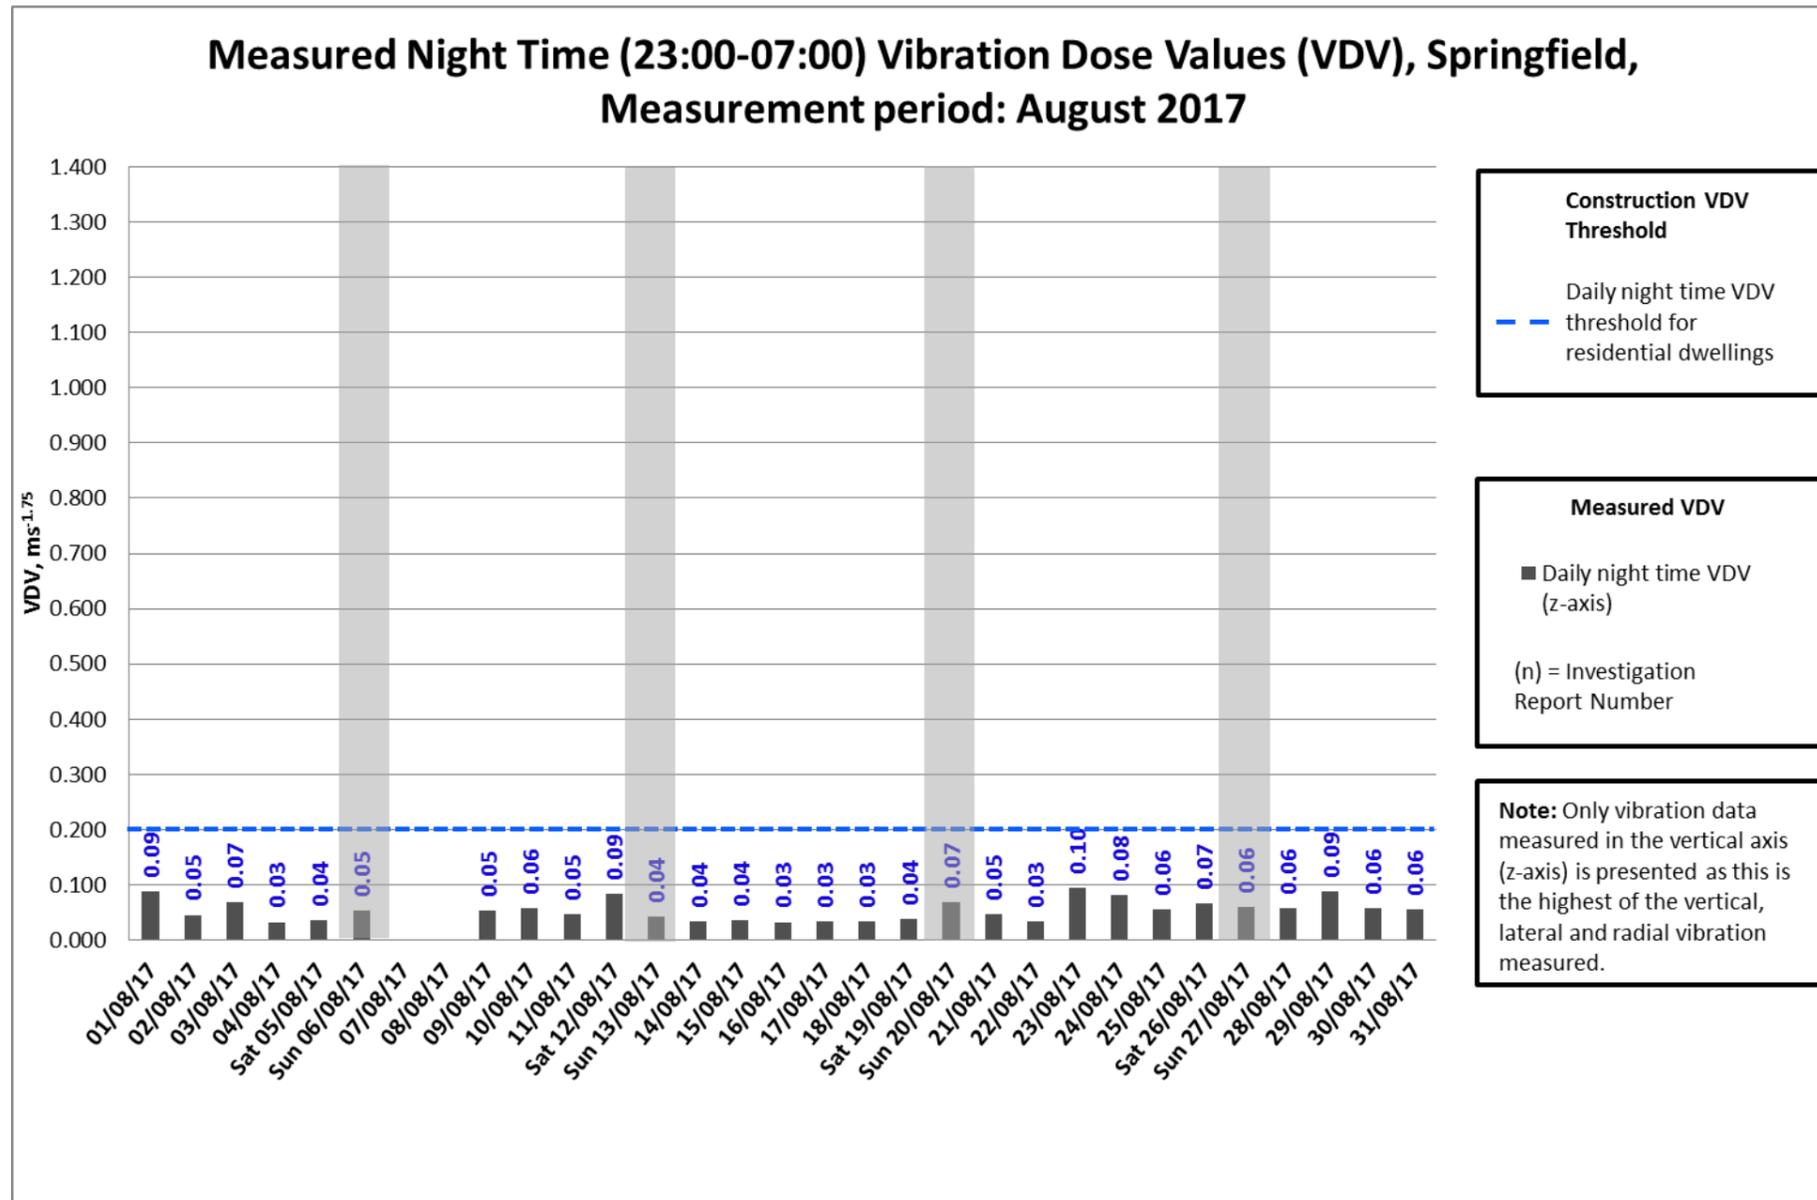
Data missing on the 7<sup>th</sup> - 8<sup>th</sup> August was caused by the annual calibration of the vibration monitor.

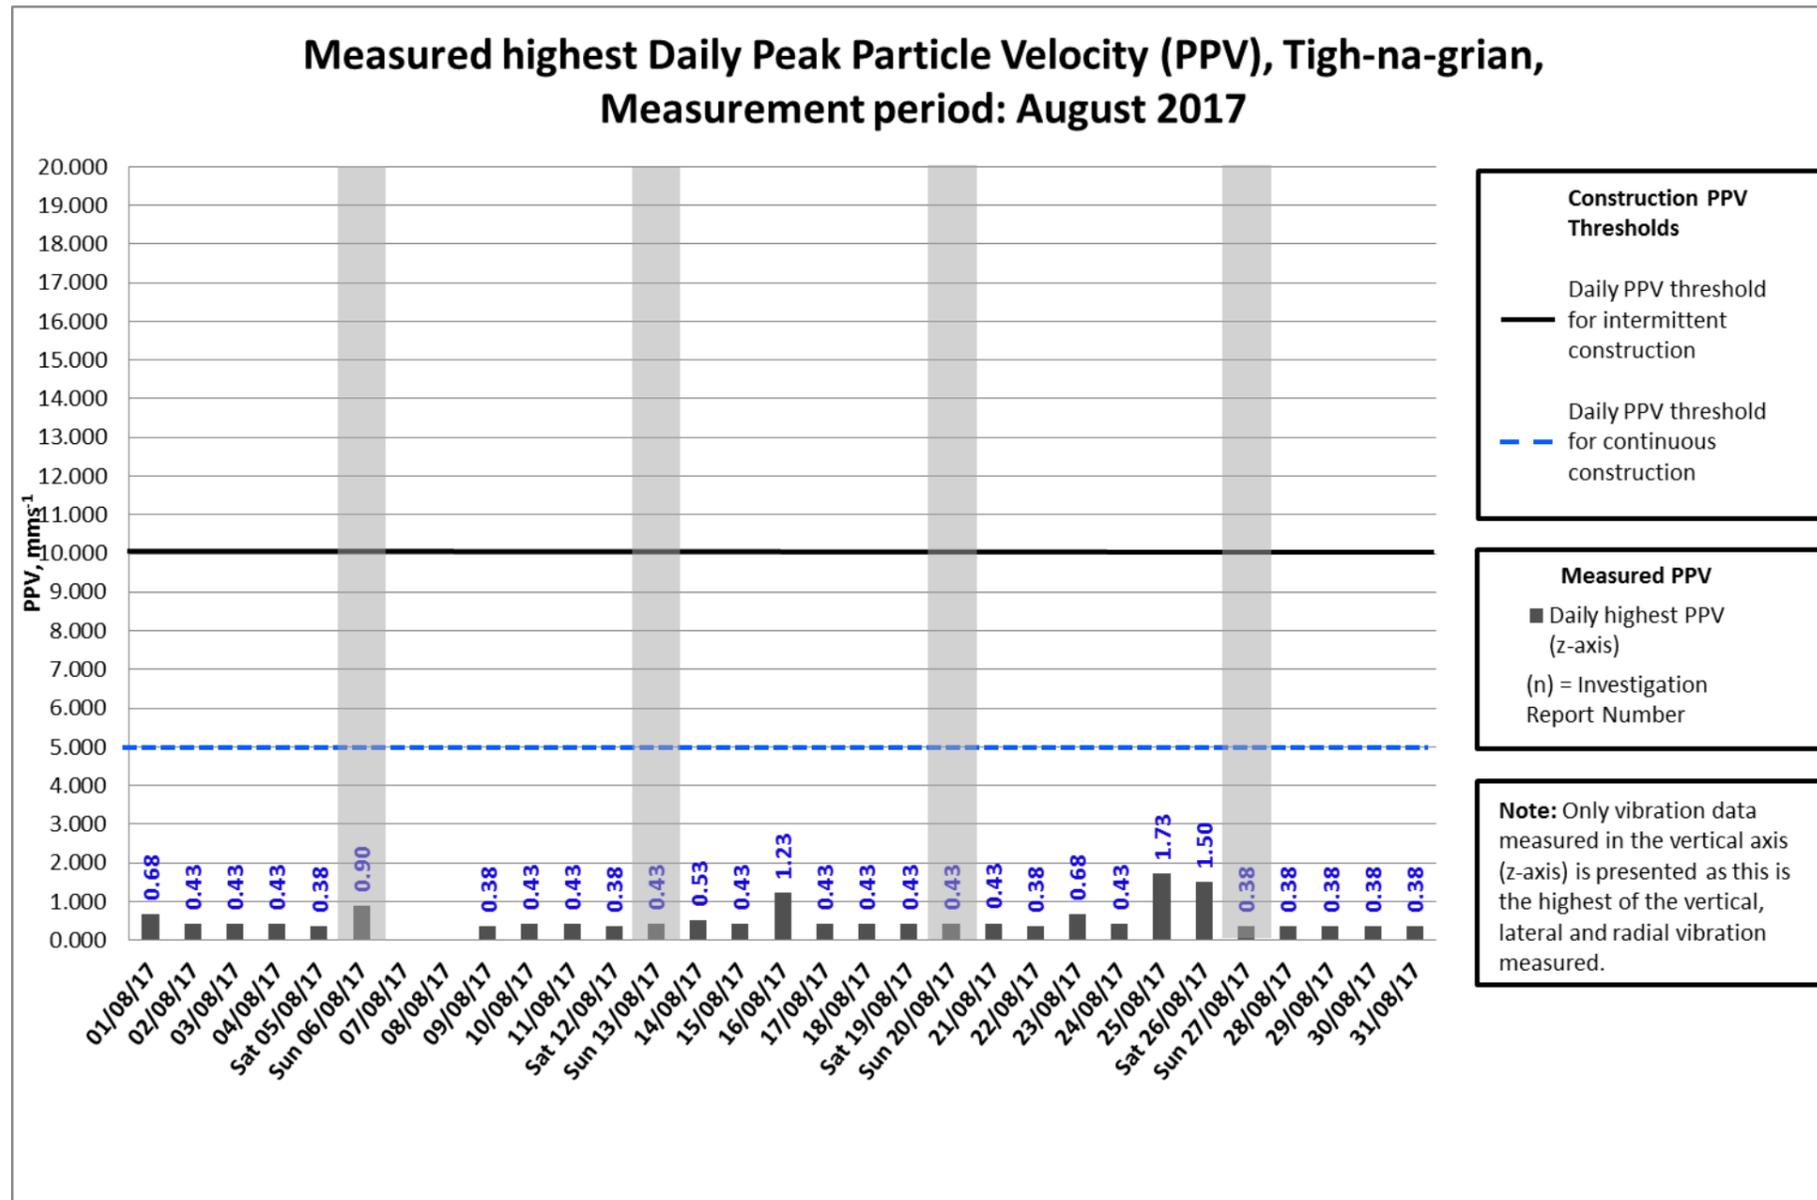
Data missing on the 7<sup>th</sup> - 8<sup>th</sup> August was caused by the annual calibration of the vibration monitor.

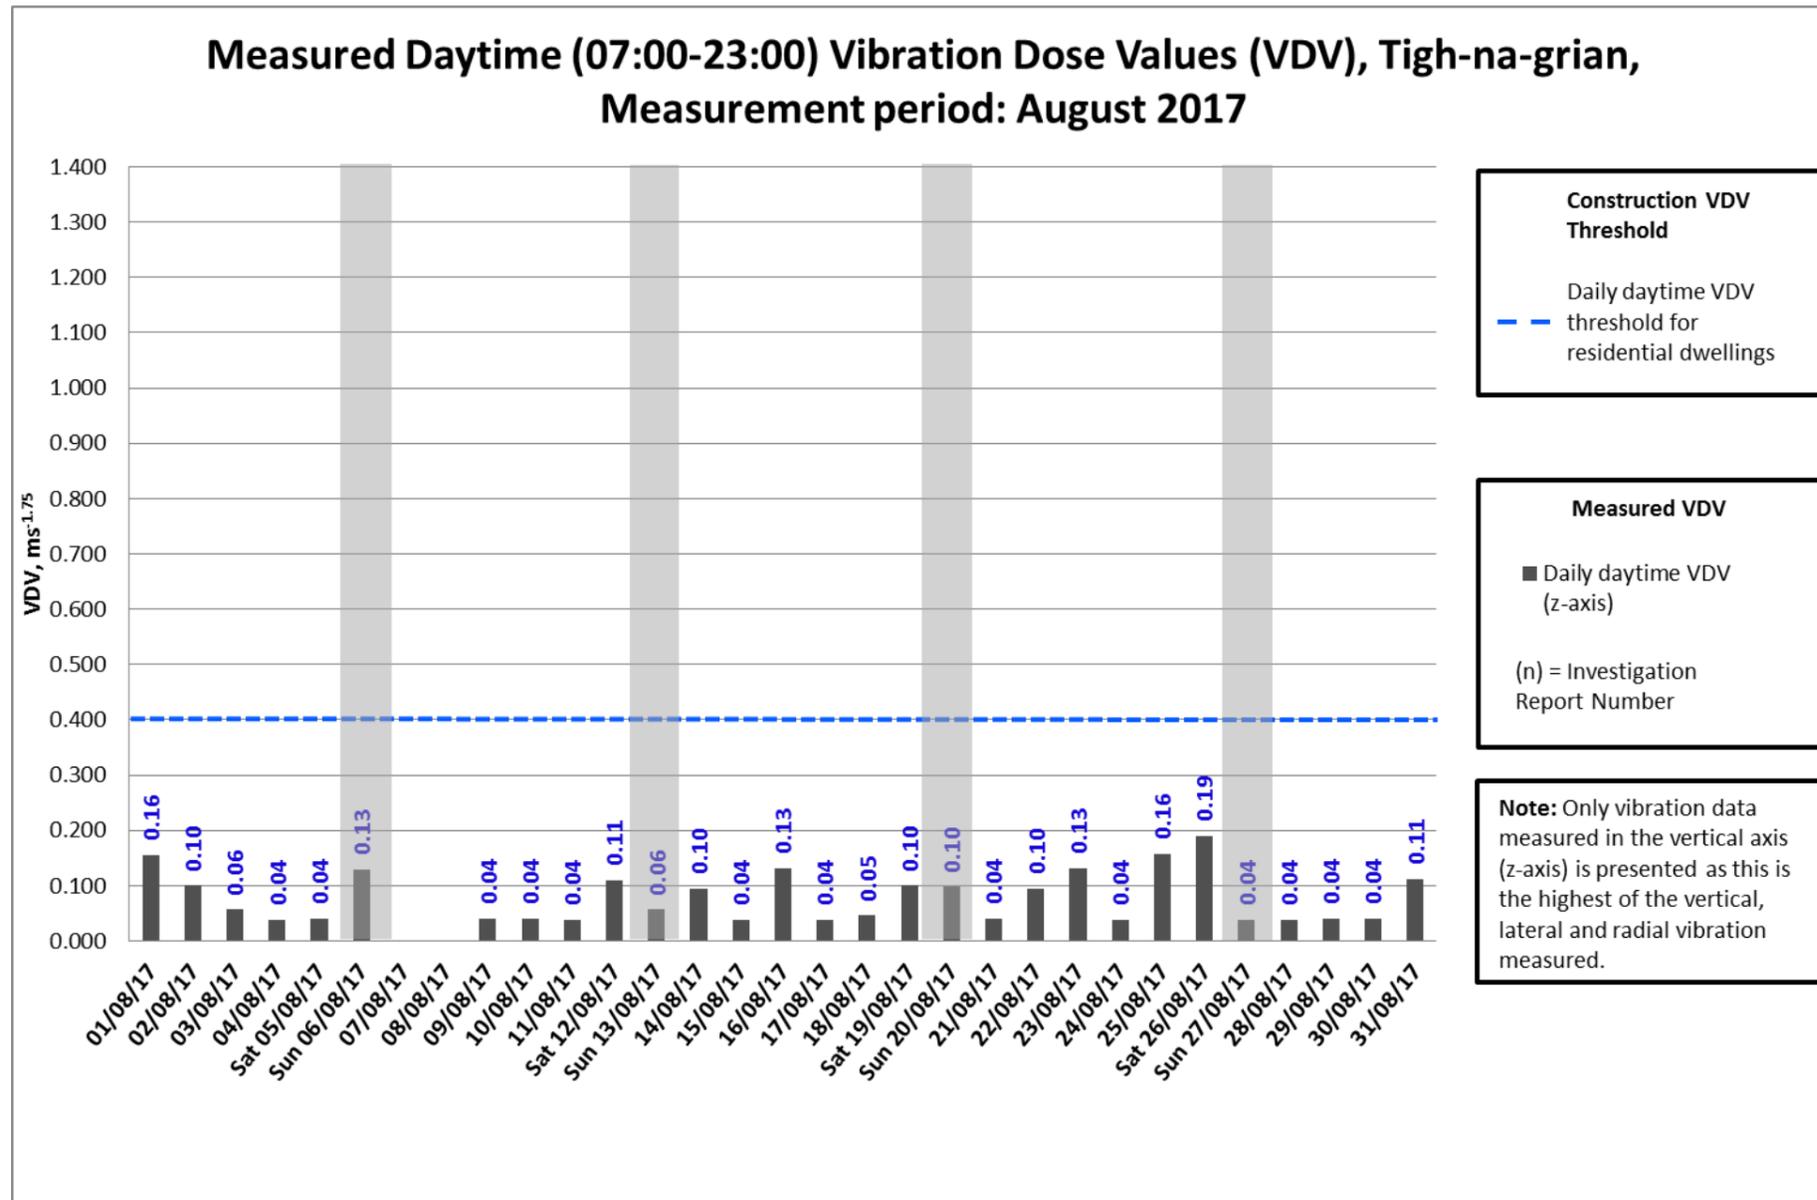
Data missing on the 7<sup>th</sup> - 8<sup>th</sup> August was caused by the annual calibration of the vibration monitor.

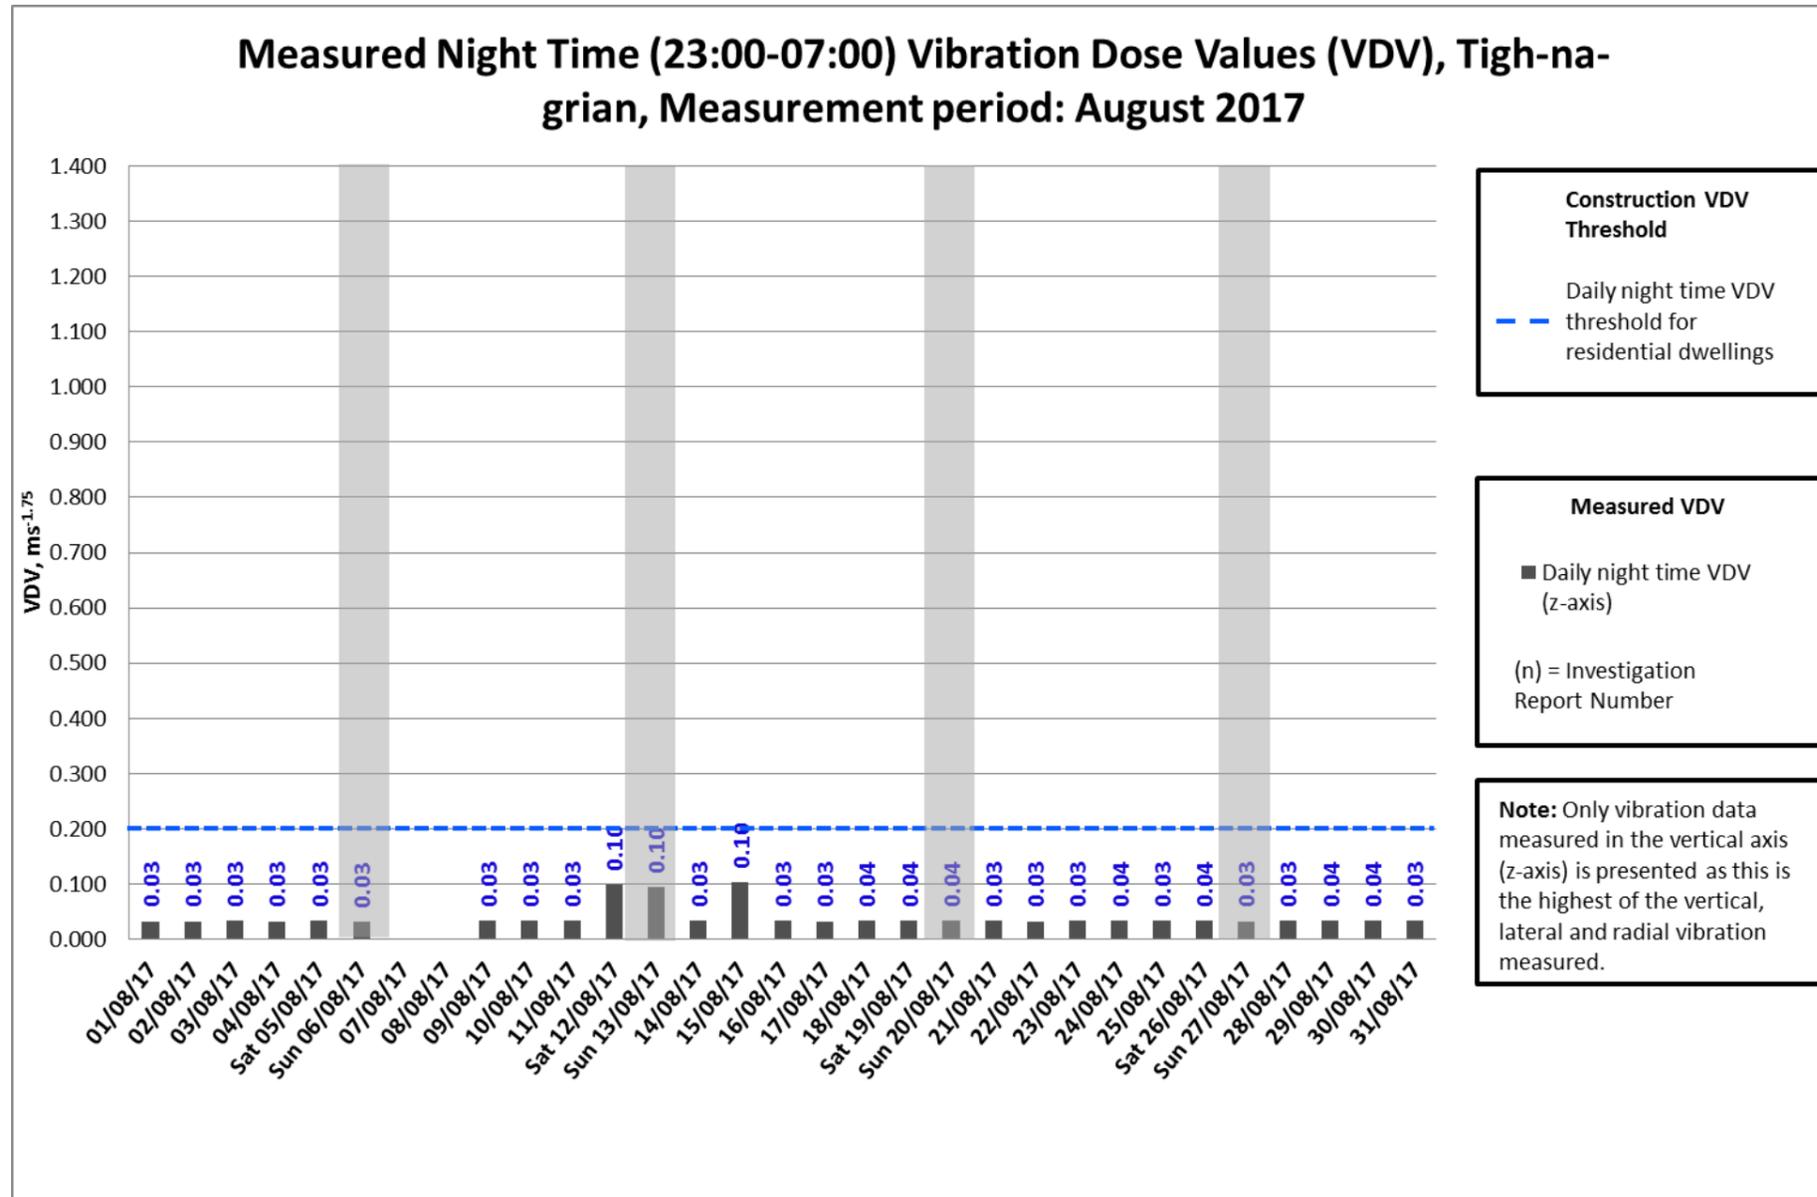
Data missing on the 7<sup>th</sup> - 8<sup>th</sup> August was caused by the annual calibration of the vibration monitor.

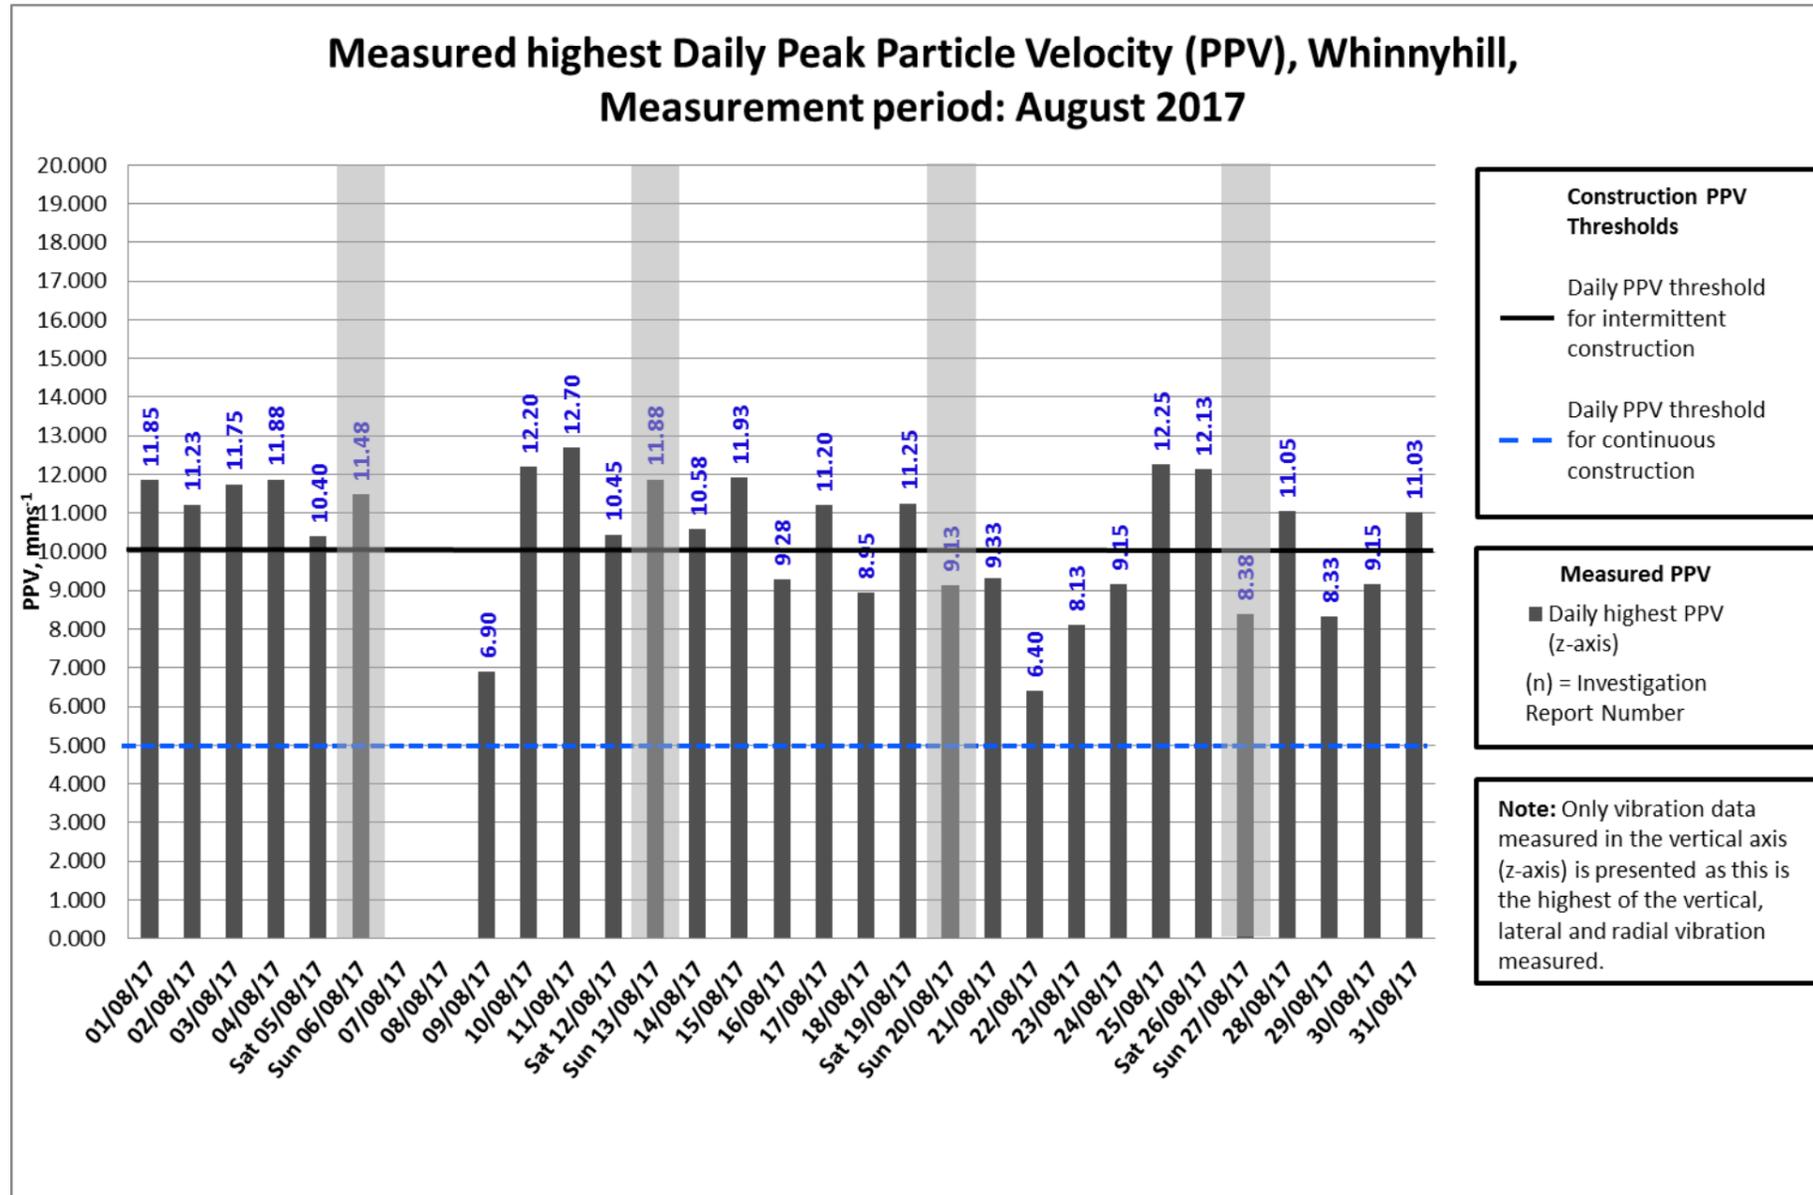
Data missing on the 7<sup>th</sup> - 8<sup>th</sup> August was caused by the annual calibration of the vibration monitor.

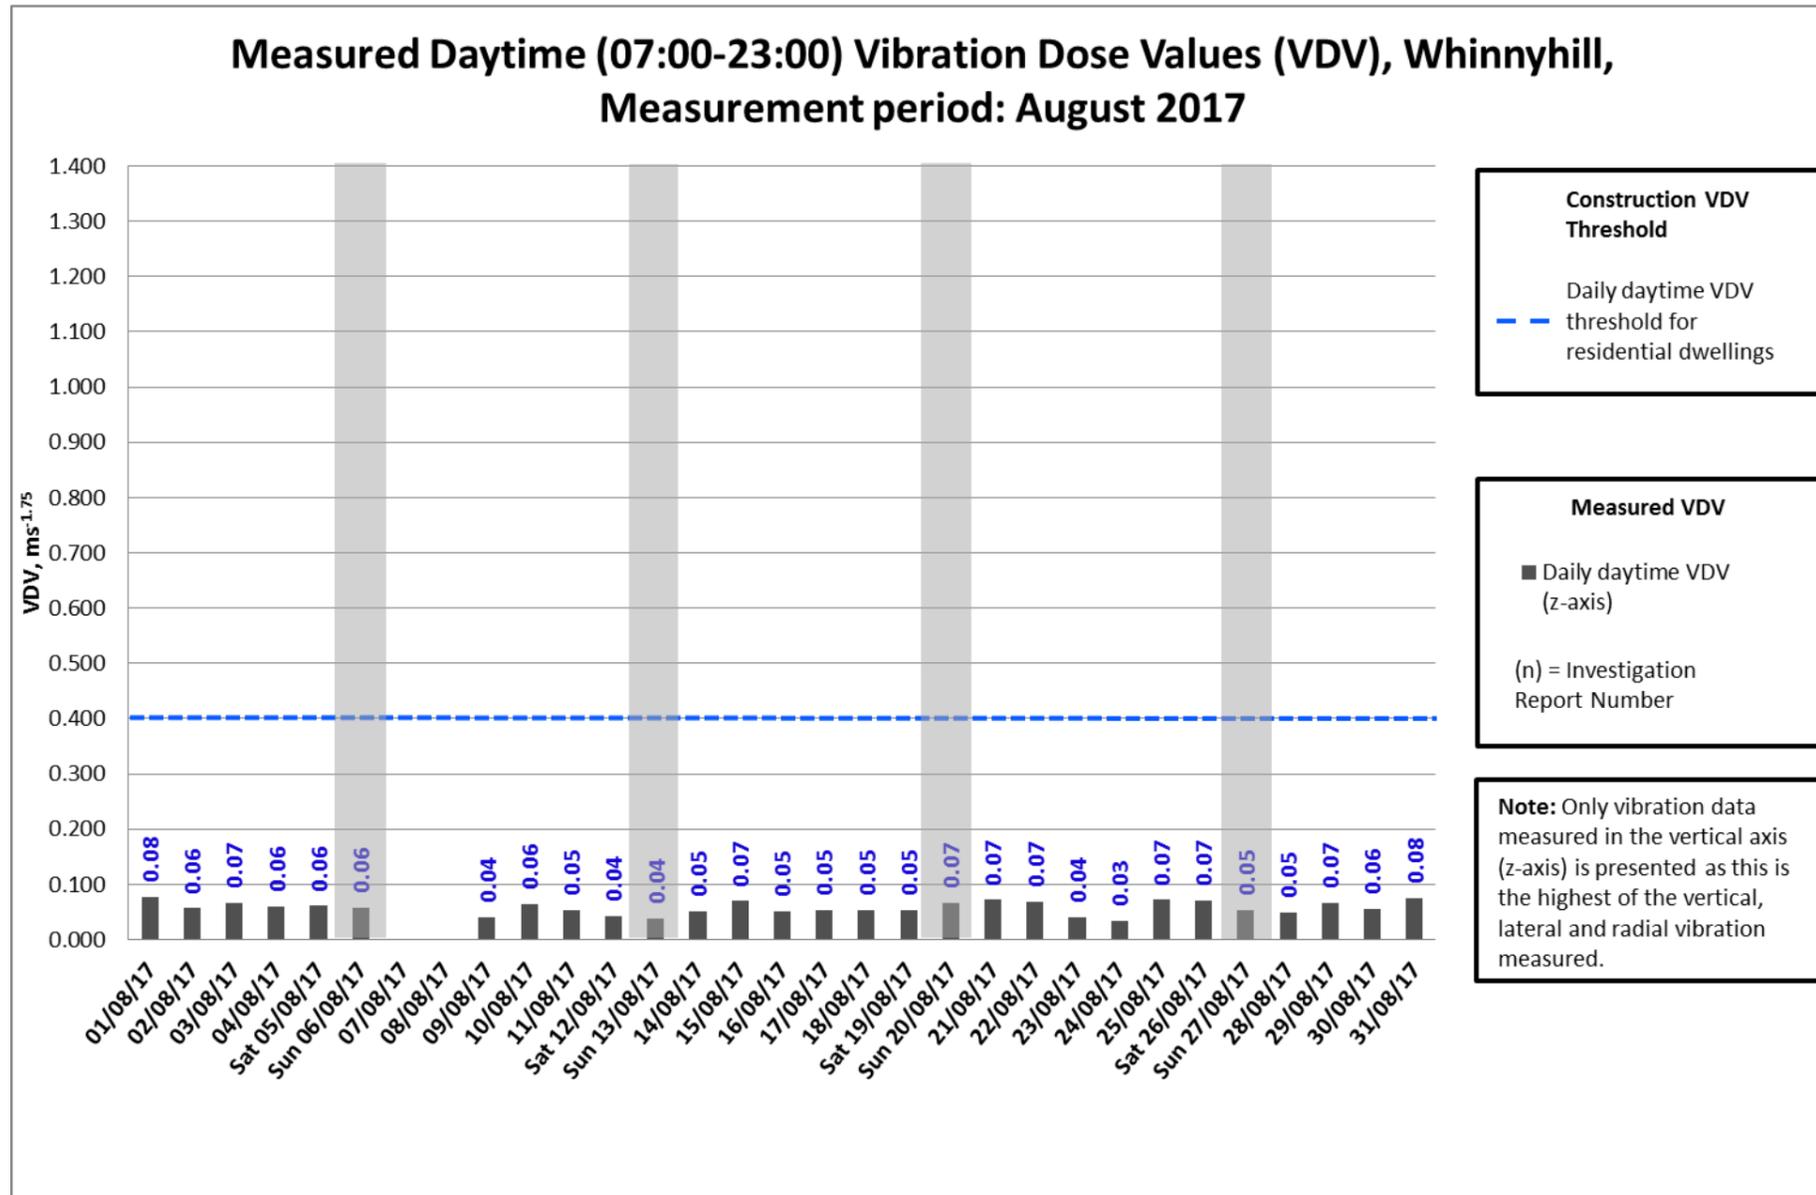
Data missing on the 7<sup>th</sup> - 8<sup>th</sup> August was caused by the annual calibration of the vibration monitor.

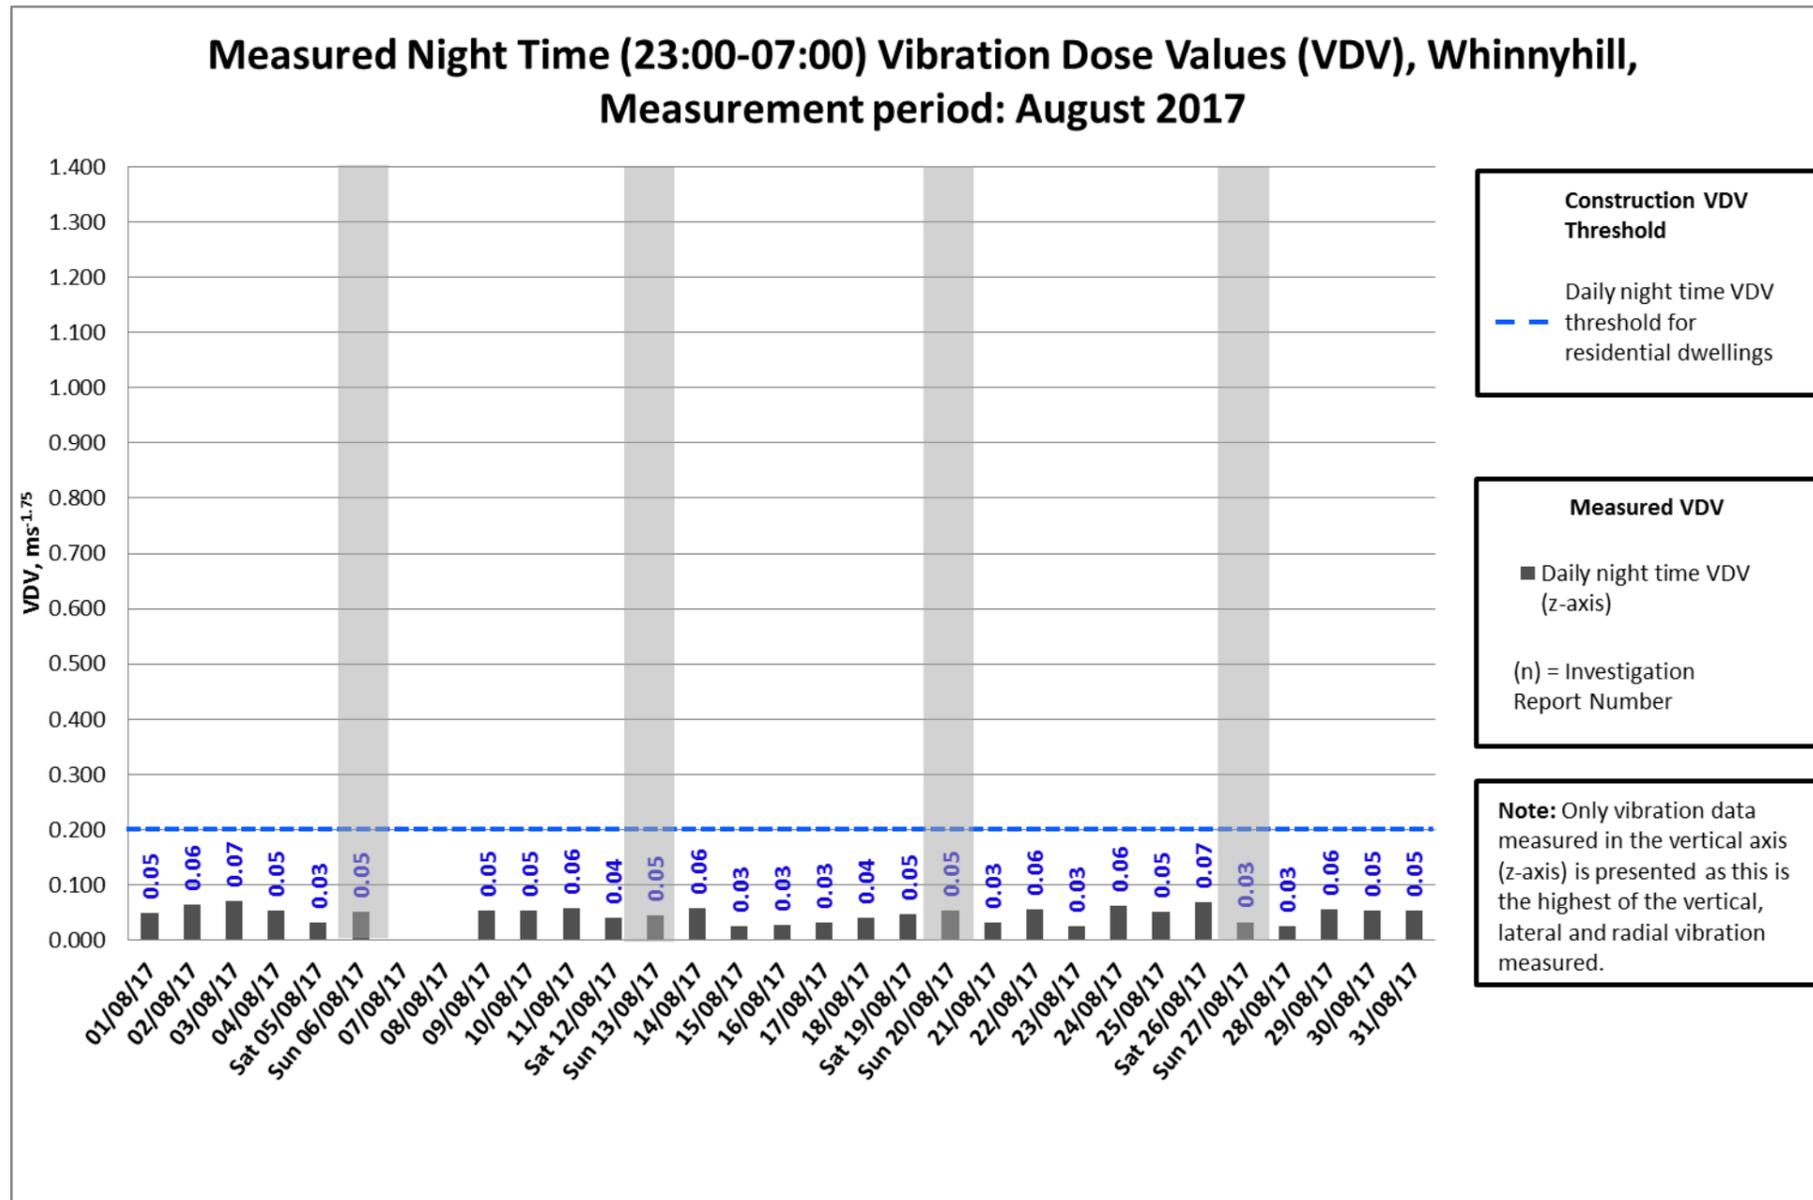
Data missing on the 7<sup>th</sup> - 8<sup>th</sup> August was caused by the annual calibration of the vibration monitor.
