# Appendix 11.4

## Hydromorphology Assessment Part 3

**Annex 11.4.3 - Hydromorphological Catchment Assessment - 117**

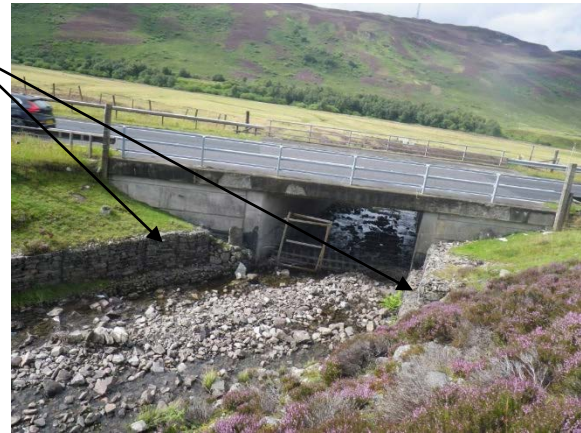
Photograph 11.4.3.117 – Downstream to crossing

Valley side erosion

Bedrock

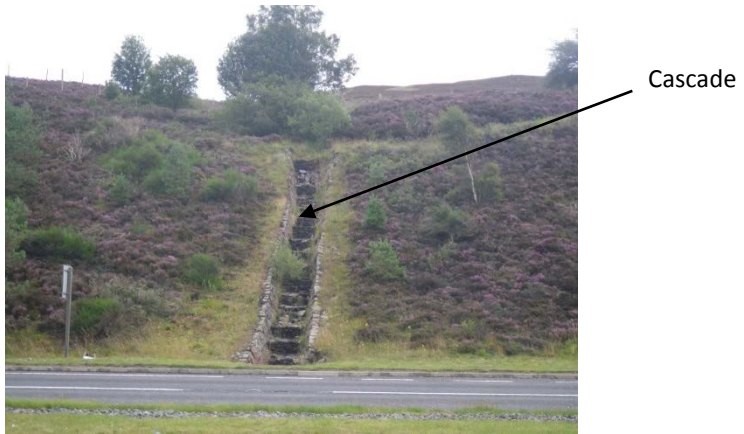
Photograph 11.4.3.124- Cascade upstream of crossing

Vertical incision	None	
	Deposition	Low	
	Lateral migration/bank erosion	None	
Damaged/unstable drains or armouring	Yes	Limited damage to cascade steps producing coarse angular material	
<b>Morphology and Process Reach downstream of crossing</b>	Channel morphology	Engineered	Cut drain
	Predominant sediment size	Fine	
	Unvegetated bars	No	
	Vertical incision	None	
	Deposition	Low	Fines and organics only. Sluggish
	Lateral migration/bank erosion	None	
	Presence and nature of infrastructure (Map 1d)	Yes	Railway
	Infrastructure type (see Drawing 11.4.3.1 d, Catchment 128)	Yes	Channel in cut drain and joins 127 to pass under railway
Channel realignment	Yes	See above	
<b>Summary behaviour</b>	<p>Channel upslope appears to have once been natural in aerial photos, but is joined at cutting crest by cross slope drains which collect hillslope drainage. Channel descends cutting in stepped, armoured cascade which has suffered damage at some of the steps. This has resulted in dislodged armour. Little sediment appears to, however, be delivered to the crossing with only some fine gravel in the catch pit. The culvert entrance at the time of the survey does not appear to be blocked at all. D/s of the culvert the channel is in a cut drain and flow appears sluggish and the channel is mostly vegetated. There is a confluence with channel 127 u/s of the railway. Channel 127 is incised slightly so there is a possibility that, if flow in channel 128 were to increase, the drain could cut back and incise, but this is unlikely.</p>
