Appendix 11.4

Hydromorphology Assessment Part 4

Annex 11.4.3 - Hydromorphological Catchment Assessment - 32-35

PROJECT 7 GLEN GARRY TO DALWHINNIE EIA
DRAWING 11.4.3.2.
Catchments 32-35 Baseline Assessment

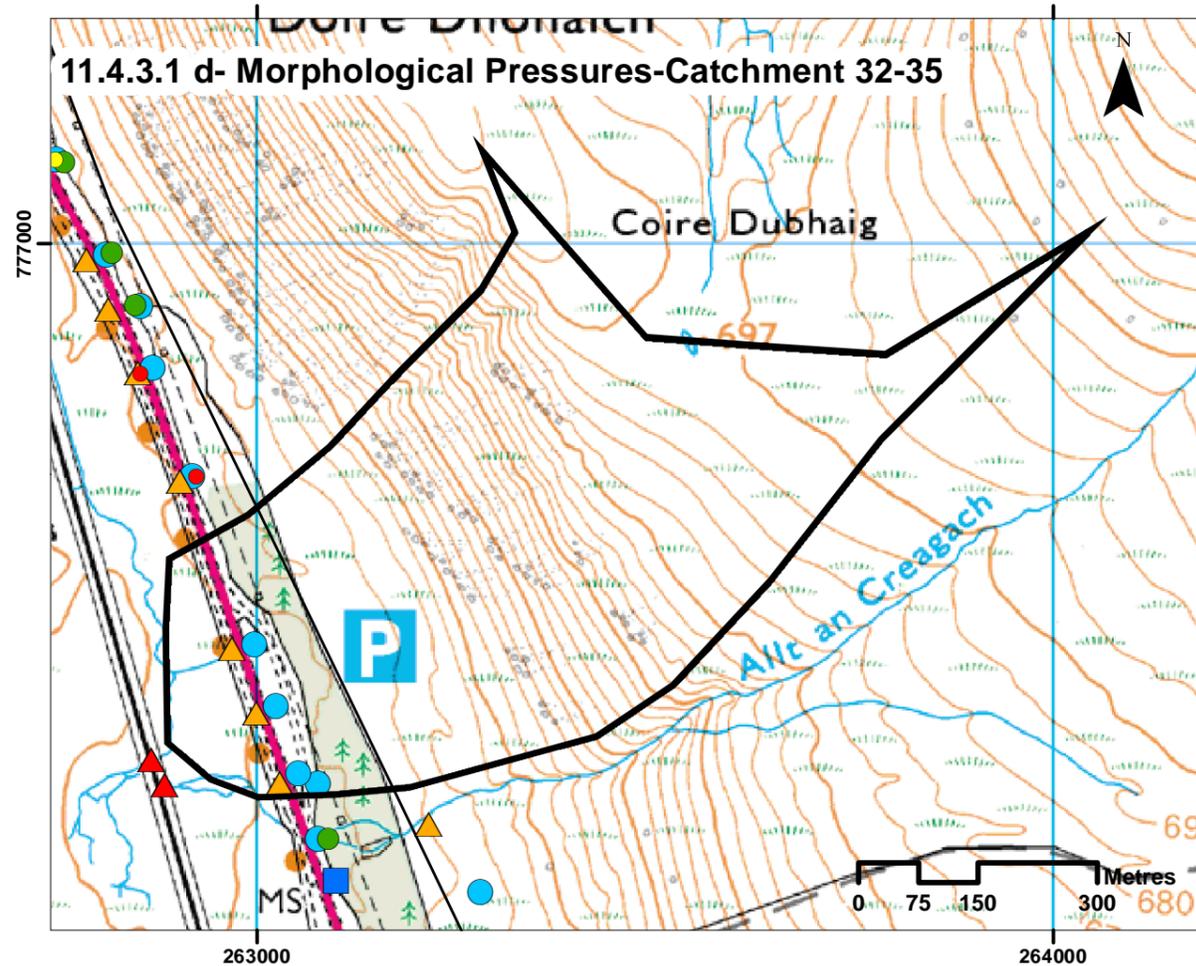
Predominant sediment size	Gravel	
	Unvegetated bars	None	
	Vertical incision	None	
	Deposition	High	Crossing 32
	Lateral migration/bank erosion	None	
	Infrastructure type (see Drawing 11.4.3.1 d, Catchment 32-35)	NMU Crossing	
	Impact of infrastructure	None	
Channel realignment	Yes		
Summary behaviour	Small hillslope drainage channels have been formalised as part of the A9. Channels relatively stable but some activity.

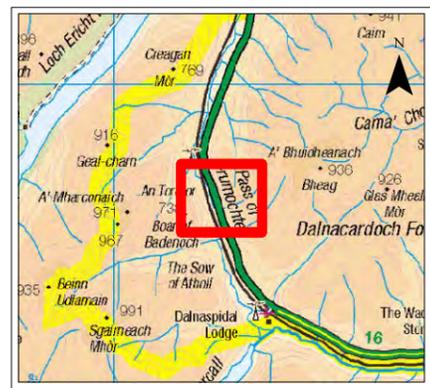
Some forestry- local change to hydrology and potential increase in sediment and floating debris inputs in the short to medium term

Flat valley floor- area of unconstrained floodplain

Debris flow adding sediment to the channel above the track

Small channels incised into very steep hillside

Hummocky glacial deposits- potential source of gravels and fines

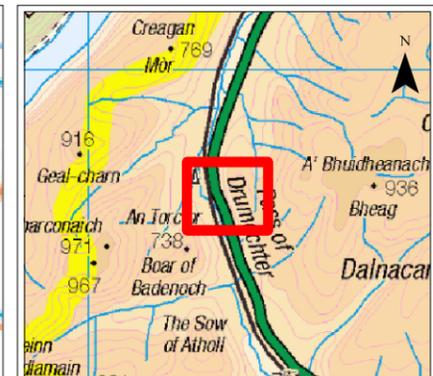
PROJECT 7 GLEN GARRY TO DALWHINNIE EIA
DRAWING 11.4.3.2.
Catchments 36-42 Baseline Assessment

Hummocky glacial deposits- potential source of gravels and fines

Some forestry- local change to hydrology and potential increase in sediment and floating debris inputs in the short to medium term

Small channels incised into hillside

Very steep slope with debris flows- some coupled to channels.

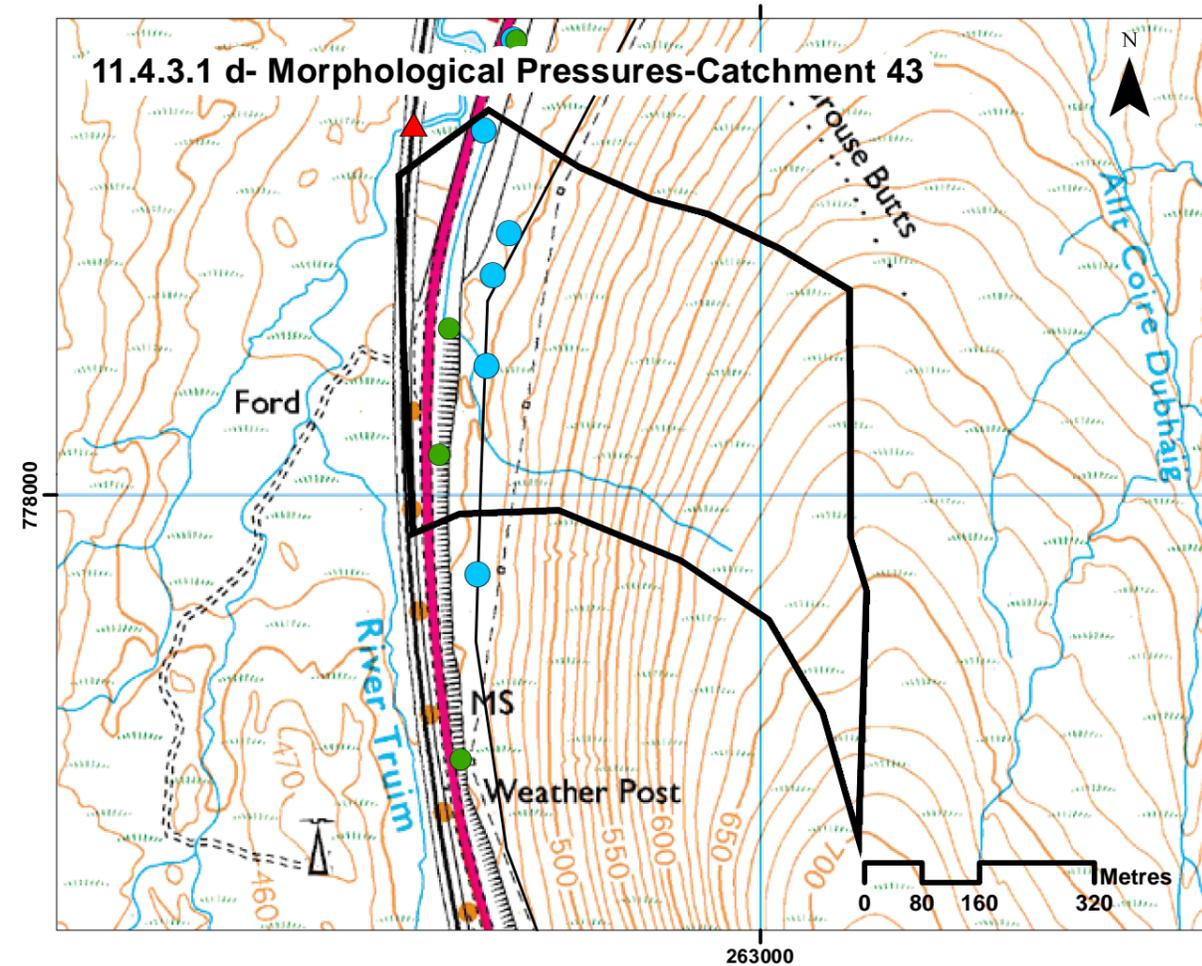
11.4.3.1 d- Morphological Pressures-Catchment 43

Lateral migration/bank erosion	None	
	Damaged/unstable drains or armouring	None	
Morphology and Process- Reach downstream of crossing	Channel morphology	Plane-Riffle	
	Predominant sediment size	Cobble and boulder	
	Unvegetated bars	Some	
	Vertical incision	Low	As channel adjusts to changing position of Truim
	Deposition	Low	
	Lateral migration/bank erosion	Low	
	Infrastructure type (see Drawing 11.4.3.1 d, Catchment 43)	None	
	Impact of infrastructure	None	
	Channel realignment	Yes	
Summary behaviour	Small hillslope channels have been formalised in a single straight, road-parallel channel at the bottom of the slope, which then cross the A9 in a single crossing. Sediment supply potential is relatively high in the catchment, but the realigned channel reduces the likely hood of sediment reaching the crossing. However deposition is likely to occur in the road-parallel section. Restoration potential/opportunity to change crossing location.

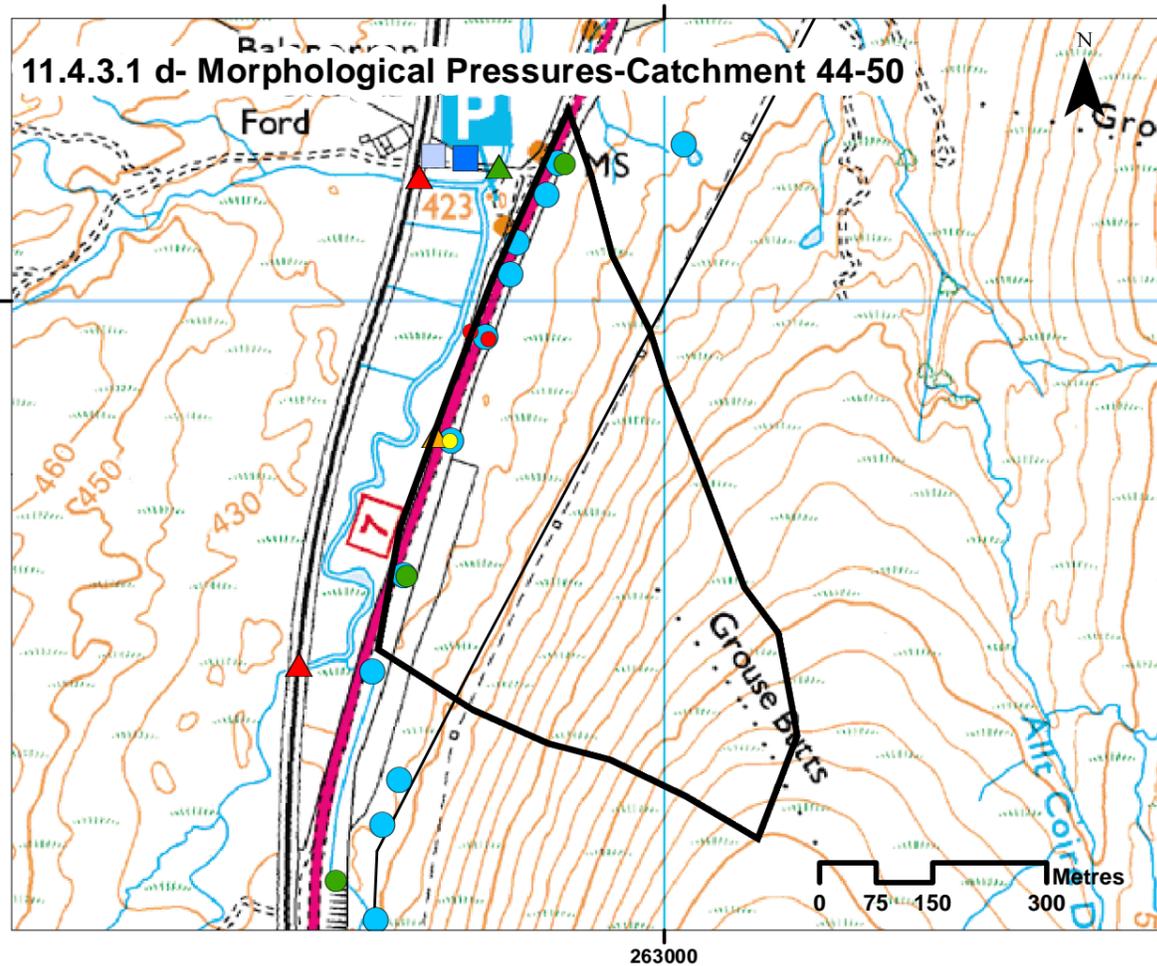
Deposition	None	
	Lateral migration/bank erosion	None	
	Damaged/unstable drains or armouring	None	
Morphology and Process- Reach downstream of crossing	Channel morphology	Engineered	
	Predominant sediment size	None visible	
	Unvegetated bars	None	
	Vertical incision	None	
	Deposition	None	
	Lateral migration/bank erosion	None	
	Infrastructure type (see Drawing 11.4.3.1 d, Catchment 44-50)	None	
	Impact of infrastructure	None	
Channel realignment	Yes	All crossings	
Summary behaviour	Small hillslope drainage channels have been formalised as part of the A9. Channels relatively stable but some activity particularly at crossing 46.

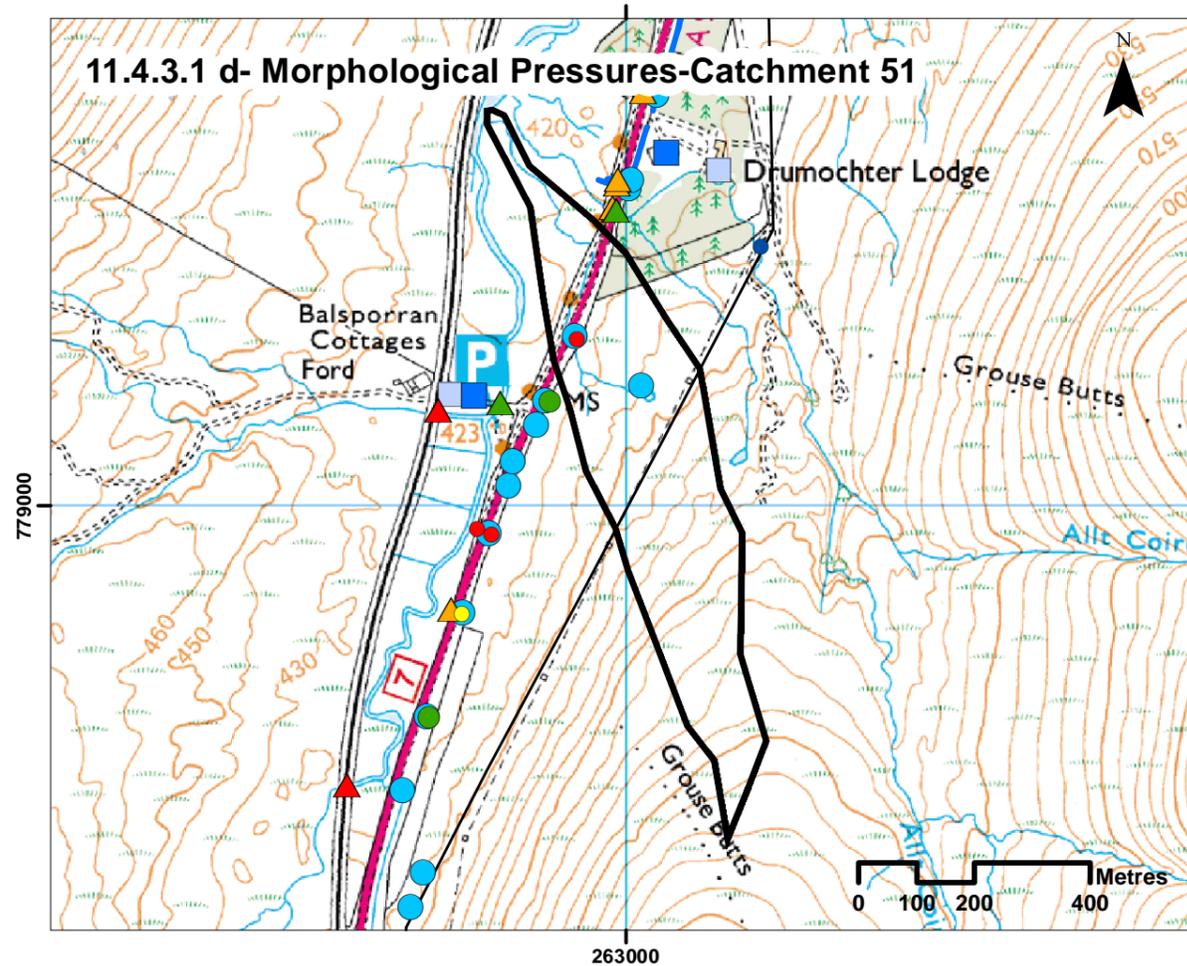
11.4.3.1 d- Morphological Pressures-Catchment 51

Predominant sediment size	None visible	
	Unvegetated bars	None	
	Vertical incision	None	
	Deposition	None	
	Lateral migration/bank erosion	None	
	Infrastructure type (see Drawing 11.4.3.1 d, Catchment 51)	NMU crossing	
	Impact of infrastructure	Fixing bed and bank position, potential to impound flows	
	Channel realignment	Yes	Possible parallel realignment undertaken to accommodate A9
Summary behaviour	Little sediment is currently entering channel, however there is potential for greater sediment inputs should the channel start to erode into the glacial mounds. Also construction of ETL track will have caused at least temporary disruption to flows from pond on upstream side of ETL track.

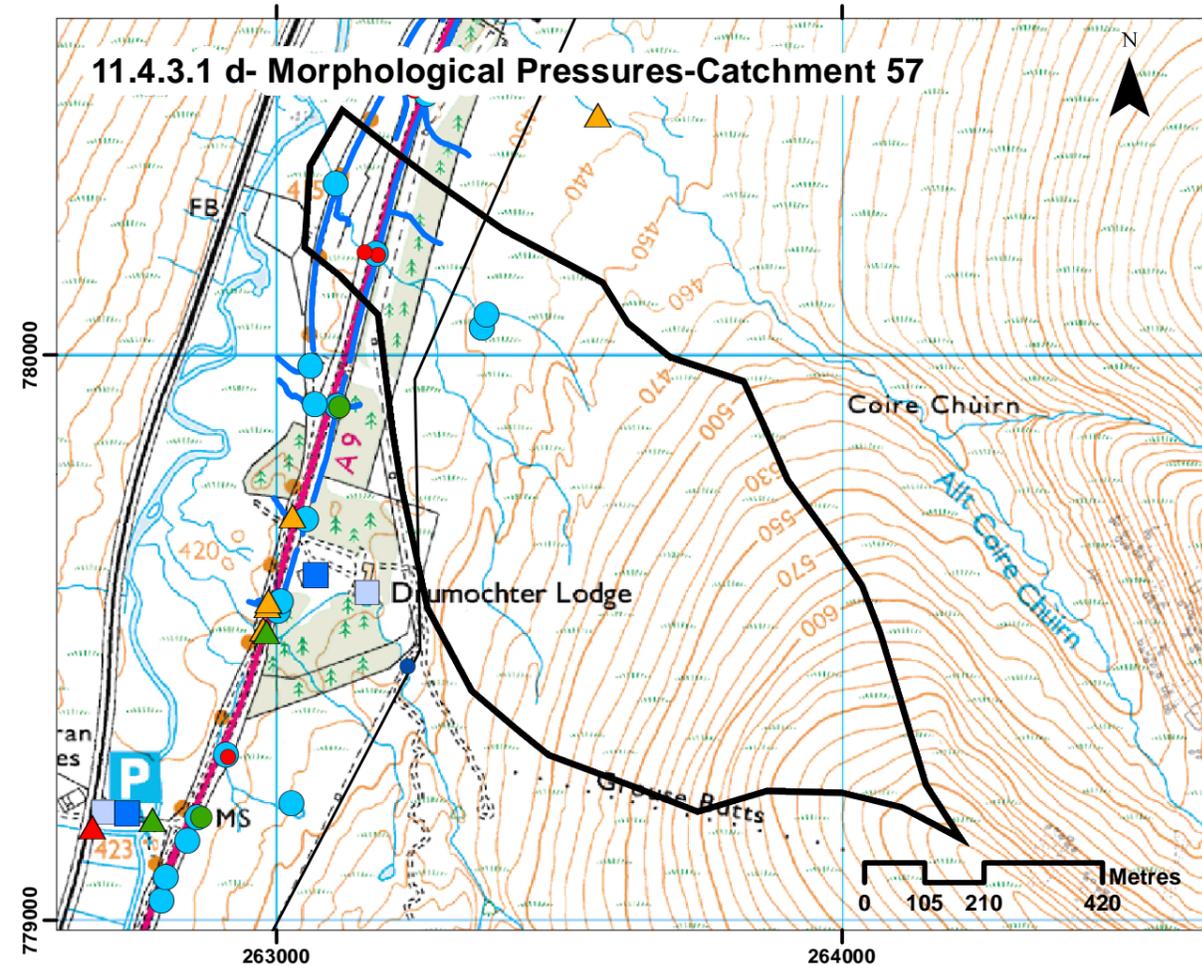
11.4.3.1 d- Morphological Pressures-Catchment 57

Deposition	None	
	Lateral migration/bank erosion	None	
	Damaged/unstable drains or armouring	None	
Morphology and Process- Reach downstream of crossing	Channel morphology	Plane bed	
	Predominant sediment size	Gravel	
	Unvegetated bars	Yes-small	
	Vertical incision	None	
	Deposition	Low	
	Lateral migration/bank erosion	None	
	Infrastructure type (see Drawing 11.4.3.1 d, Catchment 57)	NMU crossing	
Impact of infrastructure	None		
Channel realignment	Unclear- may be natural change on channel position		
Summary behaviour	Sediment is available in the catchment but it is not currently coupled with the channel. Channel is incised and confined by valley sides in some locations with potential for erosion and sediment delivery in the future. Confined channels have potential to be a future sediment source through erosion. Channel currently stable. Several drains also drain into the crossing. Channel crosses very large Allt Coire Chùirn alluvial fan and therefore there is a risk of receiving some flow from Allt Coire Chùirn in extreme events, but there is no morphological evidence in aerial photos for a recent event of this nature in this part of the fan.

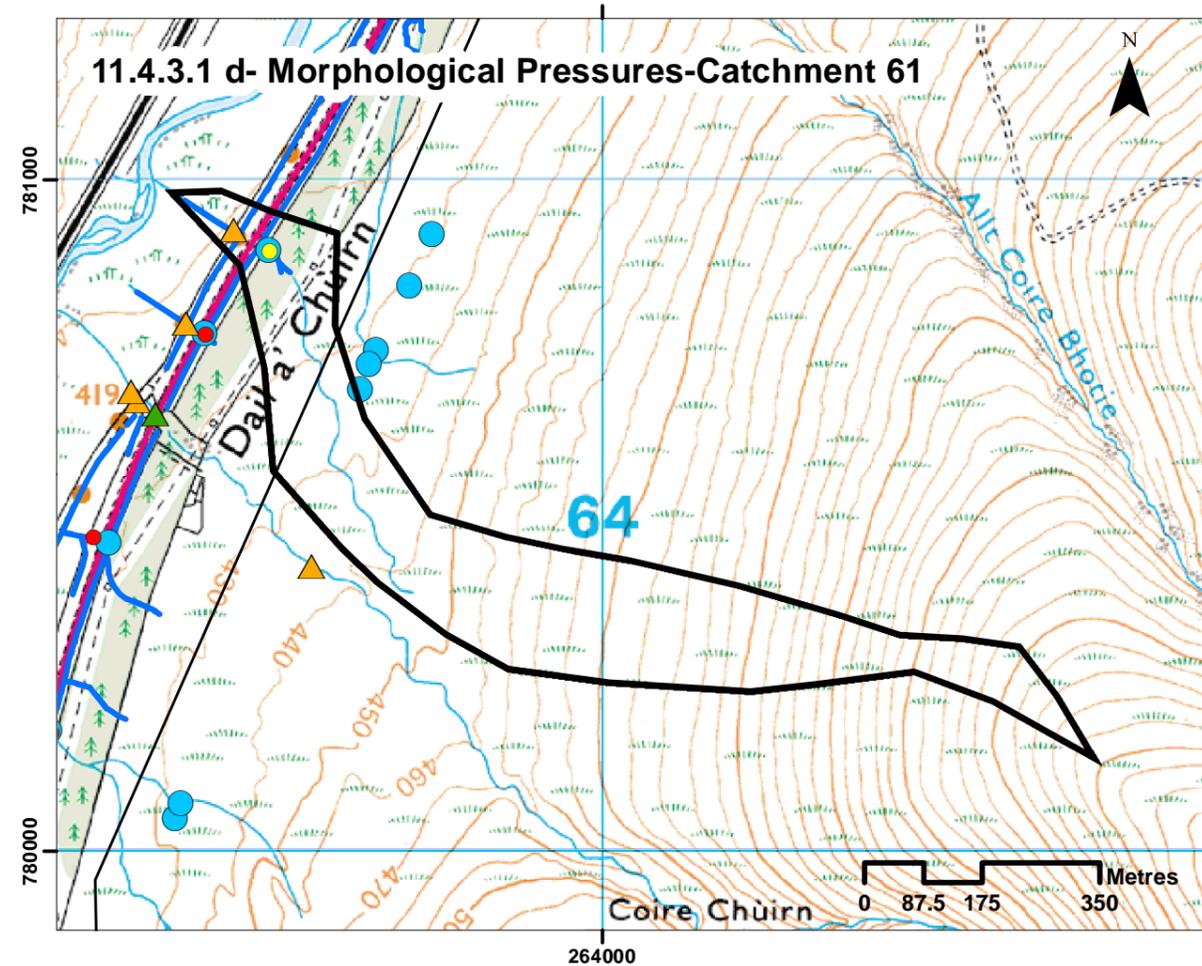
11.4.3.1 d- Morphological Pressures-Catchment 61

Vertical incision	None	
	Deposition	None	
	Lateral migration/bank erosion	None	
	Damaged/unstable drains or armouring	None	
Morphology and Process- Reach downstream of crossing	Channel morphology	Plane bed	
	Predominant sediment size	None visible	
	Unvegetated bars	None	
	Vertical incision	Low	Signs of some vertical incision, probably related to straightening.
	Deposition	None	
	Lateral migration/bank erosion	Low	
	Infrastructure type (see Drawing 11.4.3.1 d, Catchment 61)	None	
	Impact of infrastructure	None	
Channel realignment	Yes	Straightening	
Summary behaviour	Signs of some vertical incision, probably related to straightening downstream of the crossing. Most important consideration is that the channel 'source' is at the apex of the Allt a Chùirn alluvial fan making it highly probably that in extreme events this channel could receive flows from the major Allt a Chùirn (crossing 59) catchment. The morphological evidence (clearly visible channel features with only short vegetation) in the upper part of the alluvial fan indicate it may have been active as such relatively recently. As such a crossing to accommodate higher discharges than might be suggested based on the size of catchment 61 are advisable.

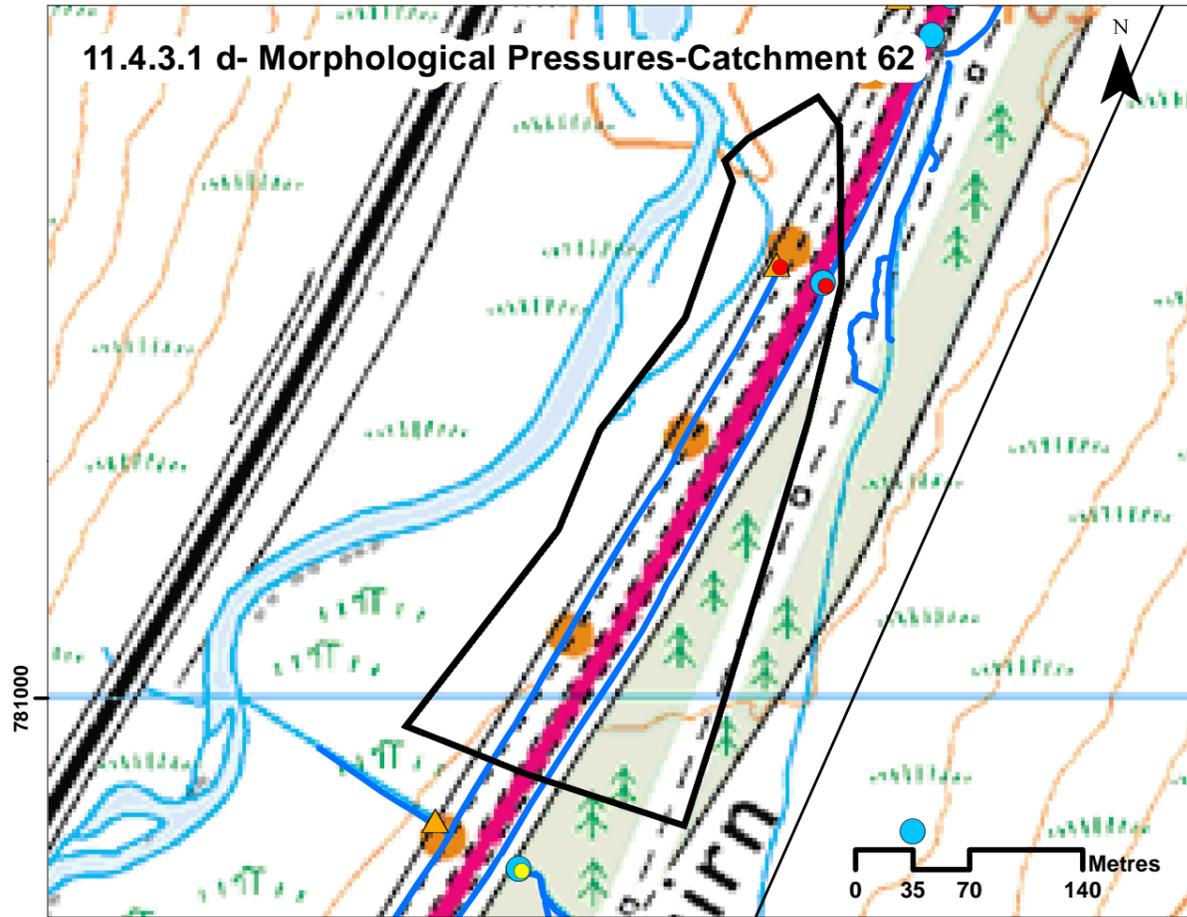
11.4.3.1 d- Morphological Pressures-Catchment 62

Deposition	Low	
	Lateral migration/bank erosion	None	
	Infrastructure type (see Drawing 11.4.3.1 d, Catchment 62)	None	
Summary behaviour	No direct sediment supply to channel, yet drain has a seemingly natural bed. Sediment source and channel cannot be identified on OS mapping or aerial imagery. Some of this sediment may have arisen from erosion where the channel bends to become road-parallel but more likely just the alluvial fan material into which the drain is cut.
