A9 Dualling Dalraddy to Slochd

Stage 2 Scheme Assessment

Appendix A10.1

Hydromorphology Assessment

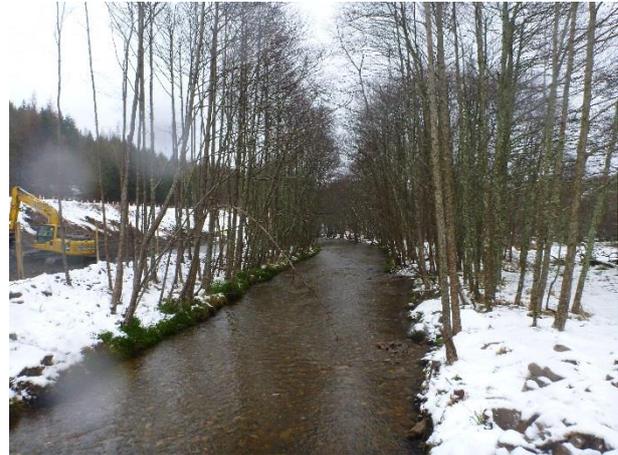
P1040417 – View downstream from temporary crossing showing wide and uniform channel leading towards Loch Alvie (NGR 2855 8092)

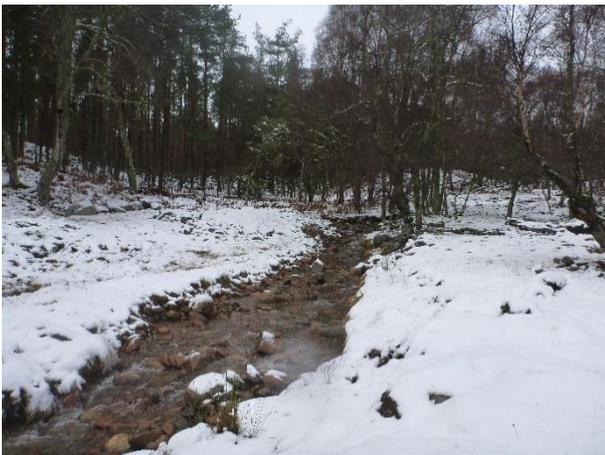
The bed and banks were primarily formed of coarse substrate, with sandy soils beyond. The steep gradient and coarse sediment had formed a step-pool sequence along the viewed section indicating a high potential stream power. There were no signs of erosion or significant deposition features, and the channel presented itself as stable transfer system.

P1040418 – View upstream from A9 verge showing a steep gravel bed stream in a dense woodland (NGR 2857 8095)

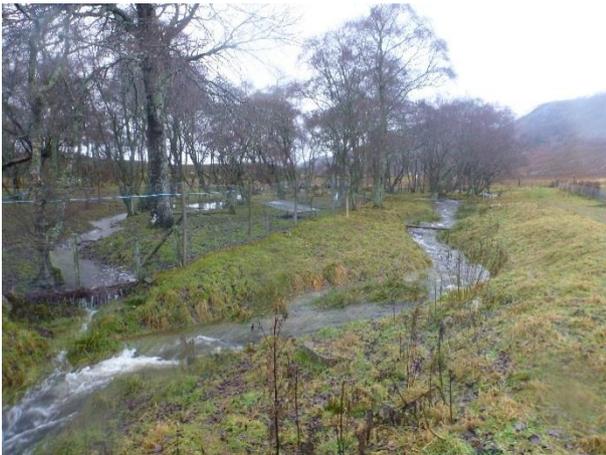
Erosion and bank slips were common along the steeper channel and there were occasional gravel bars suggesting some lateral adjustment was occurring, but overall the channel was relatively stable.

P1040513 – View upstream towards start of surveyed reach; note a chicken farm on the left of the image (RHB) (NGR 2864 8102)

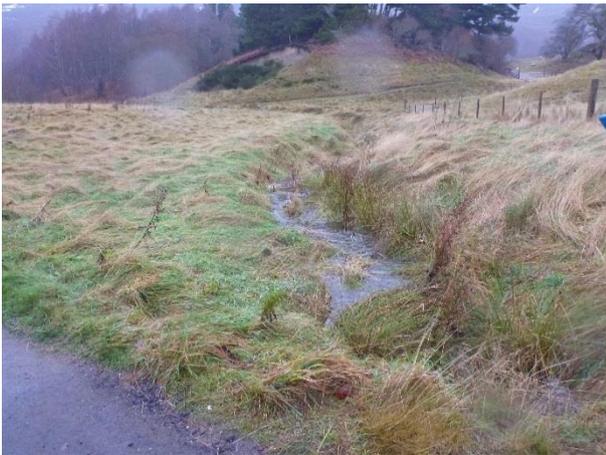
There were some localised sections where boulders were apparent, forming step-pool sequences, but on the whole the bed was mostly obscured by vegetation, indicating potential for much finer sediment to be present (silt and fine gravels perhaps). This may also indicate that the channel had little flow for large parts of the year, thus allowing the vegetation to establish. There were few signs of instability and on the whole the channel was a stable transfer reach.

P1040489 – View upstream showing well vegetated channel (NGR 2866 8103)

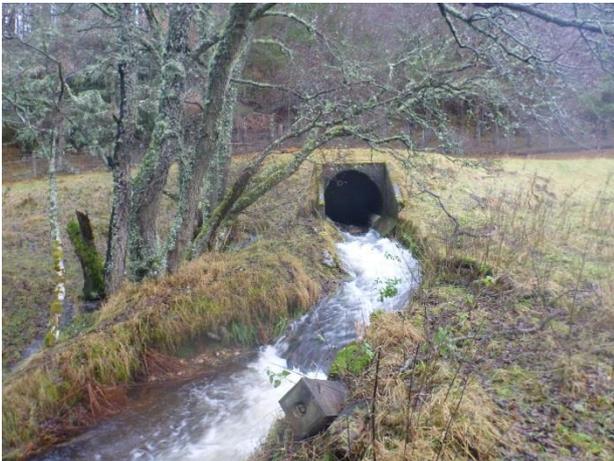
P1040532 – The channel emerges from a large culvert underneath the A9 (NGR 2867 8100)

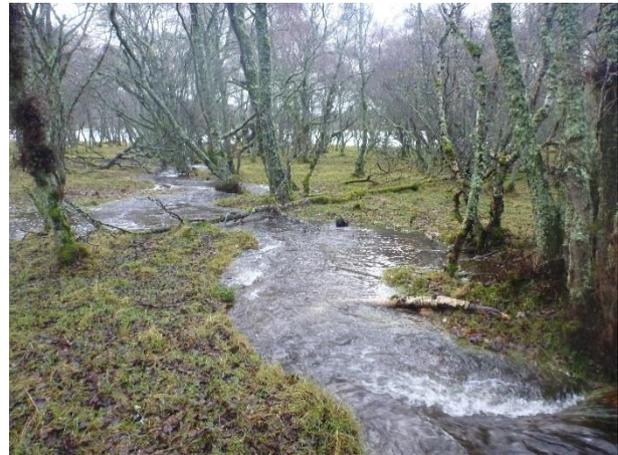
There were no signs of erosion and it was difficult to see any in-channel deposits, although there were some large woody material which had fallen in from the adjacent woodland. As such the channel was a stable transfer.

P1040537 – View downstream as the (flooded) channel flows through the woodland towards Loch Alvie (NGR 2867 8100)

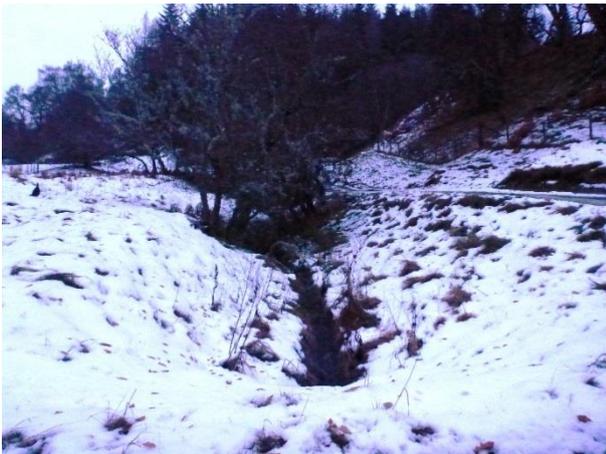
The substrate was primarily gravels and sands on the bed, the banks comprised sandy soils. The flows were rippled, with some cascades over infrequent steps, but there was little sign of any fluvial activity, with few areas of erosion and no deposition features. Overall the channel was considered to be a stable transfer reach.

P1040486 – View upstream from track crossing; track shown on the right (LHB) (NGR 2870 8103)

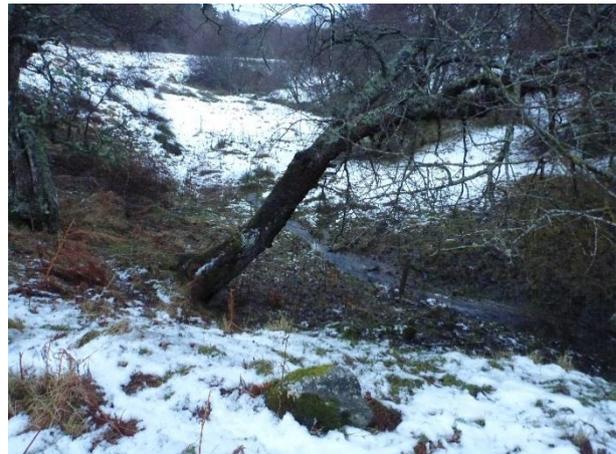
P1040471 – View upstream immediately before crossing underneath the A9 (NGR 2869 8102)

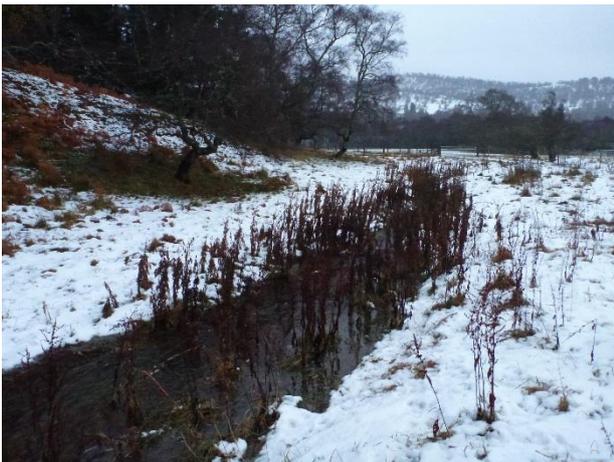
The banks were composed of sandy, earth soils. The channel immediately downstream (c.50 to 70m) of the A9 had a dense stand of in-channel emergent vegetation, which given the time of year indicated the channel was likely to have a low flow much of the year and the presence of fine substrate and some gravels were noted on the bed.

There were, once again, few signs of instability and flows were slightly less energetic (although still rippled given the high flows) than upstream due to the lesser gradient. The amount of vegetation growth downstream potentially indicates some degree of aggradation, or deposition of fine sediments, however on the whole this was quite localised. Generally, Ballinluig Burn downstream of the existing A9 was a stable transfer reach.

P1040479 – View immediately downstream of the existing A9 crossing (NGR 2869 8101)

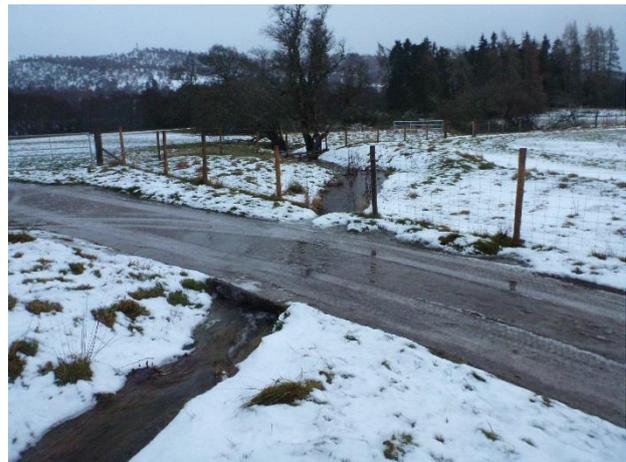
P1040482 – Crossing over the Ballinluig Burn (NGR 2869 8101)

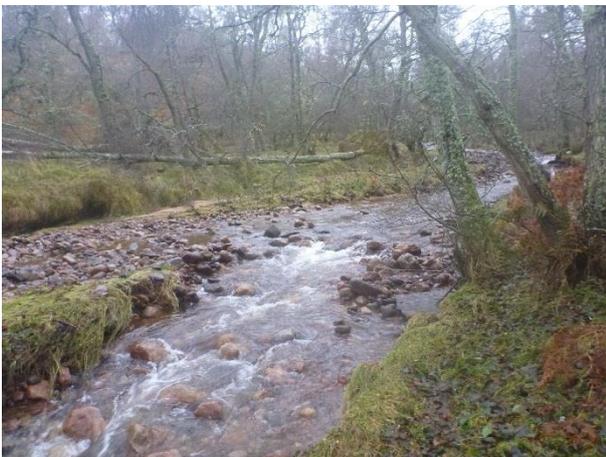
There were a number of step-pools and large gravel bars in the upper section, coinciding with a likely decrease in gradient. As the gradient increased slightly towards the Lynwilg properties the deposits were more infrequent, the channel overall was primarily a transfer, and largely stable except for some isolated areas of bank failure.

P1040923 – View upstream toward large gravel bars and high energy flows (NGR 2877 8109)

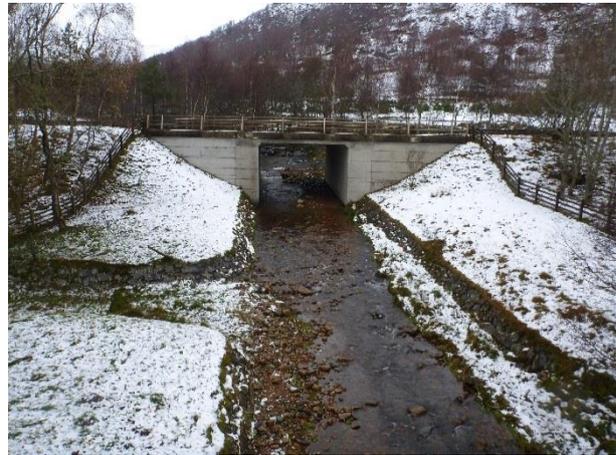
P1040470 – View upstream towards A9 crossing (NGR 2884 8106)

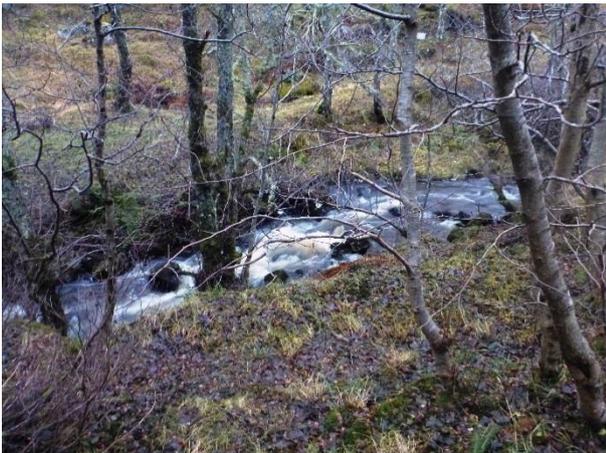
The coarse bed material and steep gradient upstream formed a series of steps creating a range of energetic flows, including chute and cascade flows. Further downstream the flows were more rippled. There were no obvious signs of erosion, and only localised deposits. Overall the channel was behaving as a stable transfer.

P1040806 – The upstream section of Aviemore Burn was steep and wooded, a series of step-pools had formed created an energetic flows over the top (NGR 2892 8139)

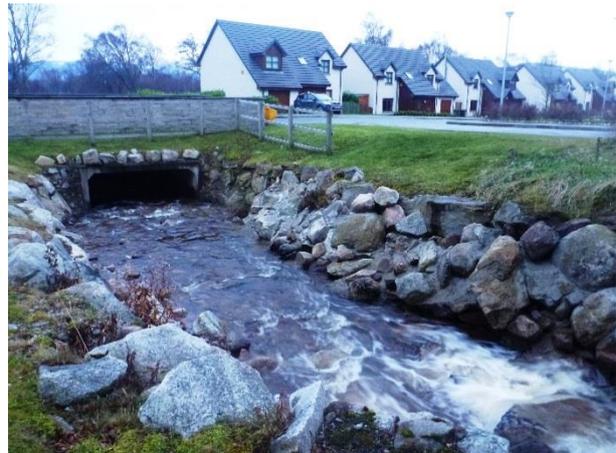
P1040811 – As the channel flows through Milton the gradient reduces slightly, and the channel was affected much more by the surrounding development (NGR 2893 8138)

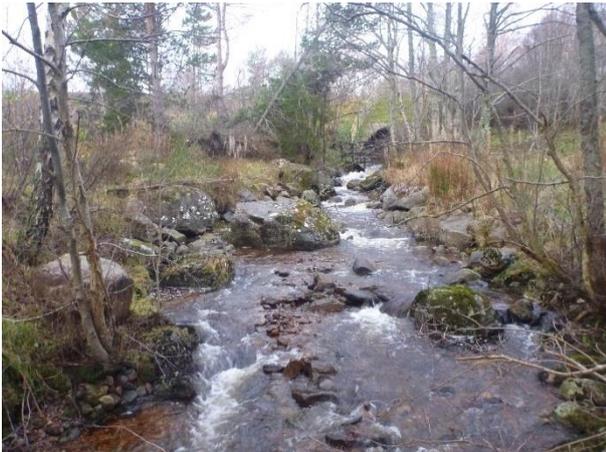
There were overall few signs of erosion and only localised minor deposition. The channel was primarily a stable transfer.

P1040829 – View upstream towards existing A9 crossing (NGR 2894 8139)

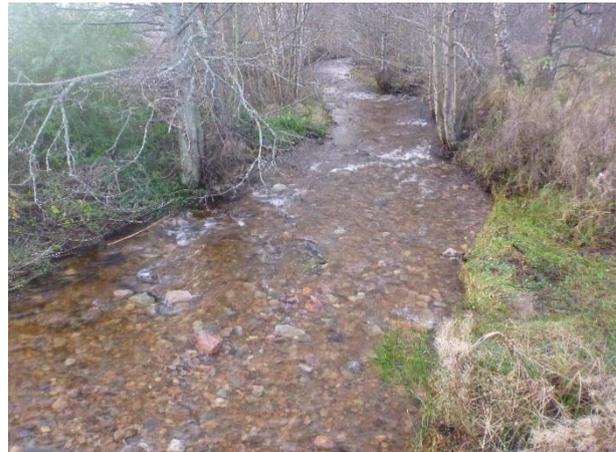
P1040828 – View downstream from Grampian View (NGR 2895 8137)

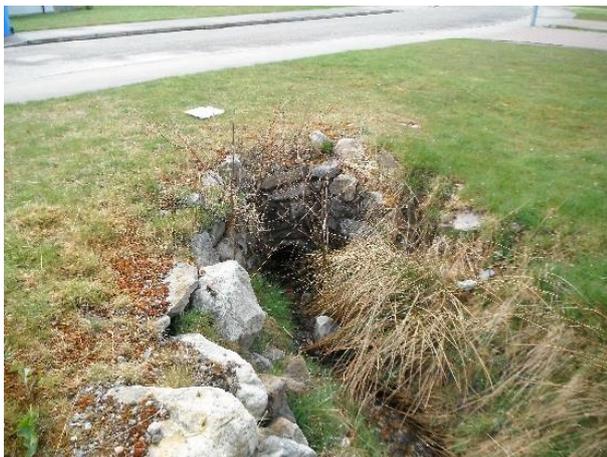
No photo reference – View upstream towards culvert approx. 450mm (NGR 2892 8139)

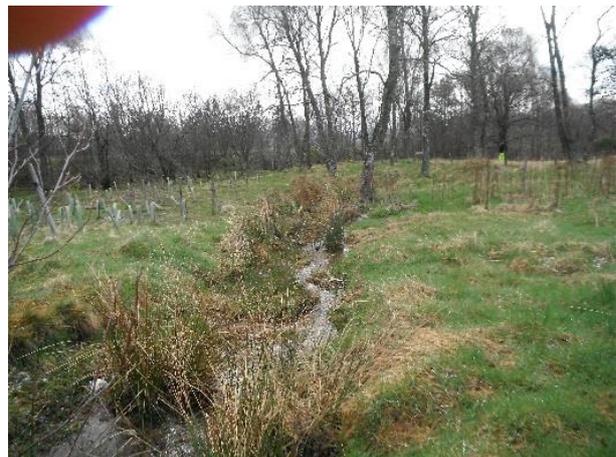
The channel does not appear to show any signs of instability, but an assessment on the primary function cannot be established due to limited information.

No photo reference – Open channel leading towards Aviemore Burn (NGR 2893 8139)

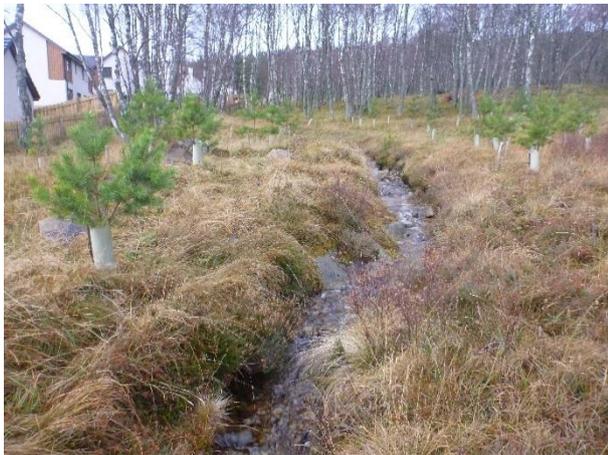
Overall there was little erosion and no deposition to indicate instability, the channel was functioning as a stable transfer.

P104837 – View upstream of tributary; new housing development shown on the left of the image (RHB) and new planting along bank tops likely associated with the development (NGR 2893 8142)

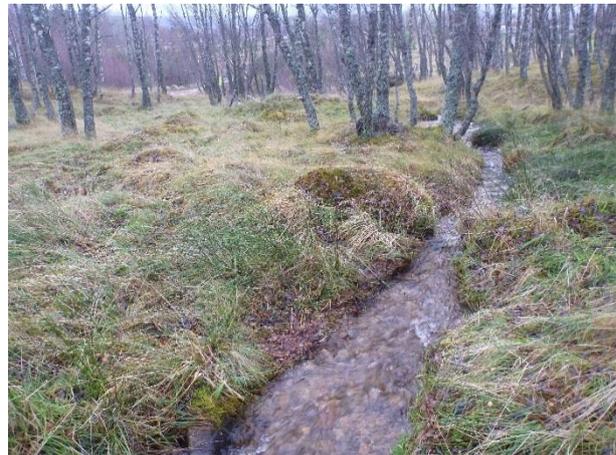
P1040843 – Gravel bed channel through grassy woodland (NGR 2894 8142)

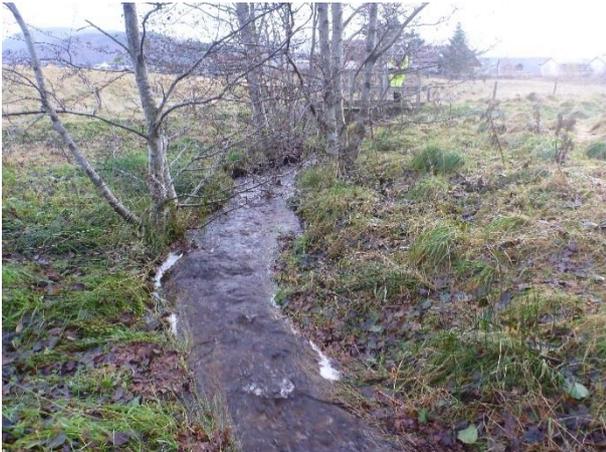
There were some step-pools where the gradient allowed it, creating chute flows, although predominantly the flows were rippled. There was little erosion or deposition, and although fine sediment was noticeably increased from upstream the channel was still mainly transferring sediment downstream.

P1040853 – View immediately downstream of A9 culvert outlet (NGR 2895 8141)

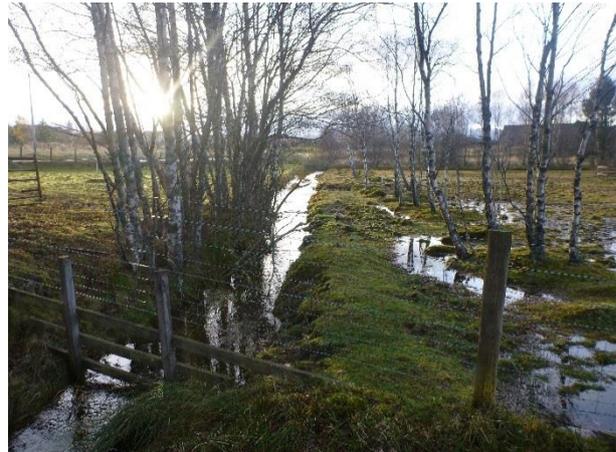
P1040865 – View immediately upstream of B9152 crossing (NGR 2897 8143)

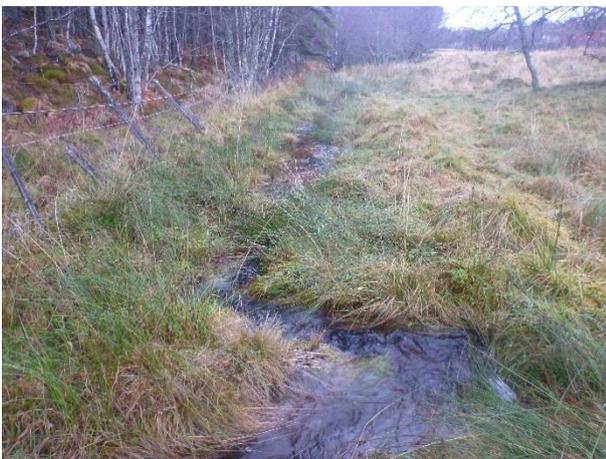
Flows ranged from rippled to chute flow, and unbroken standing waves were noted in some locations where steep sections transitioned back to more moderate gradients. The more energetic flows were localised and primarily caused by boulders or woody material within the channel. Although there were some areas of erosion noted (mainly undercutting) and some fine sediment deposition along the bed (particularly due to the low gradient), overall the channel appeared quite stable and to be transferring material downstream.

P104751 – View downstream along channel course; flows appeared relatively high at the time of survey (NGR 2899 8155)

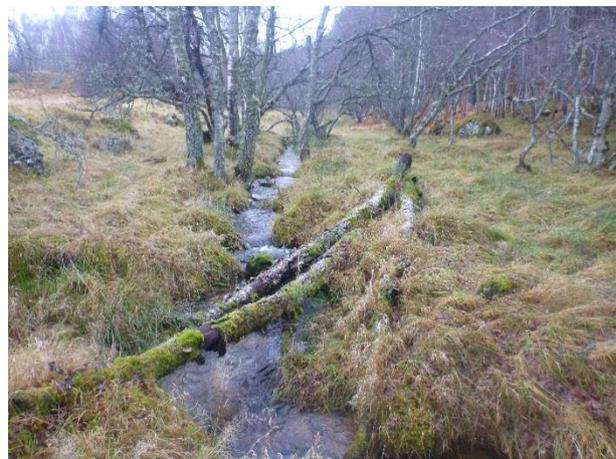
P104754 – View downstream along short wooded section of channel; the channel course was still largely straight but wood debris and steps occurred in some localised areas (NGR 2900 8155)

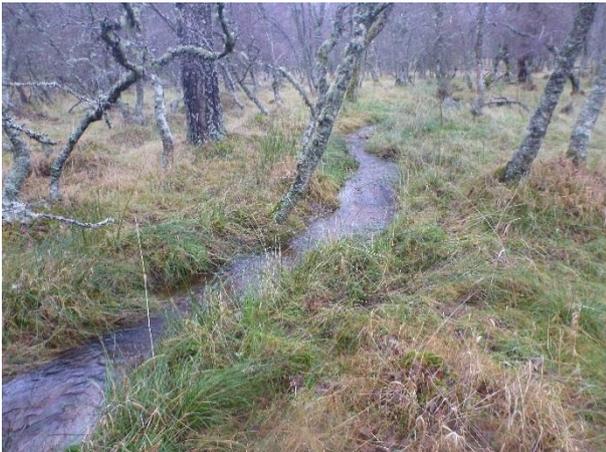
Fine sediment deposition was common throughout and some minor undercutting was evident, but only in localised stretches. Overall the channel was functioning primarily as a stable transfer.

P1040769 – View downstream from just after the A9 crossing, wooded catchment with meandering watercourse (NGR 2902 8157)

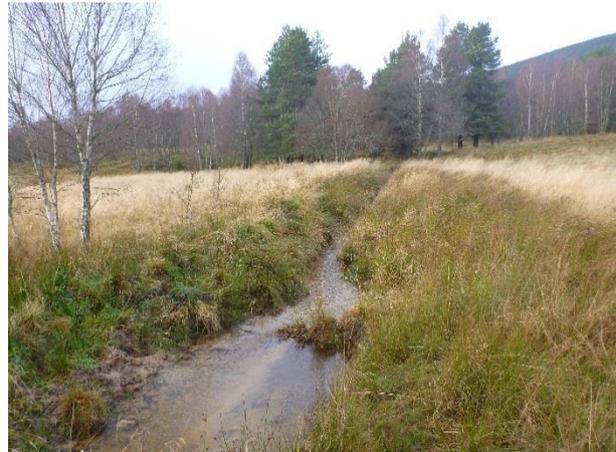
P1040872 – View upstream from the A95 crossing (NGR 2905 8156)

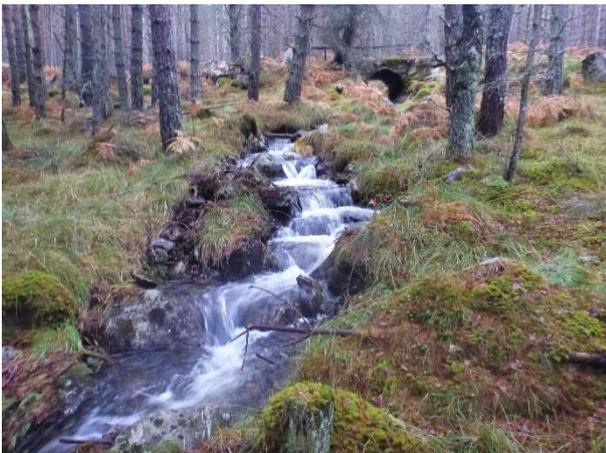
Despite the high energies there was very little erosion noted (only some minor localised undercutting), as the tree roots and boulders help to naturally regulate the channel's energies, and overall the channel was a very stable transfer system.

P1040785 – Step-pool sequence upstream just downstream of forestry access crossing (in background) (NGR 2901 8165)

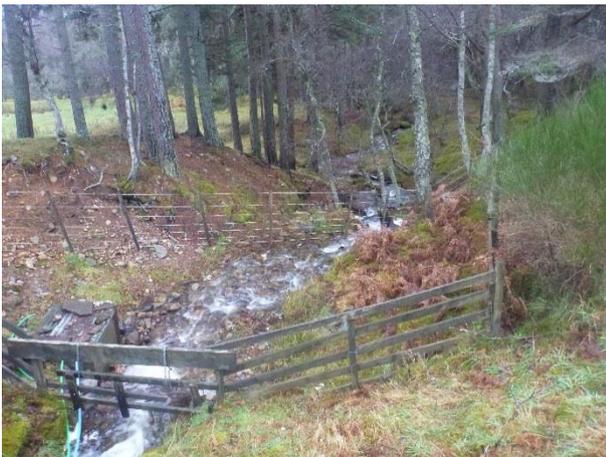
P1040798 – View from existing A9 crossing downstream (NGR 2902 8164)

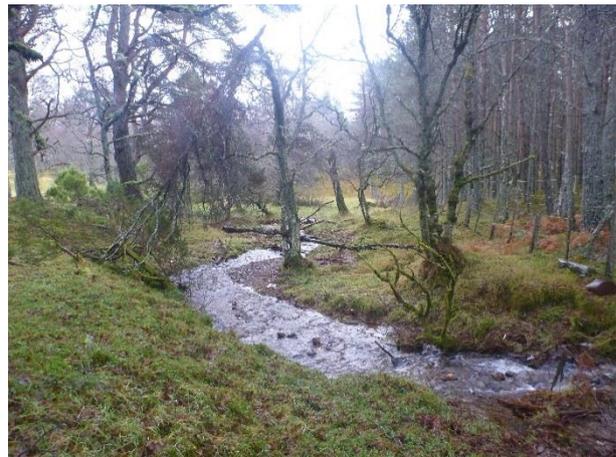
The channel possessed a meandering course and had enough gradient to form steps, although less regularly than upstream. The meandering planform and low gradient did in place encourage some gravel point bars to form (P1040889). The bed substrate comprised coarse gravels and cobbles with some fines (sands) on the margins. The banks comprised sandy soils. Flows were varied, including cascade and chutes over steps, but predominantly rippled flow.

P1040889 – View downstream of meandering planform with gravel point bars and woody debris across the channel. (NGR 2903 8163)

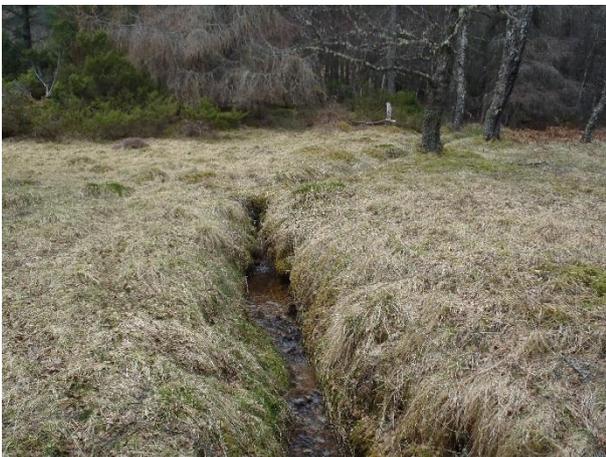
The channel is <1.0m wide, with its bed comprising coarse gravels and cobbles with the occasional boulder forming the step-pools, although towards the A9 the channel appears to be slightly incised, although no active signs of instability are visible in the photographs.

P3230023 – View upstream of A9 crossing showing deep, gravel/cobble bed stream existing a steep hillside (NGR 2903 8168)

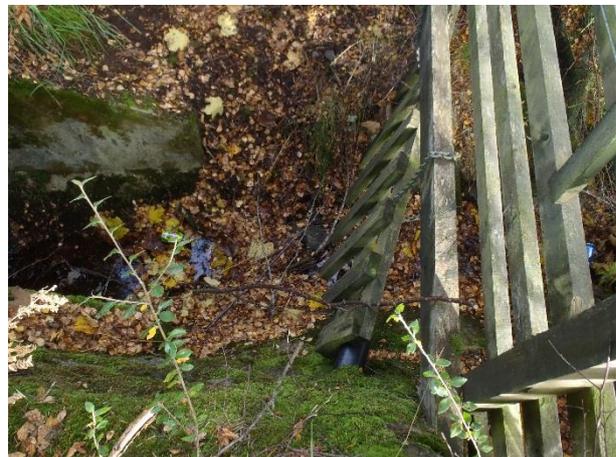
The channel around the existing A9 is heavily modified and culverted. No further survey information exists downstream of the A9.

PB110128 – View downstream of structure underneath A9 with minimal flow and a lot of leaf litter (NGR 2904 8167)

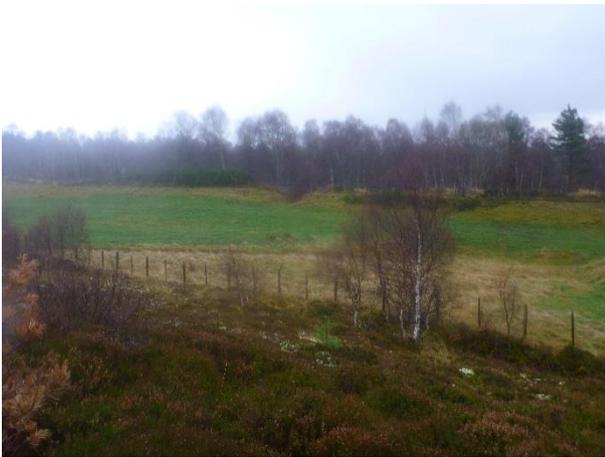
P1040925 – View across towards channel and floodplain from A9 embankment (NGR 2909 8178)

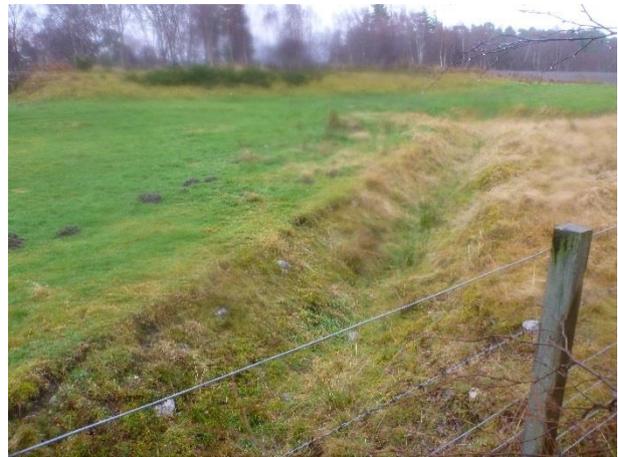
The survey of the Unnamed Drain leading toward Loch Vaa found no sign of a channel upstream (west of the A9 and only an artificially modified drainage ditch on the downstream end. There was no water or flow within the channel at the time of survey. The bed of the channel was well vegetated with grass and appeared to have had little prolonged flow contained within it for some time.

P1040929 – Ephemeral watercourse with no signs of recent flow and well vegetated bed (NGR 2910 8179)

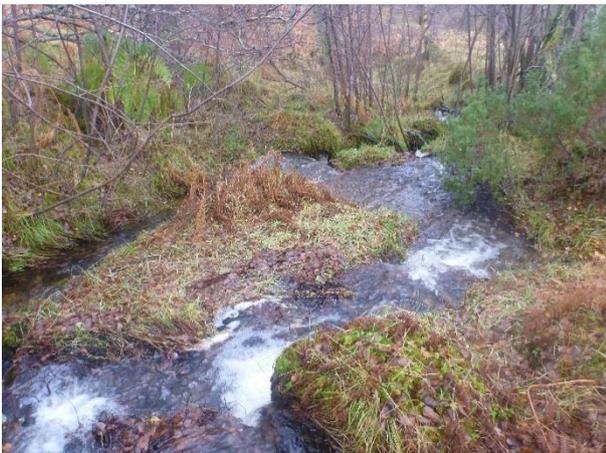
P1040704 – Channel had high flows at the time of the survey (NGR 2909 8185)

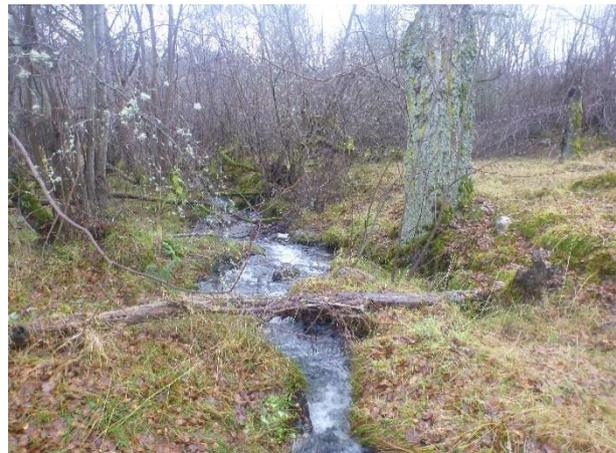
P1040712 – View downstream of broadly straight course towards existing A9 (NGR 2910 8185)

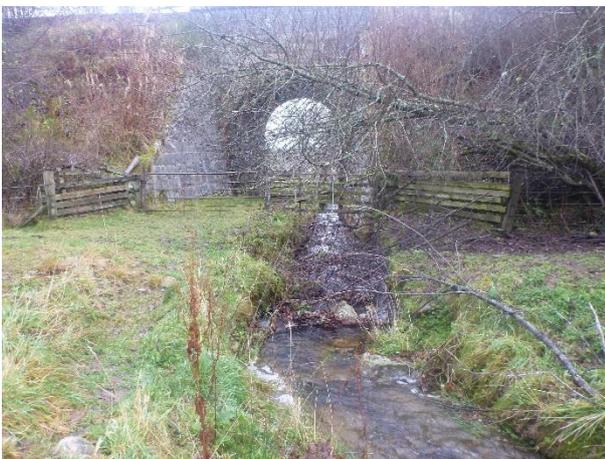
P1040720 – View downstream through the railway arch bridge and straight (and lined) channel (NGR 2911 8185)

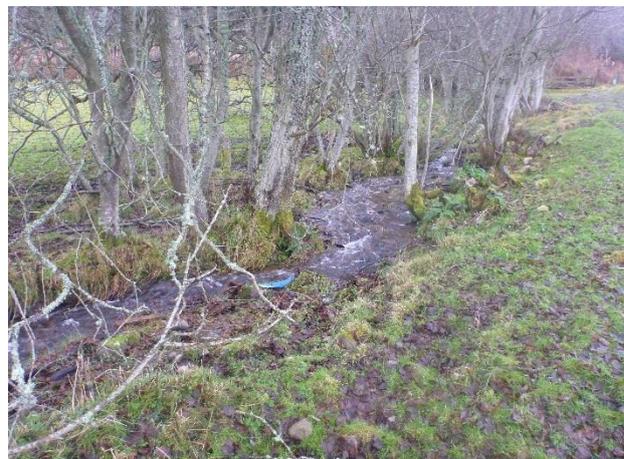
Although no fluvial erosion was noted, there were clear signs of poaching from animal crossings just downstream of the railway bridge forming a fine sediment source. Flows were mainly rippled over and around woody features and cobble substrate, however the channel became increasingly ponded downstream as the watercourse was constrained by the culvert underneath the A95 and flowed into a series of ponds downstream of the road. The channel presents several functions over a relatively short distance, with the upper modified section transferring sediment, then an area of sediment input from poaching and finally a sink around and downstream of the A95 where the flows are ponded. Although the function more relevant to the A9 scheme was a sediment transfer and downstream sink, overall the channel was stable.

P1040725 – View upstream just after the railway bridge with thin tree line and signs of poaching along the bank tops (NGR 2911 8185)

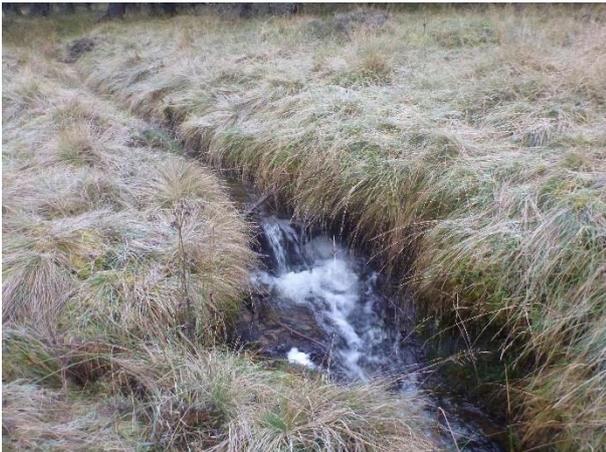
The deep channel was probably a result of a series of knickpoints creating incision moving upstream and leading to some destabilisation of the banks as they are undercut and steepened. The knickpoints and occasional fallen woody material help form a stepped longitudinal profile. Flows over these steps are energetic cascades, although lengths of rippled and smooth running flows were more common. Lower down in the reach coarser substrate forms riffles, and the channel appeared better connected to the floodplain and flows were more uniform.

P1040644 – Knickpoint and scour pool downstream displaying higher energy flows and evidence of incision (NGR 2905 8205)

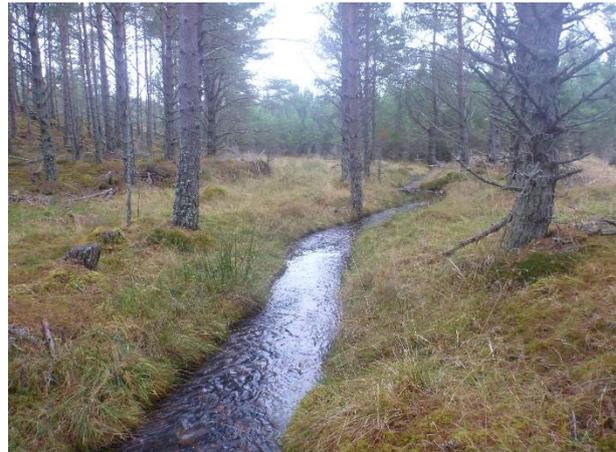
P1040670 – Further downstream towards A9 the channel was wider and better connected to the adjacent floodplain (NGR 2907 8207)

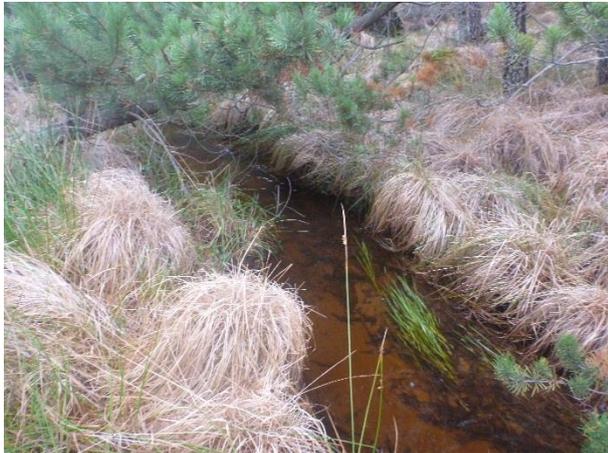
P1040985 – Fine sandy deposits on the bed with some emergent in-channel vegetation (NGR 2909 8210)

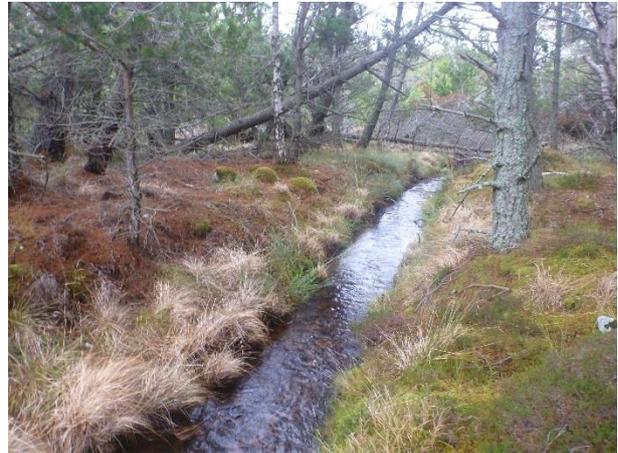
P1040690 – Typical view downstream along Fèith Mhòr (NGR 2909 8211)

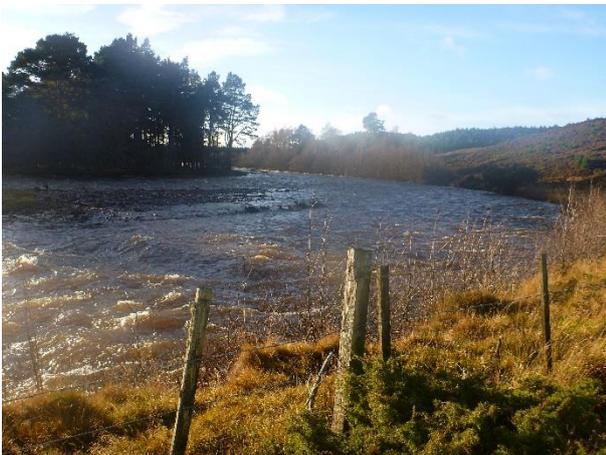
P1040593 – View upstream on River Dulnain with gravel deposits clearly visible (NGR 2887 8225)

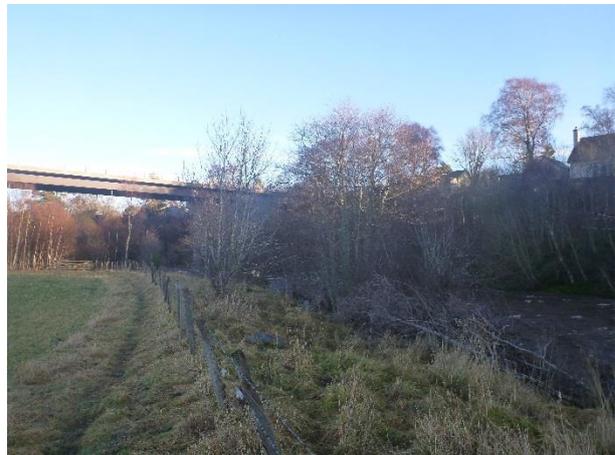
P1040609 – View downstream towards existing A9 bridge over the Dulnain (NGR 2856 8225)

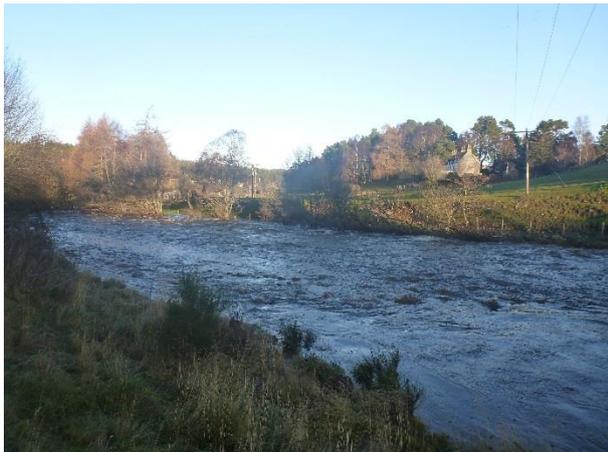
There was some bank erosion on the RHB immediately downstream of the railway, but likely that gravel bars still dominate (according to the aerial imagery). In contrast to upstream of the A9, the constrained river system means the channel was less likely to be able to adjust, and has less room to re-work the gravel bars. The channel here was still predominantly a stable transfer system, with some minor deposition.

P1040617 – View immediately downstream of railway bridge, erosion (likely poaching) on the RHB (NGR 2897 8227)

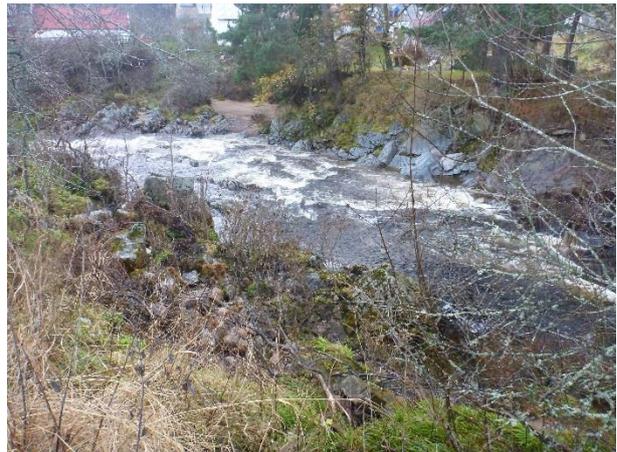
P1040945 – Bedrock channel leading into Carrbridge (NGR 2906 8230)

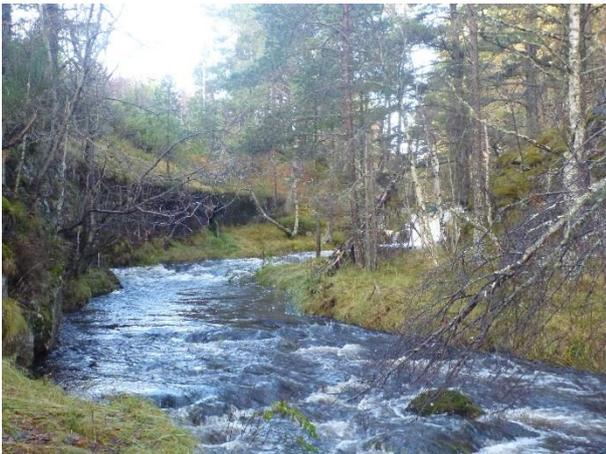
P1040564 – View upstream of waterfall in the distance and railway embankment on the left (RHB) comprising a vertical wall of stone; flows are highly energetic (NGR 2891 8234)

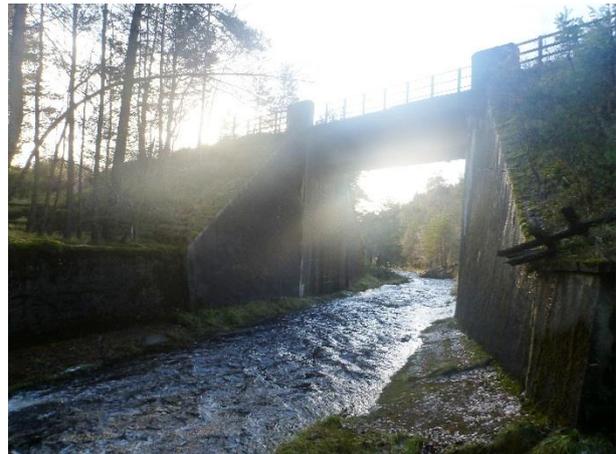
P1040573 – View downstream underneath railway bridge and concrete bed and banks (NGR 2892 8233)

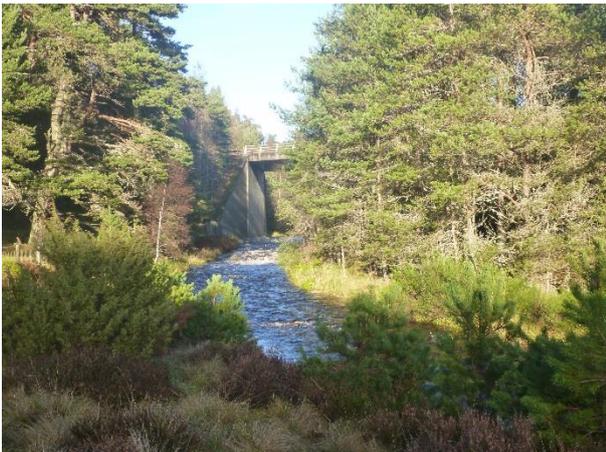
P1040584 – View upstream towards existing A9 crossing and surrounding woodland (NGR 2891 8230)

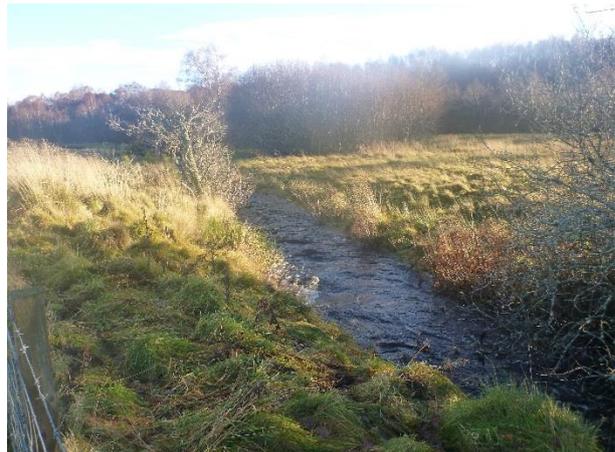
P1040603 – Further downstream the woodland was replaced with open grassland and much more uniform channel (NGR 2893 8225)

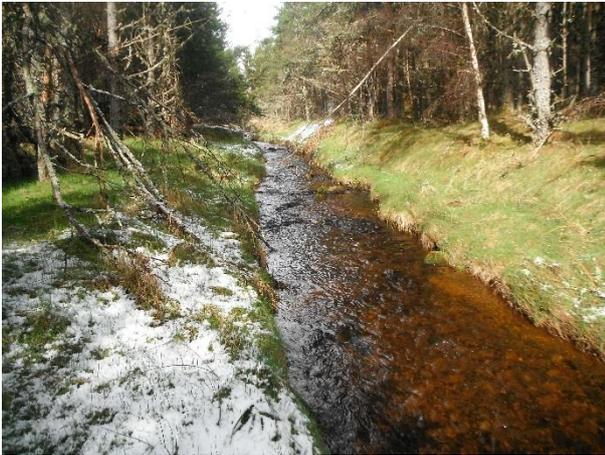
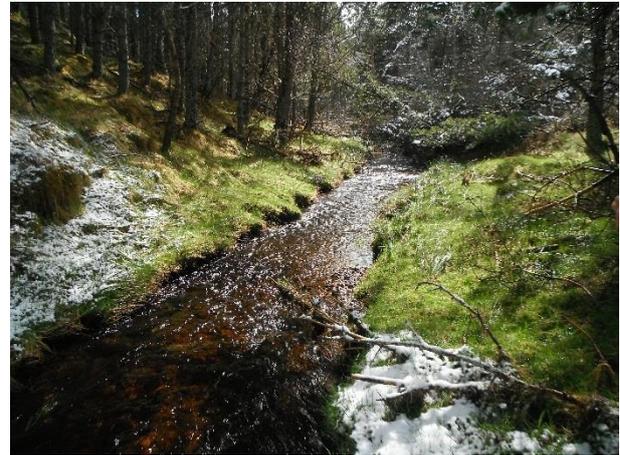
The channel is a tributary to Allt nan Ceatharnach, but is not itself directly affected by the existing A9. It has been however significantly affected by the railway and other roads, having been crossed a dozen times over a 2km distance. The planform has clearly been realigned and straightened, but does possess diverse and dynamic morphological features (see below) as it flows through a dense woodland.

There are few signs of stability, but the overall dominant processes is uncertain without further walkover information.
