**PUBLISHED PROJECT REPORT PPR898**

The performance of road surfacing in  
Scotland

Scottish Inspection Panel Report 2018

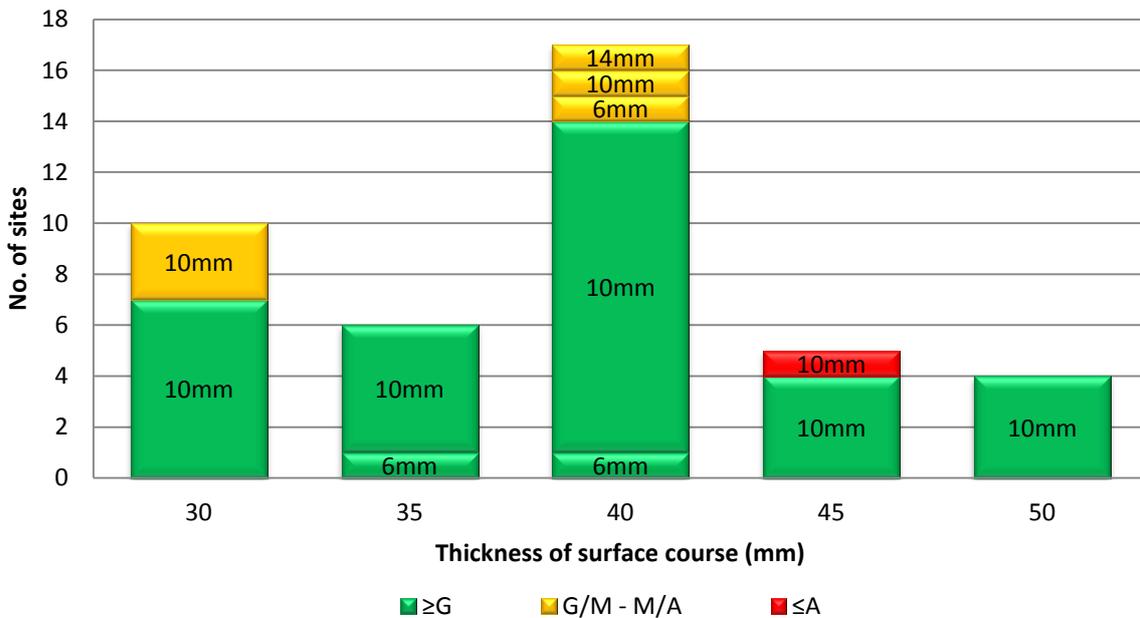
Figure 4.8: TS2010 layer thickness versus performance

The TS2010 surface course specification (TSIA No. 35, 2018) permits suppliers to lay material at different thicknesses dependent on the nominal aggregate size of the mixture. Figure 4.8 shows the layer thicknesses for the TS2010 materials inspected in 2018, along with the average panel mark. The thicknesses are based on data held on the IRIS database, and the figure includes two-year-old sites and historical sites ranging from 4.2 to 7.4 years.

The 10mm site that received a less than Acceptable score (marked red) is discussed in 4.1.2, i.e. its poor performance can be explained by other factors such as delivery or rolling temperature. Assuming the laid material thicknesses held in Transport Scotland's are accurate, there appears to be no clear evidence that thinner layers perform less well than thicker layers.
