## **PUBLISHED PROJECT REPORT PPR790**

### **Scottish Inspection Panel Report 2015**

**M J McHale**

Transport Scotland, Trunk Roads and Bus Operations Directorate  
(M McLaughlin)

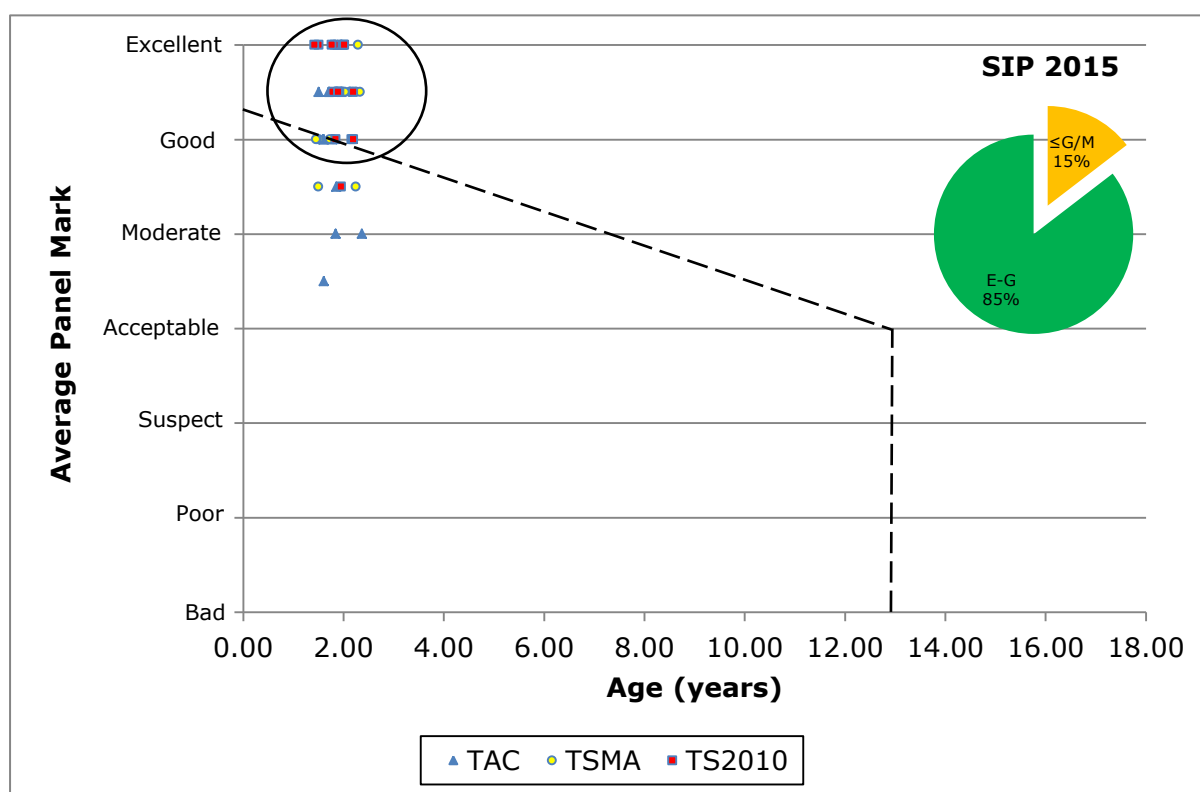
**Figure 3.1 Average visual condition markings**

A summary of the average panel marks for the 2015 survey is shown graphically in Figure 3.1. The SIP 2015 sites that were considered to be performing well have been circled in Figure 3.1. All of these sites (85%) were assessed by the panel as being E or G. Fifteen percent of the sites were given assessment scores of *Good/Moderate*, *Moderate* and *Moderate/Acceptable*.

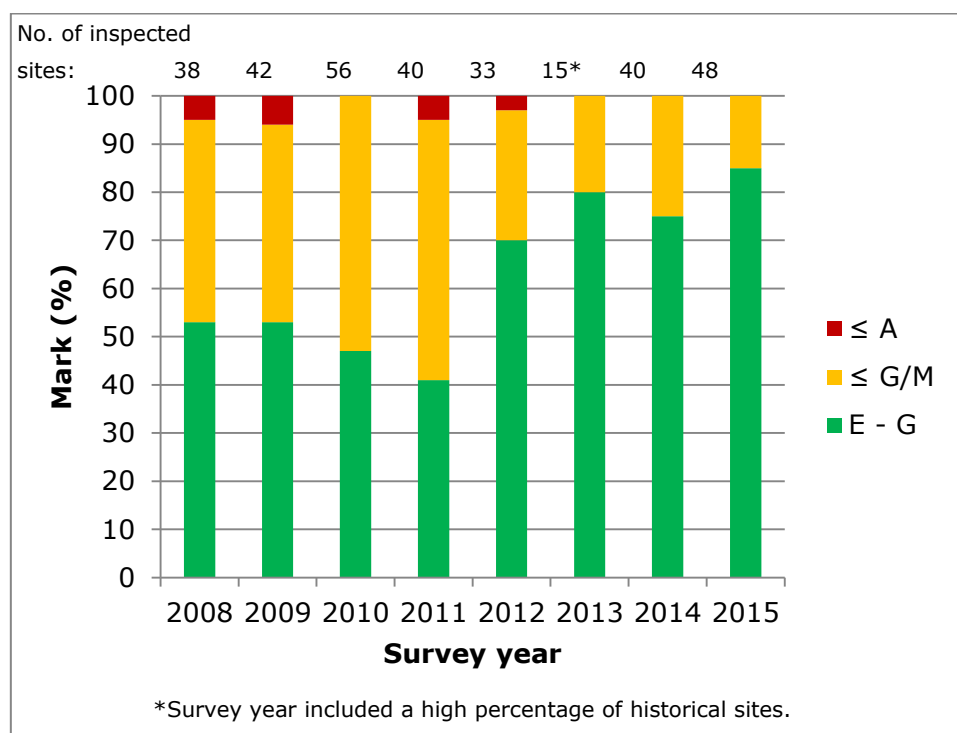
**Figure 3.2 Comparison of average markings for SIP2008-SIP2015.**

A comparison of the breakdown of average survey markings for all SIP surveys undertaken to date is shown in Figure 3.2. The surface courses examined in 2015 (laid in the 2013/14 surfacing season) received the highest percentage of E and G markings since the surveys started in 2008.

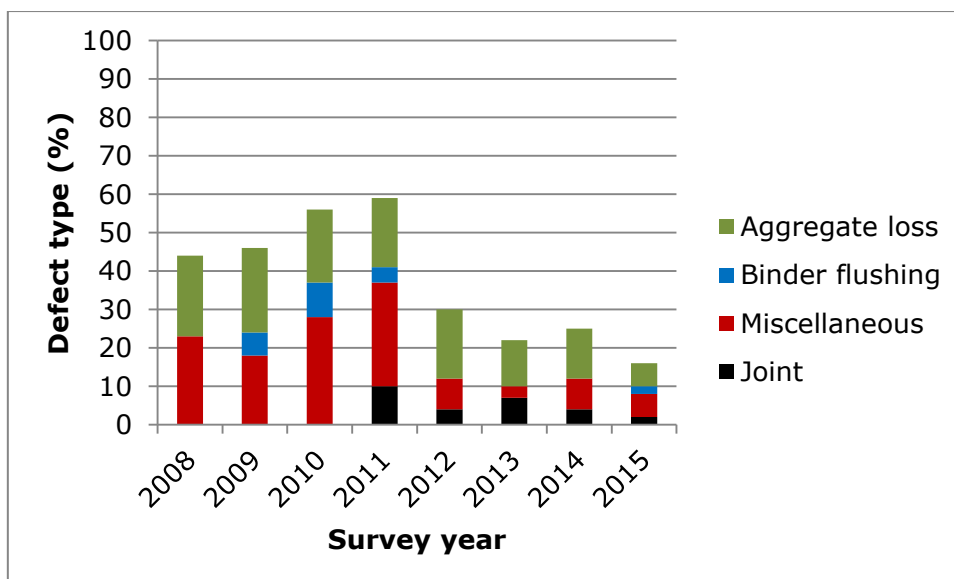
**Figure 3.3 Comparison of recorded defects for SIP surveys**

The proportion of sites exhibiting defects over the last eight SIP surveys is presented in Figure 3.3. Compared to previous surveys, the 2015 survey recorded the lowest number of visual defects. Eighty-five percent of the 2015 sites were assessed as being defect free.

Historically, aggregate loss (coded green) has been the most common defect recorded by the SIP team and efforts to reduce its occurrence have previously been unsuccessful. It can be seen from Figure 3.3 that the percentage of aggregate loss remained reasonably constant between the years 2008-2014. However, in 2015 only three sites

Miscellaneous defects (coded red) were seen to be at a similar level to 2014. These defects are related to features such as material variability and variability with traffic intensity.

Joint defects (coded black) have only been recorded as a separate defect since 2011. They are used to denote the presence of an open or a deteriorated joint. Previously they were typically noted or included under aggregate loss if the joint was fretted or appeared 'open'. Only one of the 2015 sites was noted to exhibit some type of joint defect.

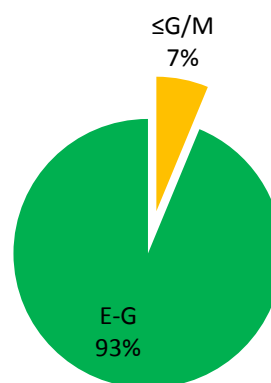
**Figure 4.1 TS2010 average markings**

Figure 4.1 shows that 13 of the 14 sites surfaced with TS2010 were assessed as either E or G by all the panel members. One site (representing 7% of the TS2010 sample) was assessed as G/M+. The site was marked at a lower level owing to the presence of some binder flushing which should not occur. However, the flushing was not thought to be of major concern owing to the presence of grit which is required as part of the TS2010 specification. Flushing can potentially reduce the skid resistance of a surface course.

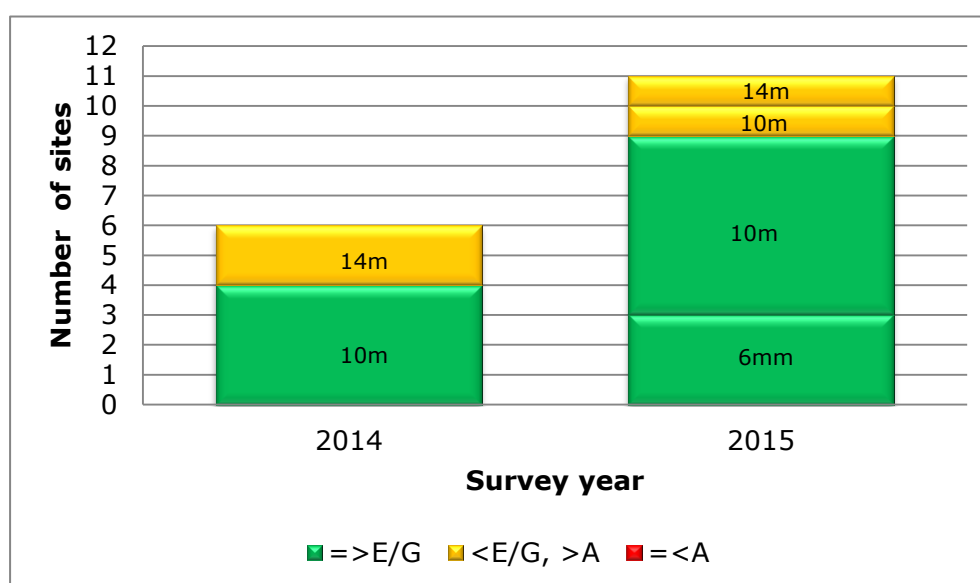
**Figure 4.3 Performance of different mixtures on highly stressed sites**

Figure 4.3 shows the performance of different mixtures, based on nominal aggregate size, on sites that were assessed to be Medium-High (M-H) or High (H) in 2015 and 2014. The figure clearly shows that there is a trend towards specifying smaller stone aggregate sizes on highly stressed sites and in general the smaller stone sizes are performing well (Figure 4.4).

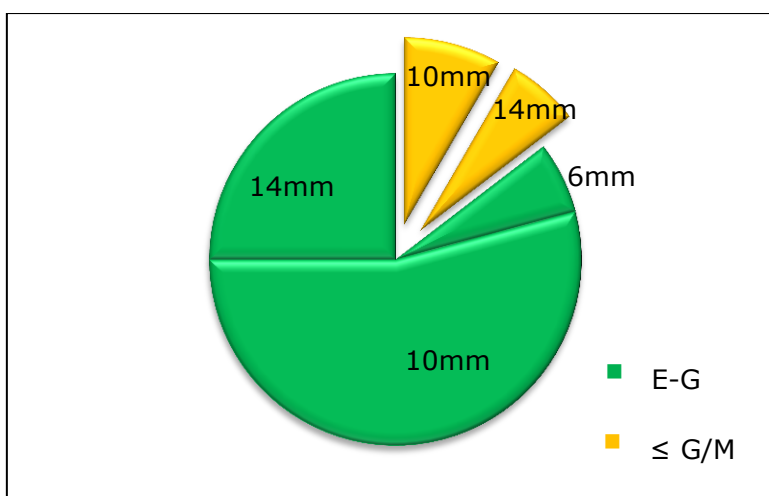
**Figure 4.5 Distribution of aggregate size for all 2015 SIP sites**

Previous analyses of defects associated with 0/14 mm mixtures revealed that they commonly exhibit aggregate loss. Figure 4.5 shows the distribution of nominal aggregate mixture size in combination with average panel mark. The seven sites (15%) that exhibited some defect are shown in amber. A breakdown of these sites reveals that three contained 0/14 mm mixtures and four 0/10 mm mixtures. It is encouraging to note that only one of the 0/14 mm sites was marked down for aggregate loss in the 2015 survey. Overall, 77 % of the 0/14 mm sites (10 sites) were defect free which is an improvement on previous years. This is likely to be a function of suppliers closing up the surface appearance and designers restricting the use of 0/14 mm mixtures to low and medium stress sites.
