Project **FORTH REPLACEMENT CROSSING**

VIBRATION MONITORING REPORT
JULY 2015

REP-00241 Rev
02

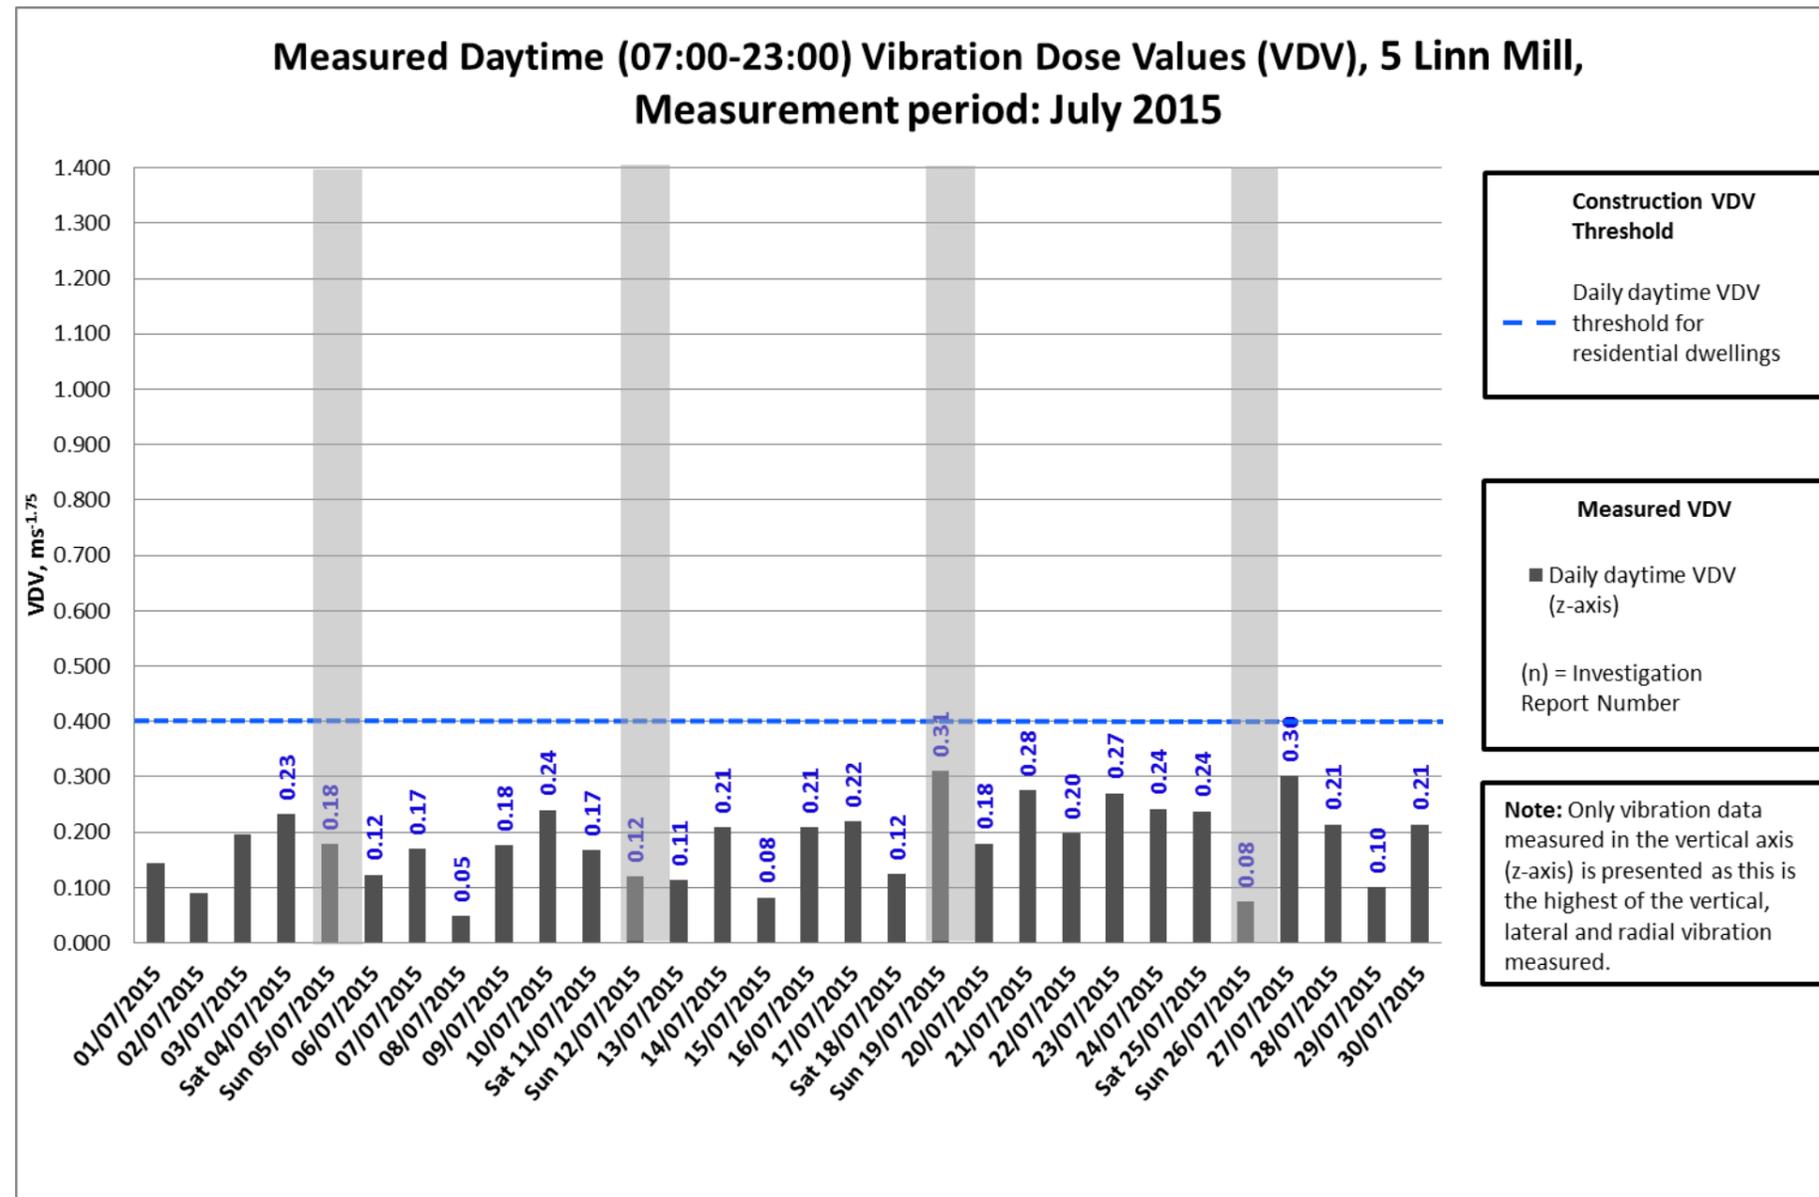
Exceedances on the 17/07/2015 and the 21/07/2015 (graph above from the 21/07/2015) have been investigated and found not to be related to construction activities. Linn mill monitor is 165 metres from the closest works, Clufflat is 200 metres from the same works.

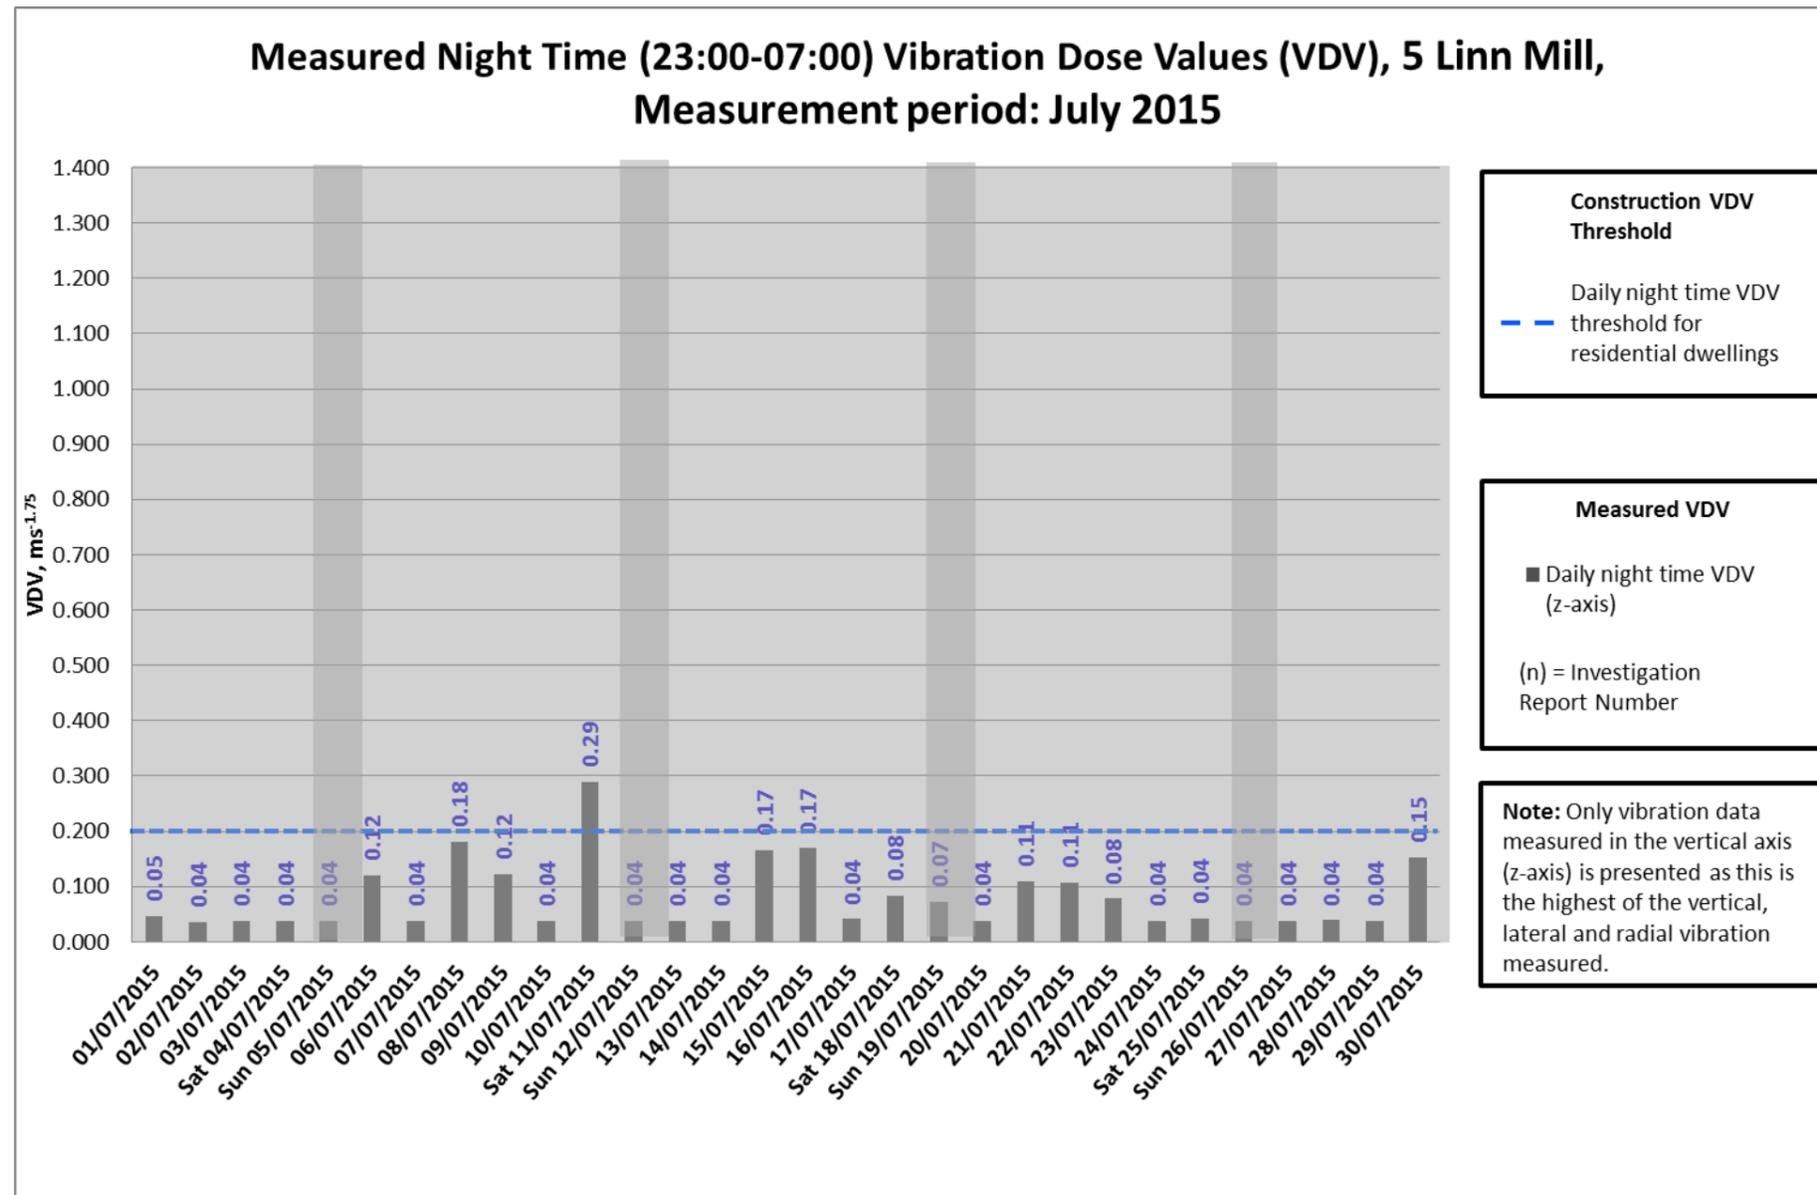
Exceedance on the 11/07/2015 has been investigated and has been found to be an isolated event not related to construction works due to the time of the exceedance.

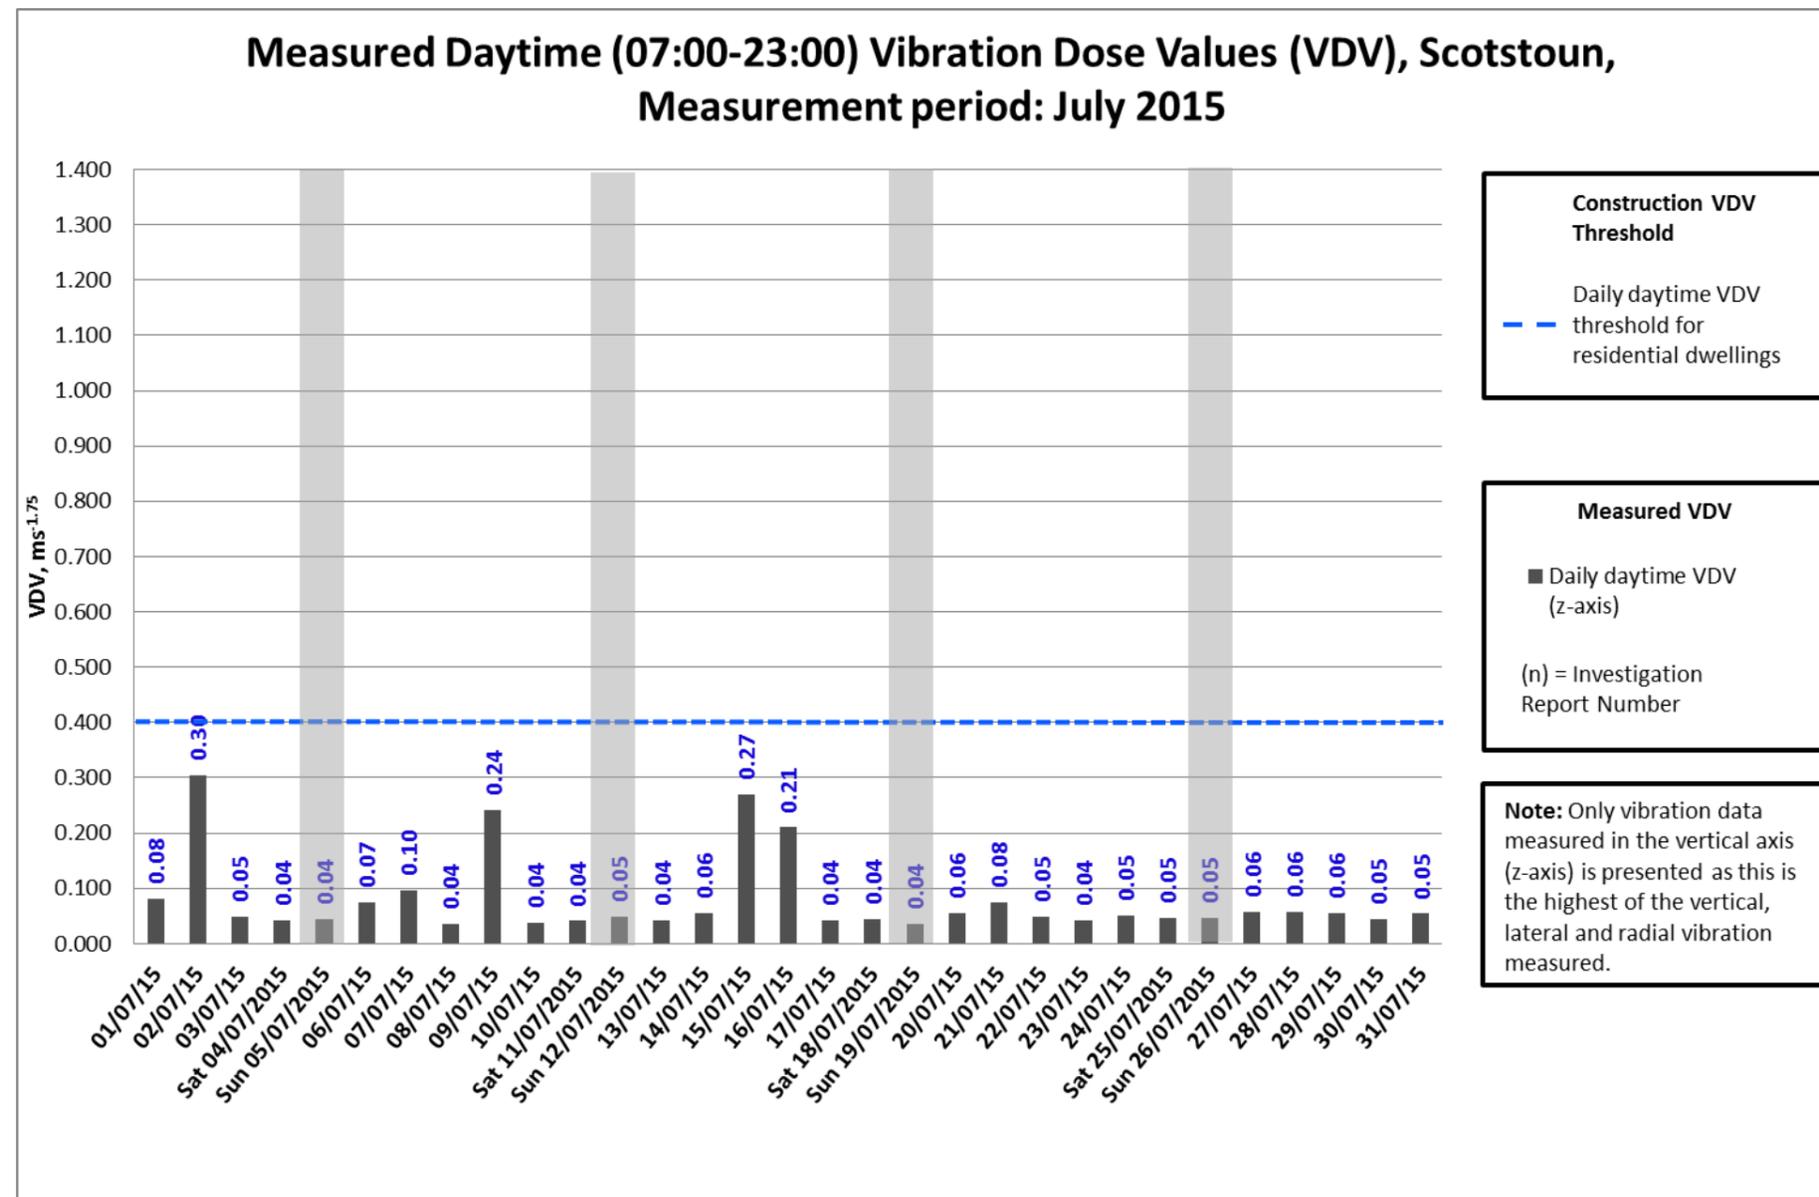
An investigation into the exceedance on the 07/07/2015 has been inconclusive in identification of the possible source of vibration. The exceedance was however intermittent in nature, which falls within the exceedance level.

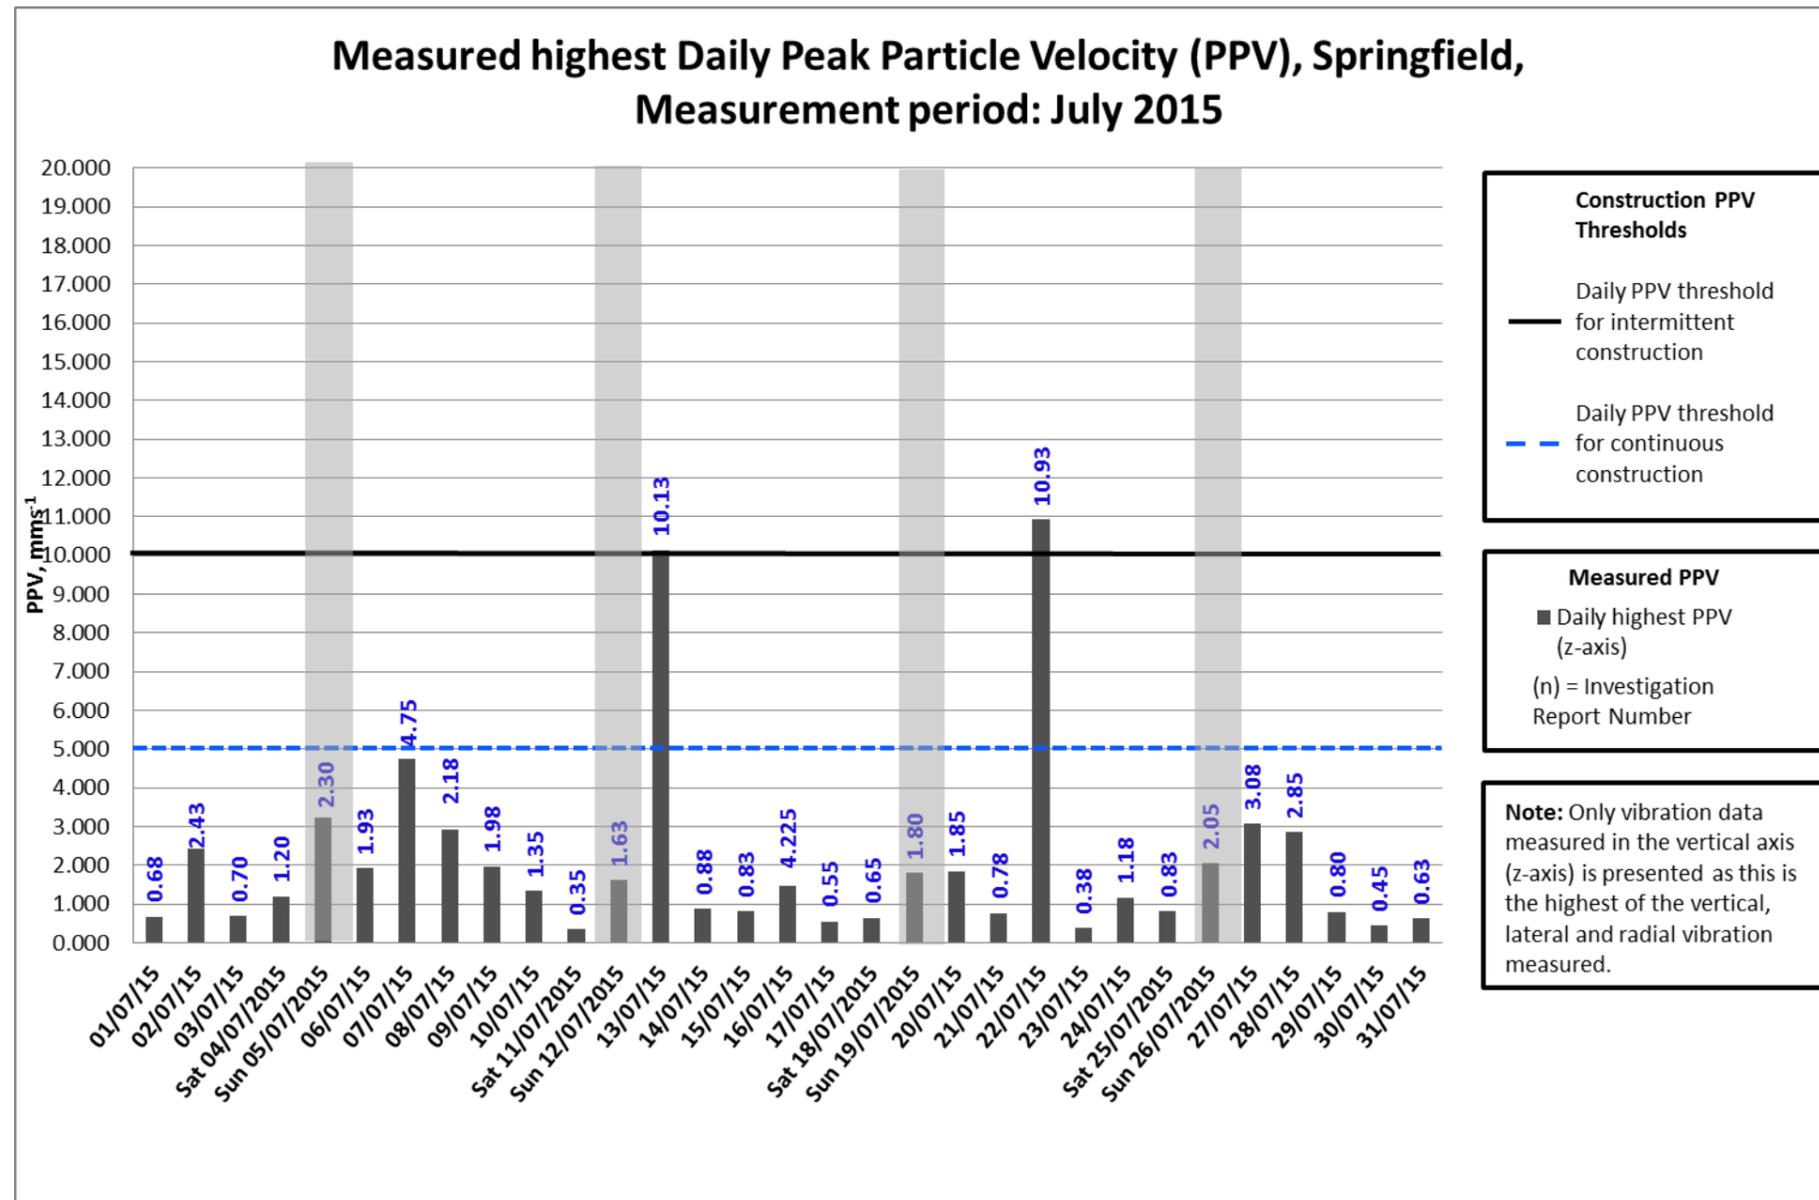
Exceedance on the 13/07/2015 has been investigated and found not to be construction related. Due to the intervening distance between the works and the Springfield monitor, a vibration level of such magnitude would also be expected to have been picked up on other monitors in that area i.e. Clufflat and Linn Mill. Subsequent analysis revealed no such similarities for the time period in question.

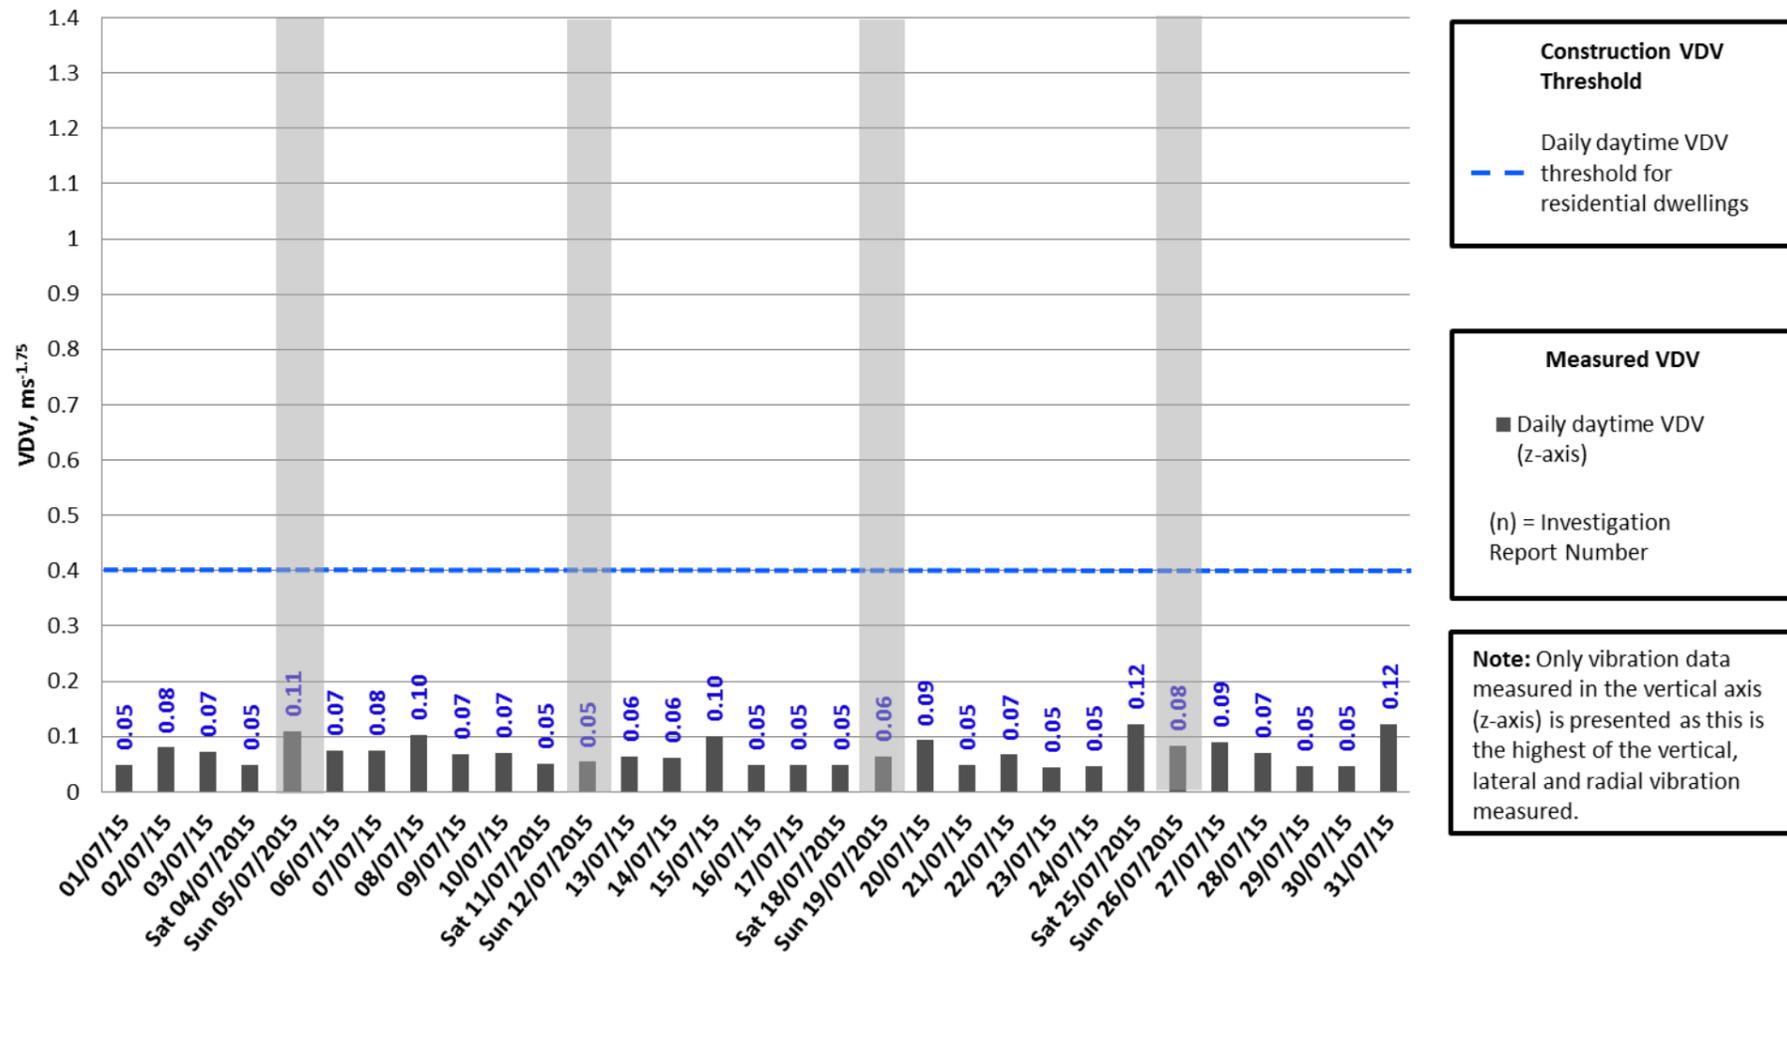
Measured Daytime (07:00-23:00) Vibration Dose Values (VDV), Springfield, Measurement period: July 2015

Exceedance on the 22/07/2015 has been investigated and found that the vibration is likely to have been caused during maintenance work on the noise monitor, which is in close proximity to the vibration monitor.

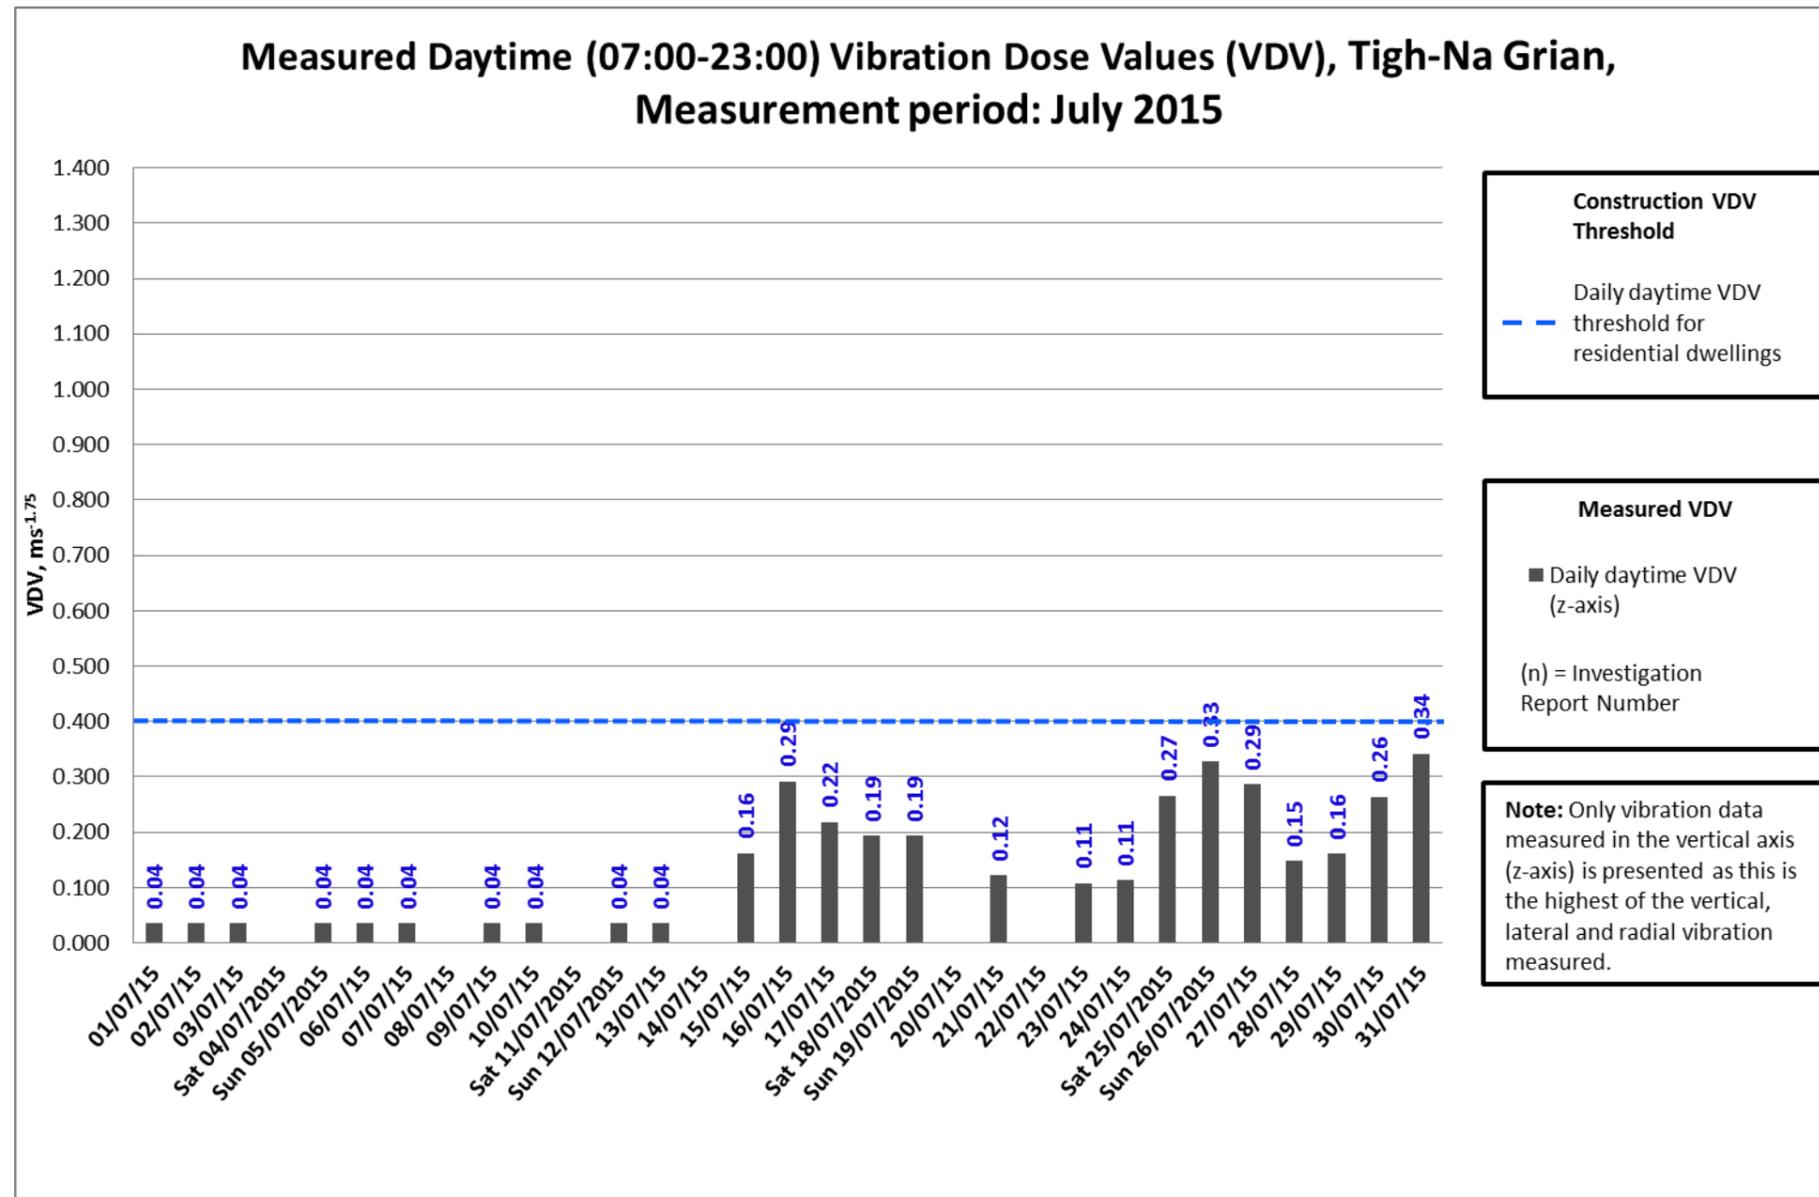
All exceedances have been investigated and have been found to be individual 'intermittent' exceedances and not constant (reference graph above from the 01/07/2015). The source of the vibration is unknown but all exceedances are within thresholds.

Data missing on the 04/07/2015, 08/07/2015, 11/07/2015, 14/07/2015, 20/07/2015 and 22/07/2015 is due to corrupt data on the monitor.

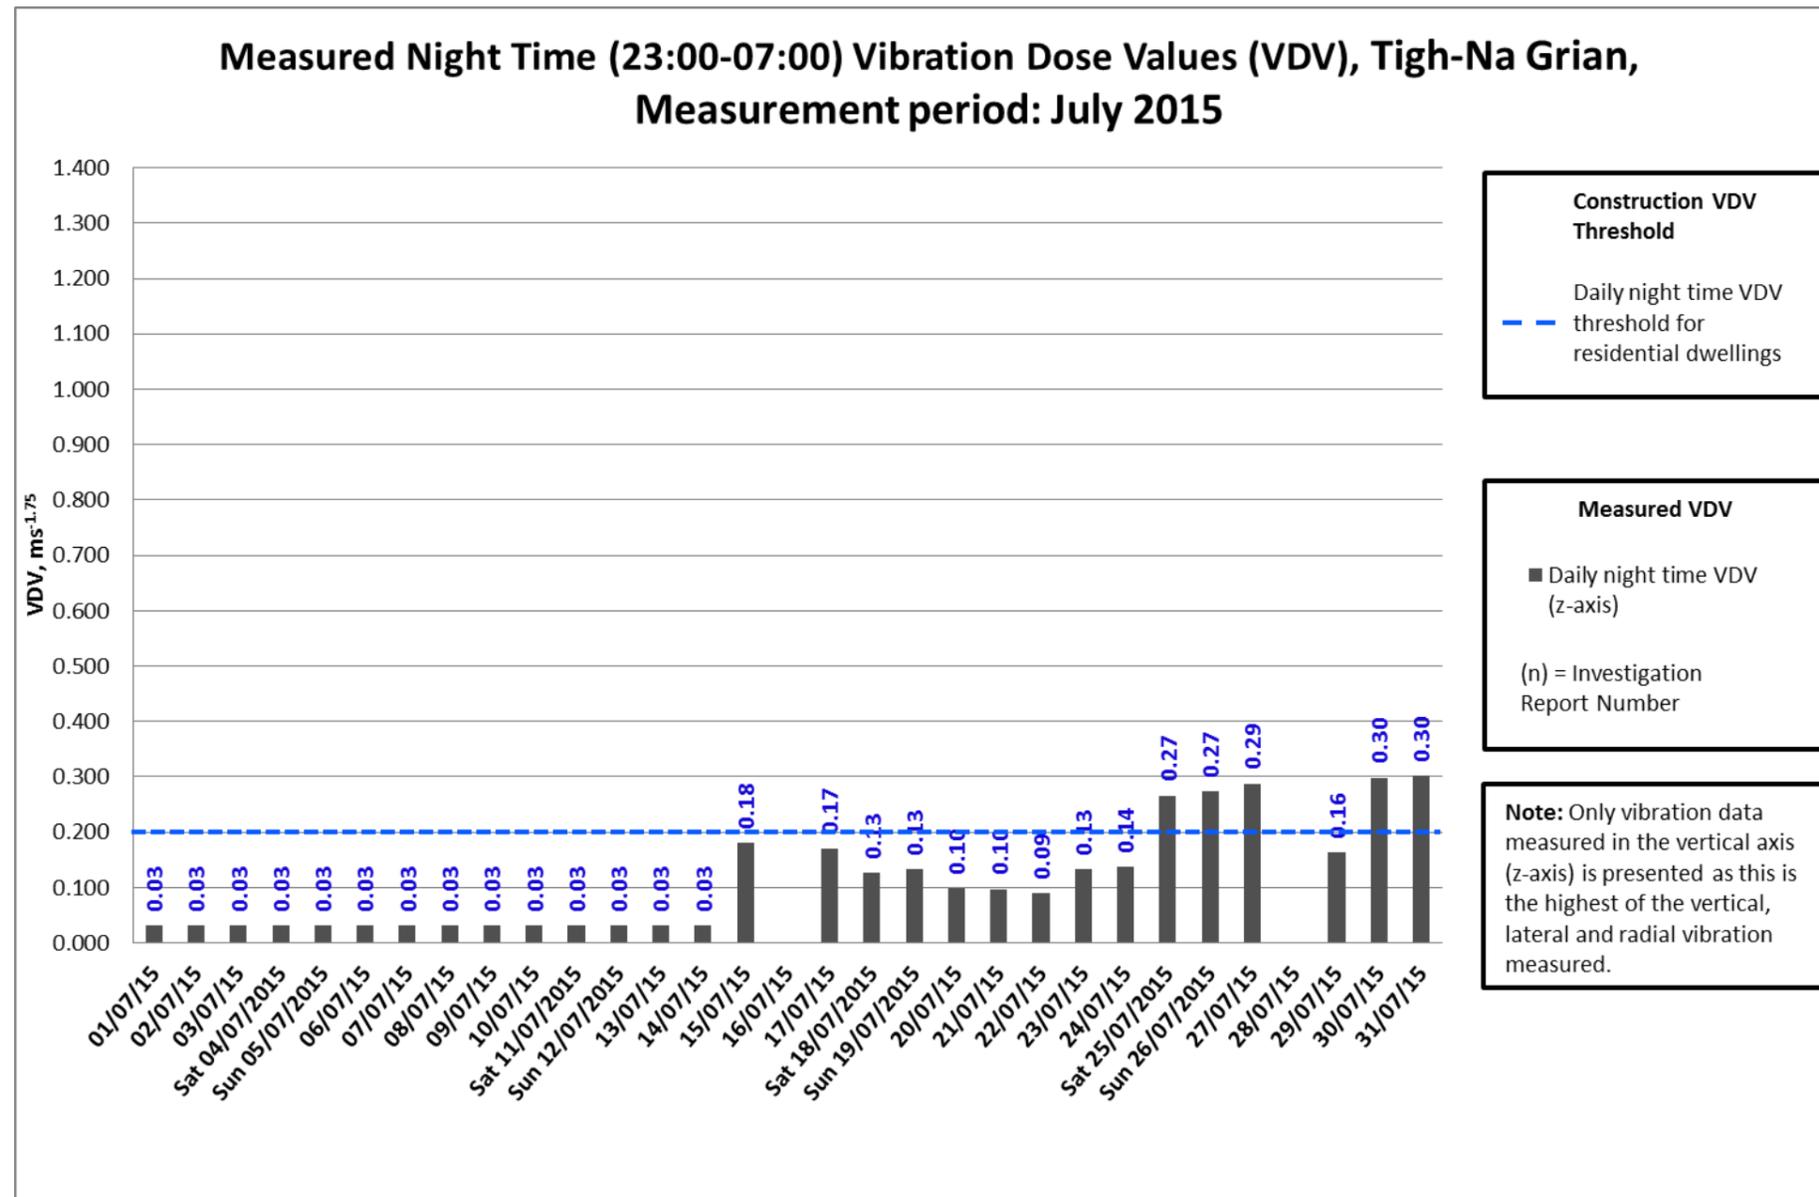
Data missing on the 04/07/2015, 08/07/2015, 11/07/2015, 14/07/2015, 20/07/2015, and 22/07/2015 is due to corrupt data on the monitor.
