Queensferry  
Crossing

Project FORTH REPLACEMENT CROSSING

VIBRATION MONITORING REPORT

JULY 2016

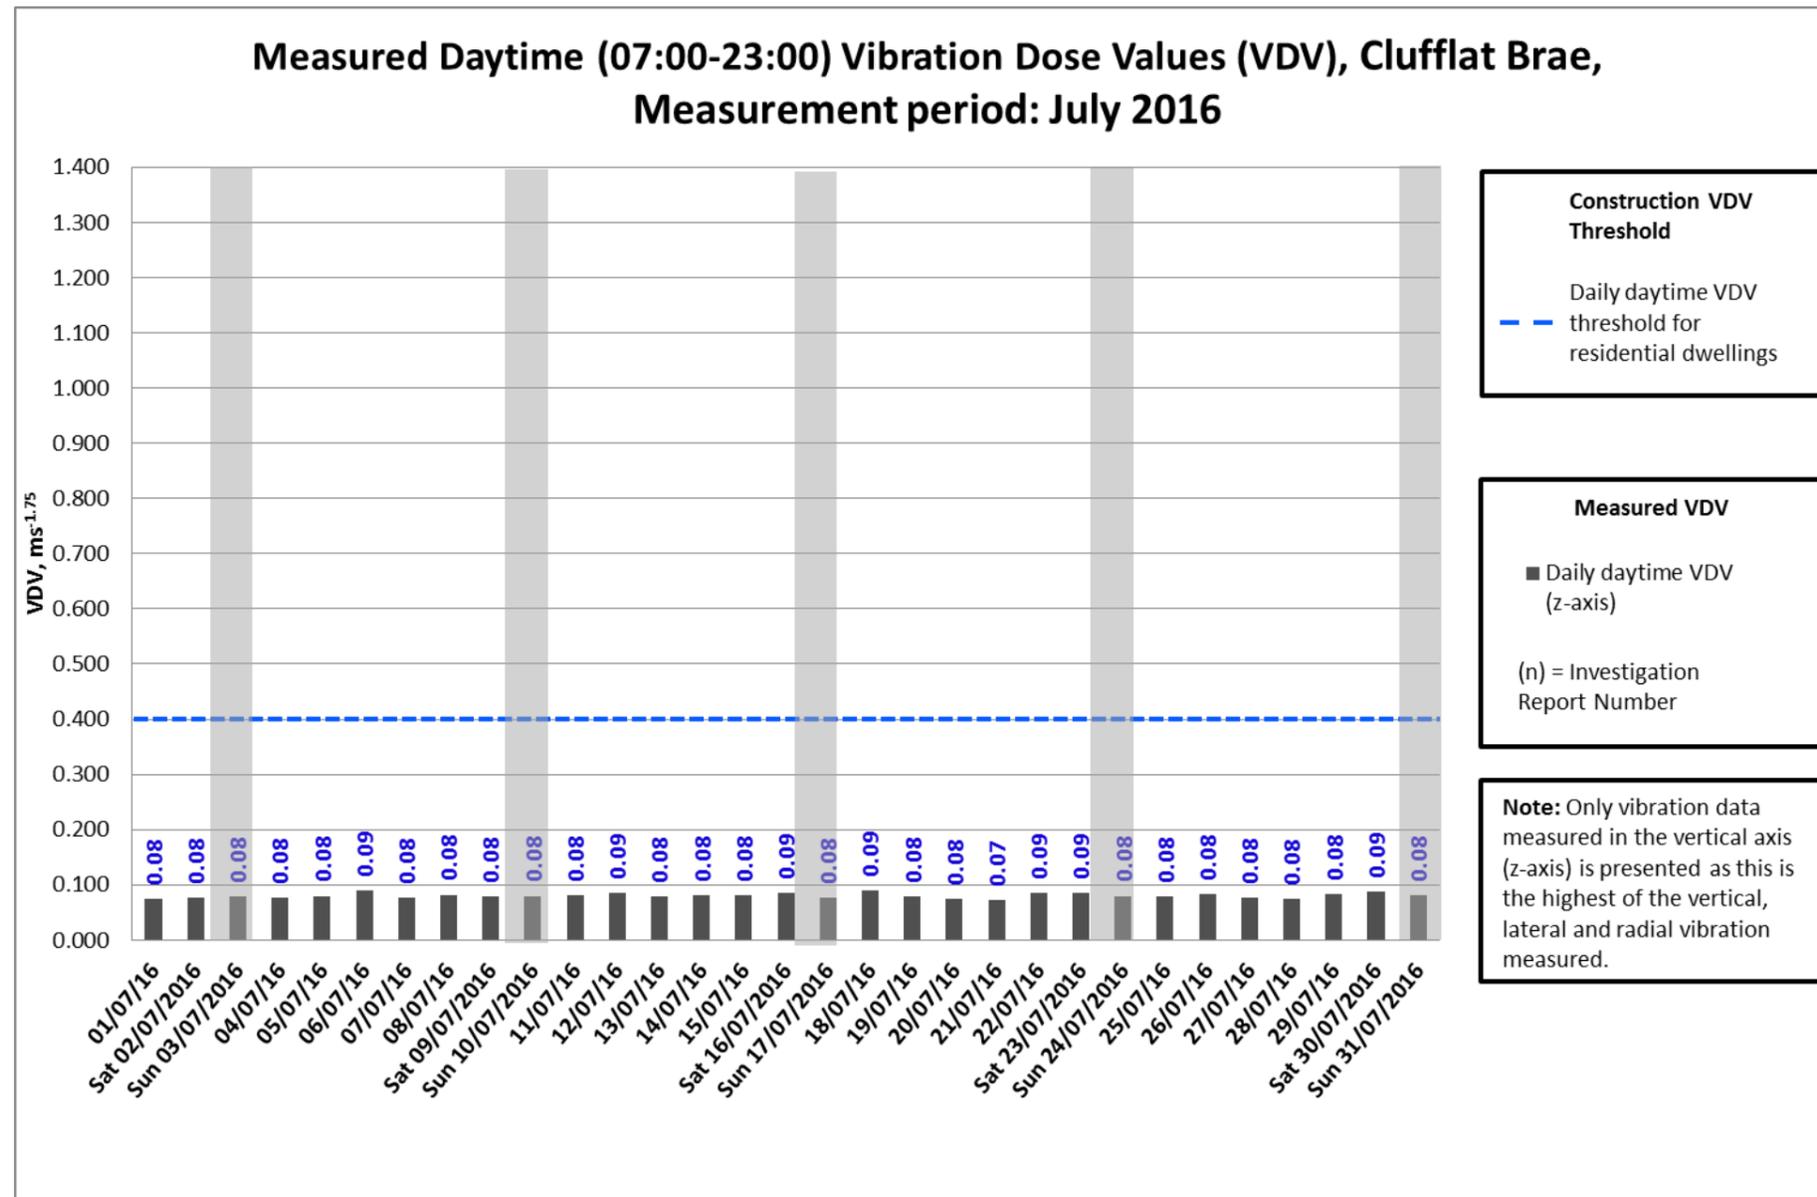
Exceedances on the 2<sup>nd</sup>, 10<sup>th</sup>, 17<sup>th</sup>, 20<sup>th</sup>, 25<sup>th</sup>, 24<sup>th</sup> and 31<sup>st</sup> of July have been investigated and found to be caused out with construction working hours and therefore it is unlikely that construction related activity was the cause of these events (graph above from the 02/07/2016).

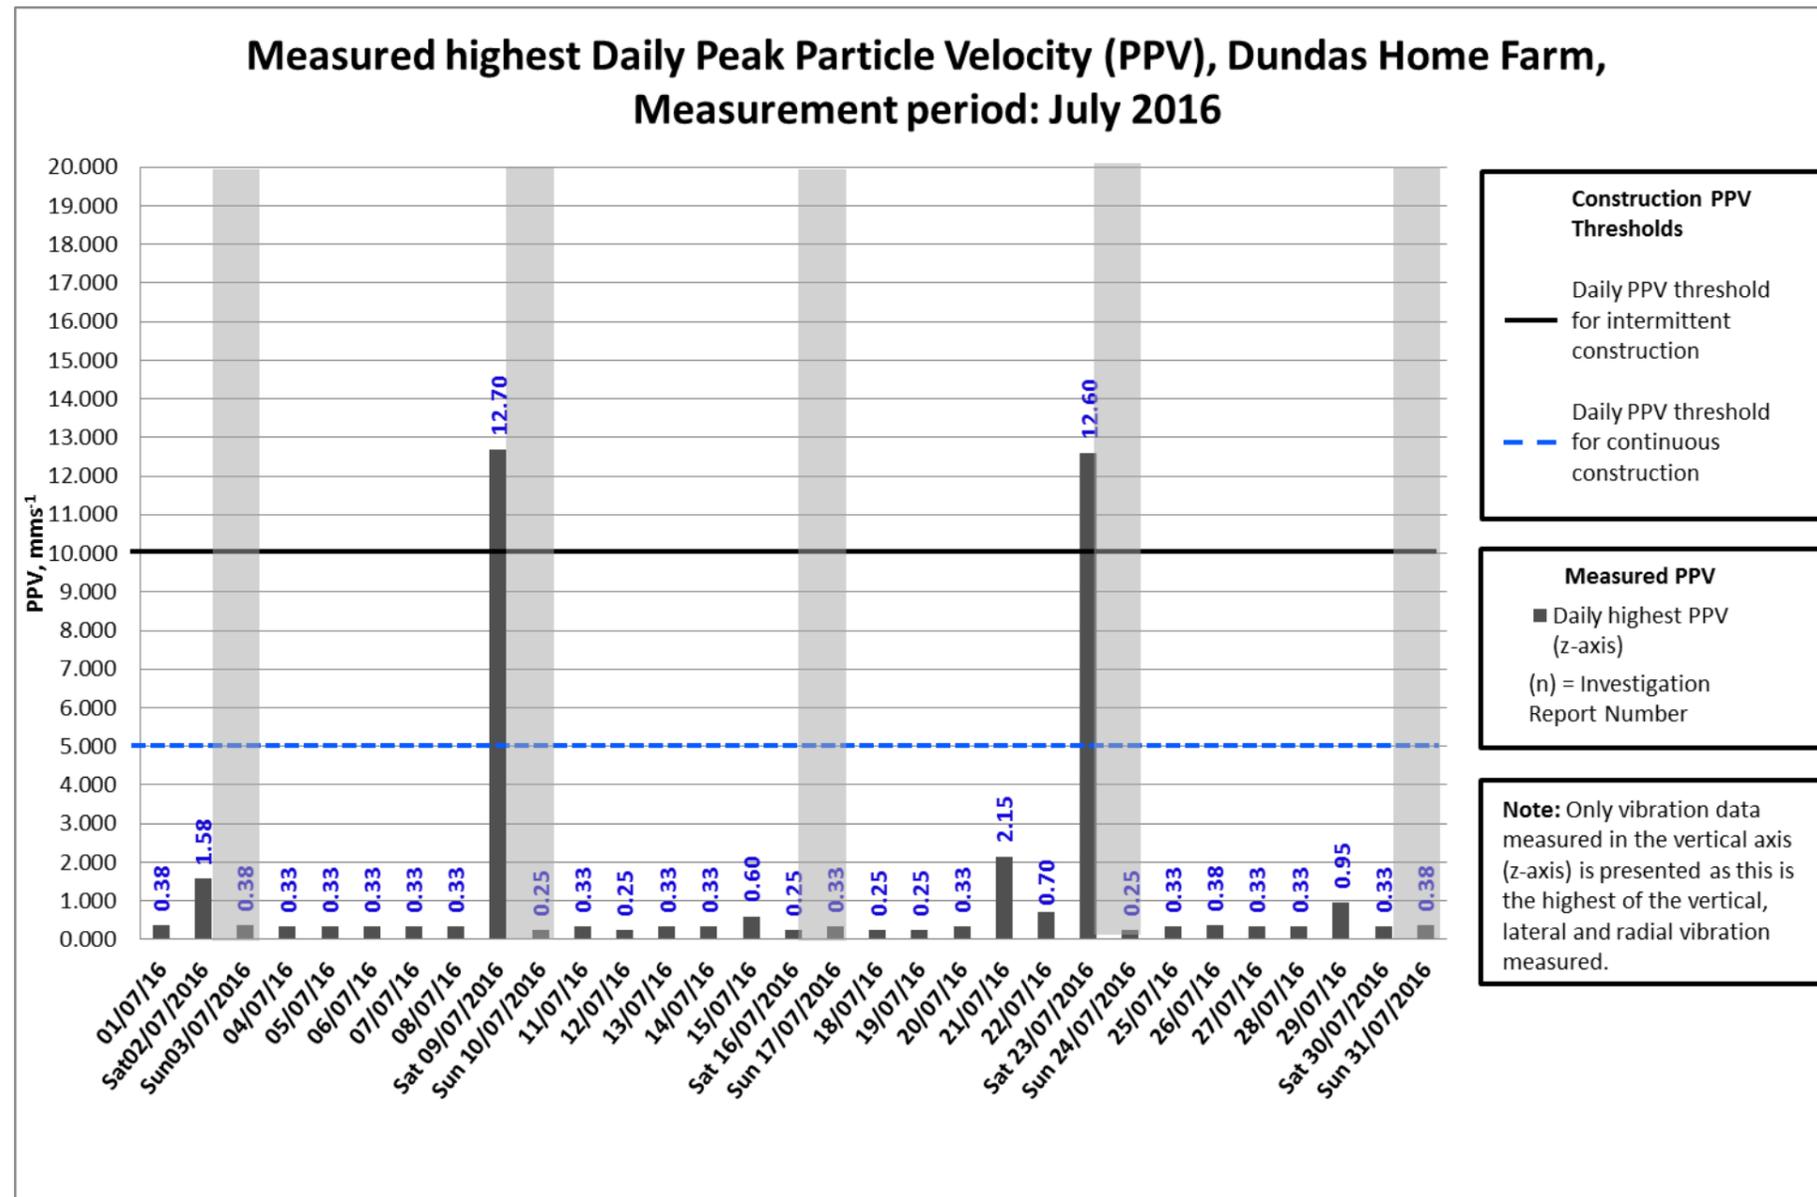
Exceedances on the 9<sup>th</sup> and 23<sup>rd</sup> of July have been investigated and found to be caused by individual isolated events (graph above from the 23/07/2016). During this period the nearest works to the monitor was 115m away. These works consisted of installation of the crash barrier, line marking and road surfacing, of these works only one had plant likely to cause threshold exceedances seen above. However if this was the case then there would be threshold exceedances consistent throughout the month rather than only being on the two days stated above. Due to this the likely cause of these exceedances may be from localised activity nearby the monitor (an example being the grass getting cut nearby the monitor).

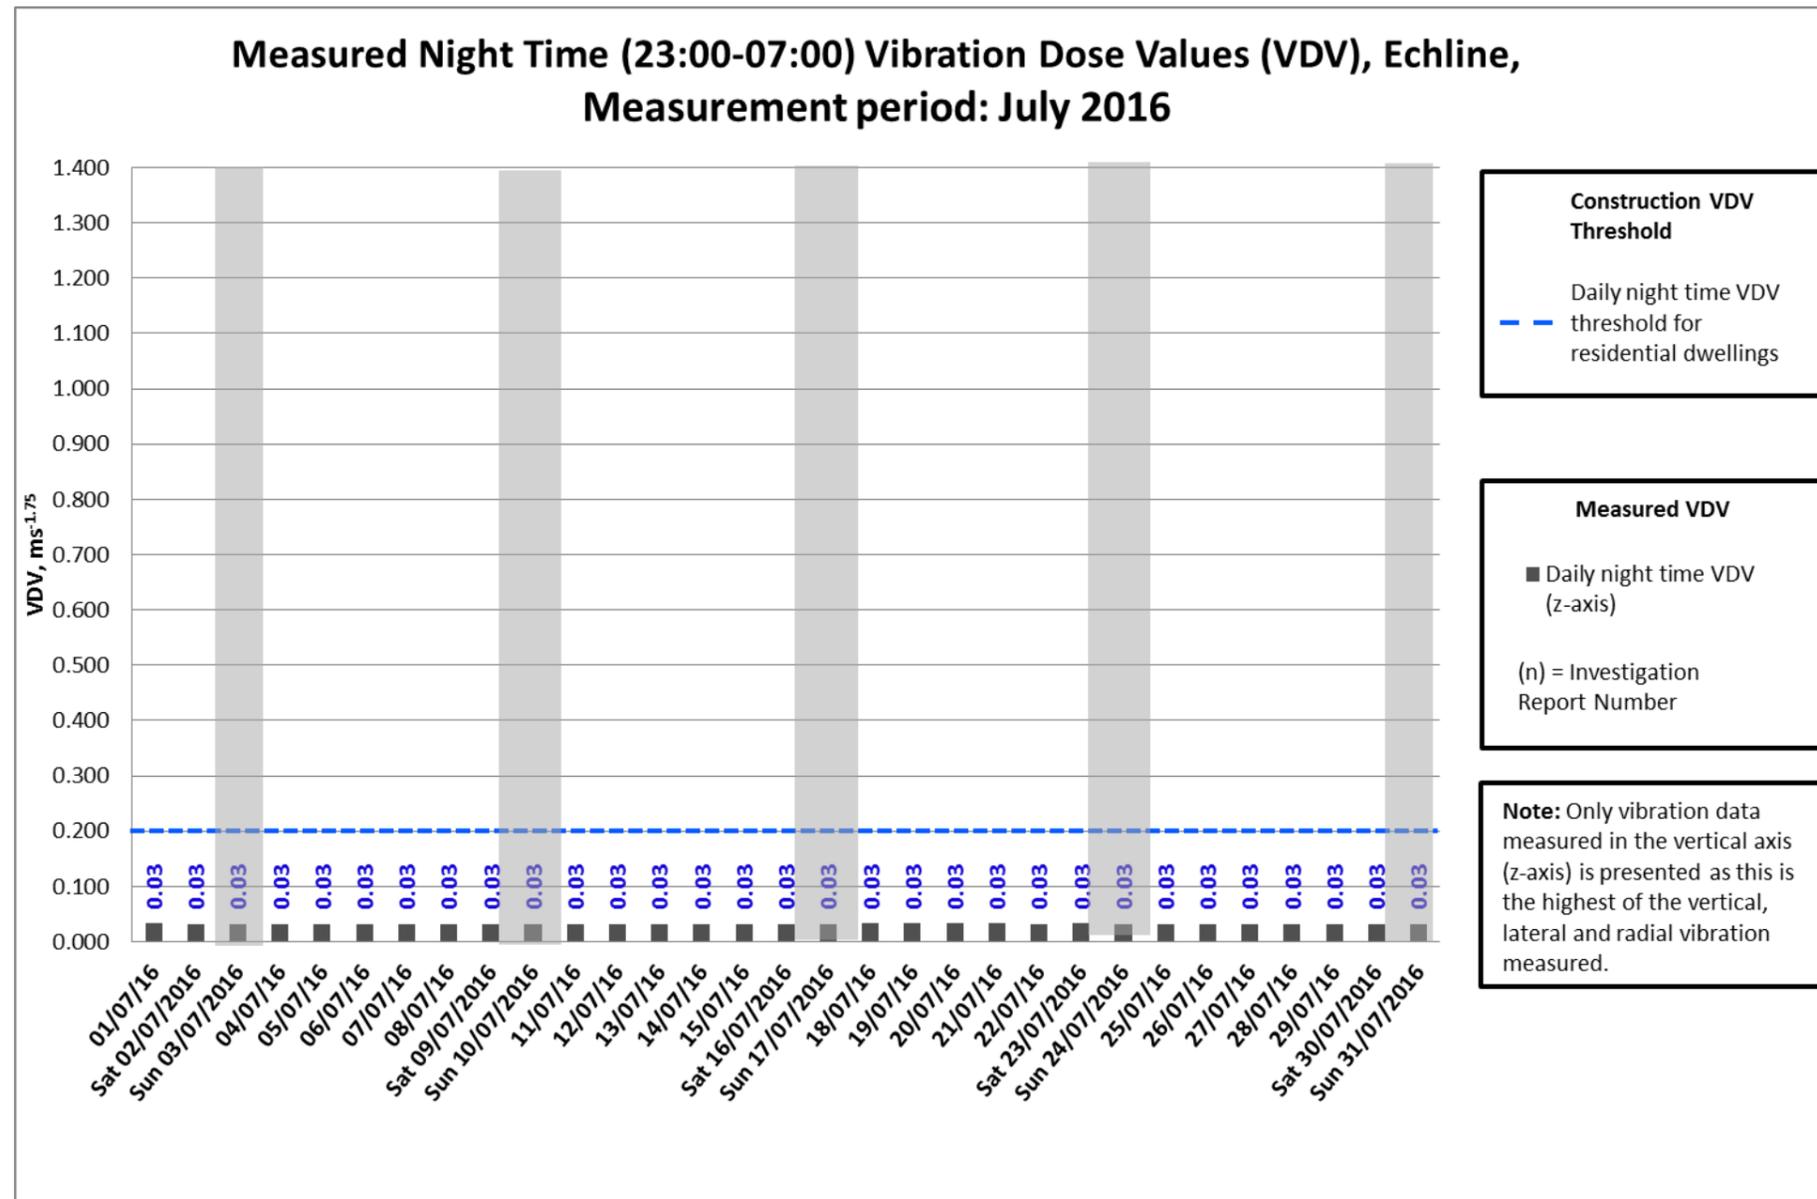
Exceedances on the 3<sup>rd</sup>, 4<sup>th</sup>, 22<sup>nd</sup> and 28<sup>th</sup> of July have been investigated and found to be caused out with construction working hours and therefore it is unlikely that construction related activity was the cause of these events (graph above from the 22/07/2016).

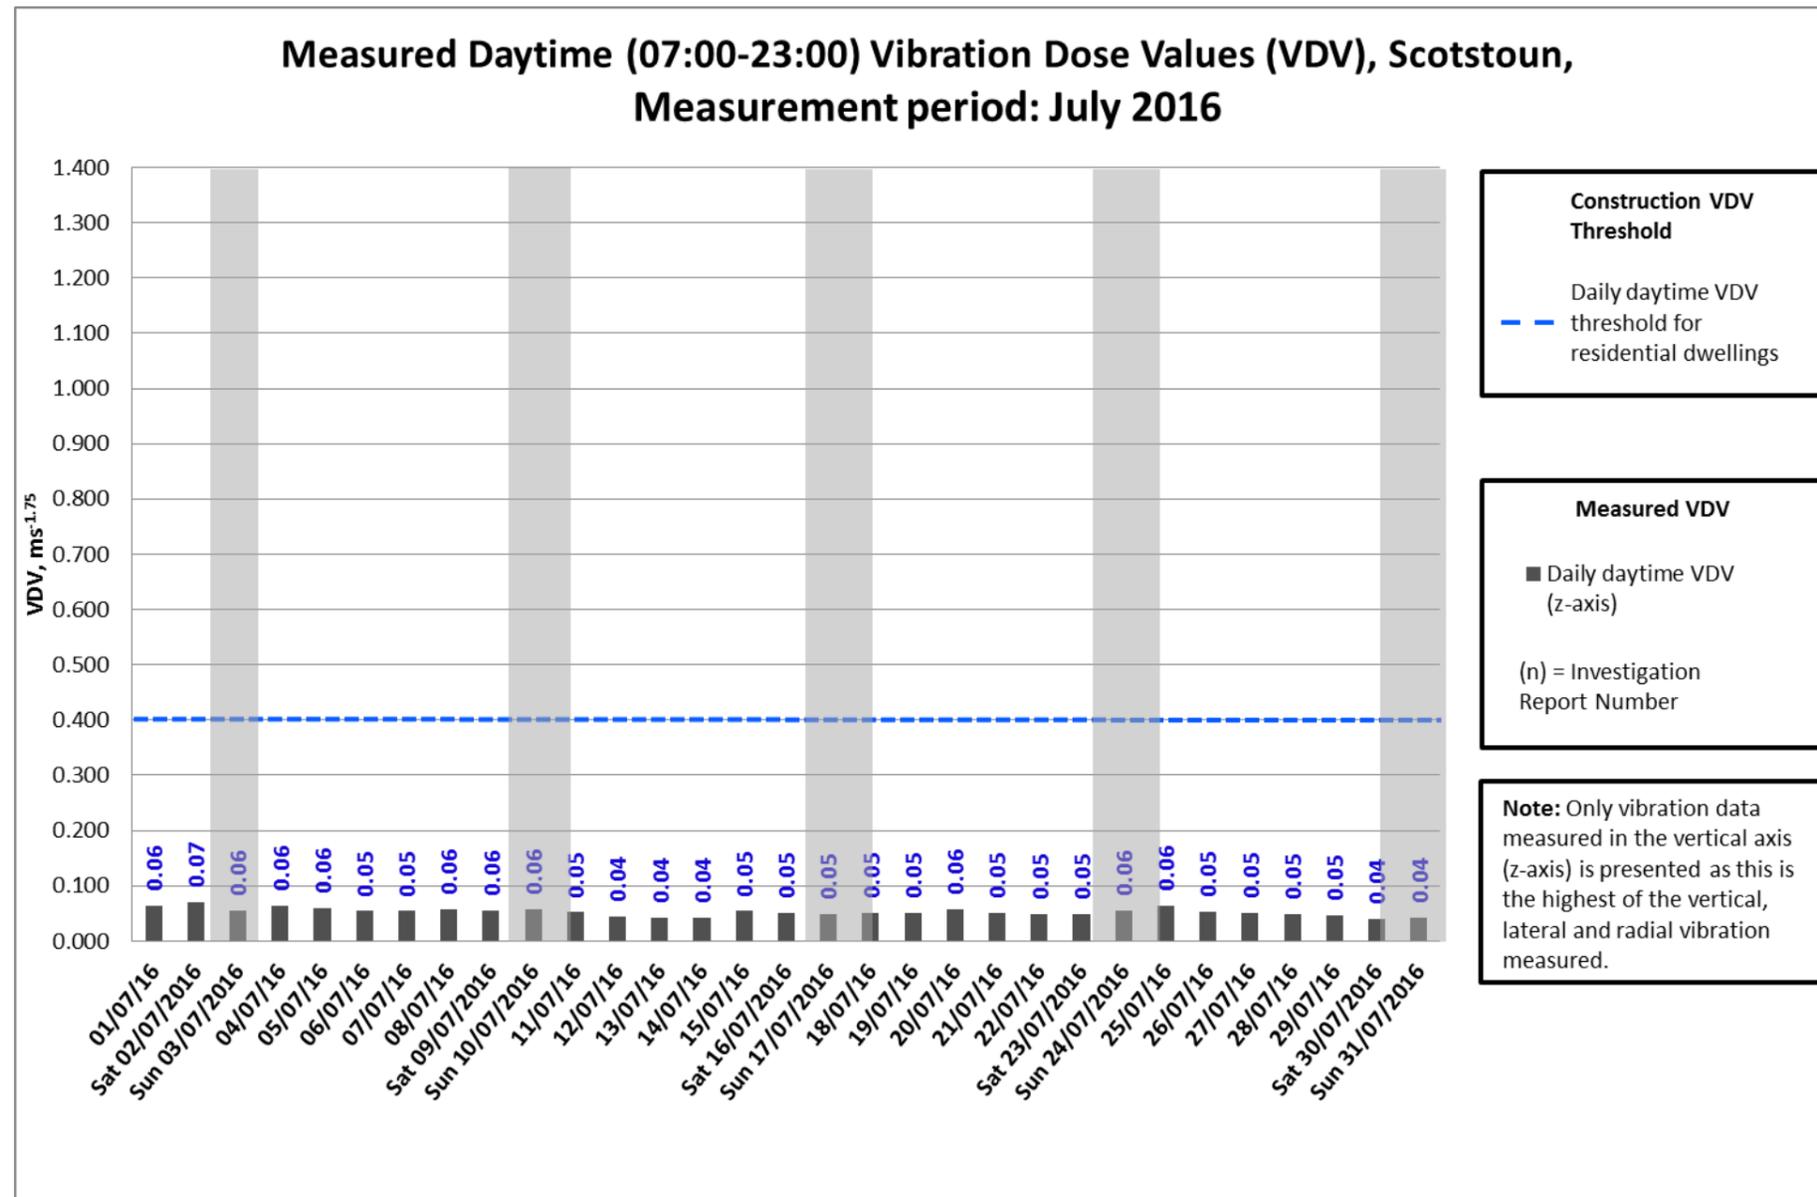
Exceedances on the 8<sup>th</sup>, 15<sup>th</sup>, 25<sup>th</sup> and 28<sup>th</sup> of July have been investigated and found to be caused by individual isolated events that are unlikely to have been construction related activities (graph above from the 25/07/2016).

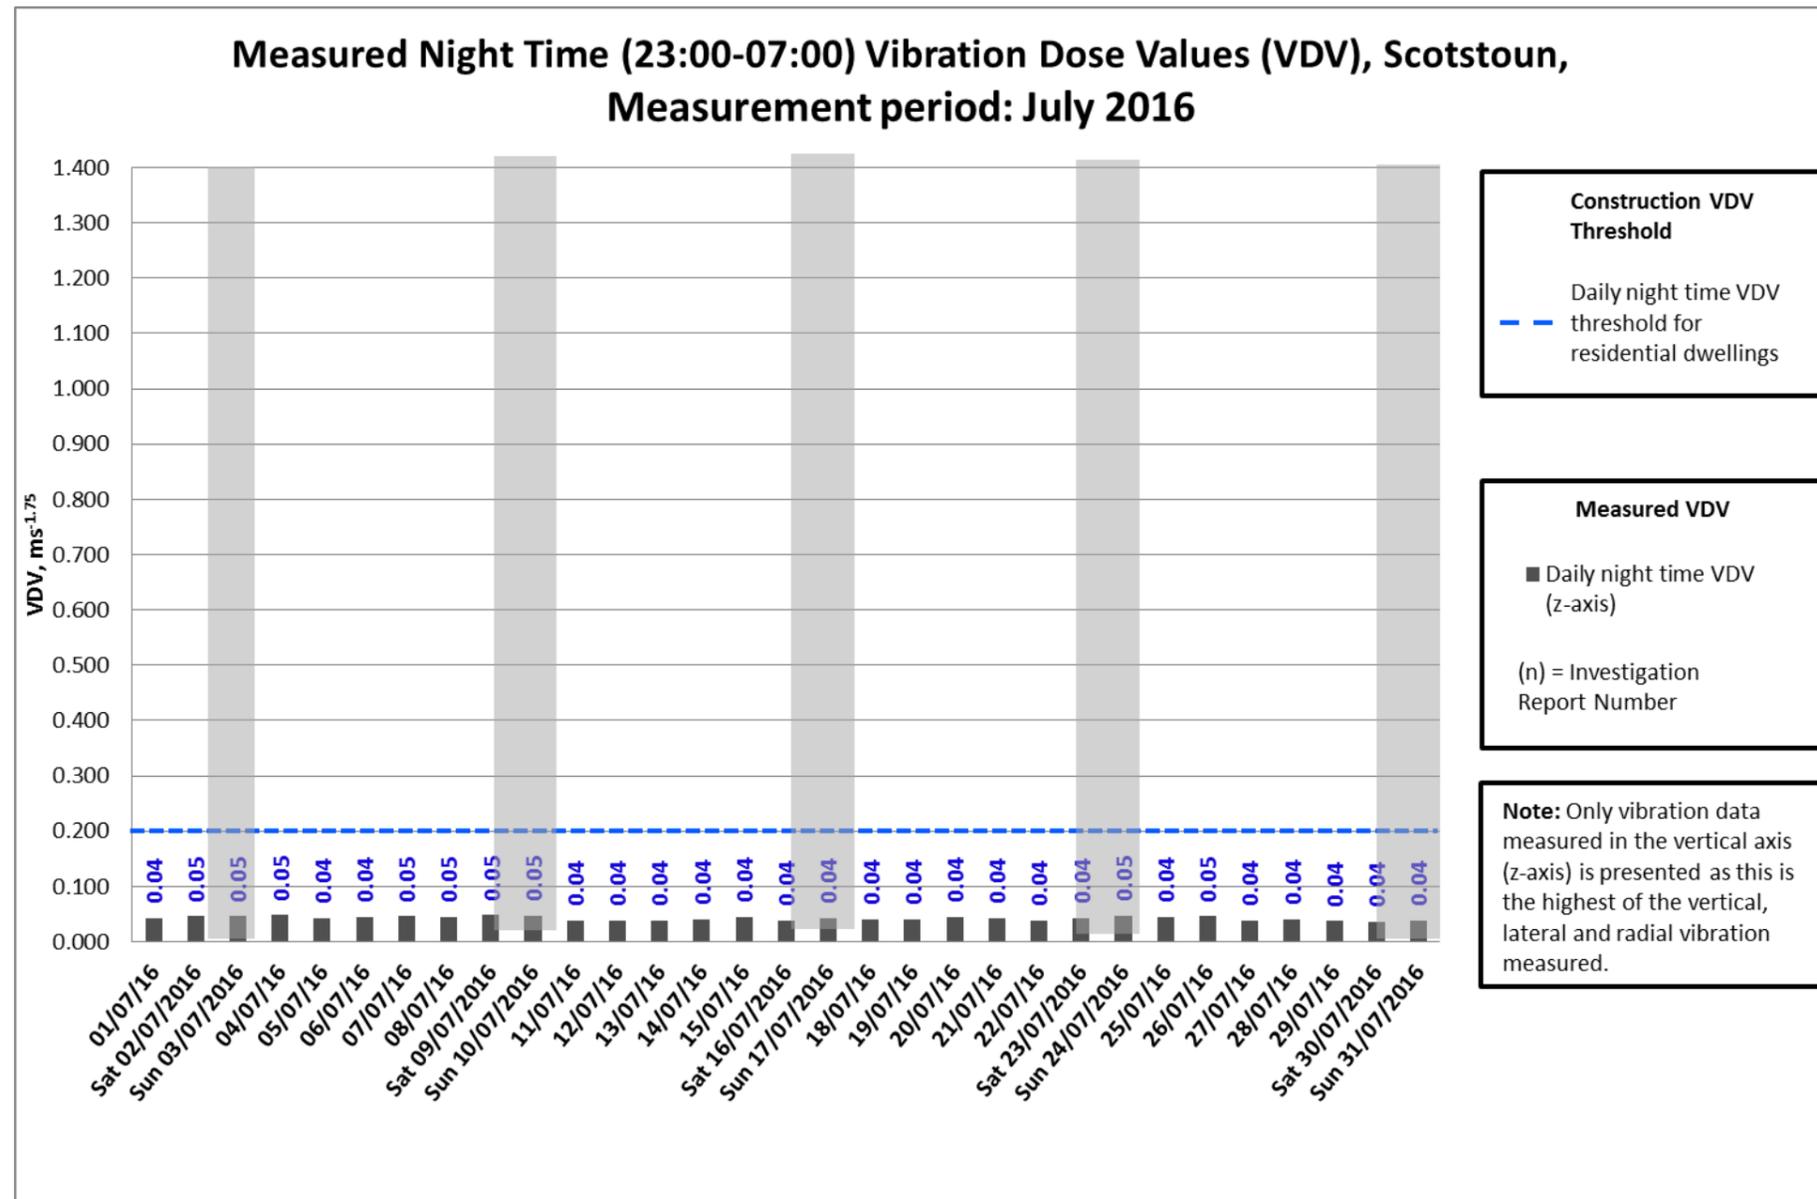
Exceedances on the 3<sup>rd</sup>, 10<sup>th</sup>, 12<sup>th</sup>, 19<sup>th</sup>, 21<sup>st</sup>, 24<sup>th</sup> and 26<sup>th</sup> of July have been investigated and found to be caused out with construction working hours and therefore it is unlikely that construction related activity was the cause of these (graph above from the 12/07/2016).

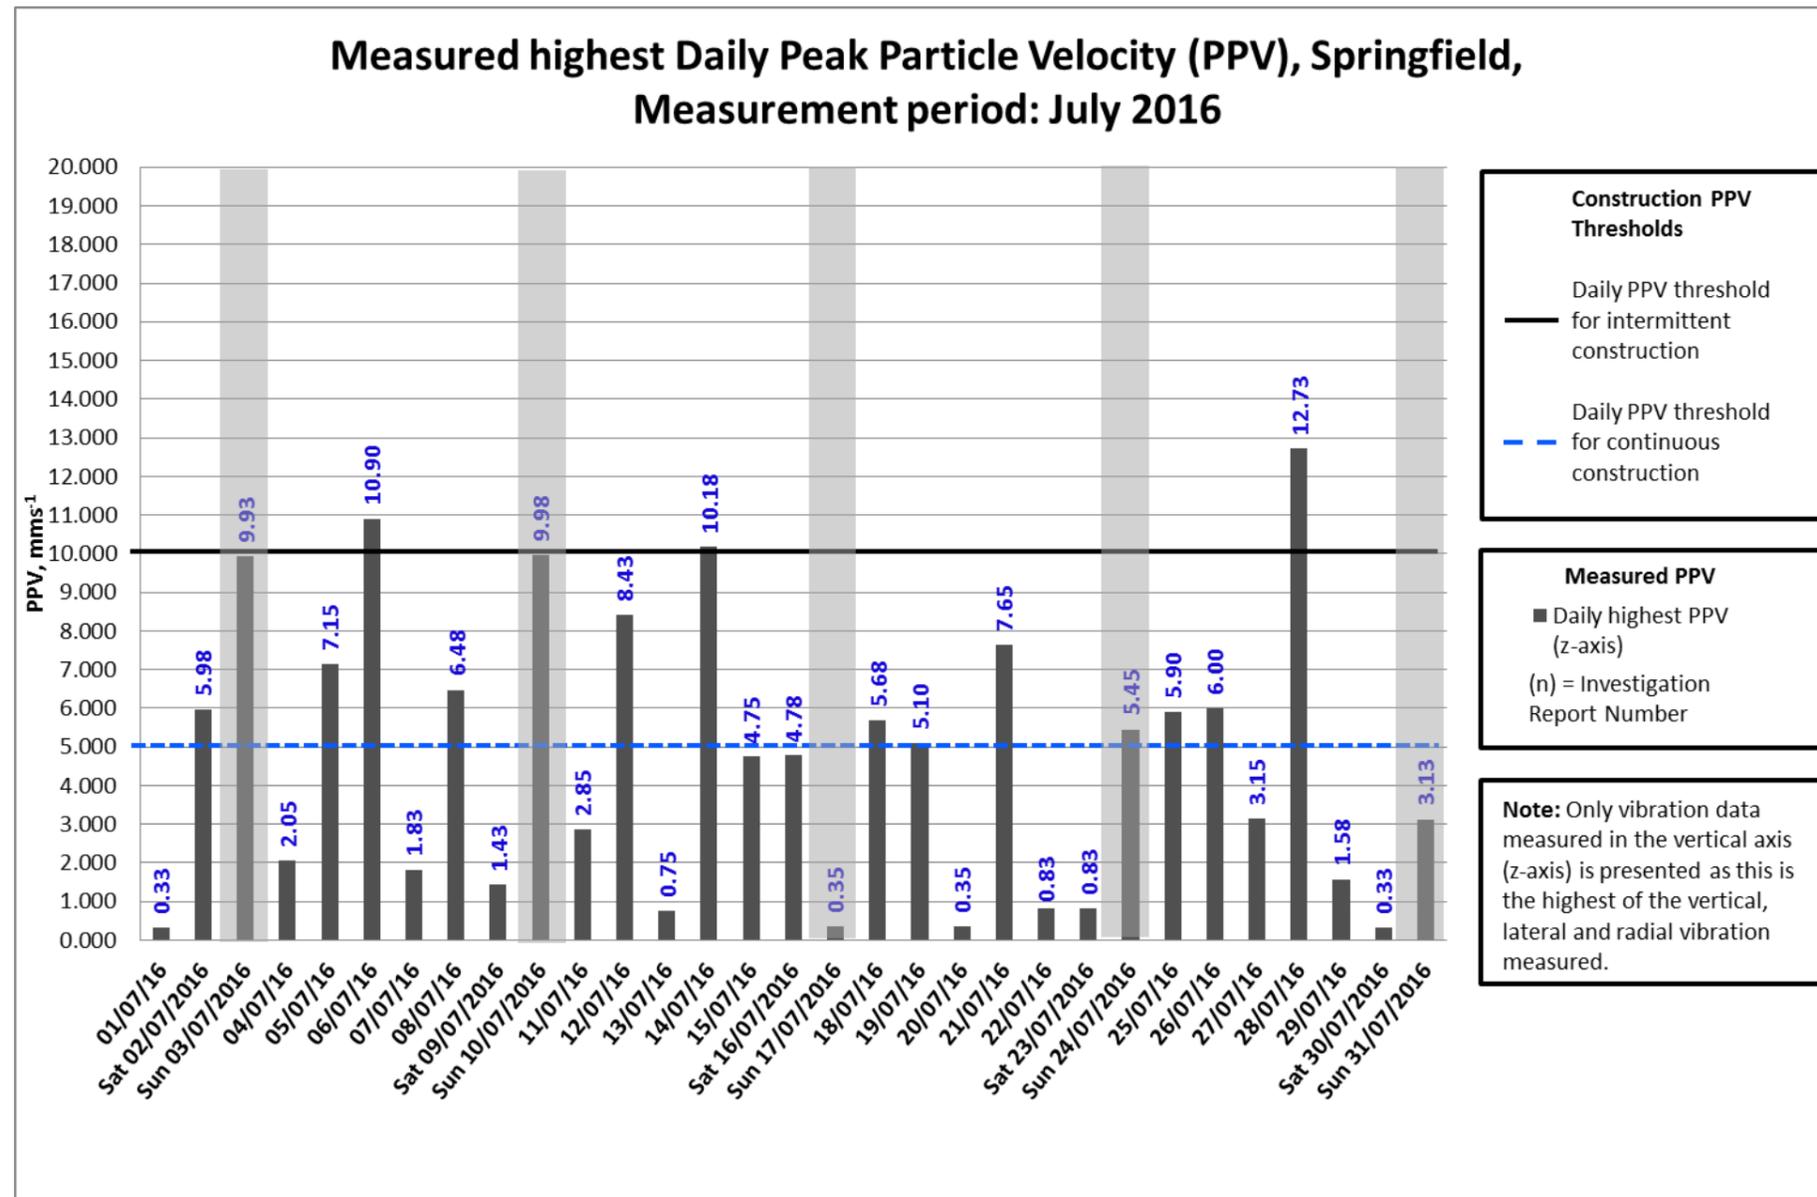
Exceedances on the 2<sup>nd</sup>, 5<sup>th</sup>, 14<sup>th</sup> and 18<sup>th</sup> of July have been investigated and found to be caused by residential activity within the vicinity of the monitor (graph above from the 14/07/2016).

During the reported period there were a number of days where the resident of the property the monitor is situated at was backfilling with gravel nearby monitor, which has had an impact on this month's readings.

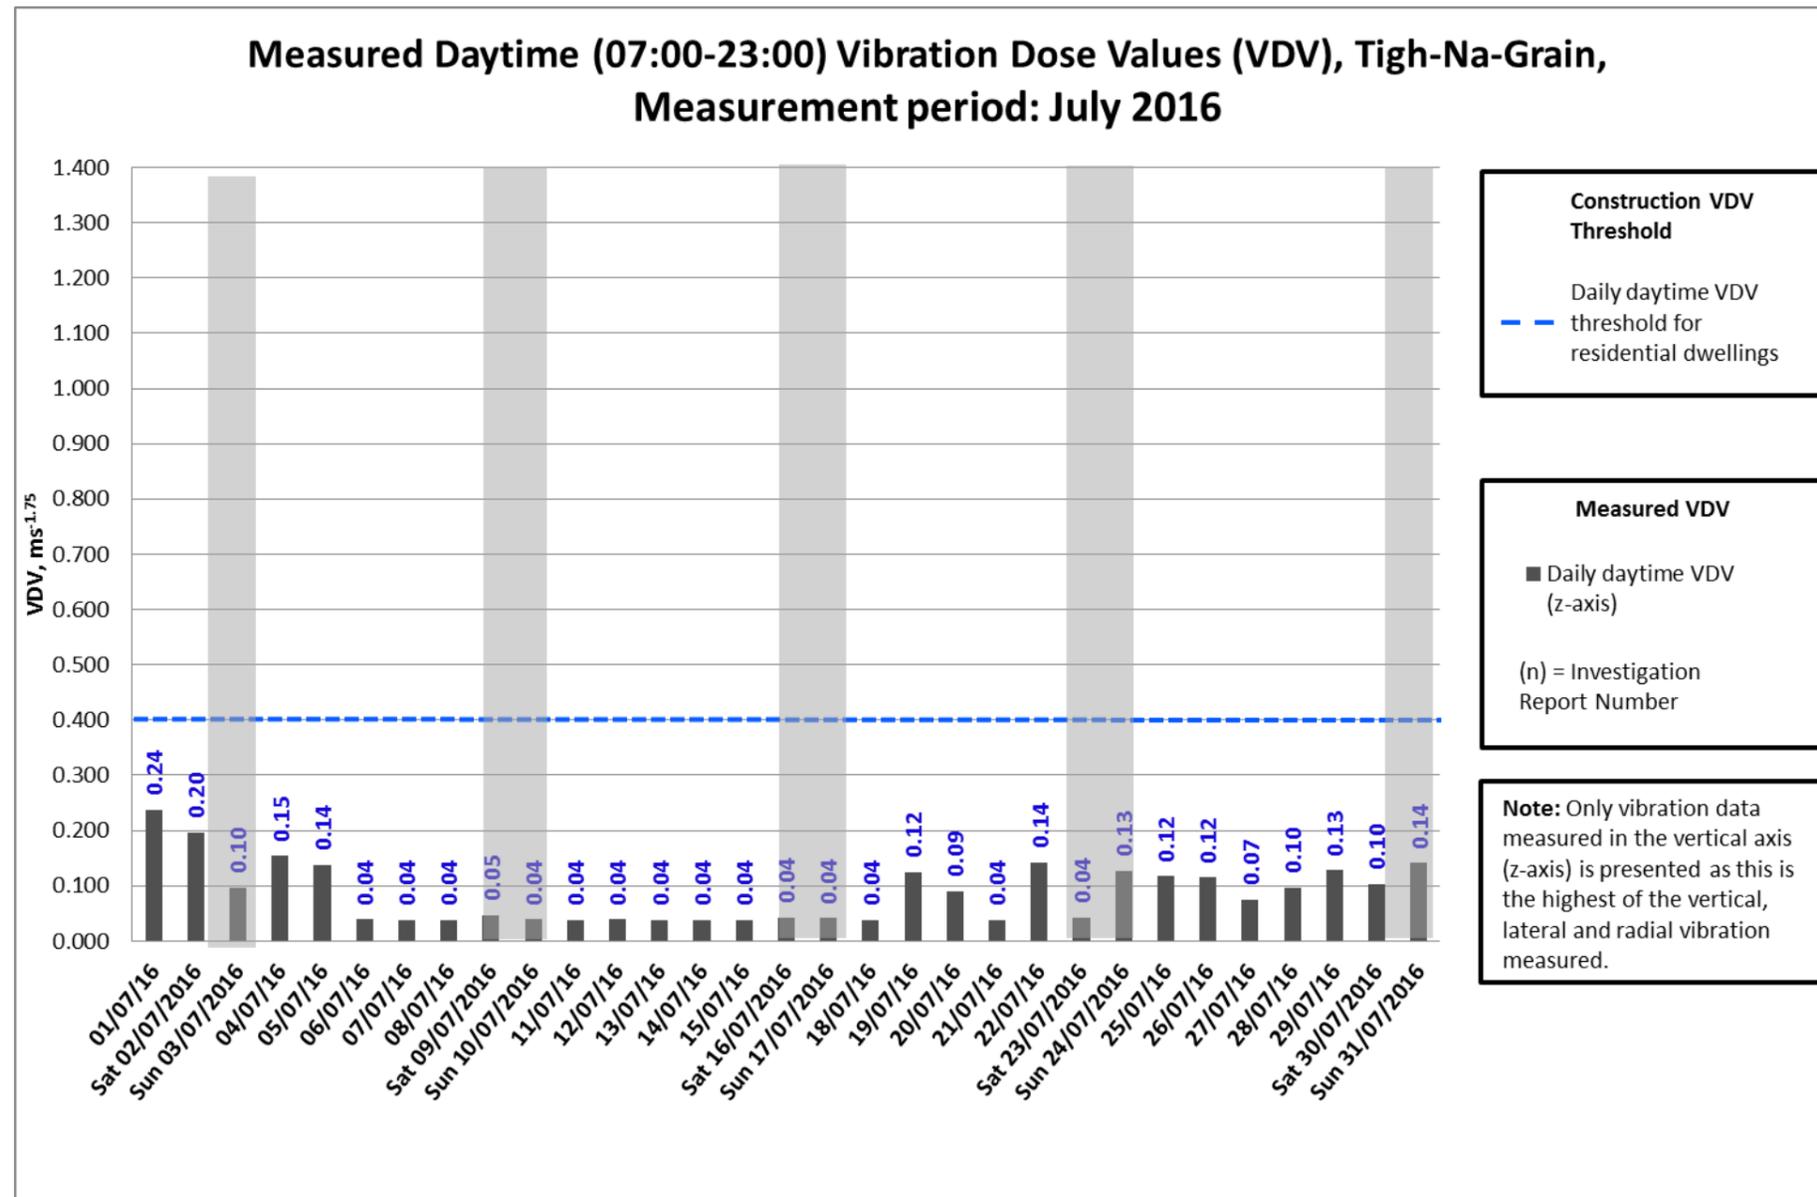
Exceedances on the 3<sup>rd</sup>, 11<sup>th</sup>, 17<sup>th</sup>, 21<sup>st</sup>, 24<sup>th</sup> and 31<sup>st</sup> of July have been investigated and found to be caused out with construction working hours and therefore it is unlikely that construction related activity was the cause of these events (graph above from the 11/07/2016).

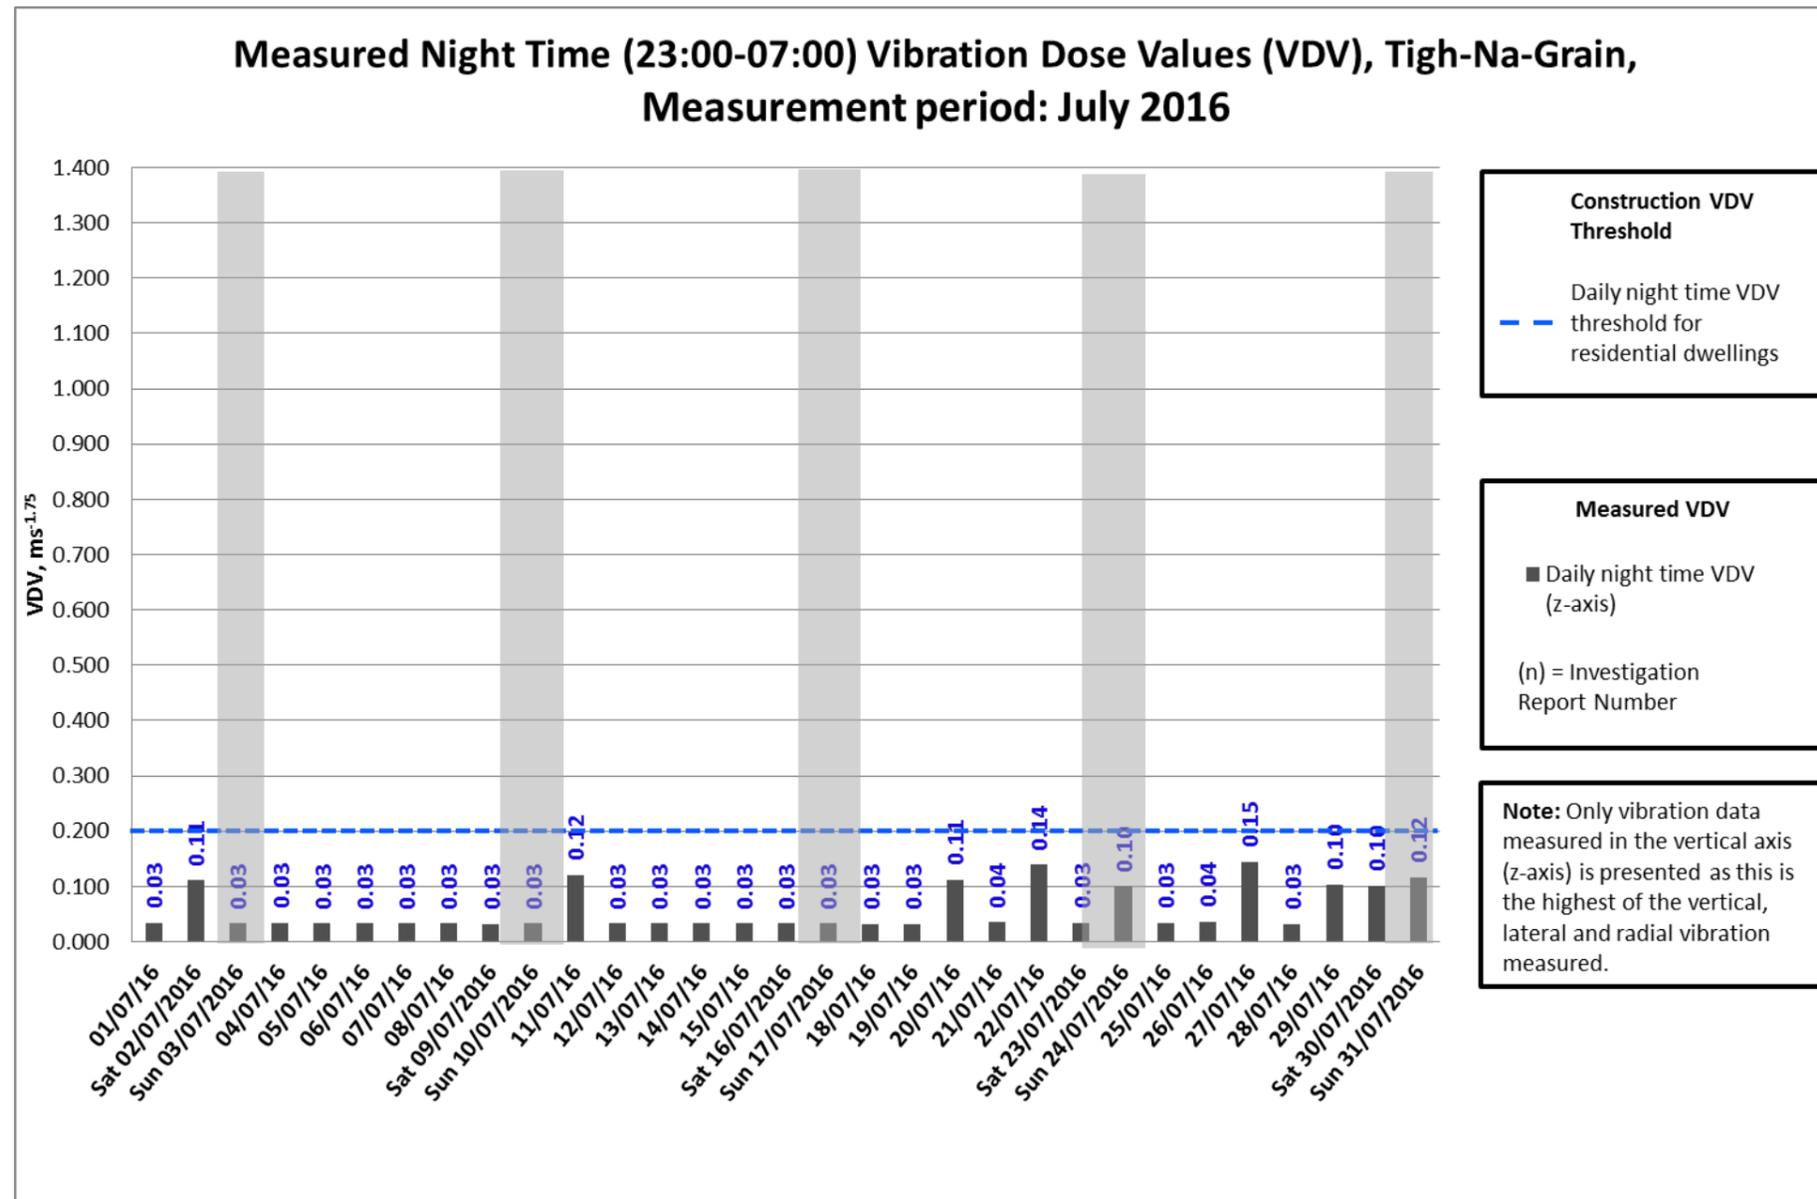
Exceedances on the 6<sup>th</sup>, 7<sup>th</sup>, 12<sup>th</sup>, 13<sup>th</sup>, 19<sup>th</sup>, 20<sup>th</sup>, 22<sup>nd</sup>, 28<sup>th</sup> and 29<sup>th</sup> of July have been investigated and found to be caused by individual isolated events that are unlikely to have been construction related activities (graph above from the 28/07/2016).
