Project **FORTH REPLACEMENT CROSSING**

VIBRATION MONITORING REPORT
JUNE 2016

Document number	Rev
REP-00284	00

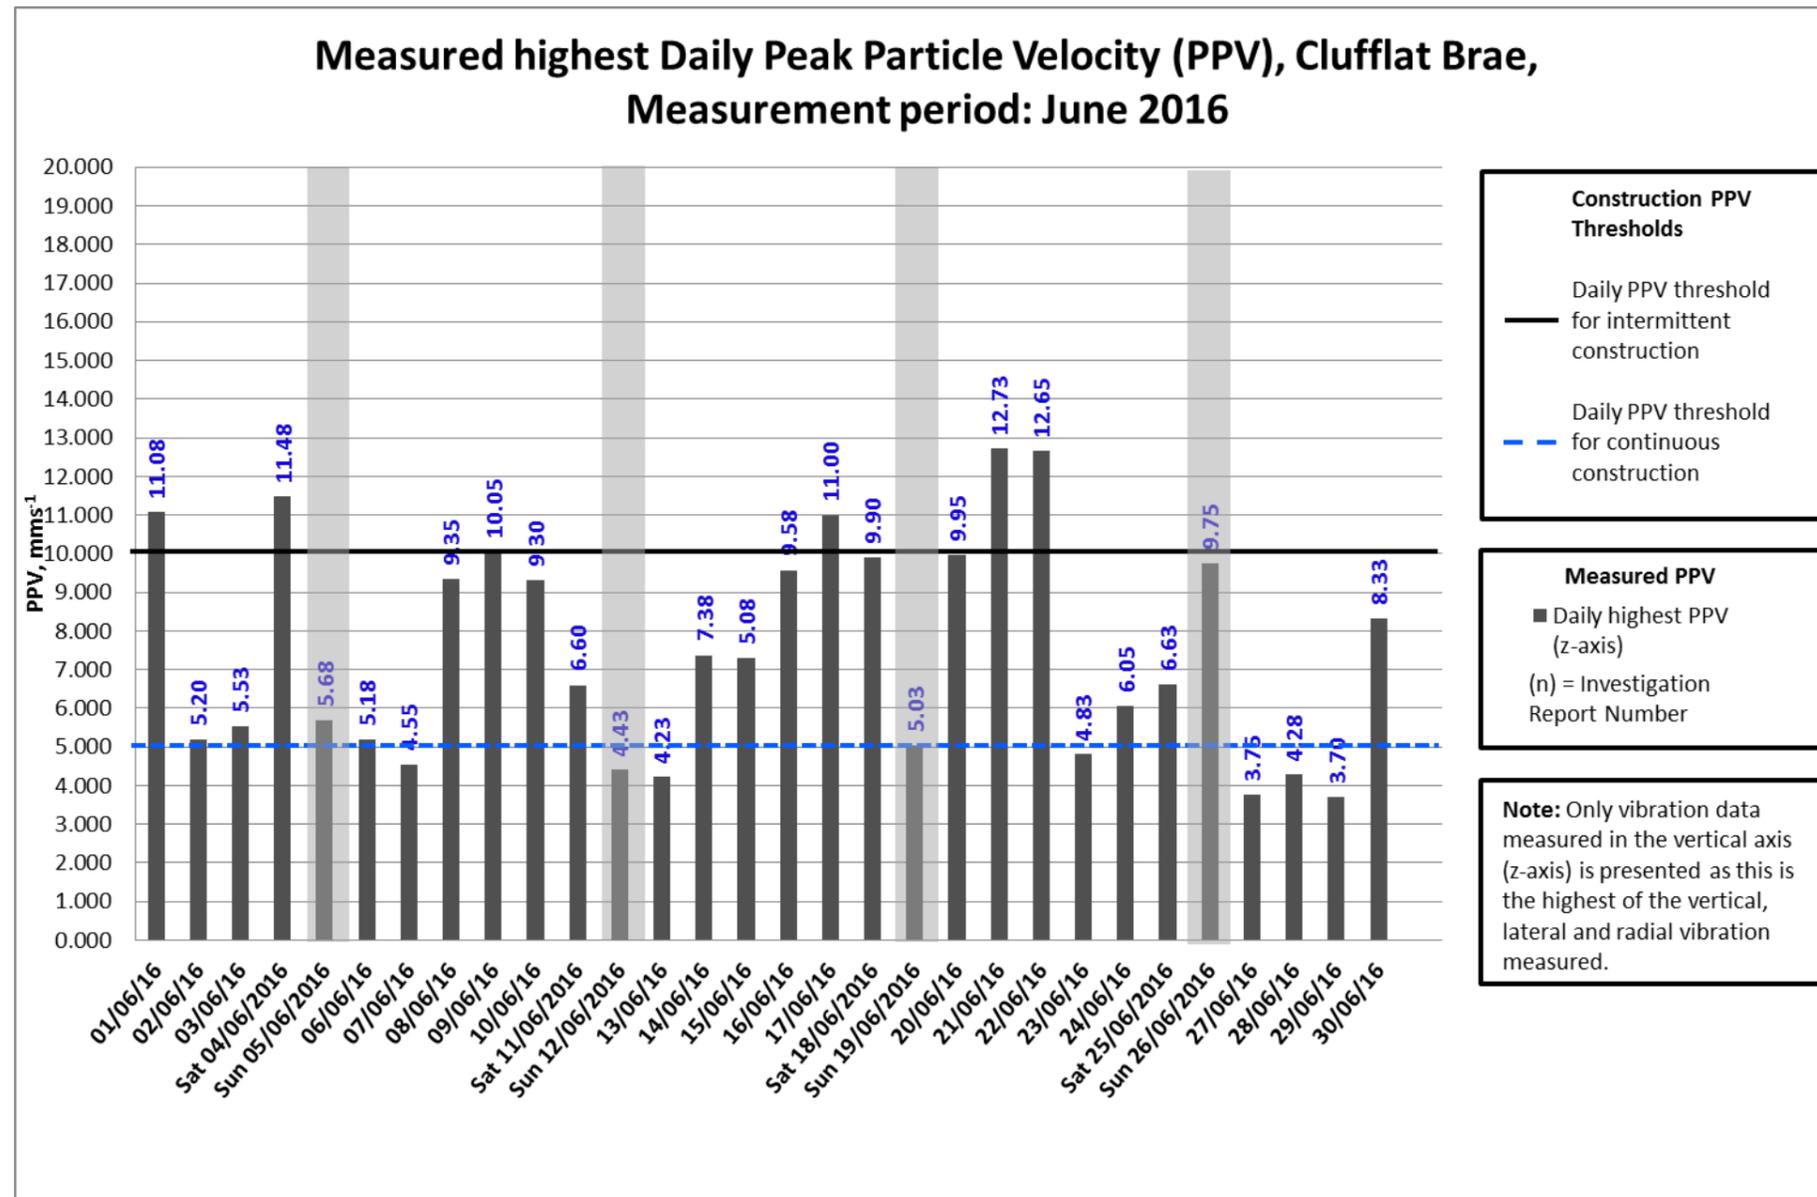
Exceedances on the 2nd, 3rd, 6th, 8th, 9th, 10th, 11th, 14th, 16th, 20th, 21st, 22nd, 24th, 25th and 30th of June have been investigated and found to be caused by individual isolated events (graph above from the 16/06/2016). Due to the closest works being approximately 220m away with minimal vibration emitting equipment used and the monitor being located in a public amenity area there is a likelihood that the exceedances seen above have been caused by pedestrian use of this area.

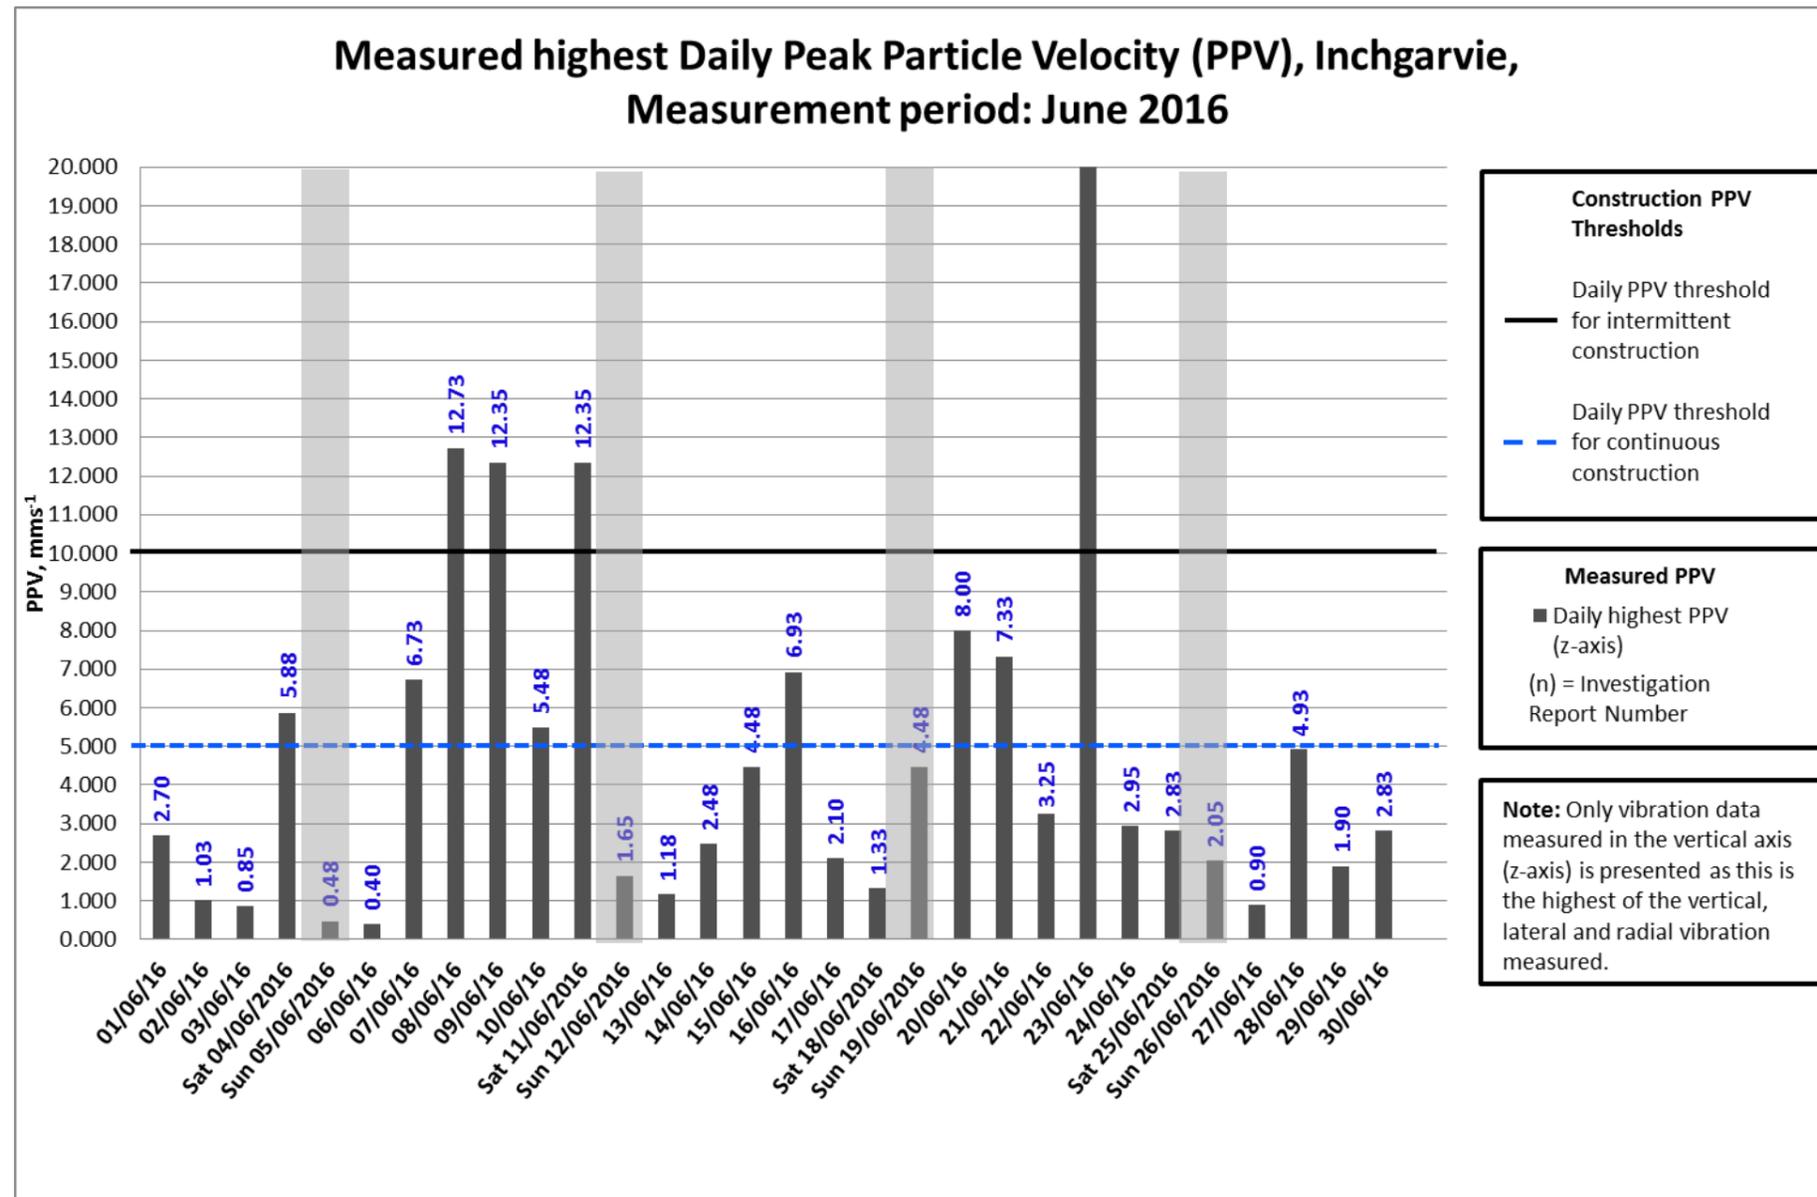
Exceedances on the 4th, 7th, 8th, 9th, 10th, 11th, 16th and 20th of June have been investigated and found to be caused by individual isolated events that are unlikely to have been construction related activities (graph above from the 11/06/2016).

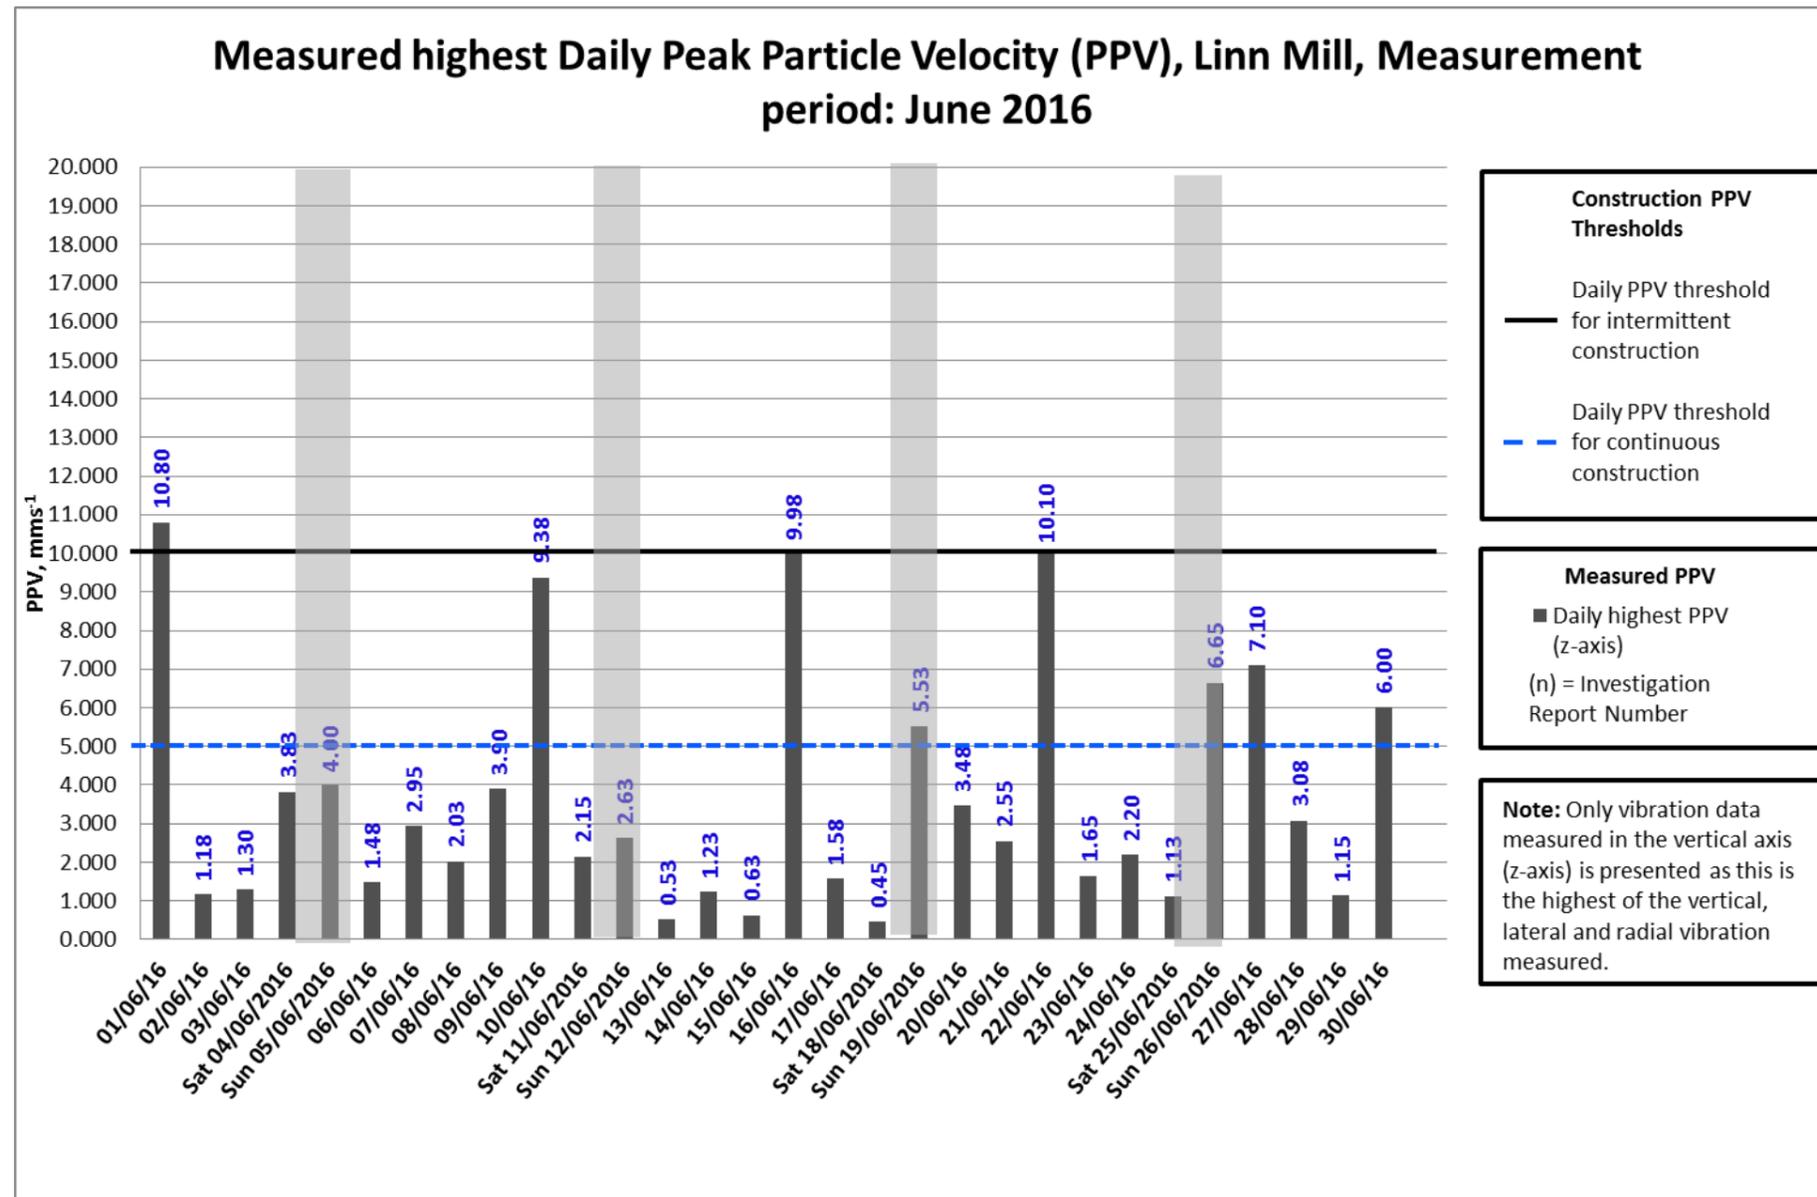
Exceedances on the 10th, 16th, 22nd, 27th and 30th of June have been investigated and found to be caused by individual isolated events that are unlikely to have been construction related activities (graph above from the 10/06/2016).

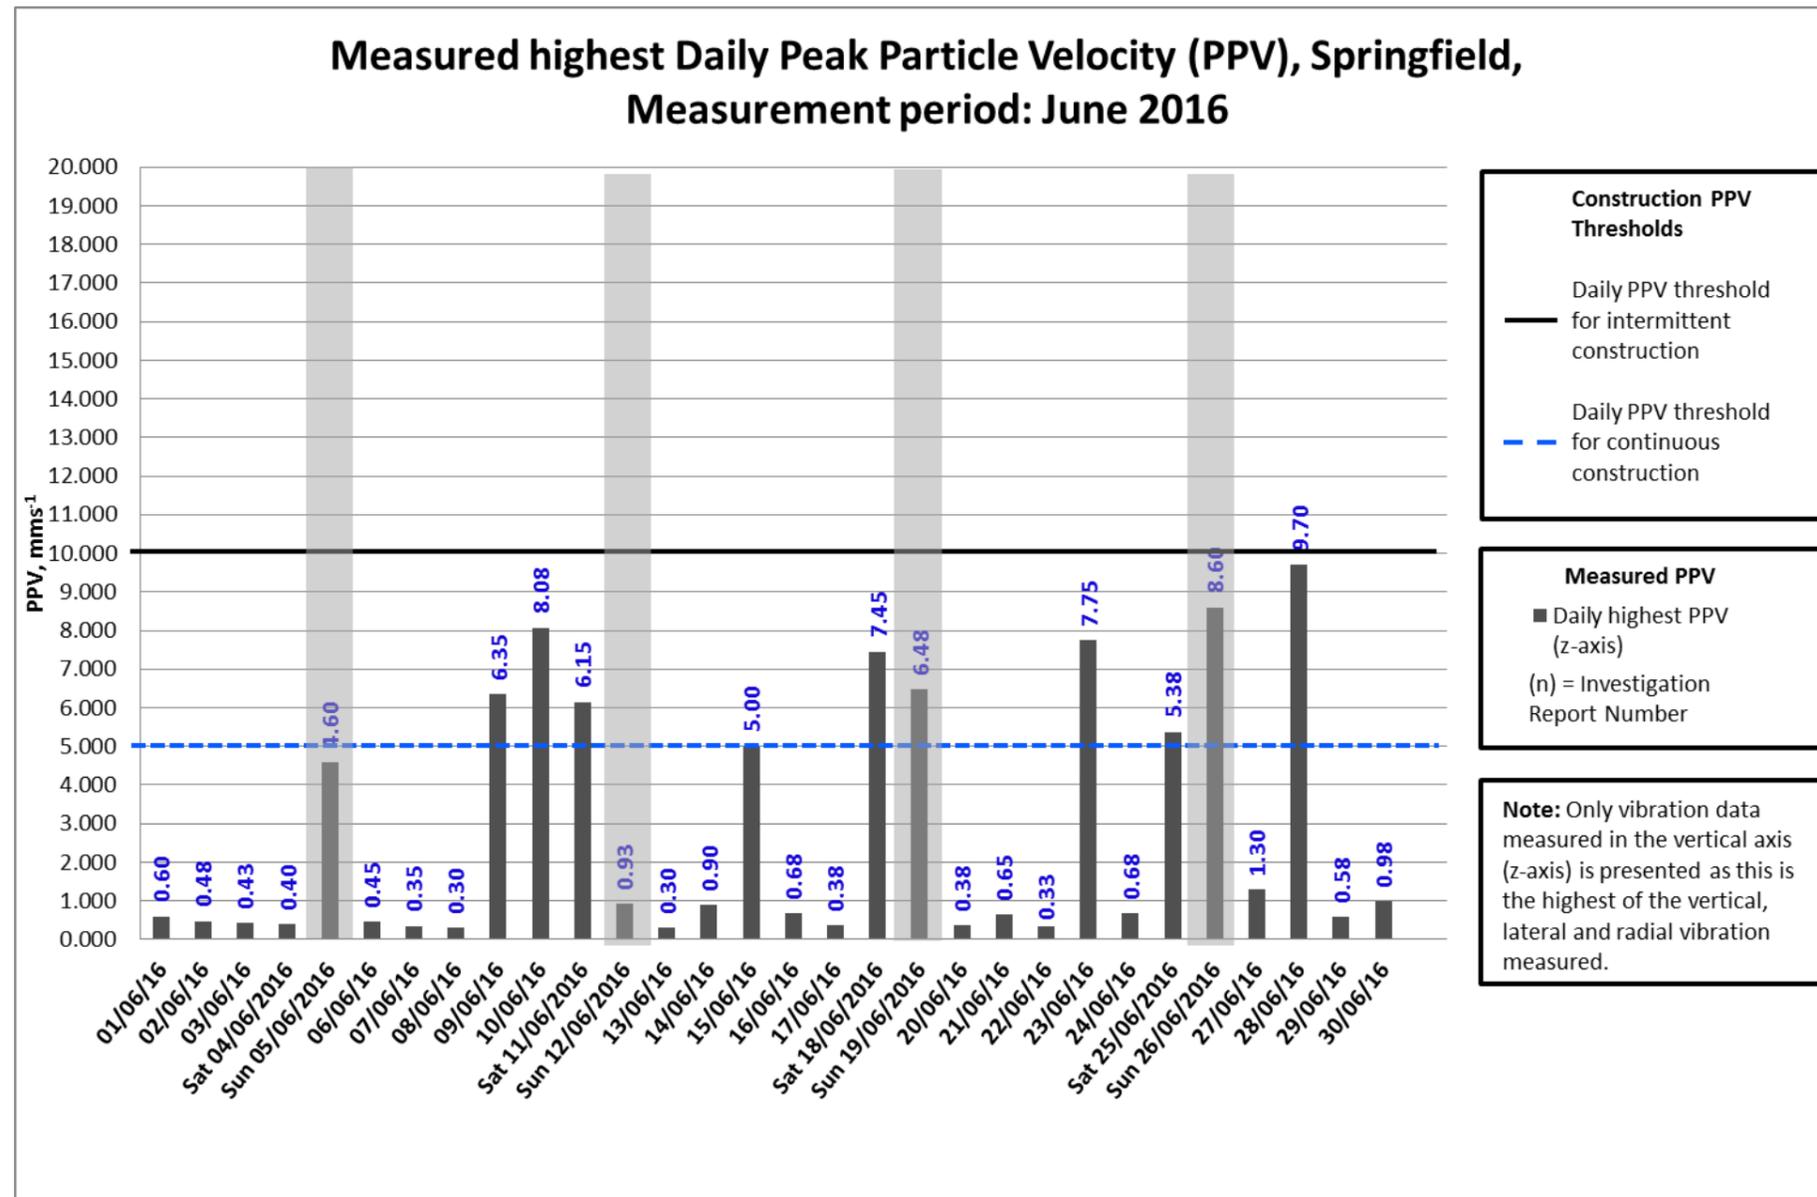
Exceedances on the 9th, 10th, 11th, 15th, 18th, 23rd, 25th and 28th of June have been investigated and found to be caused by individual isolated events that are unlikely to have been construction related activities (graph above from the 10/06/2016) .

Exceedances on the 19th and 26th of June have been investigated and were caused out of normal working hours for the road building section and as such it is unlikely that these exceedances were caused by construction related activities.

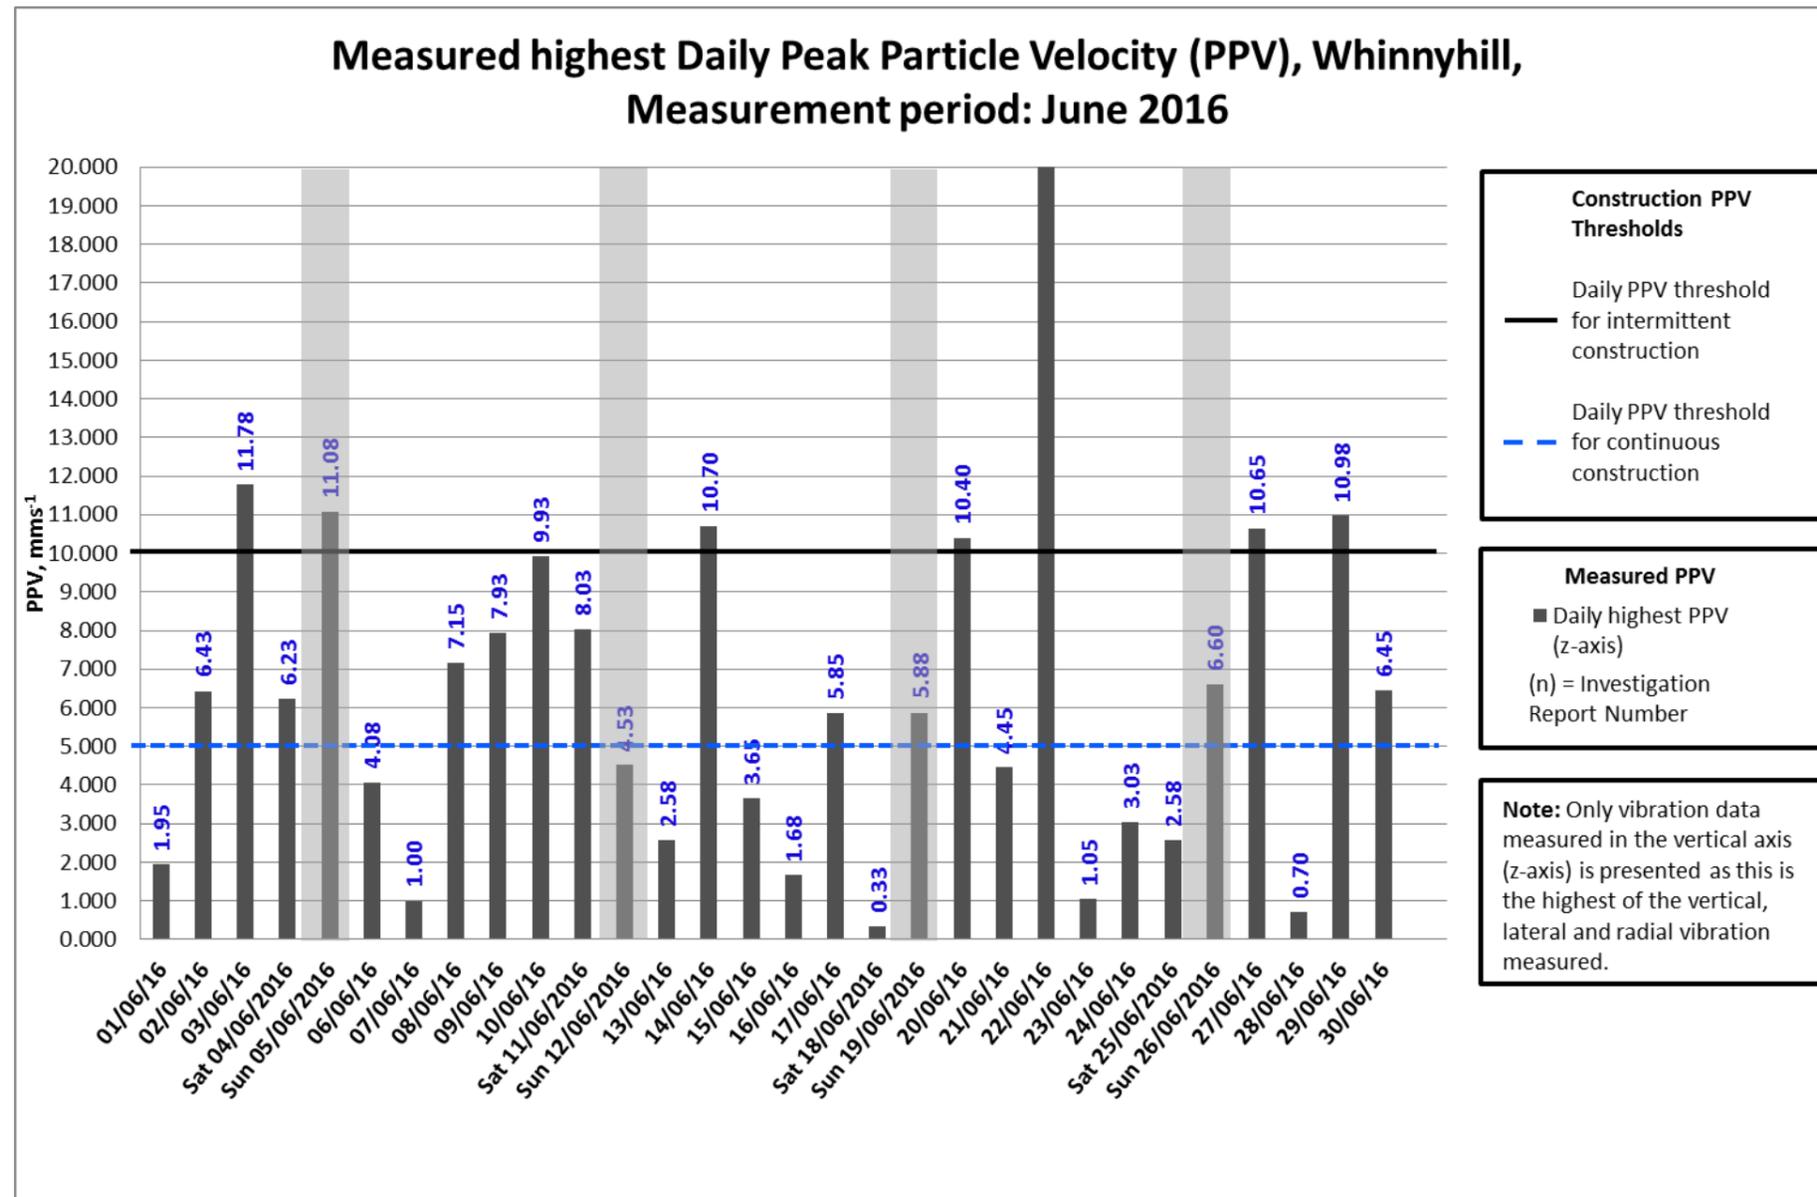
Exceedances on the 2nd, 3rd, 4th, 9th, 10th, 11th, 14th, 17th, 22nd, 27th, 29th and 30th of June have been investigated and found to have been caused by individual isolated events that are unlikely to have been construction related activities (graph above from the 22/06/2016).

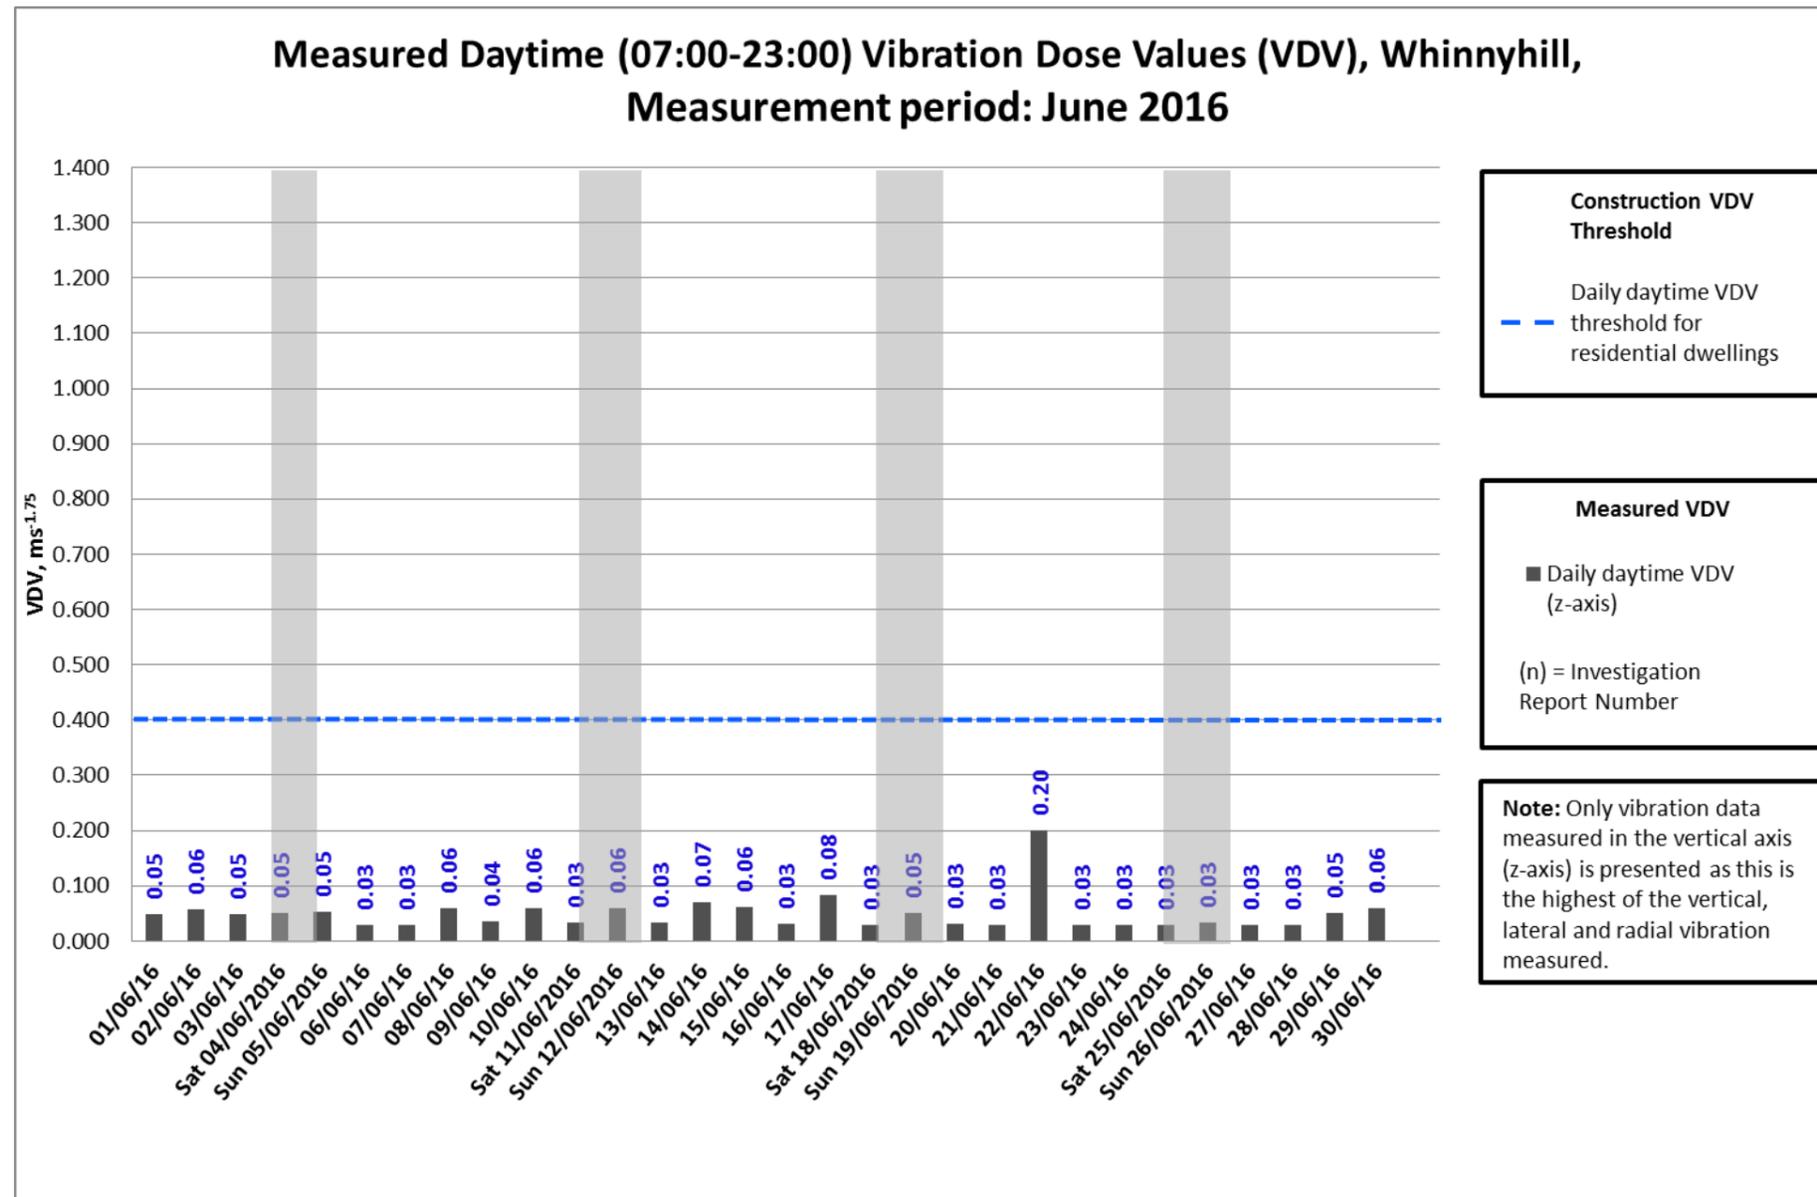
Exceedances on the 5th, 8th, 19th, 20th and 26th of June have been investigated and were caused out of normal working hours for the road building section and as such it is unlikely that these exceedances were caused by construction related activities (graph above from the 08/06/2016).
