Queensferry  
Crossing

Project FORTH REPLACEMENT CROSSING

VIBRATION MONITORING REPORT  
MAY 2016

<p>Document status</p> <p style="font-size: 1.5em; font-weight: bold;">FOR REVIEW</p>	
Made by Michael Richardson	Checked By: Steven Westwater
Initials: MRN	Initials: SWR
Document number <b>REP-00280</b>	Rev <b>00</b>

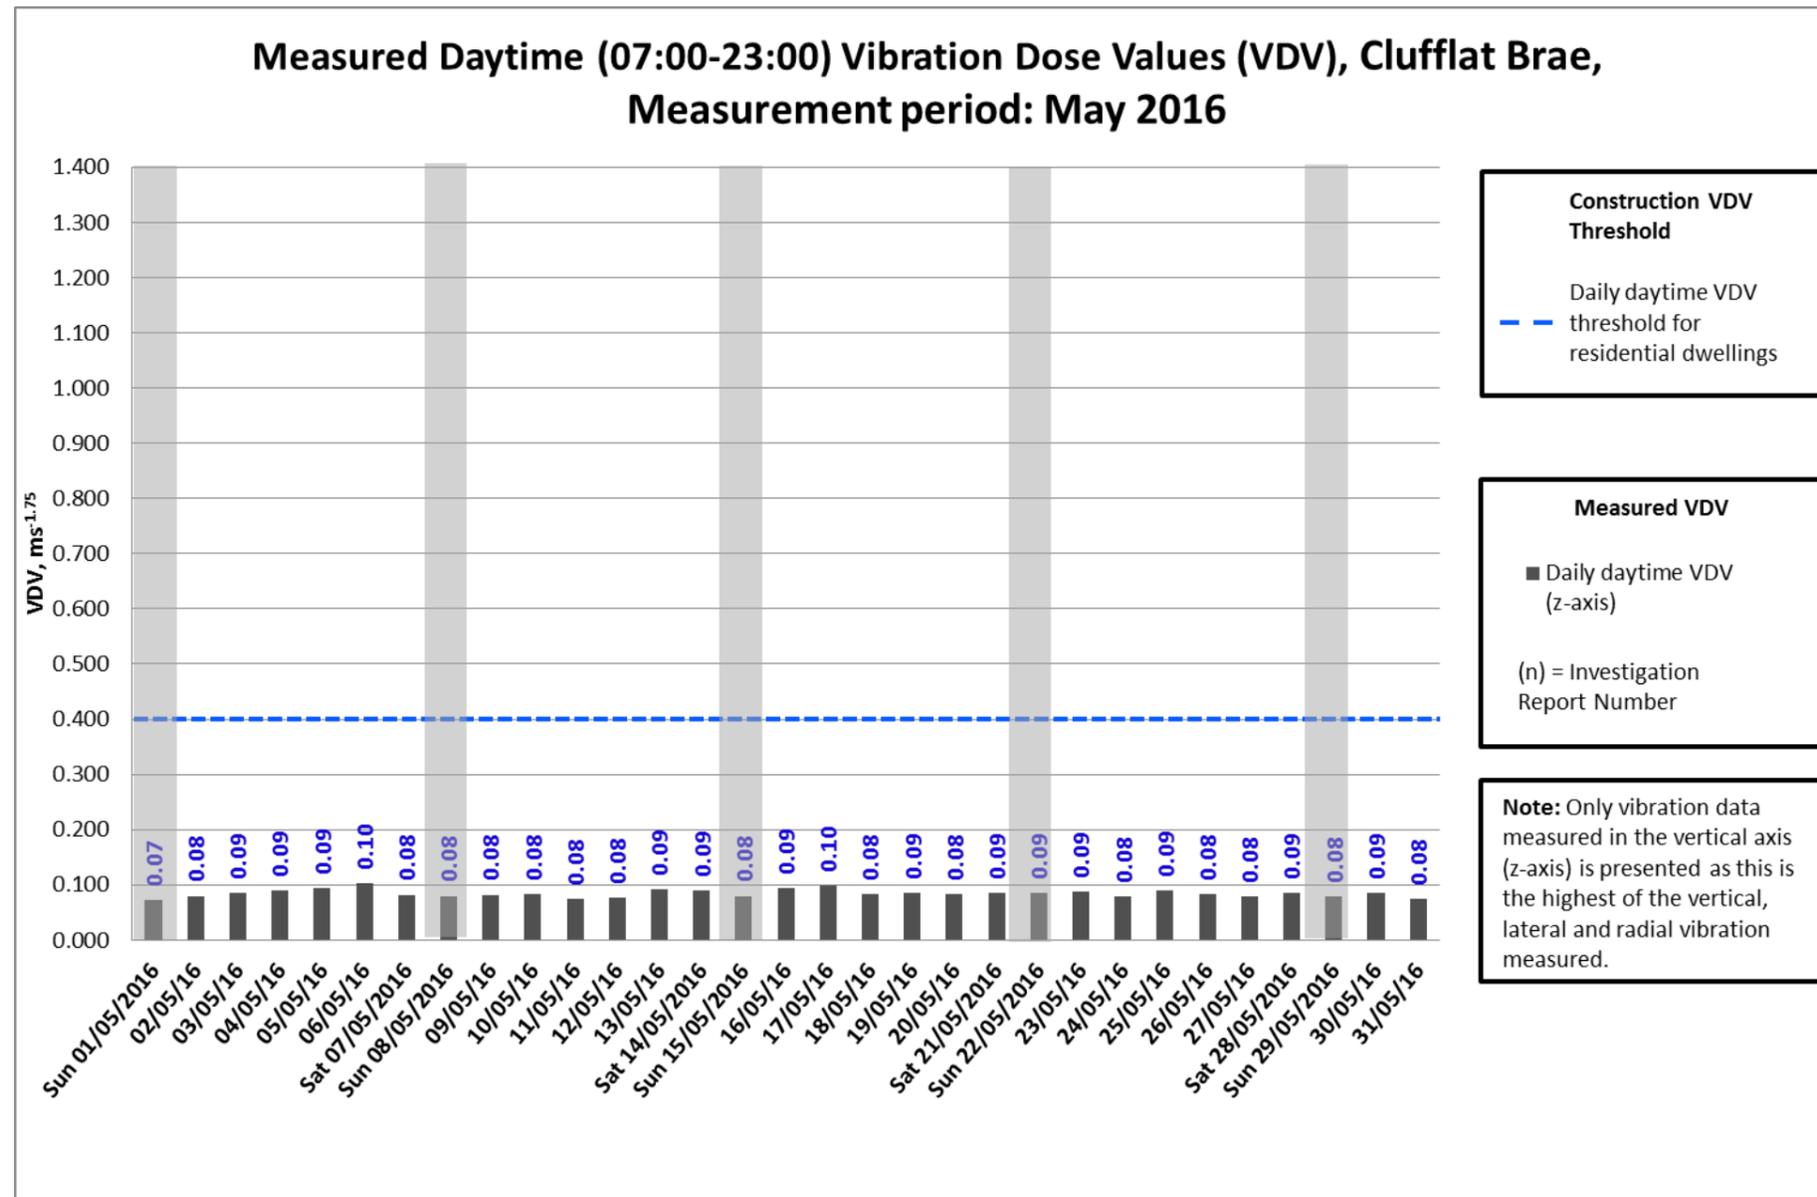
Exceedance on the 25<sup>th</sup> of May has been investigated and found to be caused by the environmental department recovering the Frisbee sample at this location. Due to close proximity of the Vibration monitor to the Frisbee monitor activity was picked up.

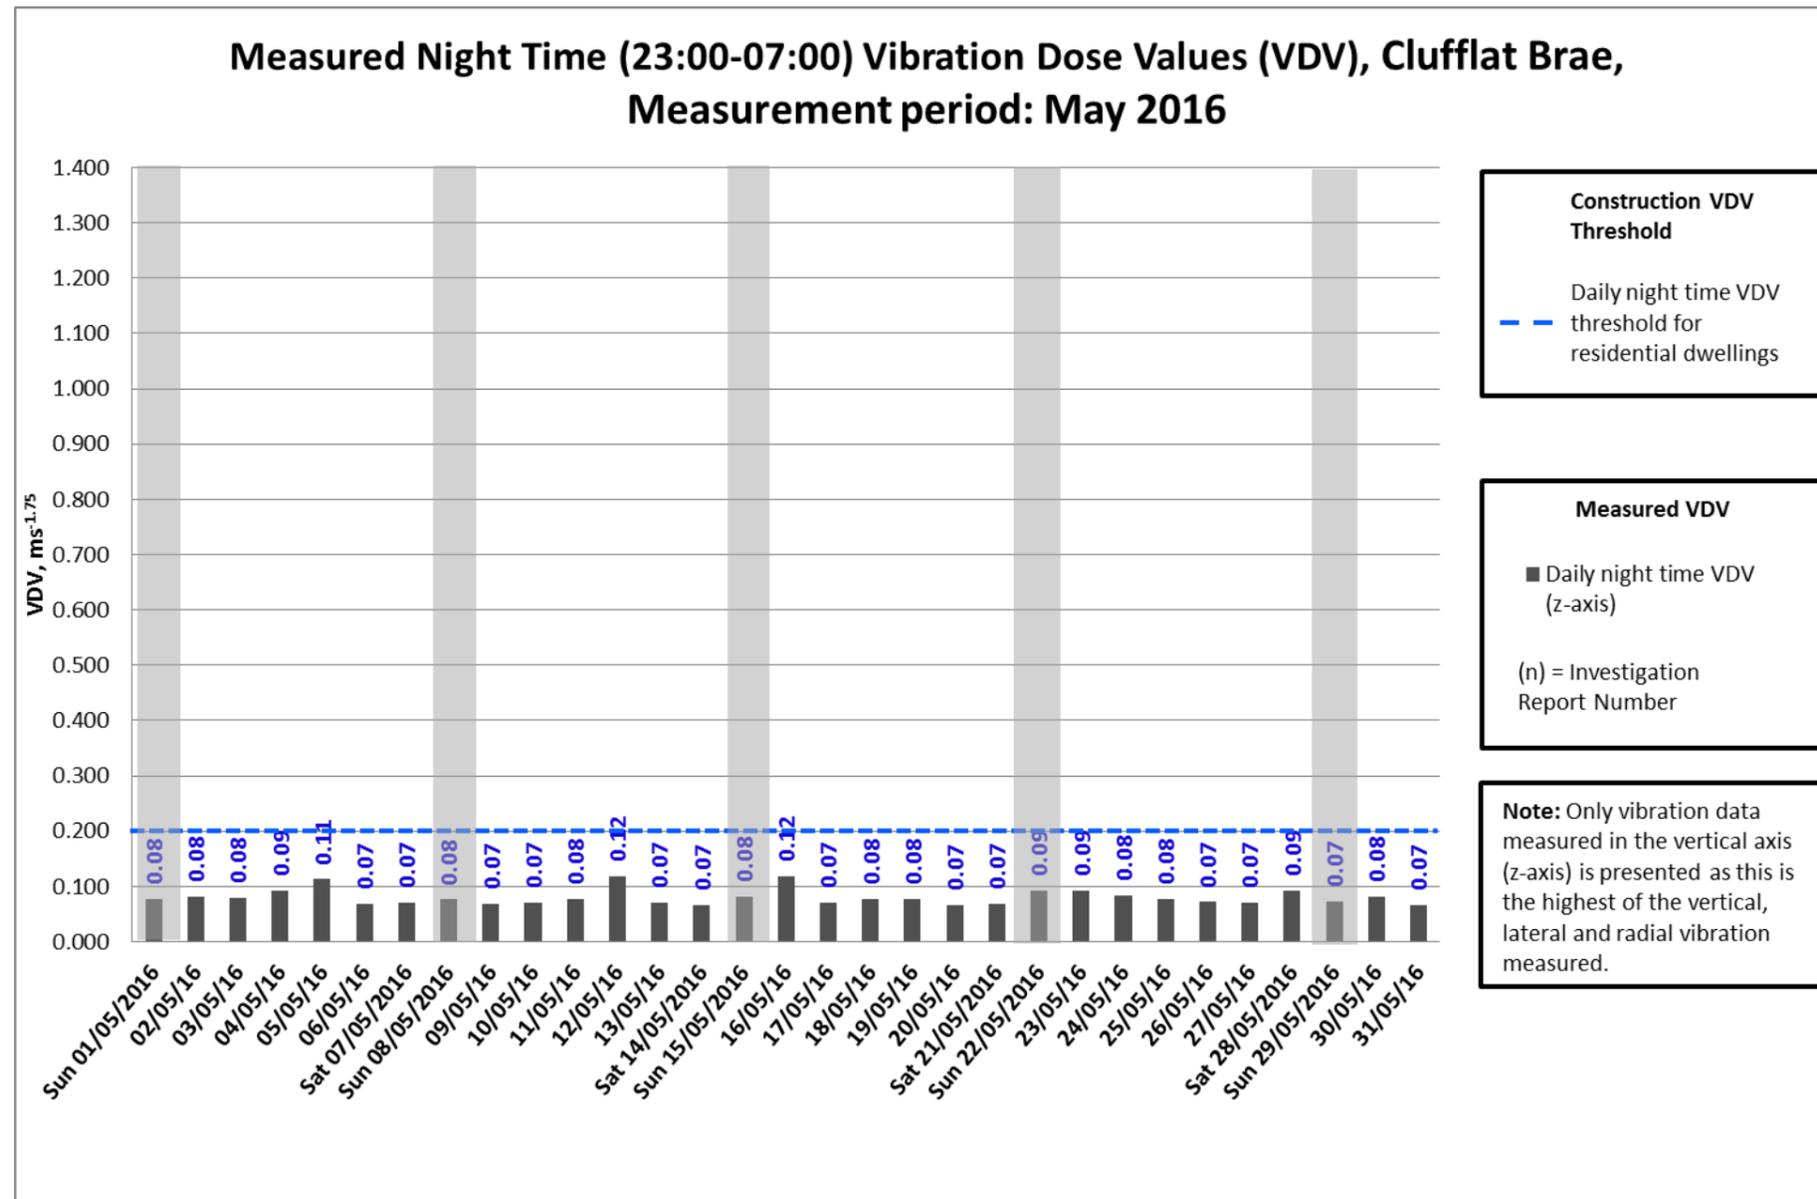
Data missing from the 1<sup>st</sup> to the 10<sup>th</sup> of May was caused by power issue at the monitor location. This has since been resolved on the 11<sup>th</sup> of May.

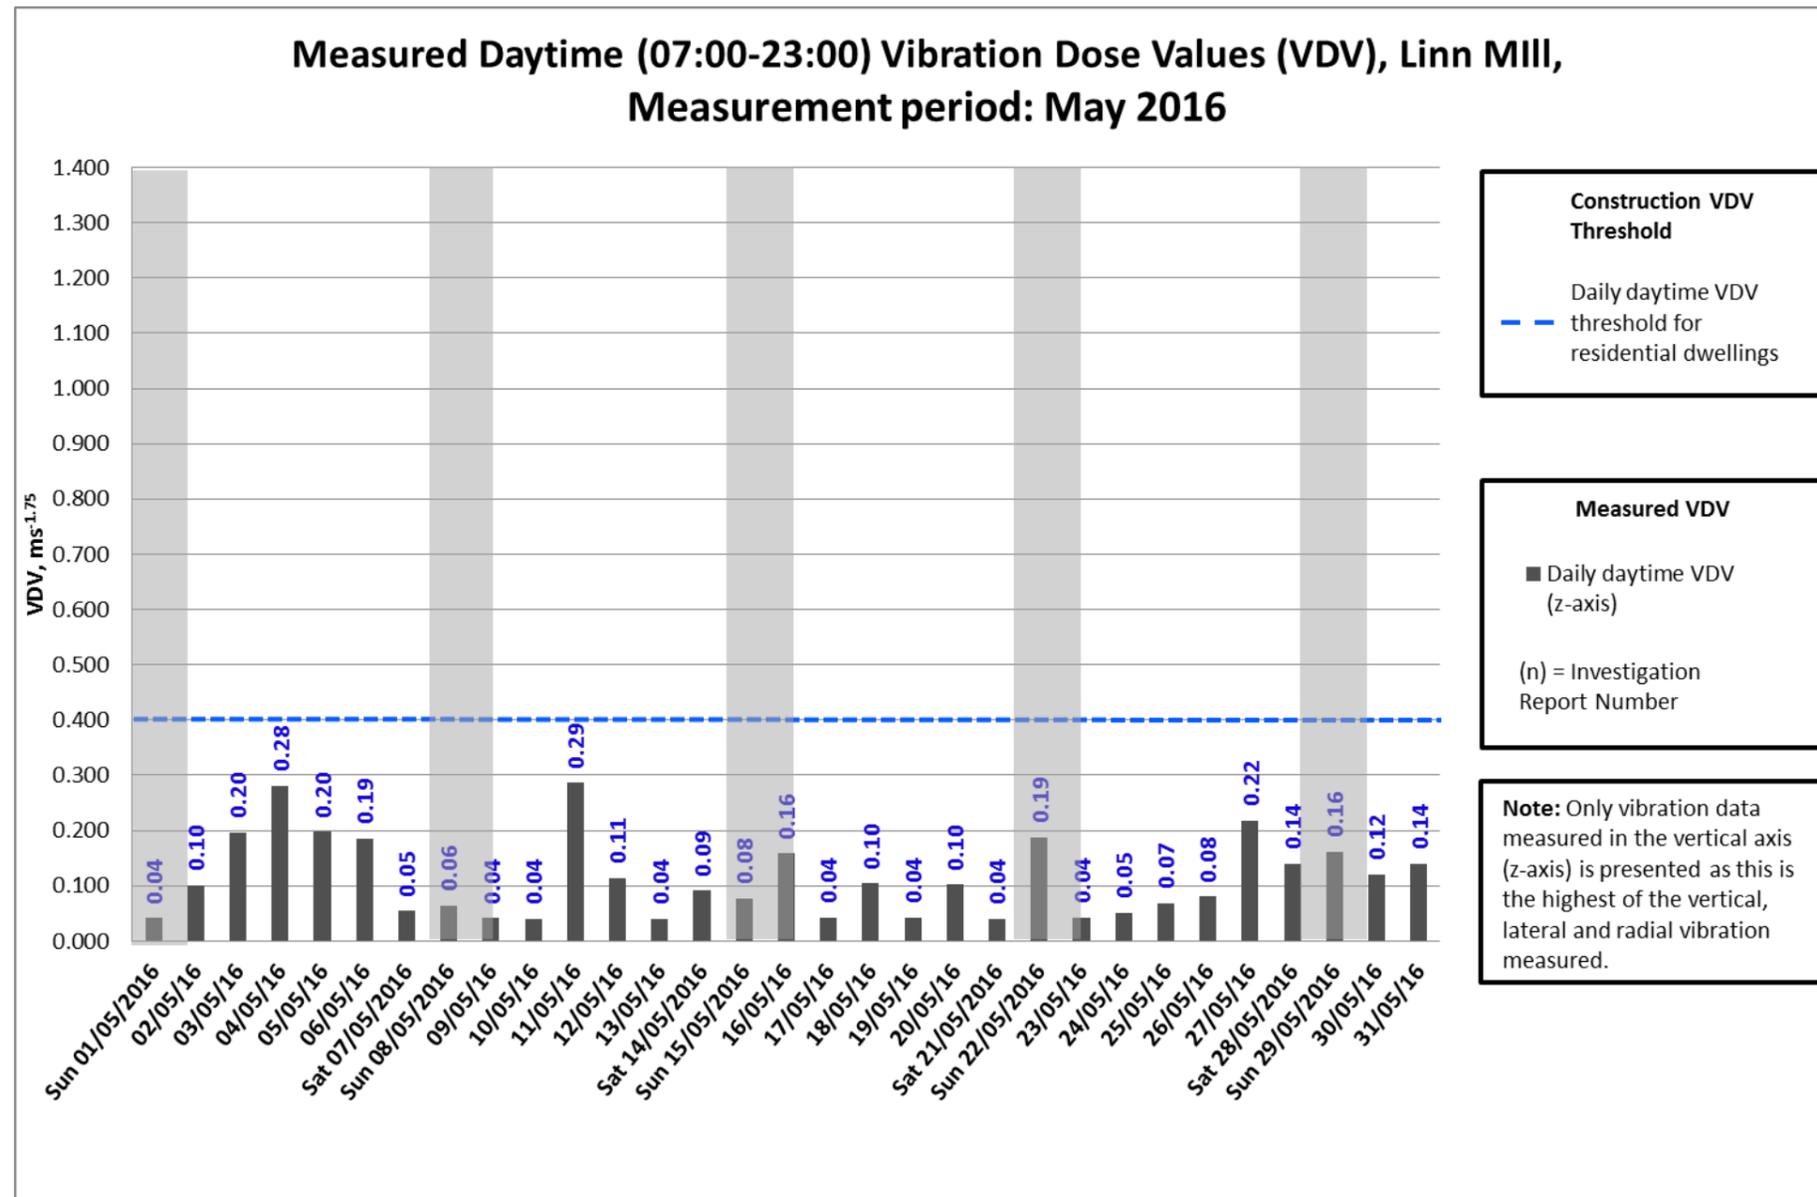
Exceedances on the 20<sup>th</sup> and 25<sup>th</sup> of May have been investigated and found to be caused out with construction working hours and therefore it is unlikely that construction related activity was the cause of these (graph above from the 20/05/2016).

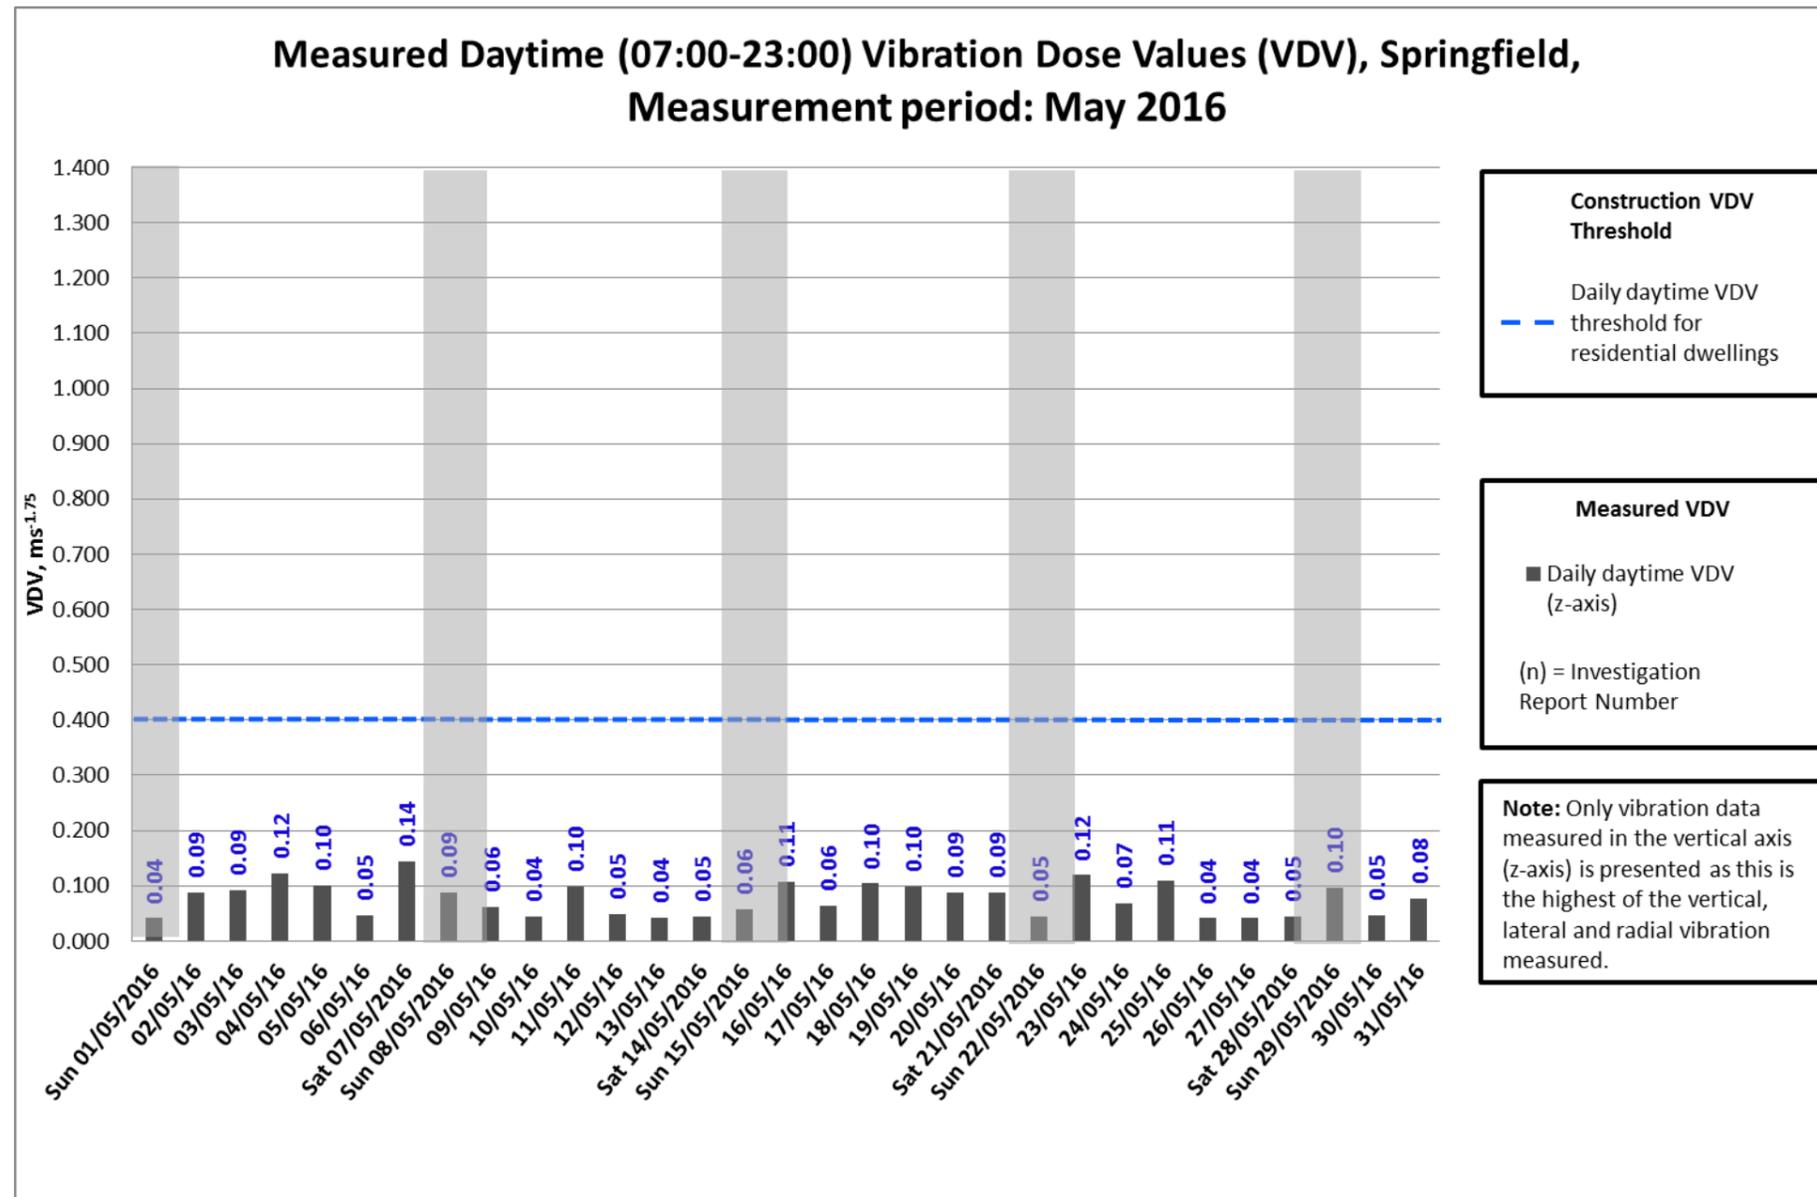
Exceedances on the 5<sup>th</sup>, 8<sup>th</sup>, 16<sup>th</sup>, 18<sup>th</sup> and 19<sup>th</sup> of May have been investigated and found to be caused out with construction working hours and therefore it is unlikely that construction related activity was the cause of these (graph above from the 05/05/2016).

During the reported period there has been significant activity from the local residents picked up on the noise monitor from which the vibration monitor is situated at. Due to this there is a likelihood that the exceedances portrayed in the graph above have been caused by this close proximity movement.

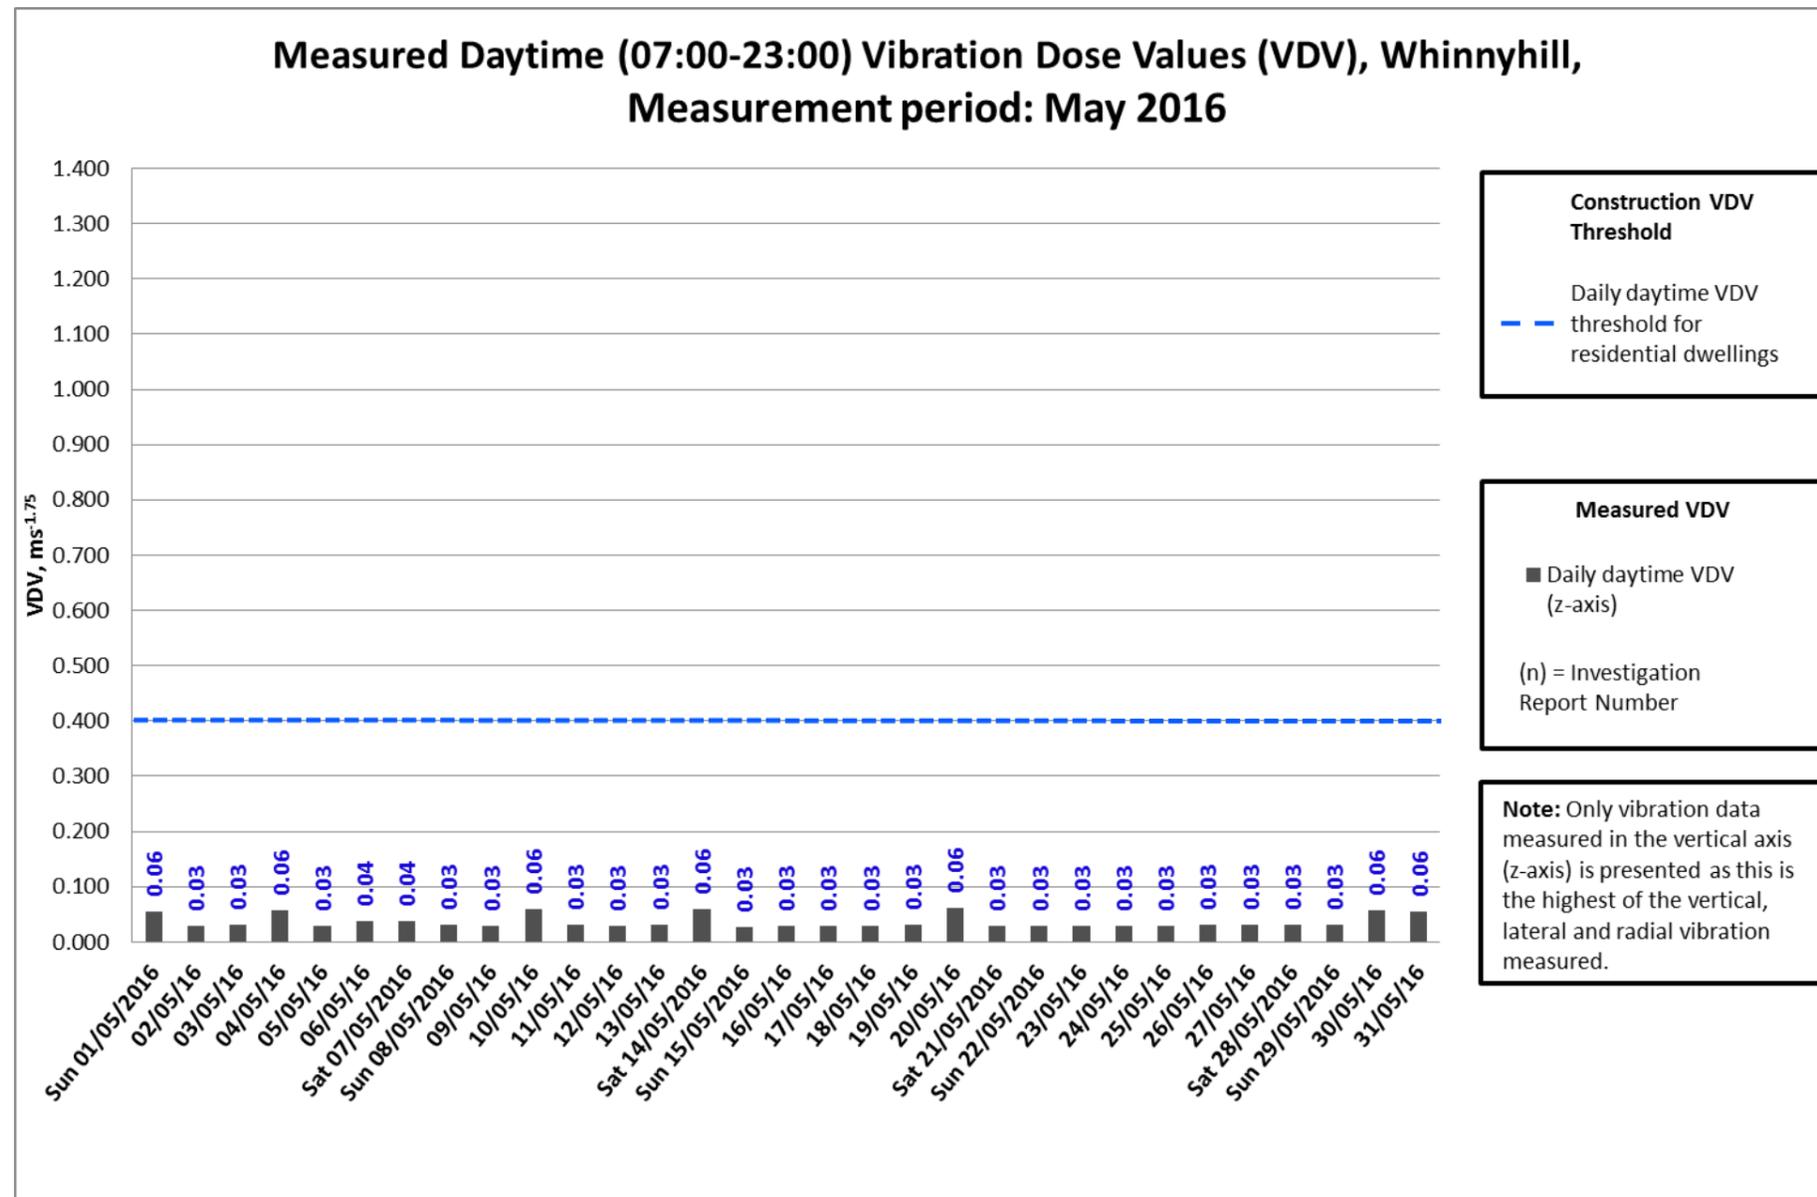
Exceedances on the 4<sup>th</sup> of May have been investigated and found to be caused out with construction working hours and therefore it is unlikely that construction related activity was the cause of these (graph above from the 04/05/2016).
