Project **FORTH REPLACEMENT CROSSING**

**VIBRATION MONITORING REPORT
NOVEMBER 2015**

Document number	Rev
REP-00260	00

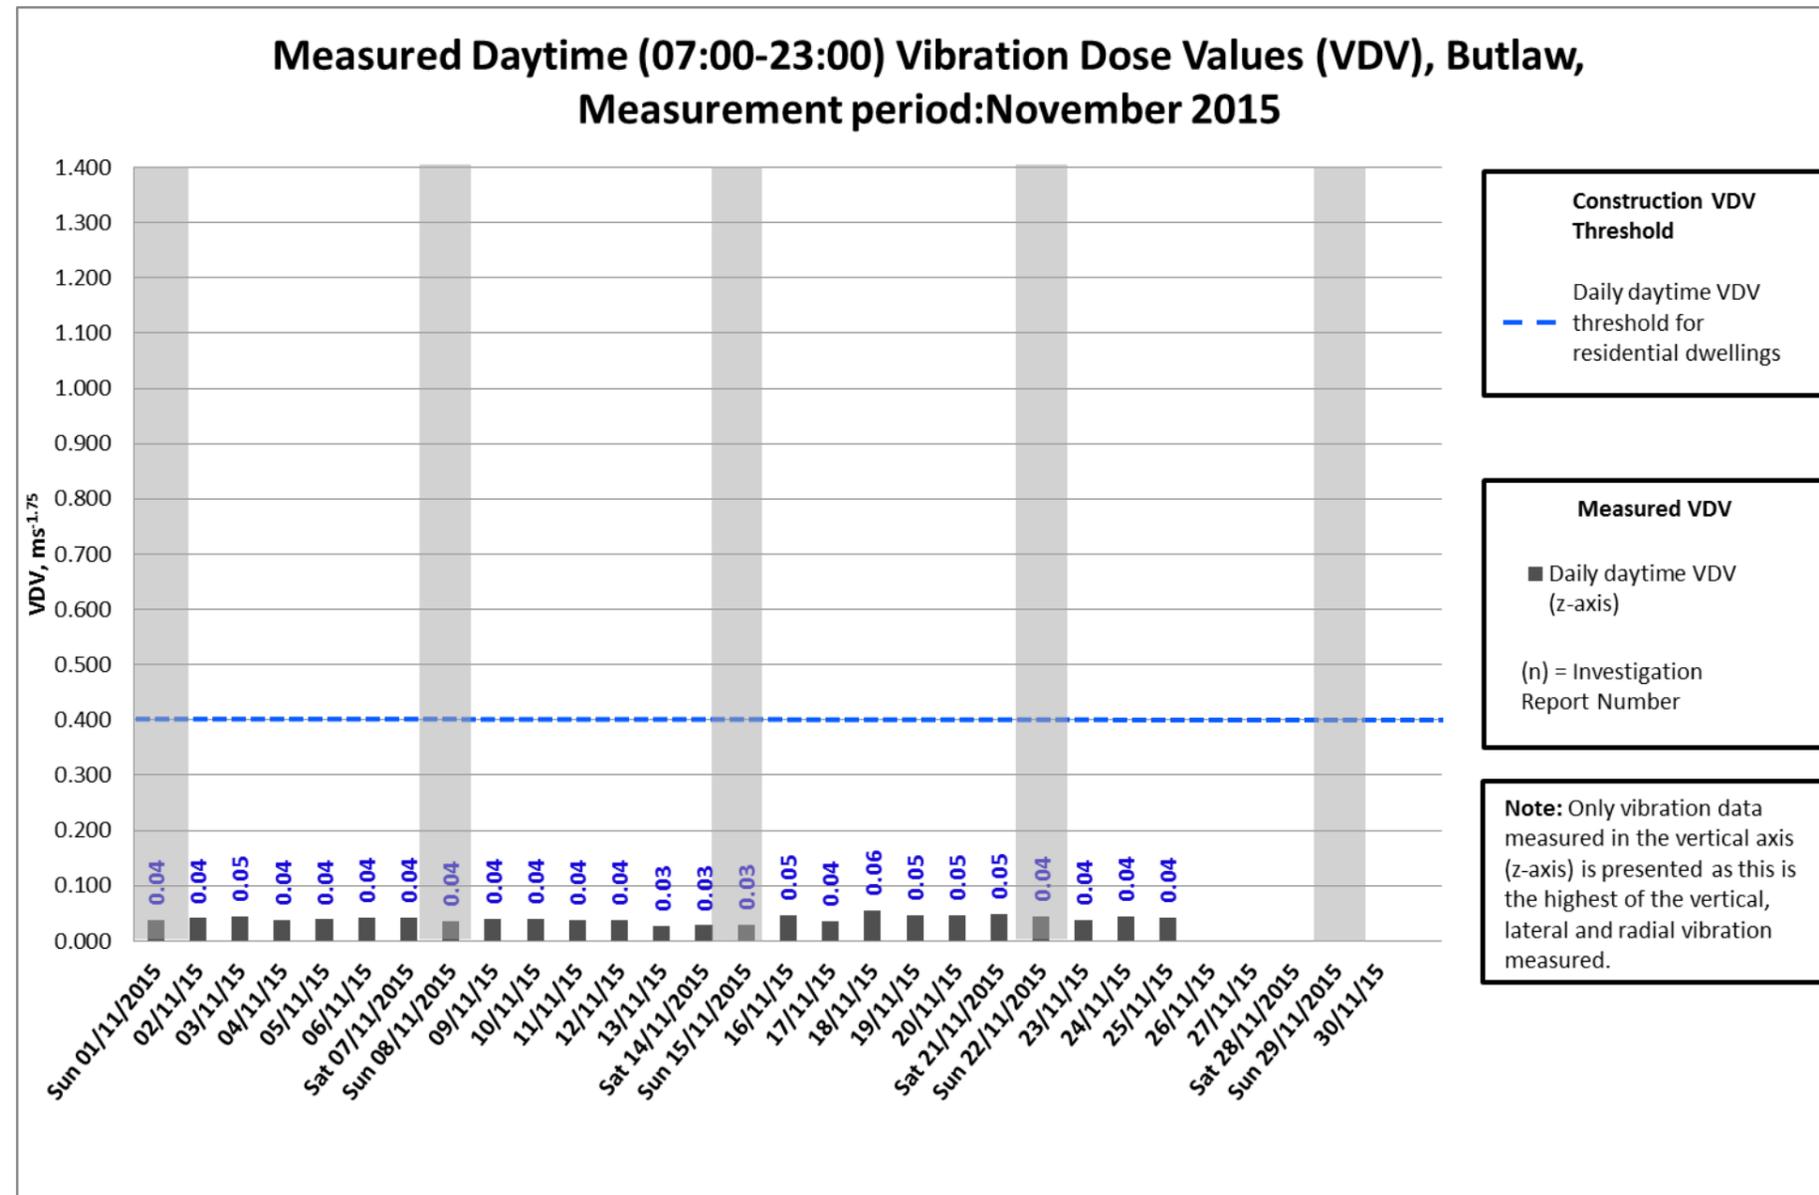
Vibration levels missing from 26/11/15-30/11/15 was caused by a power fault at the monitor this has since been repaired.

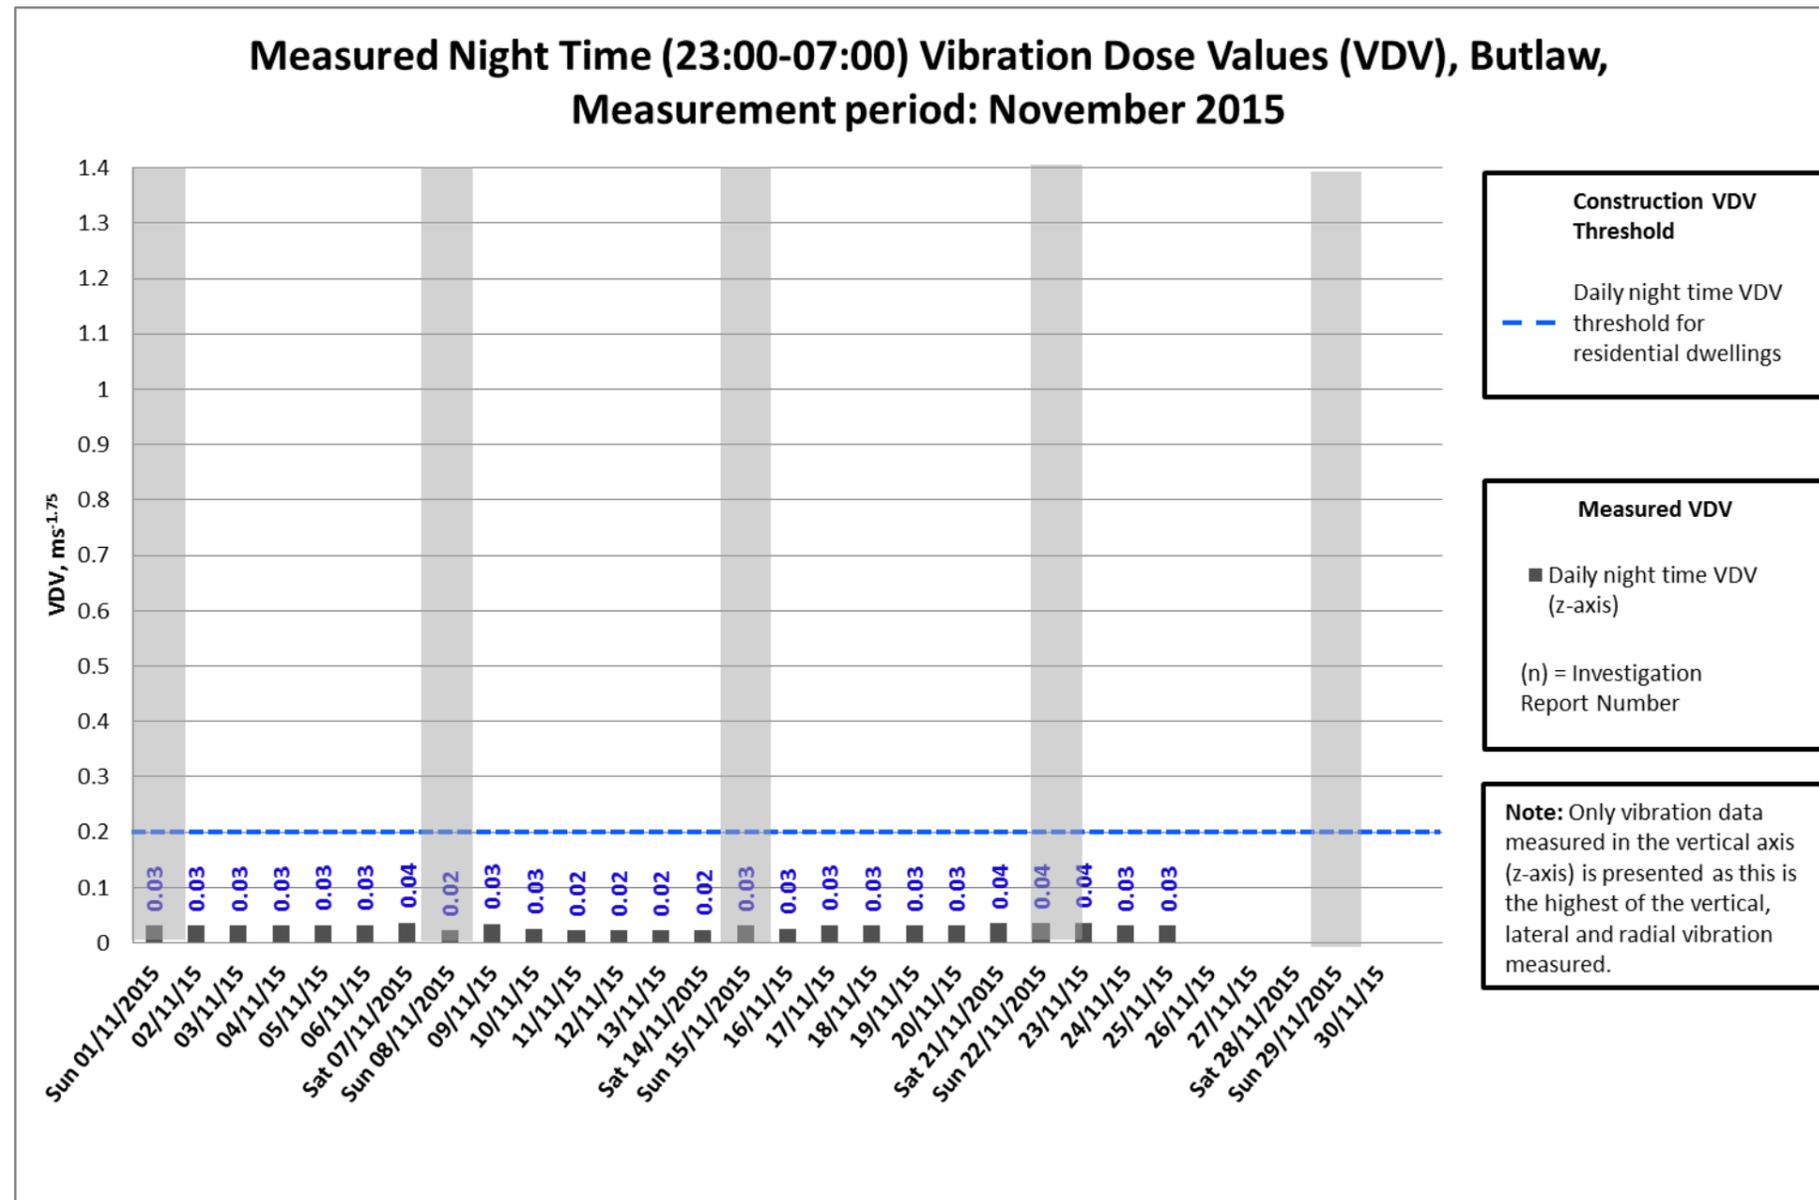
Vibration levels missing from 26/11/15-30/11/15 was caused by a power fault at the monitor this has since been repaired.

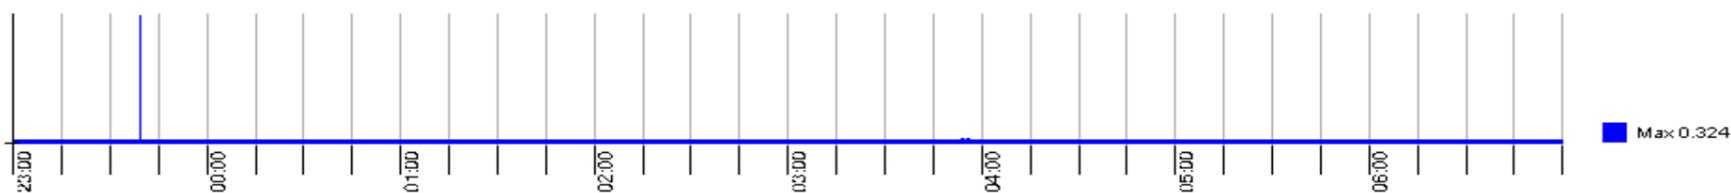
Exceedance on the 7th and 12th of November have been investigated and found to be one off isolated events out with construction working hours and are highly unlikely to have been caused by construction related activities (graph above from the 07/11/2015).

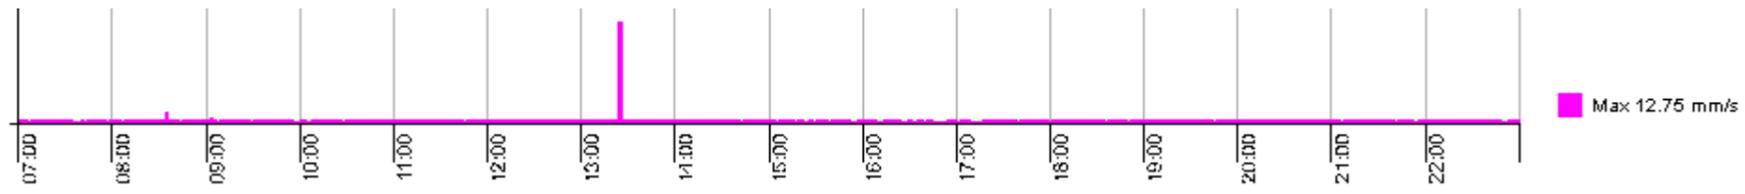
Exceedances on the 3rd, 6th, and 28th have been investigated and found to be caused by one off isolated events that are highly unlikely to have been caused by construction related activities (graph above from the 06/11/2015).

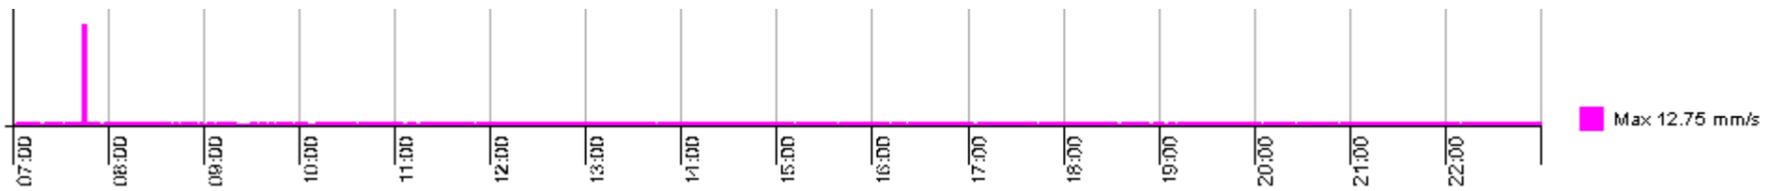
Exceedance on the 8th, 15th, 27th, and 29th have been investigated and found to be out with construction working hours and are highly unlikely to have been caused by construction related activities (graph above from the 27/11/2015).
