Project **FORTH REPLACEMENT CROSSING**

VIBRATION MONITORING REPORT
OCTOBER 2016

Document status		FOR REVIEW	
Made by David Clark		Checked By: Steven Westwater	
Initials: DCK		Initials: SWR	
Document number			Rev
REP-00297			00
This document is intellectual property of FCBC Construction JV. Copying, distribution, usage, and information on contents of this are forbidden unless explicitly authorized.

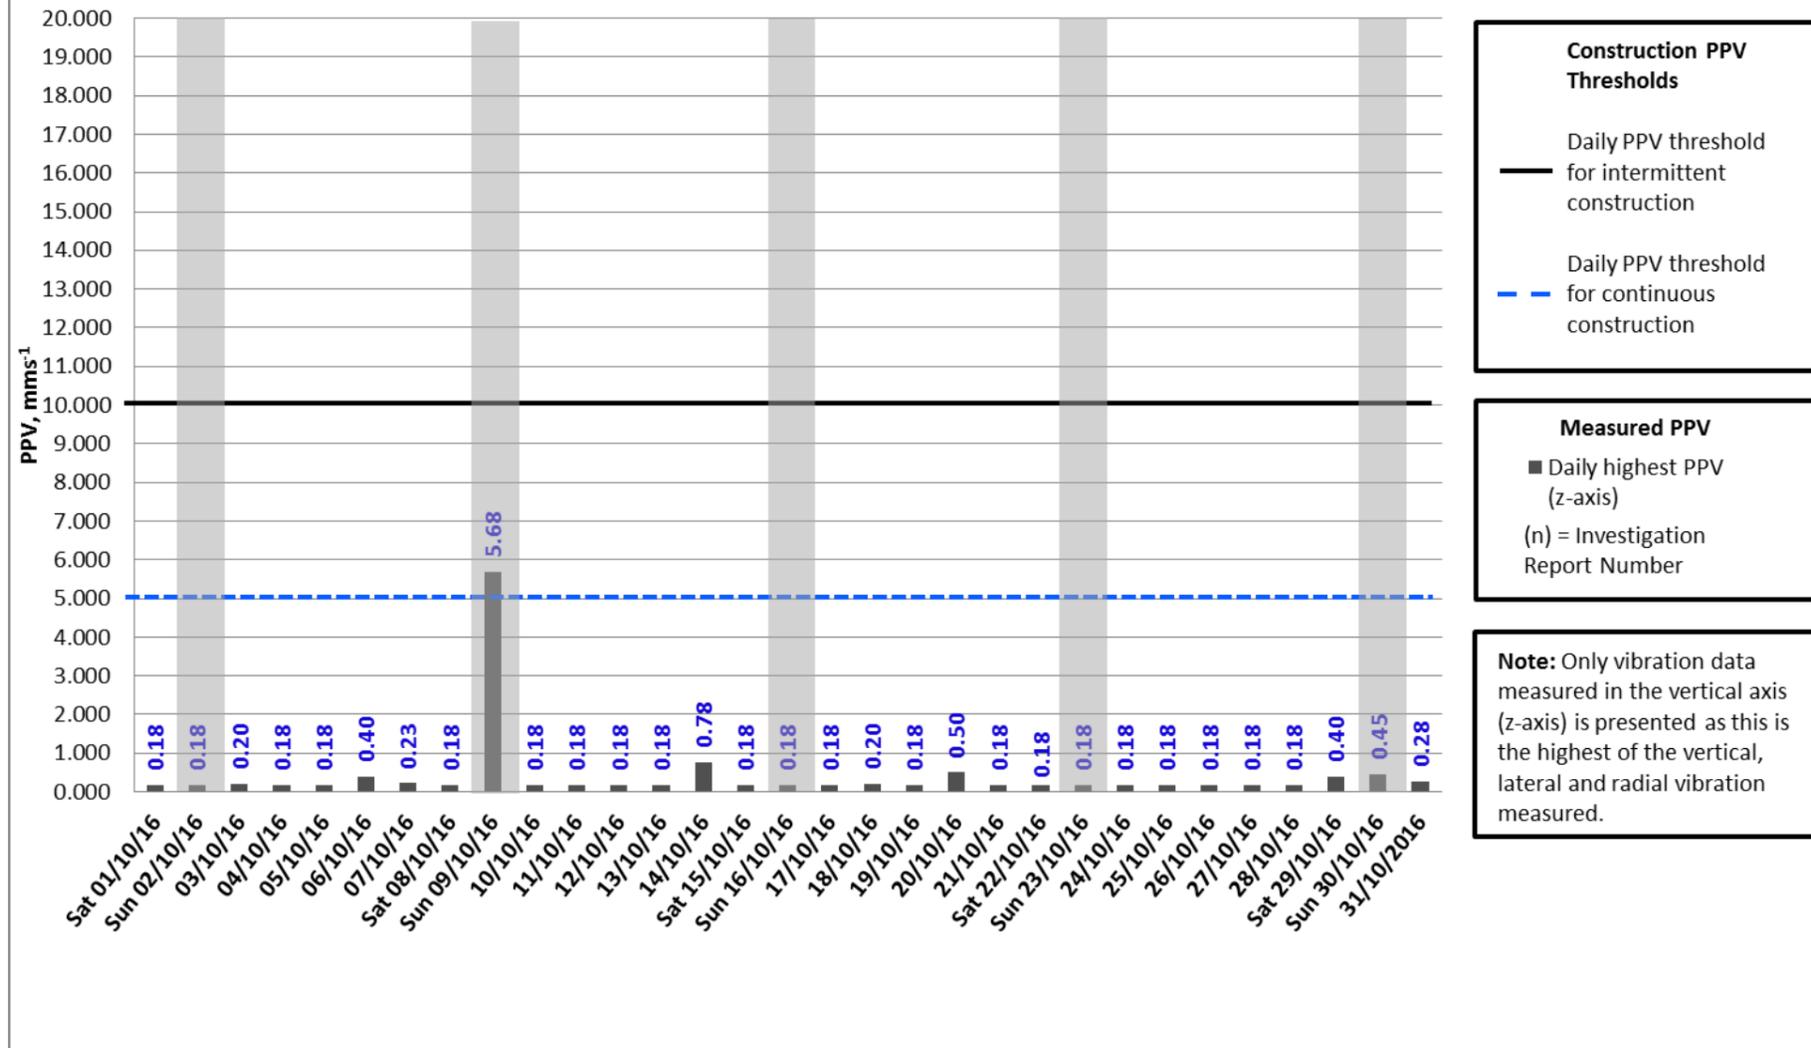
Measured highest Daily Peak Particle Velocity (PPV), Dundas Home Farm, Measurement period: October 2016

Exceedance on the 9th of October has been investigated and found to be caused out with construction working hours and therefore it is unlikely that construction related activity was the cause of these events.

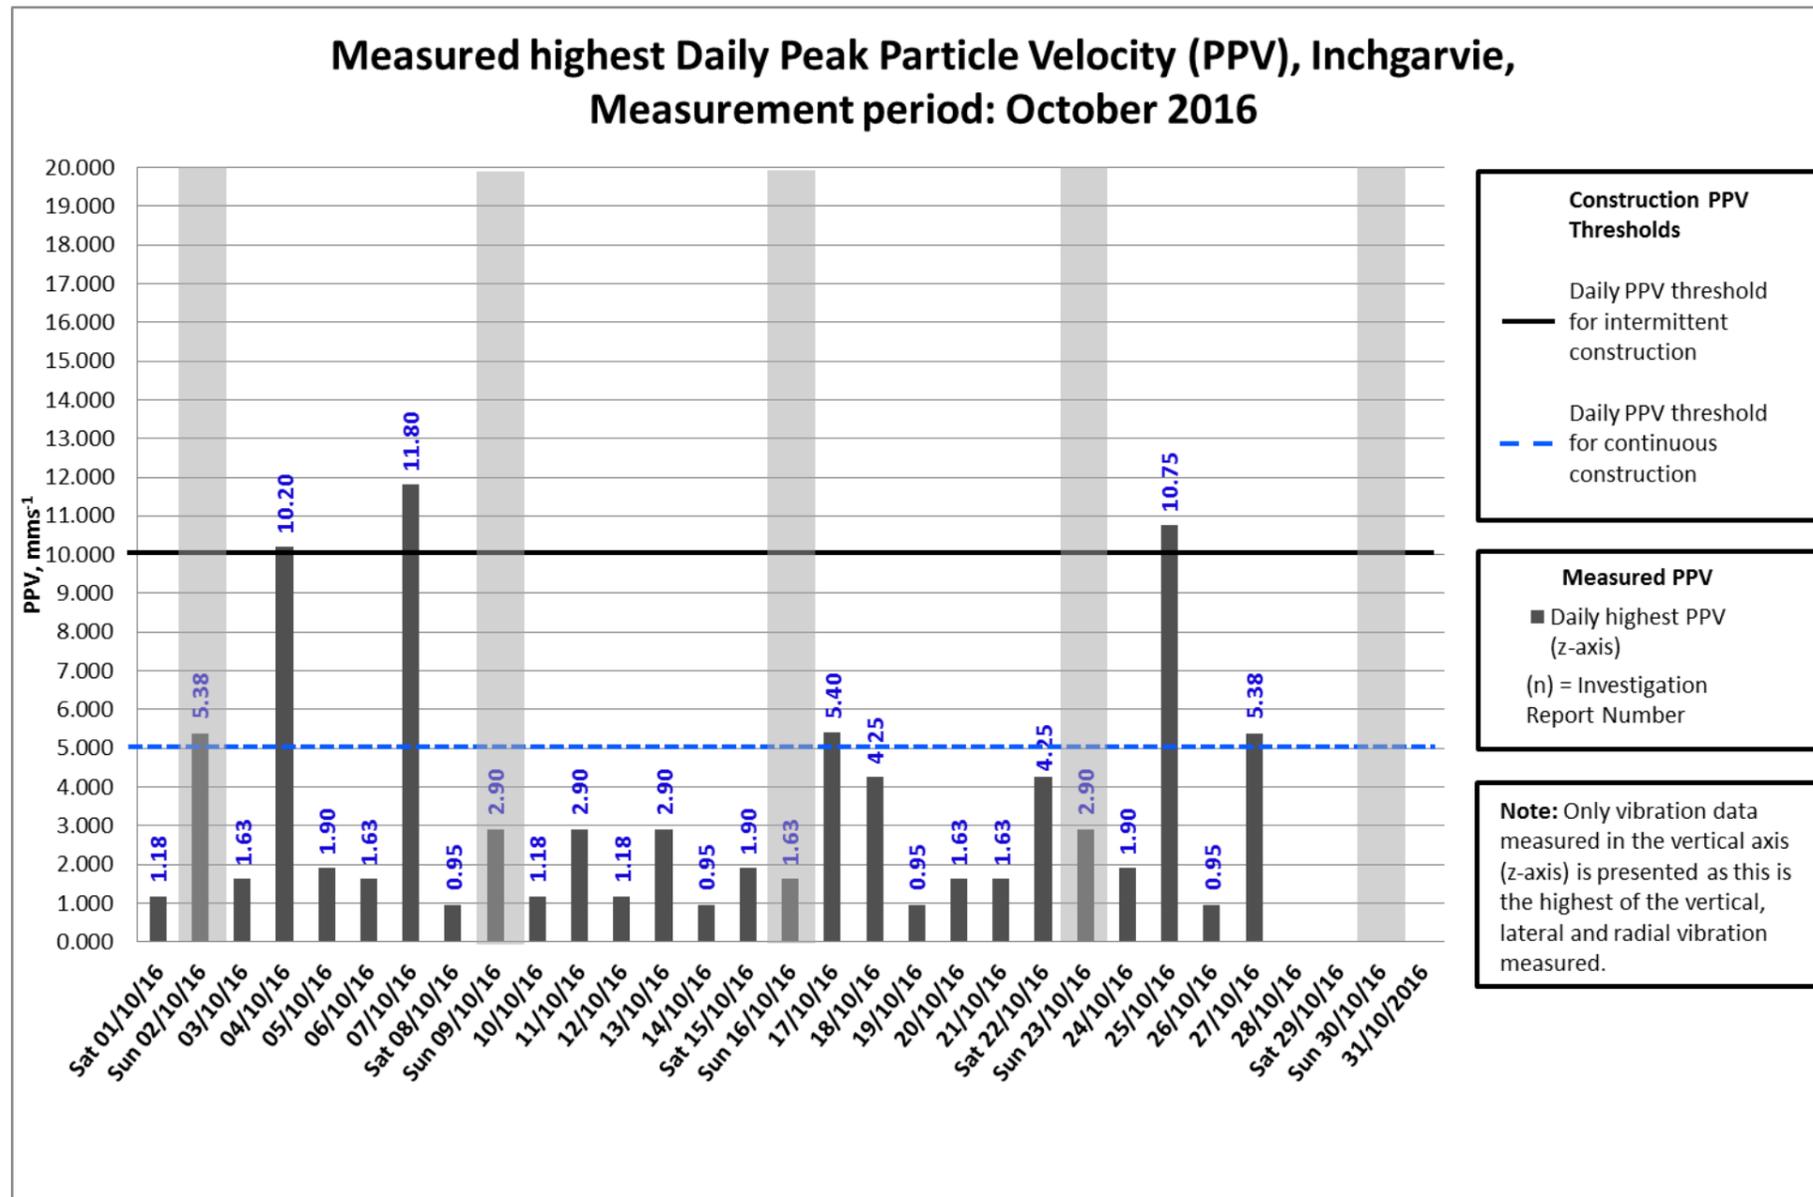
Data missing on the 28th – 31st October was caused by electrical issue with monitor.

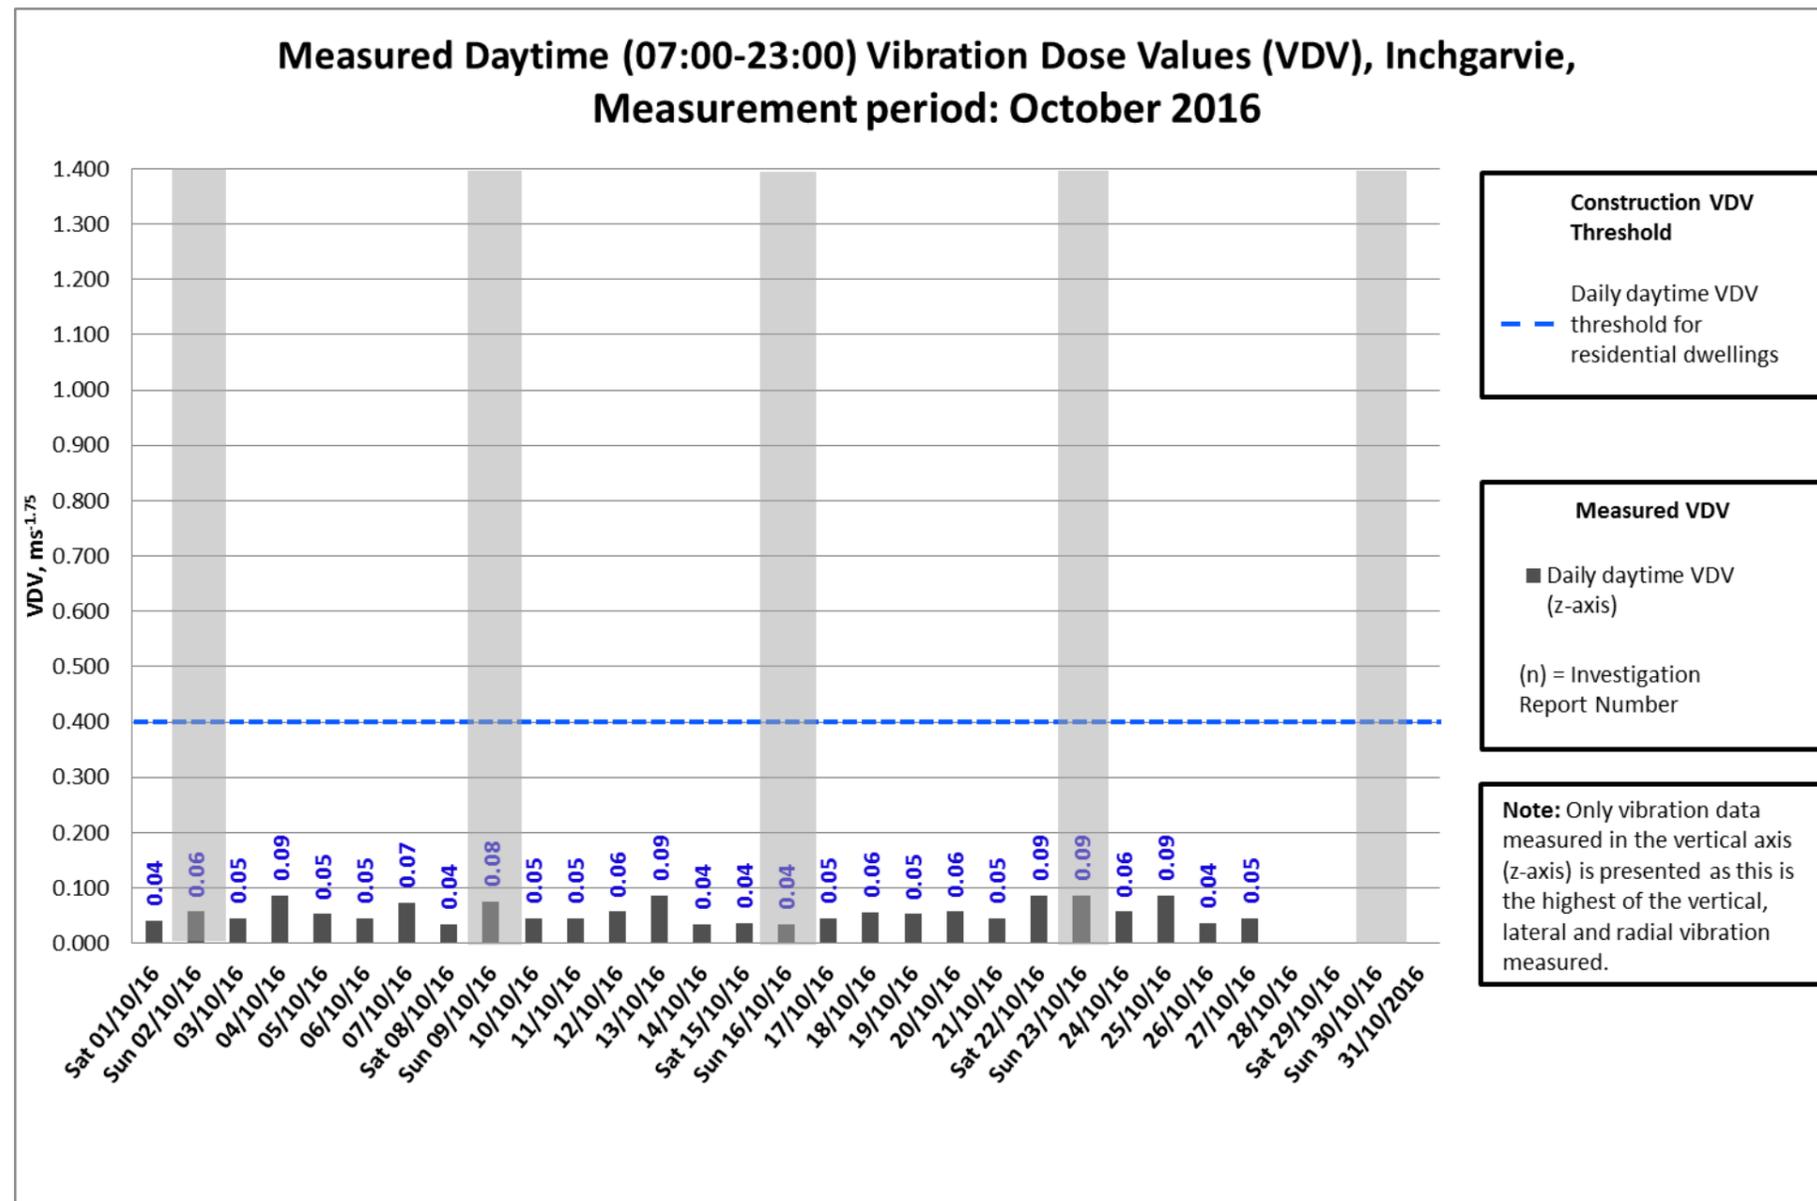
Data missing on the 28th – 31st October was caused by electrical issue with monitor.

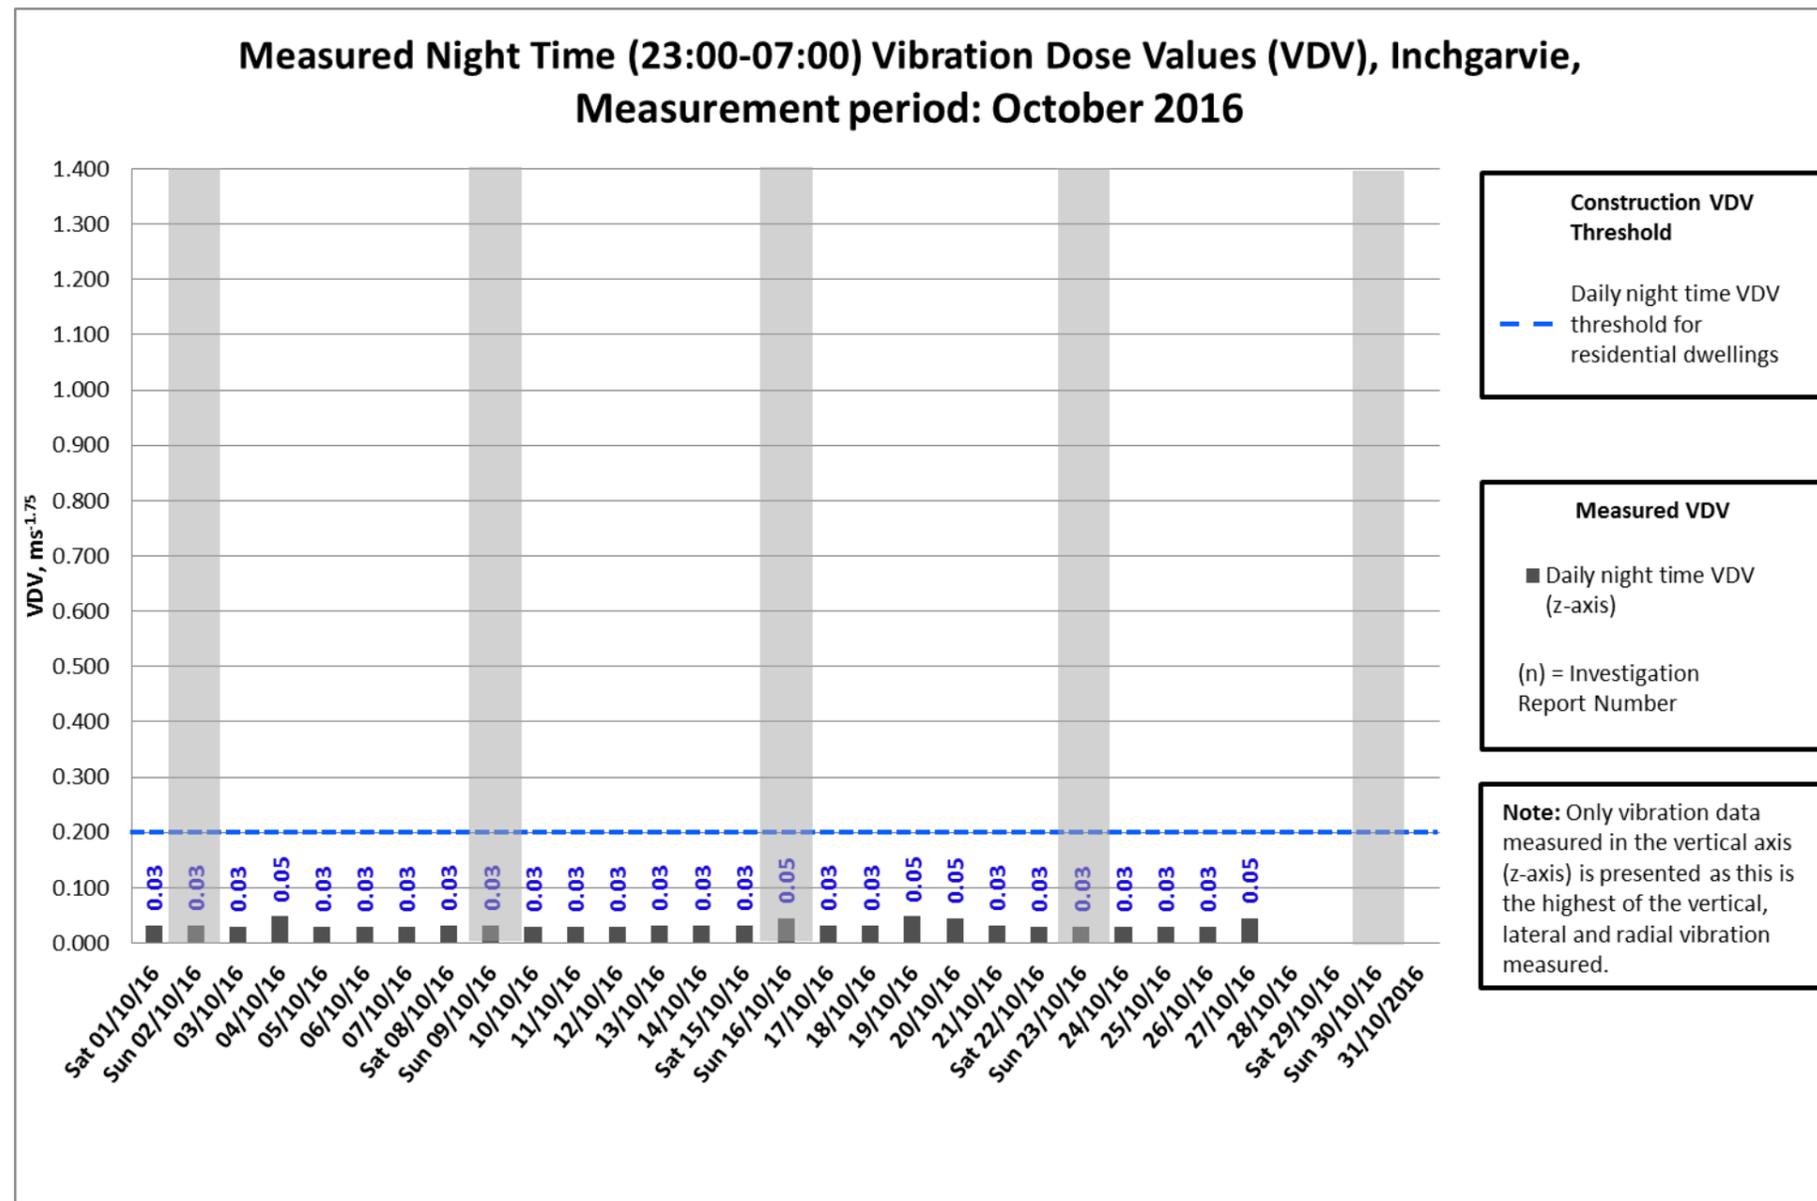
Data missing on the 28th – 31st October was caused by electrical issue with monitor.

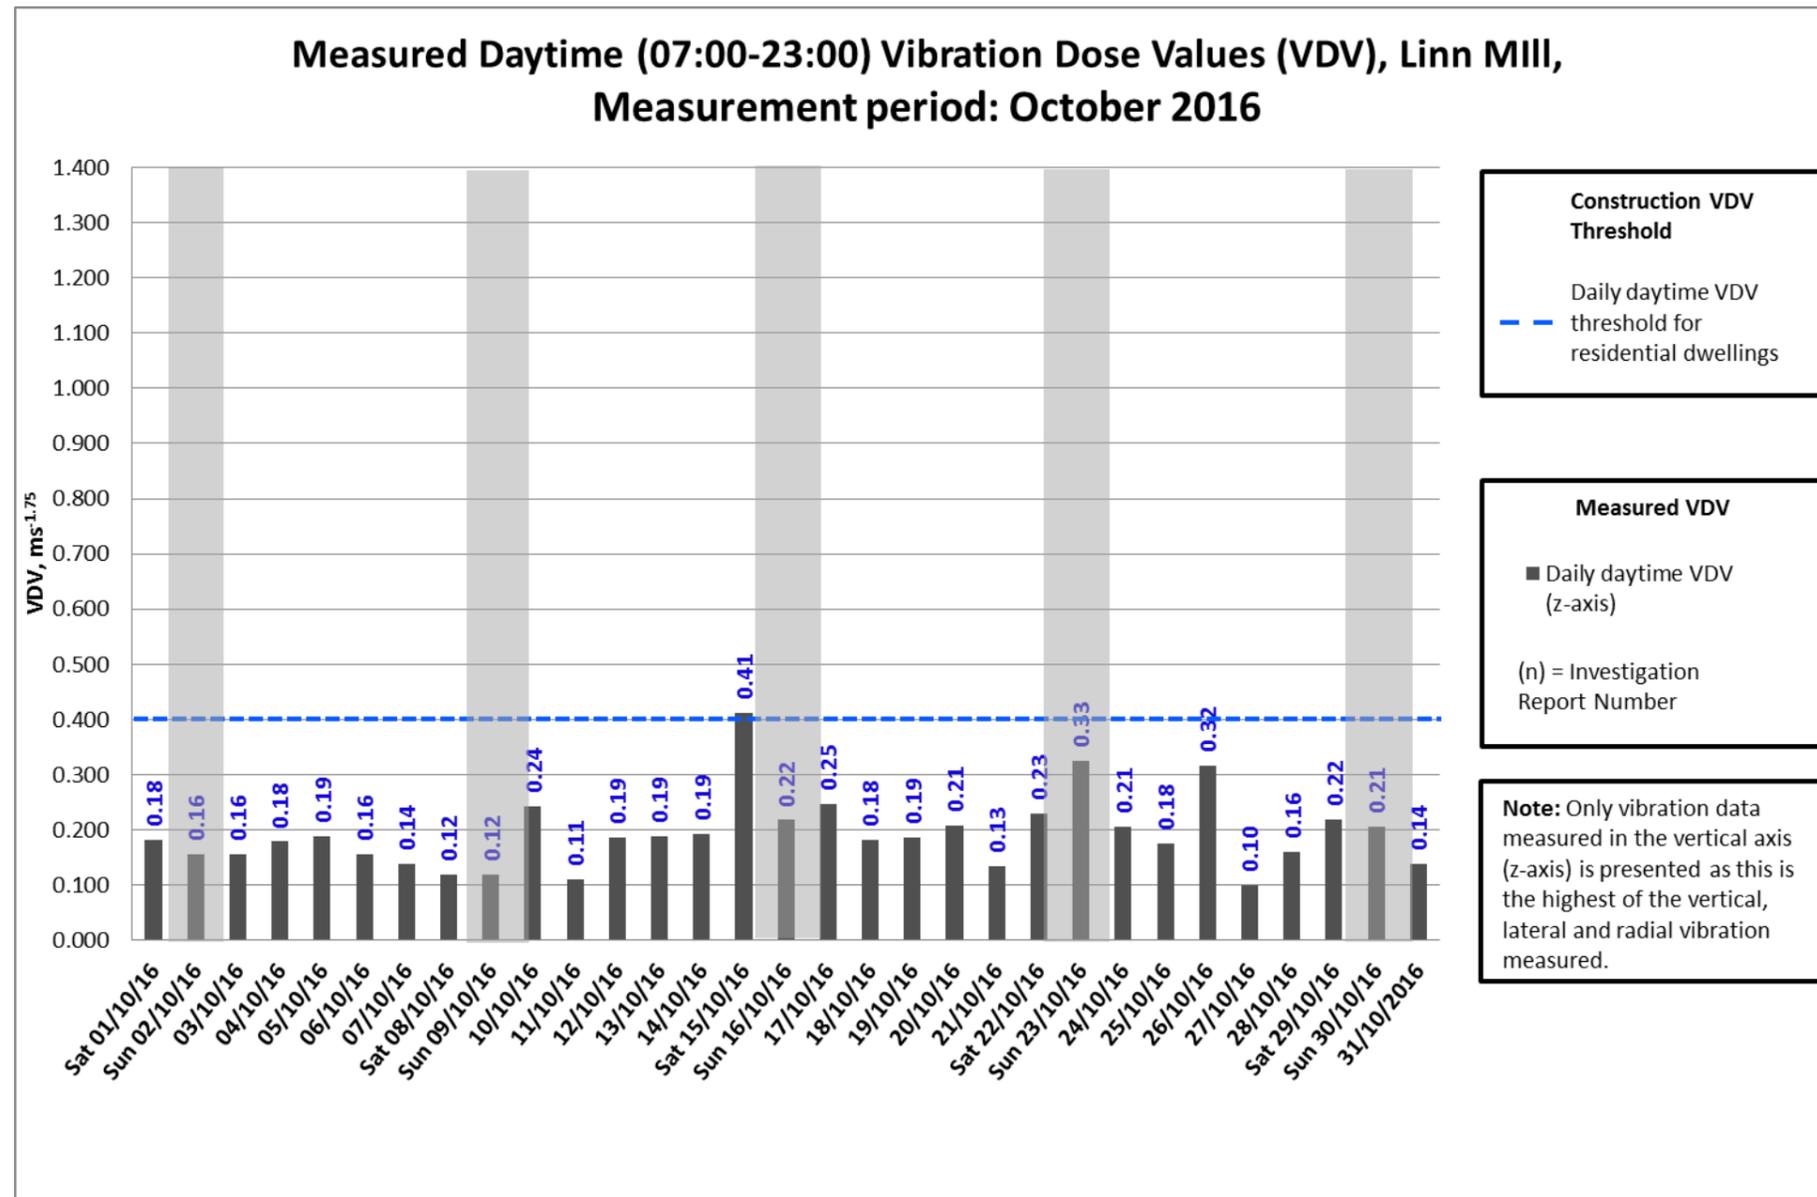
Exceedance on 15th of October has been investigated and found to have been caused by several isolated events that are unlikely to have been construction related activities.

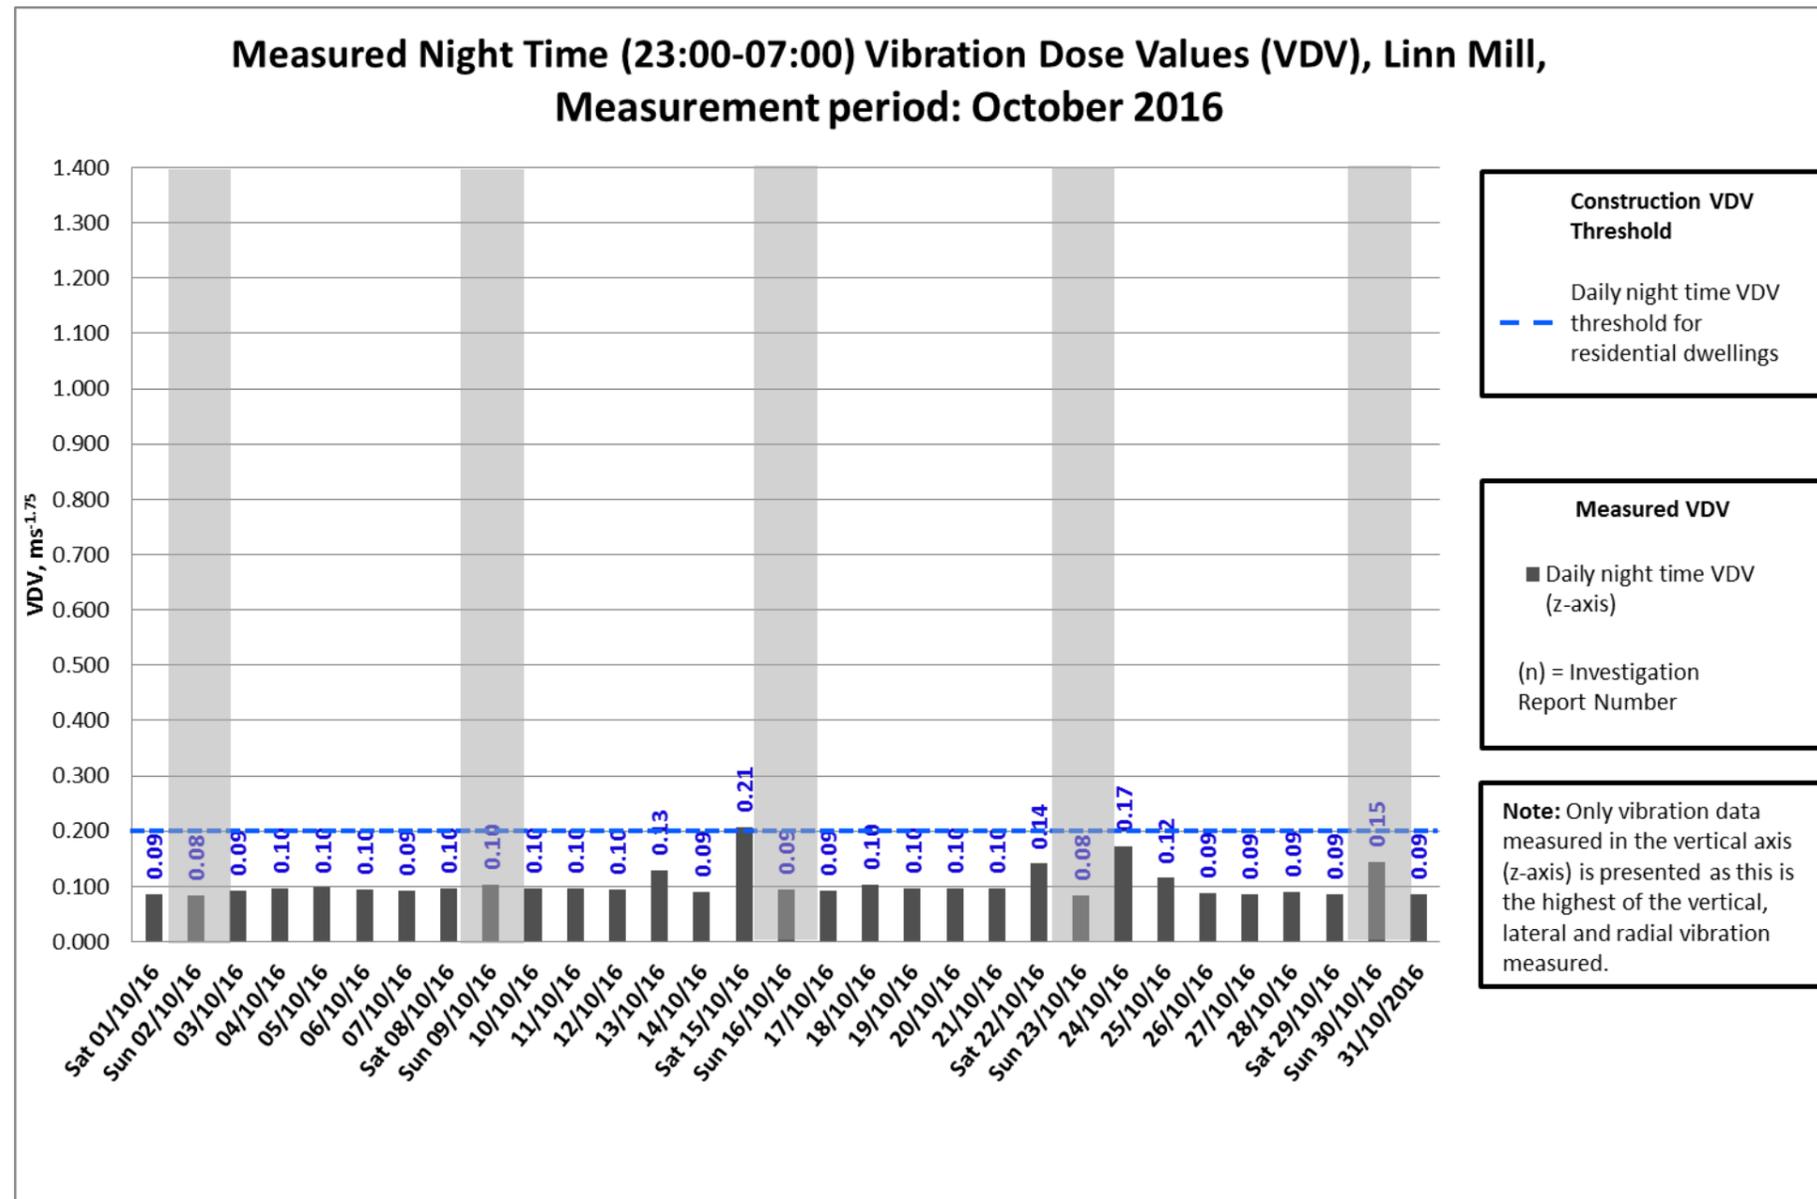
Exceedance on the 15th of October has been investigated and found to have been caused by an isolated event that is unlikely to have been a construction related activity.

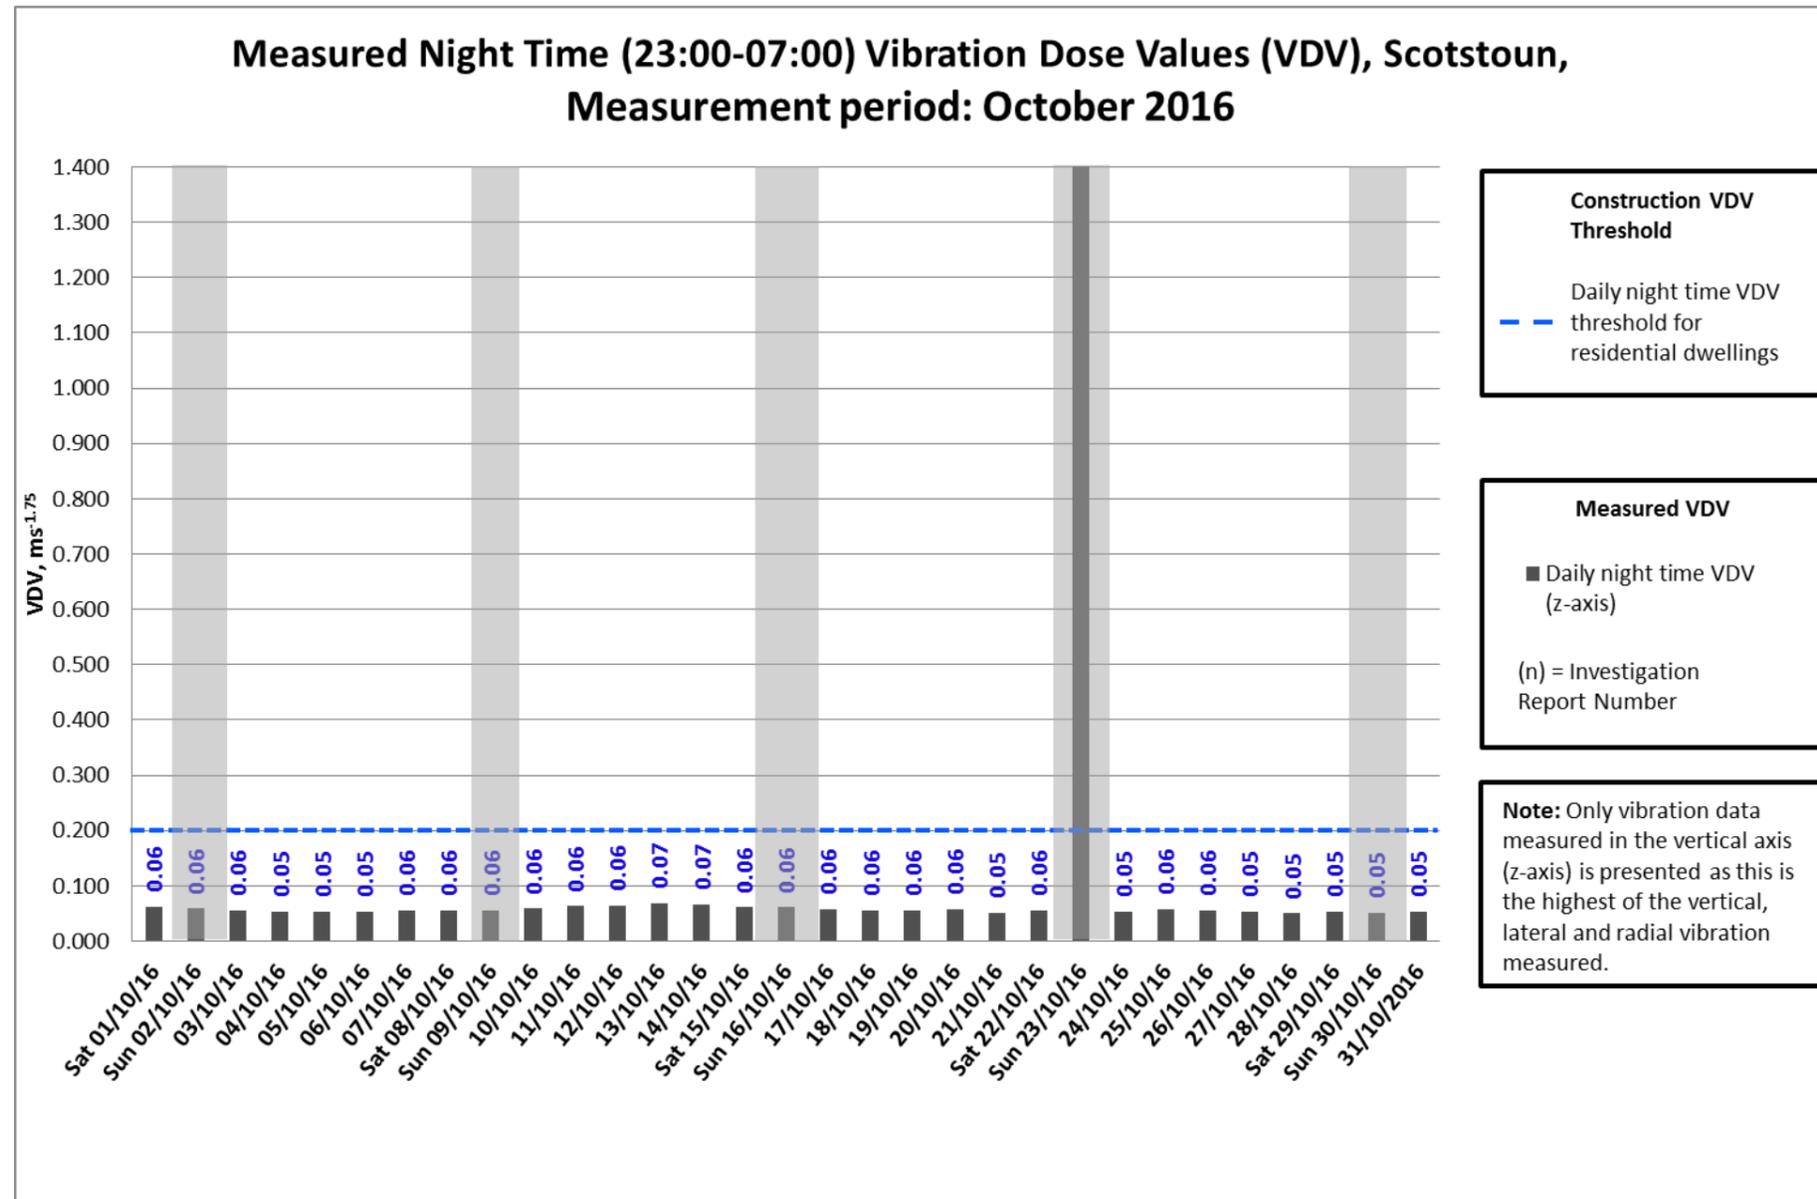
Exceedance on the 23rd of October has been investigated and found to be caused by an isolated event that is unlikely to have been a construction related activity.

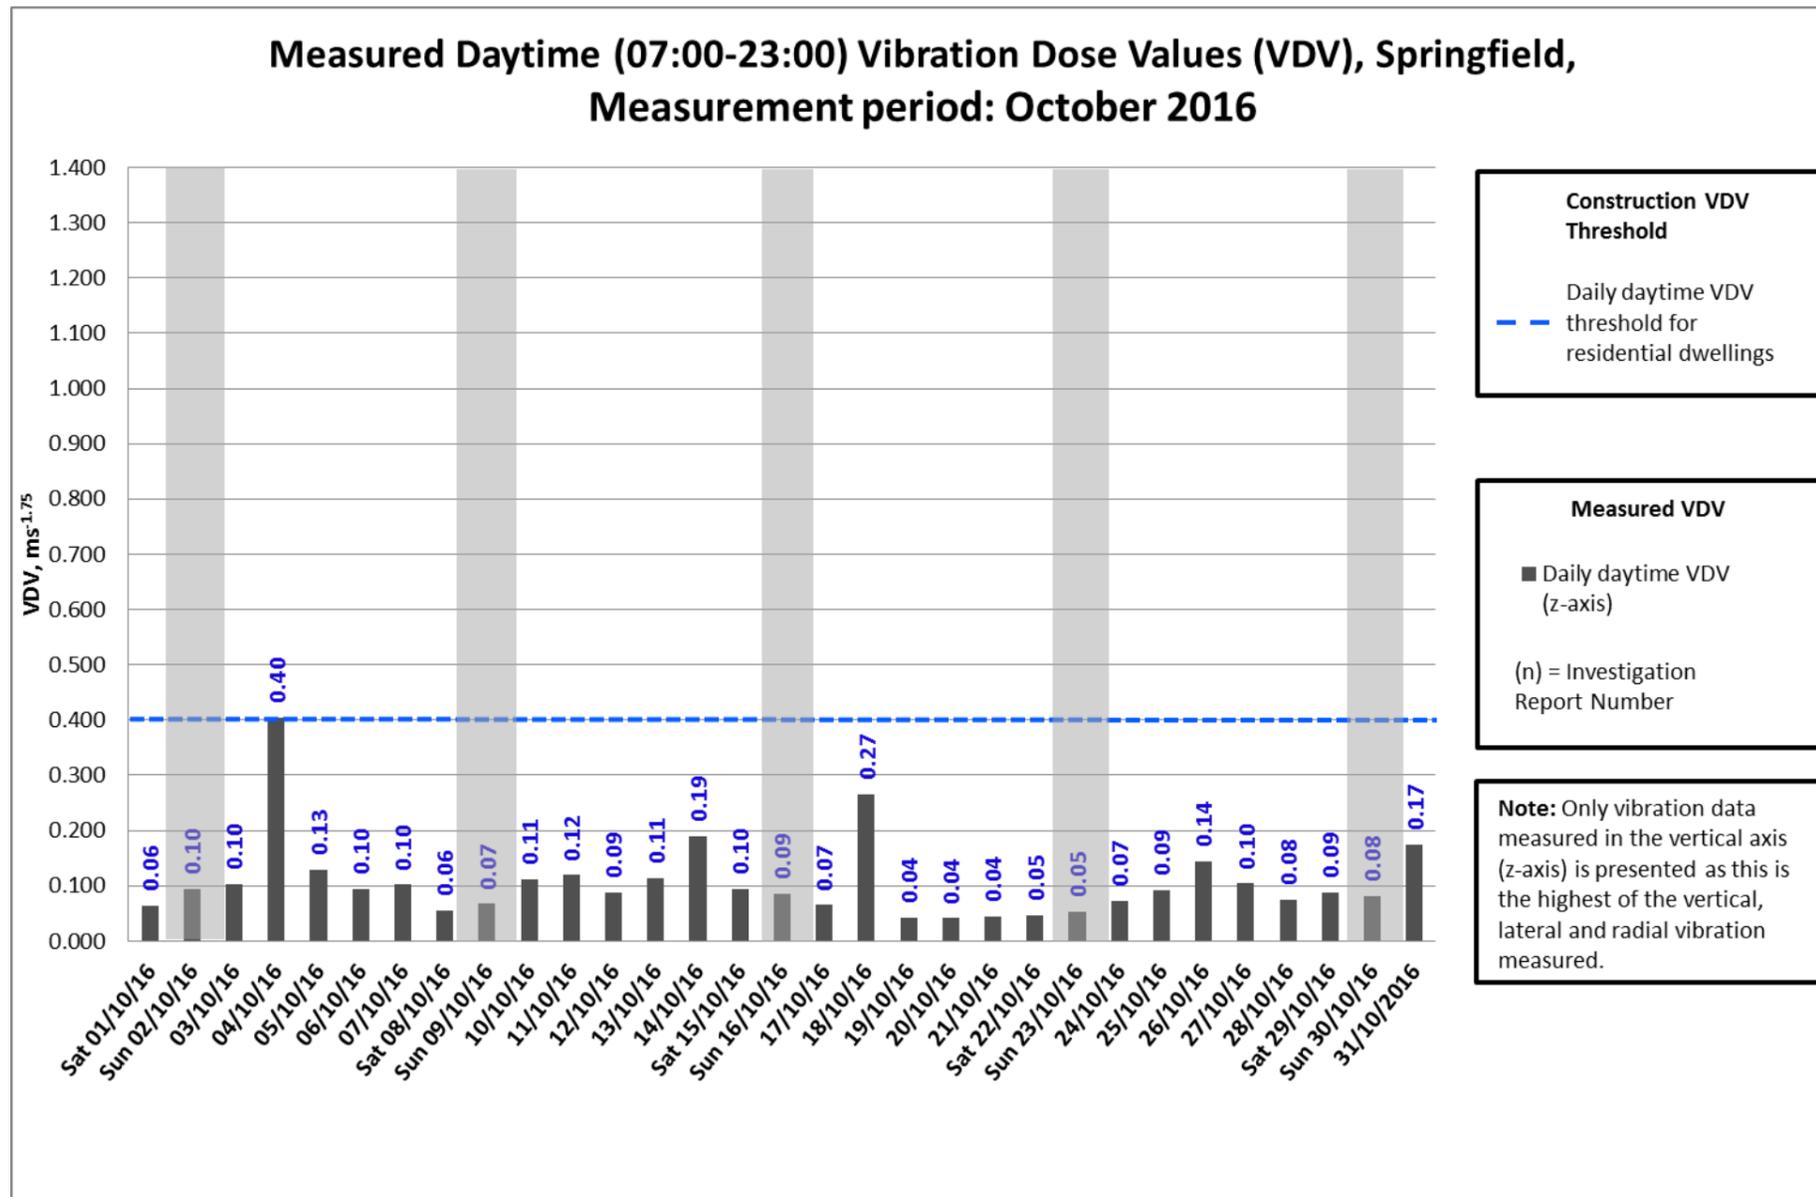
Exceedance on the 4th of October has been investigated and found to have been caused by an isolated event that is unlikely to have been due to a construction related activity.

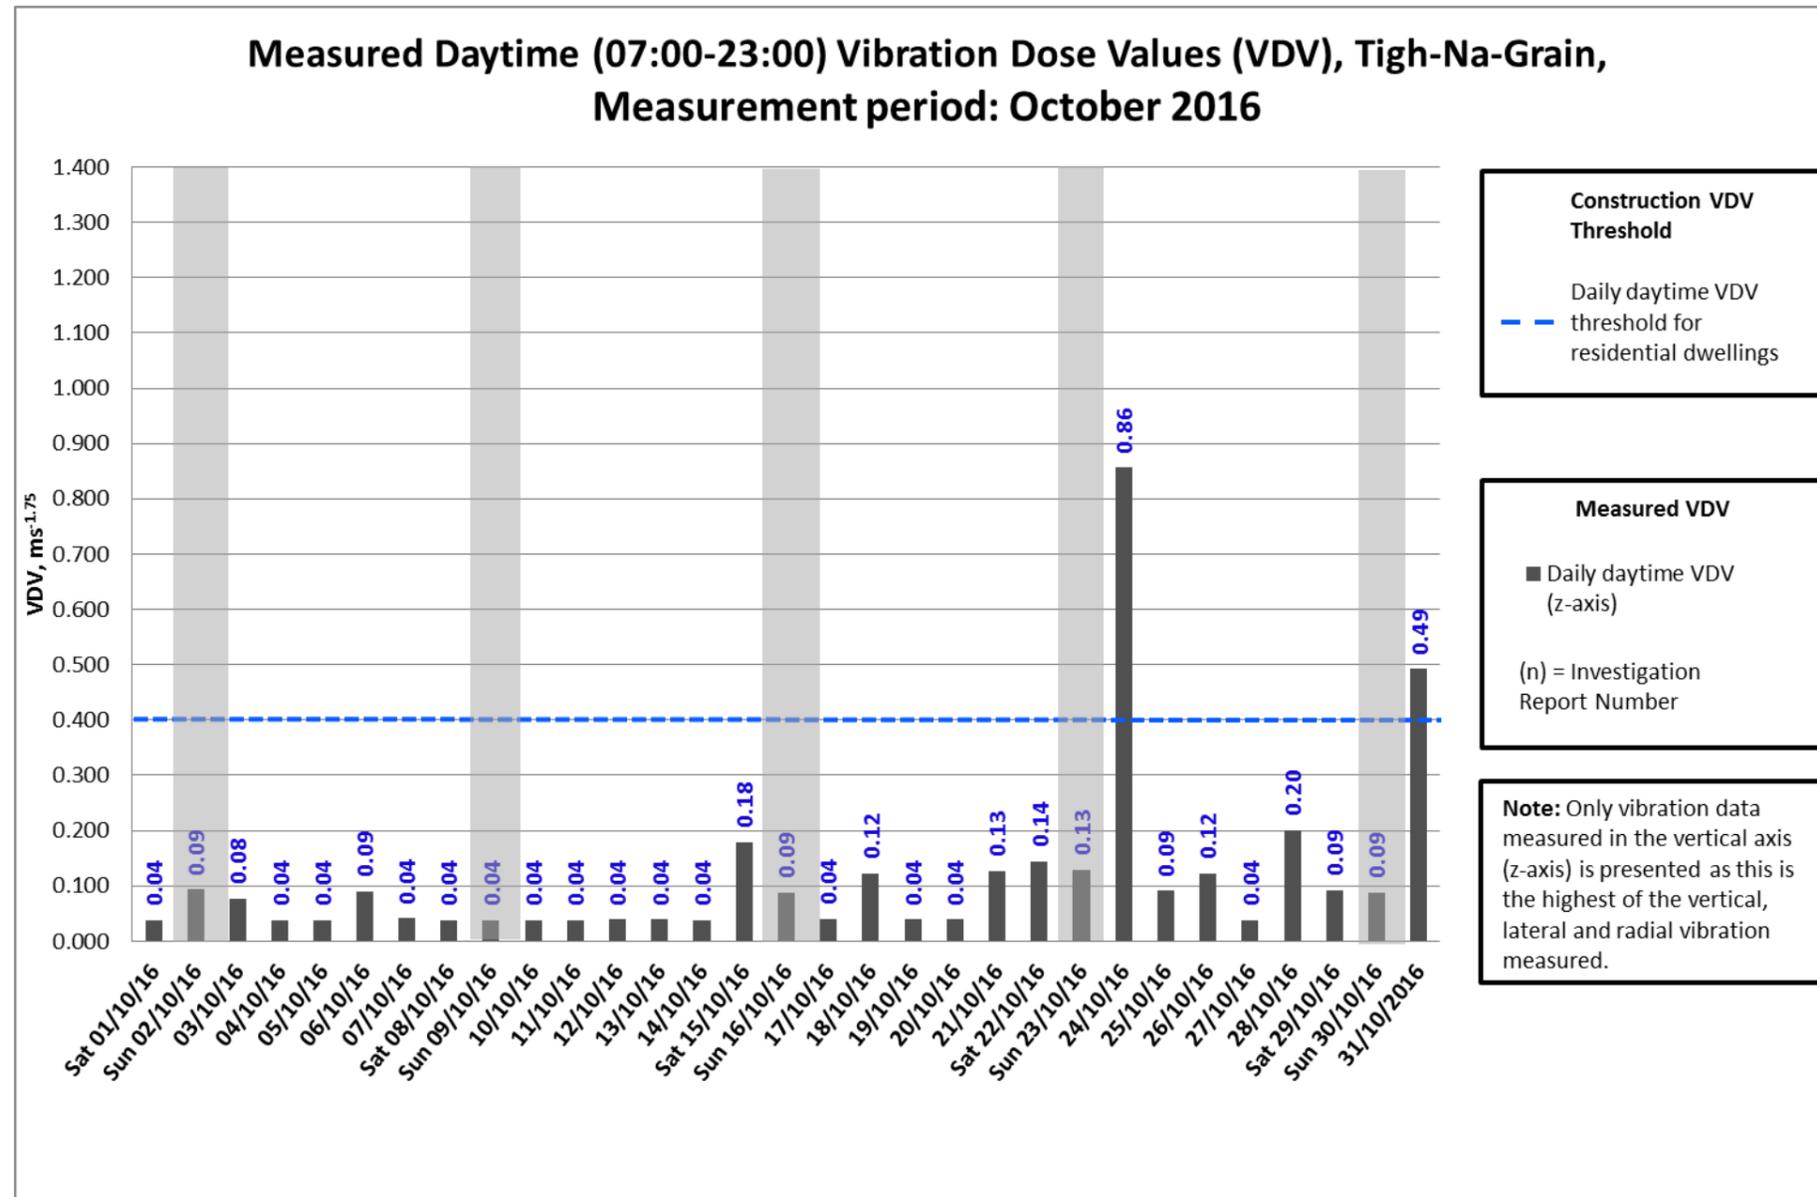
Exceedances on the 24th and 31st of October have been investigated and found to have been caused by isolated events which are unlikely to have been construction related activities (graph above from the 24/10/2016).
