**Forth Crossing** Bridge Constructors

Project **FORTH REPLACEMENT CROSSING**

**VIBRATION MONITORING REPORT  
JUNE 2015**

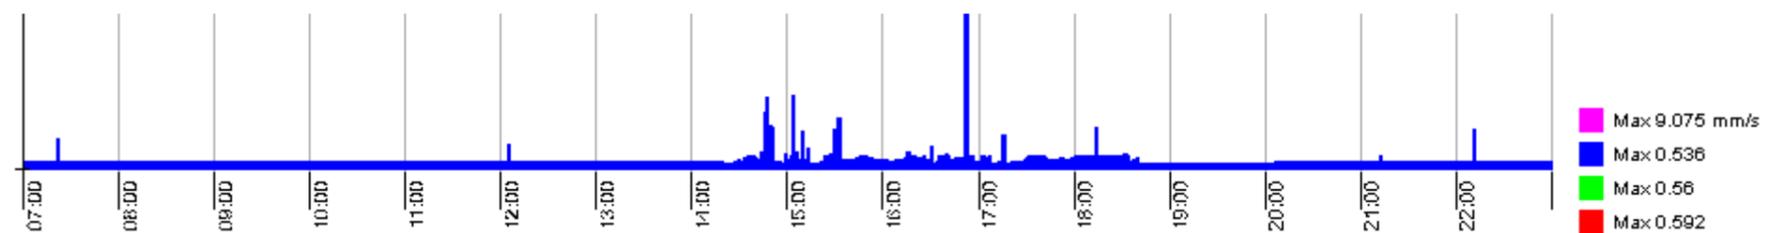
Note: The graph above shows the exceedances on the 10/06/2015. This was on the same day of the exceedance on the PPV Graph. It was investigated and found to be caused by non-Construction related activity.

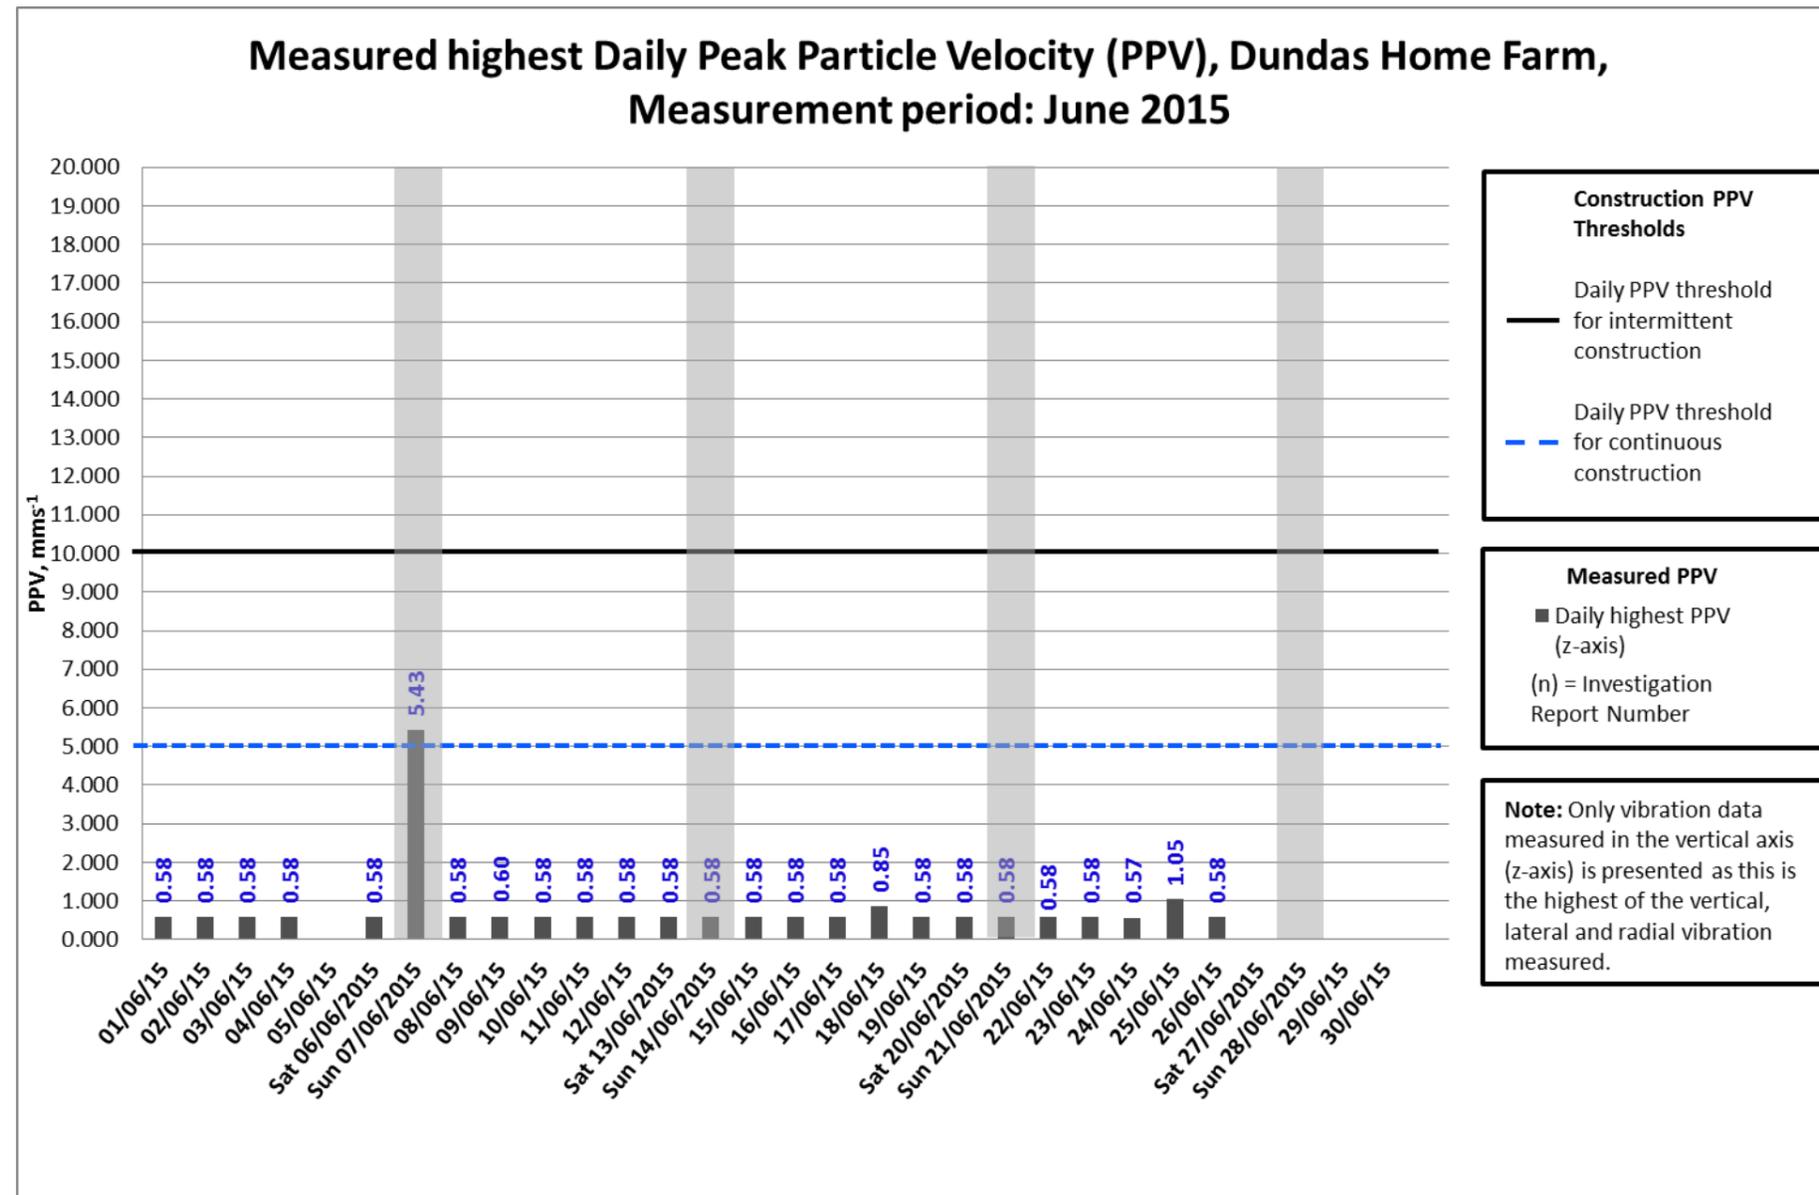
Note: During the 04/06/2015, 05/06/2015, 27/06/2015, 28/06/2015, 29/06/2015 and on the 30/06/2015 there was a power supply problem.

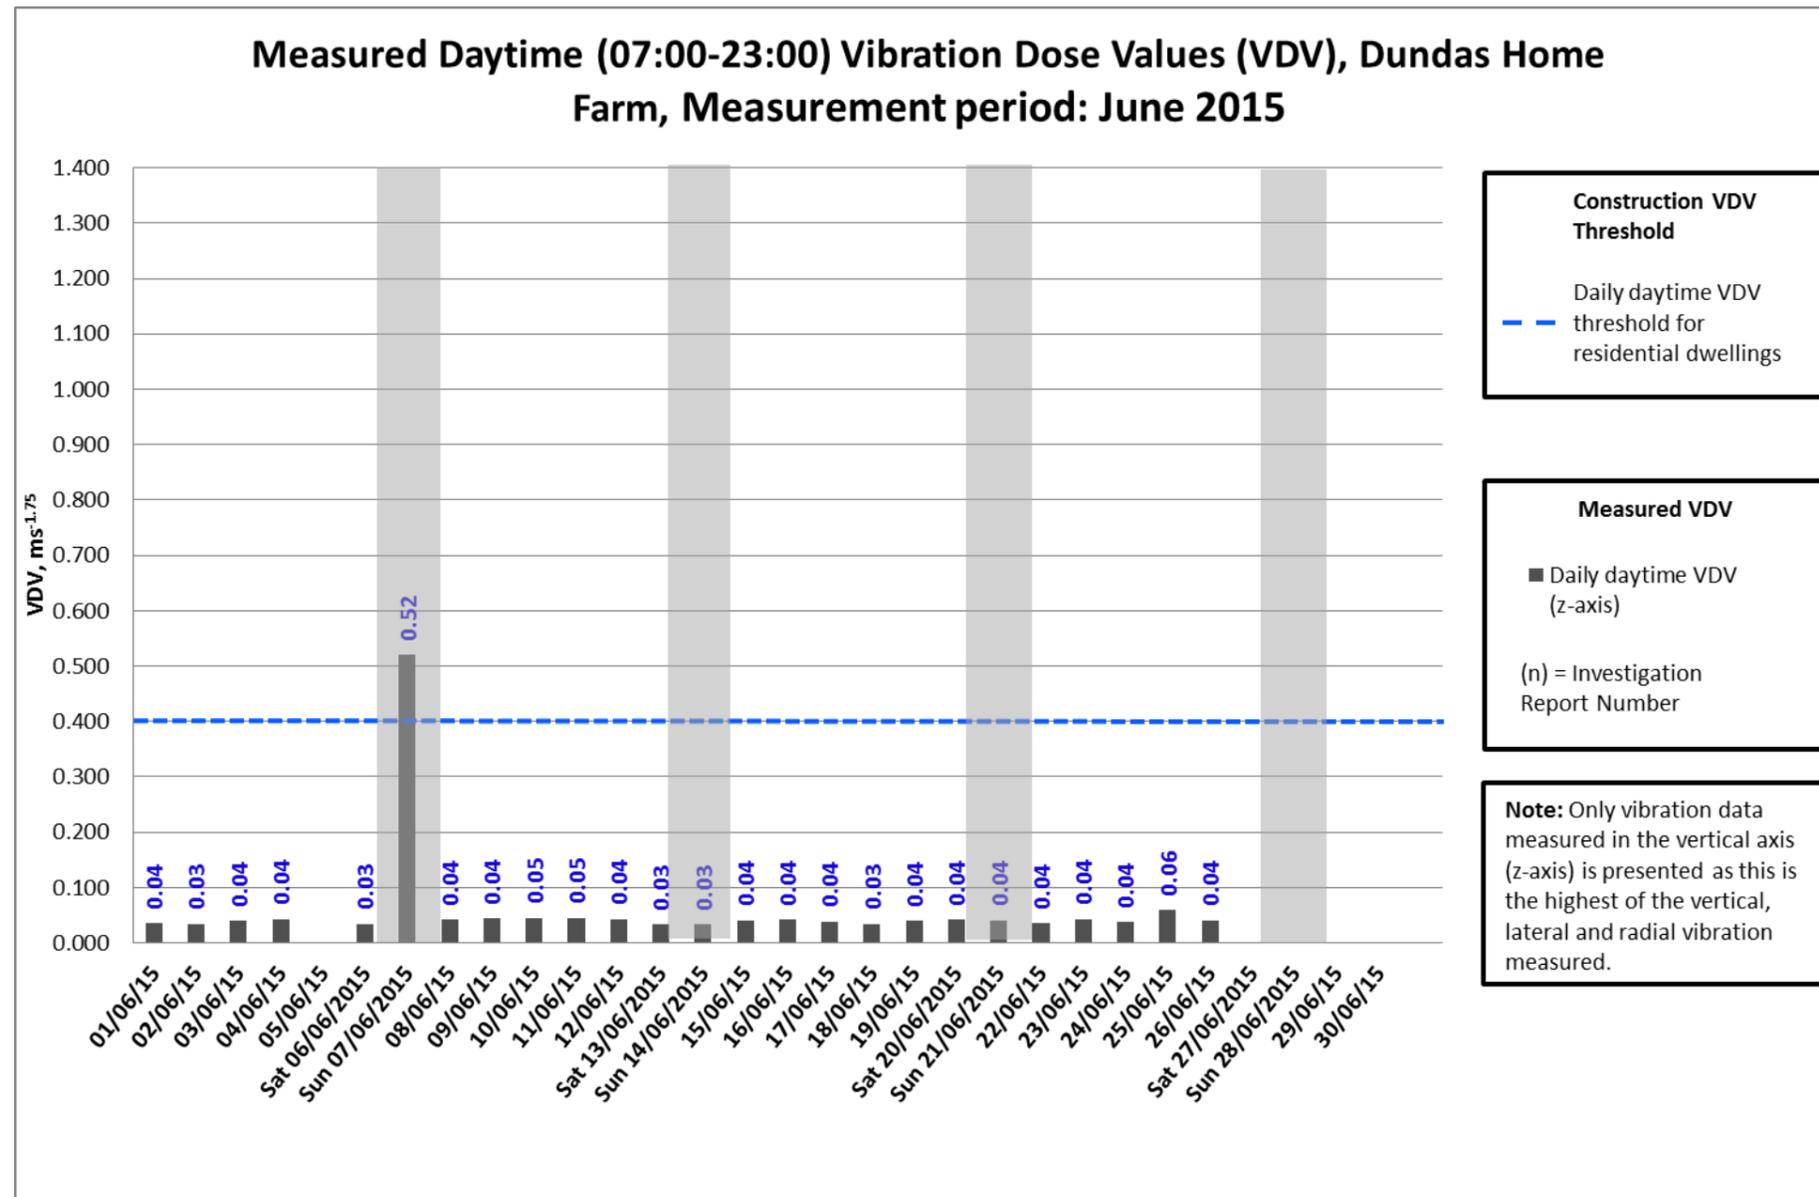
Note: During the 04/06/2015, 05/06/2015, 27/06/2015, 28/06/2015, 29/06/2015 and on the 30/06/2015 there was a power supply problem.

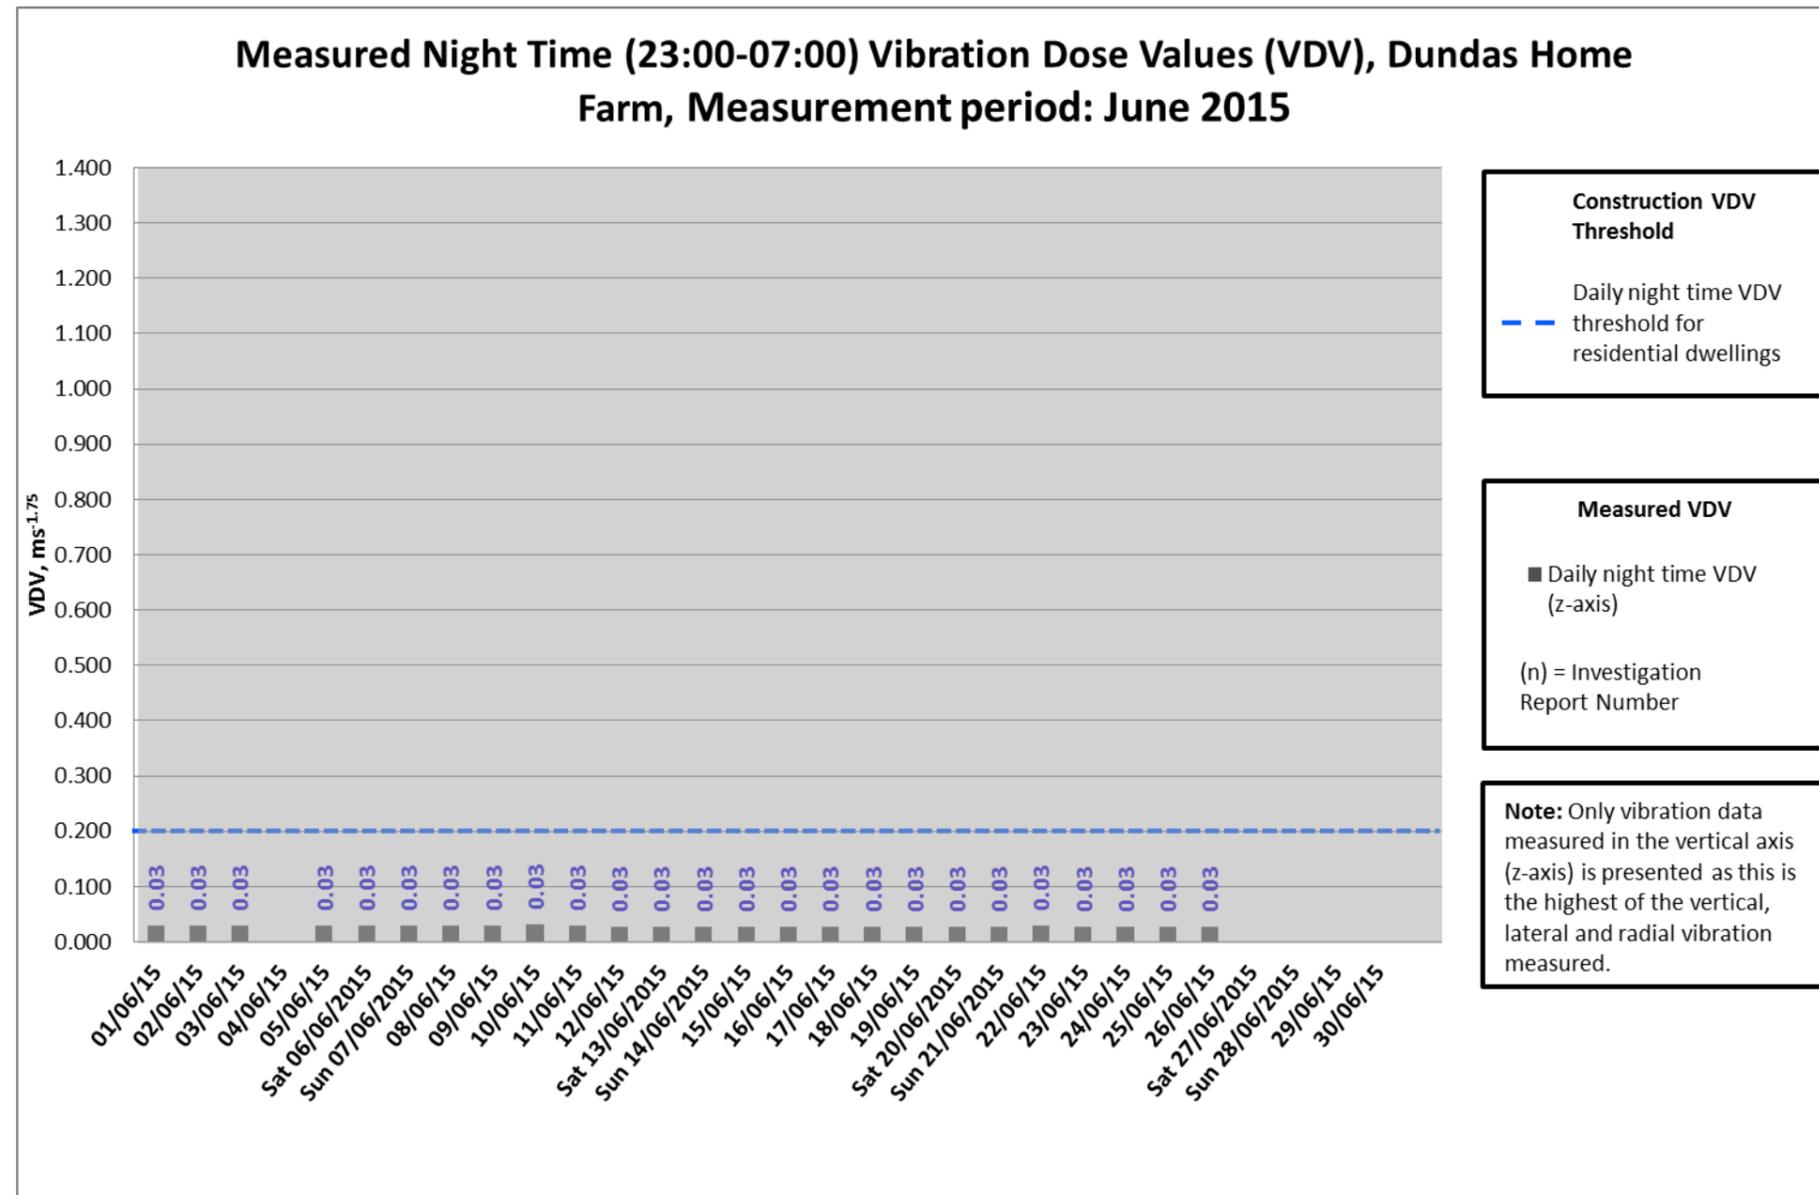
Note: During the 04/06/2015, 05/06/2015, 27/06/2015, 28/06/2015, 29/06/2015 and on the 30/06/2015 there was a power supply problem.

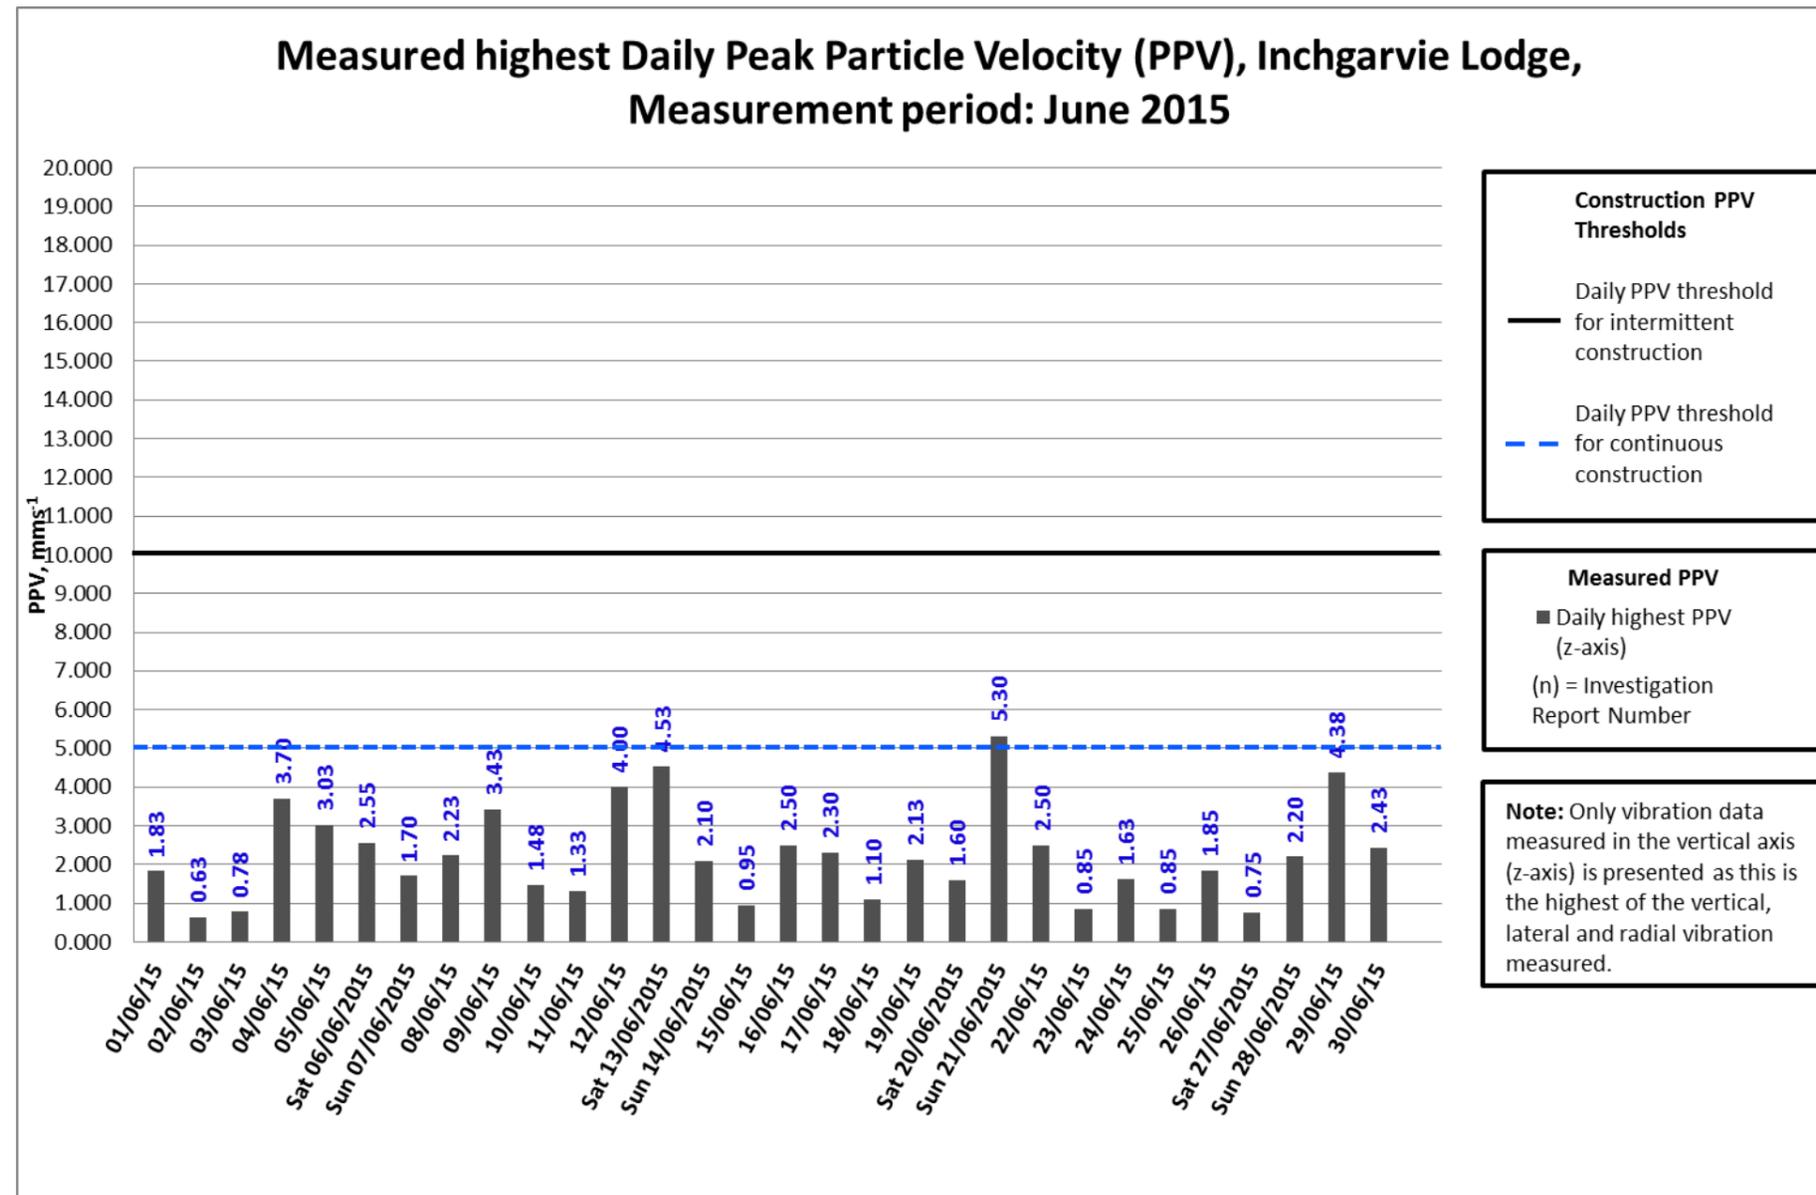
Note: There was no works carried out on Sunday the 21<sup>st</sup> of June in the area.

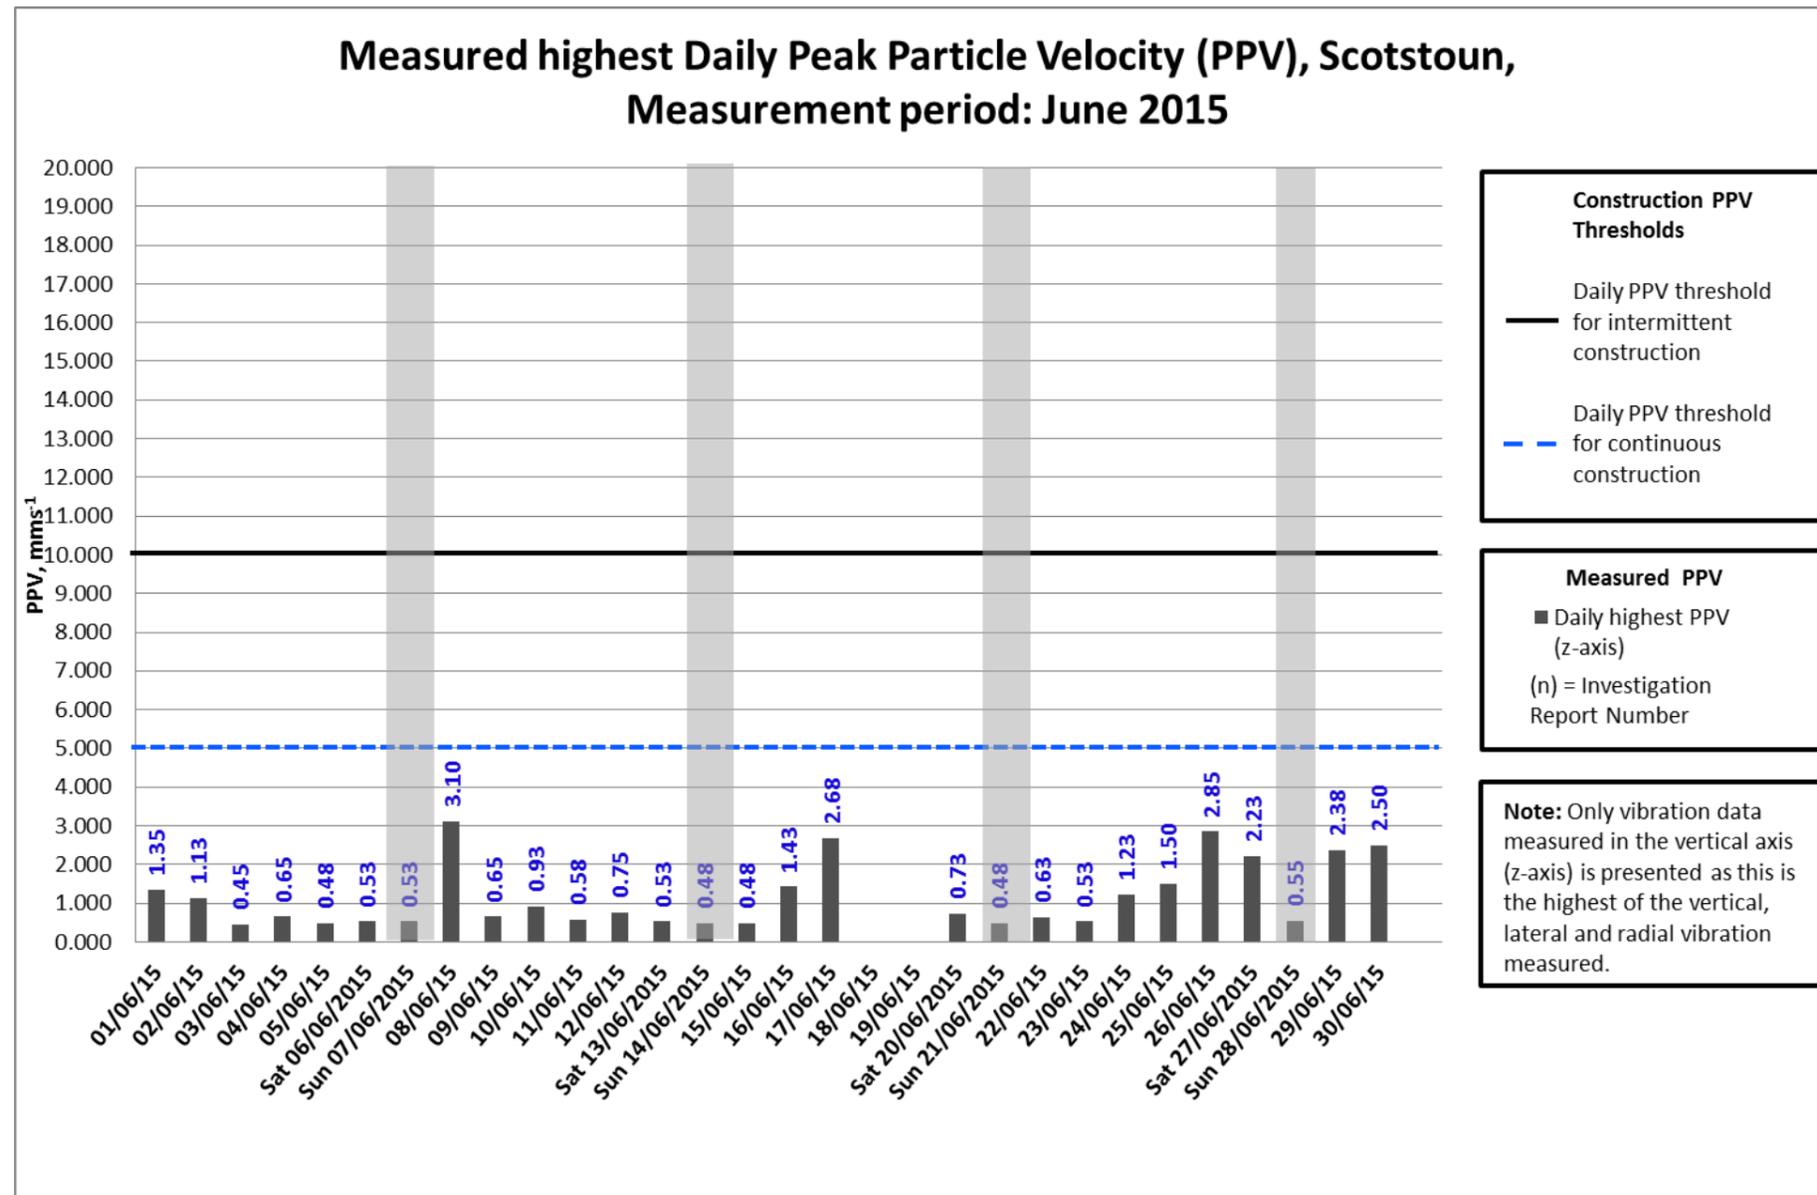
Note: Data missing due to a power problem at the monitor between the 18/06/2015 to the 19/06/2015.

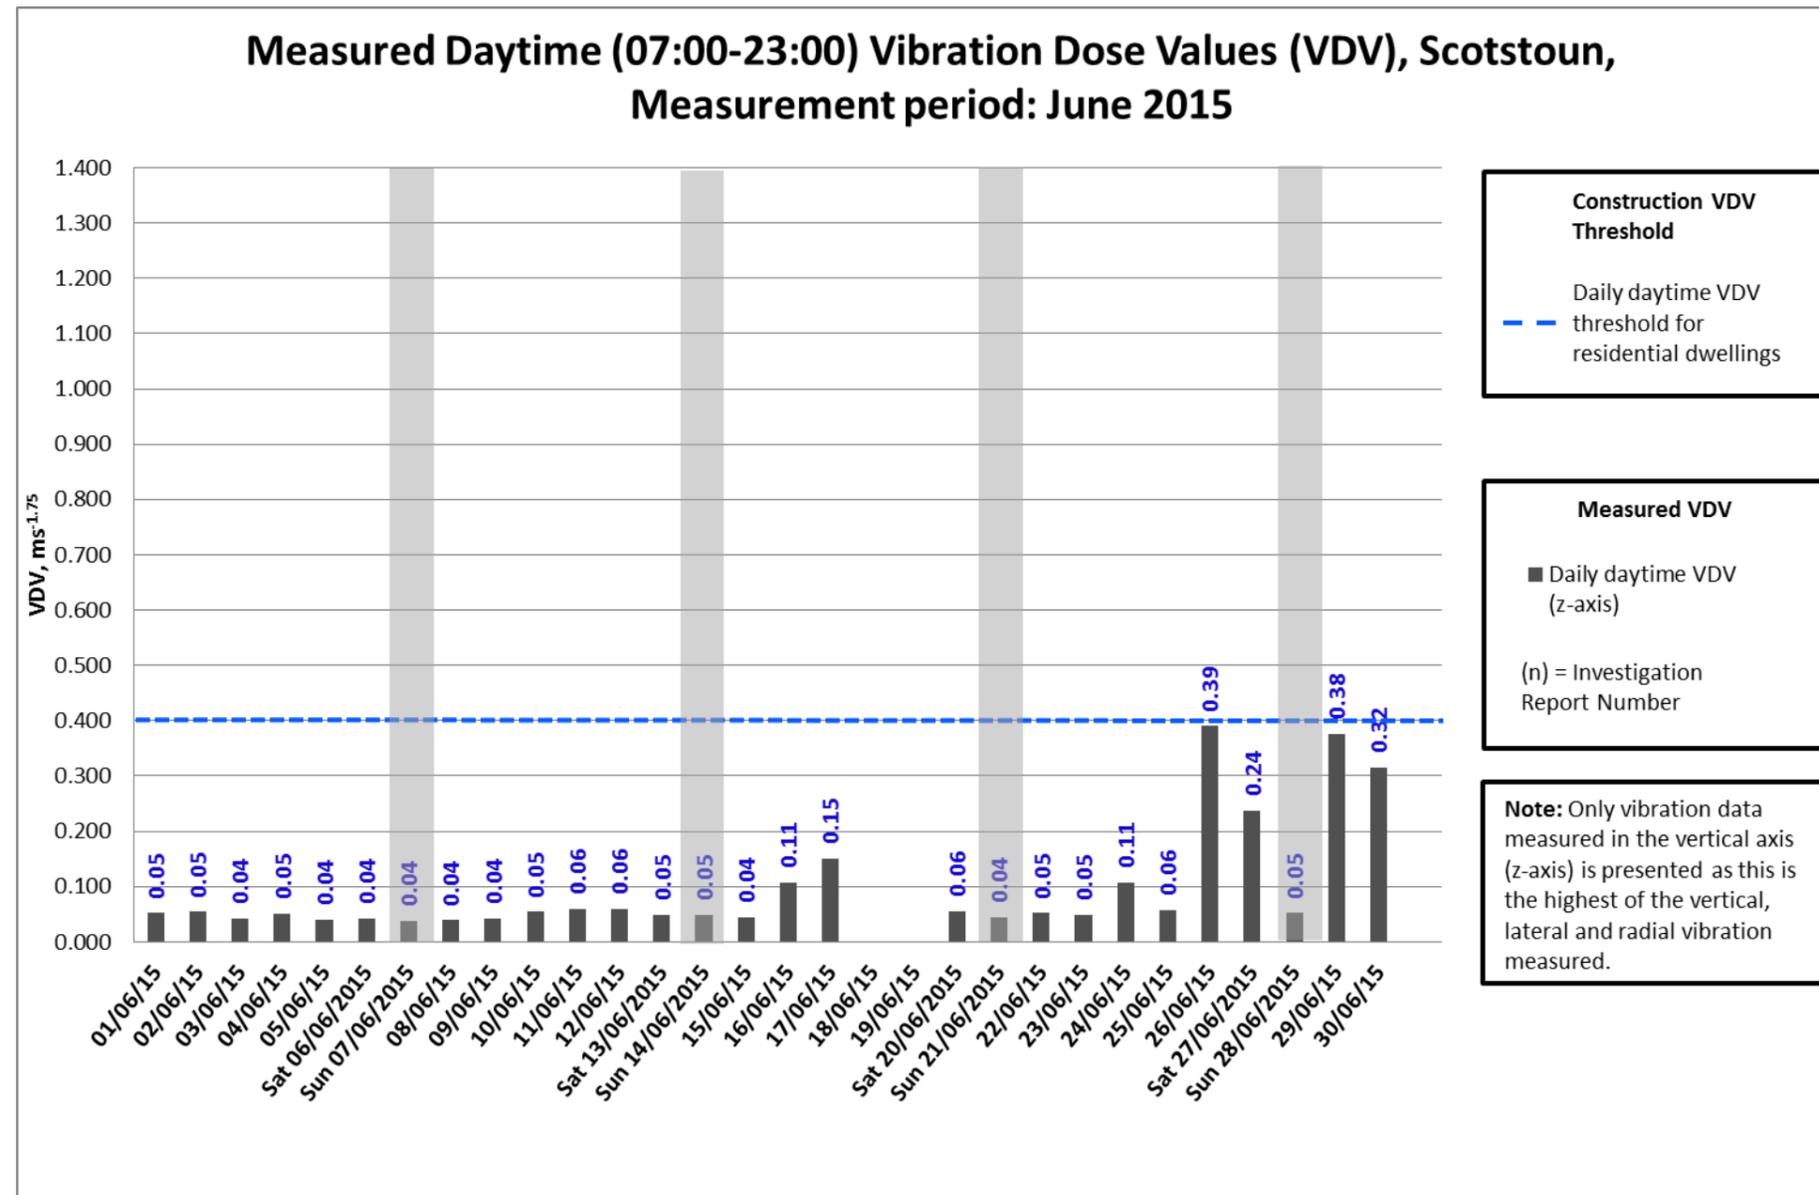
Note: Data missing due to a power problem at the monitor between the 18/06/2015 to the 19/06/2015.

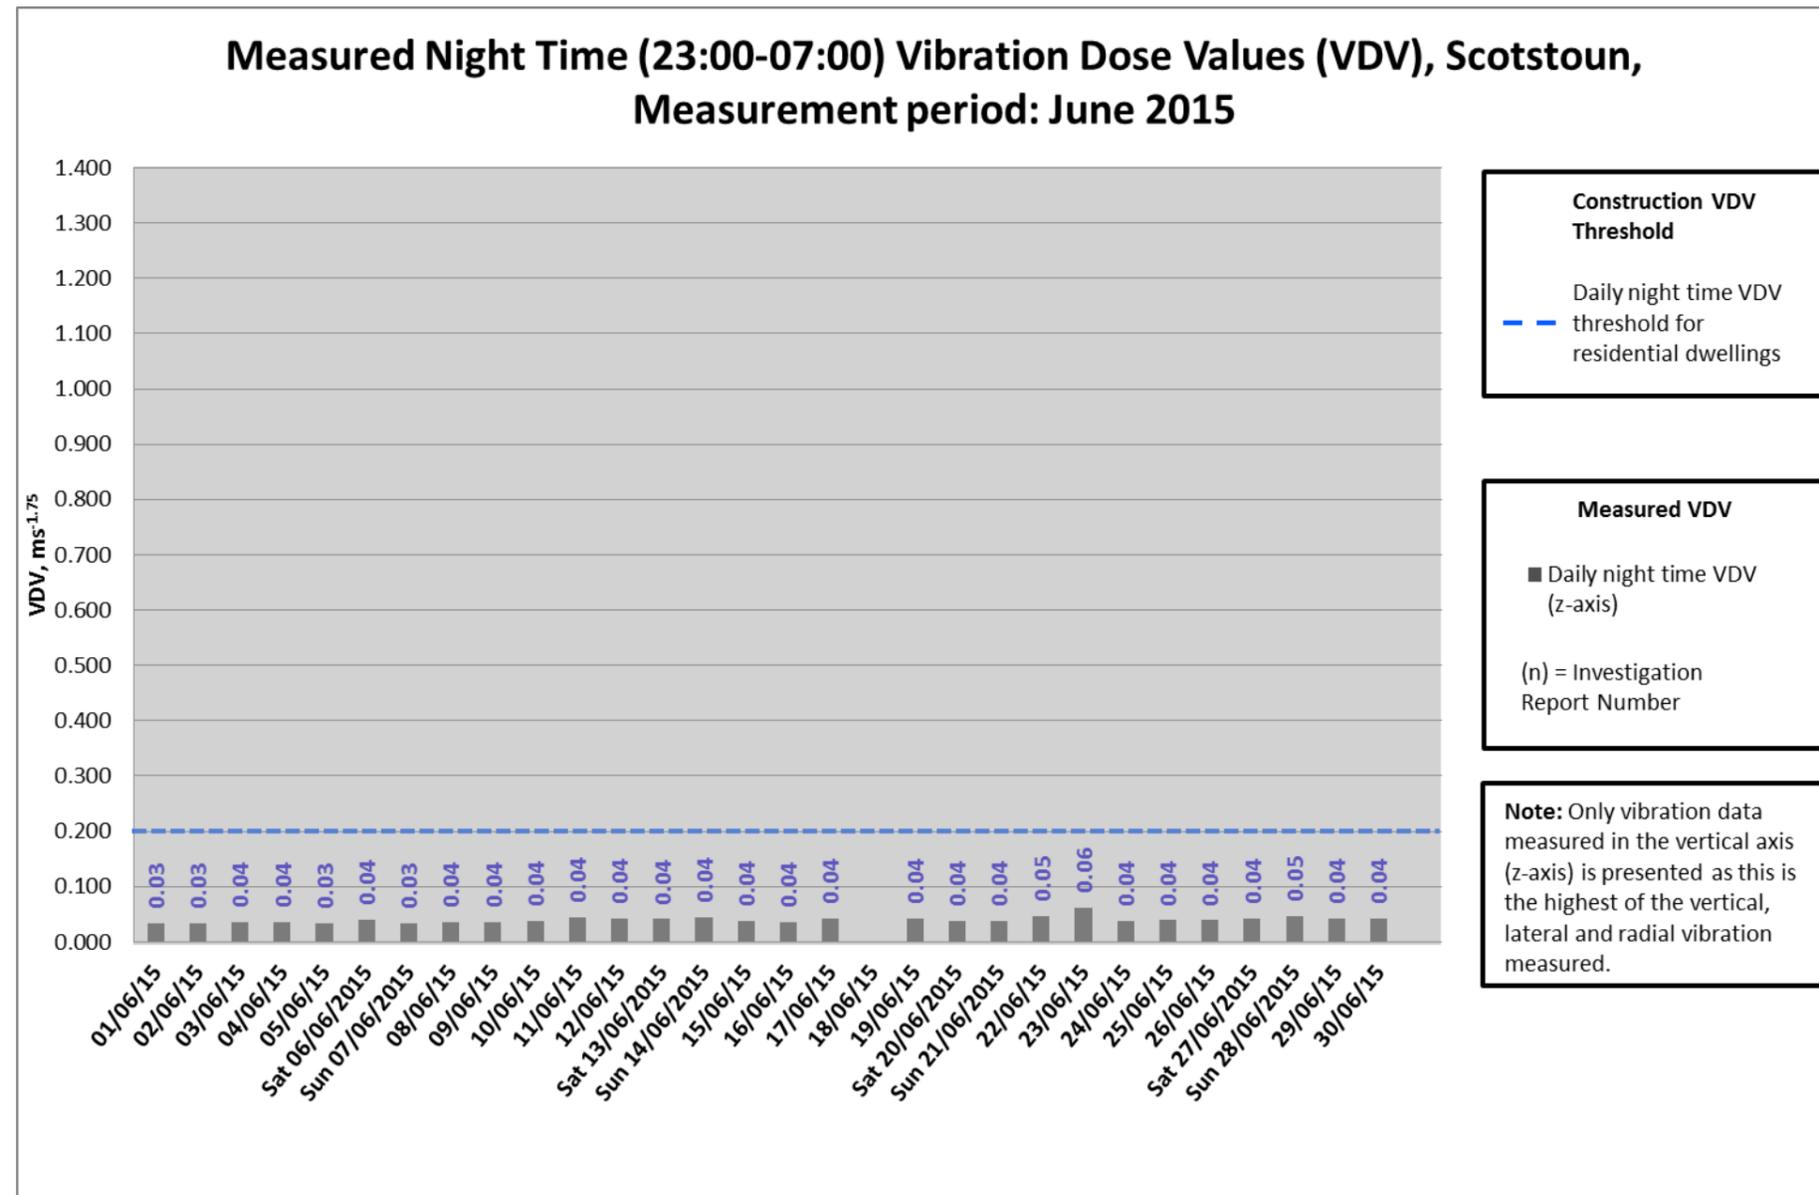
Note: Data missing due to a power problem at the monitor between the 18/06/2015 to the 19/06/2015 they supply was rectified by the evening hence why we have results for VDV evening .

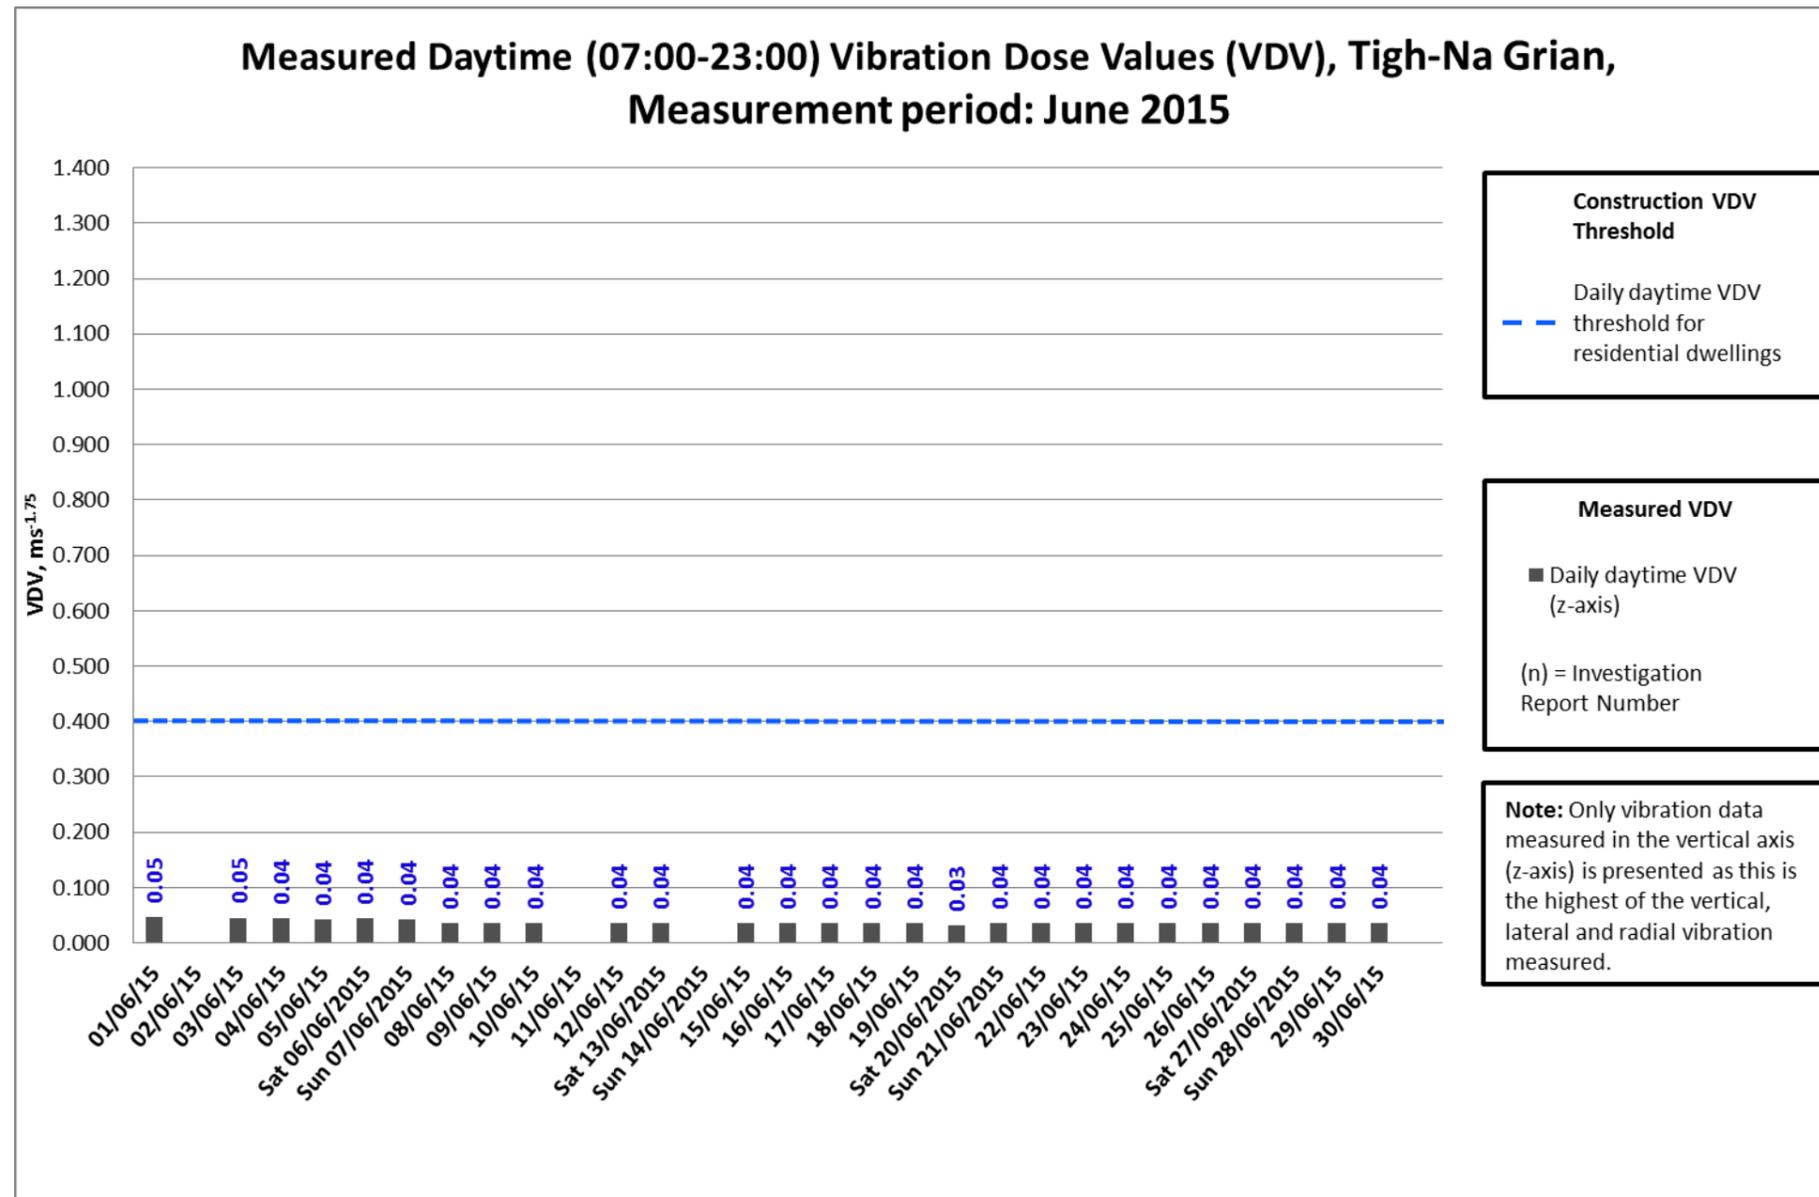
Note: Missing data on the 02/06/2015, 11/06/2015 and 14/06/2015 is due to corrupt files.

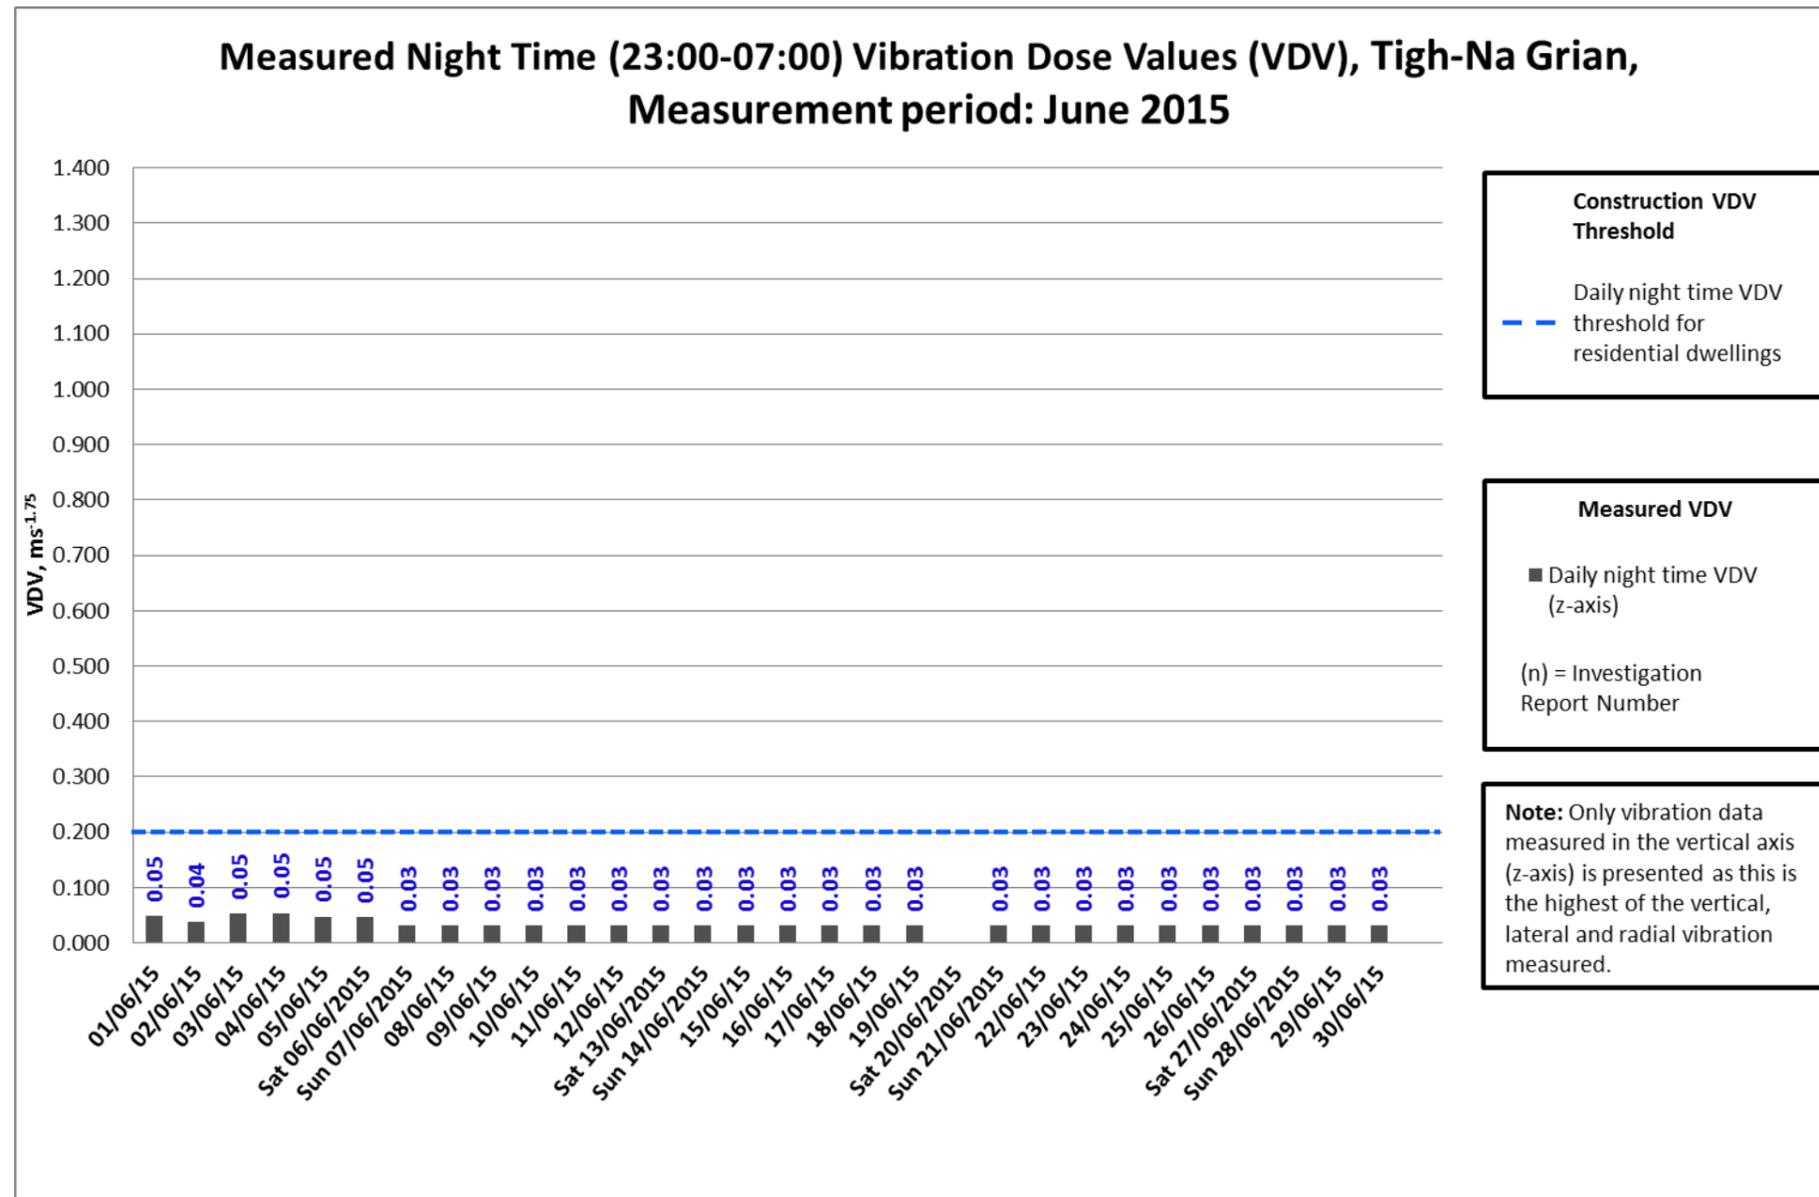
Note: Missing data on the 20/06/2015 is due to corrupt files.
