A83 Tarbet-Lochgilphead- Kennacraig Trunk Road

A83 Rest and Be Thankful

Debris Flow

Emergency Works

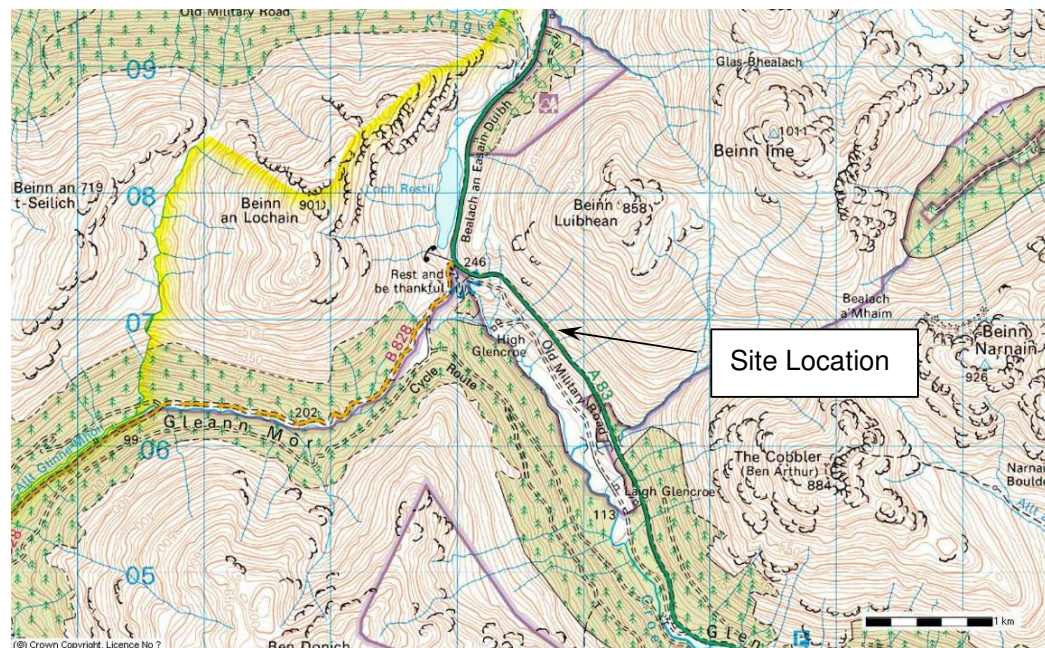
Figure 2 - Site Location Map

The site is located approximately 800m east of the B828 Lochgoilhead junction near the Rest and Be Thankful summit (see Figure 2). Carriageway elevation at this location is approximately 220m AOD. The slope ascends from the road at an approximate gradient of 1:1.4 (V:H) to the head scarp of the source area located at approximately 346m AOD. The slope ascends above the head scarp to the summit of Beinn Luibhean at an elevation of 858m AOD. The slope descends below the road at a similar gradient to the Old Military Road at an elevation of about 165m AOD.

Debris flow crossed the A83 at National Grid Ref: NN23664,07000

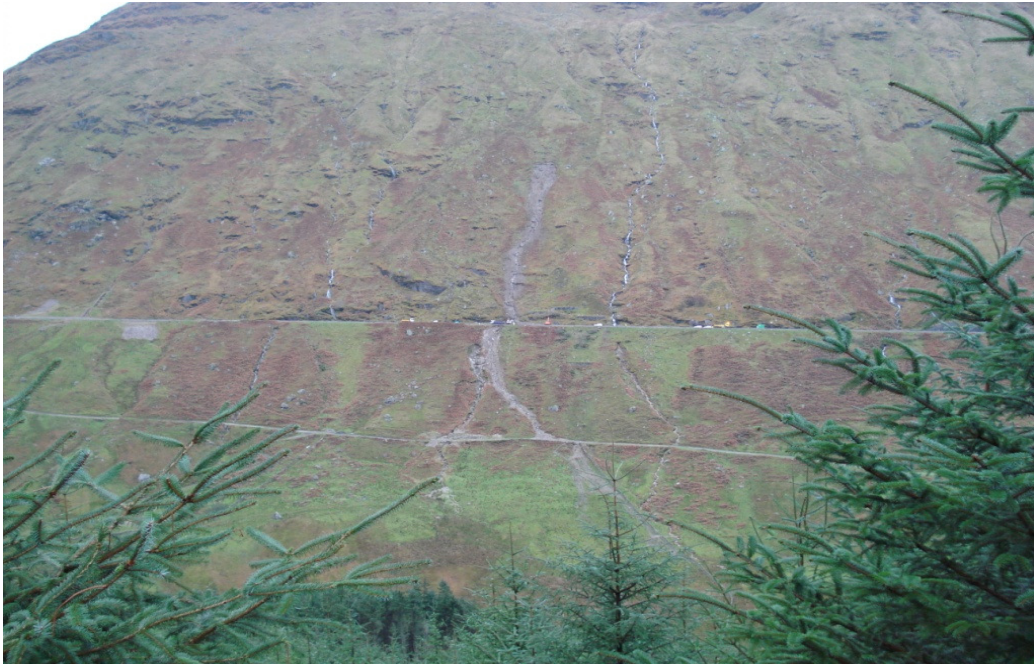
Photograph 1: Site Location

At approximately 03.00 hrs on 28th October 2007 a landslide occurred on the A83 trunk road near the Rest and Be Thankful summit (see Figure 1 and Photograph 1). Following the landslide, emergency services were provided at this location under Scheme No. 07/NW/0601/005 and OI No. 7301185. The landslide consisted of a debris flow which deposited saturated, boulder laden soils to a depth up to approximately 2.5m across the entire width of the road (see Photograph 2).
