Project FORTH REPLACEMENT CROSSING

## AIR QUALITY MONITORING REPORT DECEMBER 2015

00	11/01/2016	First revision		SWR	MRN	MRN			
Rev	Rev. Date	Purpose of revision	Purpose of revision						
Document status									
FOR REVIEW									
Made by Steven Westwater Checked By: Michael Richardson									
Initials: SWR Initials: MRN									
Document number									
REP-00261

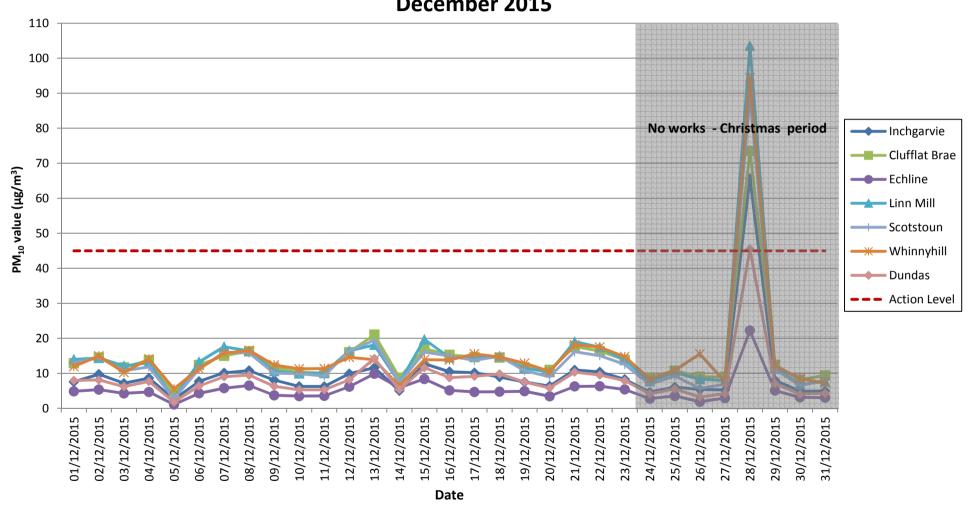
#### **APPENDIX A: LIGHT SCATTER METER RESULTS**

# Air Quality Monitoring Particulate Matter (PM10) Results for all Monitoring Locations December 2015

3.1.1. Light scatter results for December 2015 have been presented in a monthly chart; this can be found in Appendix A. Results show that the PM<sub>10</sub> levels were well below threshold levels throughout the month with the exception of the 28<sup>th</sup> December where all monitors, with the exception of Echline, showed an exceedance. As all monitors show an increase on this day and there were no construction works through the Christmas period, it is concluded that these exceedances were caused by regional air quality.

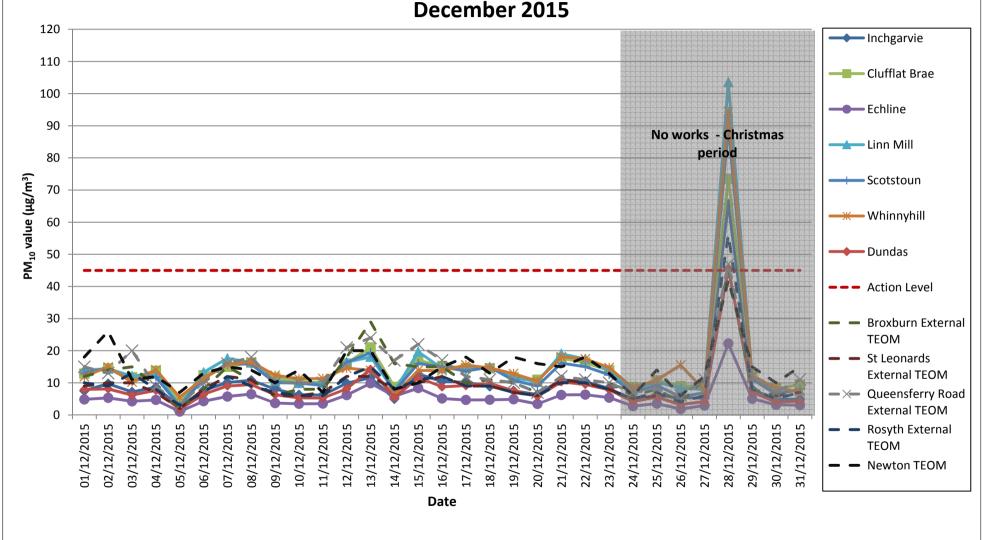
# Air Quality Monitoring: Particulate Matter (PM10) Results for all Monitoring Locations, inlcuding TEOM data December 2015

- 3.1.2. The PM<sub>10</sub> results have also been compared to the daily mean results obtained from the TEOM air quality monitoring stations located in Newton, Rosyth, and Broxburn, and from the TEOM FDMS station located at Queensferry Road and St Leonards, Edinburgh (an urban background site). The TEOM at Newton was installed by West Lothian Council, facilitated by FCBC, during December 2012. The comparison between the light scatter and TEOM results demonstrates that both sets of results generally follow the same pattern, indicating that the pattern observed throughout December was largely driven by regional changes in air quality.
