Halcrow Group Limited  
City Park 368 Alexandra Parade Glasgow G31 3AU  
Tel +44 (0) 141 552 2000 Fax +44 (0) 141 552 2525  
www.performanceauditgroup.co.uk

Acting on behalf of the Trunk Roads Network Management  
Directorate of Transport Scotland

## **REPORT ON WINTER SERVICE PROVIDED BY BEAR ON M8, M9 AND M876 BETWEEN 4 AND 5 JANUARY 2011**

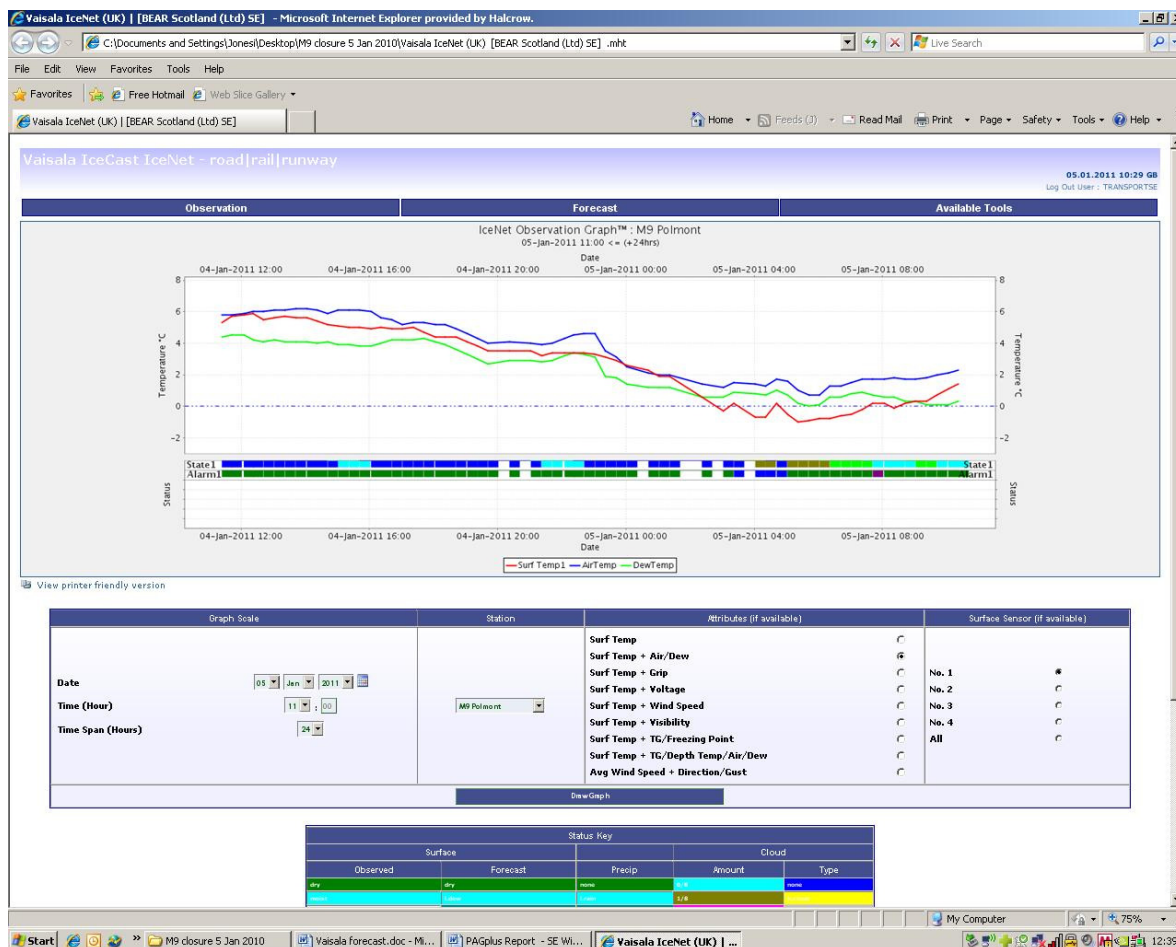
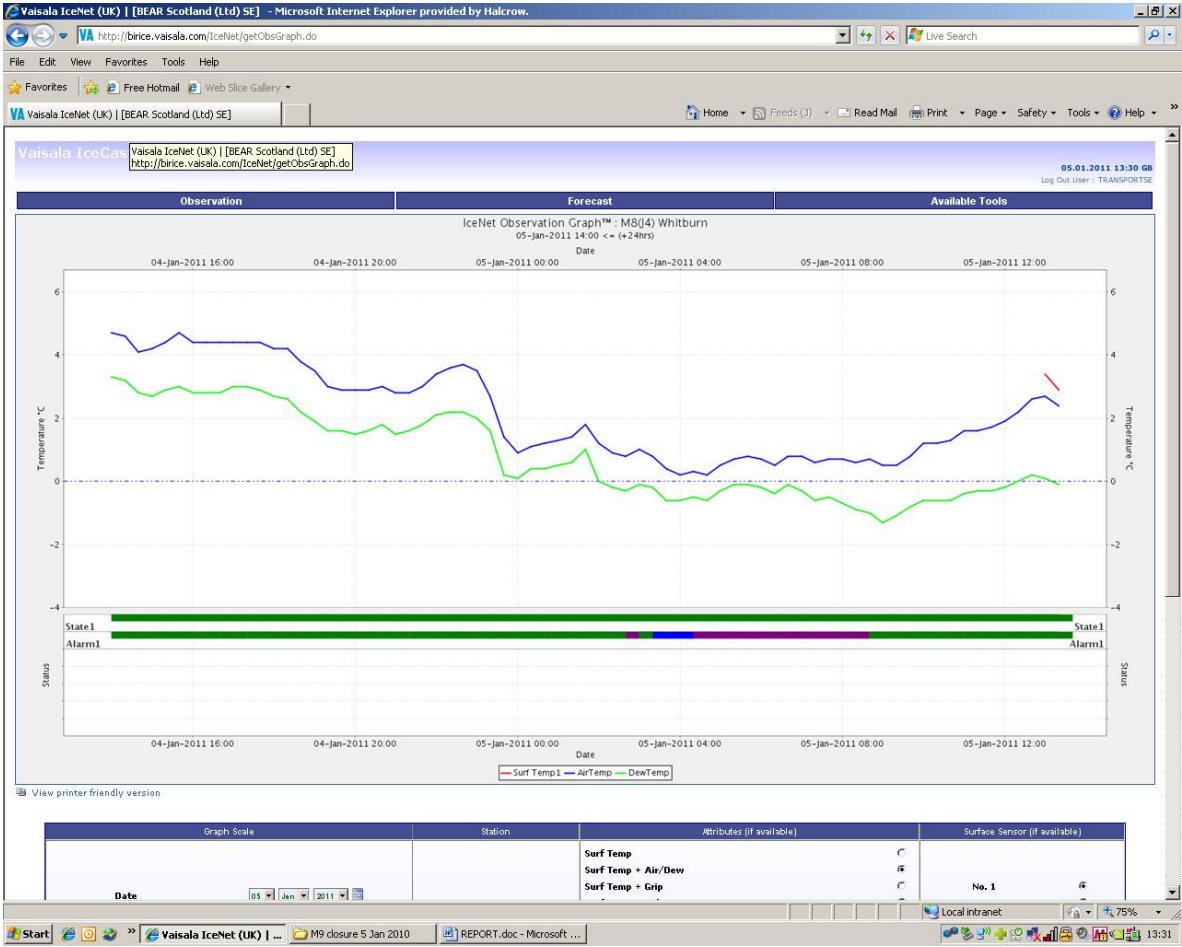
**WARN** - Ice Warning - Surface is close to freezing or ice and or frost formation will occur within a given period if the current trend continues.

**ALARM** - Ice Alarm - Surface at or below freezing point; either there is ice / frost already or there will be very soon.

## Comparison of Forecast vs Actual RSTs

Sensor	Min RST actual	Domain	Time /date of actual RST	Forecast RST
M9 Polmont	minus 1 degree C	7	05:22hrs	minus 0.5 degrees C from 04:00hrs to 07:00hrs
A985 Kincardine Bridge (nearest sensor M9 J8)	Minus 1.5 degrees C	7	04:20hrs	
M9 Bannockburn	minus 1 degree C	7	04:01hrs	minus 0.5 degrees C from 04:00hrs to 07:00hrs
M9 J3 Linlithgow	minus 1.2 degrees C	7	04:20hrs,05:20hrs and 06:04hrs	minus 0.5 degrees C from 04:00hrs to 07:00hrs
M8 J3 Livingston	minus 0.3 degrees C	6	04:20hrs and at 05:10hrs	minus 1.0 degrees C from 02:00hrs to 09:00hrs
M8 J4 Whitburn	No RST readings	6		
M8 Duntilland	minus 0.5 degrees C	6	03:40hrs	minus 1.0 degrees C from 02:00hrs to 09:00hrs
