Appendix A11.1 Baseline Conditions

Table 1: River Garry (WF100) Errochty Water confluence to Loch Faskally (Lower Reach)

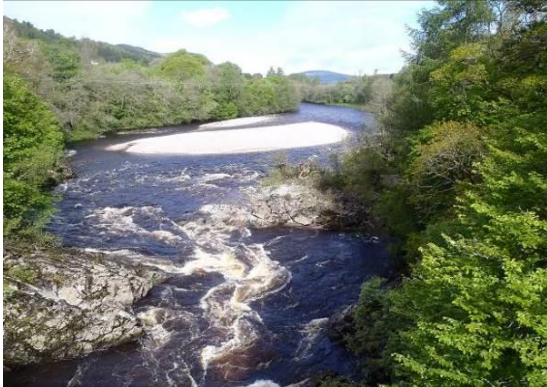
<p>Photograph 1: WF100 (River Garry) lower reach – view upstream from bridge at Killiecrankie.</p>

Fluvial Geomorphology	
<p>Water Framework Directive (SEPA) physical condition status: Good</p> <p>The lower reach of the River Garry has an actively meandering channel with a bedrock and cobble bed and river terraces present in floodplain. The channel is bordered on both banks by a steep valley. There are large depositional features throughout. The watercourse is crossed by the existing A9 clear-span bridge at Essangal and near Pitagowan.</p> <p>For a more detailed description of the watercourse, refer to Appendix A11.5 (Fluvial Geomorphology).</p>	High

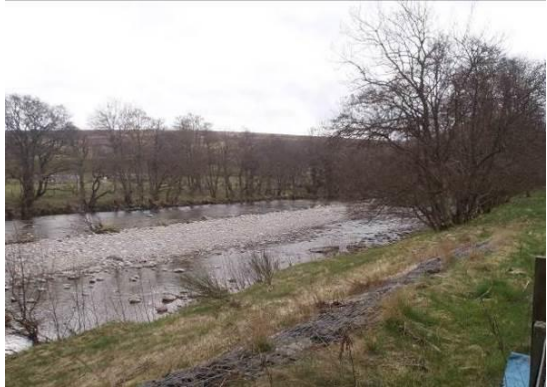
<p>Photograph 2: WF100 (River Garry) lower reach – view upstream of Pitaldonich Underbridge.</p>
Water feature type	Very large watercourse
Catchment area	745km ² (to Killiecrankie Gauging Station)
Key hydraulic connections	Tributary to the Tummel, which is a tributary of the River Tay
Surrounding land use	Predominantly agricultural (arable and pasture), woodland, forestry and numerous settlements along this reach
SEPA overall status:	Good Ecological Potential
Description of Specific Baseline Conditions	
Hydrology and Flood Risk	
<p>The River Garry is classified as a principal watercourse. Along the lower reach, the 0.5% AEP (200-year) functional floodplain extent shown on the SEPA Flood Map is narrow as flow is constrained by steep valley sides. There are only a few locations showing an extensive floodplain. The areas with greatest flood risk have been subject to detailed hydraulic modelling as part of this study. As part of this modelling an allowance for climate change (CC) was included in the 0.5% AEP (200-year) event. Where modelled, more flooding is expected during the 0.5% AEP (200-year) plus CC event than suggested by the SEPA flood map. However, the additional flooded areas are located on natural floodplains around confluences of tributaries, including WF115 (Allt Bhaic) and WF171 (Banvie Burn) and the WF173 (River Tilt) through Blair Atholl.</p> <p>Few properties lie within or close to the floodplain extent shown on the SEPA Flood Map and the modelled flood extents for this study along the River Garry in this section. Areas of greatest risk include those properties close to the floodplain in Blair Atholl.</p> <p>During the 0.5% AEP (200-year) flood event, it is estimated that flooding impacts primarily on open agricultural land. Hydraulic modelling undertaken as part of this study does however show that the Highland Main Line railway is at risk of overtopping at Kingsisland, immediately upstream of the Essangal Underbridge, and also between WF115 (Allt Bhaic) and Blair Atholl (over a longer stretch than the SEPA flood map suggests). The existing A9 is also overtopped immediately upstream of WF115 (Allt Bhaic) by the 0.5% AEP (200-year) plus CC flood event.</p> <p>The SEPA Surface Water (pluvial) Flood Map shows small scattered areas identified at risk of pluvial flooding during a 0.5% AEP (200-year) rainfall event in the vicinity of the River Garry and its floodplain. Notable locations in the vicinity of the existing A9 road include in / on the edge of the River Garry floodplain near Tomban, near WF115 (Allt Bhaic) confluence with the River Garry and near Balnastuartach. Small areas of pluvial flood risk are also shown near/in the River Garry and its floodplain around Blair Atholl, Kingsisland and Killiecrankie. The existing risk of flooding from these areas is discussed in Chapter 5 of the Flood Risk Assessment (FRA).</p>	Very High

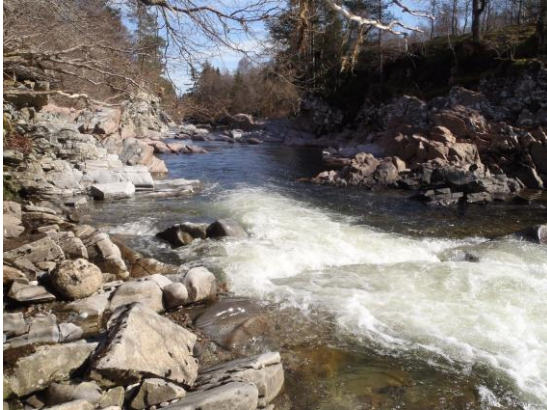
<p>Photograph 3: WF100 (River Garry) upper reach – view downstream from confluence with WF140.</p>

Fluvial Geomorphology	
<p>Water Framework Directive (SEPA) physical condition status: Good</p> <p>The upper reach of the River Garry has an actively meandering gravel bed river with river terraces present in the floodplain. The river is bordered on both banks by a steep valley. The channel has large depositional features with a defined low flow channel.</p> <p>For a more detailed description of the watercourse, refer to Appendix A11.5 (Fluvial Geomorphology).</p>	High
Water Quality	
<p>SEPA water quality status: Good (2015).</p> <p>Potential pollutant sources:</p> <ul style="list-style-type: none"> • diffuse rural sources including suspended sediment from forestry and biological pollutants from grazing livestock; • PGG-C10 Three Septic Tanks at Dalnamein Lodge within 50m of watercourse; and • diffuse runoff of contaminants associated with railway use (PGG-C1 Highland Main Line railway – crosses watercourse). 	High

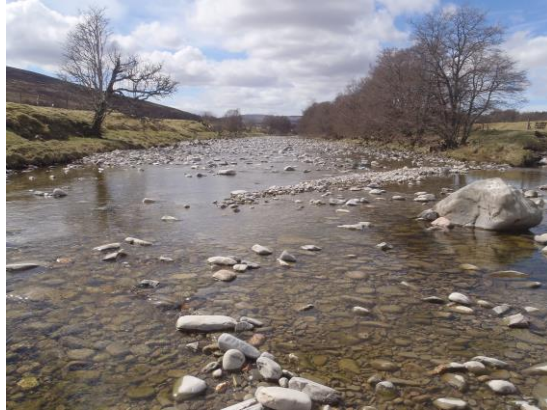
<p>Photograph 4: WF100 (River Garry) upper reach – view upstream at confluence with Allt Anndeir (WF158).</p>
Water feature type	Very large watercourse
Catchment area	375km ²
Key hydraulic connections	Tributary to the River Tay via lower reach.
Surrounding land use	Predominantly agricultural (pasture and arable), moorland in the upper catchment, woodland and forestry, some settlements.
SEPA overall status	Bad Ecological Potential
Description of Specific Baseline Conditions	
Hydrology and Flood Risk	
<p>The River Garry is classified as a principal watercourse. The upper reach of the River Garry between the Errochty Water (at the downstream end) and the Allt Carn na Saidhe (at the upstream end) is constrained by the steep topography of the valley sides. As a result, the 0.5% AEP (200-year) floodplain extent shown on the SEPA Flood Map is narrow with little natural floodplain extent. There is potentially one property at risk at Dalinturuaine (ch19200) and two properties on the edge of the SEPA Flood extent outline at some potential risk.</p> <p>No hydraulic modelling has been undertaken along this section of the River Garry as part of this assessment as the existing A9 lies comfortably outside of the floodplain, sufficiently raised above the river. The scheme is not expected to have an impact on the flood risk along this section for the 0.5% AEP (200-year) flood event.</p> <p>The SEPA Surface Water (pluvial) Flood Map shows small scattered areas identified at risk of pluvial flooding during the 0.5% AEP (200-year) rainfall event. Pluvial flood risk has been identified in small pockets in the vicinity of Calvine and Drochaid nah-Uinneige, in the floodplain around Clunes Lodge, around the River Garry floodplain and the Highland Main Line railway near Fiacail Ach Leathanaidh and around Dalnamein Lodge.</p>	High

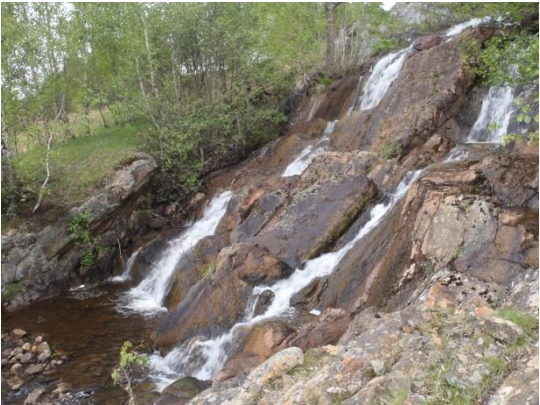
<p>Photograph 5: WF84 (Allt Eachainn) – view of bedrock cascades, immediately upstream of existing A9</p>	Water feature type: Medium watercourse
	Catchment area: 3.64km ²
	Key hydraulic connections: Discharges into lower reach of River Garry
	Surrounding land use: Woodland, agriculture and moorland.
Description of Specific Baseline Conditions	
Sensitivity	
Hydrology and Flood Risk	
<p>The SEPA Flood Map identifies a potential direct risk of flooding from the Allt Eachainn to the existing A9, the B8079, and the Highland Main Line railway located downstream of the existing A9; however, this infrastructure is located on raised embankments and structures which are not reflected on the SEPA Flood Map. The watercourse is located within a steep sided valley upstream of the existing A9 and flows down a very steep hillside downslope of the existing A9. There is no direct flood risk to adjacent populated areas, and/or industrial premises during the design flood event. However, in the absence of information on existing crossing capacity, it is assumed there may be an indirect flood risk to critical infrastructure.</p>	High

Fluvial Geomorphology	
<p>SEPA physical condition status: not classified.</p> <p>A channel with a sinuous planform, consisting of bedrock cascades and boulder and cobble step-pool sequences. The channel is culverted under the existing A9, B8079 road and Highland Main Line railway. Historical map analysis shows minimal change, with the planform remaining consistent since 1867.</p> <p>Historical change: erosion and deposition. For a more detailed description of the watercourse, refer to Appendix A11.5 (Fluvial Geomorphology).</p>	Medium
Water Quality	
<p>SEPA water quality status: not classified.</p> <p>Potential pollutant sources:</p> <ul style="list-style-type: none"> • diffuse rural sources including suspended sediment from forestry and biological pollutants from grazing livestock; • diffuse run-off of contaminants associated with A9 traffic and B8079 (KP-C1 Existing A9 – crosses watercourse) and railway use (KP-C2 Highland Main Line railway – crosses watercourse); and • KP-C3 Killiecrankie Water Treatment Works with potential contaminants associated with historic and current site activities – watercourse flows through site. 	Medium

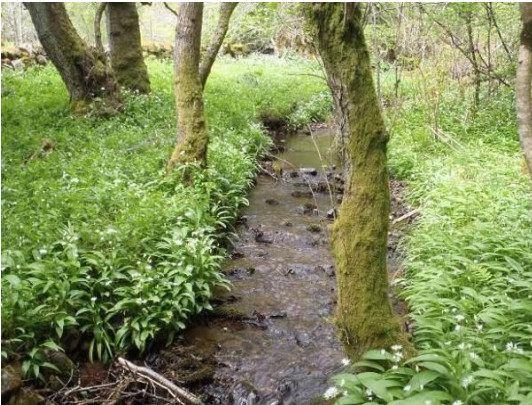
<p>Photograph 6: WF87 (Troopers Den Burn) – view upstream, facing away from the existing A9 culvert</p>	Water feature type: Small watercourse
	Catchment area: 1.27km ²
	Key hydraulic connections: Discharges into lower reach of River Garry
	Surrounding land use: Rough grazing, moorland and woodland.
Description of Specific Baseline Conditions	Sensitivity
Hydrology and Flood Risk	
This watercourse has a catchment area less than 3km ² so is not included in the SEPA Flood Map. According to the culvert capacity assessment, the existing A9 is not at risk from flooding as the existing A9 culvert flow capacity is much greater than the 0.5% AEP (200-year) plus CC peak flow. The Highland Main Line railway is also unlikely to be at risk from flooding due to it being significantly raised at this location by a viaduct.	Low
Fluvial Geomorphology	
SEPA physical condition status: not classified. The watercourse typically has a sinuous planform upstream of the existing A9. Within the immediate vicinity of the existing A9 (upstream and downstream), the channel planform has been straightened, with a 1m wide uniform cross-section and gravel bed. Small field drains discharge into the watercourse. Downstream of the B8079, the channel is approximately 1.5m wide, with a step-pool sequence and a bedrock and cobble bed. The channel is culverted under the existing A9, B8079 and Highland Main Line railway. Historical change: no change. For a more detailed description of the watercourse, refer to Appendix A11.5 (Fluvial Geomorphology).	Medium

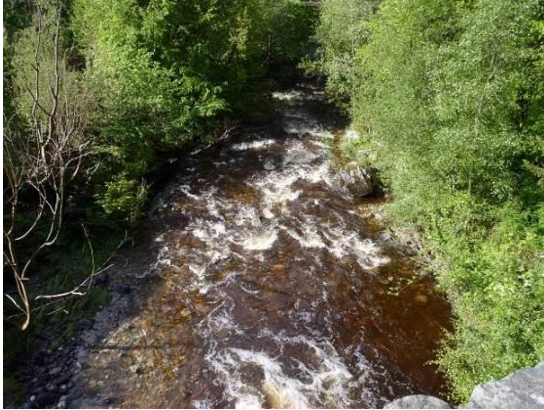
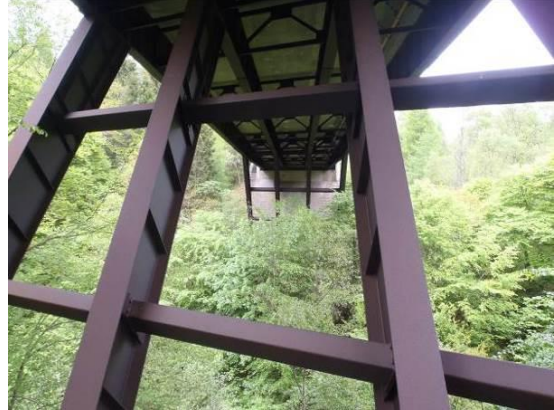
Photograph 7: WF89 (Lower Allt Girnaig) – view downstream, facing away from B8079 overbridge	Photograph 8: WF89 (Lower Allt Girnaig) – view of clear span A9 overbridge
Water feature type	Medium watercourse
Catchment area	39.53km ²
Key hydraulic connections	Flows through Killiecrankie, under the existing A9, B8079 road and the Highland Main Line Railway before discharging into the River Garry.
Surrounding land use	Rough grazing, moorland, woodland and residential (settlement of Killiecrankie).
SEPA overall status	Moderate
Description of Specific Baseline Conditions	
Hydrology and Flood Risk	
<p>The SEPA Flood Map does not identify a direct risk of flooding to critical infrastructure, including the existing A9, a minor road (B8079) or the Highland Main Line, as the watercourse is located within a steep sided valley and the surrounding infrastructure is located on raised embankments and structures. However, there are several residential properties on the edge of the SEPA flood extent, in close proximity to the watercourse. In the absence of more detailed information on existing flood risk, it is assumed these properties may be at risk from flooding during the 0.5% AEP (200-year) plus CC flood event.</p> <p>This watercourse is part of the River Tay SAC, and therefore has hydrological importance to sensitive and protected ecosystems of international status.</p>	Very High

Fluvial Geomorphology	
<p>SEPA physical condition status: High</p> <p>A large watercourse with a sinuous planform and a bedrock and boulder bed. The channel has steep banks and a step-pool sequence. Well vegetated riparian corridor measuring 20-30m on both banks consisting of coniferous trees. The channel is crossed by several bridges including the existing A9, B8079 and Highland Main Line railway.</p> <p>Historical mapping shows some evidence of localised lengths of erosion and deposition, as well as meander migration, particularly in the upstream reach.</p> <p>For a more detailed description of the watercourse, refer to Appendix A11.5 (Fluvial Geomorphology).</p>	High
Water Quality	
<p>SEPA water quality status: High (2015)</p> <p>Existing pressures: water abstraction.</p> <p>Potential pollutant sources:</p> <ul style="list-style-type: none"> • diffuse rural sources including biological pollutants from grazing livestock; • diffuse run-off of contaminants associated with A9 traffic and B8079 (KP-C1 Existing A9 – crosses watercourse) railway use (KP-C2 Highland Main Line railway – crosses watercourse); • KP-C4 Saw Mill (disused) with potential for contaminants from historic activity – within 5m of watercourse; and • KP-C37 and KP-C38 with potential for contaminants from septic tanks – within 10m and within 20m of watercourse respectively. 	Very High

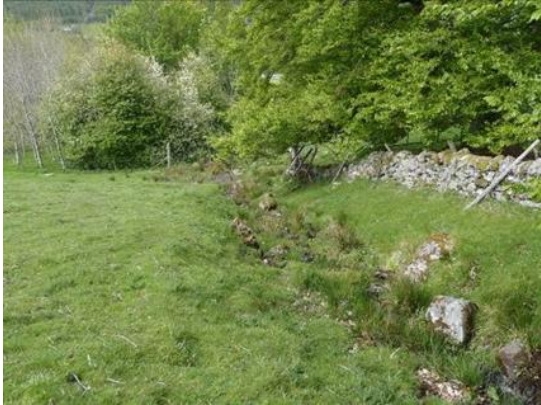
<p>Photograph 9: WF92 – view downstream, towards existing A9</p>	Water feature type: Small watercourse
	Catchment area: 0.41km ²
	Key hydraulic connections: Discharges into lower reach of River Garry
	Surrounding land use: Woodland, rough grazing and arable agriculture
Description of Specific Baseline Conditions	Sensitivity
Hydrology and Flood Risk	
<p>This watercourse has a catchment area less than 3km² so is not included in the SEPA Flood Map. The culvert capacity assessment indicates that WF92 poses an indirect flood risk to the existing A9 during 0.5 % AEP plus CC event, due to an undersized culvert.</p> <p>Further modelling has indicated that during the 0.5% AEP (200-year) event, surcharged flows from the existing A9 culvert are diverted east towards Killiecrankie, posing a flood risk to several properties. Out of bank flow paths downstream of the existing A9 have also been identified as posing a flood risk to a property and the B8079 during the 0.5% AEP plus CC event.</p>	High

Fluvial Geomorphology	
<p>SEPA physical condition status: not classified.</p> <p>A channel with a predominantly straight planform and a step-pool sequence. The channel measures approximately 0.3m wide with a fine gravel and silt substrate. The channel is culverted under two local access roads, the existing A9, the B8079 and the Highland Main Line railway. Analysis of historical mapping shows that there has been very little change to the planform since first available records in 1867.</p>	Low
Water Quality	
<p>SEPA water quality status: not classified.</p> <p>Potential pollutant sources:</p> <ul style="list-style-type: none"> • diffuse rural sources including biological pollutants from grazing livestock; • diffuse run-off of contaminants associated with A9 traffic and B8079 (KP-C1 Existing A9 – crosses watercourse) and railway use (KP-C2 Highland Main Line railway – crosses watercourse); and • KP-C39 Craigurrard with potential for contaminants from septic tanks – located on watercourse. 	Medium

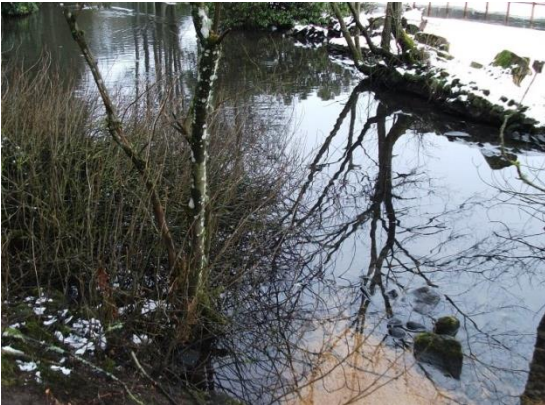
<p>Photograph 10: WF94 – view of the southernmost pond</p>	Water feature type: Drainage channel and artificial ponds
	Catchment area: 0.02km ²
	Key hydraulic connections: Fed from the catchment directly downstream of the existing A9 and a small pipe from the northern side of the existing A9.
	Surrounding land use: Woodland and residential
Description of Specific Baseline Conditions	Sensitivity
Hydrology and Flood Risk	
This watercourse has a catchment area less than 3km ² so is not included in the SEPA Flood Map. WF94 is believed to connect to WF92 downstream of existing A9 crossing. Although there is one residential property approximately 10m away from this drainage channel, there is low risk of flooding from pond features due to the very small catchment size.	Low
Fluvial Geomorphology	
SEPA physical condition status: not classified. Consists of two ponds which appear to be hydrologically connected by a small drain. The ponds appear to have become larger in size since first historical maps in 1867.	Low

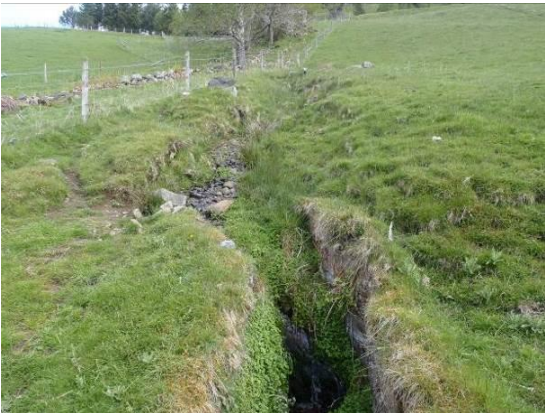
<p>Photograph 11: WF95 – view upstream, facing away from local access road</p>	Water feature type: Small watercourse
	Catchment area: 0.10km ²
	Key hydraulic connections: Discharges into WF96
	Surrounding land use: Woodland and rough grazing
Description of Specific Baseline Conditions	Sensitivity
Hydrology and Flood Risk	
This watercourse has a catchment area less than 3km ² and so is not included in the SEPA Flood Map. WF95 crosses the existing A9 and two local access roads and diverts into WF96 downstream of the existing A9. The culvert capacity assessment indicates that WF95 itself does not pose a flood risk to the existing A9 during 0.5 % (200-year) AEP plus CC flood event.	Low
Fluvial Geomorphology	
SEPA physical condition status: not classified A field drain with a straight planform, and was dry at the time of survey. The substrate predominantly consisted of gravel and scattered cobble and the channel appeared to be narrowing in some reaches. The channel measured approximately 0.8m wide and considered to be incised.	Low

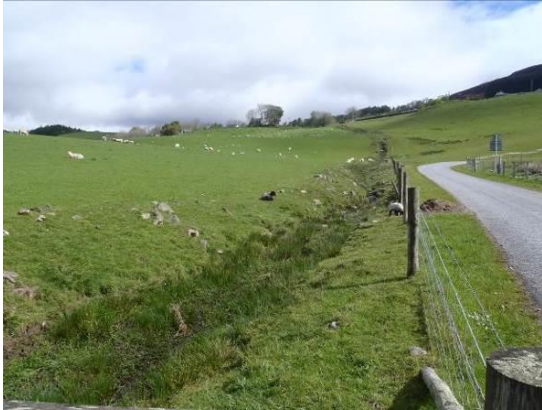
<p>Photograph 12: WF96 – view upstream, facing away from the existing A9 culvert</p>	Water feature type: Small watercourse
	Catchment area: 0.27km ²
	Key hydraulic connections: Discharges into the lower reach of River Garry
	Surrounding land use: Woodland, rough grazing, moorland and residential
Description of Specific Baseline Conditions	Sensitivity
Hydrology and Flood Risk	
<p>This watercourse has a catchment area less than 3km² so is not included in the SEPA Flood Map. The culvert capacity assessment indicates that WF96 does not pose a direct flood risk to the existing A9 during 0.5 % AEP plus CC event, as surcharging flow from the culvert has been assessed as flowing beneath the A9 via an underpass for a minor road prior to re-entering the channel downstream of the A9. There are however several residential properties within 20m of the watercourse, downstream of the existing A9 crossing, which may be at risk from flooding during the design flood event.</p>	High

Fluvial Geomorphology	
<p>SEPA physical condition status: not classified.</p> <p>A small field drainage channel with an average width of approximately 0.5m and a predominantly straight planform. The channel had a fine gravel bed with patches of silt. The flow was typically observed to be smooth. The channel is embanked for the majority of its length and is culverted under two local access routes, the existing A9, Highland Main Line railway and the B8079.</p>	Low
Water Quality	
<p>SEPA water quality status: not classified.</p> <p>Potential pollutant sources:</p> <ul style="list-style-type: none"> • diffuse rural sources including biological pollutants from grazing livestock; • diffuse run-off of contaminants associated with A9 traffic (KP-C1 Existing A9 –crosses watercourse) and railway use (KP-C2 Highland Main Line railway – crosses watercourse); • KP-C40 Killeard House, KP-C59 Mains of Orchil and KP-C72 Lettoch with potential for contaminants from septic tanks – located on watercourse. within 30m and within 40m of watercourse respectively; • KP-C6 Urrard House Sand & Gravel Pit with potential for contaminants from historic use – within 30m of watercourse; and • KP-C8 Old Limekiln with potential for contaminants associated with historic activity – within 20m of watercourse. 	Medium

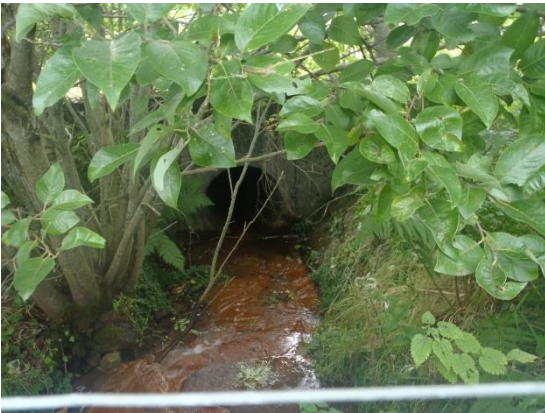
<p>Photograph 13: WF97 – view downstream to inlet of existing culvert.</p>	Water feature type: Drainage channel
	Catchment area: 0.48km ²
	Key hydraulic connections: Discharges into WF98 (Allt Chluain) downstream of the existing A9
	Surrounding land use: Rough grazing
Description of Specific Baseline Conditions	Sensitivity
Hydrology and Flood Risk	
This watercourse has a catchment area less than 3km ² and so is not included in the SEPA Flood Map. The watercourse passes through rough grazing land. The culvert capacity assessment indicates that flood flows during the 0.5% AEP (200-year) plus CC event will remain in-bank, and hence the watercourse does not pose a flood risk to the existing A9.	Low
Fluvial Geomorphology	
SEPA physical condition status: not classified A field drainage channel (measuring approximately 300m in length) which sinks approximately 250m north east of the existing A9. The channel was lined by a narrow strip of shrubs and scrub. Historical mapping shows that the watercourse previously flowed into the Allt Chluain (WF98); however, this connection was removed following the construction of the existing A9.	Low

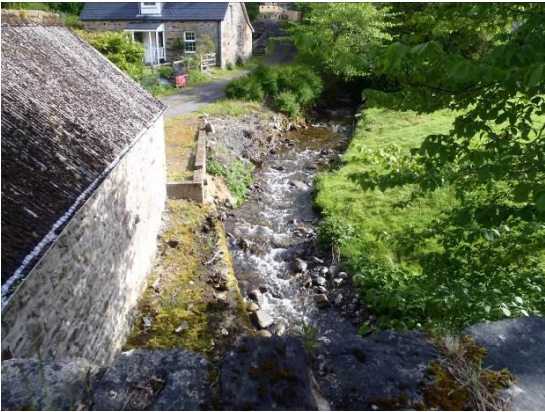
<p>Photograph 14: WF98 (Allt Chluain) – view upstream of B8079</p>	Water feature type: Medium watercourse
	Catchment area: 7.43km ²
	Key hydraulic connections: Discharges into lower reach of River Garry
	Surrounding land use: Woodland, rough grazing and residential
Description of Specific Baseline Conditions	Sensitivity
Hydrology and Flood Risk	
WF98 (Allt Chluain) flows underneath the existing A9 towards Aldclune, before discharging into the River Garry. The channel flows alongside a local access road before crossing under the B8079 and the Highland Main Line railway. Areas of the B8079 and the Highland Main Line railway, and the existing A9, are shown within the SEPA 0.5% AEP (200-year) flood extent. However, the channel is steep and incised at these points and the A9 is significantly raised above the watercourse. There are three properties partly located within the SEPA flood extent and downstream of the existing A9 crossing.	High

Fluvial Geomorphology	
SEPA physical condition status: not classified. Watercourse with a relatively straight planform and a step-pool sequence. The substrate consisted of gravel and cobble, with some gravel and sand deposits. The channel was approximately 3.5m wide, with some areas of exposed bedrock. The channel is culverted under the B8079 and Highland Main Line railway and bridged by a local access road and the existing A9. For a more detailed description of the watercourse, refer to Appendix A11.5 (Fluvial Geomorphology).	Medium
Water Quality	
SEPA water quality status: not classified. Potential pollutant sources: <ul style="list-style-type: none"> • diffuse rural sources including biological pollutants from grazing livestock; • diffuse run-off of contaminants associated with A9 traffic (KP-C1 Existing A9 –crosses watercourse) and railway use (KP-C2 Highland Main Line railway – crosses watercourse); • KP-C10 and KP-C11 – Two old Limekilns with potential for contaminants associated with historic activity – both within 20m of watercourse; and • KP-C46 Drumlowan, KP-C45 Balchroic with potential for contaminants from septic tanks – located on watercourse and within 30m of watercourse respectively. 	Medium

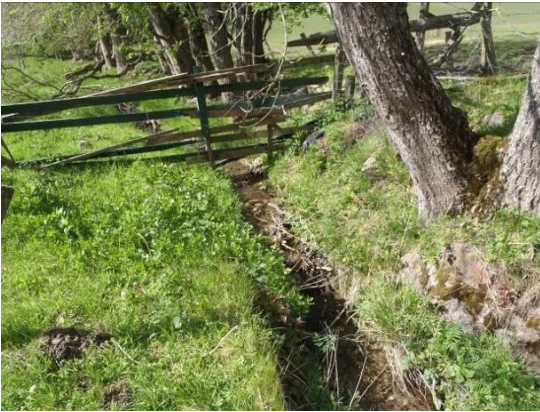
<p>Photograph 15: WF99 – view upstream of confluence with River Garry</p>	Water feature type: Small watercourse
	Catchment area: 0.86km ²
	Key hydraulic connections: Discharges into lower reach of River Garry
	Surrounding land use: Rough grazing
Description of Specific Baseline Conditions	Sensitivity
Hydrology and Flood Risk	
This watercourse has a catchment area less than 3km ² and so is not included in the SEPA Flood Map. This watercourse does not intersect with the existing A9 before it discharges into the River Garry, therefore does not pose a flood risk during the 0.5 % AEP plus CC event to the A9.	Low
Fluvial Geomorphology	
SEPA physical condition status: not classified. A small field drain, approximately 0.5m wide, with a straightened planform. The watercourse was observed to have predominantly smooth flow and a silt and fine gravel substrate. Historical mapping shows that the planform of the watercourse has not changed significantly since first records in 1867.	Low

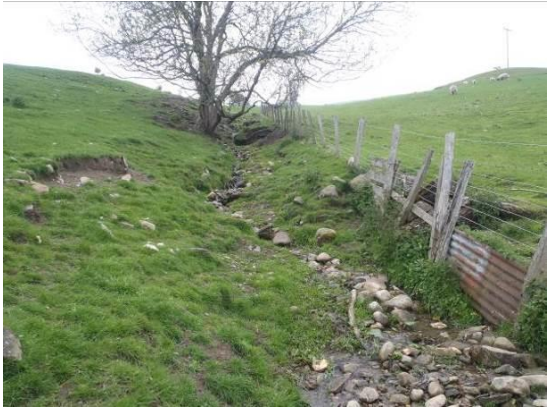
<p>Photograph 16: WF178 – view upstream, facing away from the existing A9 junction at Aldclune</p>	Water feature type: Small watercourse
	Catchment area: 0.37km ²
	Key hydraulic connections: Discharges into lower reach of River Garry.
	Surrounding land use: Rough grazing/ agriculture.
Description of Specific Baseline Conditions	Sensitivity
Hydrology and Flood Risk	
<p>This watercourse has a catchment area less than 3km² so is not included in the SEPA Flood Map. The watercourse crosses under the B8079 just upstream of its confluence with the River Garry but does not intersect with the existing A9. WF178 passes through utilisable agricultural fields with one property located within approximately 35m. In the absence of detailed information on the existing culvert capacity under the side road and Highland Main Line, it is assumed that there could be a potential flood risk to the property.</p>	High

Fluvial Geomorphology	
<p>SEPA physical condition status: not classified. A small drainage channel approximately 0.8m wide with a straightened planform. The channel was embanked on both sides upstream of the A9. The channel is culverted under the existing A9, Highland Main Line railway, B8079 and local access route. Historical mapping shows that the planform of the watercourse has not changed significantly since first records in 1867.</p>	Low
Water Quality	
<p>SEPA water quality status: not classified. Potential pollutant sources:</p> <ul style="list-style-type: none"> diffuse rural sources including biological pollutants from grazing livestock; diffuse run-off of contaminants associated with A9 junction and B8079 traffic (KP-C1 Existing A9 – junction link crosses watercourse) and railway use (KP-C2 Highland Main Line railway – crosses watercourse); and KP-C13 Old Limekiln with potential for contaminants associated with historic activity – within 10m of watercourse. 	Low

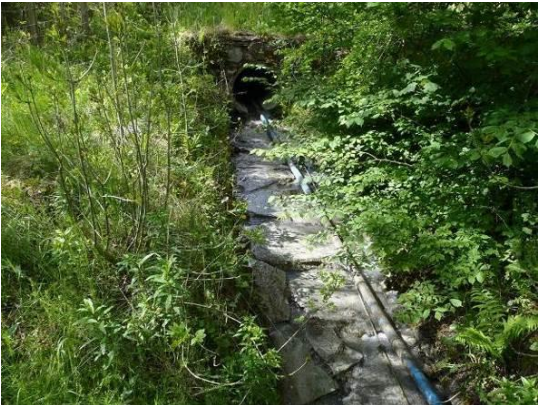
<p>Photograph 17: WF101 – view upstream, towards existing A9 culvert</p>	Water feature type: Small watercourse
	Catchment area: 0.78km ²
	Key hydraulic connections: All channels and ponds converge to discharge via a single channel to the River Garry
	Surrounding land use: Industrial (Shierglas Limestone Quarry).
Description of Specific Baseline Conditions	Sensitivity
Hydrology and Flood Risk	
This watercourse has a catchment area less than 3km ² so is not included in the SEPA Flood Map, and forms part of a quarry drainage network which crosses the A9. The culvert capacity assessment indicates the existing is not be at risk of flooding for the 0.5% AEP (200-year) plus CC event, with flows remaining in bank.	Low
Fluvial Geomorphology	
SEPA physical condition status: not classified. Flows north through a network of quarry drainage channels and under the existing A9 and a local access track into the River Garry at Shierglas. Downstream of the quarry, the channel has reinforced bed and banks, with a uniform channel cross-section measuring an average width of 0.8m. Historical mapping shows that the watercourse historically flowed straight through the existing quarry prior to 1977 and had a sluice present (in the 1900s) upstream of Shierglas Farm.	Low

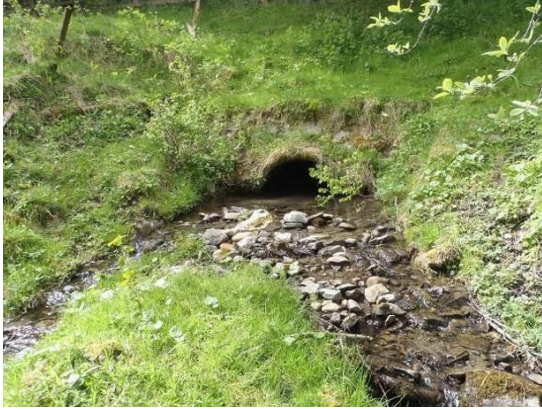
<p>Photograph 18: WF102 – view upstream, towards the existing A9 culvert</p>	Water feature type: Small watercourse
	Catchment area: 0.54km ²
	Key hydraulic connections: Discharges in to lower reach of River Garry
	Surrounding land use: Moorland, woodland and pasture.
Description of Specific Baseline Conditions	Sensitivity
Hydrology and Flood Risk	
<p>This watercourse has a catchment area less than 3km² so is not included in the SEPA Flood Map. The watercourse passes through moorland, woodland and pasture, crossing the A9 and discharging into the lower reach of the River Garry. This watercourse has been assessed by the culvert capacity assessment as not being a flood risk to the existing A9 for the 0.5% AEP (200-year) plus CC design flood event.</p>	Low
Fluvial Geomorphology	
<p>SEPA physical condition status: not classified.</p> <p>A small watercourse with a predominantly sinuous planform, step-pool sequence, and gravel and pebble substrate. The channel has a continuous vegetated riparian corridor on both banks consisting of trees, providing some stability to the banks. The channel is culverted under the existing A9 and a local access road and is crossed by a ford in the headwaters. Historic mapping shows that the planform of the watercourse has not changed significantly since first records in 1867.</p> <p>For a more detailed description of the watercourse, refer to Appendix A11.5 (Fluvial Geomorphology).</p>	Medium

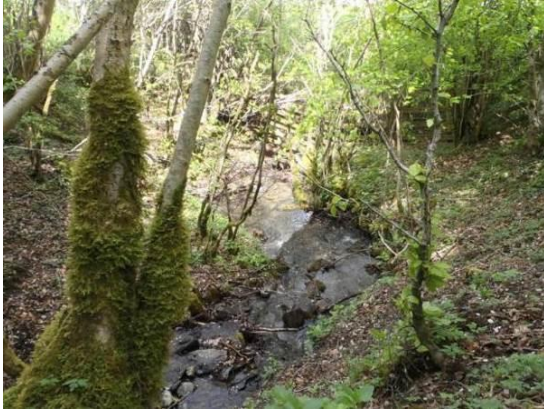
Table 17: WF103

<p>Photograph 19: WF103 – view downstream, facing away from the existing A9 culvert</p>	Water feature type: Small watercourse
	Catchment area: 0.74km ²
	Key hydraulic connections: Discharges into lower reach of River Garry
	Surrounding land use: Woodland and moorland.
Description of Specific Baseline Conditions	Sensitivity
Hydrology and Flood Risk	
This watercourse has a catchment area of less than 3km ² and so is not included in the SEPA Flood Map. According to the culvert capacity assessment, the existing A9 is not at risk from flooding during the 0.5% AEP (200-year) plus CC event with flow remaining in bank. There is however one property within approximately 20m of the watercourse which may be at risk of flooding during the design flood event.	High
Fluvial Geomorphology	
SEPA physical condition status: not classified. A small watercourse with a slightly sinuous planform and a step-pool sequence. The channel has a pebble and cobble substrate with some sand deposits. The channel was incised, measuring approximately 1m wide. The channel is culverted under the existing A9 and a local access road. Analysis of historical mapping shows that the planform of WF103 has been subject to some alterations. For a more detailed description of the watercourse, refer to Appendix A11.5 (Fluvial Geomorphology).	Medium

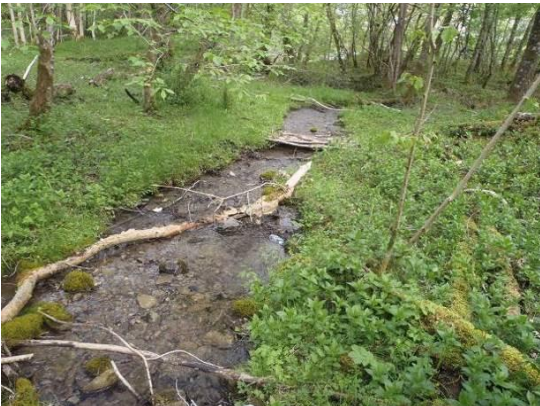
Table 18: WF104

<p>Photograph 20: WF104 – view downstream, facing away from the existing A9 culvert</p>	Water feature type: Small watercourse
	Catchment area: 0.07km ²
	Key hydraulic connections: Discharges into lower reach of River Garry.
	Surrounding land use: Woodland and moorland.
Description of Specific Baseline Conditions	Sensitivity
Hydrology and Flood Risk	
This watercourse has a catchment area of less than 3km ² and so is not included in the SEPA Flood Map. According to the culvert capacity assessment, the existing A9 is not at risk from flooding during the 0.5% AEP (200-year) plus CC event.	Low
Fluvial Geomorphology	
SEPA physical condition status: not classified. The channel has an average width of approximately 1.3m with a straight planform, step-pool sequence and a predominantly gravel substrate. The channel is culverted under the existing A9 and a local access track and is crossed by a ford in the upstream reach above the existing A9. Historical mapping shows that the planform of the watercourse has not changed significantly since first records in 1867. For a more detailed description of the watercourse, refer to Appendix A11.5 (Fluvial Geomorphology).	Medium

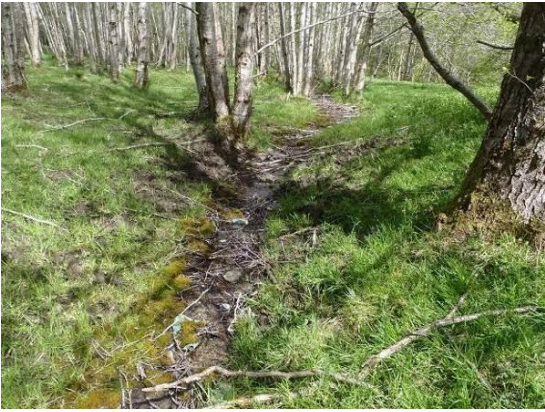
Table 19: WF105

<p>Photograph 21: WF105 –view downstream, facing away from the existing A9 culvert</p>	Water feature type: Drainage channel
	Catchment area: 0.06km ²
	Key hydraulic connections: Discharges into lower reach of the River Garry
	Surrounding land use: Woodland and moorland.
Description of Specific Baseline Conditions	Sensitivity
Hydrology and Flood Risk	
This watercourse has a catchment area of less than 3km ² and so is not included in the SEPA Flood Map. The watercourse has been assessed by the culvert capacity assessment as not posing a flood risk to the existing A9 for the 0.5% AEP (200-year) plus CC design flood event, with flow remaining in-bank.	Low
Fluvial Geomorphology	
SEPA physical condition status: not classified. A small woodland drain with an average width of approximately 0.3m. The channel substrate consisted predominantly of sand and fine gravel and is culverted under the existing A9. Historical mapping shows that the planform of the watercourse has not changed since first records in 1867.	Low

Water Supply	
Water Supply Abstractions: abstractions by Shierglas Quarry from River Garry (pass through existing culvert of WF101 (see photograph 21)).	High
Dilution and Removal of Waste Products	
<p>Medium to high dilution capacity (Q95 approx. 3.0 m³/s at Killiecrankie gauging station (NGR NN 900 635)) CAR Discharges:</p> <ul style="list-style-type: none"> • point source discharge of final effluent from Killiecrankie Sewage Treatment Works (NN 91205 62745), Blair Atholl Sewage/Waste Water Treatment Works (NN 88078 64482) and Shierglas Quarry (NN 88399 64408); • point source discharge from combined sewer overflow and emergency overflow from Blair Atholl Sewage/Waste Water Treatment Works (NN 88078 64482) and combined sewer overflow from Garryside (NN 87170 64940); • point source discharge of septic tank effluent from one domestic property (NN 90480 63269); and • diffuse source discharge of septic tank effluent to soakaways from two domestic properties within 50m of watercourse (NN 89170 64310, NN 86942 65180). 	Low

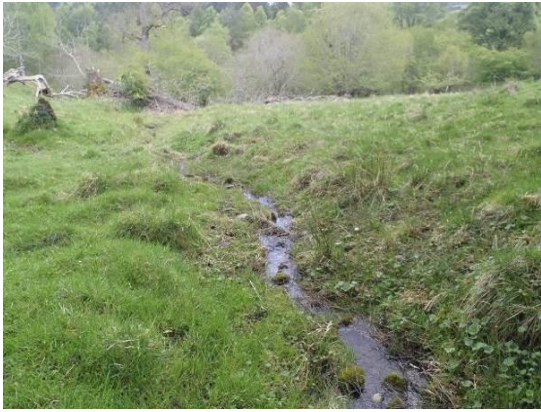
Table 21: WF106

Water feature type: Drainage channel
	Catchment area: 0.21km ²
	Key hydraulic connections: Discharges into lower reach of River Garry
	Surrounding land use: Rough grazing, scrub and woodland
Description of Specific Baseline Conditions	
Sensitivity	
Hydrology and Flood Risk	
<p>This catchment has an area less than 3km² and so is not included in the SEPA Flood Map. WF106 passes through rough grazing, scrub and woodland and has been assessed by the culvert capacity assessment as not being a flood risk to the existing A9 for the 0.5% AEP (200-year) plus CC design flood event. Out of bank flooding has been estimated to occur, however by less than 0.2m, causing no significant flooding.</p>	Low
Fluvial Geomorphology	
<p>SEPA physical condition status: not classified. A small field drain approximately 0.3m wide. The watercourse had rippled flow with fine gravel substrate. At the downstream reach (below the existing A9), the watercourse flows into a historical secondary channel of the River Garry which is approximately 2.5m wide with silt substrate. The channel is culverted under the existing A9. Historical map analysis shows erosion and deposition along the watercourse.</p>	Low

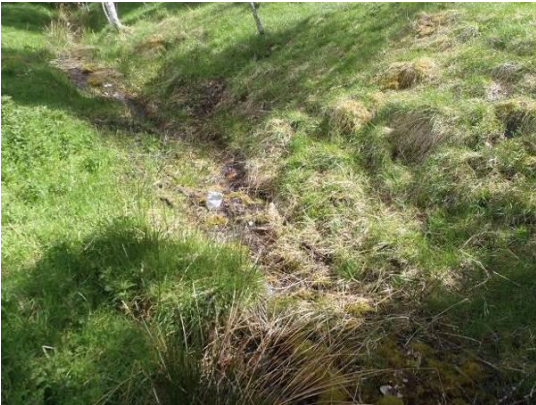
Table 22: WF107

<p>Photograph 23: WF107 – view downstream, facing away from the existing A9 culvert</p>	Water feature type: Drainage channel
	Catchment area: 0.27km ²
	Key hydraulic connections: Discharges into lower reach of River Garry
	Surrounding land use: Moorland and woodland
Description of Specific Baseline Conditions	Sensitivity
Hydrology and Flood Risk	
This catchment has an area less than 3km ² so is not included in the SEPA Flood Map. WF107 passes through moorland and woodland, and has been assessed by the culvert capacity assessment as not being a flood risk to the existing A9 for the 0.5% AEP (200-year) plus CC design flood event, with flow remaining in-bank.	Low
Fluvial Geomorphology	
SEPA physical condition status: not classified. A small woodland drainage channel, approximately 0.2m wide, with a straight platform. The substrate typically consisted of sand and fine gravel. The watercourse does not appear on historical mapping until 1989.	Low

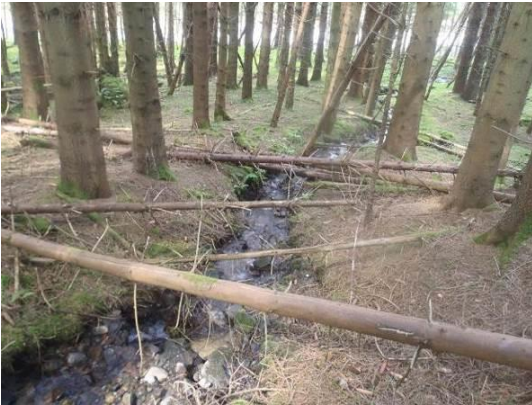
Table 23: WF108

<p>Photograph 24: WF108 – view downstream, facing away from the existing A9 culvert</p>	Water feature type: Small watercourse
	Catchment area: 0.16km ²
	Key hydraulic connections: Discharges into lower reach of River Garry
	Surrounding land use: Moorland and woodland
Description of Specific Baseline Conditions	
Sensitivity	
Hydrology and Flood Risk	
<p>This catchment has an area less than 3km² so is not included in the SEPA Flood Map. No residential properties and/or industrial premises are located in close proximity to the watercourse; however, the culvert capacity assessment indicates that WF108 poses an indirect and localised flood risk to the existing A9 during 0.5 % AEP plus CC event, due to an undersized culvert likely to result in out of bank flooding.</p>	High
Fluvial Geomorphology	
<p>SEPA physical condition status: not classified. A small, straightened and incising woodland channel with an average width of approximately 0.3m. The bed substrate predominantly consisted of sand. The channel is culverted under the existing A9 and has a ford crossing in the upstream section. Historical mapping shows that the planform of the watercourse has not changed since first records in 1867.</p>	Low

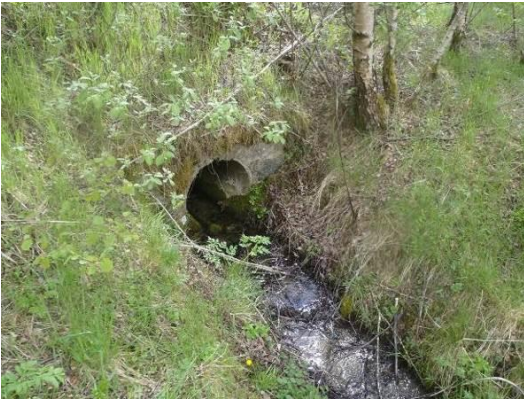
Table 24: WF109

<p>Photograph 25: WF109 – view upstream, towards existing A9 culvert</p>	Water feature type: Drainage channel
	Catchment area: 0.13km ²
	Key hydraulic connections: Discharges into lower reach of River Garry
	Surrounding land use: Moorland and woodland
Description of Specific Baseline Conditions	
Sensitivity	
Hydrology and Flood Risk	
This channel catchment has an area less than 3km ² so is not included in the SEPA Flood Map. The existing A9 has not been assessed as at risk during the 0.5 % AEP plus CC event with flow remaining in-bank.	Low
Fluvial Geomorphology	
SEPA physical condition status: not classified. A small field/woodland drain with an average width of approximately 0.3m (during bankfull flows). The watercourse had a straightened planform, rippled flow, and an earth and silt bed. The channel is culverted under the existing A9. Historical mapping shows that the planform of the watercourse has not changed since first records in 1867.	Low

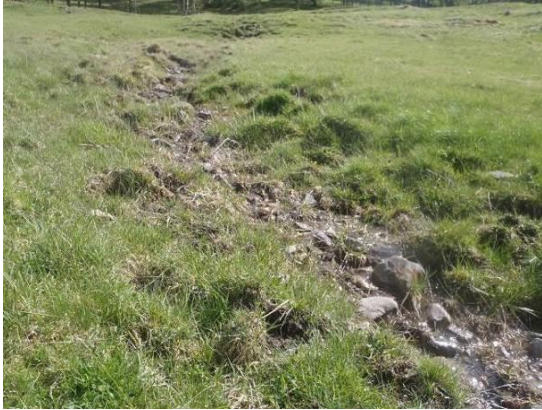
Table 25: WF110

<p>Photograph 26: WF110 – view upstream, facing away from the existing A9 culvert</p>	Water feature type: Drainage channel
	Catchment area: 0.09km ²
	Key hydraulic connections: Discharges into lower reach of River Garry
	Surrounding land use: Pasture and woodland
Description of Specific Baseline Conditions	Sensitivity
Hydrology and Flood Risk	
This catchment has an area less than 3km ² so is not included in the SEPA Flood Map. The existing A9 has not been assessed as at risk during the 0.5 % AEP plus CC event with flow remaining in-bank.	Low
Fluvial Geomorphology	
SEPA physical condition status: not classified. A small incised channel, approximately 0.3m wide, with a straight planform. A step-pool sequence was observed, and the substrate consisted of gravel. The channel is culverted under the existing A9 and a local access route. Historical mapping shows that the planform of the watercourse has not changed since first records in 1867.	Low

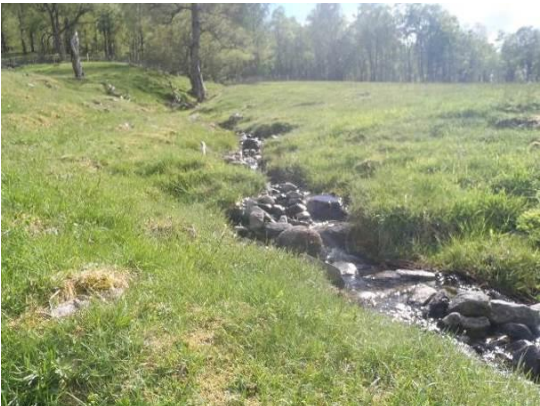
Table 26: WF111

<p>Photograph 27: WF111 – view upstream, facing away from the existing A9 culvert</p>	Water feature type: Small watercourse
	Catchment area: 0.28km ²
	Key hydraulic connections: Discharges into the lower reach of the River Garry
	Surrounding land use: Moorland, woodland and rough grazing
Description of Specific Baseline Conditions	Sensitivity
Hydrology and Flood Risk	
<p>This catchment has an area less than 3km² and so is not included in the SEPA Flood Map. No residential properties and/or industrial premises are located in close proximity to the watercourse. However, the culvert capacity assessment indicates that WF111 poses an indirect and localised flood risk to the existing A9 during 0.5 % AEP plus CC event, due to an undersized culvert likely to result in out of bank flooding.</p>	High
Fluvial Geomorphology	
<p>SEPA physical condition status: not classified.</p> <p>A small dynamic watercourse with an average width of approximately 0.4m and a step-pool sequence. The substrate consisted of cobble and pebble. The watercourse flows into a manhole chamber before flowing under the existing A9 in a culvert. Historical mapping shows that the planform of the watercourse has not changed since first records in 1867.</p> <p>For a more detailed description of the watercourse, refer to Appendix A11.5 (Fluvial Geomorphology).</p>	Medium

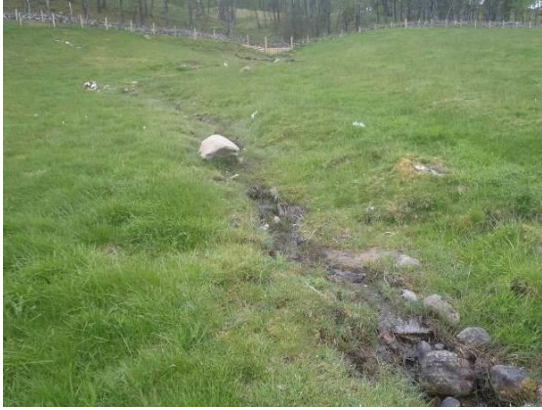
Table 27: WF112

<p>Photograph 28: WF112 – view upstream, facing away from the existing A9 culvert</p>	Water feature type: Drainage channel
	Catchment area: 0.22km ²
	Key hydraulic connections: Tributary of the River Garry
	Surrounding land use: Woodland and rough grazing
Description of Specific Baseline Conditions	Sensitivity
Hydrology and Flood Risk	
<p>This catchment has an area less than 3km² so is not included in the SEPA Flood Map. No residential properties and/or industrial premises are located in close proximity to the watercourse. The culvert capacity assessment indicates this watercourse poses an indirect and localised flood risk to the existing A9 during 0.5 % AEP plus CC event, due to an undersized culvert likely to result in out of bank flooding.</p>	High
Fluvial Geomorphology	
<p>SEPA physical condition status: not classified.</p> <p>A small field drain with an average width of approximately 0.3m. The watercourse had rippled flow, gravel and pebble substrate and a straight planform. The channel is culverted under the existing A9 and local access road. Historical mapping shows that WF112 flowed into the historical planform of the Allt Bhaic prior to the construction of the existing A9.</p>	Low

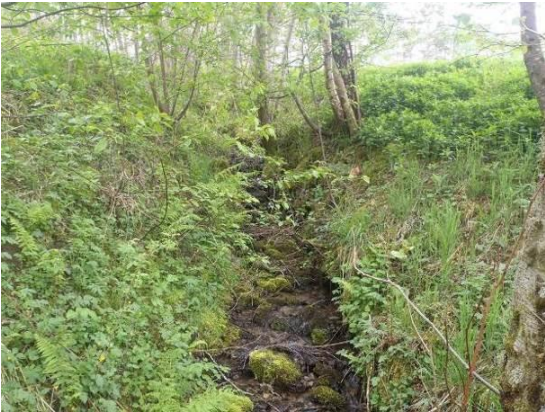
Table 28: WF113

<p>Photograph 29: WF113 – view upstream, towards the existing A9 culvert</p>	Water feature type: Drainage channel
	Catchment area: 0.26km ²
	Key hydraulic connections: Discharges into the lower reach of the River Garry
	Surrounding land use: Woodland and rough grazing
Description of Specific Baseline Conditions	Sensitivity
Hydrology and Flood Risk	
This catchment has an area less than 3km ² so is not included in the SEPA Flood Map. No residential properties and/or industrial premises are located in close proximity to the watercourse. The culvert capacity assessment indicates this watercourse poses an indirect and localised flood risk to the existing A9 during 0.5 % AEP plus CC event, due to an undersized culvert likely to result in out of bank flooding.	High
Fluvial Geomorphology	
SEPA physical condition status: not classified. A small field drain with an average width of approximately 0.3m. The channel had rippled flow, gravel and cobble substrate and a straight planform. The channel flows sub-surface in several sections south of the existing A9 and is culverted under the existing A9 and a local access road. Historical mapping shows that WF113 flowed into the historical planform of the Allt Bhaic prior to the construction of the existing A9.	Low

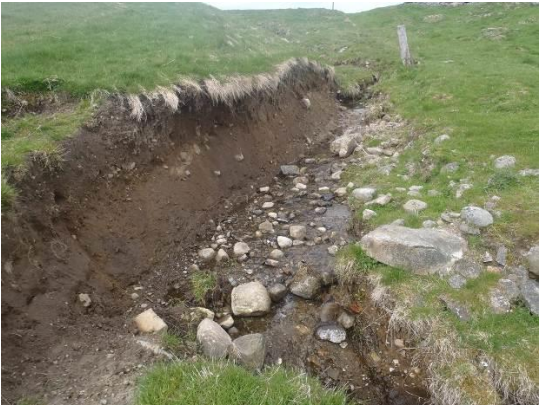
Table 29: WF114

<p>Photograph 30: WF114 – view upstream, facing away from the existing A9 culvert</p>	Water feature type: Small watercourse
	Catchment area: 0.19km ²
	Key hydraulic connections: Discharges into the lower reach of the River Garry
	Surrounding land use: Moorland, rough grazing and woodland
Description of Specific Baseline Conditions	Sensitivity
Hydrology and Flood Risk	
This catchment has an area less than 3km ² and so is not included in the SEPA Flood Map. The existing A9 has not been assessed as at risk during the 0.5 % AEP plus CC event with flow remaining in-bank.	Low
Fluvial Geomorphology	
SEPA physical condition status: not classified. A small, incised watercourse with an average width of approximately 0.4m and eroding banks as a result of mass failure, slumping and poaching. The channel had a step-pool sequence, with a gravel and cobble substrate. The channel is culverted under the existing A9 and a local access track. Historical mapping shows that WF114 flowed into the planform of the Allt Bhaic prior to the construction of the existing A9. For a more detailed description of the watercourse, refer to Appendix A11.5 (Fluvial Geomorphology).	Medium

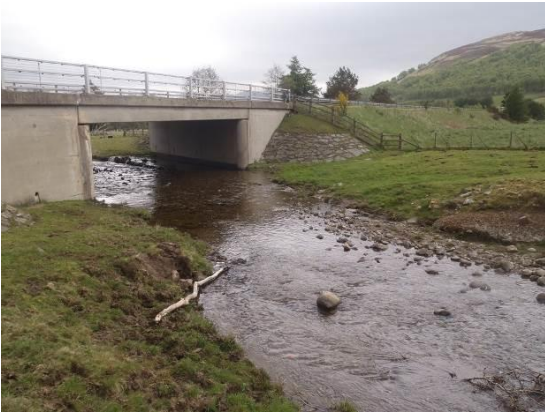
Table 30: WF115 (Allt Bhaic)

<p>Photograph 31: WF115 (Allt Bhaic) – view downstream, facing towards the existing A9 overbridge</p>	Water feature type: Medium watercourse
	Catchment area: 11.1km ²
	Key hydraulic connections: Tributary of the River Garry.
	Surrounding land use: Improved grassland for grazing and arable agriculture, woodland and moorland.
	SEPA overall status: Good
Description of Specific Baseline Conditions	Sensitivity
Hydrology and Flood Risk	
<p>The SEPA Flood Map shows a risk of flooding to agricultural and grazing land, primarily on the western floodplain of the Allt Bhaic (WF115). Hydraulic modelling undertaken as part of this assessment for the 0.5% AEP plus CC design flood indicates a larger area at risk than the SEPA Flood Map, which includes the eastern floodplain of the Allt Bhaic (WF115). Flooding on the eastern floodplain is much deeper than on the western floodplain with depths in excess of 2.5m. Whilst no properties are at risk, the modelling indicates that the existing A9 is at risk of overtopping particularly to the west of the Allt Bhaic (WF115) between ch9300-ch9800. Overtopping will be a result of flooding from both the Allt Bhaic (WF115) and the River Garry.</p> <p>This water feature is also within the River Tay SAC, and therefore has hydrological importance to sensitive and protected ecosystems of international status.</p>	Very High

Fluvial Geomorphology	
<p>SEPA physical condition status: High (2015).</p> <p>A watercourse with an average width of approximately 3.5m and some areas of bank reinforcement. The watercourse had a sinuous or meandering planform. The channel had a riffle-pool sequence, with cobble and gravel substrate. The channel is crossed by several forest tracks upstream of the existing A9 and then passes under existing A9 via a bridge, with a second bridge located downstream under a local access road. Analysis of historical maps shows that the Allt Bhaic has adjusted in the past and been modified.</p> <p>For a more detailed description of the watercourse, refer to Appendix A11.5 (Fluvial Geomorphology).</p>	High
Water Quality	
<p>SEPA water quality status: Good (2015).</p> <p>Potential pollutant sources:</p> <ul style="list-style-type: none"> • diffuse rural sources including biological pollutants from grazing livestock; and • diffuse run-off of contaminants associated with A9 traffic (KP-C1 Existing A9 –crosses watercourse). 	High

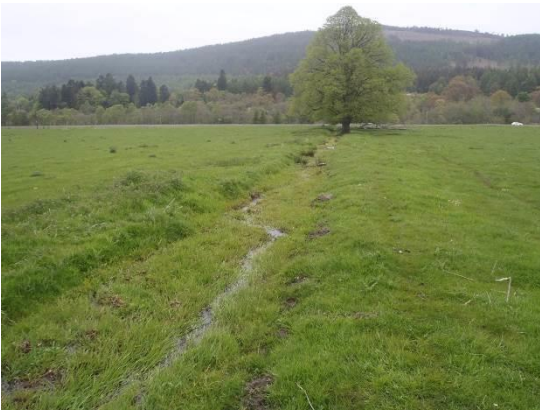
Table 31: WF116

<p>Photograph 32: WF116 – view downstream, facing towards the existing A9 culvert</p>	Water feature type: Drainage channel
	Catchment area: 0.30km ²
	Key hydraulic connections: Discharges into the lower reach of the River Garry
	Surrounding land use: Rough grazing
Description of Specific Baseline Conditions	Sensitivity
Hydrology and Flood Risk	
<p>This catchment has an area less than 3km² so is not included in the SEPA Flood Map. Although there are no residential properties and/or industrial premises located close to the watercourse, the channel passes through land used for grazing which is within the SEPA map flood extent. The culvert capacity assessment also indicates that WF116 poses an indirect and localised flood risk to the existing A9 during the 0.5 % AEP plus CC event, due to an undersized culvert likely to result in out of bank flooding.</p>	High
Fluvial Geomorphology	
<p>SEPA physical condition status: not classified.</p> <p>A small field/road drain, with a straight planform and trapezoidal channel cross-section. The watercourse had a channel bankfull width of approximately 1m and a low flow channel of 0.3m. The channel is embanked on both sides. The channel had smooth flow and silt substrate. The channel was choked with vegetation and had a tree lined riparian corridor in some locations. The channel is culverted under the existing A9 and two local access roads. Historical mapping shows that the planform of the channel has not changed since first records in 1867.</p>	Low

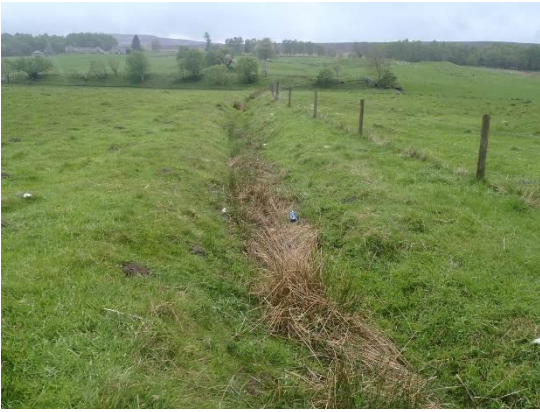
Table 32: WF117

<p>Photograph 33: WF117 – view upstream, facing away from the existing A9 culvert</p>	Water feature type: Drainage channel
	Catchment area: 0.74km ²
	Key hydraulic connections: Discharges into the lower reach of the River Garry
	Surrounding land use: Moorland, arable agriculture and rough grazing
Description of Specific Baseline Conditions	Sensitivity
Hydrology and Flood Risk	
This catchment has an area less than 3km ² so is not included in the SEPA Flood Map. The culvert capacity assessment indicates that WF117 poses an indirect and localised flood risk to the existing A9 during the 0.5 % AEP plus CC event, due to an undersized culvert likely to result in out of bank flooding.	High
Fluvial Geomorphology	
SEPA physical condition status: not classified. A small field drain with a straight planform. The channel was approximately 1m wide with a 0.25m low flow channel and 0.2m high embankments on both sides. The channel had silt substrate and was overgrown with vegetation. The channel is culverted under the existing A9 and a local access road. A length of WF117 historically formed part of Invervack Mill where a mill left branched to the east of the main channel prior to 1973. The mill impoundment is still present to this day. Prior to the construction of the existing A9 (between 1977 and 1989), the channel appears to have moved approximately 50m south of the River Garry.	Low

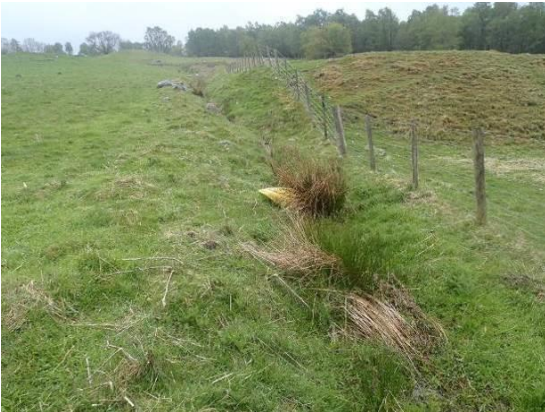
Table 33: WF118

<p>Photograph 34: WF118 - view upstream, facing away from the existing A9 culvert</p>	Water feature type: Drainage channel
	Catchment area: 0.06km ²
	Key hydraulic connections: Discharges into the lower reach of the River Garry
	Surrounding land use: Woodland and rough grazing
Description of Specific Baseline Conditions	Sensitivity
Hydrology and Flood Risk	
This watercourse has a catchment area less than 3km ² so is not included in the SEPA Flood Map. The culvert capacity assessment indicates that WF118 does not pose a flood risk to the existing A9 during the 0.5 % AEP plus CC event.	Low
Fluvial Geomorphology	
SEPA physical condition status: not classified. A small field drain with a straight planform. The channel is culverted under the existing A9 and local access road. Historical mapping shows that the planform of the watercourse has not changed since first records in 1867.	Low
Water Quality
