Appendix A11.1 Baseline Conditions

Table 1: River Garry (WF100) Errochty Water confluence to Loch Faskally (Lower Reach)

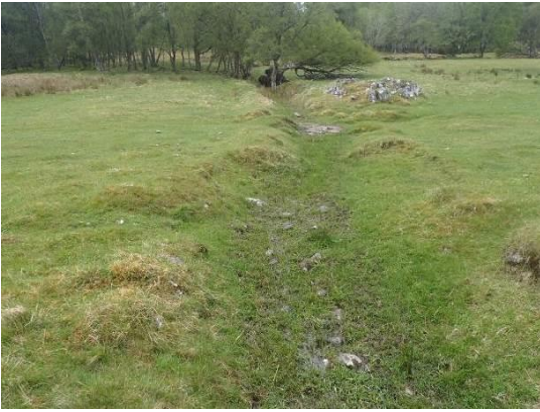
Table 34: WF119

<p>Photograph 35: WF119 – view upstream, facing away from the existing A9 culvert</p>	Water feature type: Drainage channel
	Catchment area: 0.28km ²
	Key hydraulic connections: Discharges into the lower reach of the River Garry
	Surrounding land use: Woodland and rough grazing
Description of Specific Baseline Conditions	Sensitivity
Hydrology and Flood Risk	
This watercourse has a catchment area less than 3km ² so is not included in the SEPA Flood Map. WF119 passes through woodland and rough grazing and has been assessed by the culvert capacity assessment as not being a flood risk to the existing A9 for the 0.5% AEP (200-year) plus CC design flood event.	Low
Fluvial Geomorphology	
SEPA physical condition status: not classified. A small field drain with a straight planform. The channel is culverted under the existing A9 and a local access road. Historical mapping shows that the planform of the watercourse has not changed since first records in 1867.	Low

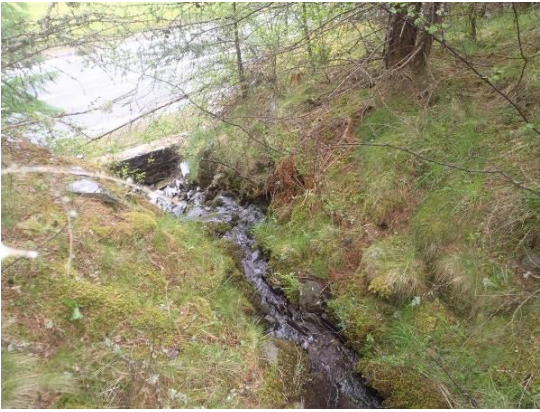
Table 35: WF120

<p>Photograph 36: WF120 – view downstream, towards existing A9 culvert, note bedrock cascade</p>	Water feature type: Drainage channel
	Catchment area: 0.32km ²
	Key hydraulic connections: Discharges into the lower reach of the River Garry.
	Surrounding land use: Woodland
Description of Specific Baseline Conditions	Sensitivity
Hydrology and Flood Risk	
This watercourse has a catchment area of less than 3km ² and so is not included in the SEPA Flood Map. The culvert capacity assessment indicates the existing A9 is not at risk from flooding during the 0.5% AEP (200-year) plus CC event.	Low
Fluvial Geomorphology	
SEPA physical condition status: not classified. A small field/woodland drain with a predominantly straight planform and gravel substrate with some unnatural rock material placed in the channel. The channel had a low flow width of approximately 0.2m and a step-pool sequence. The channel is culverted under the existing A9 and a local access track. Historical mapping shows that the planform of the watercourse has not changed since first records in 1867.	Low

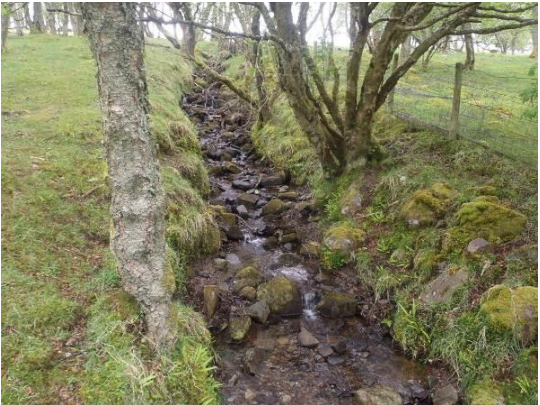
Table 36: WF121

<p>Photograph 37: WF121 – view upstream, facing away from the existing A9 culvert</p>	Water feature type: Small watercourse
	Catchment area: 0.43km ²
	Key hydraulic connections: Discharges into the lower reach of the River Garry
	Surrounding land use: Moorland, rough grazing and woodland
Description of Specific Baseline Conditions	
Sensitivity	
Hydrology and Flood Risk	
This watercourse has a catchment area less than 3km ² so is not included in the SEPA Flood Map. According to the culvert capacity assessment, the existing A9 is not at risk from flooding during the 0.5% AEP (200-year) plus CC event with flow remaining in-bank.	Low
Fluvial Geomorphology	
SEPA physical condition status: not classified. A small field/woodland drainage channel measuring approximately 0.4m wide with a step-pool sequence. The bed substrate consisted of gravel and cobble with gravel deposits. The channel was incised, with woody material in the channel and actively eroding banks. The channel is culverted under the existing A9 and a local access track. Historical mapping shows that the planform of the watercourse has not changed since first records in 1867. For a more detailed description of the watercourse, refer to Appendix A11.5 (Fluvial Geomorphology).	Medium

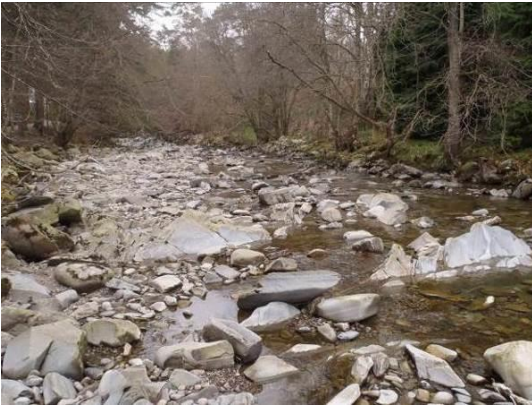
Table 37: WF123 (River Bruar)

<p>Photograph 38: River Bruar – view upstream of confluence with the River Garry</p>	Water feature type: Large watercourse
	Catchment area: 71.03km ²
	Key hydraulic connections: Tributary of the River Garry
	Surrounding land use: Rough pasture, moorland, woodland, some industrial units and settlements.
	SEPA overall status: Bad Ecological Potential
Description of Specific Baseline Conditions	Sensitivity
Hydrology and Flood Risk	
<p>The SEPA Flood Map shows a direct flood risk to the adjacent populated areas with several commercial premises at Bruar at risk from flooding during the 0.5% AEP (200-year) plus CC design flood event (The House of Bruar, shops, a museum and a car park between 10 -120m away from watercourse). This is supported by hydraulic modelling, undertaken as part of this assessment, which confirms the River Bruar (WF123) would flood the western floodplain during the design flood event.</p> <p>This water feature is also within the River Tay SAC, and therefore has hydrological importance to sensitive and protected ecosystems of international status.</p>	Very High

Fluvial Geomorphology	
<p>SEPA physical condition status: Good</p> <p>A watercourse with a sinuous planform and multiple bedrock waterfalls within a deep gorge. The channel opens out into a shallow gravel and cobble bed river with a step/pool sequence. Depositional features are present in the channel. The channel is bridged by the B8079, the Highland Main Line railway and several smaller access routes and forest tracks. Analysis of historical mapping shows that the channel has actively meandered, particularly within the upstream section.</p> <p>For a more detailed description of the watercourse, refer to Appendix A11.5 (Fluvial Geomorphology).</p>	High
Water Quality	
<p>SEPA water quality status: High (2015).</p> <p>Existing pressures: abstraction, flow restriction and impoundment resulting from renewable electricity generation.</p> <p>Potential pollutant sources:</p> <ul style="list-style-type: none"> diffuse rural sources including biological pollutants from grazing livestock and suspended sediment inputs from forestry; and diffuse run-off of contaminants associated with railway use (PGG-C1 Highland Main Line railway – crosses watercourse). 	High

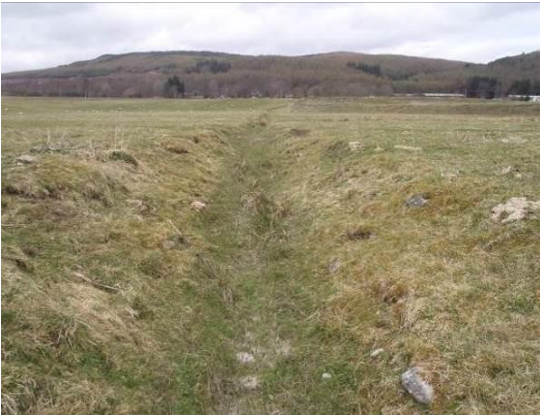
Table 38: WF125/WF126

Water feature type: Drainage channel
	Catchment area: 0.13km ²
	Key hydraulic connections: Considered likely to flow into the lower reach of the River Garry. WF126 discharges into WF125 upstream of the existing A9.
	Surrounding land use: Rough pasture, woodland (plantation), settlements, industrial units, gravel/sand pit
Description of Specific Baseline Conditions	
Sensitivity	
Hydrology and Flood Risk	
This watercourse has a catchment area less than 3km ² so is not included in the SEPA Flood Map. The channel flows underneath the Highland Main Line railway, the B847 and runs in close proximity to more than 10 industrial premises and a large car park, which have locally important economic and social uses. The culvert capacity assessment also indicates that WF125 poses an indirect and localised flood risk to the existing A9 during the 0.5 % AEP plus CC event, due to undersized culverts.	High

Fluvial Geomorphology	
SEPA physical condition status: not classified. Upstream of the existing A9, WF125 has a sinuous channel with some erosion and substrate consisted of fine gravels. Downstream of the existing A9, the watercourse is a uniform man-made field drain with straight planform and at this location the channel was embanked on both sides composed of cobble and earth substrate. The channel was dry at the time of survey. The channel is culverted under the existing A9, B847, the Highland Main Line railway and several forest tracks. Historical mapping shows that the man-made section downstream of the existing A9 has been constructed after 1991. The upstream section has not changed significantly since first records in 1867.	Low
Water Quality	
SEPA water quality status: not classified. <ul style="list-style-type: none"> • Potential pollutant sources: • point source pollutants from adjacent car park; • diffuse run-off of contaminants associated with A9 traffic (PGG-C2 Existing A9 –crosses watercourse) and railway use (PGG-C1 Highland Main Line railway – crosses watercourse); and • PGG-C7 Sand and Gravel pit disused potentially infilled with made ground of unknown composition with associated sources of potential contamination – within 30m of watercourse. 	Low

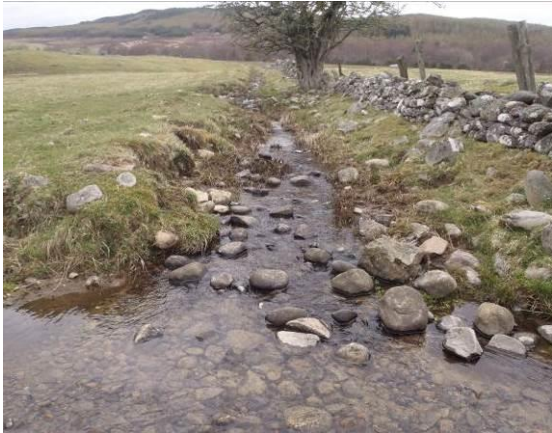
Table 39: WF127

<p>Photograph 40: WF127 – view downstream of the existing A9 at ford crossing</p>	Water feature type: Small watercourse
	Catchment area: 0.42km ²
	Key hydraulic connections: Discharges into the lower reach of the River Garry
	Surrounding land use: Upland, agricultural/ rough grazing
Description of Specific Baseline Conditions	Sensitivity
Hydrology and Flood Risk	
<p>This watercourse has a catchment area of less than 3km² and so is not included in the SEPA Flood Map. This channel flows underneath the Highland Main Line railway and the B847 road with no residential properties or industrial premises located near the watercourse. However, the culvert capacity assessment indicates that WF127 poses a flood risk to the existing A9 during 0.5 % AEP plus CC event, due to an undersized culvert. In addition, due to there being utilisable agricultural fields adjacent to the watercourse, there may be some risk of flooding and causing a detrimental impact on its economic and social uses.</p>	High

Fluvial Geomorphology	
<p>SEPA physical condition status: not classified.</p> <p>Upstream of the existing A9, the watercourse had a sinuous planform and a narrow incising channel approximately 1m wide with cobble substrate. Downstream of the existing A9, the channel was straightened with a modified, trapezoidal cross-section and cobble and coarse gravel bed. The channel is culverted under the Highland Main Line, B847 and the existing A9. The watercourse first appears on historical mapping in 1972, subsequently the planform of the watercourse has not changed significantly.</p>	Low
Water Quality	
<p>SEPA water quality status: not classified.</p> <p>Potential pollutant sources:</p> <ul style="list-style-type: none"> • diffuse rural sources including biological pollutants from grazing livestock; and • diffuse run-off of contaminants associated with A9 traffic (PGG-C2 Existing A9 –crosses watercourse) and railway use (PGG-C1 Highland Main Line railway – crosses watercourse). 	Medium

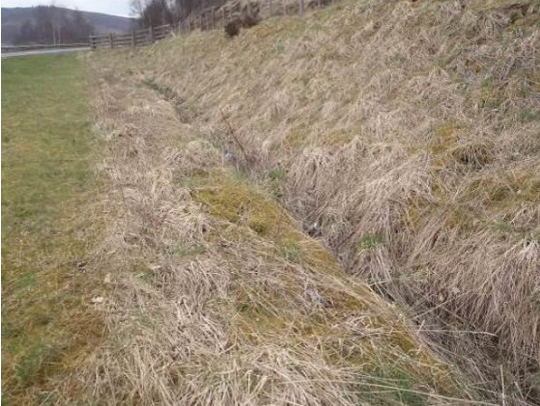
Table 40: WF128

<p>Photograph 41: WF128 – view parallel to existing A9 carriageway, adjacent to Highland Mainline railway</p>	Water feature type: Drainage channel
	Catchment area: 0.14km ²
	Key hydraulic connections: Suspected to discharge to the upper reach of the River Garry via WF129
	Surrounding land use: Rough grazing, uplands
Description of Specific Baseline Conditions	Sensitivity
Hydrology and Flood Risk	
This watercourse is not included in the SEPA Flood Map as it has a catchment area less than 3km ² . This channel flows over the Highland Main Line railway just upstream and adjacent to the existing A9. Although there are no residential properties or industrial premises in the area, the culvert capacity assessment indicates that the existing A9 could be at risk of flooding during the 0.5% AEP (200-year) plus CC design flood event, due to an undersized culvert and insufficient freeboard between the estimated head water level and the existing A9.	High

Fluvial Geomorphology	
SEPA physical condition status: not classified. A small road drain with a uniform channel cross-section and a straight planform. The channel had a limited riparian corridor, trapezoidal channel and silt bed. The channel flows south for 100m and along the margin of the Highland Main Line railway for a further 150m. The channel is culverted under the Highland Main Line railway. Downstream, the channel is formed by a network of drains which run alongside the existing A9. The watercourse first appears on historical mapping in 1986, and the planform of the watercourse has not changed significantly since.	Low
Water Quality	
SEPA water quality status: not classified. Potential pollutant sources: <ul style="list-style-type: none"> • diffuse rural sources including biological pollutants from grazing livestock; and • diffuse run-off of contaminants associated with A9 traffic (PGG-C2 Existing A9 –within 5m of watercourse) and railway use (PGG-C1 Highland Main Line railway – crosses watercourse). 	Low

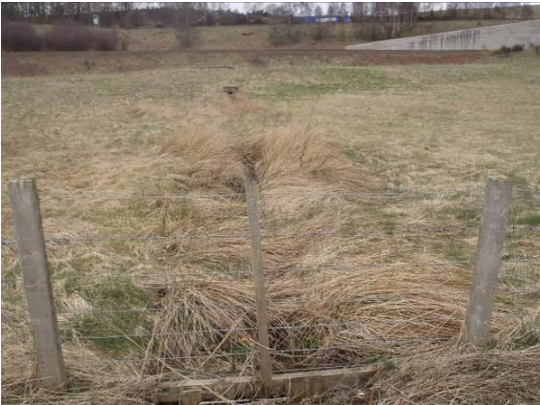
Table 41: WF129

<p>Photograph 42: WF129 – view upstream of B847 road, towards the Highland Mainline</p>	Water feature type: Drainage channel
	Catchment area: 0.15km ²
	Key hydraulic connections: Suspected to discharge to the upper reach of the River Garry
	Surrounding land use: Rough pasture
Description of Specific Baseline Conditions	Sensitivity
Hydrology and Flood Risk	
This modified watercourse / drainage channel has a catchment area less than 3km ² and so is not included in the SEPA Flood Map. The watercourse flows adjacent the B847 and the Highland Main Line railway, however the bed level is significantly lower and any out of bank flow would spill to the adjacent field. According to the culvert capacity assessment, the existing A9 is not at risk from flooding during the 0.5% AEP (200-year) plus CC event.	Low
Fluvial Geomorphology	
SEPA physical condition status: not classified. A small drainage channel which runs parallel to the Highland Main Line railway for approximately 120m. It had a straight planform and a uniform cross section with earth bed and banks which were vegetated with grass at the time of survey.	Low

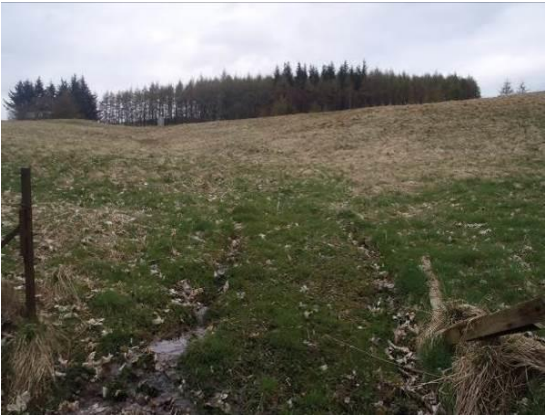
Table 42: WF131

<p>Photograph 43: WF131 – view upstream, facing towards the existing A9</p>	Water feature type: Drainage channel
	Catchment area: 0.09km ²
	Key hydraulic connections: Possibly some connectivity to the upper reach of the River Garry
	Surrounding land use: Rough grazing, uplands
Description of Specific Baseline Conditions	Sensitivity
Hydrology and Flood Risk	
This drainage channel has a catchment area less than 3km ² and so is not included in the SEPA Flood Map. The drainage channel flows adjacent to the existing A9 before being culverted under the road. There is one residential property located in close proximity to the watercourse, however the culvert capacity assessment indicates that flow will remain in-bank during the 0.5% AEP (200-year) plus CC flood event, and therefore will not be a flood risk to the existing A9, surrounding infrastructure or residential properties.	Low
Fluvial Geomorphology

SEPA physical condition status: not classified. A small drainage channel approximately 1m wide at bankfull. The watercourse had a straightened planform with uniform cross section, earth bed and banks which were vegetated with grass at the time of survey and gravel and cobble bed substrate in the upstream reach. The channel is culverted under the existing A9.	Low
Water Quality	
SEPA water quality status: not classified. Potential pollutant sources: <ul style="list-style-type: none"> • diffuse rural sources including biological pollutants from grazing livestock; and • diffuse run-off of contaminants associated with A9 traffic (PGG-C2 Existing A9 – crosses watercourse). 	Low
Dilution and Removal of Waste Products	
CAR Discharges: none.	Low
Biodiversity	
SEPA overall ecological status: not classified. Considered to exhibit 'Bad' ecosystem quality due to lack of an established bed and no riparian corridor. Authority Area importance in Chapter 12 (Ecology and Nature Conservation) as listed in CNAP. Not accessible to migratory fish species.	Low

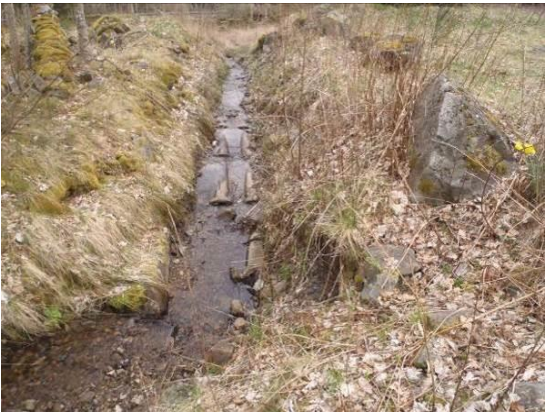
Table 43: WF132

<p>Photograph 44: WF132 – view downstream from the B847 at Calvine</p>	Water feature type: Small watercourse
	Catchment area: 0.66km ² (combined with WF133/134)
	Key hydraulic connections: This is the eastern branch of WF133 downstream of a bifurcation in the watercourse. Discharges into the upper reach of the River Garry
	Surrounding land use: Moorland, rough pasture, woodland, forestry and some residential properties
Description of Specific Baseline Conditions	Sensitivity
Hydrology and Flood Risk	
<p>This watercourse has a catchment area of less than 3km² and so is not included in the SEPA Flood Map. Baseline hydraulic modelling has indicated that during the 0.5% AEP (200-year) plus CC flood event, WF132 and WF134 (distributaries of WF133) would cause a flood risk to the existing A9, approximately eight properties within Calvine, the B847 minor road and the Highland Main Line railway. This is principally due undersized culverts underneath the A9, which result in overland flow paths towards Calvine when surcharged.</p>	High

Fluvial Geomorphology	
<p>SEPA physical condition status: not classified.</p> <p>A small watercourse in the upstream reach, with a step-pool sequence and a cobble and gravel bed. In the downstream reach the channel had a straight planform and is likely to have been historically modified with evidence of bank reinforcement. There was some channel adjustment with evidence of erosion and deposition.</p> <p>The channel is culverted under the existing A9, B847 and Highland Main Line railway. Historical mapping shows that the planform of the watercourse has not changed significantly since first records in 1867.</p> <p>For a more detailed description of the watercourse, refer to Appendix A11.5 (Fluvial Geomorphology).</p>	Medium
Water Quality	
<p>SEPA water quality status: not classified.</p> <p>Potential pollutant sources:</p> <ul style="list-style-type: none"> • diffuse run-off of contaminants associated with A9 traffic (PGG-C2 Existing A9 –crosses watercourse) and with railway use (PGG-C1 Highland Main Line railway – crosses watercourse); • PGG-C9 Calvine Garage and former petrol station with potential contamination from hydrocarbons and heavy metals – within 10m of watercourse; and • PGG-22, PGG-24 and PGG-28 Septic Tanks for properties at Calvine with potential for associated contaminants – within 10m, 20m and 50m of watercourse respectively. 	Low

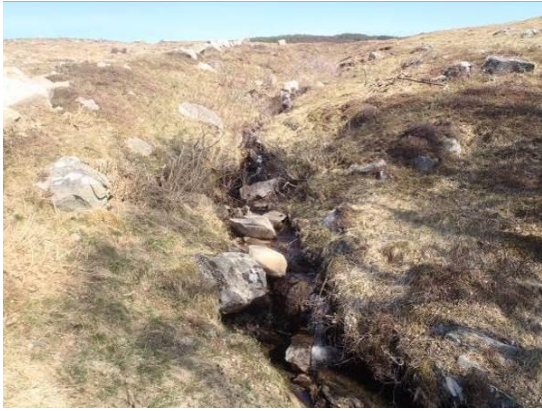
Table 44: WF133

<p>Photograph 45: WF133 – view upstream, upslope of the existing A9</p>	Water feature type: Small watercourse
	Catchment area: 0.66km ² (combined with WF132/134)
	Key hydraulic connections: This watercourse bifurcates into WF132 and WF134, which both discharge to the upper reach of the River Garry
	Surrounding land use: Moorland and mixed woodland.
Description of Specific Baseline Conditions	Sensitivity
Hydrology and Flood Risk	
<p>This watercourse has a catchment area of less than 3km² and so is not included in the SEPA Flood Map. Baseline hydraulic modelling has indicated that during the 0.5% AEP (200-year) plus CC flood event, WF132 and WF134 (distributaries of WF133) would cause a flood risk to the existing A9, approximately eight properties within Calvine, the B847 minor road and the Highland Main Line railway. This is principally due undersized culverts underneath the A9, which result in overland flow paths towards Calvine when surcharged.</p>	High

Fluvial Geomorphology	
<p>SEPA physical condition status: not classified.</p> <p>A small watercourse with a sinuous planform. The channel was very incised in places. The channel was approximately 0.5m wide at bankfull, with a step-pool sequence and a cobble and gravel bed. The channel becomes narrower 100m upstream of the A9.</p> <p>For a more detailed description of the watercourse, refer to Appendix A11.5 (Fluvial Geomorphology).</p>	Medium
Water Quality	
<p>SEPA water quality status: not classified.</p> <p>Potential pollutant sources:</p> <ul style="list-style-type: none"> diffuse rural sources including biological pollutants from grazing livestock; and diffuse run-off of contaminants associated with A9 traffic (PGG-C2 Existing A9 –crosses watercourse). 	Medium
Water supply	
<p>Water Supply Abstractions:</p> <ul style="list-style-type: none"> PGG-PWS3 serving one property. Nature and location of supply source is unknown but could be surface water fed. 	High

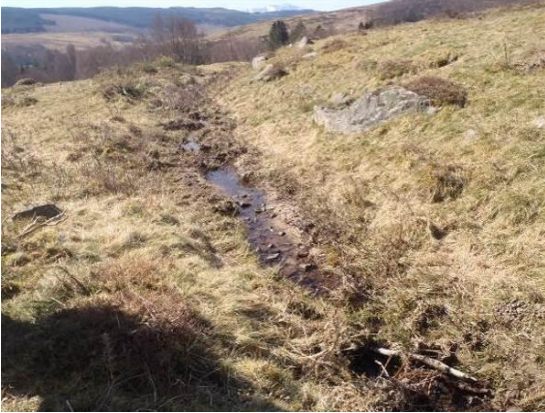
Table 45: WF134

<p>Photograph 46: WF134 – view downstream, towards existing A9</p>	Water feature type: Small watercourse
	Catchment area: 0.66km ² (combined with WF132/133). This is the western branch of WF133 downstream of a bifurcation in the watercourse.
	Key hydraulic connections: Discharges into the upper reach of the River Garry
	Surrounding land use: Rough pasture, woodland (plantation), residential
Description of Specific Baseline Conditions	Sensitivity
Hydrology and Flood Risk	
This watercourse has a catchment area of less than 3km ² and so is not included in the SEPA Flood Map. Baseline hydraulic modelling has indicated that during the 0.5% AEP (200-year) plus CC flood event, WF132 and WF134 (distributaries of WF133) would cause a flood risk to the existing A9, approximately eight properties within Calvine, the B847 minor road and the Highland Main Line railway. This is principally due undersized culverts underneath the A9, which result in overland flow paths towards Calvine when surcharged.	High

Fluvial Geomorphology	
SEPA physical condition status: not classified. A drainage channel which forms the downstream section of WF133. The watercourse was approximately 1m wide (bankfull) and had a predominantly straight planform and uniform cross-section. The channel had cobble and coarse gravel substrate, with a limited vegetated riparian corridor. The channel is culverted under the existing A9. Historical mapping shows that the planform of the watercourse has not changed significantly since first records in 1867.	Low
Water Quality	
SEPA water quality status: not classified. Potential pollutant sources: <ul style="list-style-type: none"> diffuse rural sources including biological pollutants from grazing livestock; diffuse run-off of contaminants associated with A9 traffic (PGG-C2 Existing A9 –crosses watercourse); and PGG-C23, PGG-C24, PGG-C25 and PGG-C28 Septic Tanks for properties at Calvine with potential for associated contaminants – within 30m, 10m, 0m and 10m of watercourse respectively. 	Low

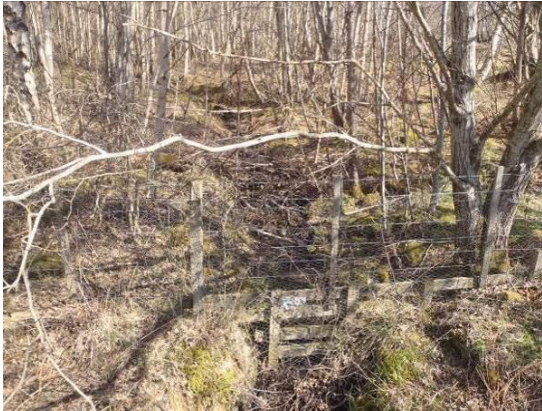
Table 46: WF136

<p>Photograph 47: WF136 – view upstream from B847 road, towards the existing A9</p>	Water feature type: Small watercourse
	Catchment area: 0.31km ²
	Key hydraulic connections: Discharges into the upper reach of the River Garry
	Surrounding land use: Woodland (plantation)
Description of Specific Baseline Conditions	Sensitivity
Hydrology and Flood Risk	
<p>This watercourse has a catchment area less than 3km² so is not included in the SEPA Flood Map. The culvert capacity assessment indicates that the existing A9 is at risk of localised flooding during the 0.5% AEP (200-year) plus CC flood event, due to undersized culverts. Further baseline hydraulic modelling has indicated that during the 0.5% AEP (200-year) plus CC flood event, WF136 would cause a flood risk to the existing A9, approximately six properties within Calvine, the B847 minor road and the Highland Main Line railway. This is due to an undersized culvert underneath the existing A9, which results in overland flow paths towards Calvine when surcharged.</p>	High

Fluvial Geomorphology	
<p>SEPA physical condition status: not classified.</p> <p>A drainage channel with a straight planform and detritus in channel. The bed material consisted of fine gravel and silt.</p> <p>The channel is culverted under the existing A9 and B847 road. The watercourse first appears on historical mapping in 1900. With the exception of the construction of Struan Primary School adjacent to the channel, the planform of the watercourse has not changed significantly since this date.</p>	Low
Water Quality	
<p>SEPA water quality status: not classified.</p> <p>Potential pollutant sources:</p> <ul style="list-style-type: none"> diffuse run-off of contaminants associated with A9 traffic (PGG-C2 Existing A9 –crosses watercourse). 	Low
Dilution and Removal of Waste Products	
CAR Licensed Discharges: none.	Low
Biodiversity	
<p>SEPA overall ecological status: not classified. Considered to exhibit 'Poor' ecosystem quality due to a low flow and interspersed riparian corridor.</p> <p>Authority Area importance in Chapter 12 (Ecology and Nature Conservation) as listed in CNAP. Not accessible to migratory fish species.</p>	Low

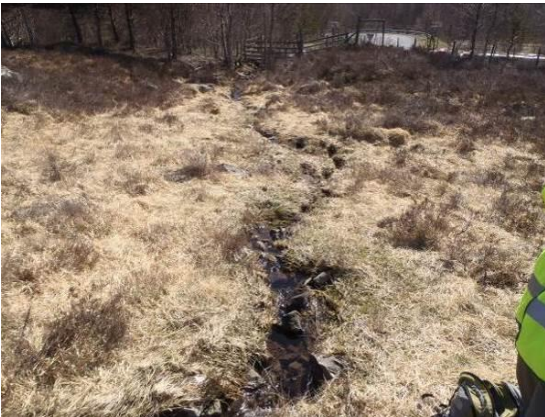
Table 47: WF137

<p>Photograph 48: WF137 – view downstream, towards existing A9</p>	Water feature type: Small watercourse
	Catchment area: 0.20km ²
	Key hydraulic connections: Discharges into the upper reach of the River Garry
	Surrounding land use: Moorland (upstream), woodland plantation (downstream)
Description of Specific Baseline Conditions	Sensitivity
Hydrology and Flood Risk	
This watercourse has a catchment area of less than 3km ² and so is not included in the SEPA Flood Map. The channel is culverted under the existing A9 and emerges downstream of the B847 with no residential properties within the vicinity of this small watercourse. The culvert capacity assessment indicates that the existing A9 is not at risk of flooding during the 0.5% AEP (200-year) plus CC flood event.	Low
Fluvial Geomorphology	
SEPA physical condition status: not classified. A watercourse with a sinuous planform. Upstream of A9 the channel was incising, measuring approximately 0.5m wide with a cobble and fine gravel bed and un-vegetated banks. Downstream of the existing A9, the channel has a uniform channel cross-section with bank reinforcement and a cobble bed. The channel is culverted under the existing A9, B847 road and a local access route. The watercourse first appears on historical mapping in 1992, and the planform has not changed significantly since.	Low

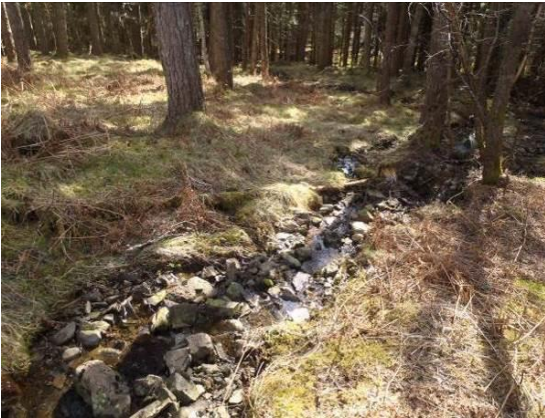
Table 48: WF139

<p>Photograph 49: WF139 – view downstream from National Cycle Route (NCR) 7</p>	Water feature type: Drainage channel
	Catchment area: 0.34km ²
	Key hydraulic connections: Discharges into the upper reach of the River Garry
	Surrounding land use: Predominantly moorland and forestry downstream of existing A9
Description of Specific Baseline Conditions	Sensitivity
Hydrology and Flood Risk	
This watercourse has a catchment area of less than 3km ² and so is not included in the SEPA Flood Map. The watercourse flows through woodland adjacent to the A9 just upstream and downstream of the existing A9 and crosses a local access road before its confluence with the River Garry. The culvert capacity assessment indicates that the existing A9 is not at risk of flooding during the 0.5% AEP (200-year) plus CC flood event.	Low
Fluvial Geomorphology	
SEPA physical condition status: not classified. A drainage channel formed of three upland drains. Upstream of the existing A9 the channels were sinuous, measuring approximately 0.3m wide. Downstream of the existing A9 the channel was straightened and concrete lined. The channel had a limited vegetated riparian corridor and is culverted under the existing A9.	Low

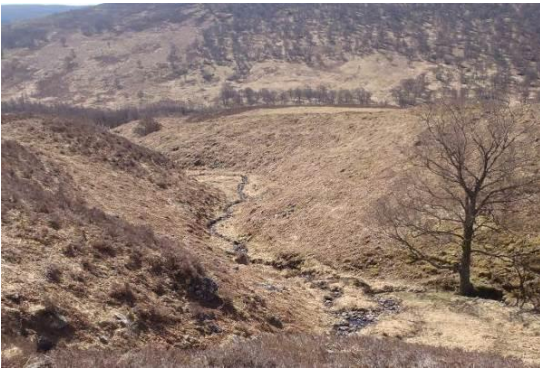
Table 49: WF140

<p>Photograph 50: WF140 – view downstream, towards existing A9</p>	Water feature type: Small watercourse
	Catchment area: 0.54km ²
	Key hydraulic connections: Discharges into the upper reach of the River Garry
	Surrounding land use: Moorland (upstream), woodland (downstream)
Description of Specific Baseline Conditions	
Sensitivity	
Hydrology and Flood Risk	
<p>This watercourse has a catchment area of less than 3km² and so is not included in the SEPA Flood Map. The watercourse flows through woodland immediately upstream and downstream crossing the existing A9 and passes a local access road before its confluence with the River Garry. The culvert capacity assessment indicates that the existing A9 is at risk of minor localised flooding during the 0.5% AEP (200-year) plus CC flood event, due to an undersized culvert, with the local access road also likely to be at flood risk.</p>	High
Fluvial Geomorphology

<p>SEPA physical condition status: not classified.</p> <p>A dynamic watercourse with a sinuous planform, step-pool sequence and a cobble and gravel bed with some boulders. The channel shows evidence of having laterally adjusted, with some incision downstream of the existing A9.</p> <p>Downstream of the existing A9 the channel was lined with concrete which had become undermined, exposing the bedrock below. Historical mapping shows that the planform of the watercourse has not changed significantly since first records in 1867.</p> <p>For a more detailed description of the watercourse, refer to Appendix A11.5(Fluvial Geomorphology).</p>	Medium
Water Quality	
<p>SEPA water quality status: not classified.</p> <p>Potential pollutant sources:</p> <ul style="list-style-type: none"> • diffuse rural sources including biological pollutants from grazing livestock; and • diffuse run-off of contaminants associated with A9 traffic (PGG-C2 Existing A9 –crosses watercourse). 	Medium

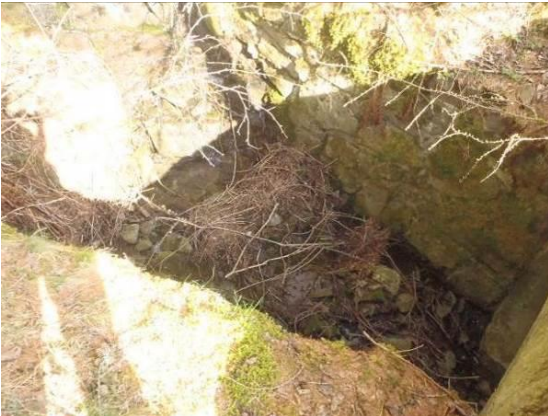
Table 50: WF141

<p>Photograph 51: WF141 – view of dry confined channel and culvert under NCR7</p>	Water feature type: Drainage channel
	Catchment area: 0.55km ²
	Key hydraulic connections: Discharges into the upper reach of the River Garry
	Surrounding land use: Forestry, moorland and rough grazing
Description of Specific Baseline Conditions	Sensitivity
Hydrology and Flood Risk	
This watercourse is not included in the SEPA Flood Map as it has a catchment area less than 3km ² . OS mapping shows there are areas of woodland, moorland and rough grazing immediately upstream and downstream of the existing A9. The channel crosses a local access road downstream of the existing A9 before its confluence with the River Garry. The culvert capacity assessment indicates that the existing A9 is not at risk of flooding during the 0.5% AEP (200-year) plus CC flood event.	Low
Fluvial Geomorphology	
SEPA physical condition status: not classified. A watercourse with a channel width of approximately 0.3m (bankfull). The channel had a straight platform, step-pool sequence and bedrock and cobble bed. The watercourse is culverted under the existing A9 and a local access track.	Low

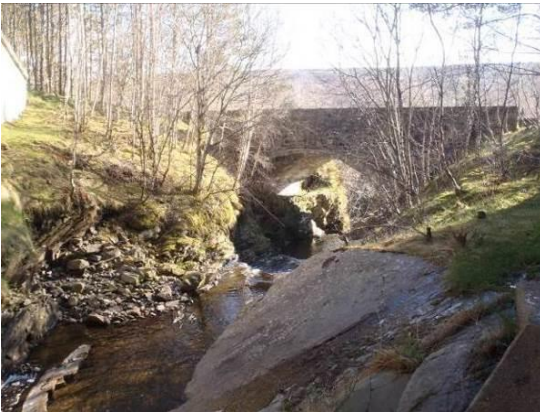
Table 51: WF142 (Allt a' Chrombaidh)

<p>Photograph 52: Allt a' Chrombaidh – view downstream from A9 overbridge to NCR 7 overbridge</p>	Water feature type: Medium watercourse
	Catchment area: 10.81km ²
	Key hydraulic connections: Tributary of the River Garry.
	Surrounding land use: Moorland and forestry
	SEPA overall status: Good
Description of Specific Baseline Conditions	Sensitivity
Hydrology and Flood Risk	
<p>The Allt a' Chrombaidh (WF142) is a larger watercourse and tributary to the River Garry. The SEPA Flood Map identifies a 0.5% AEP (200-year) flood extent, which is generally narrow due to the gradient of the watercourse and steep banks. There is an overland out-of-bank flow path indicated on the SEPA Flood Map which is assumed to be a mistake due to the banks either side of the watercourse being approximately 10m above the bed level, as indicated by topographic data at this location. The existing A9 bridge structure has been assessed as having sufficient capacity to convey the 0.5% AEP (200-year) plus CC event.</p>	Low

Fluvial Geomorphology	
<p>SEPA physical condition status: Good (2015)</p> <p>A watercourse with a varied morphology and meandering planform, with lengths of deep gorge and bedrock waterfalls and cascades. The channel had a step-pool sequence where the gradient slackened.</p> <p>The channel is crossed by a clear span bridge for the existing A9 and a local access track. Analysis of historical mapping shows that the channel has remained largely stable since 1867 with exception of some localised areas of meander migration upstream in the headwaters. For a more detailed description of the watercourse, refer to Appendix A11.5 (Fluvial Geomorphology).</p>	Very High
Water Quality	
<p>SEPA water quality status: Good (2015)</p> <p>Potential pollutant sources:</p> <ul style="list-style-type: none"> • diffuse rural sources including biological pollutants from grazing livestock and suspended sediment inputs from forestry; and • diffuse and point source pollution from run-off of contaminants associated with A9 traffic (PGG-C2 Existing A9 –crosses watercourse). 	High

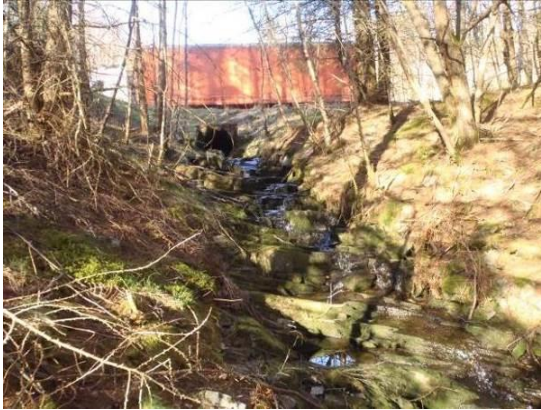
Table 52: WF143

<p>Photograph 53: WF143 – view upstream, towards the existing A9 culvert</p>	Water feature type: Small watercourse
	Catchment area: 0.22km ²
	Key hydraulic connections: Discharges into the upper reach of the River Garry.
	Surrounding land use: Moorland and woodland (downstream)
Description of Specific Baseline Conditions	Sensitivity
Hydrology and Flood Risk	
<p>This watercourse has a catchment area of less than 3km² and so is not included in the SEPA Flood Map. The watercourse OS mapping indicates that WF143 crosses a local access road downstream before its confluence with the River Garry. The culvert capacity assessment indicates that the existing A9 is not at risk of flooding during the 0.5% AEP (200-year) plus CC flood event. However, out of bank flow has been simulated to occur, which may cause a potential minor flood risk to a local access road (no residential properties or critical infrastructure units at risk).</p>	Medium

Fluvial Geomorphology	
<p>SEPA physical condition status: not classified.</p> <p>Upstream of the existing A9, WF143 is a small meandering channel, measuring approximately 0.2m wide. The channel downstream of the existing A9 had a sinuous planform, cobble and fine gravel bed and measures approximately 2m wide. The channel had a modified uniform cross-section and scattered tree lining.</p> <p>The watercourse is culverted under the existing A9 and a local access track. The watercourse is not present on historical mapping.</p>	Low
Water Quality	
<p>SEPA water quality status: not classified.</p> <p>Potential pollutant sources:</p> <ul style="list-style-type: none"> diffuse run-off of contaminants associated with A9 traffic (PGG-C2 Existing A9 –crosses watercourse). 	Medium
Dilution and Removal of Waste Products	
CAR Discharges: none.	Low
Biodiversity	
<p>SEPA overall ecological status: not classified. Considered to exhibit 'Poor' ecosystem quality due to a limited riparian corridor and only isolated areas with an established bed.</p> <p>Authority Area importance in Chapter 12 (Ecology and Nature Conservation) as listed in CNAP. Not accessible to migratory fish species.</p>	Low

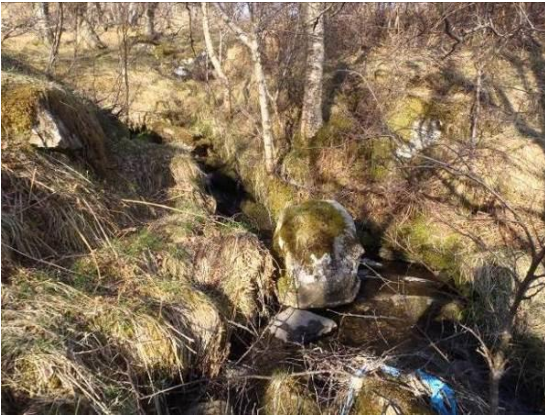
Table 53: WF144

<p>Photograph 54: WF144 – view downstream of the existing A9</p>	Water feature type: Small watercourse
	Catchment area: 0.26km ²
	Key hydraulic connections: Discharges into the upper reach of the River Garry
	Surrounding land use: Moorland and woodland (downstream)
Description of Specific Baseline Conditions	Sensitivity
Hydrology and Flood Risk	
This watercourse has a catchment area of less than 3km ² and so is not included in the SEPA Flood Map. OS mapping indicates that WF144 flows through moorland and woodland upstream and downstream of the existing A9 culvert and crosses a local access road downstream before its confluence with the River Garry. According to the culvert capacity assessment, the existing A9 is not at risk of flooding during the 0.5% AEP (200-year) plus CC flood event, with flow remaining in-bank.	Low
Fluvial Geomorphology	
SEPA physical condition status: not classified. A small watercourse with a sinuous planform, measuring approximately 1m wide at bankfull. The channel bed consisted of cobble and pebble substrate and was incising downstream of the existing A9. The channel is culverted under the existing A9. The watercourse is first shown on historical mapping in 1973, and the planform of the channel has not changed significantly since.	Low

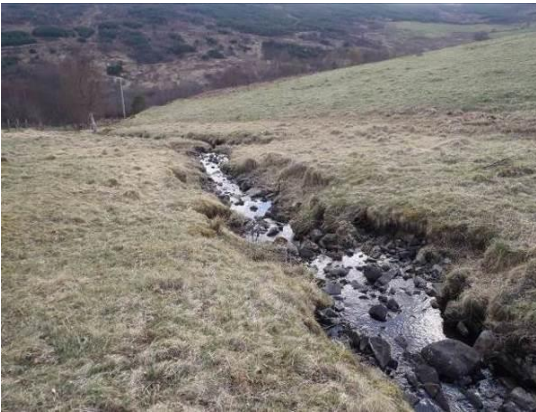
Table 54: WF145

<p>Photograph 55: WF145 – view downstream, upslope of the existing A9</p>	Water feature type: Small watercourse
	Catchment area: 0.59km ²
	Key hydraulic connections: Discharges into the upper reach of the River Garry.
	Surrounding land use: Moorland and rough grazing
Description of Specific Baseline Conditions	Sensitivity
Hydrology and Flood Risk	
<p>This watercourse has a catchment area of less than 3km² and so is not included in the SEPA Flood Map. OS mapping indicates that WF145 is culverted under a local access road just upstream of its confluence with the River Garry. WF145 also crosses the A9 and another smaller local access road further upstream.</p> <p>Baseline hydraulic modelling indicates that the existing A9 culvert has sufficient capacity to convey the 0.5% AEP (200-year) plus CC event and that the existing A9 would not be overtopped. In addition, properties downstream of the existing A9 have been assessed as being at a low risk of flooding from this watercourse as flows remain in-channel during the design event.</p>	Low

Fluvial Geomorphology	
<p>SEPA physical condition status: not classified.</p> <p>A watercourse with a sinuous planform, step-pool sequence and a cobble and pebble bed. The watercourse was approximately 1m wide at bankfull and had a 0.6m wide low flow channel. The channel had several lengths of bedrock banks and was incising upstream of the existing A9.</p> <p>The channel is culverted under the existing A9. With the exception of the construction of the existing A9 over the channel, the planform of the channel has not changed significantly since first records in 1867.</p>	Low
Water Quality	
<p>SEPA water quality status: not classified.</p> <p>Potential pollutant sources:</p> <ul style="list-style-type: none"> • diffuse rural sources including biological pollutants from grazing livestock; • diffuse run-off of contaminants associated with A9 traffic (PGG-C2 Existing A9 –crosses watercourse); and • KP-C69 Clunes Lodge with potential contaminants from a septic tank – within 40m of watercourse. 	Medium

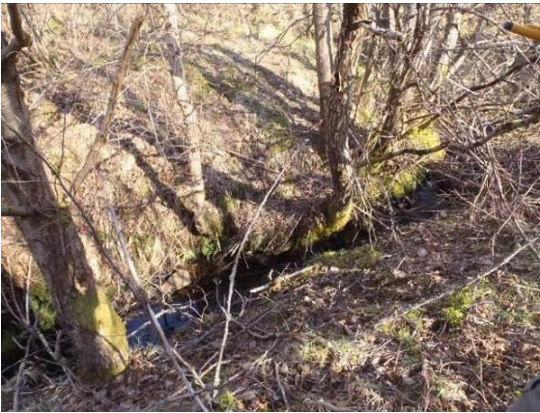
Table 55: WF147

<p>Photograph 56: WF147 – view upstream of the NCR7</p>	Water feature type: Small watercourse
	Catchment area: 0.15km ²
	Key hydraulic connections: Discharges into the upper reach of the River Garry
	Surrounding land use: Typically woodland and moorland
Description of Specific Baseline Conditions	
Sensitivity	
Hydrology and Flood Risk	
This watercourse has a catchment area less than 3km ² and so is not included in the SEPA Flood Map. OS mapping indicates that WF147 flows through woodland and moorland upstream and downstream of the existing A9. The culvert capacity assessment indicates that the existing A9 is not at risk of flooding during the 0.5% AEP (200-year) plus CC flood event with flow predicted to remain in-bank.	Low
Fluvial Geomorphology	
SEPA physical condition status: not classified. The watercourse in the upstream reach had a straightened planform and measured approximately 0.3m wide. The channel in the downstream reach also had a straight planform, with a uniform cross-section measuring approximately 0.6m wide (bankfull). The watercourse had a gravel and cobble bed and bedrock banks. The channel was incising, with signs of channel adjustment. The channel is culverted under the existing A9 and a local access road. The watercourse is first shown on historical mapping in 1975, and the planform of the channel has not change significantly since.	Low

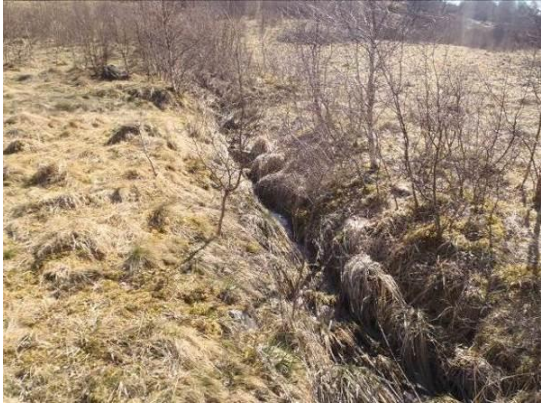
Table 56: WF148

<p>Photograph 57: WF148 – view upstream of the confluence with (WF149) Allt nan Cuinneag</p>	Water feature type: Minor watercourse
	Catchment area: 0.10km ²
	Key hydraulic connections: Discharges into WF149 (Allt nan Cuinneag)
	Surrounding land use: Moorland and rough grazing
Description of Specific Baseline Conditions	Sensitivity
Hydrology and Flood Risk	
<p>This watercourse has a catchment area less than 3km² and so is not included in the SEPA Flood Map. The watercourse flows through woodland and rough grazing upstream and downstream of the existing A9, and joins WF149 downstream of the existing A9. The culvert capacity assessment indicates that the existing A9 is not at risk of flooding during the 0.5% AEP (200-year) plus CC flood event with flow predicted to remain in-bank.</p>	Low
Fluvial Geomorphology	
<p>SEPA physical condition status: not classified.</p> <p>A drainage channel with a sinuous planform upstream of the existing A9. Downstream of the existing A9, the channel was straight and concrete lined, with a trapezoidal cross-section. The watercourse is first shown on historical mapping in 1986, and the planform of the channel has not changed significantly since.</p>	Low

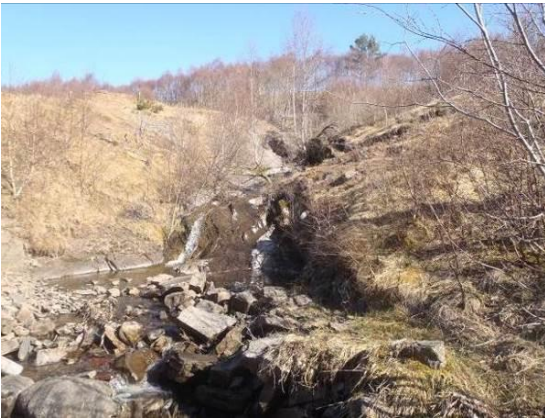
Table 57: WF149 (Allt nan Cuinneag)

<p>Photograph 58: Allt nan Cuinneag – view upstream, towards the existing A9 embankment</p>	Water feature type: Medium watercourse
	Catchment area: 1.47km ²
	Key hydraulic connections: Tributary of the River Garry. WF148 feeds in WF149 upstream of its confluence with the River Garry.
	Surrounding land use: Moorland (upstream) and rough pasture (downstream)
Description of Specific Baseline Conditions	Sensitivity
Hydrology and Flood Risk	
Allt nan Cuinneag (WF149) is not included in the SEPA Flood Map as it has a catchment area of less than 3km ² . OS mapping indicates this watercourse flows through an area of moorland upstream and rough pasture downstream of the existing A9 crossing. However, the watercourse is incised at this location and the A9 is raised above the floodplain, therefore posing no flood risk to this critical infrastructure or residential properties during the design flood event. The watercourse is joined by WF148 just upstream of a local access road before its confluence with the River Garry downstream.	Low

Fluvial Geomorphology	
SEPA physical condition status: not classified. A watercourse with stable meanders and a bedrock step-pool sequence with some gravels and cobbles present. The channel had some vegetated riparian zone present consisting of trees and bushes. The upstream reach was within a steep sided valley. Immediately downstream of the existing A9 there was a large concrete spillway structure. With the exception of some minor lateral adjustment and meander migration in the upstream section, the planform of the watercourse has not changes significantly since first records in 1867. For a more detailed description of the watercourse, refer to Appendix A11.5 (Fluvial Geomorphology).	Medium
Water Quality	
SEPA water quality status: not classified. Potential pollutant sources: <ul style="list-style-type: none"> • diffuse rural sources including biological pollutants from grazing livestock; • diffuse run-off of contaminants associated with A9 traffic (PGG-C2 Existing A9 –crosses watercourse); and • PGG-C6 Disused Quarry with potential for contaminants associated with infill material – located within 30m of watercourse. 	Medium

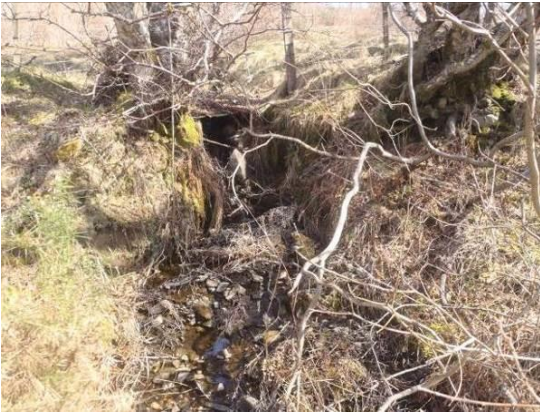
Table 58: WF150

<p>Photograph 59: WF150 – view upstream, towards the existing A9 culvert</p>	Water feature type: Minor watercourse and drainage channels
	Catchment area: 0.31km ²
	Key hydraulic connections: Discharges into WF149 (Allt nan Cuiineag)
	Surrounding land use: Rough grazing and woodland.
Description of Specific Baseline Conditions	Sensitivity
Hydrology and Flood Risk	
This watercourse is not included in the SEPA Flood Map as it has a catchment area of less than 3km ² . This watercourse is connected to pre-earthwork drains running adjacent to the existing A9. Although there are no residential properties or industrial premises within this vicinity, the culvert capacity assessment indicates that the existing A9 could be at risk of flooding during the 0.5% AEP (200-year) plus CC design flood event, due to an undersized culvert.	High
Fluvial Geomorphology	
SEPA physical condition status: not classified. WF150 consists of a series of drainage channels which have straightened planforms, are lined with concrete and have uniform trapezoidal cross-sections. The channel is culverted under the existing A9. The watercourse is not present on historical mapping.	Low

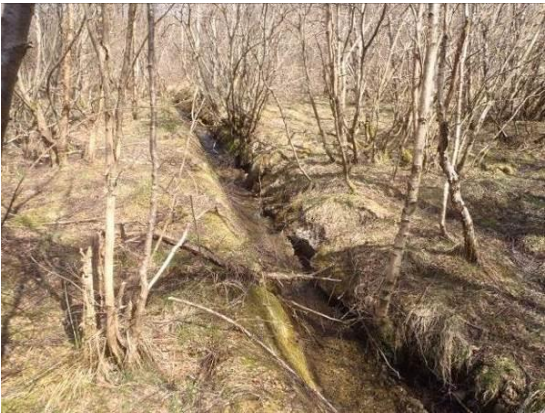
Table 59: WF151

<p>Photograph 60: WF151 – view of artificial concrete channel, downstream of the existing A9</p>	Water feature type: Small watercourse
	Catchment area: 0.28km ²
	Key hydraulic connections: Discharges into the upper reach of the River Garry.
	Surrounding land use: Moorland, rough grazing, woodland.
Description of Specific Baseline Conditions	
Sensitivity	
Hydrology and Flood Risk	
This watercourse has a catchment area of less than 3km ² and so is not included in the SEPA Flood Map. The watercourse flows through an area of moorland and rough pasture upstream and woodland downstream of the existing A9 crossing with no residential properties. The culvert capacity assessment indicates that the existing A9 is not at risk of flooding during the 0.5% AEP (200-year) plus CC flood event with flow predicted to remain in-bank.	Low
Fluvial Geomorphology	
SEPA physical condition status: not classified. A small watercourse with a sinuous planform and a cobble/gravel bed in the upstream reach. The watercourse then passes under the A9 in a concrete channel which continues approximately 40m downstream where a knickpoint (a sharp change in channel slope) has developed. The watercourse has eroded the concrete chute into a natural cobble/gravel bedded channel which meanders to the confluence with the River Garry. The watercourse is first shown on historical mapping in 1975, and the planform of the channel has not changed significantly since. For a more detailed description of the watercourse, refer to Appendix A11.5 (Fluvial Geomorphology).	Medium

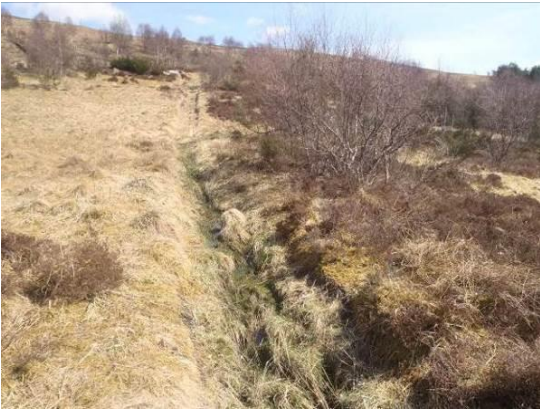
Table 60: WF152

<p>Photograph 61: WF152 – view upstream, towards the existing A9</p>	Water feature type: Drainage channel
	Catchment area: 0.04km ²
	Key hydraulic connections: Discharges into the upper reach of the River Garry
	Surrounding land use: Moorland, rough grazing and woodland
Description of Specific Baseline Conditions	Sensitivity
Hydrology and Flood Risk	
This drainage channel has a catchment area less than 3km ² so is not included in the SEPA Flood Map. The drainage channel flows through woodland upstream of the existing A9 culvert and is then culverted under the existing A9 before flowing under a local access road before its confluence with the River Garry. According to the culvert capacity assessment, the existing A9 is not at risk from flooding during the 0.5% AEP (200-year) plus CC event.	Low
Fluvial Geomorphology	
SEPA physical condition status: not classified. WF152 consists of a series of drainage channels which have straightened planforms, are lined with concrete and have uniform trapezoidal cross-sections. The watercourse is culverted under the existing A9. The watercourse is not present on historical mapping.	Low

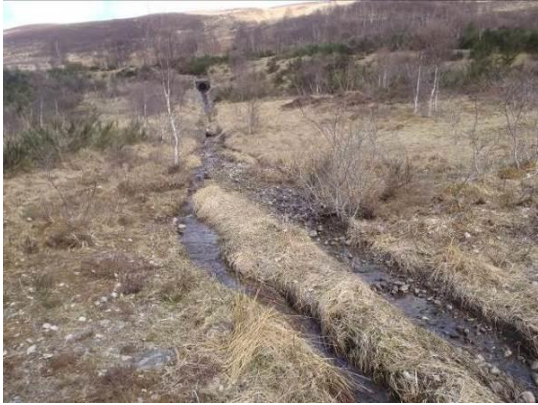
Table 61: WF153

Water feature type: Small watercourse
	Catchment area: 0.20km ²
	Key hydraulic connections: Discharges into the upper reach of the River Garry
	Surrounding land use: Moorland, rough grazing and woodland
Description of Specific Baseline Conditions	
Hydrology and Flood Risk	
This watercourse has a catchment area less than 3km ² so is not included in the SEPA Flood Map. The watercourse flows through woodland upstream of the existing A9 culvert and is then culverted under the existing A9 towards the River Garry with no residential properties near this location. According to the culvert capacity assessment, the existing A9 is not at risk from flooding during the 0.5% AEP (200-year) plus CC event.	Low
Fluvial Geomorphology	
SEPA physical condition status: not classified. Upstream of the A9, WF153 is narrow and incising, with cobble and gravel substrate. Downstream of the existing A9 the channel was straightened and concrete lined, with some sections exhibiting natural recovery with concrete being undermined to expose a natural bed. The channel is culverted under the existing A9. The watercourse is first shown on historical mapping in 1974, and the planform of the channel has not changed significantly since.	Low

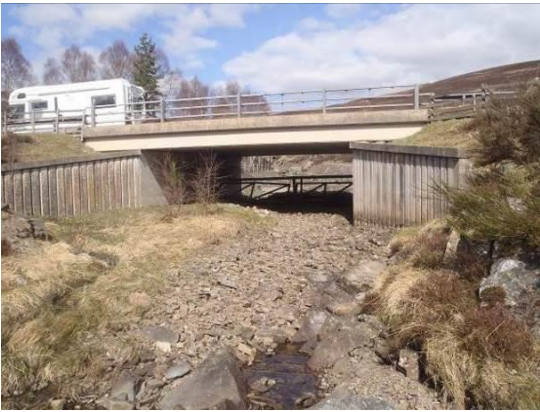
Table 62: WF88/167 (Allt Crom Bhruthaich)

<p>Photograph 63: Allt Crom Bhruthaich – view upstream, towards the existing A9 overbridge (note: dry flow conditions)</p>	Water feature type: Medium watercourse
	Catchment area: 3.33km ²
	Key hydraulic connections: Tributary of the River Garry
	Surrounding land use: Moorland and rough grazing
Description of Specific Baseline Conditions	Sensitivity
Hydrology and Flood Risk	
The Allt Crom Bhruthaich (WF88/167) is a tributary to the River Garry. Although the SEPA Flood Map identifies a 0.5% AEP (200-year) floodplain, it is narrow due to the steep gradient of the watercourse and local topography. The risk of flooding to the existing A9 is therefore low as it is located approximately 4m above bed level. However, the watercourse also flows under a local access road, which is shown to be located partly within the SEPA Flood Map extent outline before its confluence with the River Garry, and may therefore be at potential risk of minor localised flooding during the design flood event.	Medium

Fluvial Geomorphology	
SEPA physical condition status: not classified. A large watercourse with a sinuous planform and numerous waterfalls. The upstream reach appeared to be severely impacted by abstraction, preventing the watercourse reaching High sensitivity. No water was present in the channel at the time of the survey, and it is likely to only be wet during extremely high flows. The channel had a boulder and cobble substrate and a steep gradient. Analysis of historical mapping shows that WF88/167 has undergone some lateral adjustment and meander migration through erosion and deposition since 1867, particularly in the upstream reach. For a more detailed description of the watercourse, refer to Appendix A11.5 (Fluvial Geomorphology).	Medium
Water Quality	
SEPA water quality status: not classified. Existing pressures: likely to be impacted by abstraction. Potential pollutant sources: <ul style="list-style-type: none"> • diffuse rural sources including biological pollutants from grazing livestock; and • diffuse run-off of contaminants associated with A9 traffic (PGG-C2 Existing A9 –crosses watercourse). 	Low

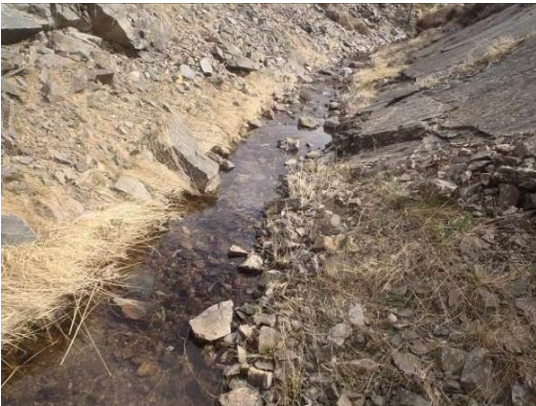
Table 63: WF154

<p>Photograph 64: WF154 – view upstream, towards the existing A9 culvert</p>	Water feature type: Small watercourse
	Catchment area: 0.43km ²
	Key hydraulic connections: Discharges into the upper reach of the River Garry
	Surrounding land use: Woodland and moorland
Description of Specific Baseline Conditions	Sensitivity
Hydrology and Flood Risk	
This watercourse has a catchment area less than 3km ² and so is not included in the SEPA Flood Map. The watercourse flows through moorland and woodland either side of the existing A9 with no residential properties near this location. According to the culvert capacity assessment, the existing A9 is not at risk from flooding during the 0.5% AEP (200-year) plus CC event.	Low
Fluvial Geomorphology	
SEPA physical condition status: not classified. A small watercourse with a sinuous planform and cobble and gravel substrate. Upstream of the existing A9, the channel was approximately 1m wide at bankfull, with a step/pool sequence. Downstream of the existing A9, bedrock was visible within the channel, and it had a straighter planform. There were some boulders within the channel, which could potentially be as a result of past modifications. Analysis of historical mapping shows that WF154 has laterally adjusted in the past including meander migration through erosion and deposition. For a more detailed description of the watercourse, refer to Appendix A11.5 (Fluvial Geomorphology).	Medium

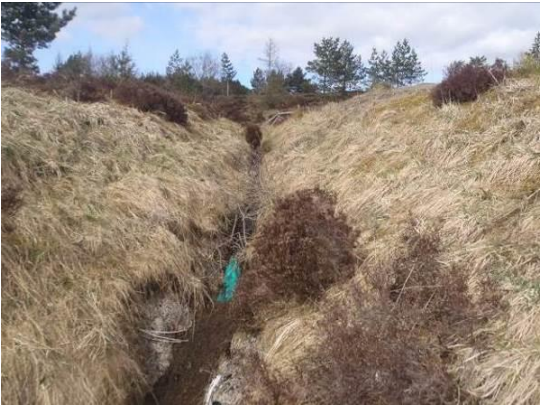
Table 64: WF155

<p>Photograph 65: WF155 – view upstream, towards the existing A9 culvert</p>	Water feature type: Drainage channel
	Catchment area: 0.13km ²
	Key hydraulic connections: Discharges into the upper reach of the River Garry
	Surrounding land use: Uplands, forestry
Description of Specific Baseline Conditions	Sensitivity
Hydrology and Flood Risk	
This watercourse has a catchment area less than 3km ² and so is not included in the SEPA Flood Map. According to the culvert capacity assessment however, the existing A9 is not at risk from flooding during the 0.5% AEP (200-year) plus CC event.	Low
Fluvial Geomorphology	
SEPA physical condition status: not classified. A small watercourse with a straight planform and trapezoidal concrete cross-section. The watercourse had sections where the concrete had been undermined and exposed natural gravel bed substrate. A knickpoint also appears to be migrating upstream within the length south of the existing A9. The channel had a limited vegetated riparian corridor. The channel is culverted under the existing A9 and a local access track. Analysis of historical mapping shows that some minor changes to the planform were made to the south of the access track between 1974 and 1975.	Low
